Re: Response to Texas Commission on Environmental Quality (TCEQ) Comments on
Post-Response Action Care Report, dated September 29, 2017
Union Pacific Railroad Houston Wood Preserving Works Facility
4910 Liberty Road Facility, Houston, Texas
Post-Closure Care Permit No. HW-50343; Industrial SWR No. 31547
CN600131098; RN100674613

Response to TCEQ Comments on the PRACR dated September 29, 2017
UPRR Houston Wood Preserving Works
4910 Liberty Road, Houston, Texas

POST-HARVEY SOIL CAP INSPECTION RECORD, PHOTOLOG, AND FIGURE

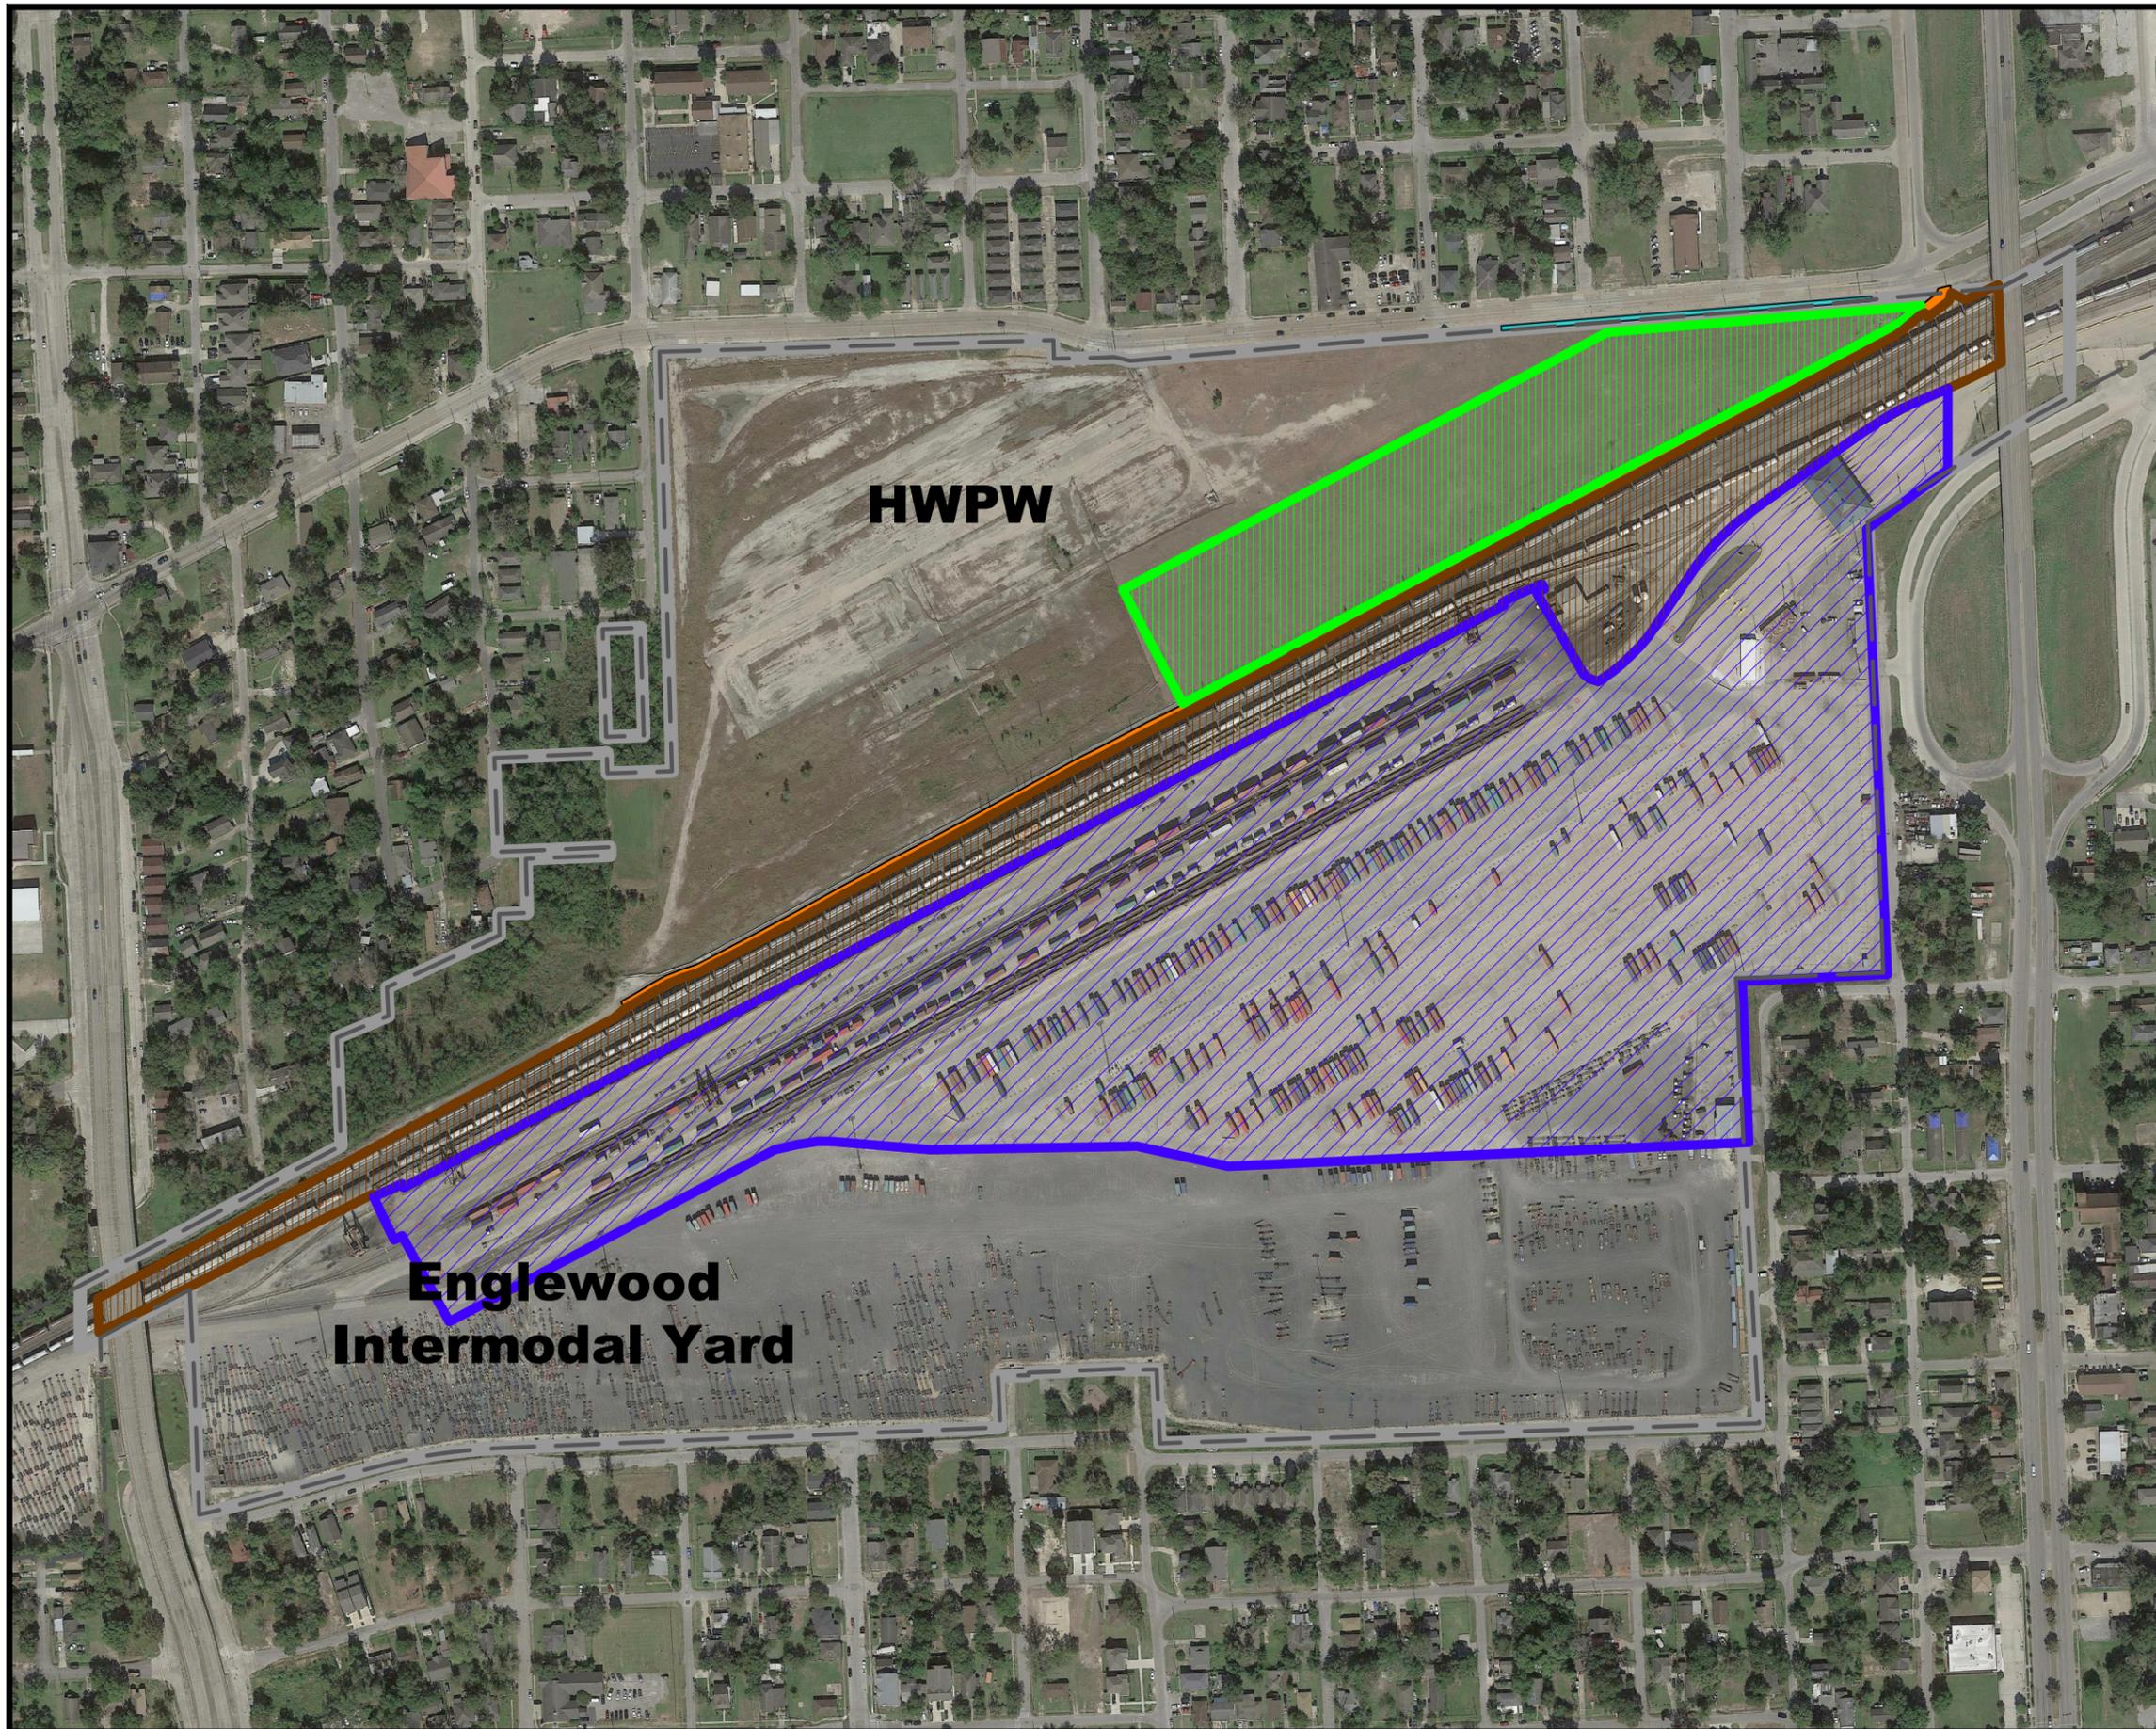
In addition to the minor repairs noted above, UPRR is evaluating responses to address the tar-like seeps noted in the Englewood Intermodal Yard. During the routine quarterly inspection on July 17, 2017, a tar-like substance was observed surfacing through the joints and cracks in the concrete and asphalt surfaces in the area shown in the attached Figure 1.

Currently, the plan is to remove areas of the concrete pavement where the seeps have been identified, excavate impacted soils underneath the area, and repair and replace the subgrade and pavement in the area. UPRR plans to implement the response over the next two months. Following the repairs to the pavement, UPRR will submit to the TCEQ documentation on the repairs.

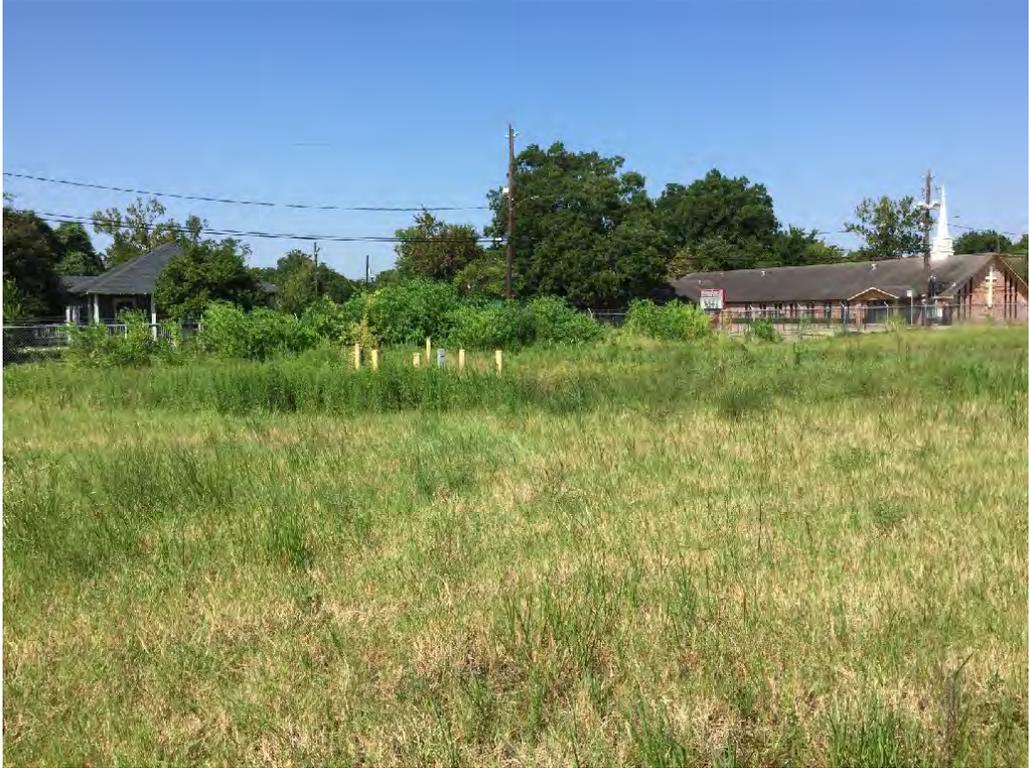
Description: Soil Cap Area: Healthy vegetation cover on soil cap looking north-northwest. Some overgrown vegetation along northern fence.			
Lat: 29.78720556 Long: -95.31913889			
Photo No. 4	Date: 8/31/17

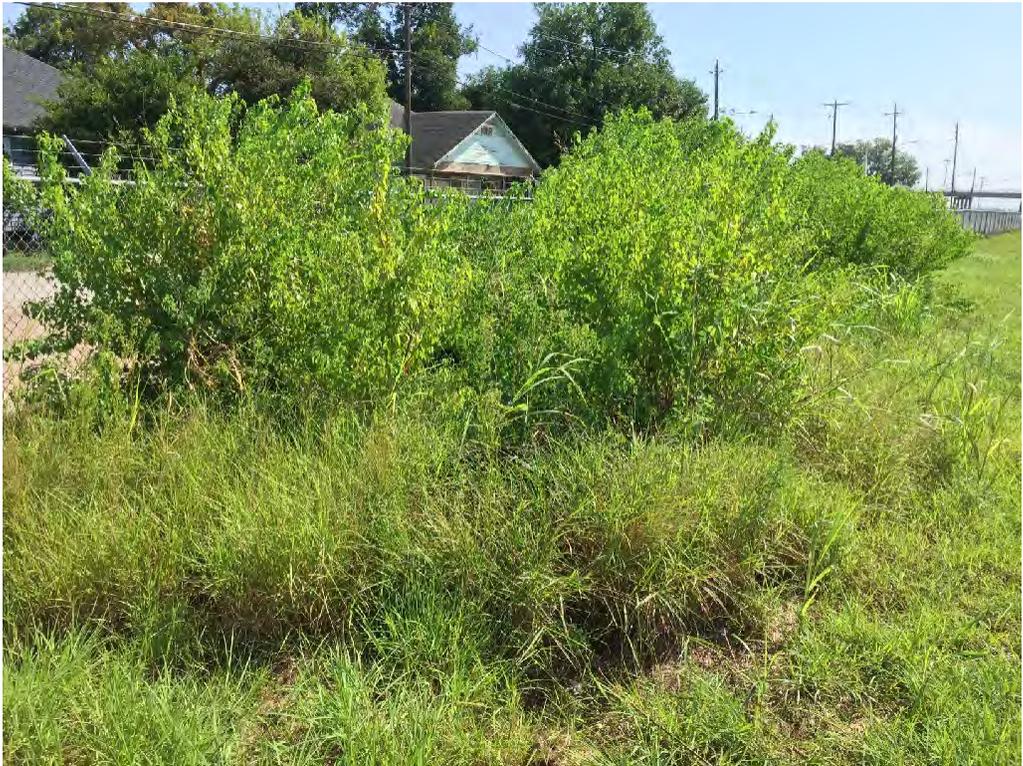
Description: Soil Cap Area: Overgrown vegetation along 80 linear feet of the northern fence line approximately 100 feet from the main HWPW entrance.			
Lat: 29.78748056 Long: -95.31935

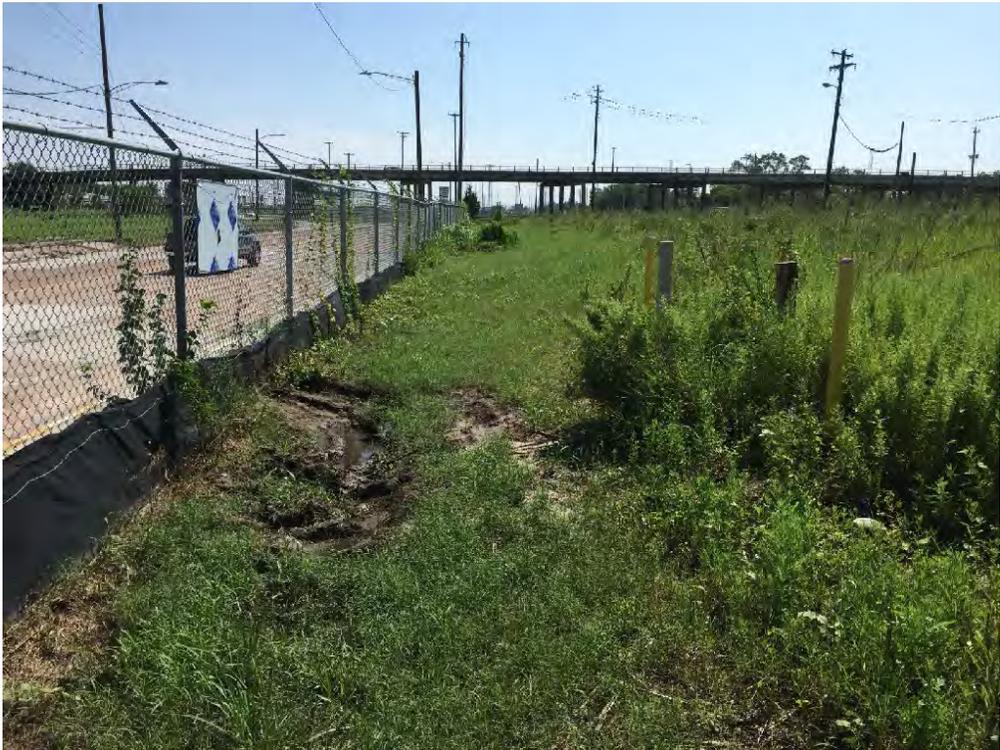
Description: Soil Cap Area: Rut along northern fence line (outside of capped area) caused by a mower. Facing east toward Lockwood bridge. Lat: 29.78756944 Long: -95.31758056

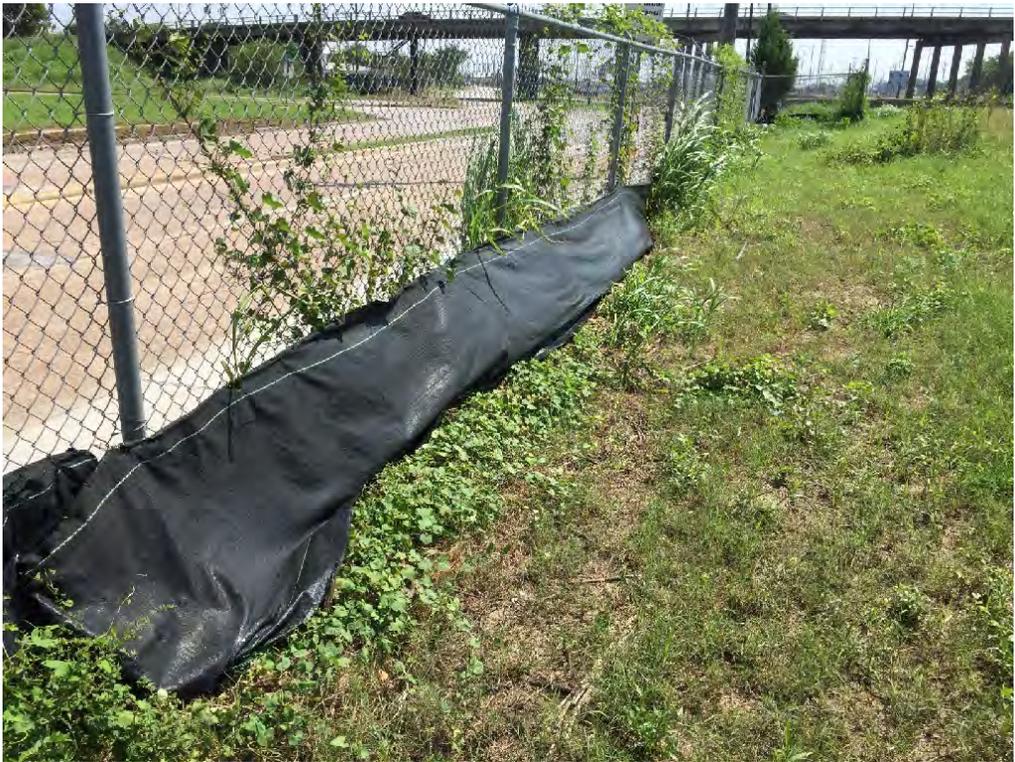
Description: Soil Cap Area: Loose silt fence on northern fence along Liberty Road. Lat: 29.78758056 Long: -95.31716111

- b. Silt fencing that is no longer needed for stormwater or sediment control will be removed from the Site.
- c. UPRR is in the process of conducting minor repairs to the capped area where the ruts/rills have been observed. Once the minor repairs are completed, documentation on the repairs will be submitted to the TCEQ in a follow-up submittal.

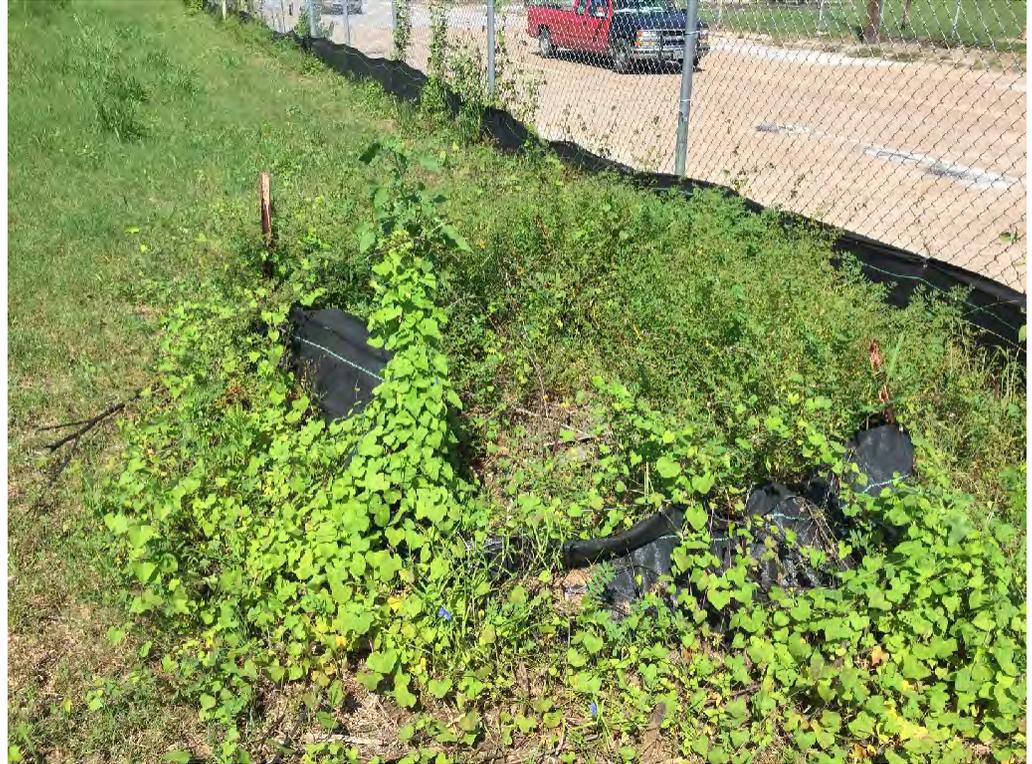
Photo No. <b style="font-size: 1.2em;">9	Date: 8/31/17
Description: Soil Cap Area: Silt fence around storm water drain, Liberty Road in the background Lat: 29.78757222 Long: -95.31780278

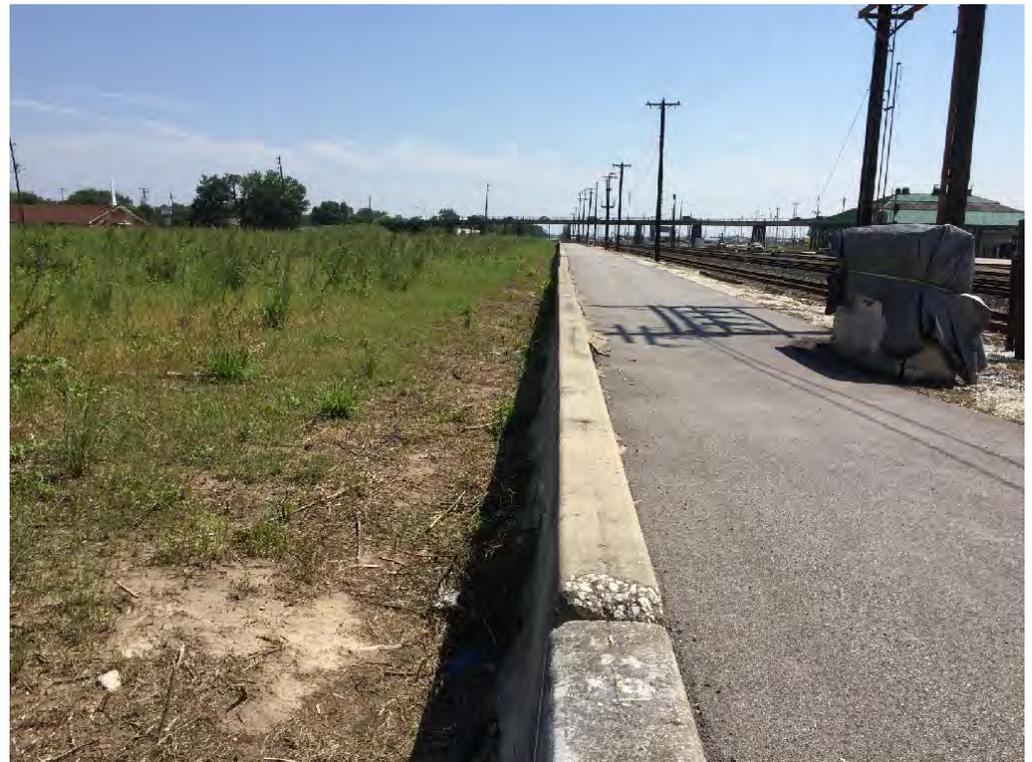
Photo No. <b style="font-size: 1.2em;">10	Date: 8/31/17
Description: Asphalt Cap/Soil Cap Areas: Grass cut too short along southern concrete barrier causing the vegetation to die. Facing east toward Lockwood Bridge. Lat: 29.78653611 Long: -95.318925

- d. Similar to the previous comment, UPRR is in the process of conducting minor repairs for the bare patches and minor erosion noted around the soil cap area. Re-establishment of vegetation may take a few months given the dormancy of the vegetation during the winter time until later in the spring. Once the minor repairs are completed, documentation on the repairs will be submitted to the TCEQ in a follow-up submittal.

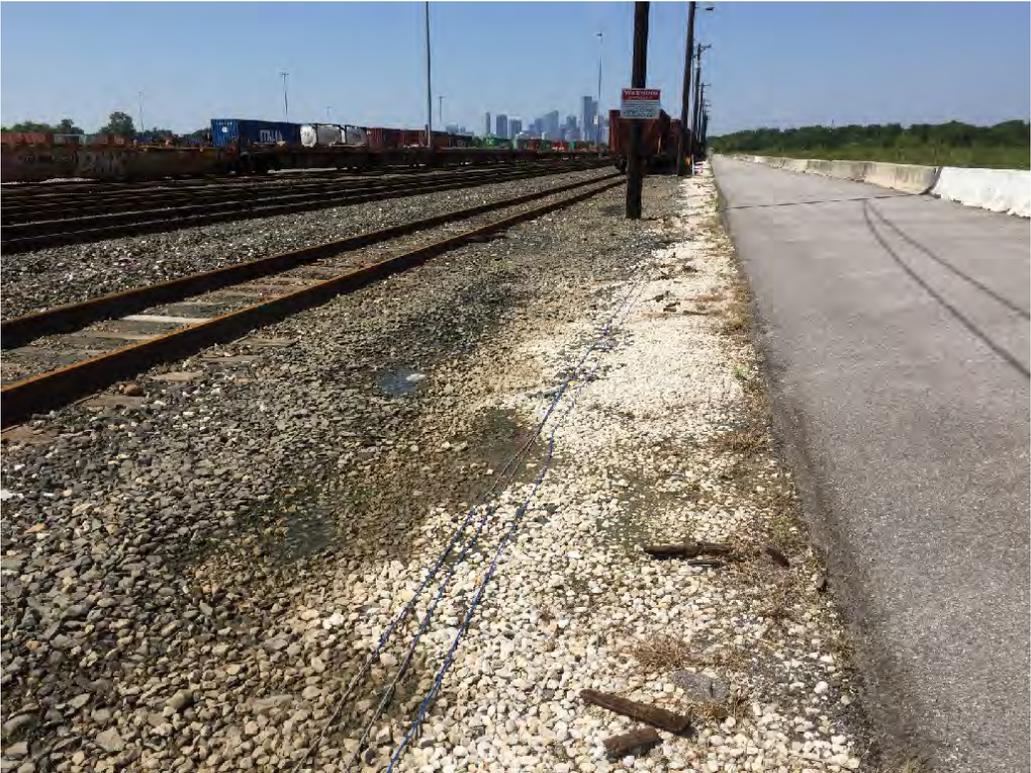
Description: Ballast Cap Area: Minor amounts of debris and water in ballast cap, facing west. Lat: 29.78648333 Long: -95.31883889

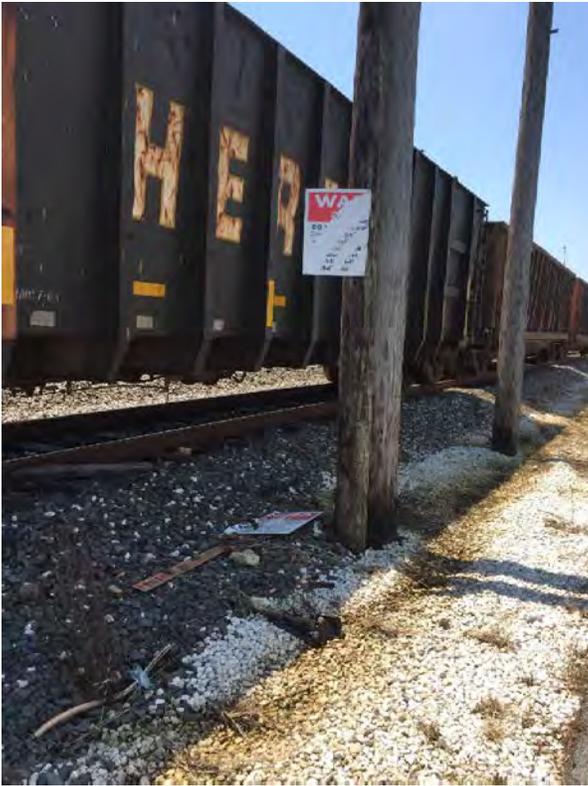
Description: Ballast Cap Area: Damaged sign along southwestern area of asphalt road. Lat: 29.78525833 Long: -95.32198333		
Photo No. 14	Date: 8/31/17

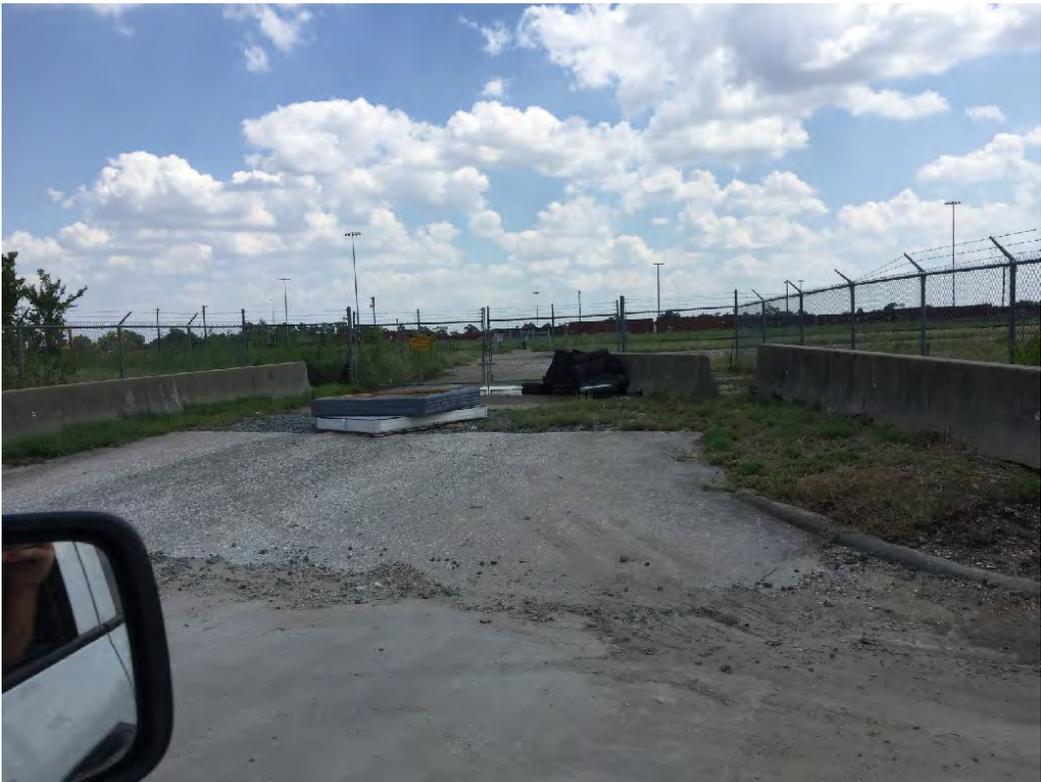
Description: Perimeter Fence Area: Furniture dumped on HWPW driveway. Lat: 29.78754167 Long: -95.321075

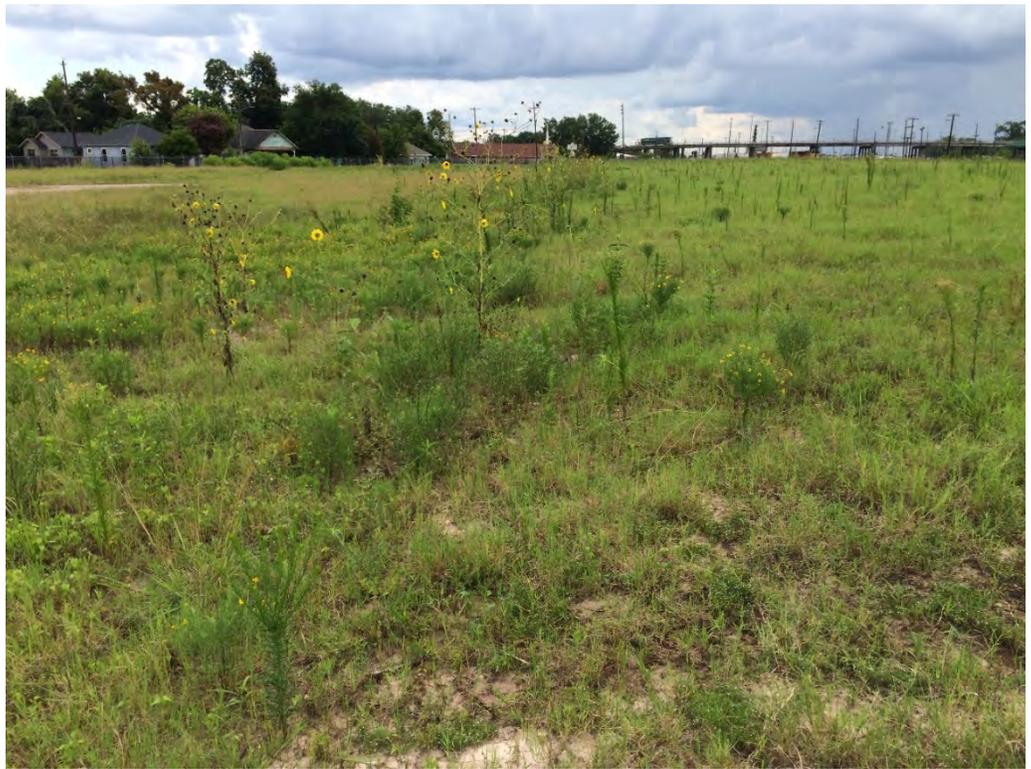
Photo No. 3	Date: 7/17/17
Description: Soil Cap Area: Soil Cap-Intrusive Plants-Tall sunflower seeds along north slope Lat: 29.78673056 Long: -95.32012222

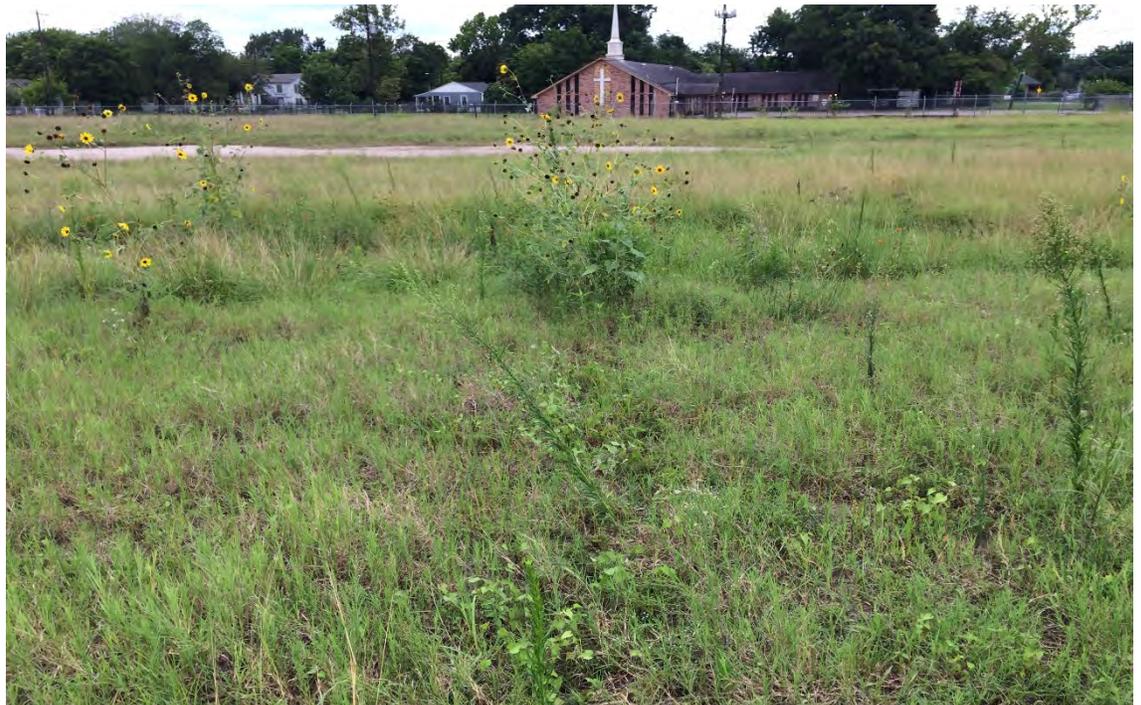
Photo No. 4	Date: 7/17/17
Description: Soil Cap Area: Soil Cap-Intrusive Plants-Tall vegetation along north slope Lat: 29.78687778 Long: -95.319625

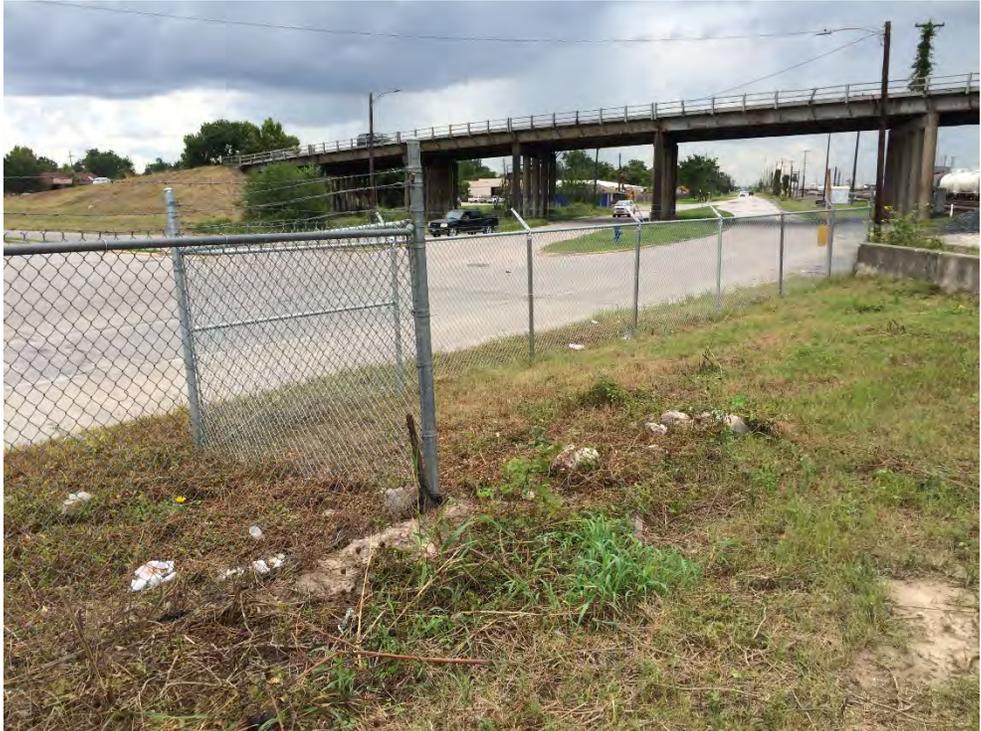
Description: Perimeter Fence: Security fence-Repaired northeast corner Lat: 29.78759722 Long: -95.31665

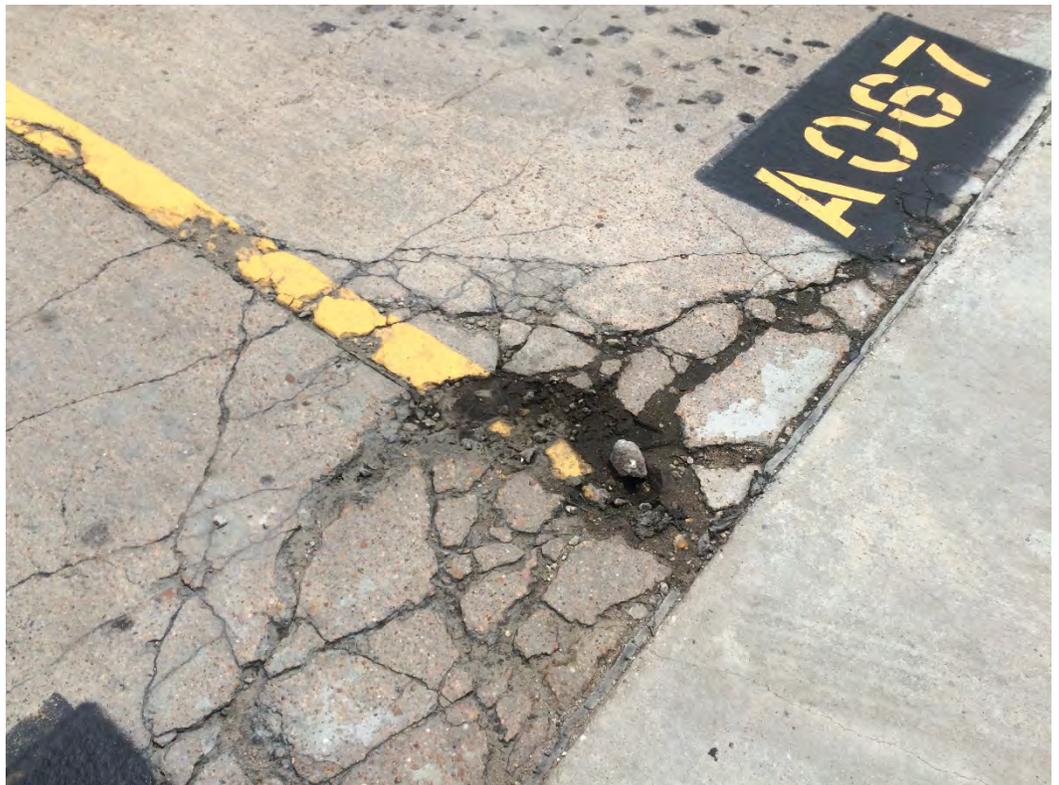
Photo No.
28

Englewood Intermodal
Yard Concrete Cap
Area – cracked
concrete, no soil
exposed.

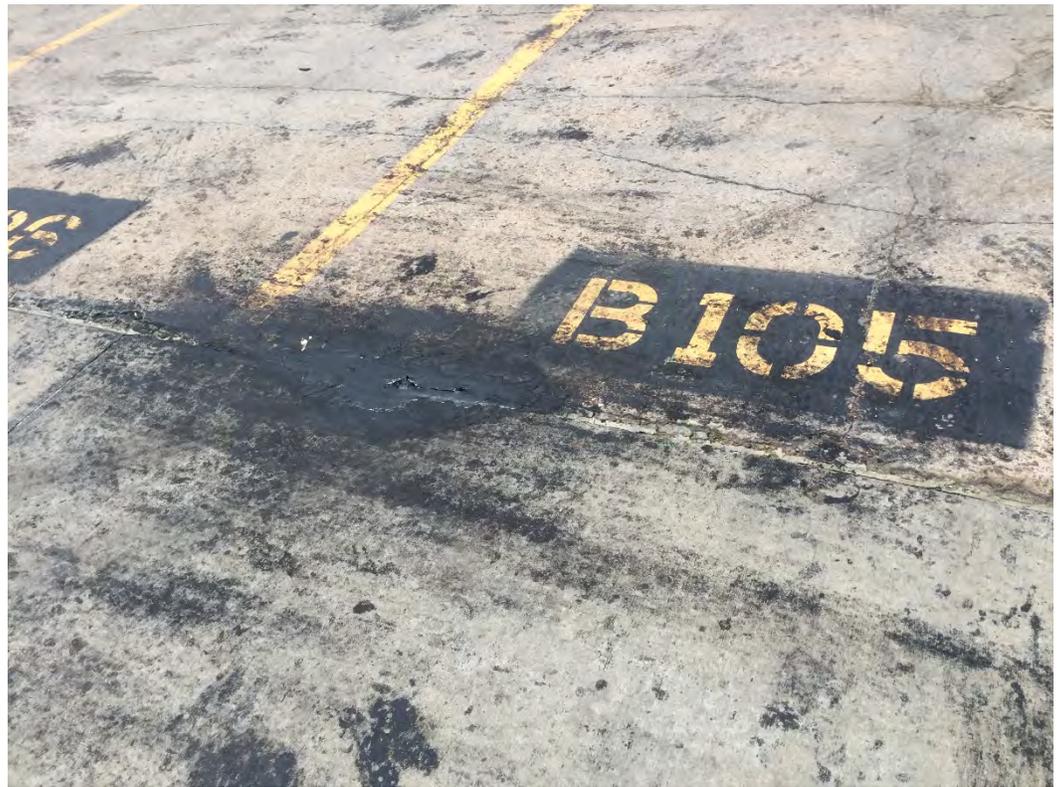
Englewood Intermodal
Yard Concrete Cap
Area – cracked
concrete, no soil
exposed.

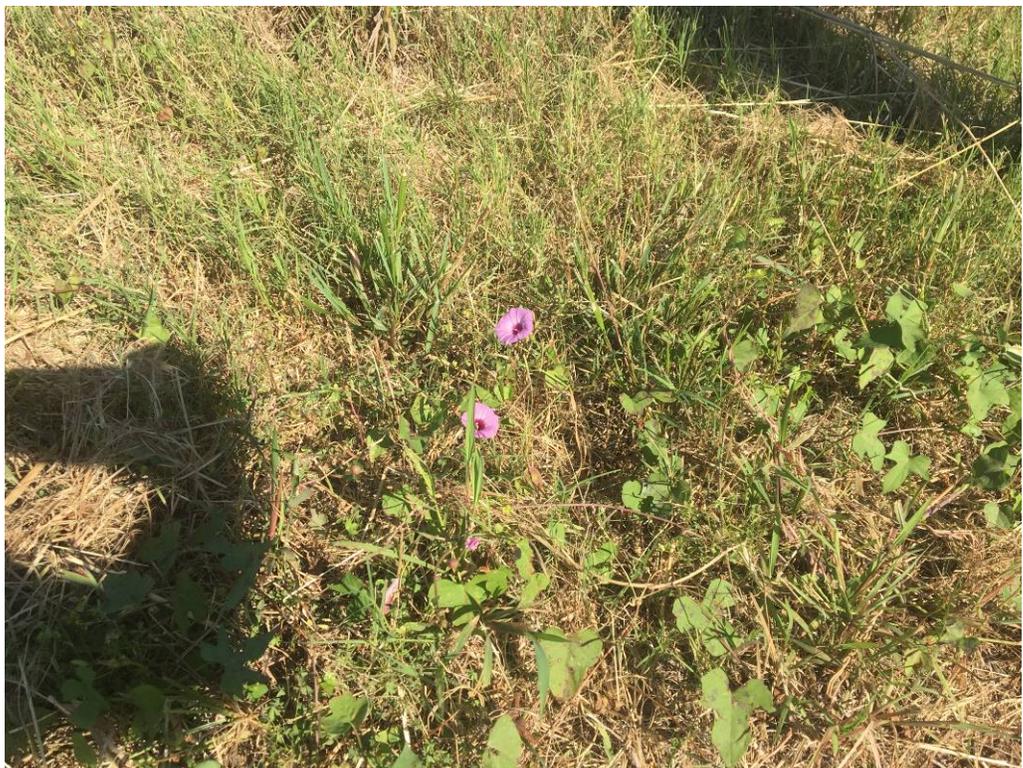
Photo No. 14	Date: 10/18/17
Description: Soil Cap Area: View of pollinator plants along the southern portion of the soil cap area. Lat: 29.78581944, Long: -95.320625

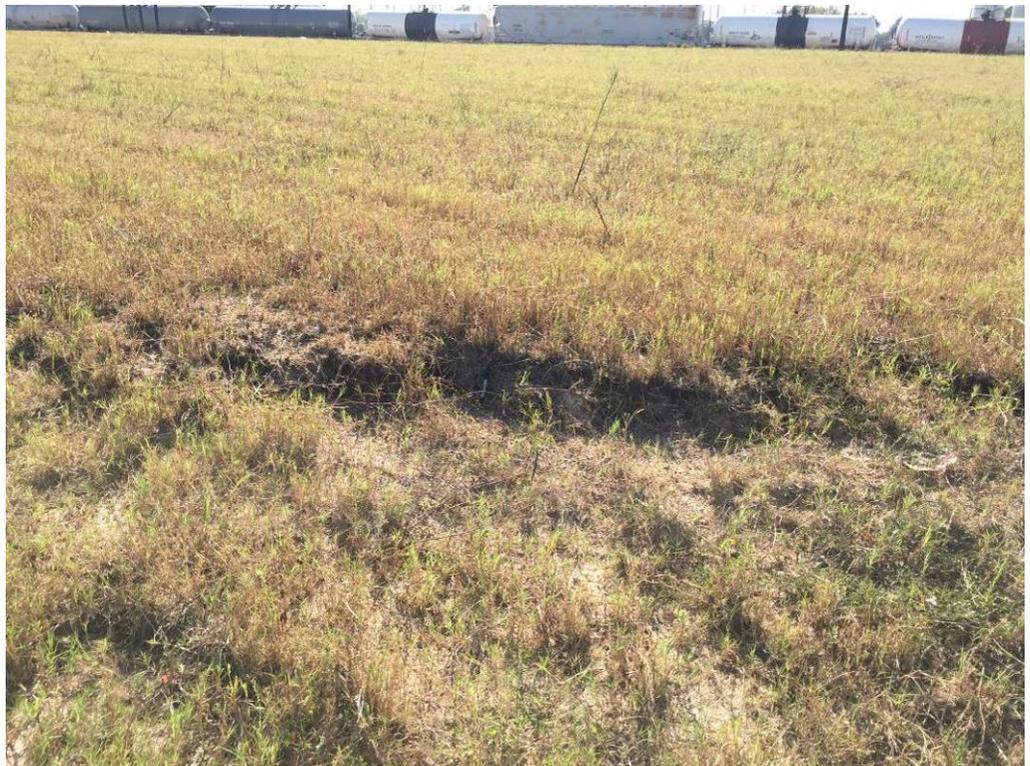
Photo No.
16

- Soil Cap – The soil cap had been mowed in early October 2017. The soil cap area did not appear to have any significant erosion, sloughing, or subsidence noted. Some minor erosion rills (Photo No. 16 (Lat: 29.78736667, Long: -95.31867222)) and a few bare spots (Photo No. 12 (Lat: 29.78735278, Long: -95.31870278) and Photo No. 13 (Lat: 29.787575, Long: -95.31664167)) were observed along the slopes of the soil cap, but the cap appeared to be functioning as designed.

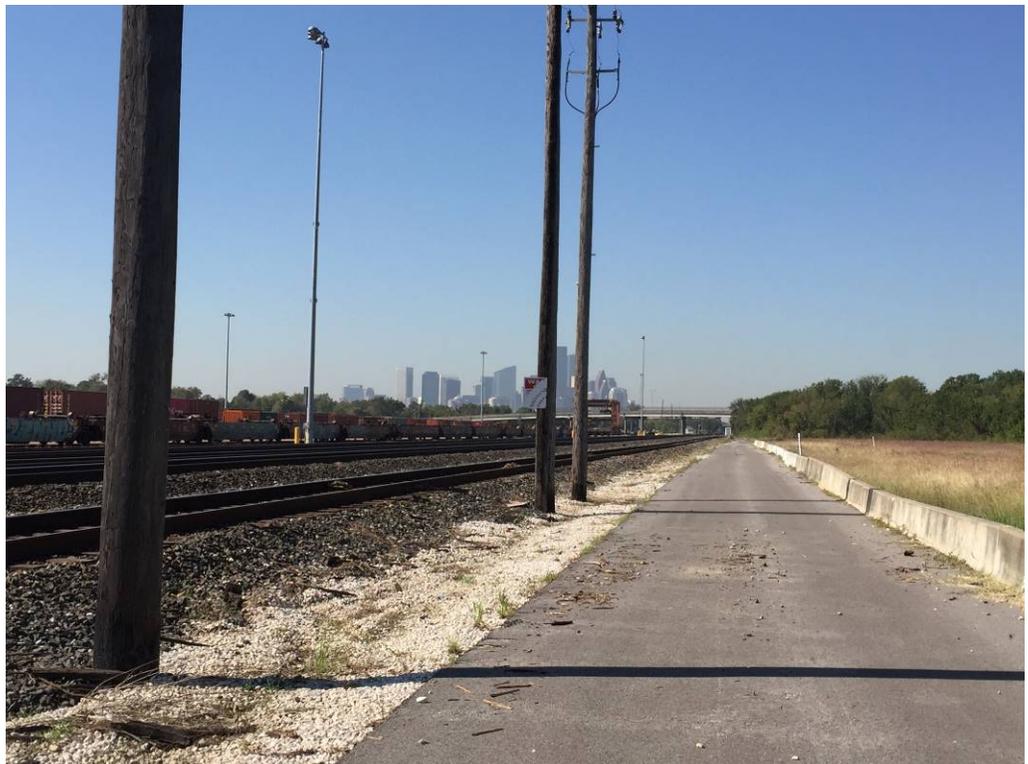
Photo No.
30

View of ballast cap and
asphalt road areas,
damaged warning sign
along asphalt road

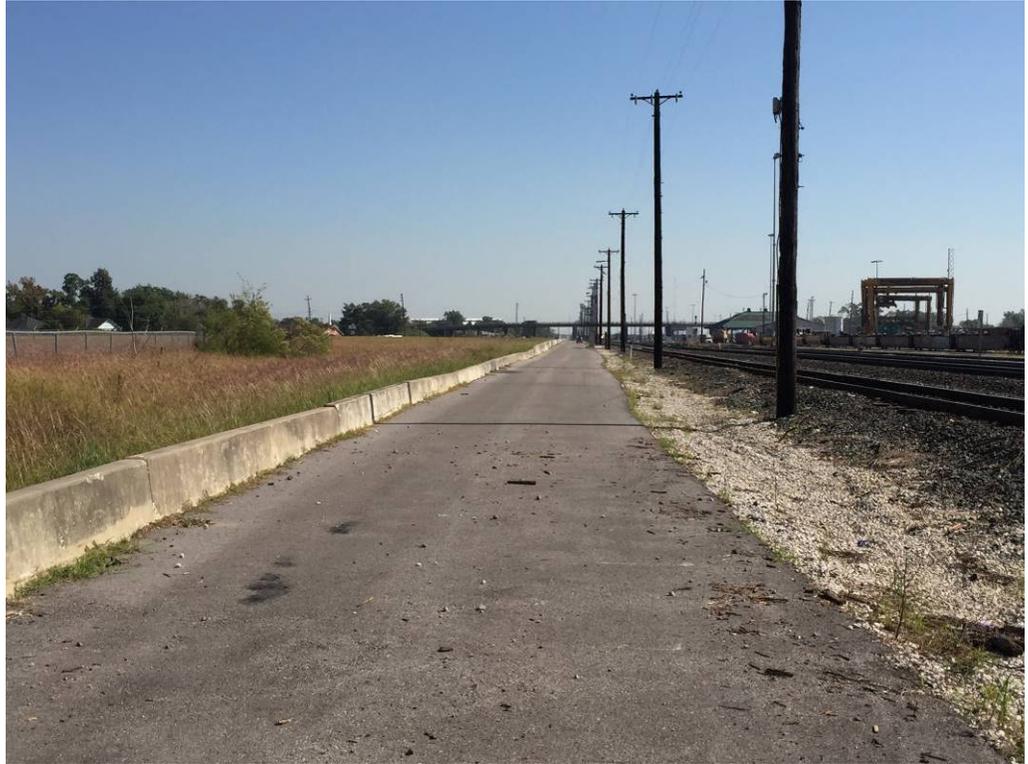
- Concrete Sidewalk Cap - Sidewalk cap area appeared to be in good condition and functioning as intended.
- Asphalt Road Cap – Asphalt road cap appeared to be in good condition. A small oil stain noted on the asphalt (Photo Nos. 31 (Lat: 29.78536389, Long: -95.32168611) and 32 (Lat: 29.78533056, Long: -95.32170833)). UPRR will monitor the oil stain areas.

View of asphalt cap
area and ballast cap
area, looking northeast.
Note small oily stains
on pavement.

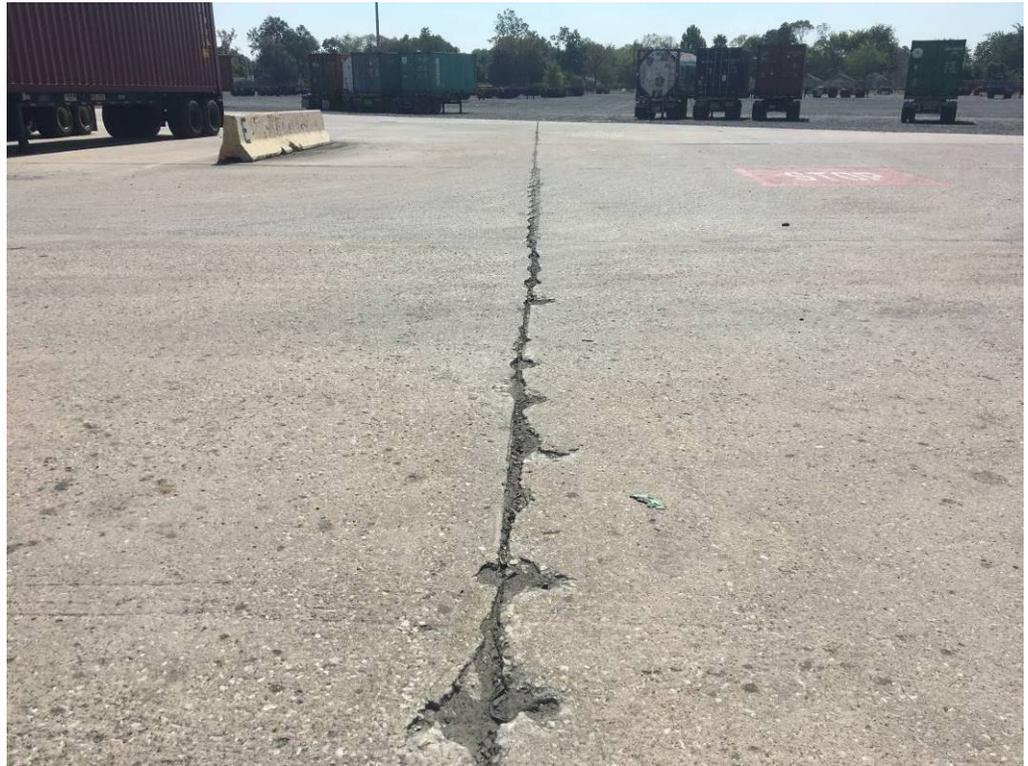
Concrete Cap Area:
Joint damage but no
soil exposed.
