October 17, 2022

Project No. 19119232

**Re: MONTHLY STATUS UPDATE – ENGLEWOOD INTERMODAL YARD – NAPL COLLECTION
SYSTEM/CONCRETE CAP REPAIRS
UNION PACIFIC RAILROAD HOUSTON WOOD PRESERVING WORKS FACILITY
4910 LIBERTY ROAD FACILITY, HOUSTON, TEXAS
POST-CLOSURE CARE PERMIT NO. HW-50343; INDUSTRIAL SWR NO. 31547**

Weekly Inspection Photolog

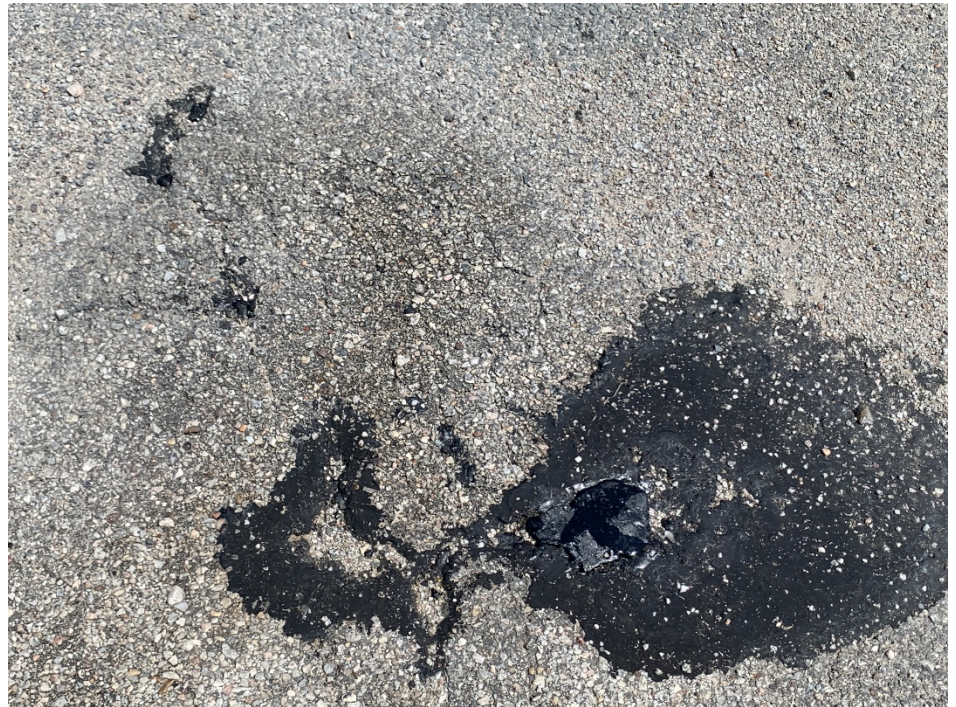
Photo No.
1

Stall A011, a small amount of tar-like material at a crack in the asphalt pavement, material was removed.

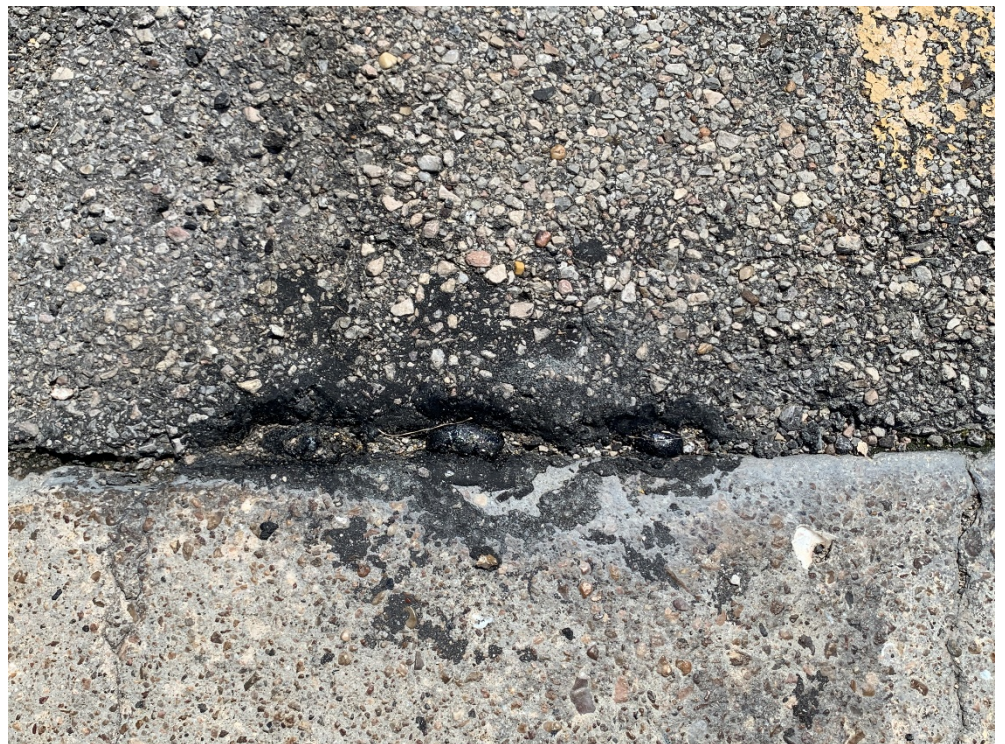
Photo No.
2

Stall A022, a small amount of tar-like material at a crack in the asphalt pavement, material was removed.

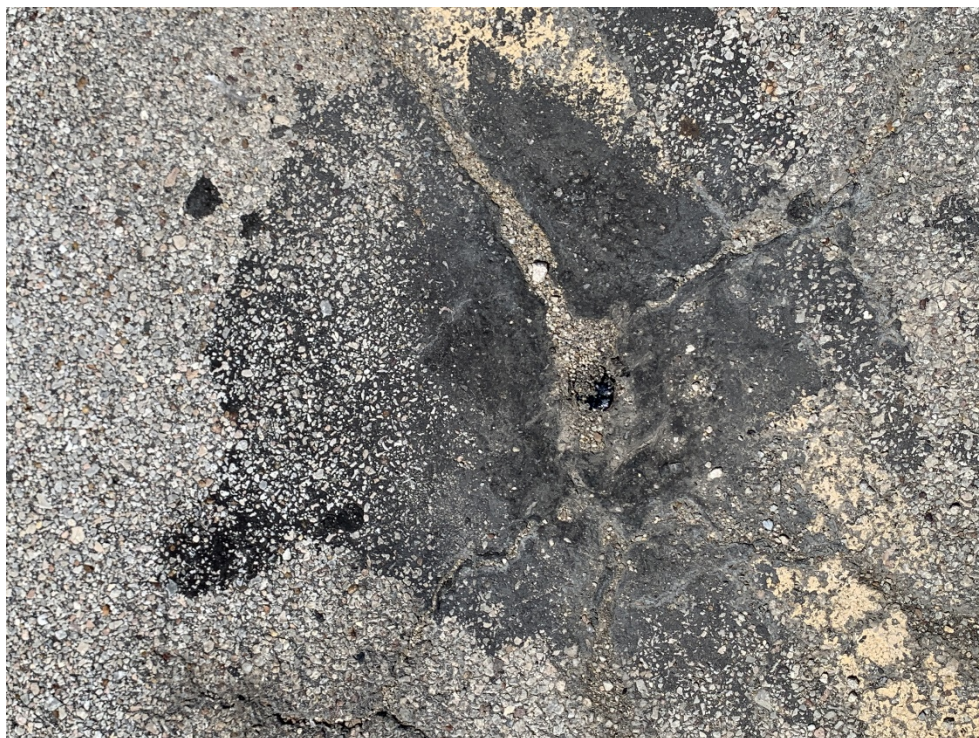
Photo No.
3

Stall B101, very small amount of tar-like material at a crack in the asphalt pavement, material was removed.

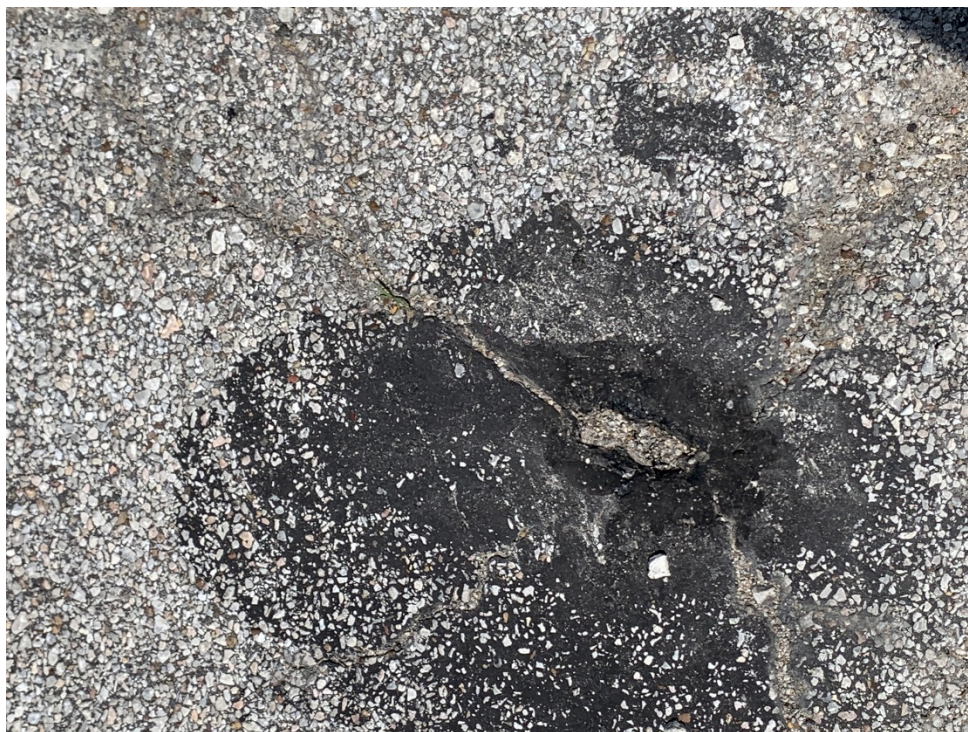
Photo No.
4

Stall B105, a small amount of tar-like material in pavement area, material was removed.

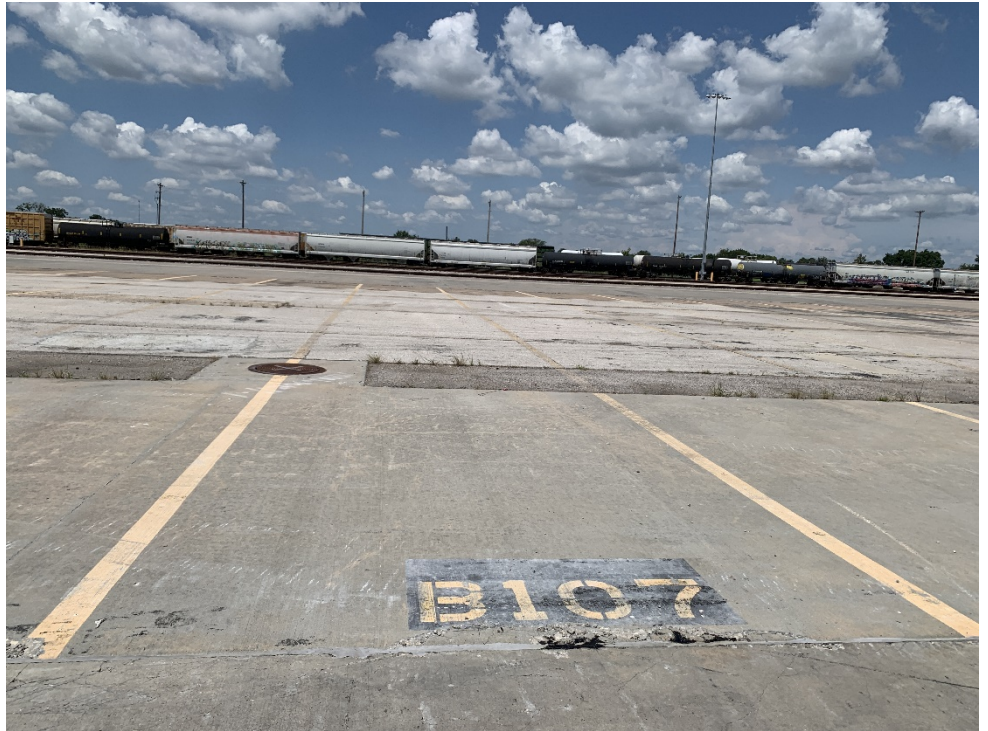
Photo No.
5

- A small tar-like material seep was observed on the southern edge of the NAPL Collection System in cracks in the cement along the joint of Stall B107 during all four inspections in September (Photo Nos. 5 and 21). This seep was first observed during the July 6, 2022 weekly inspection.

Stall B107, view of NAPL Collection System (Sump B107/B108), a small amount of tar-like material at concrete joint along the southern edge of the excavated area. Material was removed. Looking north.

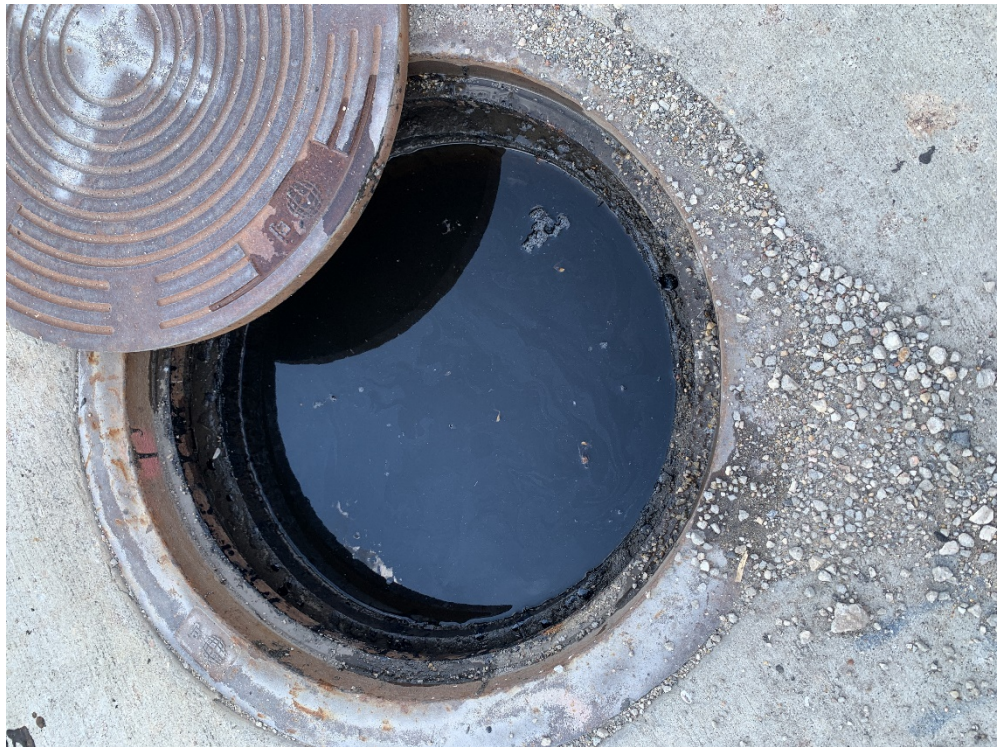
Photo No.
6

Sump 1 (B099/B100), 3 inches of freeboard in sump, no odor or sheen noted.

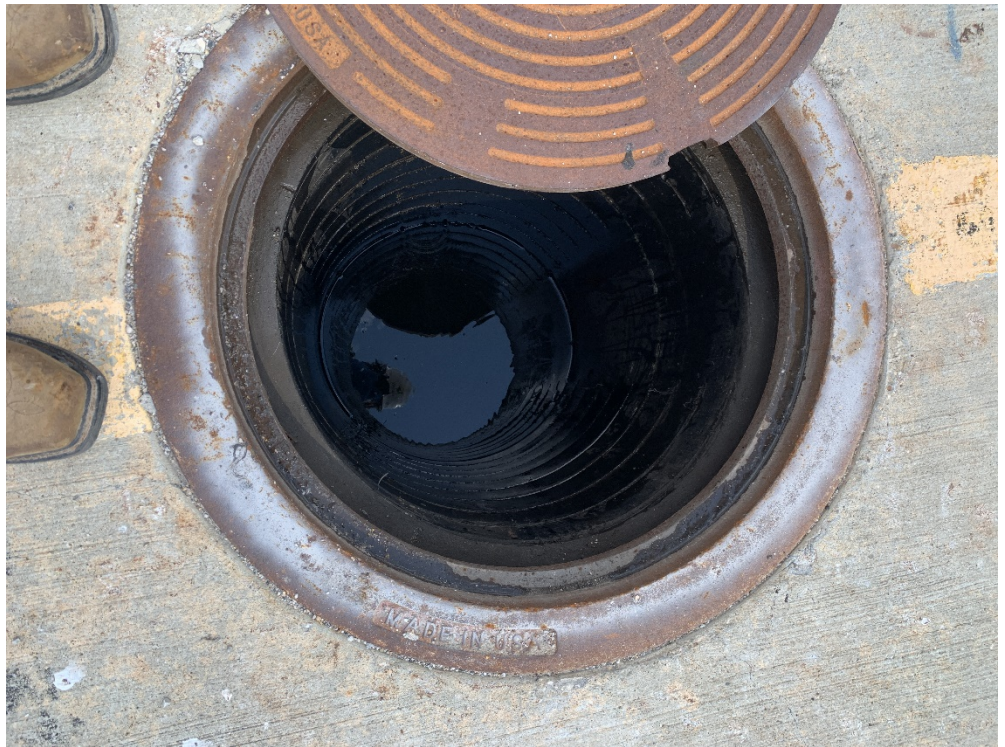
Photo No.
7

Sump 2 (B103/B104), 37 inches of freeboard. No sheen or odor noted.

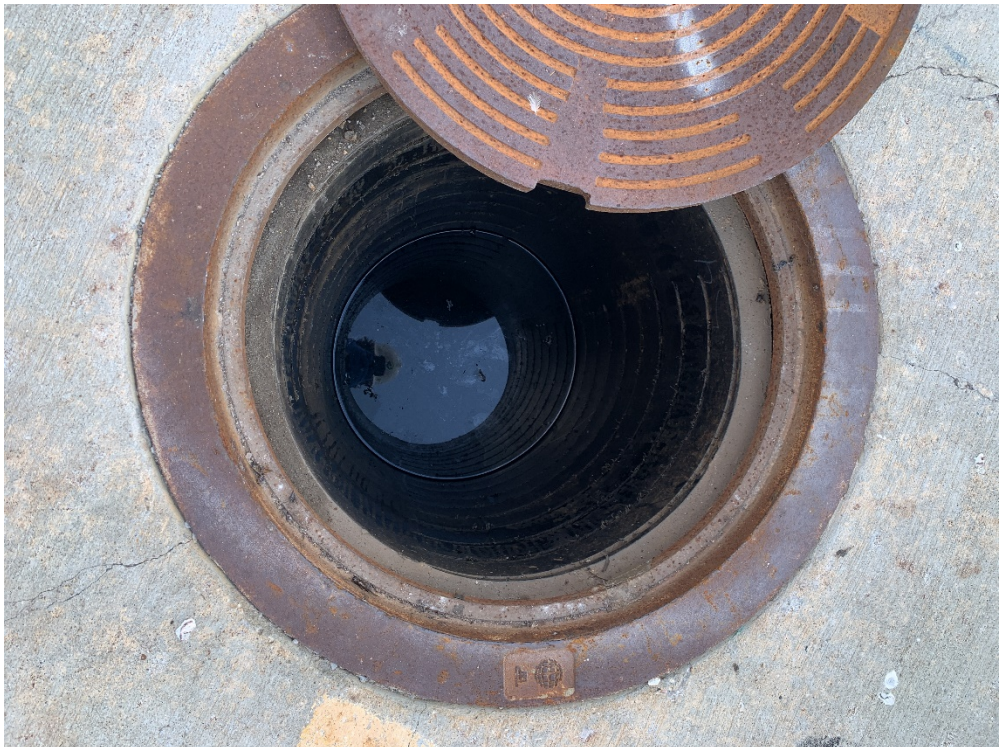
Photo No.
8

Sump 3 (B107/B108), 37 inches of freeboard in sump. No sheen or odor noted.

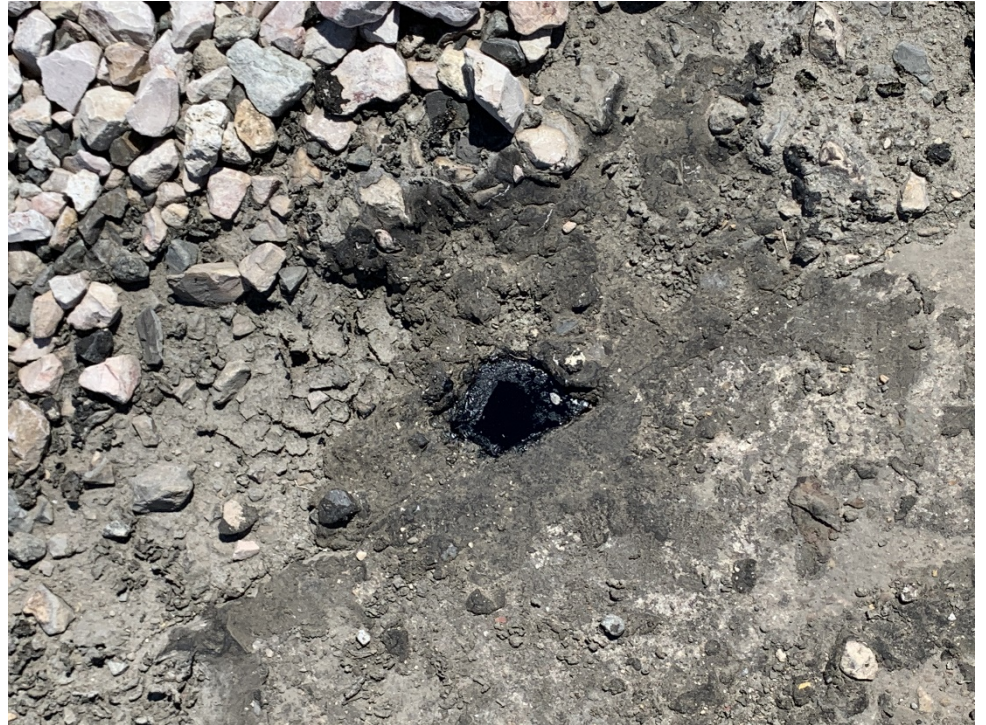
Photo No. 9	Inspection Date: 09/14/2022
------------------------------	---------------------------------------

North side of Track 802 where medium amount of tar-like material seep observed near track. Material was removed.

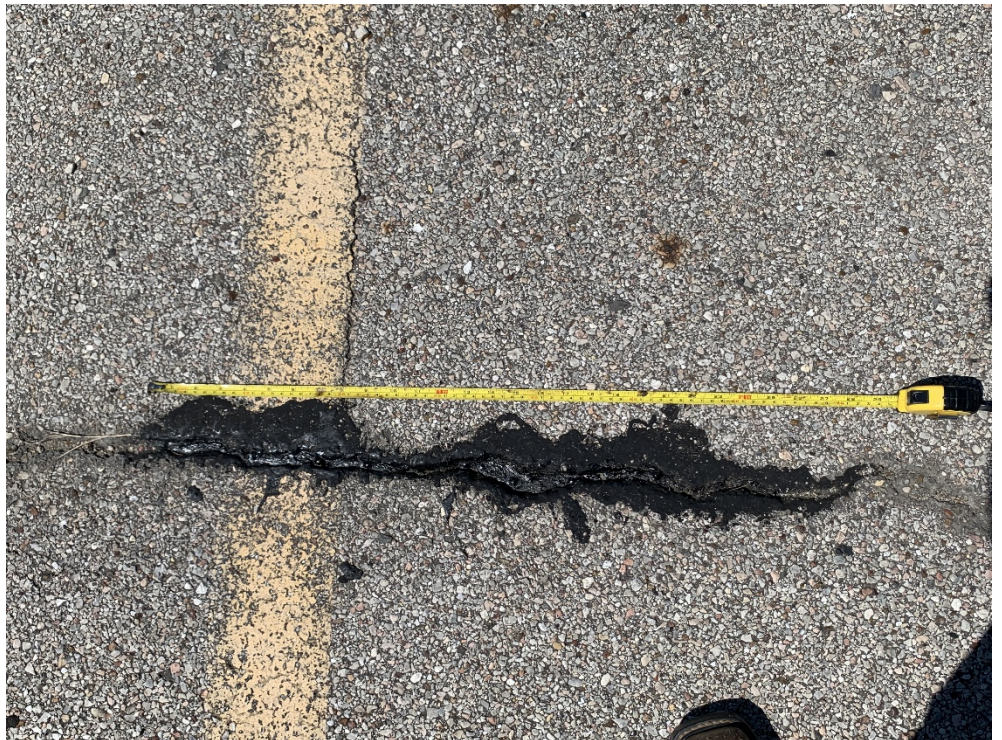
Photo No. 10	Inspection Date: 09/14/2022
-------------------------------	---------------------------------------

Stall B056, a small amount of tar-like material at a crack in the asphalt pavement, material was removed.

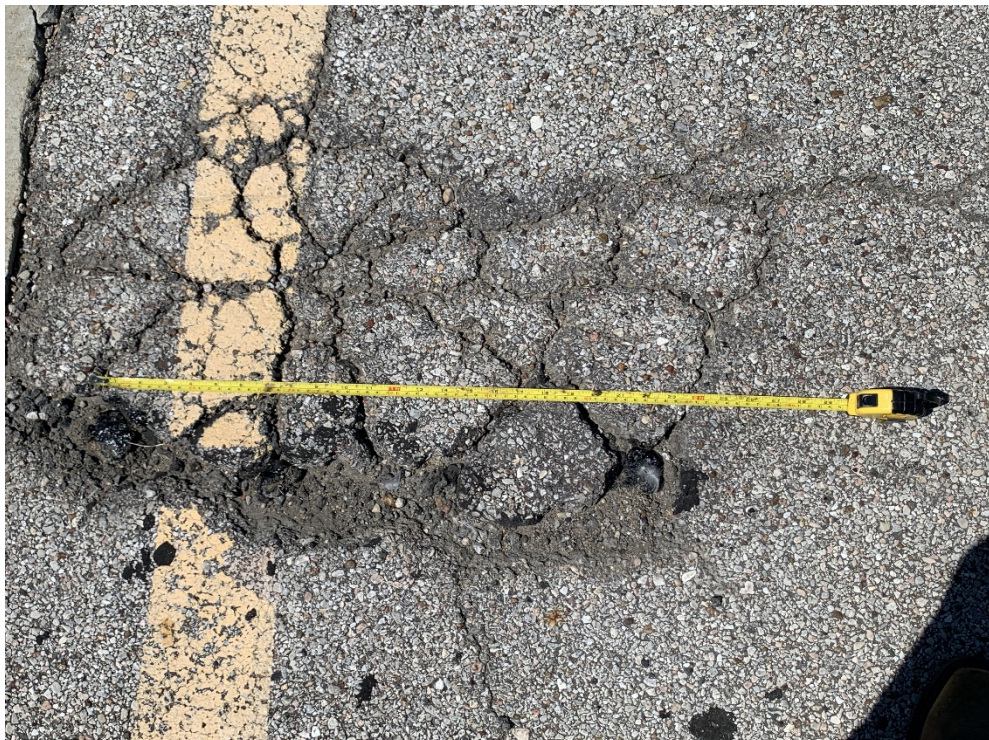
Description: Stall B057, very small amount of tar-like material at historical seep location in asphalt cracks, no seeps observed where nearby test pit was conducted (July 2020), material was removed. Lat: 29.7847472 Long: - 95.3195417			
Photo No. 12	Inspection Date: 09/14/2022

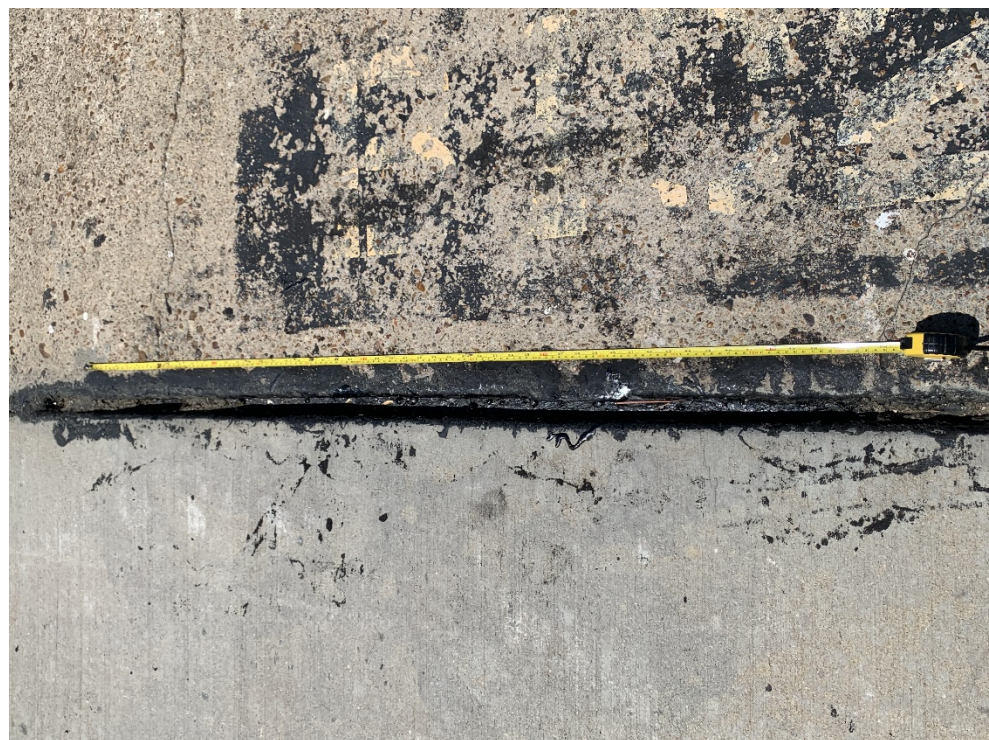
Description: Stall B102, small amount of tar-like material observed within concrete joint, residual staining on concrete surface noted. Lat: 29.7842203 Long: - 95.320827

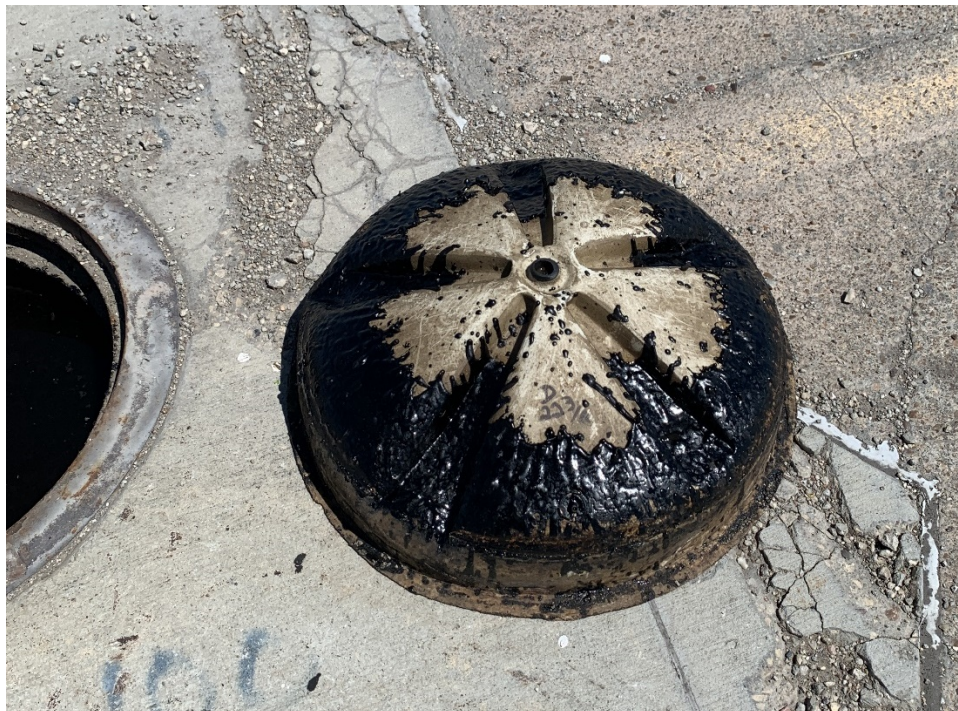
Photo No. 13	Inspection Date: 09/14/2022
-------------------------------	---------------------------------------

An accumulation of NAPL on the bottom of the inflow protector in Sump 1 was observed during the inspection on September 14, 2022 (Photo No. 13). The material was removed, and the inflow protector was monitoring during subsequent inspections for additional NAPL accumulation. No additional accumulation was observed through September 28, 2022 (Photo No. 31).

Sump 1 (B099/B100), NAPL accumulation noted on the bottom of the inflow protector, material was removed. No NAPL recovered from within sump.

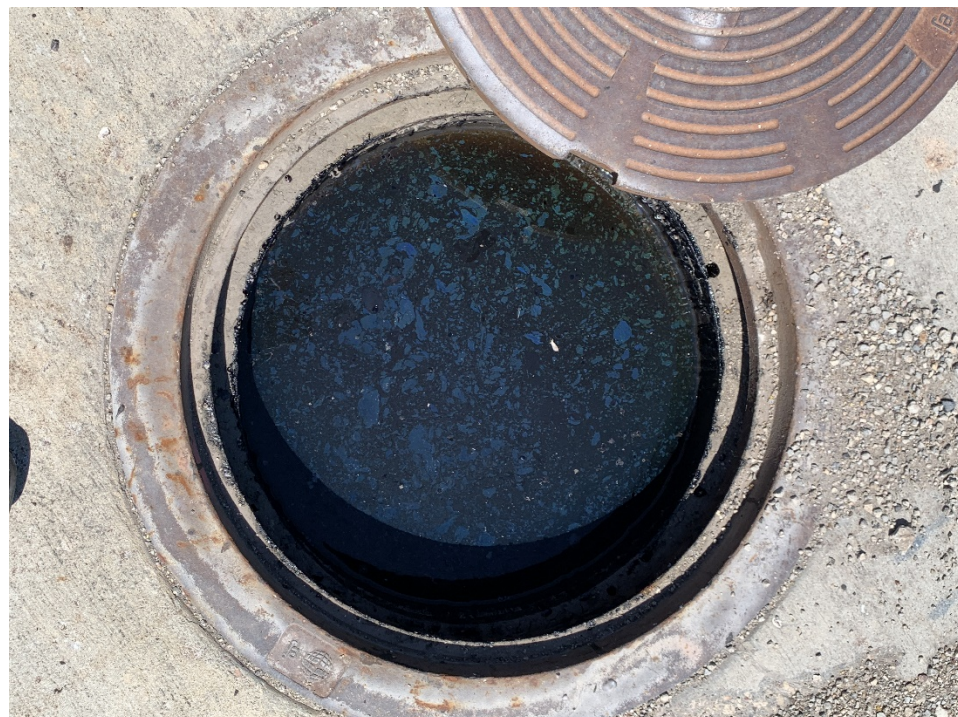
Photo No. 14	Inspection Date: 09/14/2022
-------------------------------	---------------------------------------

observed as being brown in color. A sheen was observed in Sump 1 on September 14, 2022 (Photo No. 14), Sump 3 on September 21, 2022 (Photo No. 24), and Sumps 1 and 3 on September 28, 2022. (Photo Nos. 30 and 32). No odors were reported during the September inspections.

Sump 1 (B099/B100), 1 inch of freeboard in sump. Sheen noted on the water surface. No odor noted.

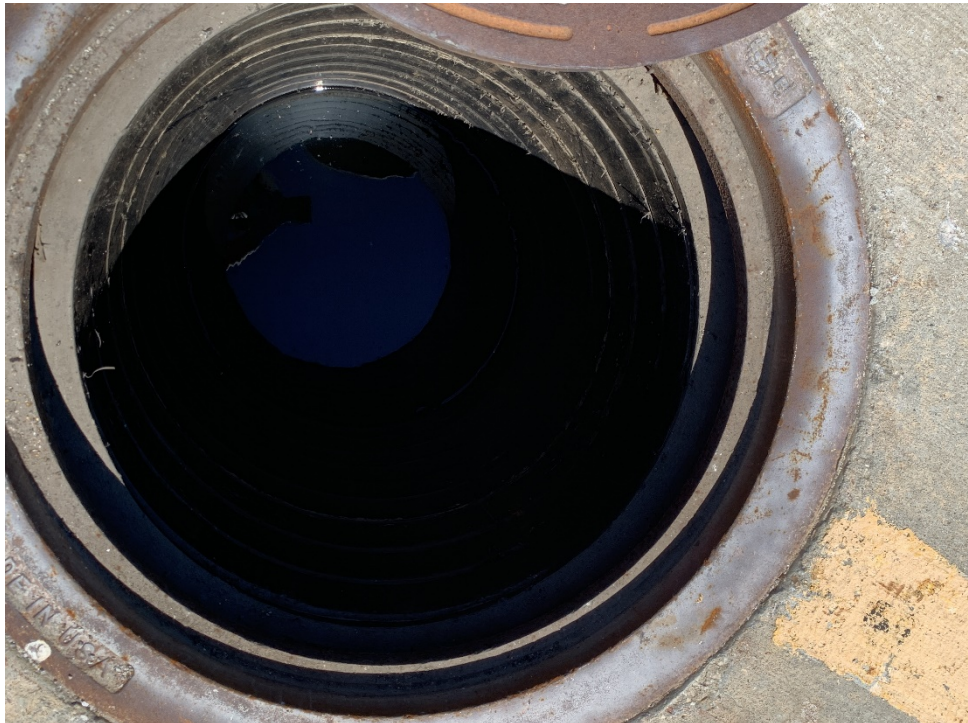
Description: Sump 2 (B103/B104), 34 inches of freeboard in sump. No sheen or odor noted. Lat: 29.7842861 Long: - 95.3208611			
Photo No. 16	Inspection Date: 09/14/2022

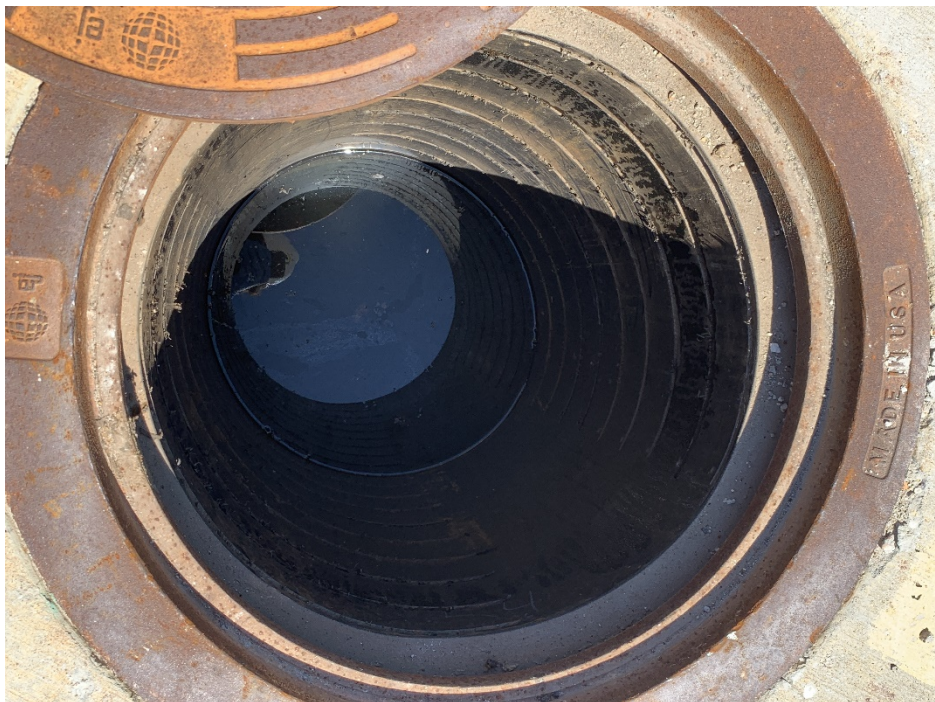
Description: Sump 3 (B107/B108), 31 inches of freeboard in sump. No sheen or odor noted. Lat: 29.784172 Long: -95.320998

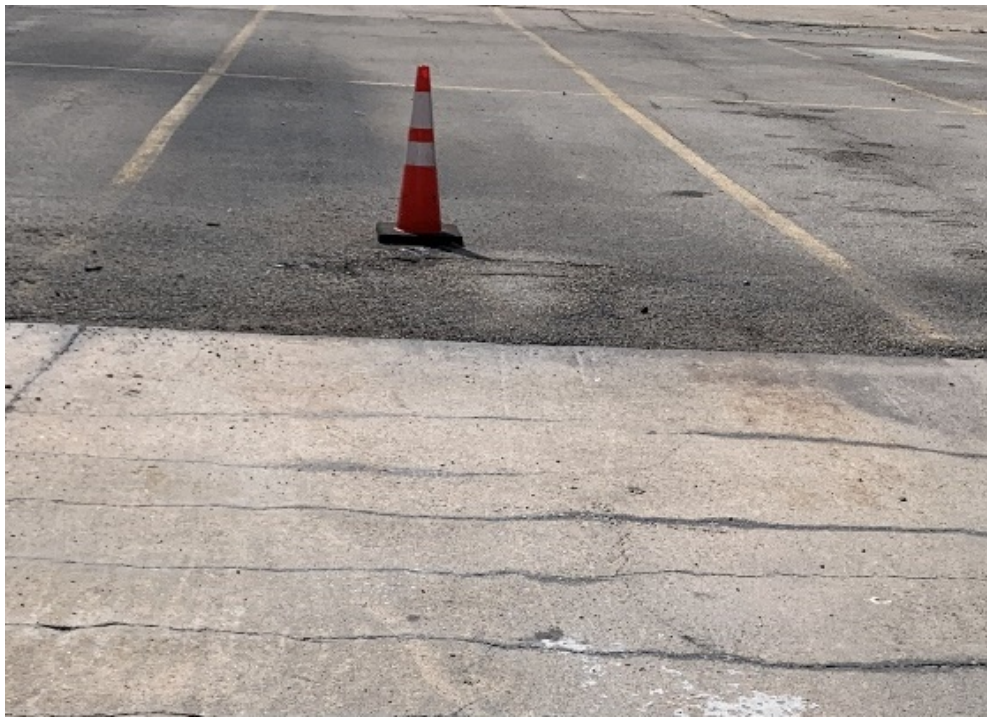
Description: Stall A011, a small amount of tar-like material at a crack in the asphalt pavement at the center of the stall (in front of the traffic cone), material was removed, looking south. Lat: 29.785392, Long: -95.318655			
Photo No. 18	Inspection Date: 09/21/2022

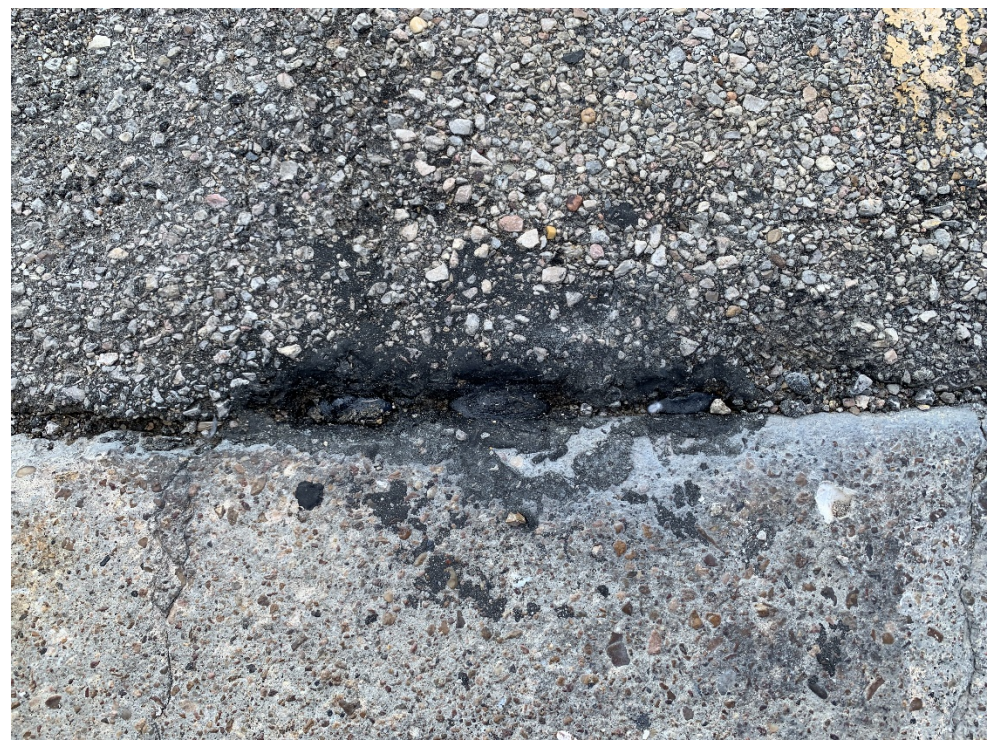
Description: Stall A022, a small amount of tar-like material at a crack in the asphalt pavement, material was removed. Lat: 29.785392, Long: -95.318655

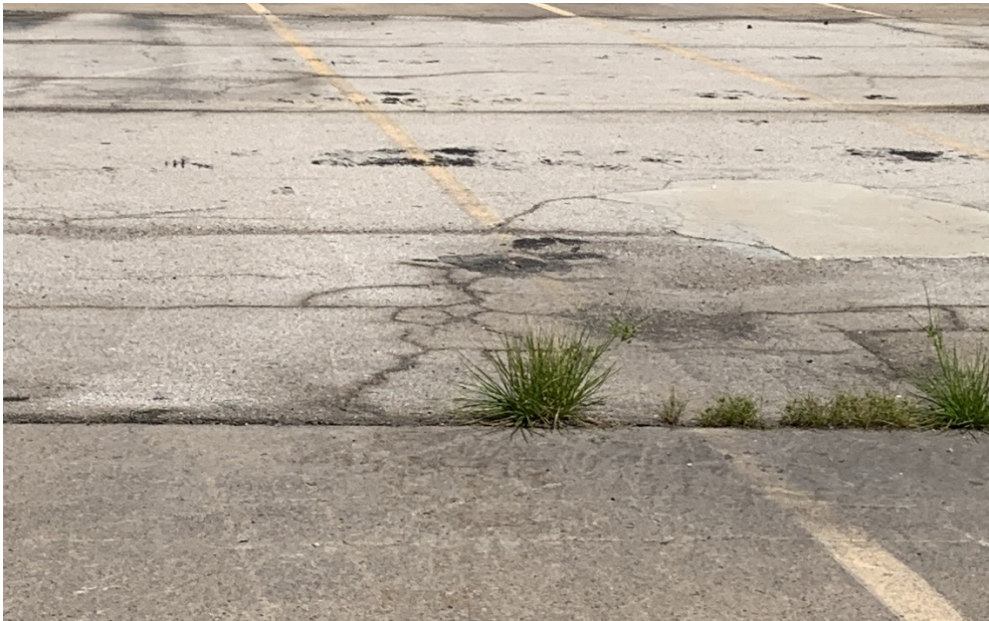
Client Name: Union Pacific Railroad		Site Location: Englewood Intermodal Yard, Houston, Texas	Project No. 19119232
Photo No. 19	Inspection Date: 09/21/2022	<p>Description:</p> <p>Stall B101, very small amount of tar-like material at a crack in the asphalt pavement (center of the photo), material was removed, looking north.</p> <p>Lat: 29.784275 Long: - 95.320813</p>

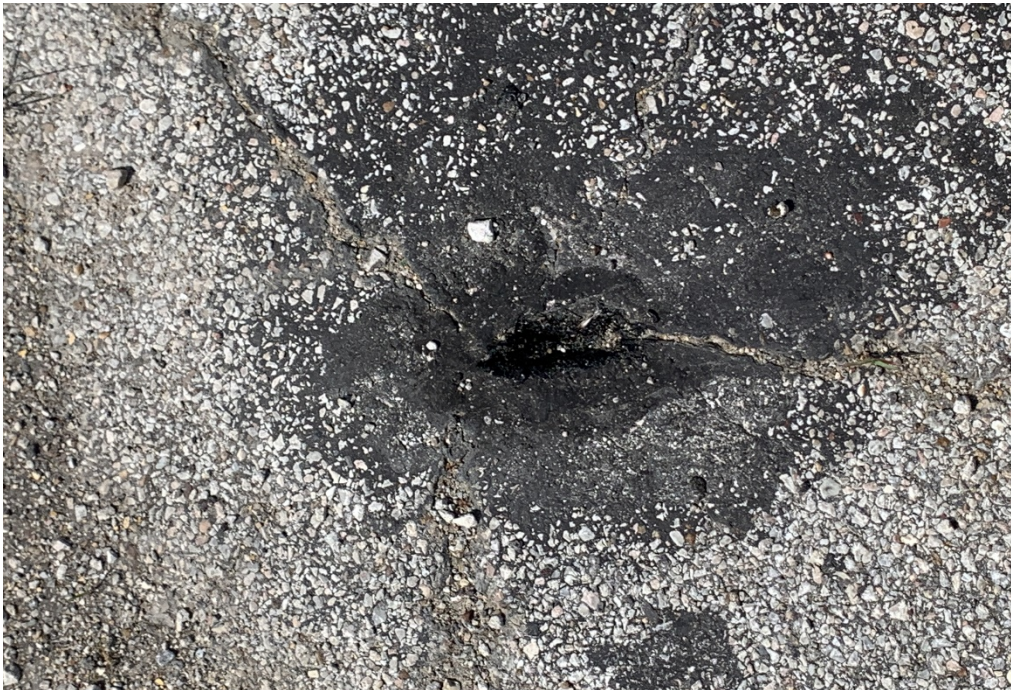
Photo No. 20	Inspection Date: 09/21/2022	<p>Description:</p> <p>Stall B105, a very small amount of tar-like material in pavement area, material was removed.</p> <p>Lat: 29.784236, Long: -95.320939</p>

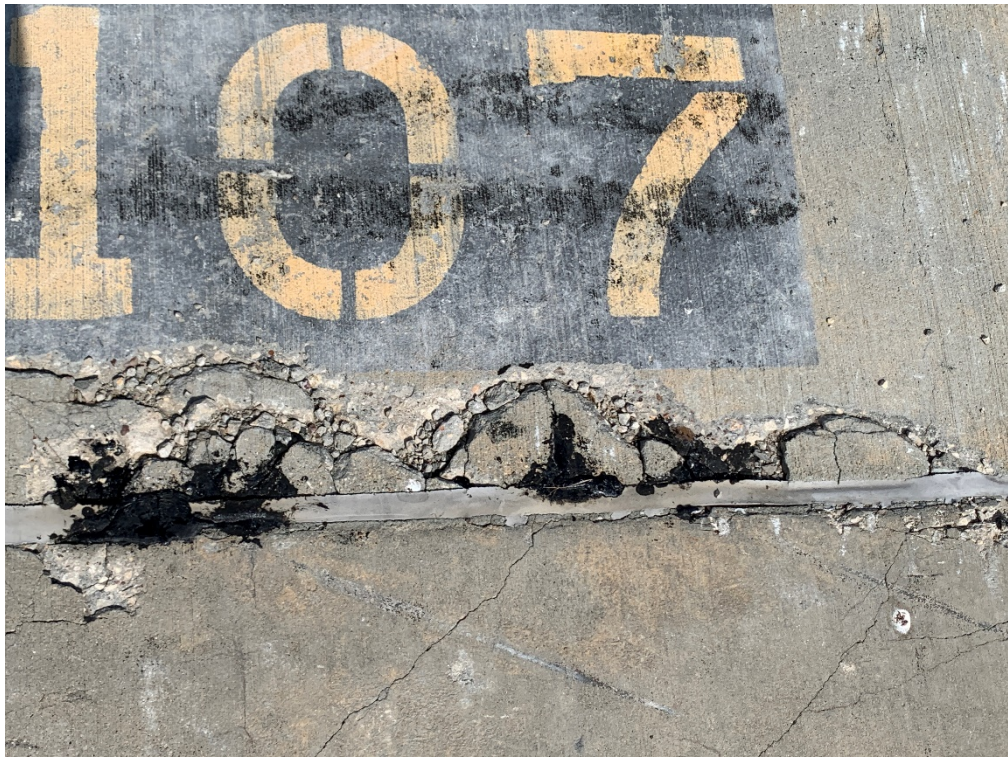
Description: Stall B107, a small amount of tar-like material at concrete joint along the southern edge of the excavated area. Material was removed. Lat: 29.784156 Long: -95.320953			
Photo No. 22	Inspection Date: 09/21/2022

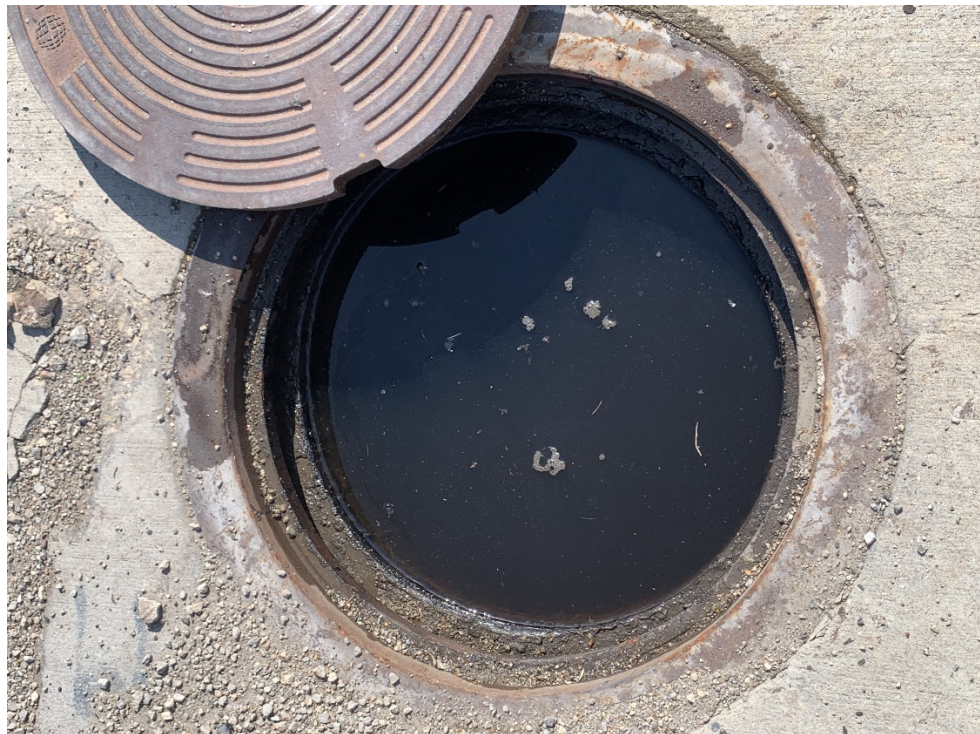
Description: Sump 1 (B099/B100), 2.2 inches of freeboard in sump. No sheen or odor noted. Lat: 29.7844000 Long: - 95.3205861

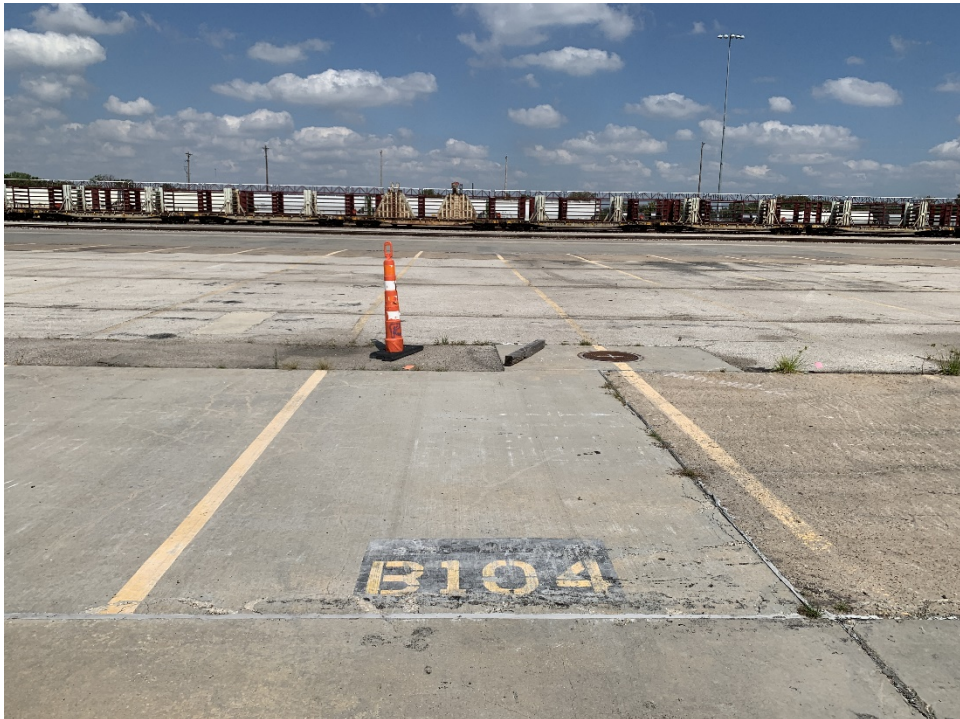
Description: Stall B104, view of NAPL Collection System, Sump 2 (B103/B104), 25.5 inches of freeboard in sump. No sheen or odor noted. Lat: 29.7842861 Long: - 95.3208611			
Photo No. 24	Inspection Date: 09/21/2022

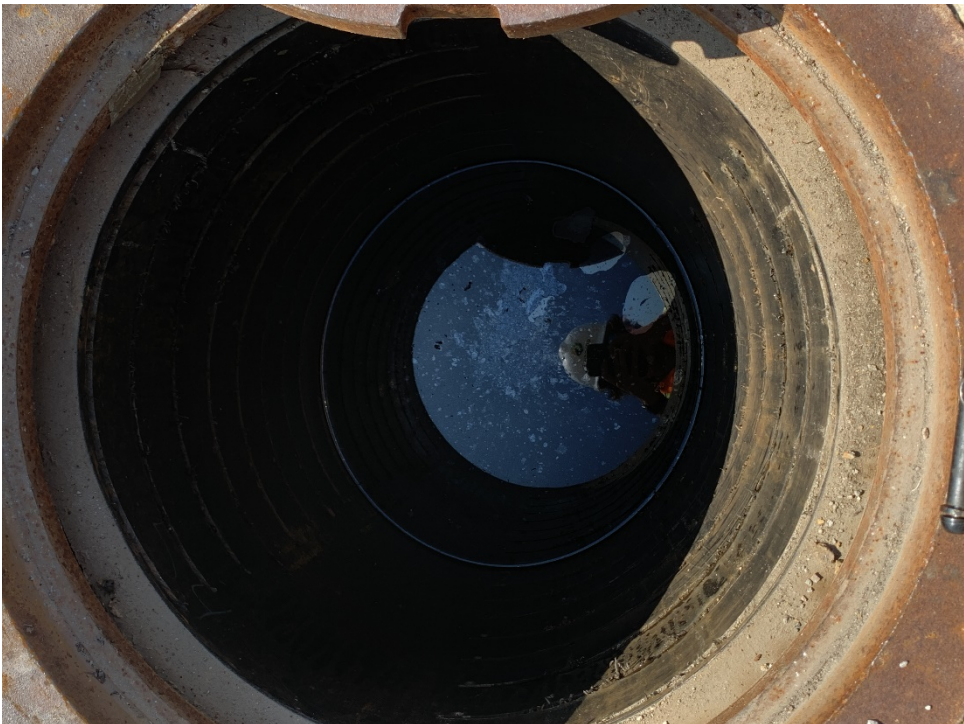
Description: Sump 3 (B107/B108), 27.5 inches of freeboard in sump. Sheen noted on the water surface. No odor noted. Lat: 29.784172 Long: -95.320998

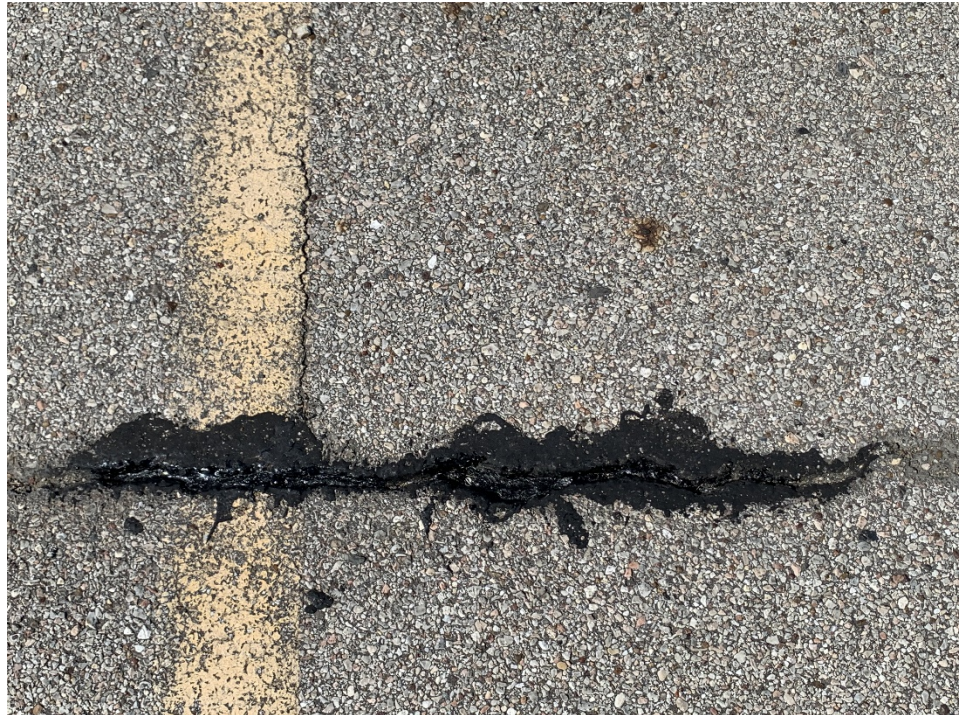
Photo No.
25

Stall B056, a very small amount of tar-like material at a crack in the asphalt pavement, material was removed.

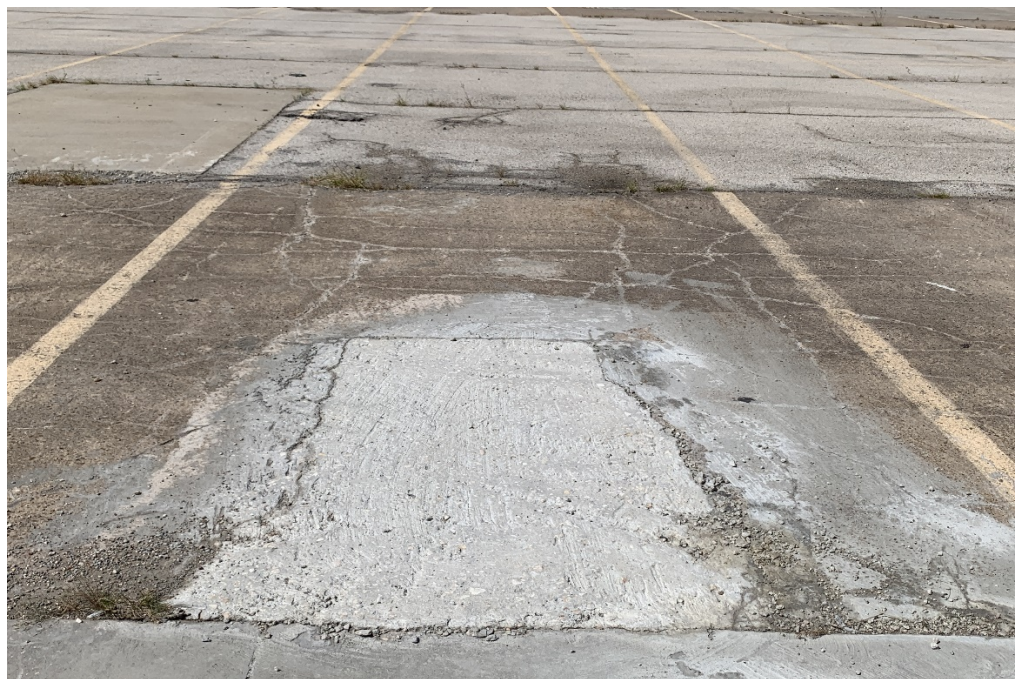
Photo No.
26

Stall B057, very small amount of tar-like material at historical seep location in asphalt cracks along western stall boundary, no seeps observed where nearby test pit was conducted (July 2020), material was removed, looking northwest.

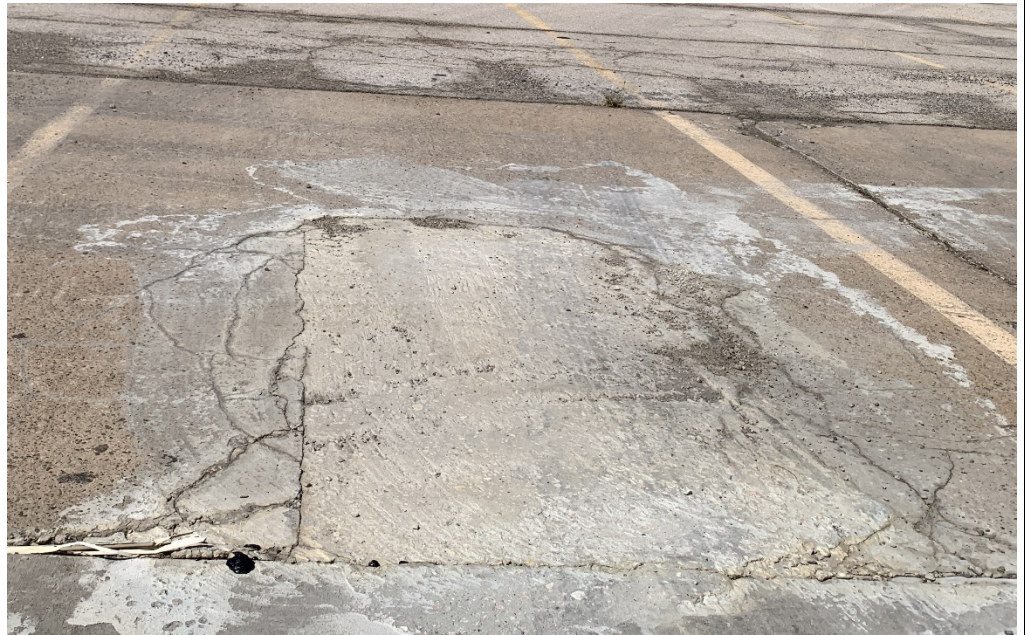
Photo No.
27

During the inspection on September 28, 2022, a small amount of tar like material was observed in stall B096 adjacent to the test pit patch, near the historical seep location, along the concrete joint at the front of the stall (Photo No. 27). Through September 2022, no NAPL seeps have been observed at the six other test pit locations (stalls A010, A021, A098, B013, B057, and B108). The seep observed in stalls B057 (Photo Nos. 11 and 26) during the September inspections is located in cracks in the asphalt pavement and not at the test pit location.

Stall B096, small amount of tar-like material observed near historical seep location along concrete joint adjacent to July 2020 test pit.

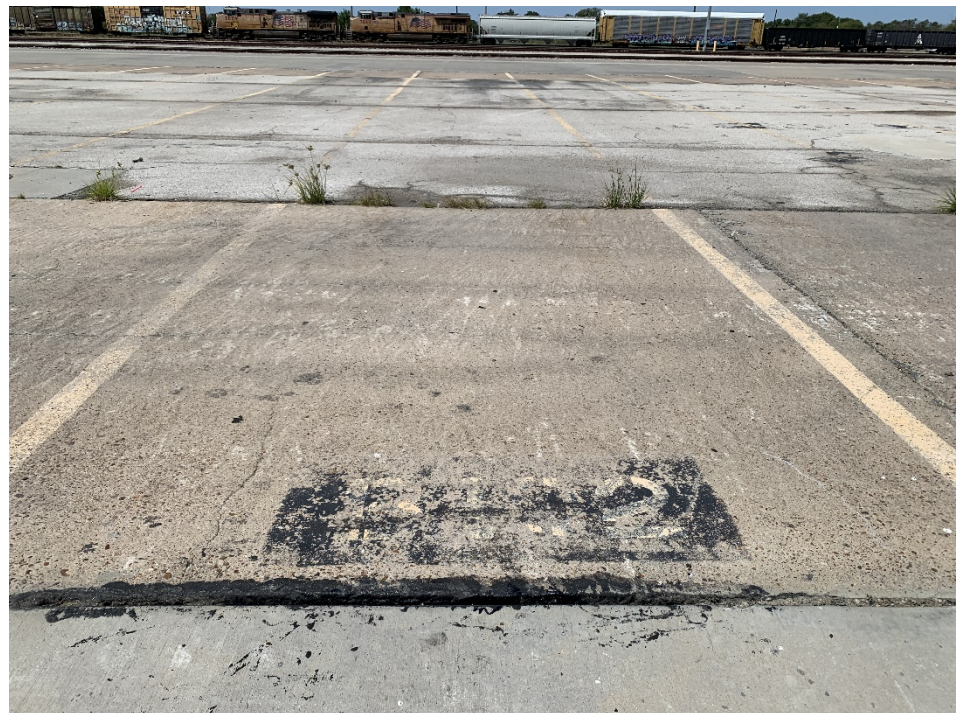
Photo No.
28

Stall B102, small amount of tar-like material observed within joint, residual staining on concrete surface noted, material was removed, looking northwest.

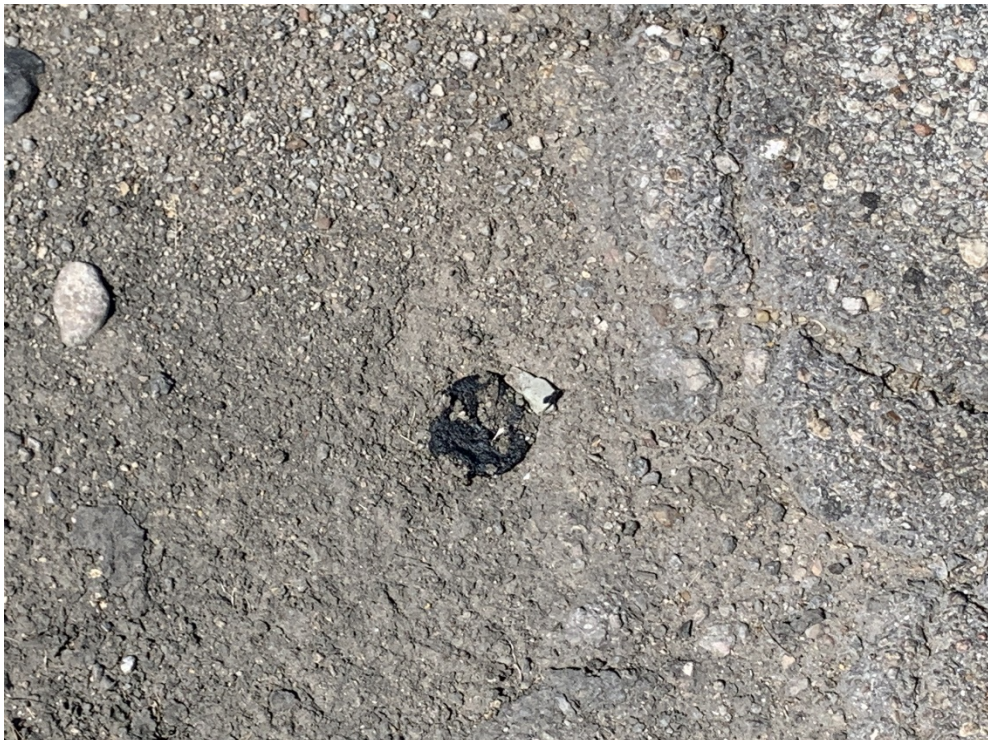
Description: Stall B102, small amount of tar-like material observed asphalt crack near center of stall, material was removed. Lat: 29.7842203 Long: - 95.320827			
Photo No. 30	Inspection Date: 09/28/2022
