October 17, 2022

Project No. 19119232

**Re: MONTHLY STATUS UPDATE – ENGLEWOOD INTERMODAL YARD – NAPL COLLECTION
SYSTEM/CONCRETE CAP REPAIRS
UNION PACIFIC RAILROAD HOUSTON WOOD PRESERVING WORKS FACILITY
4910 LIBERTY ROAD FACILITY, HOUSTON, TEXAS
POST-CLOSURE CARE PERMIT NO. HW-50343; INDUSTRIAL SWR NO. 31547**

Weekly Inspection Photolog

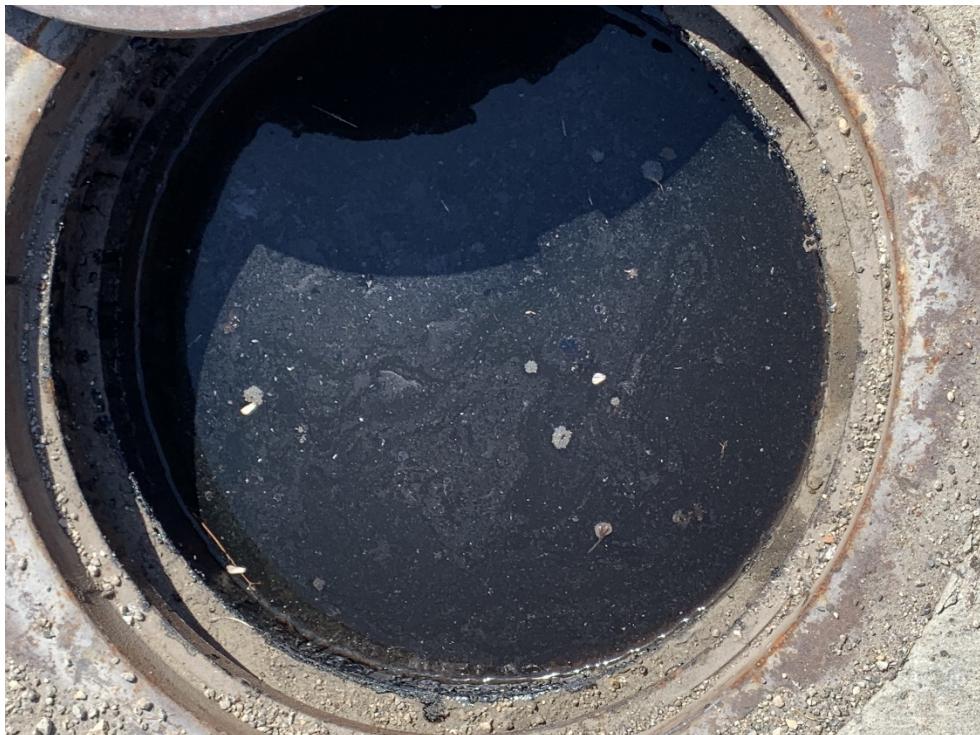
observed as being brown in color. A sheen was observed in Sump 1 on September 14, 2022 (Photo No. 14), Sump 3 on September 21, 2022 (Photo No. 24), and Sumps 1 and 3 on September 28, 2022. (Photo Nos. 30 and 32). No odors were reported during the September inspections.

Description: Sump 1 (B099/B100), 3 inches of freeboard in sump. Sheen noted on the water surface. No odor noted. Lat: 29.7844000 Long: - 95.3205861

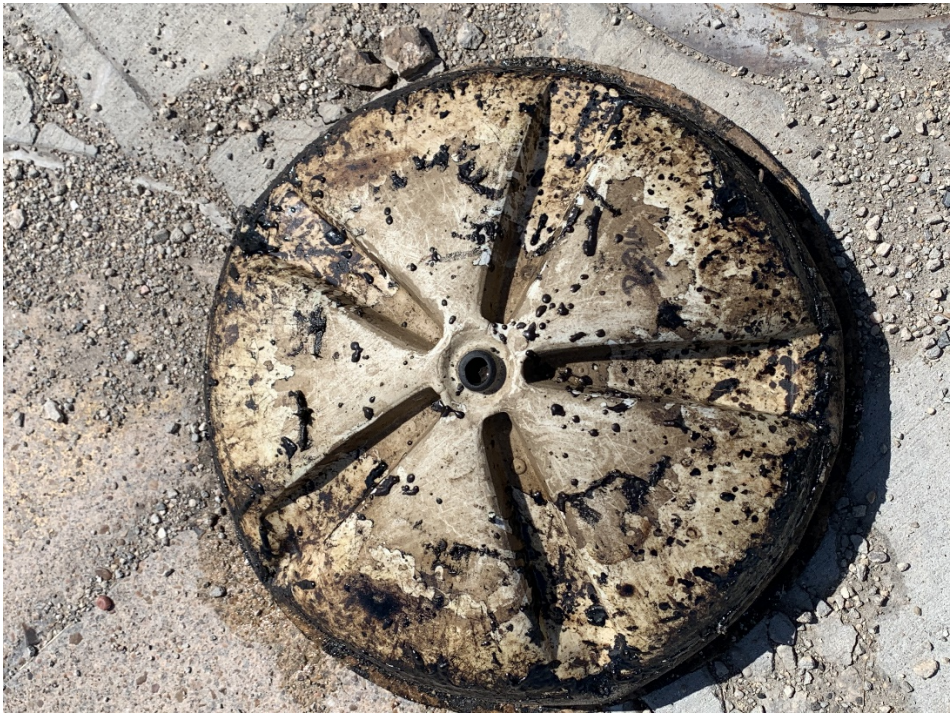
An accumulation of NAPL on the bottom of the inflow protector in Sump 1 was observed during the inspection on September 14, 2022 (Photo No. 13). The material was removed, and the inflow protector was monitoring during subsequent inspections for additional NAPL accumulation. No additional accumulation was observed through September 28, 2022 (Photo No. 31).

Client Name: Union Pacific Railroad		Site Location: Englewood Intermodal Yard, Houston, Texas	Project No. 19119232
Photo No. 31	Inspection Date: 09/28/2022	<div> <p>Description:</p> <p>Sump 1 (B099/B100), no notable NAPL accumulation noted on the bottom of the inflow protector after the material was removed during the 9/14/2022 inspection.</p> <p>Lat: 29.7844000 Long: - 95.3205861</p> </div>

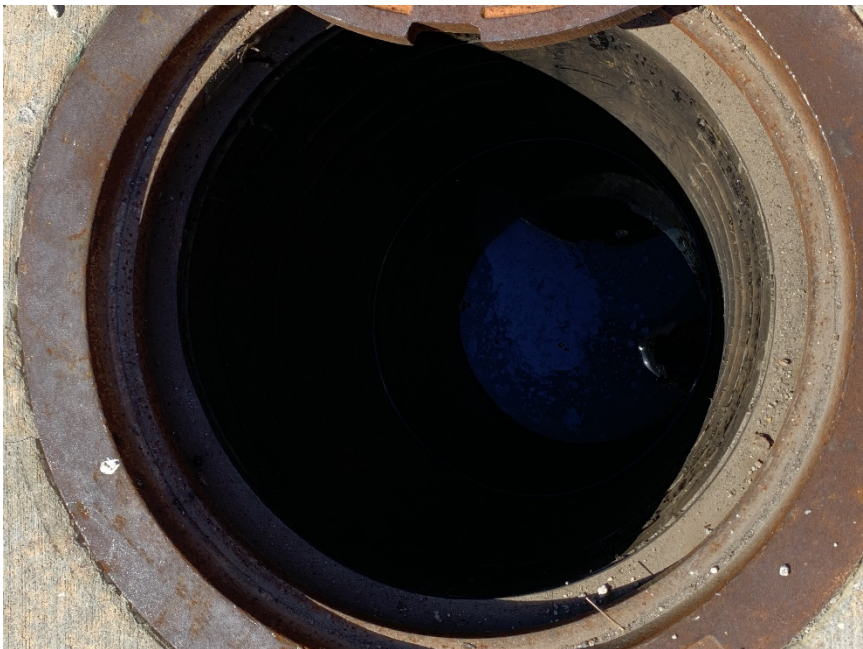
Photo No. 32	Inspection Date: 09/28/2022	<div> <p>Description:</p> <p>Sump 3 (B107/B108), 31 inches of freeboard in sump. Sheen noted on the water surface. No odor noted.</p> <p>Lat: 29.784172 Long: -95.320998</p> </div>

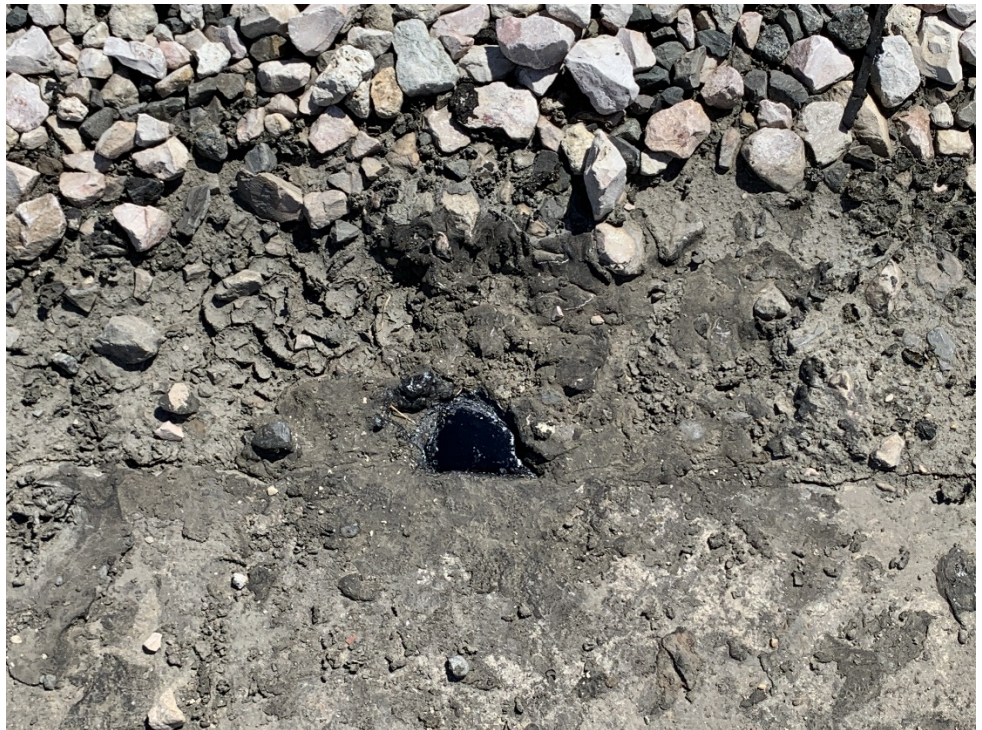
Photo No.
33

Right of way by Track 802. Small amount of tar-like material near track, material was removed.

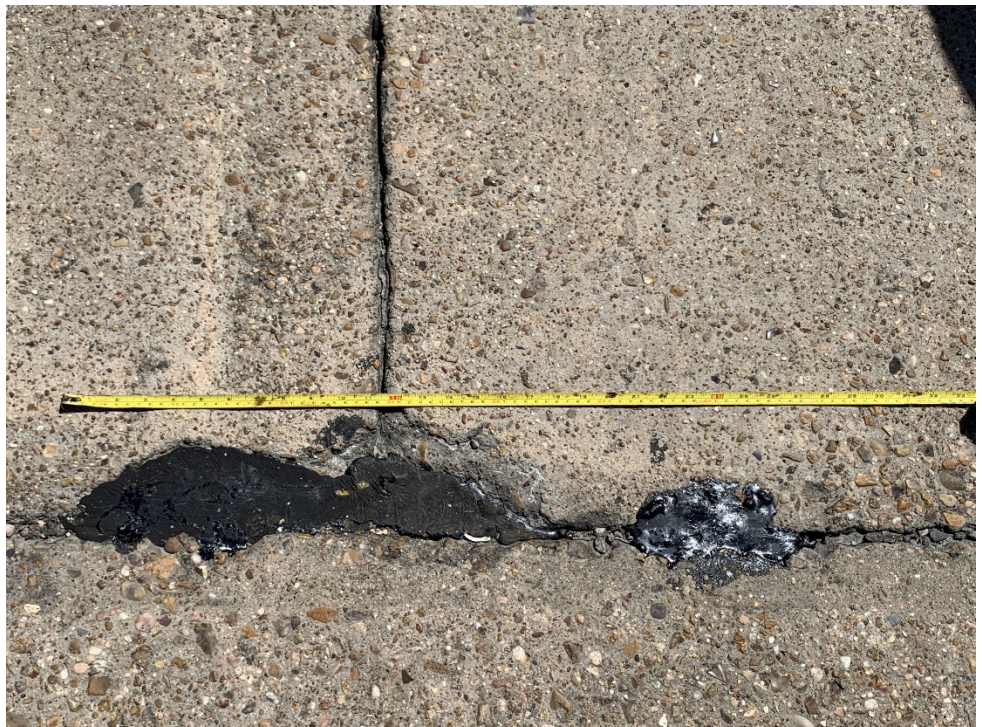
Photo No.
34

- As detailed in the July 2022 Monthly Status Update, a tar-like material seep was observed next to Track 802 that is located approximately 280 feet northwest of the NAPL Collection System. The tar-like material seep is located along on the northern side of the track at the edge of the railroad ballast (Photo Nos. 9 and 33), and was observed during three of the four inspections in September (September 7th, 14th, and 28th). During the September 28, 2022 inspection, an additional tar-like material seep was observed within the concrete road area (RD-14) about 45 feet north of Track 802 and east of the existing Track 802 seep location (Photo No. 34).

New seep location observed within the concrete road area (RD-14) north of Track 802 (East of existing Track 802 seep location), moderate amount of tar-like material observed along a concrete joint, material was removed.
