Project No. 19119232

**Re: MONTHLY STATUS UPDATE – ENGLEWOOD INTERMODAL YARD – NAPL COLLECTION
SYSTEM/CONCRETE CAP REPAIRS
UNION PACIFIC RAILROAD HOUSTON WOOD PRESERVING WORKS FACILITY
4910 LIBERTY ROAD FACILITY, HOUSTON, TEXAS
POST-CLOSURE CARE PERMIT NO. HW-50343; INDUSTRIAL SWR NO. 31547**

Weekly Inspection Photolog

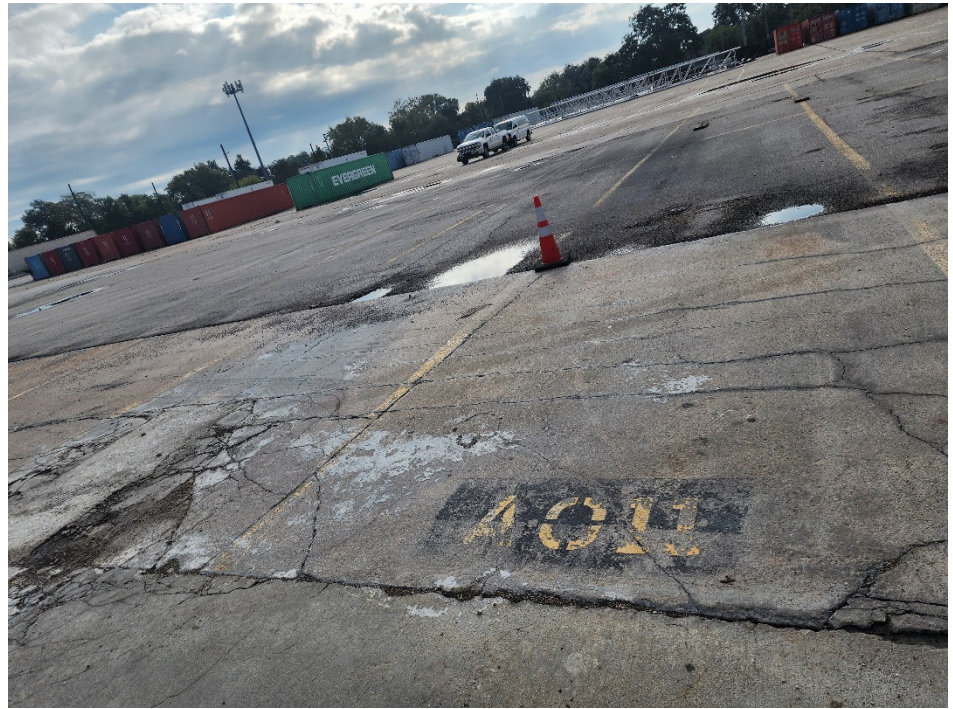
Photo No.
1

Stalls A010 and A011, no new tar-like material observed, looking southeast.

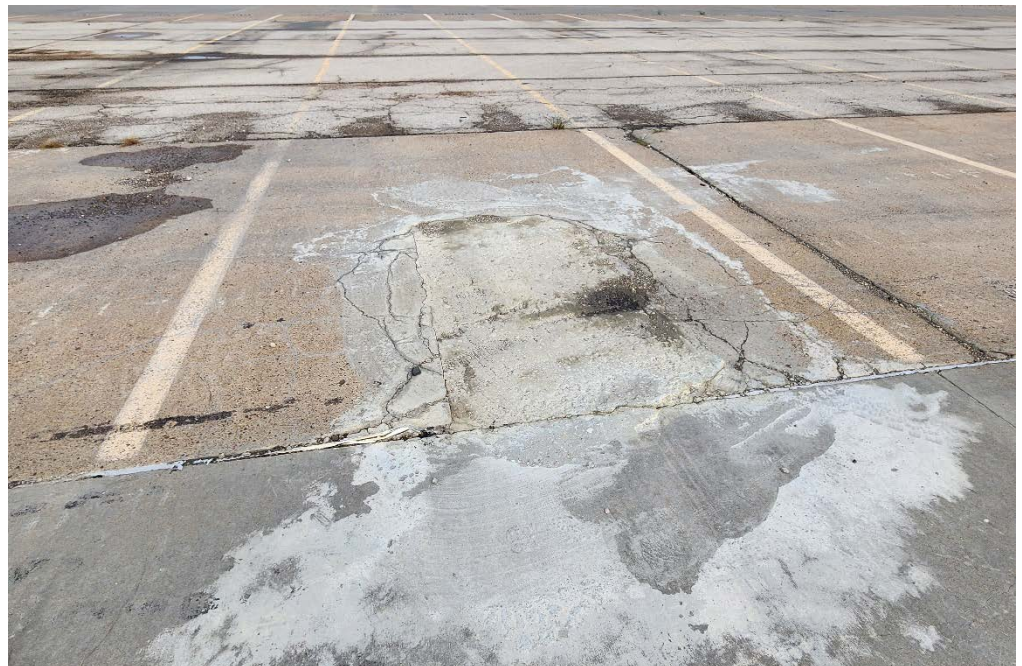
Photo No.
2

Stall B096, very small amount of tar-like material observed near historical seep location along concrete joint adjacent to July 2020 test pit.

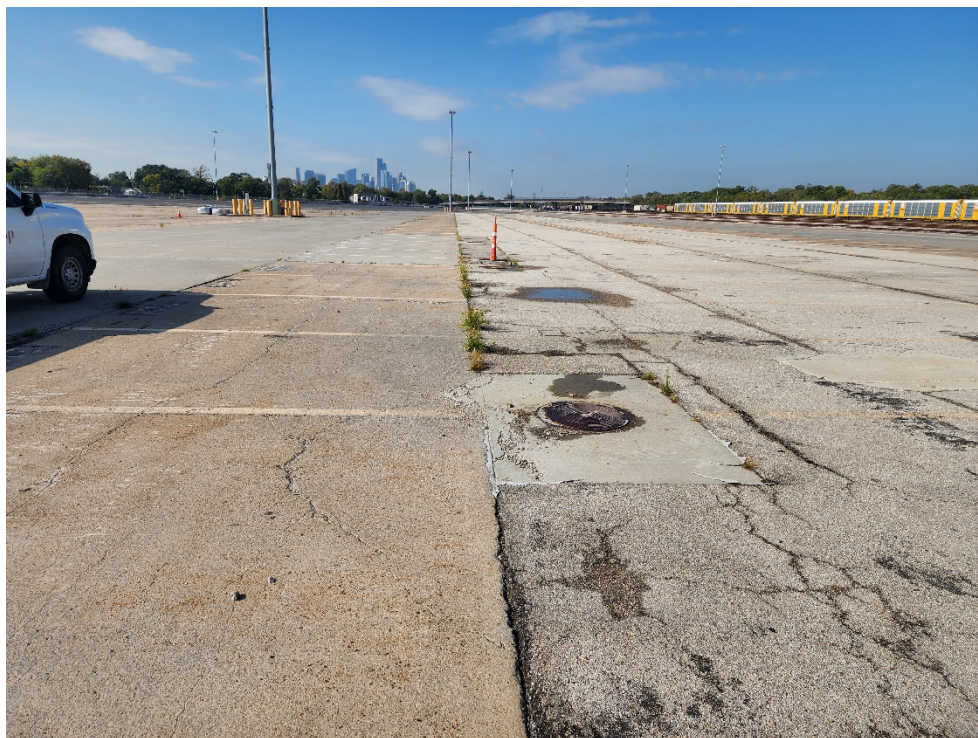
Photo No.
3

Stalls B099-B110, view of NAPL collection system, standing water from recent rain event, looking west.

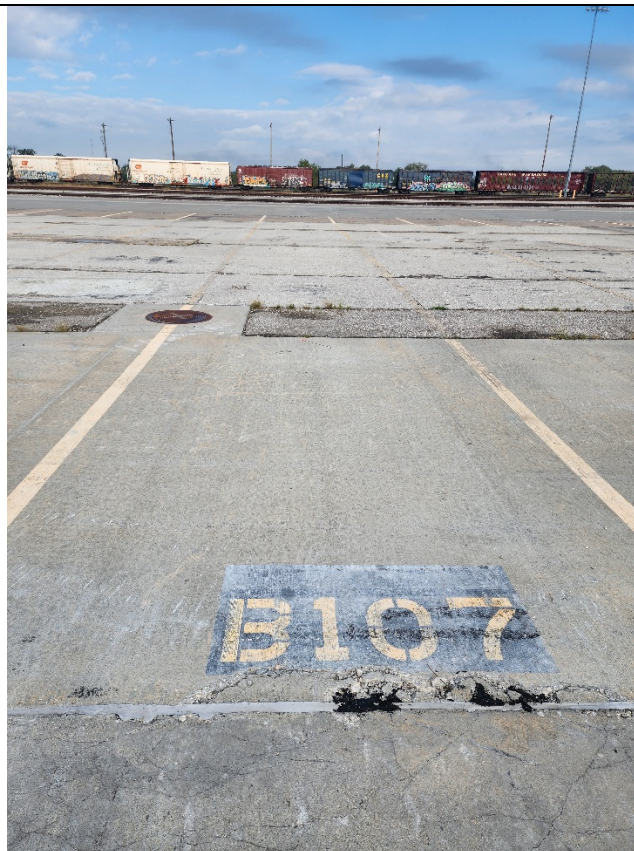
Photo No.
4

- A small tar-like material seep was observed on the southern edge of the NAPL Collection System in cracks in the cement along the joint of Stall B107 during the July 6, 2022 weekly inspection, no new tar-like material was observed at this seep location in November 2022.

Stall B107, no new tar-like material observed at seep location on concrete joint along the southern edge of the excavated area, looking northwest.

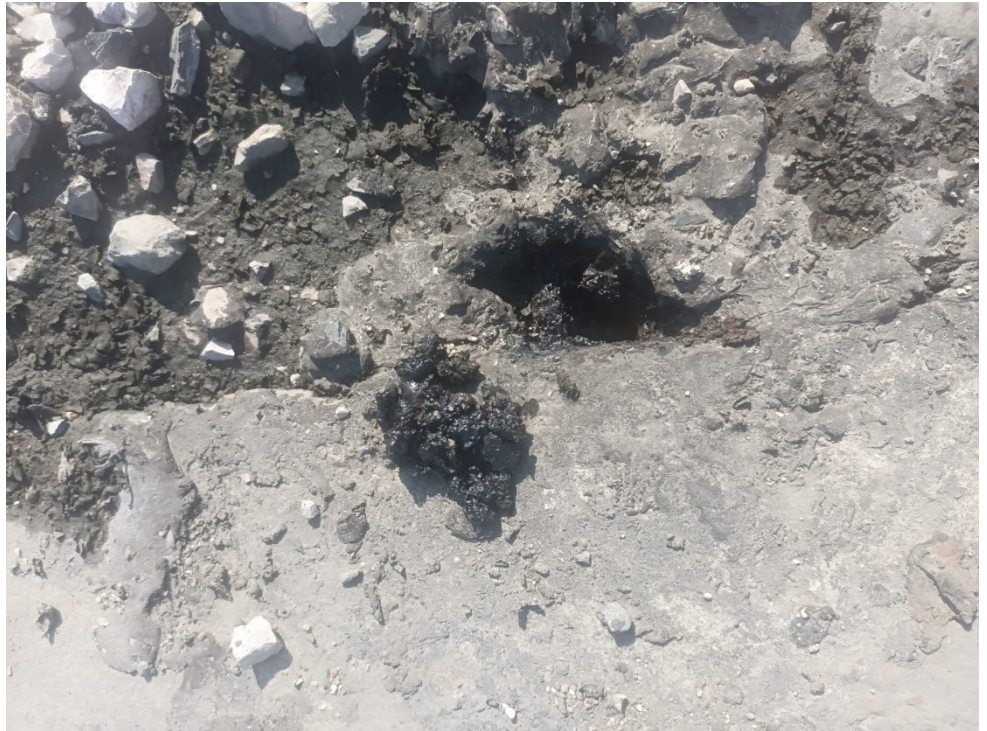
Photo No.
5

- As detailed in the July 2022 Monthly Status Update, a tar-like material seep was observed next to Track 802 that is located approximately 280 feet northwest of the NAPL Collection System. The tar-like material seep is located along on the northern side of the track at the edge of the railroad ballast (Photo No. 5). Small amounts of seeped material were observed at this location during two of the five inspections in November (November 2nd and 9th). During the September 28, 2022 inspection, an additional tar-like material seep was observed within the concrete road area (RD-14) about 45 feet north of Track 802 and east of the existing Track 802 seep location. A small amount of tar-like material was observed at RD-14 in one of the five inspections in November (November 9th) (Photo No. 16).

North side of Track 802 where a small amount of tar-like material seep was observed near track, material was removed.

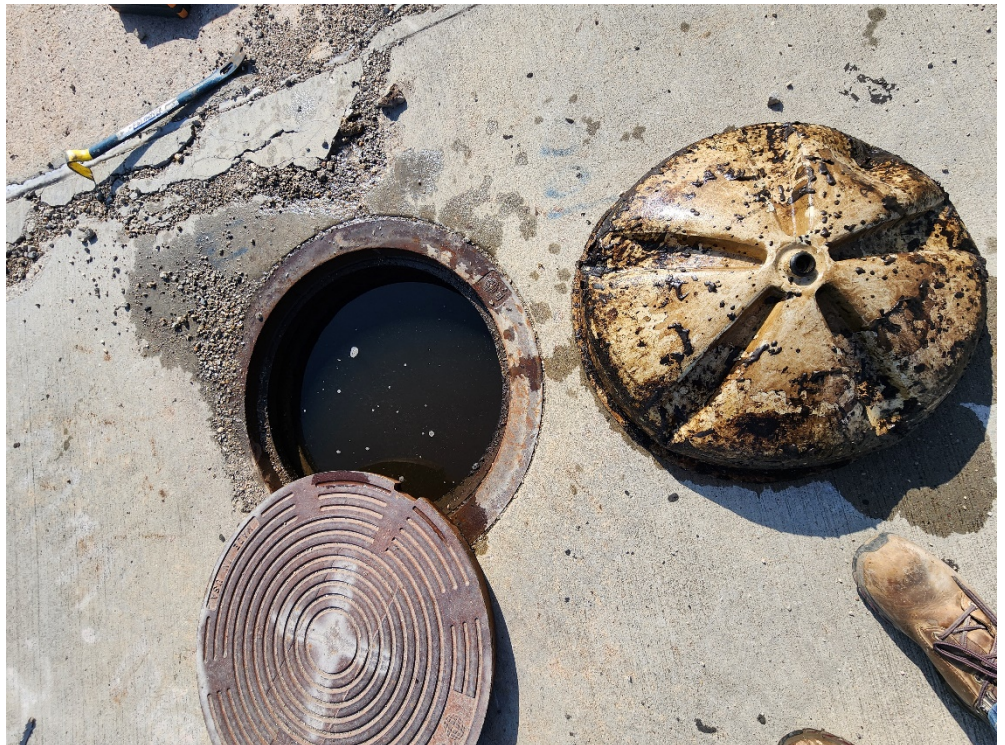
Photo No.
6

An accumulation of NAPL on the bottom of the inflow protector in Sump 1 was observed during the inspection on September 14, 2022. The material was removed, and the inflow protector was monitoring during subsequent inspections for additional NAPL accumulation. No additional accumulation was observed through November 30, 2022.

Sump 1 (B099/B100), 4 inches of freeboard in sump, no sheen or odor noted, no new NAPL accumulation on inflow protector.

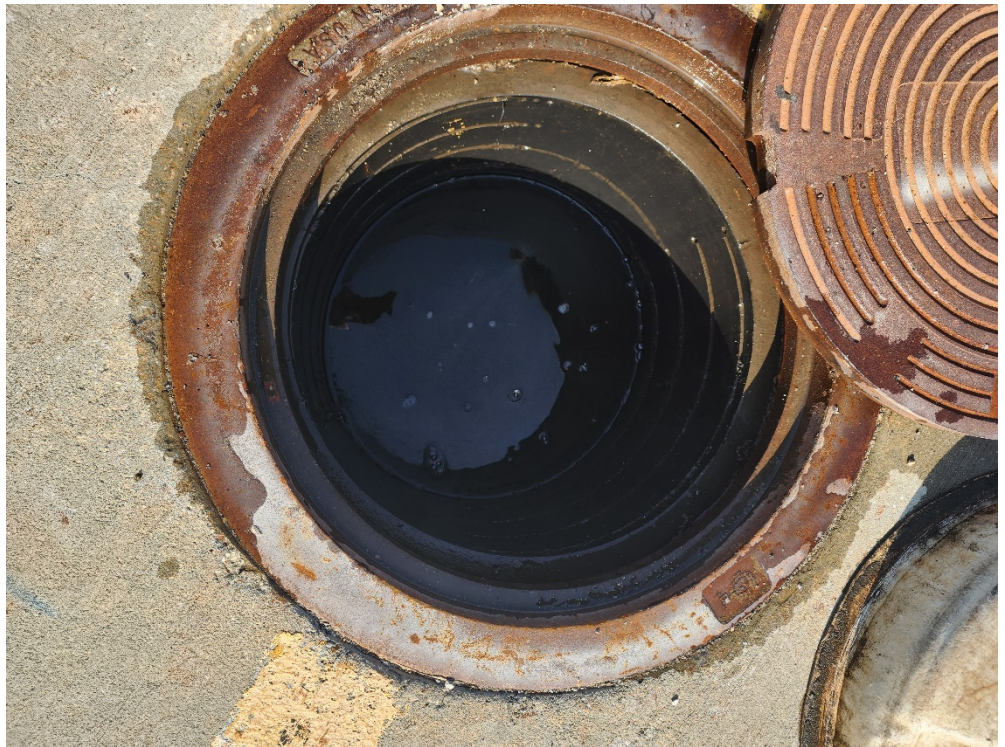
Photo No.
7

Sump 2 (B103/B104), 19 inches of freeboard. No sheen or odor noted.

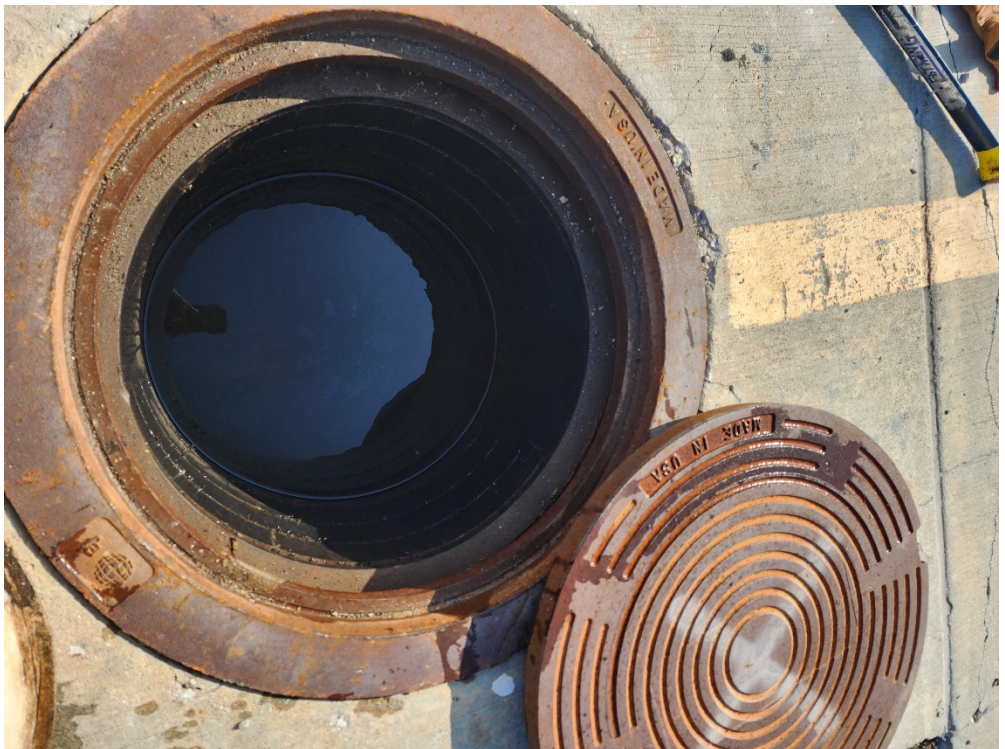
Photo No.
8

Sump 3 (B107/B108), 19 inches of freeboard in sump, no sheen or odor noted.

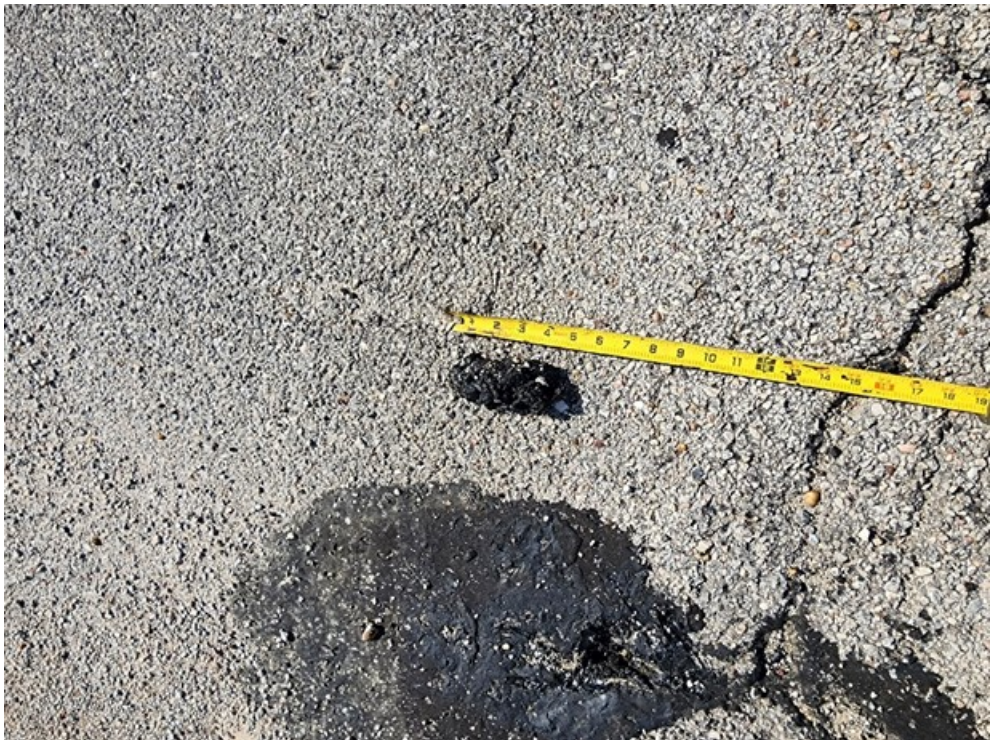
Description: Stall A011, a small amount of tar-like material at a crack in the asphalt pavement, material was removed. Lat: 29.785392, Long: -95.318655			
Photo No. 10	Inspection Date: 11/09/2022

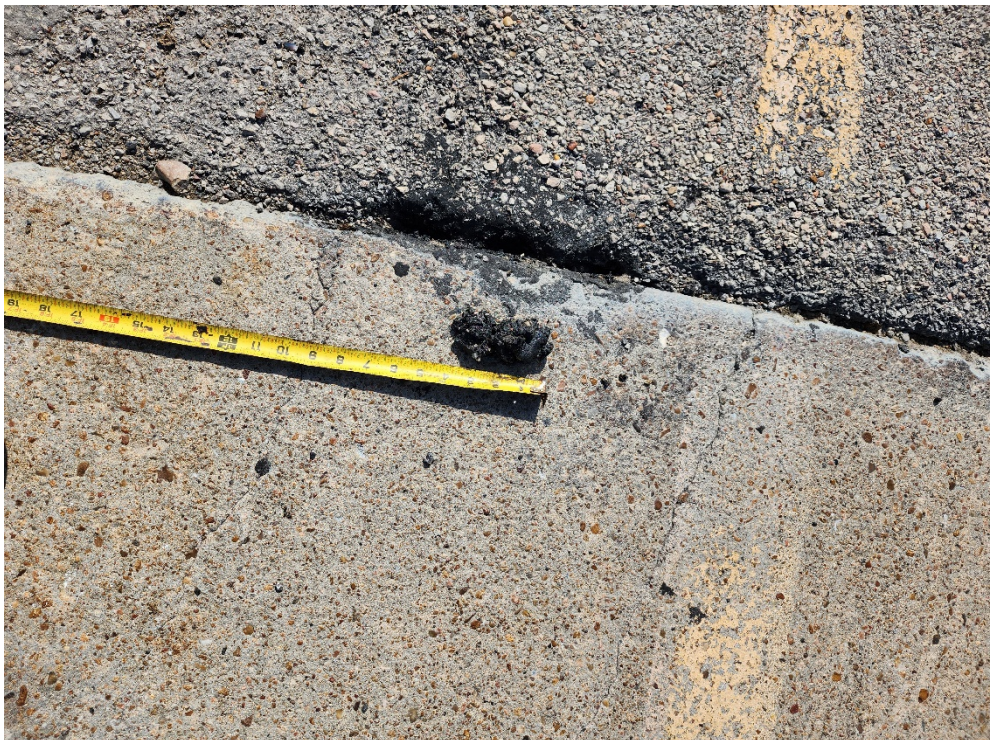
Description: Stall A022, a small amount of tar-like material at a crack in the asphalt pavement, material was removed. Lat: 29.785392, Long: -95.318655

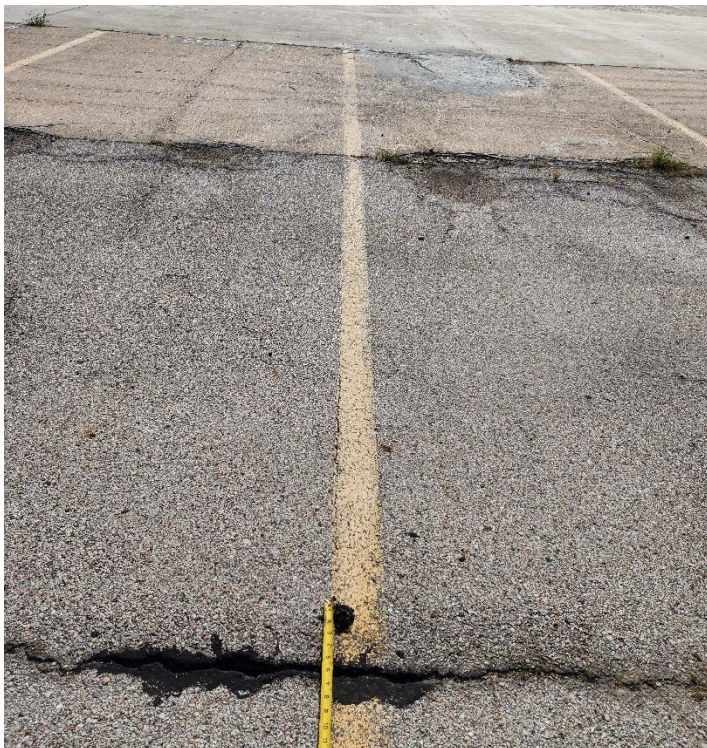
Description: Stall B056, a very small amount of tar-like material at a crack in the asphalt pavement, material was removed, looking southeast Lat: 29.7847472 Long: - 95.3195417			
Photo No. 12	Inspection Date: 11/09/2022

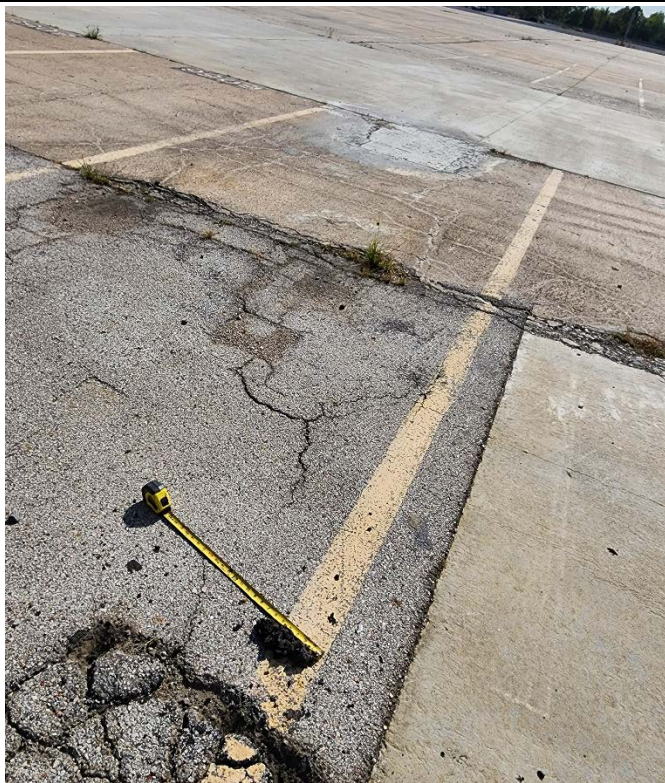
Description: Stall B057, small amount of tar-like material at historical seep location in asphalt cracks, no seeps observed where nearby test pit was conducted (July 2020), material was removed, looking southeast. Lat: 29.7847472 Long: - 95.3195417

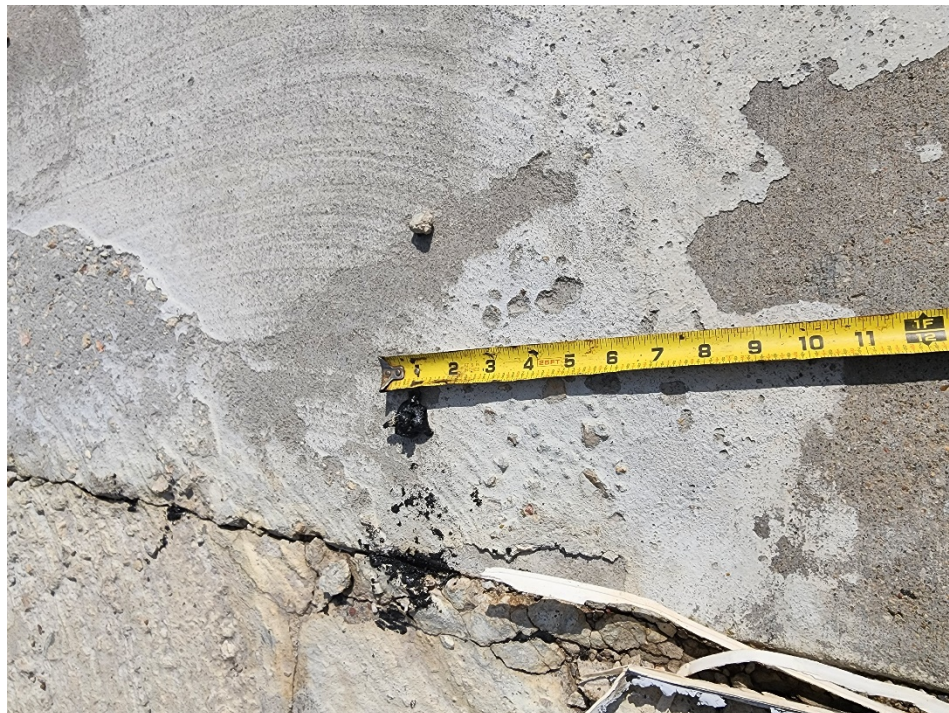
Photo No. 13	Inspection Date: 11/09/2022
-------------------------------	---------------------------------------

During the inspection on September 28, 2022, a small amount of tar like material was observed in stall B096 adjacent to the test pit patch for the first time since the test pit installation. Tar like material was recovered from B096 near the historical seep location, along the concrete joint at the front of the stall during three of the five inspections in November (Photo Nos. 2, 13, and 18). Through November 2022, no NAPL seeps have been observed at the six other test pit locations (stalls A010, A021, A098, B013, B057, and B108). The seep observed in stalls B057 (Photo No. 12) during the November 9, 2022 inspection is located in cracks in the asphalt pavement and not at the test pit location.

Stall B096, very small amount of tar-like material observed near historical seep location along concrete joint adjacent to July 2020 test pit.

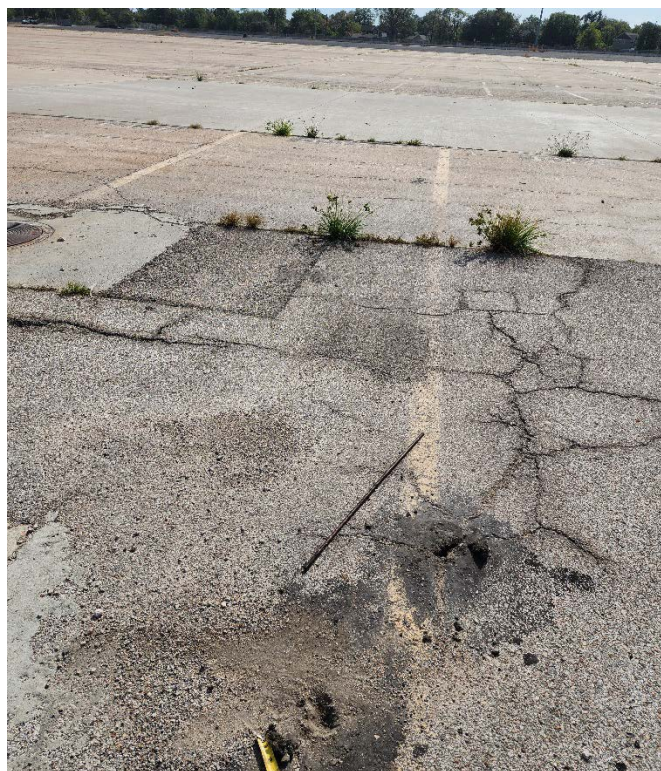
Photo No. 14	Inspection Date: 11/09/2022
-------------------------------	---------------------------------------

Stall B101, very small amount of tar-like material at a crack in the asphalt pavement along B100-B101 stall boundary, material was removed, looking southeast.

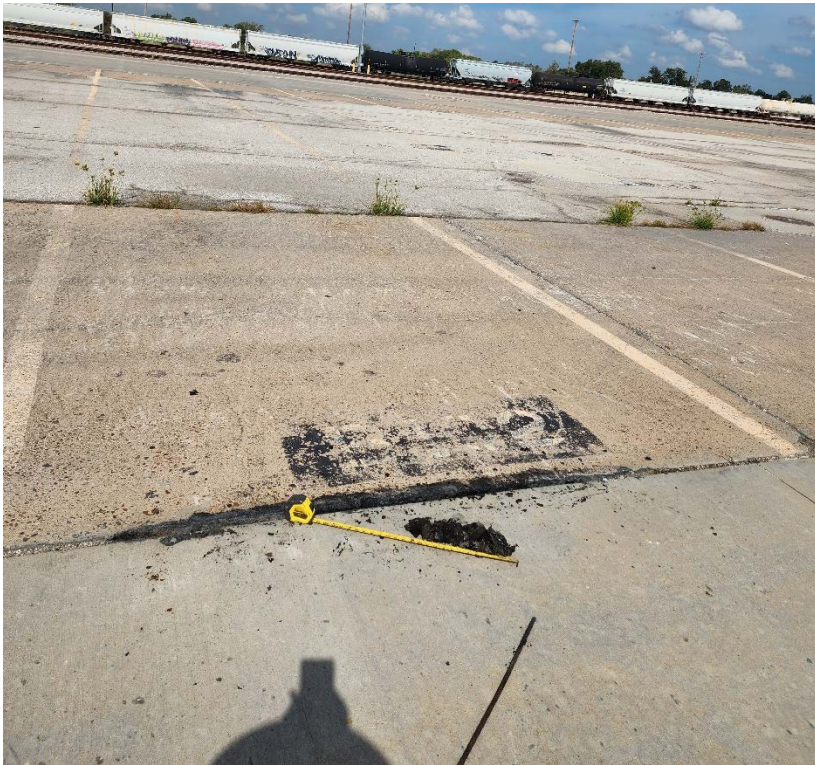
During September 2021, track marks from a container transport vehicle running over the seep in stall B102 were observed and barricades were set up surrounding the seep location to prevent further tracking. The barricades are checked and reset, as needed, during the weekly inspections. UPRR remediation contractor US Ecology pressure washed the tar-like material tracking in October 2021. No new track marks were observed around stall B102 during the November 2022 weekly inspections.

Description: Stall B102, small amount of tar-like material observed within concrete joint, residual staining on concrete surface noted. Lat: 29.7842203 Long: - 95.320827			
Photo No. 16	Inspection Date: 11/09/2022

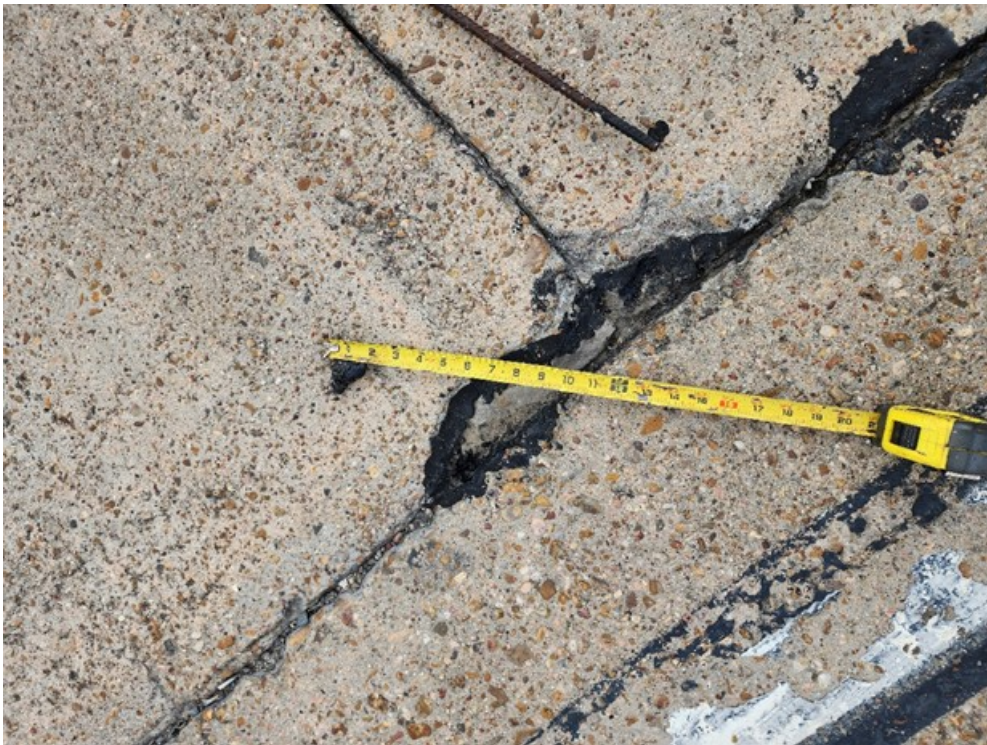
Description: Seep location observed within the concrete road area (RD-14) north of Track 802 (East of existing Track 802 seep location), very small amount of tar-like material observed along a concrete joint, material was removed. Lat: 29.78505 Long: -95.32124

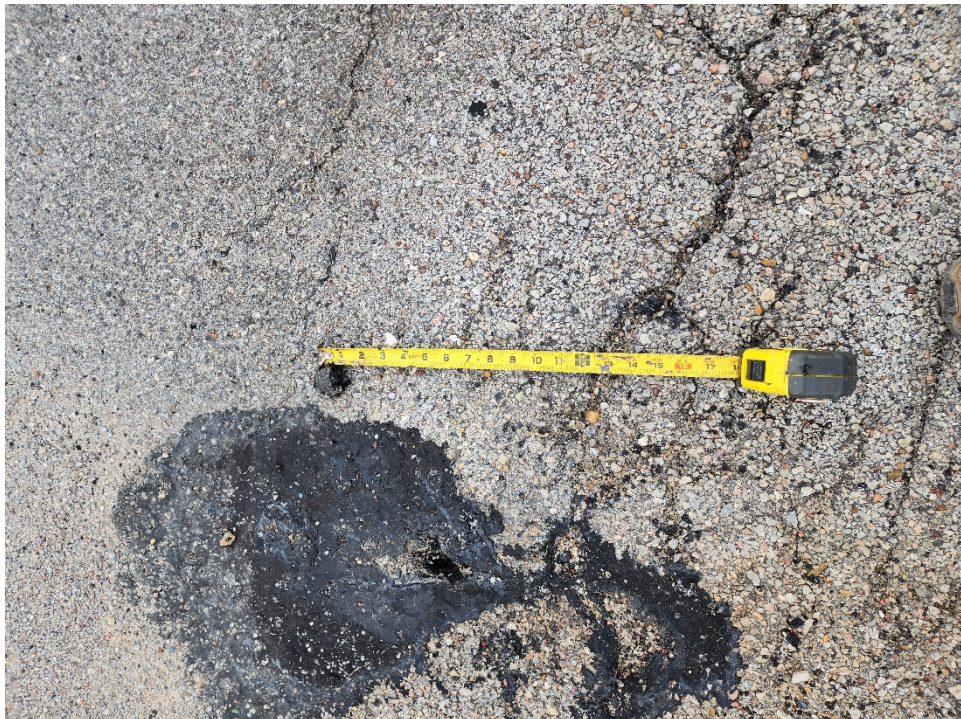
Description: Stall A011, a small amount of tar-like material at a crack in the asphalt pavement, material was removed. Lat: 29.785392, Long: -95.318655			
Photo No. 18	Inspection Date: 11/16/2022

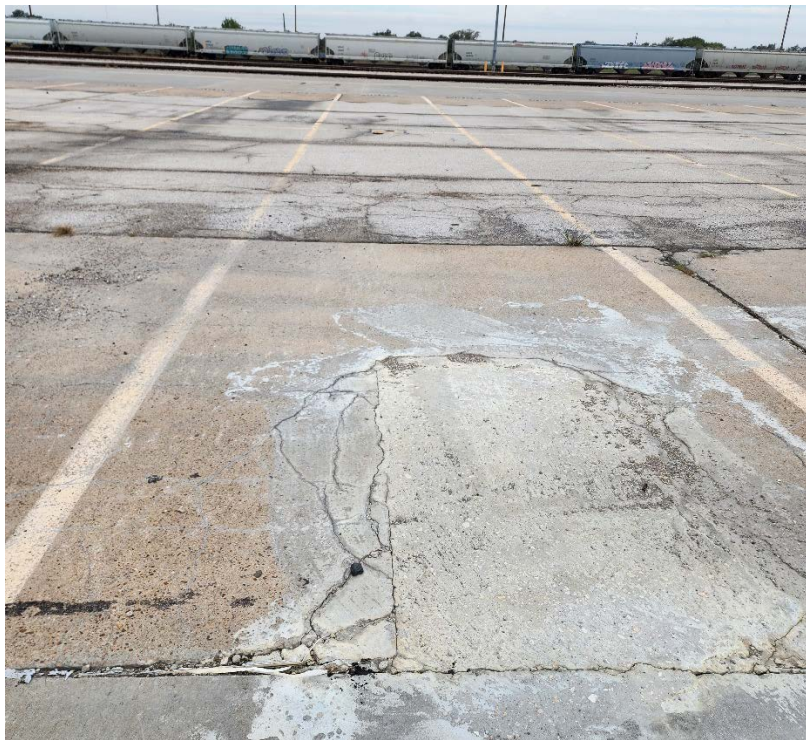
Description: Stall B096, very small amount of tar-like material observed near historical seep location along concrete joint adjacent to July 2020 test pit. Lat: 29.7842528 Long: - 95.3206250

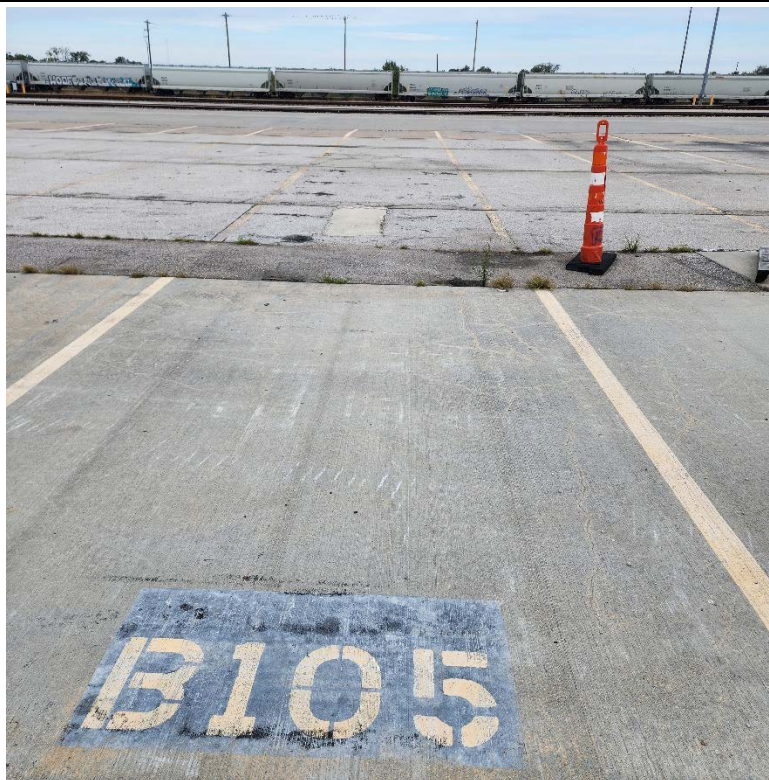
Photo No. 19	Inspection Date: 11/16/2022
-------------------------------	---------------------------------------

Stall B105, no tar-like material observed, looking northwest.

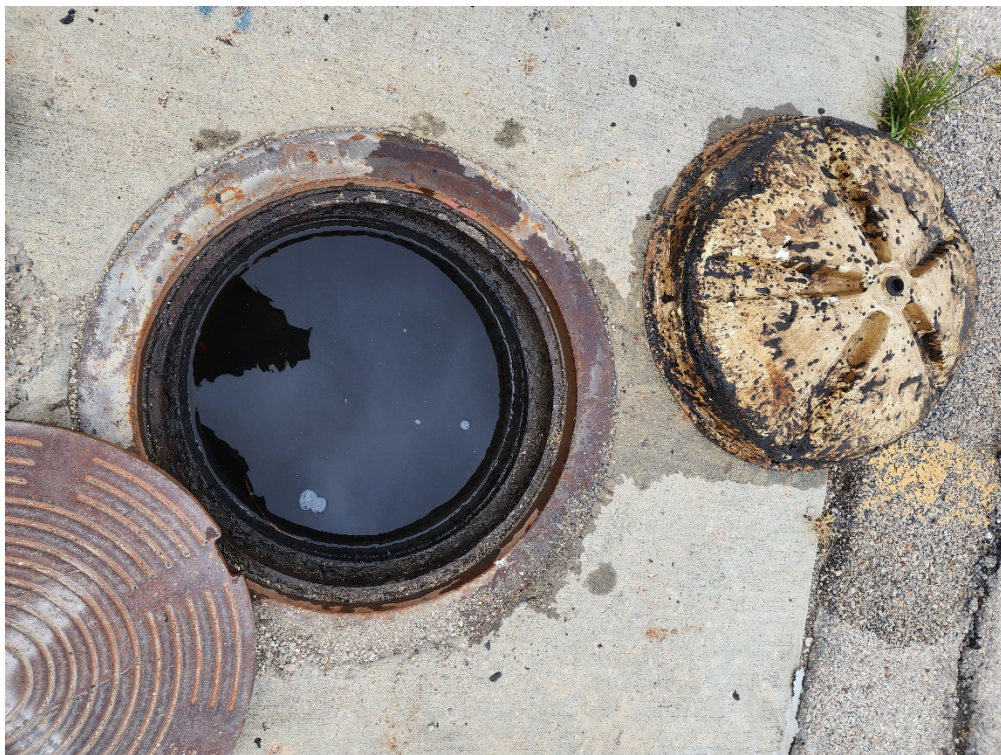
Photo No. 20	Inspection Date: 11/16/2022
-------------------------------	---------------------------------------

Sump 1 (B099/B100), 8 inches of freeboard in sump, no sheen or odor noted, no new NAPL accumulation on the inflow protector.

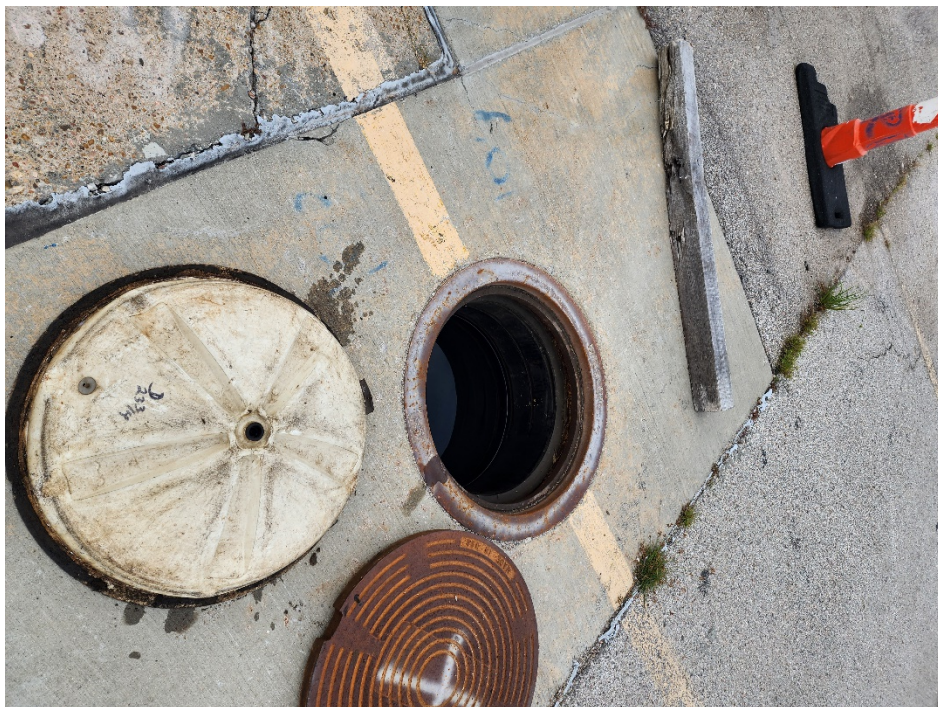
Photo No. 21	Inspection Date: 11/16/2022
-------------------------------	---------------------------------------

Sump 2 (B103/B104), 14 inches of freeboard in sump, no sheen or odor noted.

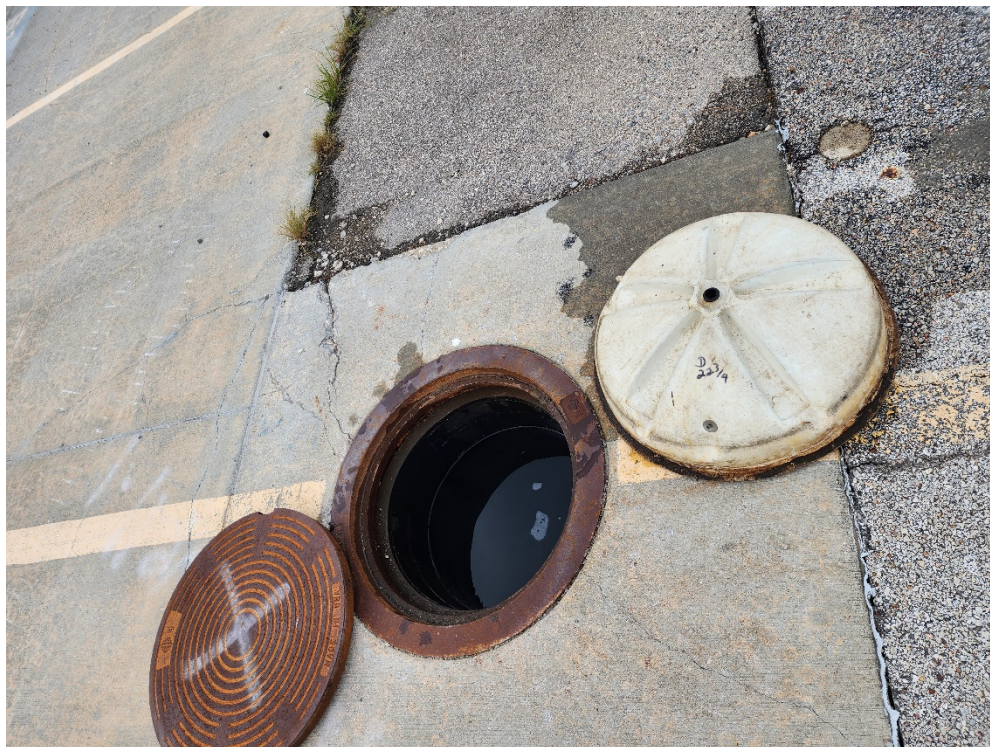
Photo No. 22	Inspection Date: 11/16/2022
-------------------------------	---------------------------------------

Sump 3 (B107/B108), 12 inches of freeboard in sump, no sheen or odor noted.

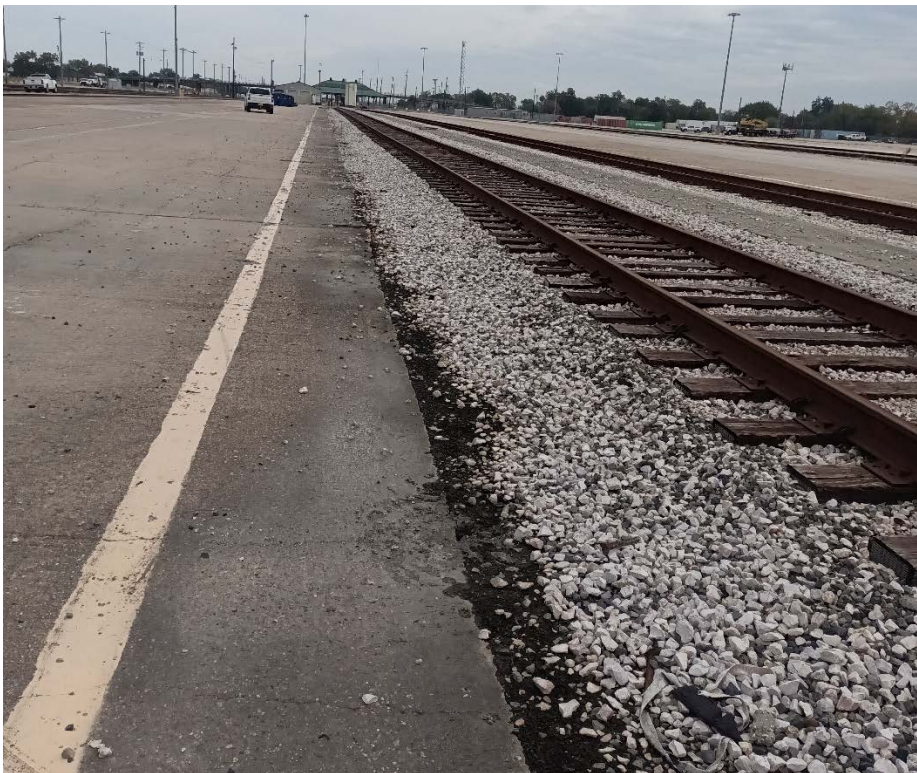
Description: North side of Track 802 no new tar-like material observed at the seep location along the edge of the ballast, looking east. Lat: 29.784947 Long: -95.321214			
Photo No. 24	Inspection Date: 11/16/2022

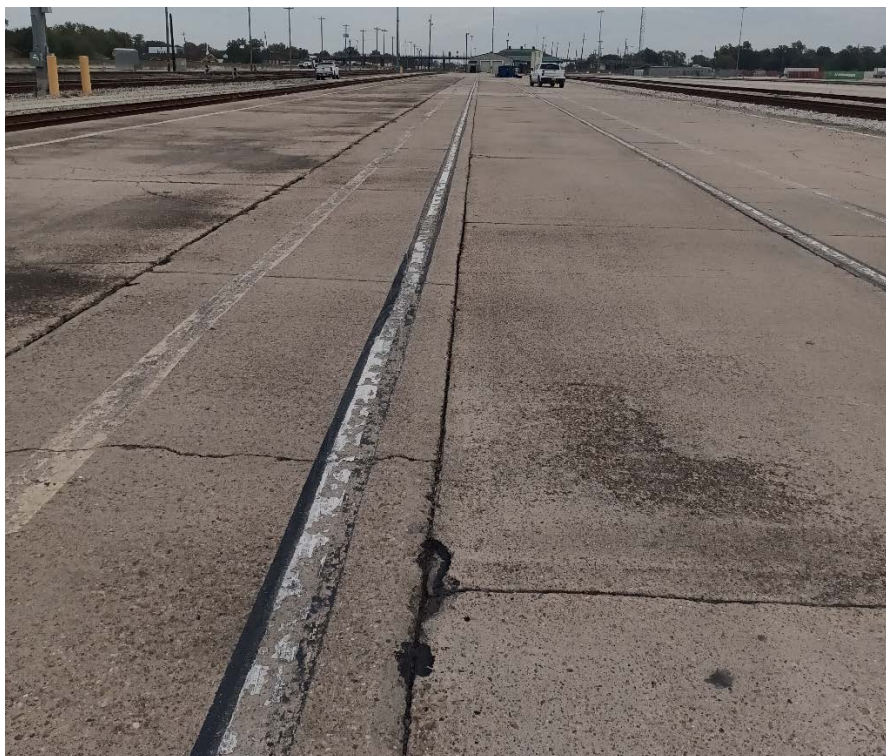
Description: Seep location observed within the concrete road area (RD-14) north of Track 802 (East of existing Track 802 seep location), no new tar-like material observed along a concrete joint, looking east. Lat: 29.78505 Long: -95.32124

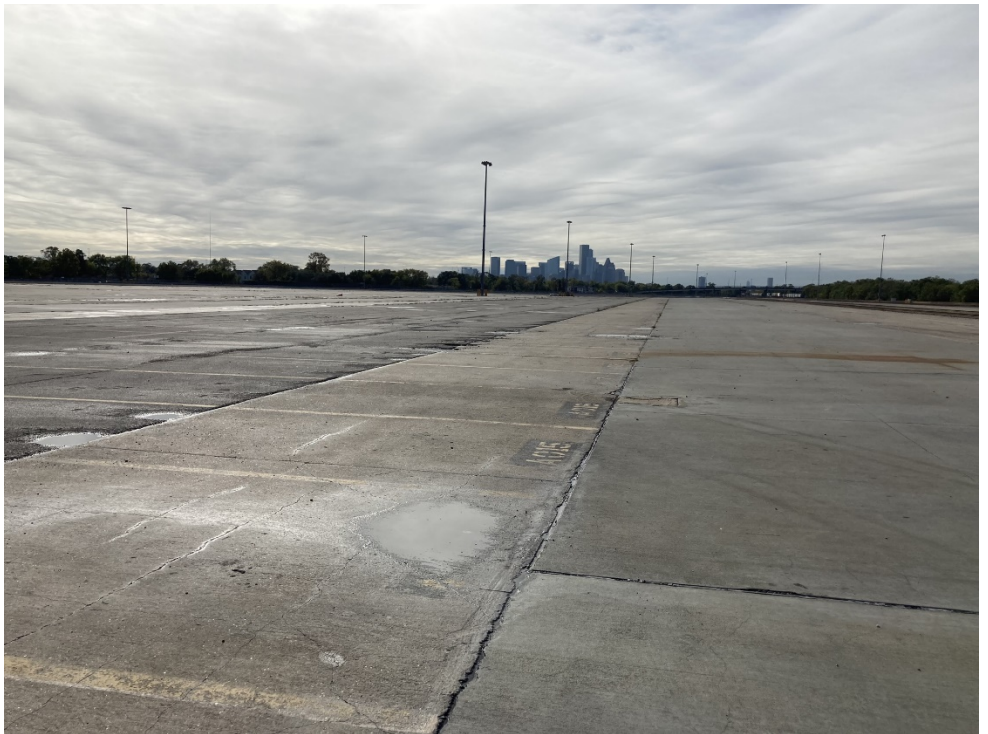
Description: Eastern end of A and B rows, no new tar-like material observed, standing water from recent rain event, looking west. Lat: 29.785392, Long: -95.318655			
Photo No. 26	Inspection Date: 11/22/2022

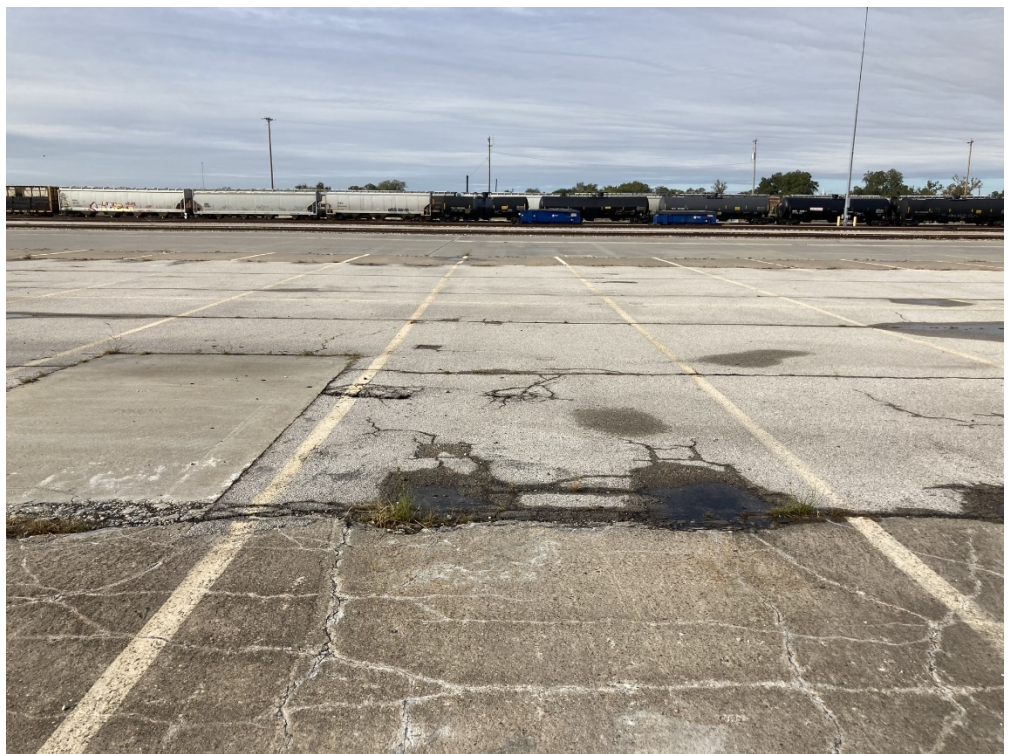
Description: Stall B056-B058, no tar-like material at historical seep locations in B046 or B057, no seeps observed where nearby test pit was conducted (July 2020), standing water from recent rain event, looking northwest. Lat: 29.7847472 Long: - 95.3195417

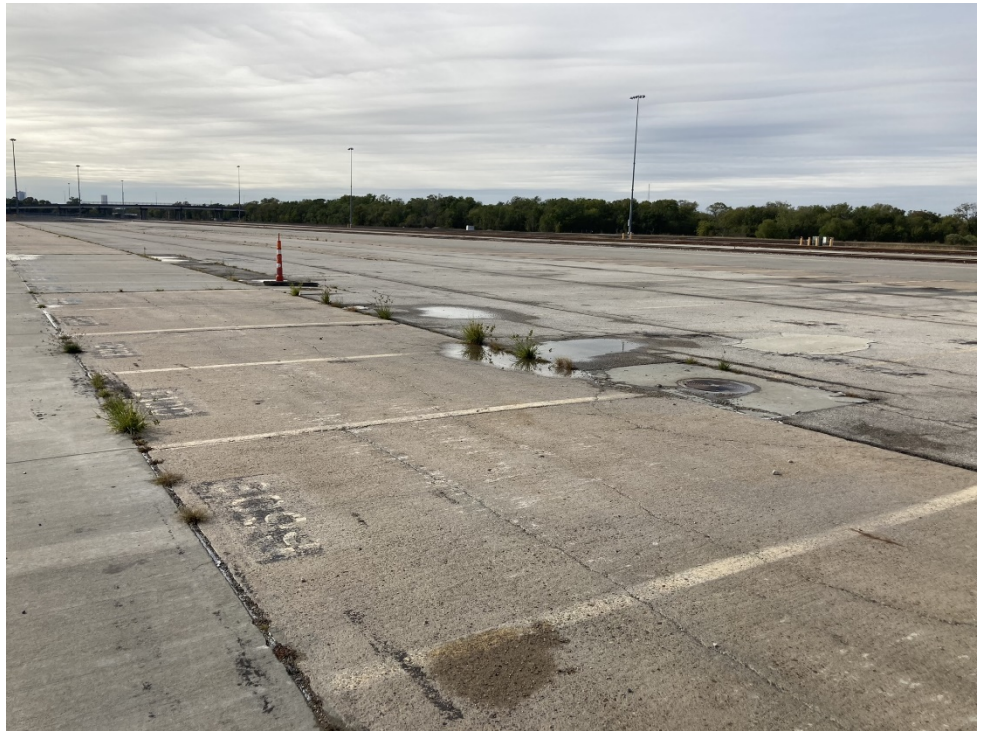
Photo No.
27

Stalls B099-B110, NAPL collection system area, no new tar-like material observed, standing water from recent rain event, looking northwest.

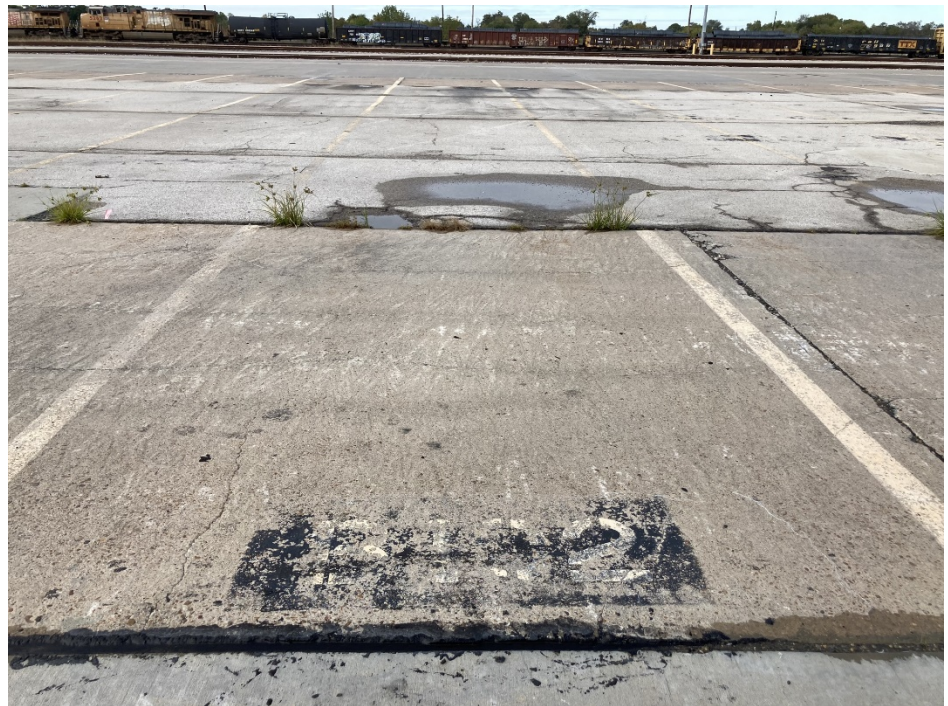
Photo No.
28

Stall B102, no tar-like material seep observed within joint, residual staining on concrete surface noted, standing water from recent rain event, looking northwest.

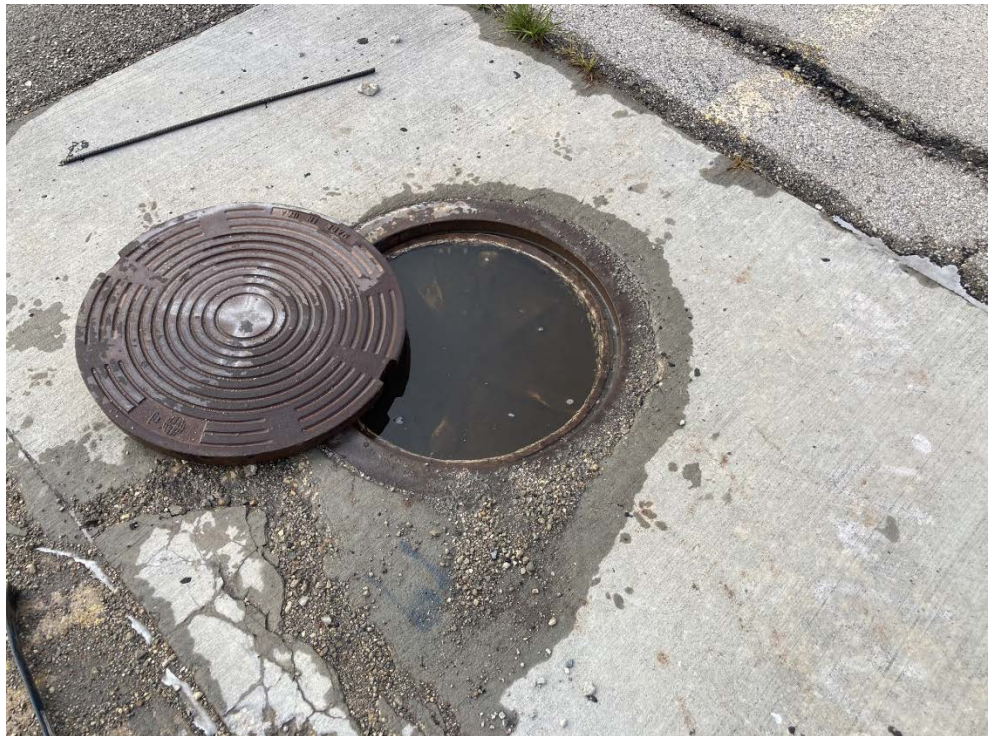
Photo No.
29

Sump 1 (B099/B100), 0 inches of freeboard in sump, inflow protector was not removable due to the high water level in the sump, no sheen or odor noted.

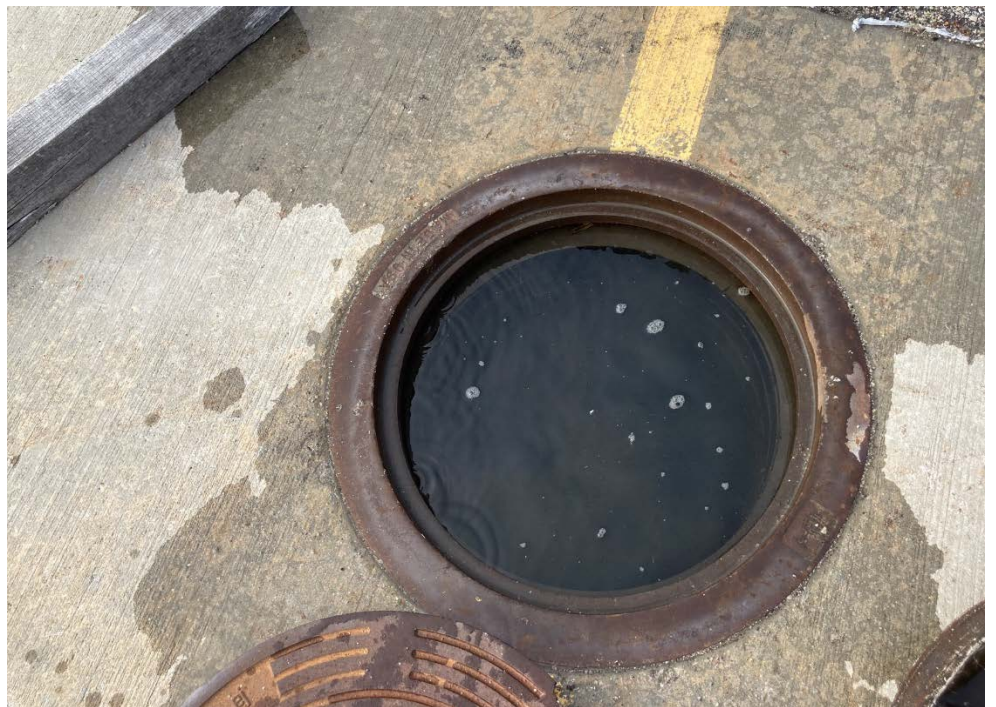
Photo No.
30

Sump 2 (B103/B104), 0 inches of freeboard. No sheen or odor noted.
