Project No. 19119232

**Re: MONTHLY STATUS UPDATE – ENGLEWOOD INTERMODAL YARD – NAPL COLLECTION
SYSTEM/CONCRETE CAP REPAIRS
UNION PACIFIC RAILROAD HOUSTON WOOD PRESERVING WORKS FACILITY
4910 LIBERTY ROAD FACILITY, HOUSTON, TEXAS
POST-CLOSURE CARE PERMIT NO. HW-50343; INDUSTRIAL SWR NO. 31547**

Weekly Inspection Photolog

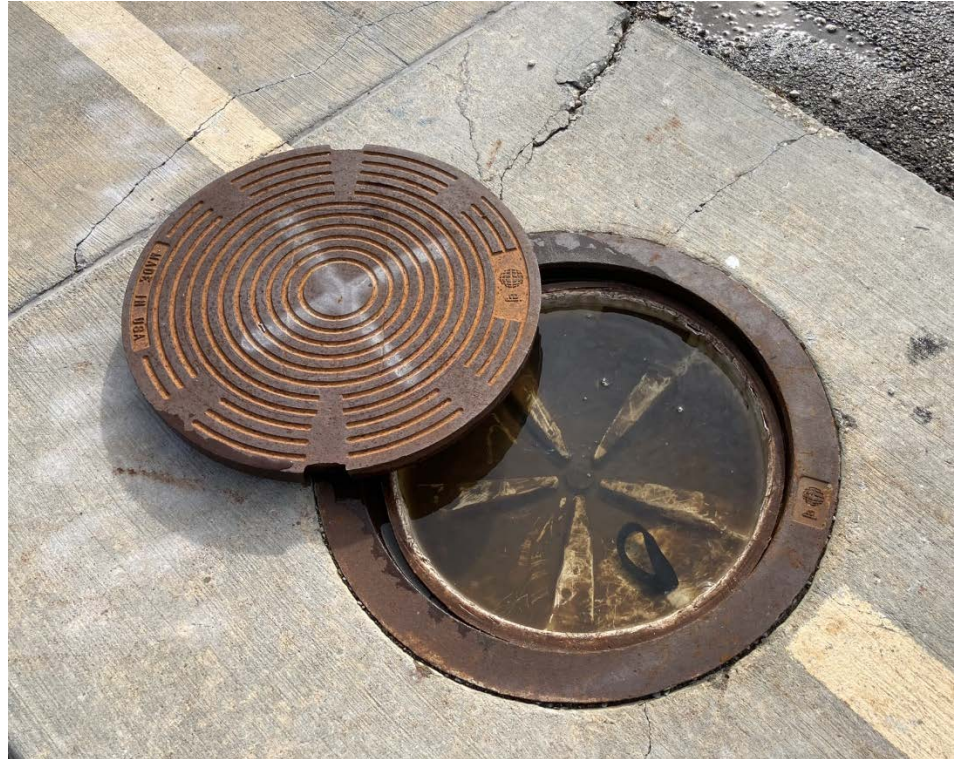
Photo No.
31

Sump 3 (B107/B108), 0 inches of freeboard in sump, inflow protector was not removable due to the high water level in the sump, no sheen or odor noted.

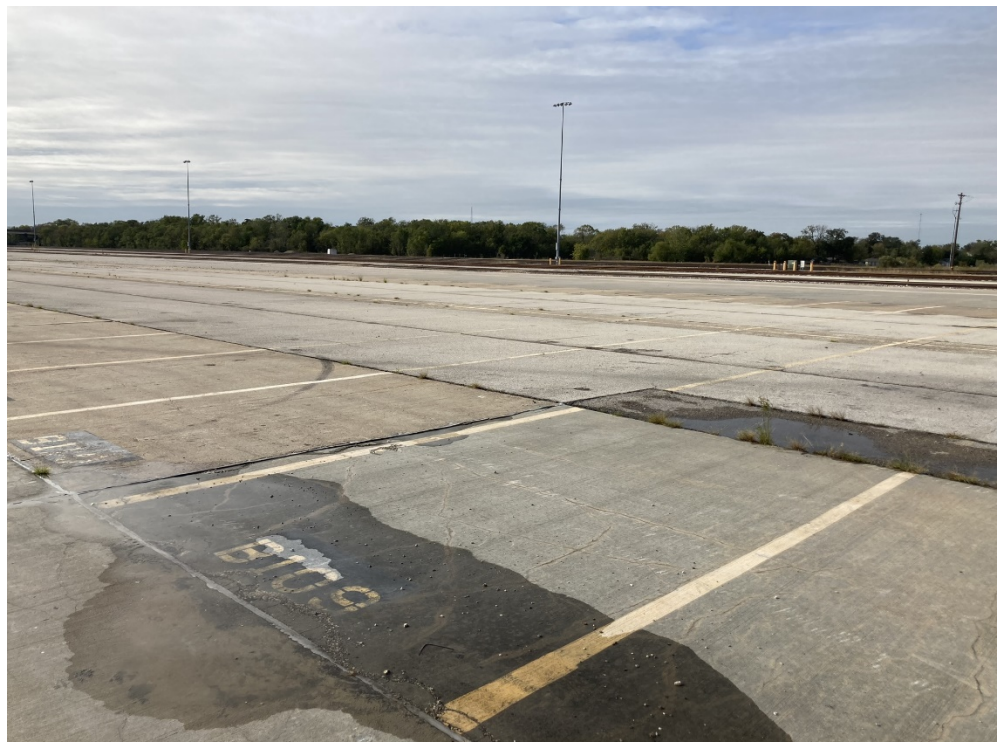
Photo No.
32

Stall B109, western end of NAPI Collection system, no tar-like material observed, water on pavement from recent rain event, looking northwest.

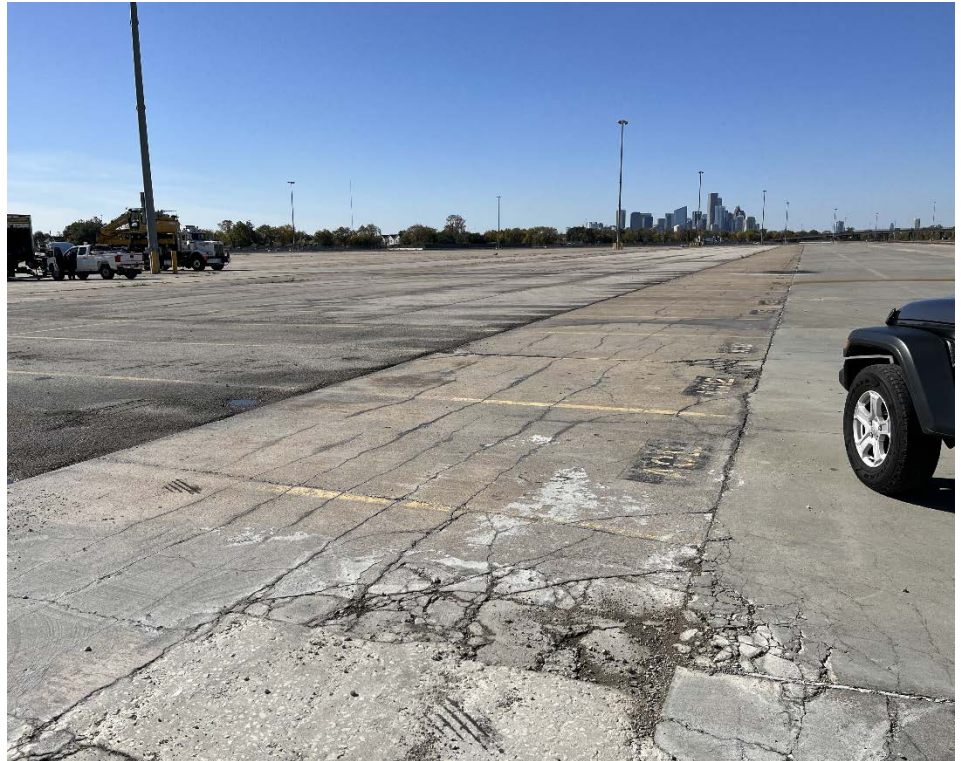
Photo No.
33

Stall A010, view of eastern end of A row. No tar-like material seeps observed, looking west.

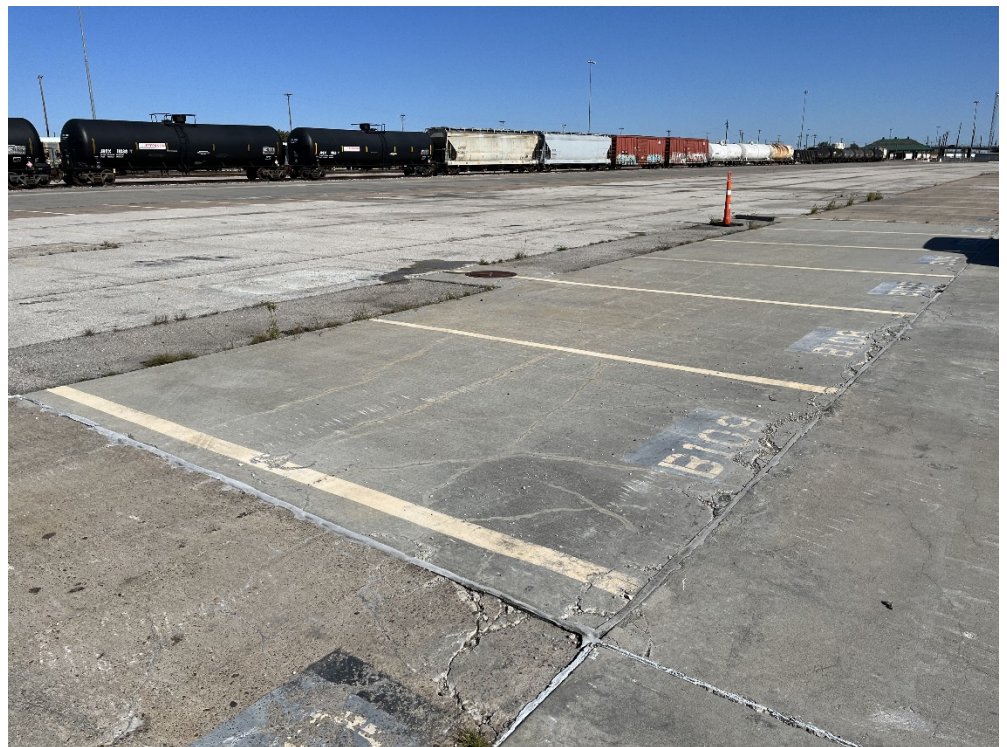
Photo No.
34

Stall B109, view of NAPI Collection system, no tar-like material seeps observed, looking northeast.

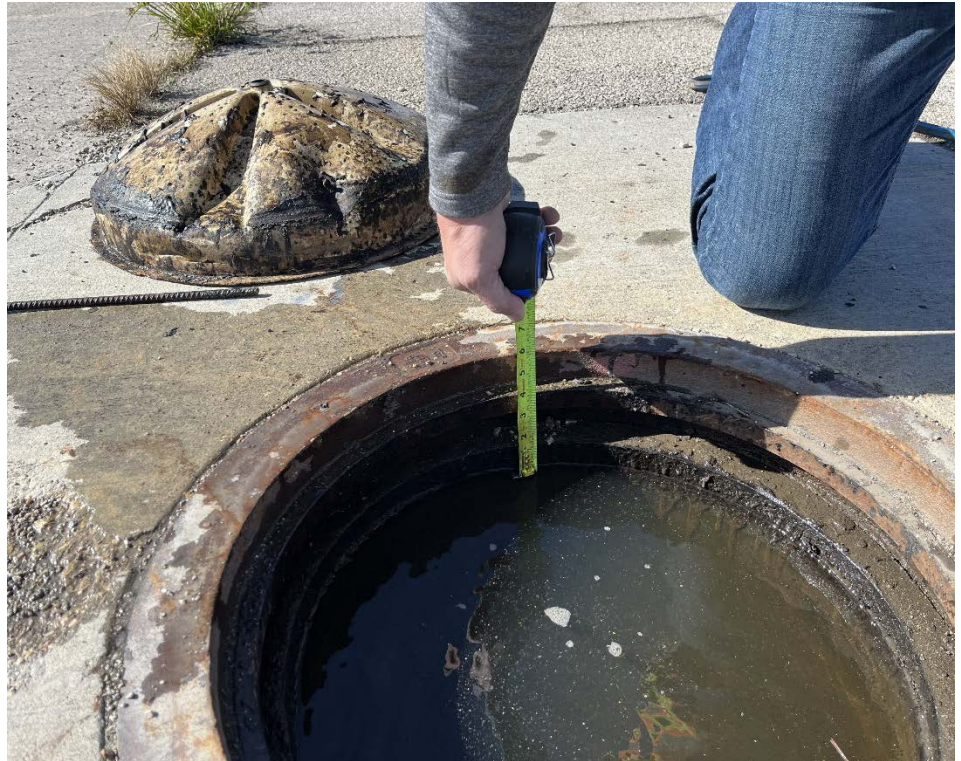
Photo No.
35

Sump 1 (B099/B100), 3 inches of freeboard in sump, very slight sheen observed, no odor noted. No new NAPL accumulation on inflow protector.

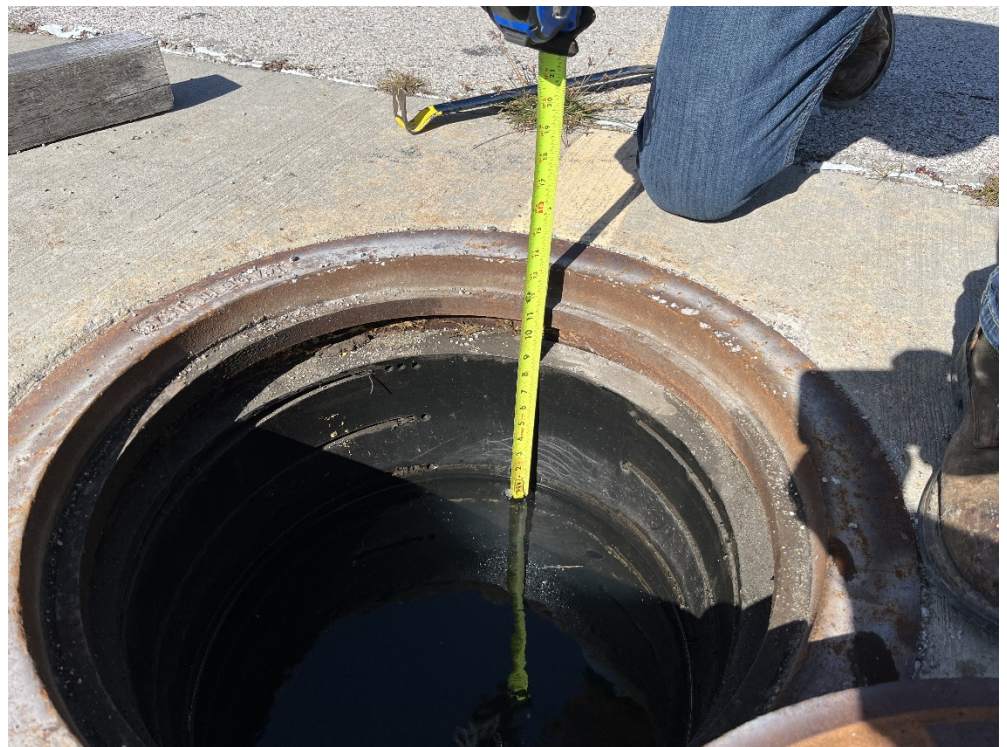
Photo No.
36

Sump 2 (B103/B104), 10 inches of freeboard, very slight sheen observed, no odor noted.

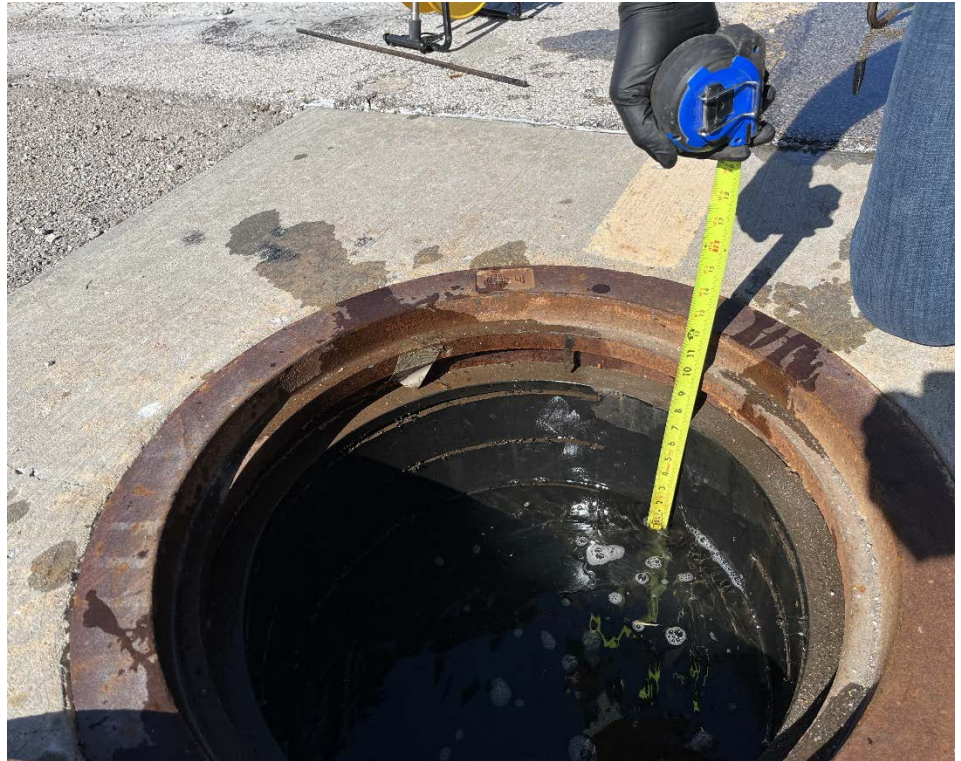
Photo No.
37

Sump 3 (B107/B108), 9 inches of freeboard in sump, very slight sheen observed, no odor noted.

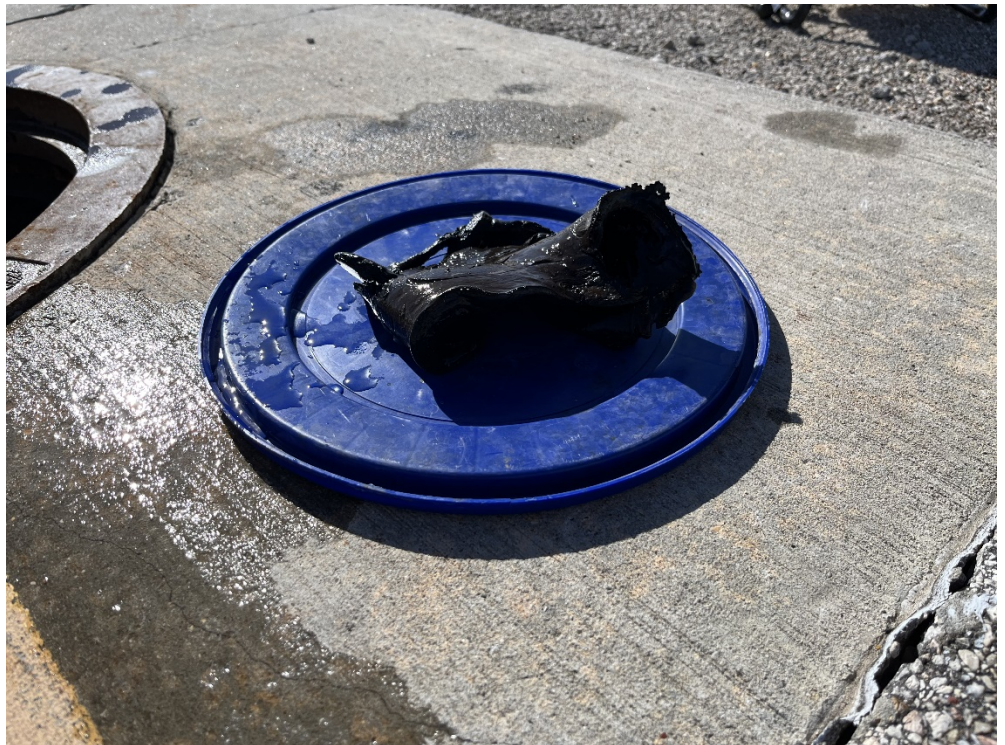
Photo No.
38

Sump 3 (B107/B108), small amount of rubbery tar-like material (approx. 0.2 gal) recovered from sump.
