September 15, 2022

Project No. 19119232

Re: **MONTHLY STATUS UPDATE – ENGLEWOOD INTERMODAL YARD – NAPL COLLECTION SYSTEM/CONCRETE CAP REPAIRS  
UNION PACIFIC RAILROAD HOUSTON WOOD PRESERVING WORKS FACILITY  
4910 LIBERTY ROAD FACILITY, HOUSTON, TEXAS  
POST-CLOSURE CARE PERMIT NO. HW-50343; INDUSTRIAL SWR NO. 31547**

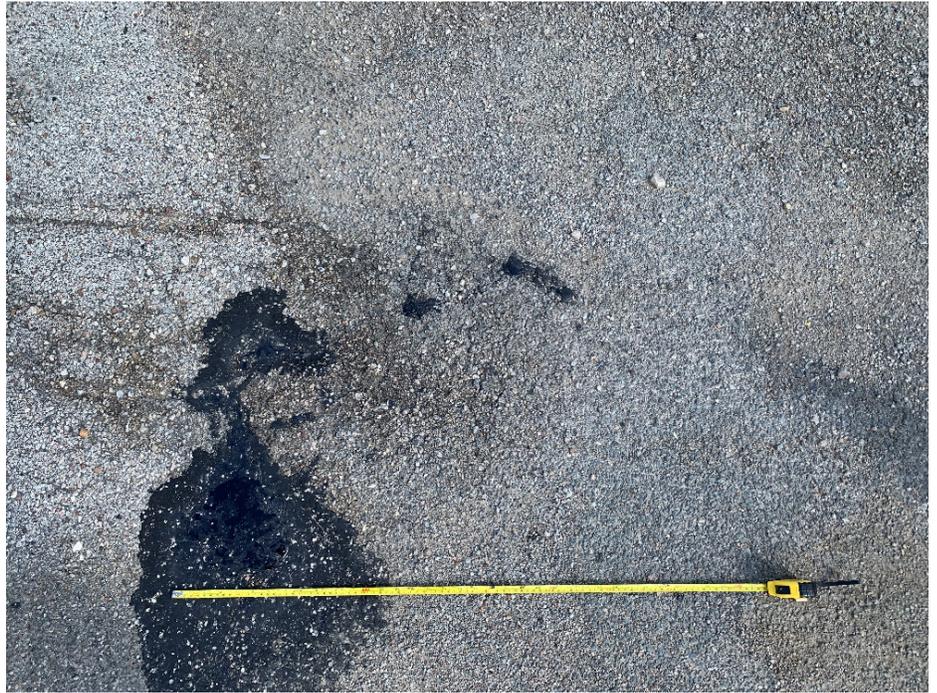
Stall A011, a small amount of tar-like material at a crack in the asphalt pavement, material was removed.

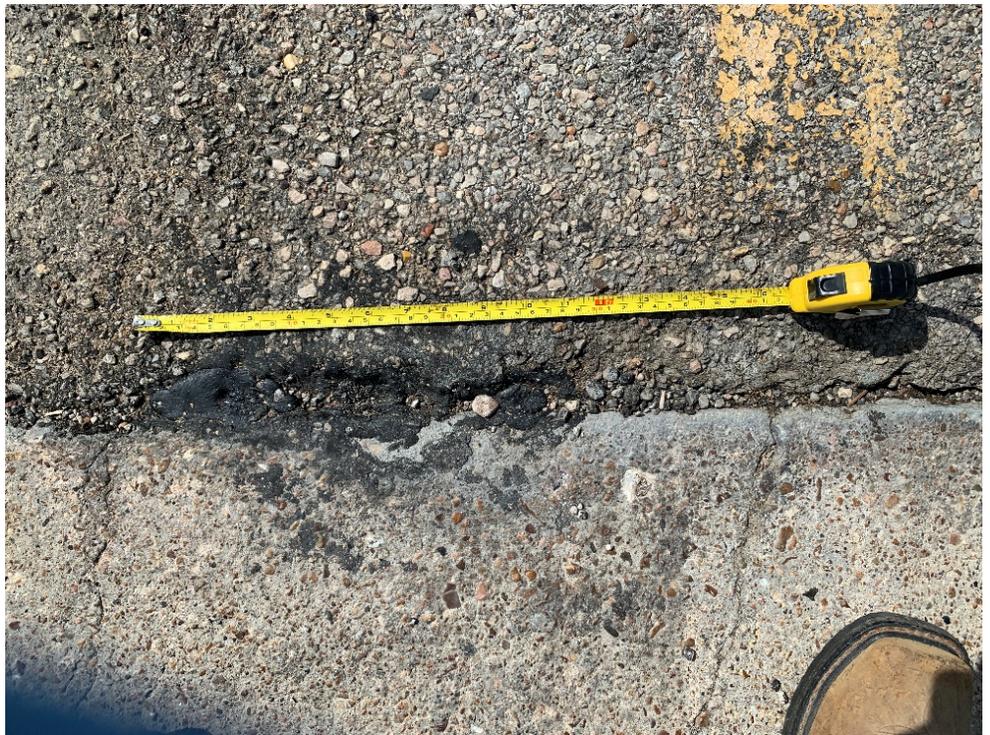
**Photo No.**  
**2**

Stall A022, a small amount of tar-like material at a crack in the asphalt pavement, material was removed.

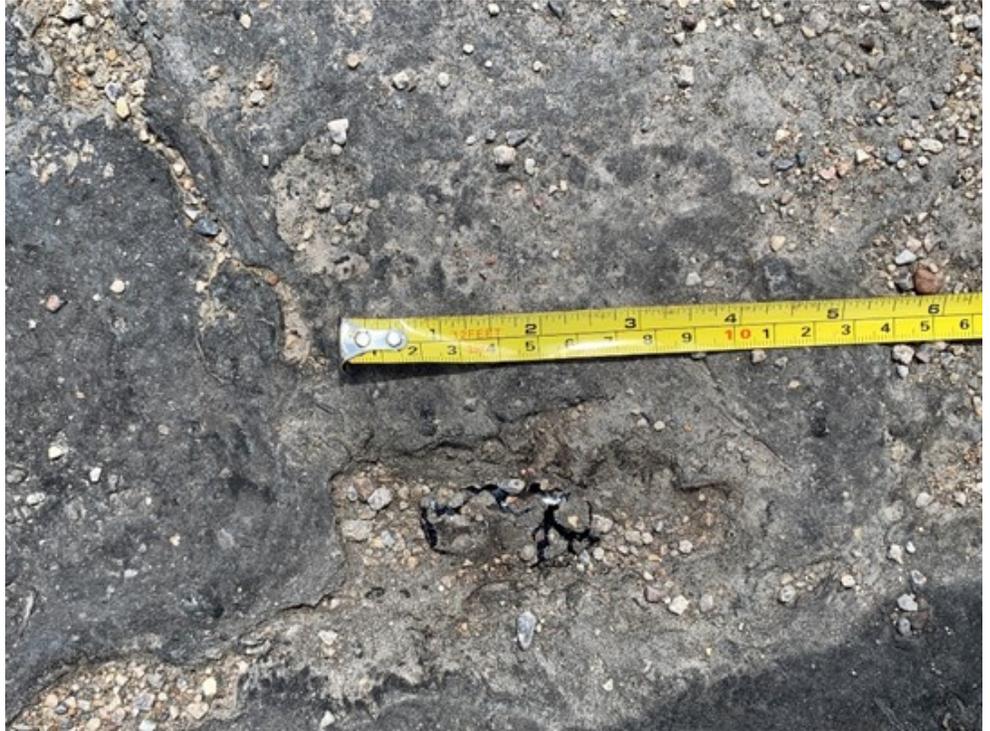
Stall B101, very small amount of tar-like material at a crack in the asphalt pavement, material was removed.

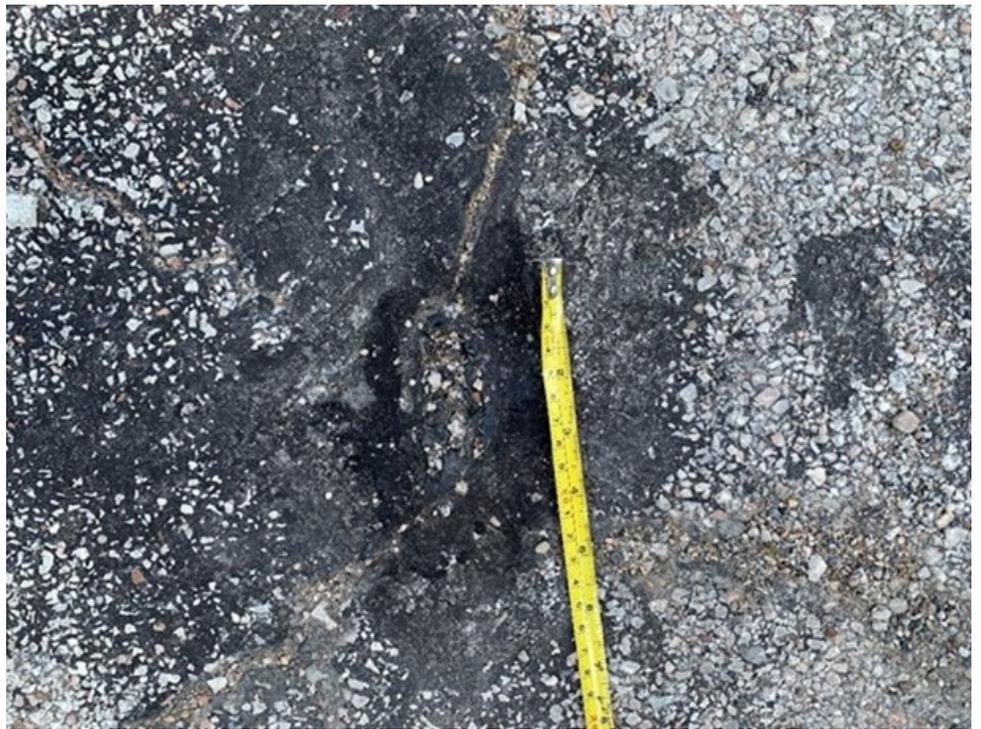
**Photo No.**  
**4**

Stall B105, a small amount of tar-like material in pavement area, material was removed.

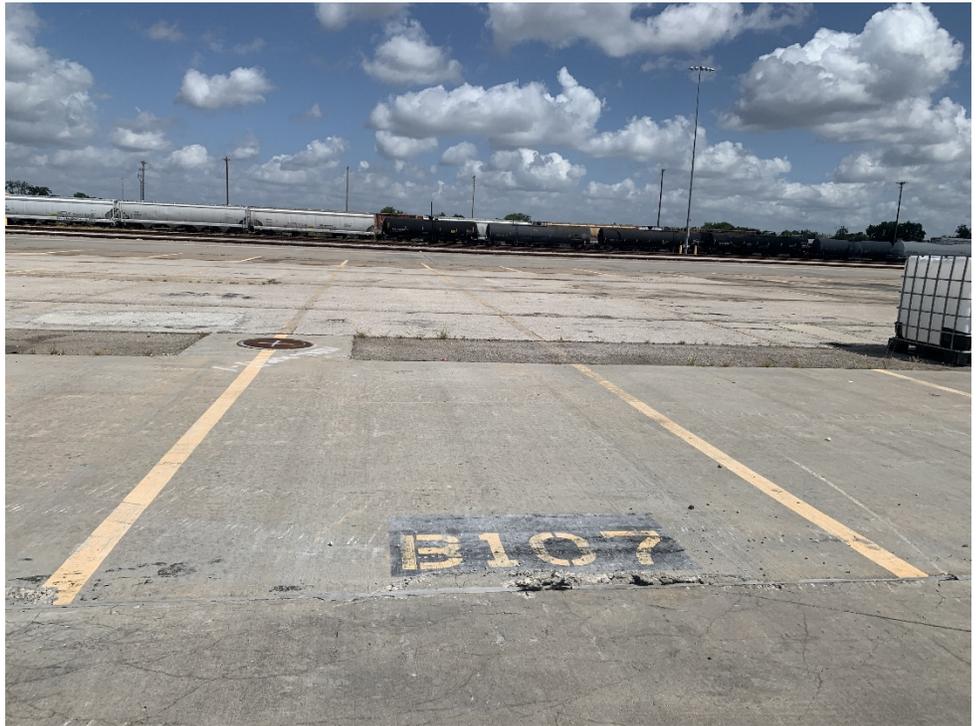
- A small tar-like material seep was observed on the southern edge of the NAPL Collection System in cracks in the cement along the joint of Stall B107 during all five inspections in August (Photo Nos. 5 and 36). This seep was first observed during the July 6, 2022 weekly inspection.

Stall B107, view of NAPL Collection System (Sump B107/B108), a small amount of tar-like material at concrete joint along the southern edge of the excavated area. Material was removed. Looking north.

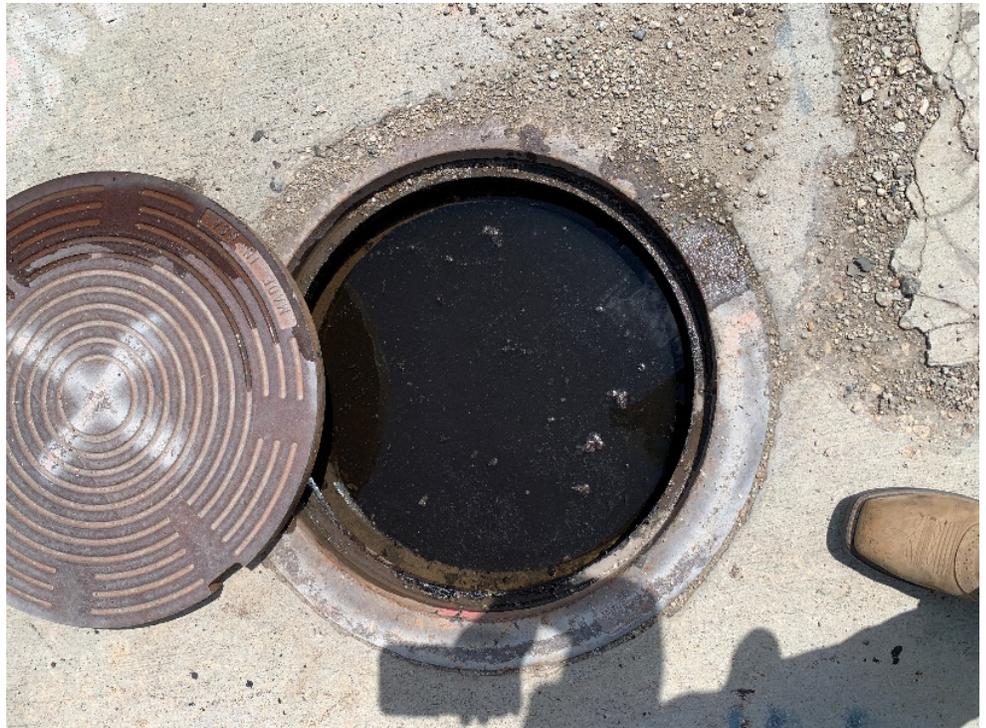
**Photo No.**  
**6**

Sump 1 (B099/B100), 5 inches of freeboard in sump, no odor or sheen noted.

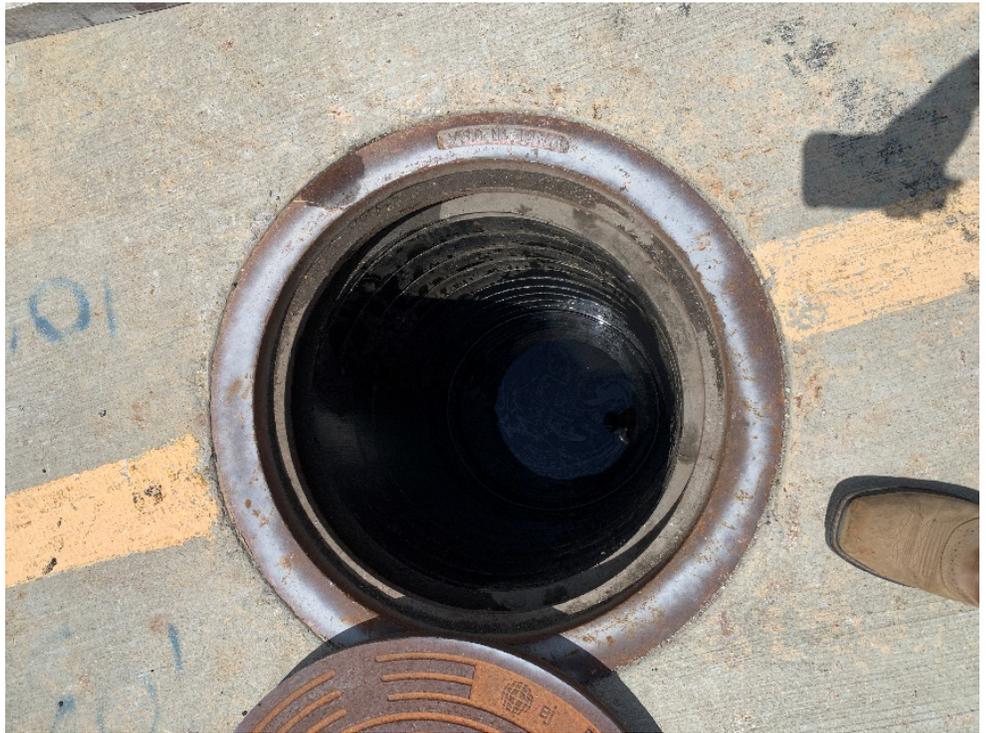
Sump 2 (B103/B104), 39 inches of freeboard. No sheen or odor noted.

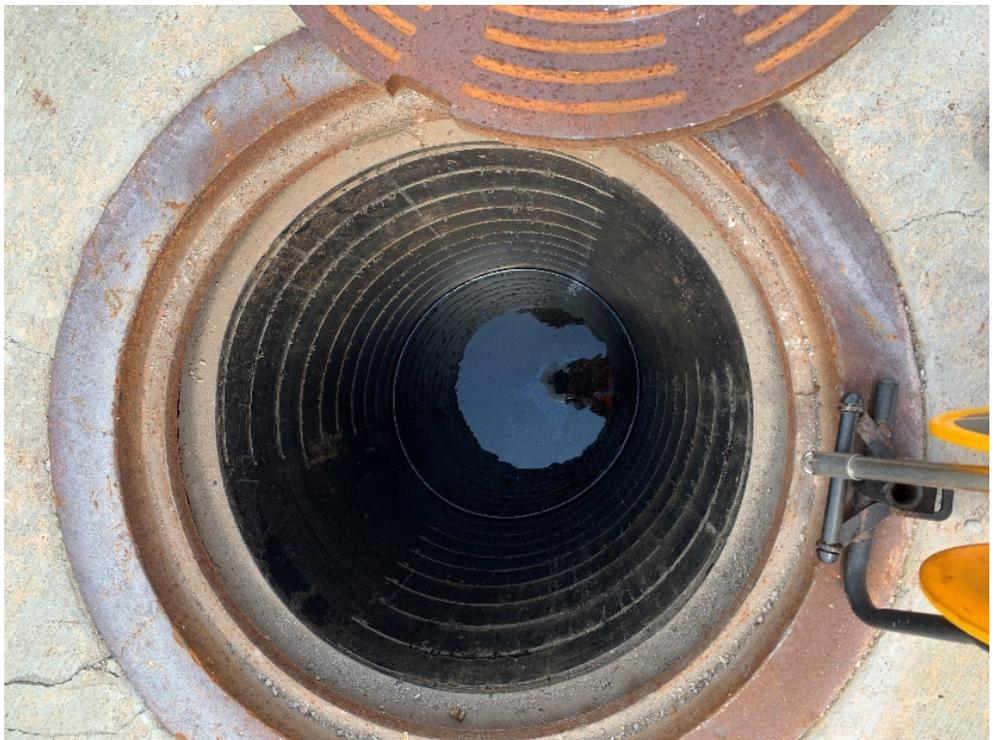
**Photo No.**  
**8**

Sump 3 (B107/B108), 39 inches of freeboard in sump. No sheen or odor noted.

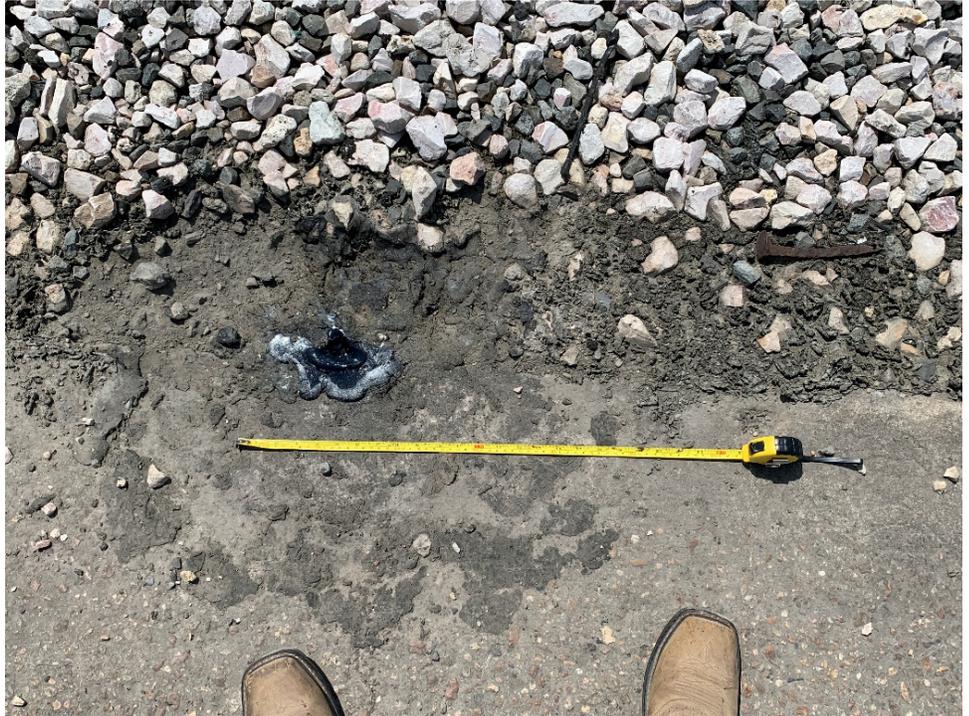
<b>Photo No.</b> 9	<b>Inspection Date:</b> 08/10/2022
-----------------------	---------------------------------------

- As detailed in the July 2022 Monthly Status Update, a tar-like material seep was observed next to Track 802 that is located approximately 280 feet northwest of the NAPL Collection System. The tar-like material seep is located along on the northern side of the track at the edge of the railroad ballast (Photo Nos. 9, 27, and 37), and was observed during all five inspections in August.

North side of Track 802 where medium amount of tar-like material seep observed near track. Material was removed.

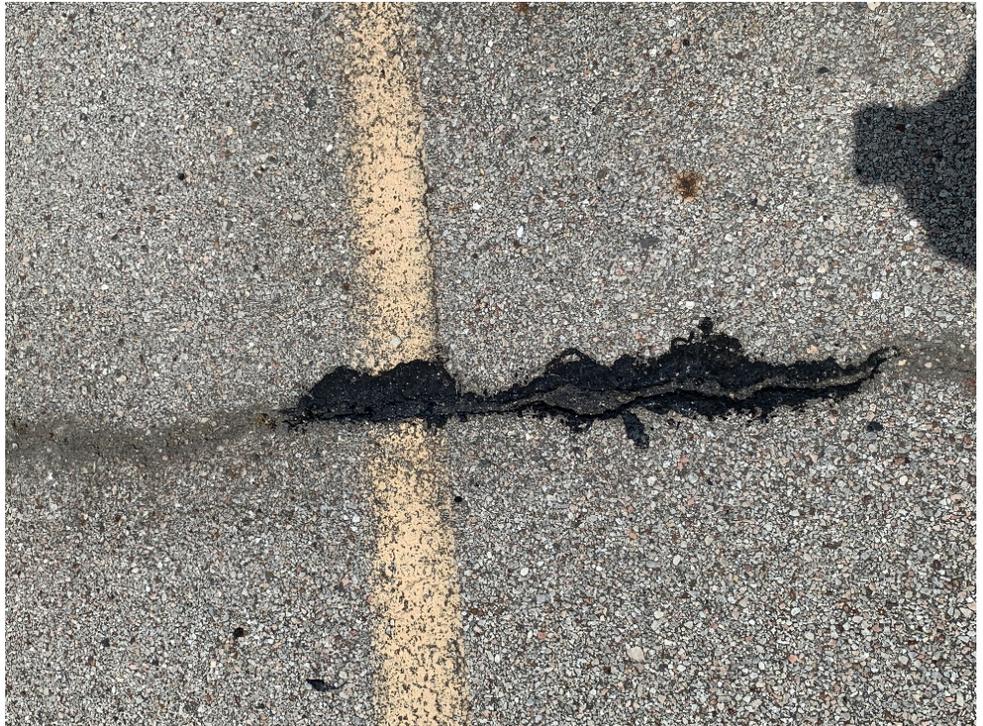
<b>Photo No.</b> 10	<b>Inspection Date:</b> 08/10/2022
------------------------	---------------------------------------

Stall B056, a small amount of tar-like material at a crack in the asphalt pavement, material was removed.

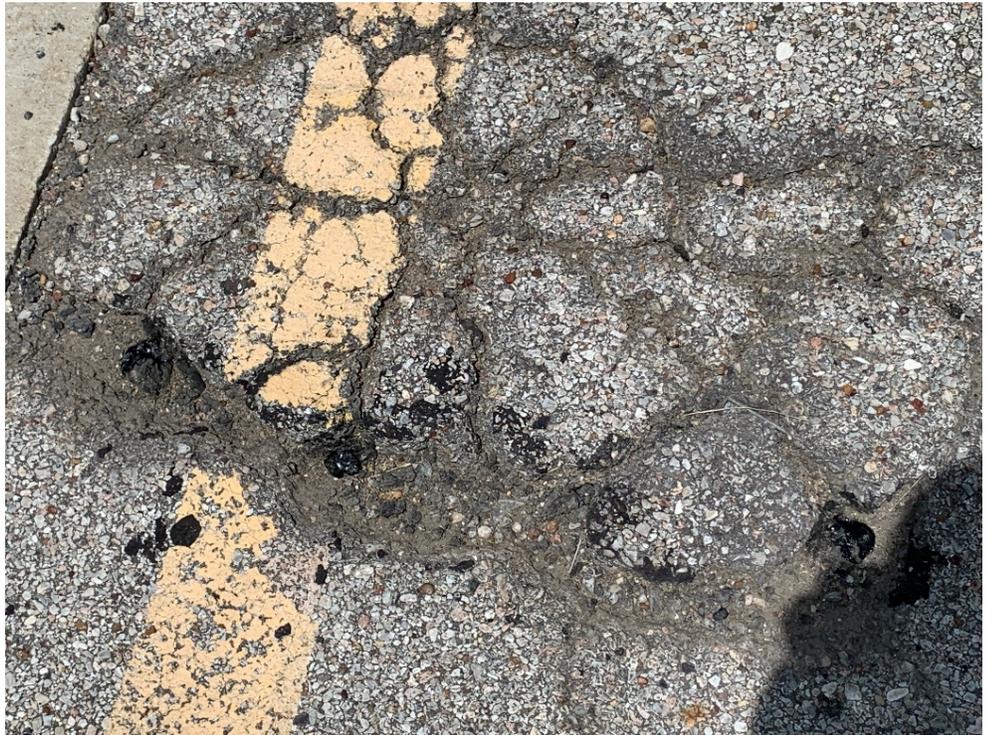
<b>Photo No.</b> <b>11</b>	<b>Inspection Date:</b> 08/10/2022
-------------------------------	---------------------------------------

Stall B057, very small amount of tar-like material at historical seep location in asphalt cracks, no seeps observed where nearby test pit was conducted (July 2020), material was removed.

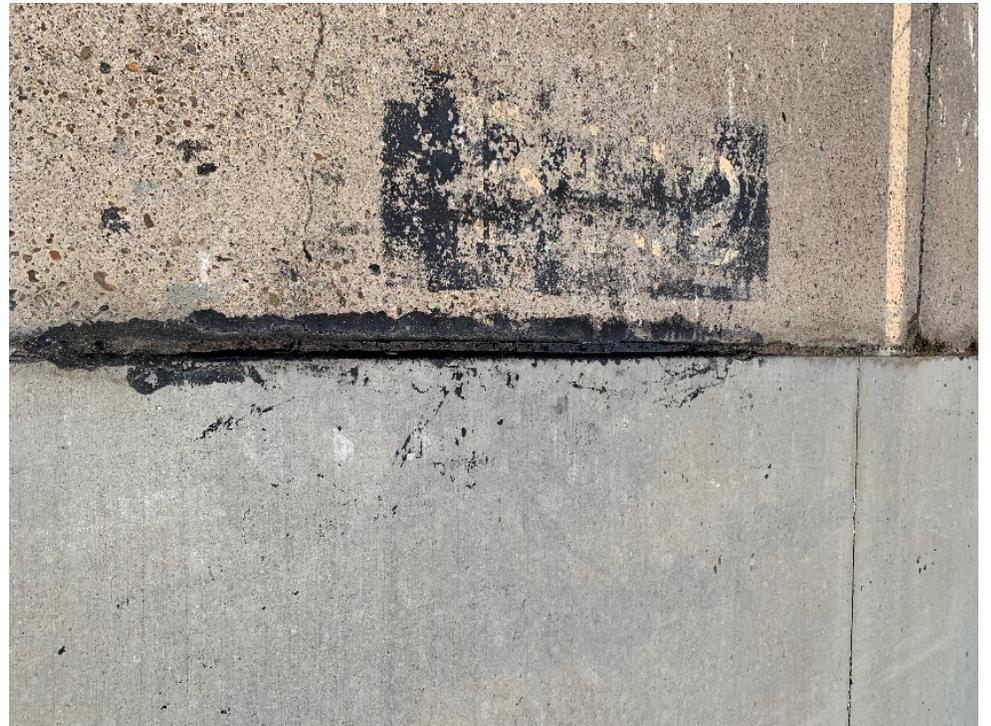
<b>Photo No.</b> <b>12</b>	<b>Inspection Date:</b> 08/10/2022
-------------------------------	---------------------------------------

Stall B102, small amount of tar-like material observed within concrete joint, residual staining on concrete surface noted.

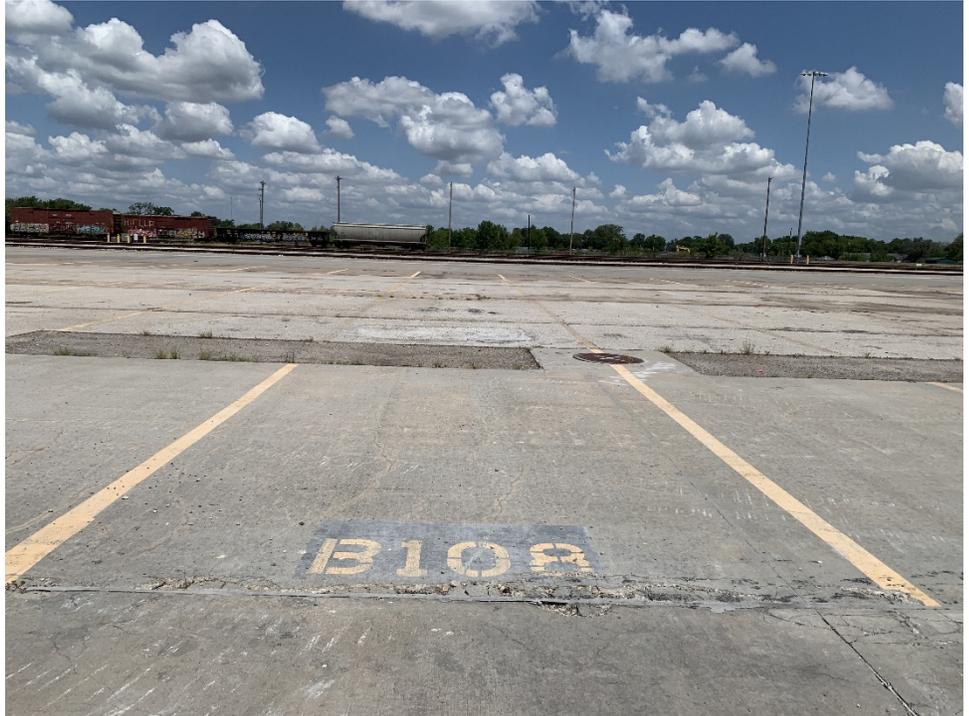
<b>Photo No.</b> <b>13</b>	<b>Inspection Date:</b> 08/10/2022
-------------------------------	---------------------------------------

Stall B108, view of NAPL Collection System (Sump B107/B108 and test pit in background). No tar-like material seeps observed where test pit (July 2020) conducted, looking northwest.

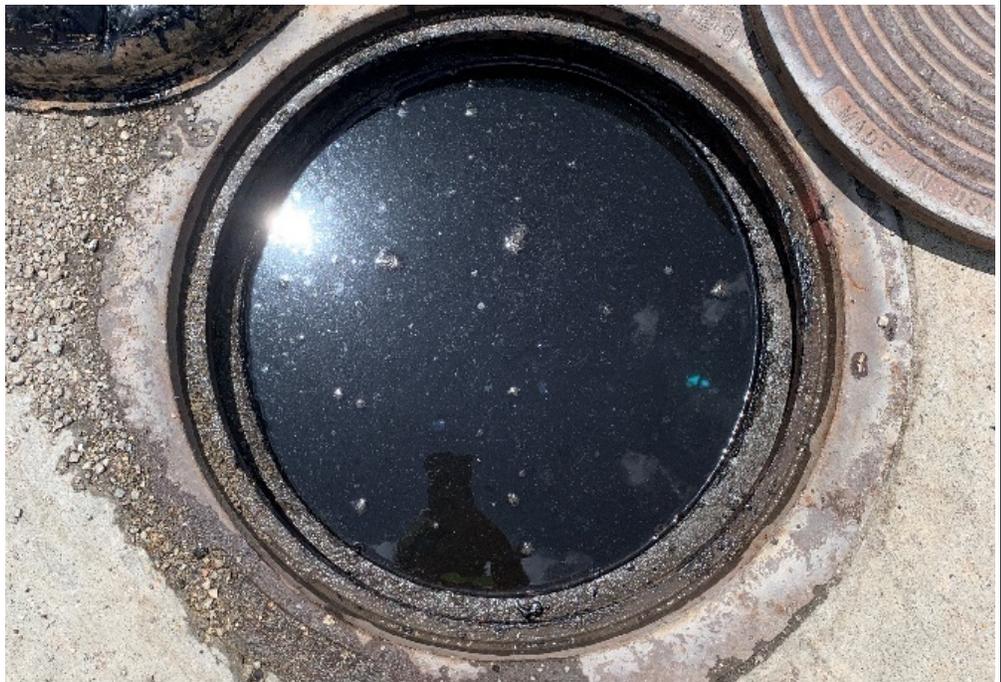
<b>Photo No.</b> <b>14</b>	<b>Inspection Date:</b> 08/10/2022
-------------------------------	---------------------------------------

Sump 1 (B099/B100), 5.5 inches of freeboard in sump. No sheen observed on water in sump or odor noted.

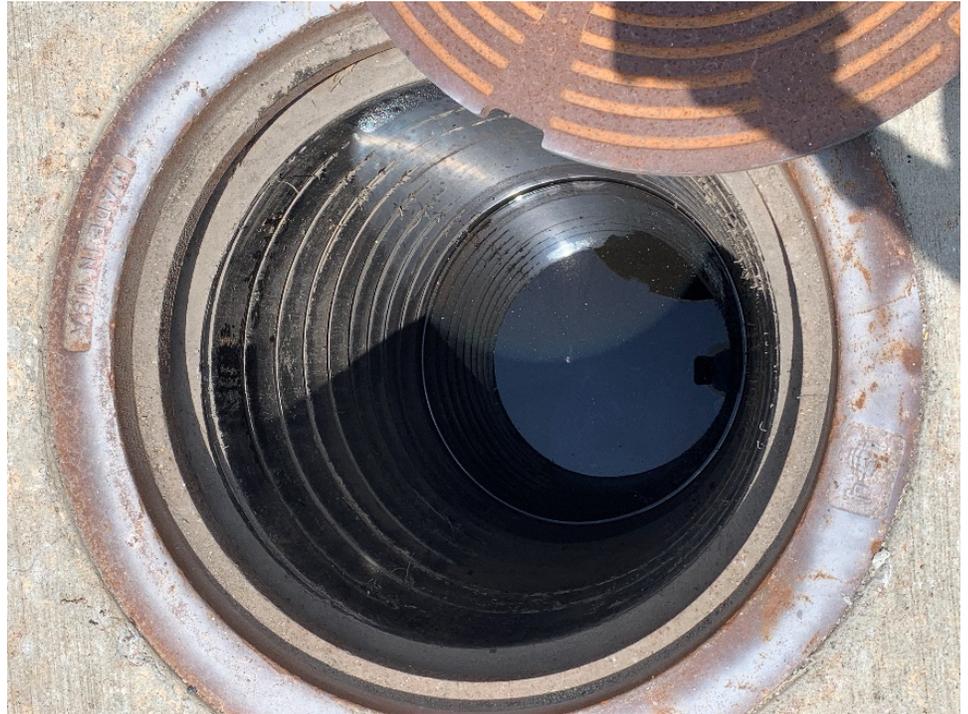
<b>Photo No.</b> <b>15</b>	<b>Inspection Date:</b> 08/10/22
-------------------------------	-------------------------------------

Sump 2 (B103/B104), 38 inches of freeboard in sump. No sheen or odor noted.

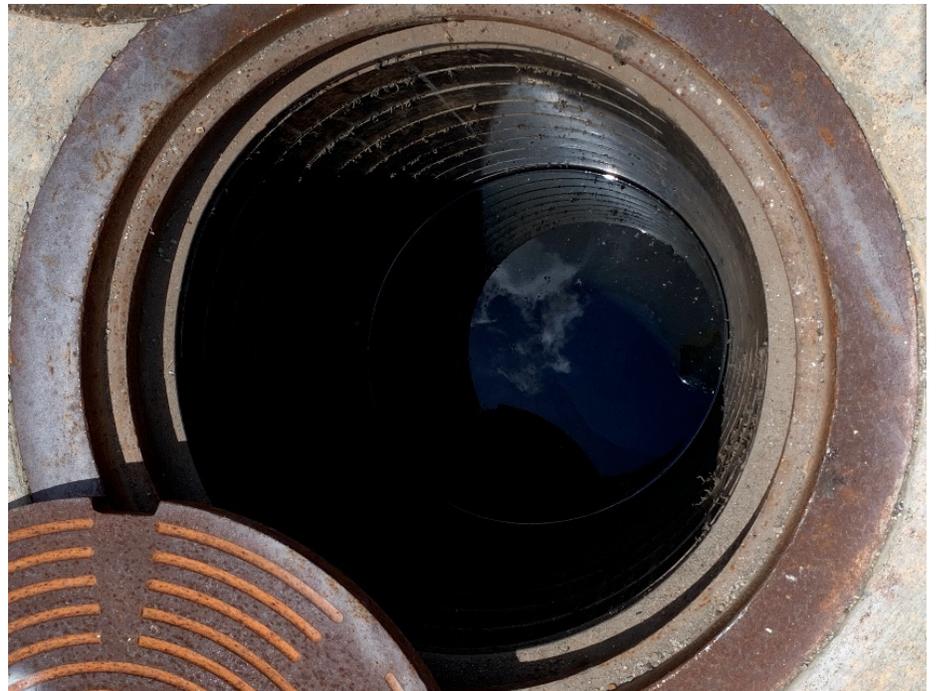
<b>Photo No.</b> <b>16</b>	<b>Inspection Date:</b> 08/10/2022
-------------------------------	---------------------------------------

observed in Sump 3 during the August 10, 2022 inspection (Photo No. 16) and in Sump 2 during the August 31, 2022 inspection (Photo No. 39). No odors were reported during the August inspections.

Sump 3 (B107/B108), 38 inches of freeboard in sump. Sheen noted on the water surface. No odor noted.

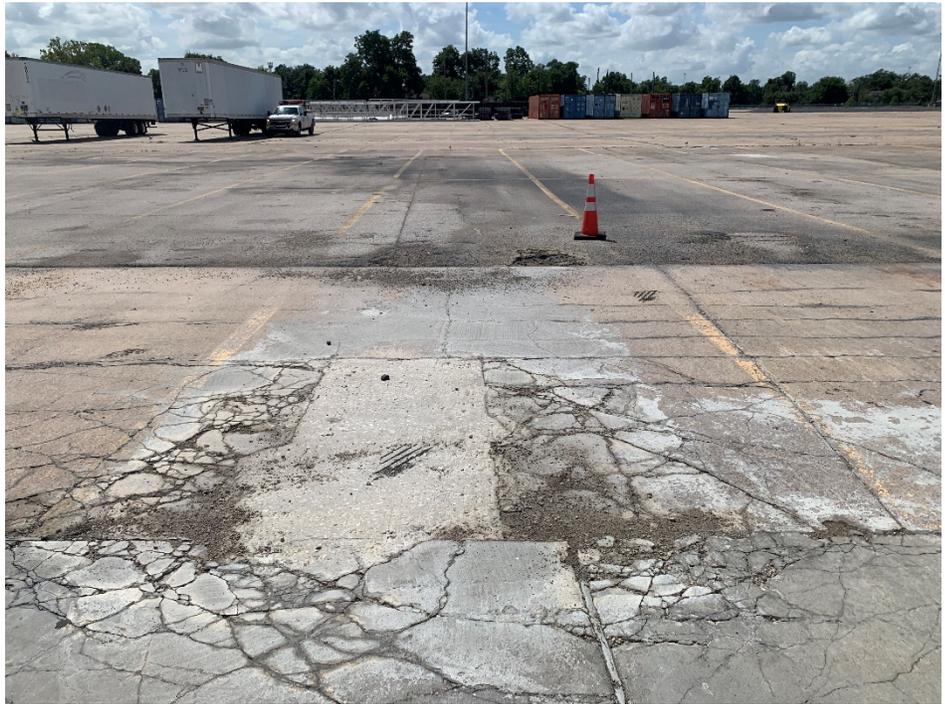
<b>Photo No.:</b> 17	<b>Inspection Date:</b> 08/17/2022
-------------------------	---------------------------------------

Stall A010, no tar-like material seeps observed where test pit conducted (July 2020, looking south).

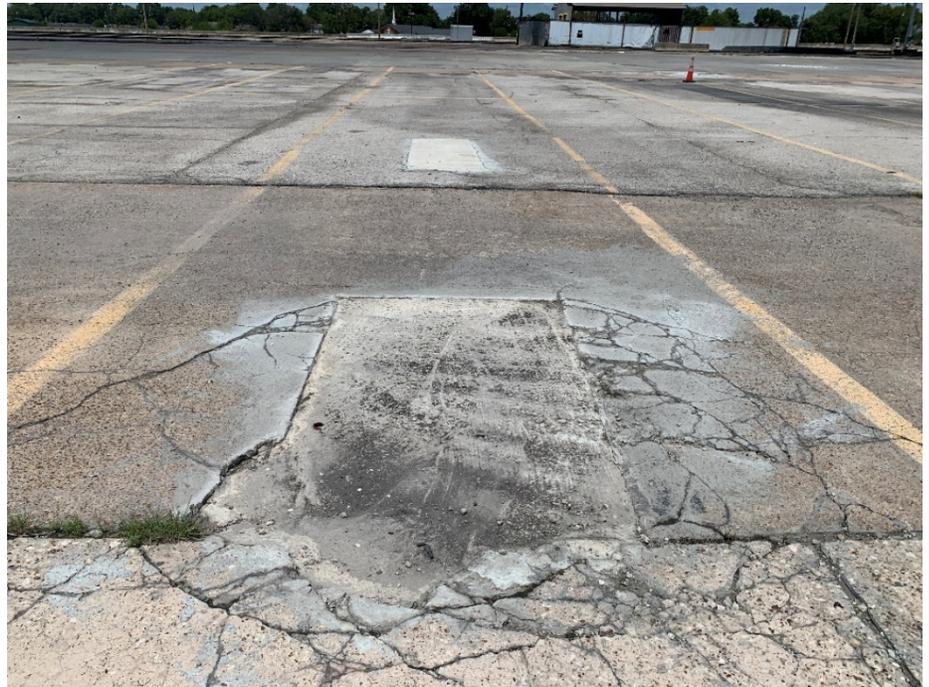
<b>Photo No.:</b> 18	<b>Inspection Date:</b> 08/17/2022
-------------------------	---------------------------------------

Stall B013, no tar-like material seep observed where test pit conducted (July 2020), looking north.

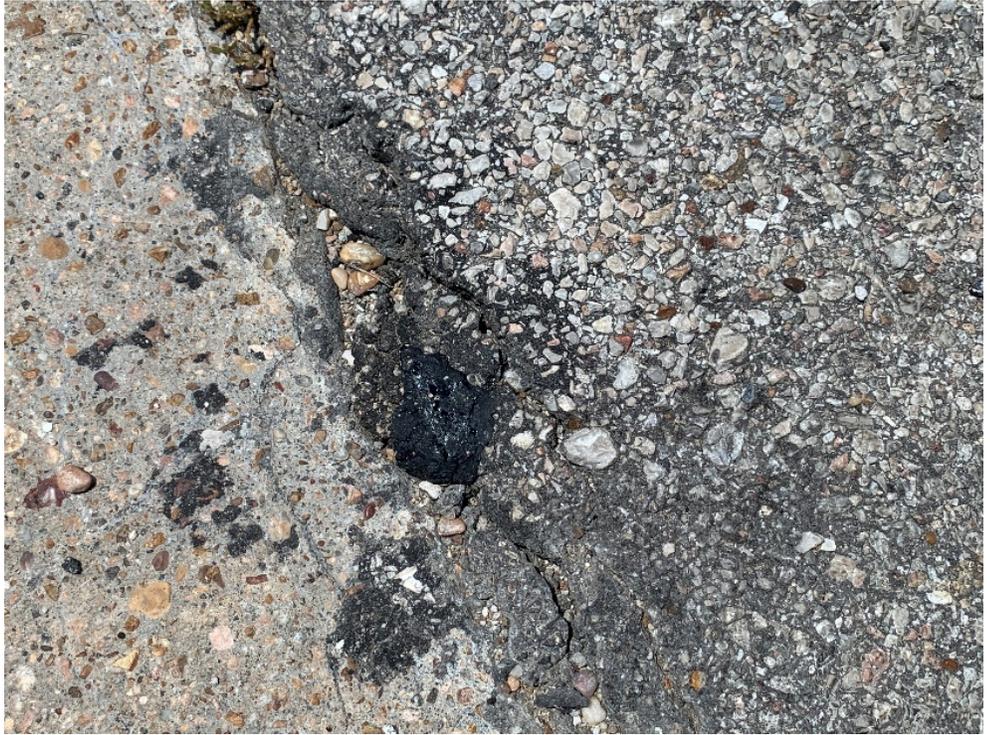
<b>Photo No.</b> 19	<b>Inspection Date:</b> 08/17/2022
------------------------	---------------------------------------

Stall B013, very small amount of tar-like material at historical seep location at a crack in the asphalt pavement, material was removed.

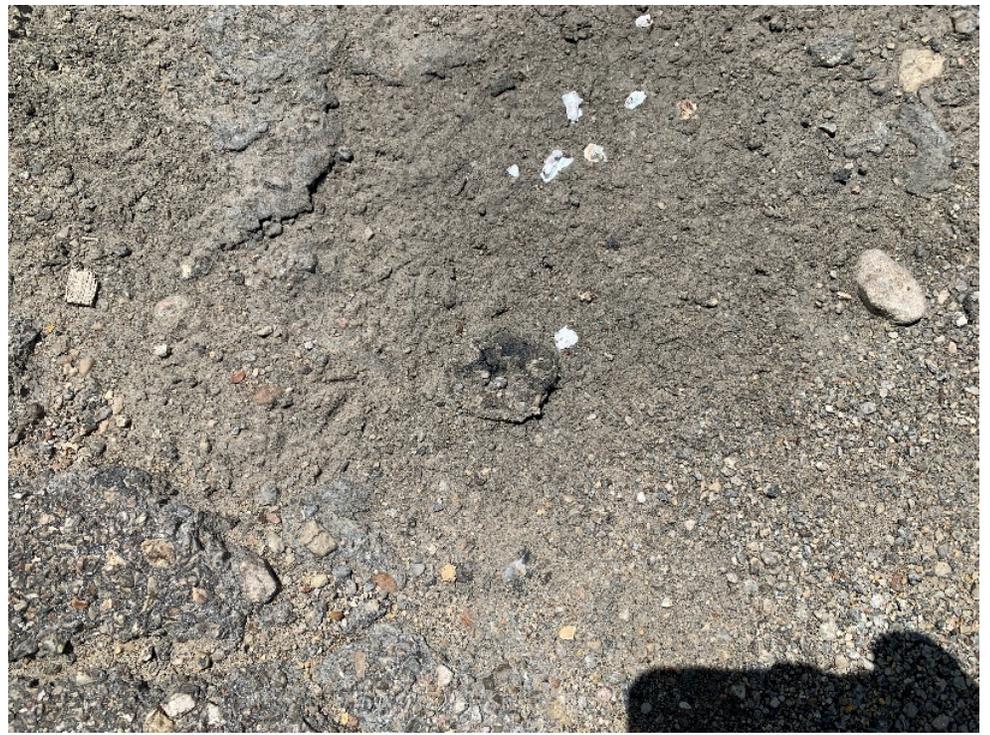
<b>Photo No.</b> 20	<b>Inspection Date:</b> 08/17/2022
------------------------	---------------------------------------

Stall B102, small amount of tar-like material observed. Material was removed.

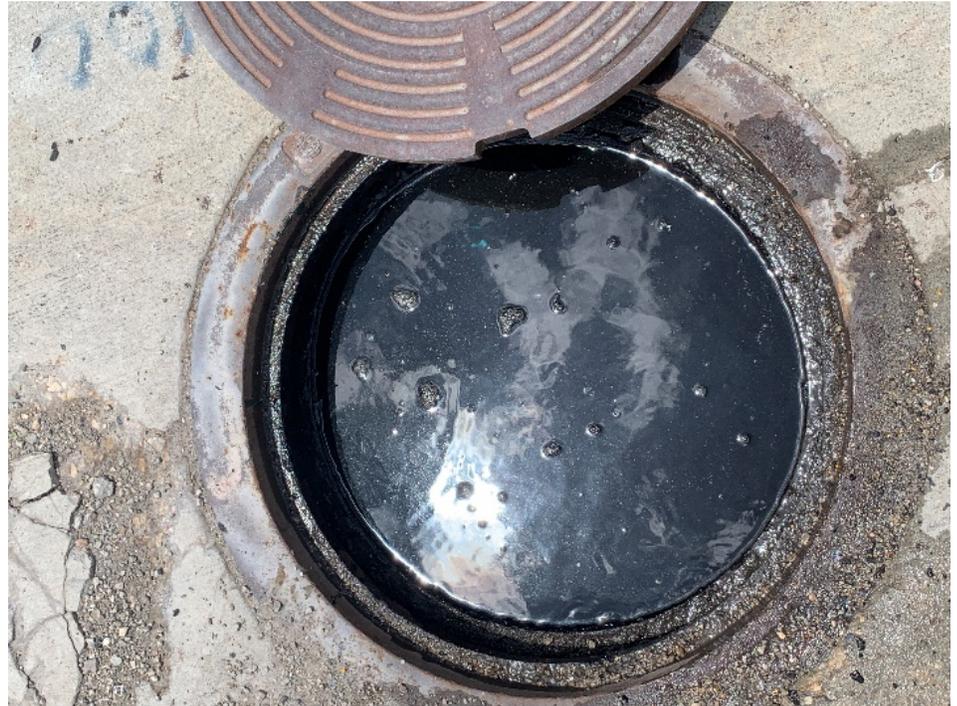
<b>Photo No.</b> <b>21</b>	<b>Inspection Date:</b> 08/17/2022
-------------------------------	---------------------------------------

Sump 1 (B099/B100), 5.5 inches of freeboard in sump. No sheen or odor noted.

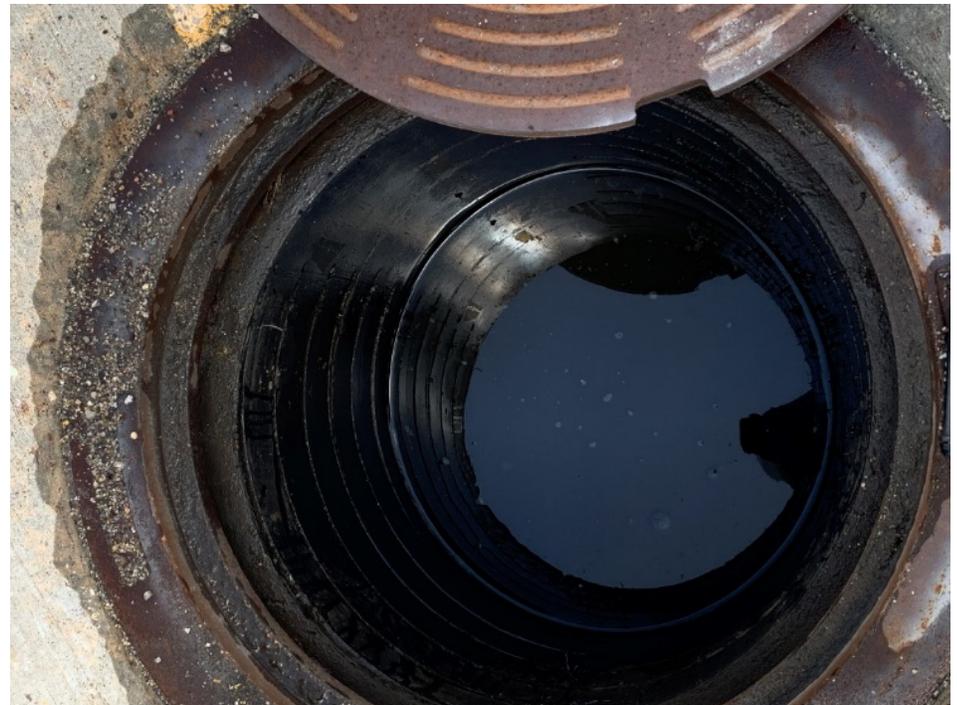
<b>Photo No.</b> <b>22</b>	<b>Inspection Date:</b> 08/17/2022
-------------------------------	---------------------------------------

Sump 2 (B103/B104), 25.5 inches of freeboard in sump. No sheen or odor noted.

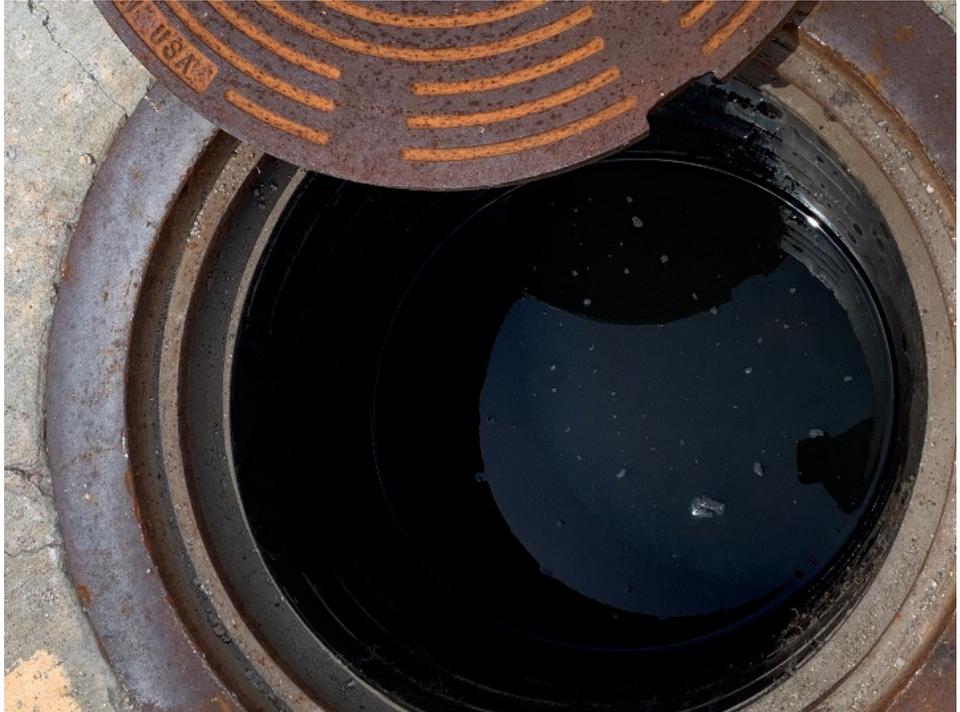
<b>Photo No.</b> <b>23</b>	<b>Inspection Date:</b> 08/17/2022
-------------------------------	---------------------------------------

Sump 3 (B107/B108), 25 inches of freeboard in sump. No sheen or odor noted.

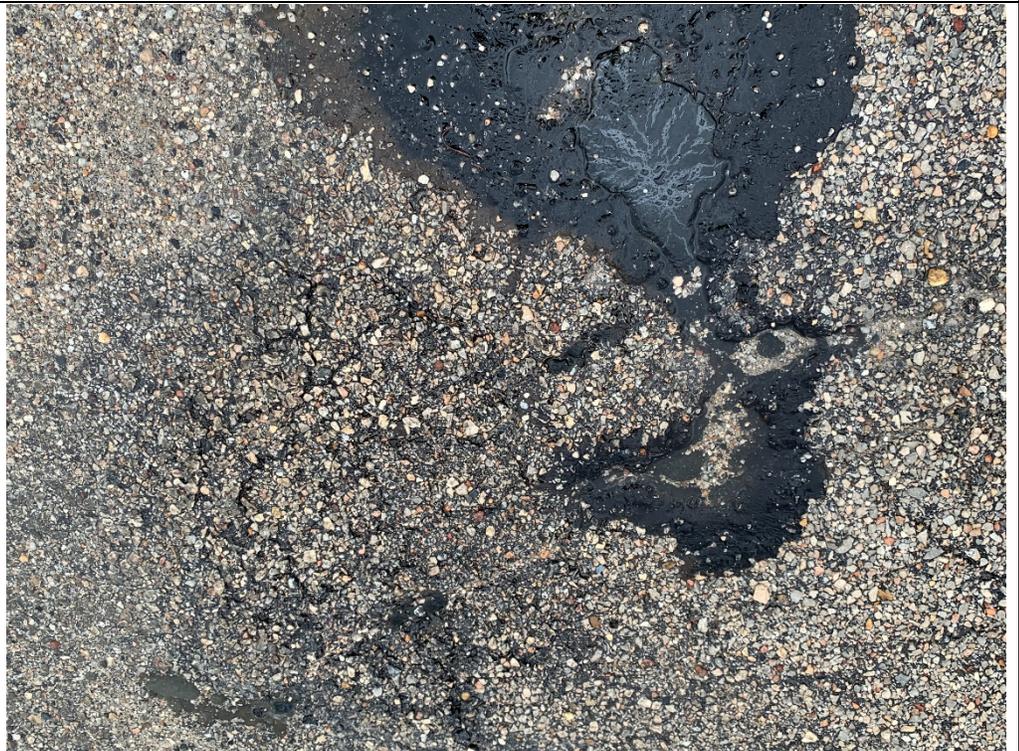
<b>Photo No.</b> <b>24</b>	<b>Inspection Date:</b> 08/24/2022
-------------------------------	---------------------------------------

Stall A011, a small amount of tar-like material at a crack in the asphalt pavement, material was removed.

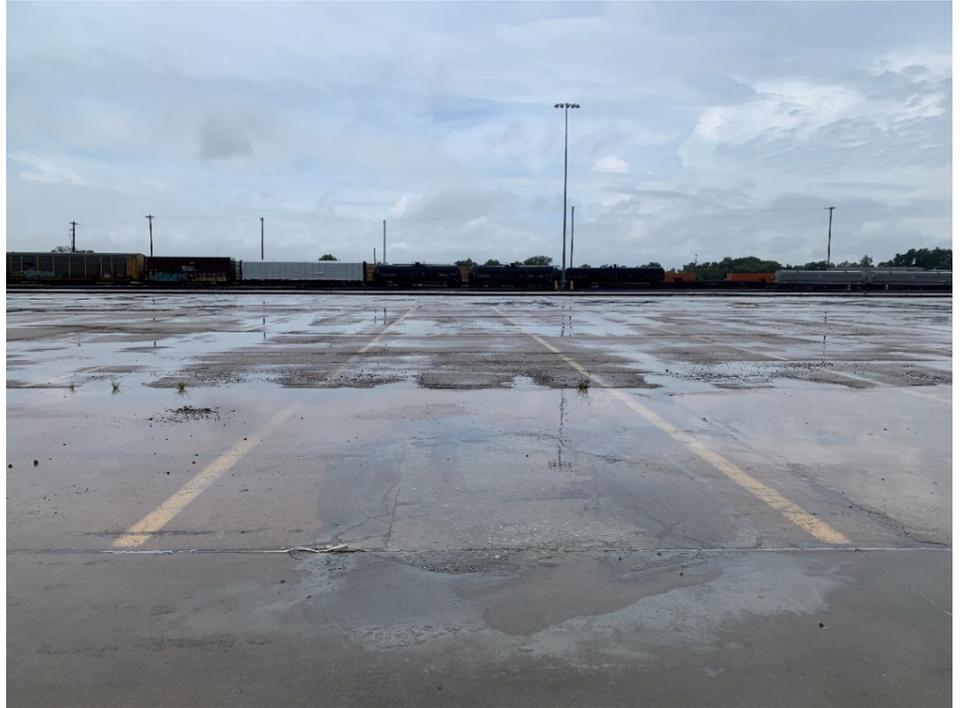
<b>Photo No.</b> <b>25</b>	<b>Inspection Date:</b> 08/24/2022
-------------------------------	---------------------------------------

Stall B096, no tar-like material seeps observed where test pit conducted (July 2020). Water on pavement due to ongoing rain event.

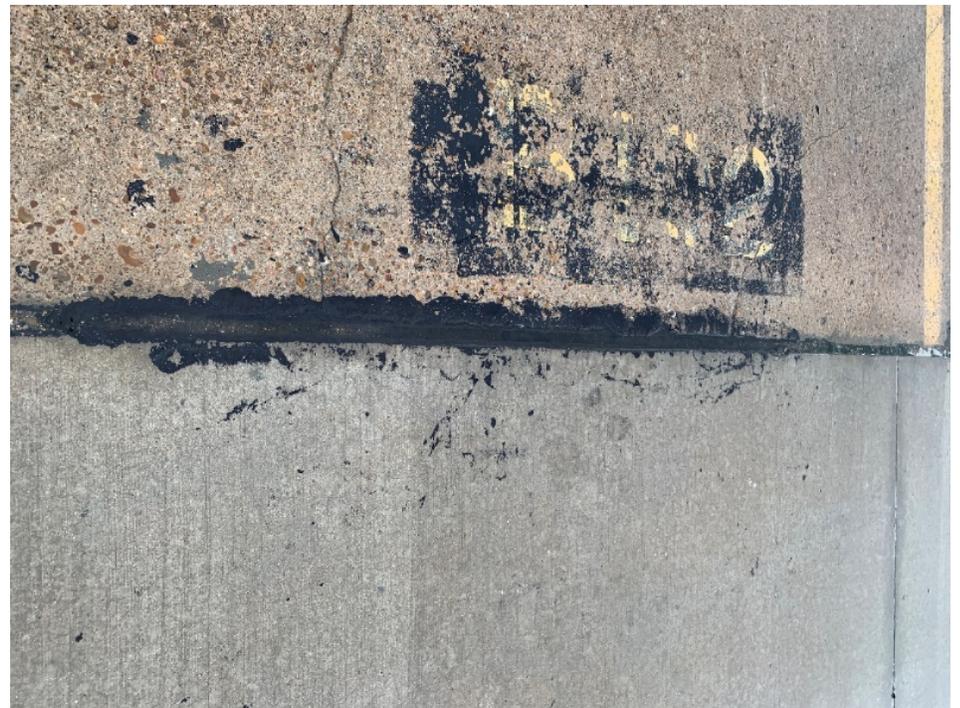
<b>Photo No.</b> <b>26</b>	<b>Inspection Date:</b> 08/24/2022
-------------------------------	---------------------------------------

Stall B102, small amount of tar-like material observed within joint, residual staining on concrete surface noted. Water on pavement due to ongoing rain event.

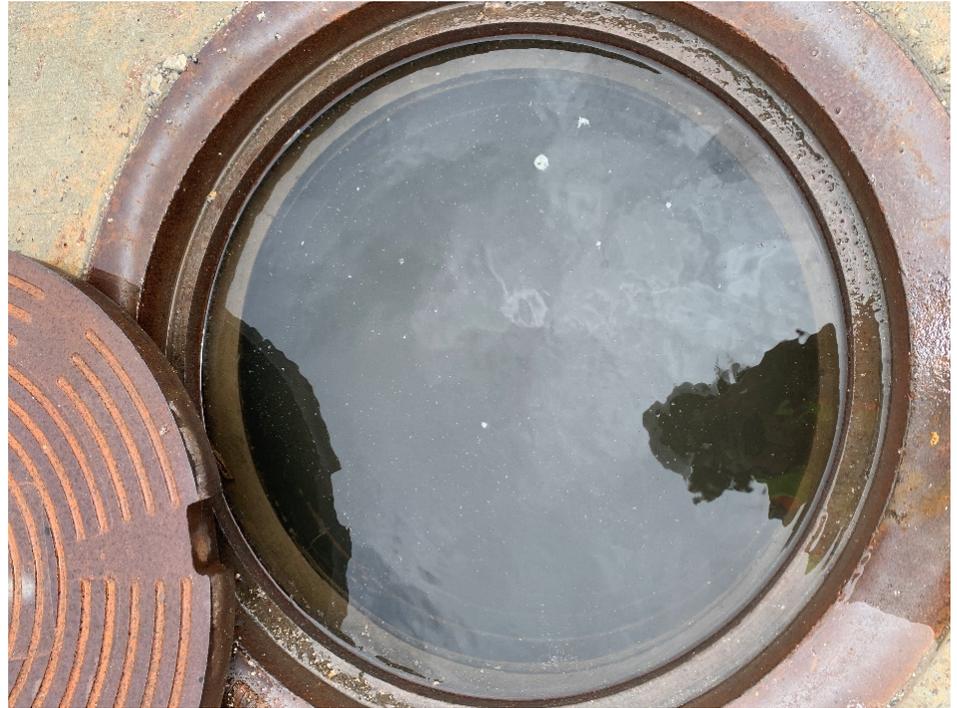
<b>Photo No.</b> <b>29</b>	<b>Inspection Date:</b> 08/24/2022
-------------------------------	---------------------------------------

Sump 2 (B103/B104), 0.5 inches of freeboard in sump. No sheen or odor noted.

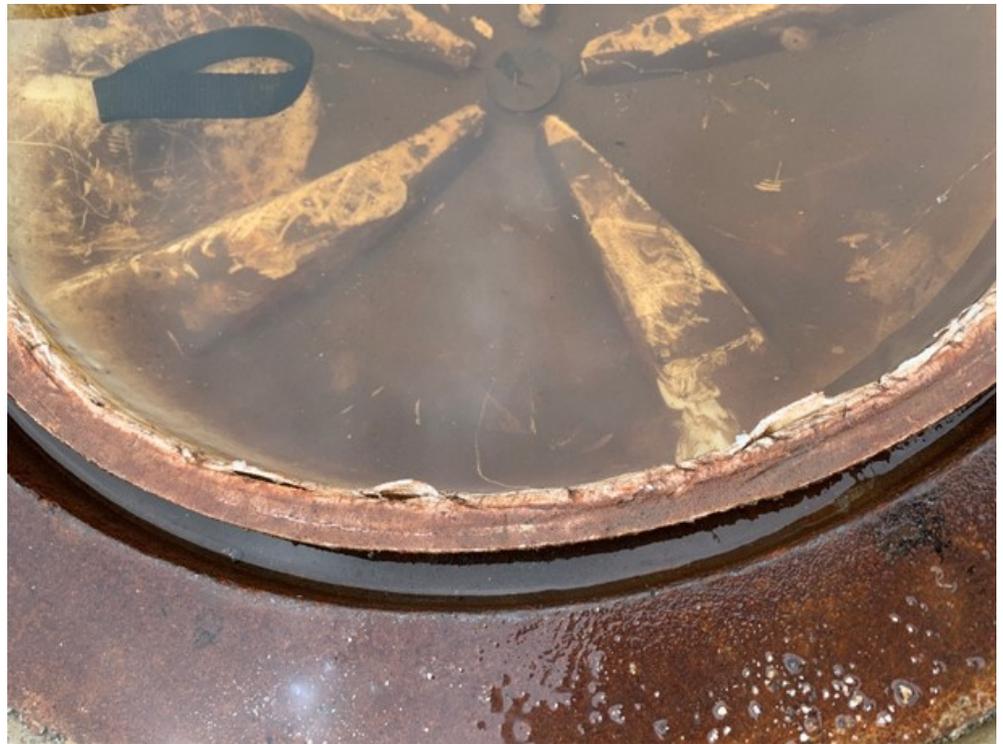
<b>Photo No.</b> <b>30</b>	<b>Inspection Date:</b> 08/24/2022
-------------------------------	---------------------------------------

Sump 3 (B107/B108), 0 inches of freeboard in sump. No sheen or odor noted. Water flowing into sump from ongoing rain event.

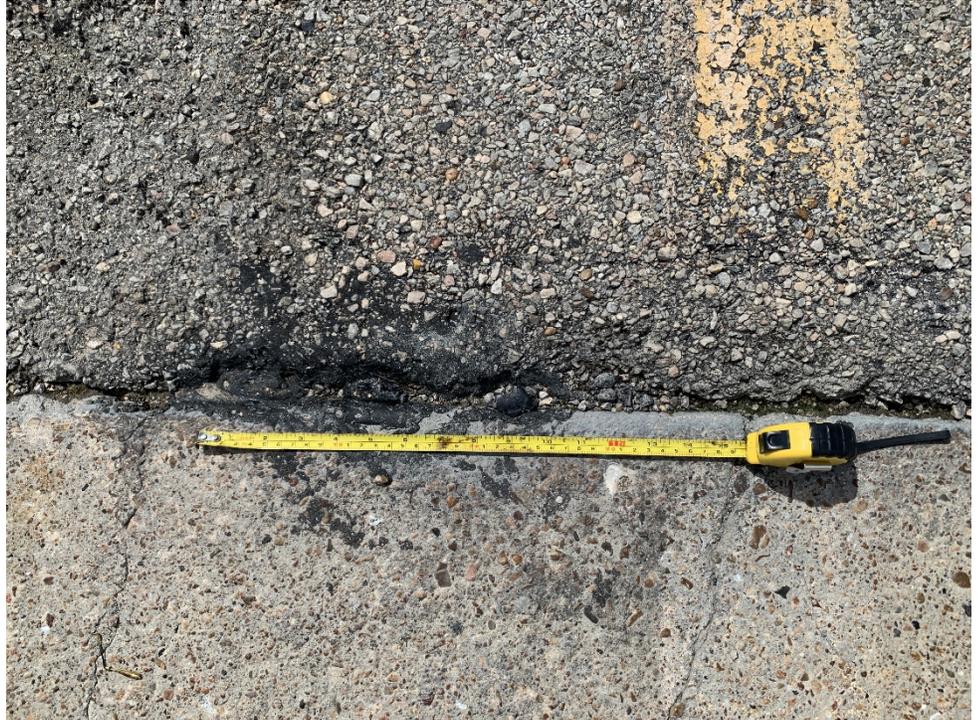
<b>Photo No.:</b> <b>31</b>	<b>Inspection Date:</b> 08/31/2022
--------------------------------	---------------------------------------

Stall A022, a small amount of tar-like material at a crack in the asphalt pavement, material was removed.

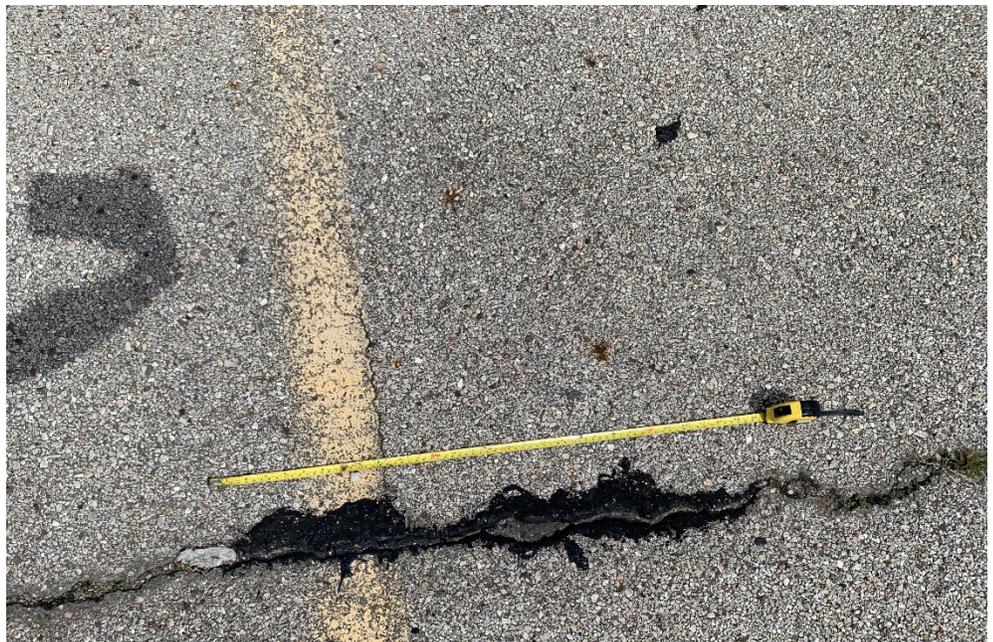
<b>Photo No.:</b> <b>32</b>	<b>Inspection Date:</b> 08/31/2022
--------------------------------	---------------------------------------

Stall B056, a very small amount of tar-like material at a crack in the asphalt pavement, material was removed.
