September 15, 2022

Project No. 19119232

Re: **MONTHLY STATUS UPDATE – ENGLEWOOD INTERMODAL YARD – NAPL COLLECTION SYSTEM/CONCRETE CAP REPAIRS  
UNION PACIFIC RAILROAD HOUSTON WOOD PRESERVING WORKS FACILITY  
4910 LIBERTY ROAD FACILITY, HOUSTON, TEXAS  
POST-CLOSURE CARE PERMIT NO. HW-50343; INDUSTRIAL SWR NO. 31547**

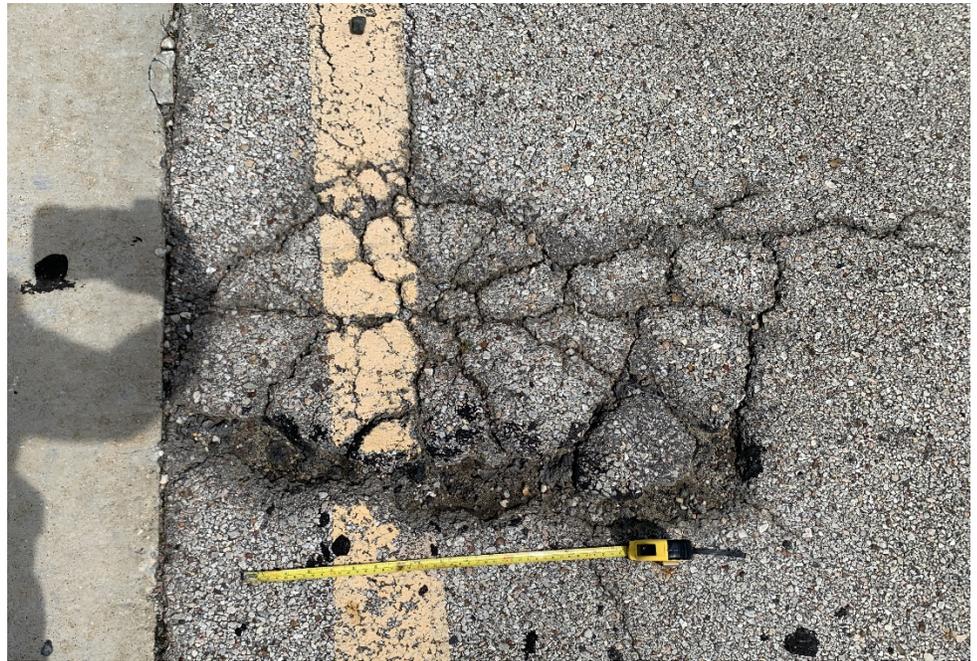
<b>Photo No.:</b> 33	<b>Inspection Date:</b> 08/31/2022
-------------------------	---------------------------------------

Stall B057, very small amount of tar-like material at historical seep location in asphalt cracks, no seeps observed where nearby test pit was conducted (July 2020), material was removed.

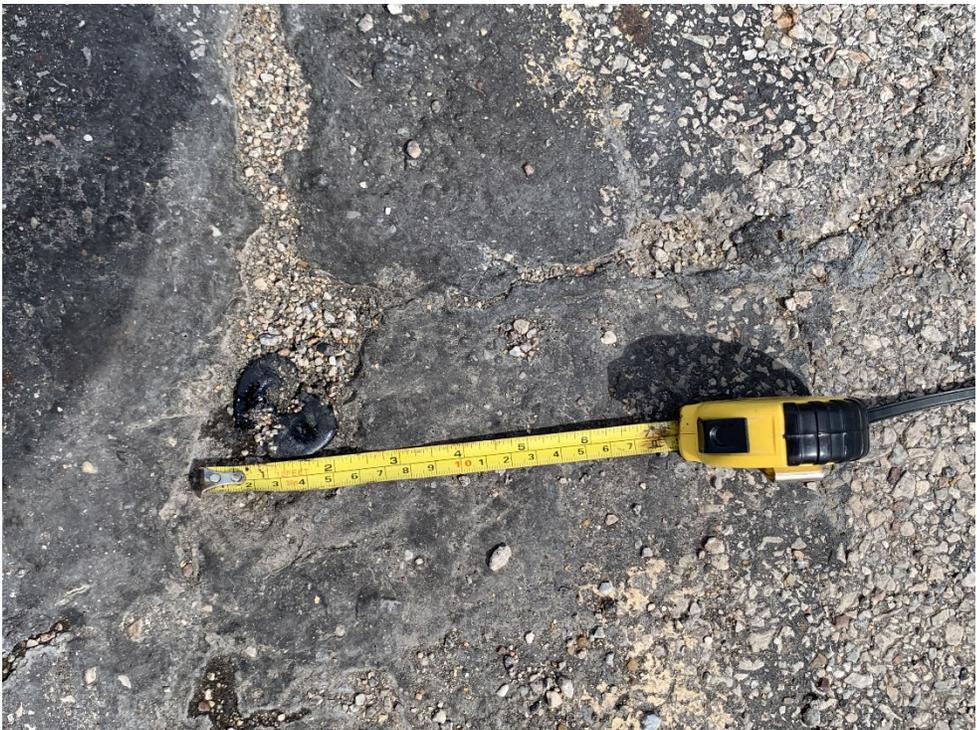
<b>Photo No.:</b> 34	<b>Inspection Date:</b> 08/31/2022
-------------------------	---------------------------------------

Stall B101, very small amount of tar-like material at a crack in the asphalt pavement, material was removed.

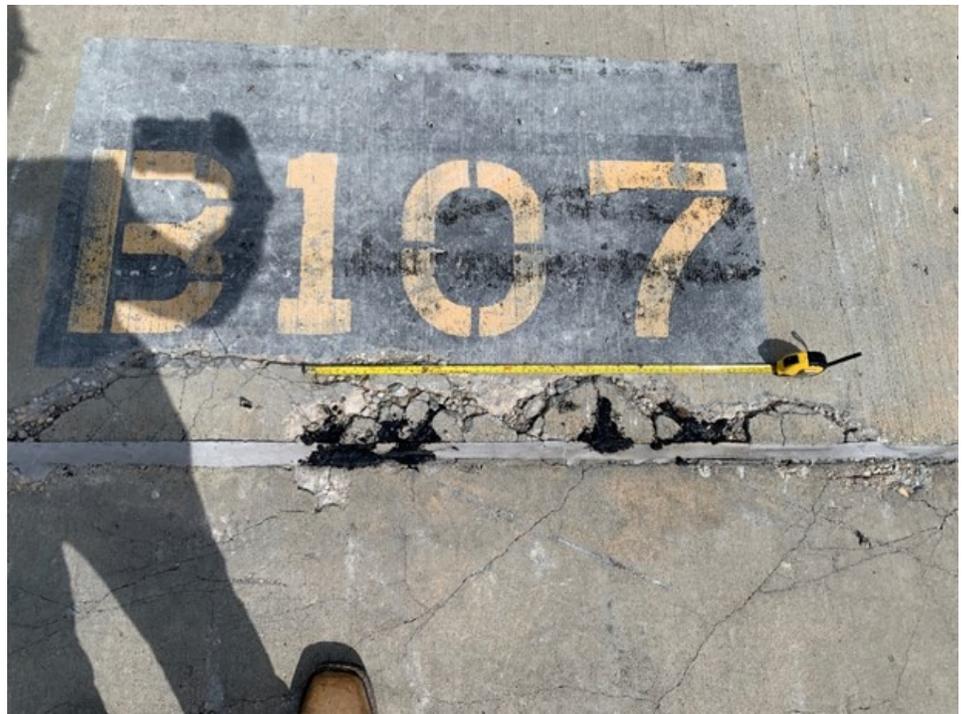
<b>Photo No.</b> <b>36</b>	<b>Inspection Date:</b> 08/31/2022
-------------------------------	---------------------------------------

- A small tar-like material seep was observed on the southern edge of the NAPL Collection System in cracks in the cement along the joint of Stall B107 during all five inspections in August (Photo Nos. 5 and 36). This seep was first observed during the July 6, 2022 weekly inspection.

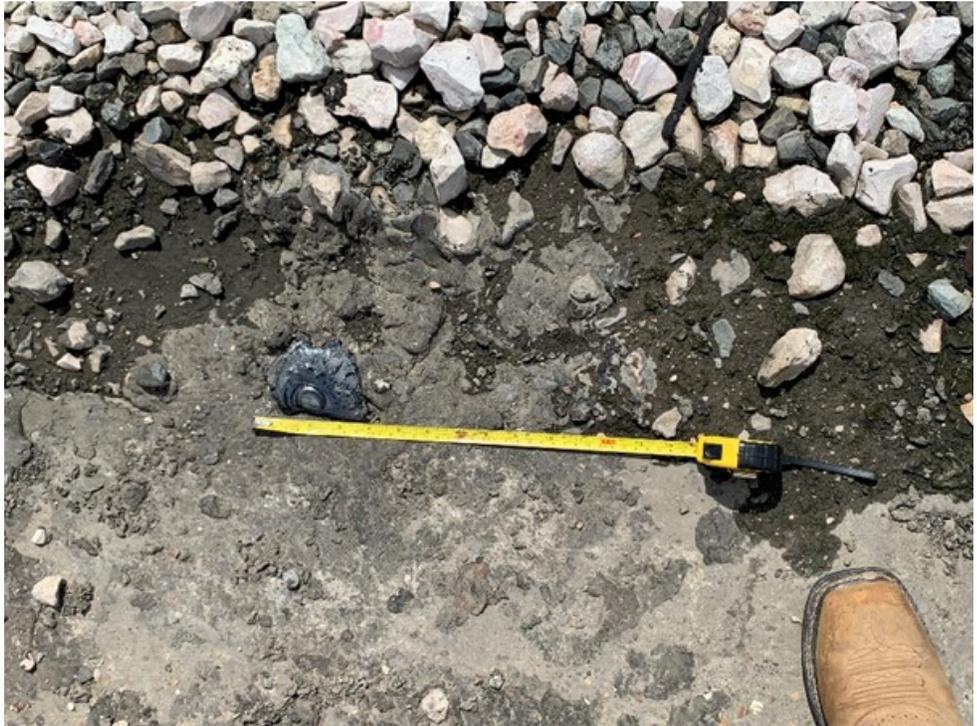
<b>Photo No.:</b> 37	<b>Inspection Date:</b> 08/31/2022
-------------------------	---------------------------------------

- As detailed in the July 2022 Monthly Status Update, a tar-like material seep was observed next to Track 802 that is located approximately 280 feet northwest of the NAPL Collection System. The tar-like material seep is located along on the northern side of the track at the edge of the railroad ballast (Photo Nos. 9, 27, and 37), and was observed during all five inspections in August.

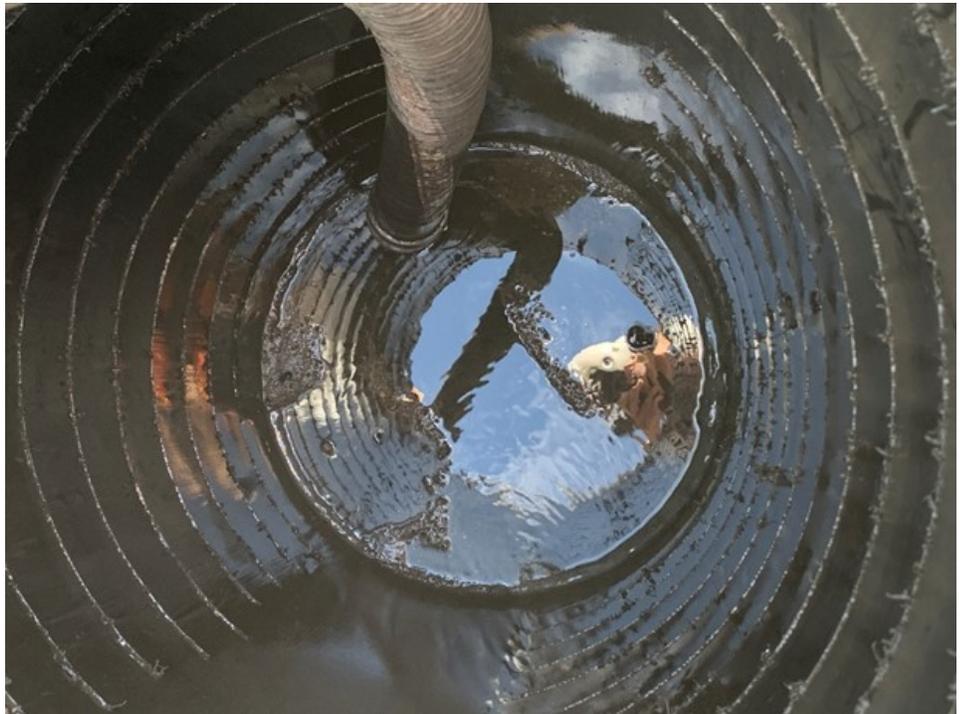
<b>Photo No.:</b> 38	<b>Inspection Date:</b> 08/31/2022
-------------------------	---------------------------------------

Sump 1 (B099/B100) after pump down. 52 inches of freeboard in sump. No odor or sheen noted. No NAPL observed.

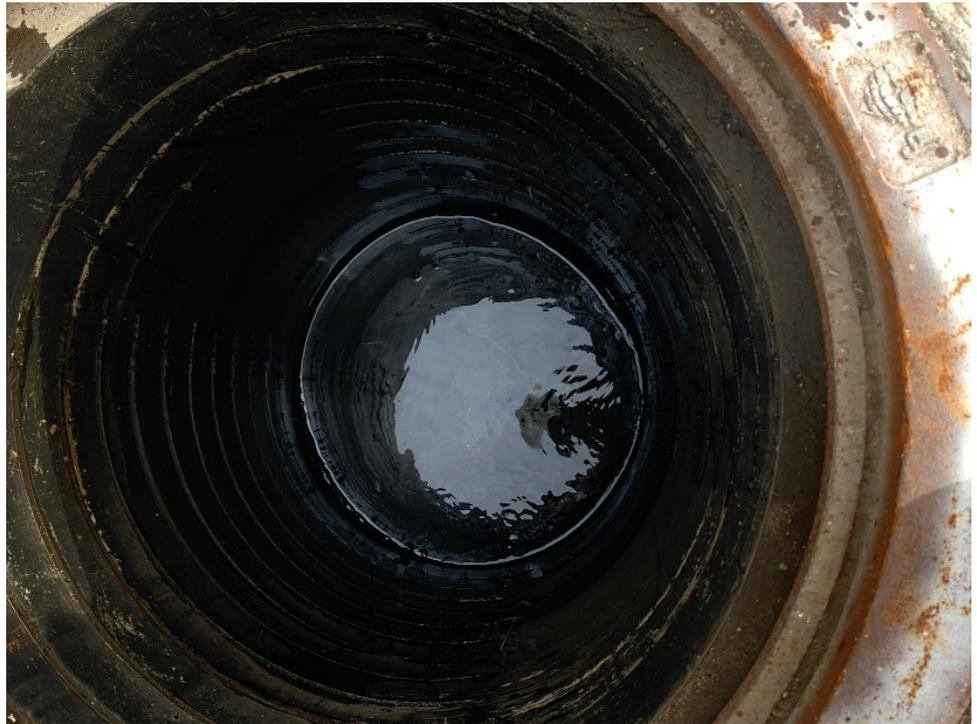
<b>Photo No.</b> <b>39</b>	<b>Inspection Date:</b> 08/31/2022
-------------------------------	---------------------------------------

observed in Sump 3 during the August 10, 2022 inspection (Photo No. 16) and in Sump 2 during the August 31, 2022 inspection (Photo No. 39). No odors were reported during the August inspections.

Sump 2 (B103/B104). 52 inches of freeboard in sump. Sheen observed on water surface, no odor noted.

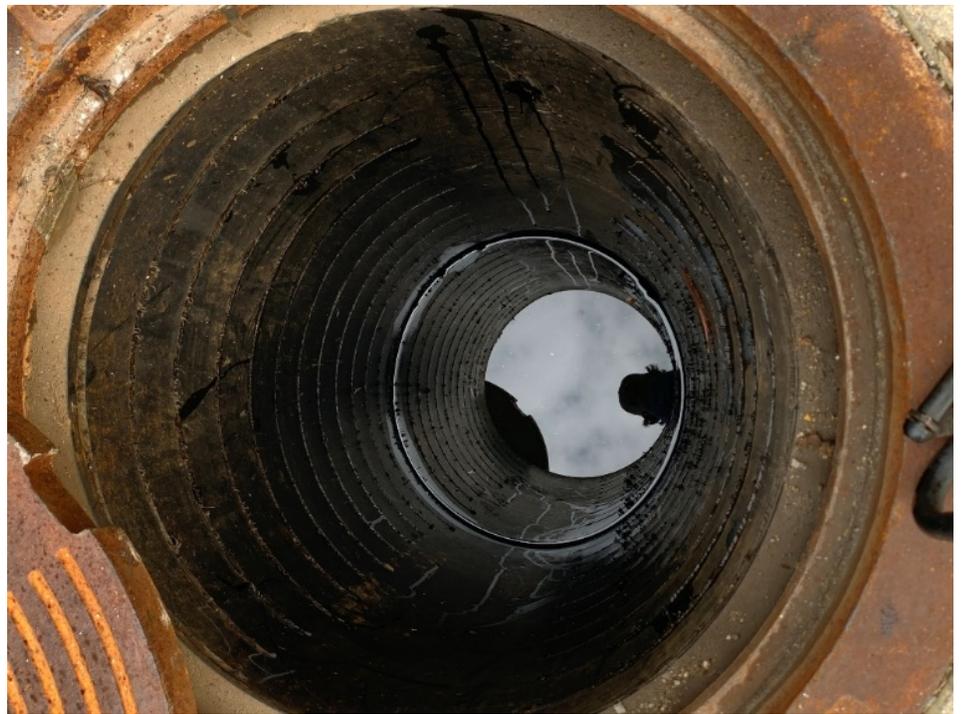
<b>Photo No.</b> <b>40</b>	<b>Inspection Date:</b> 08/31/2022
-------------------------------	---------------------------------------

Sump 3 (B107/B108). 48 inches of freeboard in sump. No sheen or odor noted. No NAPL observed.
