Project No. 19119232

Re: **MONTHLY STATUS UPDATE – ENGLEWOOD INTERMODAL YARD – NAPL COLLECTION SYSTEM/CONCRETE CAP REPAIRS
UNION PACIFIC RAILROAD HOUSTON WOOD PRESERVING WORKS FACILITY
4910 LIBERTY ROAD FACILITY, HOUSTON, TEXAS
POST-CLOSURE CARE PERMIT NO. HW-50343; INDUSTRIAL SWR NO. 31547**

Weekly Inspection Photolog

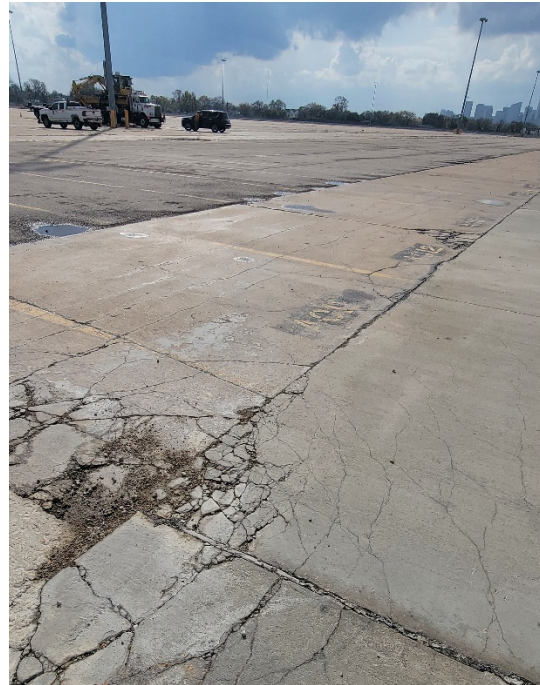
Photo No.
1

Stalls A010 and A011, no new tar-like material observed, standing water from recent rain event, looking southwest.

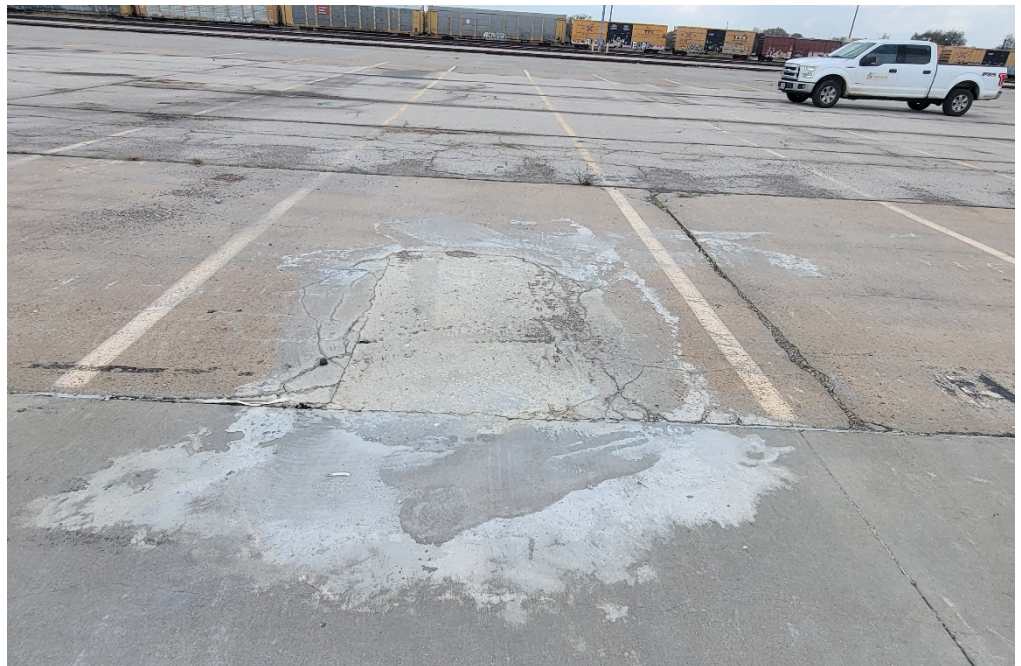
Photo No.
2

Stall B096, no new tar-like material observed at historical seep location adjacent to July 2020 test pit, looking northwest.

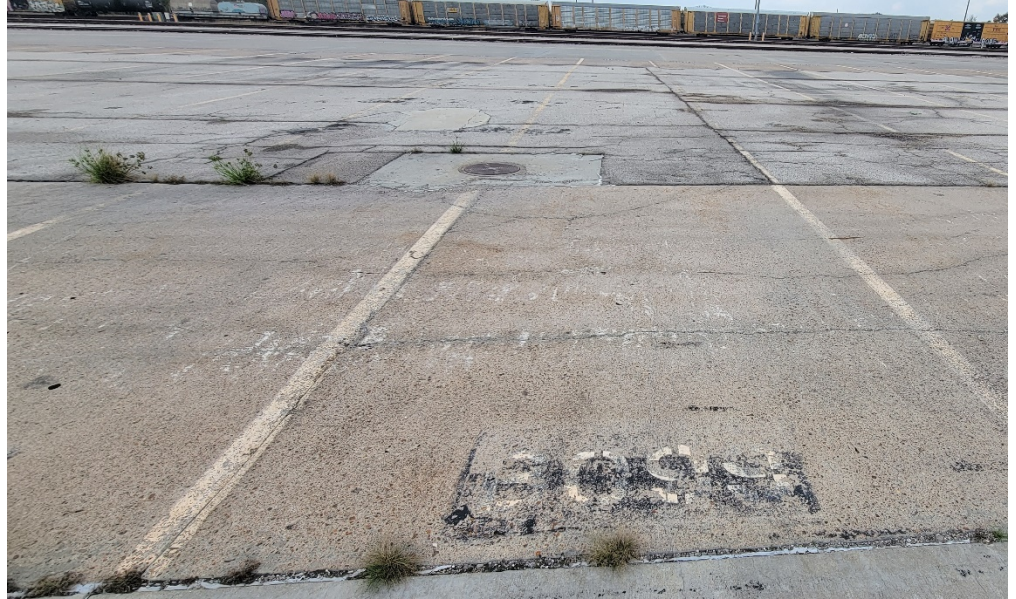
Photo No.
3

Stalls B099-B100, view of NAPL collection system, looking northwest.

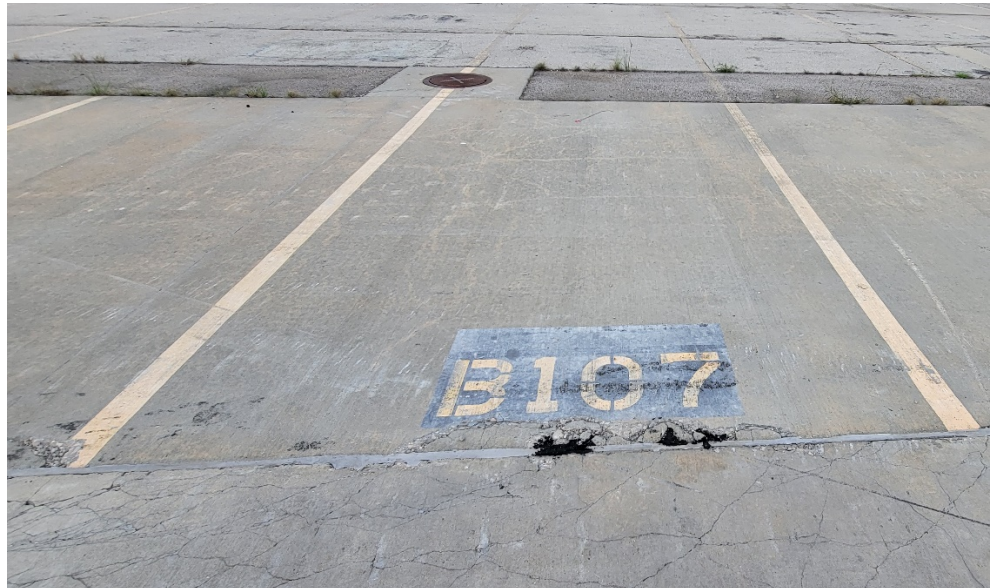
Photo No.
4

- A small tar-like material seep was observed on the southern edge of the NAPL Collection System in cracks in the cement along the joint of Stall B107 during the July 6, 2022 weekly inspection, no new tar-like material was observed at this seep location in December 2022.

Stalls B107-B108, view of NAPL collection system, no new tar-like material observed at seep location on concrete joint along the southern edge of the excavated area, looking northwest.

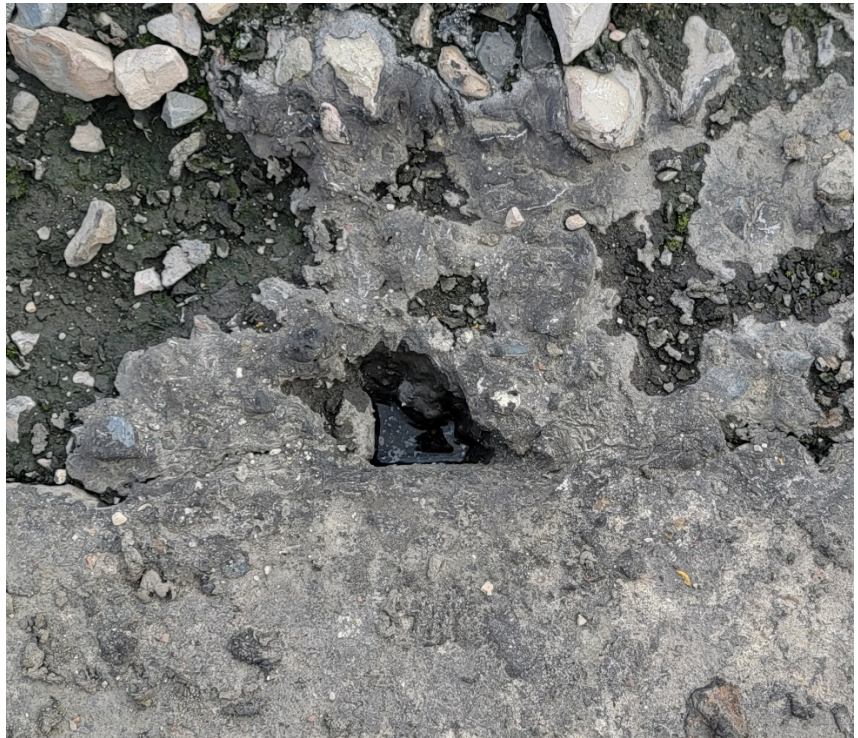
Photo No.
5

North side of Track 802, no new tar-like material observed at seep location near the edge of the ballast.

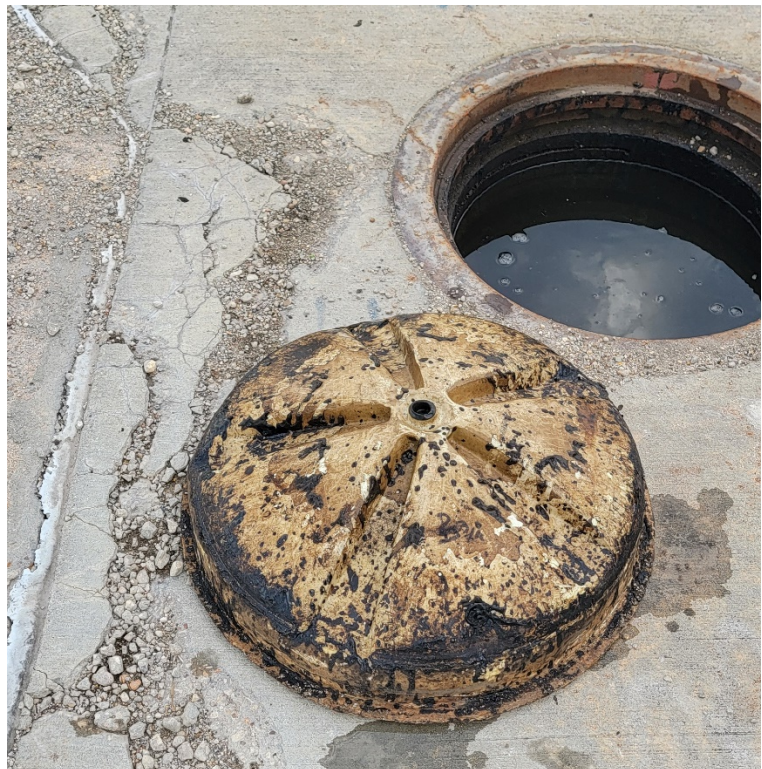
Photo No.
6

- Water levels in NAPL Collection System Sump 1 (B099/B100 stalls), Sump 2 (B103/B104 stalls), and Sump 3 (B107/B108 stalls) were measured at 4 inches, 13.5 inches and 13 inches, respectively during the inspection on December 7, 2022 (Photo Nos. 6-8). During the inspection on December 14, 2022, all three sumps were observed to be full following a rain event (Photo Nos. 14-16). By the December 28, 2022 inspection, the water levels in Sump 1, 2, and 3 had decreased to 16 inches, 14 inches and 14 inches, respectively, (Photo Nos. 29-31) from the top of the sumps. The water in the sumps was observed as being brown in color. No sheen or odors were reported during the December inspections.

Sump 1 (B099/B100), 4 inches of freeboard in sump, no sheen or odor noted, no new NAPL accumulation on inflow protector.

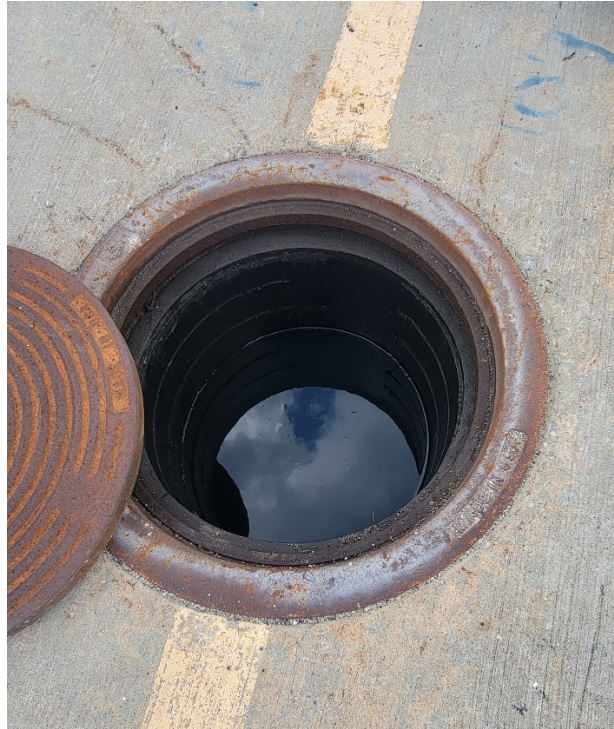
Photo No.
7

Sump 2 (B103/B104), 13.5 inches of freeboard. No sheen or odor noted.

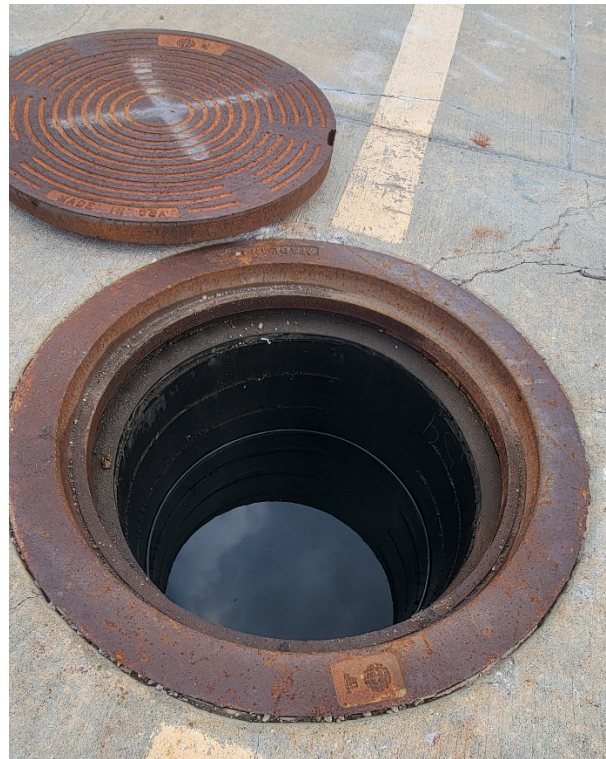
Photo No.
8

Sump 3 (B107/B108), 19 inches of freeboard in sump, no sheen or odor noted.

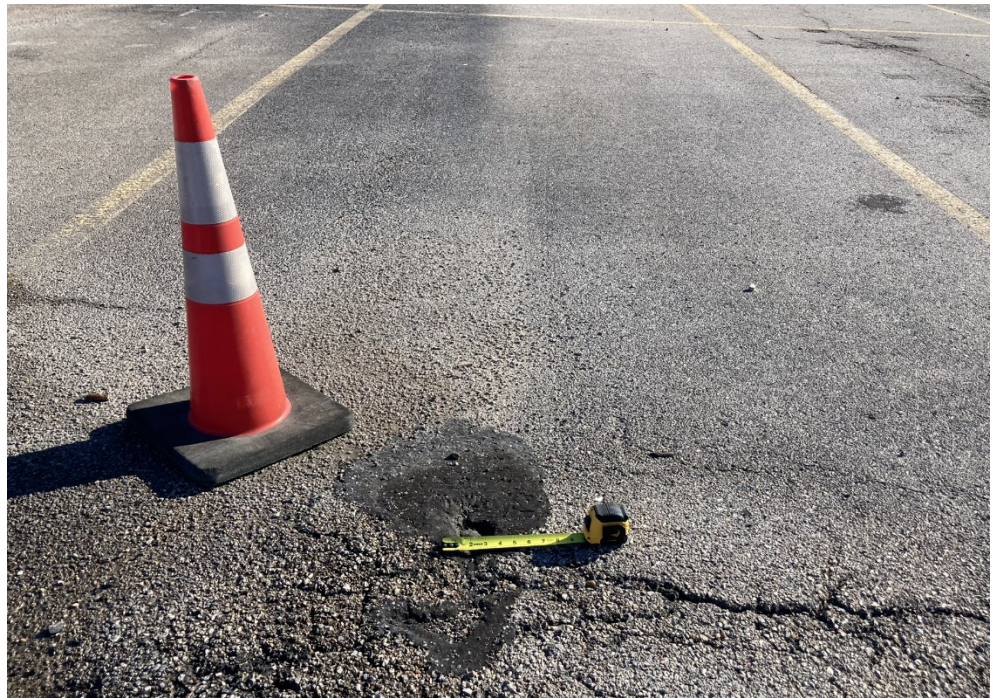
Photo No.
9

Seep Observations Outside the NAPL Collection System Area	
Stall Number	Observation Date(s)
A011	December 14 th and 21 st (Photo Nos. 9 and 17)
B096	December 14 th (Photo No. 11)

Stall A011, a small amount of tar-like material at a crack in the asphalt pavement, material was removed.

- Tar-like material observed during the weekly inspection events was removed and recovered using a hand tool to scrape up the material. During December, the number of tar-like material seeps observed and total amount of material removed during the weekly inspections decreased compared to the November 2022 weekly inspections. No tar-like material seeps were observed during the first or last inspections of the month (December 7th and 28th). Less than 0.1 gallons of tar-like material was recovered for the month from the seep locations. The material that was recovered was placed in a drum staged at the CSA for disposal.

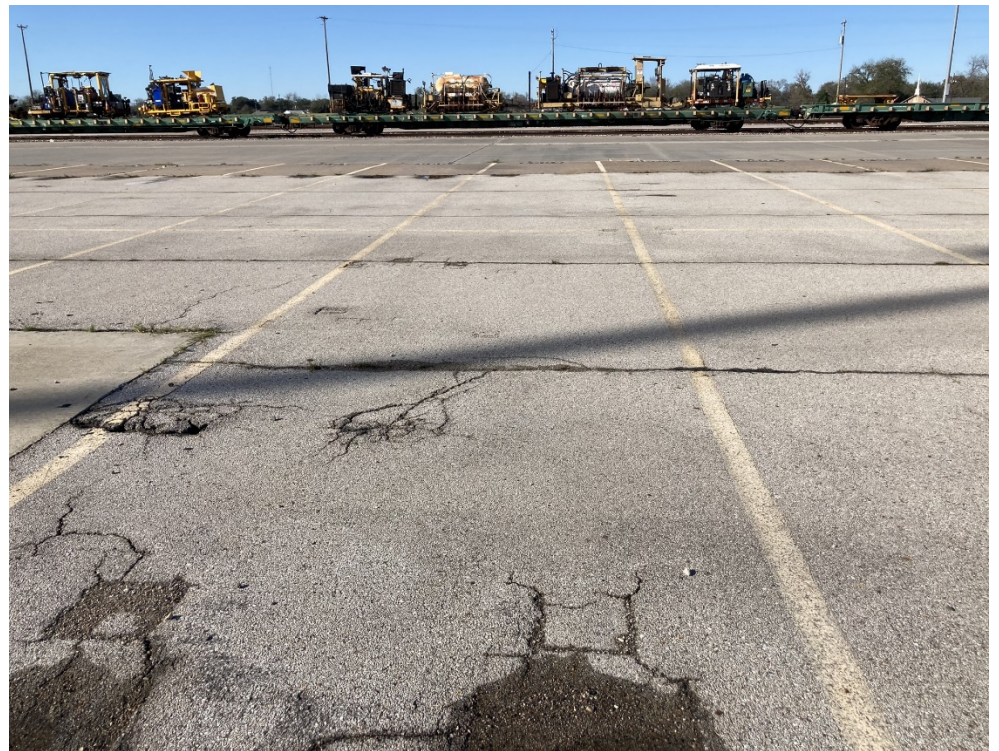
Photo No.
10

Stalls B056-B057, no new tar-like material at historical seep locations, pavement wet from recent rain event, looking northwest

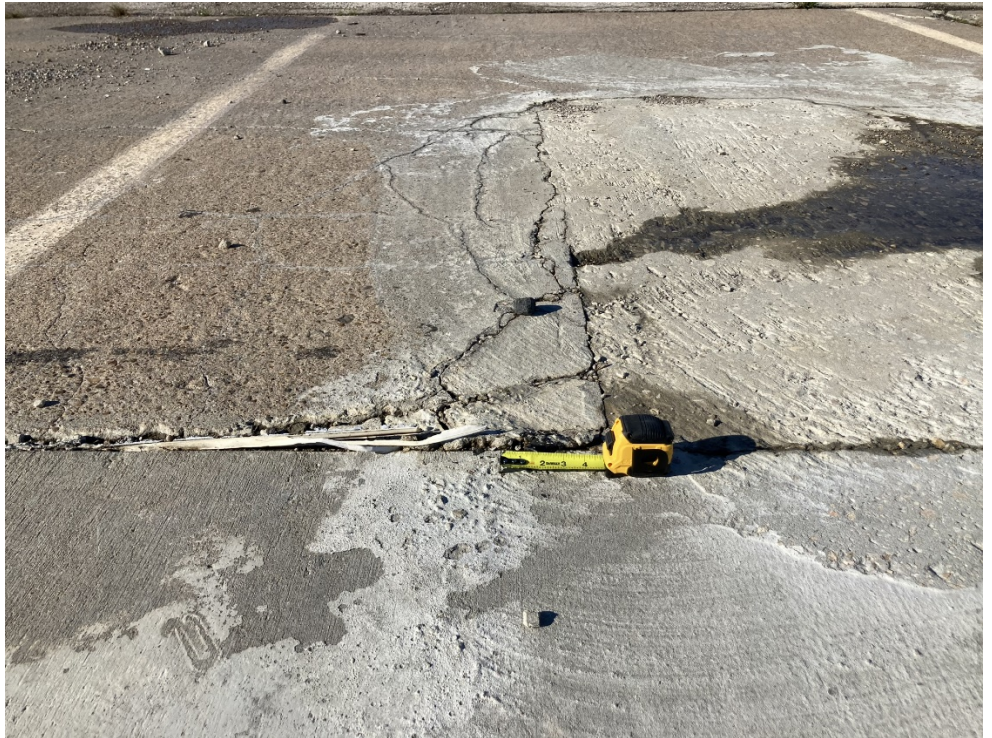
Photo No.
11

During the inspection on September 28, 2022, a small amount of tar like material was observed in stall B096 adjacent to the test pit patch for the first time since the test pit installation. Tar like material was recovered from B096 near the historical seep location, along the concrete joint at the front of the stall during one of the four inspections in December (Photo No. 11). Through December 2022, no NAPL seeps have been observed at the six other test pit locations (stalls A010, A021, A098, B013, B057, and B108).

Stall B096, very small amount of tar-like material observed near historical seep location along concrete joint adjacent to July 2020 test pit, pavement wet from recent rain event, material was removed.

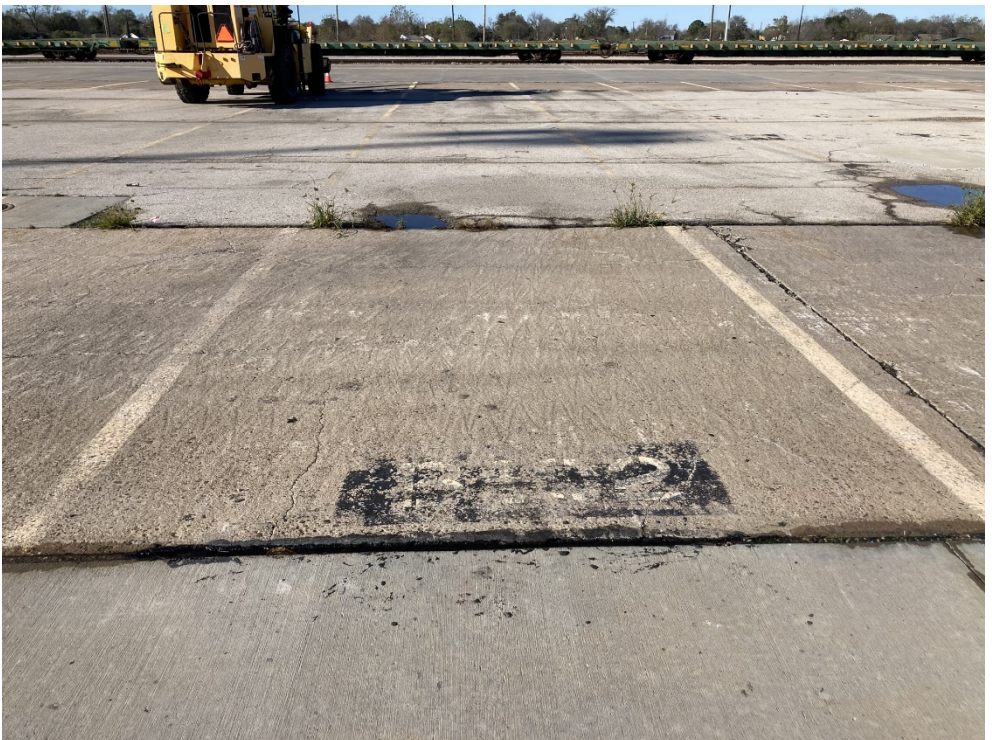
Photo No.
12

Stall B102, no new tar-like material observed within concrete joint, residual staining on concrete surface noted, standing water from recent rain event, looking northwest.

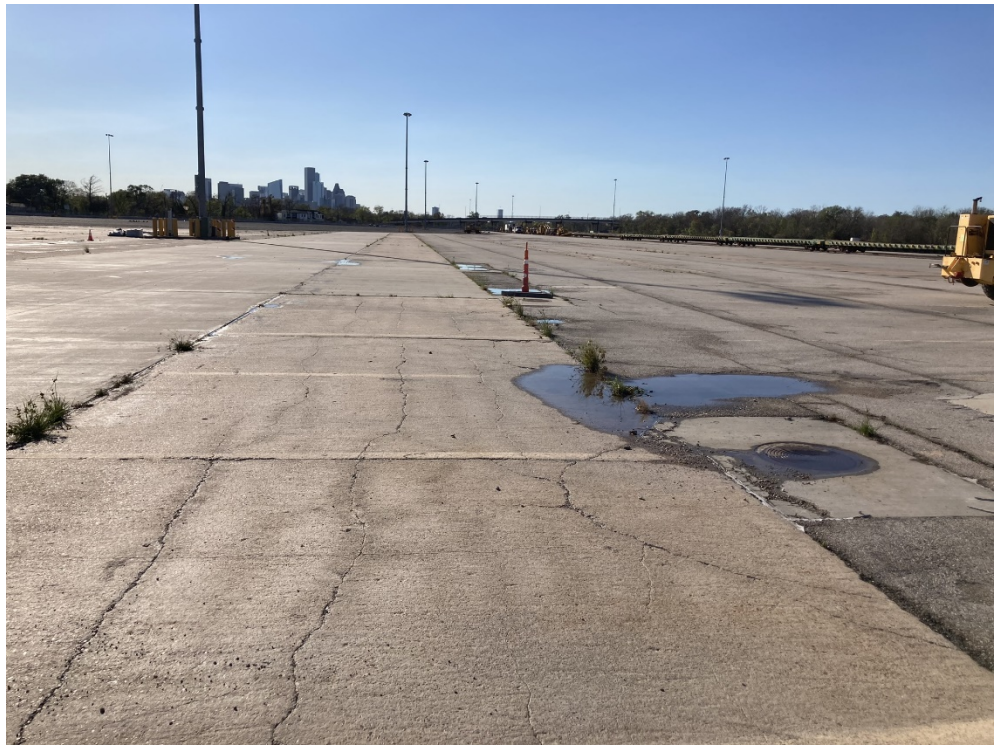
Photo No.
13

Stalls B099-B110, view of NAPL collection system, standing water from recent rain event, looking west.

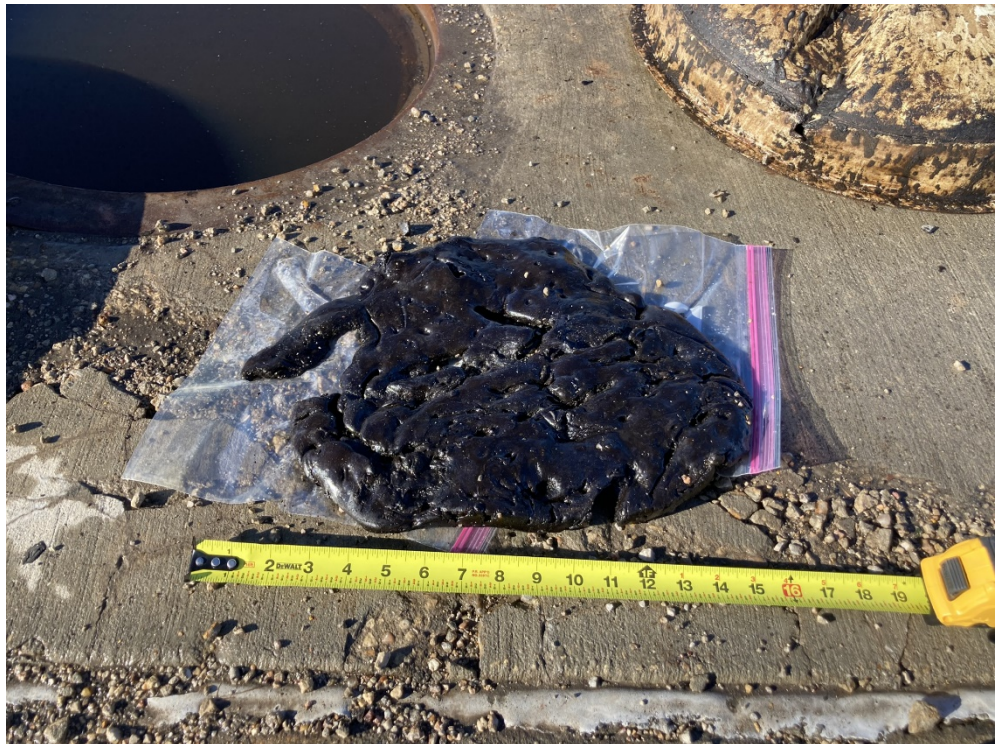
Photo No.
14

during the weekly inspections. During the weekly inspection on December 14, 2022, the dipper tool was replaced with a hoe to aid in the recovery of any DNAPL present in the sumps. Using the hoe on December 14th less than 0.4 gallons (approx.) of a rubbery tar-like material (Photo No. 14) was recovered from Sump 1 and approximately 0.1 gallons was recovered from Sump 3 (Photo No. 16). A notation on the presence of NAPL in each sump, tabulation of depth and thickness of NAPL if detected, and a tabulation of total mass of NAPL recovered from each sump is provided on the enclosed Table 1. Any NAPL recovered from the sumps is placed in a drum for disposal. The drum is staged at the Container Storage Area (CSA).

Sump 1 (B099/B100), 0 inches of freeboard in sump, no sheen or odor noted, no new NAPL accumulation on inflow protector, small amount of rubbery tar-like material (approx. 0.4 gal) recovered from sump .

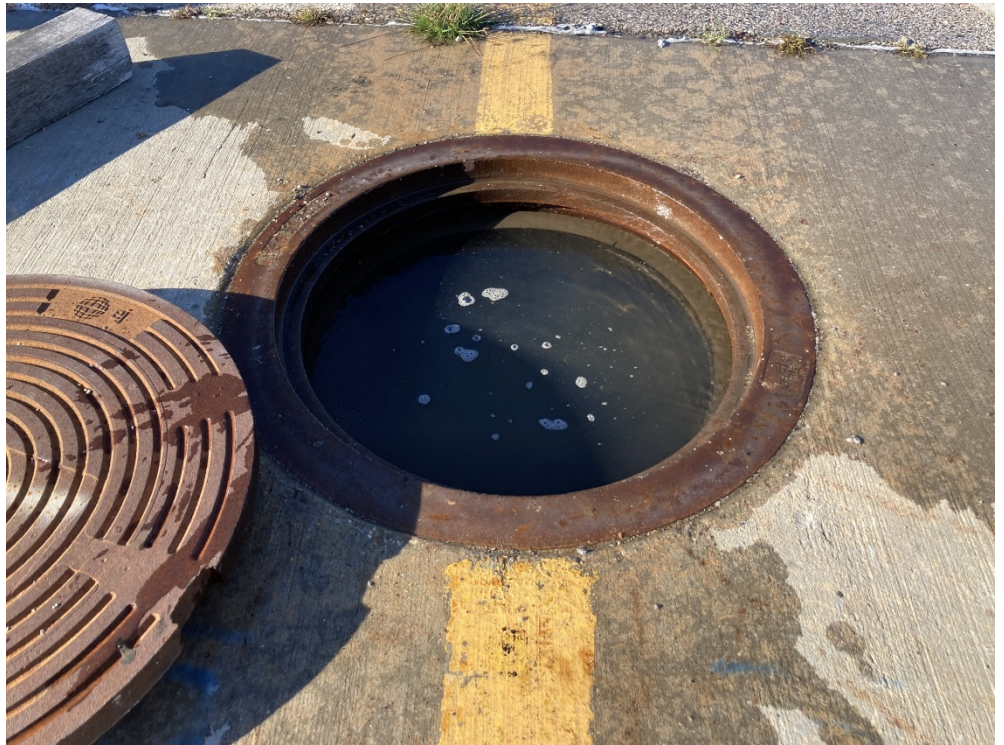
Photo No.
15

Sump 2 (B103/B104), 0 inches of freeboard. No sheen or odor noted, no tar-like material recovered.

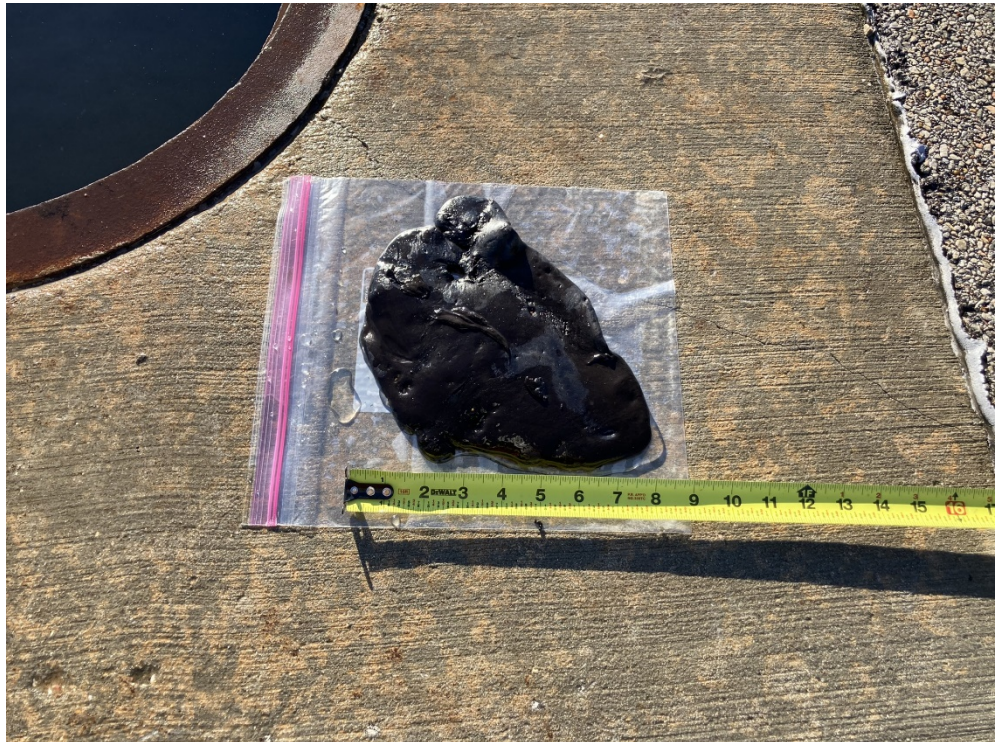
Photo No.
16

Sump 3 (B107/B108), 0 inches of freeboard, no sheen or odor noted, small amount of rubbery tar-like material (approx. 0.1 gal) recovered from sump.

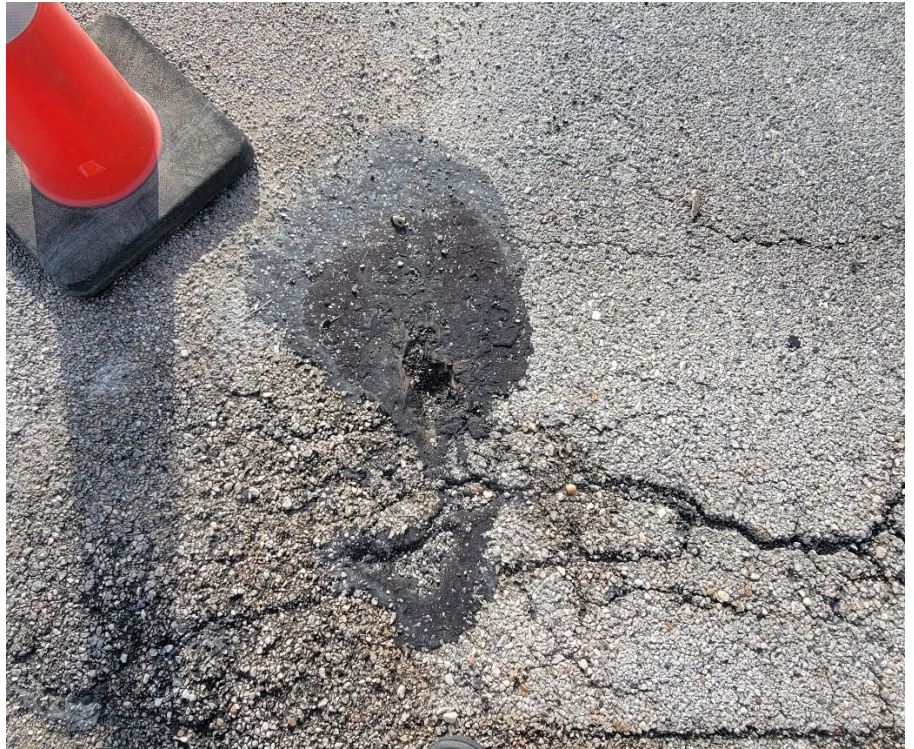
Photo No.
17

Stall A011, a small amount of tar-like material at a crack in the asphalt pavement, material was removed.

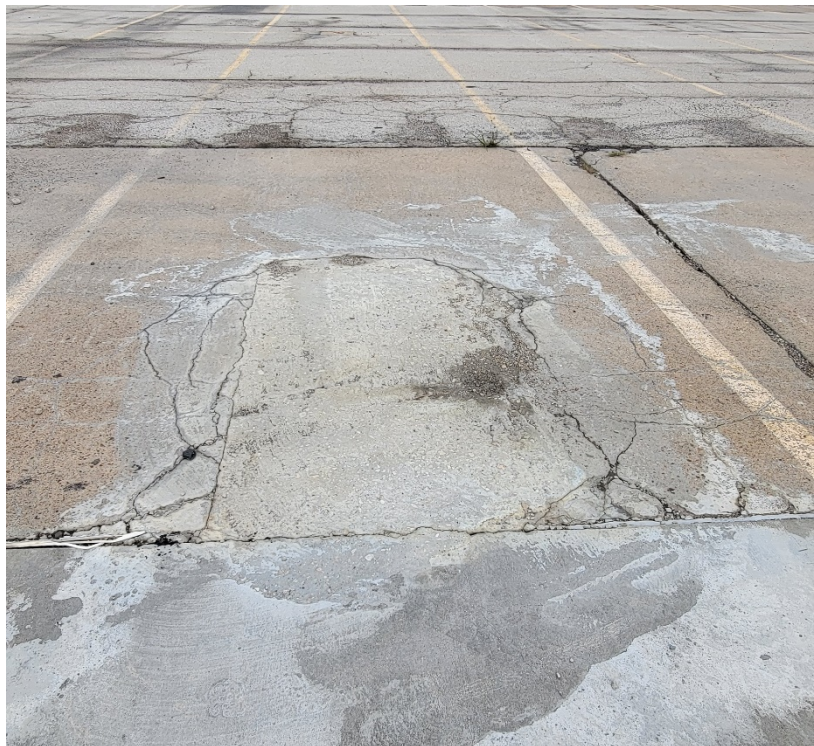
Photo No.
18

Stall B096, no new tar-like material observed near historical seep location along concrete joint adjacent to July 2020 test pit, looking northwest.

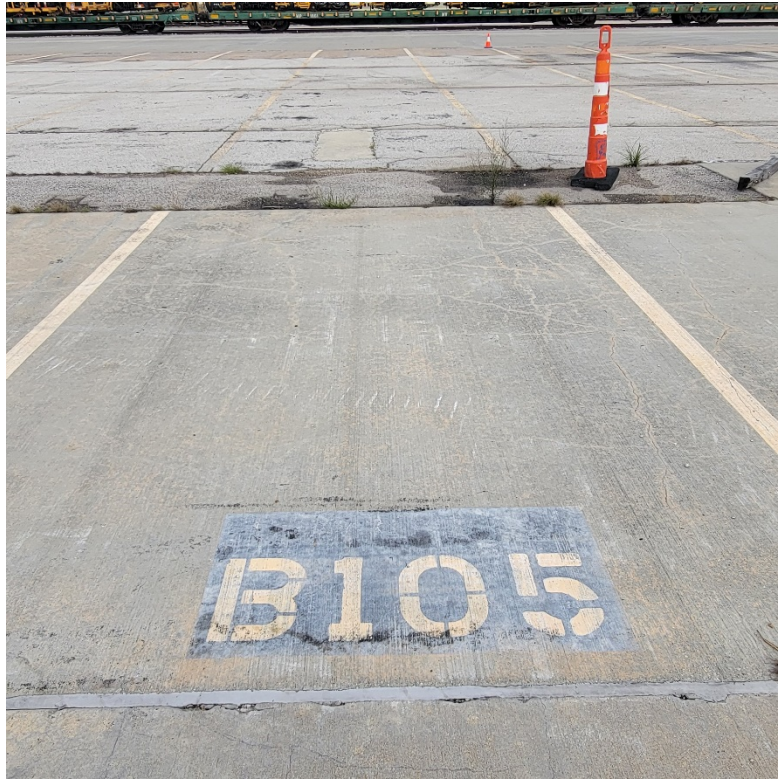
Photo No.
19

Stall B105, no tar-like material observed, looking northwest.

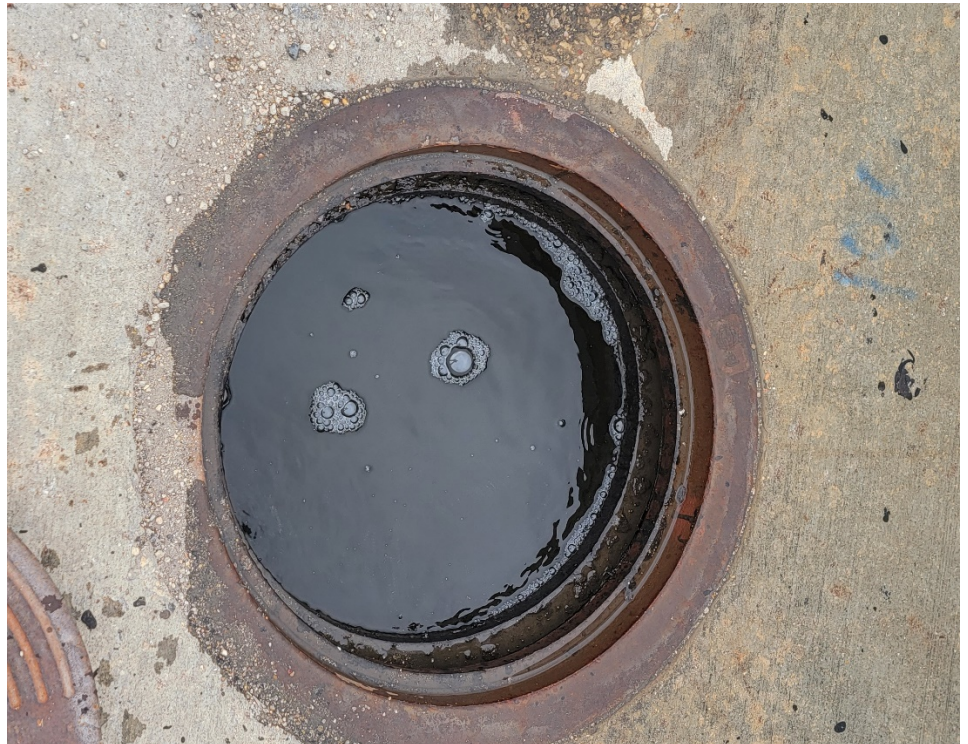
Photo No.
20

Sump 1 (B099/B100), 4 inches of freeboard in sump, no sheen or odor noted, no new NAPL accumulation on the inflow protector.

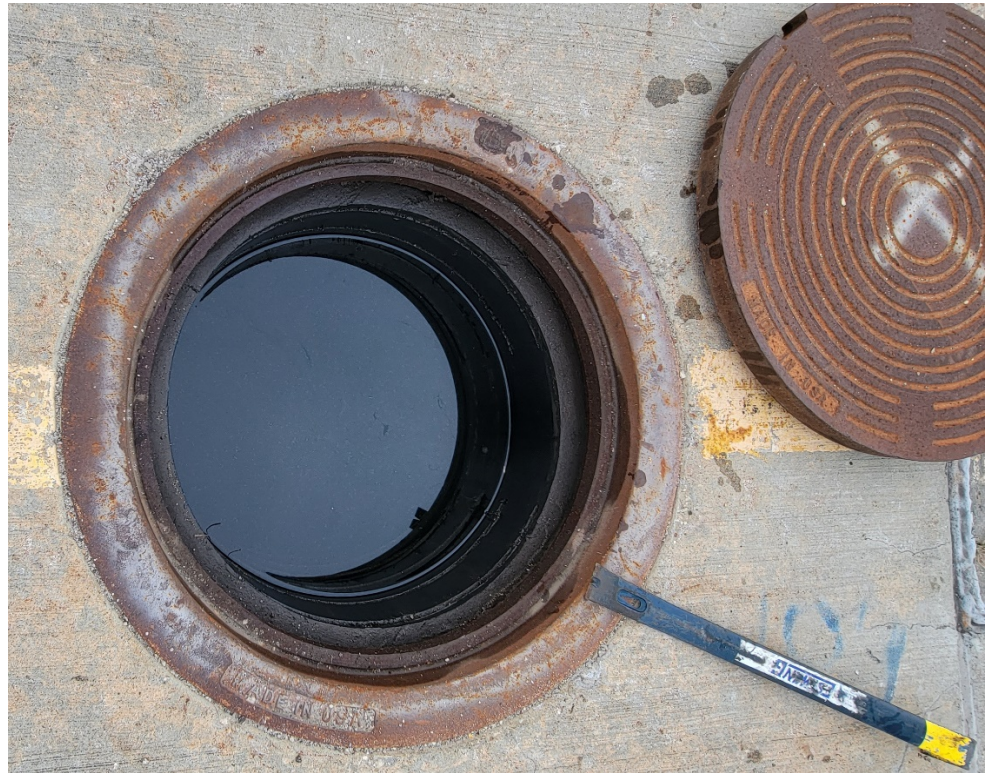
Photo No.
21

Sump 2 (B103/B104), 8 inches of freeboard in sump, no sheen or odor noted.

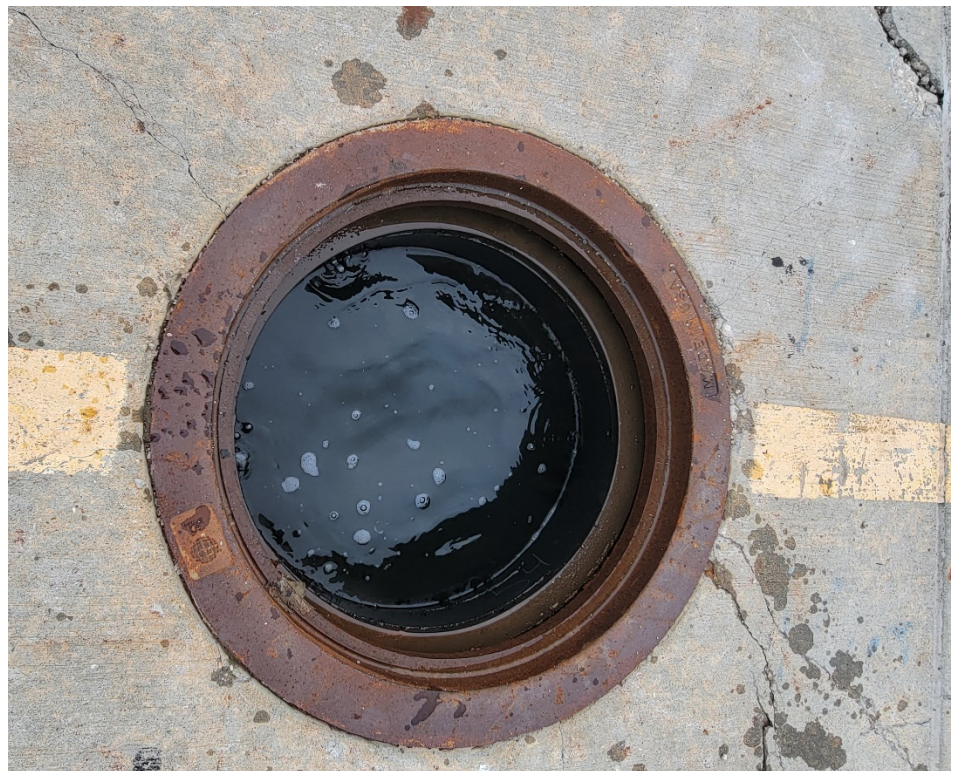
Photo No.
22

Sump 3 (B107/B108), 7 inches of freeboard in sump, no sheen or odor noted.

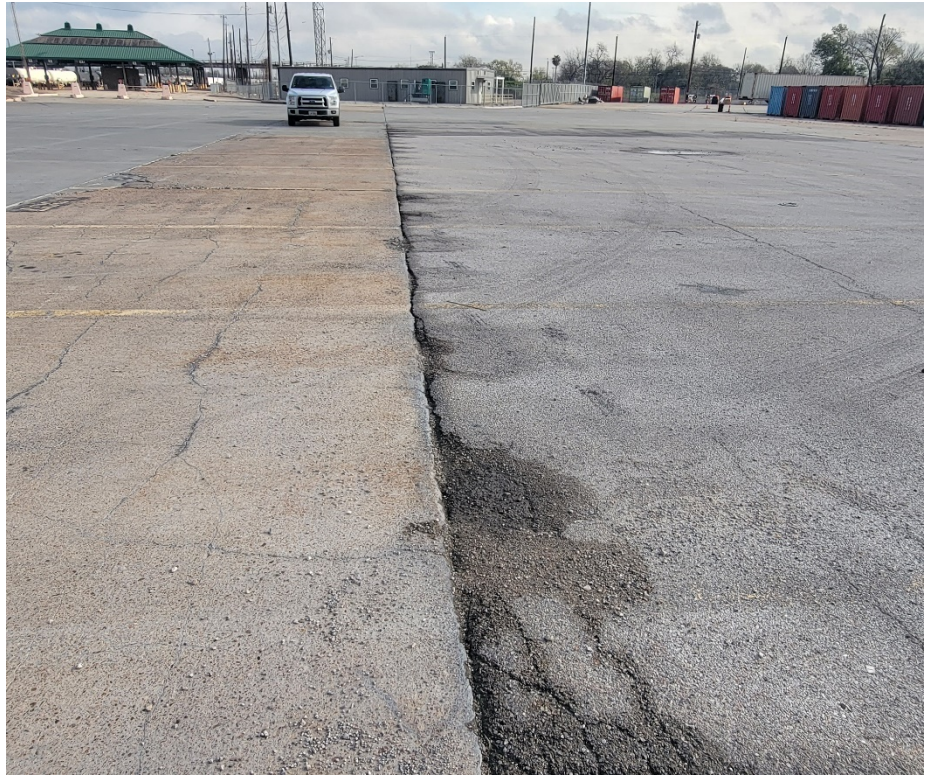
Photo No.
23

Eastern end of A and B rows, pavement wet from recent rain event, looking east.

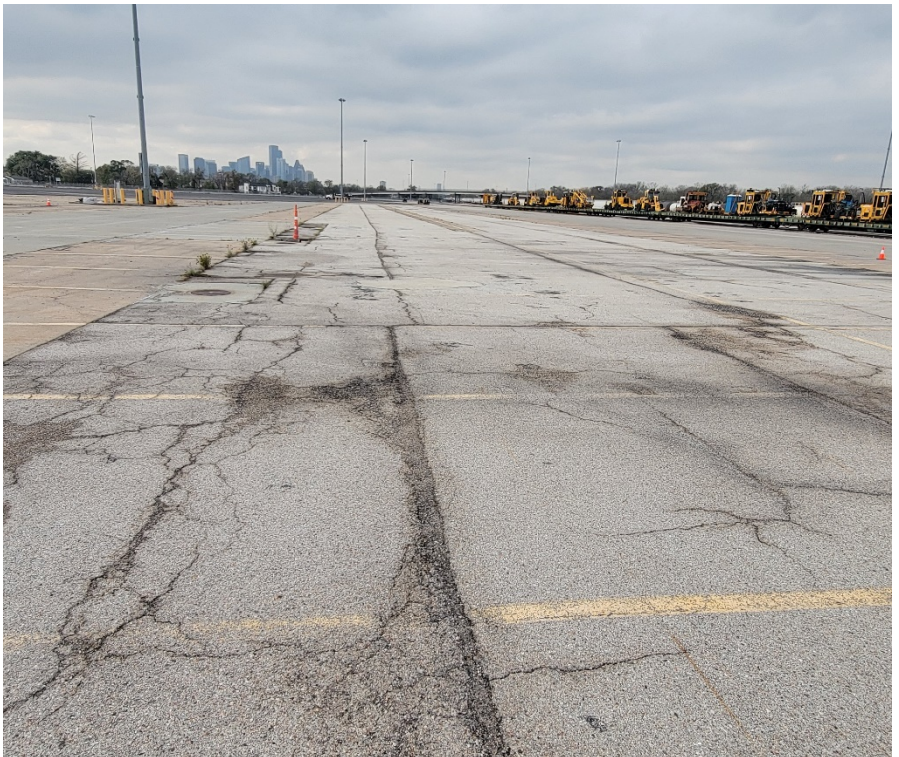
Photo No.
24

Stalls B096-B110, NAPL collection system area, no new tar-like material observed, pavement wet from recent rain event, looking west.

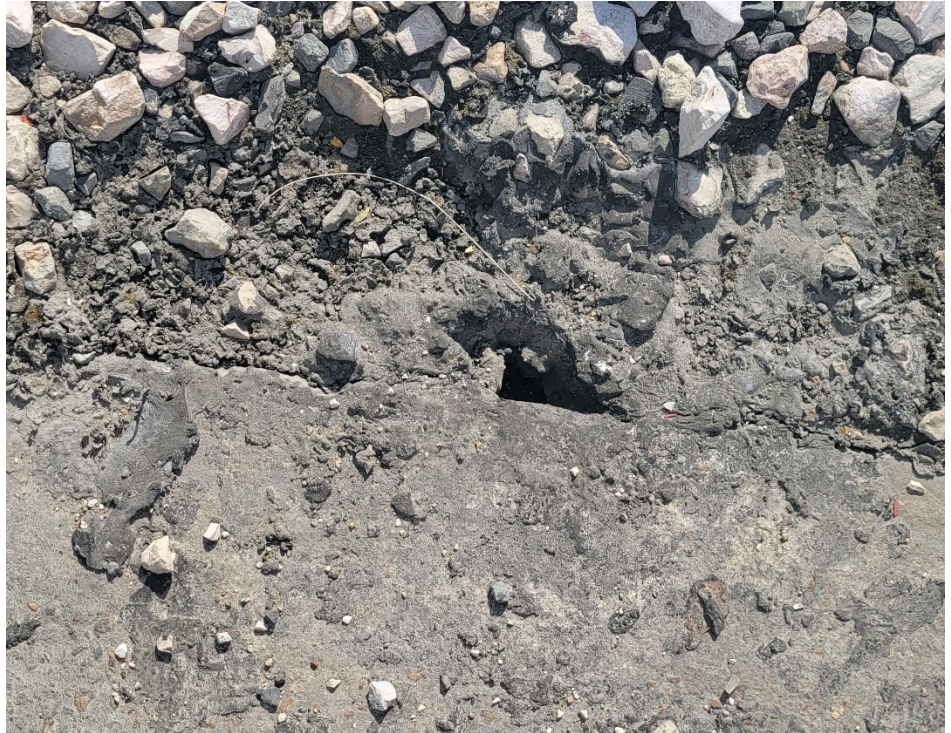
Photo No.
25

- As detailed in the July 2022 Monthly Status Update, a tar-like material seep was observed next to Track 802 that is located approximately 280 feet northwest of the NAPL Collection System. The tar-like material seep is located along on the northern side of the track at the edge of the railroad ballast (Photo No. 5). During the September 28, 2022 weekly inspection, an additional tar-like material seep was observed within the concrete road area (RD-14) about 45 feet north of Track 802 and east of the existing Track 802 seep location (Photo No. 26). No new tar-like material was observed at either of these locations during December 2022.

North side of Track 802 no new tar-like material observed at the seep location along the edge of the ballast, looking east.

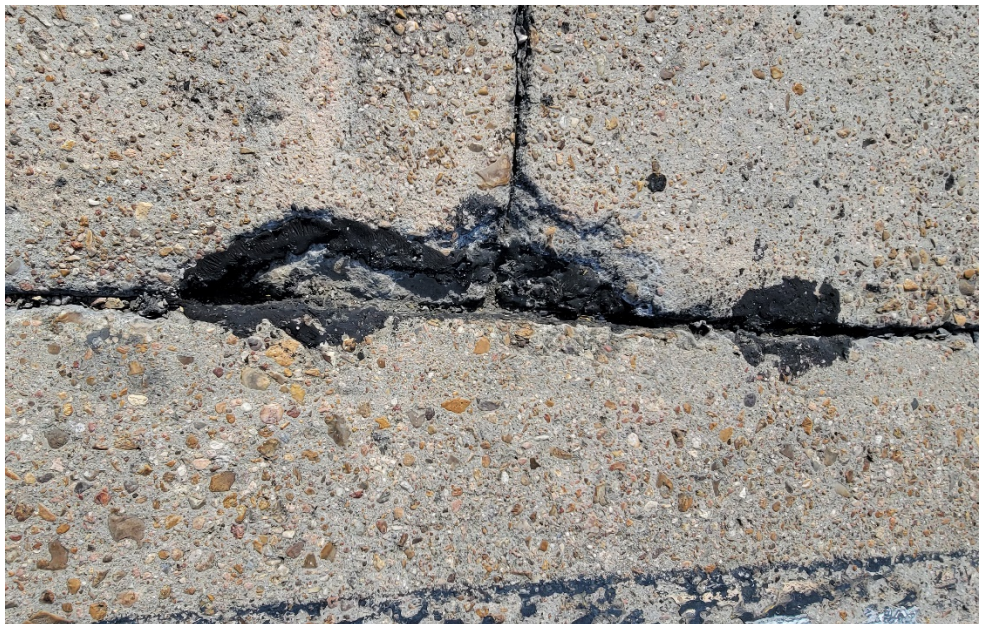
Photo No.
26

Seep location observed within the concrete road area (RD-14) north of Track 802 (East of existing Track 802 seep location), no new tar-like material observed along a concrete joint, looking east.

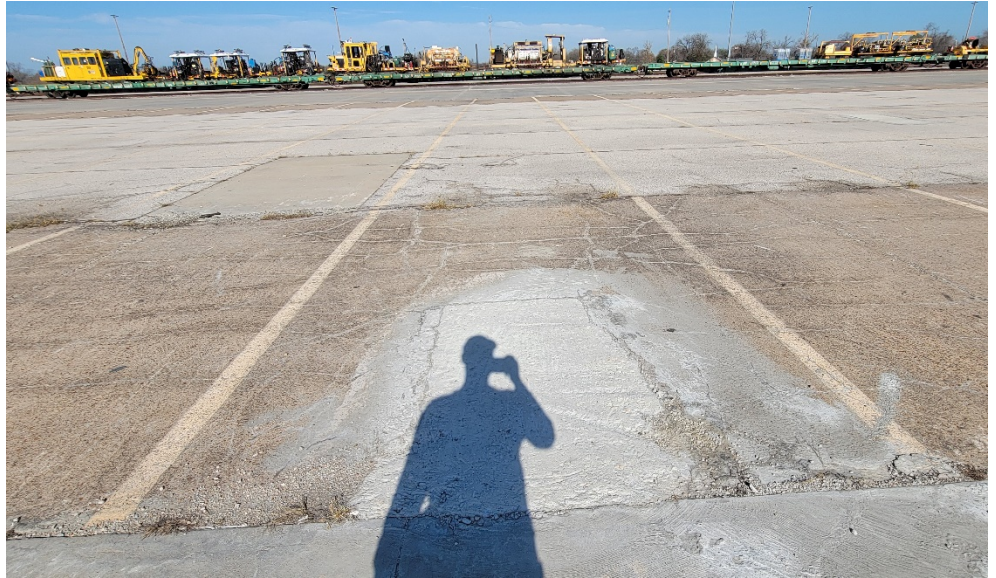
Photo No.
27

Stall B056-B058, no tar-like material at historical seep locations in B046 or B057, no seeps observed where nearby test pit was conducted (July 2020), looking northwest.

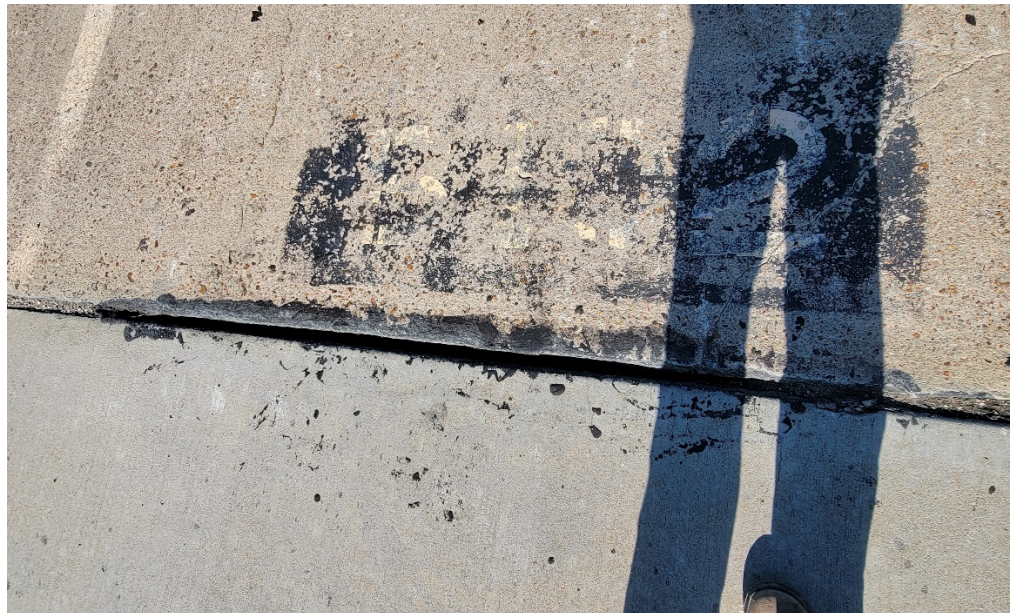
Photo No.
28

Stall B102, no tar-like material seep observed within joint, residual staining on concrete surface noted, looking northwest.

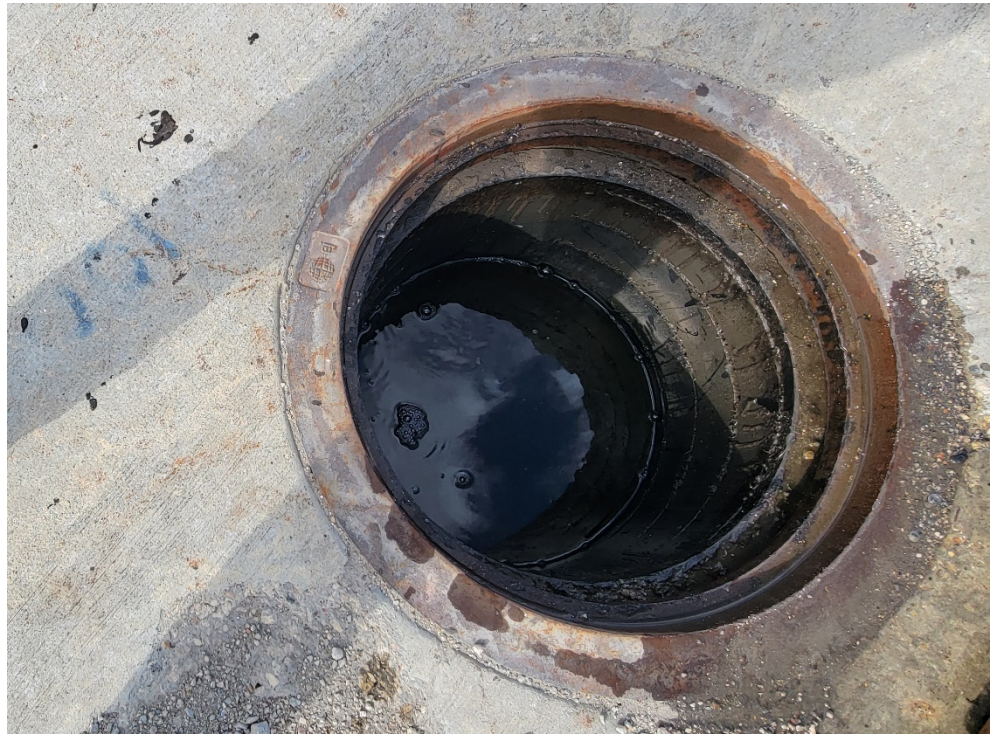
Photo No.
29

Sump 1 (B099/B100), 16 inches of freeboard in sump, no new NAPL accumulation on inflow protector, no sheen or odor noted.

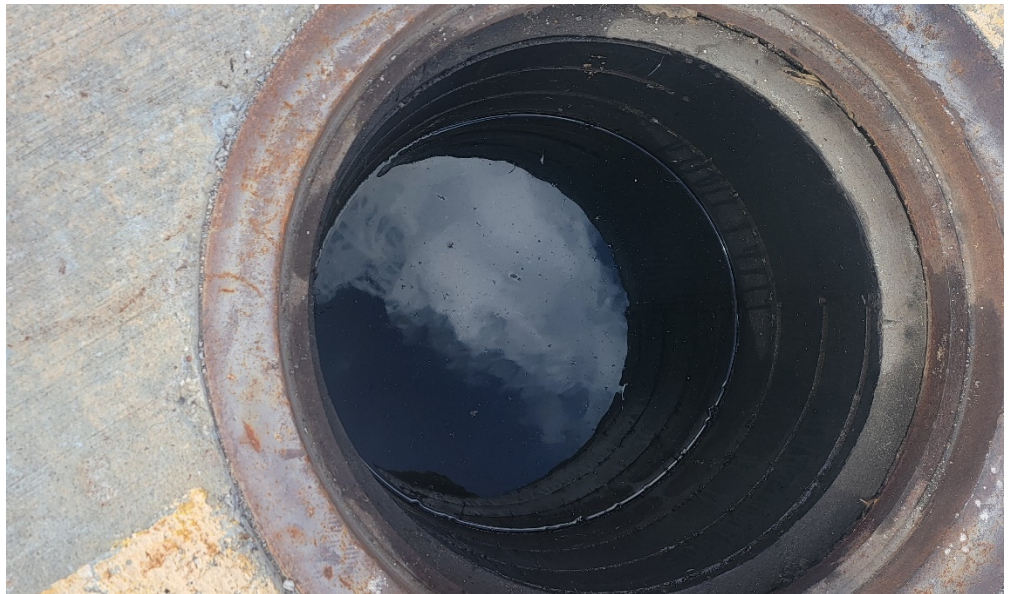
Photo No.
30

Sump 2 (B103/B104), 14 inches of freeboard, no sheen or odor noted.

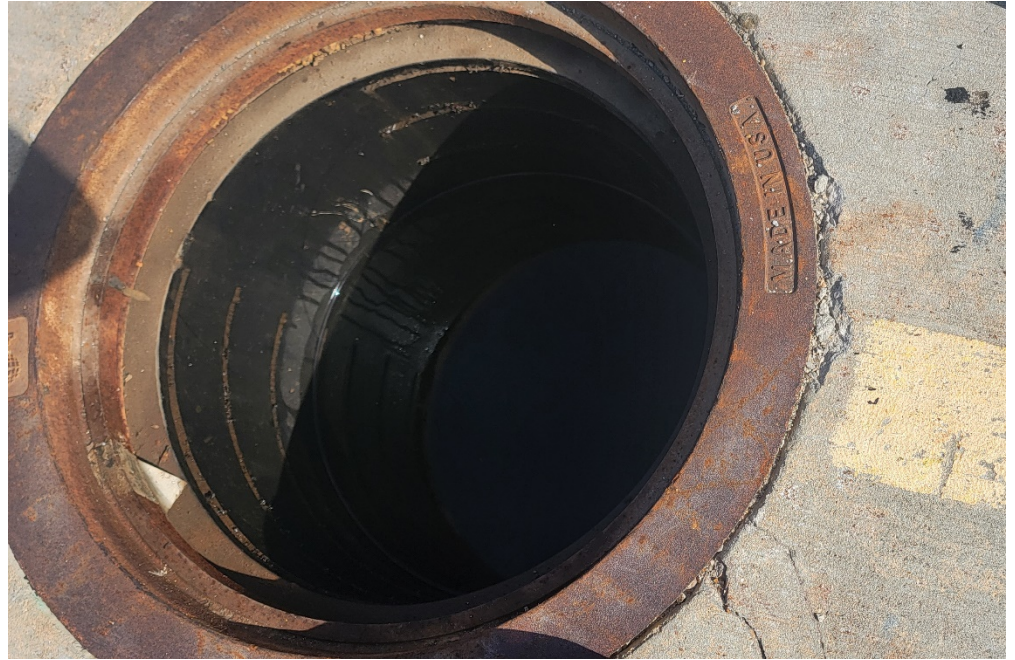
Photo No.
31

Sump 3 (B107/B108), 14 inches of freeboard in sump, no sheen or odor noted.

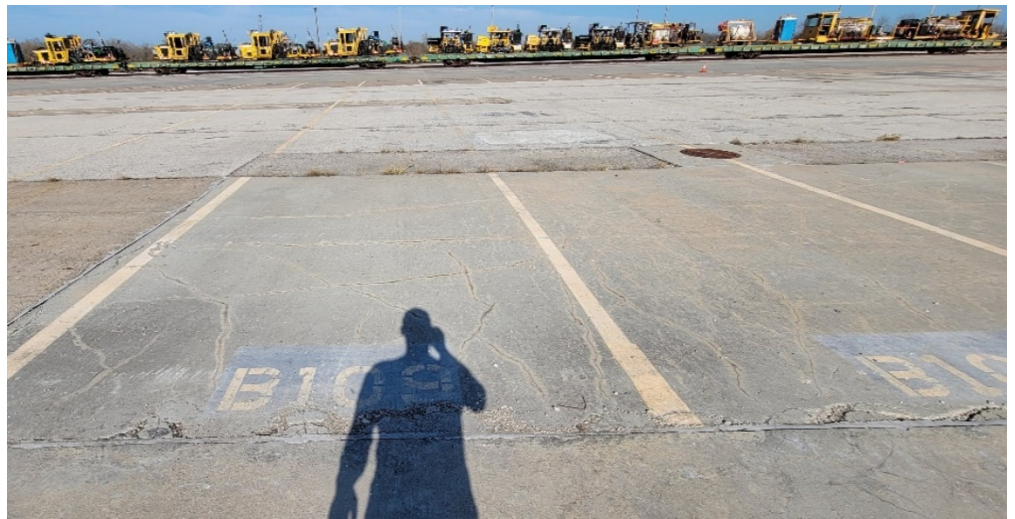
Photo No.
32

Stall B109, western end of NAPL Collection system, no tar-like material observed, looking northwest.
