Project No. 19119232

Re: **MONTHLY STATUS UPDATE – ENGLEWOOD INTERMODAL YARD – NAPL COLLECTION SYSTEM/CONCRETE CAP REPAIRS  
UNION PACIFIC RAILROAD HOUSTON WOOD PRESERVING WORKS FACILITY  
4910 LIBERTY ROAD FACILITY, HOUSTON, TEXAS  
POST-CLOSURE CARE PERMIT NO. HW-50343; INDUSTRIAL SWR NO. 31547**

## **Weekly Inspection Photolog**

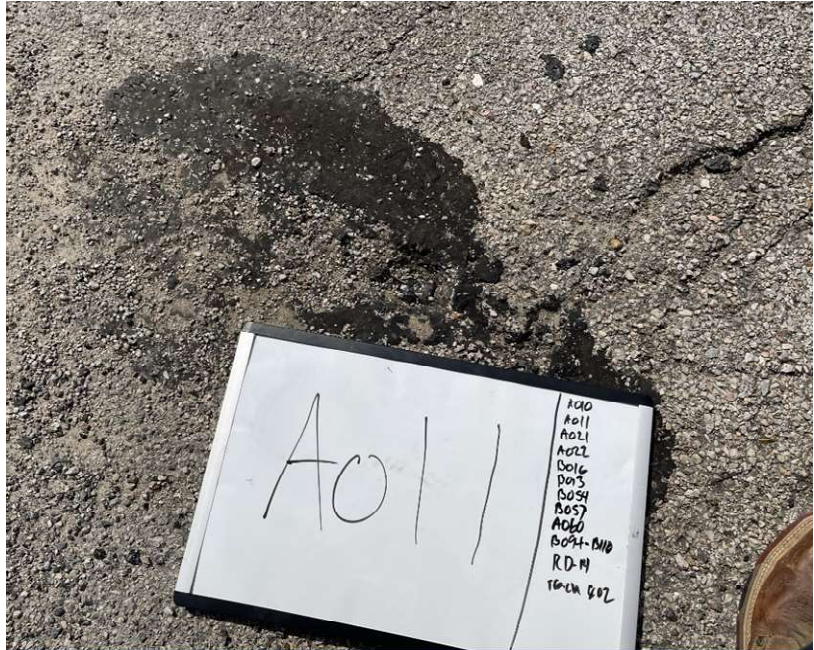
**Photo No.**  
**1**

Stall A011 small amount of tar-like material observed at historical seep location along concrete joint adjacent to July 2020 test pit, material was removed.

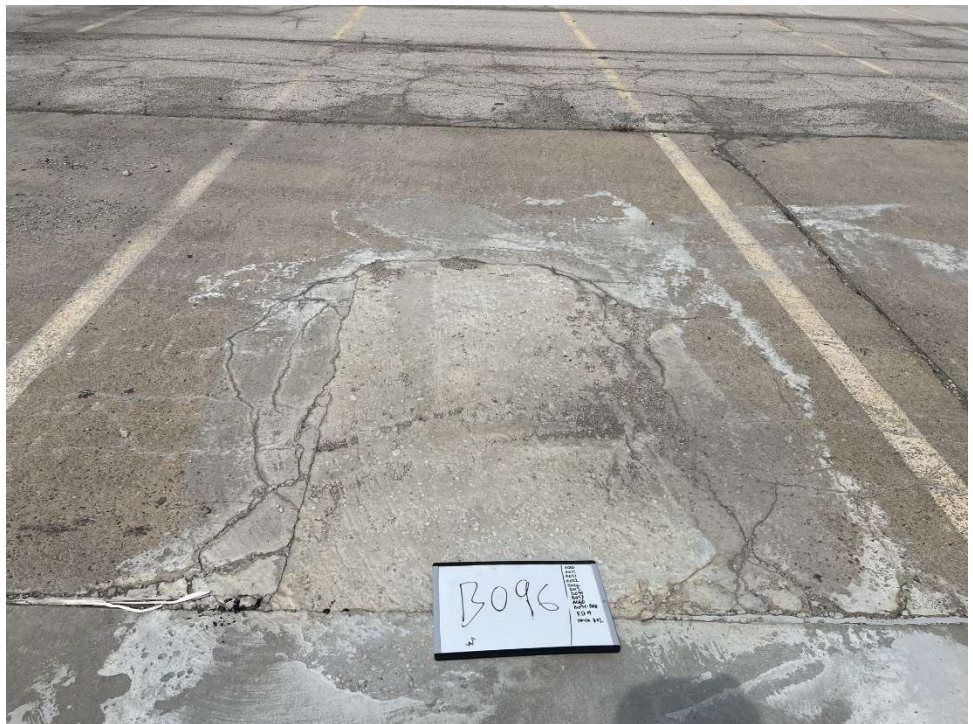
**Photo No.**  
**2**

Stall B096, no new tar-like material observed at historical seep location adjacent to July 2020 test pit, looking northwest.

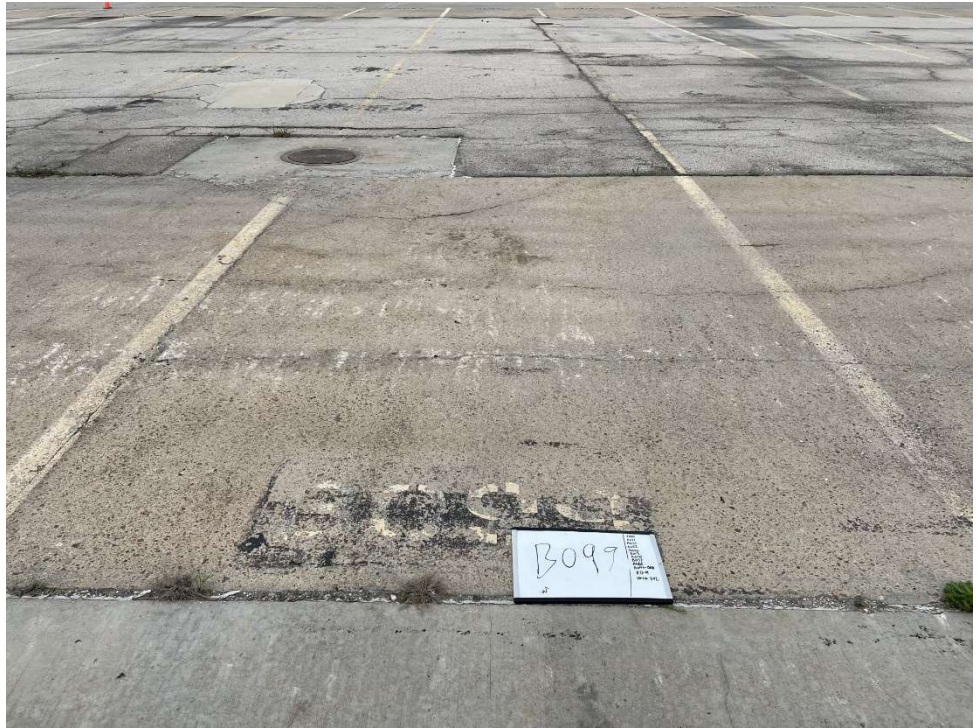
**Photo No.**  
**3**

Stalls B099-B100, view of NAPL collection system (Sump 1 in background of photo), looking northwest.

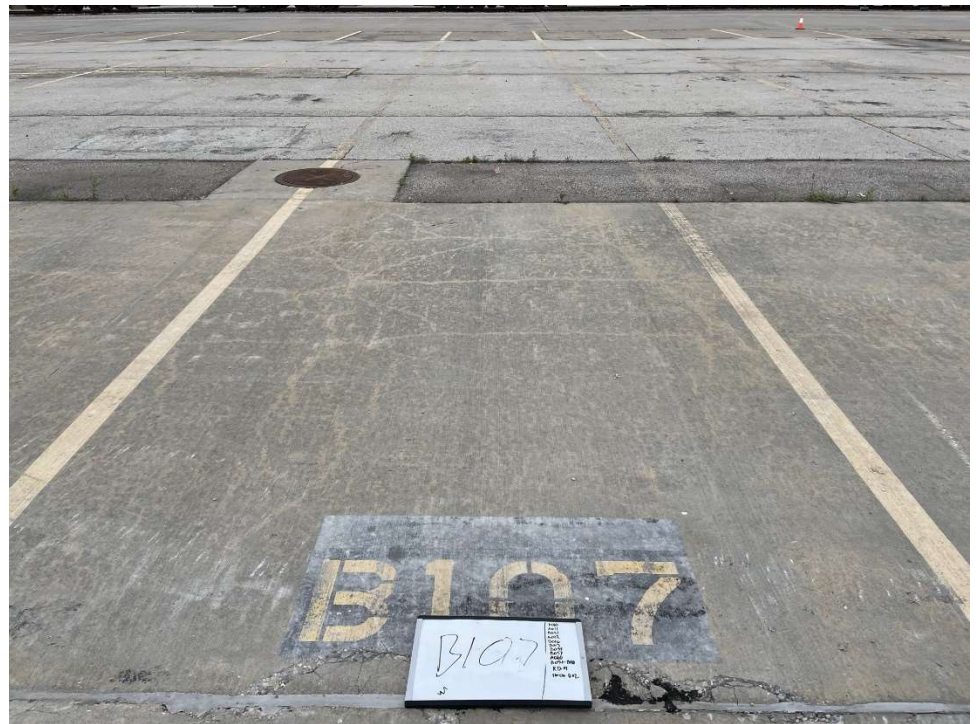
**Photo No.**  
**4**

Stalls B107 view of NAPL collection system (Sump 3 in background of photo), no new tar-like material observed at seep location on concrete joint along the southern edge of the excavated area, looking northwest.

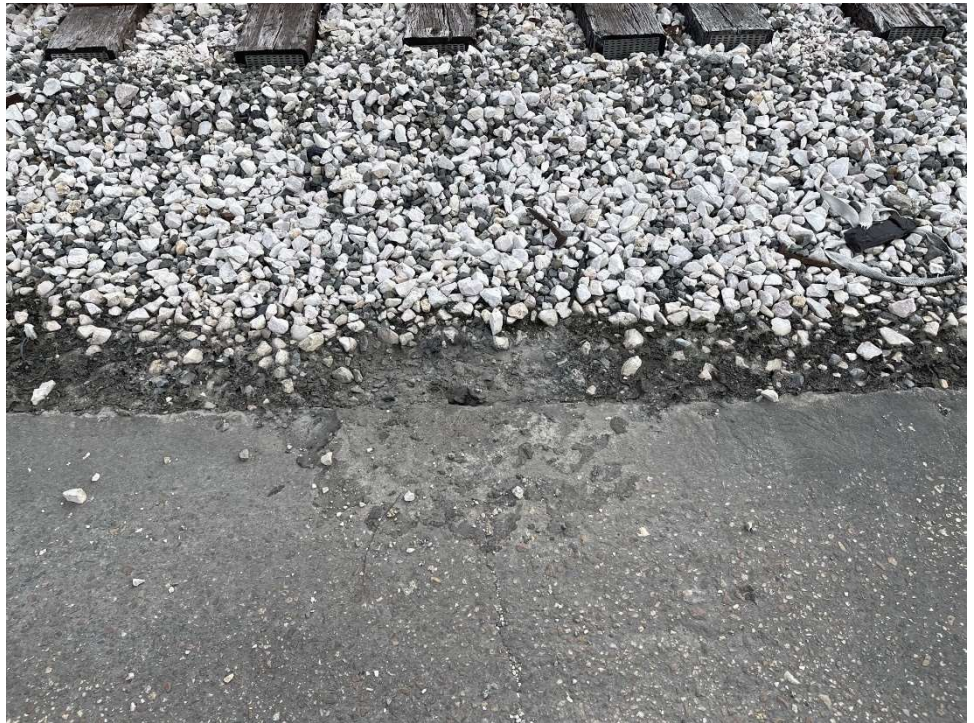
**Photo No.**  
**5**

North side of Track 802, no new tar-like material observed at seep location near the edge of the ballast, looking southeast.

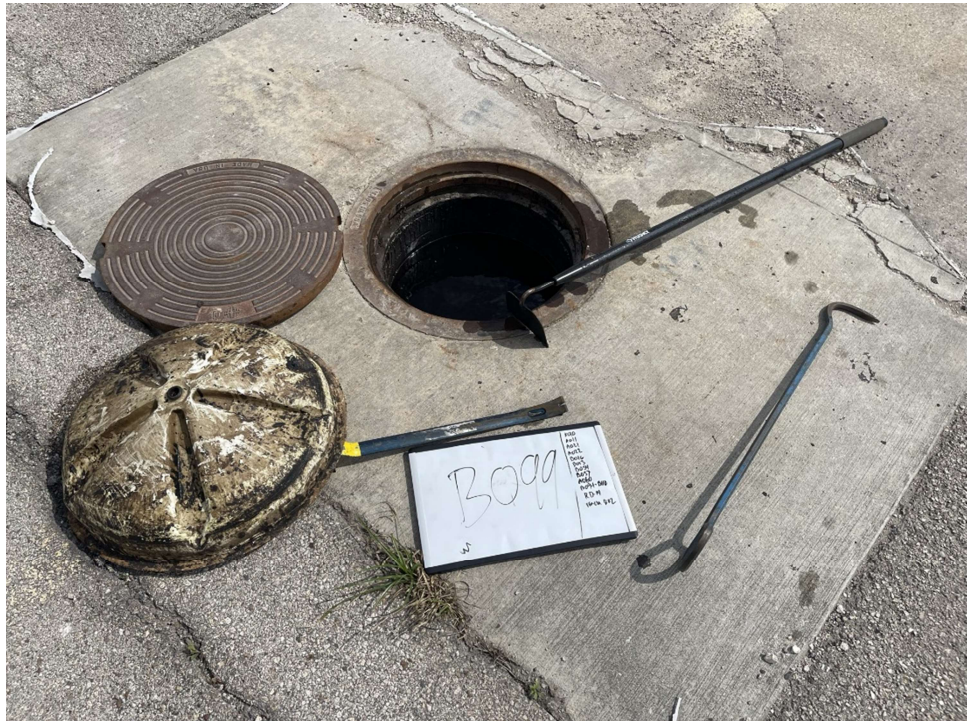
**Photo No.**  
**6**

Sump 1 (B099/B100), 9 inches of freeboard in sump, sheen observed, no odor noted, no new NAPL accumulation on inflow protector.

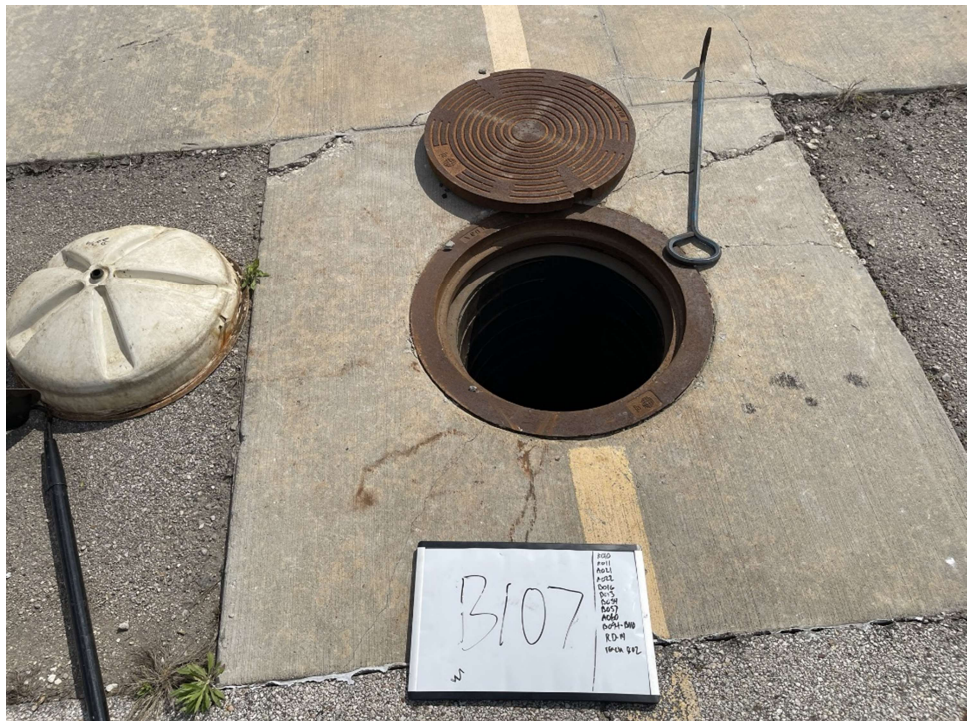
**Photo No.**  
8

Sump 3 (B107/B108), 40 inches of freeboard in sump, sheen observed, no odor noted.

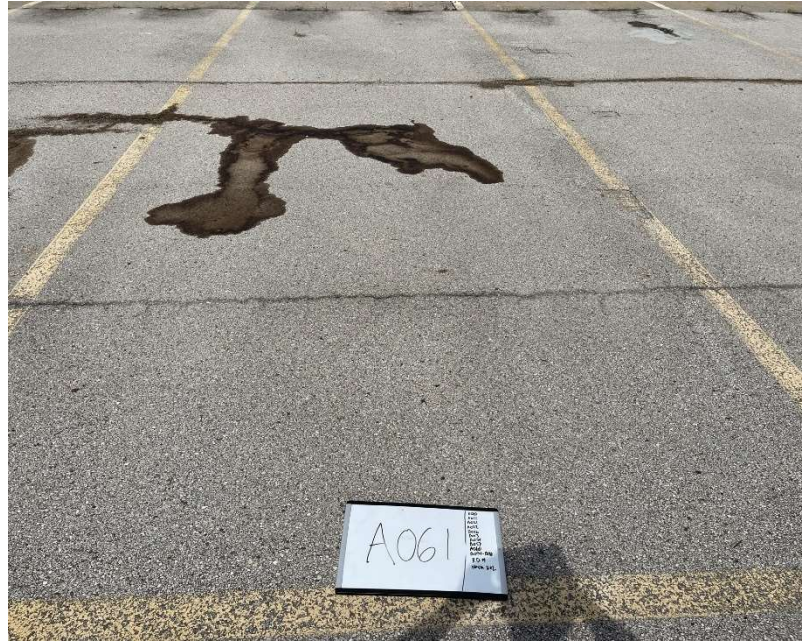
**Photo No.**  
**9**

- During the inspection on March 1, 2023, light brown staining, similar to previous years, was observed along cracks in the paved areas throughout A and B row stalls with heavier staining noted in stalls A060-A065 (Photo Nos. 9 & 10). UPRR remediation contractor arrived onsite on March 3, 2023 and minimal staining was visible. On March 8, 2023 brown staining/residue was observed in the A and B row stalls with the heaviest staining occurring in stalls A058-A062 (Photo No. 19). UPRR remediation contractor arrived onsite on March 8, 2023 to pressure wash and vacuum the affected area, residual staining was noted after cleaning (Photo No. 20). By the March 15, 2023 inspection, brown staining and residue had returned again with heaviest staining present in stalls A060-A070 (Photo No. 27). UPRR remediation contractor OMI arrived onsite on March 15, 2023 to pressure wash and vacuum the affected area, residual staining was present after cleaning (Photo No. 28). Wash water from clean up events was placed into a tote onsite for disposal. By the March 22, 2023 inspection, no new staining was observed but some residual staining was noted in the same areas (Photo No. 36). UPRR will continue to have a remediation contractor pressure wash and collect the water in the areas where the brown staining and seeps are observed, as needed.

Stall A061, Brown residue and staining observed within A and B row stalls, before cleaning, looking south.

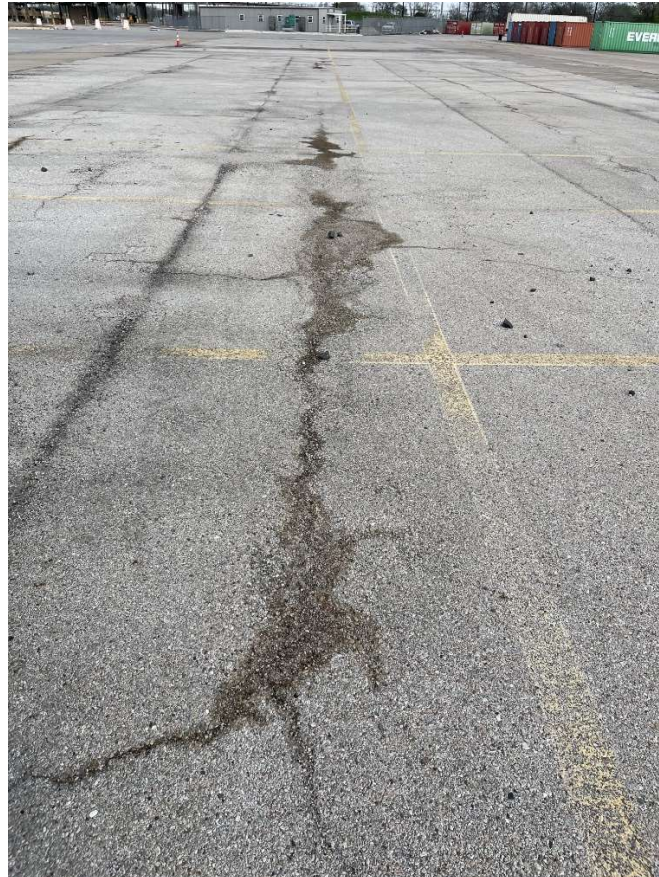
**Photo No.**  
**10**

Eastern end of A and B row stalls, brown staining observed before cleaning, looking east.

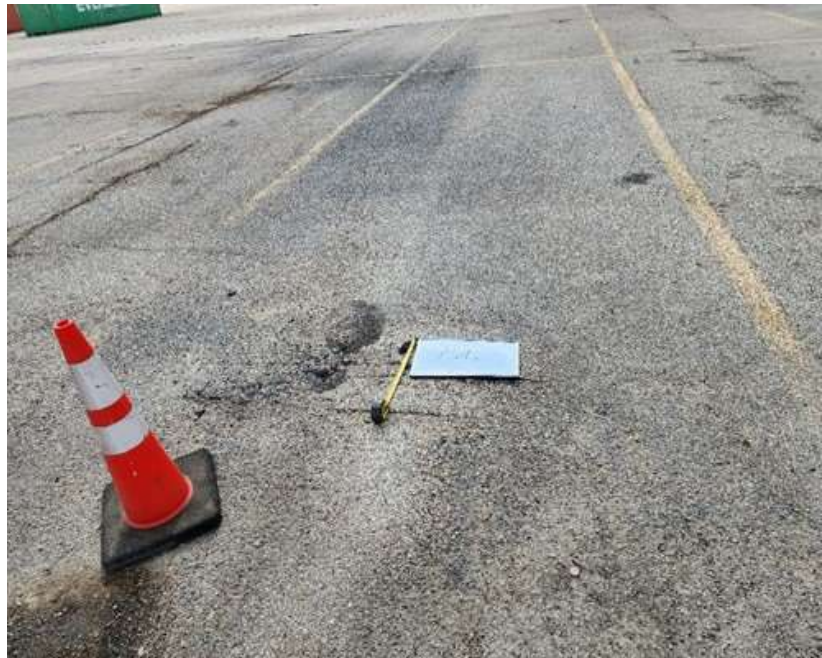
**Photo No.**  
**11**

Stall A011, very small amount of tar-like material observed at historical seep location, looking southeast. Material was removed.

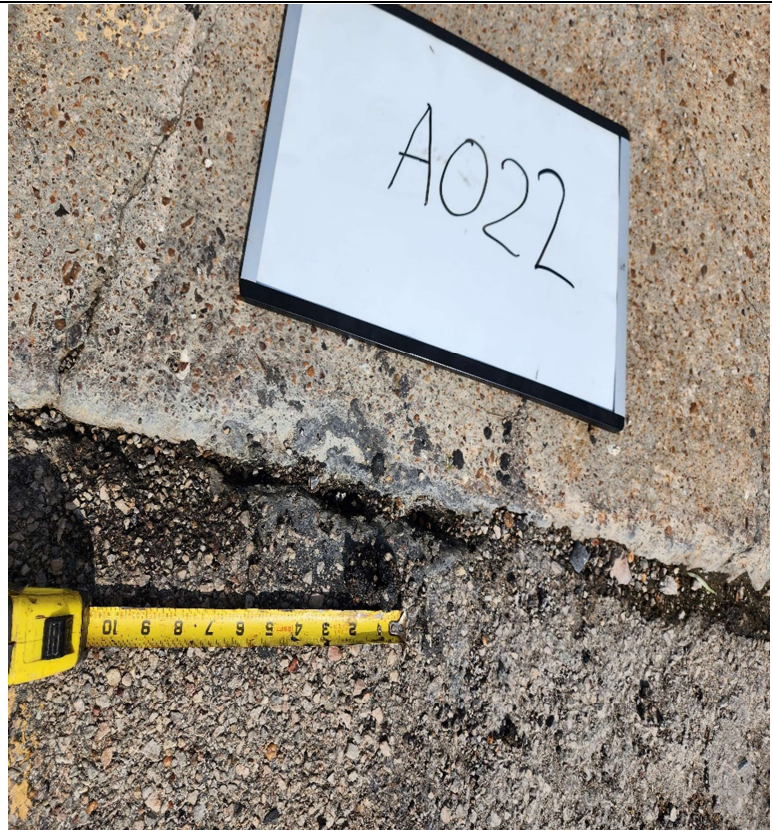
**Photo No.**  
**12**

Stall A022, very small amount of tar-like material observed at the seep location along the edge tar-like material seeps observed, looking northwest. Material was removed.

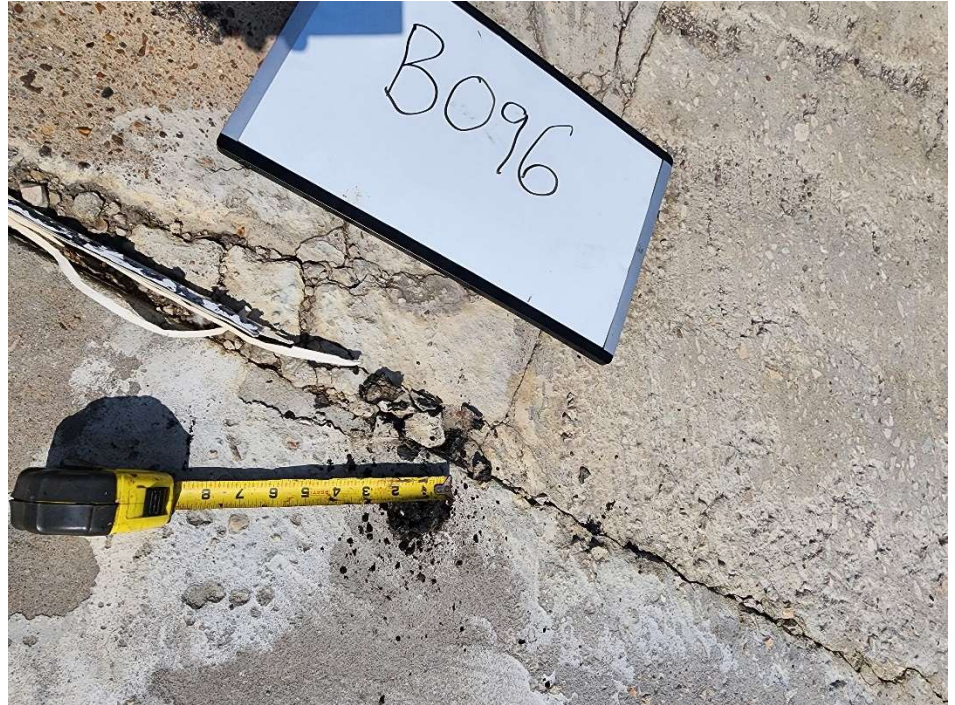
Stall B096, very small amount of tar-like material observed near historical seep location along concrete joint adjacent to July 2020 test pit, material was removed.

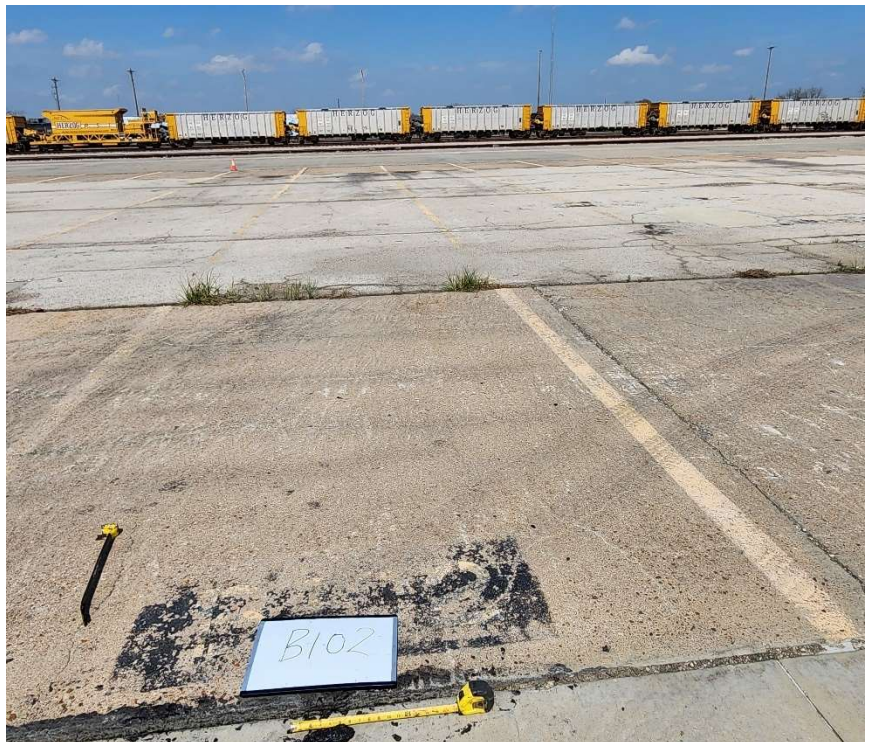
**Photo No.**  
**14**

Stall B102, small amount of tar-like material observed within concrete joint, residual staining on concrete surface noted, looking northwest.

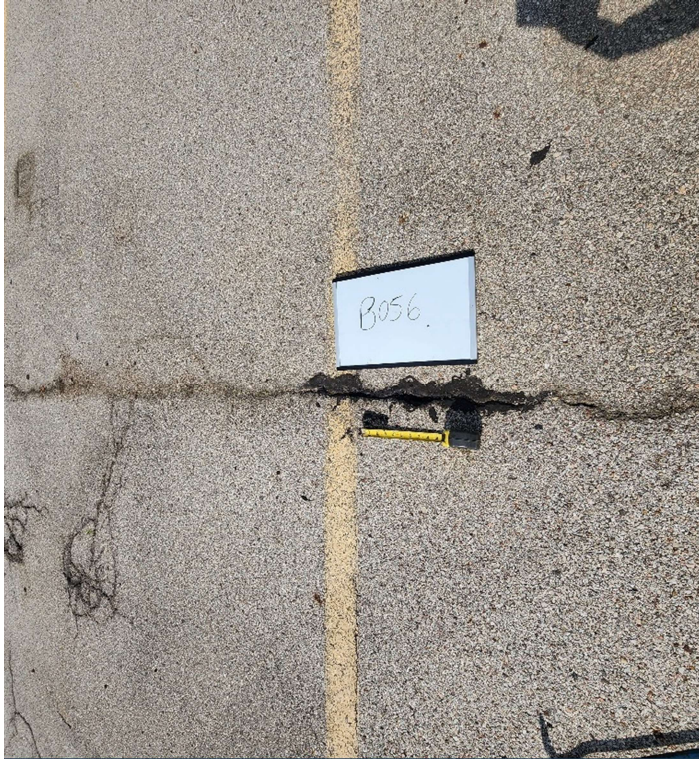
Stall B056, very small amount of tar-like material observed at historical seep location, looking northeast. Material was removed.

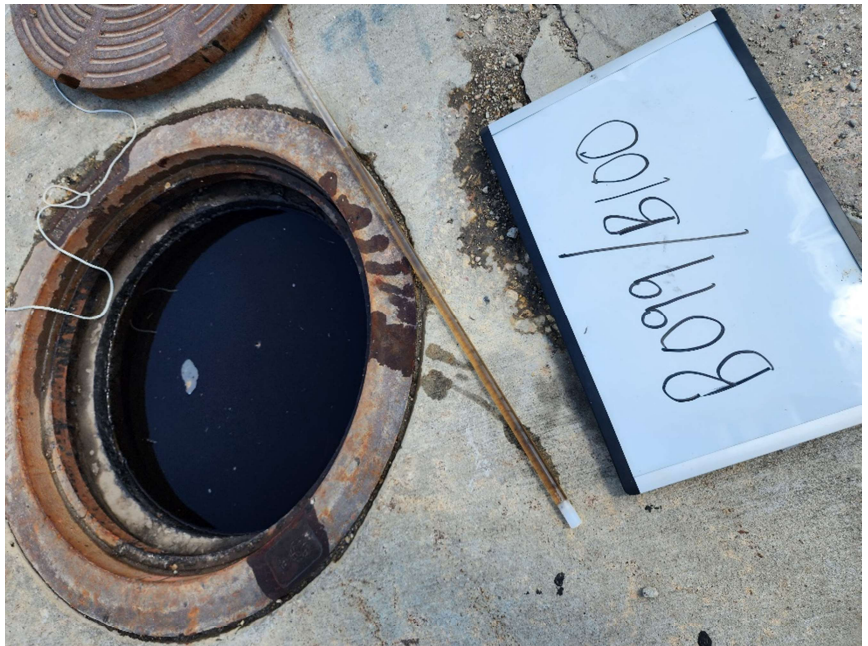
**Photo No.**  
**16**

Sump 1 (B099/B100), 5 inches of freeboard in sump, no sheen or odor noted, no new NAPL accumulation on inflow protector. bailer used to observe watercolor, watercolor noted as light brown.

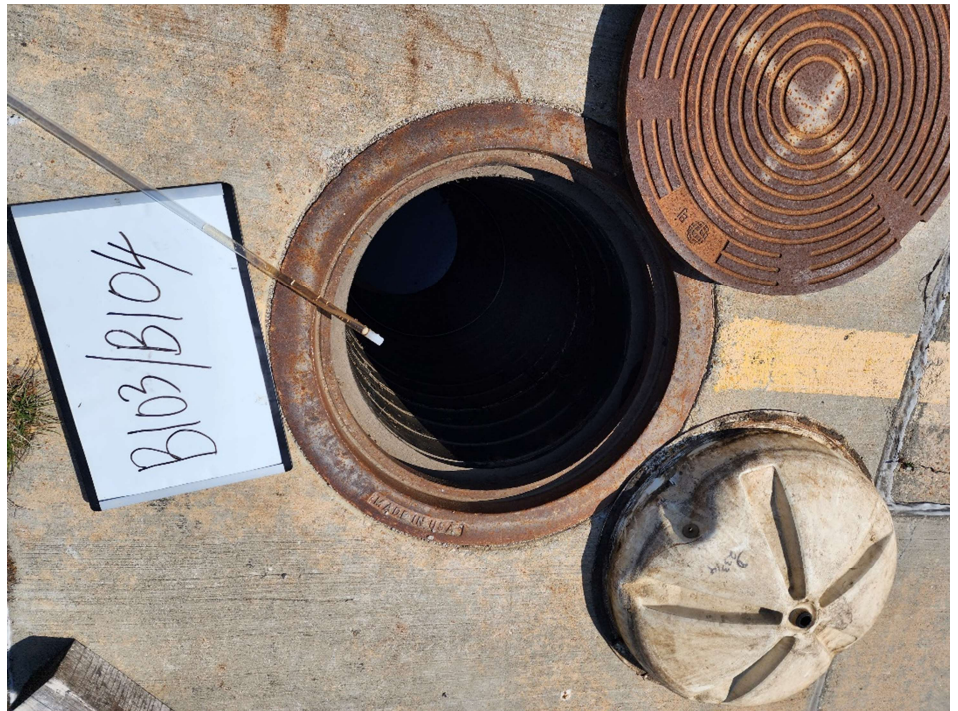
Sump 2 (B103/B104), 42 inches of freeboard. No sheen or odor noted. Bailer used to observe color of the water, which was noted as light brown.

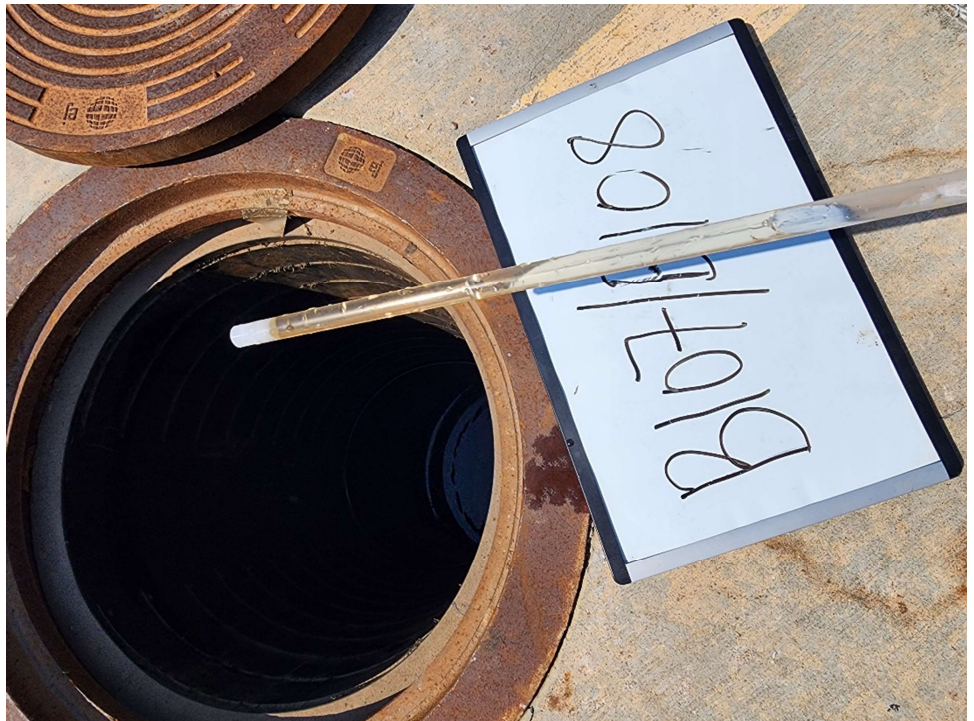
Sump 3 (B107/B108) with 41 inches of freeboard, no sheen or odor noted. bailer used to observe color of the water, which was noted as clear.

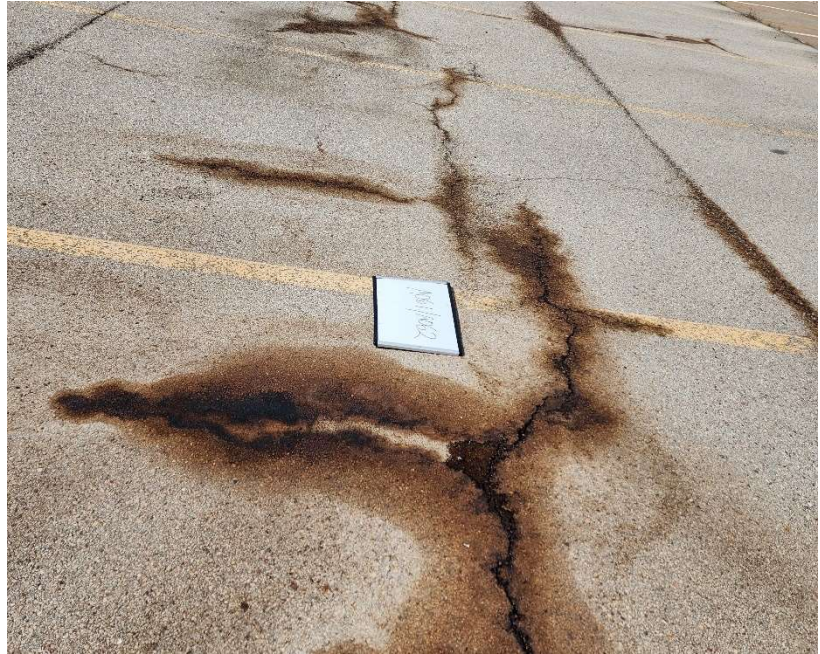
Slots A058-A062, Brown residual and staining material observed within asphalt cracks, before cleaning. looking west.

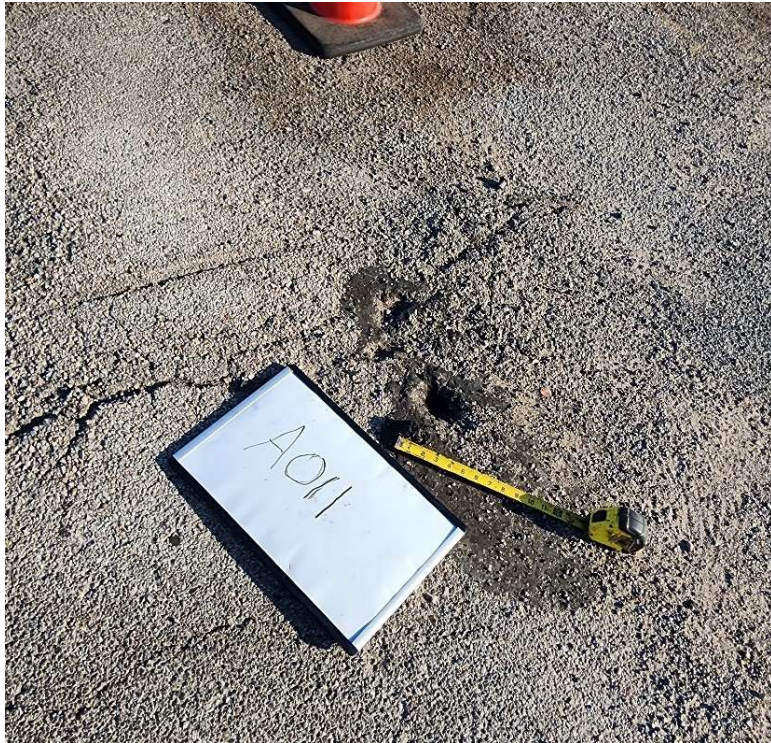
Stall A011, very small amount of tar-like material observed at historical seep location. Material was removed.

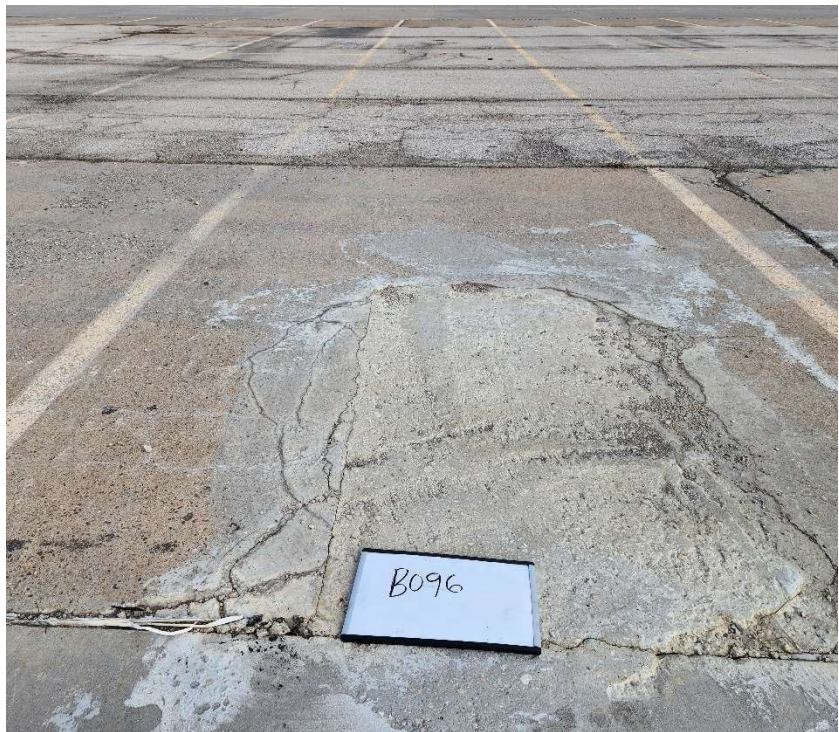
**Photo No.**  
**22**

Stall B096, no new tar-like material observed near historical seep location along concrete joint adjacent to July 2020 test pit, looking northwest.

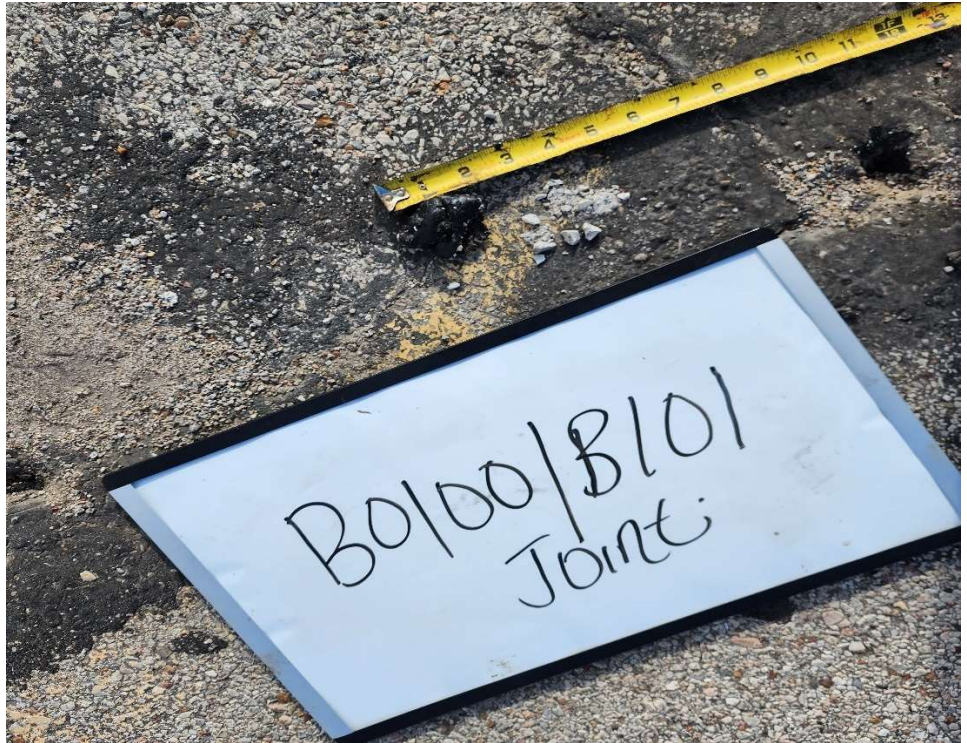
Stall B101 joint, very small amount of tar-like material observed at historical seep location along asphalt crack. Material was removed.

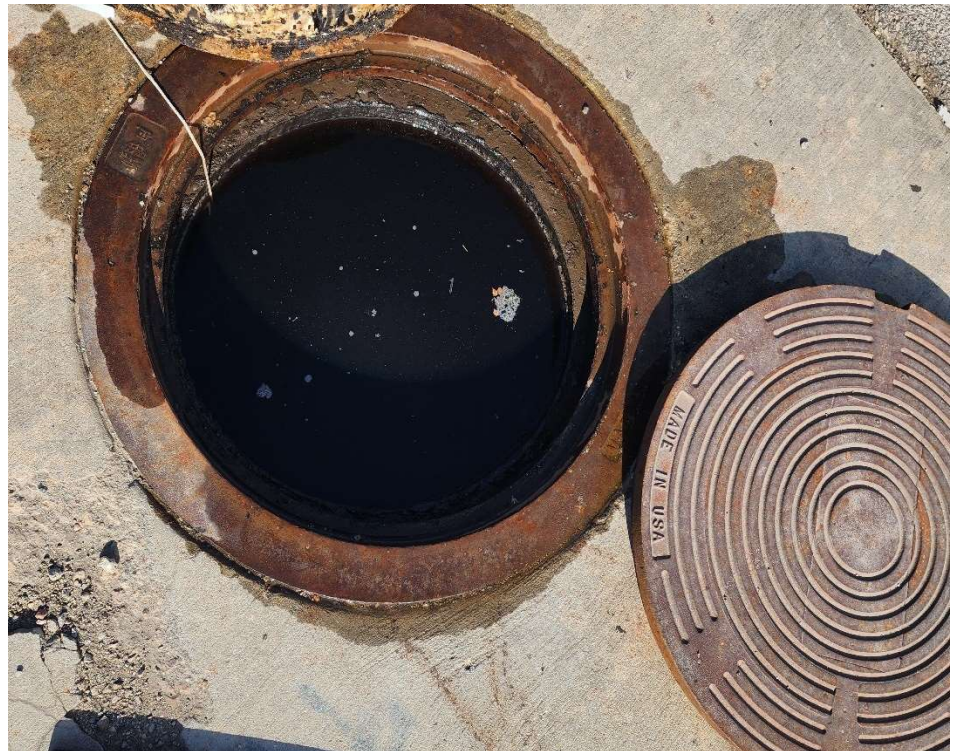
**Photo No.**  
**24**

Sump 1 (B099/B100), 4 inches of freeboard in sump, no sheen or odor noted, no new NAPL accumulation on the inflow protector, bailer used to observe color of the water, which was noted as brown.

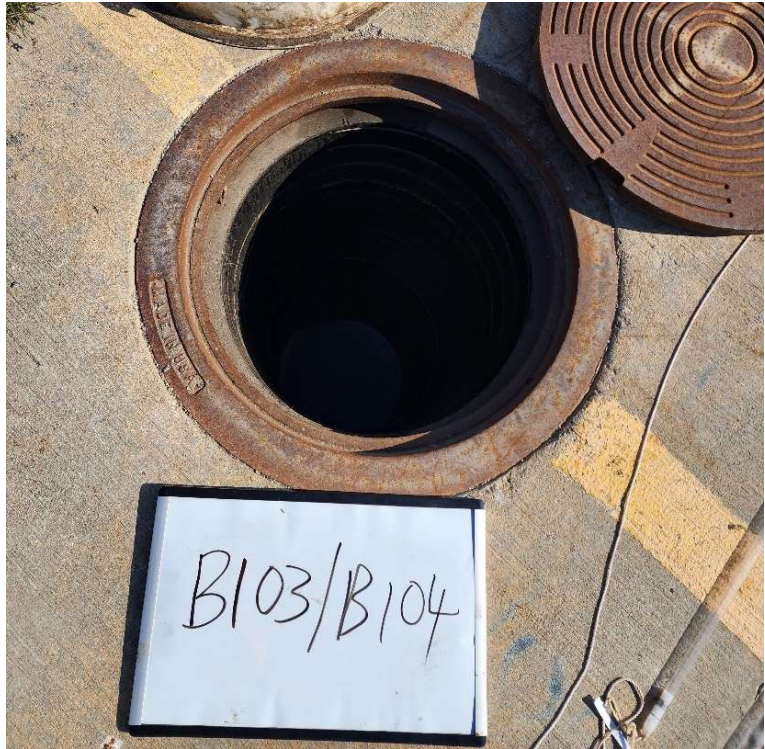
<b>Photo No.</b> <b>25</b>	<b>Inspection Date:</b> 03/15/2023
-------------------------------	---------------------------------------

Sump 2 (B103/B104), 42 inches of freeboard in sump, no sheen or odor noted, bailer used to observe color of the water, which was noted as light brown.

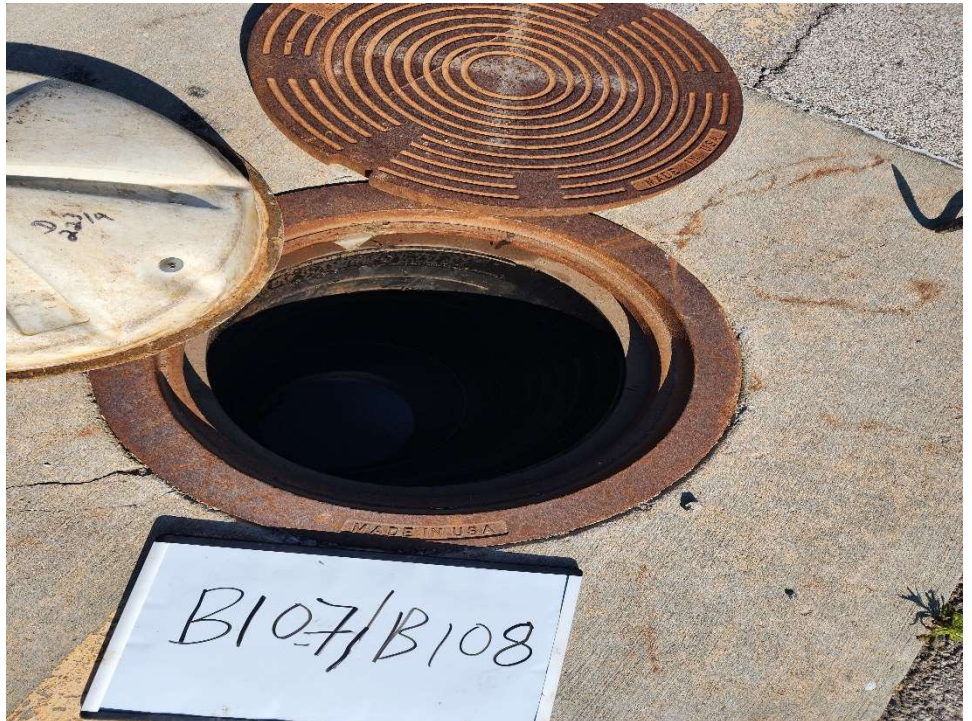
<b>Photo No.</b> <b>26</b>	<b>Inspection Date:</b> 03/15/2023
-------------------------------	---------------------------------------

Sump 3 (B107/B108), 2.5 inches of freeboard in sump, no sheen or odor noted, bailer used to observe color of the water, which was noted as very light brown.

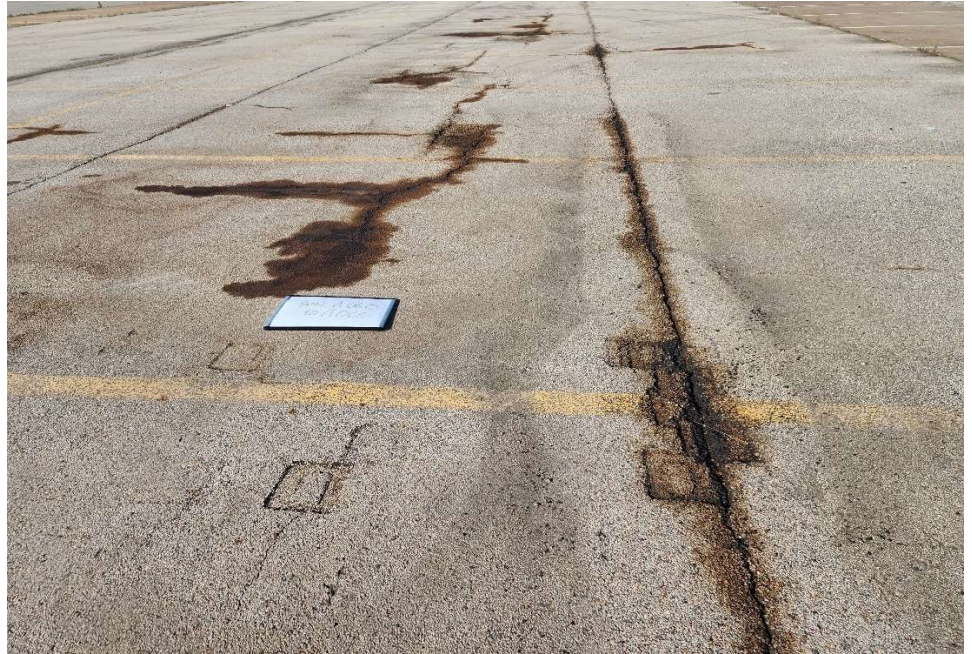
Stalls A60-A68, brown staining material observed within asphalt cracks, prior to cleaning, looking west.

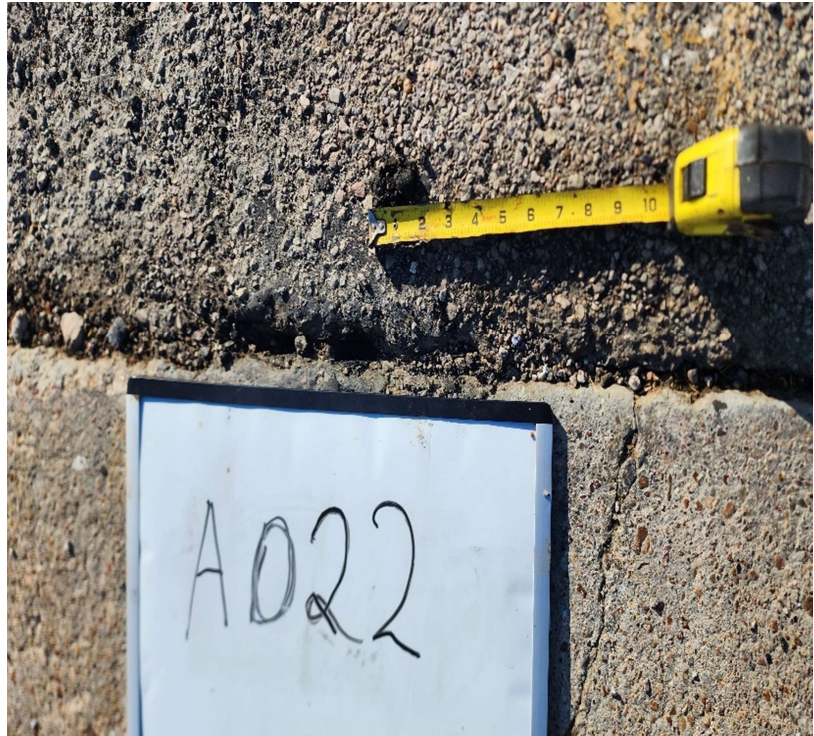
Stall A022, small amount of tar-like material observed at the seep location along the edge tar-like material seeps observed, looking northwest. Material was removed.

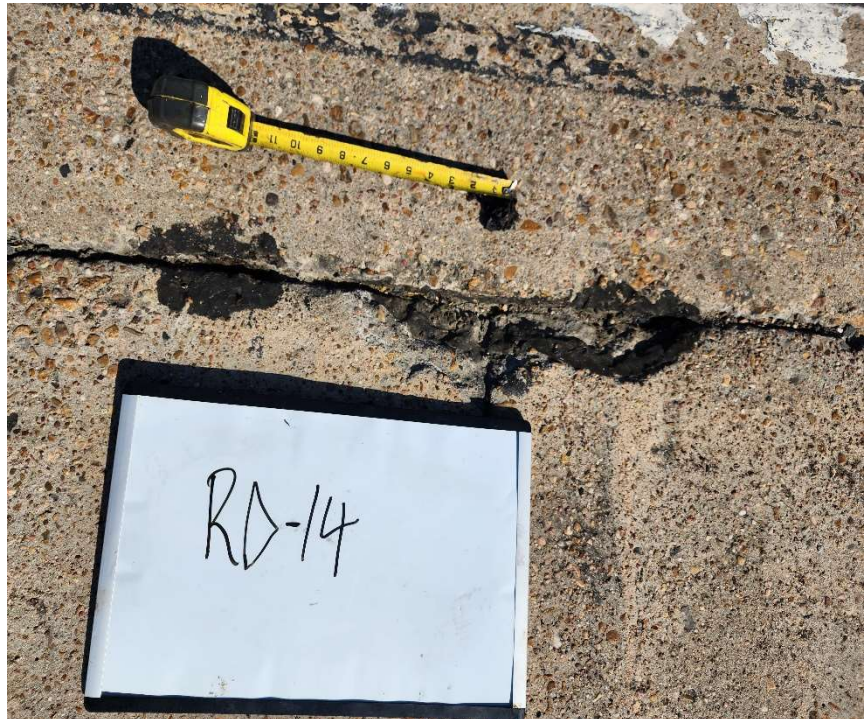
**Photo No.**  
**30**

Seep location observed within the concrete road area (RD-14) north of Track 802 (East of existing Track 802 seep location), very small amount of tar-like material observed along a concrete joint. Material was removed.

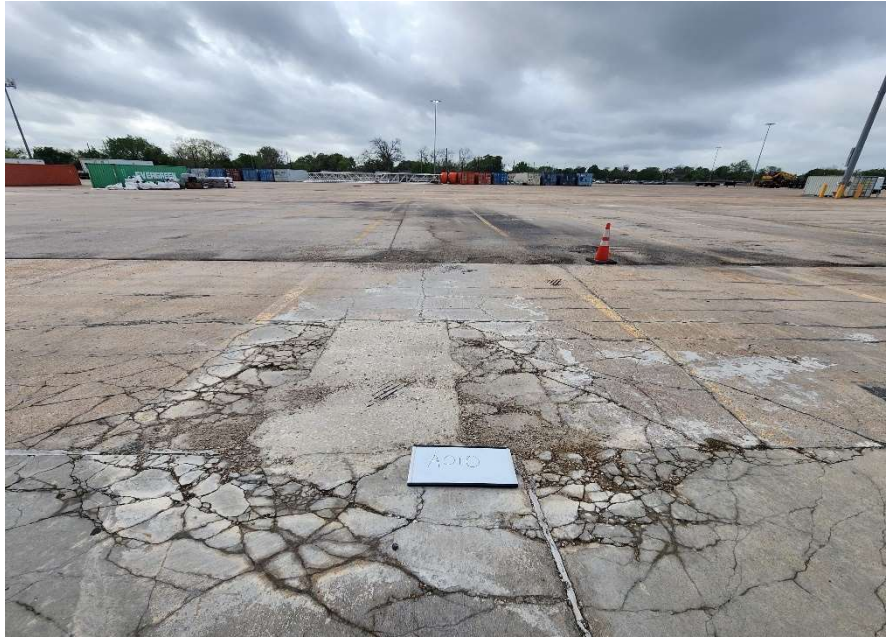
Stalls A010-A011, no tar-like material at historical seep location, or at the test pit (July 2020), looking southeast.

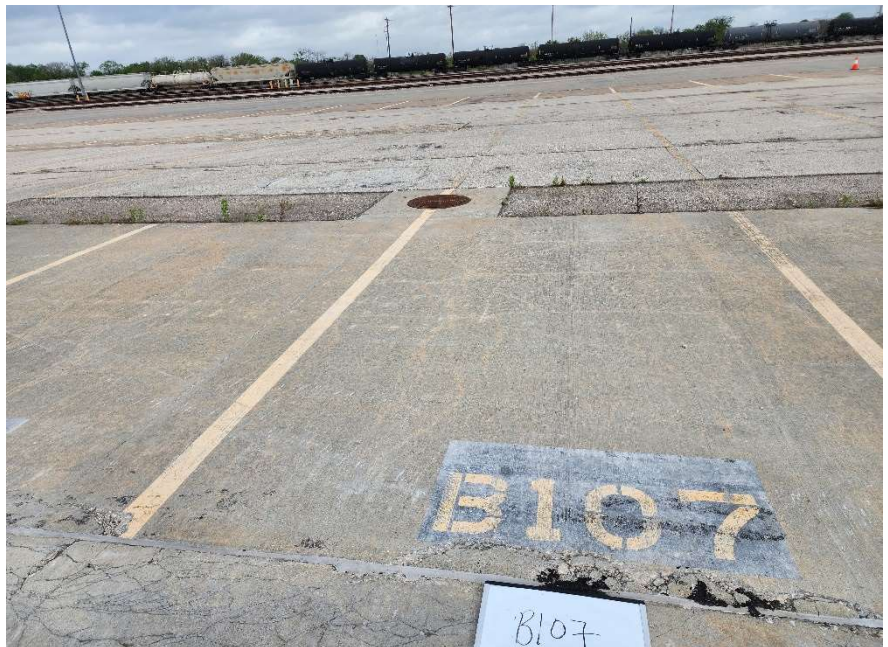
**Photo No.**  
**32**

Stalls B107-B108, view of NAPL collection system (Sump 3 in background of photo), no new tar-like material observed at seep location on concrete joint along the southern edge of the excavated area, looking northwest.

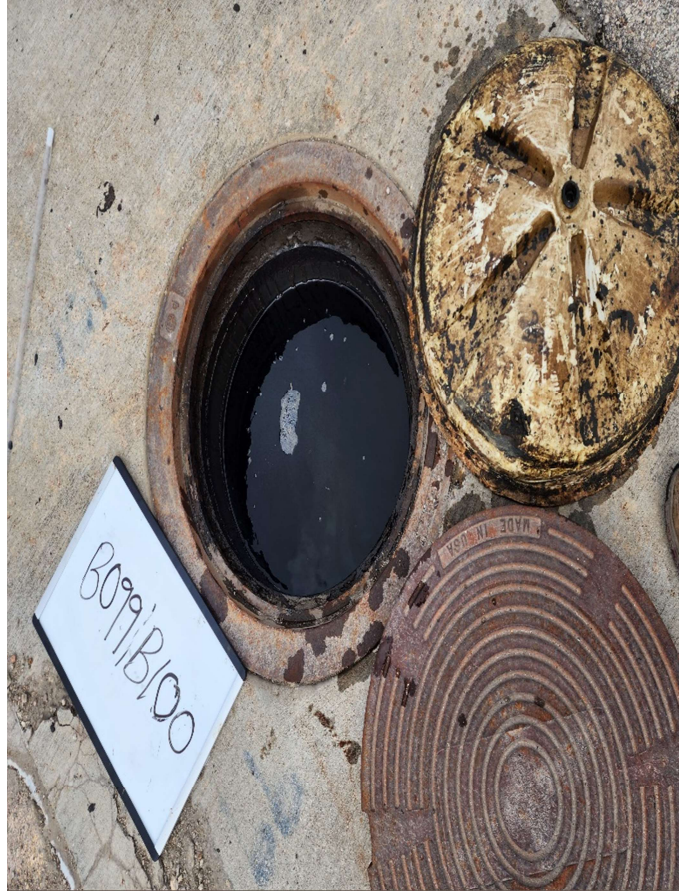
Sump 1 (B099/B100), 8 inches of freeboard in sump, no new NAPL accumulation on inflow protector, no sheen or odor noted, color was noted as light brown.

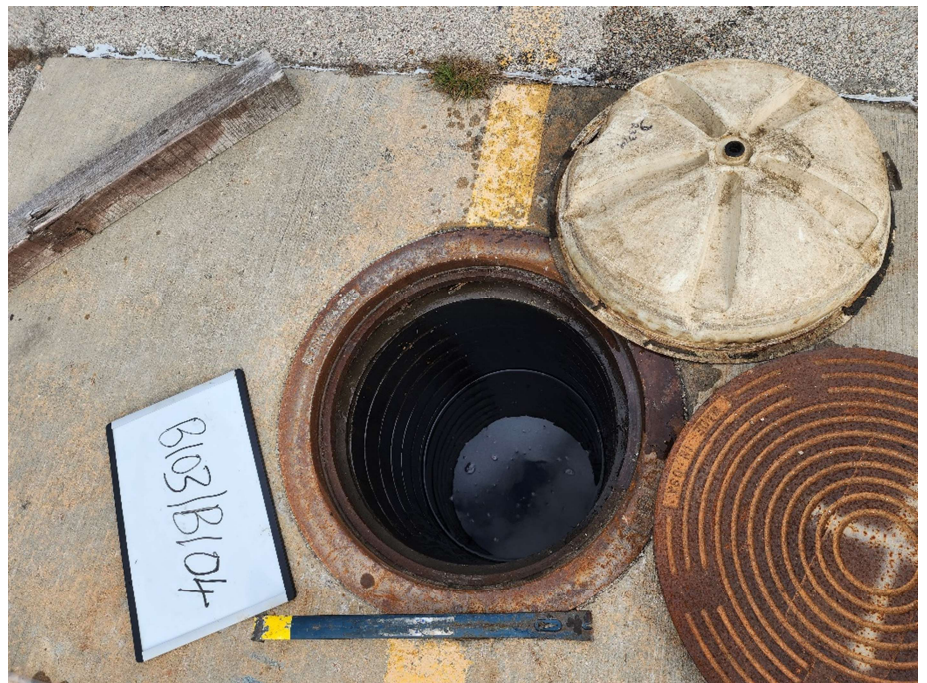
Sump 2 (B103/B104), 26.5 inches of freeboard, no sheen or odor noted, color was noted as clear.

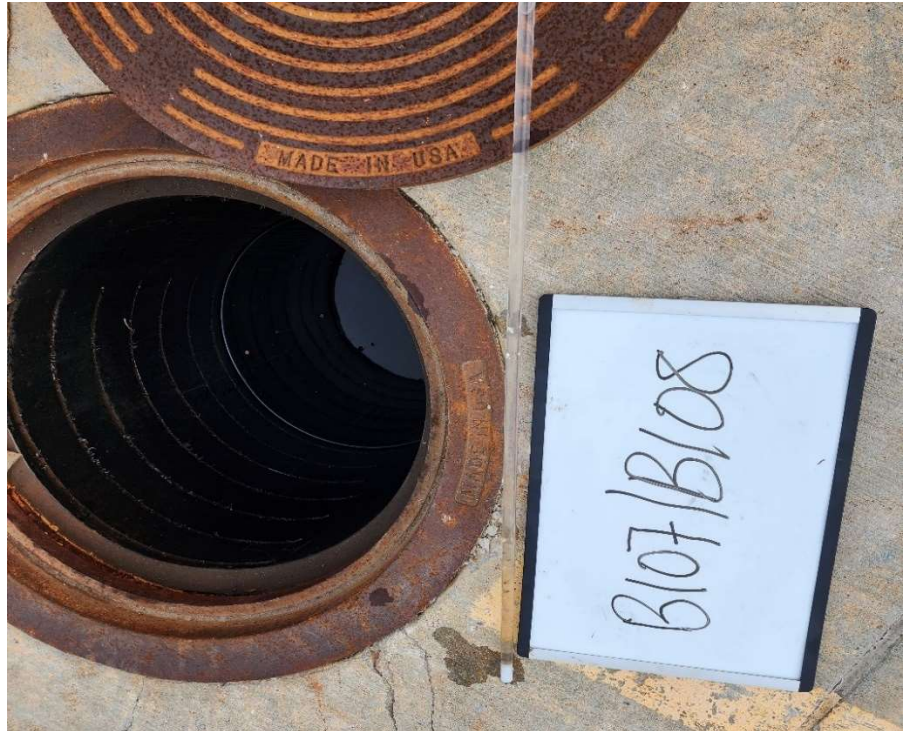
Sump 3 (B107/B108), 25.5 inches of freeboard in sump, no sheen observed on the water, no odor noted, color was noted as clear.

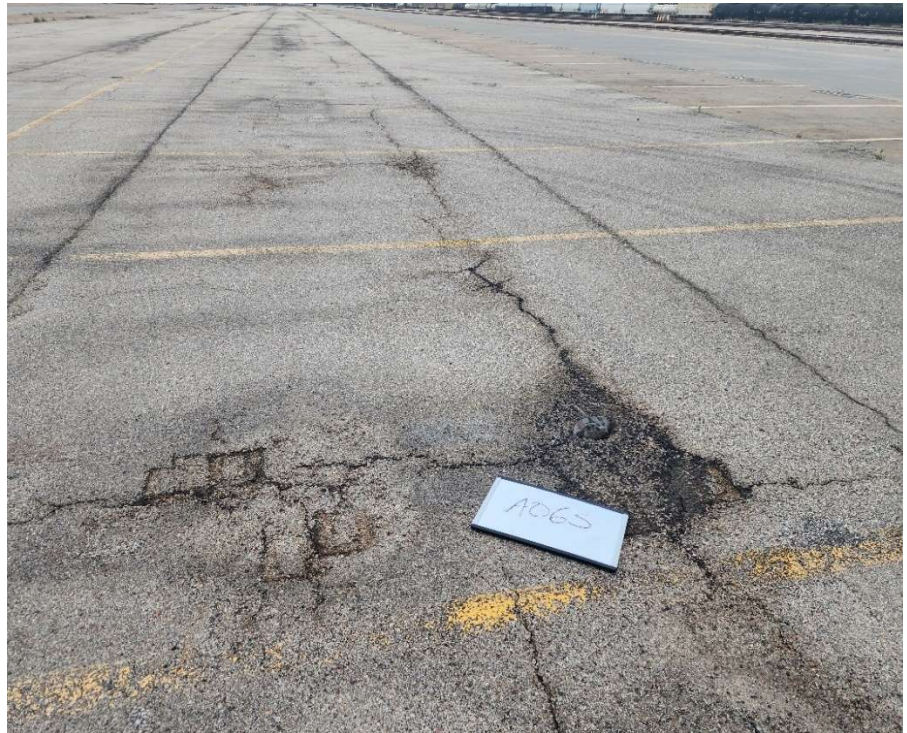
**Photo No.**  
**36**

Stalls A060-A065, no new staining observed, some residual staining noted, looking west.
