Project No. 19119232

Re: **MONTHLY STATUS UPDATE – ENGLEWOOD INTERMODAL YARD – NAPL COLLECTION SYSTEM/CONCRETE CAP REPAIRS  
UNION PACIFIC RAILROAD HOUSTON WOOD PRESERVING WORKS FACILITY  
4910 LIBERTY ROAD FACILITY, HOUSTON, TEXAS  
POST-CLOSURE CARE PERMIT NO. HW-50343; INDUSTRIAL SWR NO. 31547**

## **Weekly Inspection Photolog**

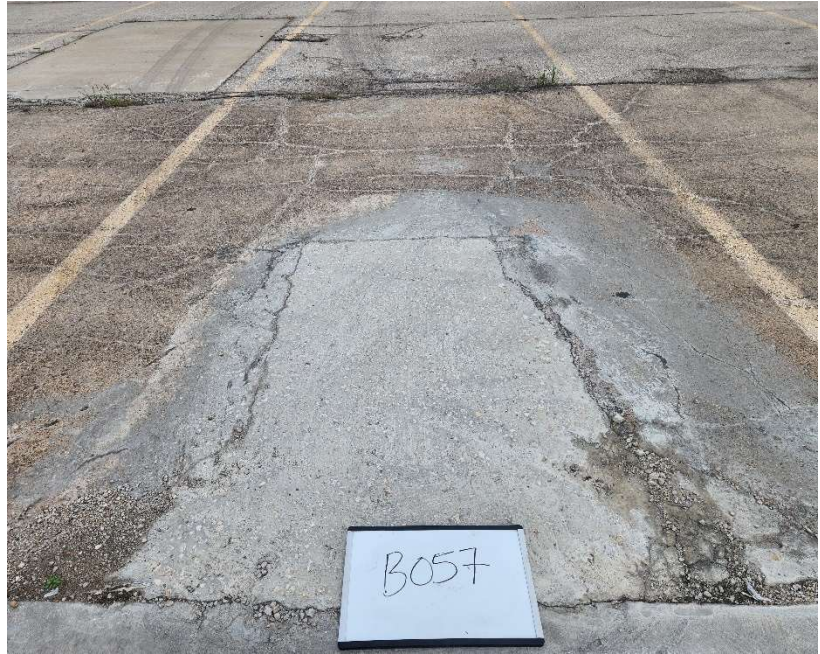
Stall B057, no tar-like material at historical seep location, or at the test pit (July 2020), looking northwest.

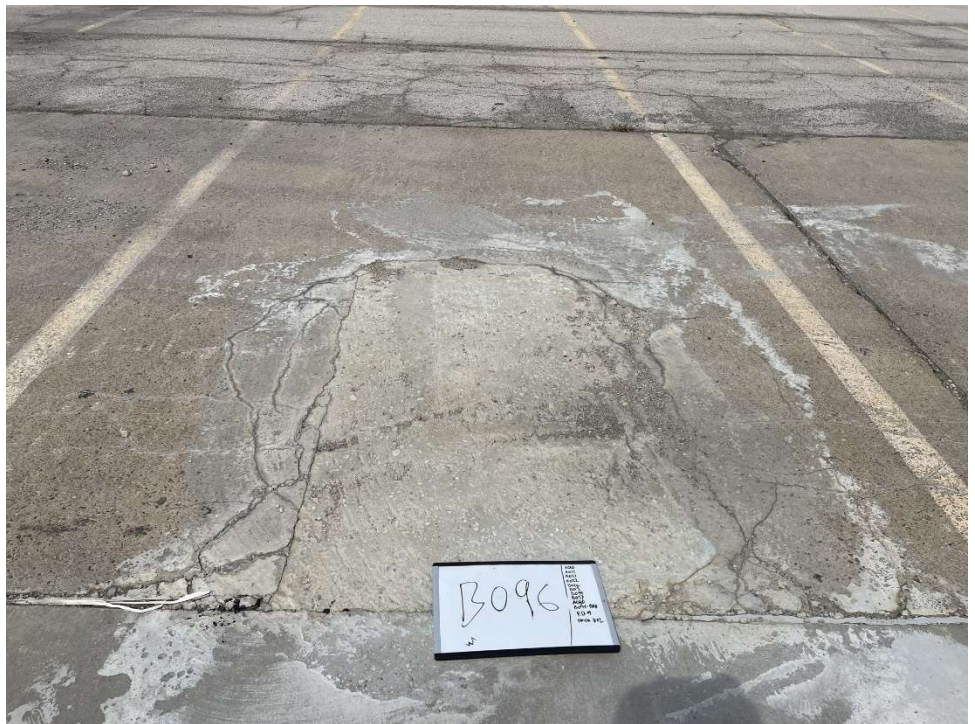
**Photo No.**  
**38**

Stall B096, no new tar-like material observed at historical seep location adjacent to July 2020 test pit, looking northwest.

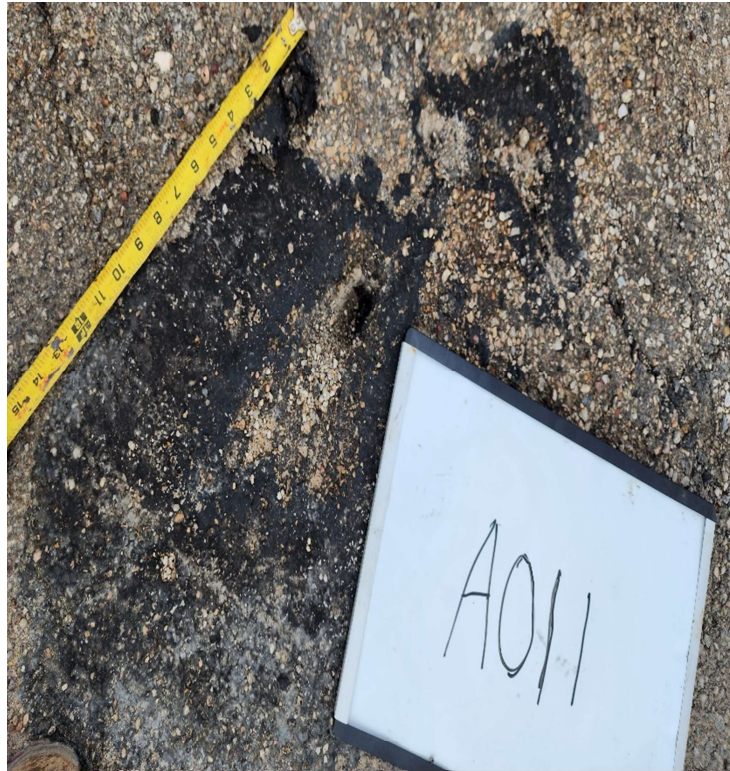
Stall A011 very small amount of tar-like material observed at historical seep location along concrete joint adjacent to July 2020 test pit. Material was removed.

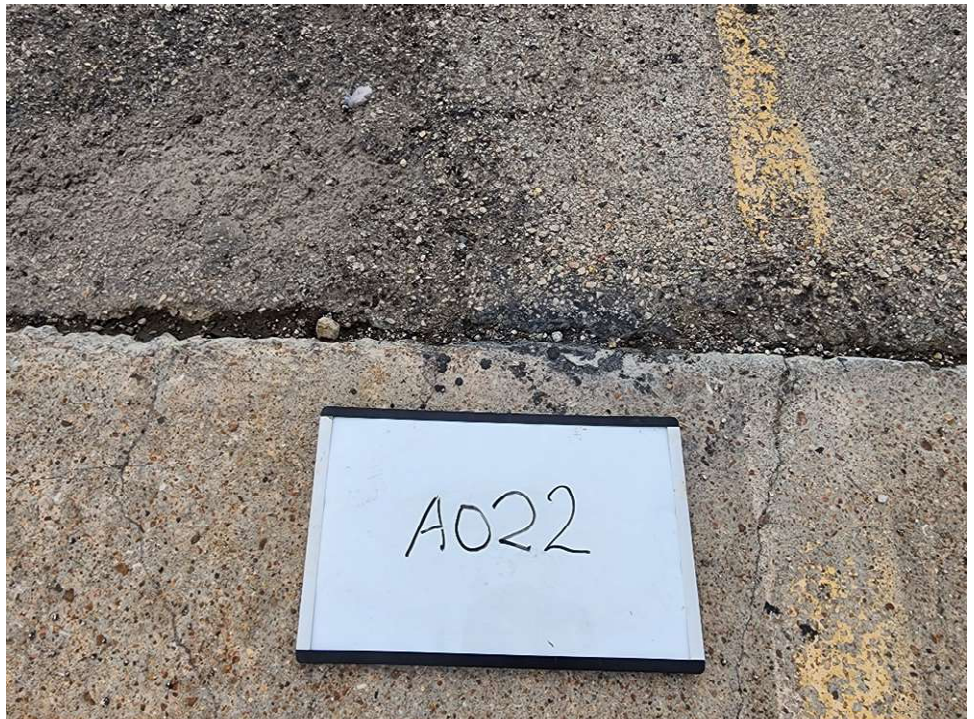
**Photo No.**  
**40**

Stall A022, no new tar-like material observed at the historical seep location, looking northwest.

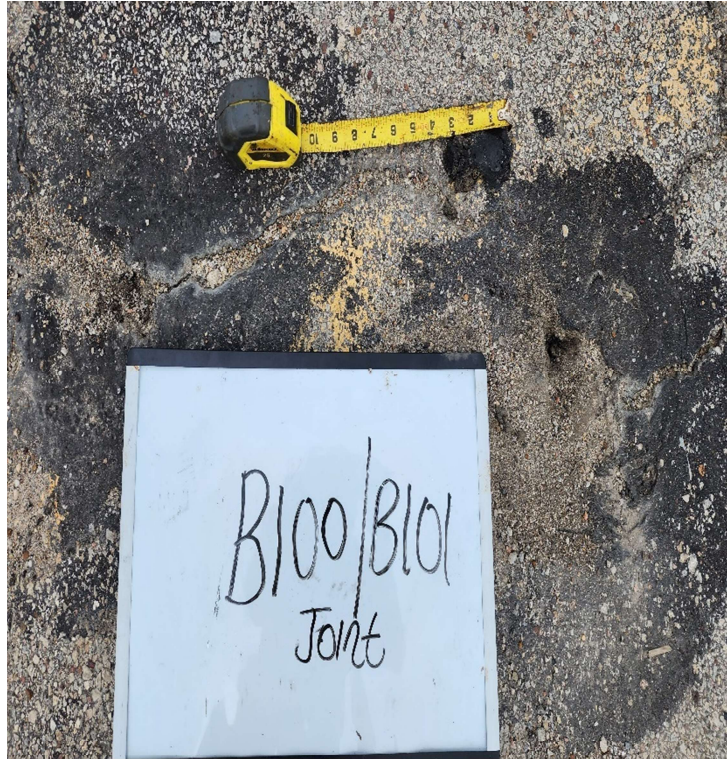
Stall B101 joint, very small amount of tar-like material observed near historical seep location along asphalt crack.

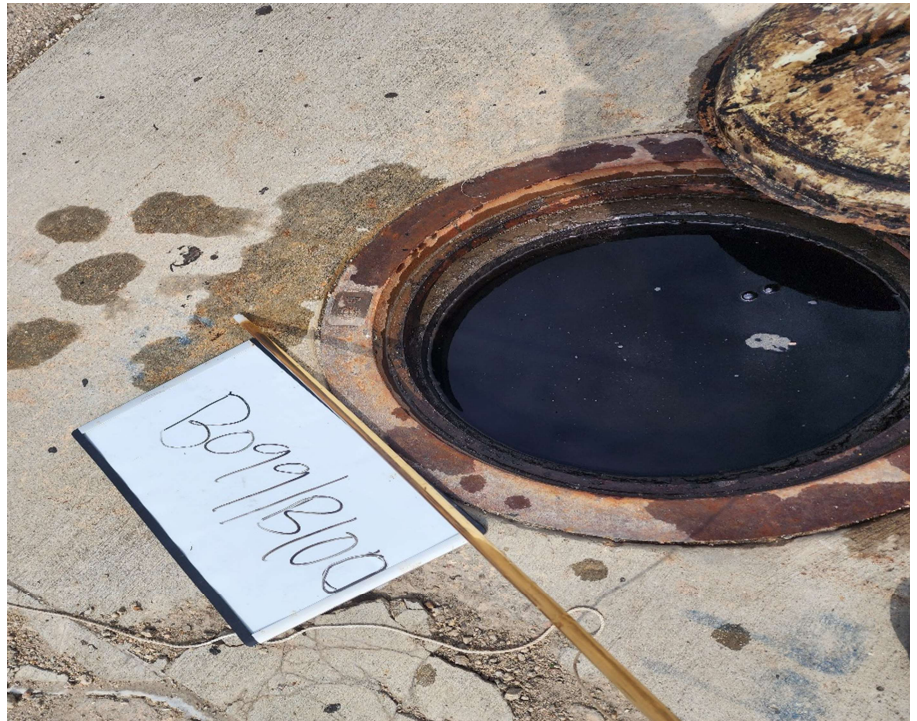
**Photo No.**  
42

Sump 1 (B099/B100), 3 inches of freeboard in sump, no new NAPL accumulation on inflow protector, no sheen or odor noted, color was noted as light brown.

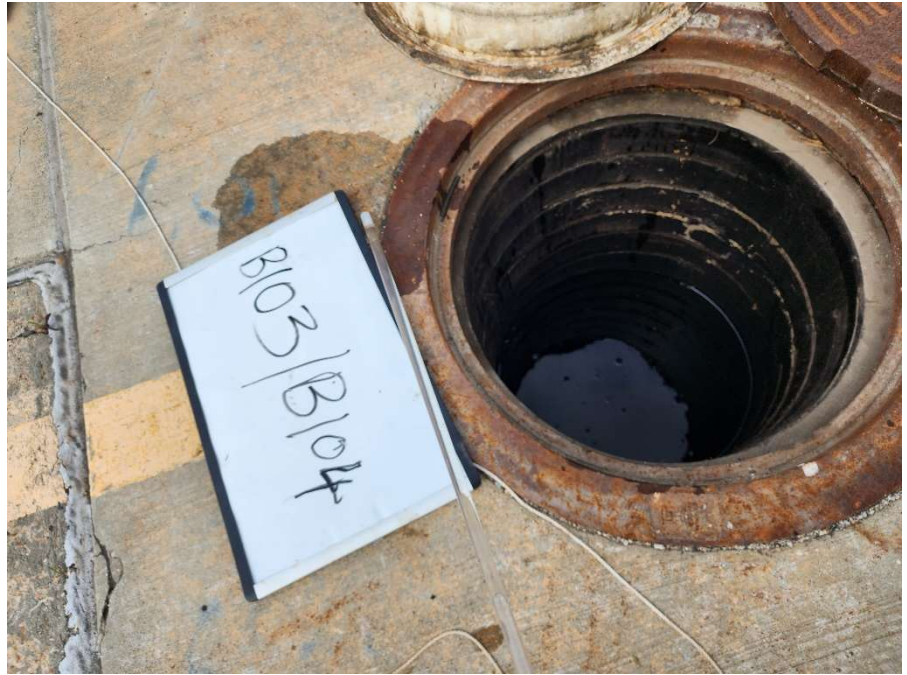
Sump 2 (B103/B104), 24 inches of freeboard, no sheen observed on the water, no odor noted, color was noted as clear.

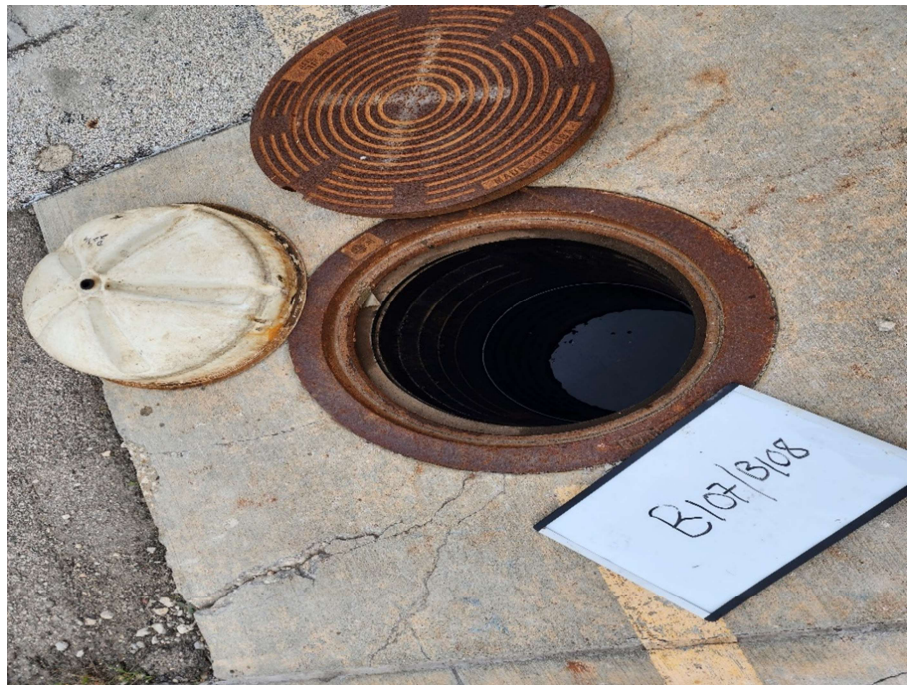
Sump 3 (B107/B108), 25 inches of freeboard in sump, no sheen observed on the water, no odor noted, color was noted as clear.

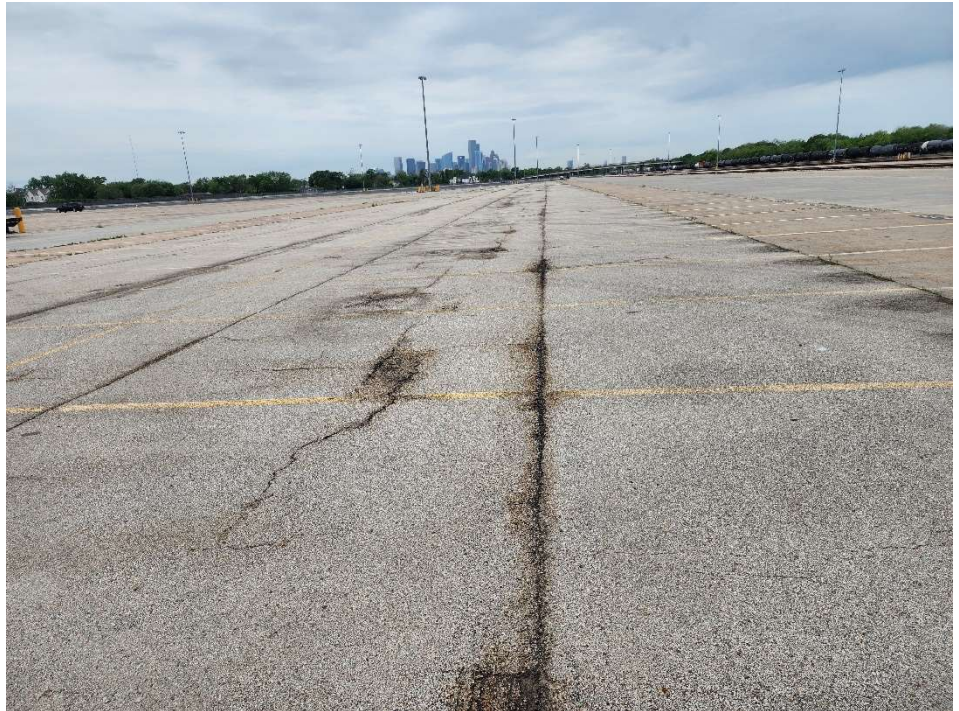
Stalls A060-A065, no new staining observed, some residual noted, looking west.

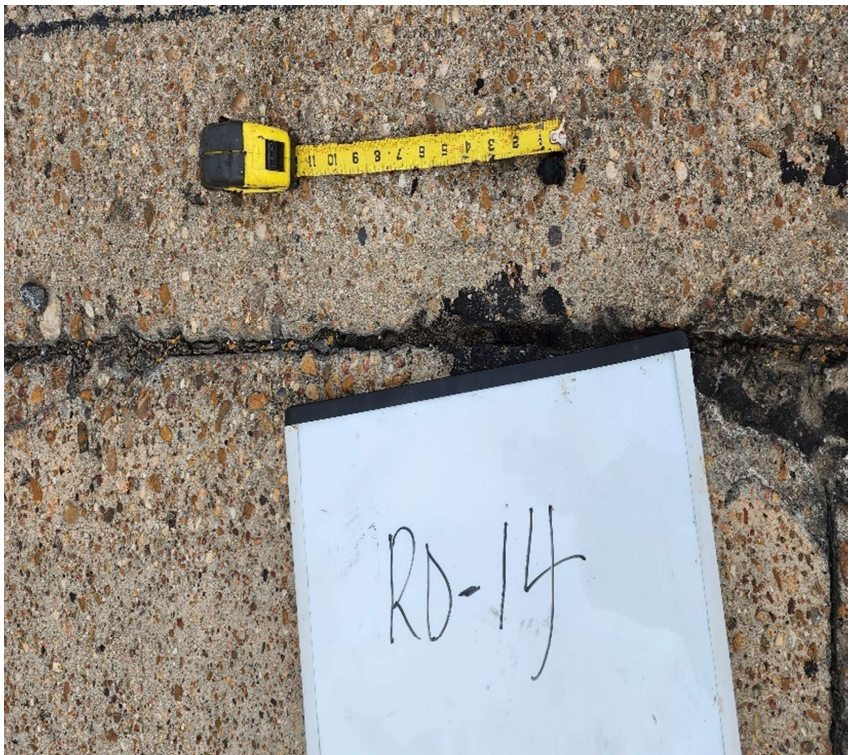
**Photo No.**  
**46**

Seep location observed within the concrete road area (RD-14) north of Track 802 (East of existing Track 802 seep location), very small amount of tar-like material observed along a concrete joint. Material was removed.
