June 9, 2023

Project No. 31406585.016

**Re: MONTHLY STATUS UPDATE – ENGLEWOOD INTERMODAL YARD – NAPL COLLECTION
SYSTEM/CONCRETE CAP REPAIRS
UNION PACIFIC RAILROAD HOUSTON WOOD PRESERVING WORKS FACILITY
4910 LIBERTY ROAD FACILITY, HOUSTON, TEXAS
POST-CLOSURE CARE PERMIT NO. HW-50343; INDUSTRIAL SWR NO. 31547**

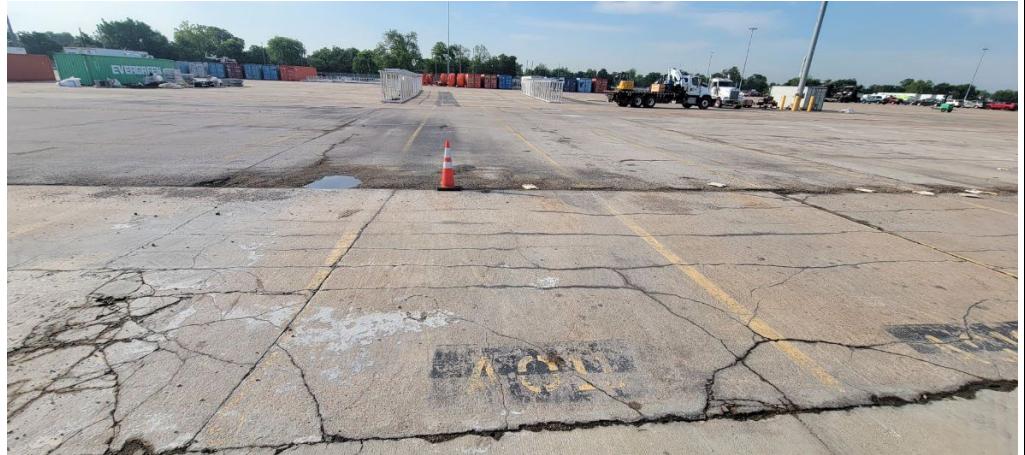
Stall A011 some tar-like material observed at historical seep location along asphalt crack, material was removed. Seep water observed along asphalt cracks, looking southeast.

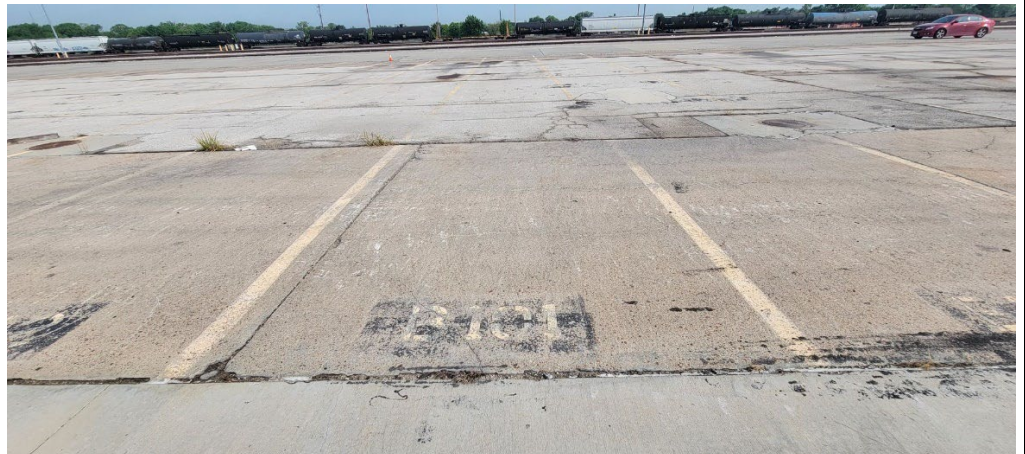
Stall B101, some tar-like material observed near historical seep location along asphalt crack, material removed. (Sump B099/B100 in background of photo), looking southeast.

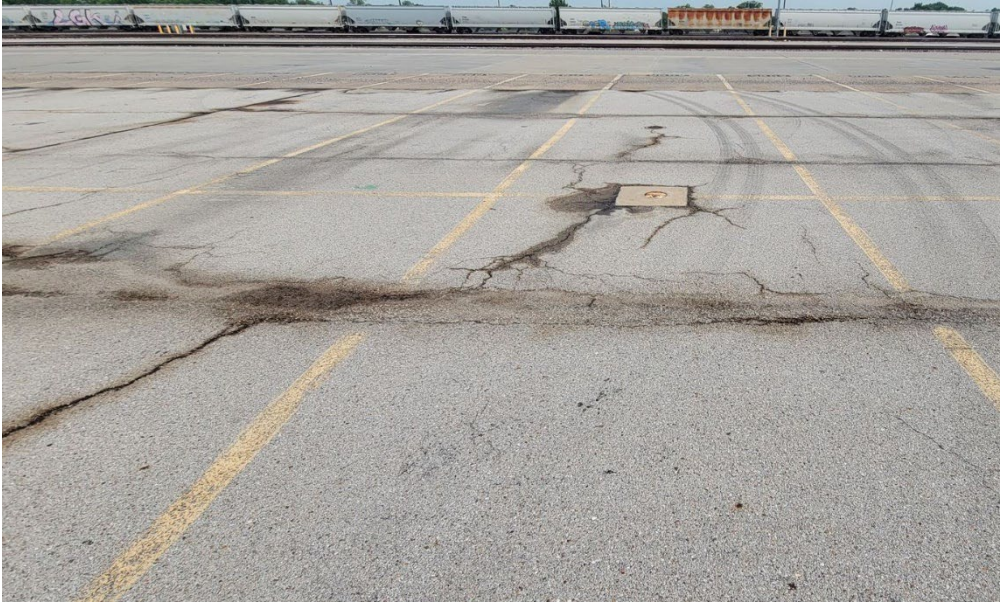
| Photo No. 3 | Inspection Date: 05/03/2023 | <p>Description:</p> <p>Stall B096, some staining and cracking concrete observed at historical seepage location. No tar-like material observed.</p> <p>Lat: 29.78417 Long: - 95.32091</p> | |

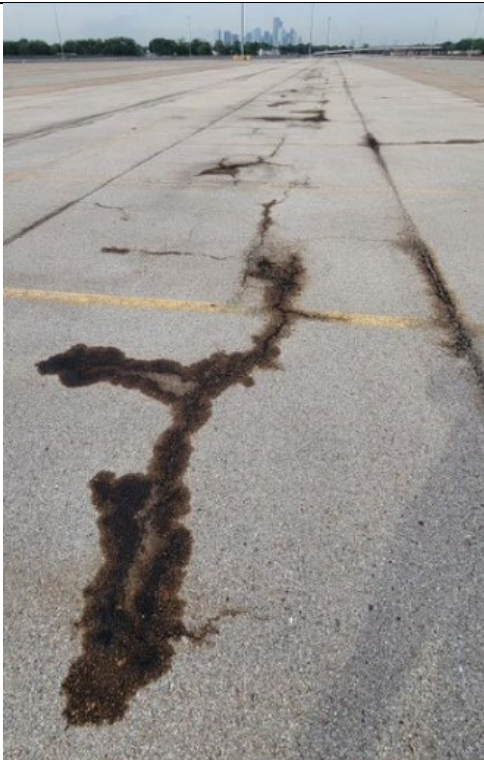
| Photo No. 4 | Inspection Date: 05/03/2023 | <p>Description:</p> <p>Stall A061, brown residue and staining observed within Rows A and B before cleaning, looking southwest. UPRR remediation contractor OMI removed staining and seepage by power washing the area.</p> <p>Lat: 29.784858 Long: -95.319733</p> | |

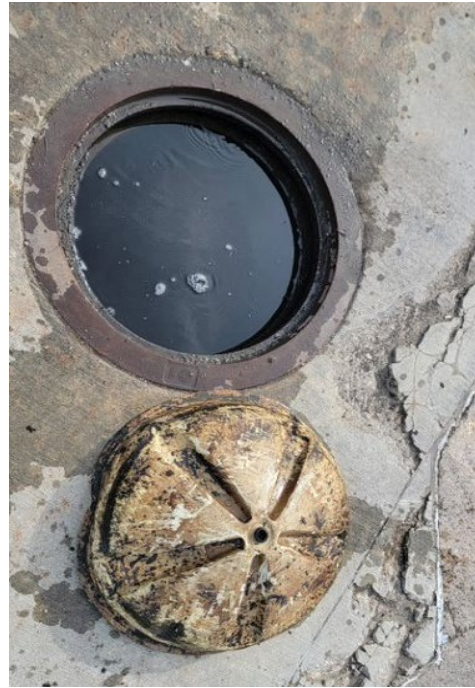
Sump 1 (B099/B100), 3 inches of freeboard in sump, no sheen observed, no odor noted, no new NAPL accumulation on inflow protector, color noted as brown/turbid.

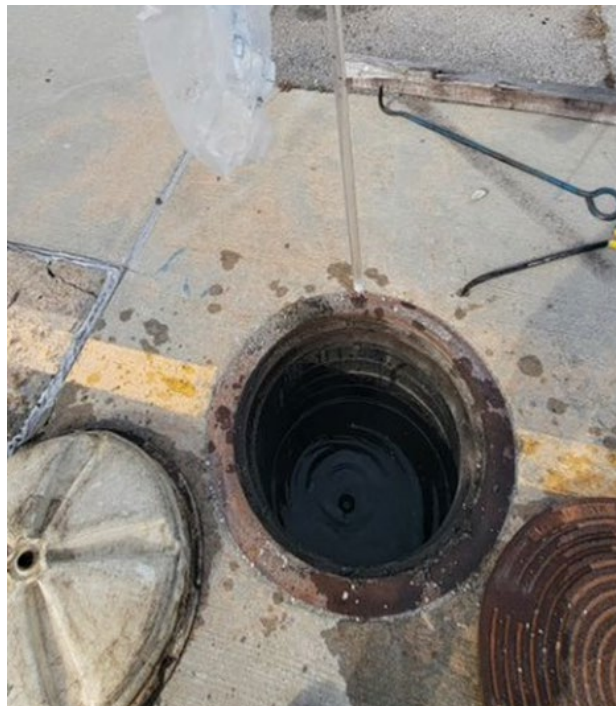
Sump 2 (B103/B104), 18 inches of freeboard, no sheen observed, no odor noted, color noted as clear.

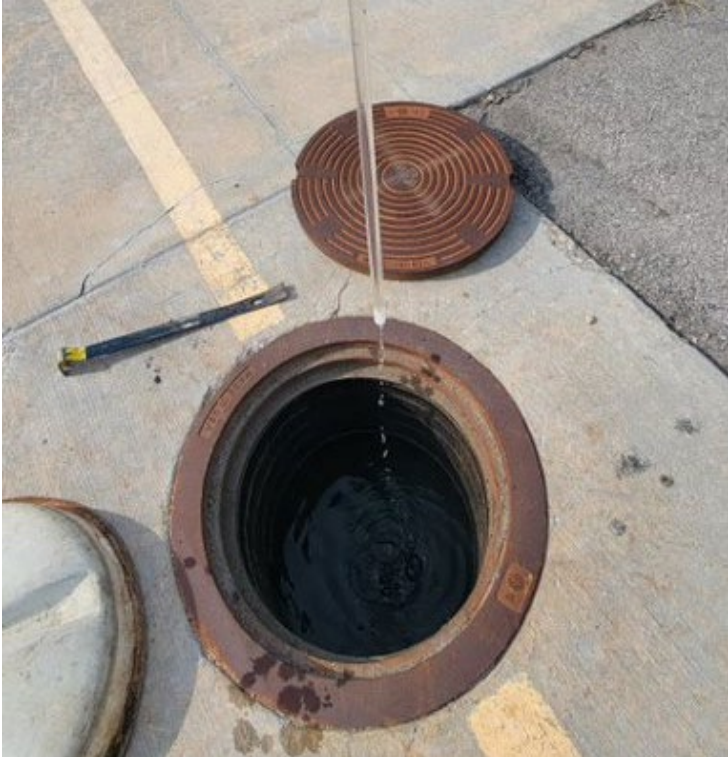
| Description: Sump 3 (B107/B108), 17.5 inches of freeboard in sump, no sheen observed, no odor noted, color noted as clear Lat: 29.784172 Long: -95.320998 | | |

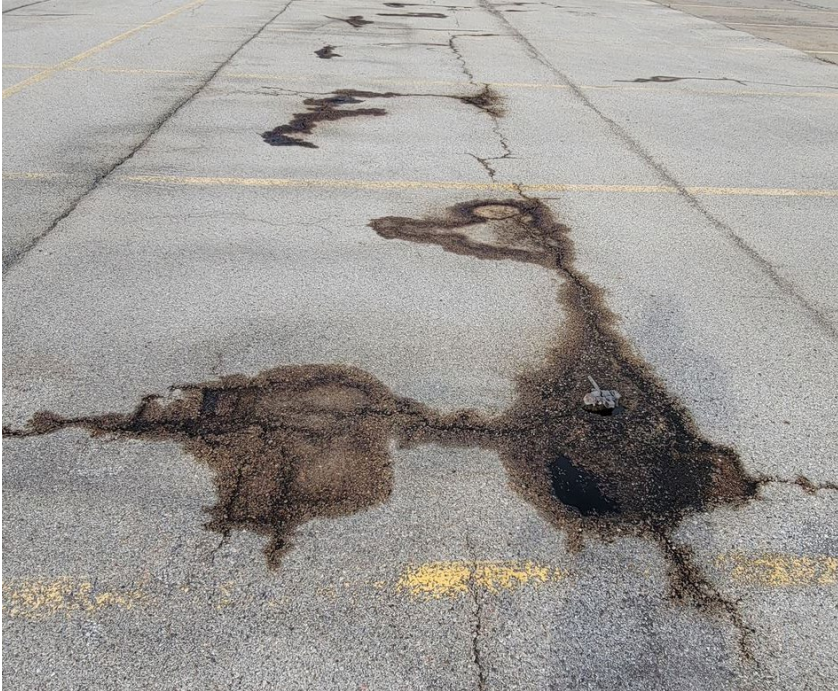
| Description: Stall A065, staining observed along asphalt cracks of Row A and B stalls, looking east. UPRR remediation contractor OMI removed staining and seepage by power washing the area. Lat: 29.784858 Long: -95.319733 | | | |

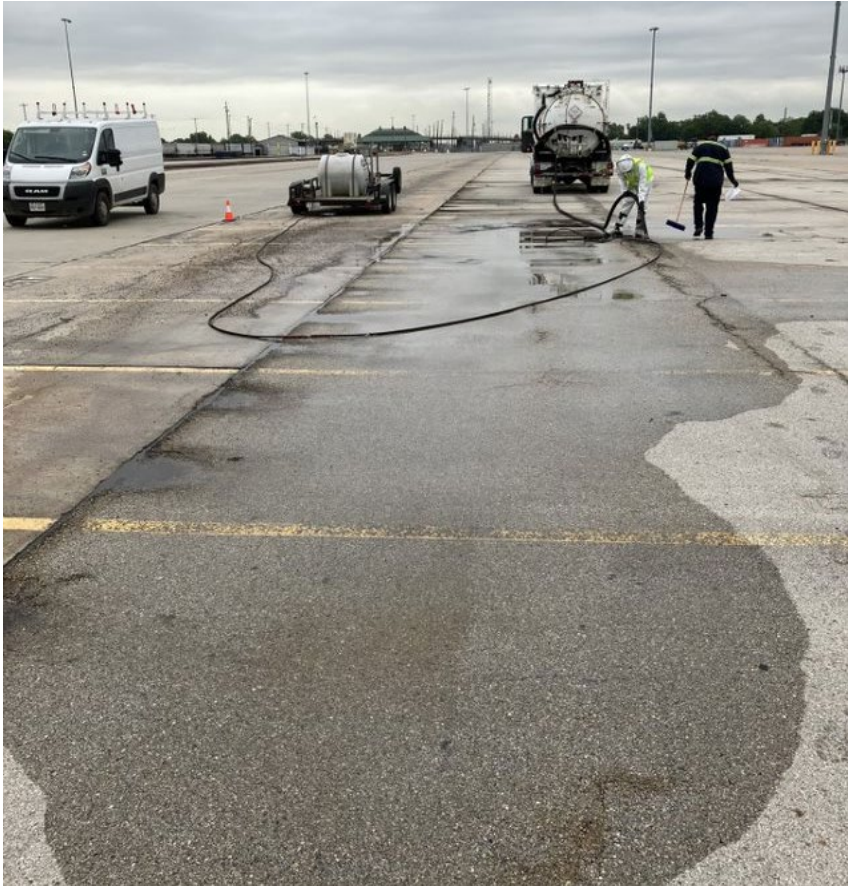
| Description: Row A of stalls, UPRR remediation contractor OMI using power washing truck to remove brown staining. Lat: 29.784858 Long: -95.319733 | | |

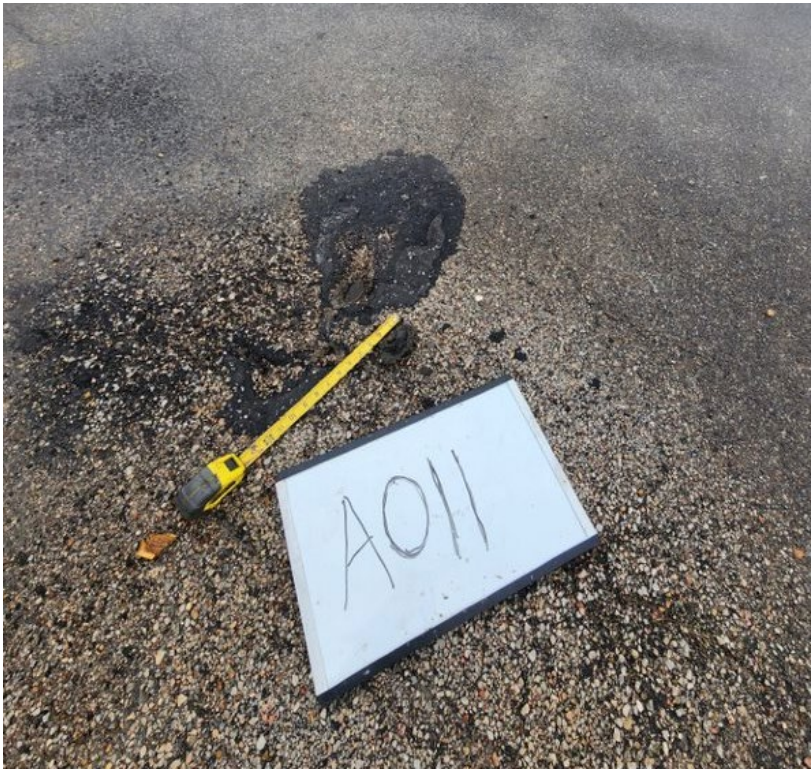
| Description: Stall A011, some tar-like material observed at historical seep location, looking southeast. Material was removed. Lat: 29.785392, Long: -95.318655 | | | |

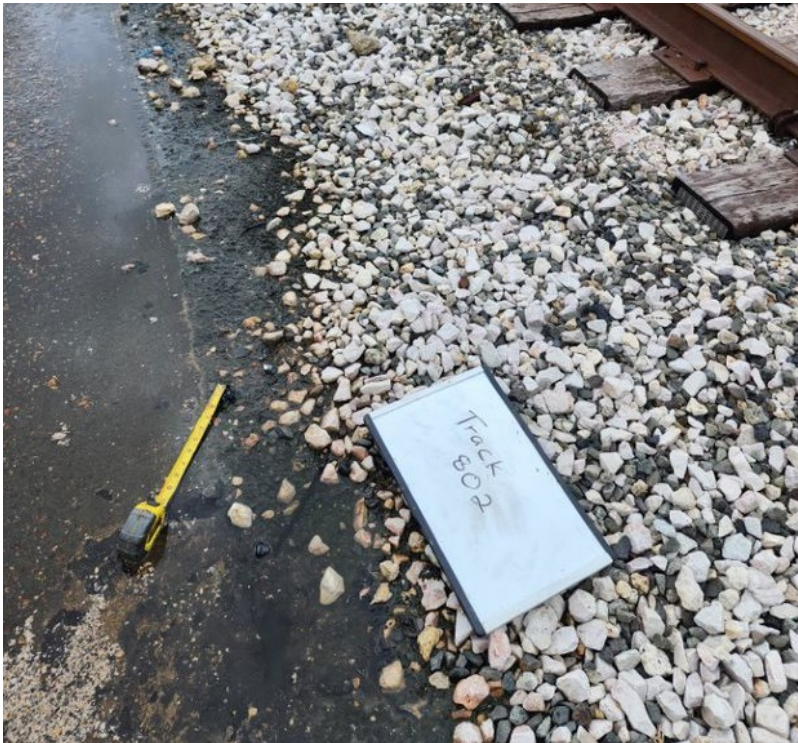
| Description: North side of Track 802, some tar-like material observed at seep location near the edge of the ballast, material removed. Lat: 29.784947 Long: -95.321214 | | | |

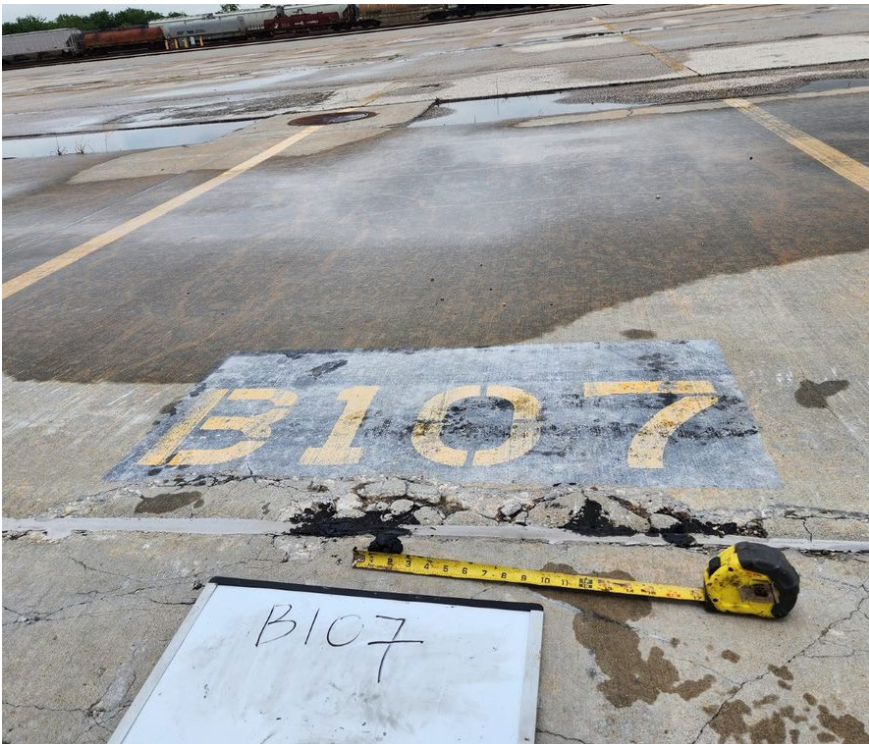
| 13 | 05/10/2023 | |

| <p>Description:</p> <p>Stalls B107, view of NAPL collection system (Sump 3 in background of photo), some new tar-like material observed and removed at seep location on concrete joint along the southern edge of the excavated area, looking northwest.</p> <p>Lat: 29.784156 Long: -95.320953</p> | | |

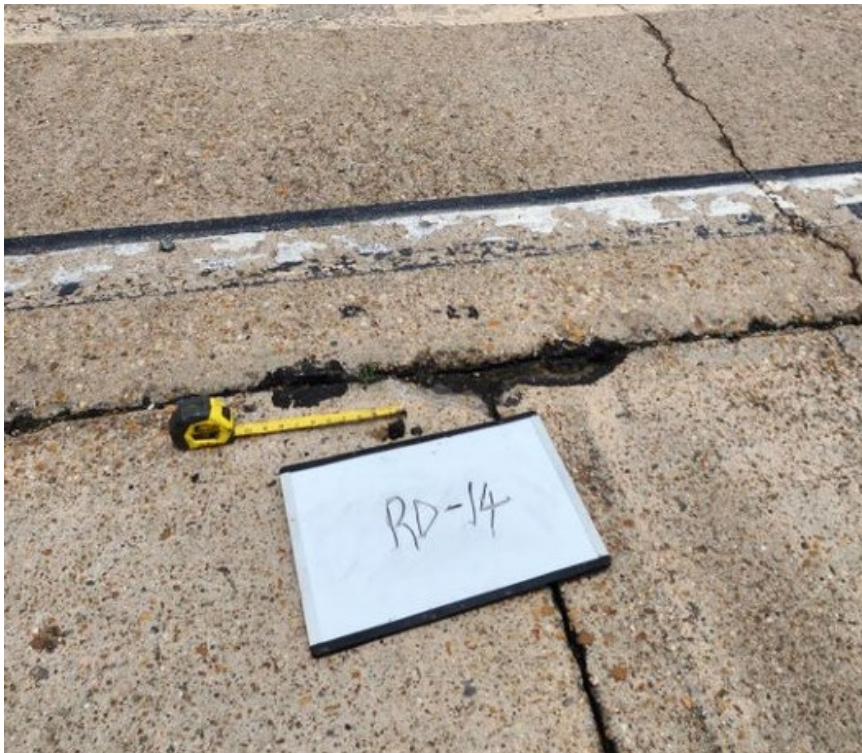
| Description: RD-14 Seep location observed within the concrete road area (RD-14) north of Track 802 (east of existing Track 802 seep location), very small amount of tar-like material observed along a concrete joint, material was removed. Lat: 29.785064 Long: -95.321219 | |

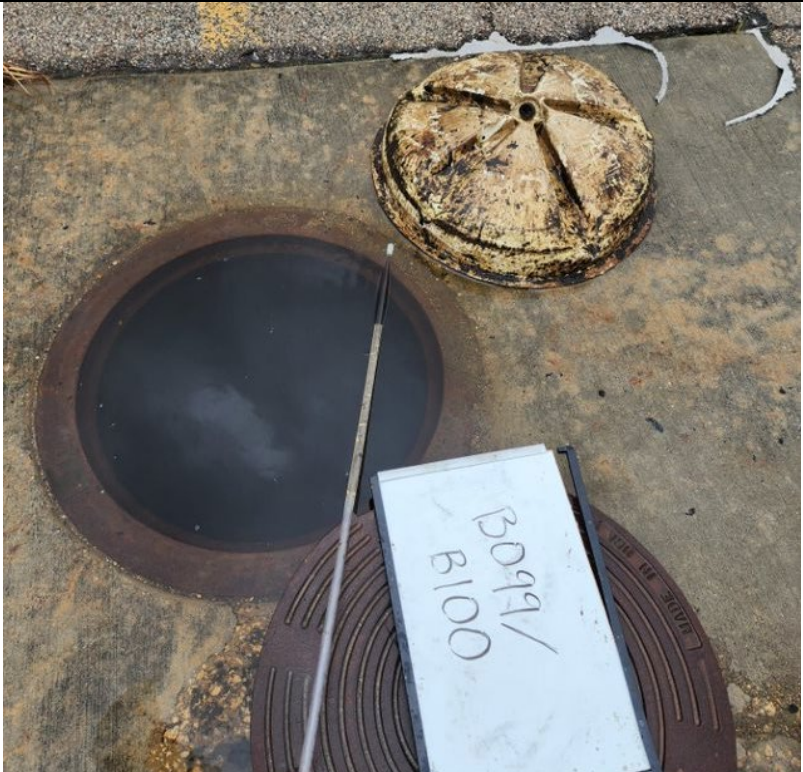
| Description: Sump 1 (B099/B100), 0 inches of freeboard in sump, water ponding at sump due to recent rainfall event, no sheen or odor noted, no new NAPL accumulation on inflow protector, watercolor noted as light brown. Lat: 29.7844000 Long: - 95.3205861 | | |

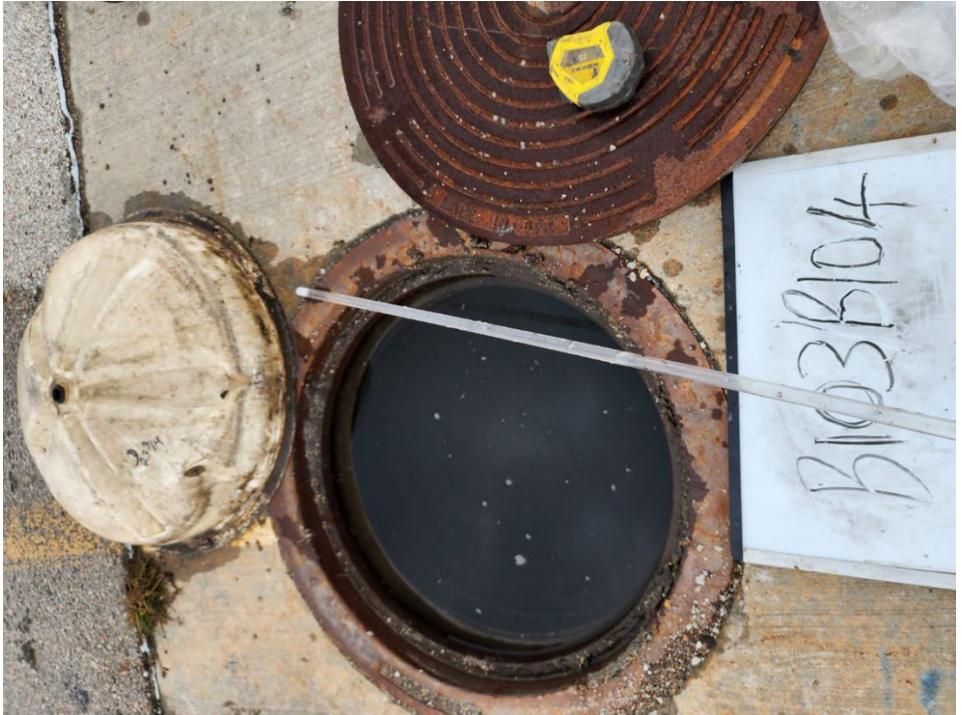
| Description: Sump 2 (B103/B104), 1.5 inches of freeboard before pumping. No sheen or odor noted, color noted as clear. Lat: 29.7842861 Long: - 95.3208611 | | | |

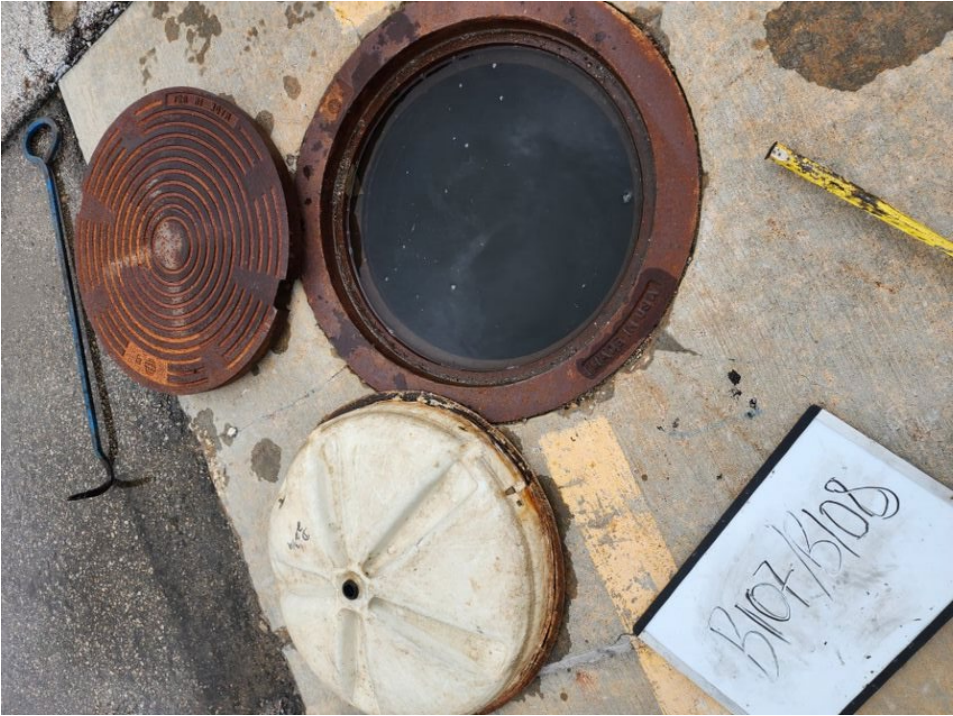
| Description: Sump 3 (B107/ B108), 0 inches of freeboard, sheen observed, no odor noted, color noted as clear. Lat: 29.784172 Long: -95.320998 | | |

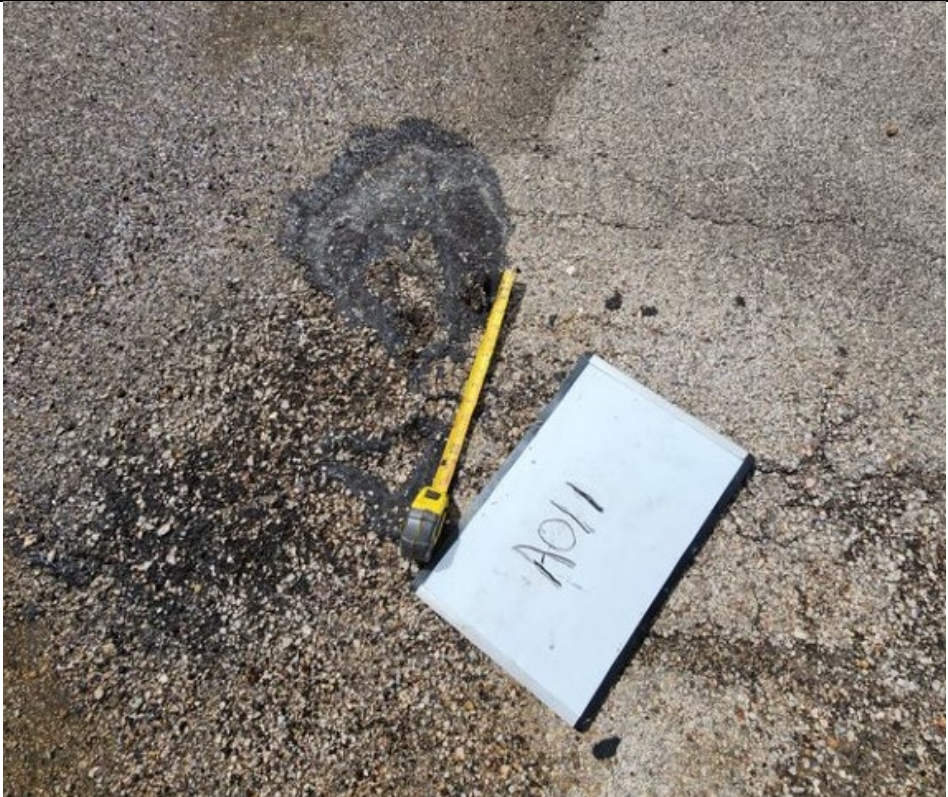
| Description: Stall A011, some tar-like material observed at historical seep location. Material was removed. Lat: 29.785392, Long: -95.318655 | | | |

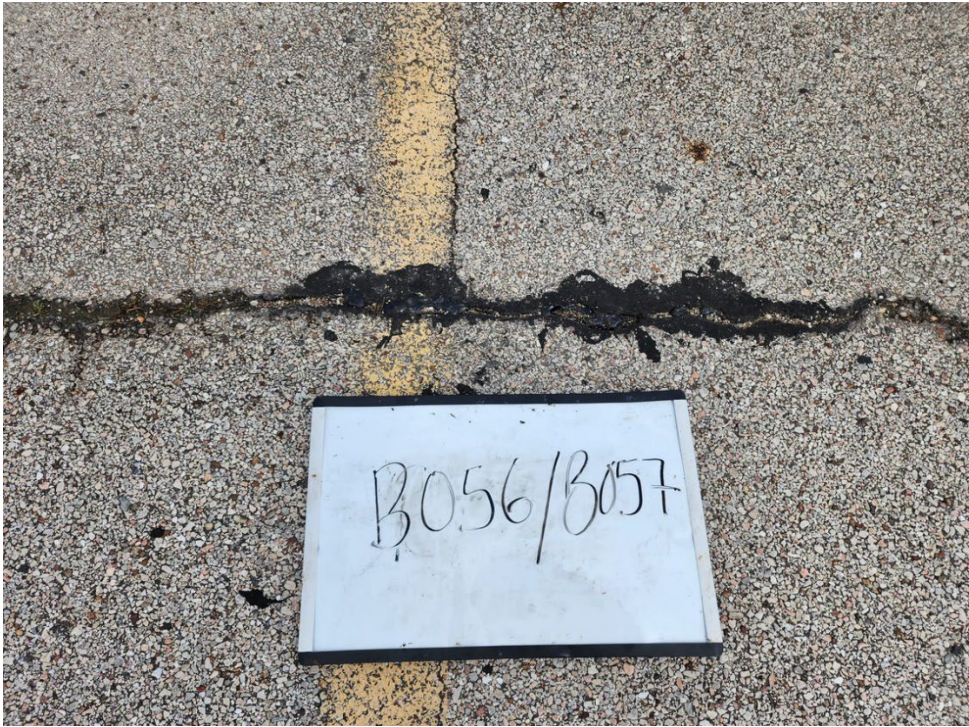
| Description: Slot B056, some tar-like material seeping observed at asphalt crack, material removed. Lat: 29.7847472 Long: - 95.3195417 | | |

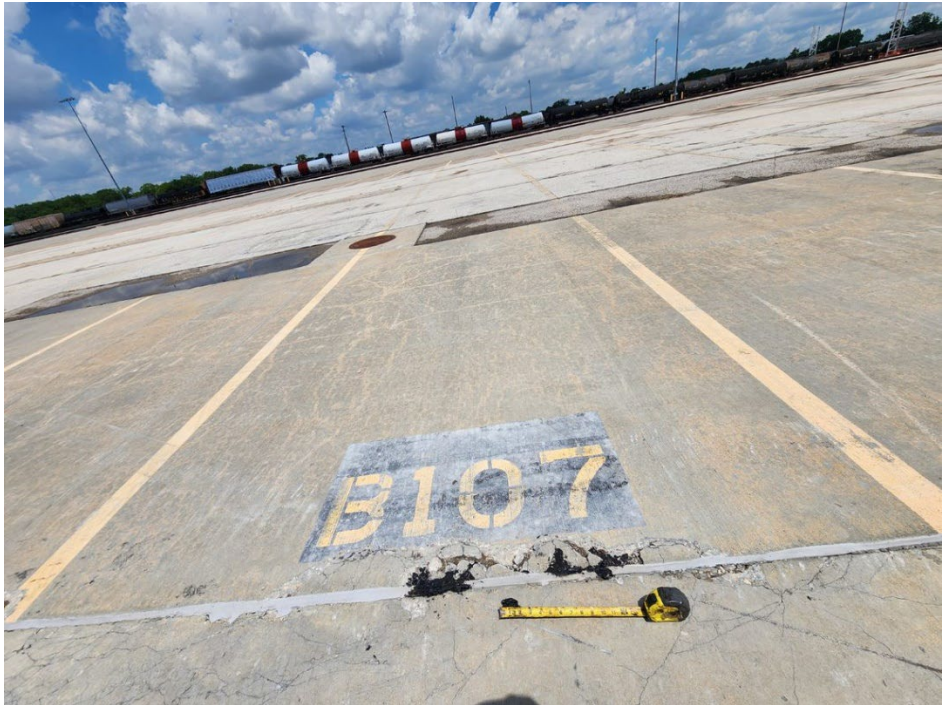
| Description: Stalls B107-B108, view of NAPL collection system (Sump 3 in background of photo), very small tar-like material observed at seep location on concrete joint along the southern edge of the excavated area, material removed, looking northwest. Lat: 29.784156 Long: -95.320953 | | | |

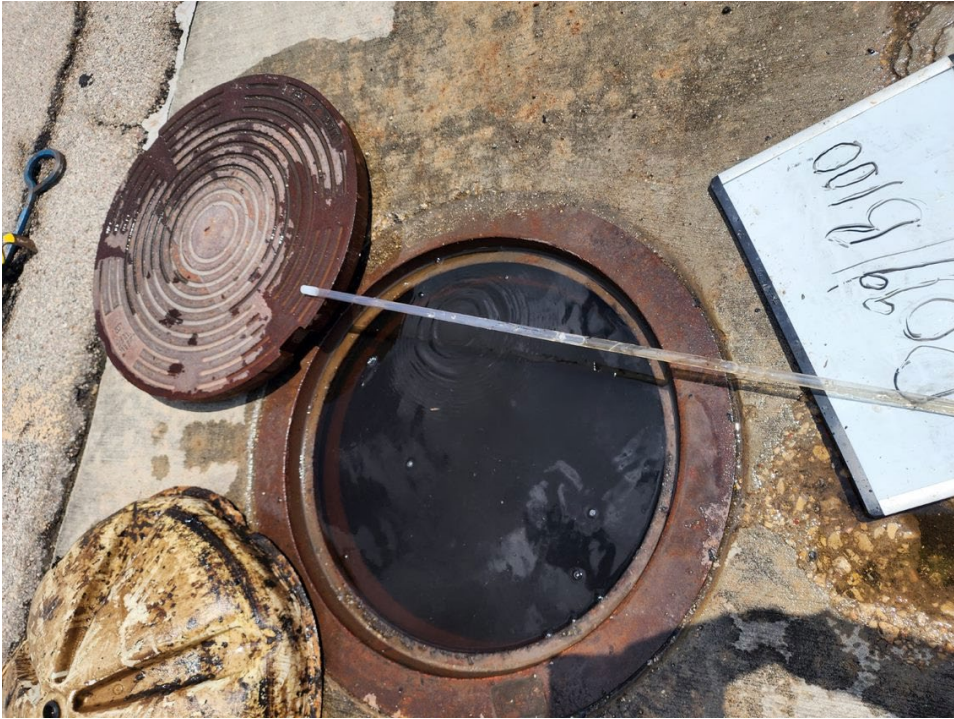
| Description: <p>Sump 1 (B099/B100), water level at top of the manhole, no sheen or odor noted, no new NAPL accumulation on the inflow protector, color noted as light brown.</p> <p>Lat: 29.7844000 Long: - 95.3205861</p> | | |

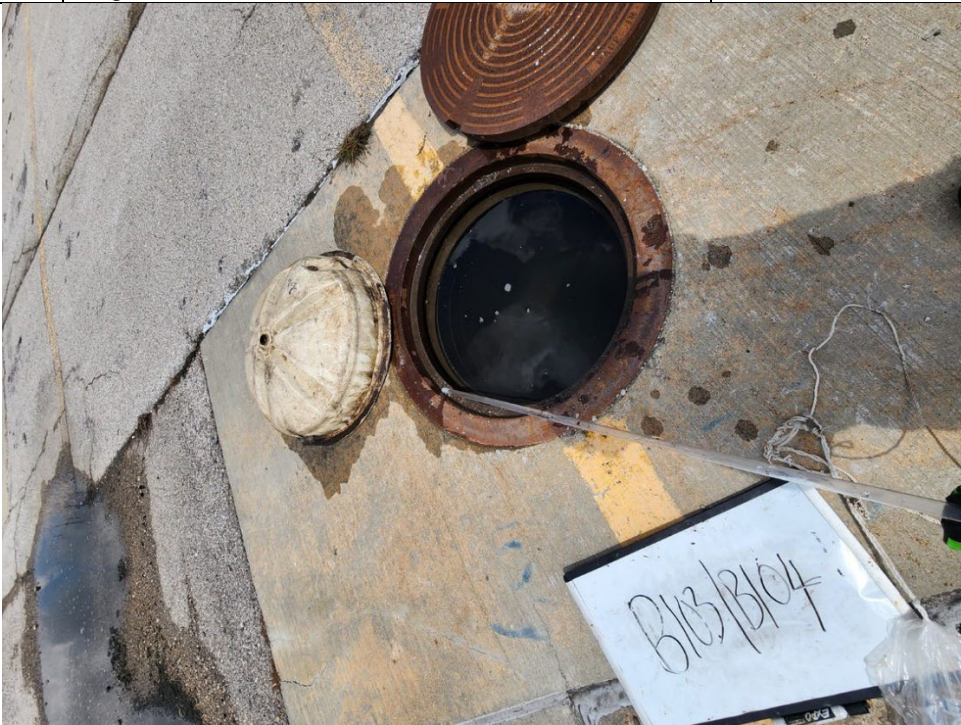
| Description: <p>Sump 2 (B103/B104), water level at top of the manhole, no sheen or odor noted, color noted as clear.</p> <p>Lat: 29.7842861 Long: - 95.3208611</p> | | |

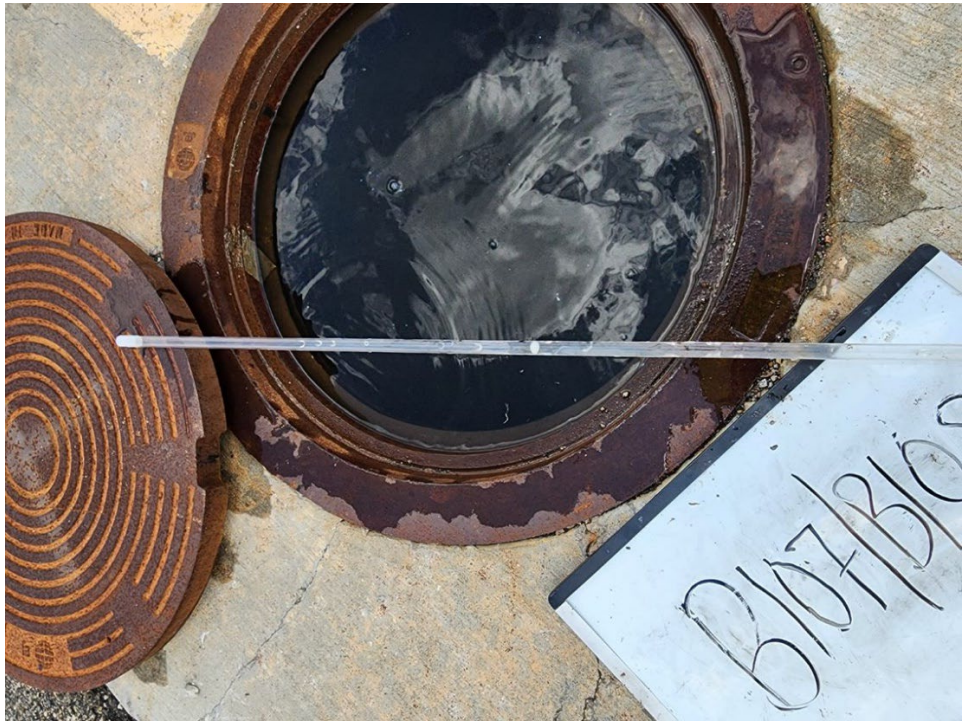
| Description: Sump 3 (B107/B108), water level at top of the manhole, sheen observed, no odor noted, color noted as clear. Lat: 29.784172 Long: -95.320998 | | |

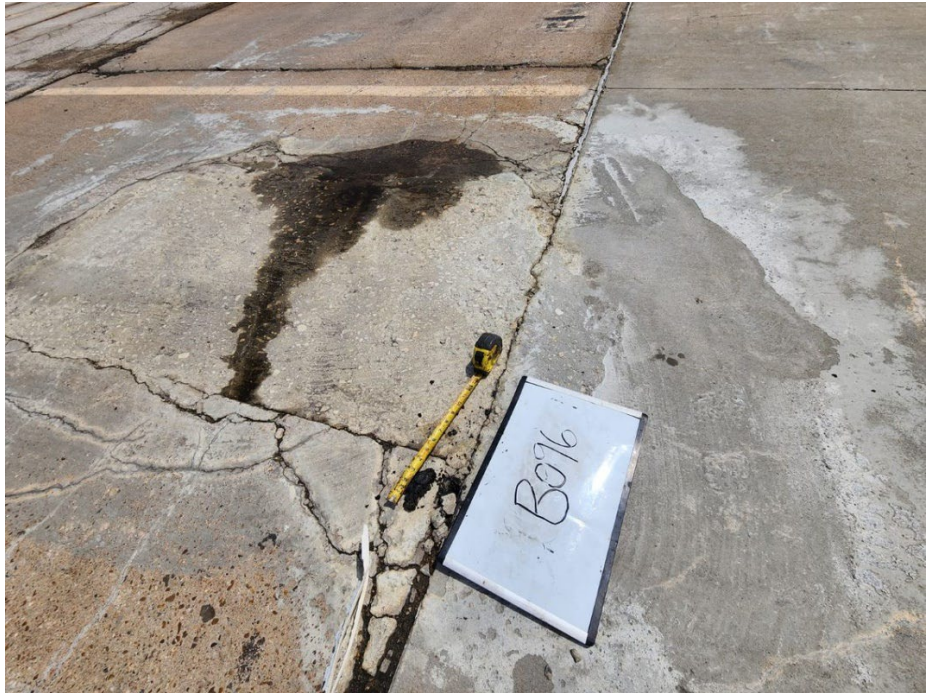
| Description: Slot B096, small amount of tar-like material seeps observed where test pit conducted (July 2020), material removed, looking northwest. Lat: 29.7842528 Long: - 95.3206250 | | | |

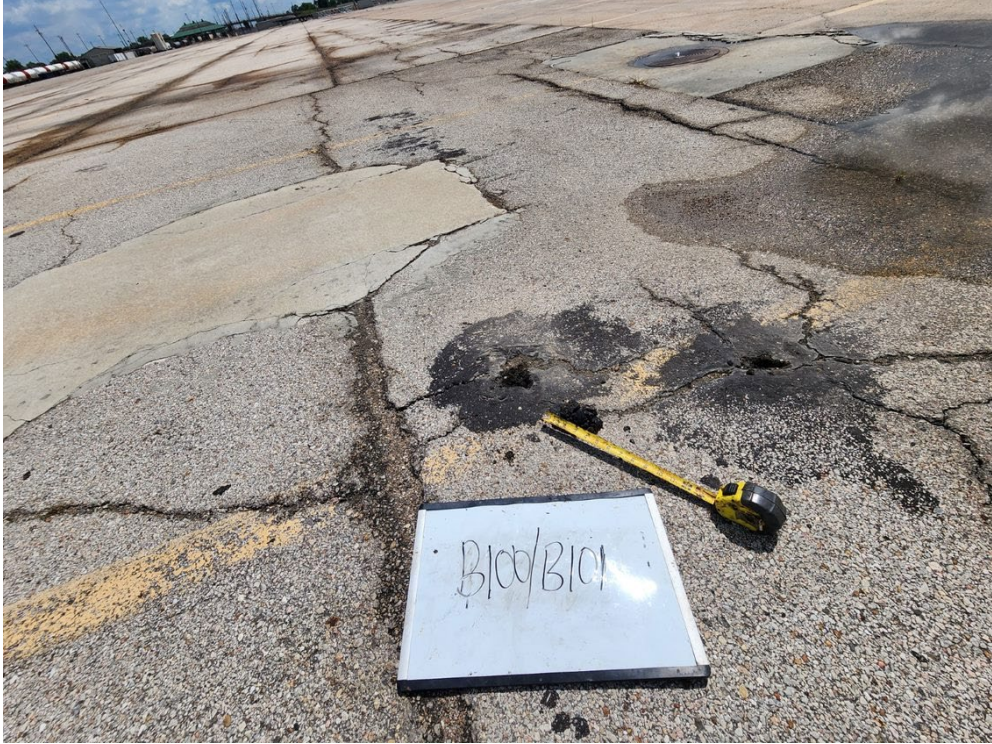
| Description: Slot B100/B101, view of NAPL collection system (Sump 2 in background of photo), some tar-like material observed at historical seep location along asphalt crack, material was removed, looking northwest. Lat: 29.7842203 Long: - 95.320827 | | |

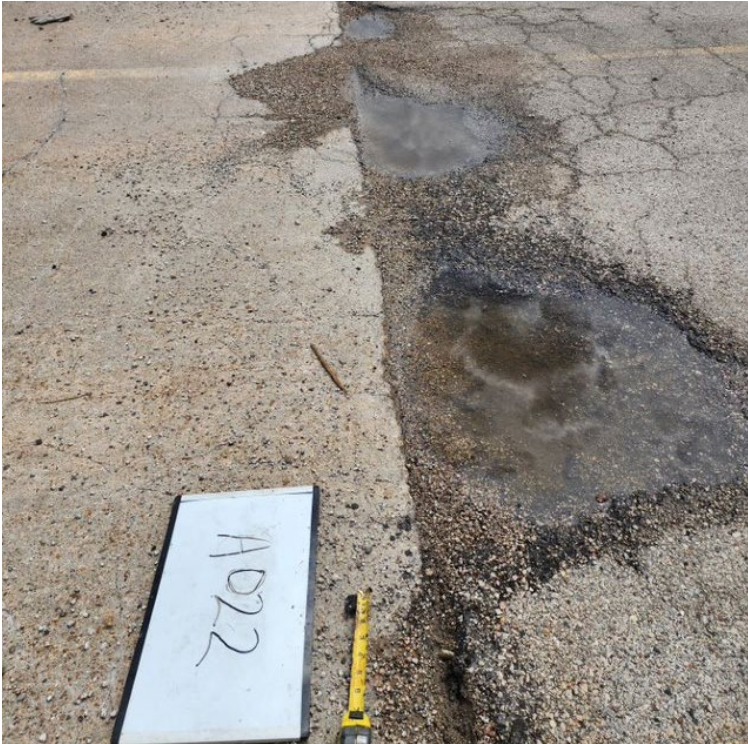
| Description: Stall A022, small amount of tar-like material observed at the seep location along the contact with the concrete pavement, looking northeast. Material was removed. Standing water from recent rain event. Lat: 29.785381 Long: - 95.318619 | | | |

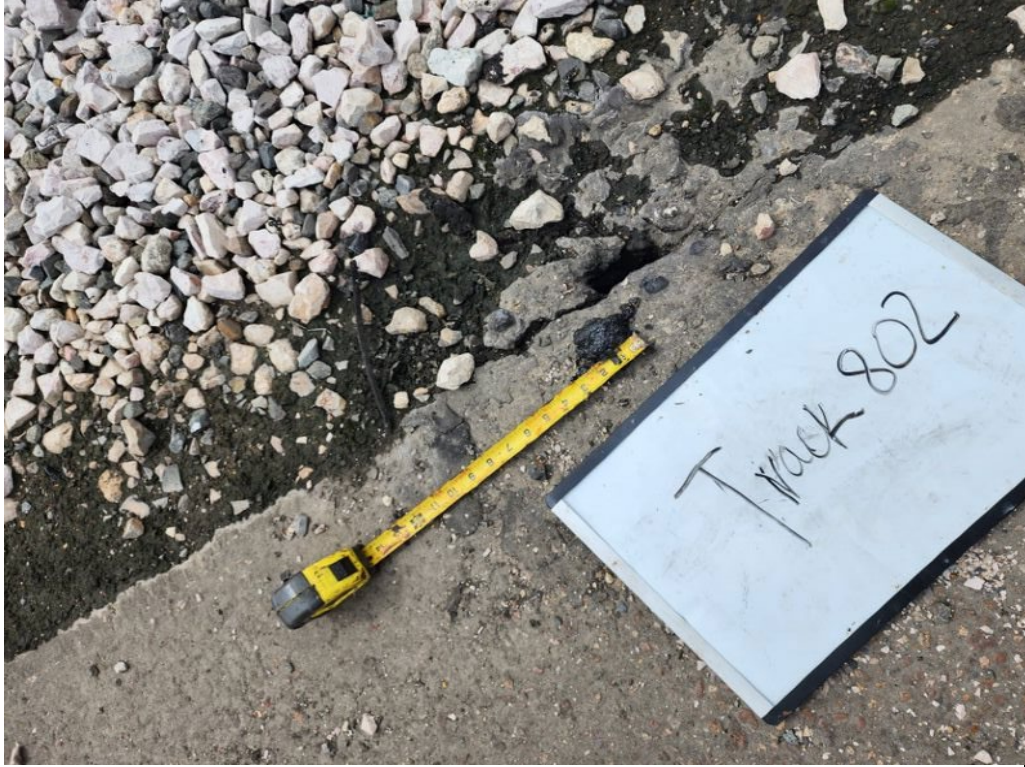
| Description: North side of Track 802, some tar-like material observed at seep location near the edge of the ballast, material removed. Lat: 29.784947 Long: -95.321214 | | |

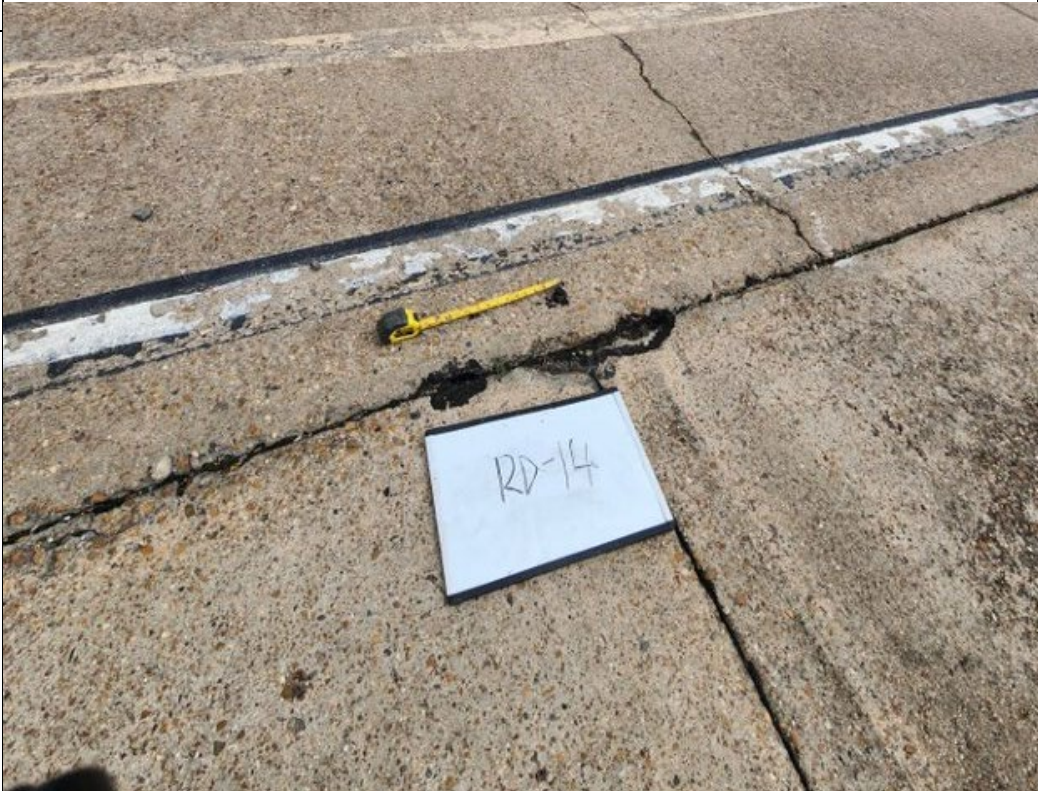
| Description: RD-14 Seep location observed within the concrete road area (RD-14) north of Track 802 (east of existing Track 802 seep location), very small amount of tar-like material observed along a concrete joint, material was removed. Lat: 29.785064 Long: -95.321219 | | |

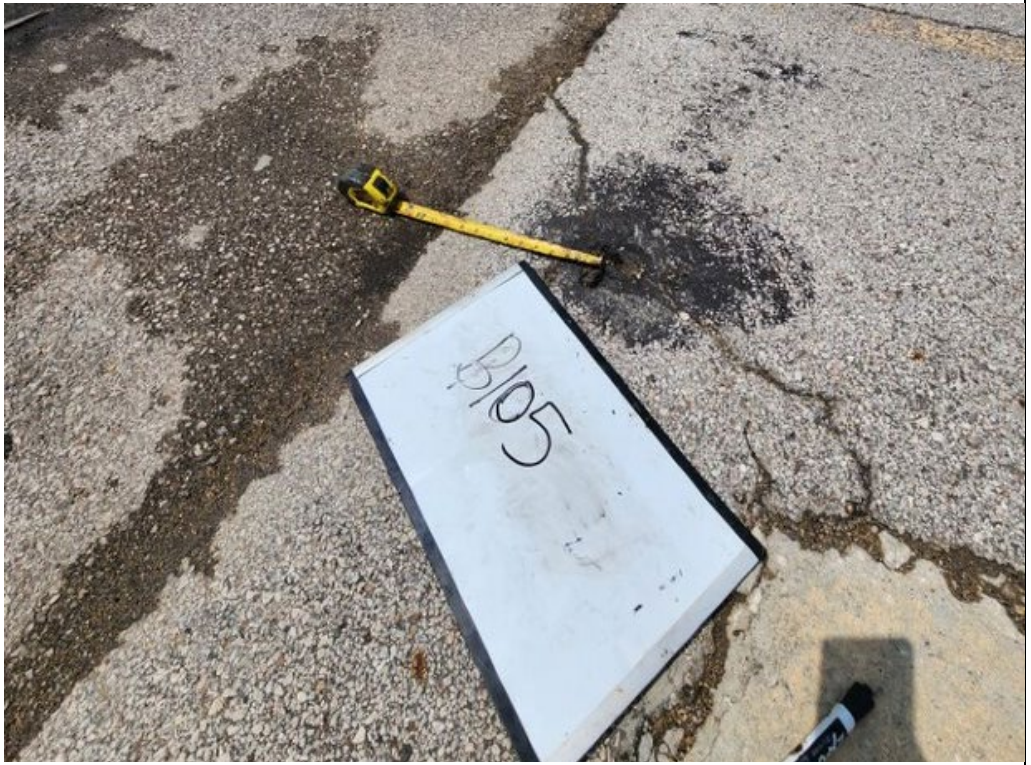
| Description: Stall B105, some tar-like material observed within concrete crack, residual staining on concrete surface noted. Lat: 29.784180 Long: -95.320917 | | |

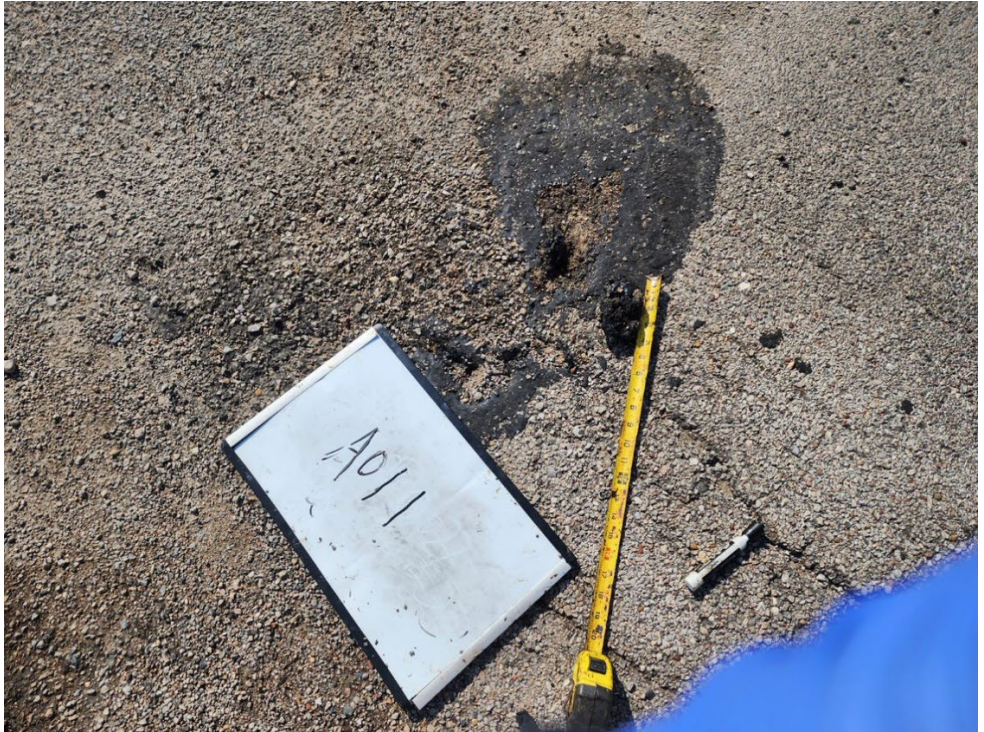
| Description: Stalls A011, some tar-like material observed at historical seep location, material removed. Some seep water and staining observed along asphalt cracks. Lat: 29.785392, Long: -95.318655 | | | |

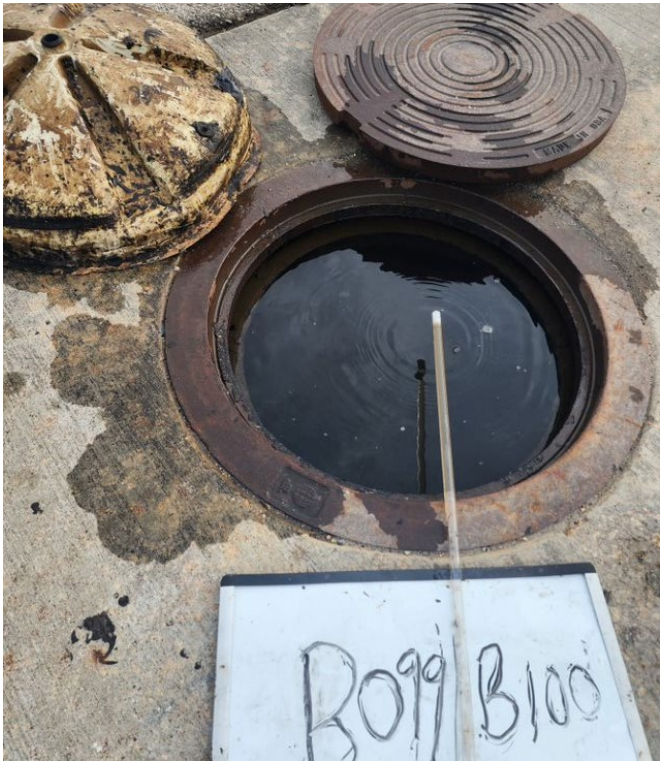
| Description: Sump 1 (B099/B100), 2 inches of freeboard in sump, no new NAPL accumulation on inflow protector, sheen observed, no odor noted, color noted as light brown. Lat: 29.7844000 Long: - 95.3205861 | | | |

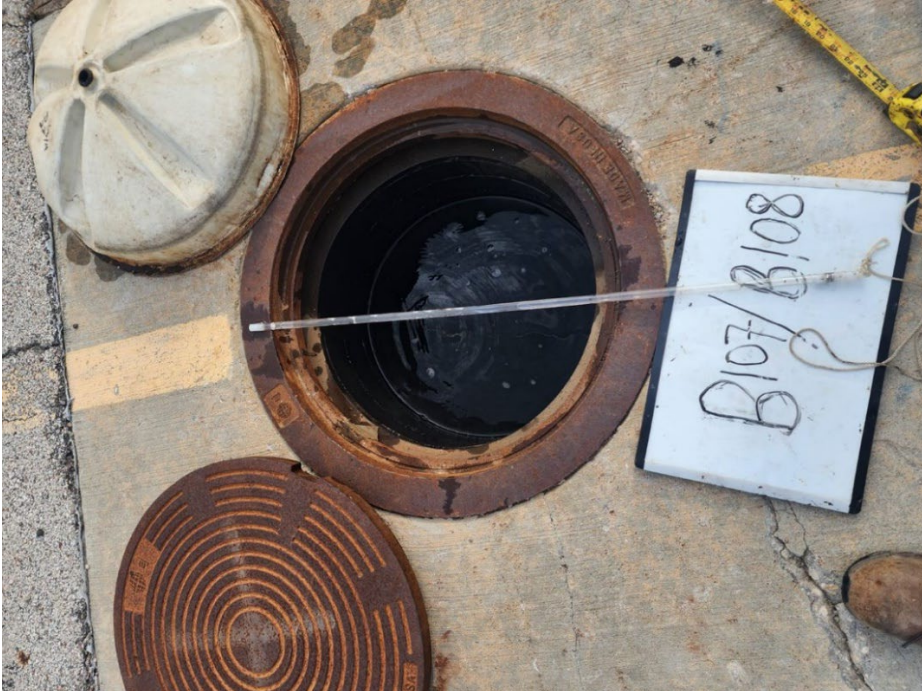
| Description: Sump 3 (B107/B108), 13 inches of freeboard in sump, no sheen or odor noted, color noted as clear. Lat: 29.784172 Long: -95.320998 | | | |

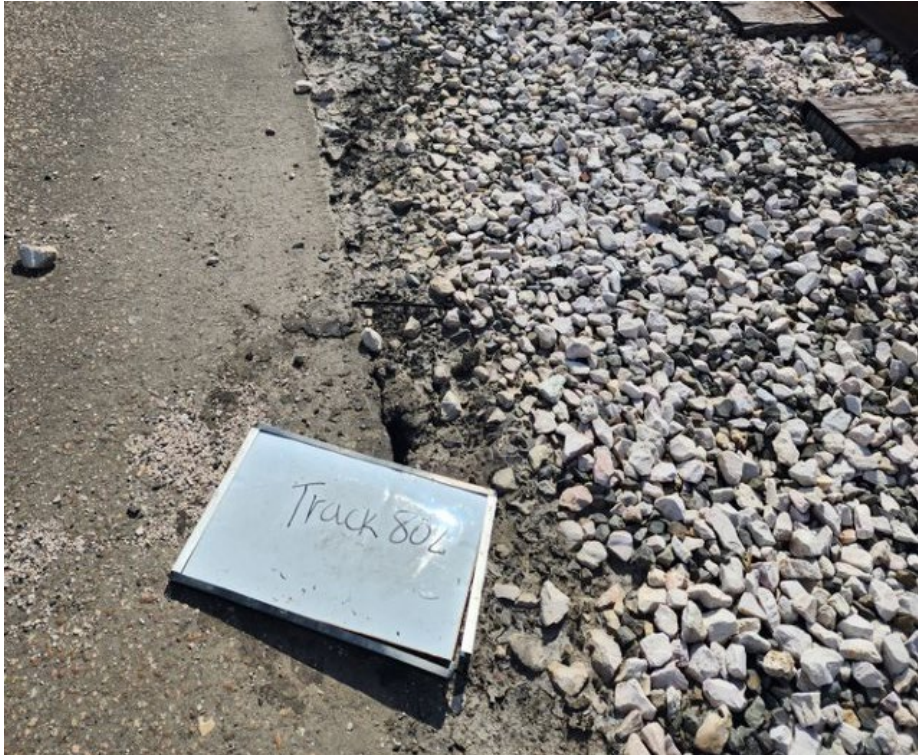
| Description: North side of Track 802, some tar-like material observed at seep location near the edge of the ballast, looking southeast. Lat: 29.784947 Long: -95.321214 | | | |

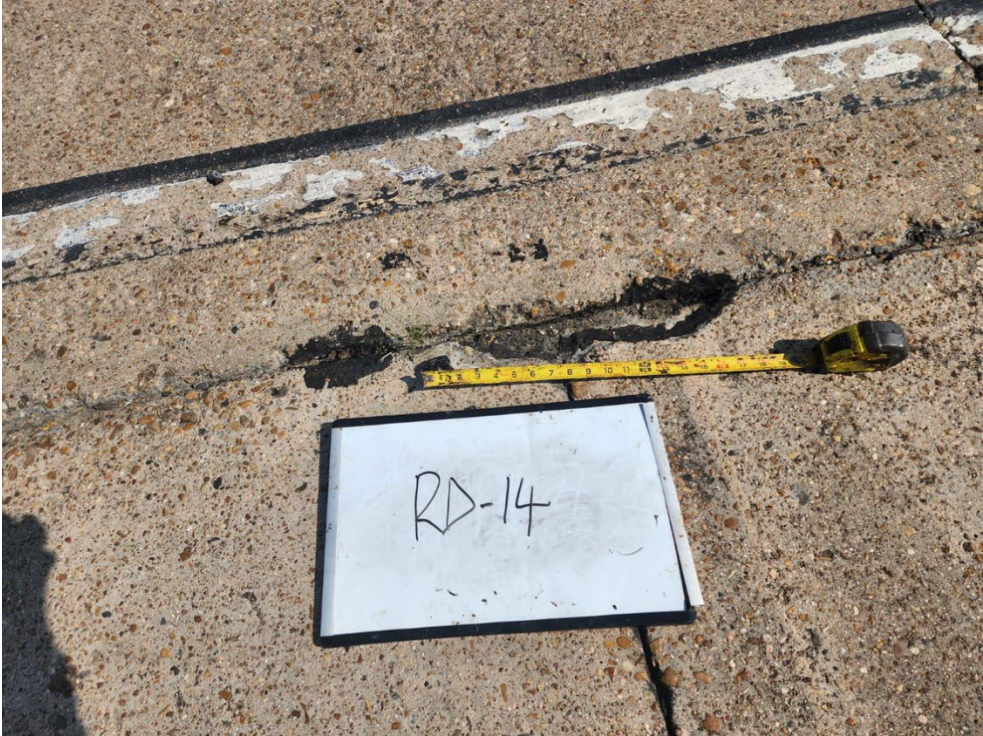
| Description: RD-14 Seep location observed within the concrete road area (RD-14) north of Track 802 (east of existing Track 802 seep location), very small amount of tar-like material observed along a concrete joint, material was removed. Lat: 29.785064 Long: -95.321219 | |
