June 9, 2023

Project No. 31406585.016

**Re: MONTHLY STATUS UPDATE – ENGLEWOOD INTERMODAL YARD – NAPL COLLECTION
SYSTEM/CONCRETE CAP REPAIRS
UNION PACIFIC RAILROAD HOUSTON WOOD PRESERVING WORKS FACILITY
4910 LIBERTY ROAD FACILITY, HOUSTON, TEXAS
POST-CLOSURE CARE PERMIT NO. HW-50343; INDUSTRIAL SWR NO. 31547**

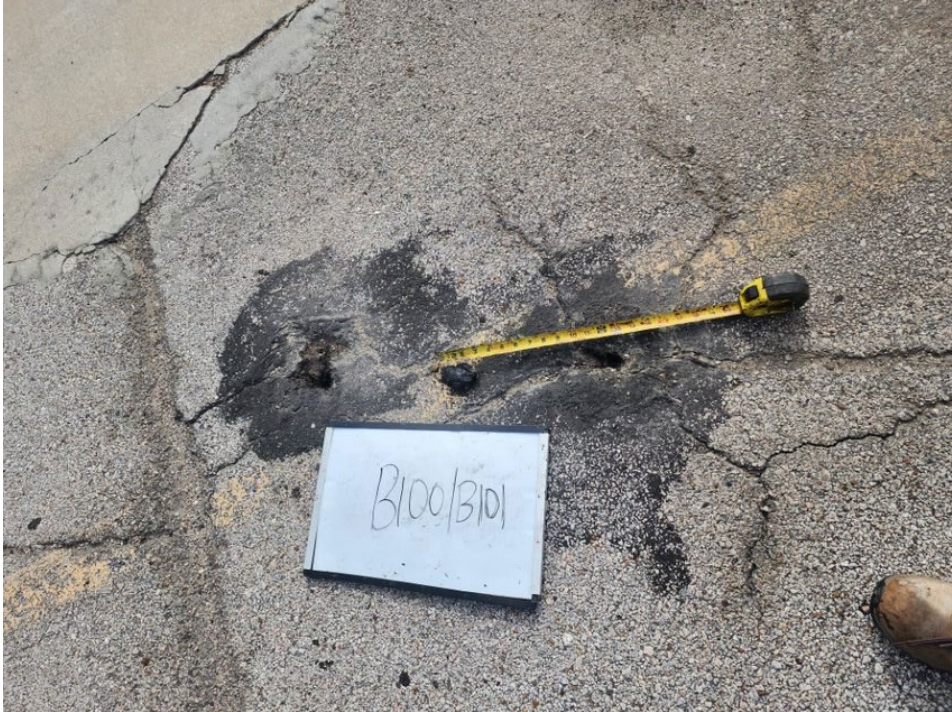
| Description: Stall B101, small amount of tar-like material observed near historical seep location, material removed. Lat: 29.7842528 Long: - 95.3206250 | | | |

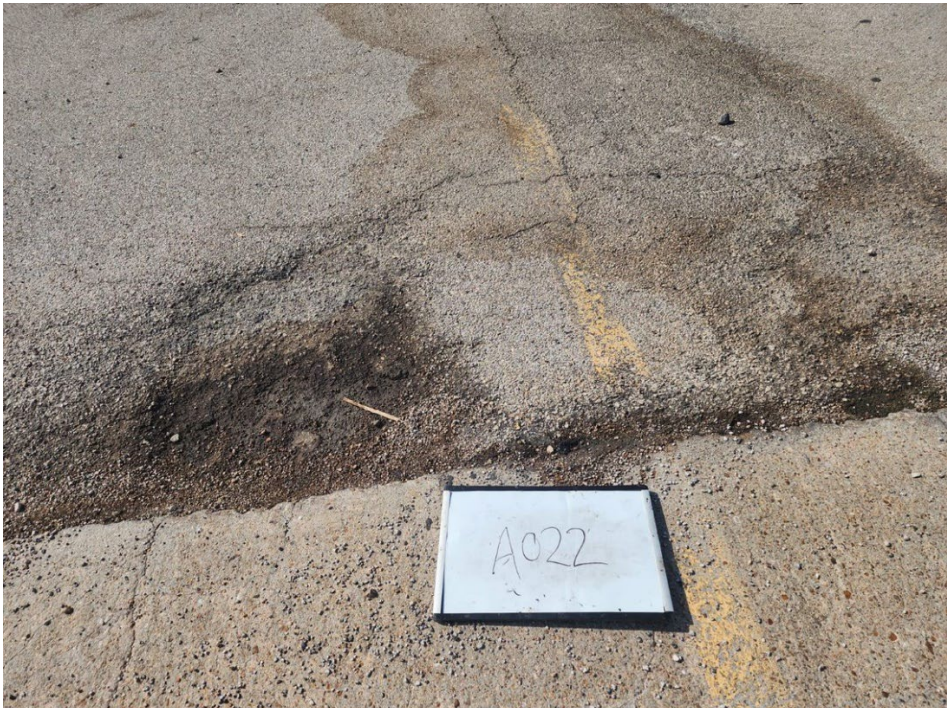
| Description: Stall A022, no tar-like material observed at the seep location along the edge of the concrete pavement, looking southeast. Lat: 29.785381 Long: - 95.318619 | | | |

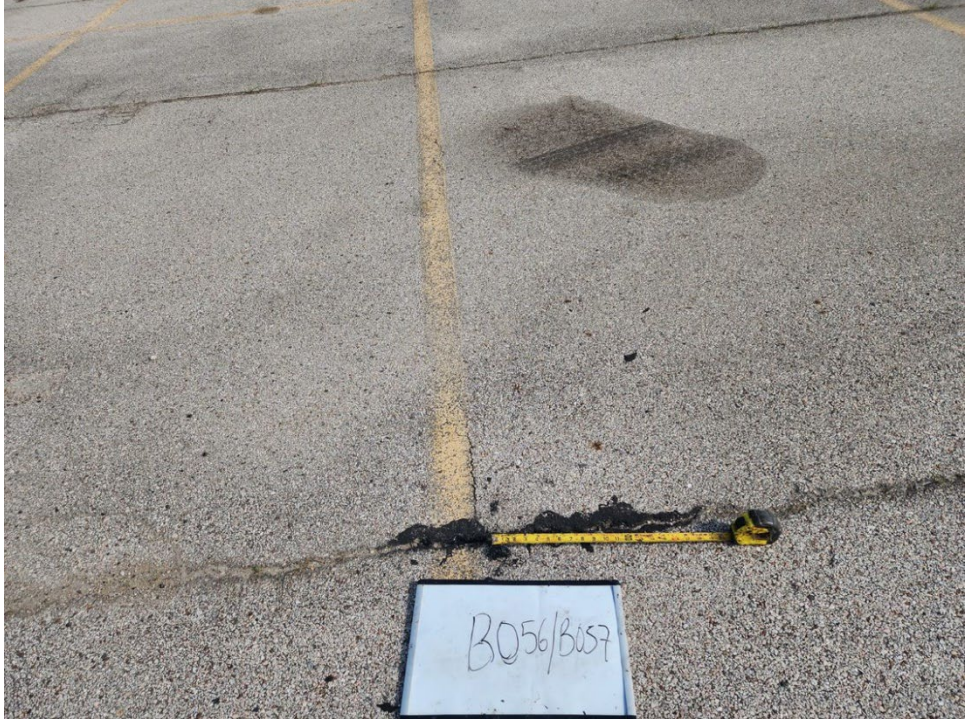
| Description: Stall B056, some tar-like material seeping observed at asphalt crack, material removed. Lat: 29.7847472 Long: - 95.3195417 | |

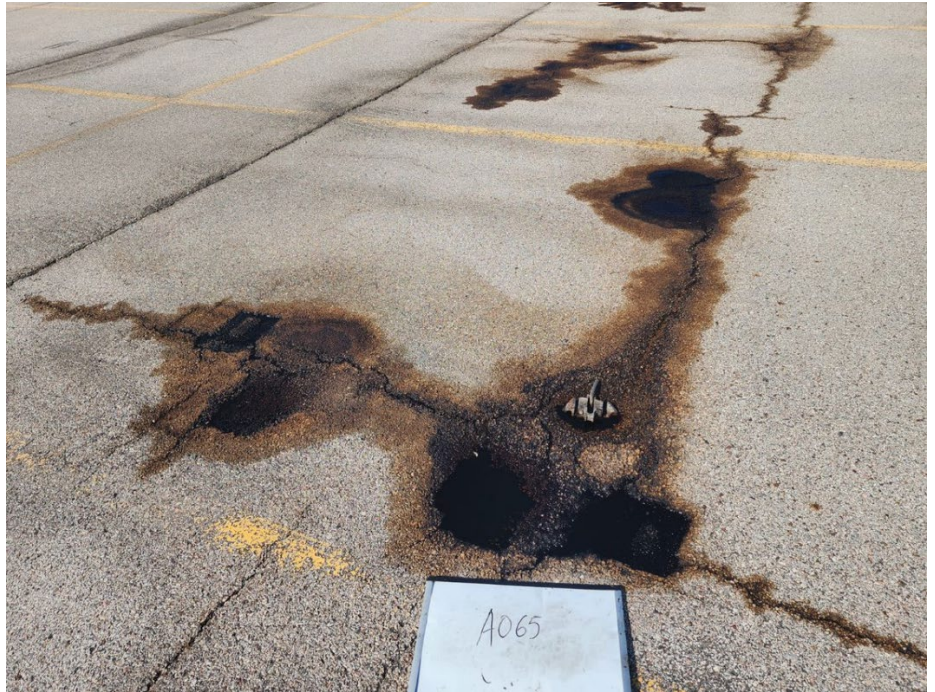
| Description: Stall A065, staining and seep water observed along asphalt cracks of Rows A and B, looking west. UPRR remediation contractor OMI absorbed liquid with absorbent pads. Lat: 29.784858 Long: -95.319733 | | | |

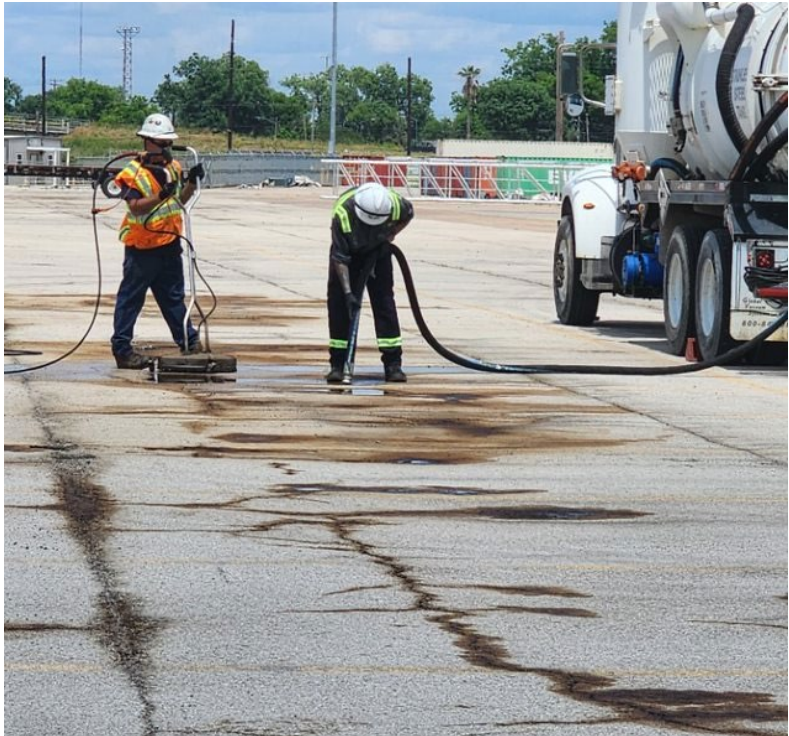
| Description: UPRR remediation contractor OMI cleaning Stall A065, using a water truck to power wash staining and seepage. Looking east. Lat: 29.784858 Long: -95.319733 | | |

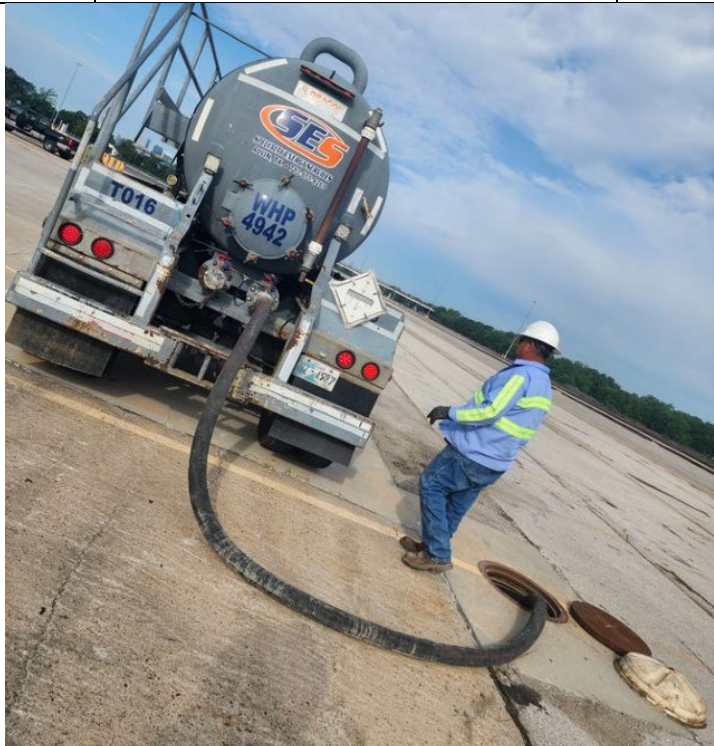
| Description: UPRR remediation contractor OMI pumping water out of Sump 3 (B107/B108). Looking west. Lat: 29.784172 Long: -95.320998 | | | |

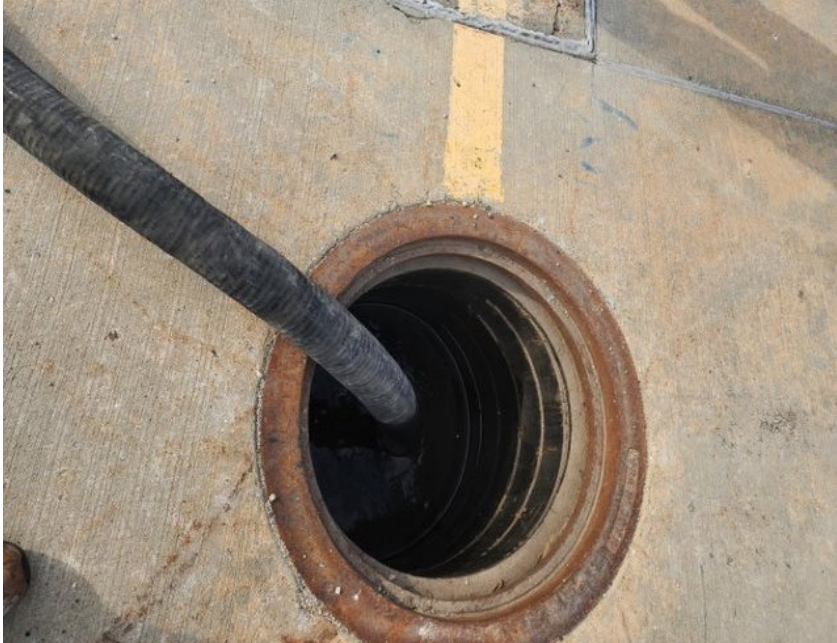
| Description: UPRR remediation contractor OMI pumped 8,300 gallons of water total out of all three sumps. Shown is Sump 3 (B107/B108) after being pumped down. Lat: 29.784172 Long: -95.320998 | | | |

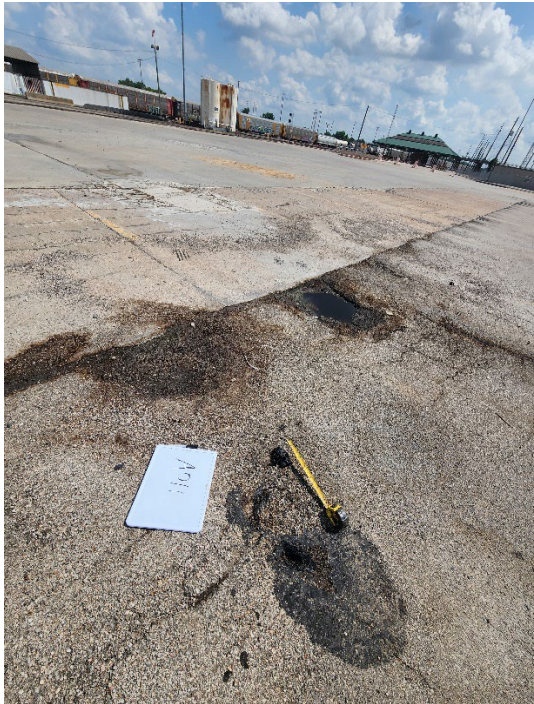
| Description: Stall A011, some tar-like material observed at historical seep location, material removed. Some seep water and staining observed along asphalt cracks. Lat: 29.785392, Long: -95.318655 | | | |

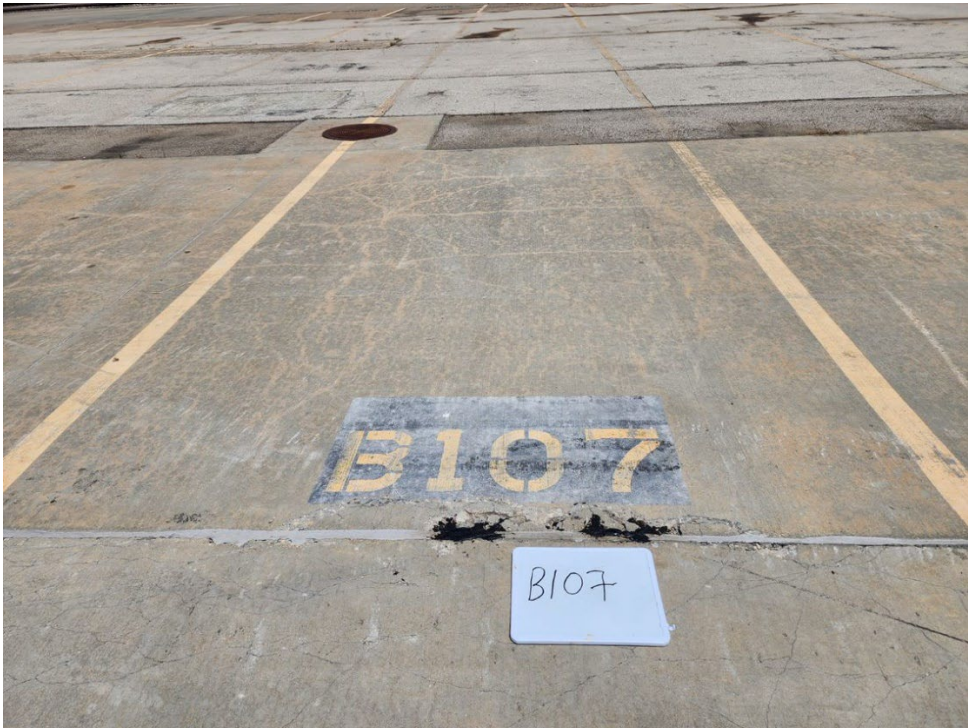
| Description: Stall B107, view of NAPL collection system (Sump 3 in background of photo), some tar-like material observed at seep location on concrete joint along the southern edge of the excavated area, material removed, looking northwest. Lat: 29.784156 Long: -95.320953 | | |

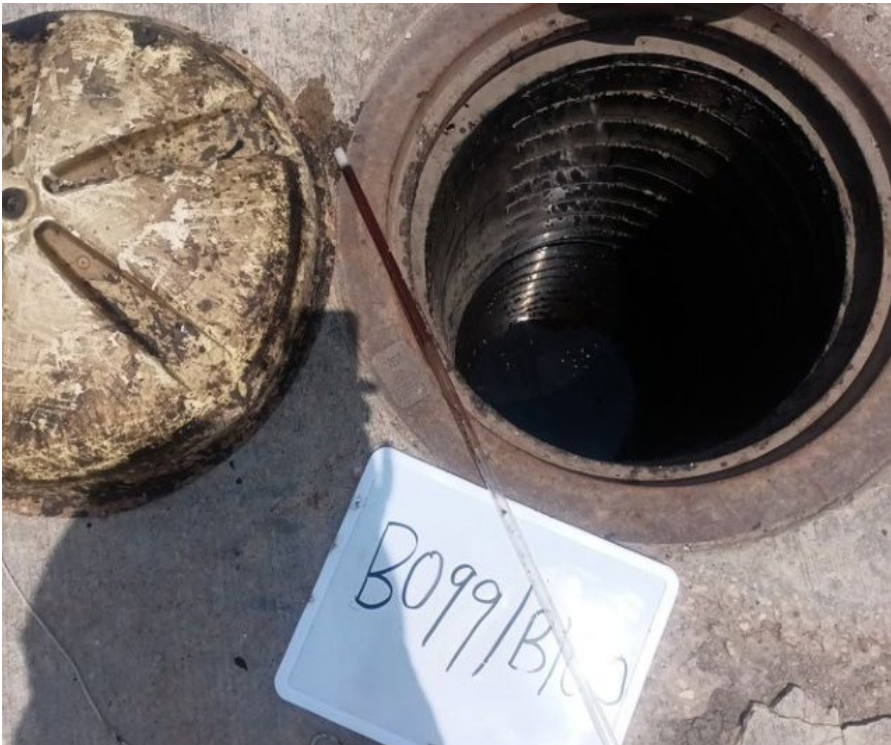
| Description: Sump 1 (B099/B100), 28 inches of freeboard in sump, no new NAPL accumulation on inflow protector, sheen observed, no odor noted, color noted as brown. Lat: 29.7844000 Long: - 95.3205861 | | | |

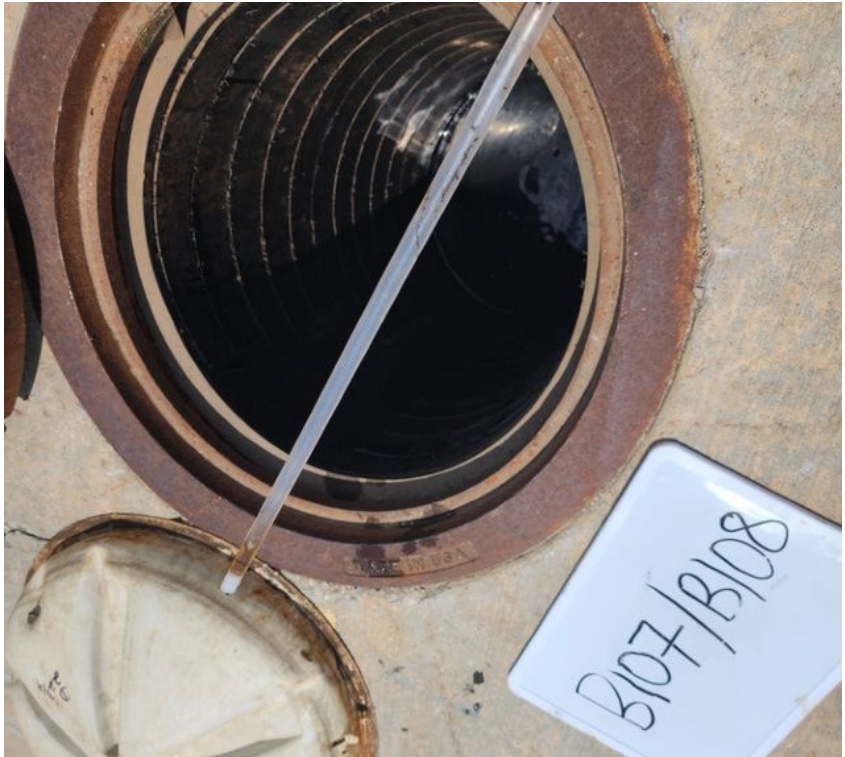
| Description: Sump 3 (B107/B108), 49 inches of freeboard in sump, no sheen or odor noted, color noted as light brown. Lat: 29.784172 Long: -95.320998 | | | |

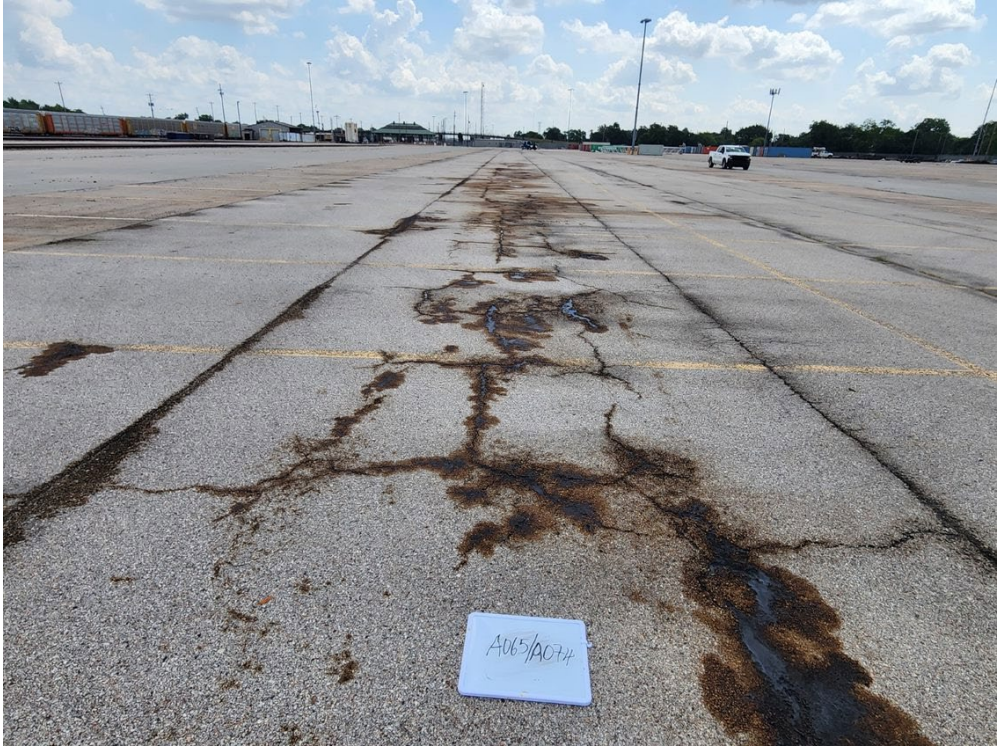
| Description: Stalls A060-A075, brown staining observed in Rows A and B, looking southwest. Lat: 29.784858 Long: -95.319733 | | |

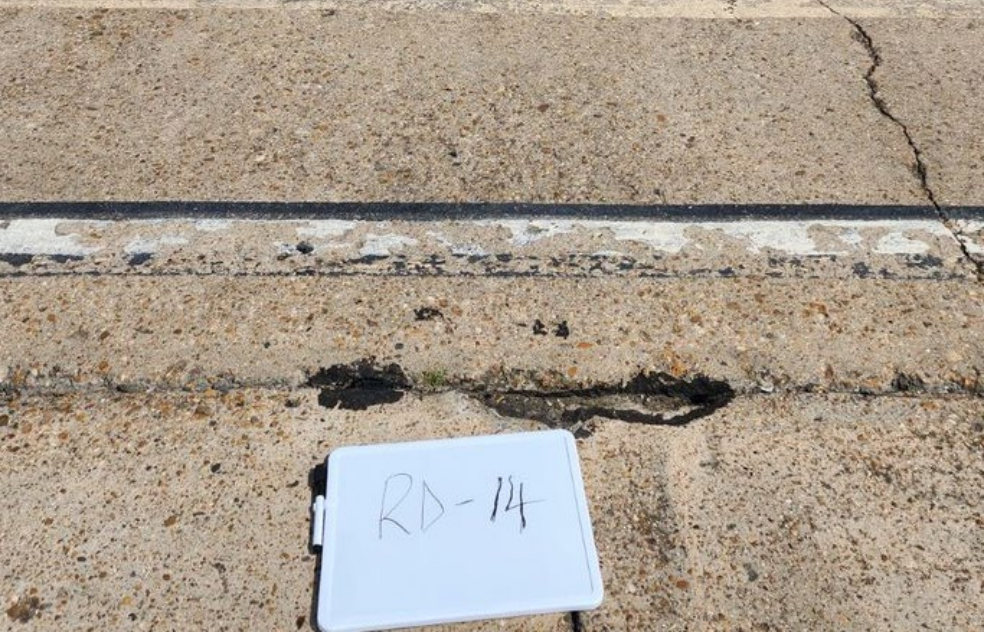
| Description: RD-14 Seep location observed within the concrete road area (RD-14) north of Track 802 (east of existing Track 802 seep location), no tar-like material observed along a concrete joint. Lat: 29.785064 Long: -95.321219 | | |

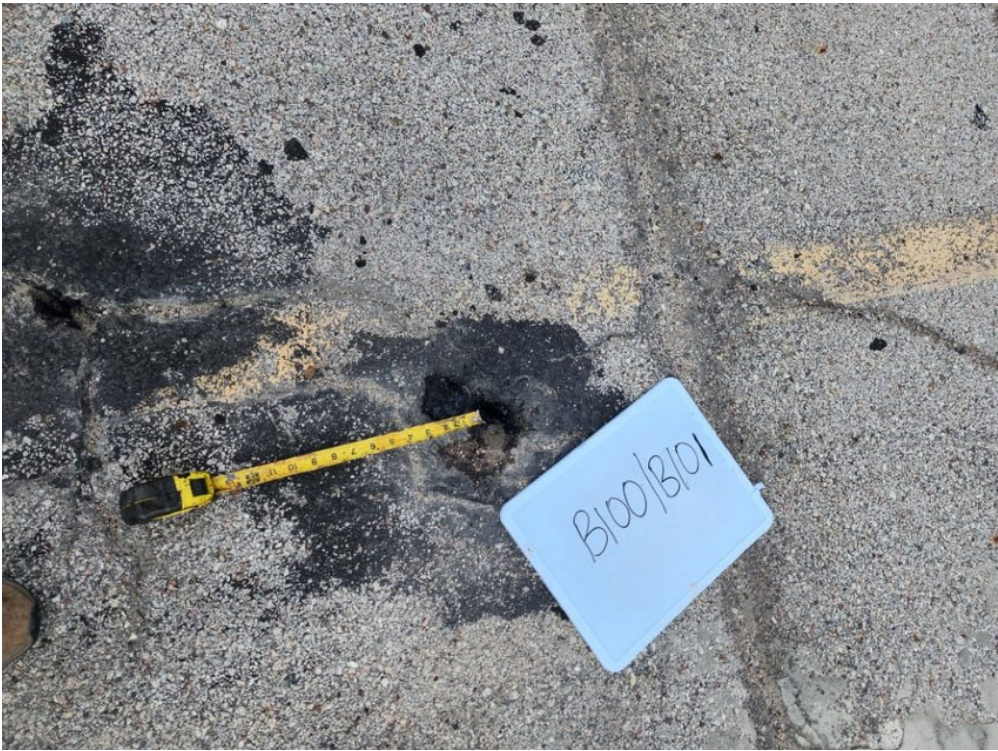
| Description: Stall B101, small amount of tar-like material observed near historical seep location, material removed. Lat: 29.7842528 Long: - 95.3206250 | | | |

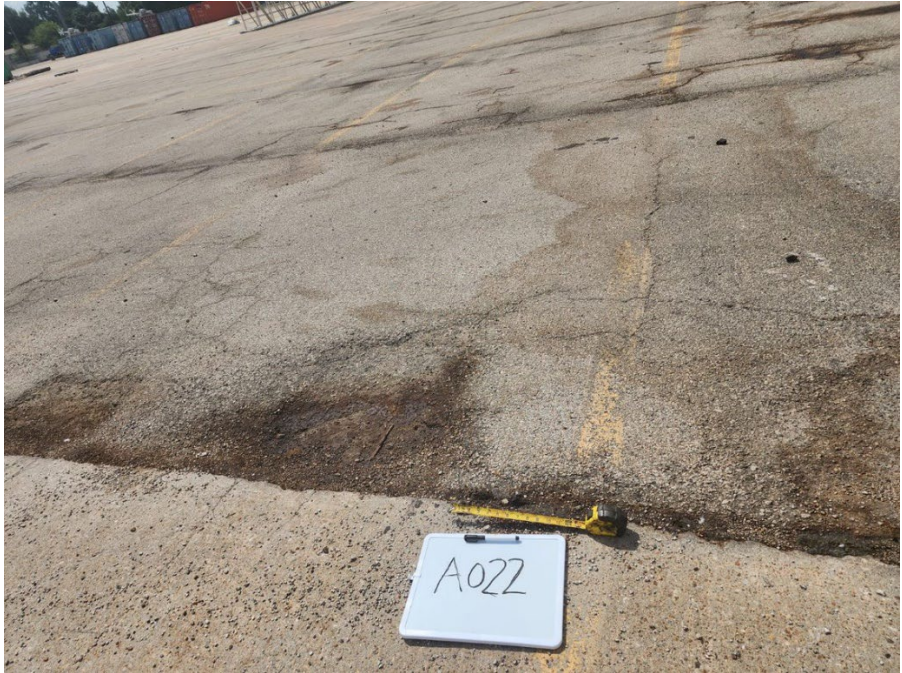
| Description: Stall A022, a small amount of tar-like material observed at the seep location along the edge of the concrete pavement, looking southeast. Lat: 29.785381 Long: - 95.318619 | | | |

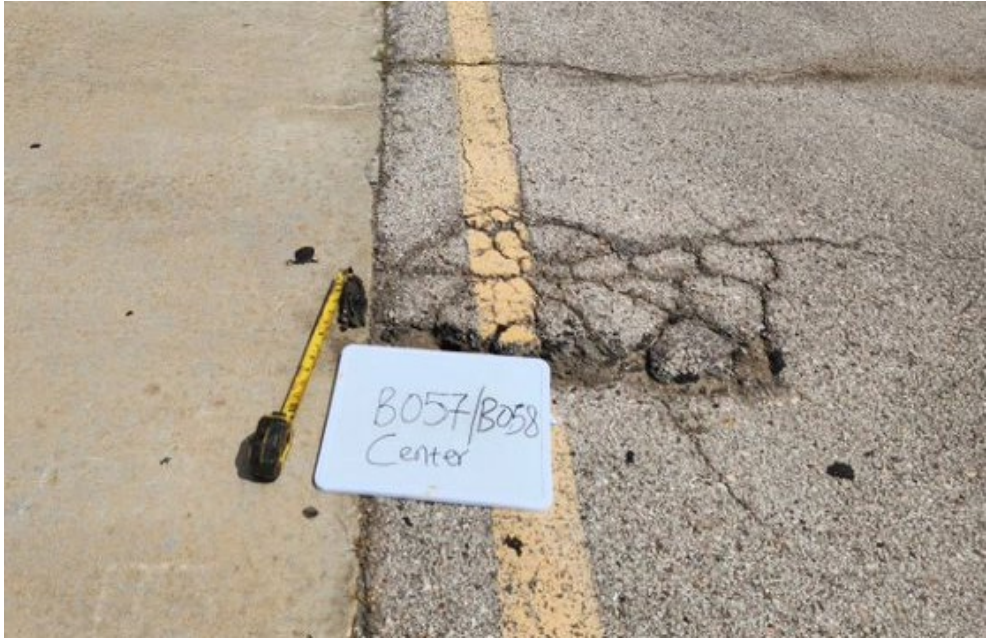
| Description: Stall B057, some tar-like material seeping at historical seep location in asphalt cracks, no seeps observed where test pit conducted (July 2020), some seep water and staining observed along asphalt cracks in Rows A and B, looking west. Lat: 29.7847472 Long: - 95.3195417 | | |

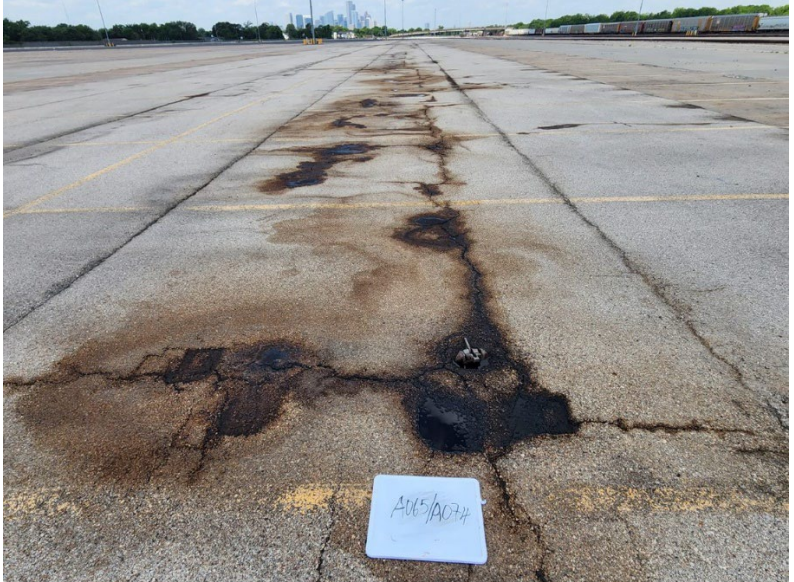
| Description: Stall A065, staining and seep water observed along asphalt cracks of Rows A and B, looking southwest. UPRR remediation contractor OMI absorbed liquid with absorbent pads. Lat: 29.784858 Long: -95.319733 | | | |

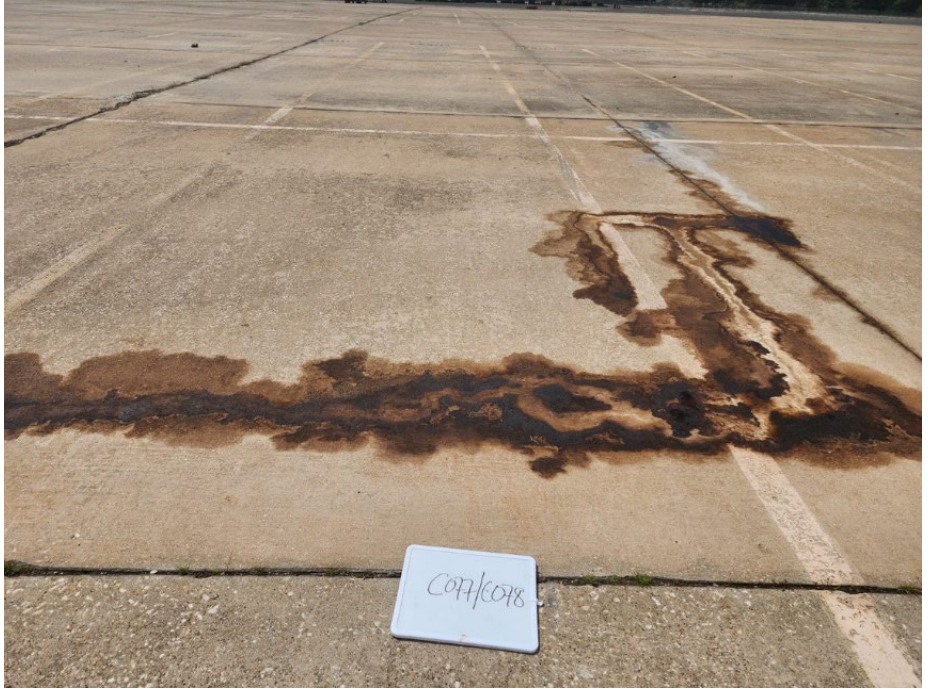
| Description: Slot C077 and C078, brown staining observed in Row C. Lat: 29.7847472 Long: - 95.3195417 | | |

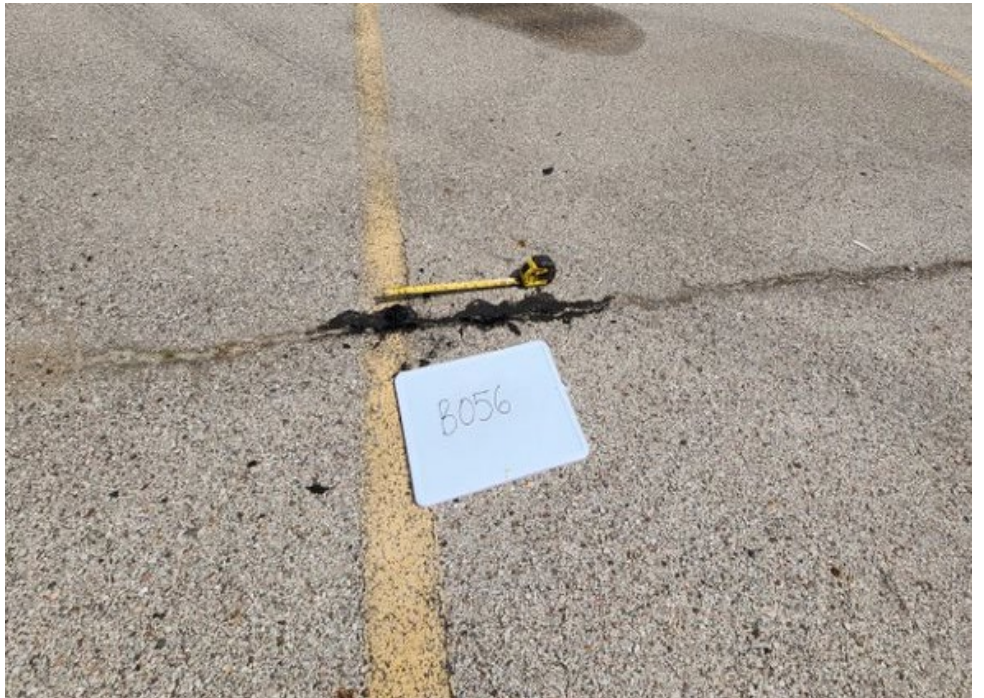
| Description: Slot B056, some tar-like material seeping observed at asphalt crack, material removed. Lat: 29.7847472 Long: - 95.3195417 | | | |

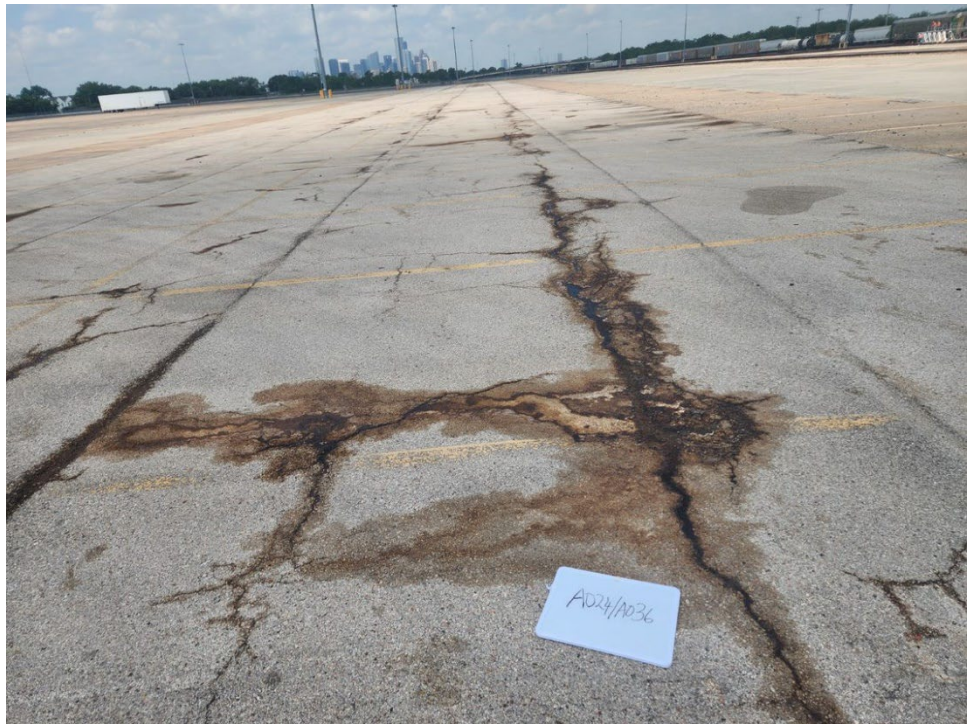
| Description: Stalls A024-A036, brown staining observed in rows A and B, looking southwest. Lat: 29.785250 Long: - 95.318777 | | |
