July 14, 2023

Project No. 31406585.016

**Re: MONTHLY STATUS UPDATE – ENGLEWOOD INTERMODAL YARD – NAPL COLLECTION
SYSTEM/CONCRETE CAP REPAIRS
UNION PACIFIC RAILROAD HOUSTON WOOD PRESERVING WORKS FACILITY
4910 LIBERTY ROAD FACILITY, HOUSTON, TEXAS
POST-CLOSURE CARE PERMIT NO. HW-50343; INDUSTRIAL SWR NO. 31547**

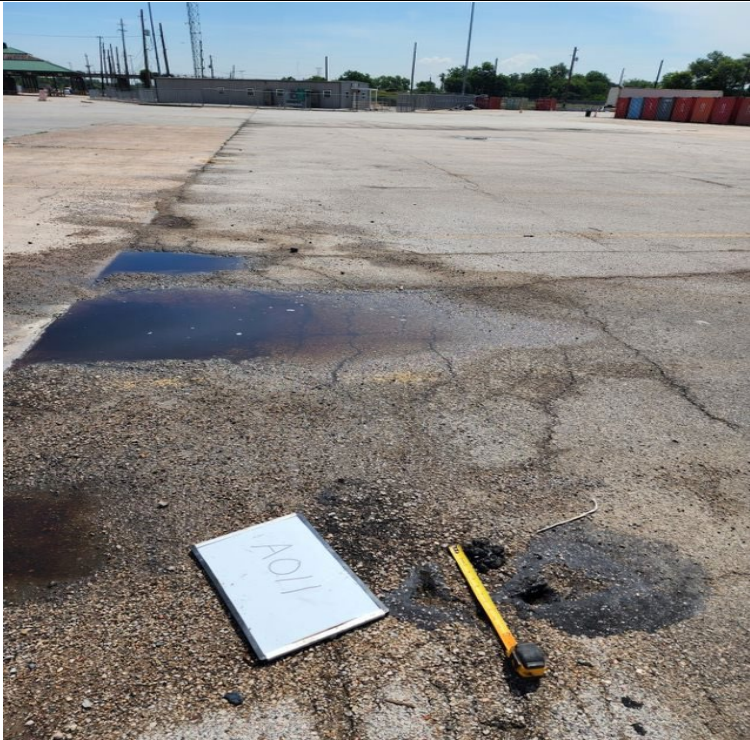
Description: Stall A011 some tar-like material observed at historical seep location along asphalt crack, material was removed. Water from recent rain event observed along asphalt cracks, looking east. Lat: 29.785392, Long: -95.318655			
Photo No. 2	Inspection Date: 6/7/2023

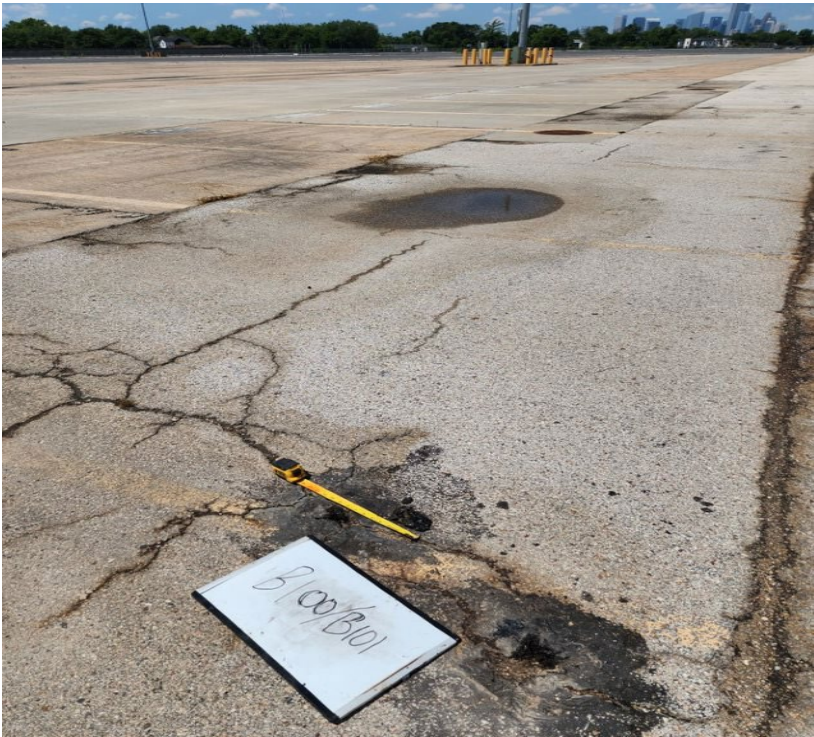
Description: Stall B100/B101, some tar-like material observed near historical seep location along asphalt crack, material removed. (Sump B103/B104 in background of photo), pavement wet from recent rain event, looking west. Lat: 29.7842528 Long: - 95.3206250

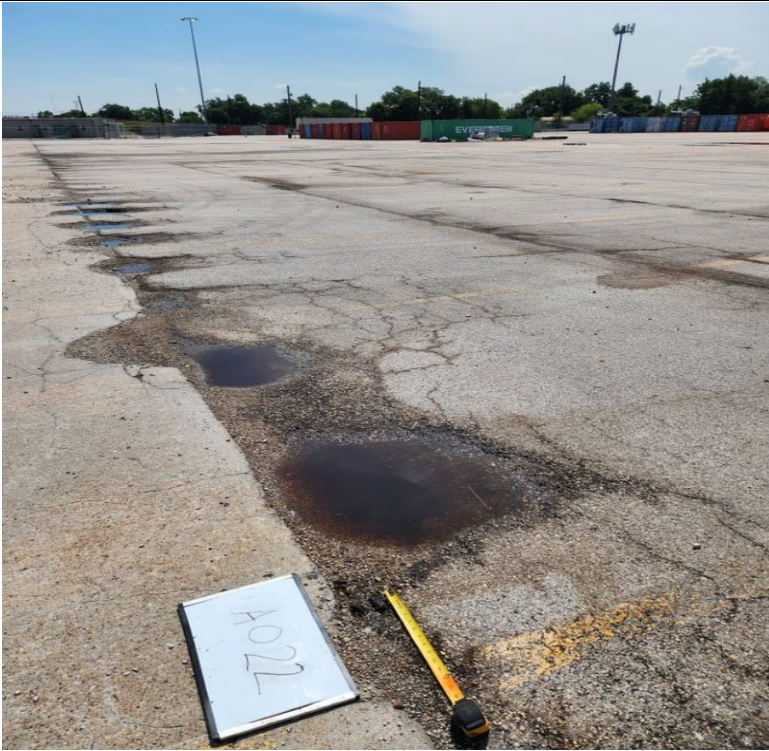
Description: Stall A022, a small amount of tar-like material observed at the seep location along the edge, pavement wet from recent rain event, looking south east Lat: 29.785381 Long: - 95.318619			
Photo No. 4	Inspection Date: 6/7/2023

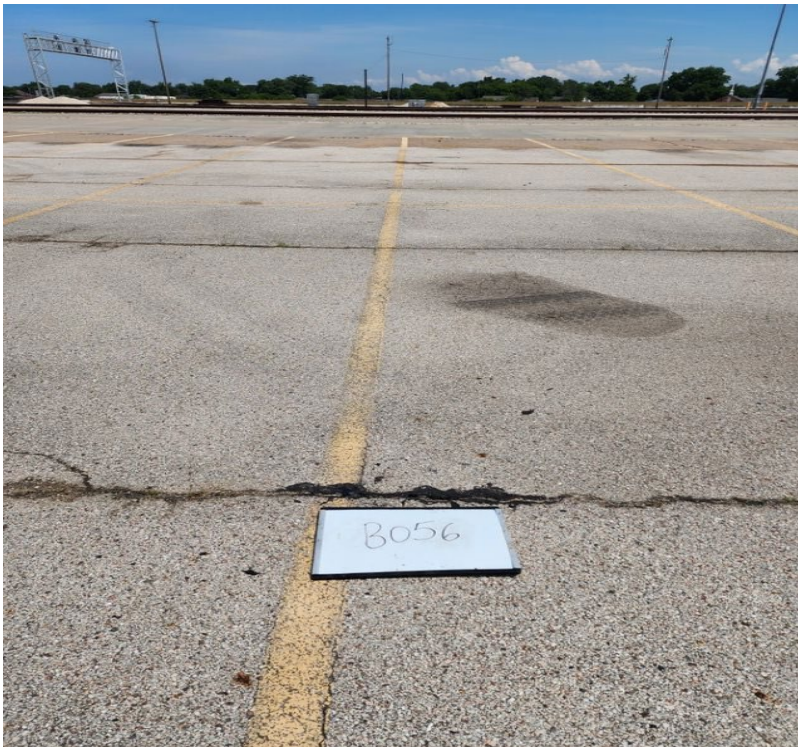
Description: Slot B056, a small amount of tar-like material seeping at asphalt crack, material was removed. Looking North Lat: 29.7847472 Long: -95.3195417

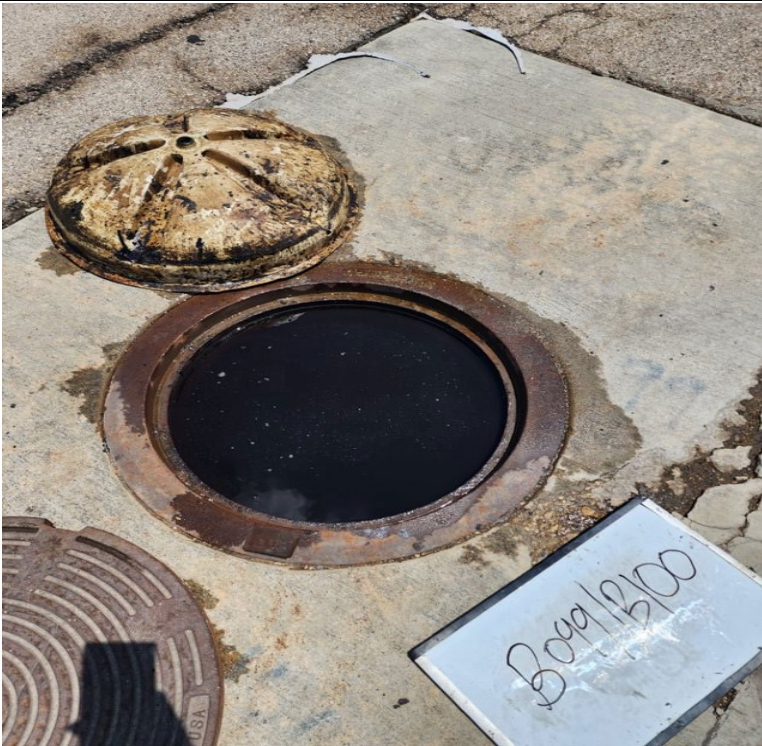
Description: Sump 1 (B099/B100), 3 inches of freeboard in sump, sheen observed, no odor noted, no new NAPL accumulation on inflow protector, color noted as brown/turbid. Lat: 29.7844000 Long: - 95.3205861			
Photo No. 6	Inspection Date: 6/7/2023

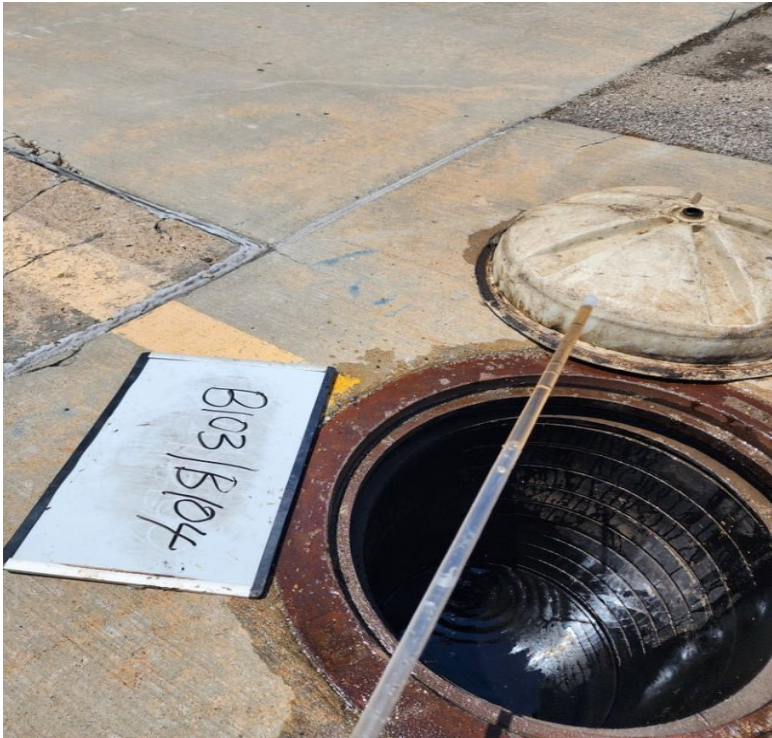
Description: Sump 2 (B103/B104), 38 inches of freeboard, sheen observed, no odor noted, color noted as light brown. Lat: 29.7842861 Long: - 95.3208611

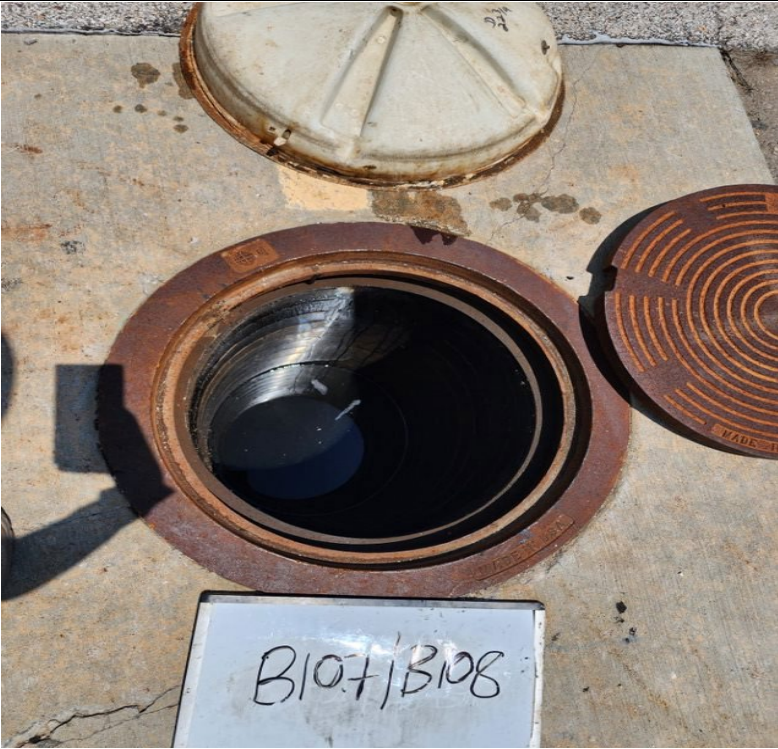
Description: Sump 3 (B107/B108), 37 inches of freeboard in sump, sheen observed, no odor noted, color noted as light brown. Lat: 29.784172 Long: -95.320998			
Photo No. 8	Inspection Date: 6/7/2023

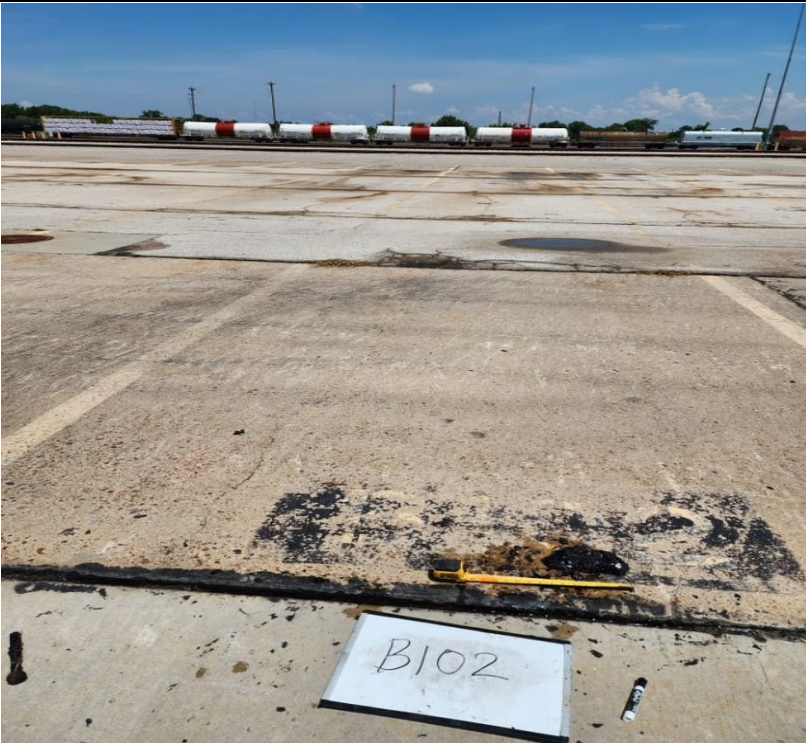
Description: Stall B102, small amount of tar-like material observed within concrete joint, residual staining on concrete surface noted. Lat: 29.7842203 Long: -95.3208267

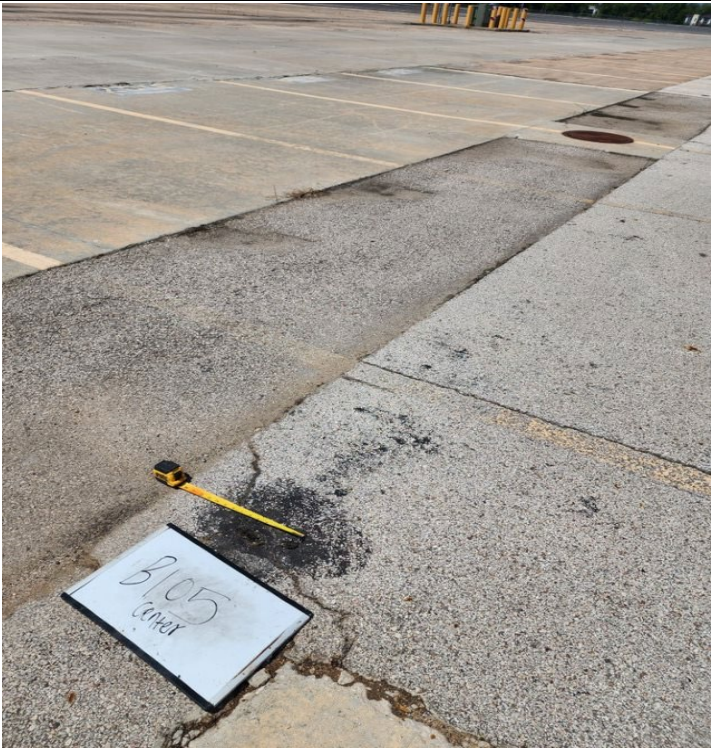
Description: Stall B105, view of NAPL collection system (Sump 3 in background of photo), very small tar-like material observed at seep location, material removed, looking southwest. Lat: 29.784236 Long: -95.320939			
Photo No. 10	Inspection Date: 6/7/2023

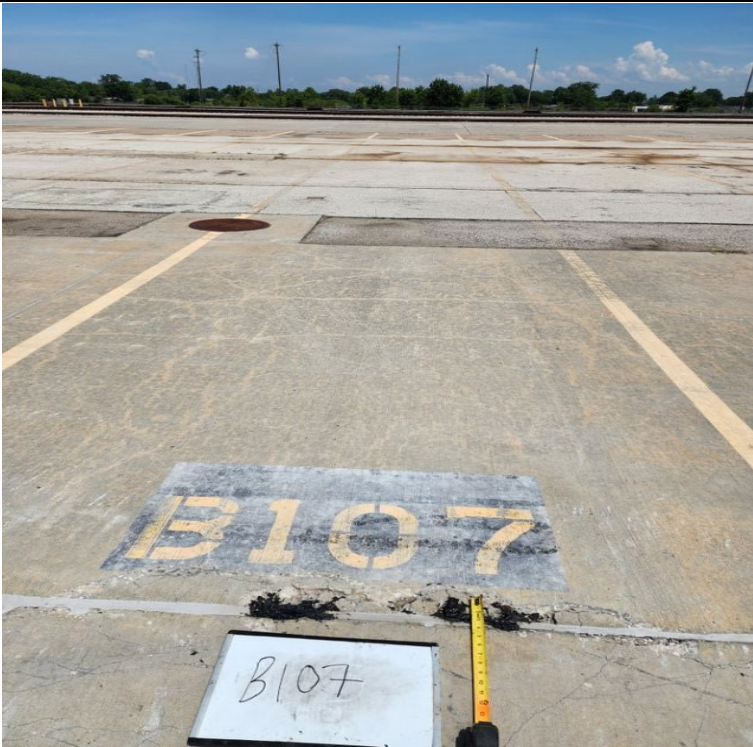
- A small tar-like material seep was observed on the southern edge of the NAPL Collection System in cracks in the cement along the joint of Stall B107 during the July 6, 2022 weekly inspection. A small amount of tar-like material was recovered at this location on June 7, 14, 21 and 28, 2023 (Photo Nos. 10, 19, 43, and 44).

Description: Stall B107, view of NAPL collection system (Sump 3 in background of photo), looking north, some tar-like material observed at seep location on concrete joint along the southern edge of the excavated area, material removed. Lat: 29.784156 Long: -95.320953

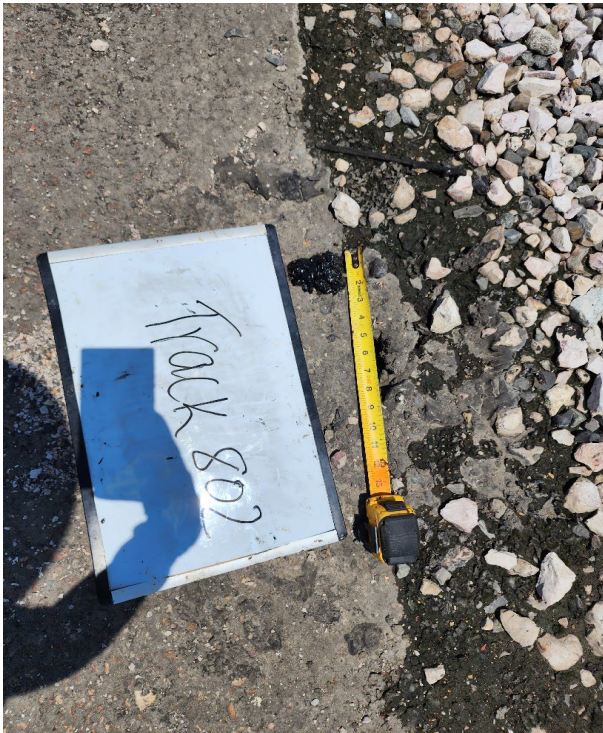
Description: North side of Track 802, some tar-like material observed at seep location near the edge of the ballast, pavement wet from recent rain event. Material removed. Lat: 29.784947 Long: - 95.321214			
Photo No. 12	Inspection Date: 6/7/2023

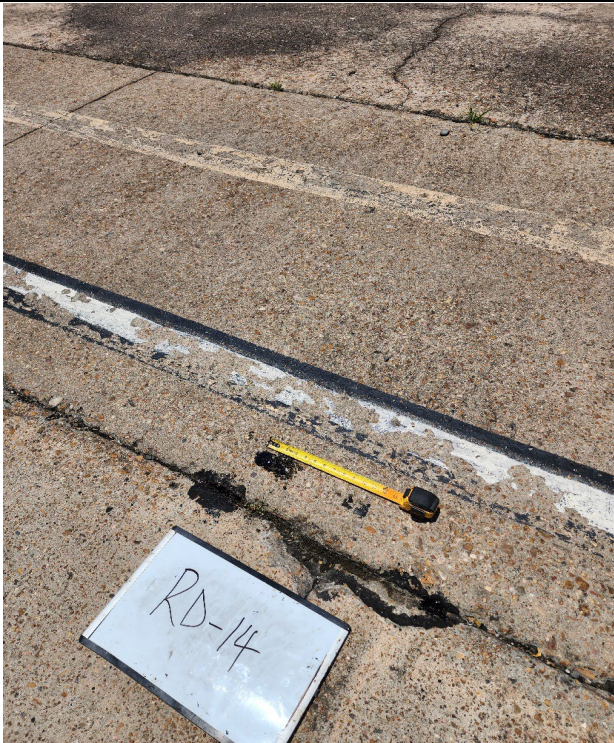
Description: RD-14 Seep location observed within the concrete road area (RD-14) north of Track 802 (east of existing Track 802 seep location), very small amount of tar-like material observed along a concrete joint, material was removed. Lat: 29.785064 Long: -95.321219

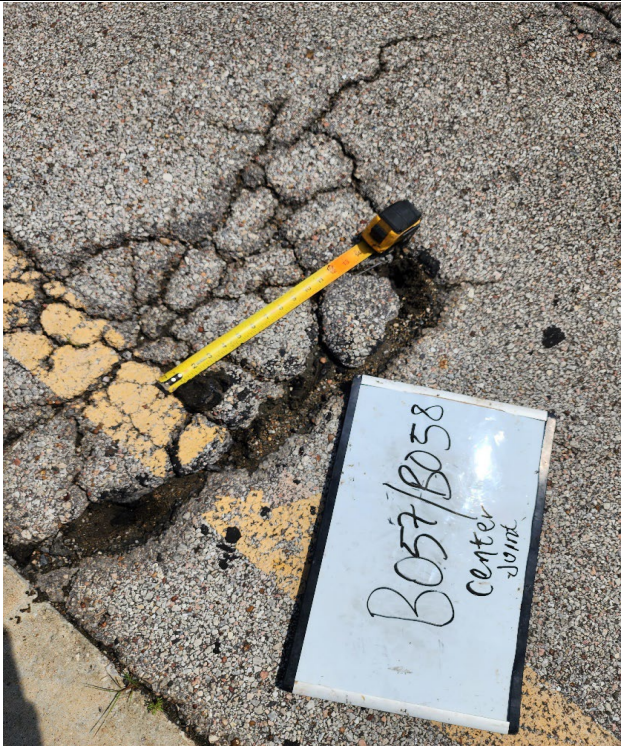
Description: Slot B057, very small amount of tar-like material seeping at historical seep location in asphalt cracks, no seep observed where test pit conducted (July 2020), material was removed. Lat: 29.7847472 Long: -95.3195417			
Photo No. 14	Inspection Date: 6/14/2023

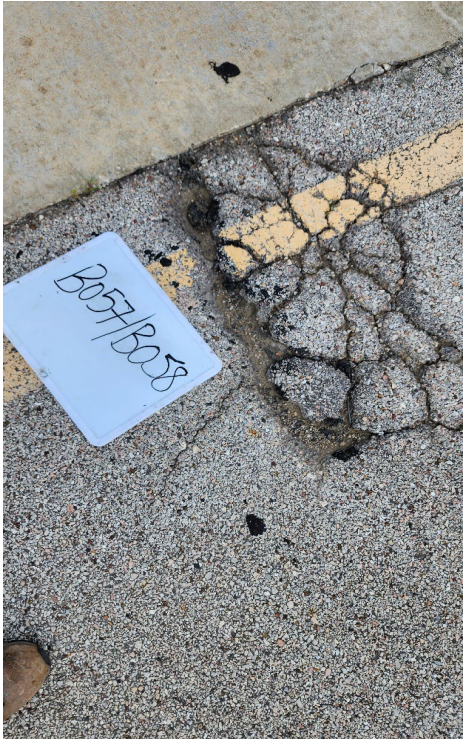
Description: Slot B057, very small amount of tar-like material seeping at historical seep location in asphalt cracks, no seep observed where test pit conducted (July 2020), material was removed. Lat: 29.7847472 Long: -95.3195417

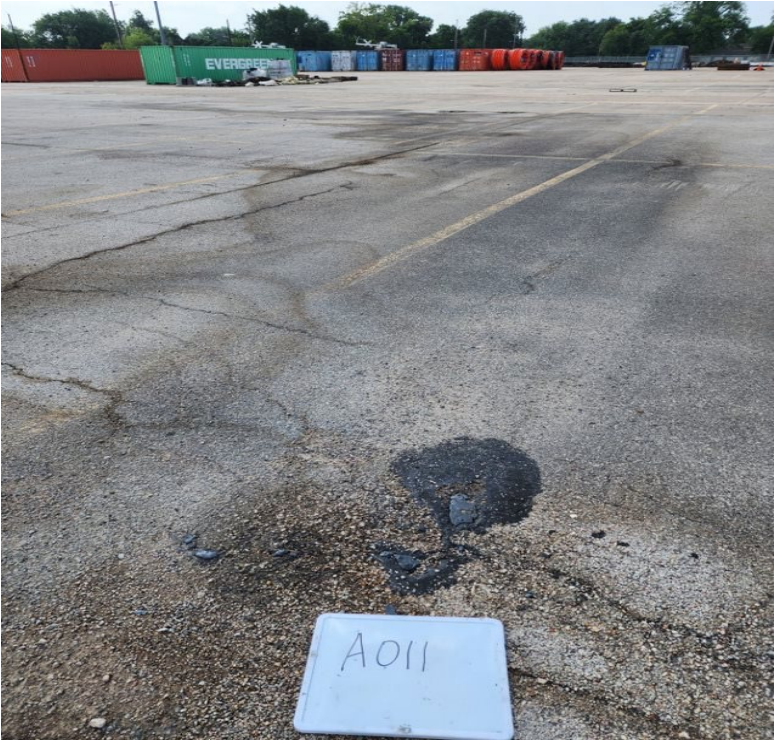
Description: Stall A011, some tar-like material observed at historical seep location, looking southeast, material was removed.			
Lat: 29.785392 Long: - 95.318655			
Photo No. 16	Inspection Date: 6/14/2023

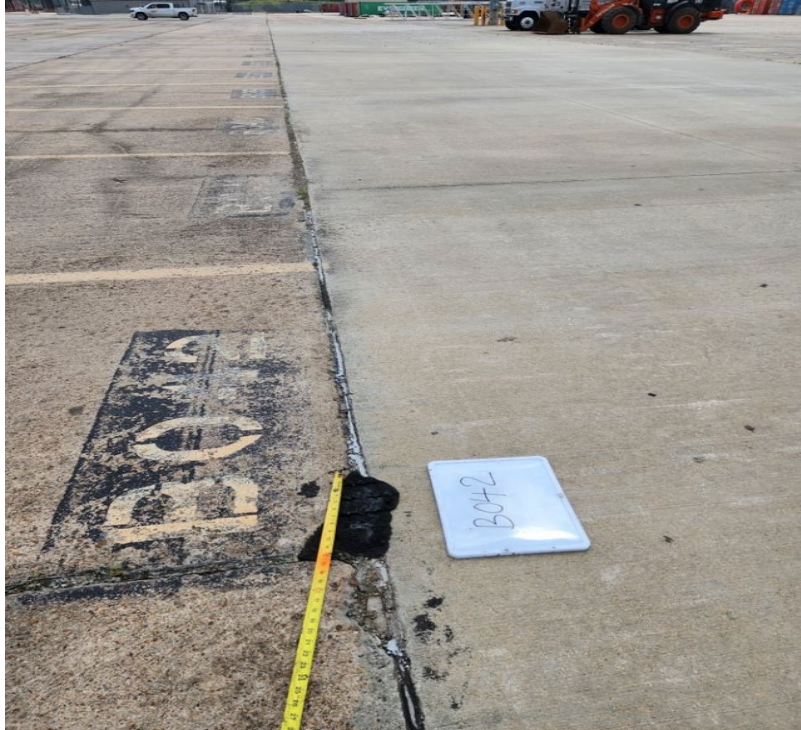
Description: Stall B042, some tar-like material observed at seep location on concrete joint along the southern edge, material removed. looking east.			
Lat: 29.784926 Long: -95.319124

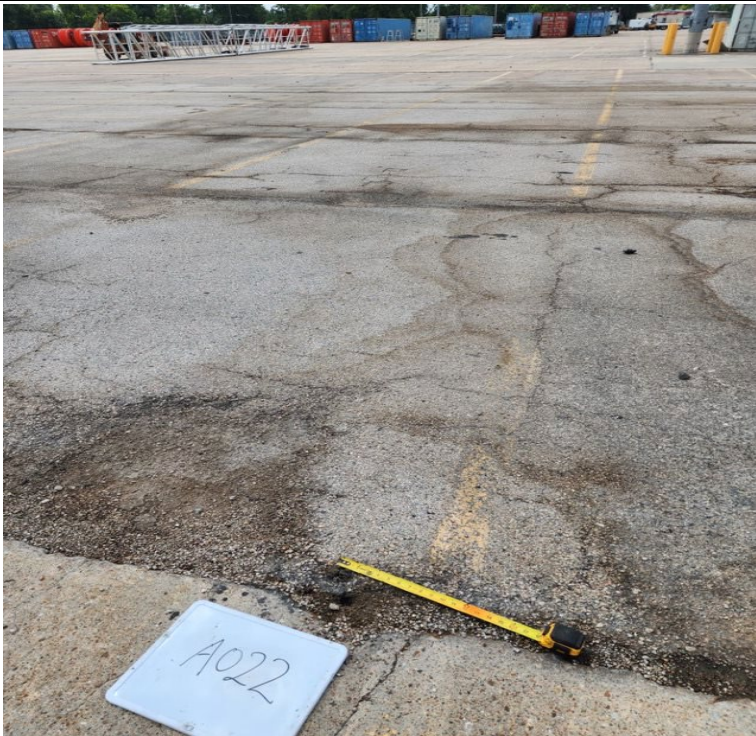
Description: Stall A022, some tar-like material observed at historical seep location, material was removed. looking southeast.			
Lat: 29.785381 Long: - 95.318619			
Photo No. 18	Inspection Date: 6/14/2023

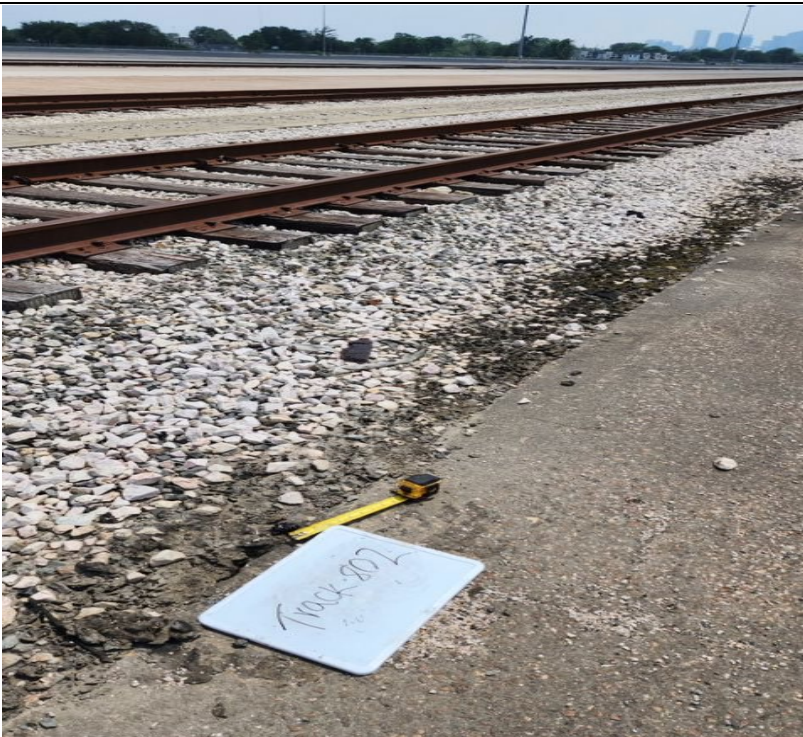
Description: North side of Track 802, some tar-like material observed at seep location near the edge of the ballast, material removed, looking southwest.			
Lat: 29.784947 Long: -95.321214

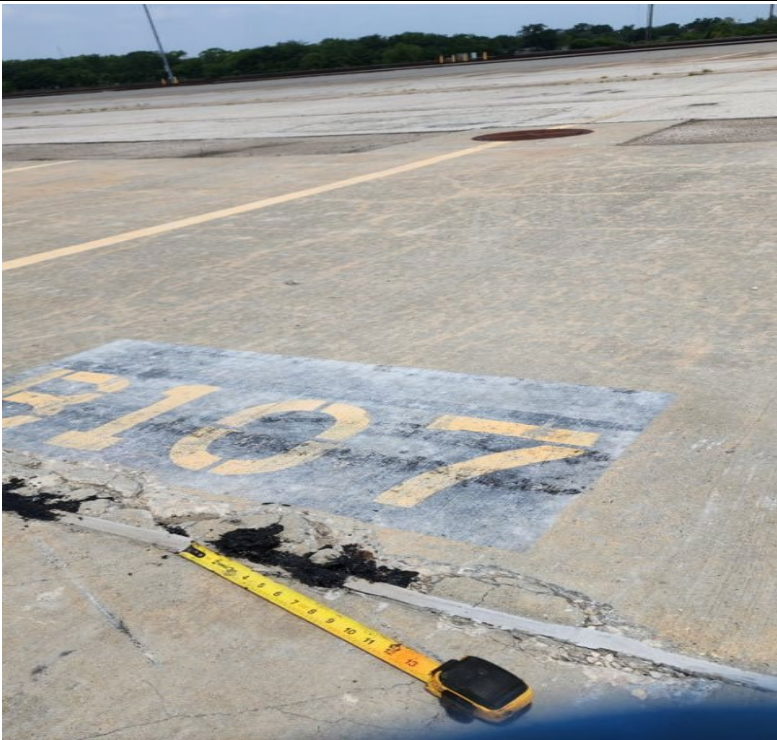
Description: Stalls B107, view of NAPL collection system (Sump 3 in background of photo), some new tar-like material observed and removed at seep location on concrete joint along the southern edge of the excavated area, looking northwest. Lat: 29.784156 Long: -95.320953			
Photo No. 20	Inspection Date: 6/14/2023

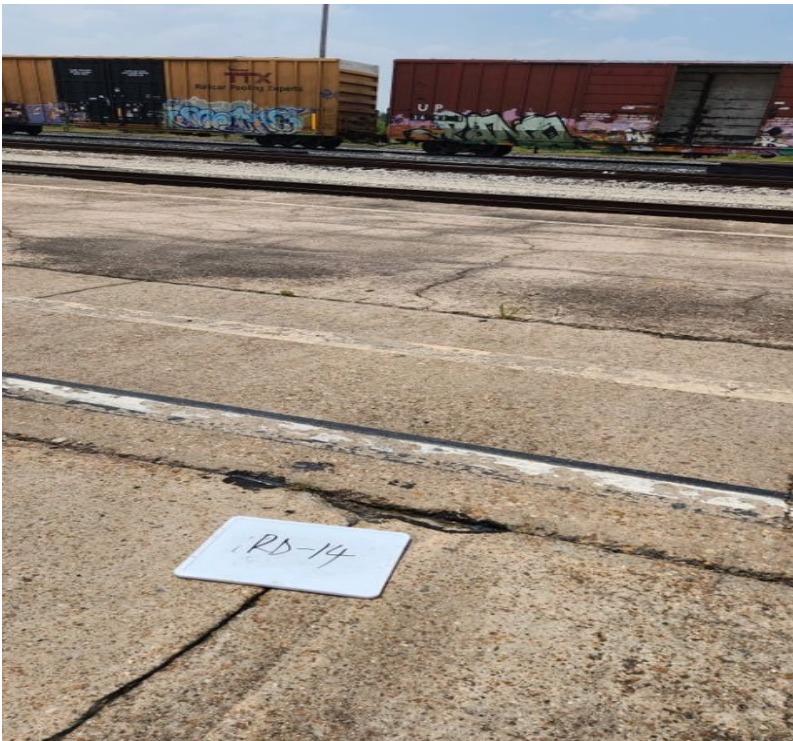
Description: RD-14 Seep location observed within the concrete road area (RD-14) north of Track 802 (east of existing Track 802 seep location), very small amount of tar-like material observed along a concrete joint, material was removed. Lat: 29.785064 Long: -95.321219

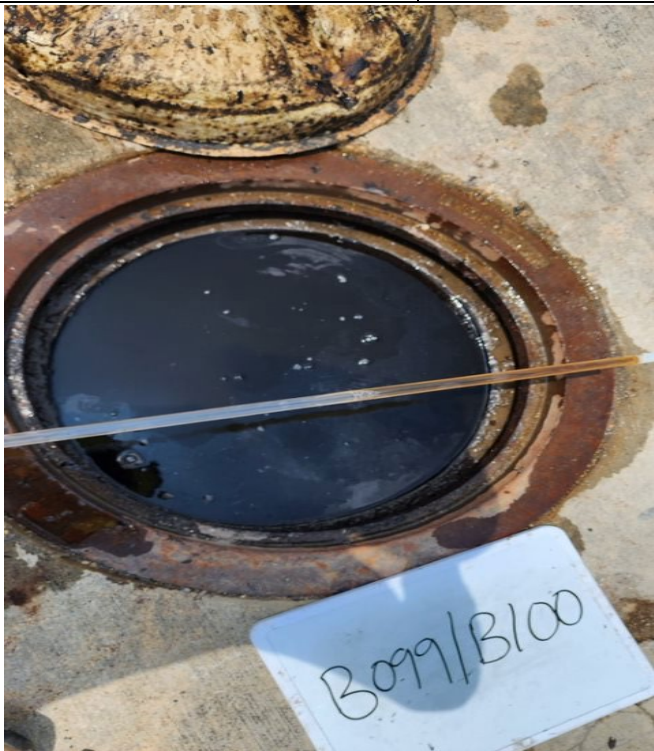
PHOTOGRAPHIC LOG	
Client Name: Union Pacific Railroad		Site Location: Englewood Intermodal Yard, Houston, Texas	Project No. 31406585.016
Photo No. 21	Inspection Date: 6/14/2023	<div> <p>Description: Sump 1 (B099/B100), 4 inches of freeboard in sump, water ponding at sump due to recent rainfall event, sheen observed, no odor noted, no new NAPL accumulation on inflow protector, watercolor noted as dark brown.</p> <p>Lat: 29.7844000 Long: - 95.3205861</p> </div>

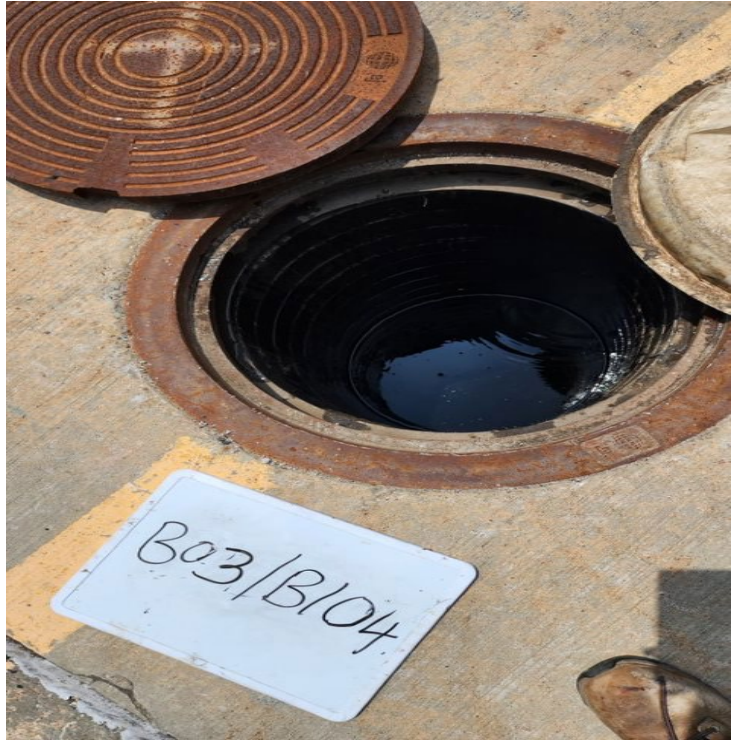
Photo No. 22	Inspection Date: 6/14/2023	<div> <p>Description: Sump 2 (B103/B104), 38 inches of freeboard in sump. No sheen or odor noted, color noted as light brown.</p> <p>Lat: 29.7842861 Long: - 95.3208611</p> </div>

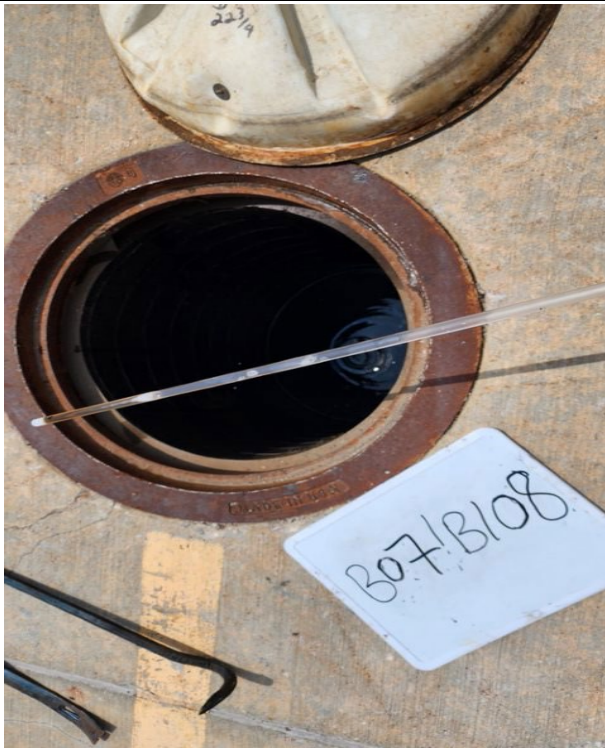
Description: Sump 3 (B107/B108), 37 inches of freeboard in sump, sheen observed, no odor noted, watercolor noted as light brown.			
Lat: 29.784172 Long: - 95.320998			
Photo No. 24	Inspection Date: 6/14/2023

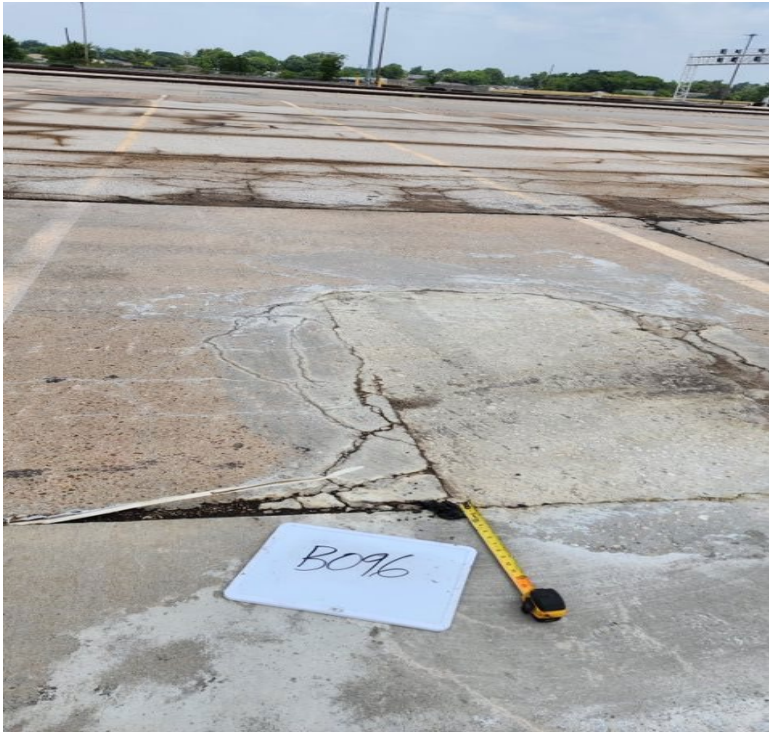
Description: Slot B096, very small amount of tar-like material seeps observed where test pit conducted (July 2020), material removed, looking north.			
Lat: 29.7842528 Long: - 95.3206250

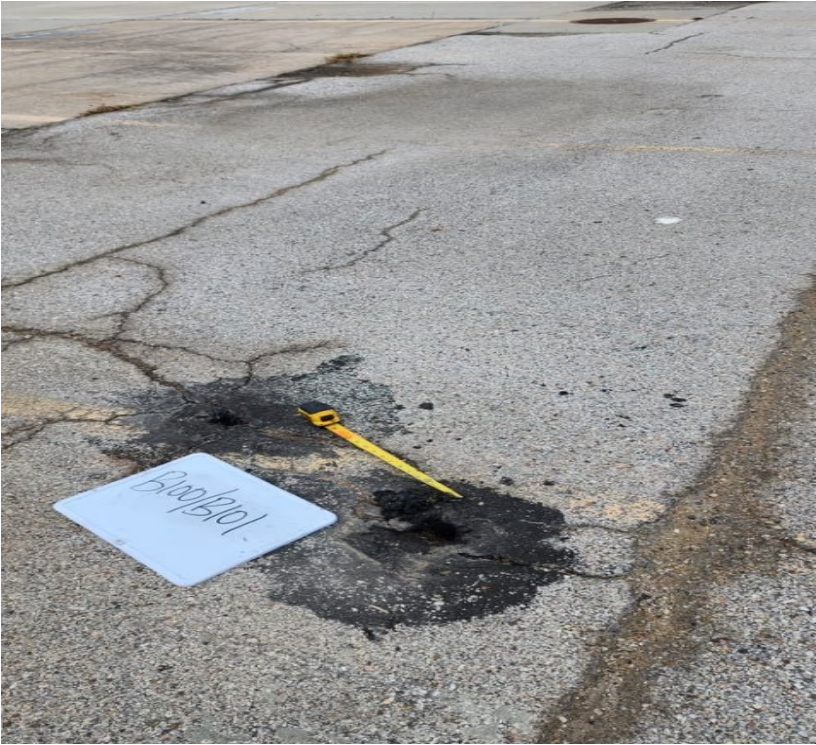
Description: Stall B100, some tar-like material observed near historical seep location along asphalt crack, material removed (Sump B099/B100 in background of photo). Lat: 29.7844000 Long: - 95.3205861			
Photo No. 26	Inspection Date: 6/14/2023

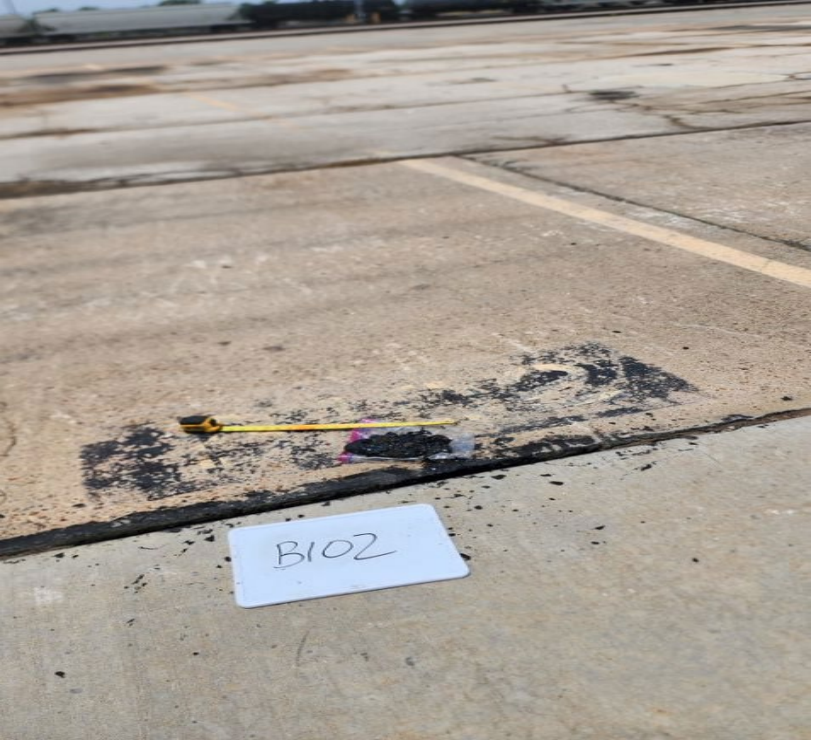
Description: Stall B102, small amount of tarlike material observed within concrete joint. residual staining on concrete surface noted. material was removed. looking north. Lat: 29.7842203 Long: - 95.320827

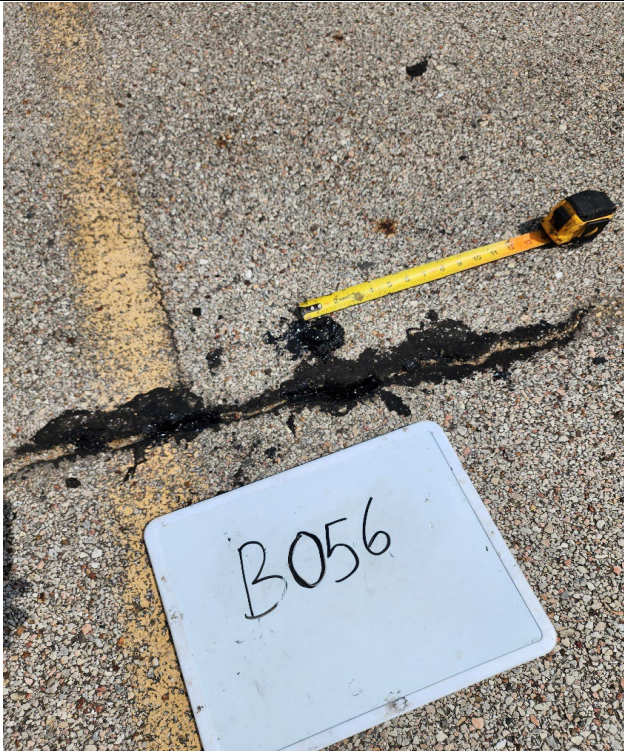
Description: Stall B056, a small amount of tar-like material seeping at asphalt crack, material was removed.			
Lat: 29.7847472 Long: -95.3195417			
Photo No. 28	Inspection Date: 6/21/2023

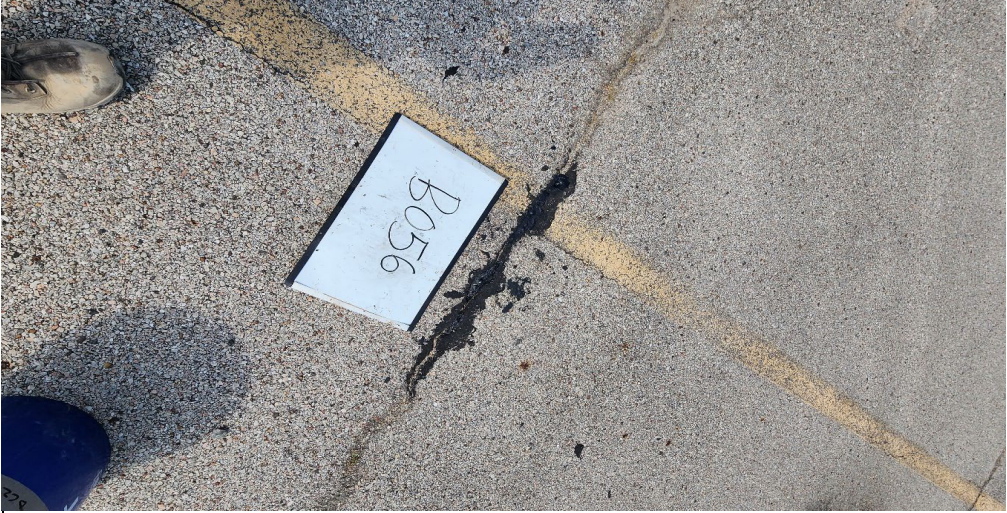
Description: Stall B056, a small amount of tar-like material seeping at asphalt crack, material was removed.			
Lat: 29.7847472 Long: -95.3195417

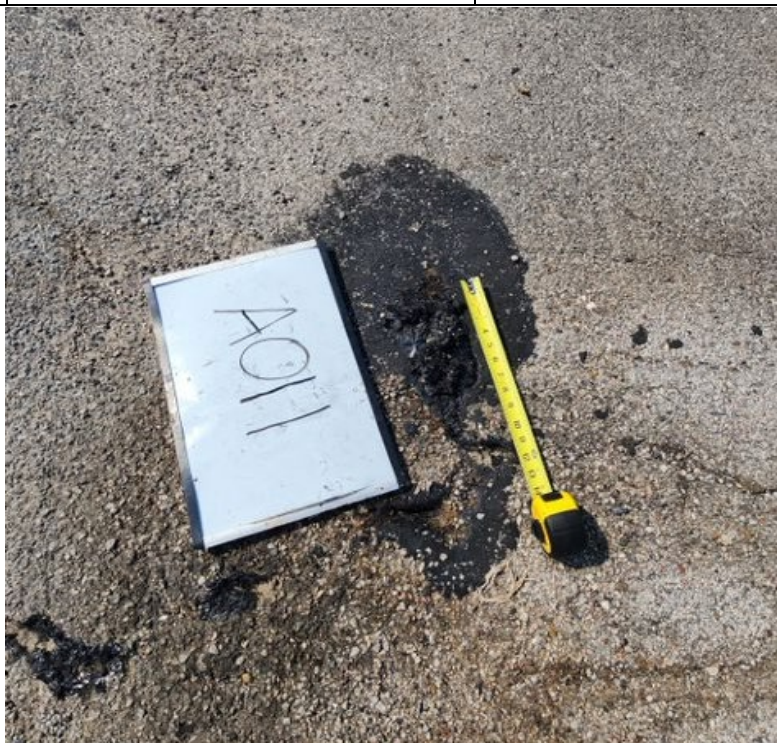
Stall A011 some tar-like material observed at historical seep location along asphalt crack, material was removed.

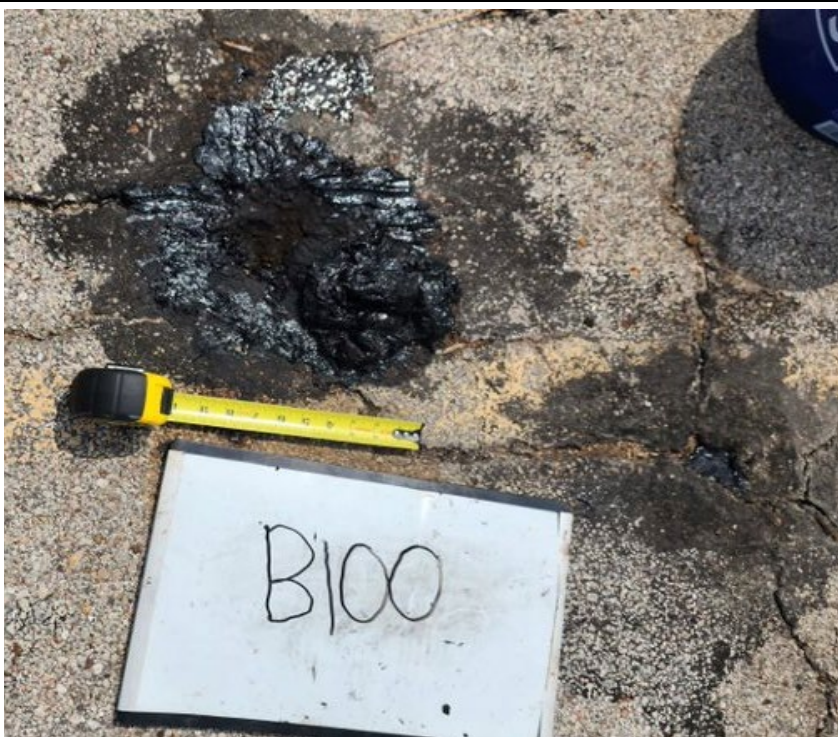
Stall B100, some tar-like material observed near historical seep location along asphalt crack, material removed.

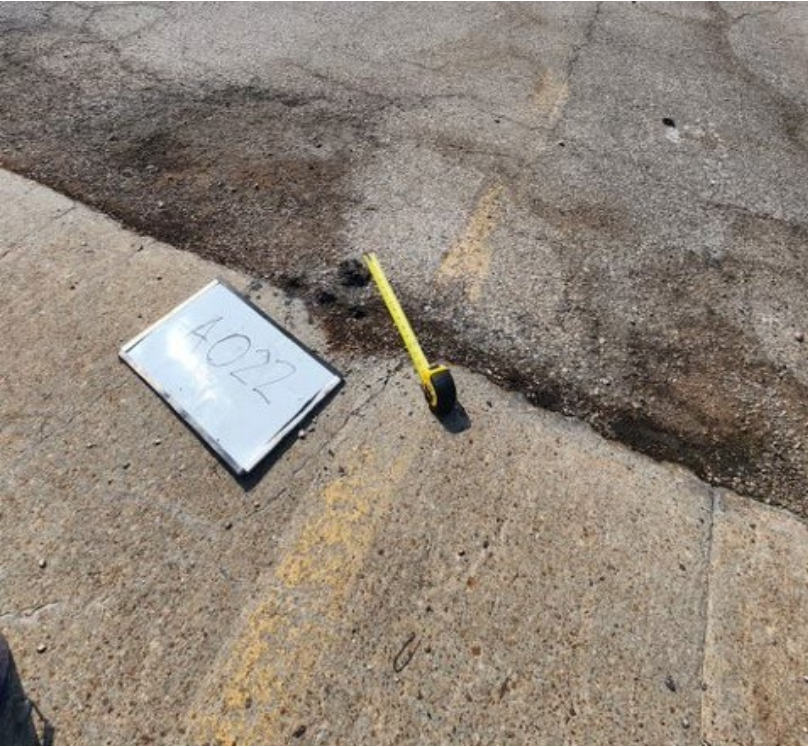
Description: Stall A022, a small amount of tar-like material observed at the seep location along the edge, material was removed, looking southeast. Lat: 29.785381 Long: - 95.318619			
Photo No. 32	Inspection Date: 6/21/2023

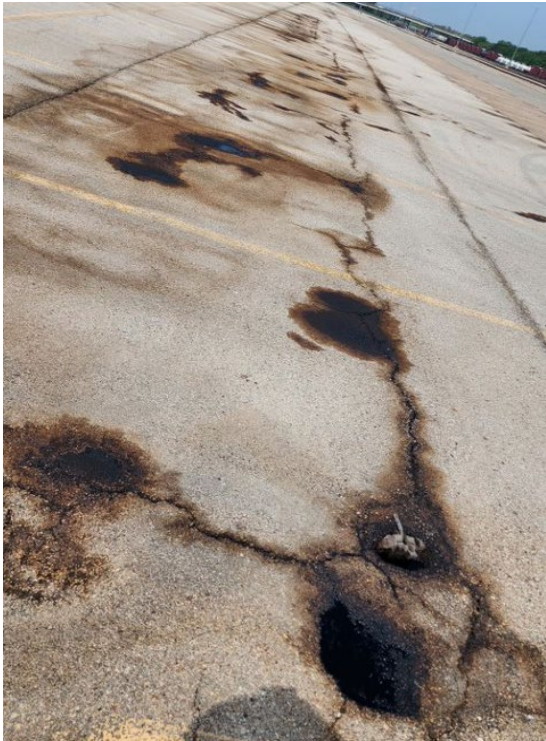
Description: Stall A065, staining observed along asphalt cracks of Row A and B stalls, looking east. UPRR remediation contractor OMI removed staining and seepage by power washing the area on 6/23/23. Lat: 29.784858 Long: -95.319733

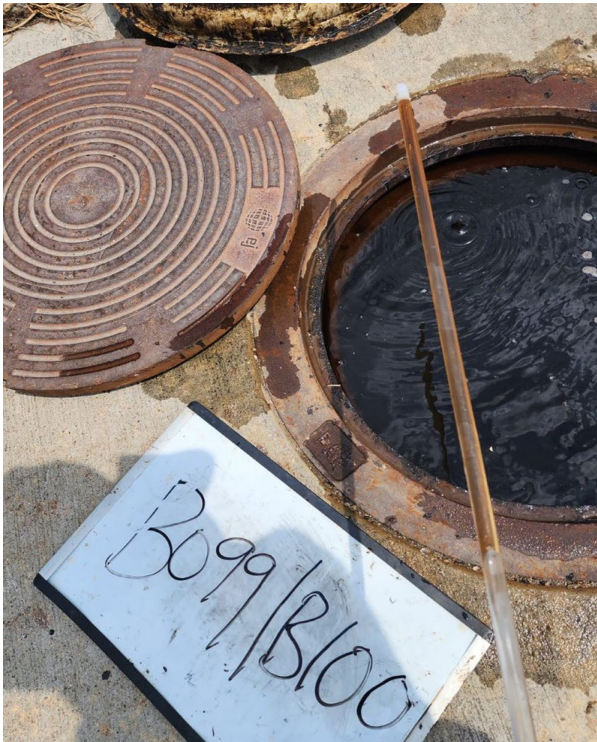
Description: Sump 1 (B099/B100), 3 inches of freeboard in sump, water ponding at sump due to recent rainfall event, no sheen or odor noted, no new NAPL accumulation on inflow protector, watercolor noted as dark brown. Lat: 29.7844000 Long: - 95.3205861			
Photo No. 34	Inspection Date: 6/21/2023

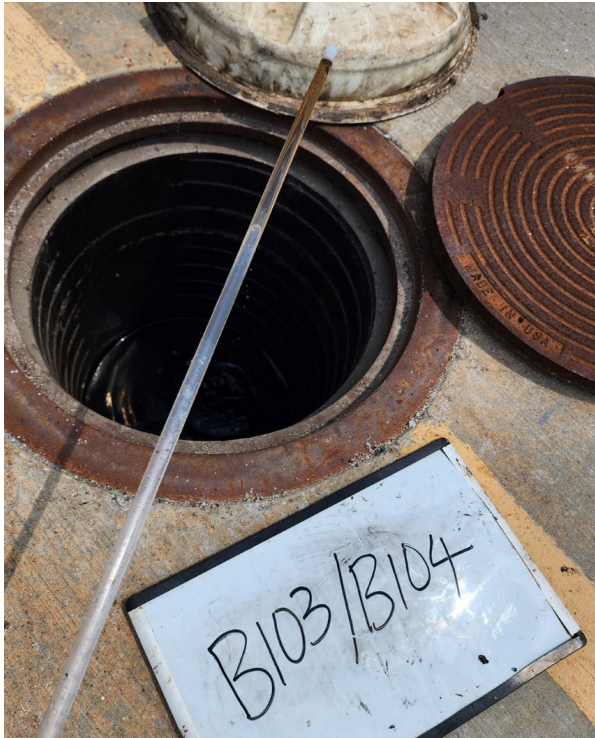
Description: Sump 2 (B103/B104), 36 inches of freeboard in sump. No sheen or odor noted, color noted as dark brown. Lat: 29.7842861 Long: - 95.3208611

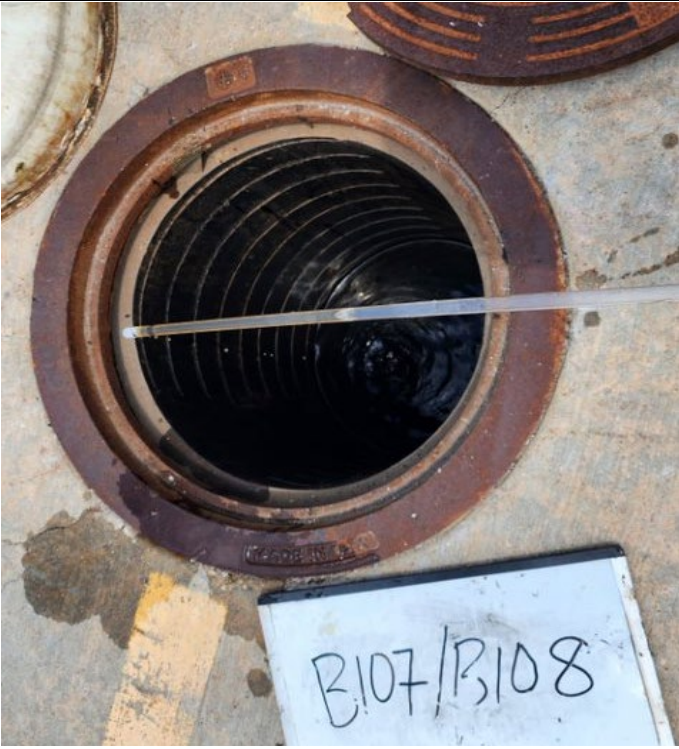
Description: Sump 3 (B107/B108), 37 inches of freeboard in sump, sheen observed, no odor noted, watercolor noted as light brown. Lat: 29.784172 Long: - 95.320998			
Photo No. 36	Inspection Date: 6/21/2023

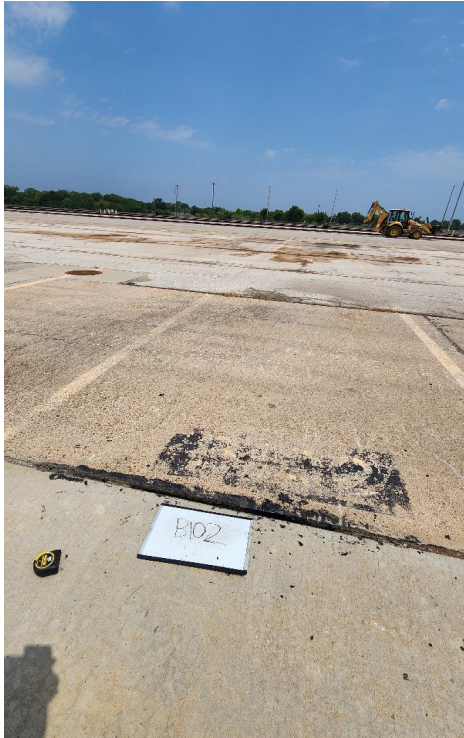
Description: Stall B102, small amount of tarlike material observed within concrete joint. residual staining on concrete surface noted. material was removed. Lat: 29.7842203 Long: - 95.320827

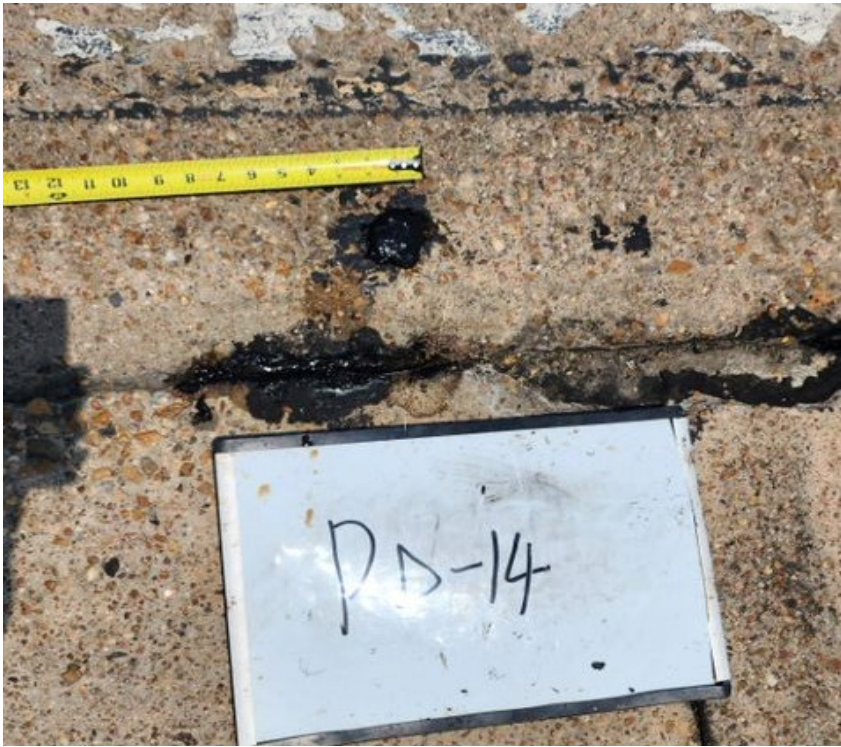
Description: RD-14 Seep location observed within the concrete road area (RD-14) north of Track 802 (east of existing Track 802 seep location), very small amount of tar-like material observed along a concrete joint, material was removed. Lat: 29.785064 Long: - 95.321219			
Photo No. 38	Inspection Date: 6/21/2023

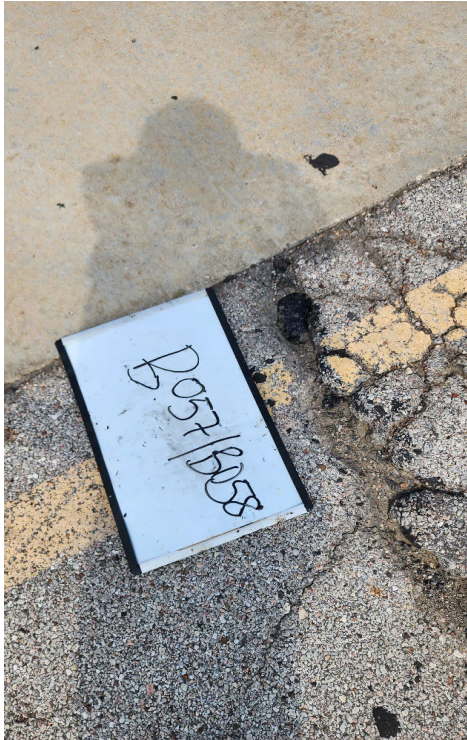
Description: Slot B057, very small amount of tar-like material seeping at historical seep location in asphalt cracks, no seep observed where test pit conducted (July 2020), material was removed. Lat: 29.7847472 Long: - 95.3195417
