July 14, 2023

Project No. 31406585.016

**Re: MONTHLY STATUS UPDATE – ENGLEWOOD INTERMODAL YARD – NAPL COLLECTION
SYSTEM/CONCRETE CAP REPAIRS
UNION PACIFIC RAILROAD HOUSTON WOOD PRESERVING WORKS FACILITY
4910 LIBERTY ROAD FACILITY, HOUSTON, TEXAS
POST-CLOSURE CARE PERMIT NO. HW-50343; INDUSTRIAL SWR NO. 31547**

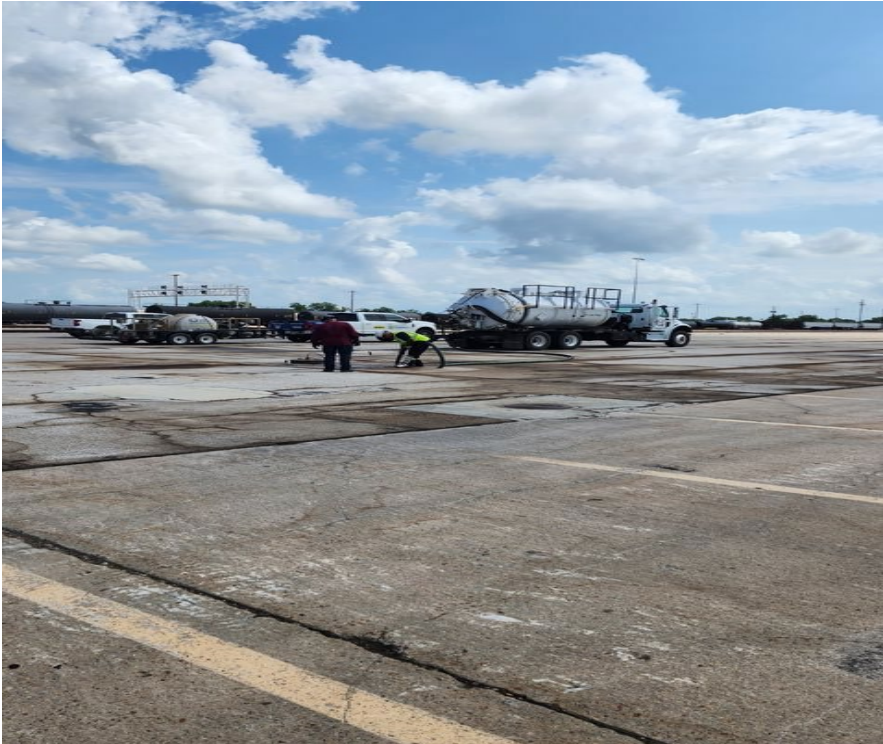
Photo No. 40	Inspection Date: 6/23/2023	<div> <div> Description: UPRR remediation contractor OMI cleaning the brown staining. </div> <div> Lat: 29.784855 Long: - 95.319730 </div> </div>

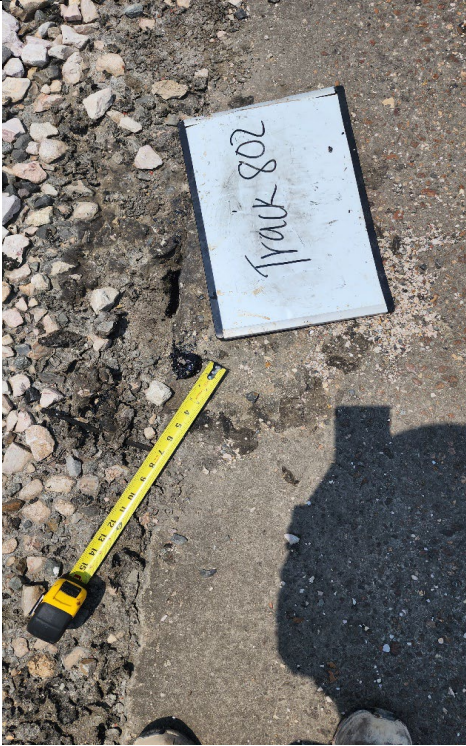
</div>	
Description: North side of Track 802, some tar-like material observed at seep location near the edge of the ballast, material removed.			
Lat: 29.784947 Long: - 95.321214			
Photo No. 42	Inspection Date: 6/21/2023	<div>

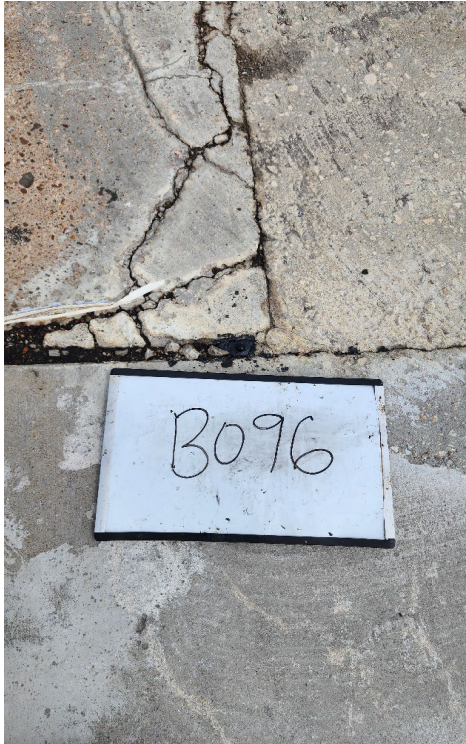
</div>	
Description: Slot B096, very small amount of tar-like material seeps observed where test pit conducted (July 2020), material removed, brown staining observed.			
Lat: 29.7842528 Long: -95.3206250

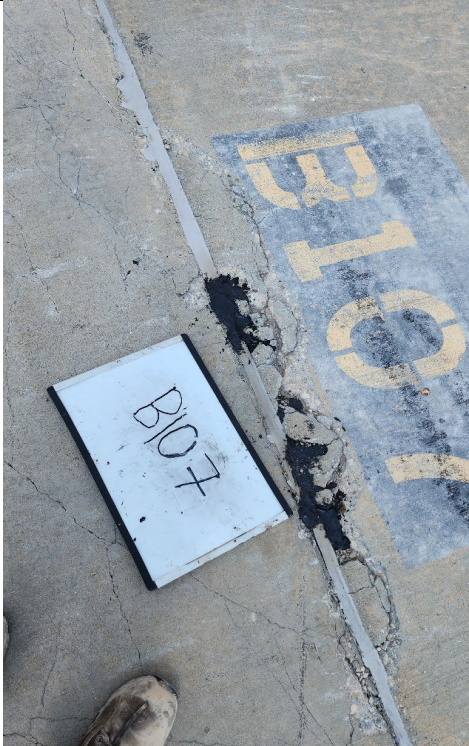
</div>	
Description: Stall B107, view of NAPL collection system (Sump 3 in background of photo), some new tar-like material observed and removed at seep location on concrete joint along the southern edge of the excavated area. Lat: 29.784156 Long: -95.320953			
Photo No. 44	Inspection Date: 6/28/2023	<div>

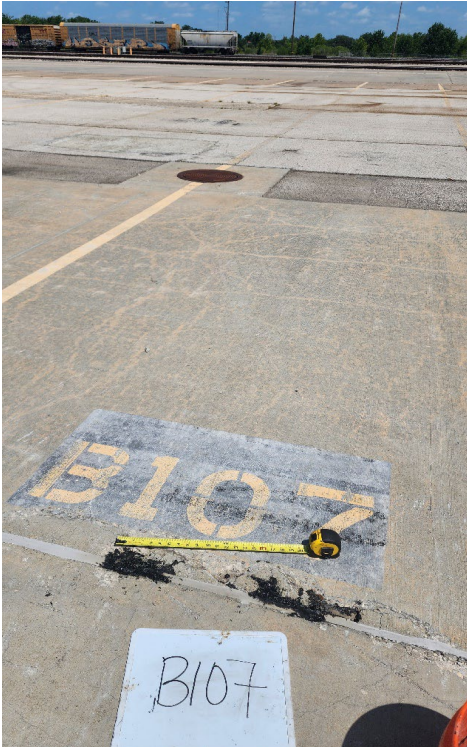
</div>	
Description: Stall B107, view of NAPL collection system (Sump 3 in background of photo), some new tar-like material observed and removed at seep location on concrete joint along the southern edge of the excavated area, looking northwest. Lat: 29.784156 Long: -95.320953

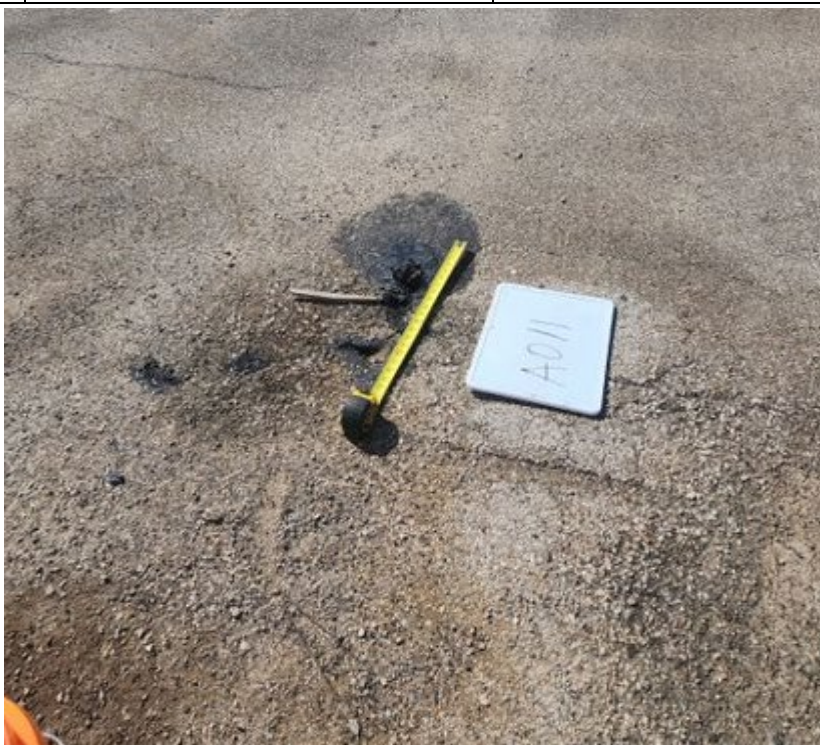
Stall A011 some tar-like material observed at historical seep location along asphalt crack, material was removed.

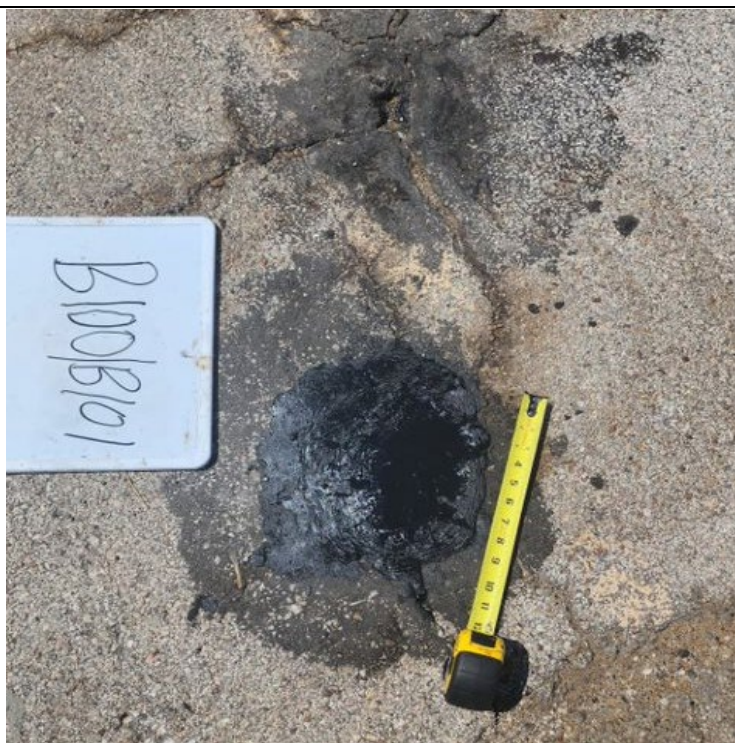
Stall B100, some tar-like material observed near historical seep location along asphalt crack, material removed.

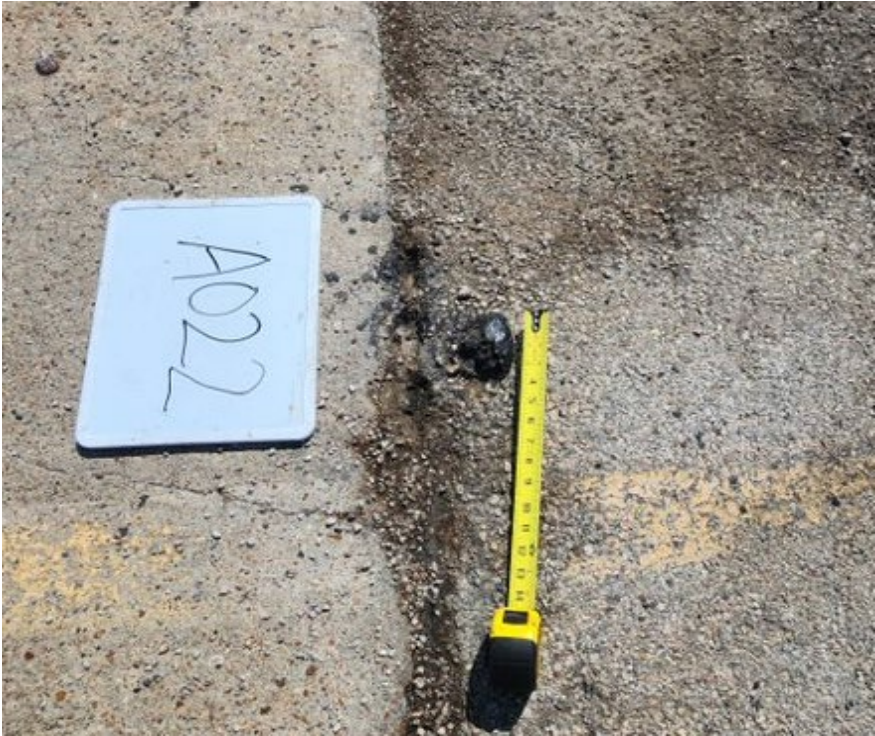
Description: Stall A022, a small amount of tar-like material observed at the seep location along the edge, material was removed.			
Lat: 29.785381 Long: - 95.318619			
Photo No. 48	Inspection Date: 6/28/2023

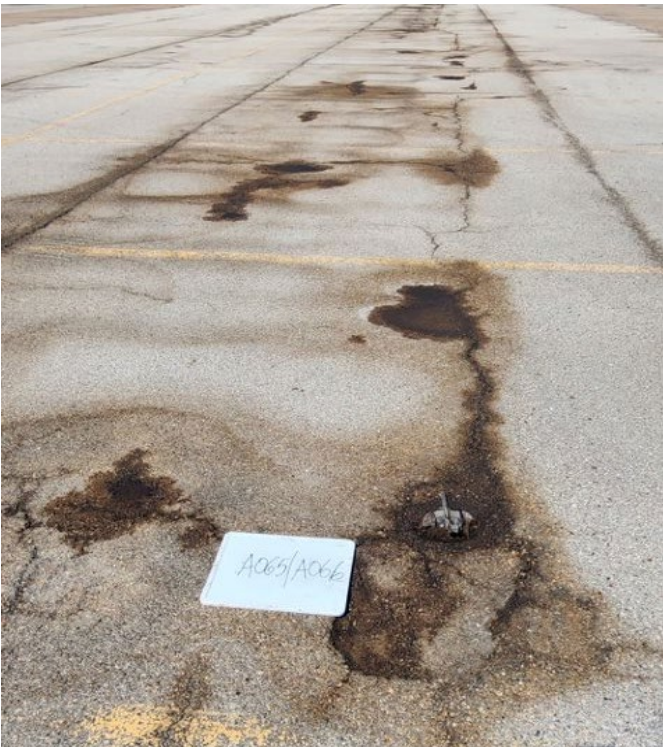
Description: Stall A065, staining observed along asphalt cracks of Row A and B stalls, looking east. UPRR remediation contractor OMI removed staining and seepage by power washing the area on 6/30/23.			
Lat: 29.784858 Long: -95.319733

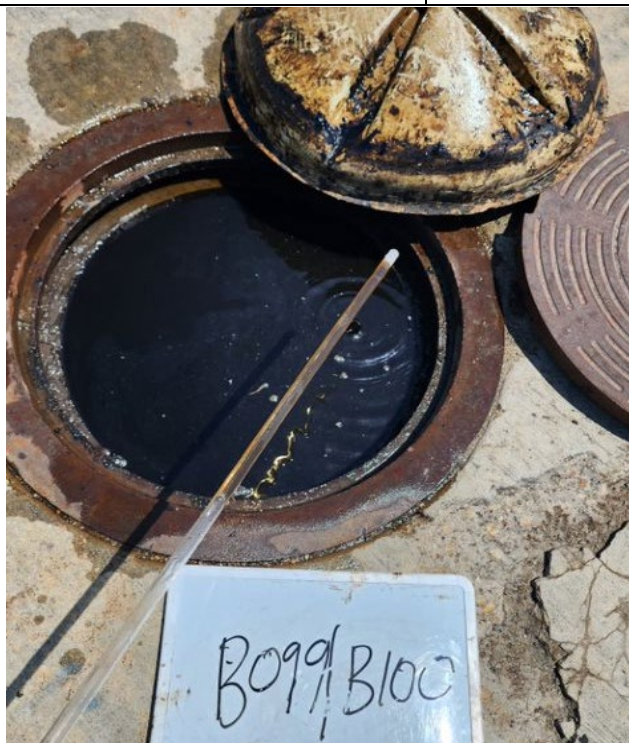
Sump 1 (B099/B100), 3 inches of freeboard in sump, water ponding at sump due to recent rainfall event, no sheen or odor noted, no new NAPL accumulation on inflow protector, watercolor noted as dark brown.

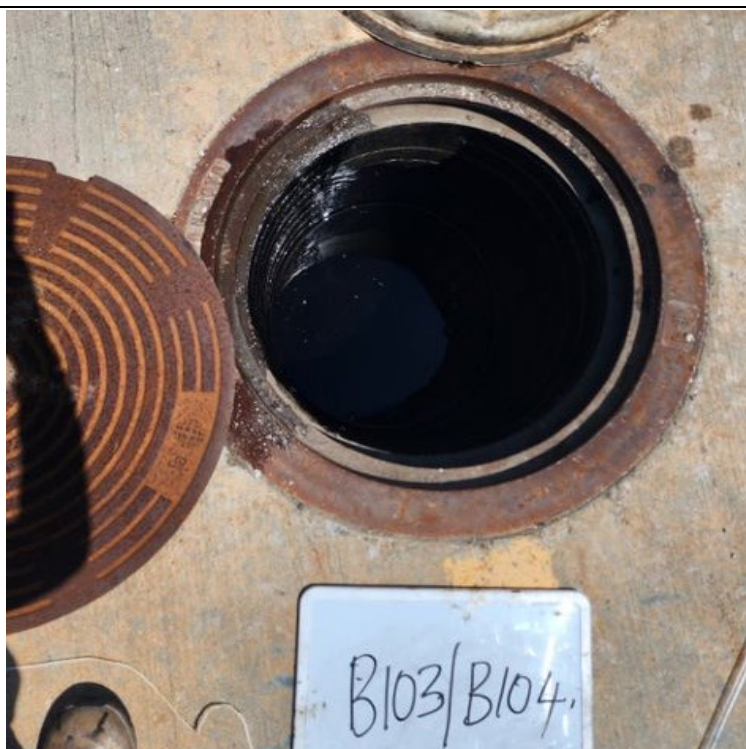
Sump 2 (B103/B104), 31 inches of freeboard in sump. No sheen or odor noted, color noted as light brown.

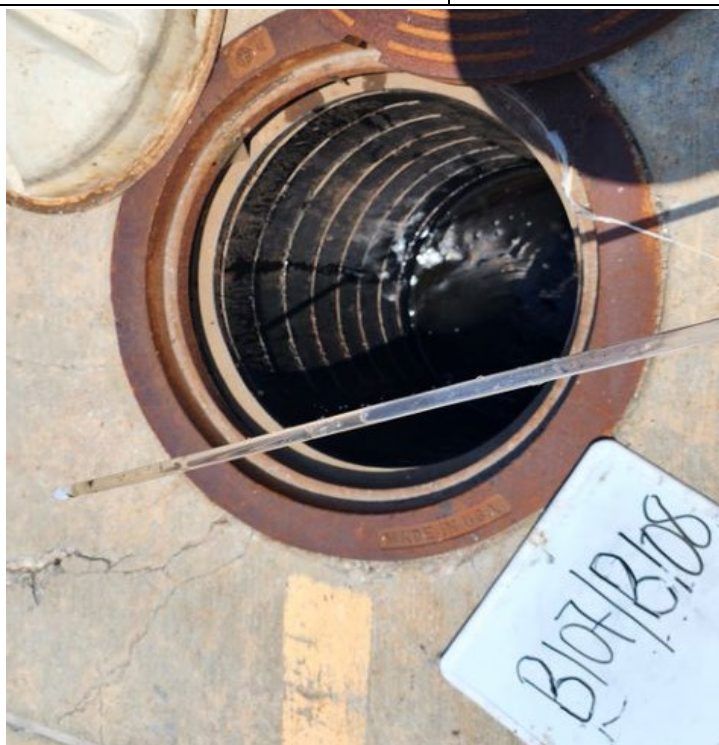
Sump 3 (B107/B108), 31 inches of freeboard in sump, sheen observed, no odor noted, watercolor noted as clear.

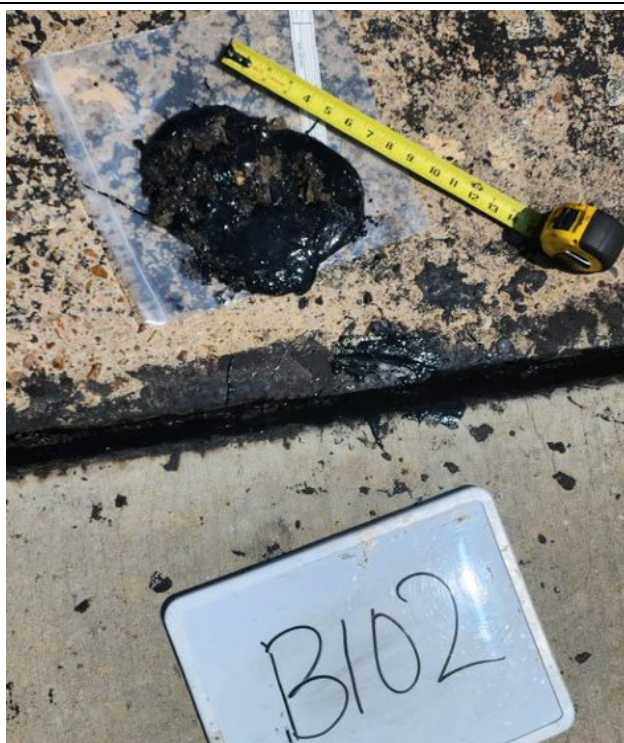
Stall B102, small amount of tarlike material observed within concrete joint. residual staining on concrete surface noted. material was removed.

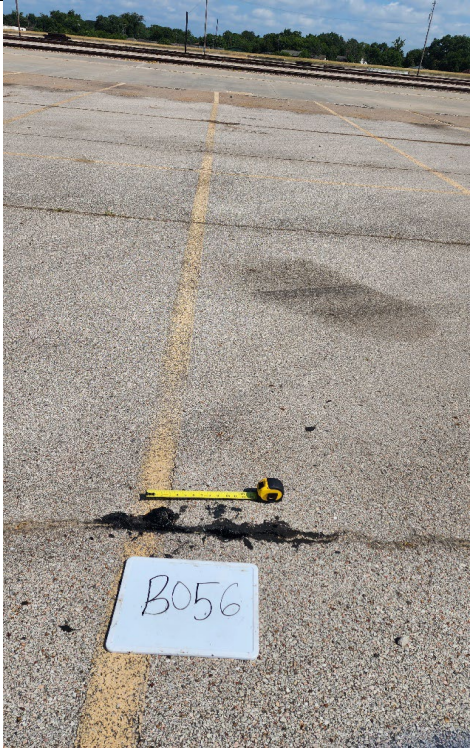
Description: Slot B056, a small amount of tar-like material seeping at asphalt crack, material was removed. Looking North Lat: 29.7847472 Long: -95.3195417			
Photo No. 54	Inspection Date: 6/21/2023

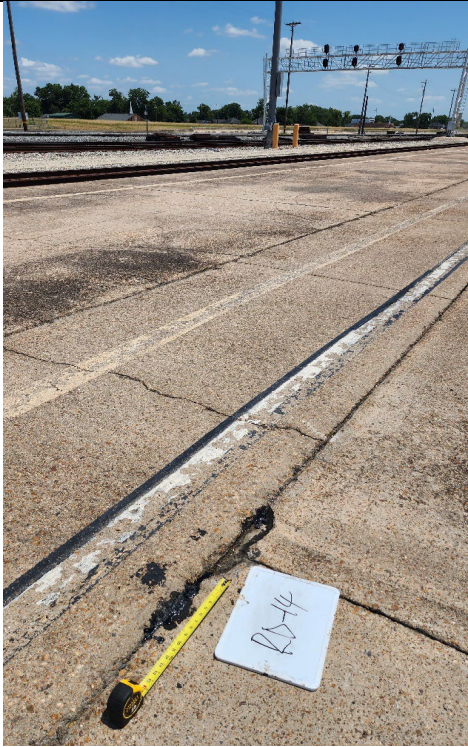
Description: RD-14 Seep location observed within the concrete road area (RD-14) north of Track 802 (east of existing Track 802 seep location), very small amount of tar-like material observed along a concrete joint, looking northeast, material was removed. Lat: 29.785064 Long: - 95.321219

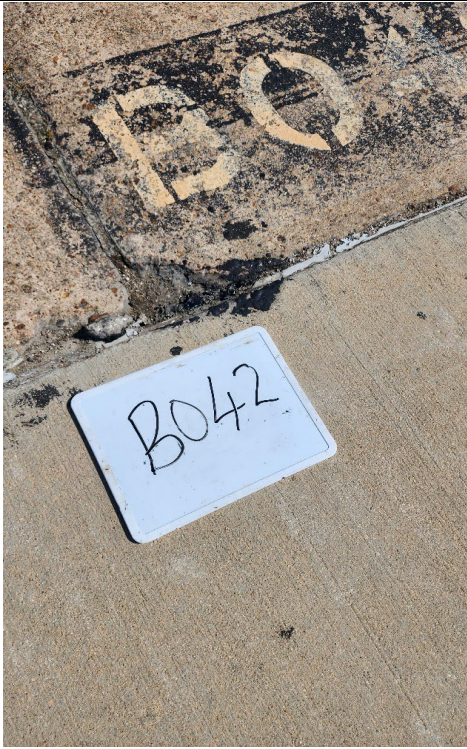
</div>	
Description: Slot B042, small amount of tar-like material seeping at joint. material was removed.			
Lat: 29.784926 Long: - 95.319124			
Photo No. 56	Inspection Date: 8/30/2023	<div>

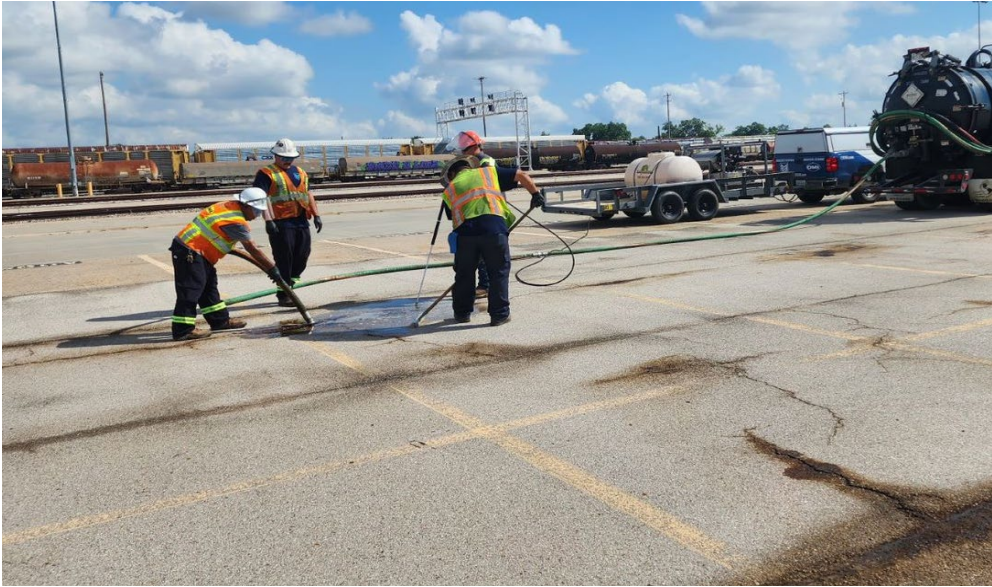
</div>	
Description: UPRR remediation contractor OMI cleaning the brown staining.			
Lat: 29.784855 Long: - 95.319730

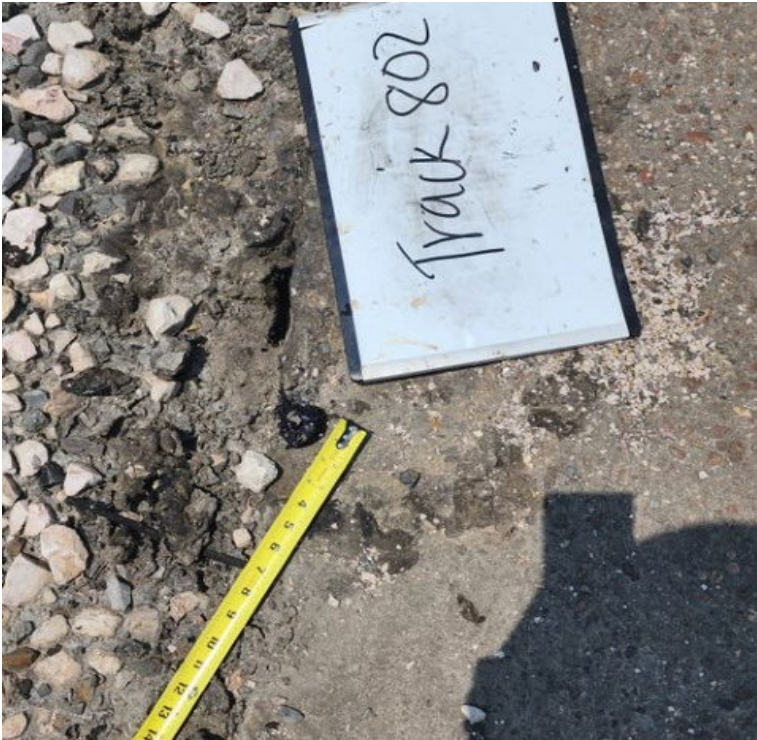
Description: North side of Track 802, some tar-like material observed at seep location near the edge of the ballast, material removed.			
Lat: 29.784947 Long: - 95.321214			
Photo No. 58	Inspection Date: 6/28/2023

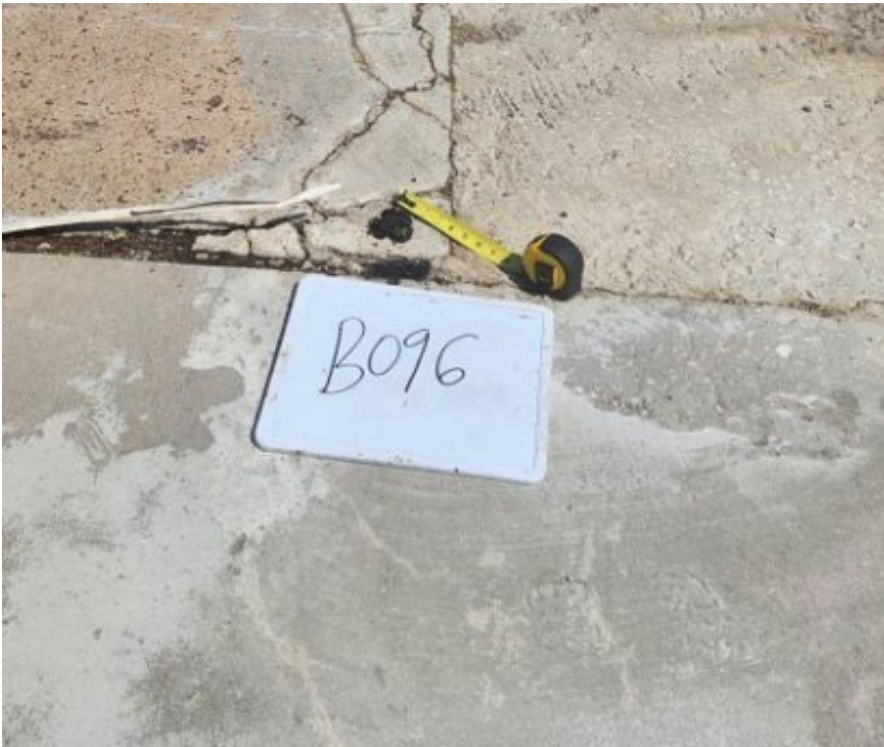
Description: Slot B096, very small amount of tar-like material seeps observed where test pit conducted (July 2020), material removed.			
Lat: 29.7842528 Long: -95.3206250

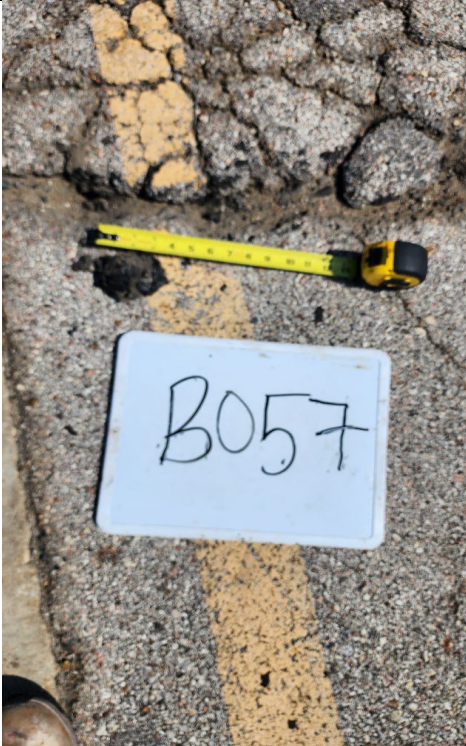
PHOTOGRAPHIC LOG	
Client Name: Union Pacific Railroad		Site Location: Englewood Intermodal Yard, Houston, Texas	Project No. 31406585.016
Photo No. 59	Inspection Date: 6/28/2023	<div> <div> Description: Slot B057, very small amount of tar-like material seeping at historical seep location in asphalt cracks, no seep observed where test pit conducted (July 2020), material was removed. </div> <div> Lat: 29.7847472 Long: - 95.3195417 </div> </div>
