August 15, 2023

Project No. 31406585.016

**Re: MONTHLY STATUS UPDATE – ENGLEWOOD INTERMODAL YARD – NAPL COLLECTION
SYSTEM/CONCRETE CAP REPAIRS
UNION PACIFIC RAILROAD HOUSTON WOOD PRESERVING WORKS FACILITY
4910 LIBERTY ROAD FACILITY, HOUSTON, TEXAS
POST-CLOSURE CARE PERMIT NO. HW-50343; INDUSTRIAL SWR NO. 31547**

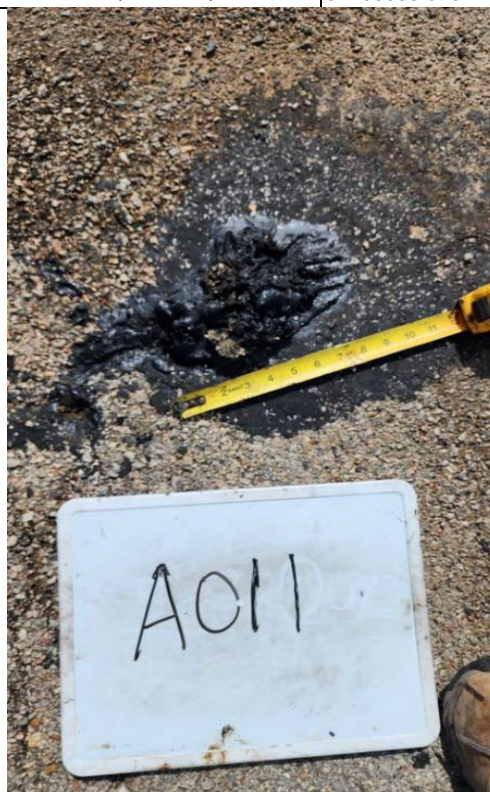
Stall A011 some tar-like material observed at historical seep location along asphalt crack, material was removed. View looking southeast.

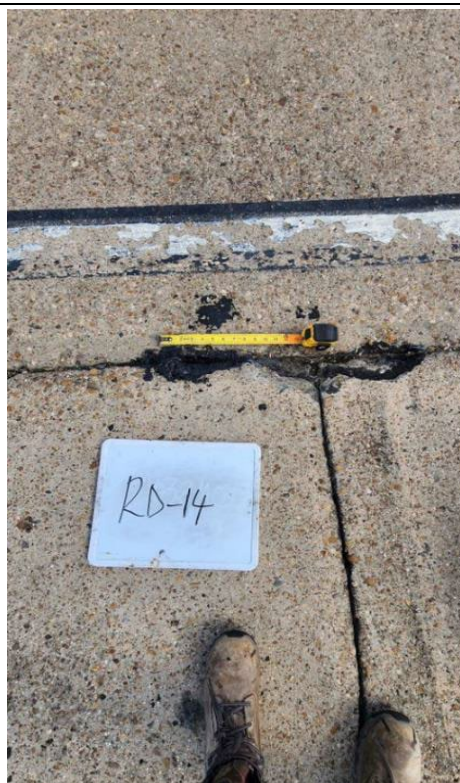
2

RD-14 Seep location observed within the concrete road area (RD-14) north of Track 802 (east of existing Track 802 seep location), very small amount of tar-like material observed along a concrete joint, material was removed.

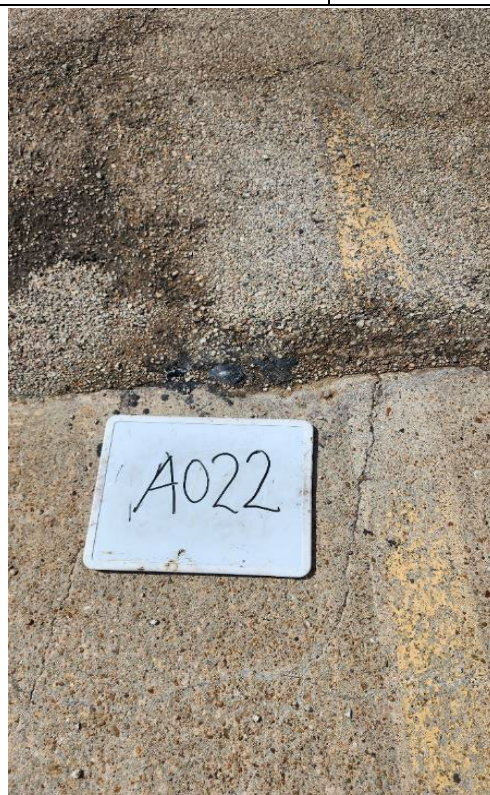
Stall A022. Some tar-like material observed at historical seep location along asphalt crack, material was removed.

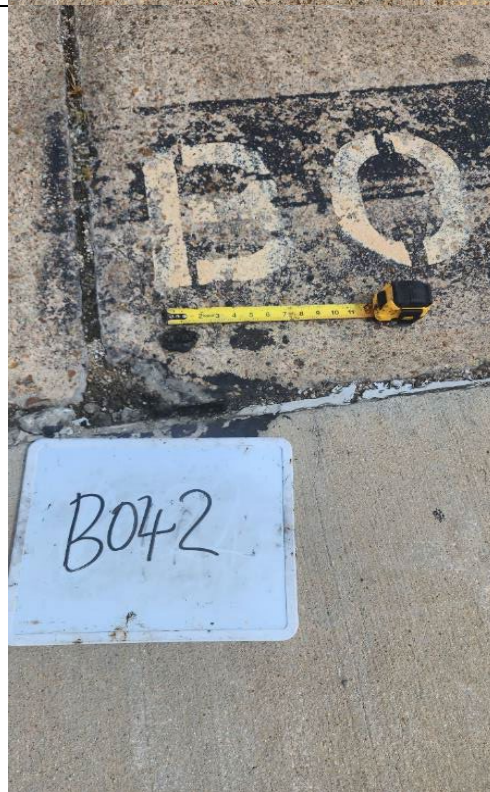
4

Stall BO42. Some tar-like material observed at historical seep location along asphalt crack, material was removed.

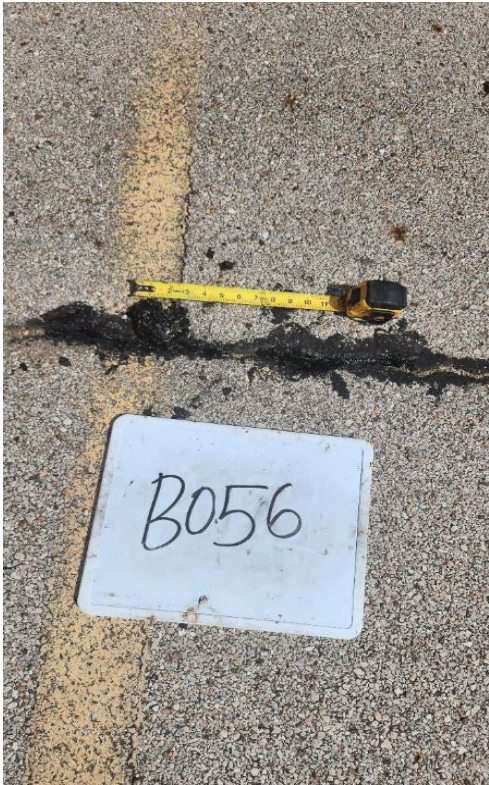
PHOTOGRAPHIC LOG	
Client Name: Union Pacific Railroad		Site Location: Englewood Intermodal Yard, Houston, Texas	Project No. 31406585.016
Photo No. 5	Inspection Date: 7/5/2023	<div> <div> Description: Stall B056. Some tar-like material observed at historical seep location along asphalt crack, material was removed. Lat: 29.784751 Long: -95.319532 </div> <div>

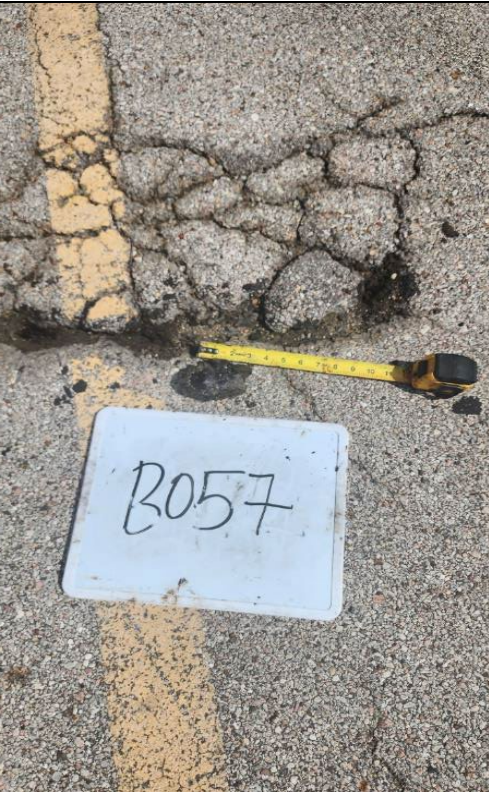
</div> </div>	
Photo No. 6	Inspection Date: 7/5/2023	<div> <div> Description: Stall B057. Some tar-like material observed at historical seep location along asphalt crack, material was removed. Lat: 29.784747 Long: -95.319549 </div> <div>

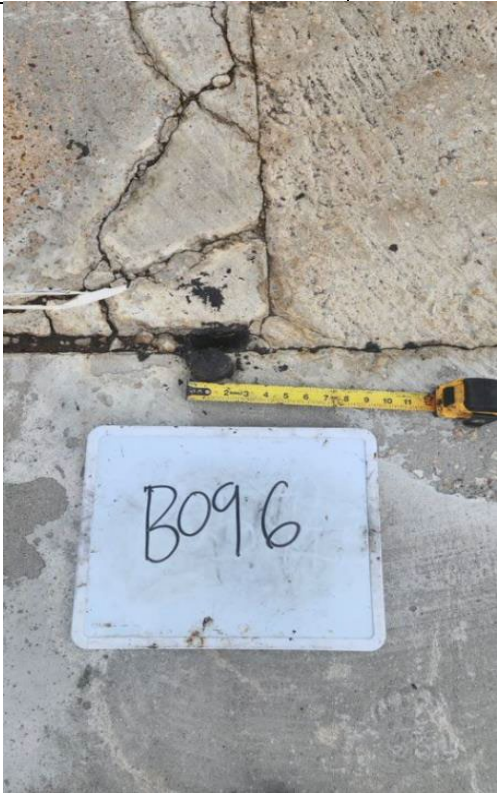
PHOTOGRAPHIC LOG	
Client Name: Union Pacific Railroad		Site Location: Englewood Intermodal Yard, Houston, Texas	
Project No.: 31406585.016			
Photo No. 7	Inspection Date: 7/5/2023	<div> <p>Description:</p> <p>Stall B096, some staining and cracking concrete observed at former test pit location. Some tar-like material observed and removed.</p> <p>Lat: 29.78417 Long: - 95.32091</p> </div>

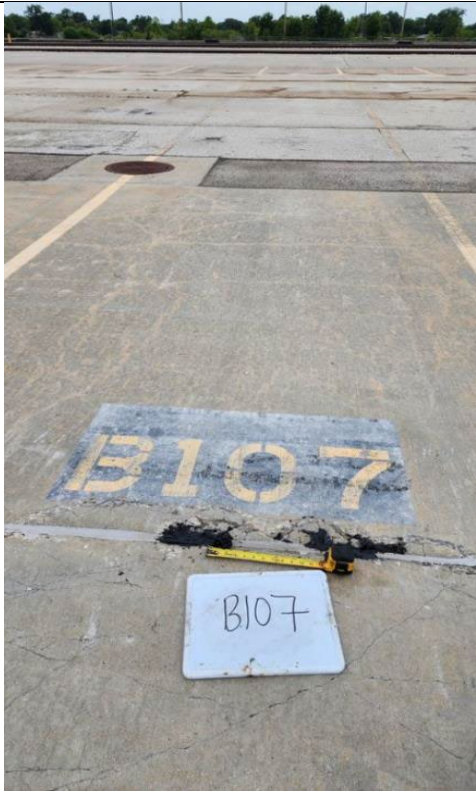
- Some small tar-like material seeps were observed on the asphalt or concrete in the NAPL Collection System in Stall B107 during the July 5, 12, 19, and 26 2023 inspections (Photo Nos. 8, 19, 41, 55). The tar-like material was recovered from these locations when observed.

Photo No. 8	Inspection Date: 7/5/2023	<div> <p>Description:</p> <p>Stalls B107, some new tar-like material observed and removed at seep location on concrete joint along the southern edge of the excavated area, looking northwest.</p> <p>Lat: 29.784137 Long: -95.32096</p> </div>

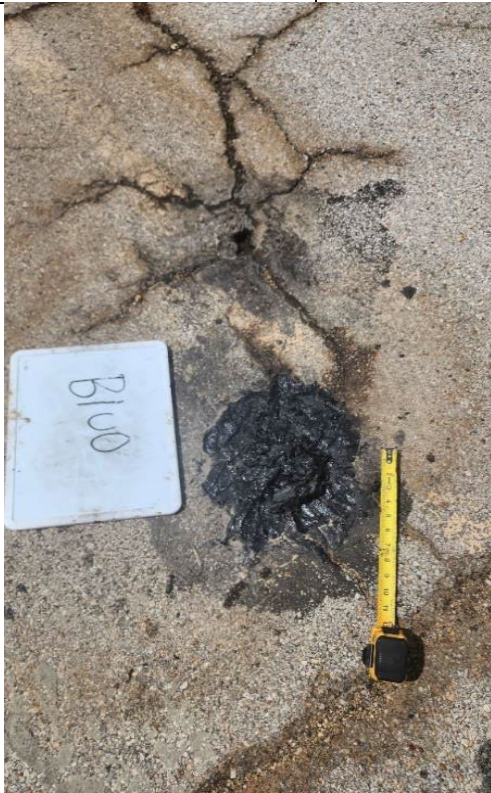
PHOTOGRAPHIC LOG	
Client Name: Union Pacific Railroad		Site Location: Englewood Intermodal Yard, Houston, Texas	Project No. 31406585.016
Photo No. 9	Inspection Date: 7/5/2023

Description: Stall B100, Some tar-like material observed and removed. Lat: 29.7844000 Long: - 95.3205861			
Photo No. 10	Inspection Date: 7/5/2023

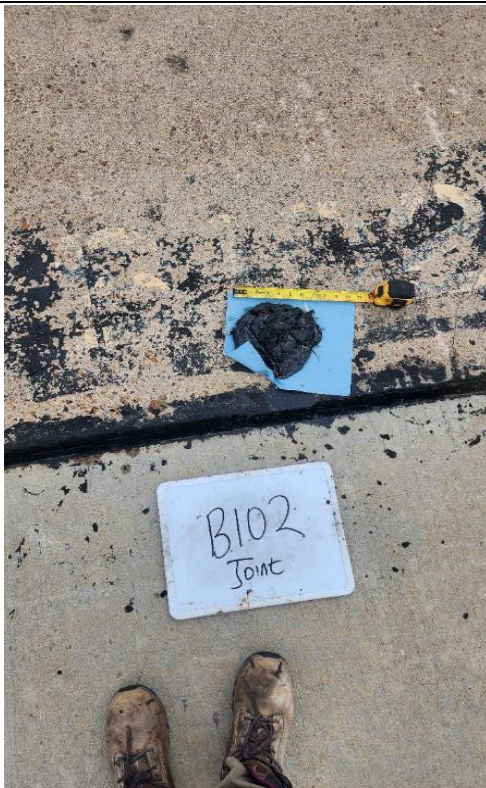
Description: Stall B102, tar-like material observed and removed. Lat: 29.784233 Long: -95.320847

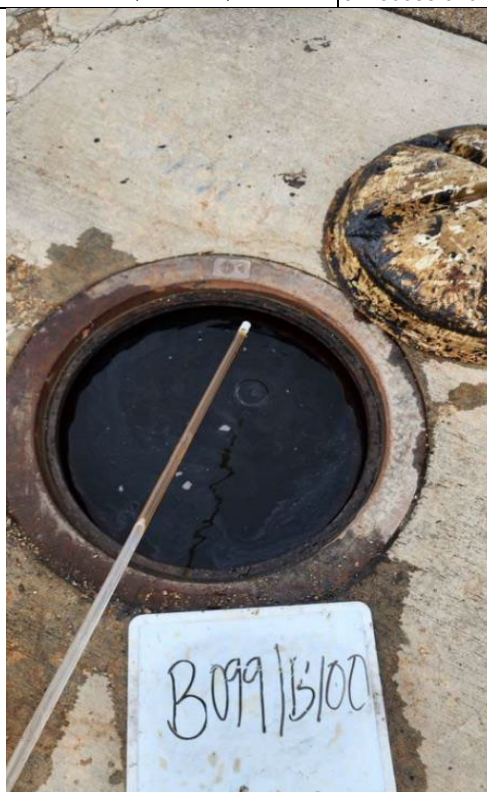
Sump 1 (B099/B100), 3 inches of freeboard in sump, sheen observed, no odor noted, no new NAPL accumulation on inflow protector, color noted as brown/turbid.

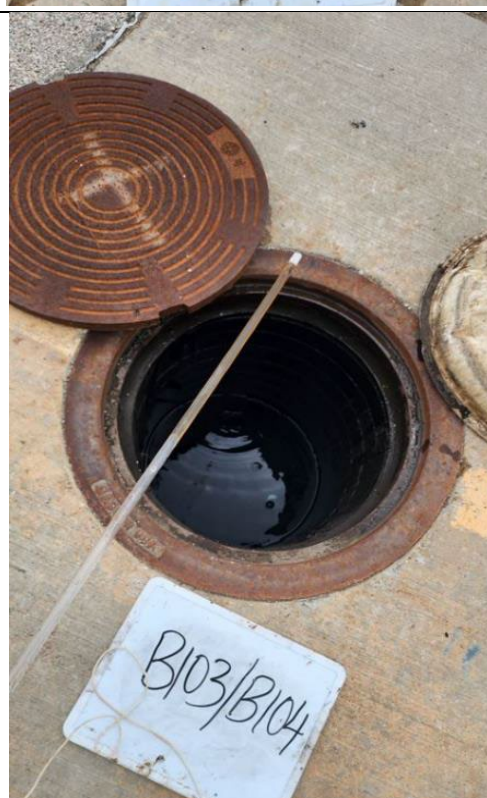
12

Sump 2 (B103/B104), 29 inches of freeboard, no sheen observed, no odor noted, color noted as light brown.

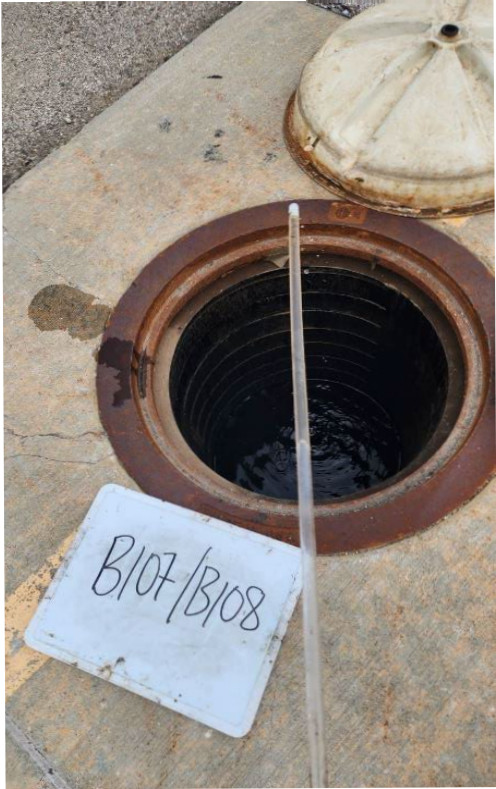
PHOTOGRAPHIC LOG	
Client Name: Union Pacific Railroad		Site Location: Englewood Intermodal Yard, Houston, Texas	Project No. 31406585.016
Photo No. 13	Inspection Date: 7/5/2023	<div> <div> Description: Sump 3 (B107/B108), 29 inches of freeboard in sump, sheen observed, no odor noted, color noted as clear. Lat: 29.784172 Long: -95.320998 </div> <div>

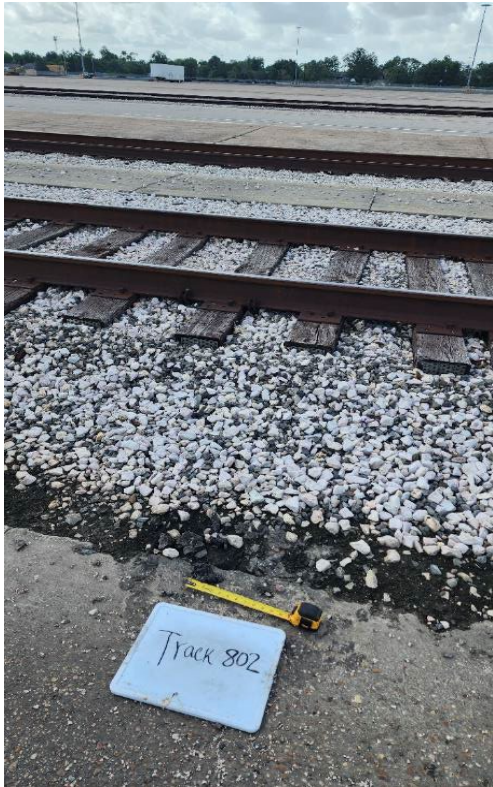
</div> </div>	
Photo No. 14	Inspection Date: 7/5/2023	<div> <div> Description: North side of Track 802, some tar-like material observed at seep location near the edge of the ballast, material removed. Looking Southeast Lat: 29.784895 Long: -95.321327 </div> <div>

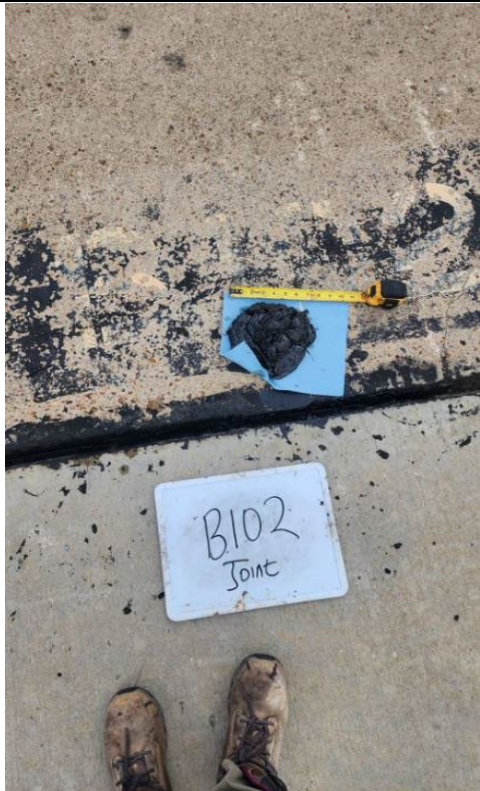
Client Name: Union Pacific Railroad		Site Location: Englewood Intermodal Yard, Houston, Texas	Project No. 31406585.016
Photo No. 15	Inspection Date: 7/5/2023

Description: Stall B102 Joint , new tar-like material observed and removed at seep location along stall joint. Lat: 29.784197 Long: -95.320821			
Photo No. 16	Inspection Date: 7/12/2023

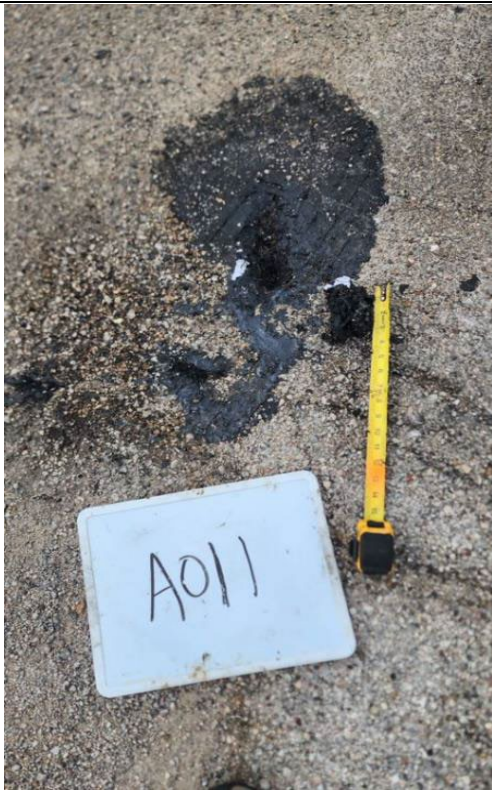
Description: Stall A011 some tar-like material observed at historical seep location along asphalt crack, material was removed. View looking southeast. Lat: 29.785467 Long: -95.318341

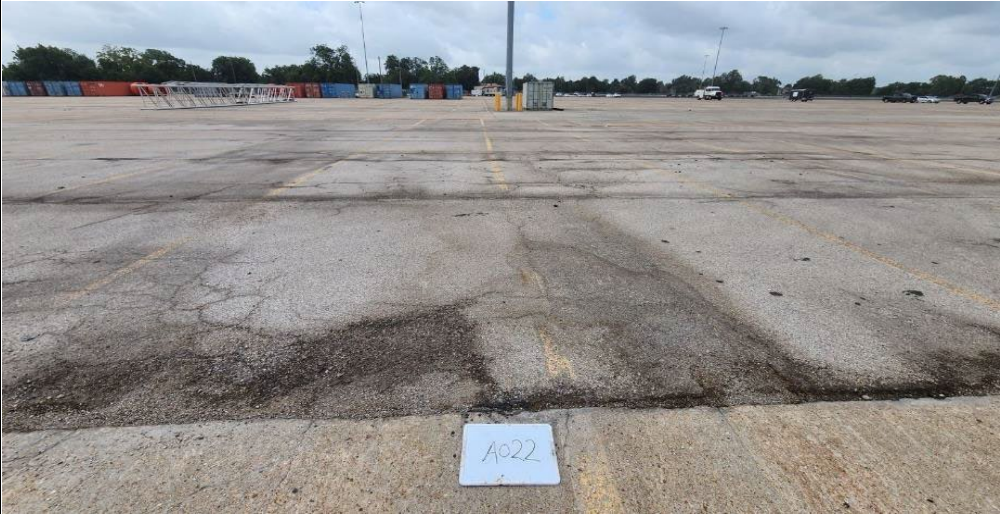
PHOTOGRAPHIC LOG	
Client Name: Union Pacific Railroad		Site Location: Englewood Intermodal Yard, Houston, Texas	Project No. 31406585.016
Photo No. 17	Inspection Date: 7/12/2023

Description: Stall A022. Some tar-like material observed at historical seep location along asphalt crack, material was removed. Looking South Lat: 29.785378 Long:-95.318694			
Photo No. 18	Inspection Date: 7/12/2023

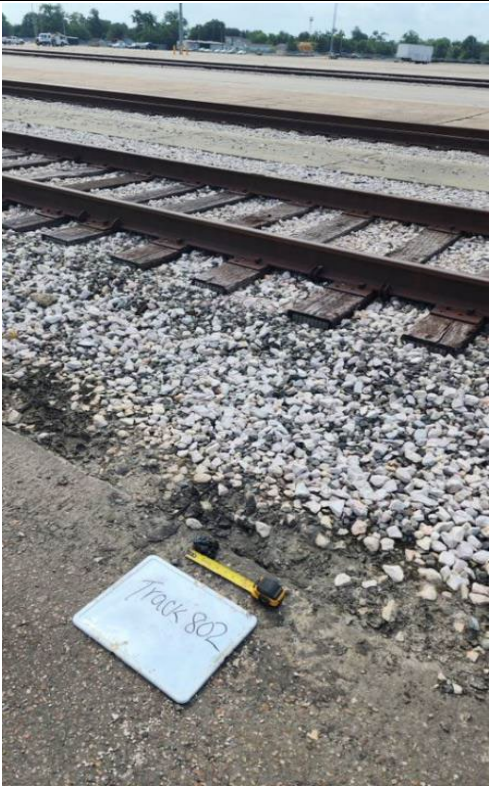
Description: North side of Track 802, some tar-like material observed at seep location near the edge of the ballast, material removed. Looking Southeast. Lat: 29.784895 Long: -95.321327

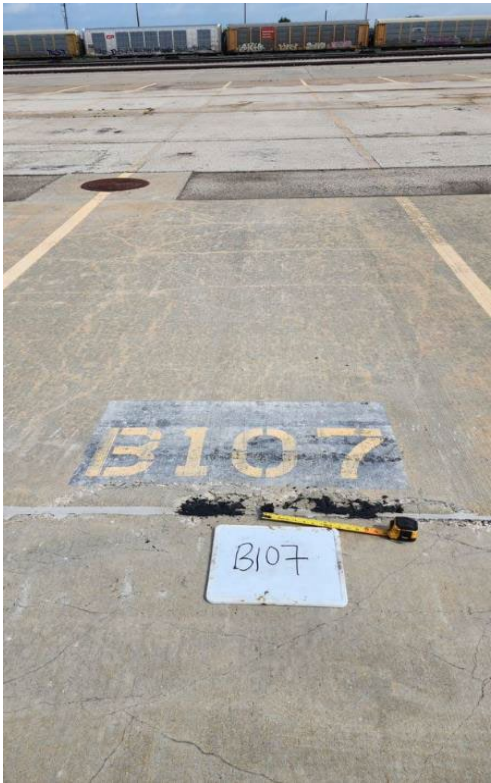
PHOTOGRAPHIC LOG	
Client Name: Union Pacific Railroad		Site Location: Englewood Intermodal Yard, Houston, Texas	Project No. 31406585.016
Photo No. 19	Inspection Date: 7/12/2023	<div> <div> Description: Stalls B107, view of NAPL collection system (Sump 3 in background of photo), some new tar-like material observed and removed at seep location on concrete joint along the southern edge of the excavated area, looking northwest. Lat: 29.784137 Long: -95.32096 </div> <div>

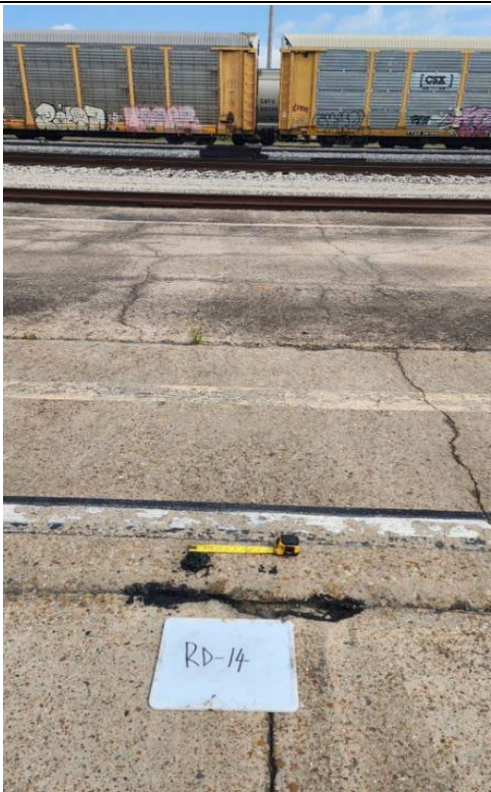
</div> </div>	
Photo No. 20	Inspection Date: 7/12/2023	<div> <div> Description: RD-14 Seep location observed within the concrete road area (RD-14) north of Track 802 (east of existing Track 802 seep location), very small amount of tar-like material observed along a concrete joint, material was removed. </div> <div> Lat: 29.785064 Long: -95.321219 </div> <div>

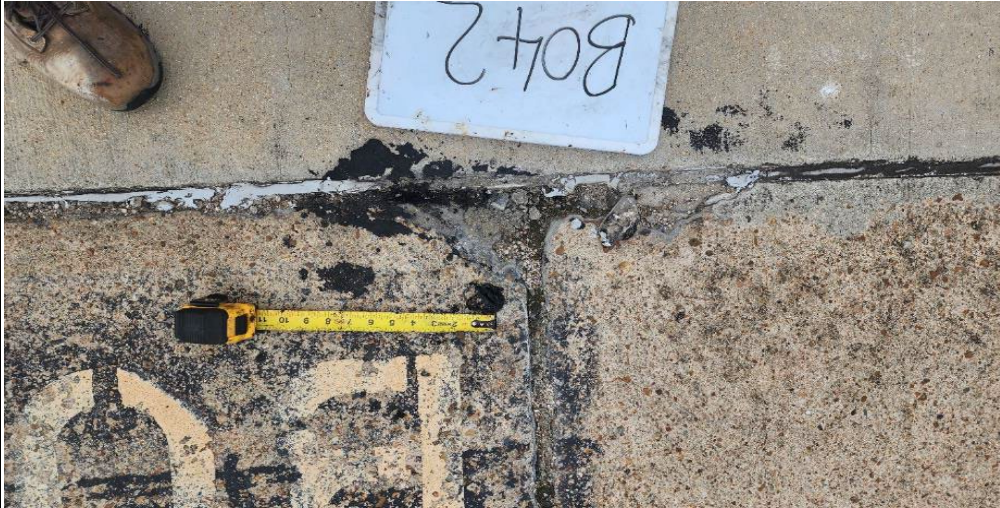
PHOTOGRAPHIC LOG	
Client Name: Union Pacific Railroad		Site Location: Englewood Intermodal Yard, Houston, Texas	Project No. 31406585.016
Photo No. 21	Inspection Date: 7/12/2023

Description: Stall B042. Some tar-like material observed at historical seep location along asphalt crack, material was removed. Lat: 29.784923 Long: -95.319124			
Photo No. 22	Inspection Date: 7/12/2023

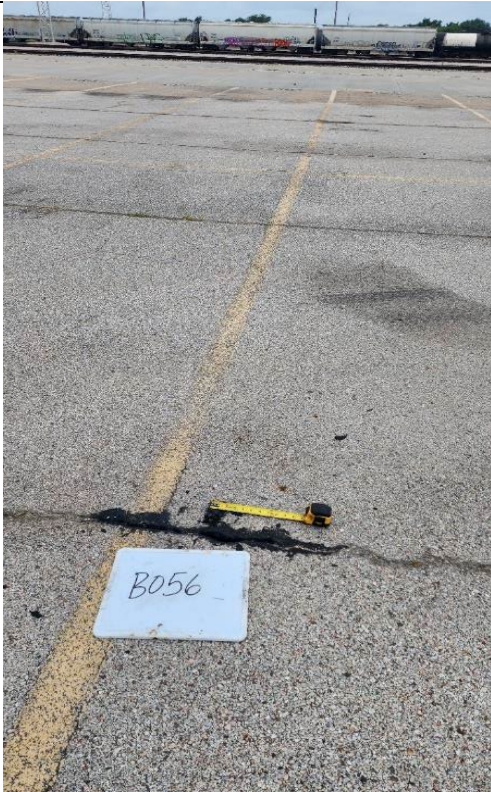
Description: Stall B056. Some tar-like material observed at historical seep location along asphalt crack, material was removed. Looking North Lat: 29.784751 Long: -95.319532

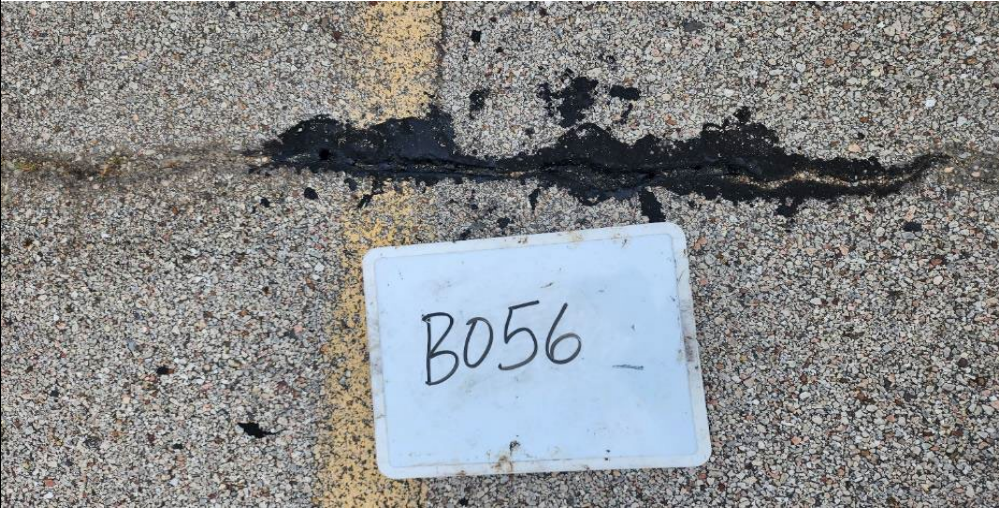
PHOTOGRAPHIC LOG	
Client Name: Union Pacific Railroad		Site Location: Englewood Intermodal Yard, Houston, Texas	Project No. 31406585.016
Photo No. 23	Inspection Date: 7/12/2023

Description: Stall B056. Some tar-like material observed at historical seep location along asphalt crack, material was removed. Lat: 29.784751 Long: -95.319532			
Photo No. 24	Inspection Date: 7/12/2023

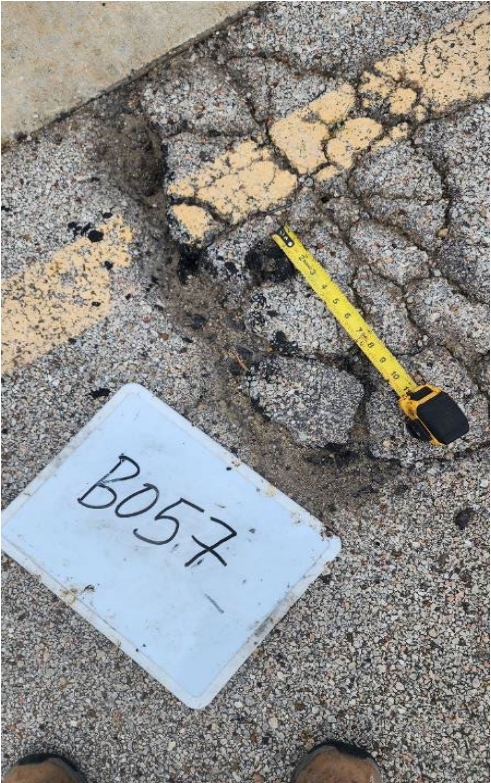
Description: Stall B057. Some tar-like material observed at historical seep location along asphalt crack, material was removed. Lat: 29.784747 Long: -95.319549

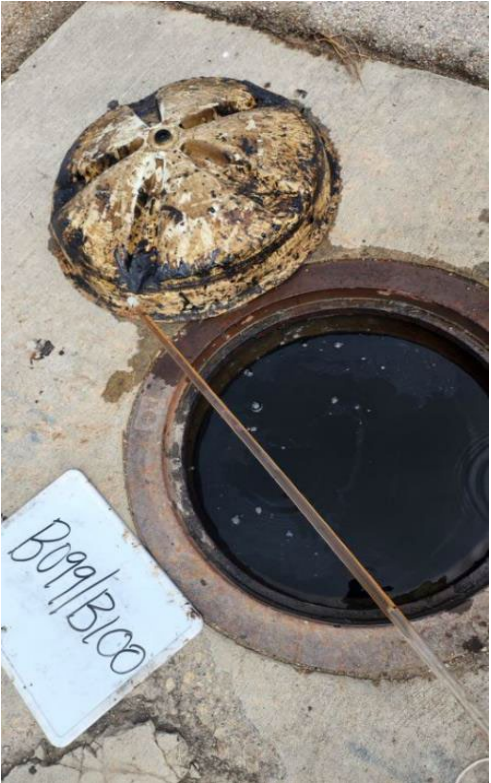
PHOTOGRAPHIC LOG	
Client Name: Union Pacific Railroad		Site Location: Englewood Intermodal Yard, Houston, Texas	Project No. 31406585.016
Photo No. 25	Inspection Date: 7/12/2023

Description: Sump 1 (B099/B100), 3 inches of freeboard in sump, no odor noted, sheen observed, no new NAPL accumulation on inflow protector, watercolor noted as brown. Lat: 29.7844000 Long: - 95.3205861			
Photo No. 26	Inspection Date: 7/12/2023

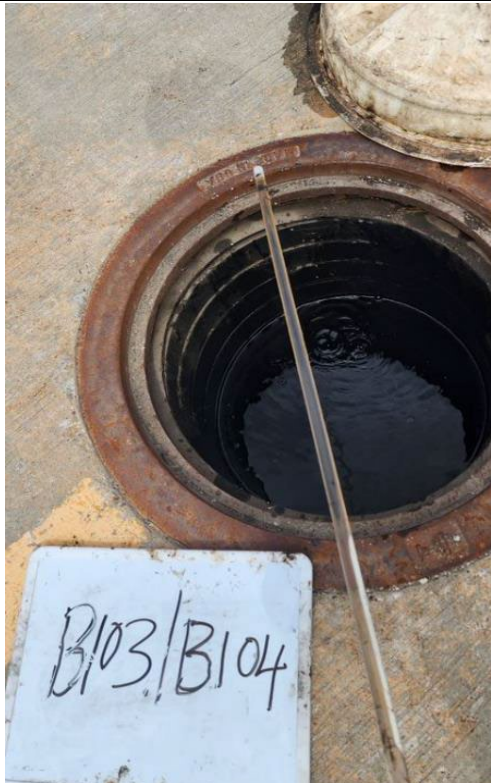
Description: Sump 2 (B103/B104), 20 inches of freeboard before pumping. No sheen or odor noted, color noted as light brown. Lat: 29.7842861 Long: - 95.3208611

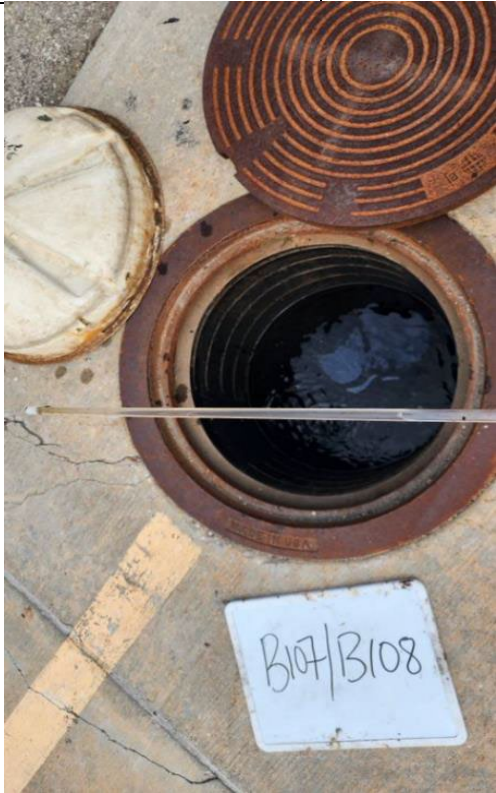
PHOTOGRAPHIC LOG	
Client Name: Union Pacific Railroad		Site Location: Englewood Intermodal Yard, Houston, Texas	Project No. 31406585.016
Photo No. 27	Inspection Date: 7/12/2023

Description: Sump 3 (B107/B108), 19 inches of freeboard in sump, no odor noted, sheen observed, no new NAPL accumulation on inflow protector, watercolor noted as clear. Lat: 29.7844000 Long: - 95.3205861			
Photo No. 28	Inspection Date: 7/12/2023

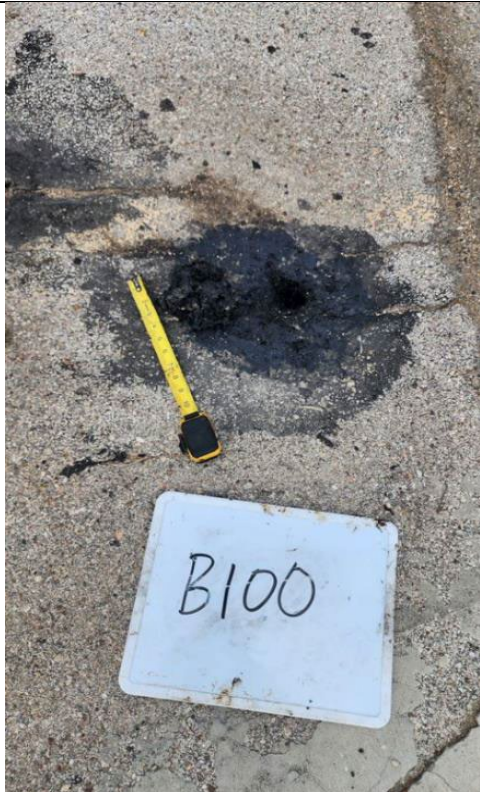
Description: Stall B100, some new tar-like material observed and removed at seep location on concrete crack/hole in concrete. Lat: 29.7842517 Long: -95.3208166

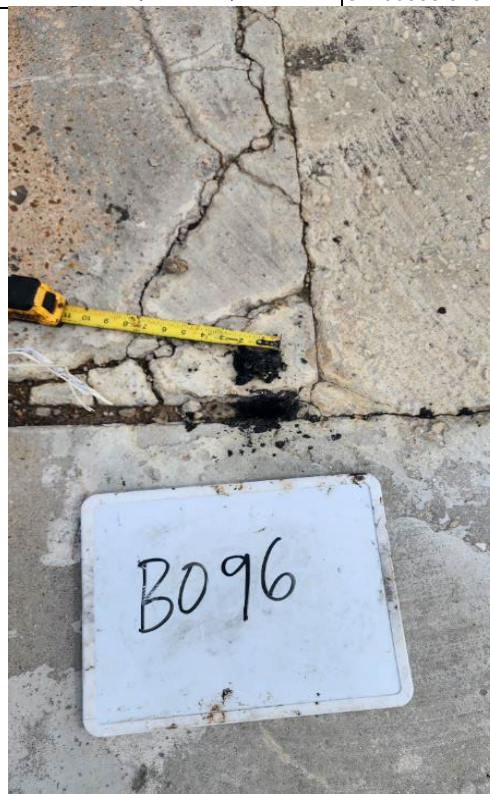
Stall B096, some staining and cracking concrete observed at former test pit location. Some tar-like material observed and removed.

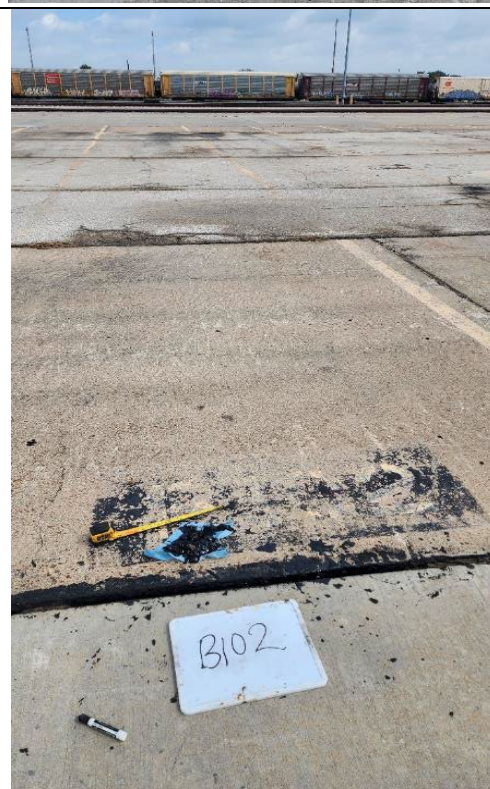
30

Stall B102 Joint, tar-like material observed and removed at seep location along stall joint. Looking northeast.

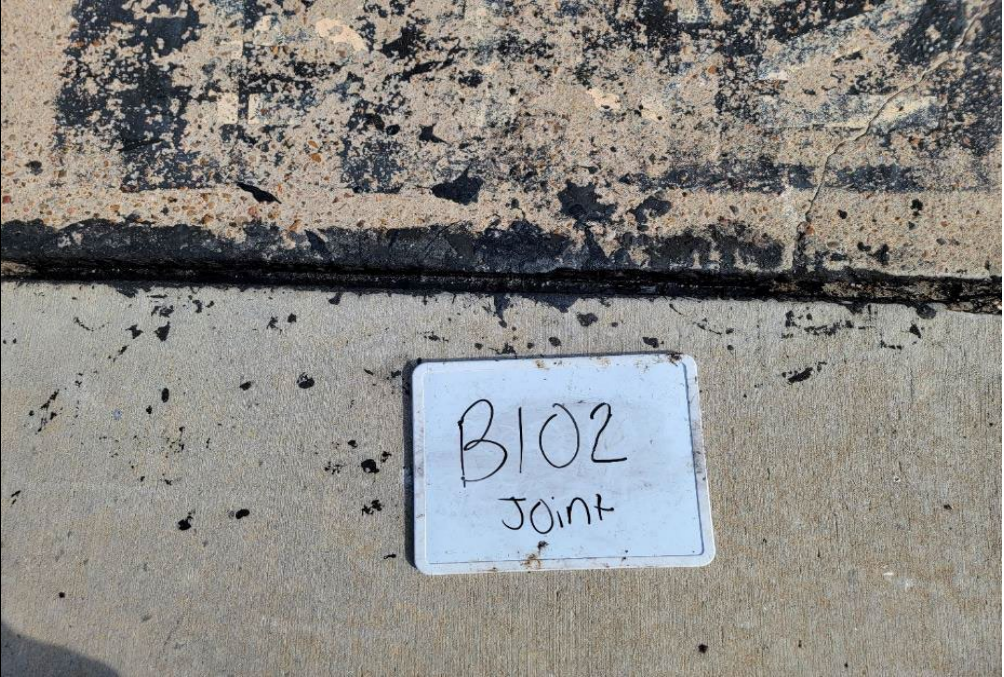
PHOTOGRAPHIC LOG	
Client Name: Union Pacific Railroad		Site Location: Englewood Intermodal Yard, Houston, Texas	Project No. 31406585.016
Photo No. 31	Inspection Date: 7/12/2023

Description: Stall B102 Joint, tar-like material observed and removed at seep location along stall joint. Lat: 29.784197 Long: -95.320821			
Photo No. 32	Inspection Date: 7/19/2023

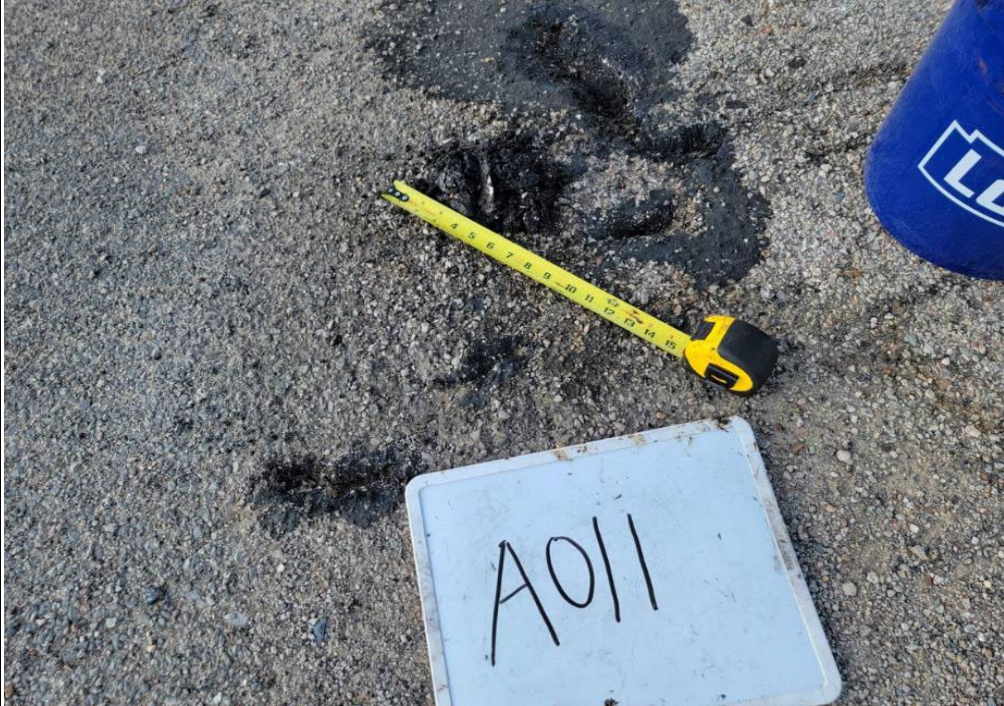
Description: Stall A011 some tar-like material observed at historical seep location along asphalt crack, material was removed. View looking southeast. Lat: 29.785392, Long: -95.318655

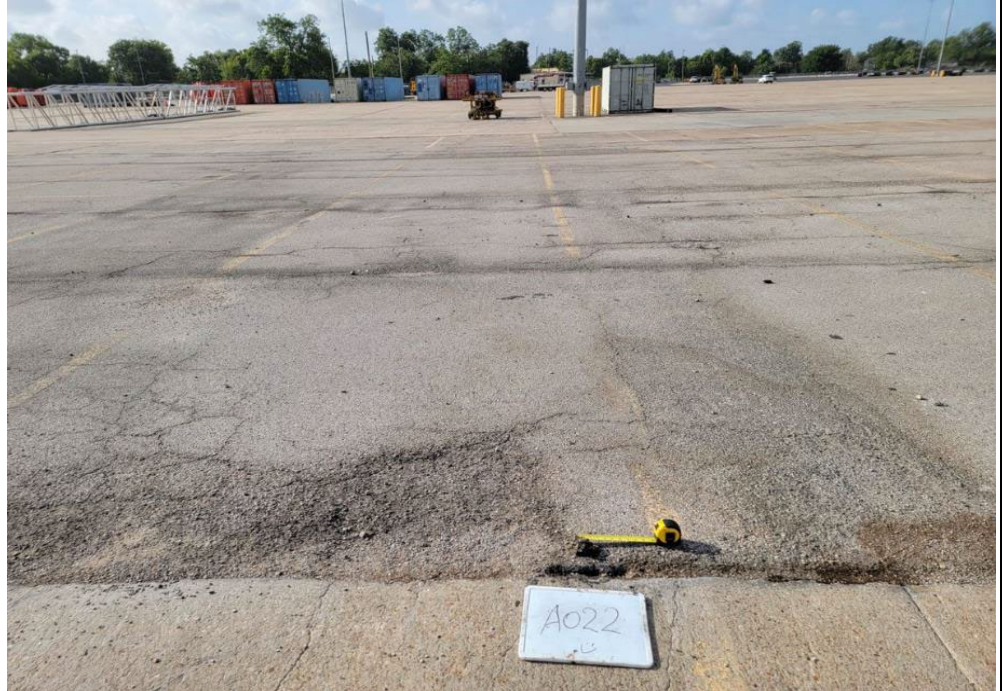
Stall A022, some tar-like material observed at the seep location along the edge tar-like material seeps observed and removed, view looking southeast.

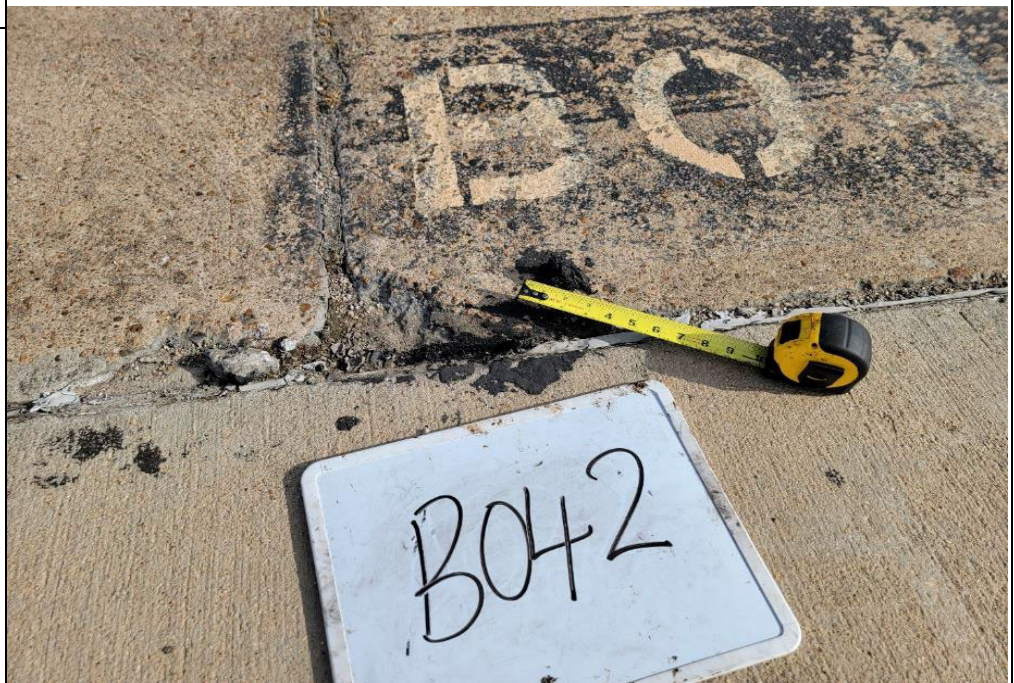
Photo No.
34

Stall BO42. Some tar-like material observed at historical seep location along asphalt crack, material was removed.

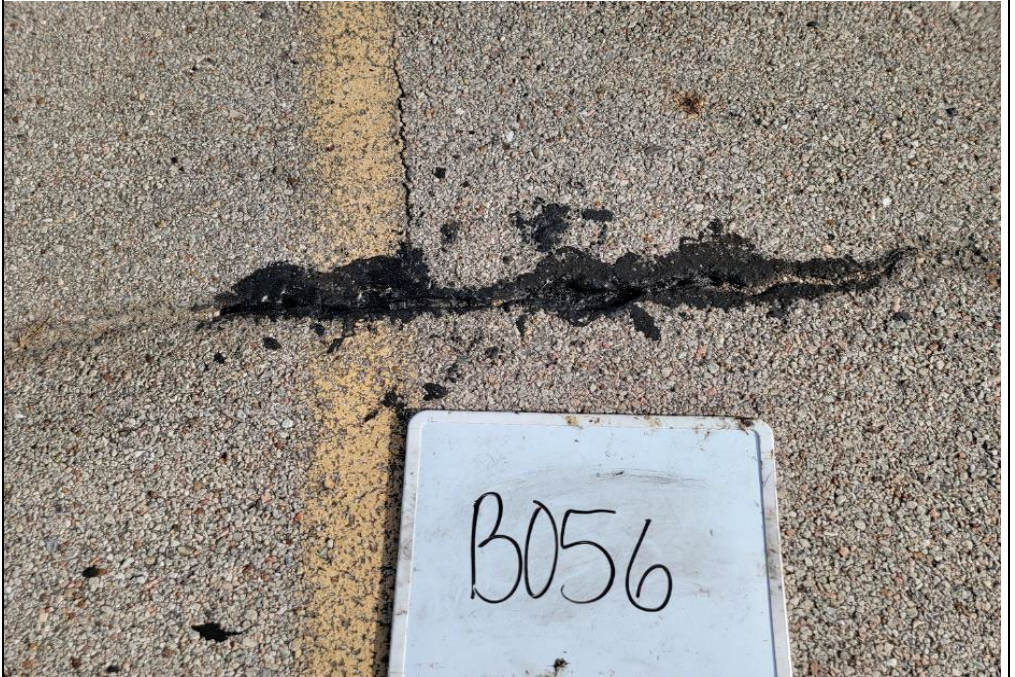
Photo No. 35	Inspection Date: 7/19/2023	
Description: Stall B056. Some tar-like material observed at historical seep location along asphalt crack, material was removed. Lat: 29.784751 Long: -95.319532

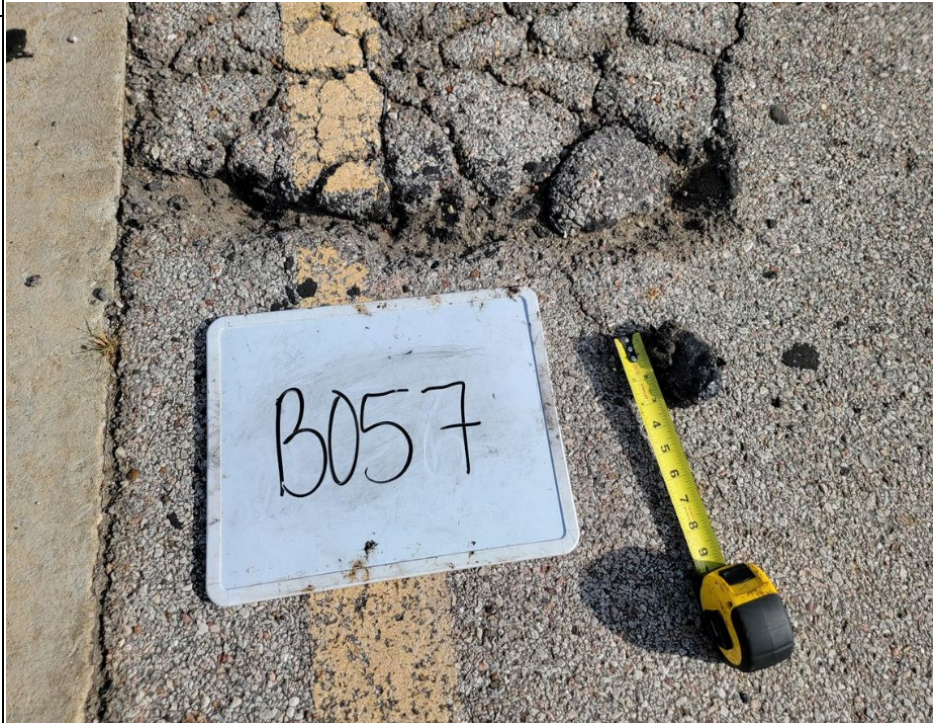
Photo No. 36	Inspection Date: 7/19/2023	
Description: Stall B057, some new tar-like material observed and removed at seep location along asphalt crack. Lat: 29.784769 Long: -95.3195798

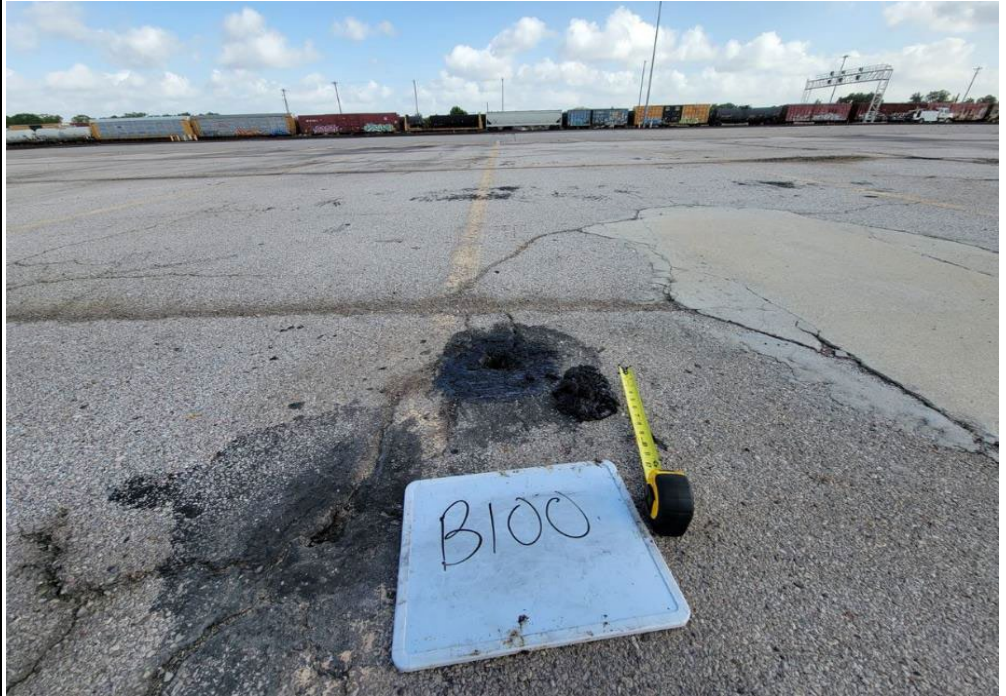
Stall B100, tar-like material observed and removed at seep location along asphalt crack/hole in the asphalt. Test pit on right of photo. Looking North.

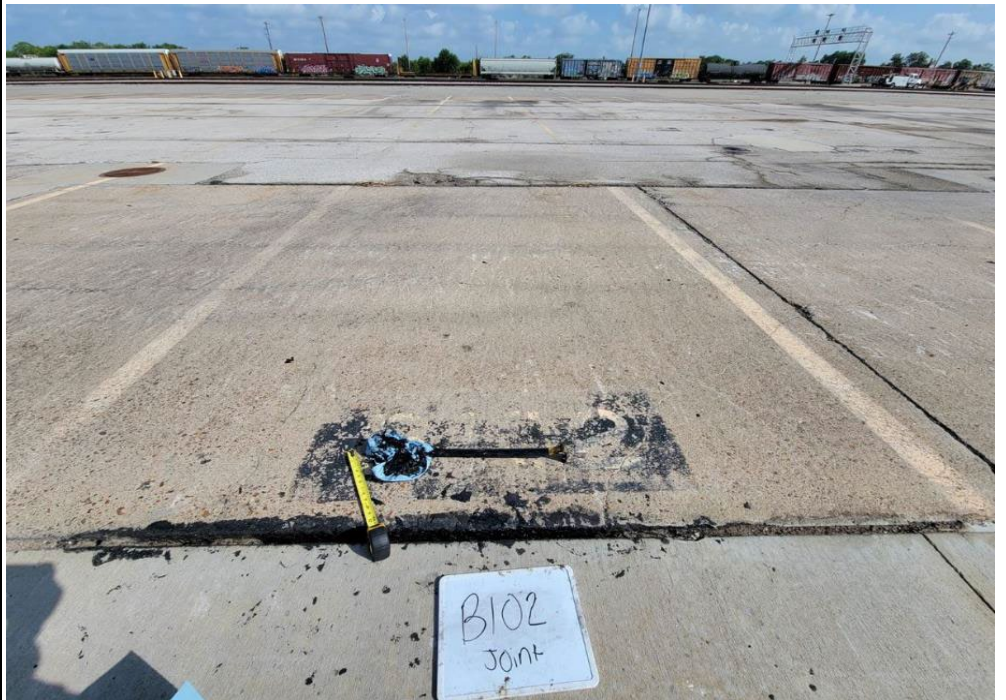
Photo No.
38

Stall B102 Joint, tar-like material observed and removed at seep location along stall joint.

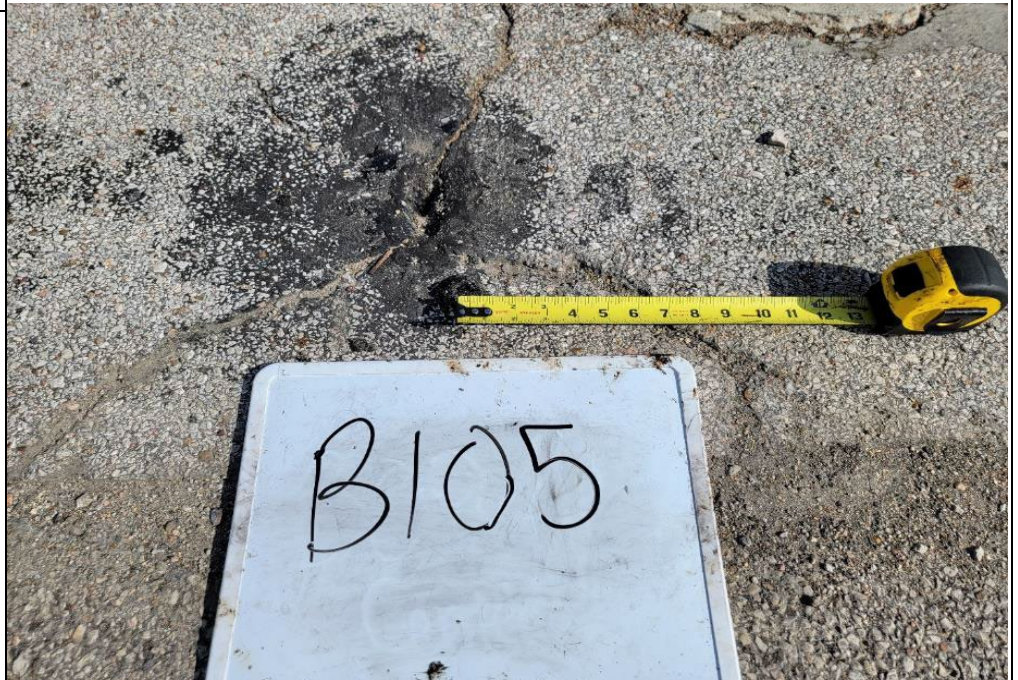
Seep Observations Outside the NAPL Collection System Area	
Stall Number	Observation Date(s)
A011	July 5 th , July 12 th , July 19 th , and July 26 th (Photo Nos. 1, 16, 32 and 47)
A022	July 5 th , July 12 th , July 19 th , and July 26 th (Photo Nos. 3, 17, and 33, 48)
B042	July 5 th , July 12 st , July 19 th , and July 26 th (Photo Nos.4, 21, 34, and 49)
B056	July 5 th , July 12 th , July 19 th , and July 26 th (Photo Nos. 5, 23, 35, and 50)
B057	July 5 th , July 12 th , July 19 th , and July 26 th (Photo No. 6, 24, 36, and 51)
B100	July 5 th , July 12 th , July 19 th , July 26 th (Photo Nos. 9, 28, 37, and 52)
B102	July 5 th , July 12 th , July 19 th , July 26 th (Photo Nos. 10, 30, 31, 38, and 53)
B105	July 19 th (Photo No. 39)

Stall B105, tar-like material observed and removed at seep location along asphalt crack/hole in the asphalt.

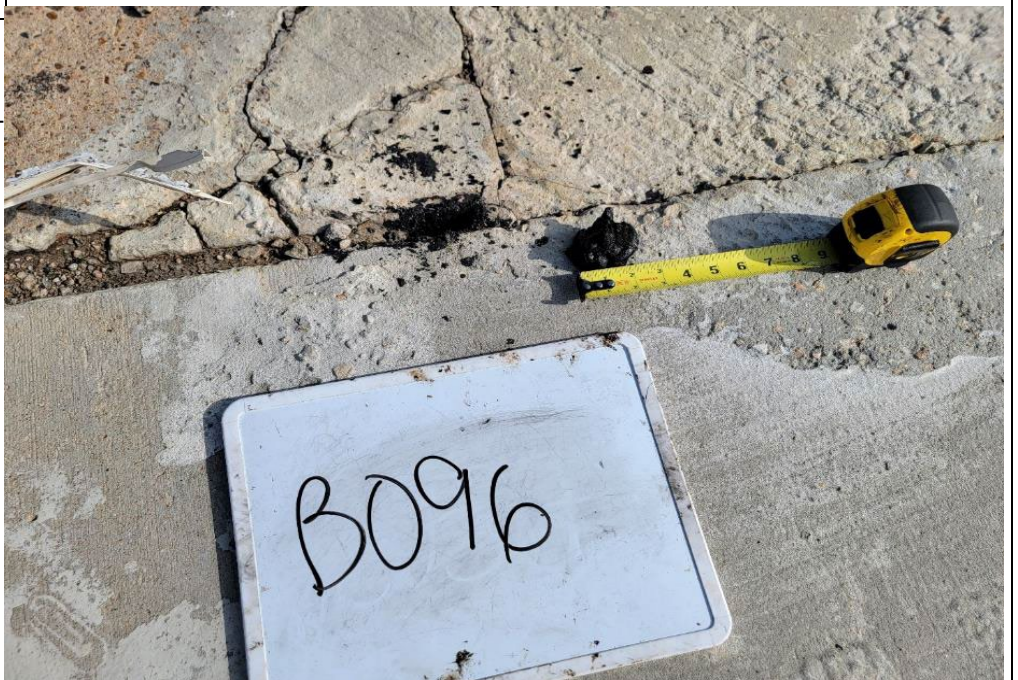
40

Stall B096, some staining and cracking concrete observed at historical seepage location. Some tar-like material observed and removed.

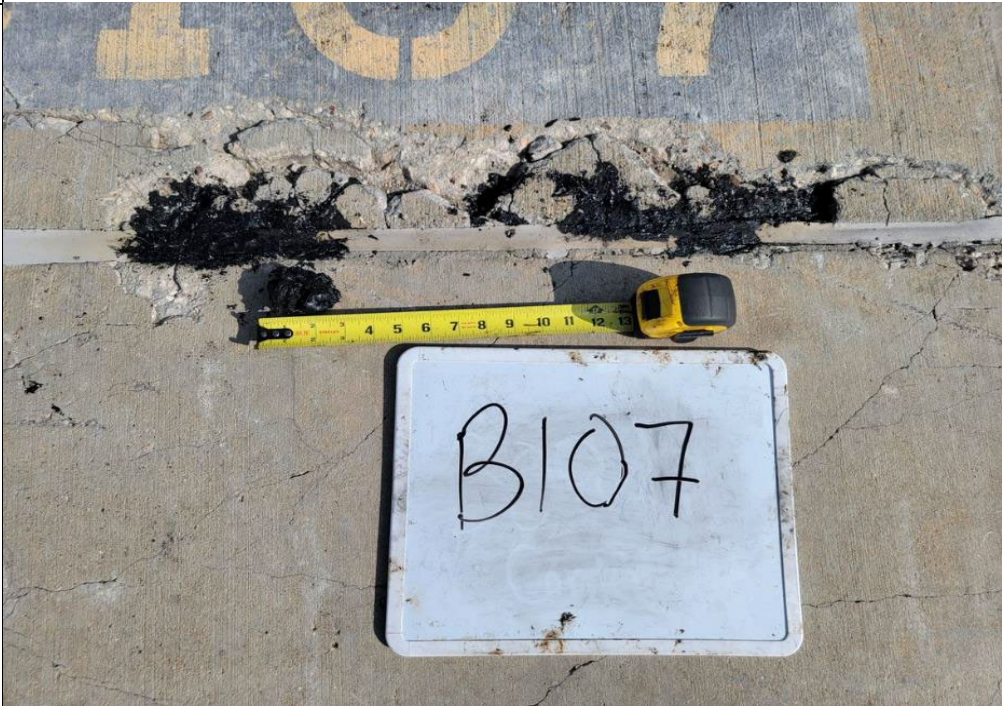
PHOTOGRAPHIC LOG	
Client Name: Union Pacific Railroad		Site Location: Englewood Intermodal Yard, Houston, Texas	Project No. 31406585.016
Photo No. 41	Inspection Date: 7/19/2023		
Description: Stalls B107, some new tar-like material observed and removed at seep location on concrete joint along the southern edge of the excavated area, looking northwest. Lat: 29.784156 Long: -95.320953
