August 15, 2023

Project No. 31406585.016

**Re: MONTHLY STATUS UPDATE – ENGLEWOOD INTERMODAL YARD – NAPL COLLECTION
SYSTEM/CONCRETE CAP REPAIRS
UNION PACIFIC RAILROAD HOUSTON WOOD PRESERVING WORKS FACILITY
4910 LIBERTY ROAD FACILITY, HOUSTON, TEXAS
POST-CLOSURE CARE PERMIT NO. HW-50343; INDUSTRIAL SWR NO. 31547**

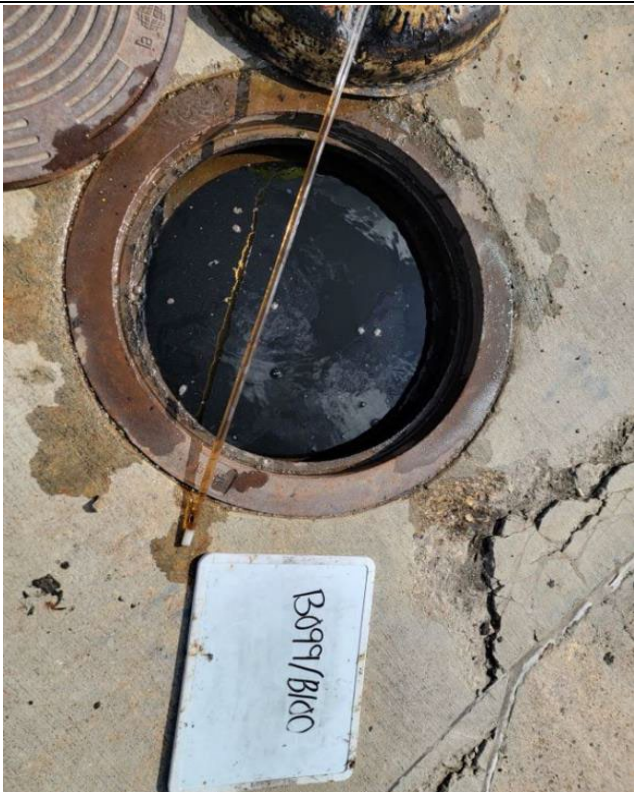
Photo No. 42	Inspection Date: 7/19/2023		
Description: Sump 1 (B099/B100), 3 inches of freeboard in sump, no odor noted, sheen observed, no new NAPL accumulation on inflow protector, watercolor noted as brown. Lat: 29.7844000 Long: -95.3205861

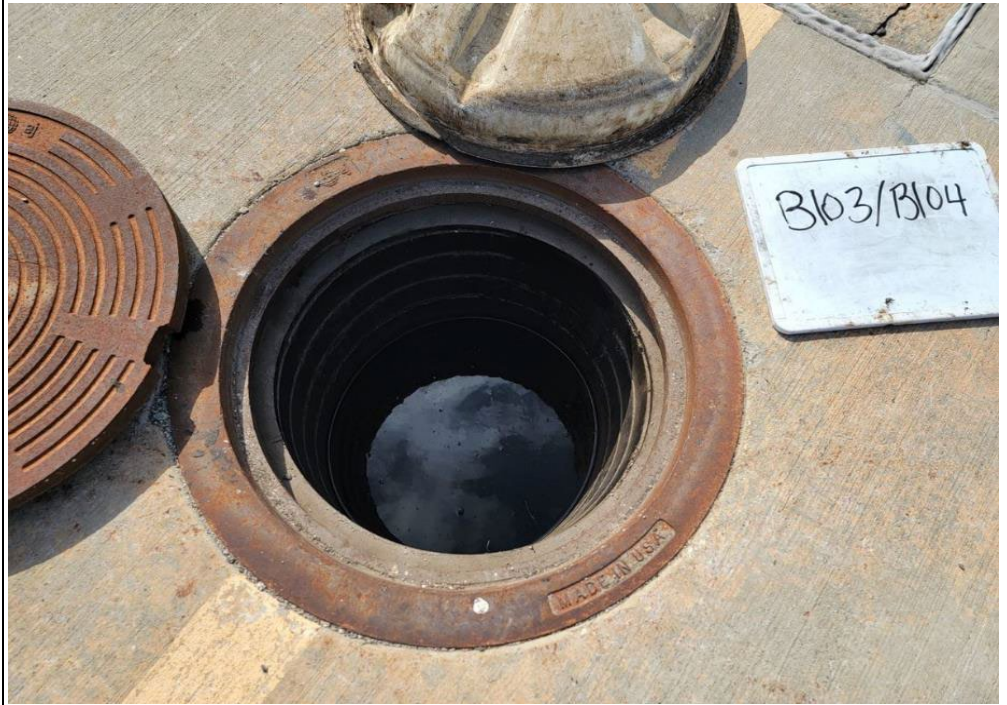
Sump 2 (B103/B104), 19 inches of freeboard before pumping. No sheen or odor noted, color noted as clear.

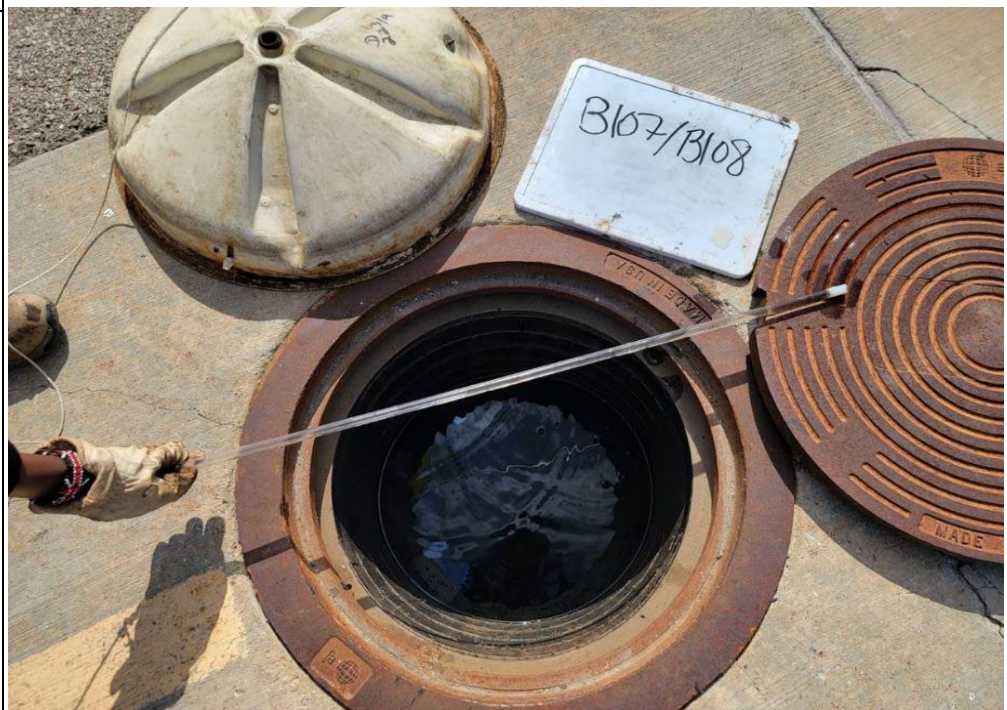
Photo No.
44

Sump 3 (B107/B108), 19 inches of freeboard in sump, no odor noted, sheen observed, no new NAPL accumulation on inflow protector, watercolor noted as clear.

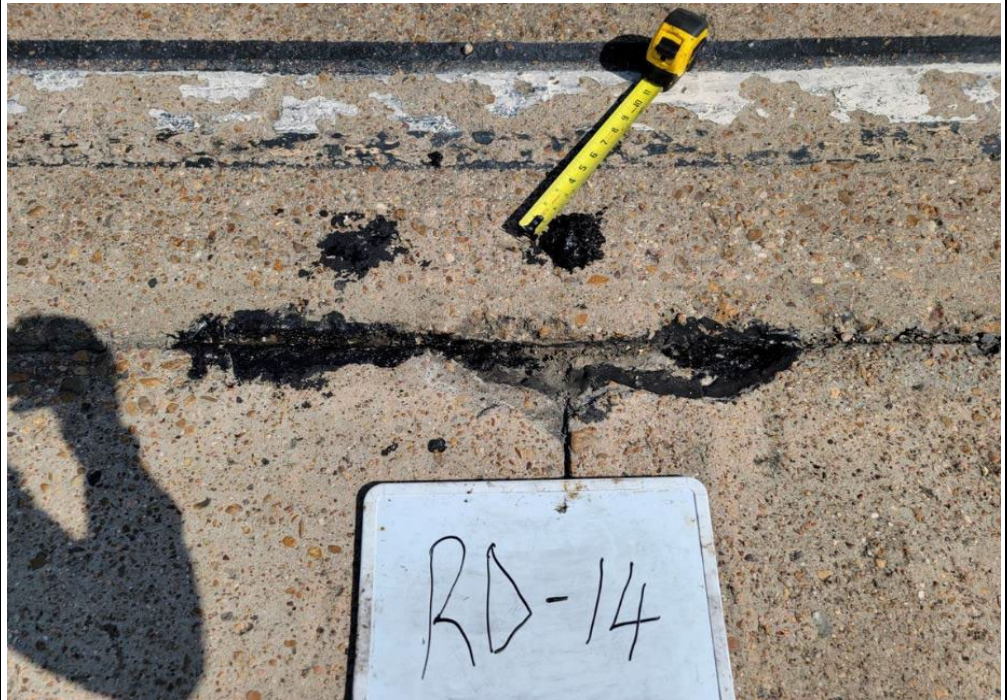
RD-14 Seep location observed within the concrete road area (RD-14) north of Track 802 (east of existing Track 802 seep location), small amount of tar-like material observed along a concrete joint, material was removed.

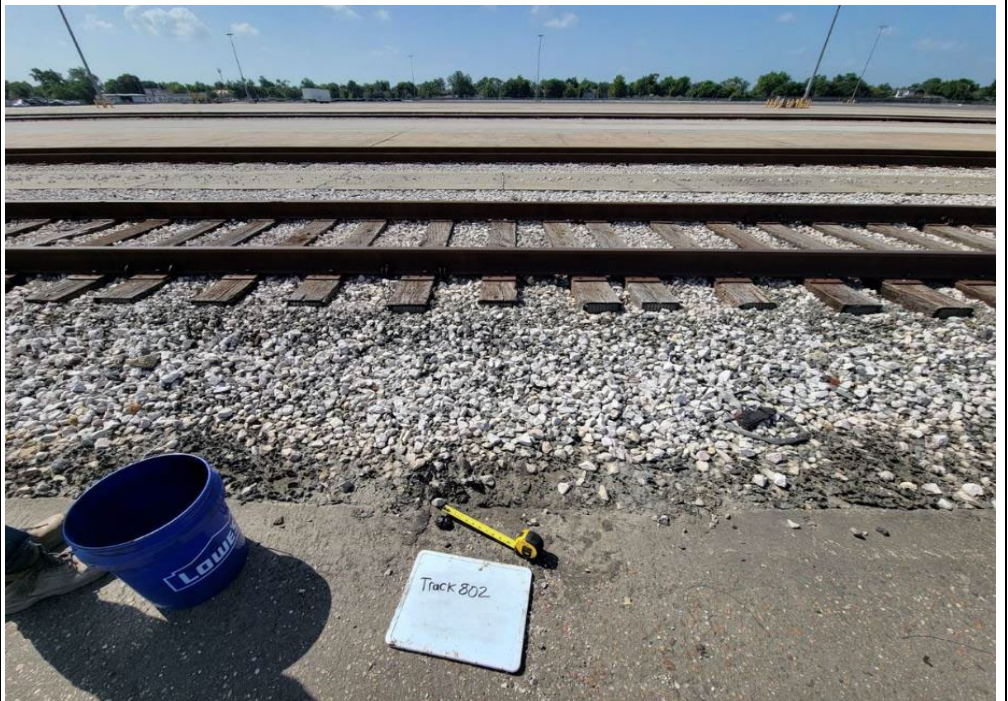
46

North side of Track 802, some tar-like material observed at seep location near the edge of the ballast, material removed.

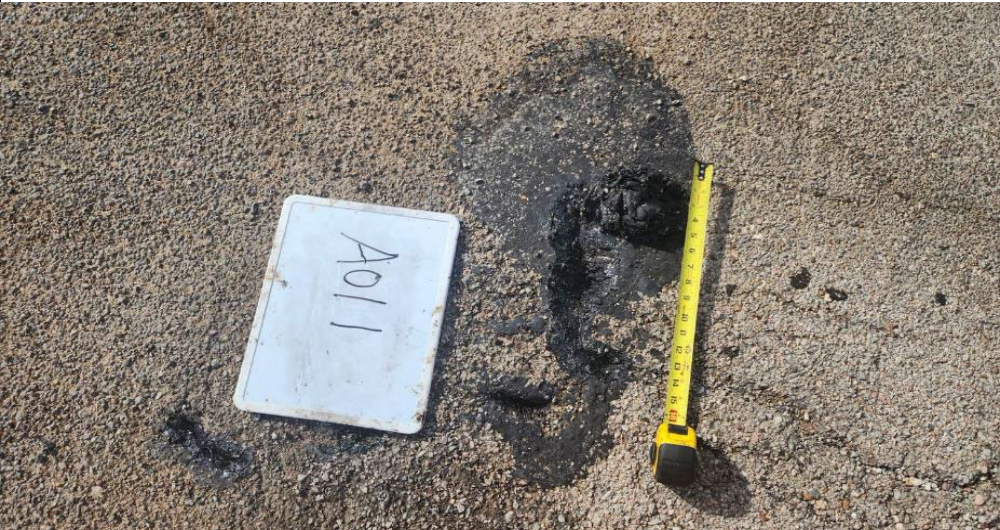
PHOTOGRAPHIC LOG	
Client Name: Union Pacific Railroad		Site Location: Englewood Intermodal Yard, Houston, Texas	Project No. 31406585.016
Photo No. 47	Inspection Date: 7/26/2023

Description: Stall A011 some tar-like material observed at historical seep location along asphalt crack, material was removed. View looking southeast. Lat: 29.785392, Long: -95.318655			
Photo No. 48	Inspection Date: 7/26/2023

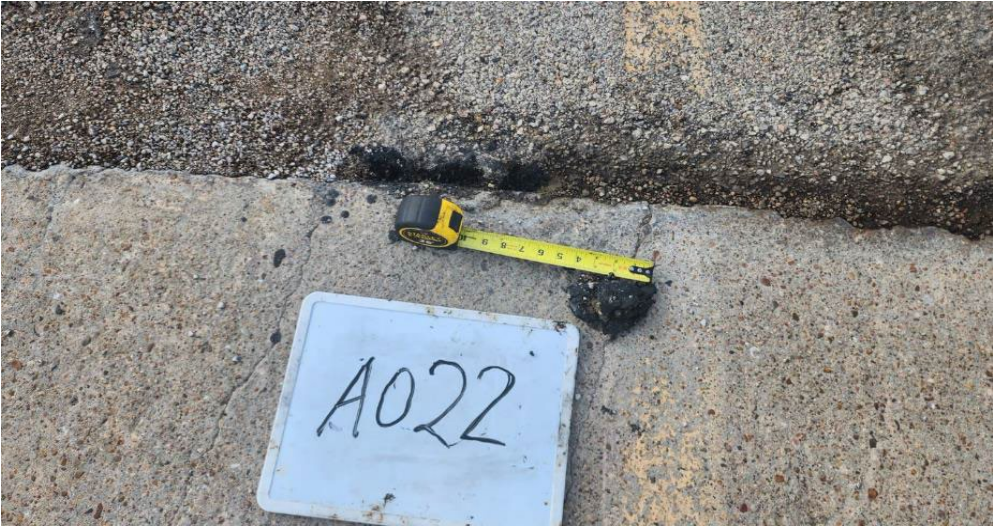
Description: Stall A022, some tar-like material observed at the seep location along the edge tar-like material seeps observed, looking southeast. Lat: 29.785381 Long: - 95.318619

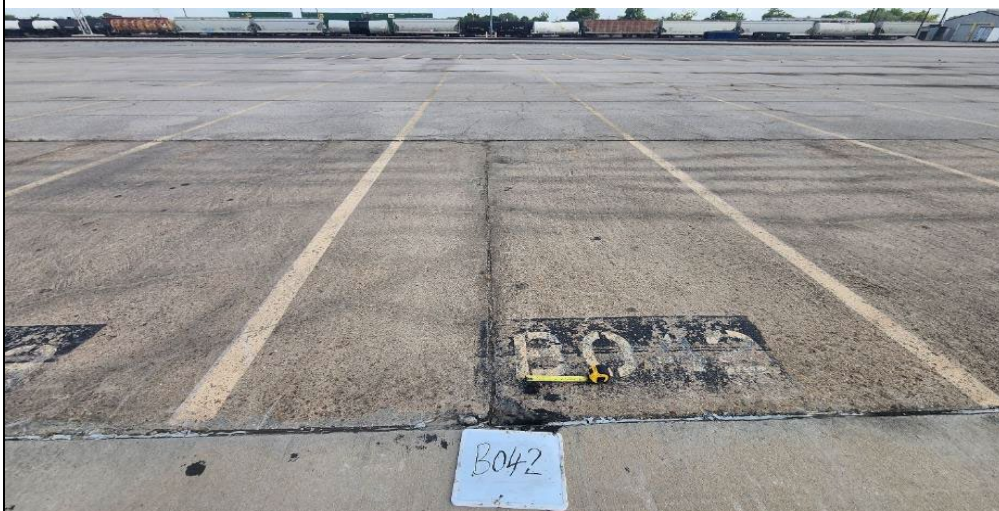
Stall B042. Some tar-like material observed at historical seep location along asphalt crack, material was removed. Looking North

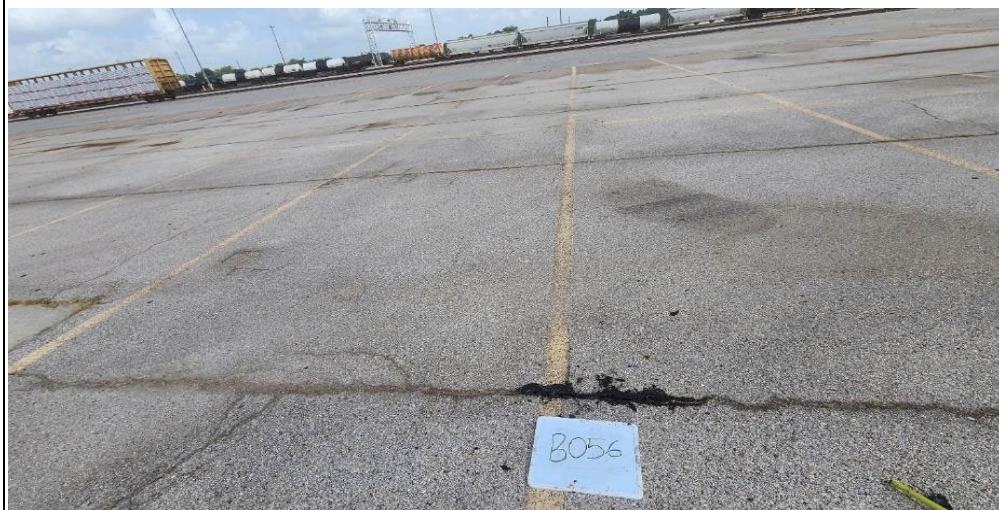
50

Stall B056. Some tar-like material observed at historical seep location along asphalt crack, material was removed. Looking North

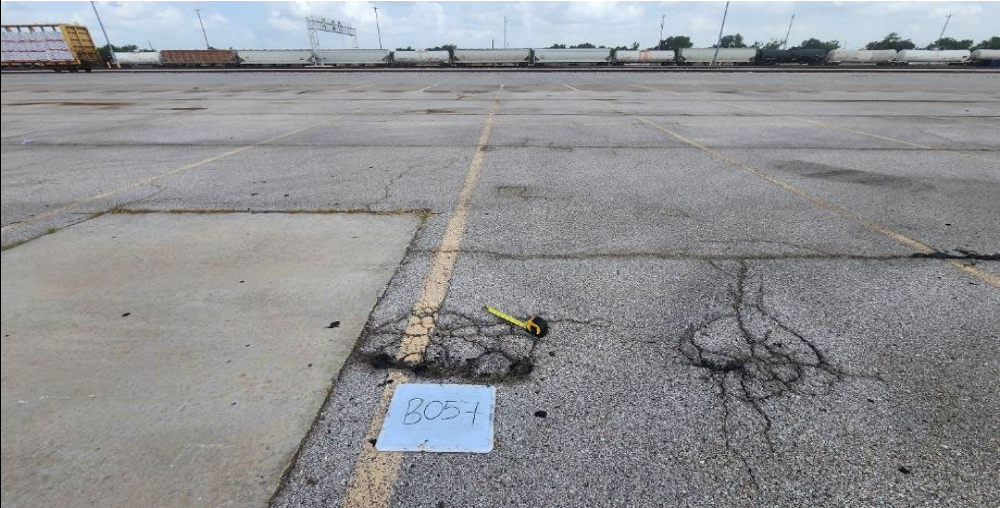
PHOTOGRAPHIC LOG	
Client Name: Union Pacific Railroad		Site Location: Englewood Intermodal Yard, Houston, Texas	Project No. 31406585.016
Photo No. 51	Inspection Date: 7/26/2023

Description: Stall B057, some new tar-like material observed and removed at seep location along asphalt crack. Looking North Lat: 29.784769 Long: -95.3195798			
Photo No. 52	Inspection Date: 7/26/2023

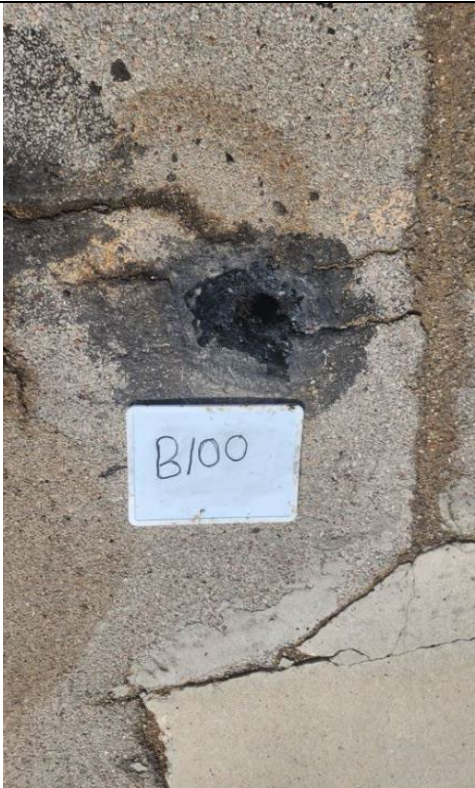
Description: Stall B100, tar-like material observed and removed at seep location along asphalt crack/ hole in the asphalt. Lat: 29.7842517 Long: -95.3208166

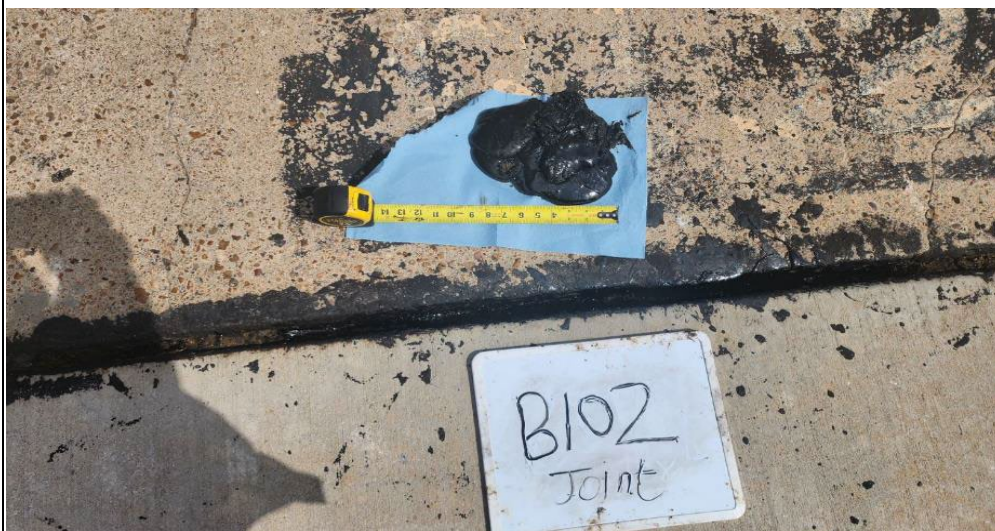
Stall B102 Joint, tar-like material observed and removed at seep location along stall joint.

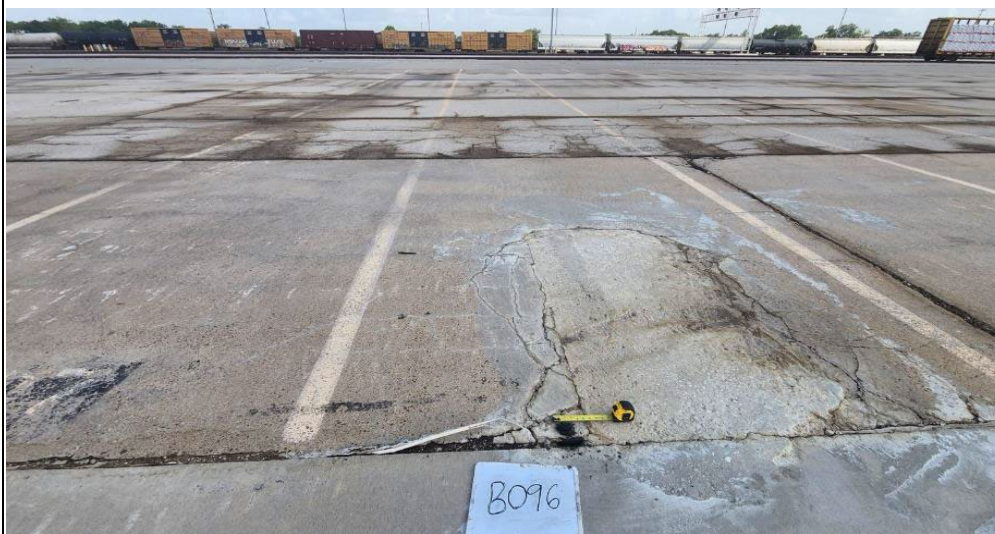
54

Stall B096, some staining and cracking concrete observed at former test pit location. Some tar-like material observed and removed.

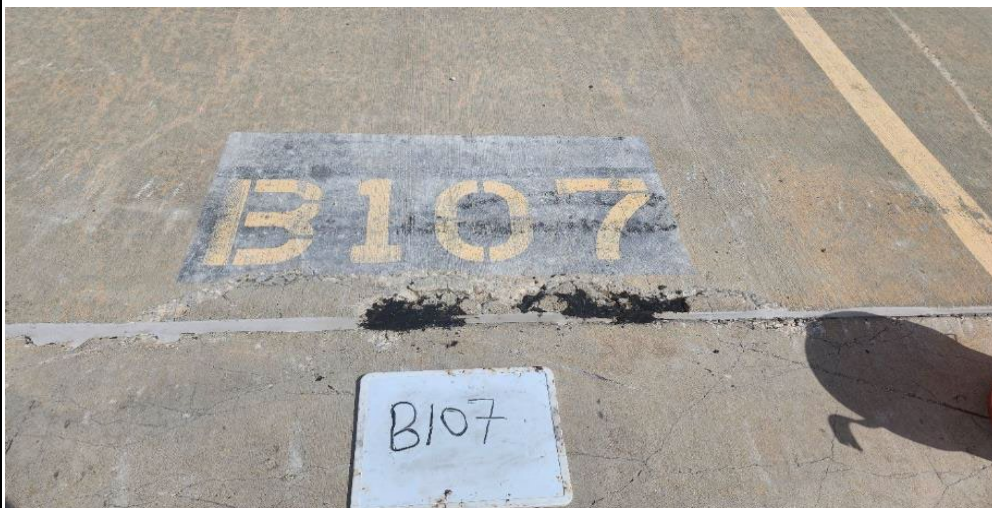
Stalls B107, some new tar-like material observed and removed at seep location on concrete joint along the southern edge of the excavated area, looking northwest.

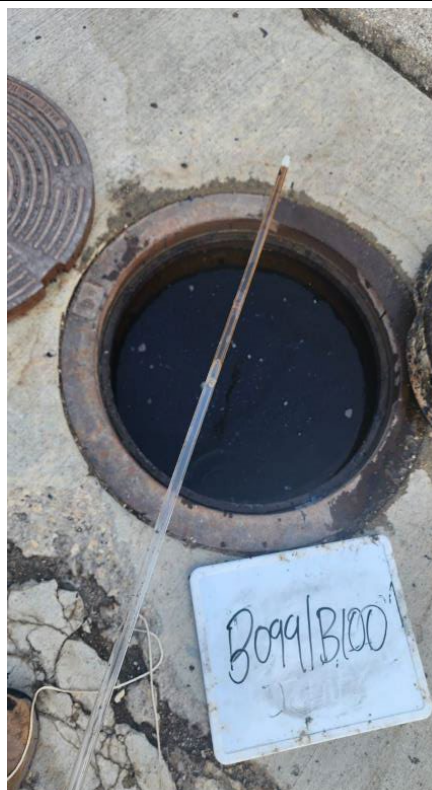
56

Sump 1 (B099/B100), 3 inches of freeboard in sump, no odor noted, sheen observed, no new NAPL accumulation on inflow protector, watercolor noted as brown.

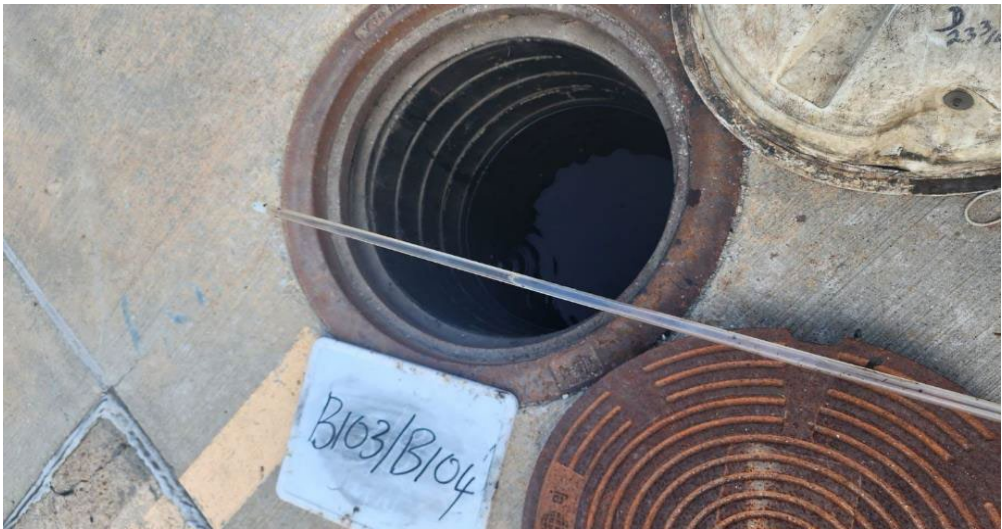
PHOTOGRAPHIC LOG	
Client Name: Union Pacific Railroad		Site Location: Englewood Intermodal Yard, Houston, Texas	Project No. 31406585.016
Photo No. 57	Inspection Date: 7/26/2023

Description: Sump 2 (B103/B104), 21 inches of freeboard before pumping. No sheen or odor noted, color noted as light brown. Lat: 29.7842861 Long: - 95.3208611			
Photo No. 58	Inspection Date: 7/26/2023

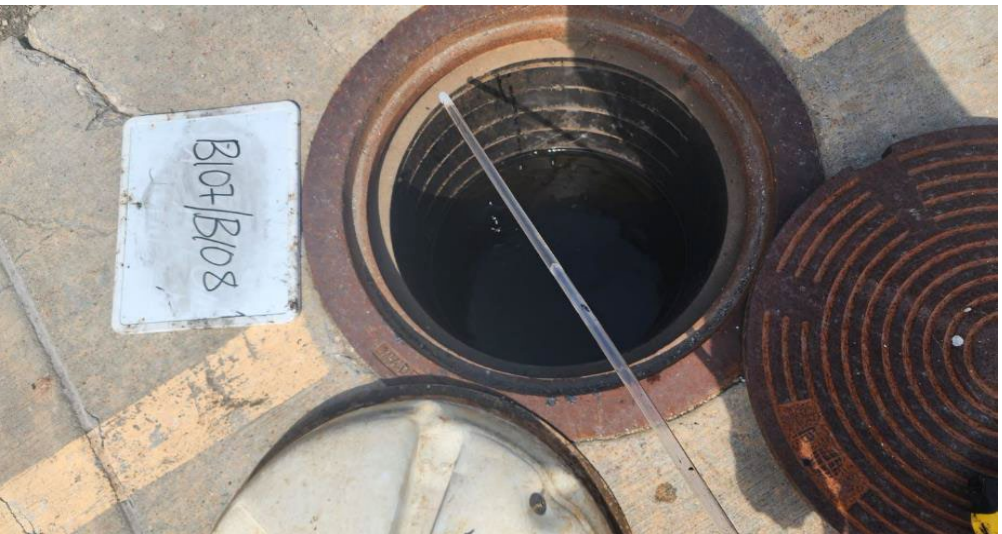
Description: Sump 3 (B107/B108), 20 inches of freeboard in sump, no odor noted, sheen observed, no new NAPL accumulation on inflow protector, watercolor noted as clear. Lat: 29.7844000 Long: - 95.3205861

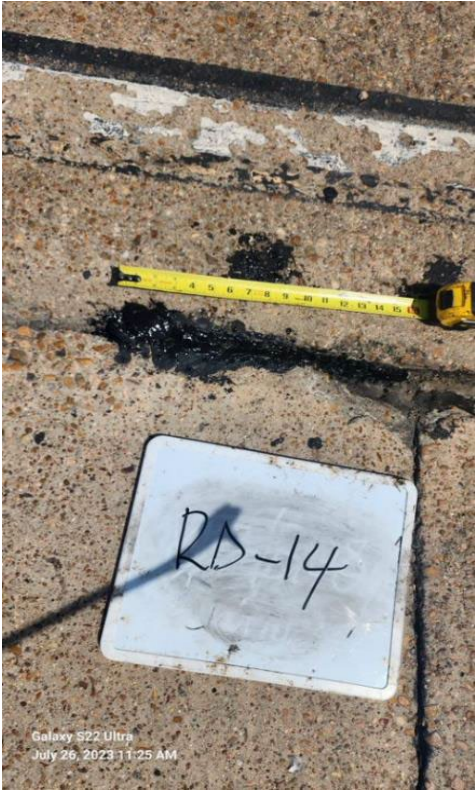
PHOTOGRAPHIC LOG	
Client Name: Union Pacific Railroad		Site Location: Englewood Intermodal Yard, Houston, Texas	Project No. 31406585.016
Photo No. 59	Inspection Date: 7/26/2023

Description: RD-14 Seep location observed within the concrete road area (RD-14) north of Track 802 (east of existing Track 802 seep location), small amount of tar-like material observed along a concrete joint, material was removed. Lat: 29.785064 Long: -95.321219			
Photo No. 60	Inspection Date: 7/26/2023

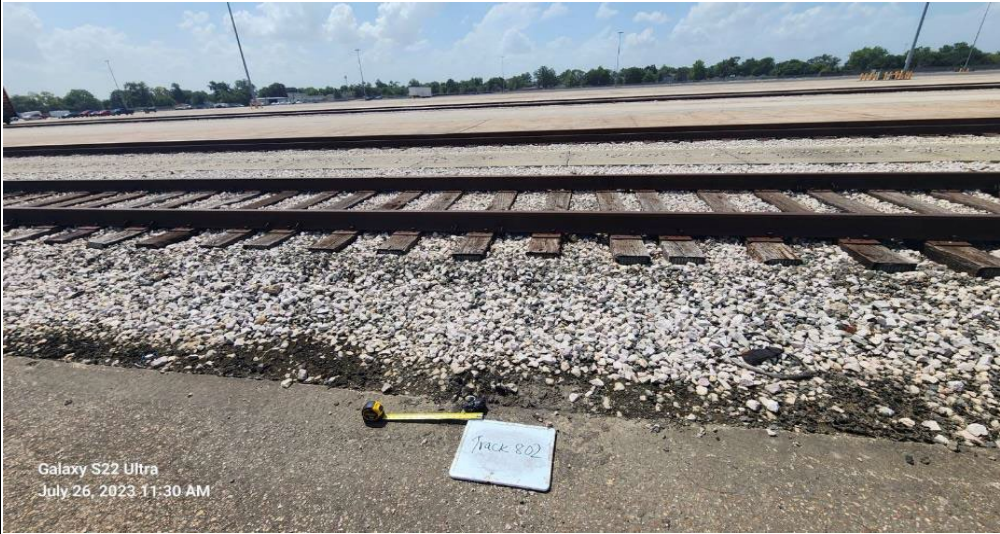
Description: North side of Track 802, some tar-like material observed at seep location near the edge of the ballast, material removed. Lat: 29.784947 Long: -95.321214
