September 15, 2023

Project No. 31406585.016

**Re: MONTHLY STATUS UPDATE – ENGLEWOOD INTERMODAL YARD – NAPL COLLECTION
SYSTEM/CONCRETE CAP REPAIRS
UNION PACIFIC RAILROAD HOUSTON WOOD PRESERVING WORKS FACILITY
4910 LIBERTY ROAD FACILITY, HOUSTON, TEXAS
POST-CLOSURE CARE PERMIT NO. HW-50343; INDUSTRIAL SWR NO. 31547**

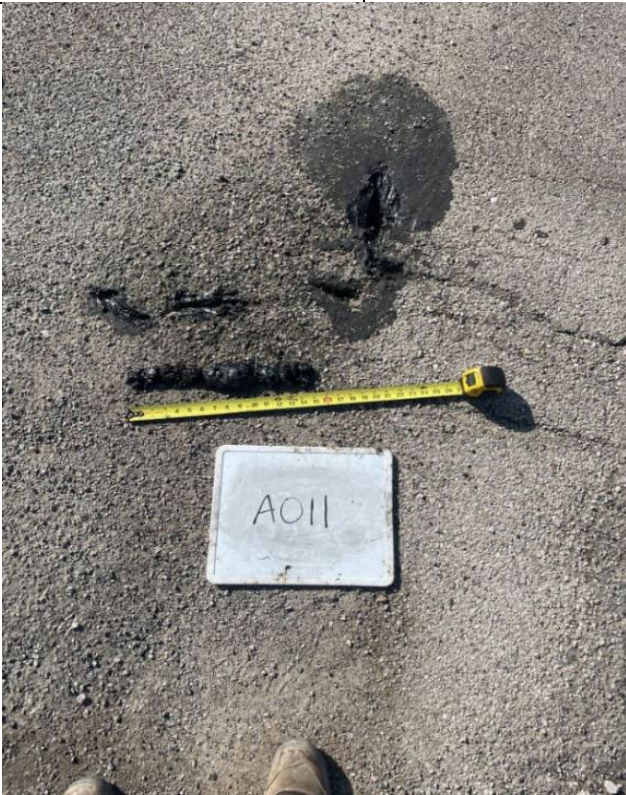
Description: Stall A011 tar-like material observed at historical seep location along asphalt crack, material was removed. Lat: 29.785467 Long: -95.318341			
Photo No. 2	Inspection Date: 8/2/2023

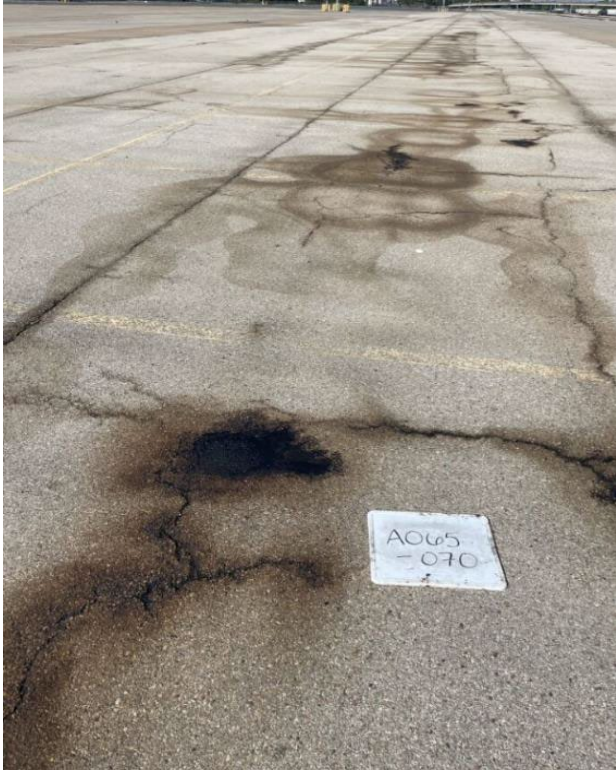
Description: Stalls A065 - A070 some minimal staining observed. Lat: 29.784858 Long: -95.319733

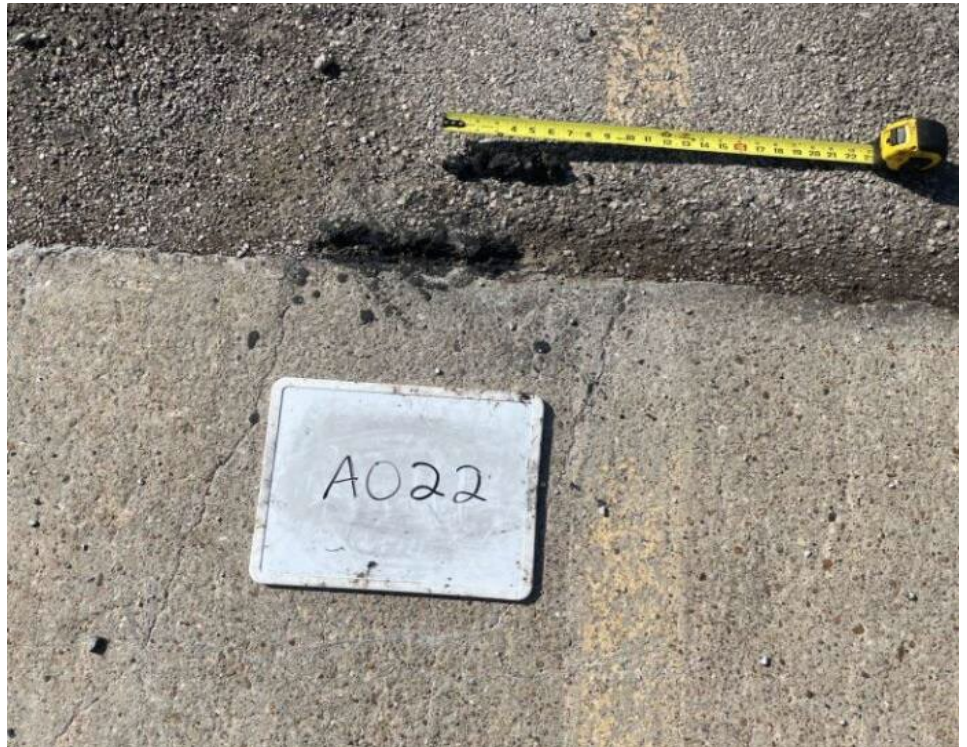
Stall A022. Some tar-like material observed at historical seep location along asphalt crack, material was removed.

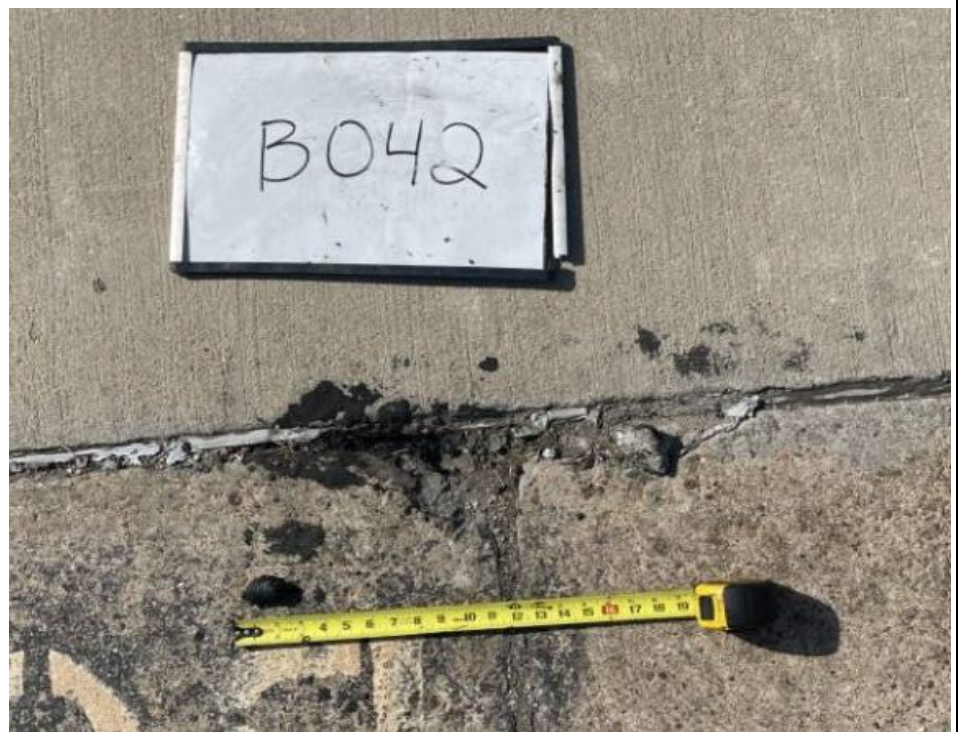
Stall BO42. A very small amount of tar-like material observed at historical seep location along asphalt crack, material was removed.

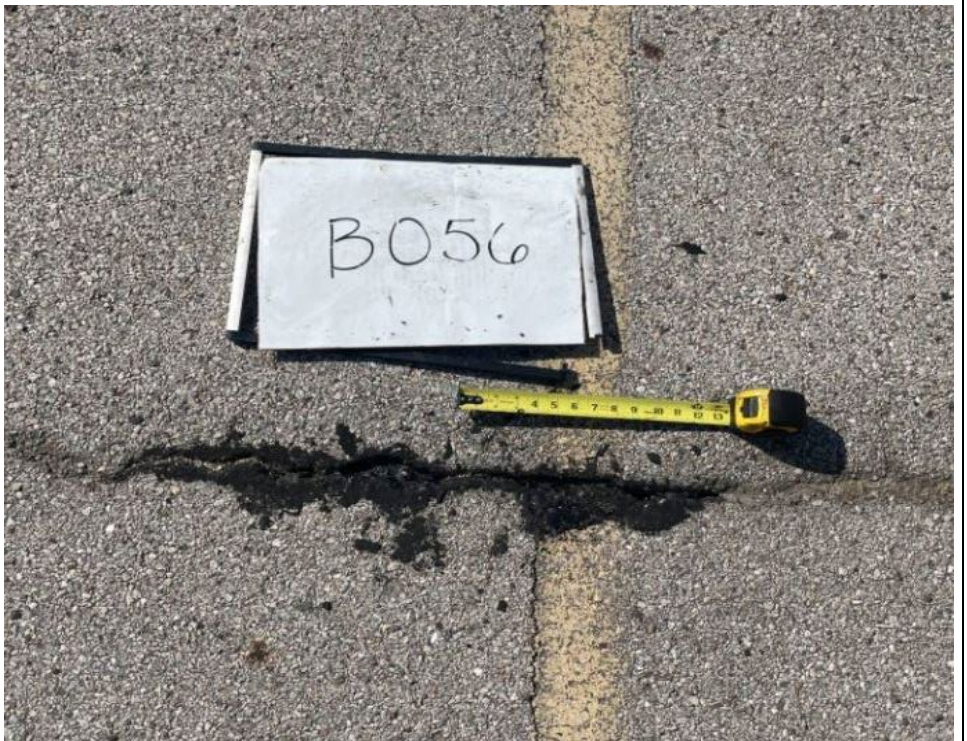
Photo No. 5	Inspection Date: 8/2/2023
Description: Stall B056. Some tar-like material observed at historical seep location along asphalt crack, material was removed. Lat: 29.784751 Long: -95.319532

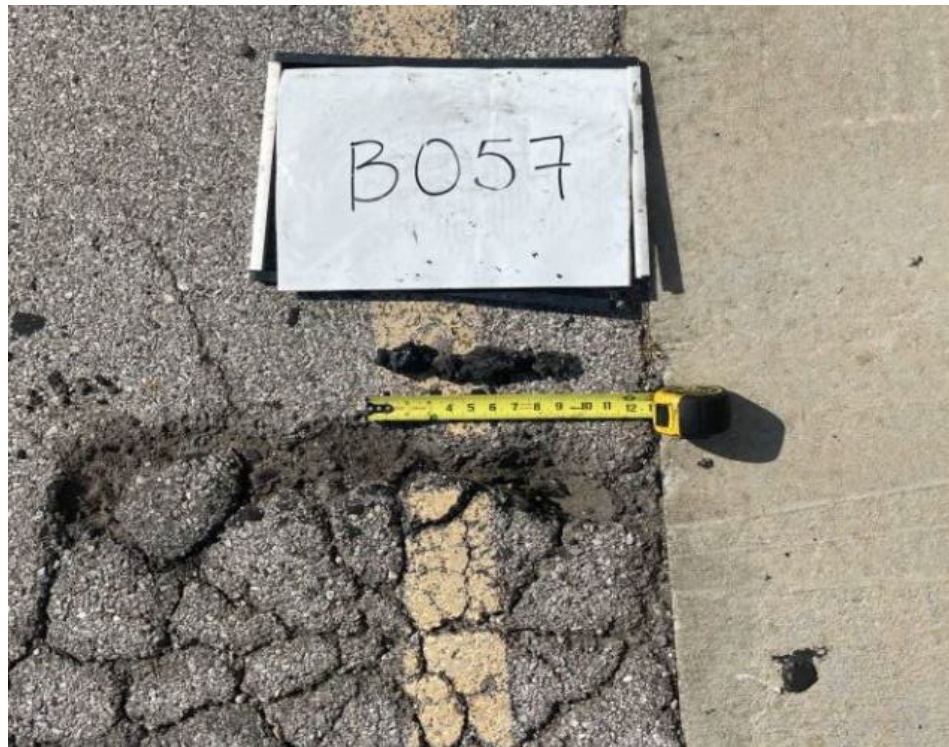
Photo No. 6	Inspection Date: 8/2/2023

<p>Description:</p> <p>Stall B057. Some tar-like material observed at historical seep location along asphalt crack, material was removed.</p> <p>Lat: 29.784747 Long: -95.319549</p>

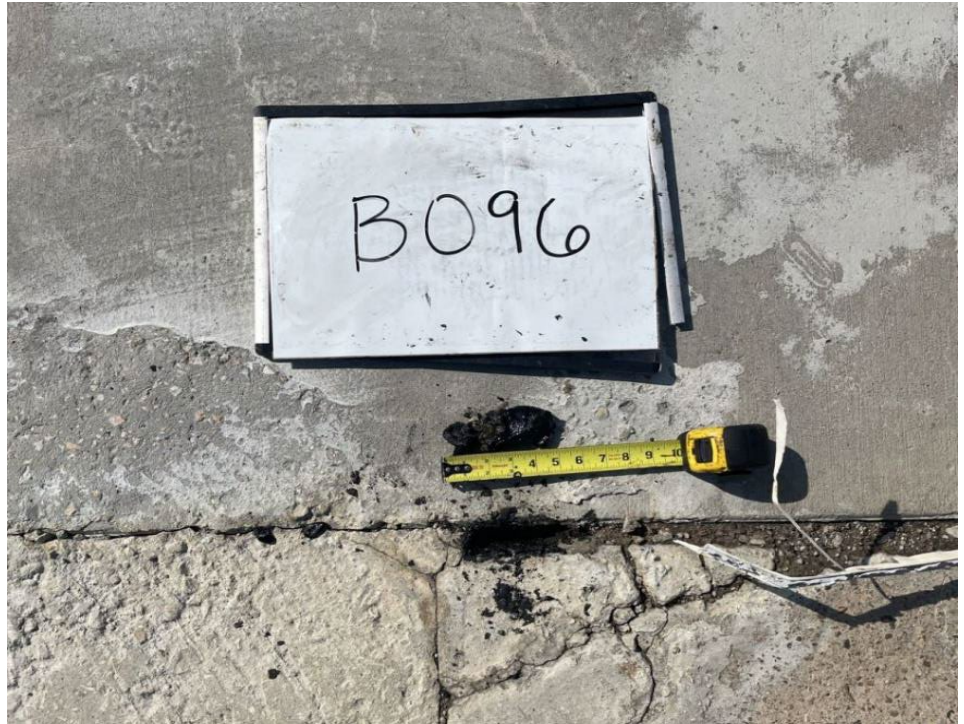
Stall B096, some staining and cracking concrete observed at former test pit location. Some tar-like material observed and removed.

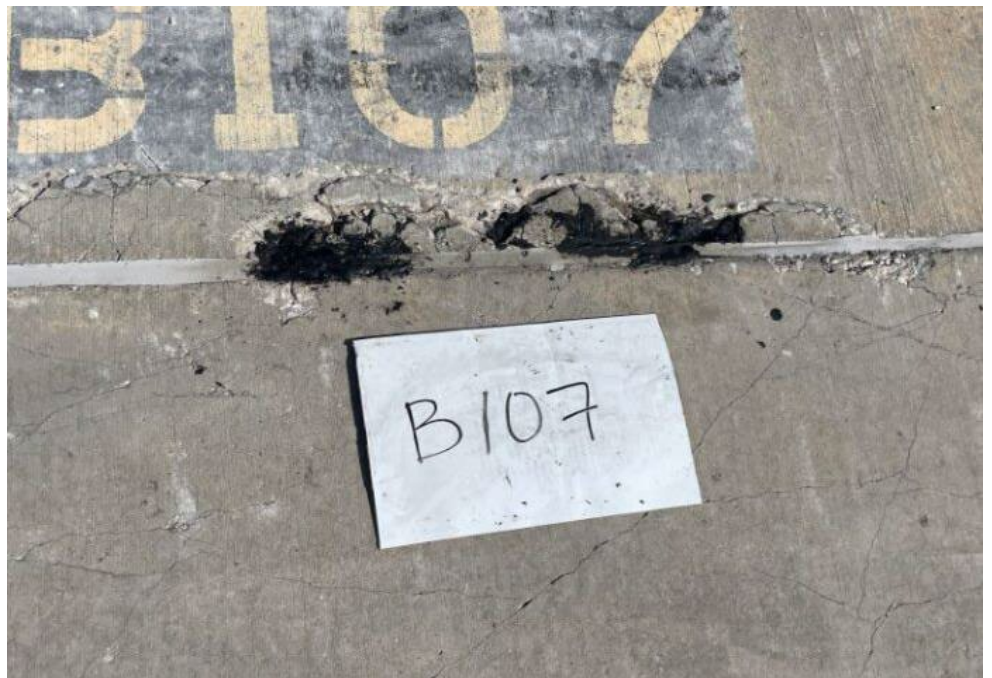
Photo No.
8

- Some small tar-like material seeps were observed on the asphalt or concrete in Stall B107 during the August 2, 9, 16, and 23, 2023 inspections (Photo Nos. 8, 19, 41, and 55). The tar-like material was recovered from these locations when observed.

Stalls B107, some new tar-like material observed and removed at seep location on concrete joint along the southern edge of the excavated area.

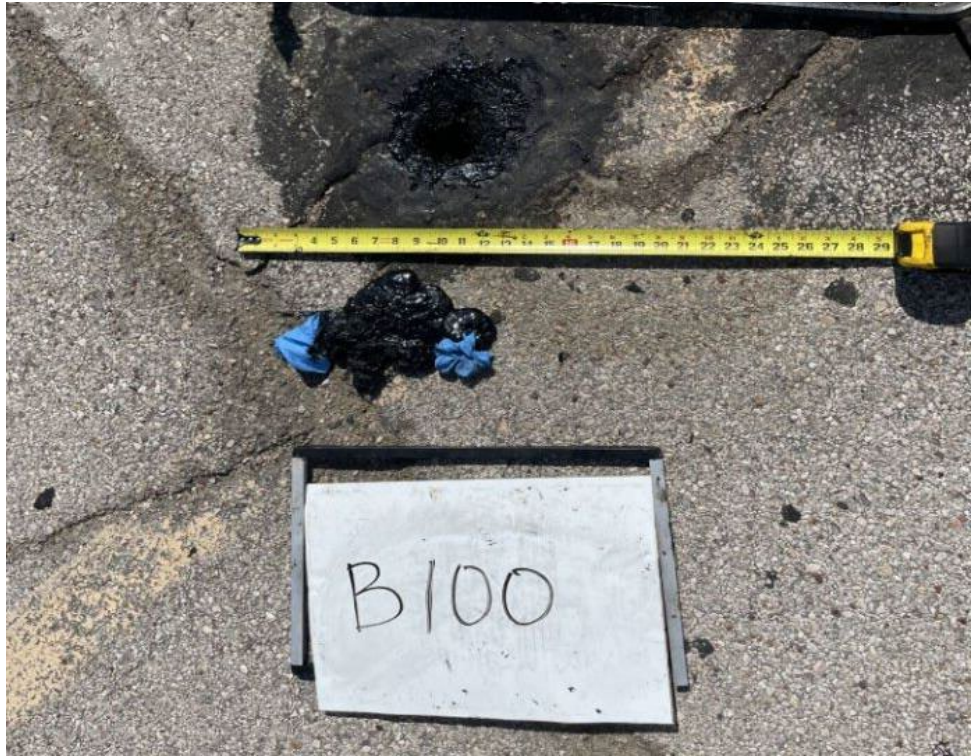
Stall B100, Some tar-like material observed and removed.

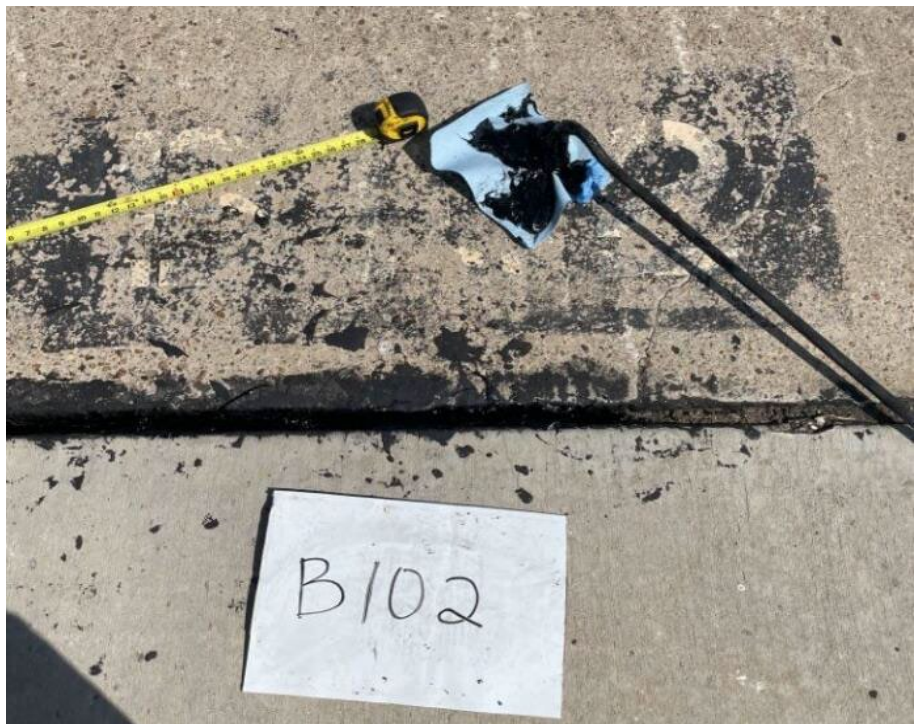
Stall B102 (joint), tar-like material observed and removed.

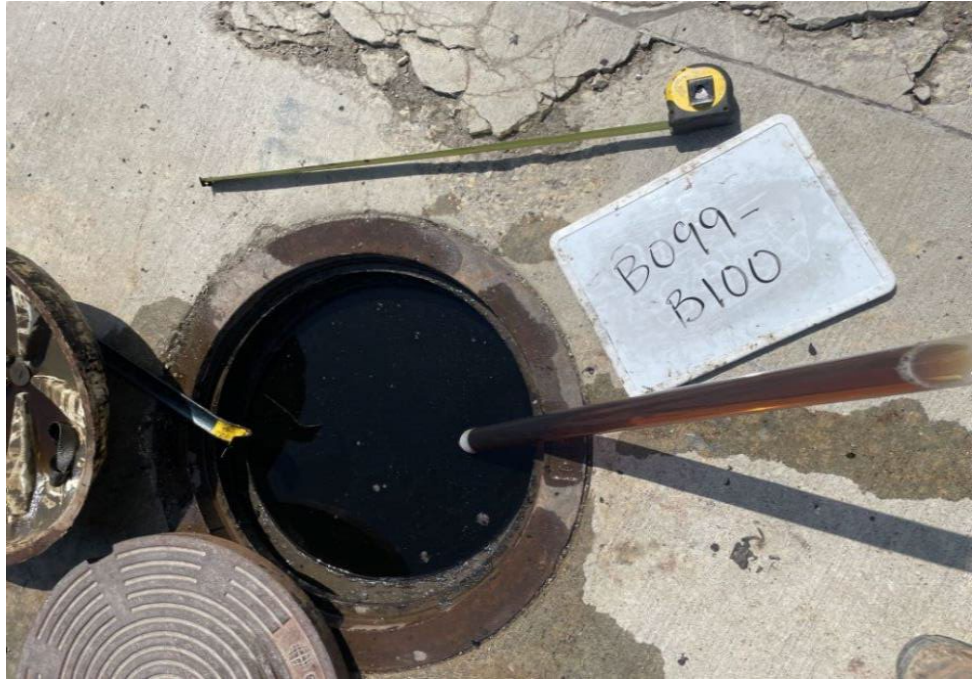
Sump 1 (B099/B100), 0 inches of freeboard in sump, no sheen or odor observed, no new NAPL accumulation on inflow protector, color noted as dark brown.

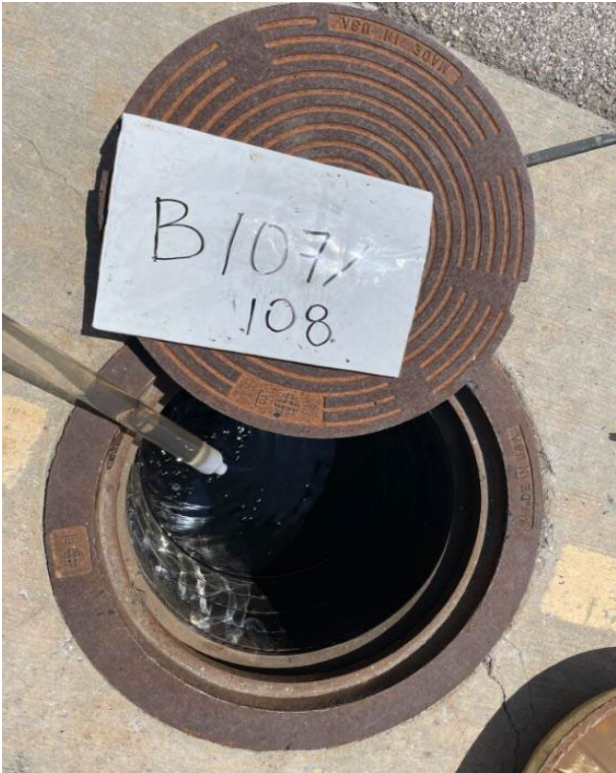
Description: Sump 3 (B107/B108), 15.5 inches of freeboard in sump, sheen observed, no odor noted, color noted as clear. Lat: 29.784172 Long: -95.320998			
Photo No. 14	Inspection Date: 8/2/2023

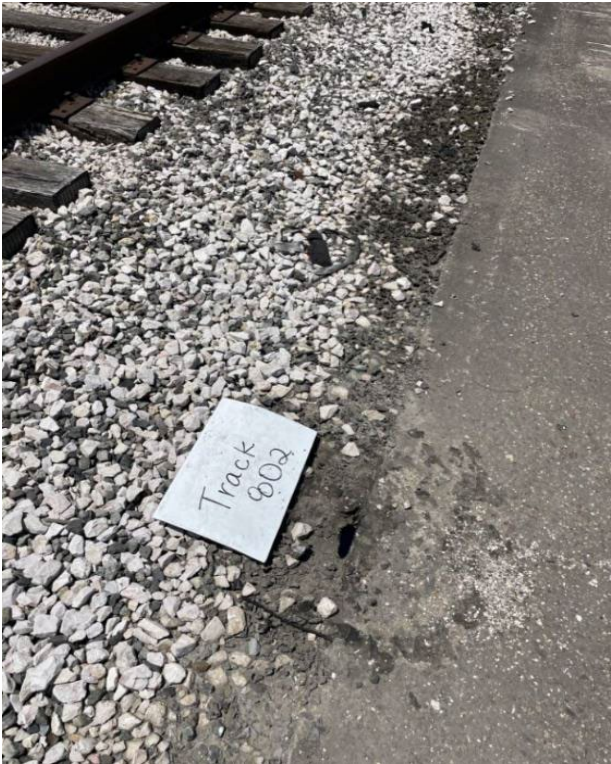
Description: North side of Track 802, a small amount of tar-like material observed at seep location near the edge of the ballast, material removed. Looking Southwest. Lat: 29.784895 Long: -95.321327

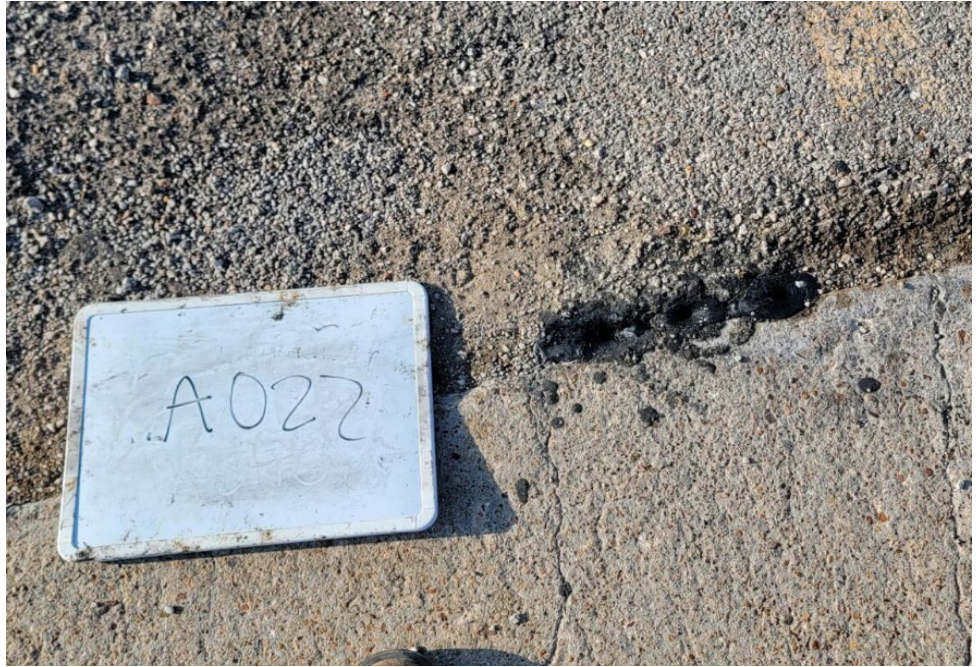
Stall A022. Some tar-like material observed at historical seep location along asphalt crack, material was removed.

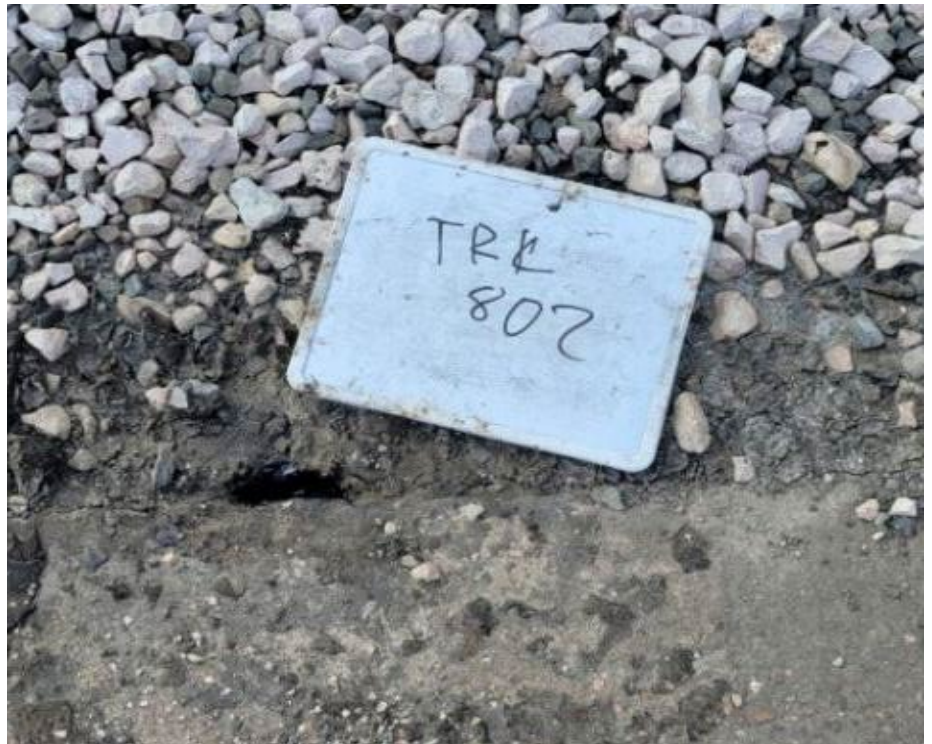
North side of Track 802, some tar-like material observed at seep location near the edge of the ballast, material removed.

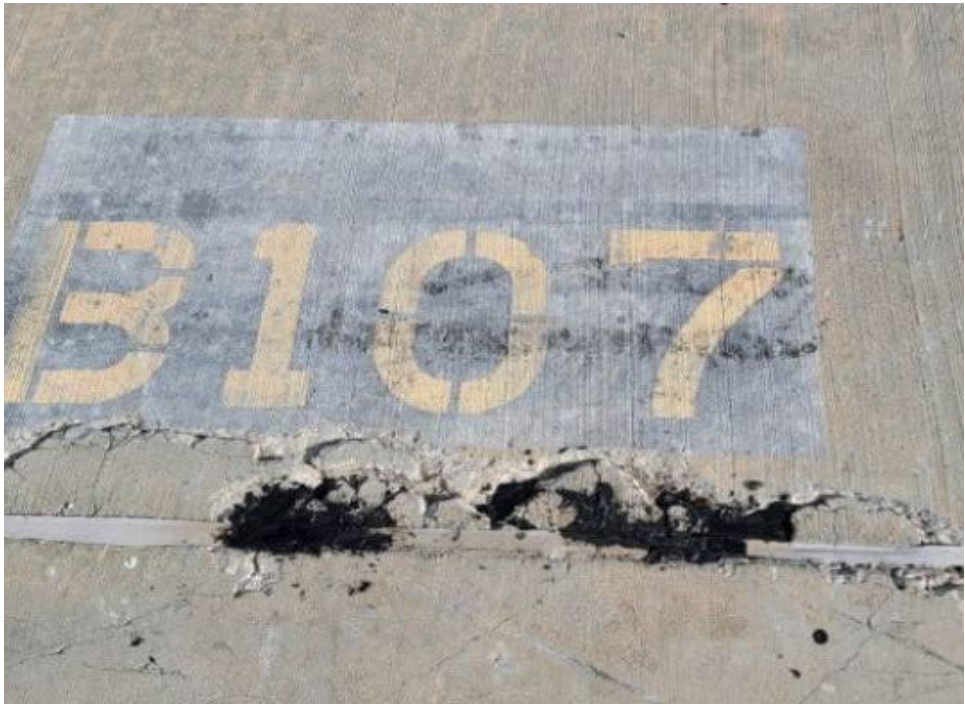
Description: Stalls B107, view of NAPL collection system, some new tar-like material observed and removed at seep location on concrete joint along the southern edge of the excavated area. Lat: 29.784137 Long: -95.32096			
Photo No. 20	Inspection Date: 8/9/2023

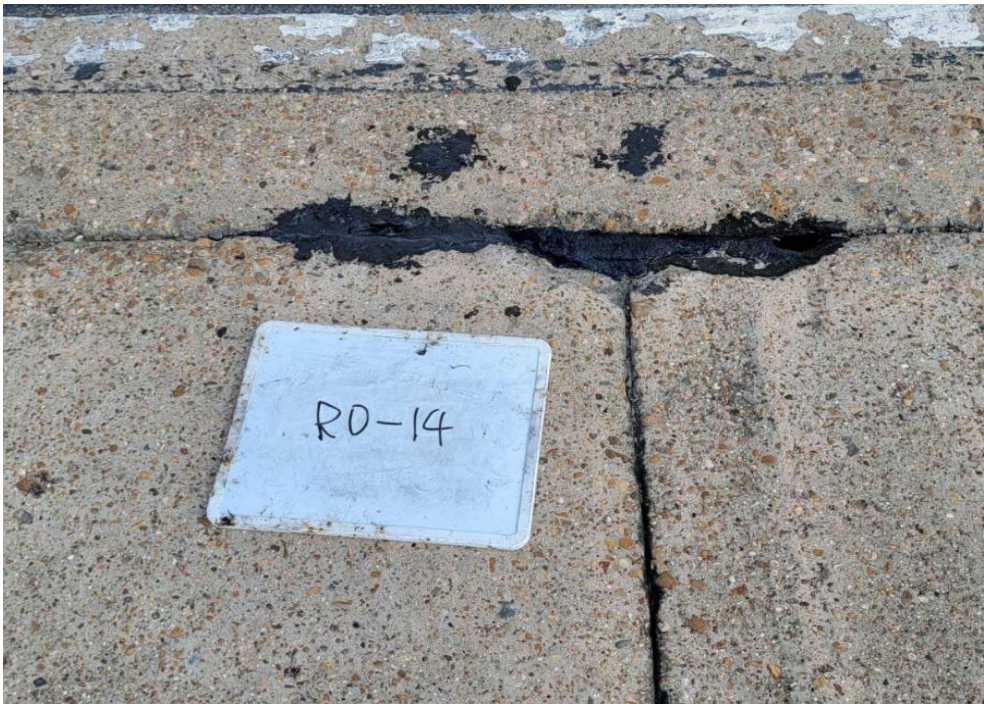
Description: RD-14 Seep location observed within the concrete road area (RD-14) north of Track 802 (east of existing Track 802 seep location), very small amount of tar-like material observed along a concrete joint, material was removed. Lat: 29.785064 Long: -95.321219

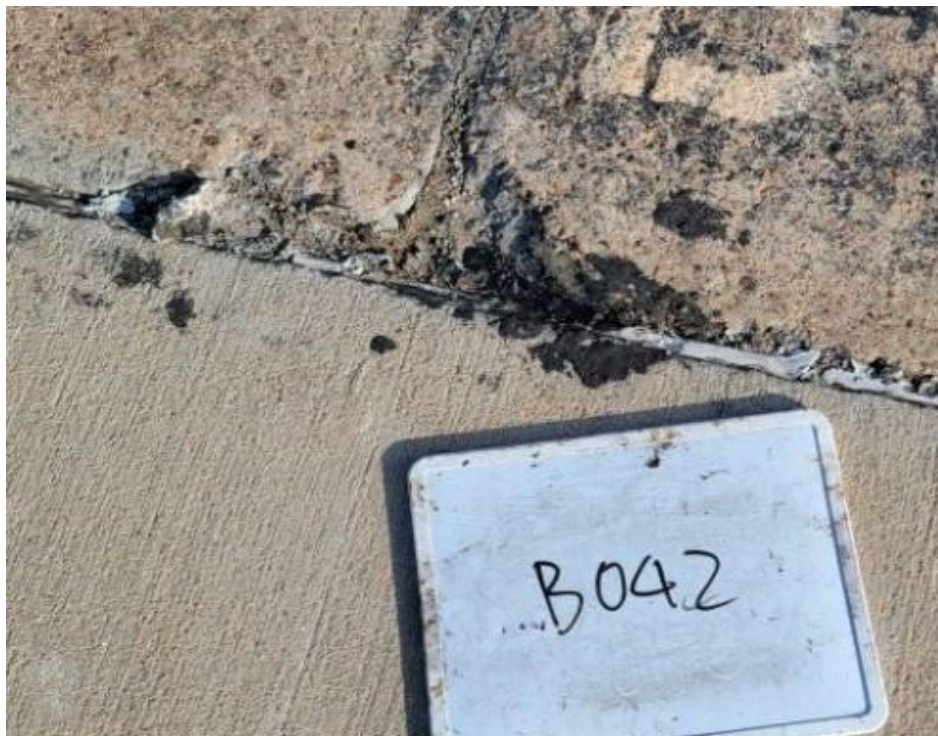
Stall B042. Some tar-like material observed at historical seep location along asphalt crack, material was removed.

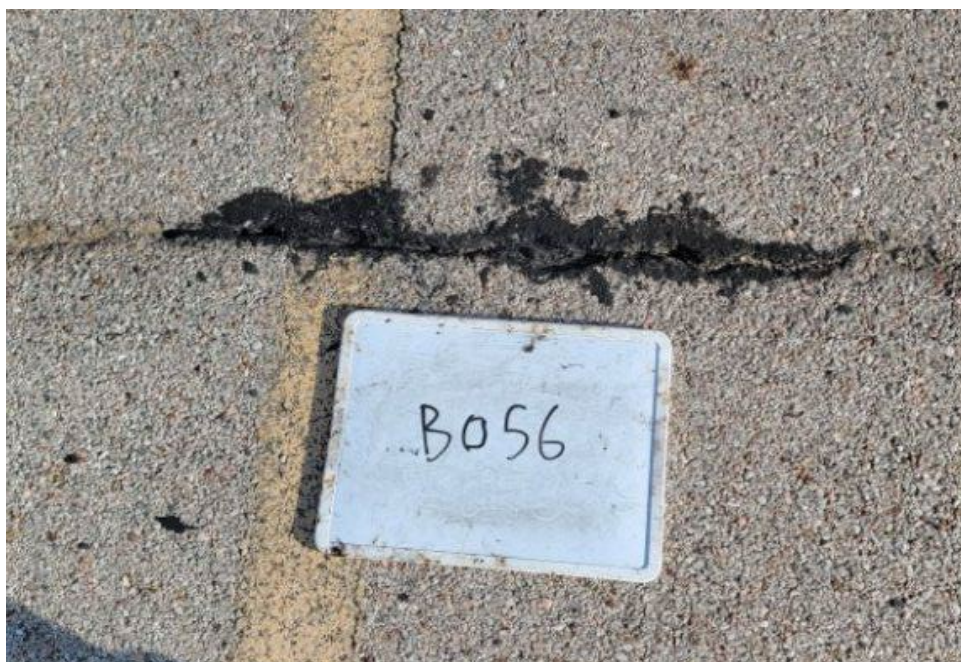
Stall B056. Some tar-like material observed at historical seep location along asphalt crack, material was removed.

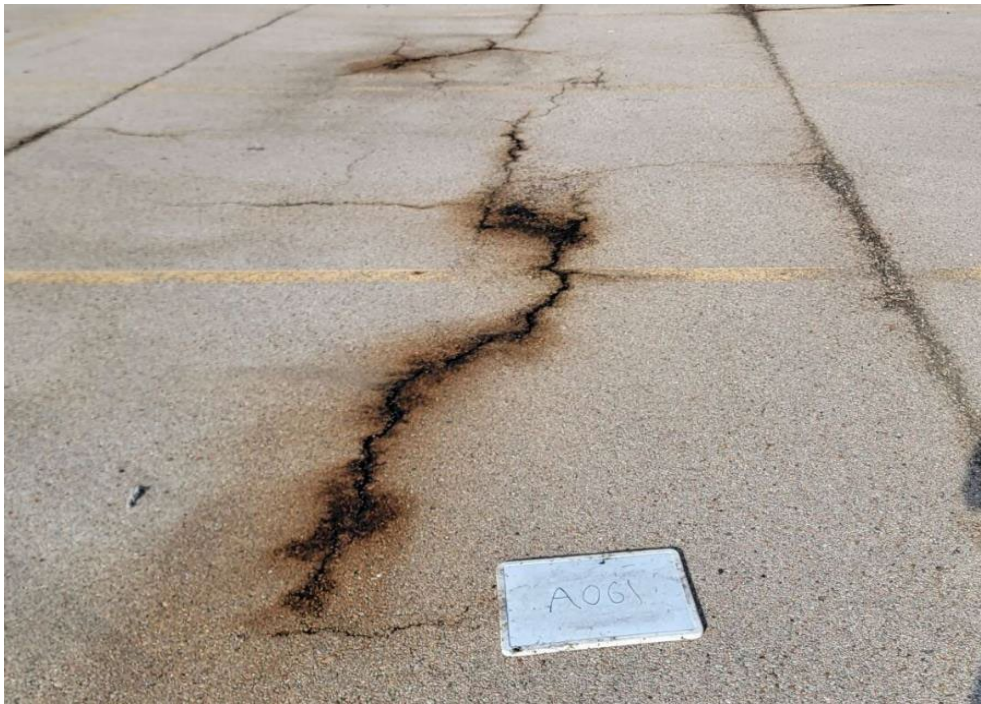
Description: Stall A061, some staining observed along cracks in pavement. Looking west. Lat: 29.784858 Long: -95.319733			
Photo No. 24	Inspection Date: 8/9/2023

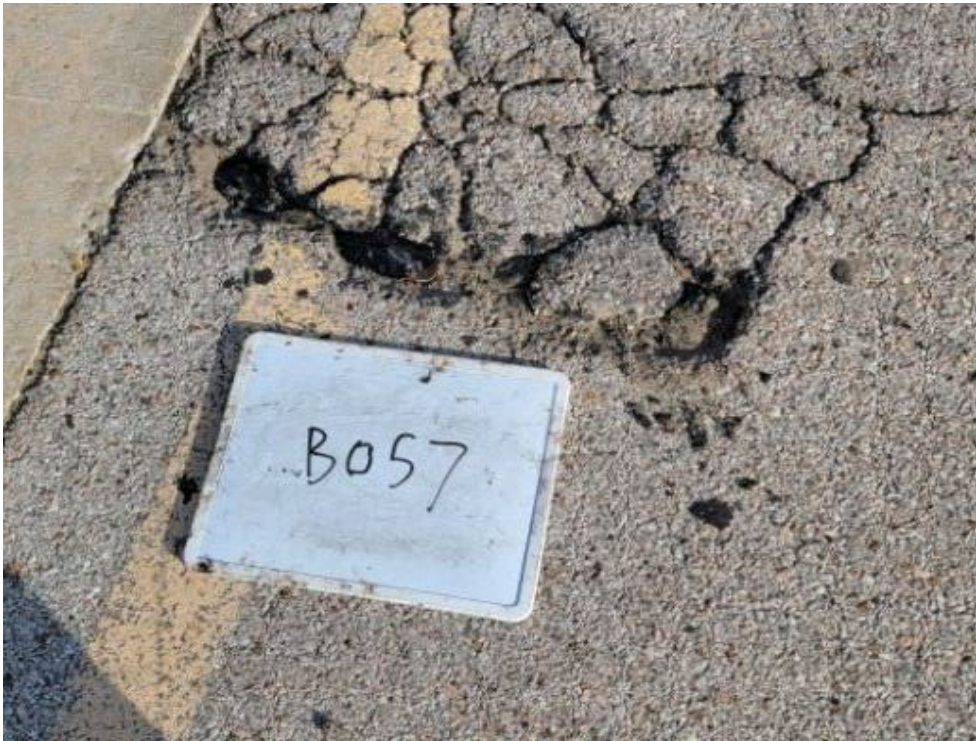
Description: Stall B057. Some tar-like material observed at historical seep location along asphalt crack, material was removed. Lat: 29.784747 Long: -95.319549

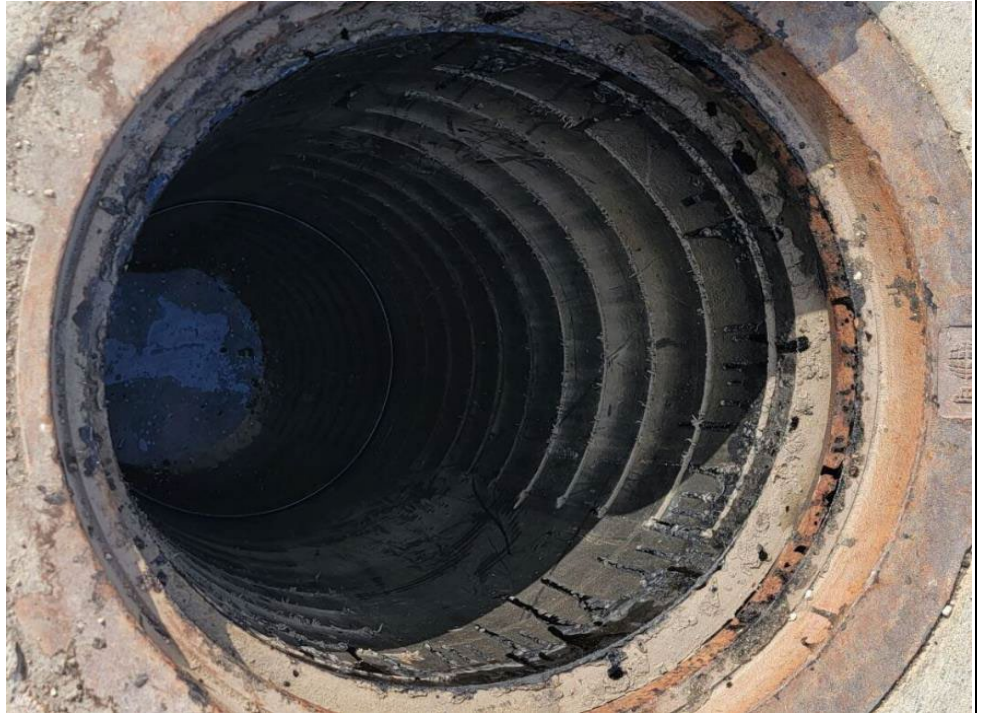
Sump 1 (B099/B100), 42 inches of freeboard in sump, no odor noted, sheen observed, no new NAPL accumulation on inflow protector, water color noted as brown.

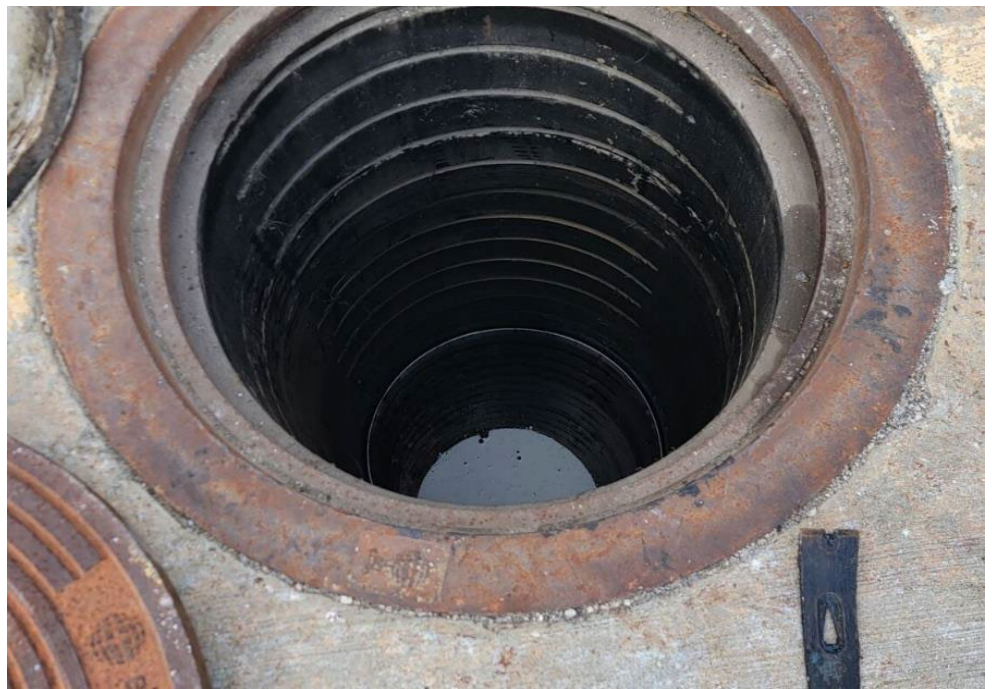
Sump 2 (B103/B104), 47 inches of freeboard before pumping. No sheen or odor noted, color noted as light brown.

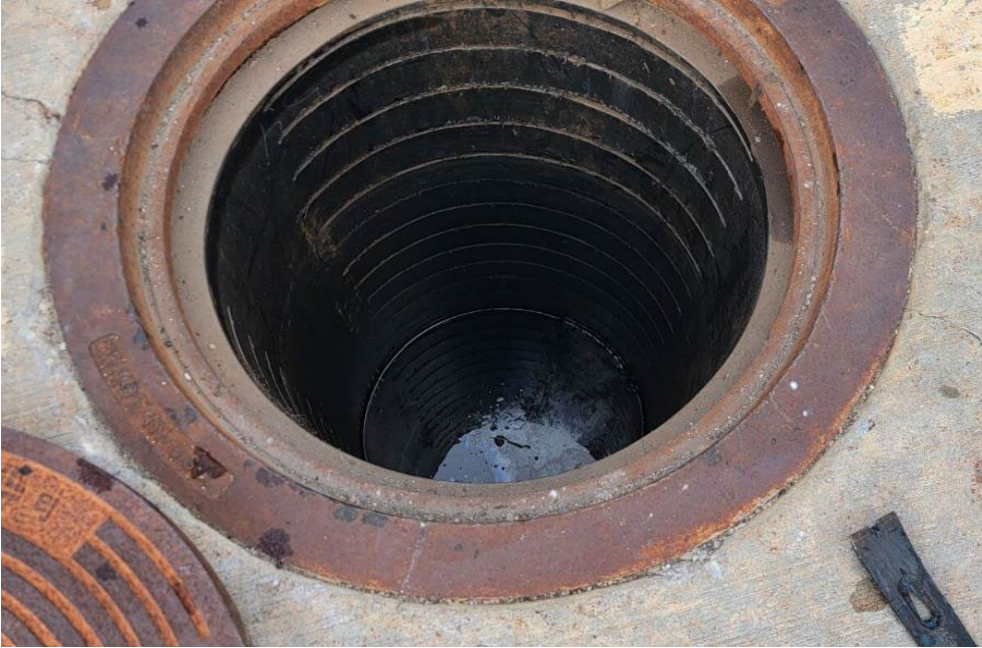
Description: Sump 3 (B107/B108), 47 inches of freeboard in sump, no odor noted, sheen observed, no new NAPL accumulation on inflow protector, water color noted as clear. Lat: 29.7844000 Long: - 95.3205861			
Photo No. 28	Inspection Date: 8/9/2023

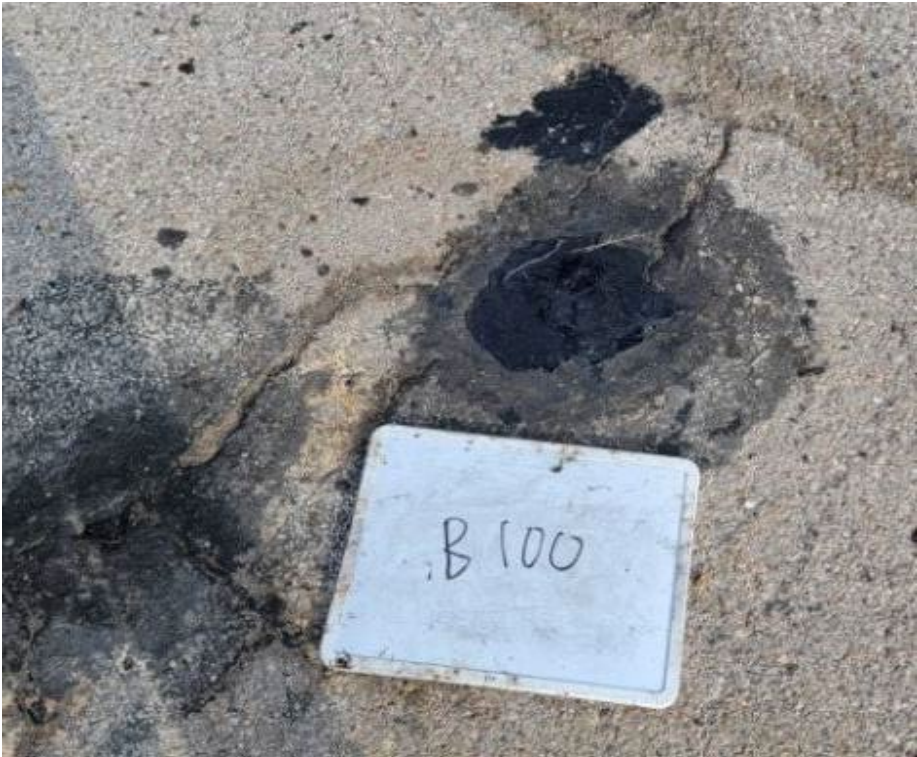
Description: Stall B100, some new tar-like material observed and removed at seep location on concrete crack/hole in concrete. Lat: 29.7842517 Long: -95.3208166

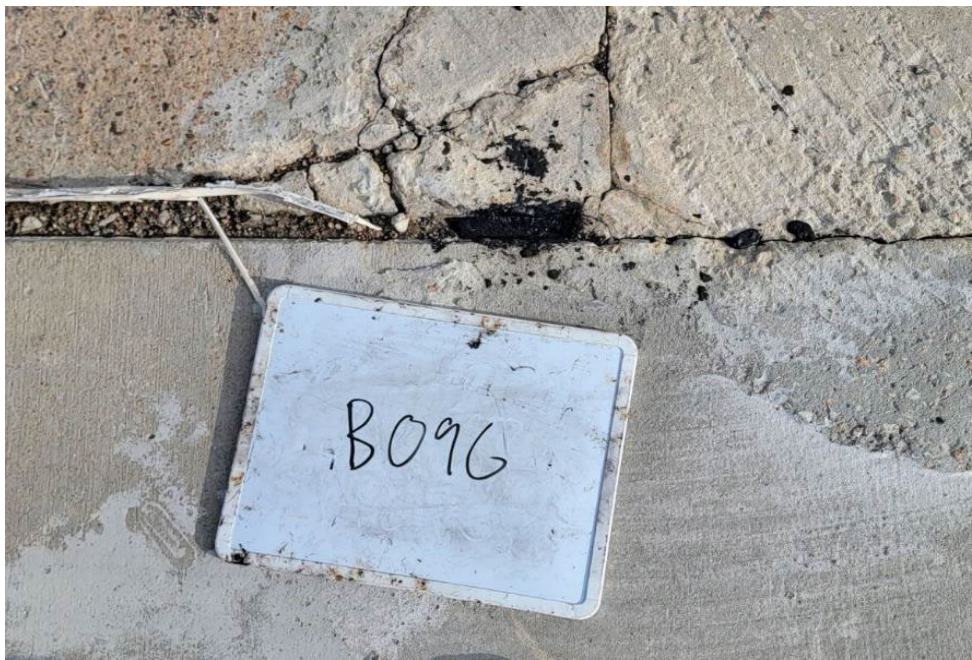
Stall B096, some staining and cracking concrete observed at former test pit location. Some tar-like material observed and removed.

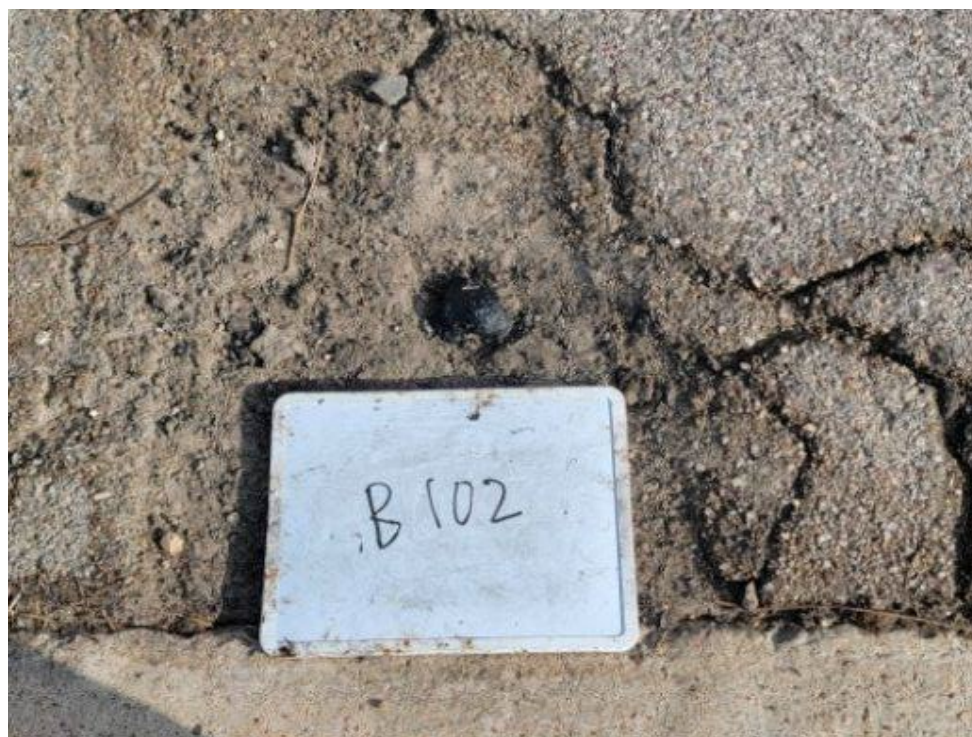
Stall B102 (center), tar-like material observed and removed at seep location along cracks in pavement.

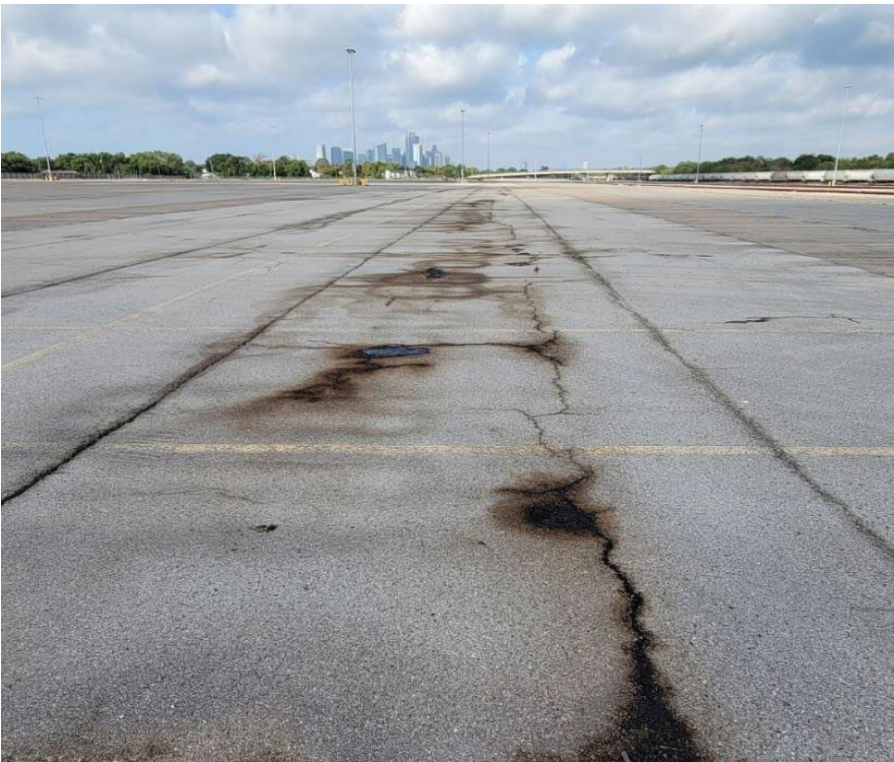
Description: Stalls A065 - A070 some minimal staining observed. Looking west. Lat: 29.784858 Long: -95.319733			
Photo No. 32	Inspection Date: 8/16/2023

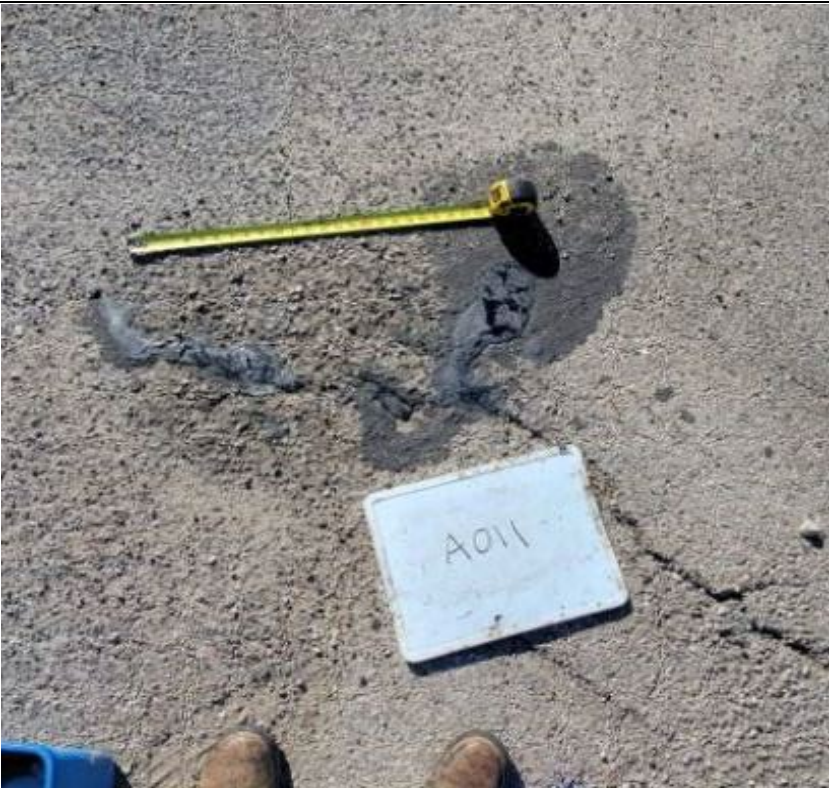
Description: Stall A011 some tar-like material observed at historical seep location along asphalt crack, material was removed. Lat: 29.785392, Long: -95.318655

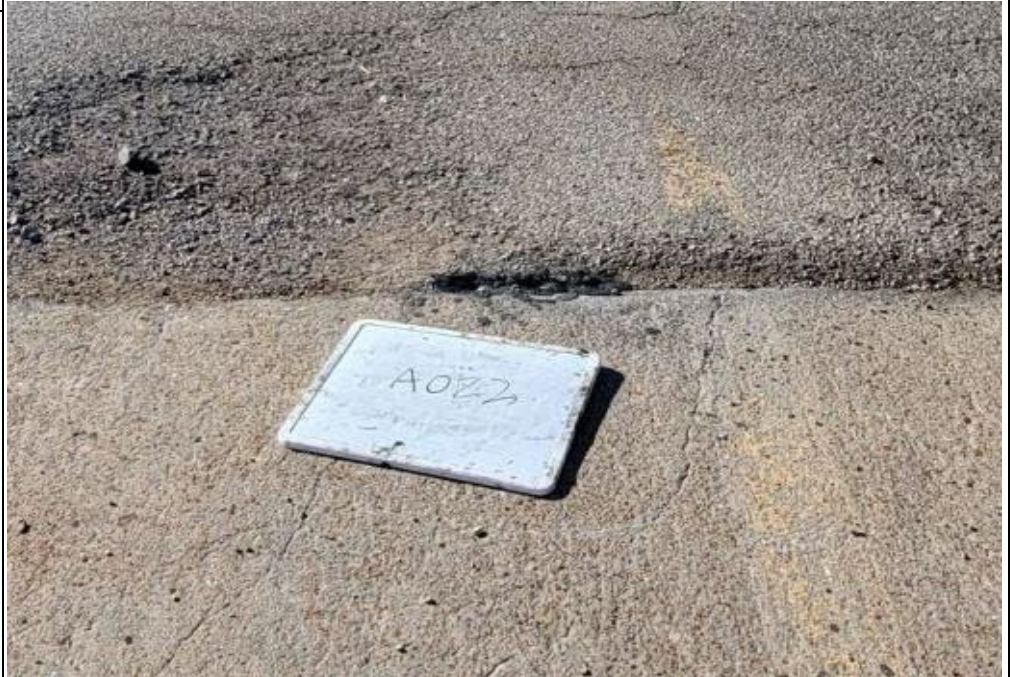
Stall A022, some tar-like material observed at the seep location along the edge tar-like material seeps observed and removed. Looking south.

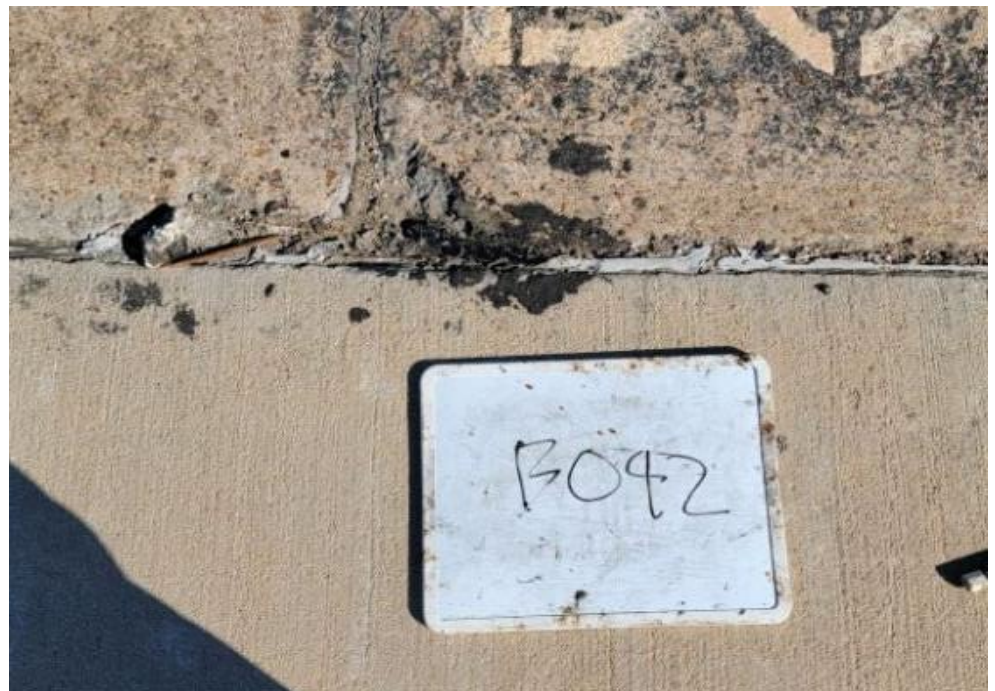
Stall BO42. Some tar-like material observed at historical seep location along asphalt crack, material was removed.

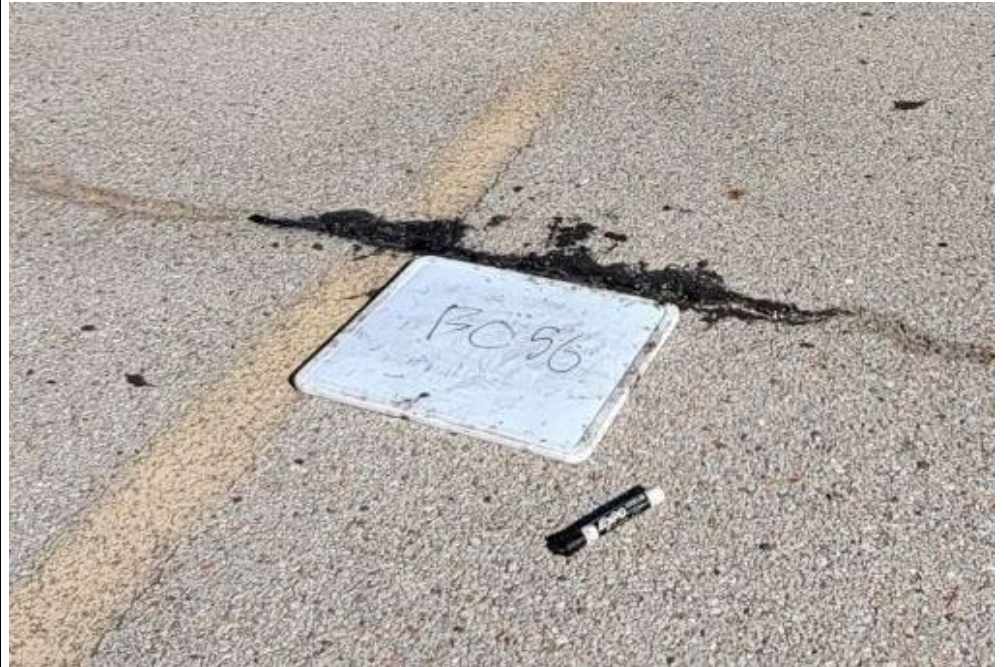
Stall B056. Some tar-like material observed at historical seep location along asphalt crack, material was removed.

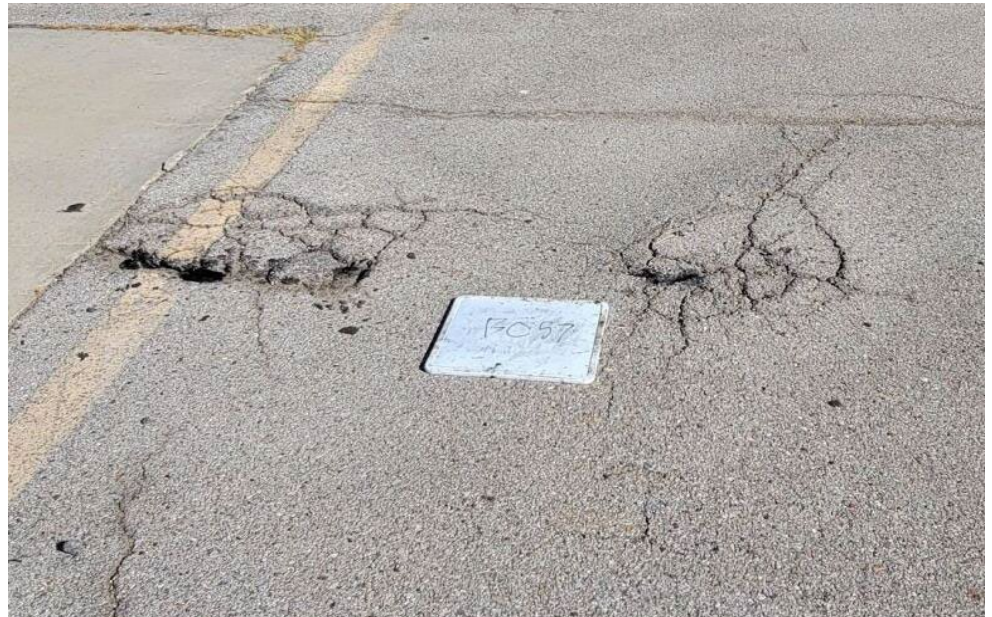
Stall B057, some new tar-like material observed and removed at seep location along asphalt crack. Looking north.
