September 15, 2023

Project No. 31406585.016

**Re: MONTHLY STATUS UPDATE – ENGLEWOOD INTERMODAL YARD – NAPL COLLECTION
SYSTEM/CONCRETE CAP REPAIRS
UNION PACIFIC RAILROAD HOUSTON WOOD PRESERVING WORKS FACILITY
4910 LIBERTY ROAD FACILITY, HOUSTON, TEXAS
POST-CLOSURE CARE PERMIT NO. HW-50343; INDUSTRIAL SWR NO. 31547**

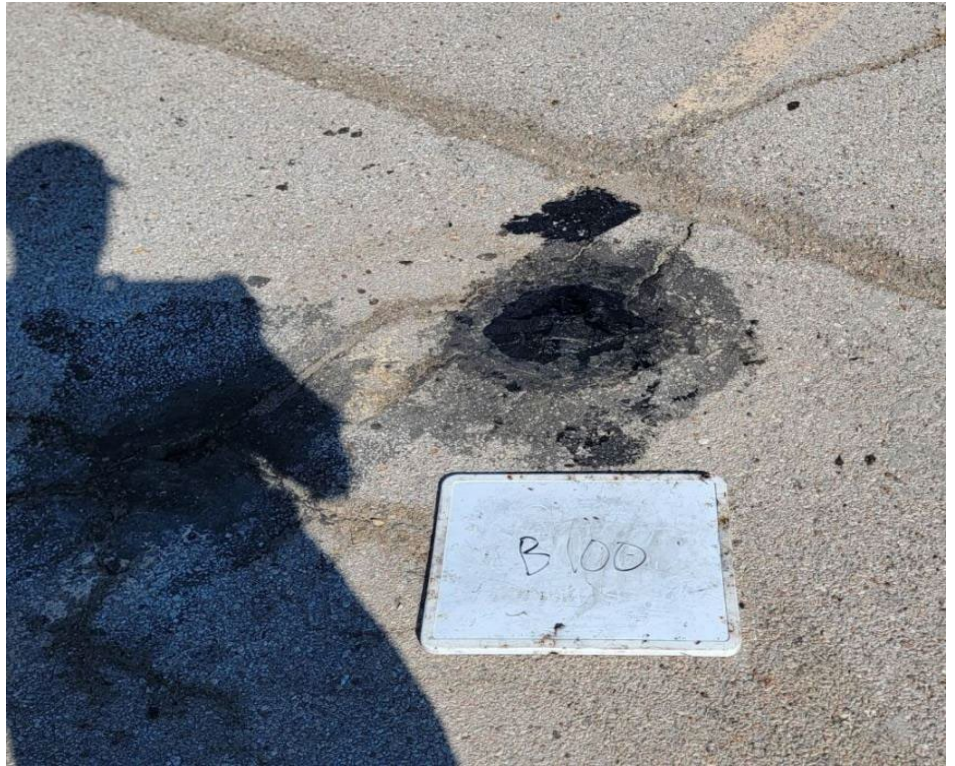
Stall B100, tar-like material observed and removed at seep location along asphalt crack/hole in the asphalt. Test pit on right of photo. Looking Northwest.

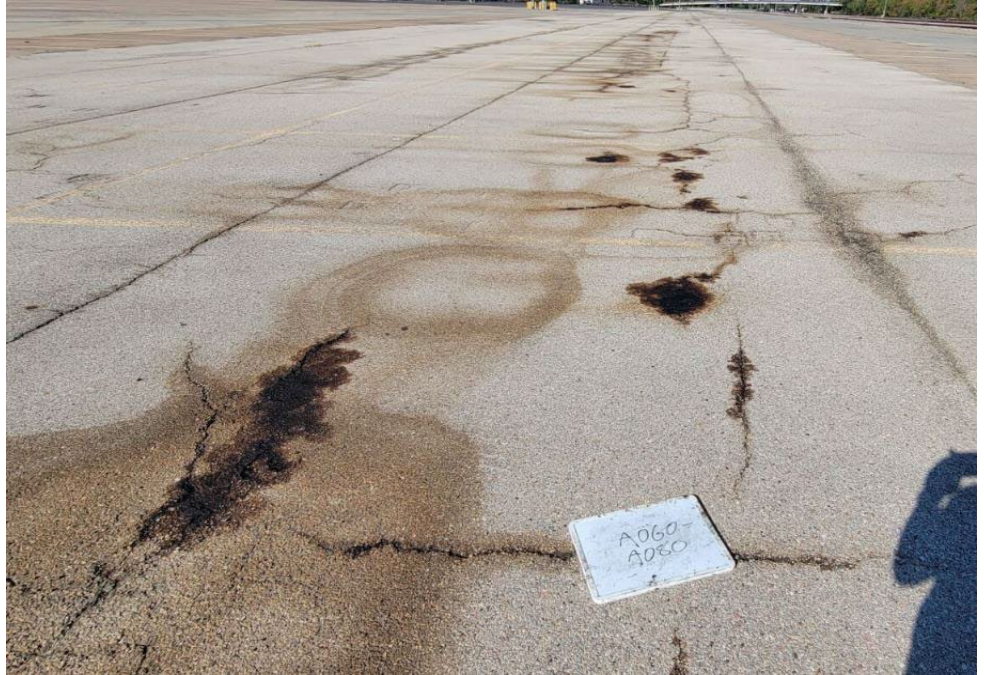
Stalls A060 - A080, some staining observed along cracks in pavement. Looking west.

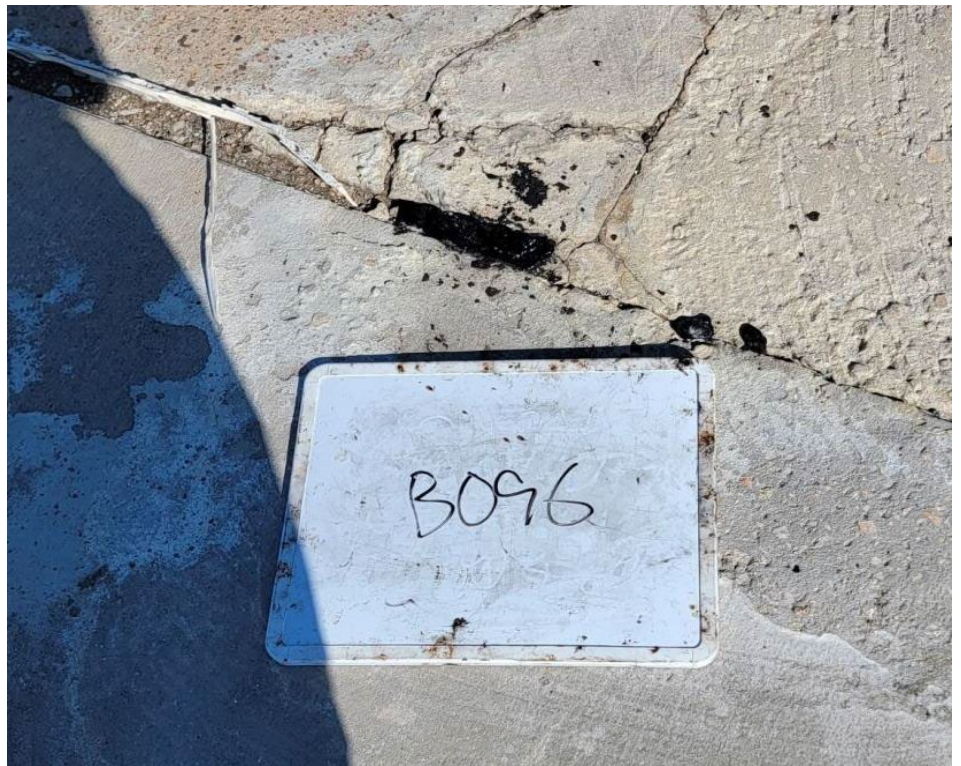
Photo No.
40

Stall B096, some staining and cracking concrete observed at historical seepage location. Some tar-like material observed and removed.

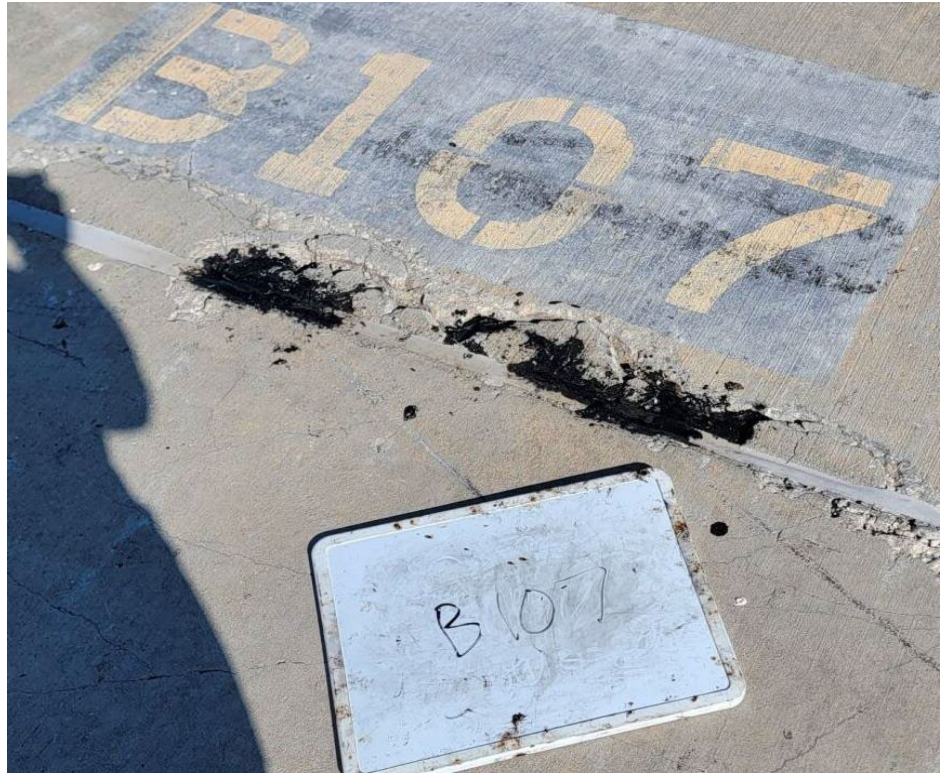
Stalls B107, some new tar-like material observed and removed at seep location on concrete joint along the southern edge of the excavated area.

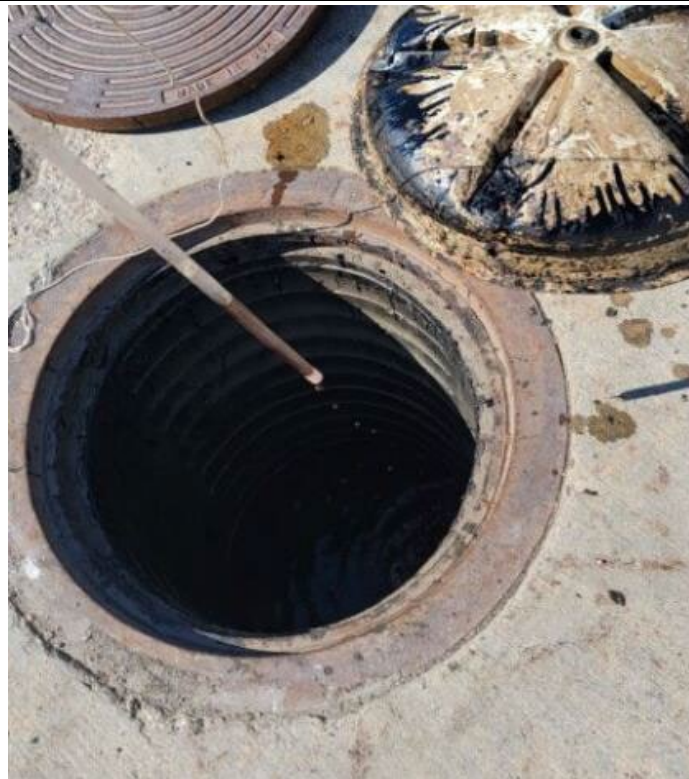
Sump 1 (B099/B100), 38.5 inches of freeboard in sump, no odor noted, sheen observed, no new NAPL accumulation on inflow protector, water color noted as brown.

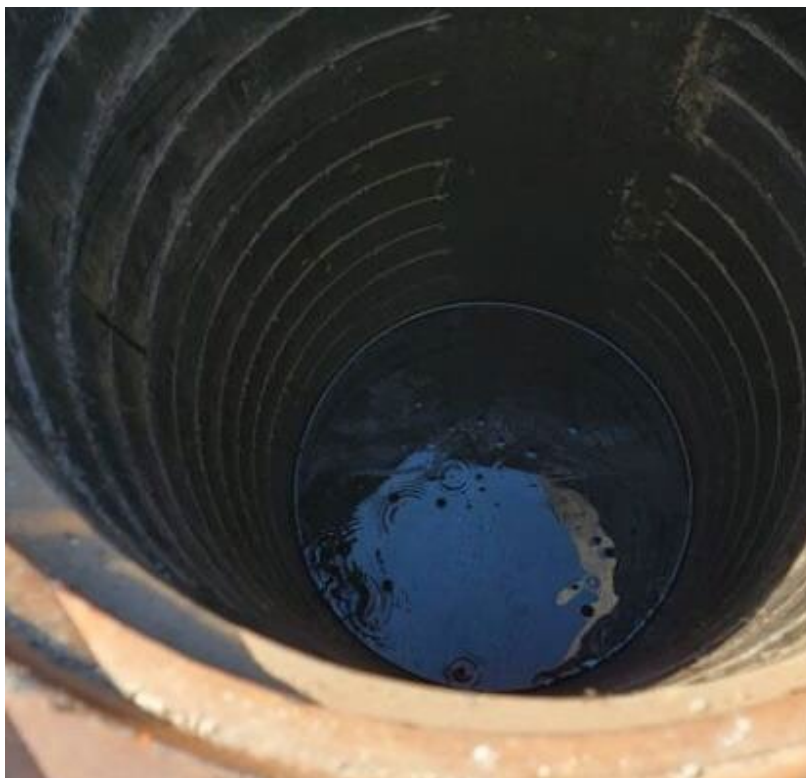
Sump 3 (B107/B108), 47 inches of freeboard in sump, no odor noted, sheen observed, no new NAPL accumulation on inflow protector, water color noted as light brown.

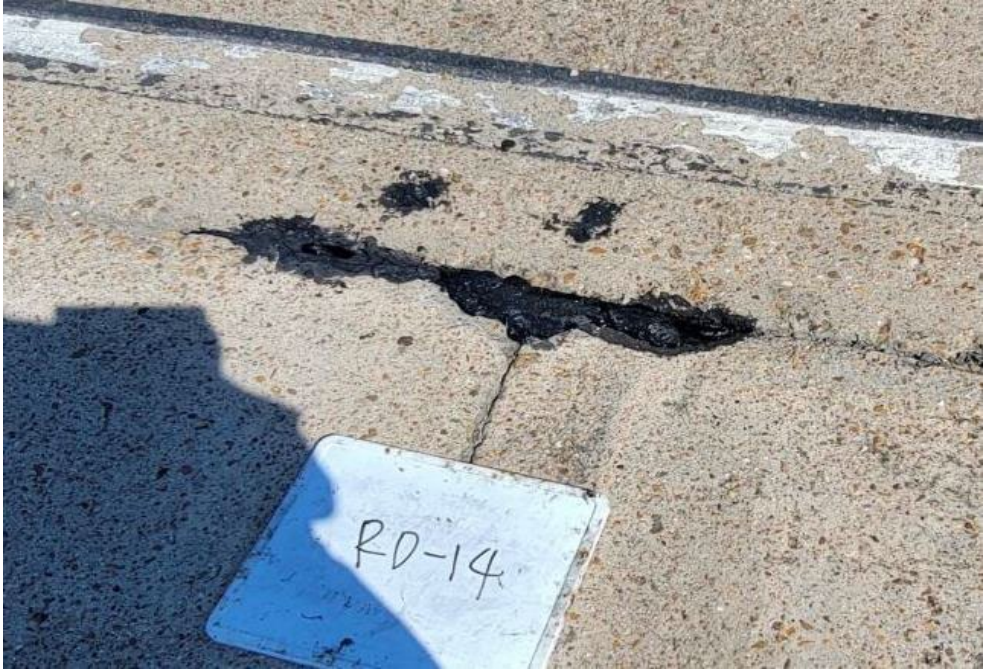
Description: RD-14 Seep location observed within the concrete road area (RD-14) north of Track 802 (east of existing Track 802 seep location), small amount of tar-like material observed along a concrete joint, material was removed. Lat: 29.785064 Long: -95.321219			
Photo No. 46	Inspection Date: 8/16/2023

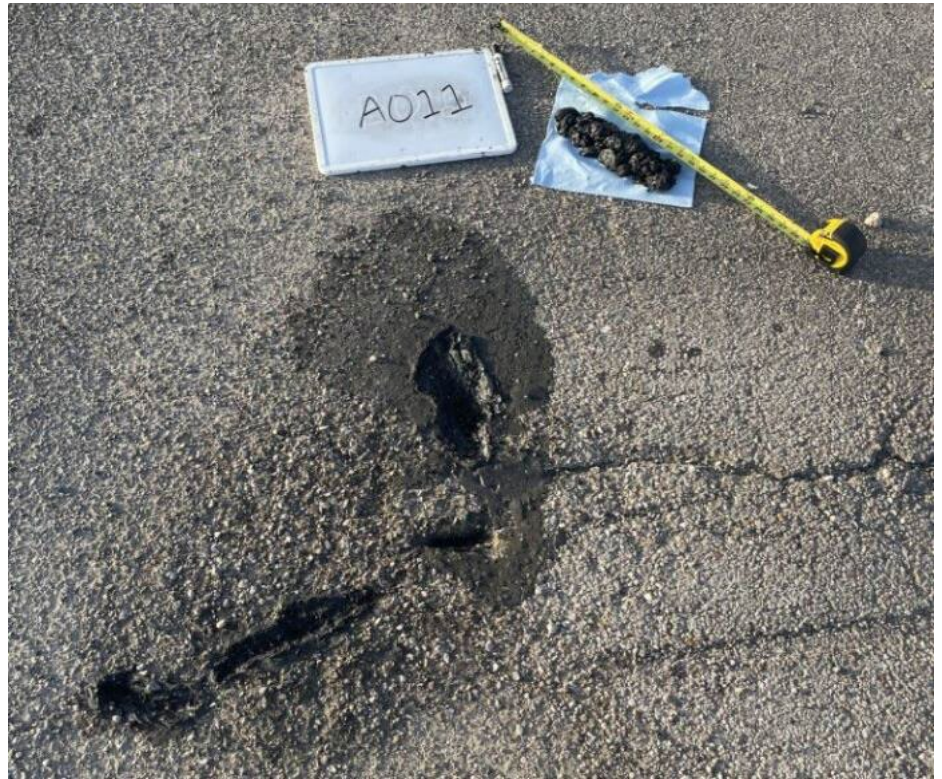
Stall A011 some tar-like material observed at historical seep location along asphalt crack, material was removed.

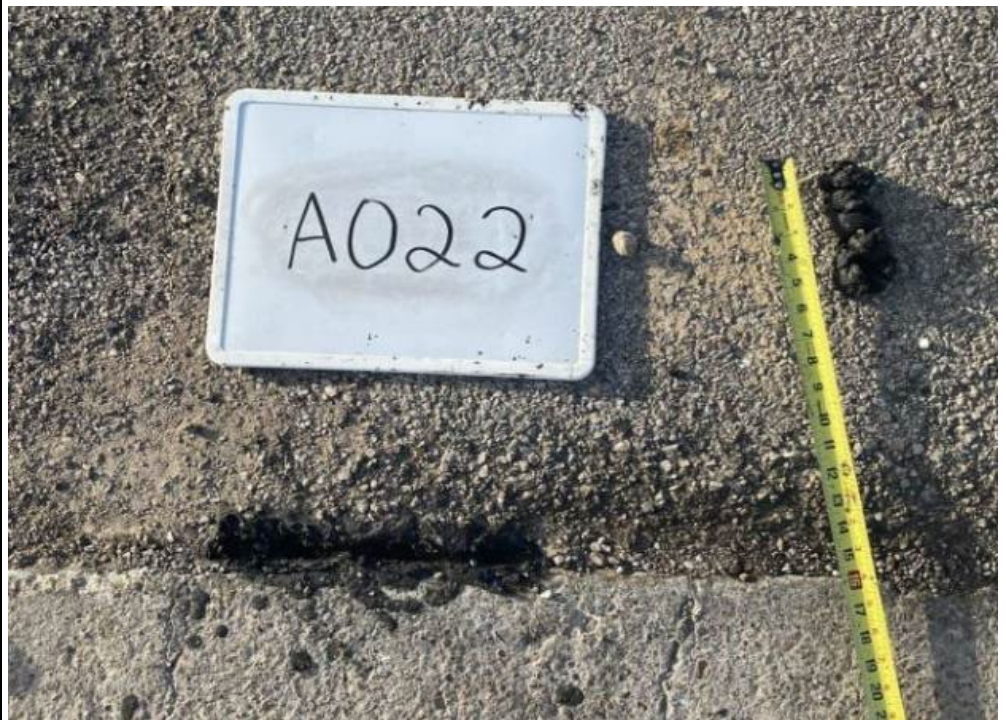
Stall A022, some tar-like material observed at the seep location along the edge tar-like material seeps observed.

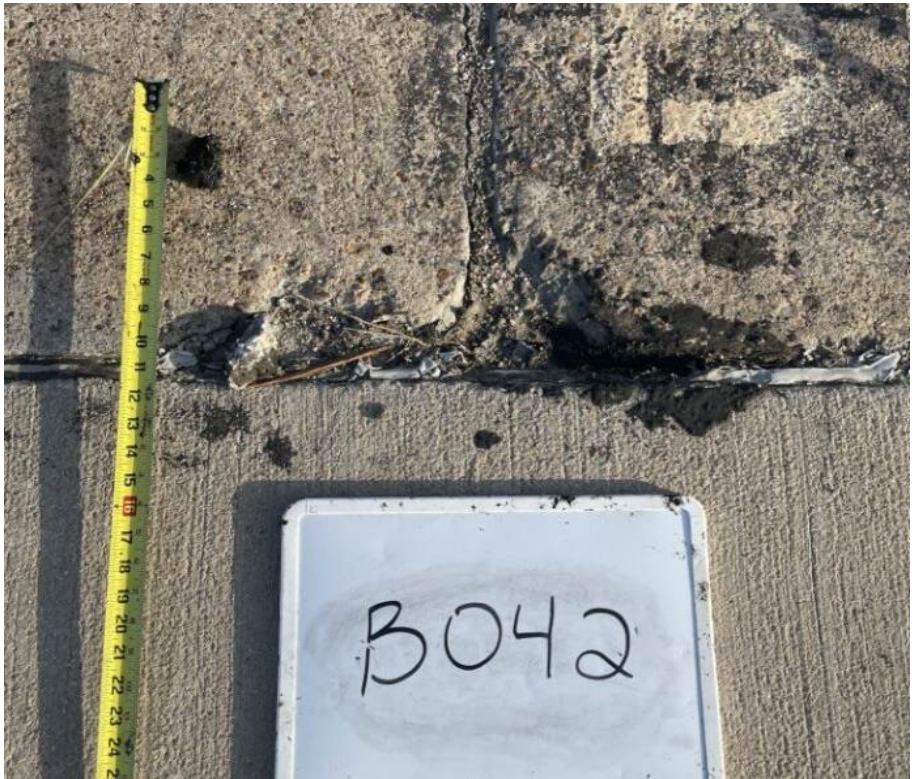
Stall B042. Some tar-like material observed at historical seep location along asphalt crack, material was removed.

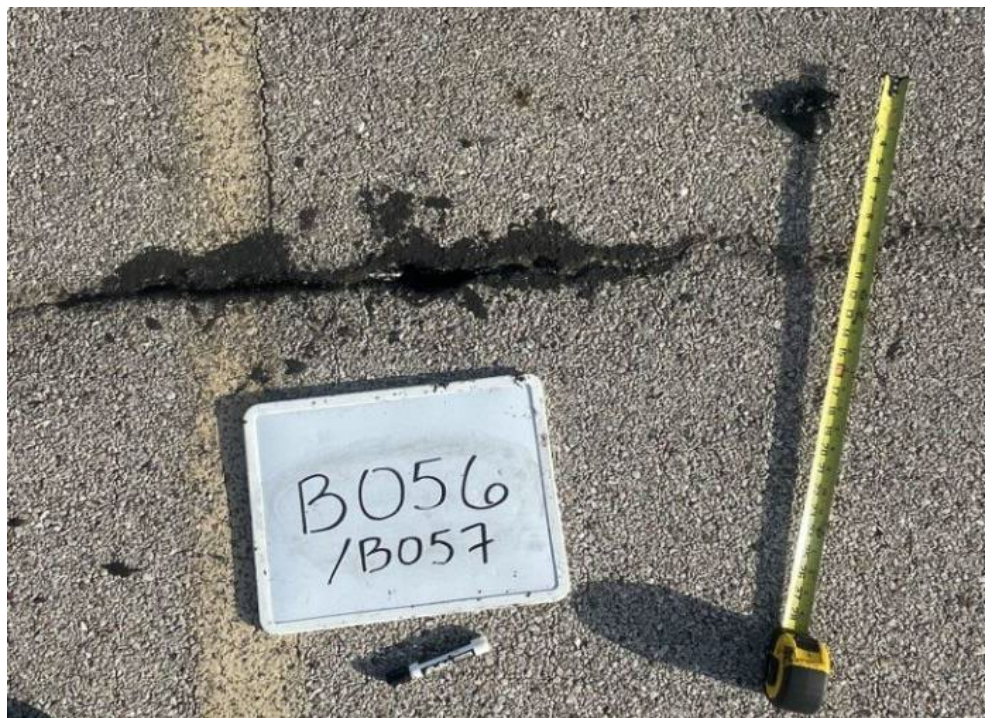
Stall B056. Some tar-like material observed at historical seep location along asphalt crack, material was removed.

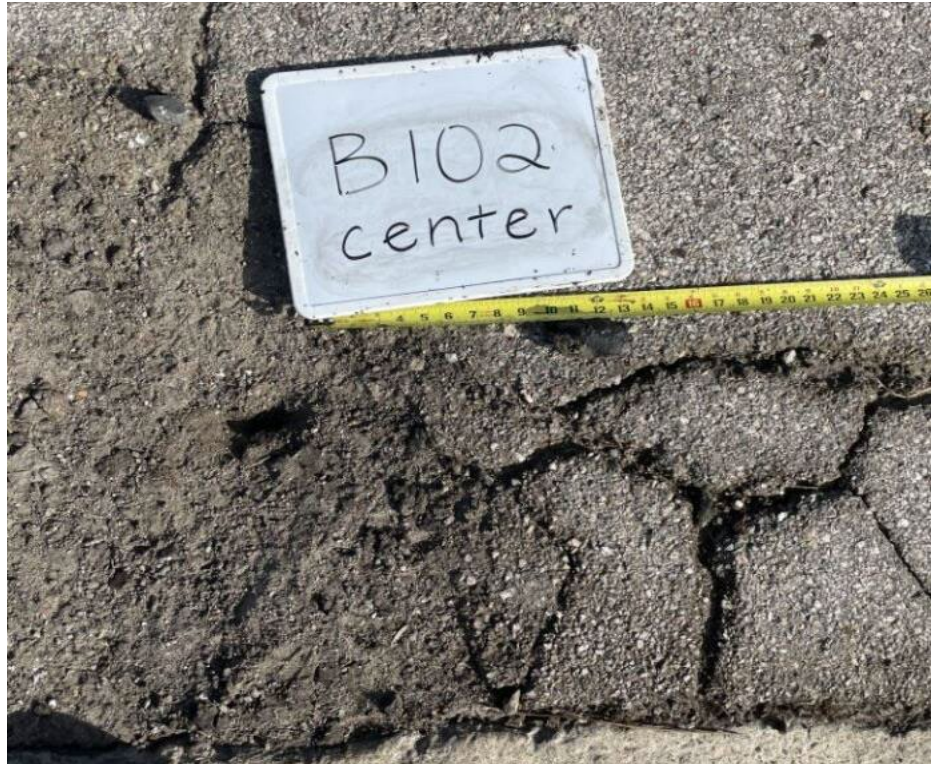
Stall 102 (center), tar-like material observed and removed at seep location where pavement is cracked.

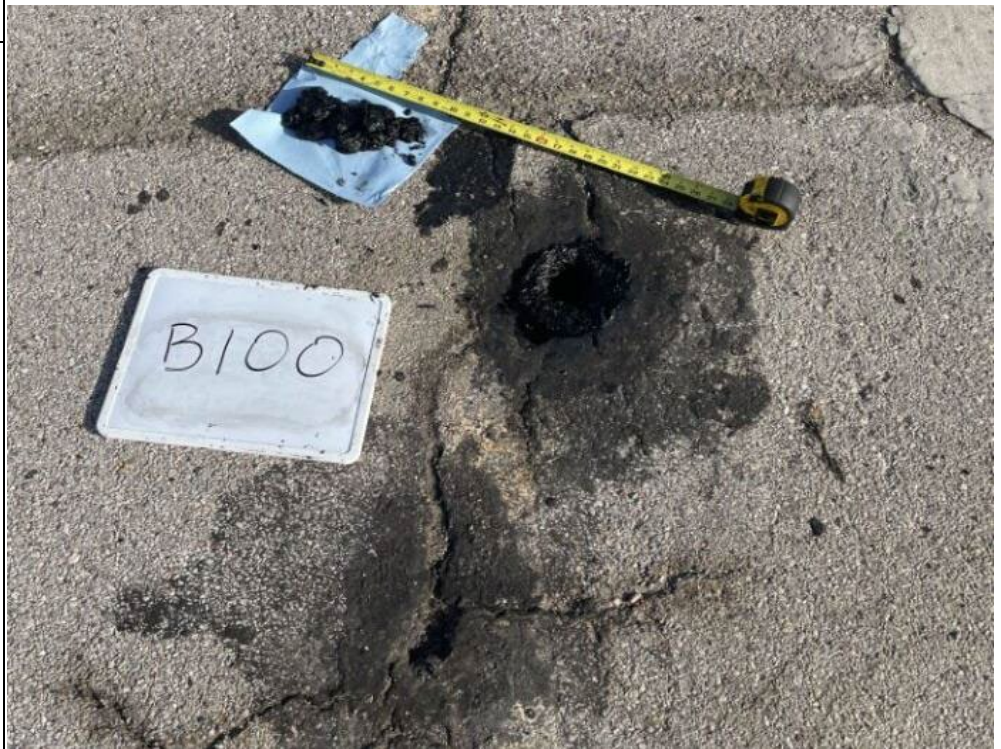
Stall B100, tar-like material observed and removed at seep location along asphalt crack/hole in the asphalt.

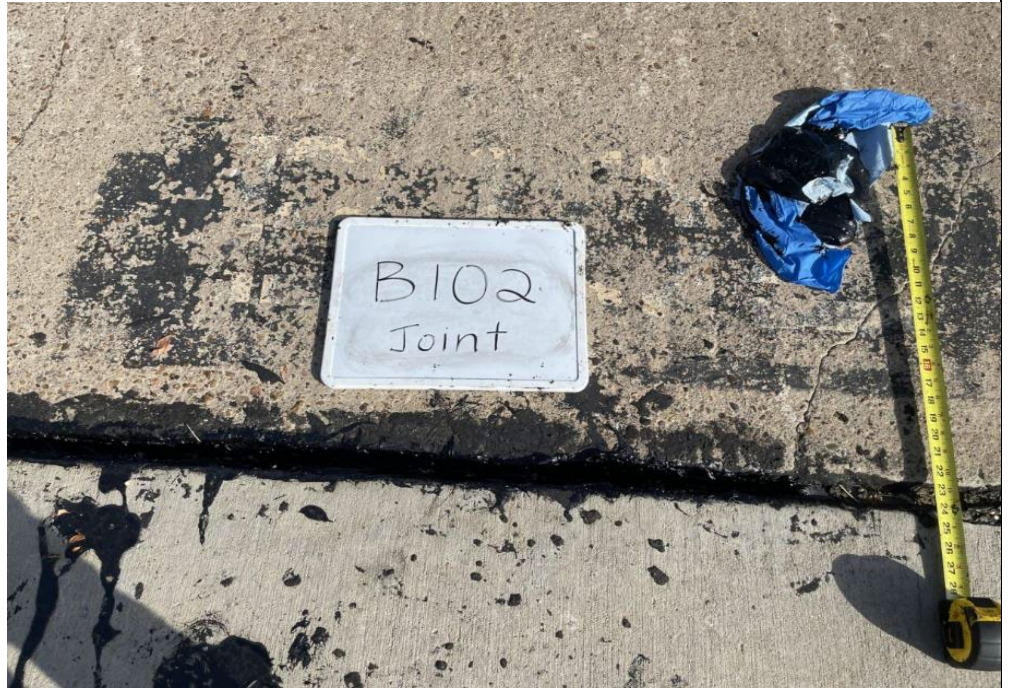
Stall B102 Joint, tar-like material observed and removed at seep location along stall joint.

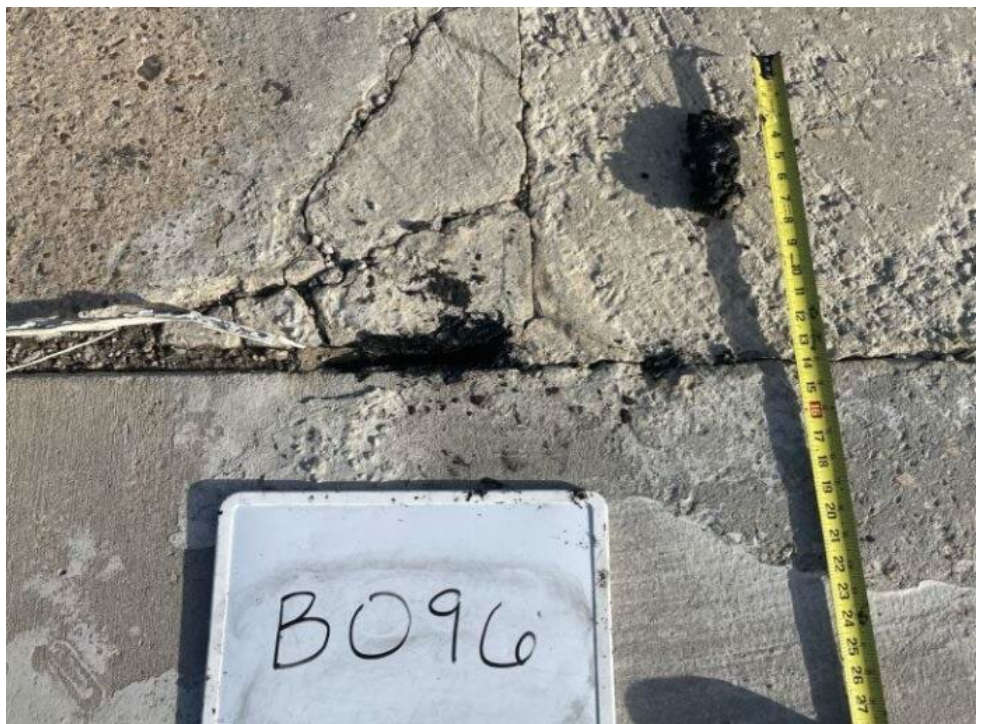
Stall B096, some staining and cracking concrete observed at former test pit location. Some tar-like material observed and removed.

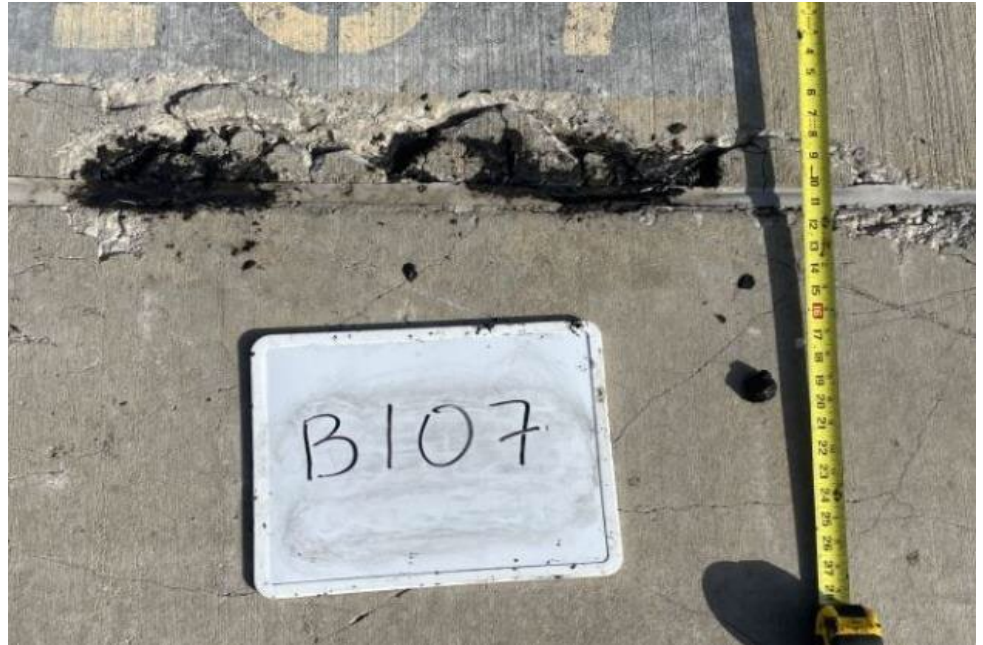
Stalls B107, some new tar-like material observed and removed at seep location on concrete joint along the southern edge of the excavated area.

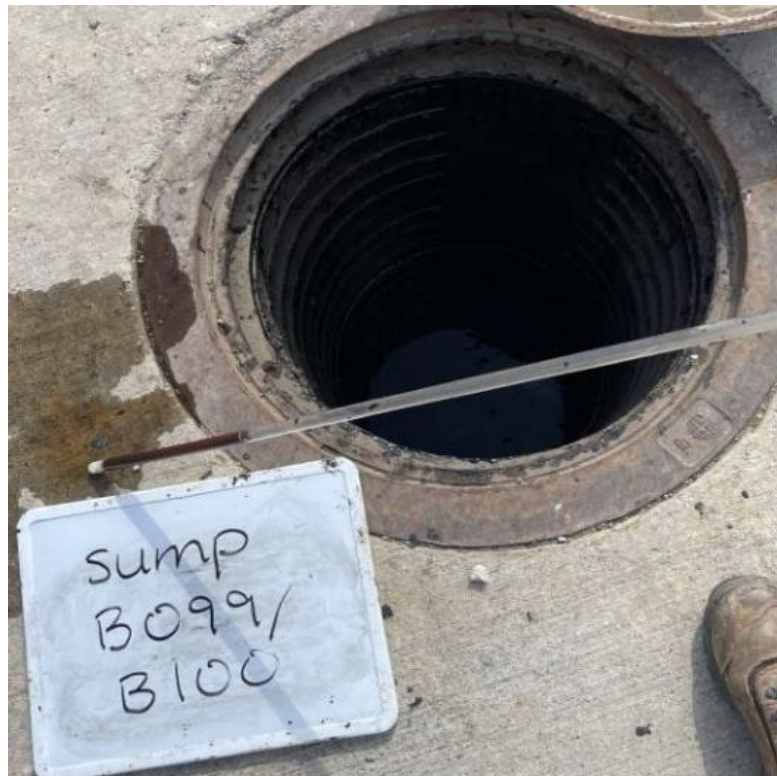
Sump 1 (B099/B100), 33 inches of freeboard in sump, no odor noted, sheen observed, no new NAPL accumulation on inflow protector, water color noted as dark brown.

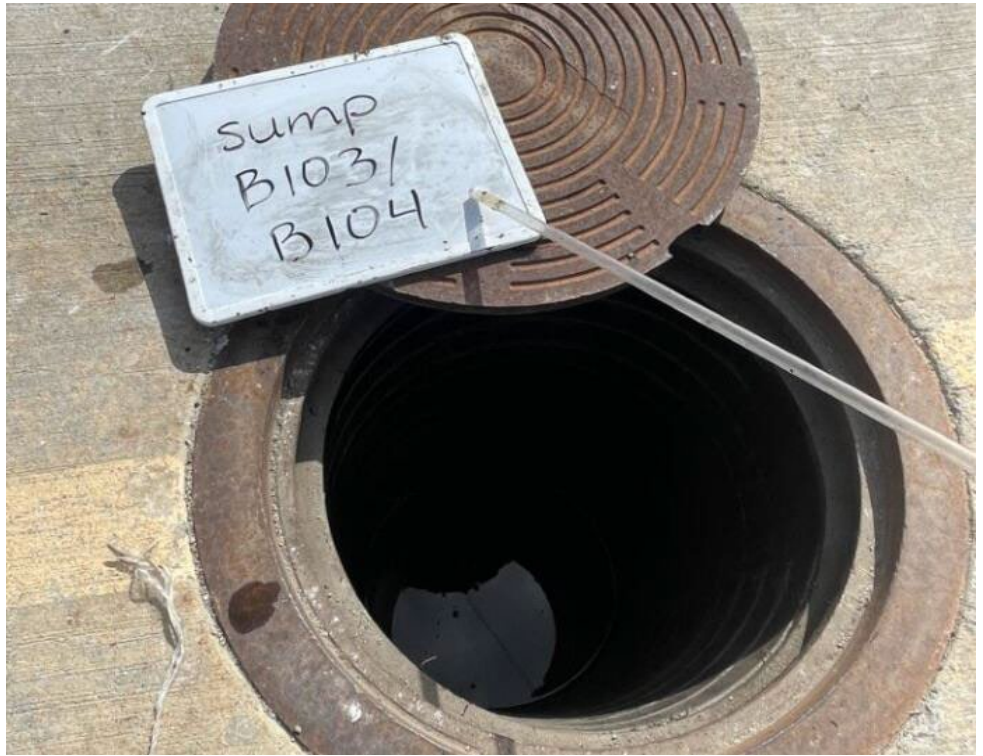
Sump 2 (B103/B104), 46 inches of freeboard before pumping. Sheen observed. No odor noted, color noted as light brown.

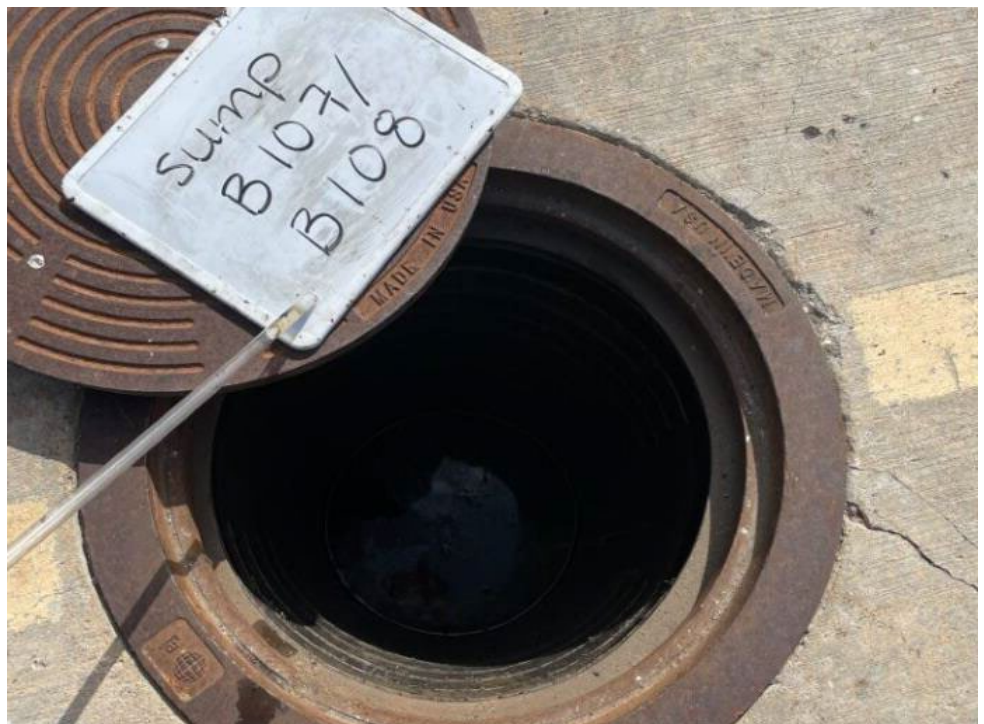
Sump 3 (B107/B108), 46 inches of freeboard in sump, no odor noted, sheen observed, no new NAPL accumulation on inflow protector, water color noted as light brown.

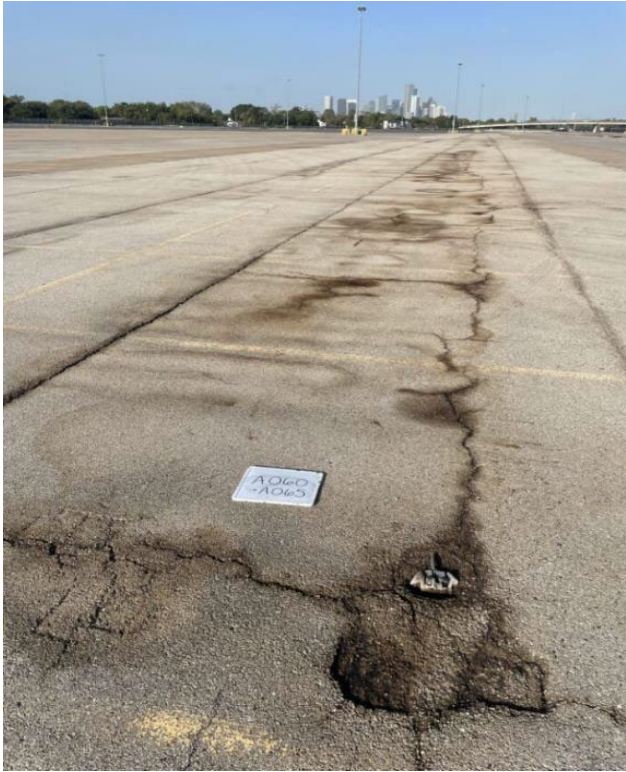
Description: Stalls A060 - A065. Some minimal staining observed where pavement is cracked. Looking west Lat: 29.784858 Long: -95.319733			
Photo No. 60	Inspection Date: 7/26/2023

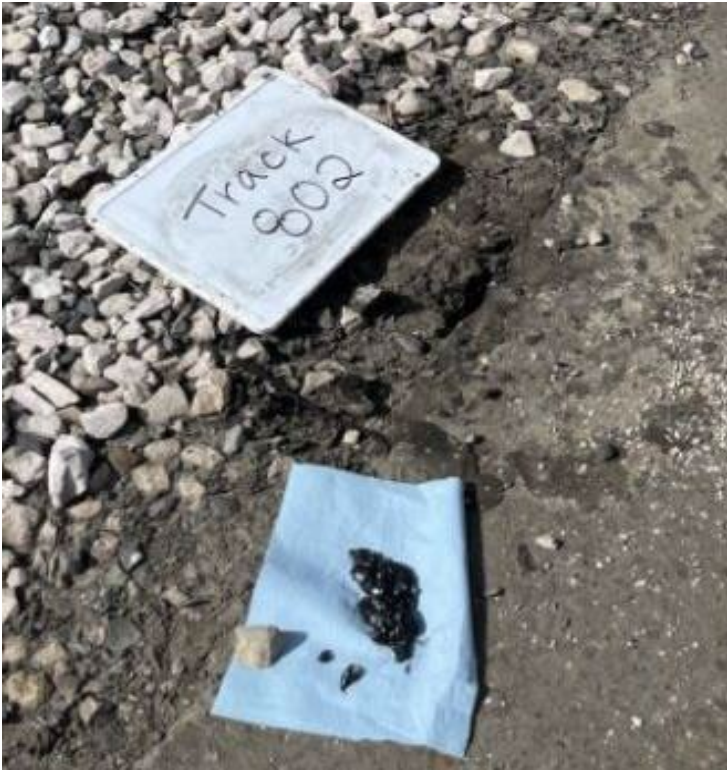
Description: North side of Track 802, some tar-like material observed at seep location near the edge of the ballast, material removed. Lat: 29.784947 Long: -95.321214

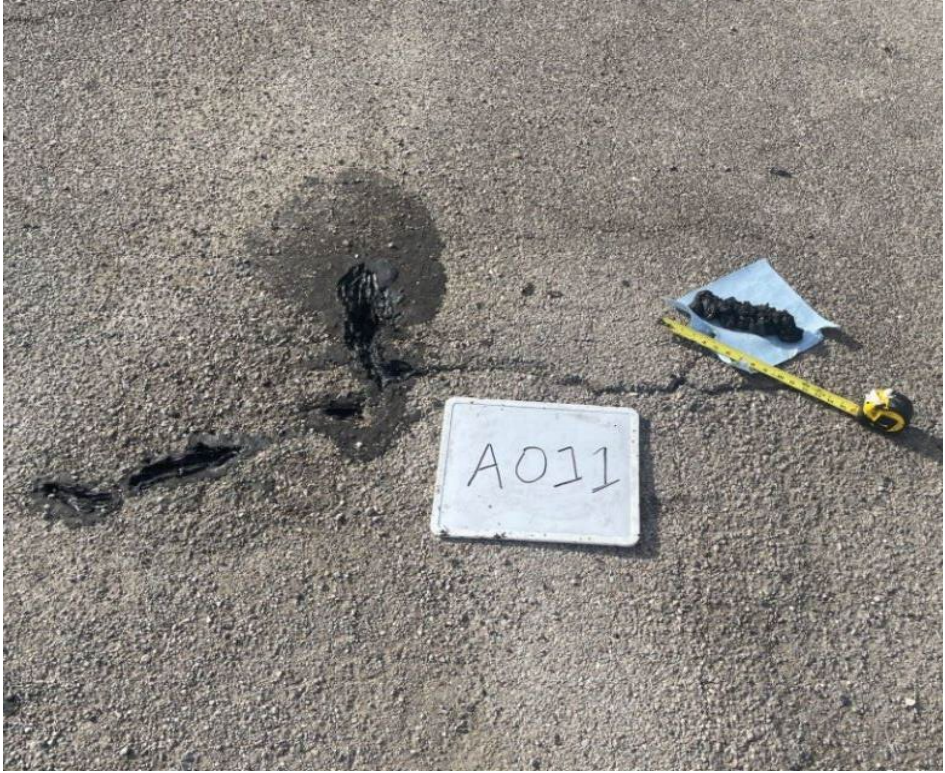
Description: Stall A011 some tar-like material observed at historical seep location along asphalt crack, material was removed. Lat: 29.785392, Long: -95.318655			
Photo No. 62	Inspection Date: 8/30/2023

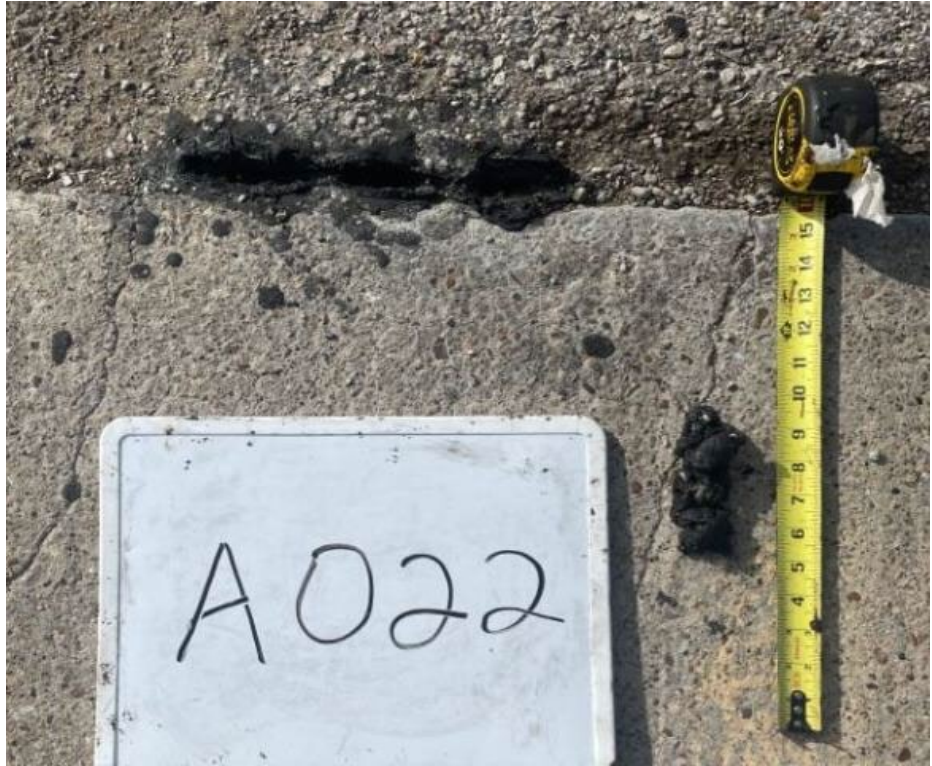
Description: Stall A022, some tar-like material observed at the seep location along the edge tar-like material seeps observed. Lat: 29.785381 Long: -95.318619

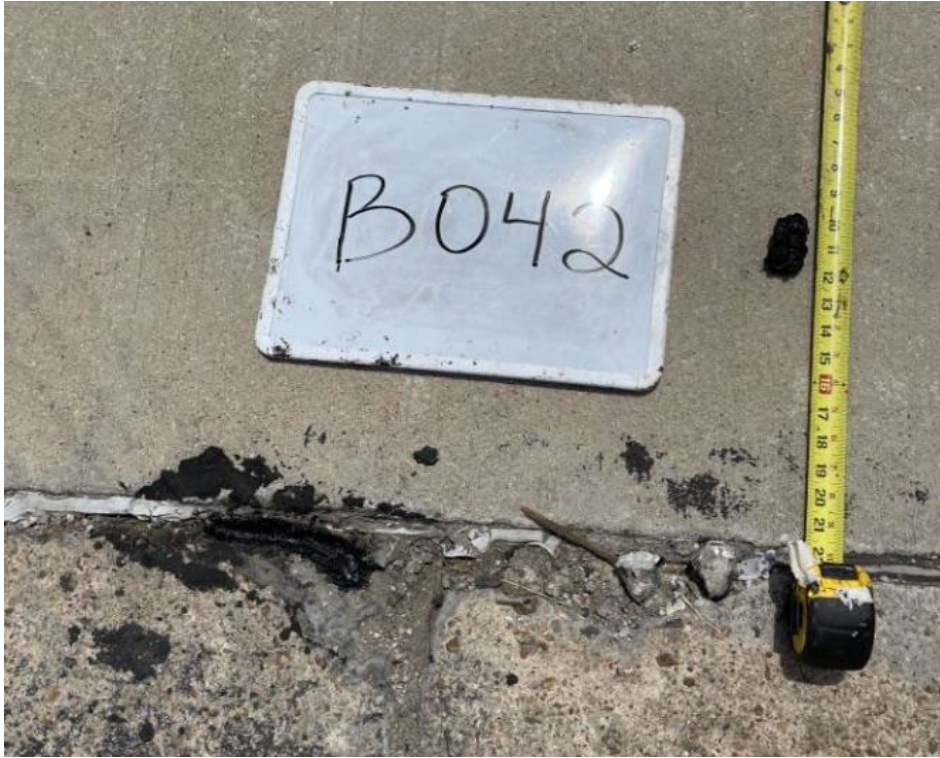
Description: Stall B042. Some tar-like material observed at historical seep location along asphalt crack, material was removed. Lat: 29.784923 Long: -95.319124			
Photo No. 64	Inspection Date: 8/30/2023

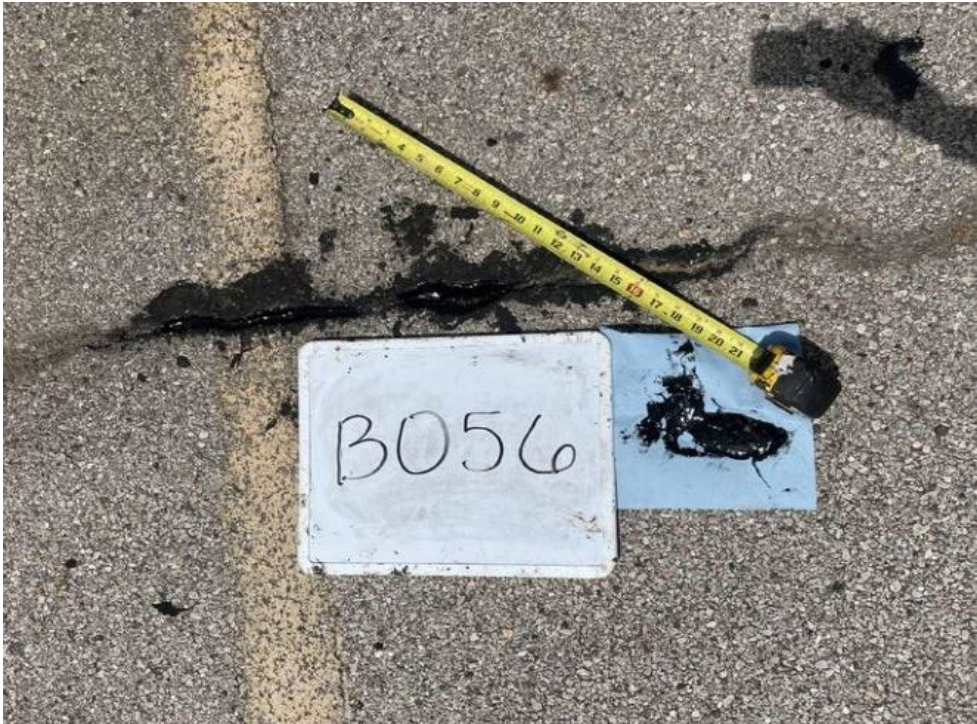
Description: Stall B056. Some tar-like material observed at historical seep location along asphalt crack, material was removed. Lat: 29.784751 Long: -95.319532

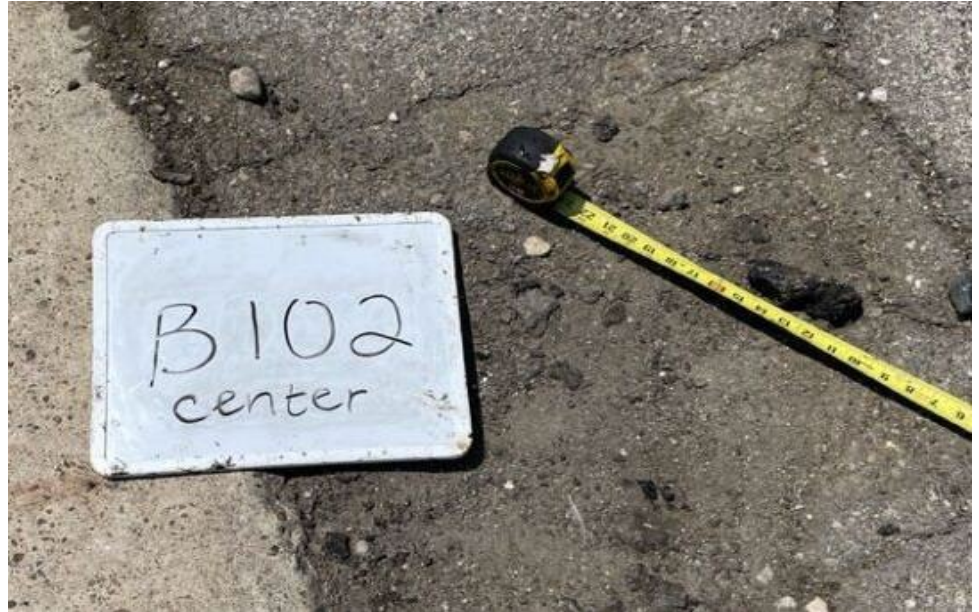
Stall 102 (center), tar-like material observed and removed at seep location where pavement is cracked.

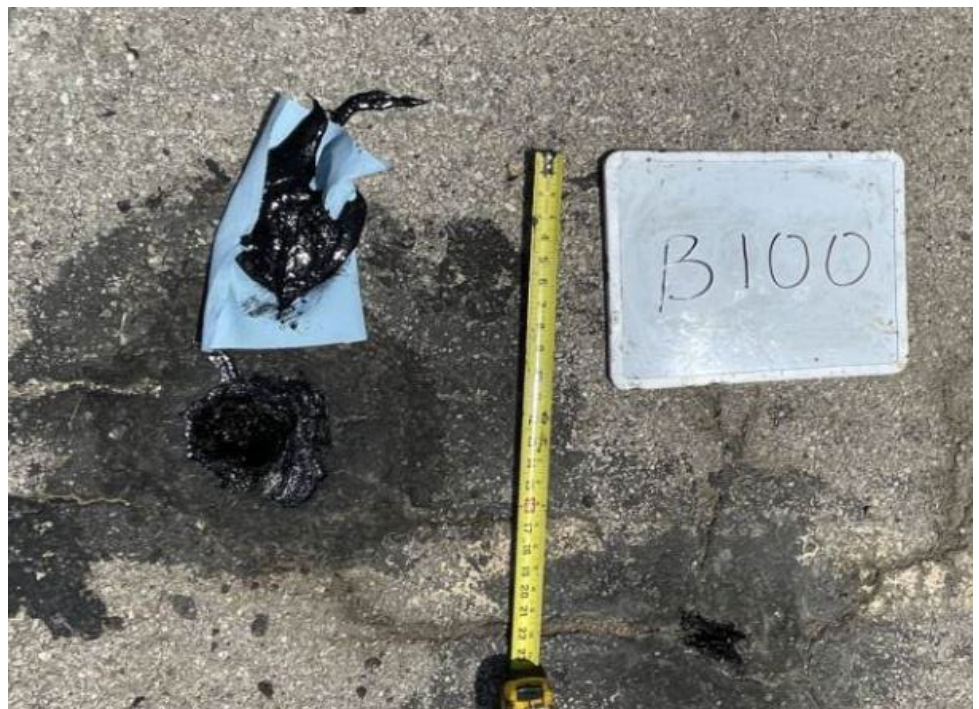
Stall B100, tar-like material observed and removed at seep location along asphalt crack/hole in the asphalt.

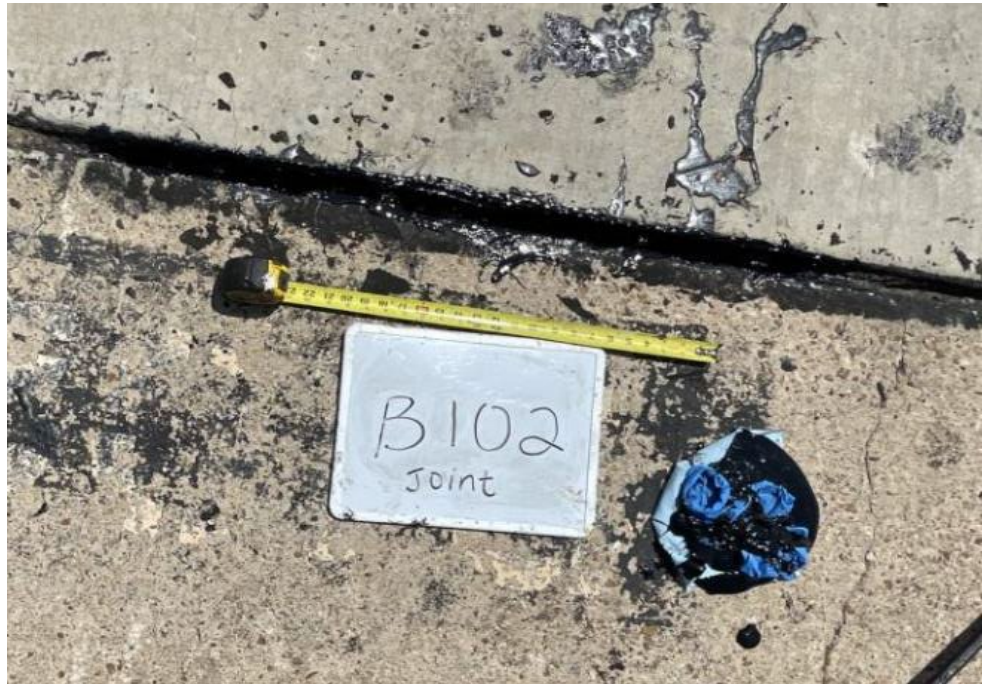
Stall B102 Joint, tar-like material observed and removed at seep location along stall joint.

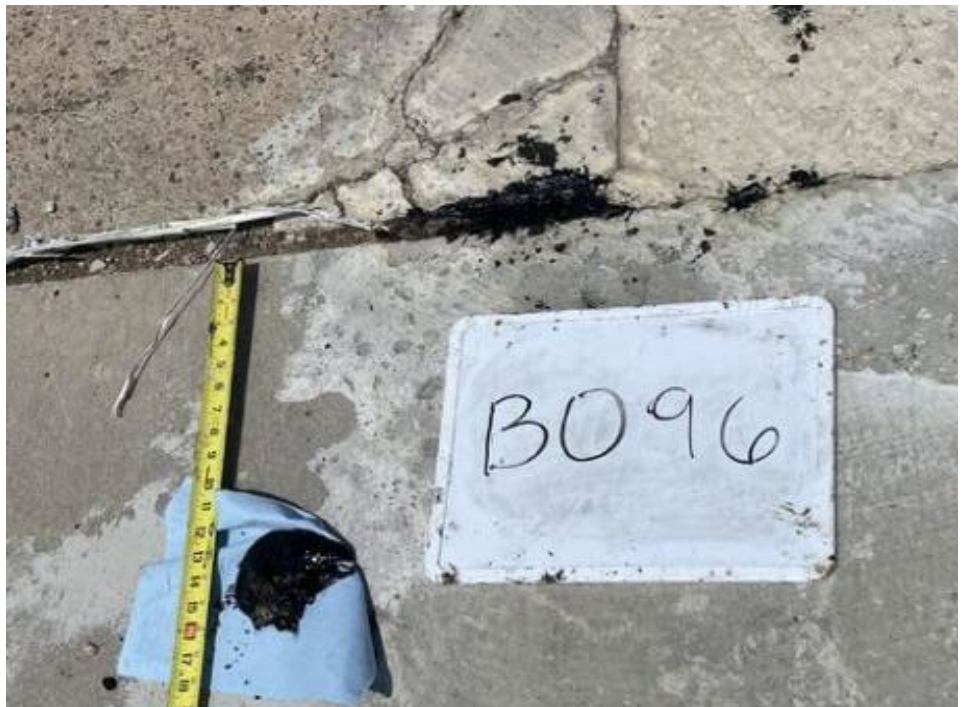
Stall B096, some staining and cracking concrete observed at former test pit location. Some tar-like material observed and removed.

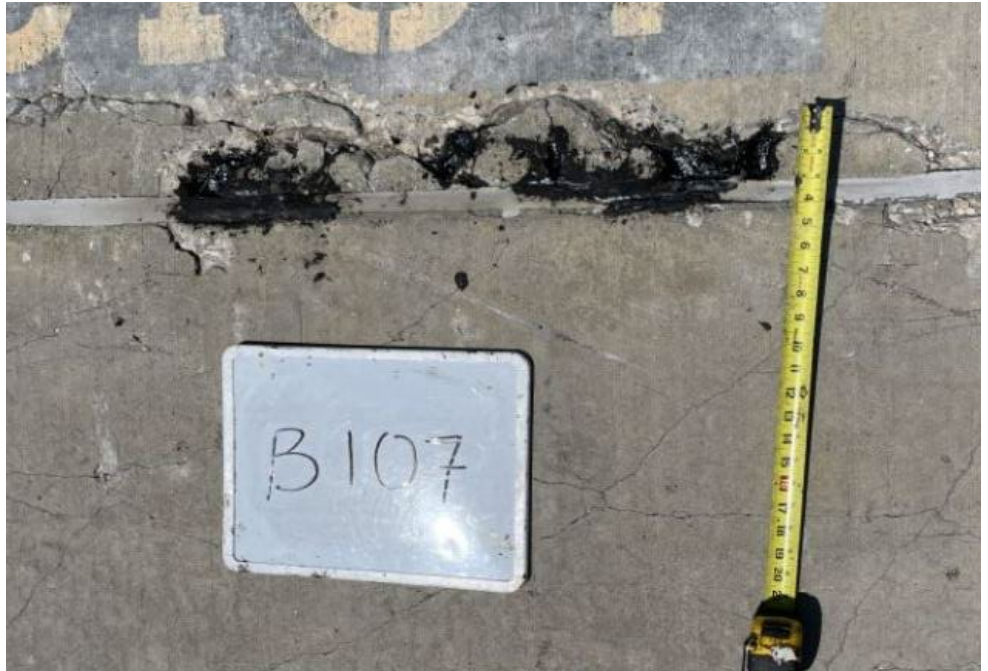
Stalls B107, no new tar-like material observed at seep location on concrete joint along the southern edge of the excavated area.

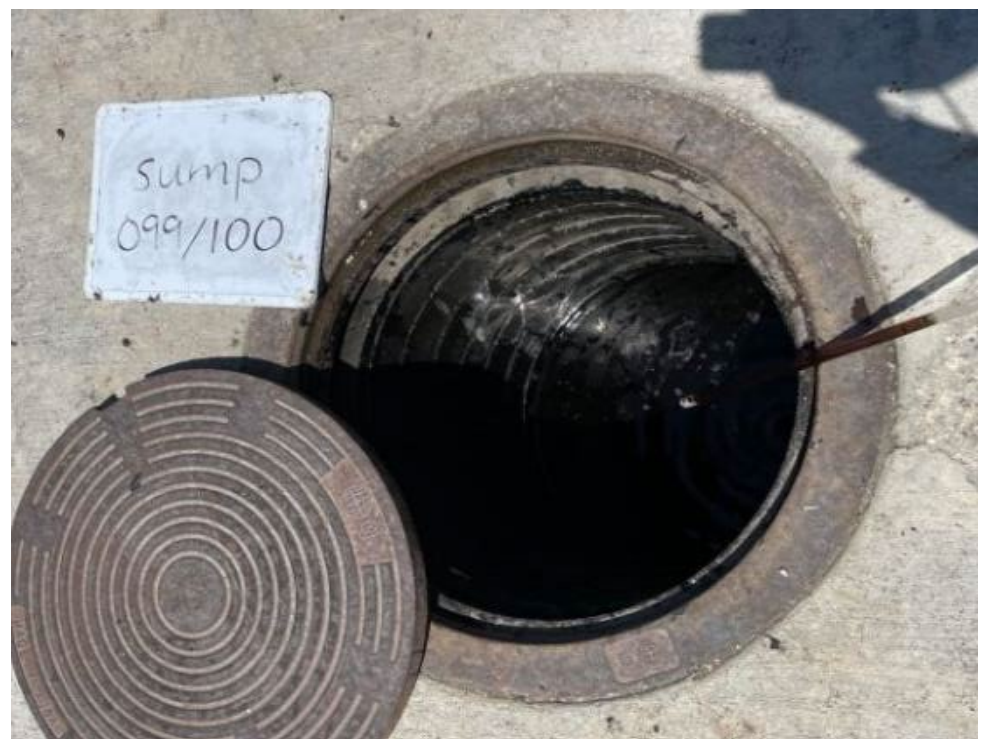
Sump 1 (B099/B100), 33 inches of freeboard in sump, no odor or sheen observed, no new NAPL accumulation on inflow protector, water color noted as dark brown.

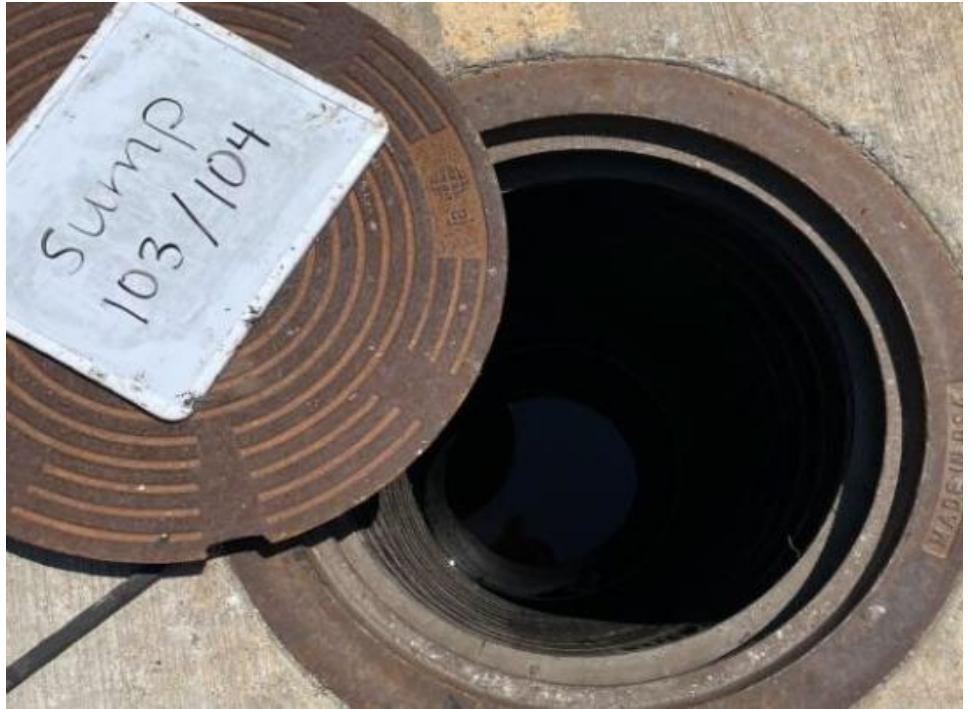
Sump 2 (B103/B104), 46 inches of freeboard before pumping. Sheen observed. No odor noted, color noted as light brown.
