September 15, 2023

Project No. 31406585.016

**Re: MONTHLY STATUS UPDATE – ENGLEWOOD INTERMODAL YARD – NAPL COLLECTION
SYSTEM/CONCRETE CAP REPAIRS
UNION PACIFIC RAILROAD HOUSTON WOOD PRESERVING WORKS FACILITY
4910 LIBERTY ROAD FACILITY, HOUSTON, TEXAS
POST-CLOSURE CARE PERMIT NO. HW-50343; INDUSTRIAL SWR NO. 31547**

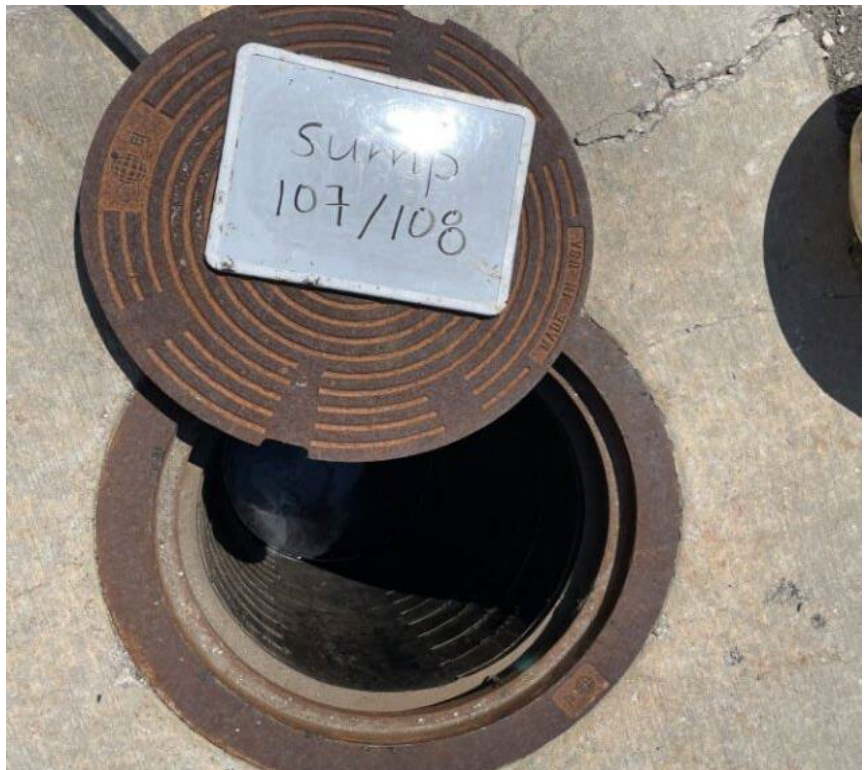
Photo No.
72

Sump 3 (B107/B108), 44 inches of freeboard in sump, no odor noted, sheen observed, no new NAPL accumulation on inflow protector, water color noted as light brown.

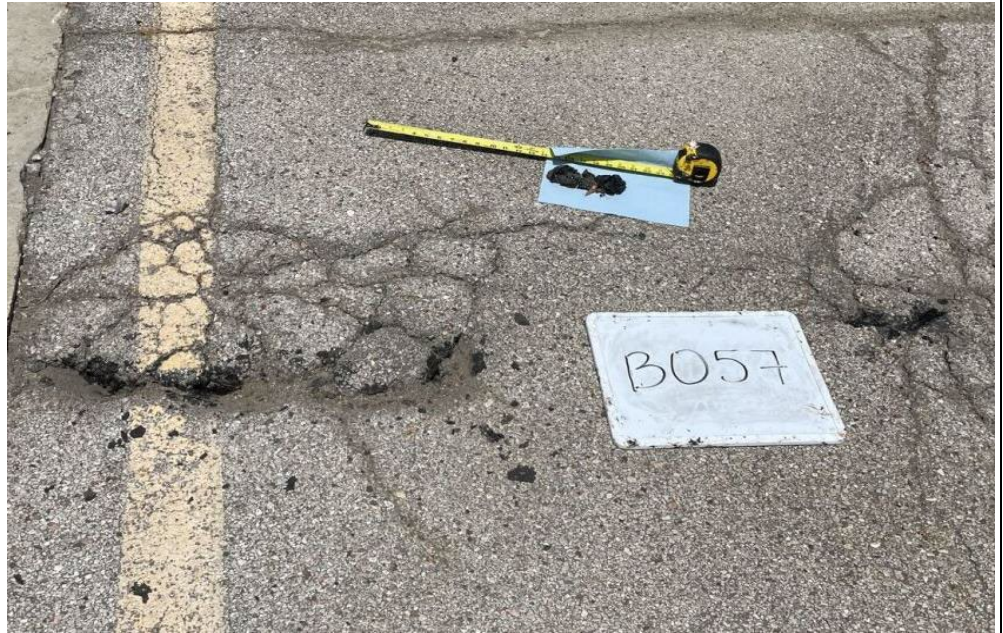
Stall B057, some new tar-like material observed and removed at seep location along asphalt crack.

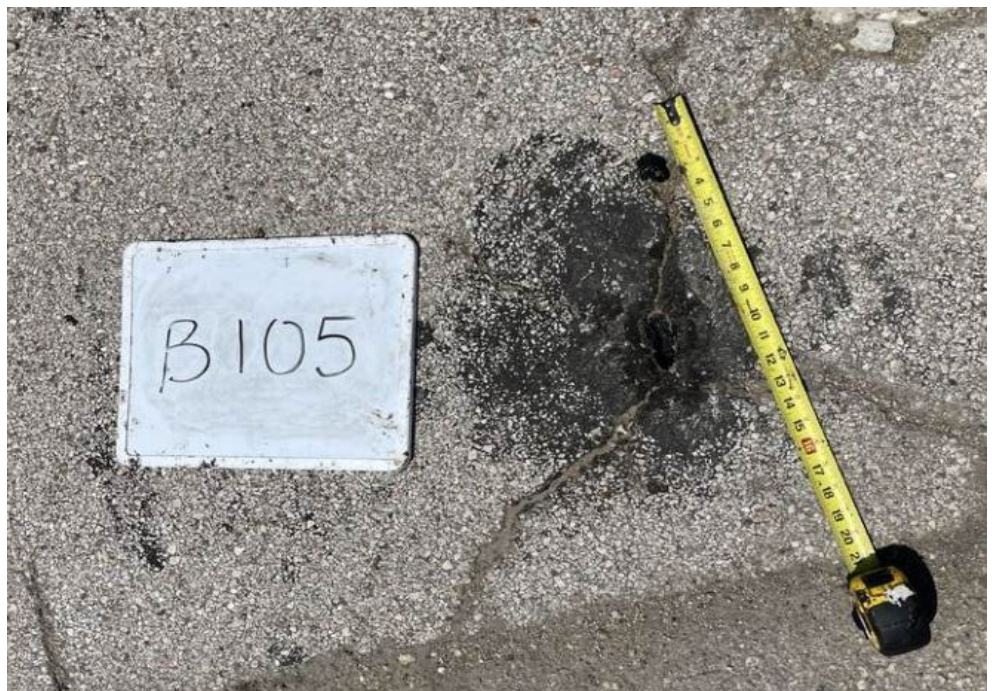
Photo No.
74

Stall B105, some new tar-like material observed at seep location along asphalt crack.
