November 15, 2023

Project No. 31406585.016

**Re: MONTHLY STATUS UPDATE – ENGLEWOOD INTERMODAL YARD – NAPL COLLECTION
SYSTEM/CONCRETE CAP REPAIRS
UNION PACIFIC RAILROAD HOUSTON WOOD PRESERVING WORKS FACILITY
4910 LIBERTY ROAD FACILITY, HOUSTON, TEXAS
POST-CLOSURE CARE PERMIT NO. HW-50343; INDUSTRIAL SWR NO. 31547**

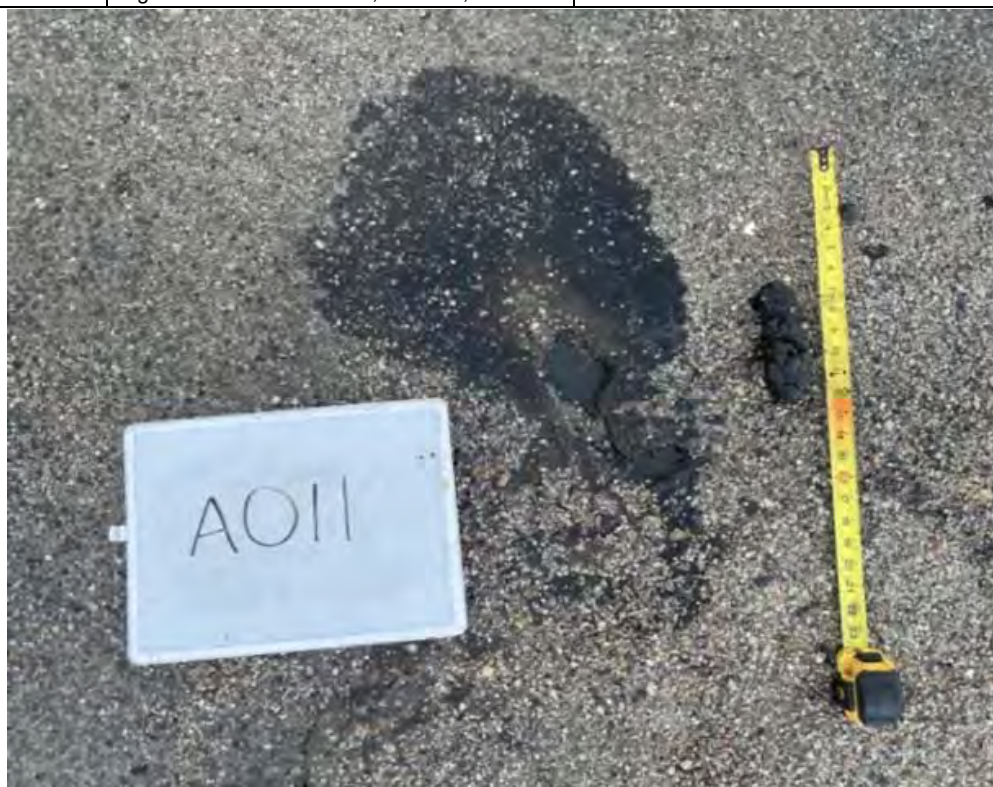
Stall A011 tar-like material observed at historical seep location along asphalt crack, material was removed.

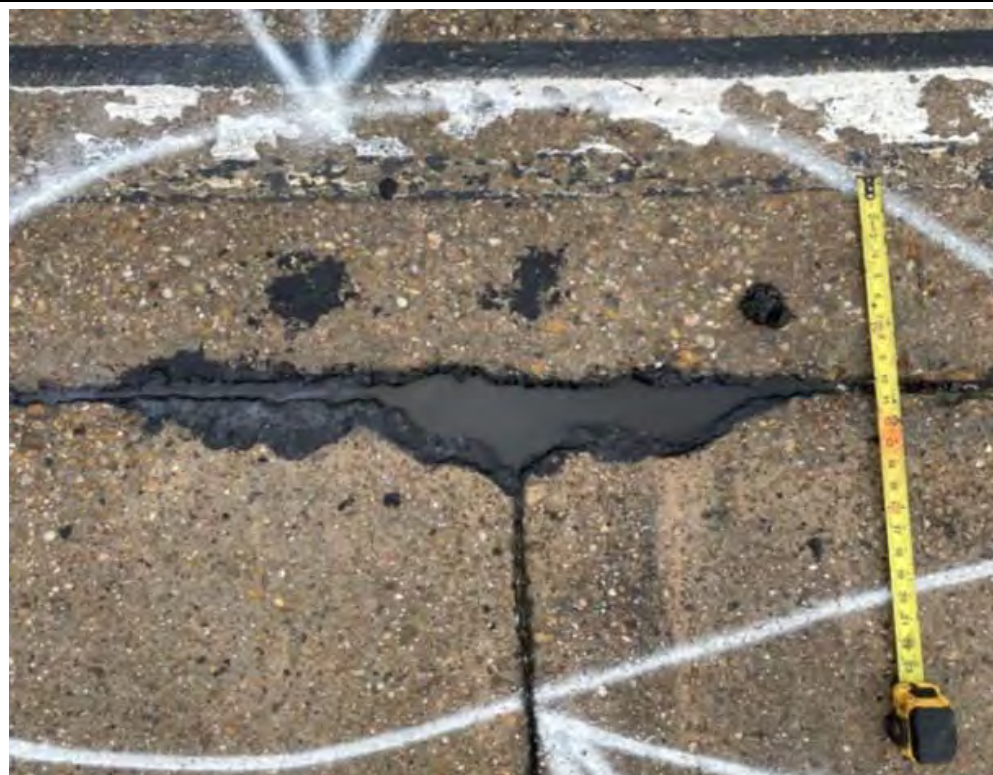
2

RD-14 Seep location observed within the concrete road area north of Track 802 (east of existing Track 802 seep location), very small amount of tar-like material observed along a concrete joint, material was removed. Area is wet

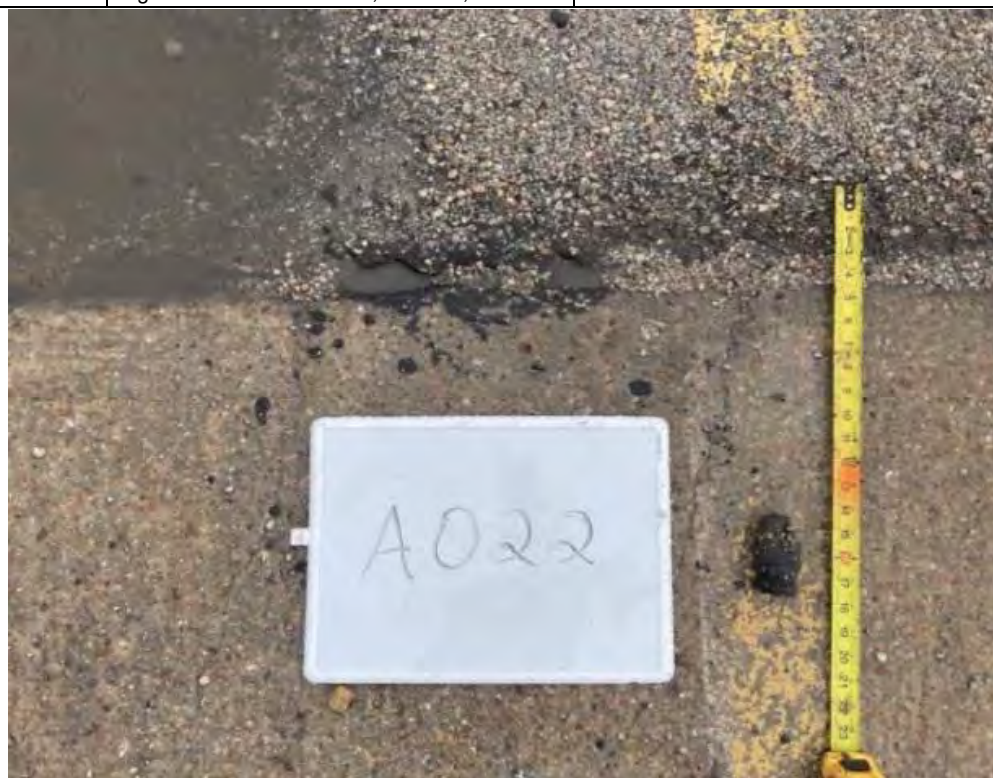
Stall A022. Some tar-like material observed at historical seep location along asphalt crack, material was removed. Area is wet from rain.

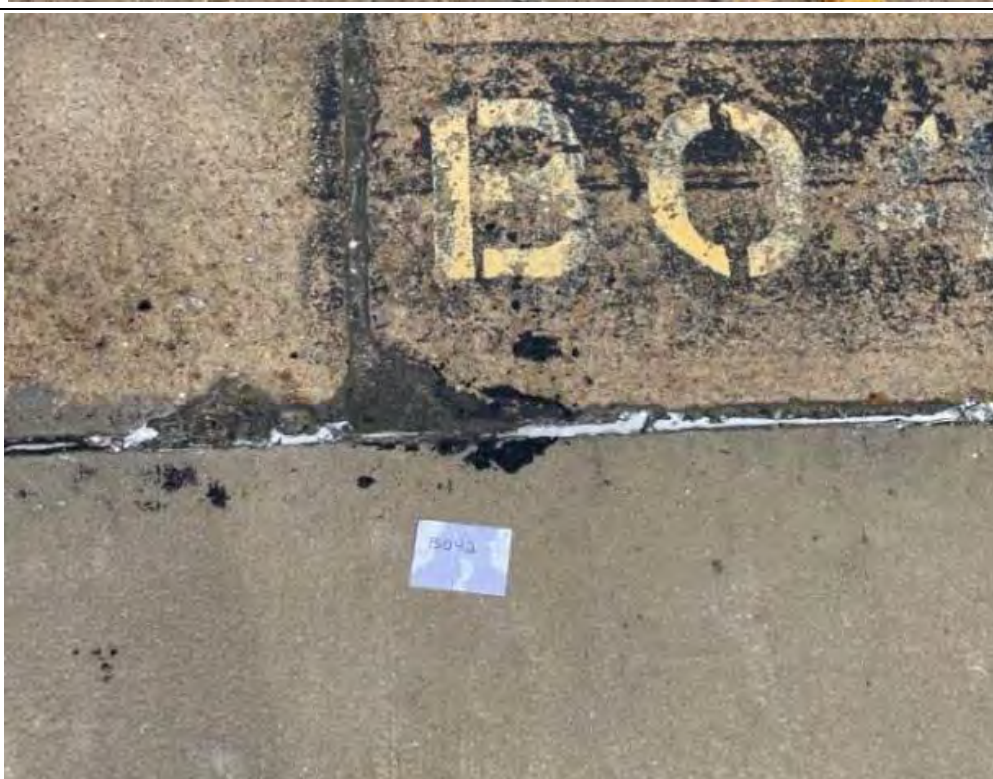
4

Stall B042. No tar-like material observed at historical seep location along asphalt crack.

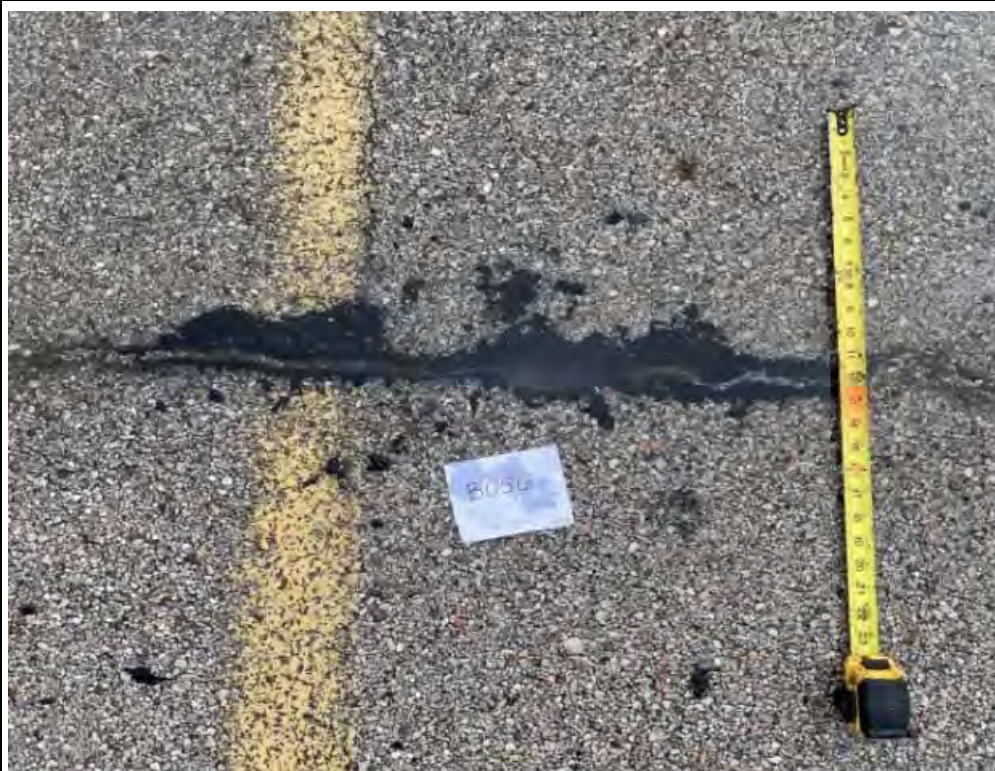
Stall B056. No tar-like material observed at historical seep location along asphalt crack.

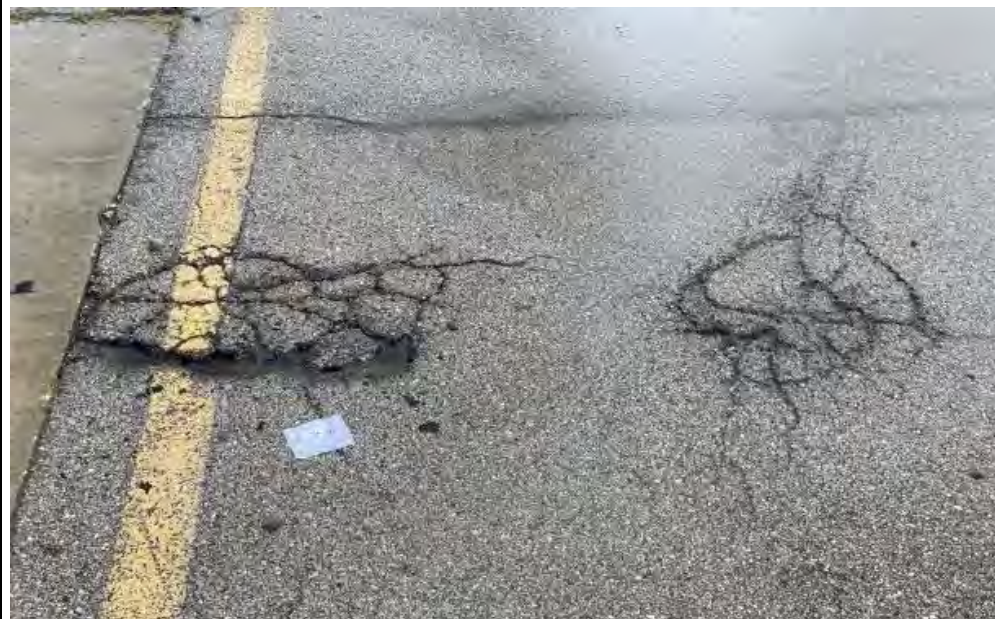
6

Stall B057. No tar-like material observed at historical seep location along asphalt crack.

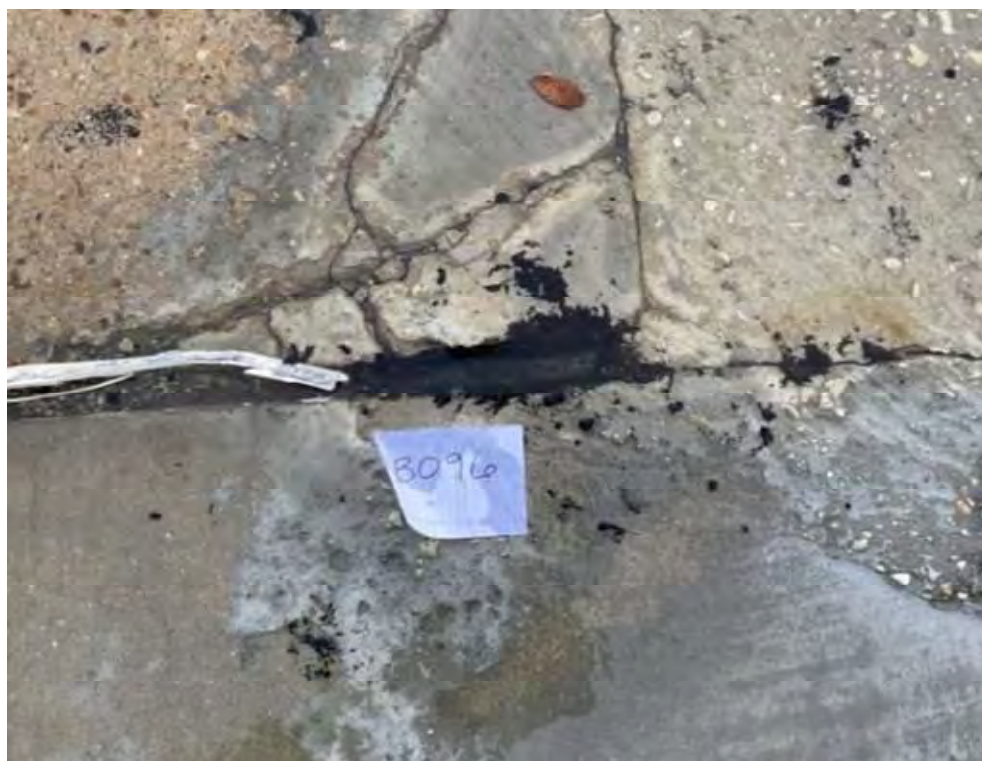
Stall B096, some tar-like material observed and removed.

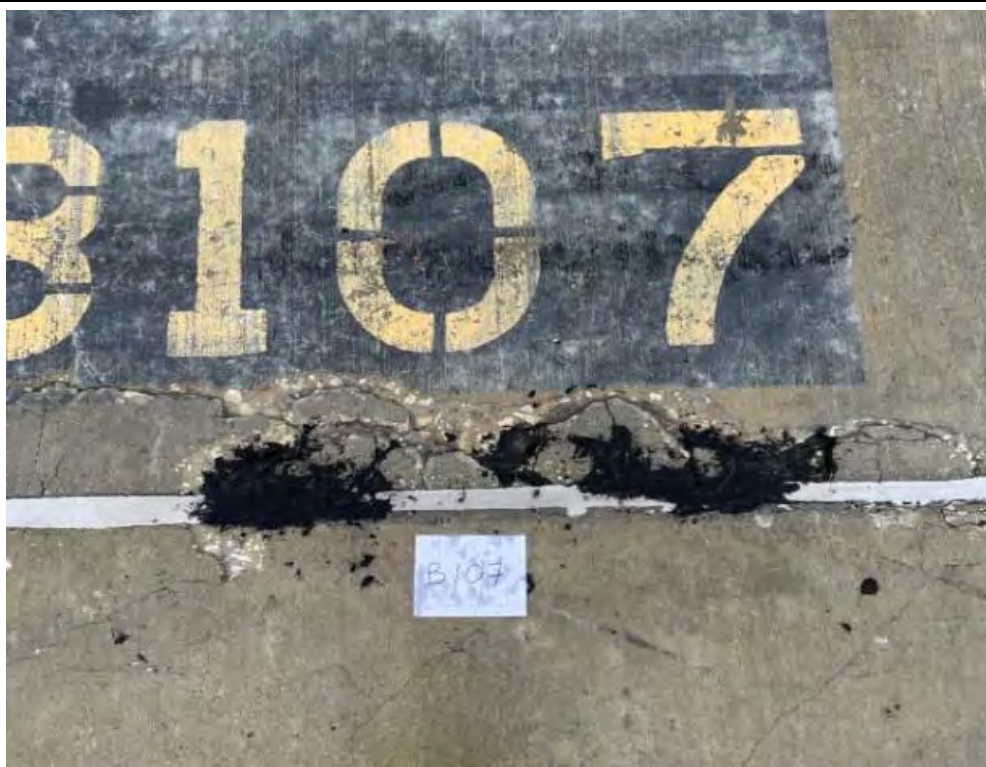
8

Stall B107, no new tar-like material observed at seep location on concrete joint along the southern edge of the excavated area.

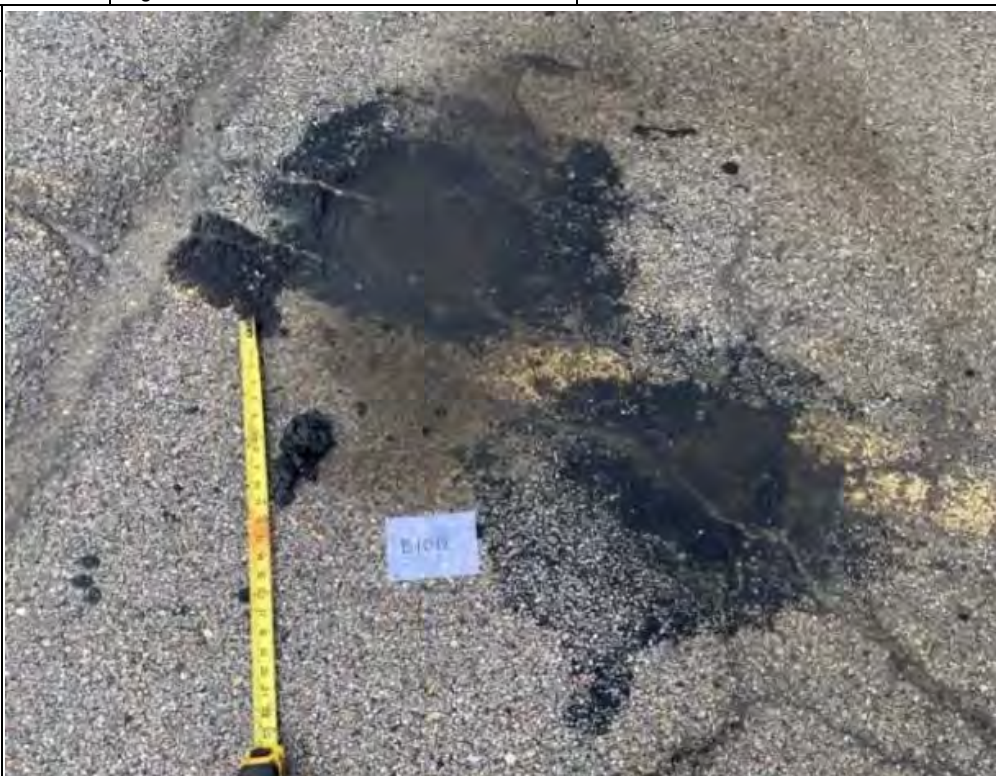
Stall B100, some tar-like material observed near historical seep location along asphalt crack, material removed.

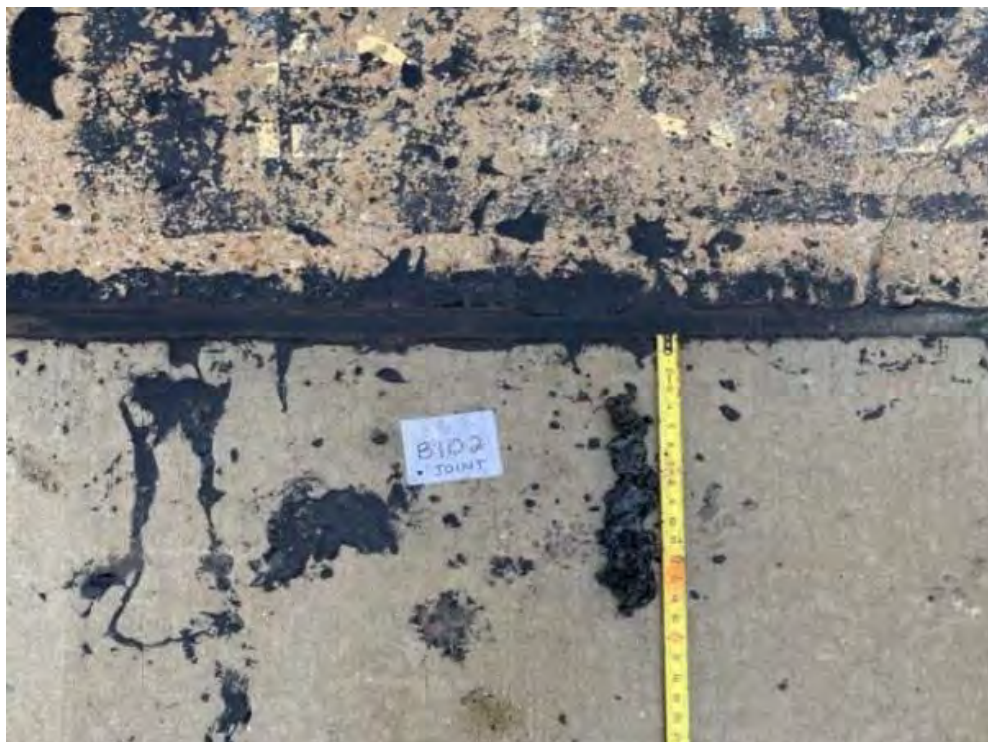
10

Stall B102 (joint), tar-like material observed and removed.

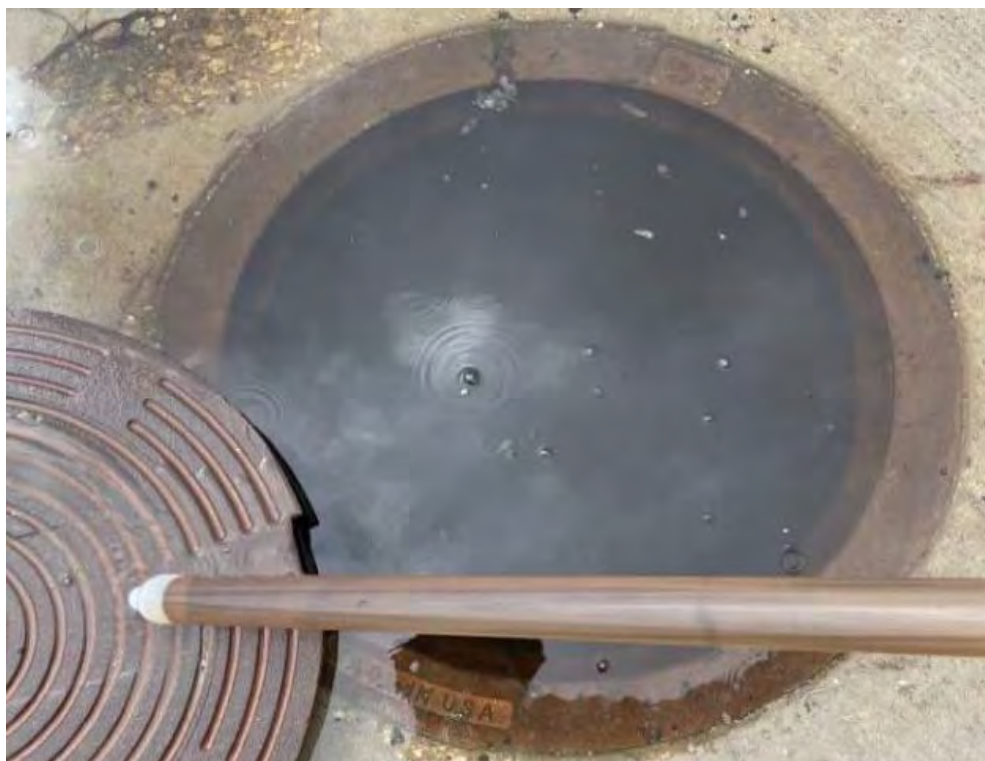
Sump 1 (B099/B100), 0 inch of freeboard in sump, no sheen observed, no odor noted, no NAPL accumulation on inflow protector, color noted as brown.

Water observed is from recent rain events.

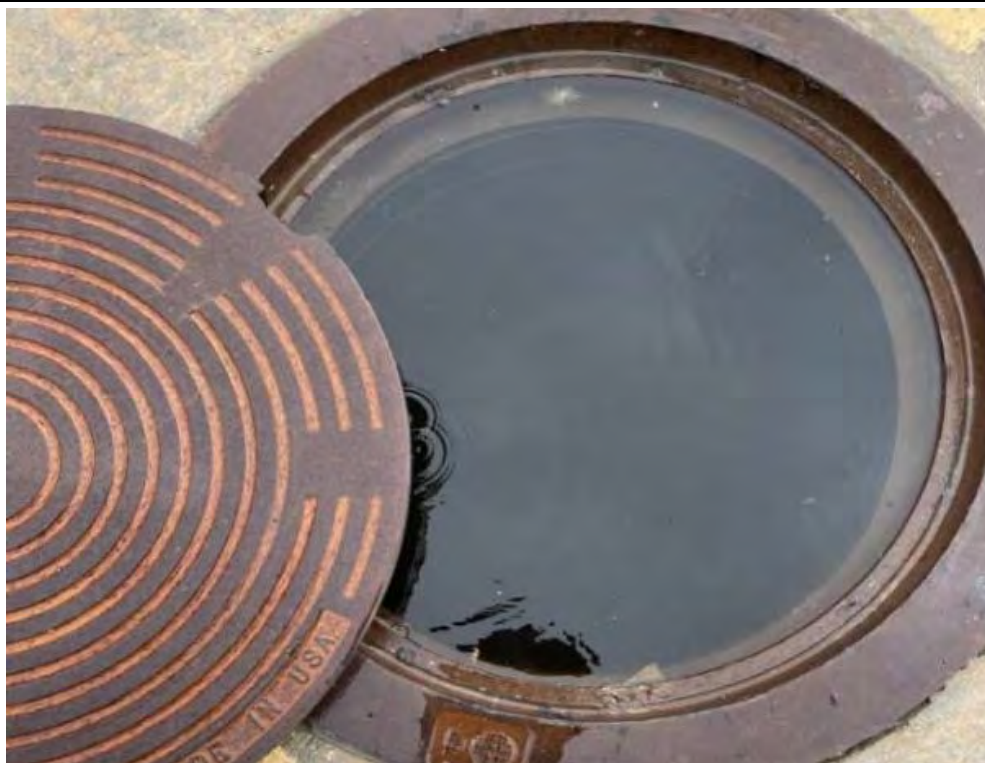
12

Sump 2 (B103/B104), 0 inches of freeboard, no sheen observed, no odor noted, color noted as light brown.

Water observed is from recent rain events.

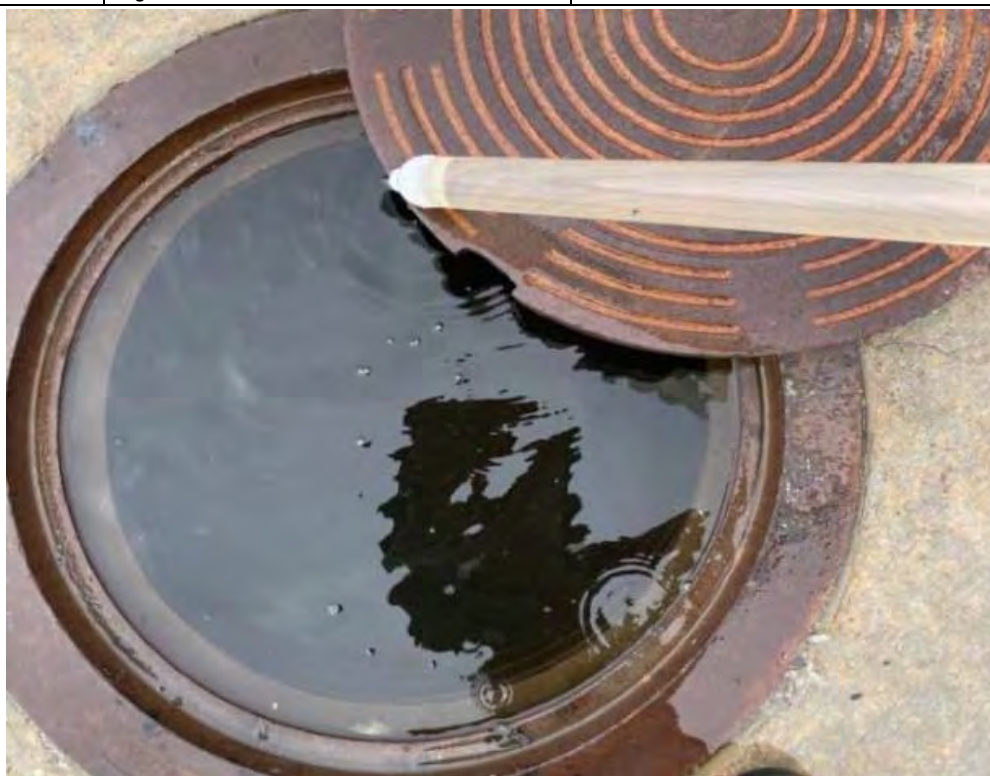
Sump 3 (B107/B108), 0 inches of freeboard in sump, no sheen observed, no odor noted, color noted as light brown.

Water observed is from recent rain events.

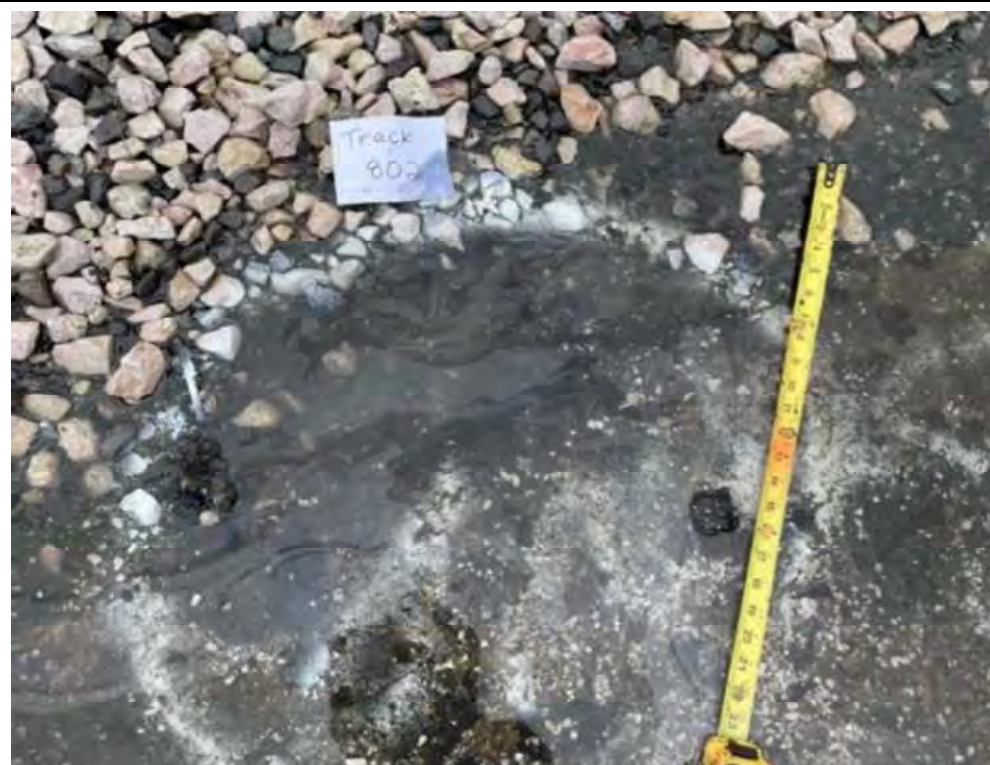
14

North side of Track 802, a small amount of tar-like material observed at seep location near the edge of the ballast, material removed. Area wet from recent rain event.

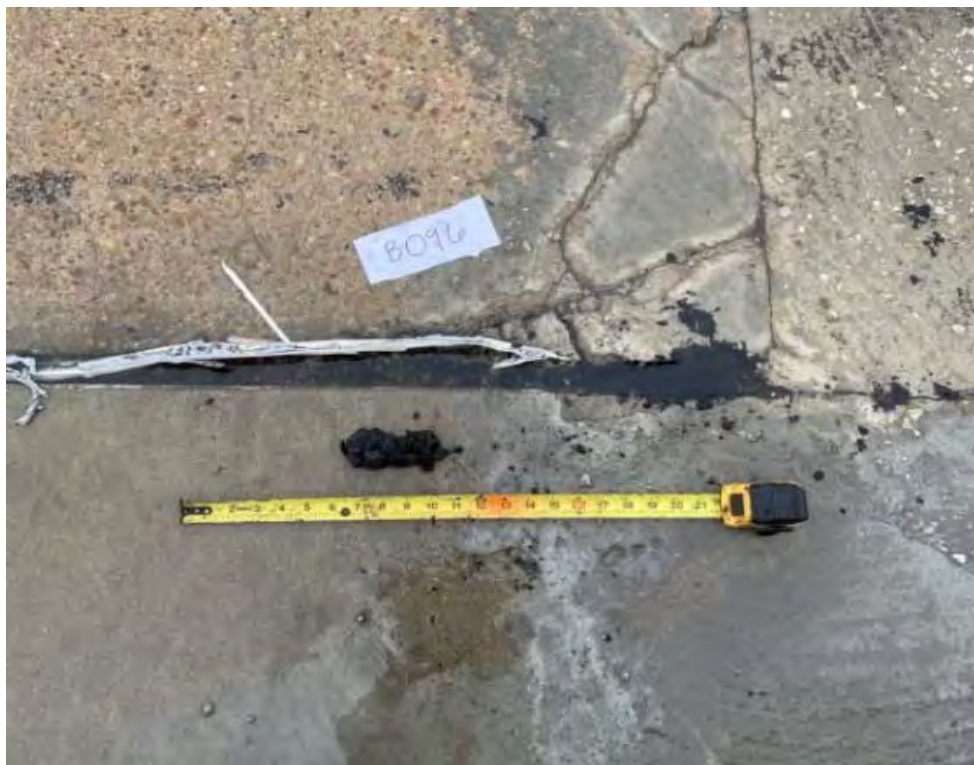
Stall B096, some tar-like material observed at historical seep location along concrete joint, material was removed.

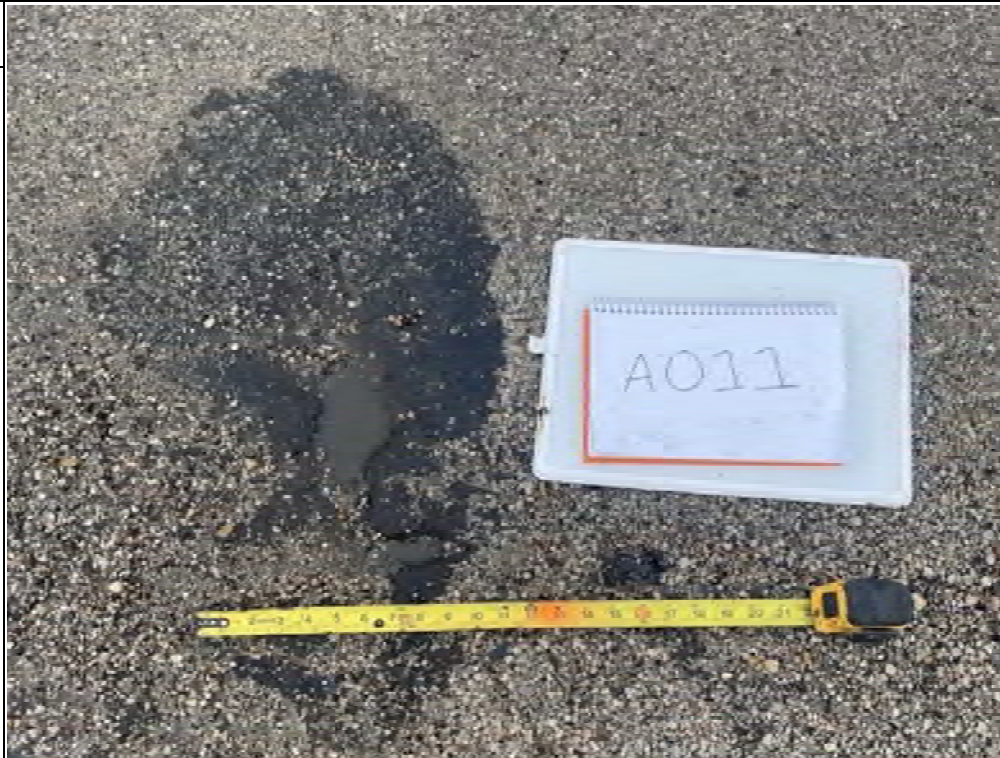
Photo No.
16

Stall A011 some tar-like material observed at historical seep location along asphalt crack, material was removed. View looking southeast.

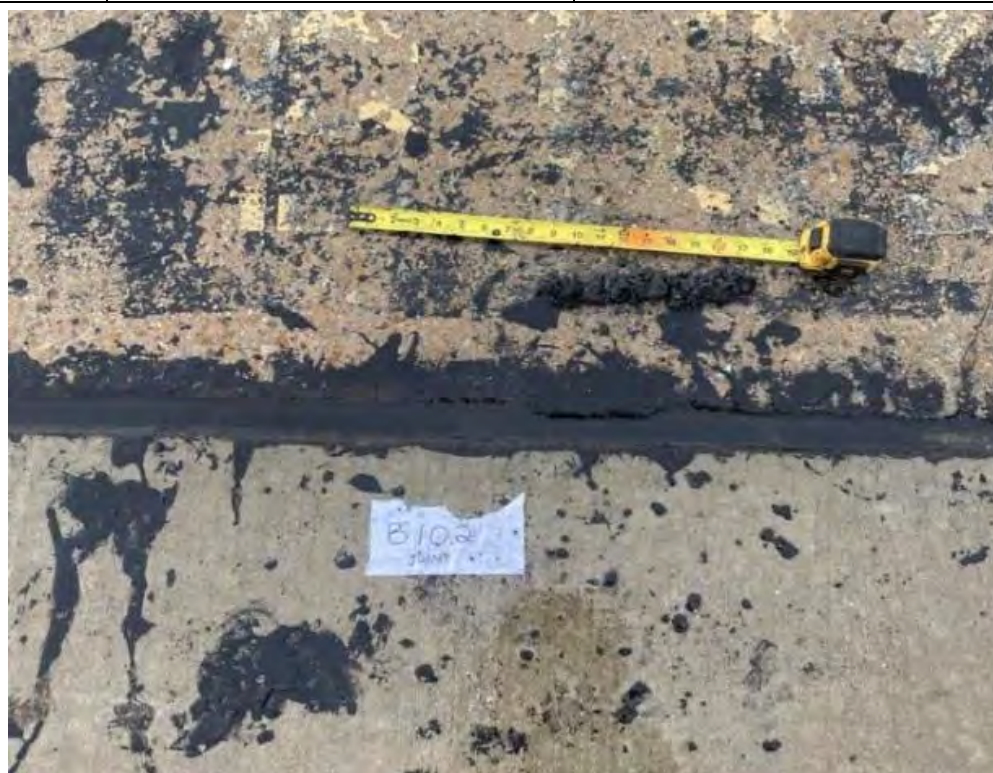
Stall 102 (joint) tar-like material observed at historical seep site along concrete joint, tar-like material was removed.

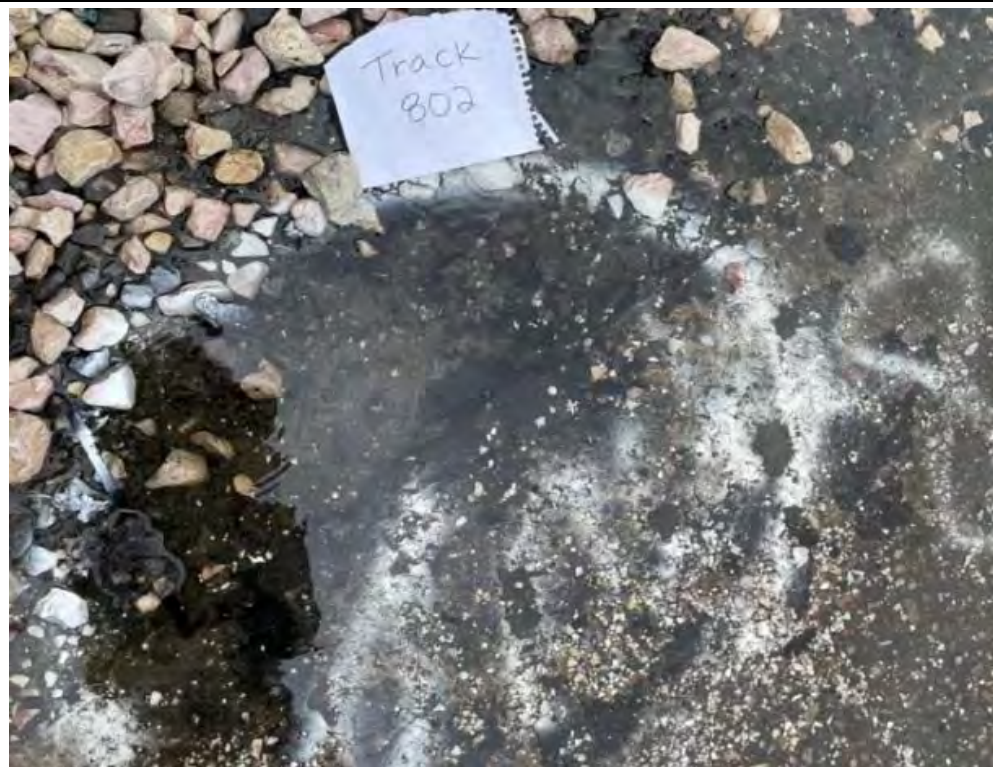
Photo No. 18	Inspection Date: 10/11/2023
-------------------------------	---------------------------------------

North side of Track 802, a small amount of tar-like material observed at seep location near the edge of the ballast, material removed. Area wet from recent rain event.

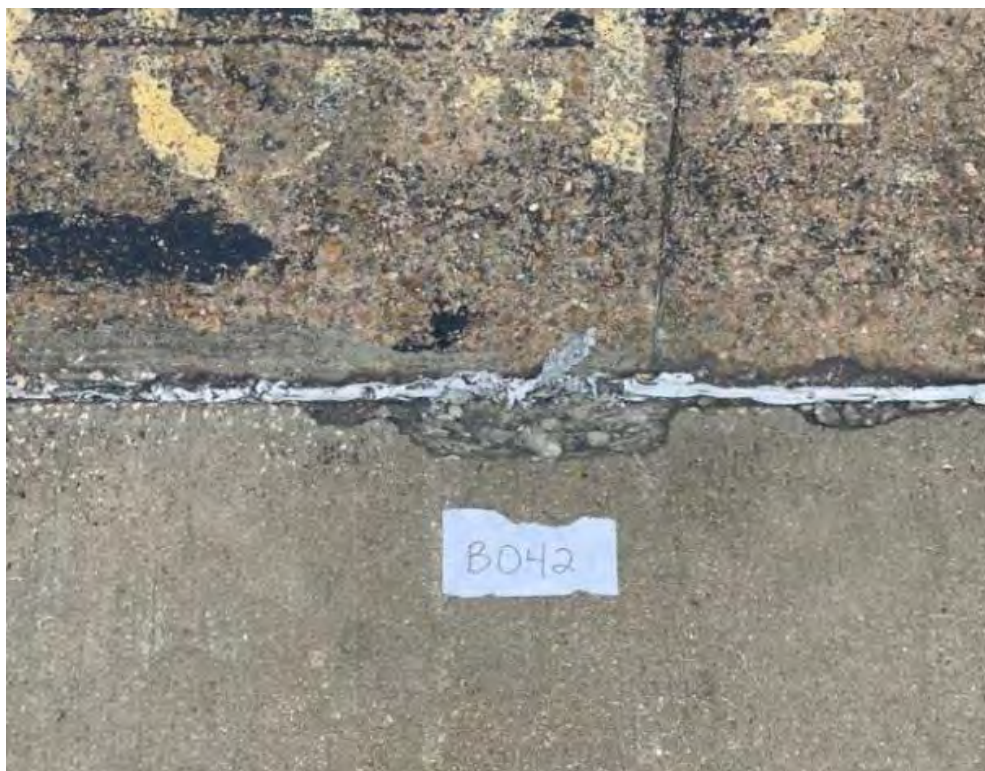
Stall B042. No tar-like material observed at historical seep location along asphalt crack.

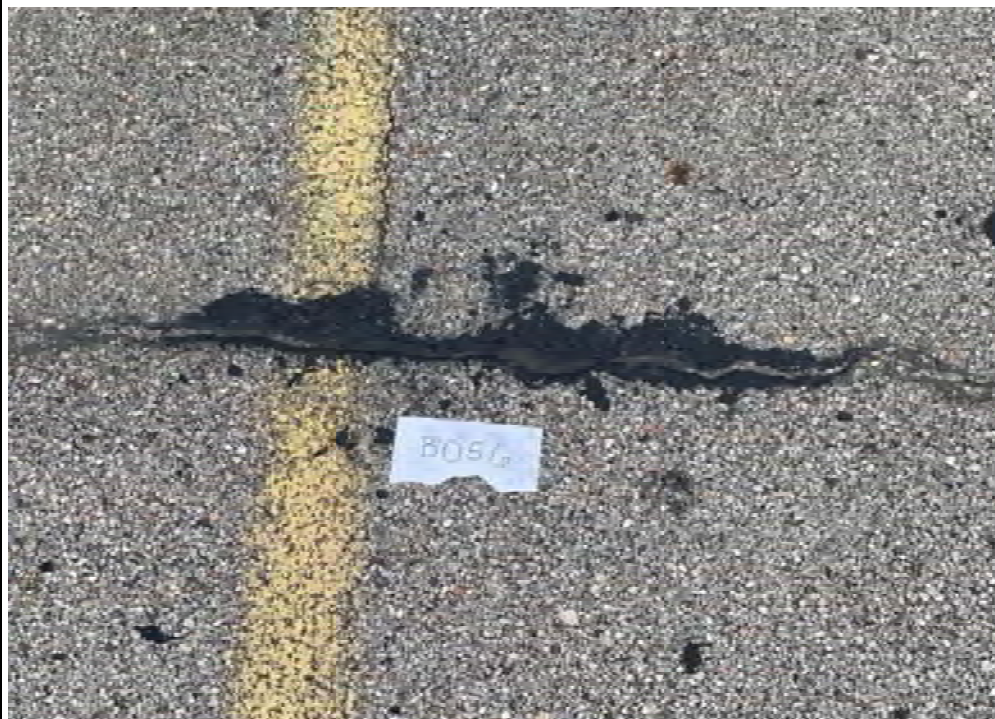
22

Stall B056. No tar-like material observed at historical seep location along asphalt crack.

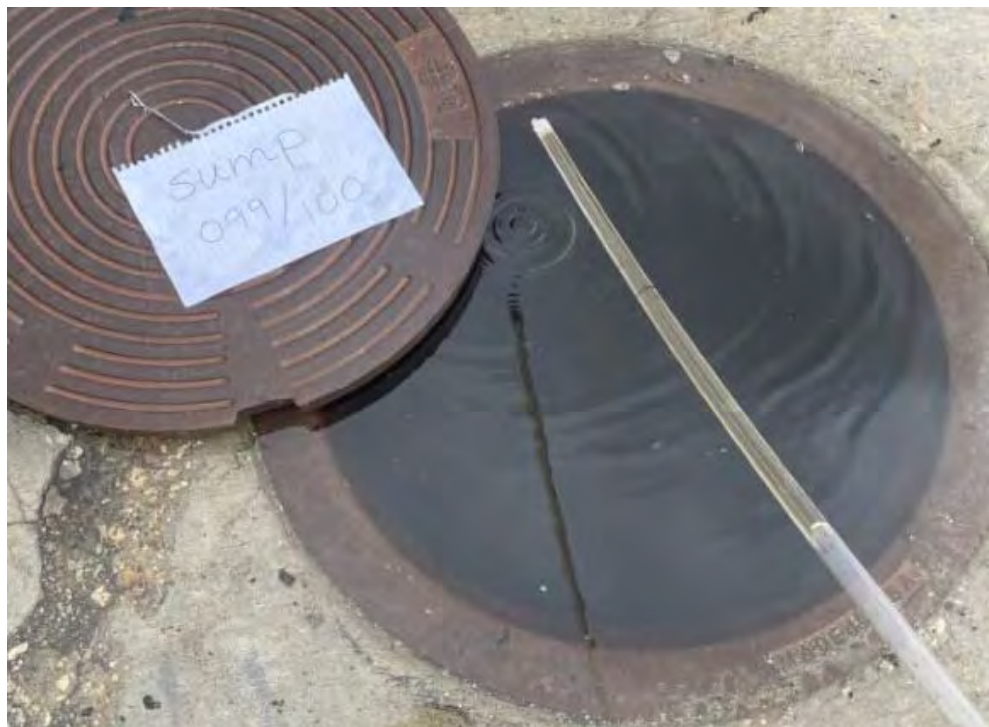
Sump 1 (B099/B100), 0 inches of freeboard in sump, no odor noted, no sheen observed, no NAPL accumulation on inflow protector, water color noted as light brown.

Water observed is from recent rain events.

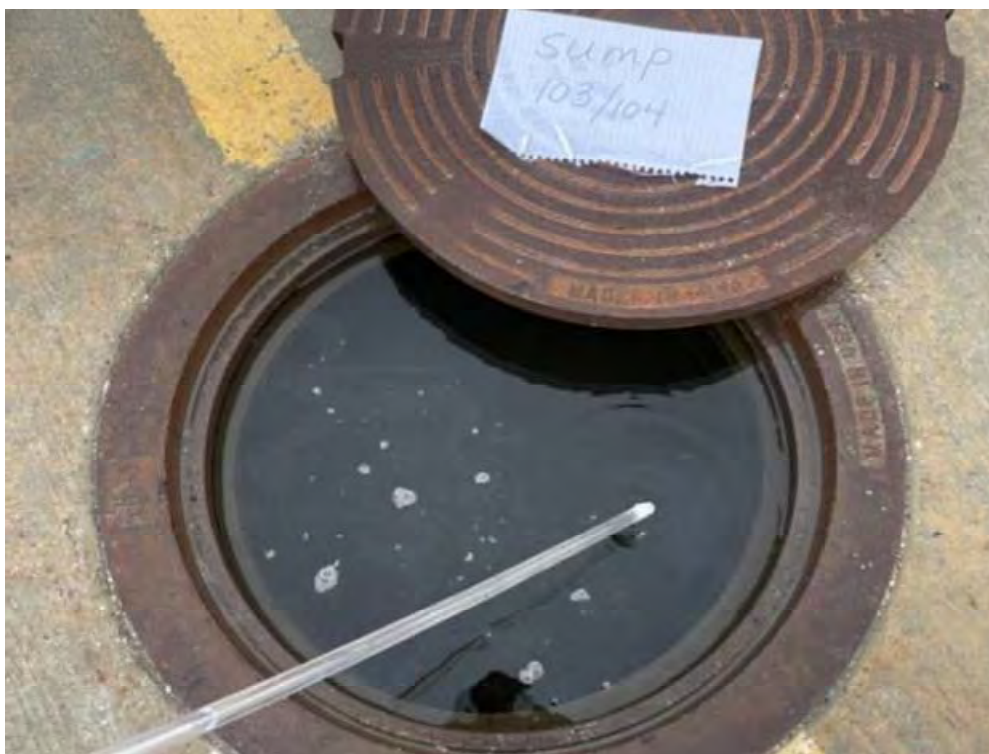
26

Sump 2 (B103/B104), 0 inches of freeboard before pumping. No odor noted, color noted as clear, sheen observed.

Water observed is from recent rain events.

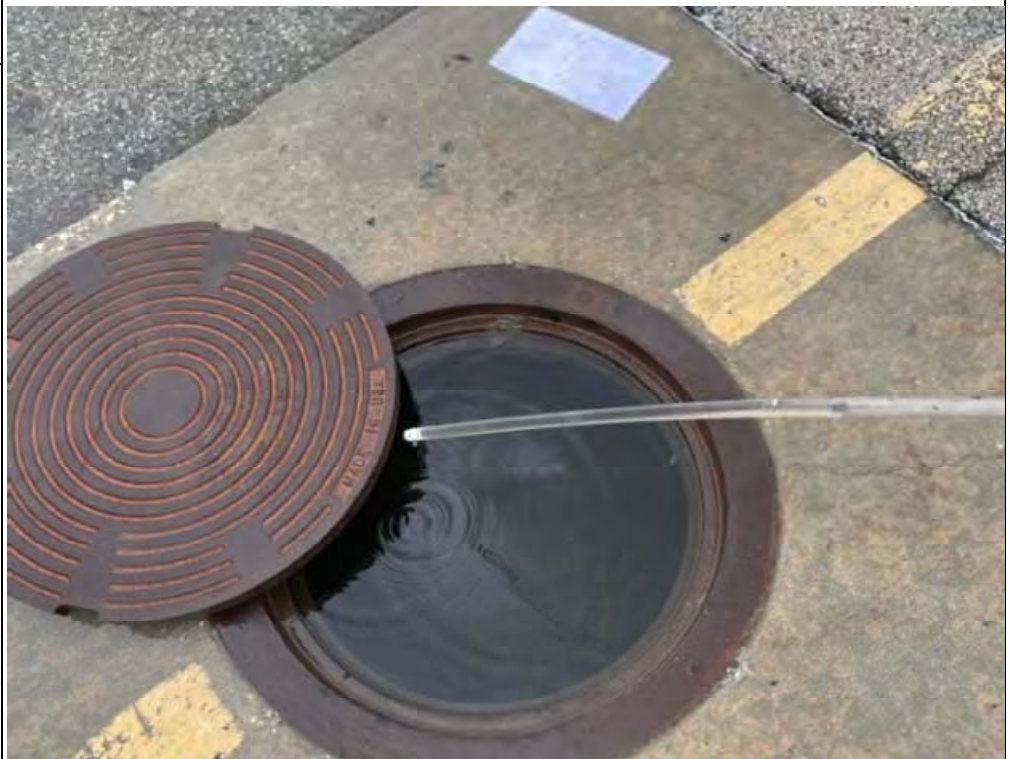
Sump 3 (B107/B108), 0 inches of freeboard in sump, no odor noted, no sheen observed, no NAPL accumulation on inflow protector, water color noted as clear.

Water observed is from recent rain events.

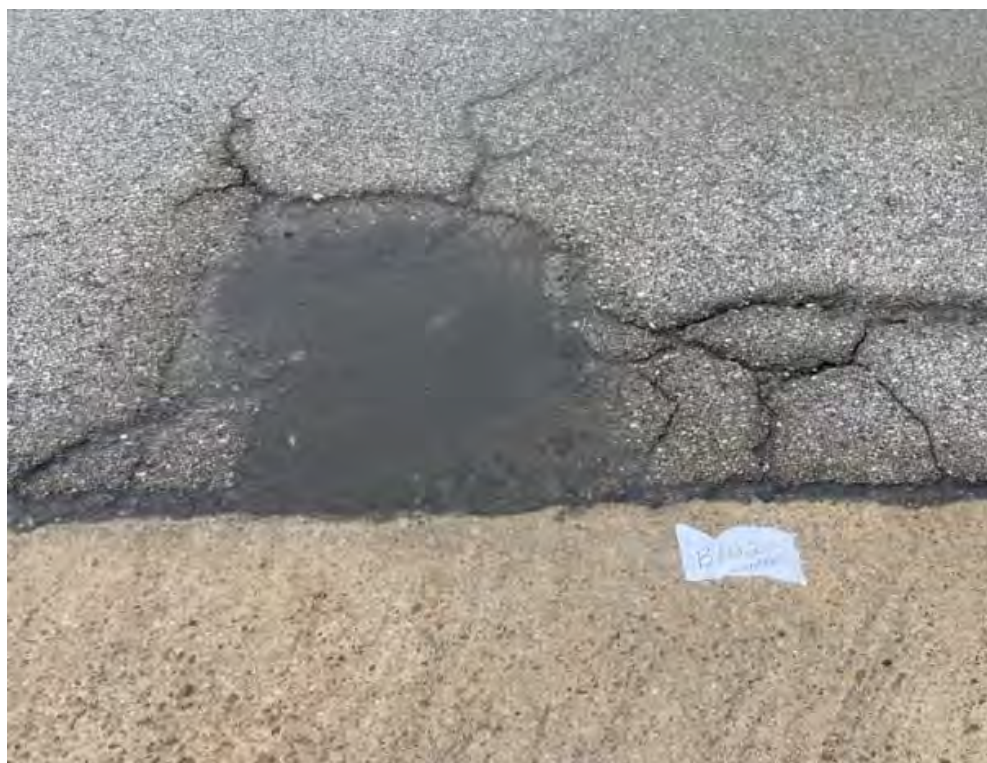
30

Stall B102 (center), no tar-like material observed at seep location along cracks in pavement. Area wet from recent rain event.

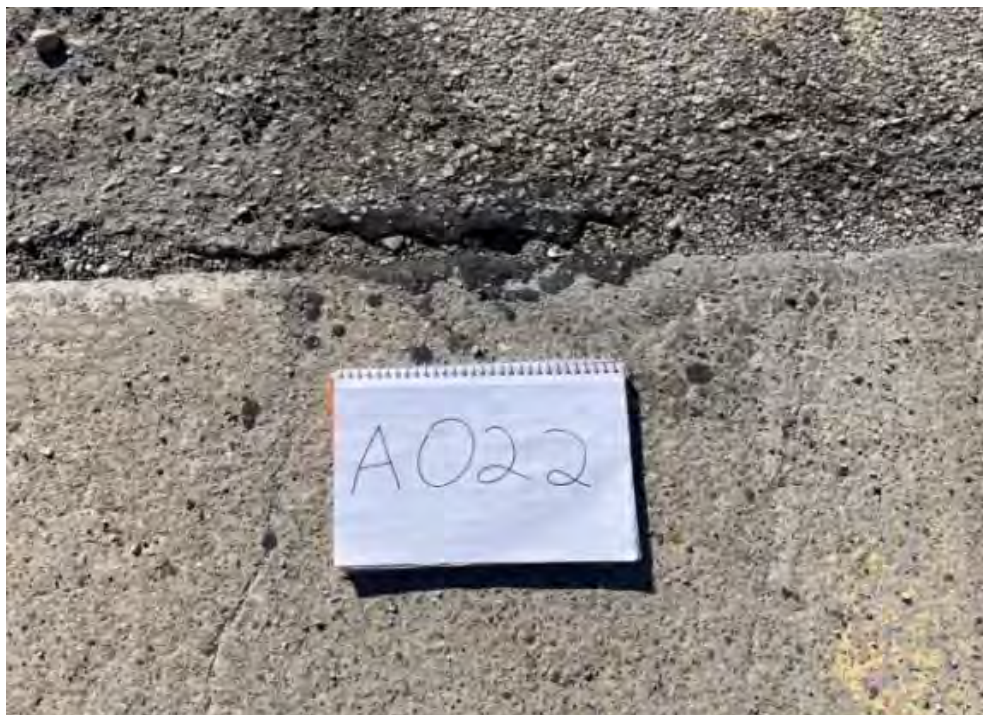
Stall A022, no tar-like material observed at the seep location along the edge.

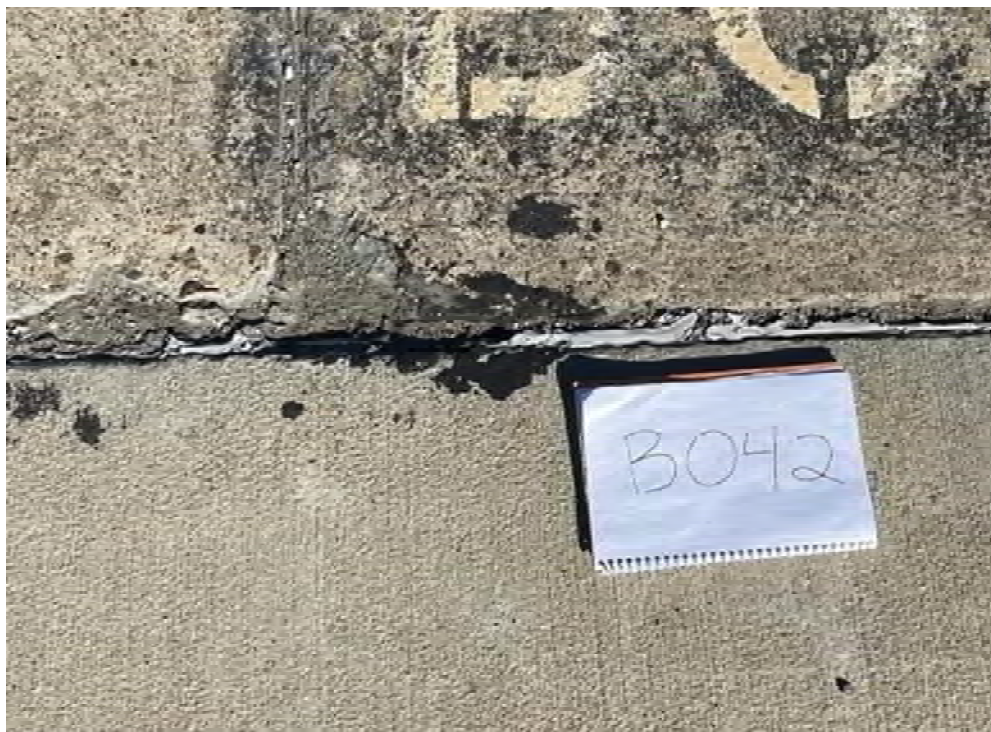
34

Stall B042. No tar-like material observed at historical seep location along asphalt crack.

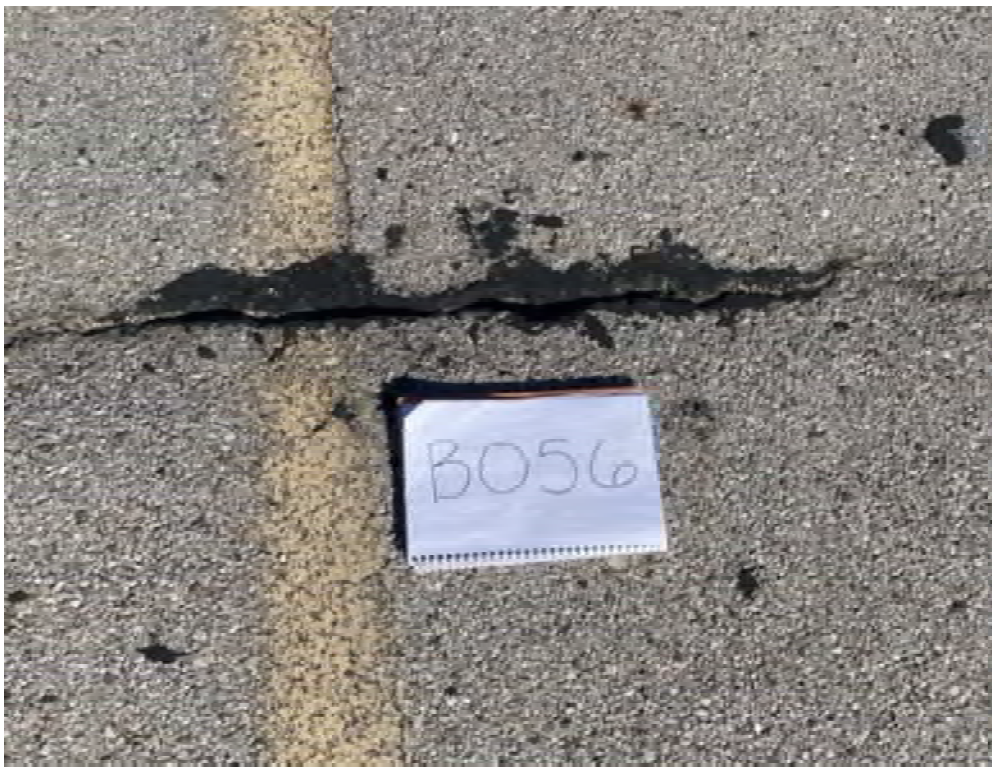
Client Name: Union Pacific Railroad		Site Location: Englewood Intermodal Yard, Houston, Texas	Project No. 31406585.016
Photo No. 35	Inspection Date: 10/18/2023

Description: Stall B056. No tar-like material observed at historical seep location along asphalt crack. Lat: 29.784751 Long: -95.319532			
Photo No. 36	Inspection Date: 10/18/2023

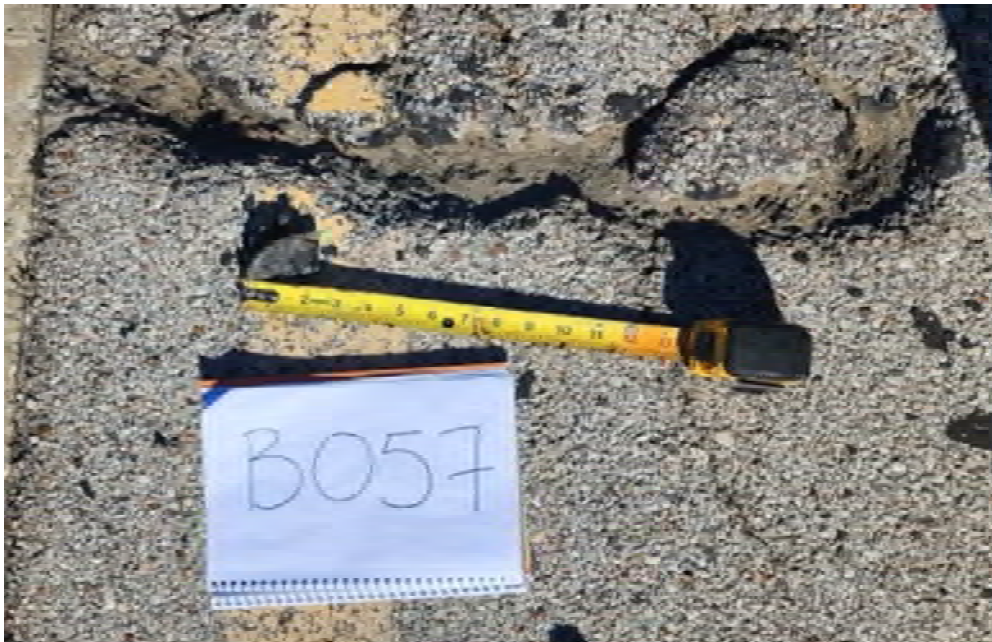
Description: Stall B057, some new tar-like material observed and removed at seep location along asphalt crack. Lat: 29.784769 Long: -95.3195798

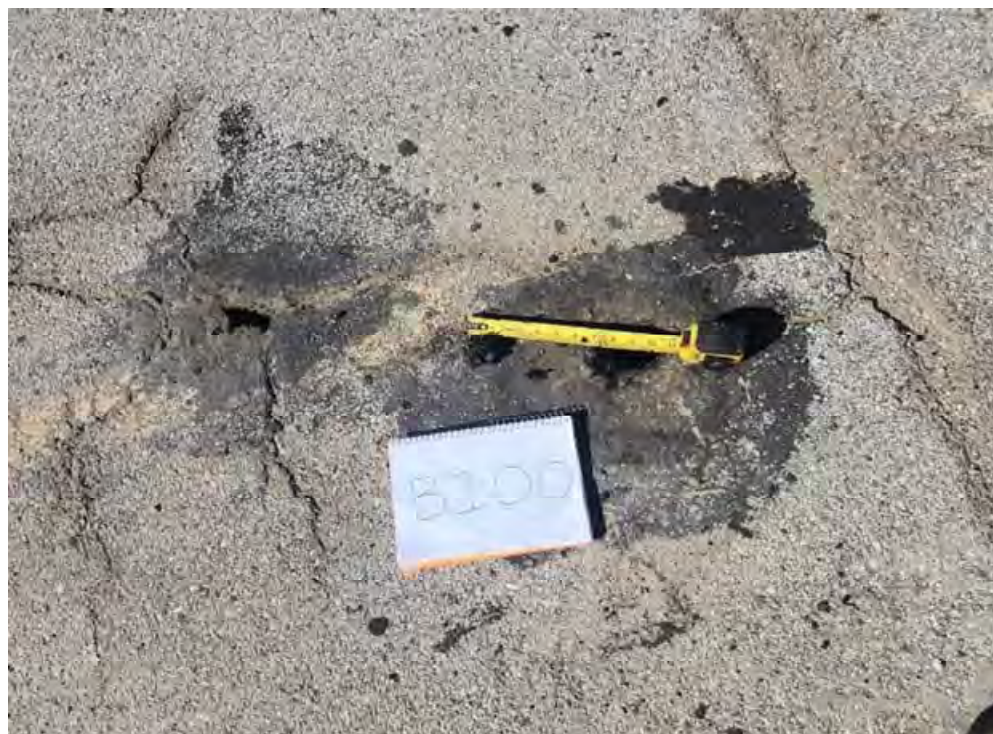
Stall B100, tar-like material observed and removed at seep location along asphalt crack/hole in the asphalt.
