November 15, 2023

Project No. 31406585.016

**Re: MONTHLY STATUS UPDATE – ENGLEWOOD INTERMODAL YARD – NAPL COLLECTION
SYSTEM/CONCRETE CAP REPAIRS
UNION PACIFIC RAILROAD HOUSTON WOOD PRESERVING WORKS FACILITY
4910 LIBERTY ROAD FACILITY, HOUSTON, TEXAS
POST-CLOSURE CARE PERMIT NO. HW-50343; INDUSTRIAL SWR NO. 31547**

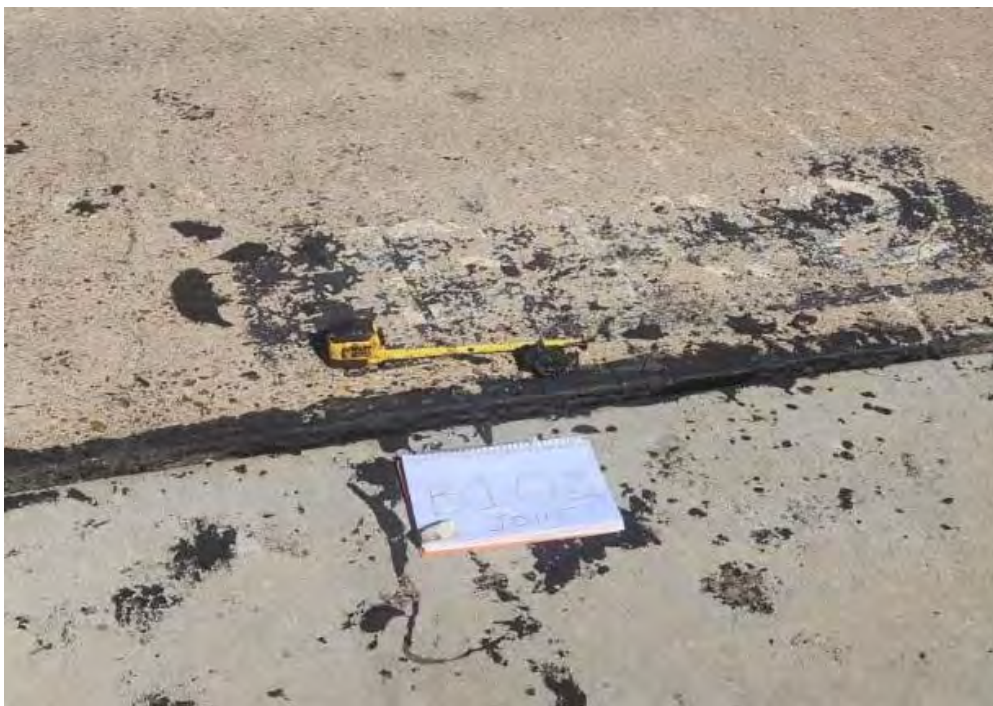
38

Stall B102 Joint, tar-like material observed and removed at seep location along stall joint.

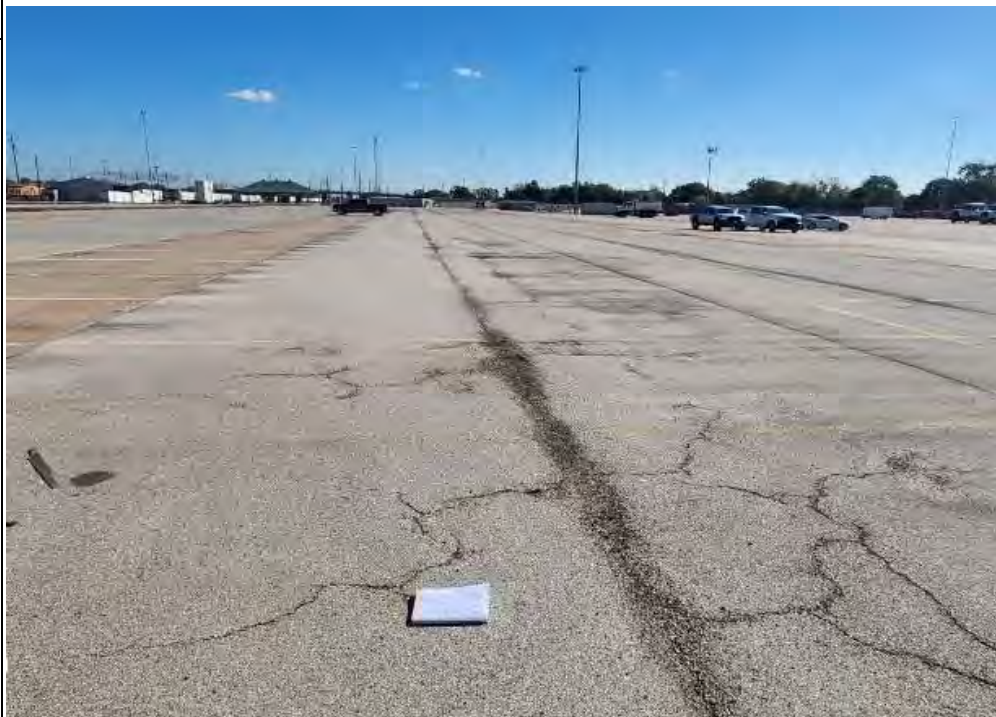
Stalls A060 - A065, some residual staining previously observed along cracks in pavement. No new water seeps observed. Viewing west.

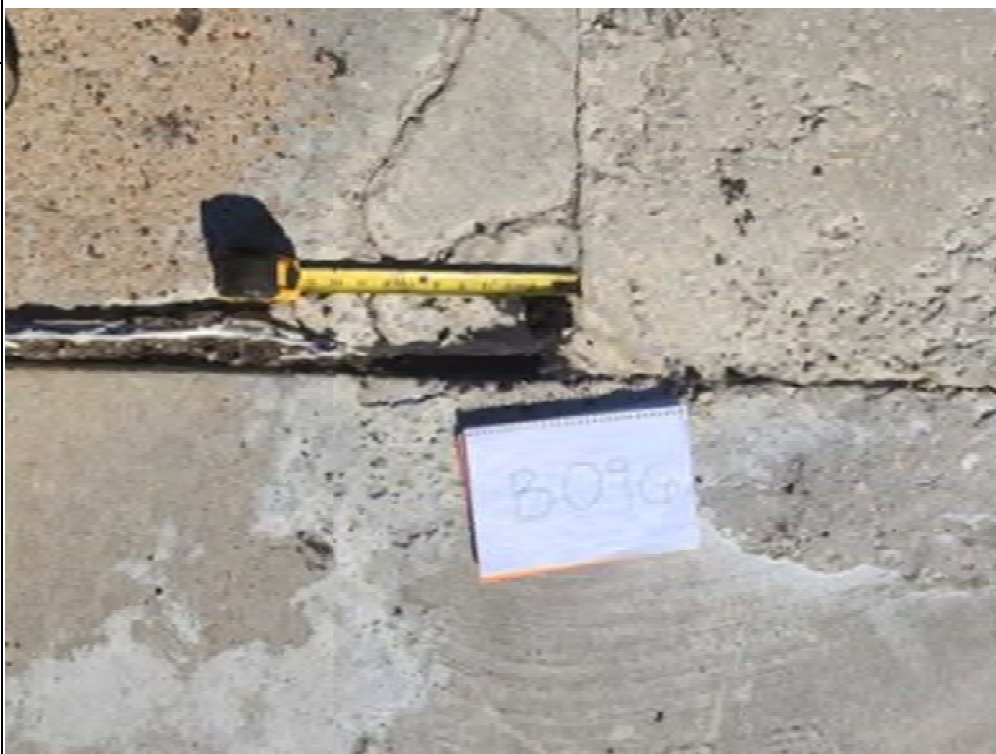
40

Stall B096, some tar-like material observed at historical seep location along concrete joint, material was removed.

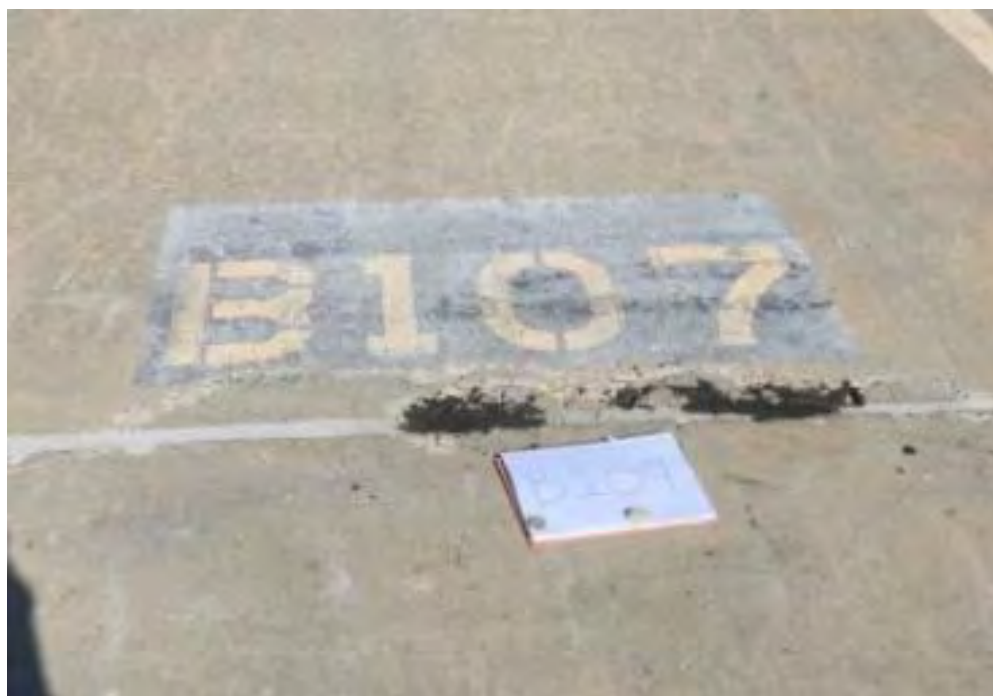
Stalls B107, no new tar-like material observed at seep location on concrete joint along the southern edge of the excavated area.

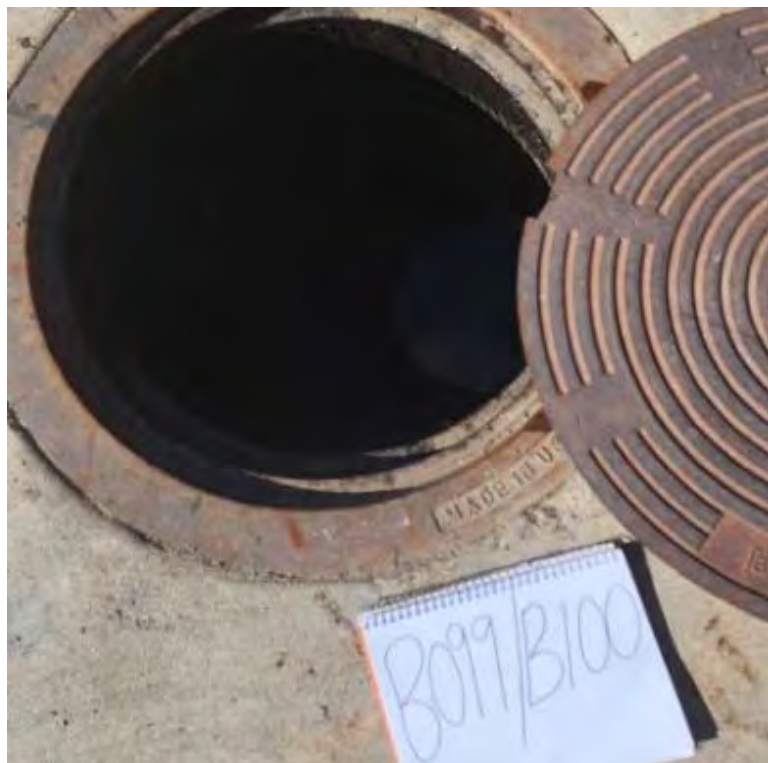
42

Sump 1 (B099/B100), 46 inches of freeboard in sump, no odor noted, sheen observed, no NAPL accumulation on inflow protector, water color noted as brown.

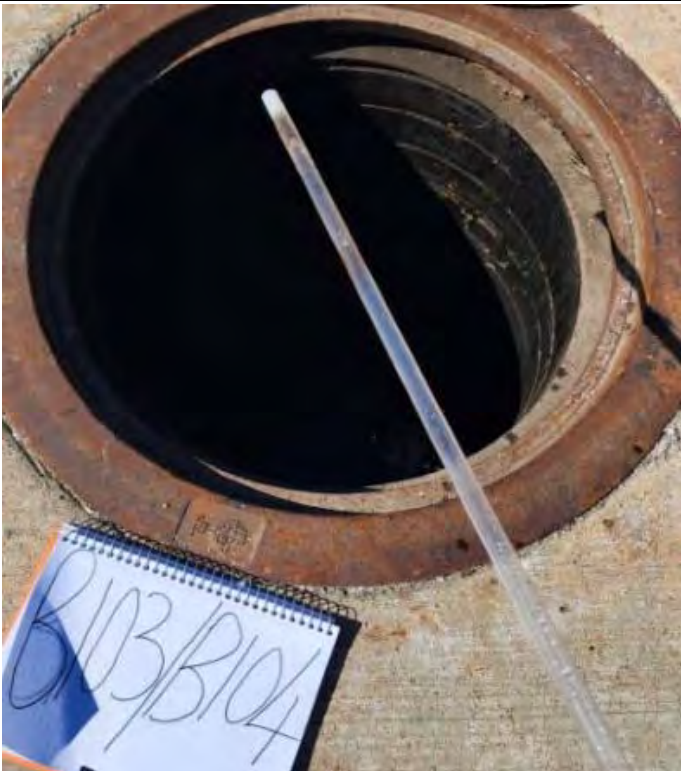
Client Name: Union Pacific Railroad		Site Location: Englewood Intermodal Yard, Houston, Texas	Project No. 31406585.016
Photo No. 43	Inspection Date: 10/18/2023

Description: Sump 2 (B103/B104), 48 inches of freeboard before pumping. No sheen or odor noted, color noted as clear. Lat: 29.7842861 Long: - 95.3208611			
Photo No. 44	Inspection Date: 10/18/2023

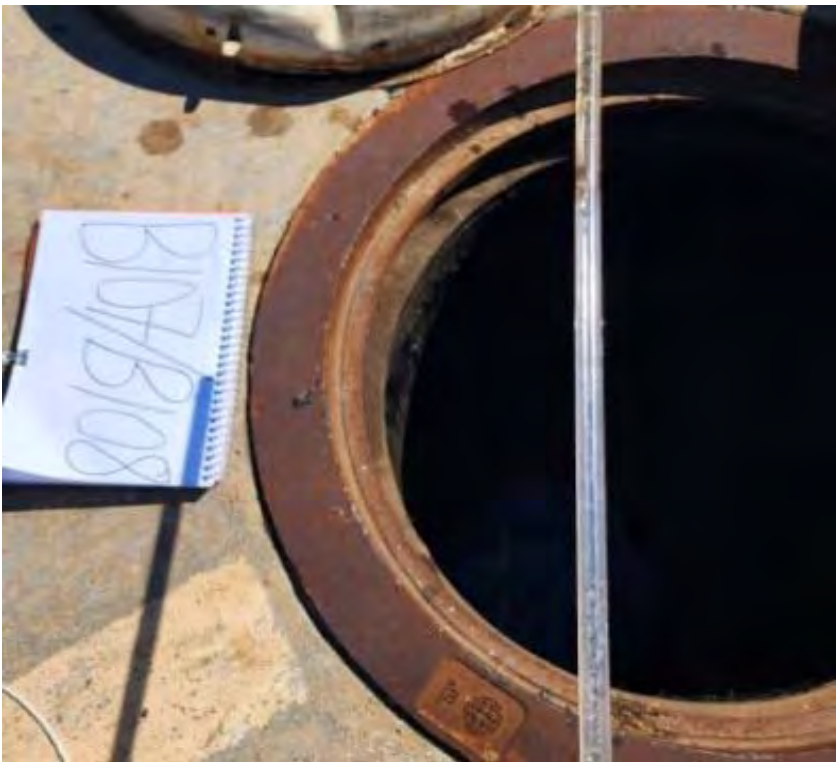
Description: Sump 3 (B107/B108), 47 inches of freeboard in sump, no odor noted, sheen observed, no new NAPL accumulation on inflow protector, water color noted as light brown. Lat: 29.7844000 Long: - 95.3205861

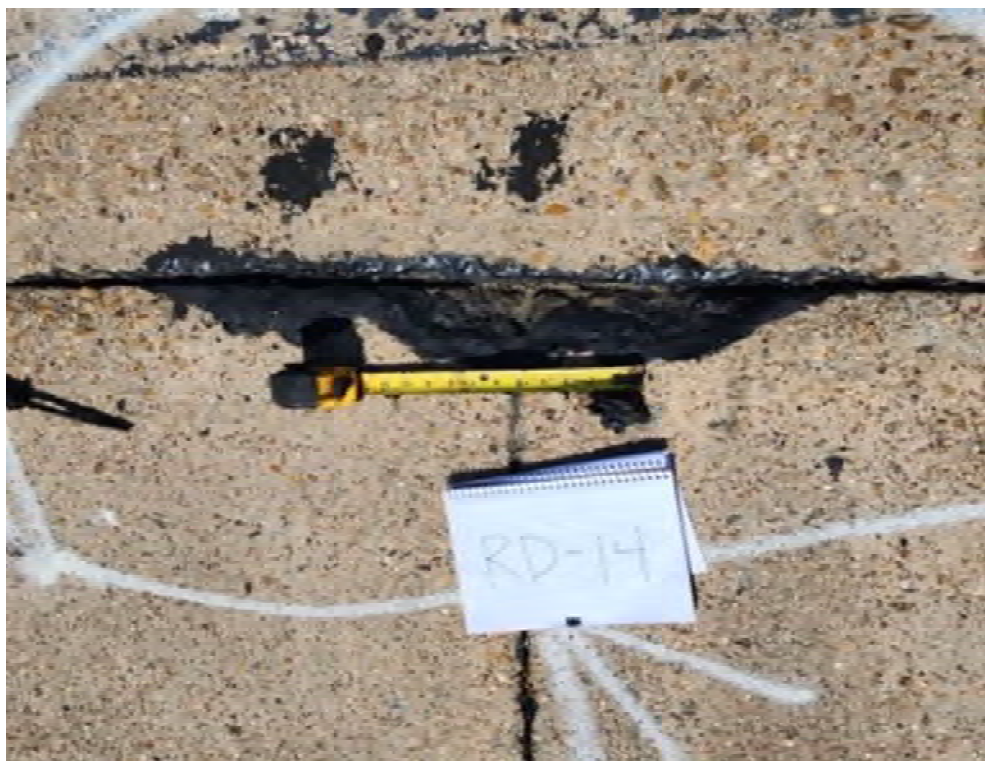
RD-14 Seep location observed within the concrete road area (RD-14) north of Track 802 (east of existing Track 802 seep location), very small amount of tar-like material observed along a concrete joint, material was removed.

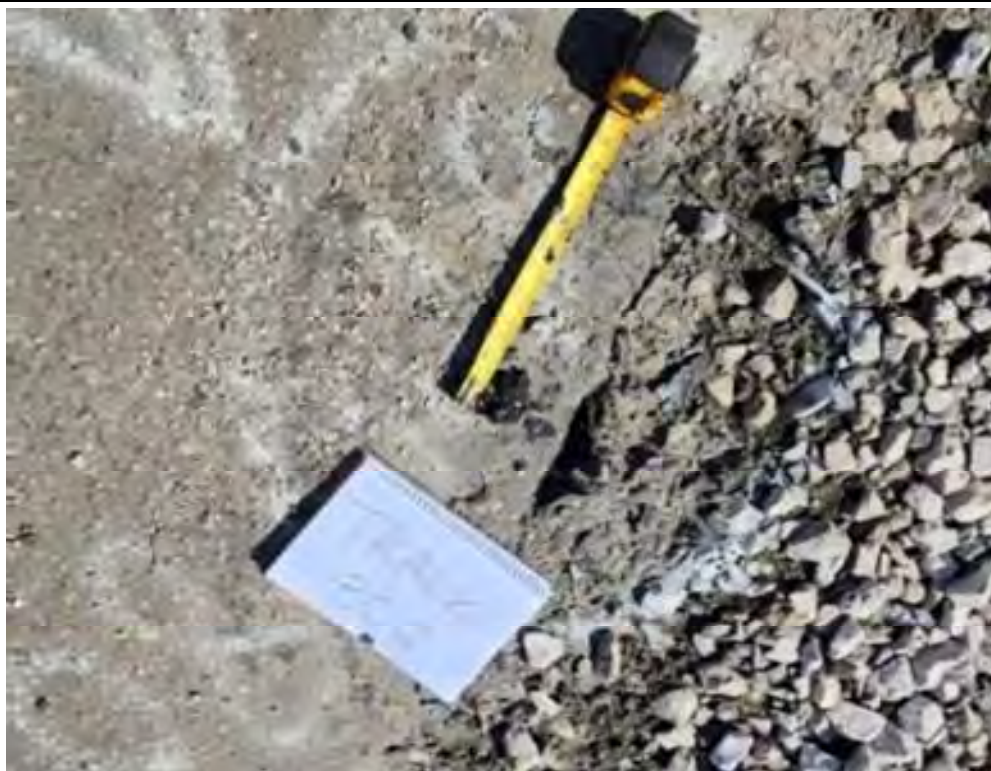
46

North side of Track 802, a small amount of tar-like material observed at seep location near the edge of the ballast, material removed.

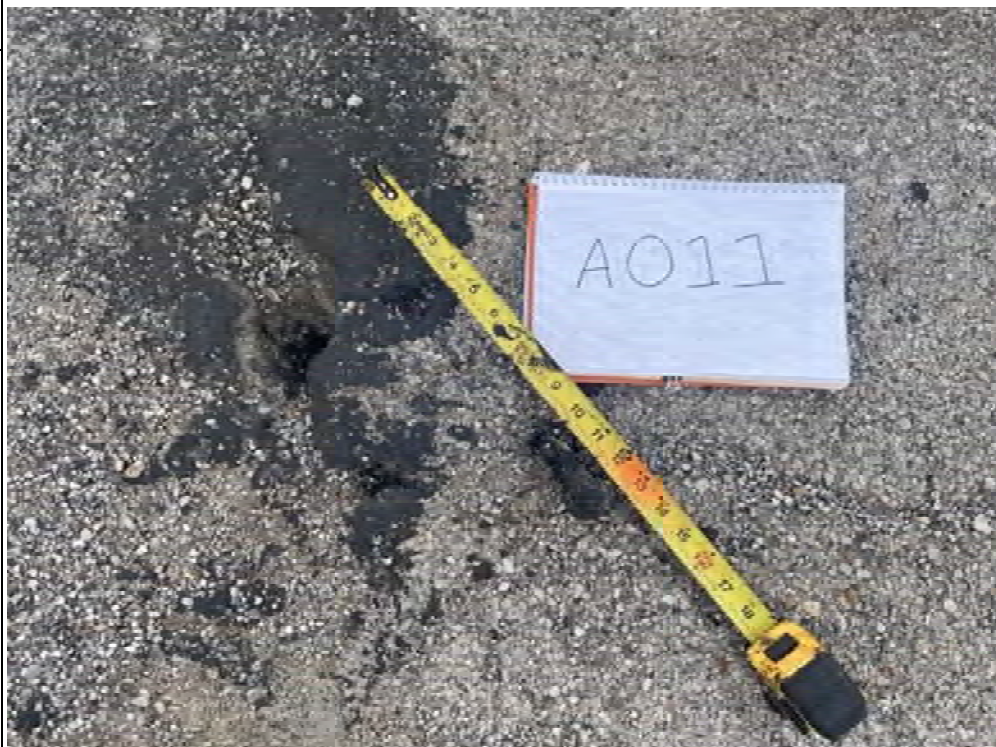
Stall A011 some tar-like material observed at historical seep location along asphalt crack, material was removed.

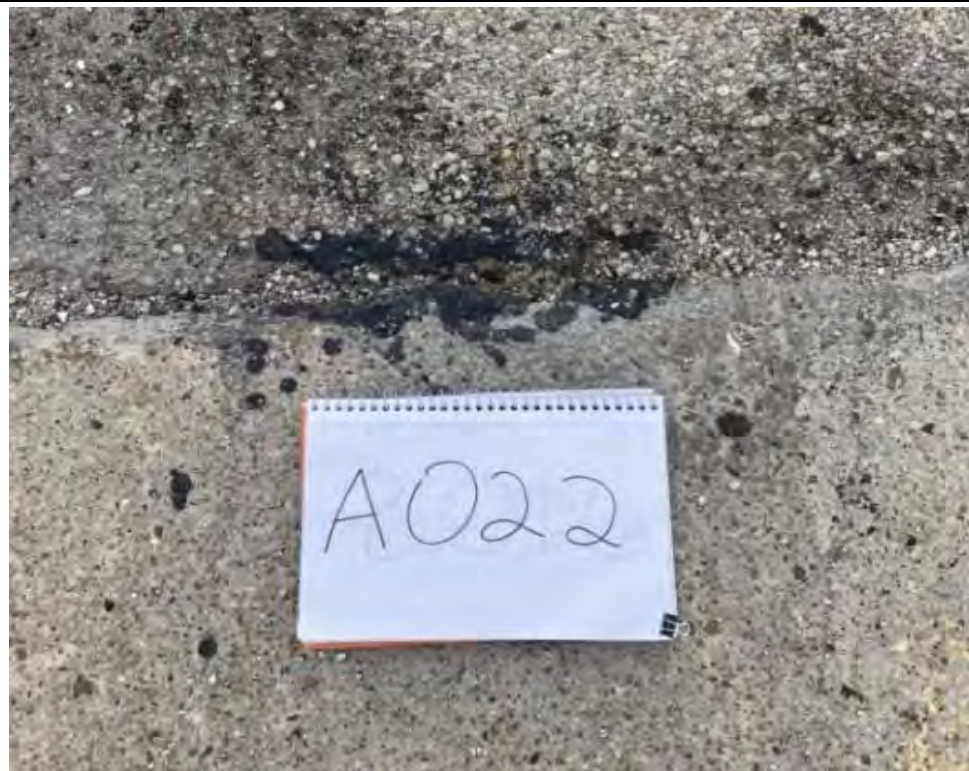
48

Stall A022, no tar-like material observed at the seep location along the edge.

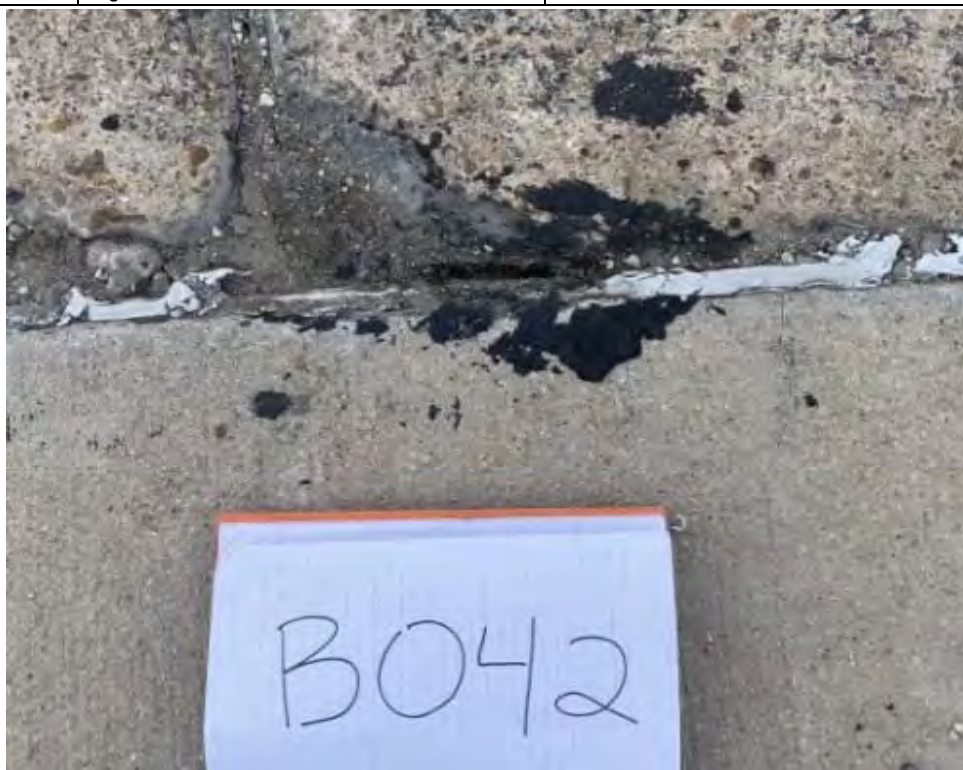
Stall B042. No tar-like material observed at historical seep location along asphalt crack, material was removed.

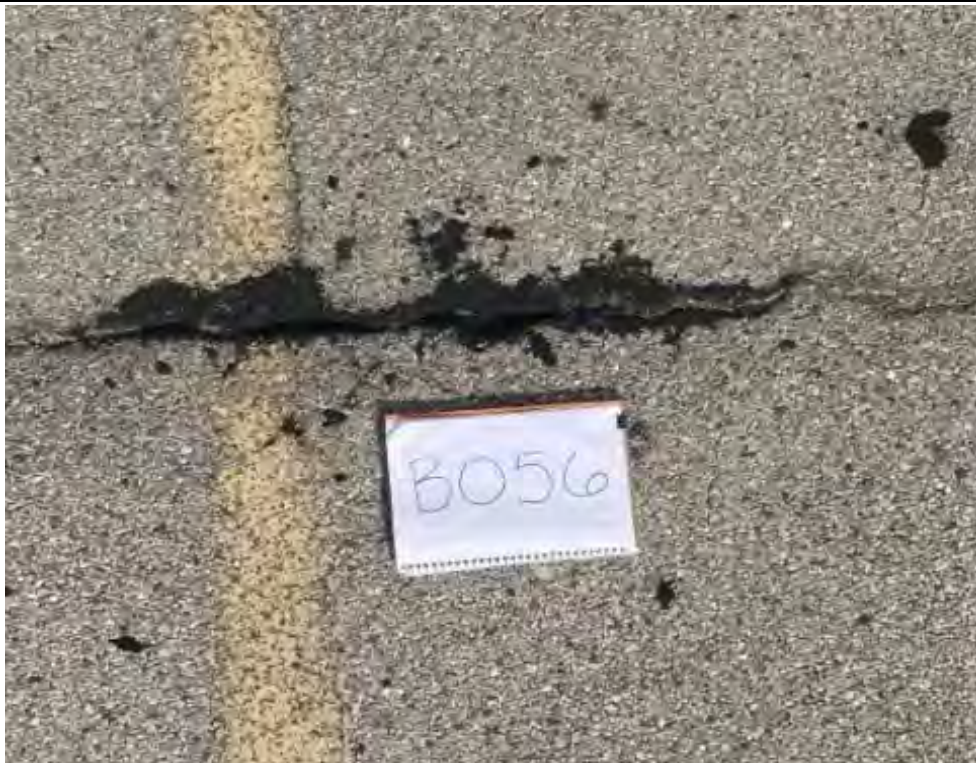
50

Stall B056. No tar-like material observed at historical seep location along asphalt crack, material was removed.

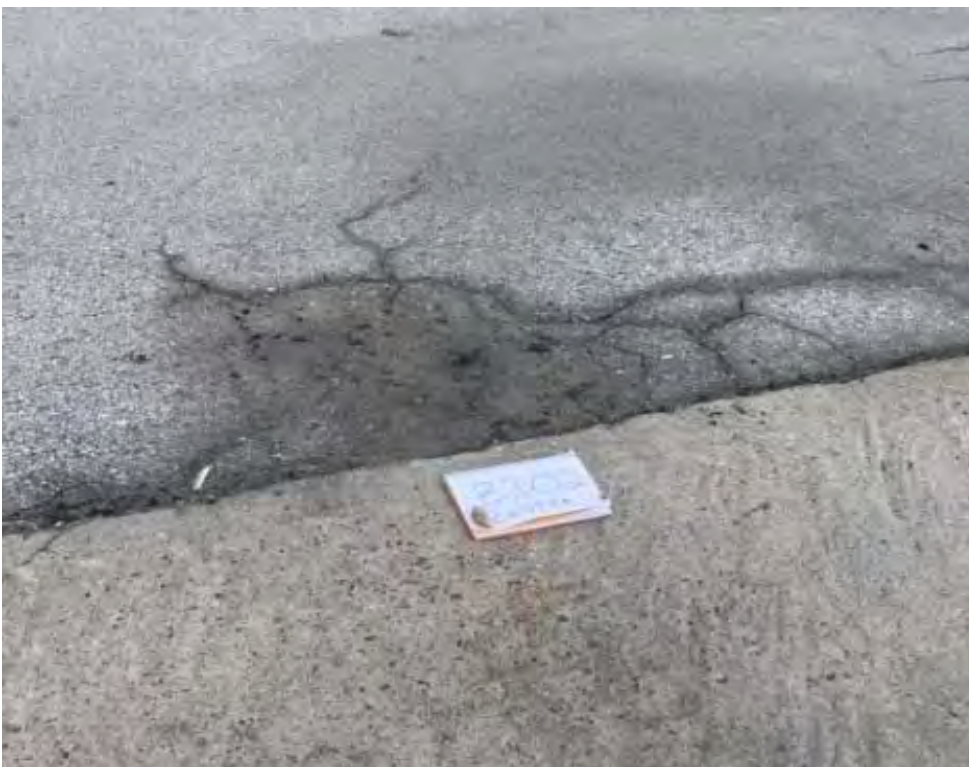
51	10/25/2023	
Description: Stall 102 (center), no tar-like material observed at seep location where pavement is cracked. Lat: 29.784769 Long: -95.3195798

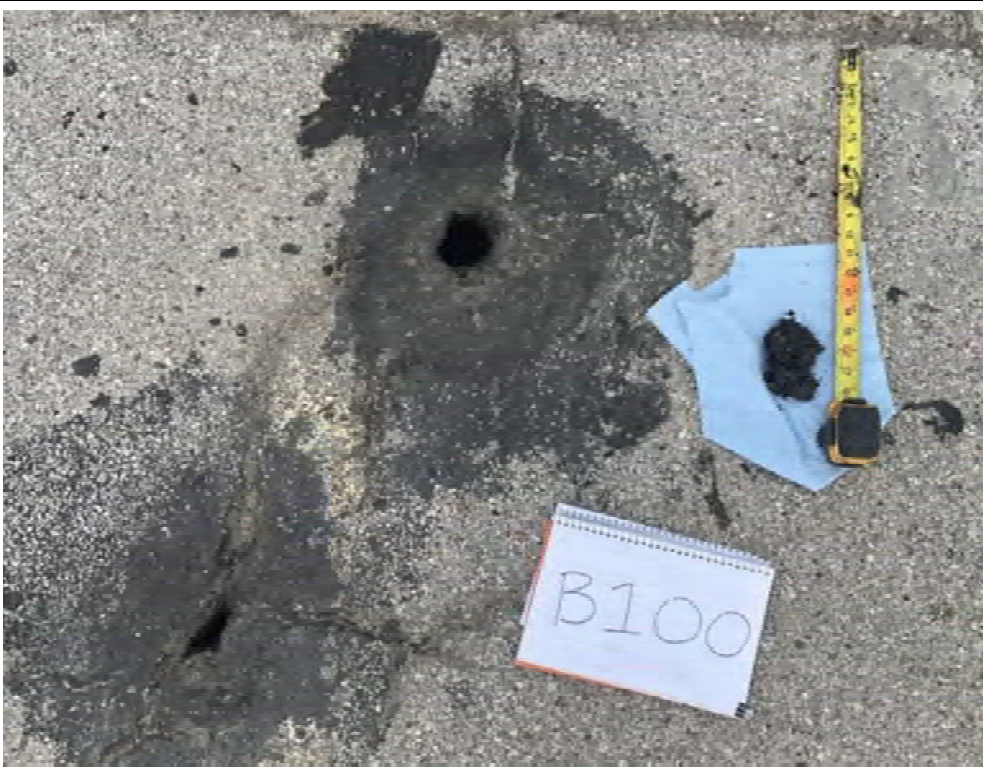
52	10/25/2023	
Description: Stall B100, tar-like material observed and removed at seep location along asphalt crack/ hole in the asphalt. Lat: 29.7842517 Long: -95.3208166

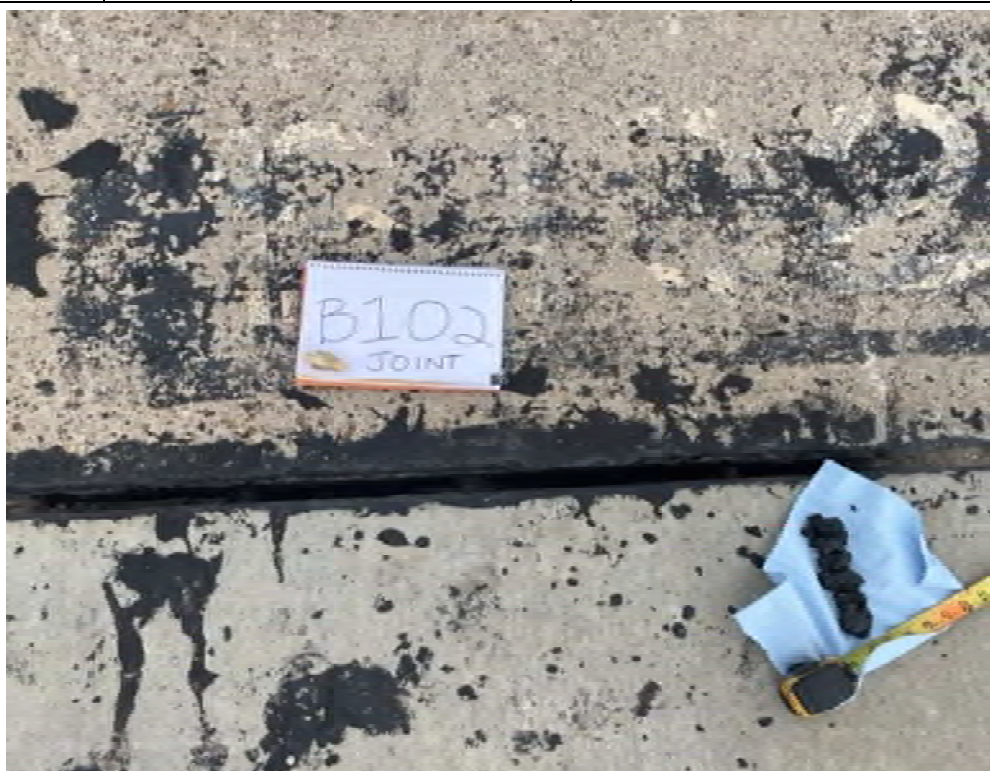
Stall B102 Joint, tar-like material observed and removed at seep location along stall joint.

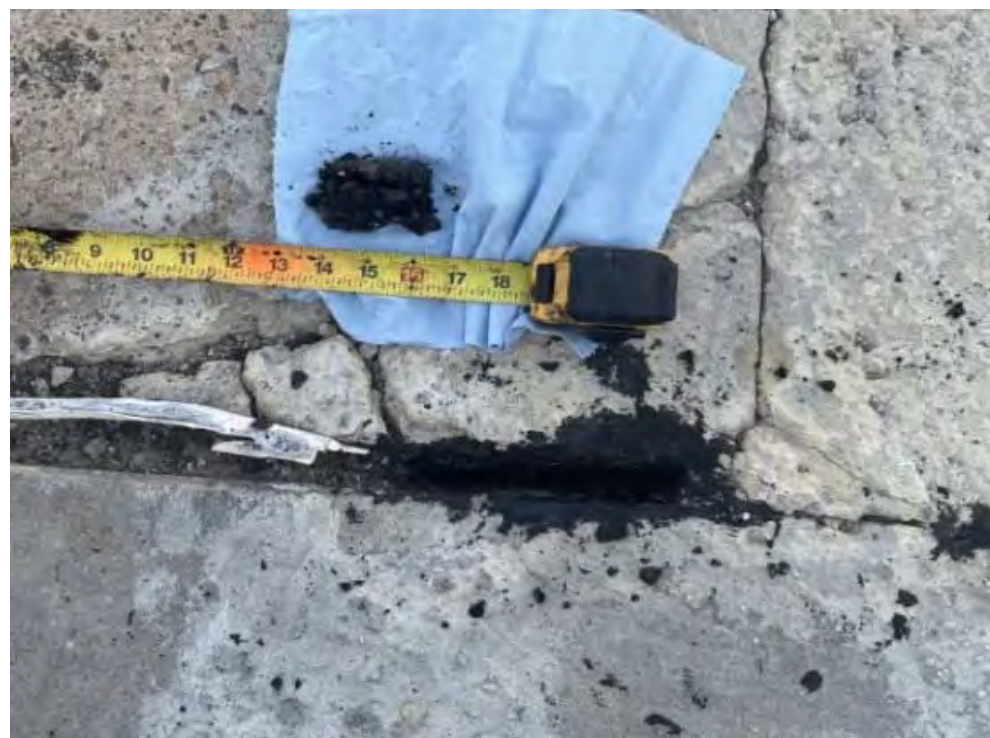
54

Stall B096, some tar-like material observed at historical seep location along concrete joint, material was removed.

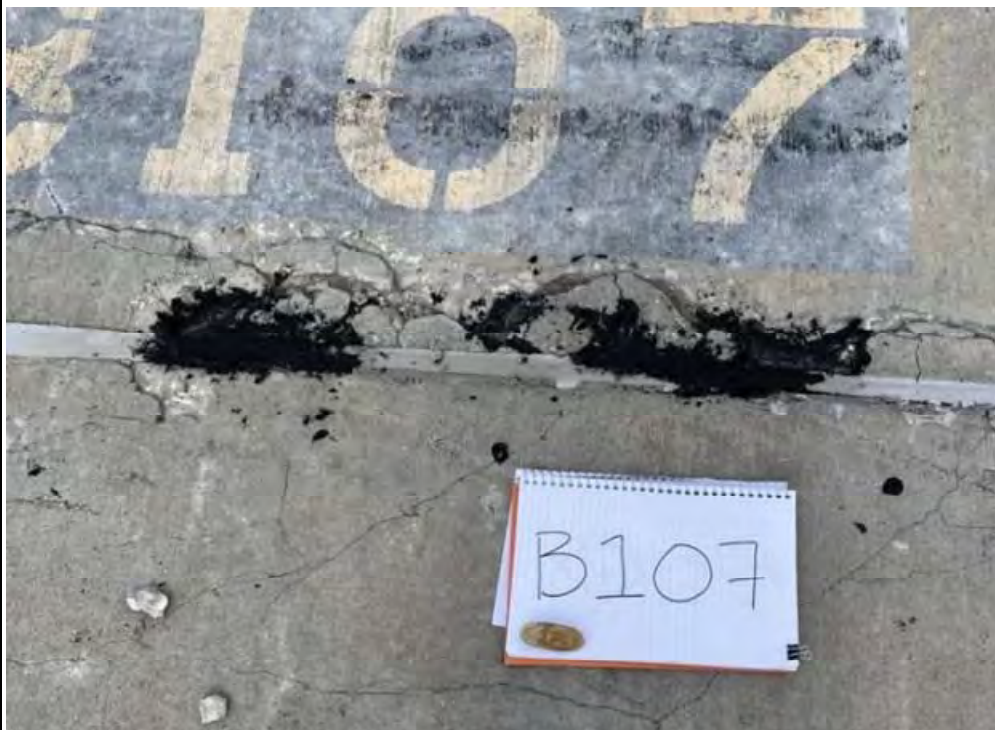
Stalls B107, no new tar-like material observed and removed at seep location on concrete joint along the southern edge of the excavated area.

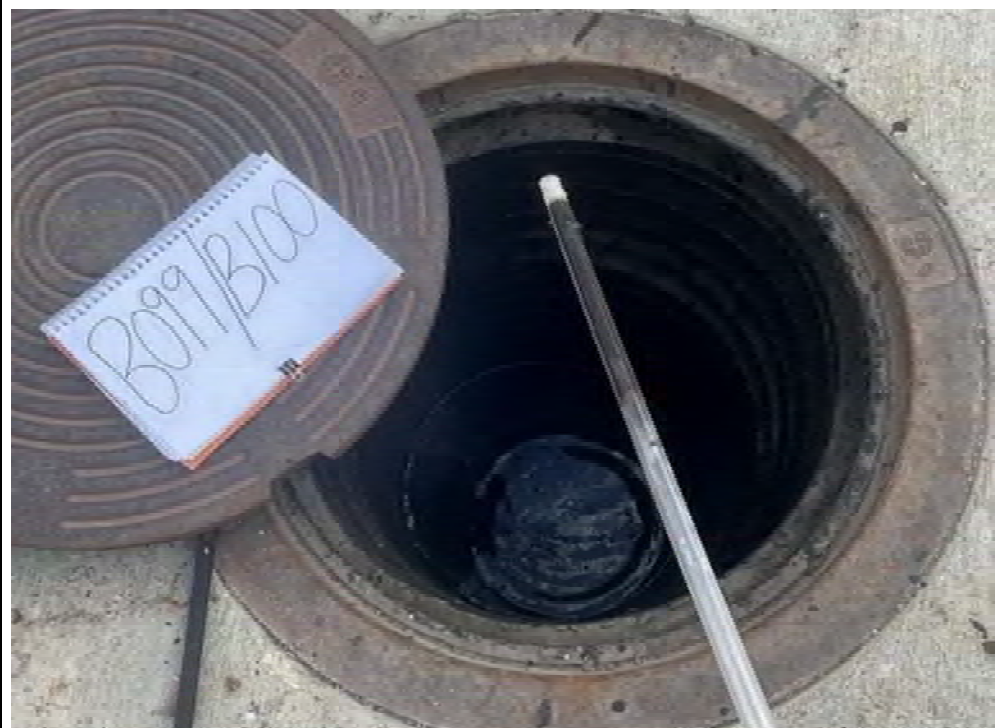
Photo No. 56	Inspection Date: 10/25/2023
-------------------------------	---------------------------------------

Sump 1 (B099/B100), 39 inches of freeboard in sump, no odor noted, sheen observed, no new NAPL accumulation on inflow protector, water color noted as dark brown.

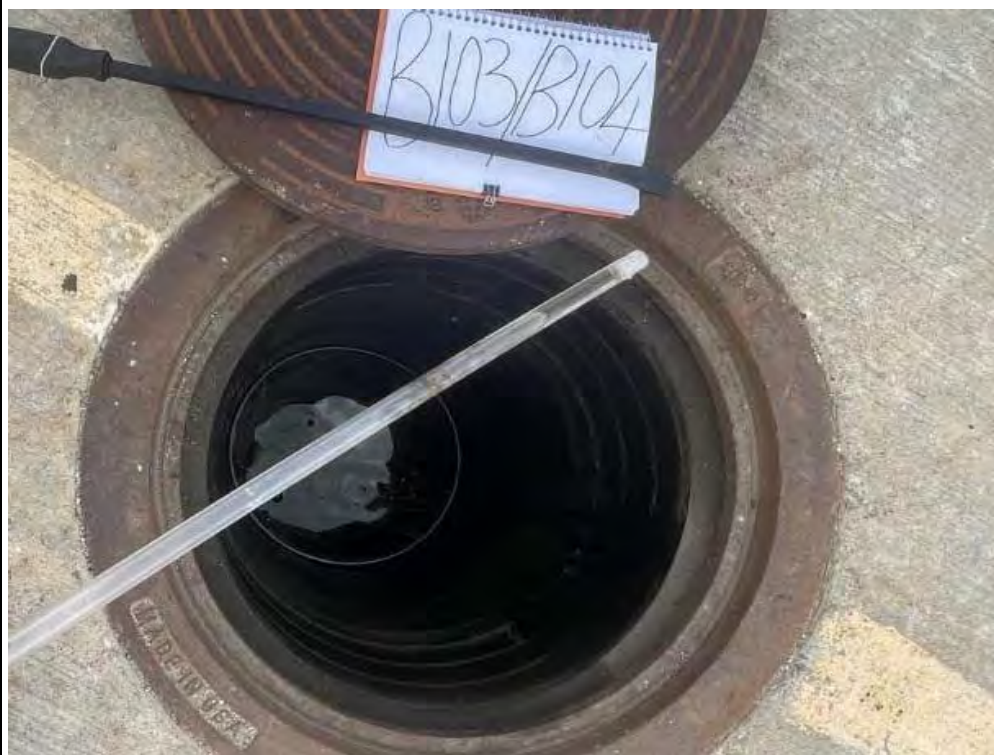
Sump 2 (B103/B104), 44 inches of freeboard before pumping. No sheen or odor observed, water color noted as light brown.

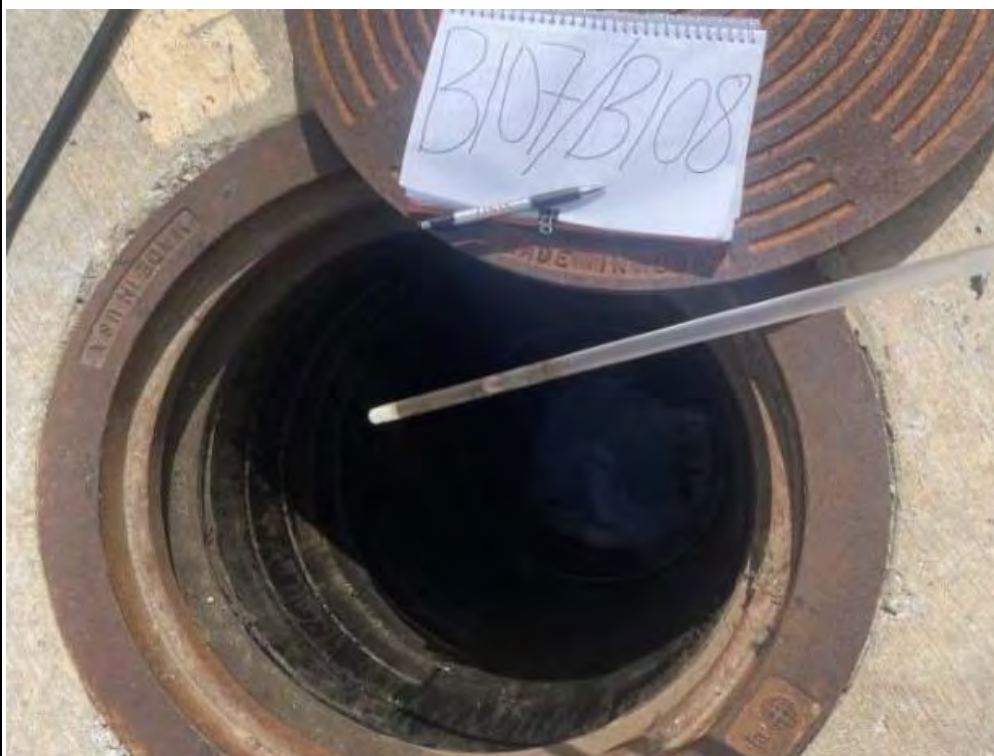
58

Sump 3 (B107/B108), 43 inches of freeboard in sump, no odor noted, sheen observed, no new NAPL accumulation on inflow protector, water color noted as light brown.

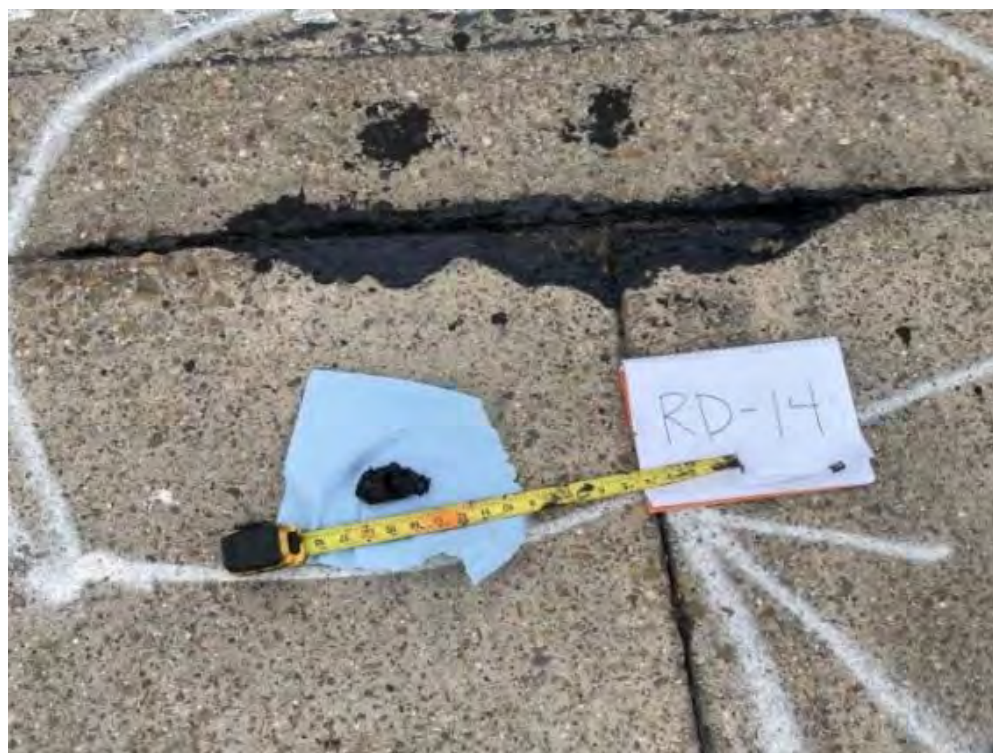
RD-14 Seep location observed within the concrete road area north of Track 802 (east of existing Track 802 seep location), tar-like material observed along a concrete joint, material was removed.

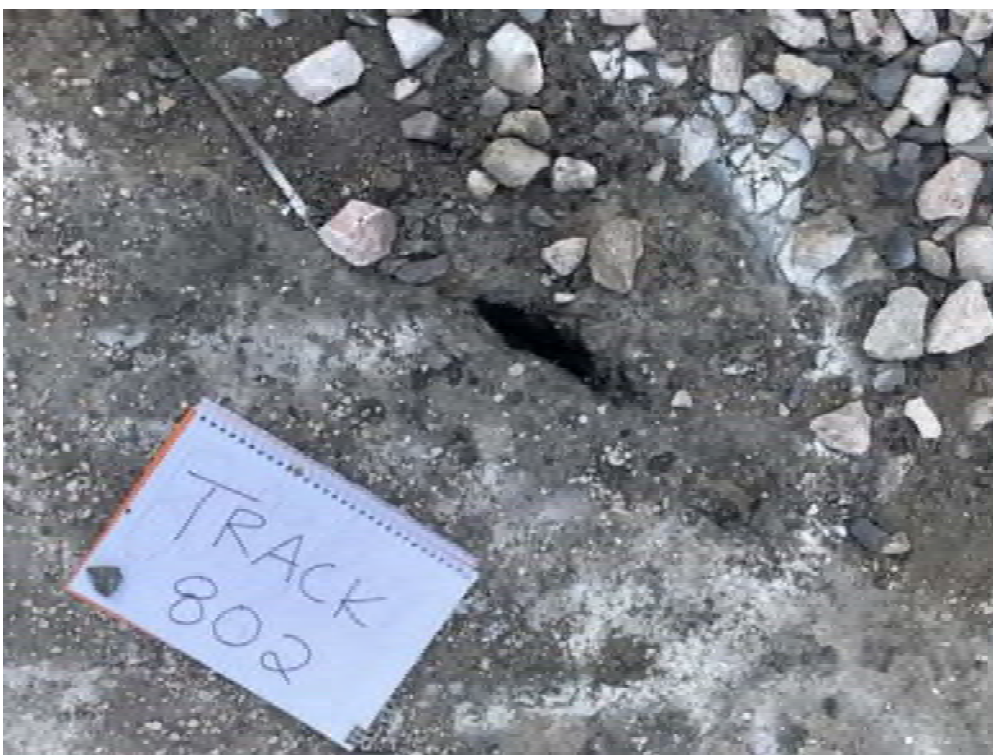
60

North side of Track 802, no tar-like material observed at seep location near the edge of the ballast.
