January 12, 2024

Project No. 31406585.016

**Re: MONTHLY STATUS UPDATE – ENGLEWOOD INTERMODAL YARD – NAPL COLLECTION
SYSTEM/CONCRETE CAP REPAIRS
UNION PACIFIC RAILROAD HOUSTON WOOD PRESERVING WORKS FACILITY
4910 LIBERTY ROAD FACILITY, HOUSTON, TEXAS
POST-CLOSURE CARE PERMIT NO. HW-50343; INDUSTRIAL SWR NO. 31547**

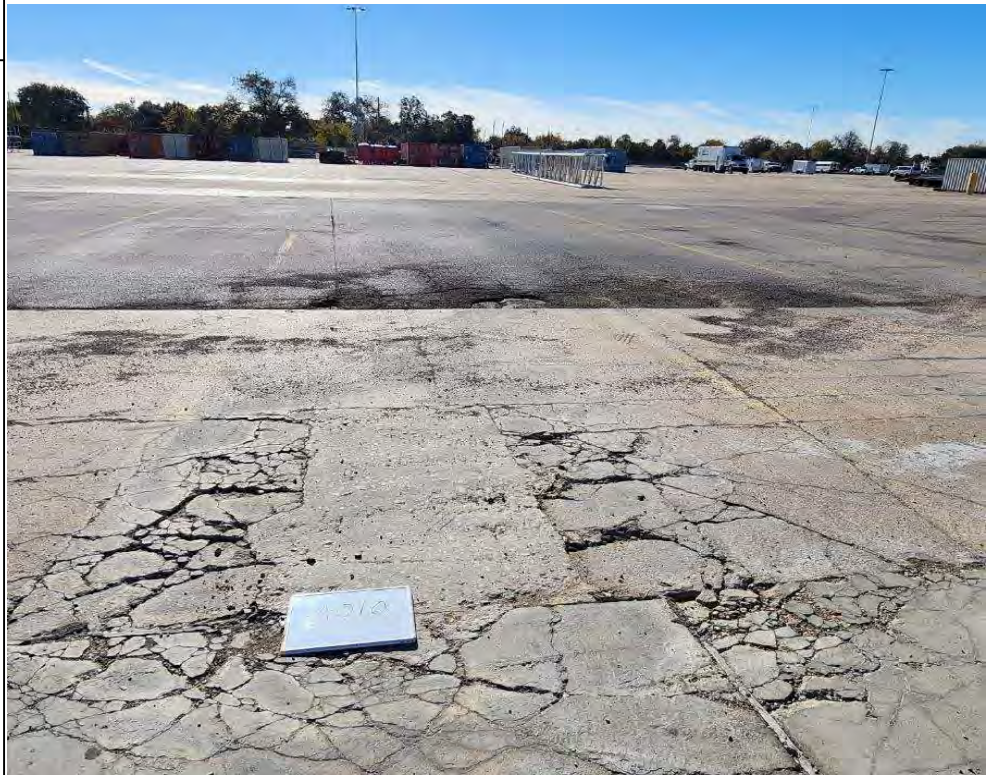
Stall A010. No tar-like material observed at Test Pit A010.

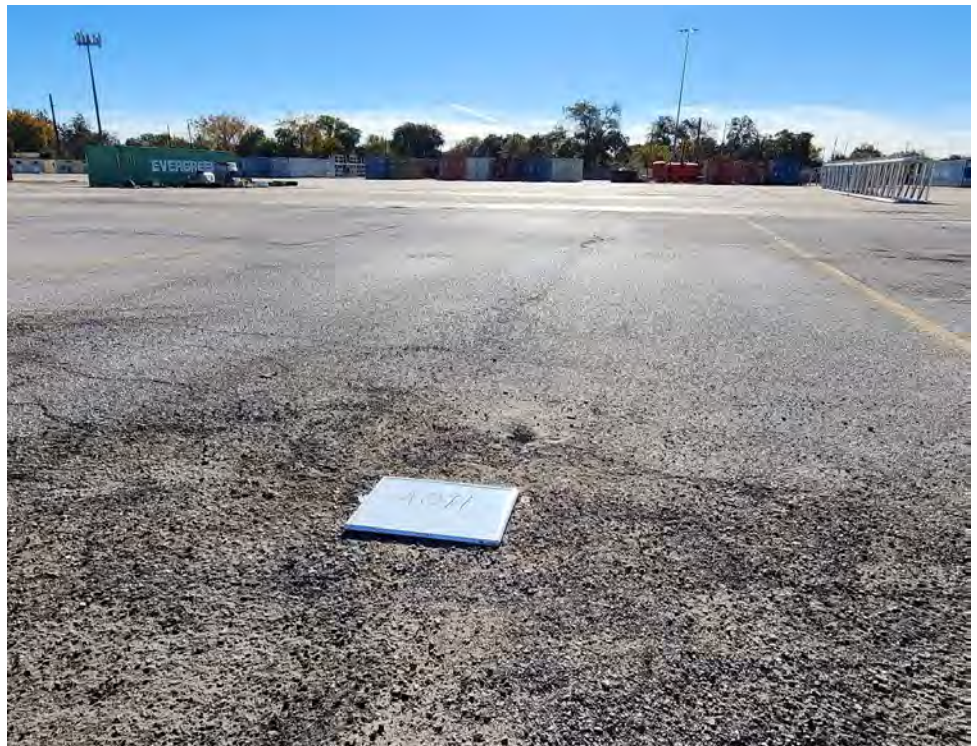
2

Stall A011. No tar-like material observed at historical seep location along asphalt crack.

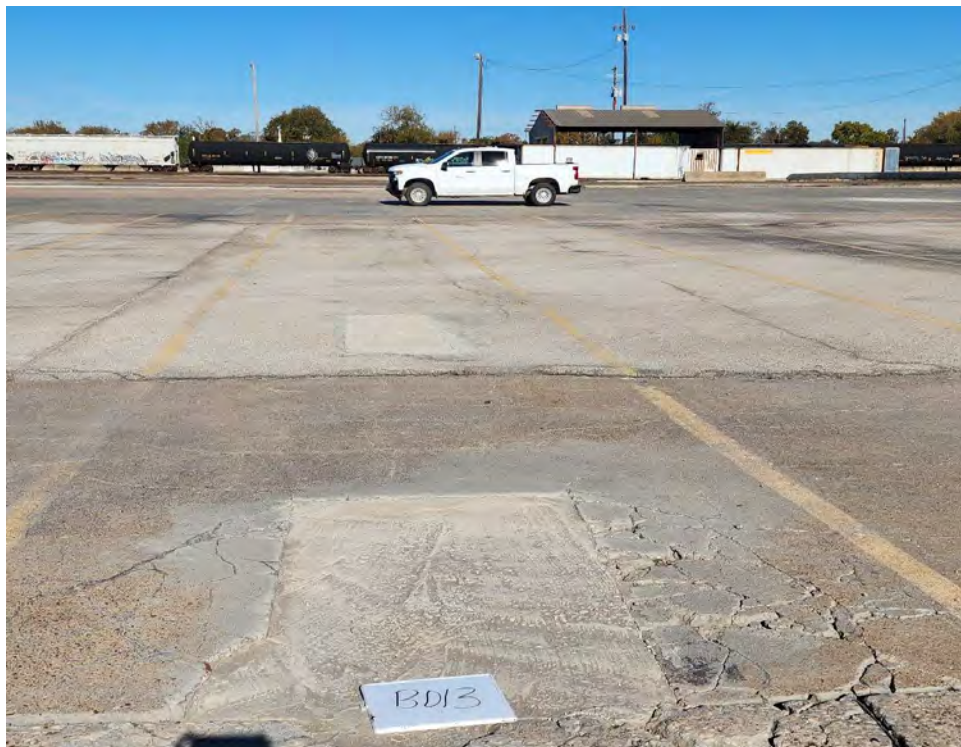
Stall B013. No tar-like material seeps observed at Test Pit B013.

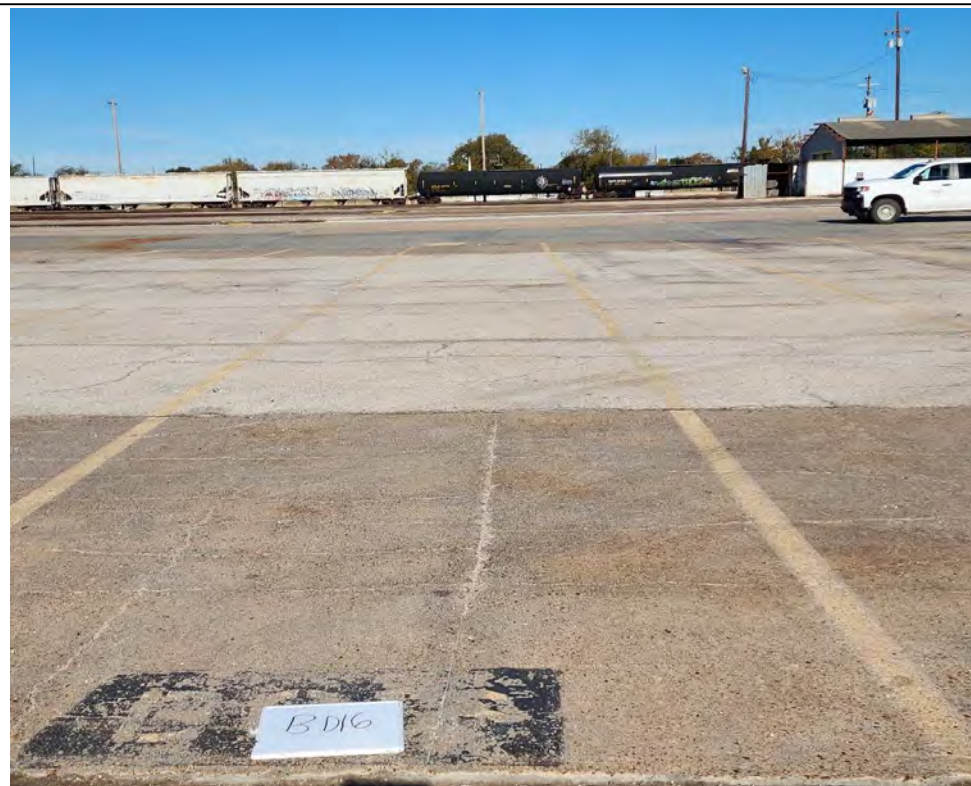
4

Stall B016. No tar-like material observed at historical seep location along asphalt crack.

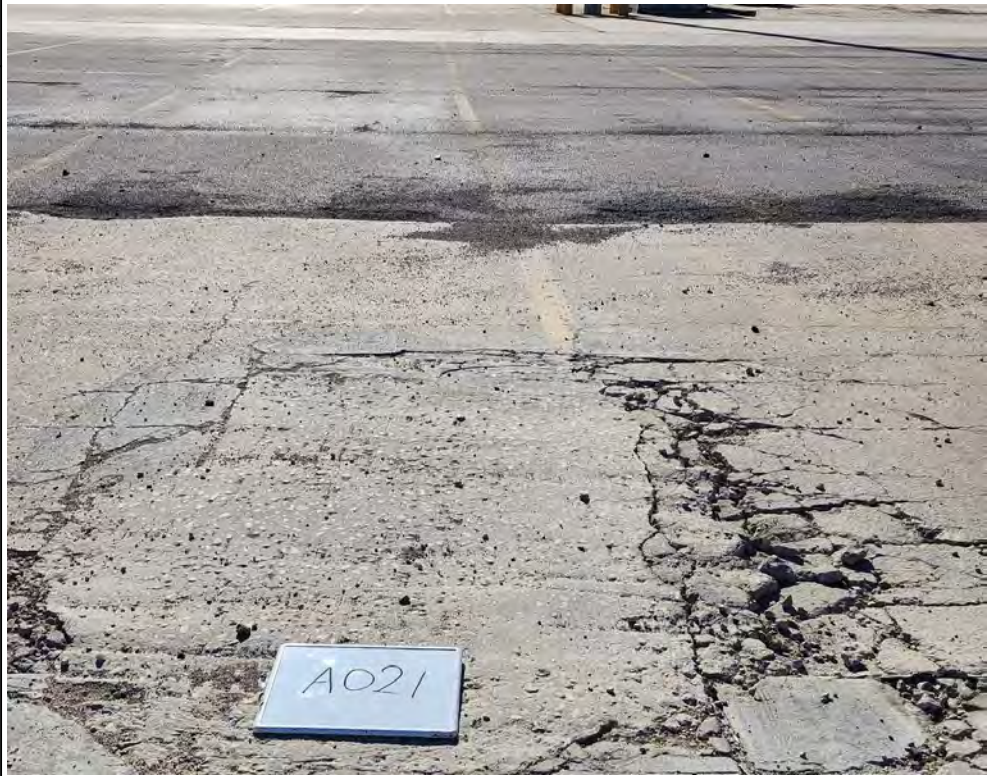
Stall A021. No tar-like material seeps observed at Test Pit A021.

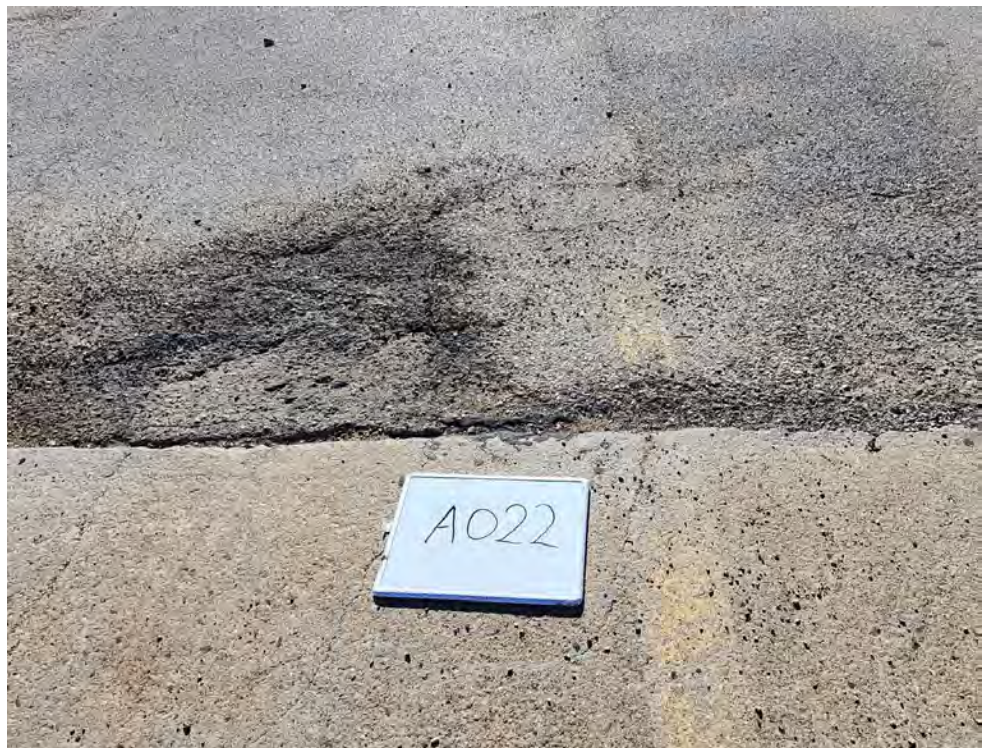
6

Stall A022. No new tar-like material observed at historical seep location along asphalt crack.

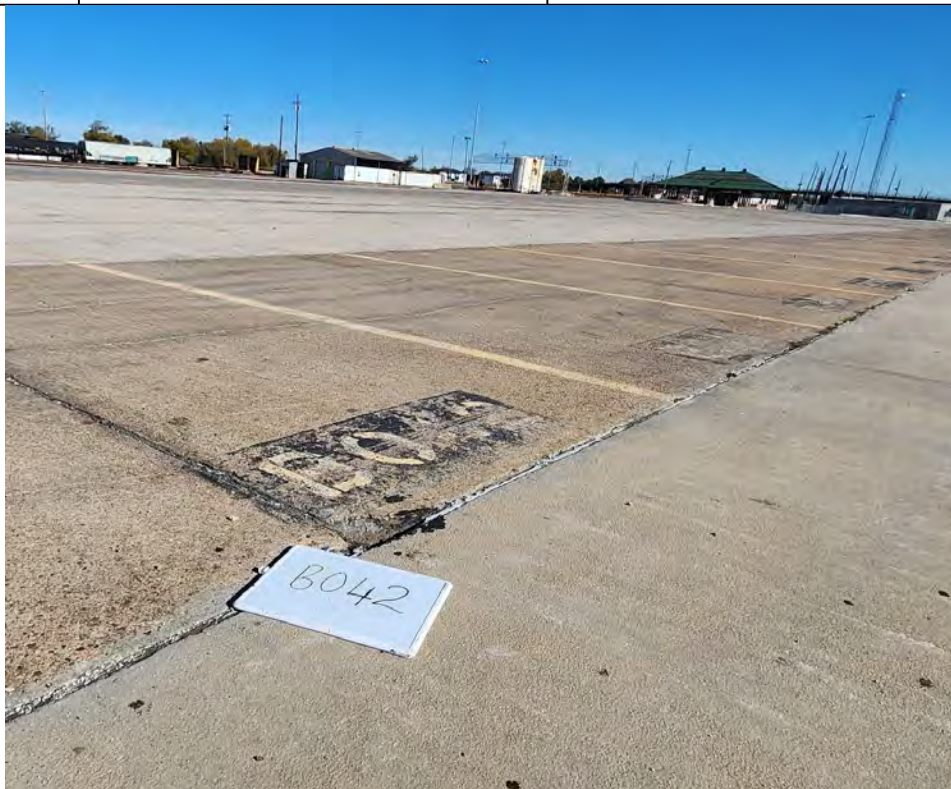
Stall B042. No new tar-like material observed at historical seep location along asphalt crack.

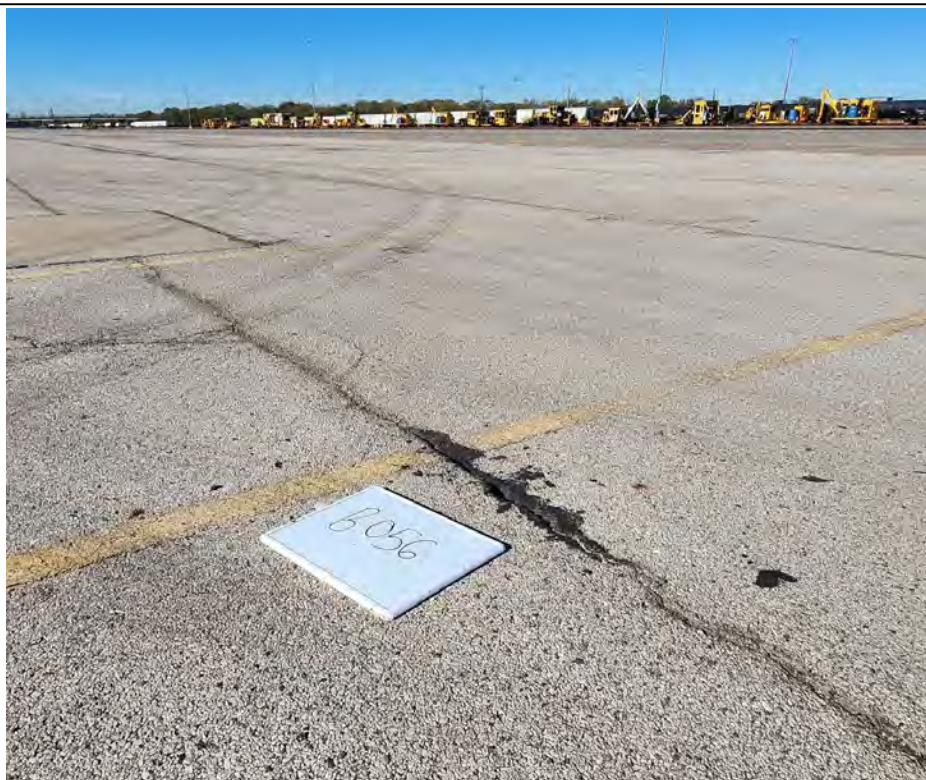
8

Stall B056. No new tar-like material observed at historical seep location along asphalt crack.

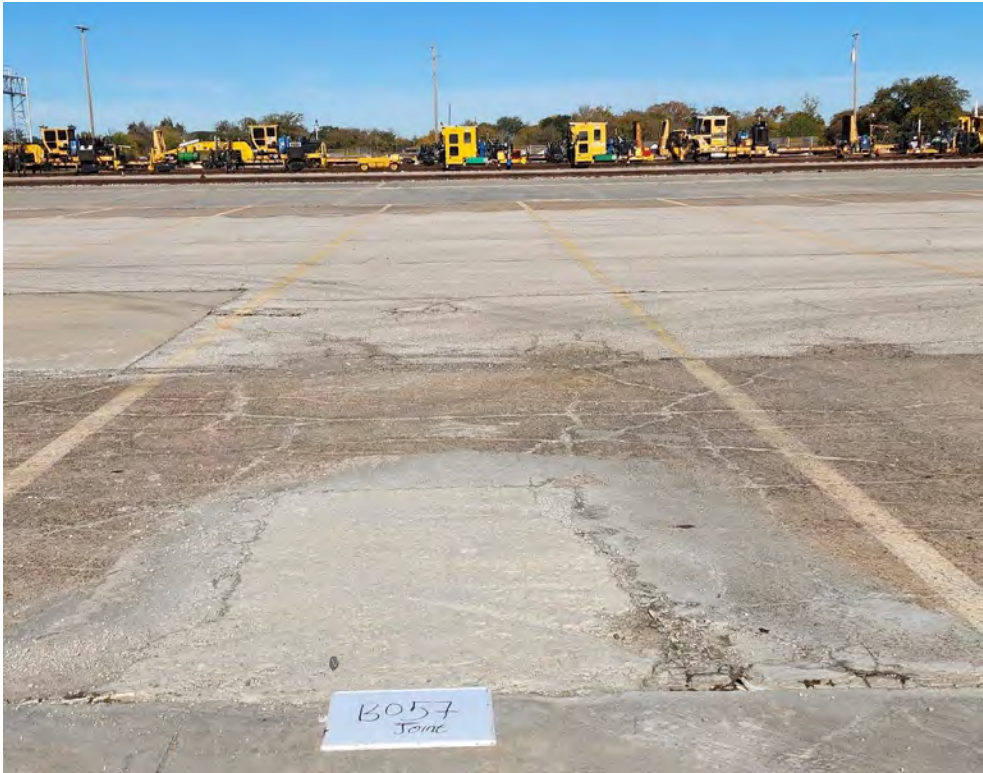
Description: Stall B057 (joint), no tar-like material observed at historical seep location at Test Pit B057. Lat: 29.784747 Long: -95.319549			
Photo No. 10	Inspection Date: 12/6/2023

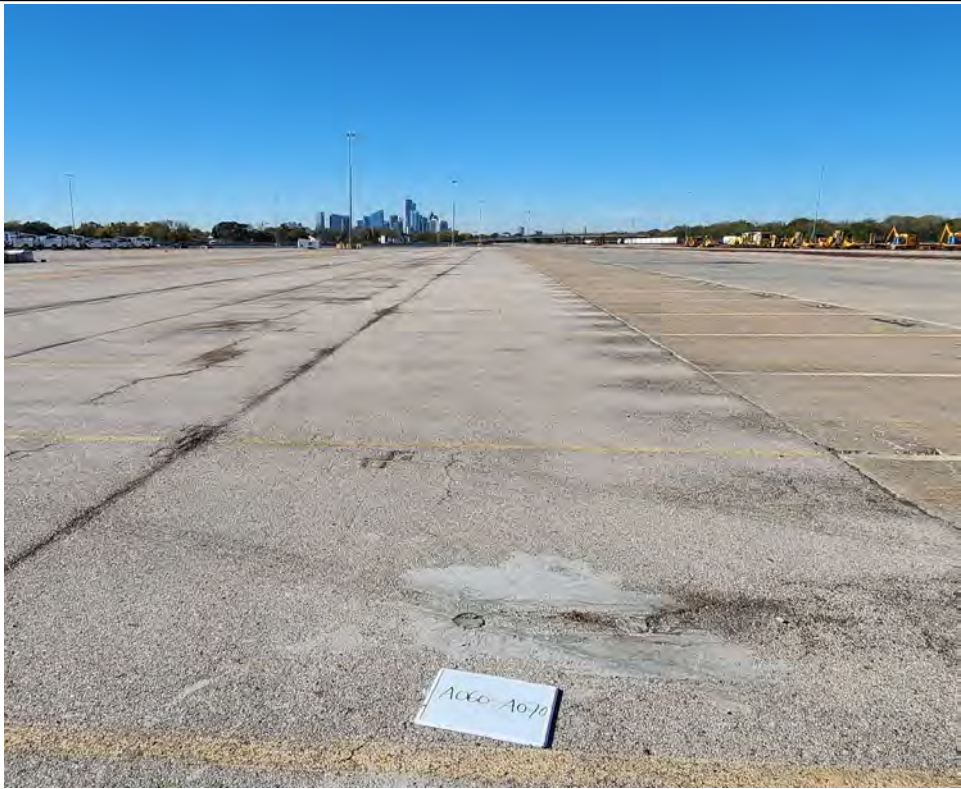
Description: Stalls A060 - A070. Looking southwest. No residual staining observed along cracks in asphalt. Lat: 29.784858 Long: -95.319733

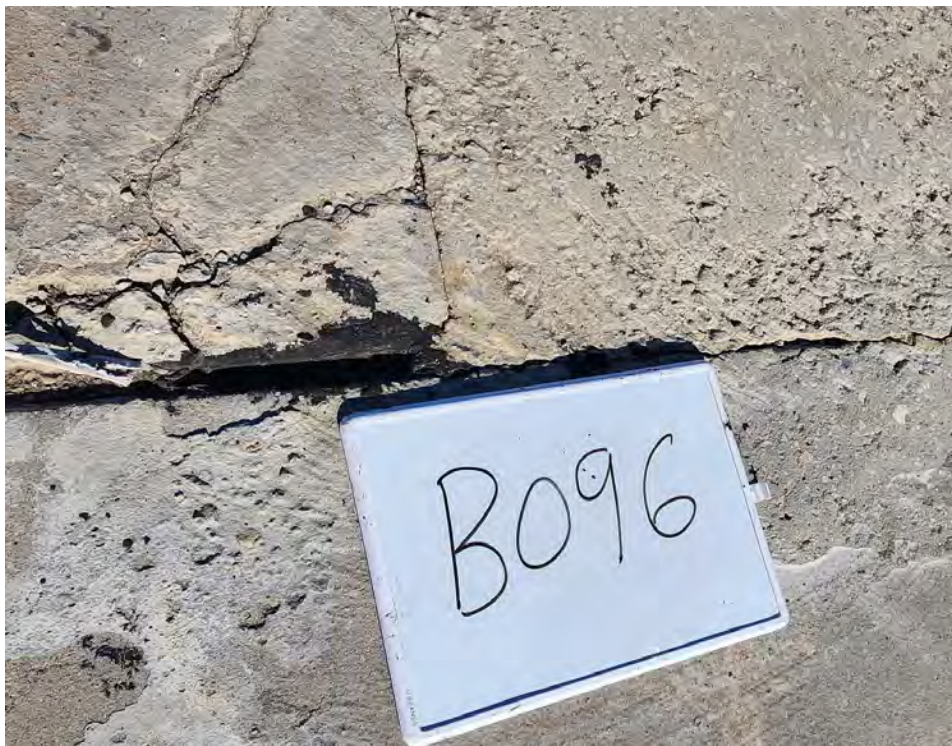
Stall B096, no new tar-like material observed at historical seep location along concrete joint at Test Pit B096.

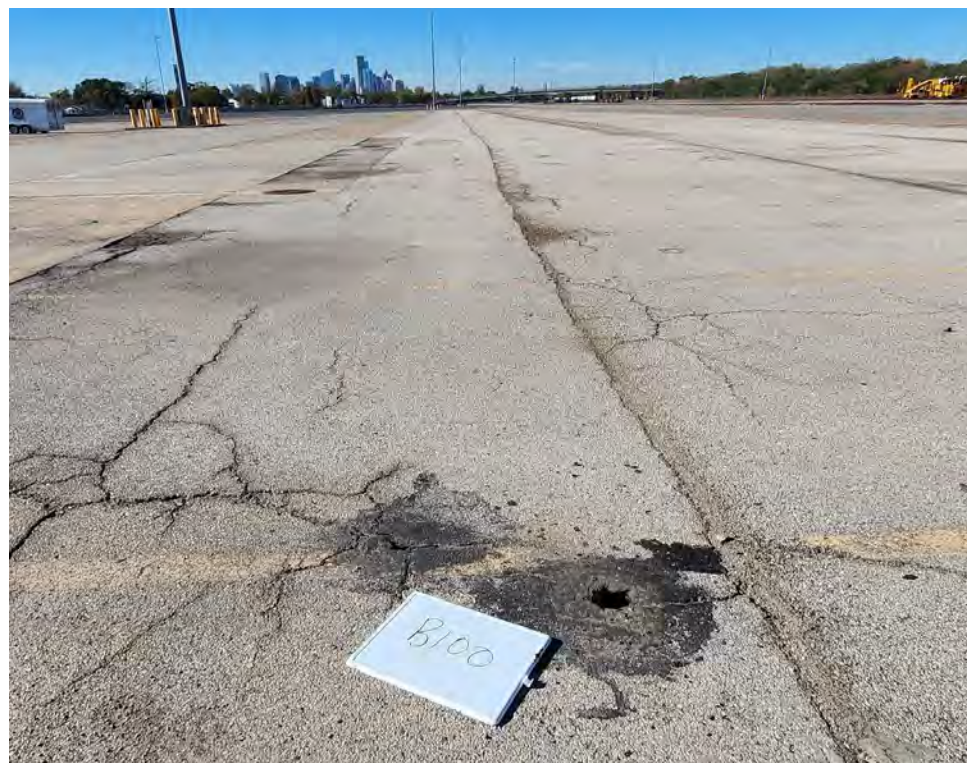
12

Stall B100, no new tar-like material observed on concrete crack/hole in concrete.

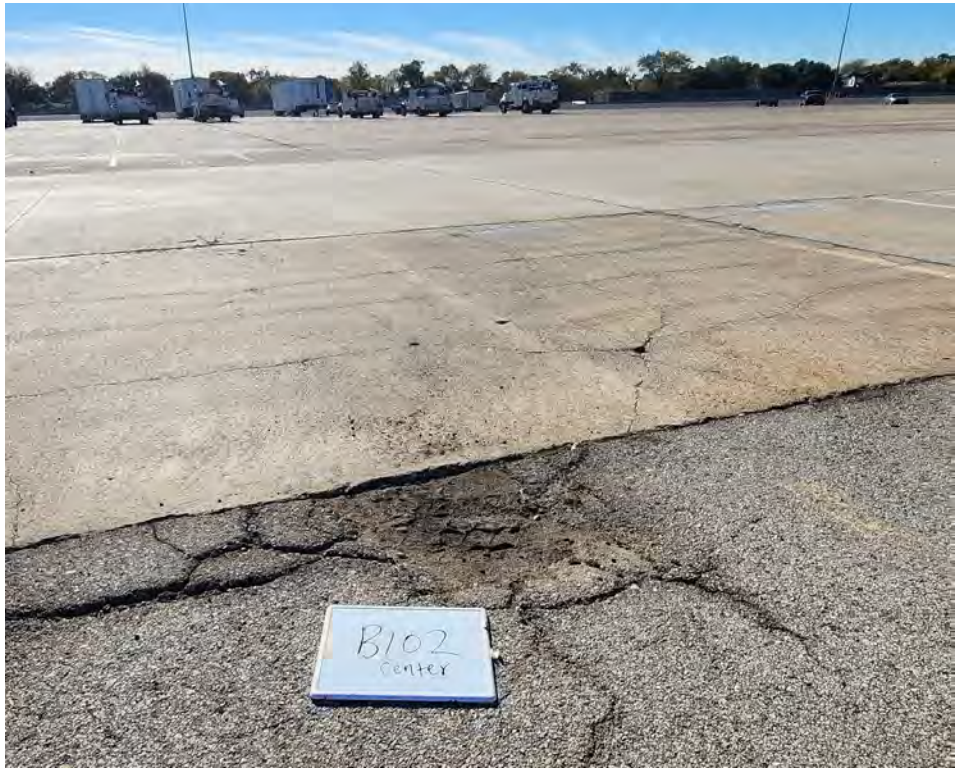
Stall B102 (center), no tar-like material observed at seep location along cracks in pavement.

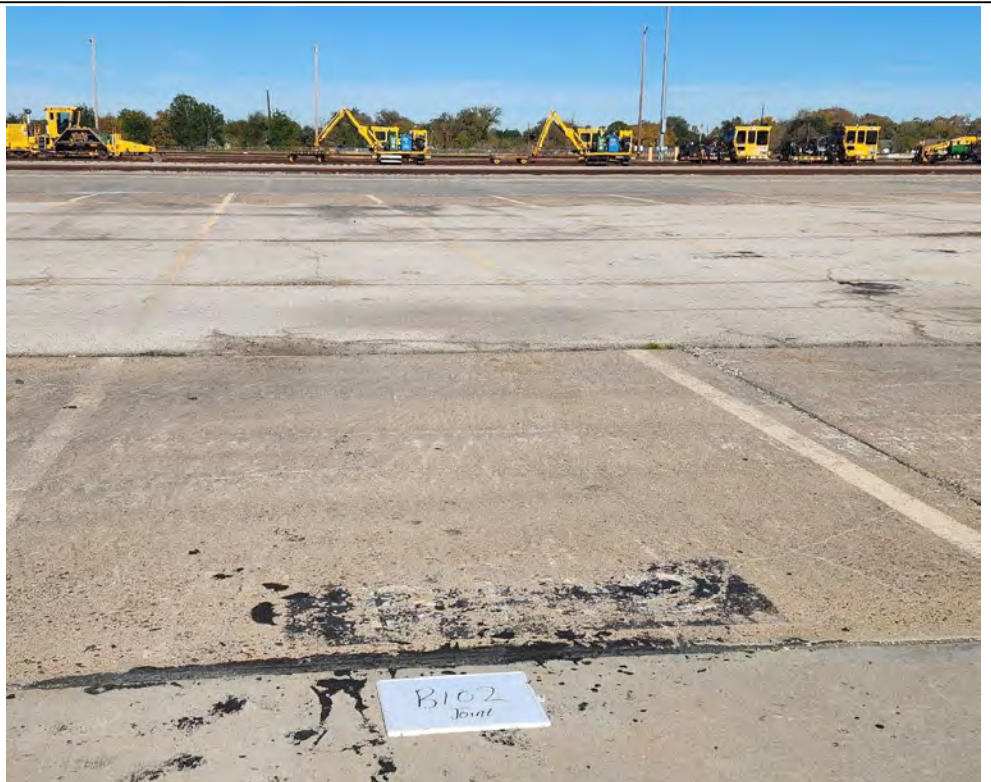
14

Stall B102 (joint) no new tar-like material observed at historical seep site along concrete joint.

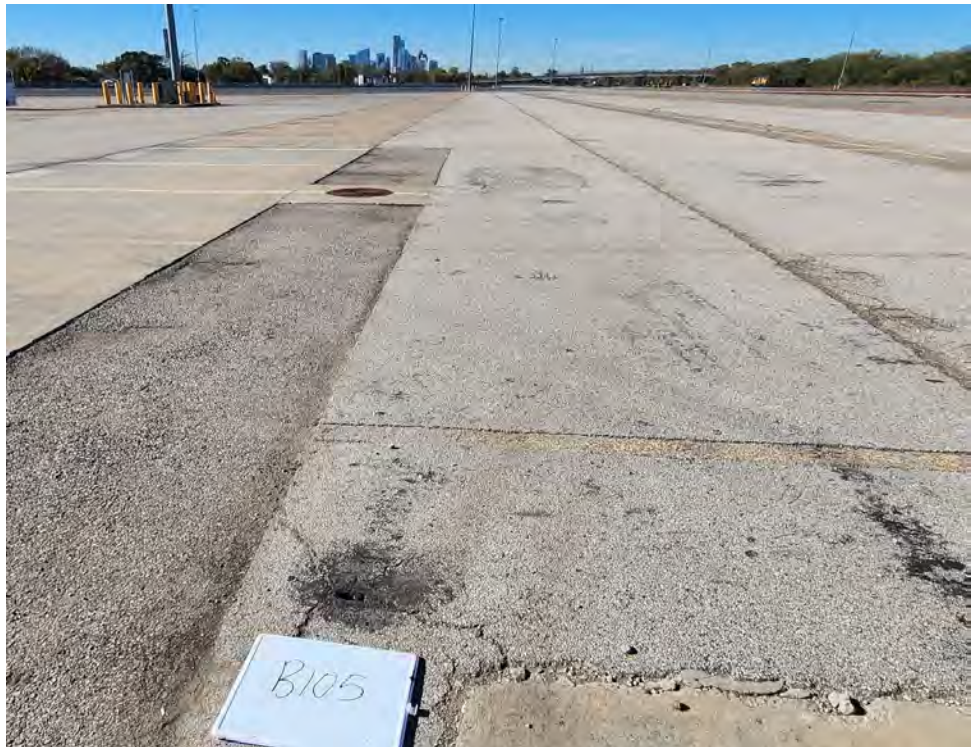
Stall B105. No new tar-like material observed at historical seep location along asphalt crack.

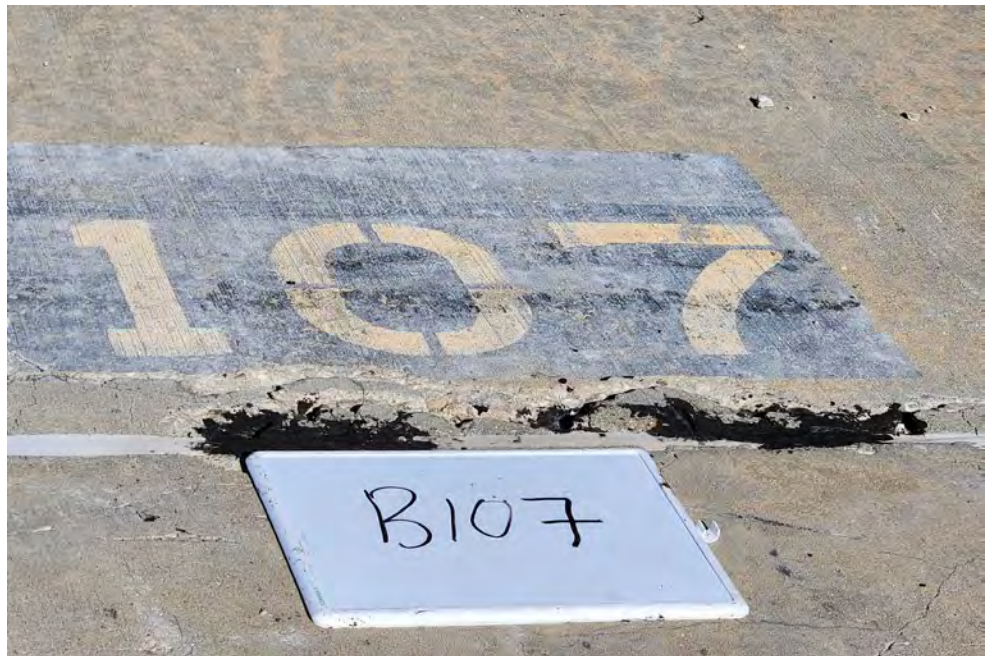
Photo No.
16

- No new tar-like material seeps were observed along the concrete joint between the NAPL Collection System and the existing concrete at Stall B107 during the December 2023 inspections (Photo Nos. 16, 33, 60, 82).

Stall B107, no new tar-like material observed at seep location on concrete joint along the southern edge of the excavated area.

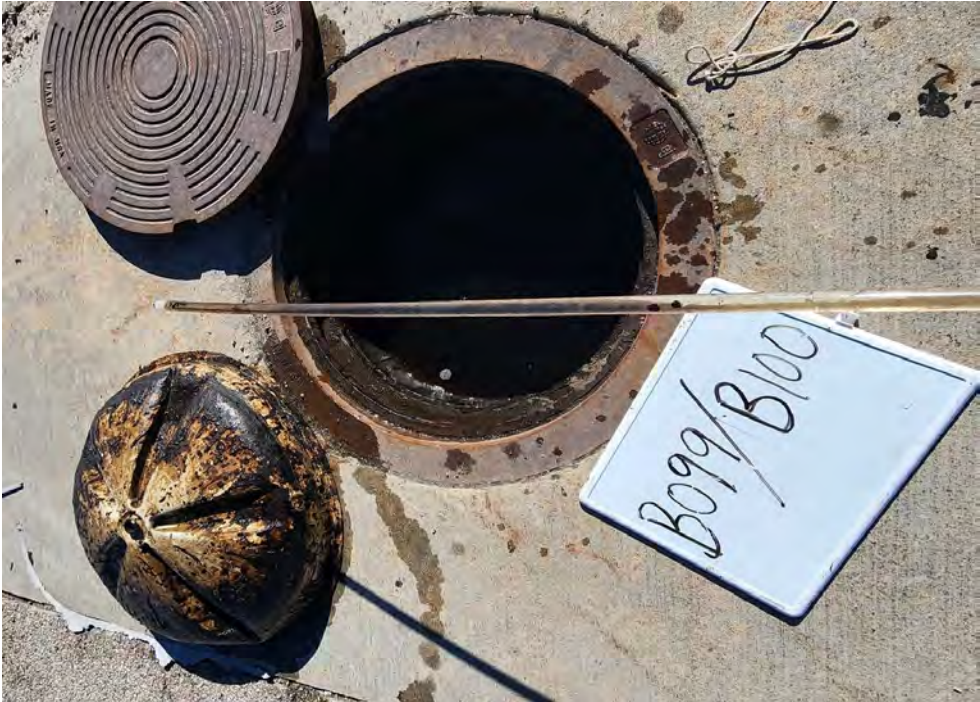
Description: Sump 1 (B099/B100), 8 inches of freeboard in sump, no odor noted, no sheen observed, water color noted as light brown. Lat: 29.7844000 Long: - 95.3205861			
Photo No. 18	Inspection Date: 12/6/2023

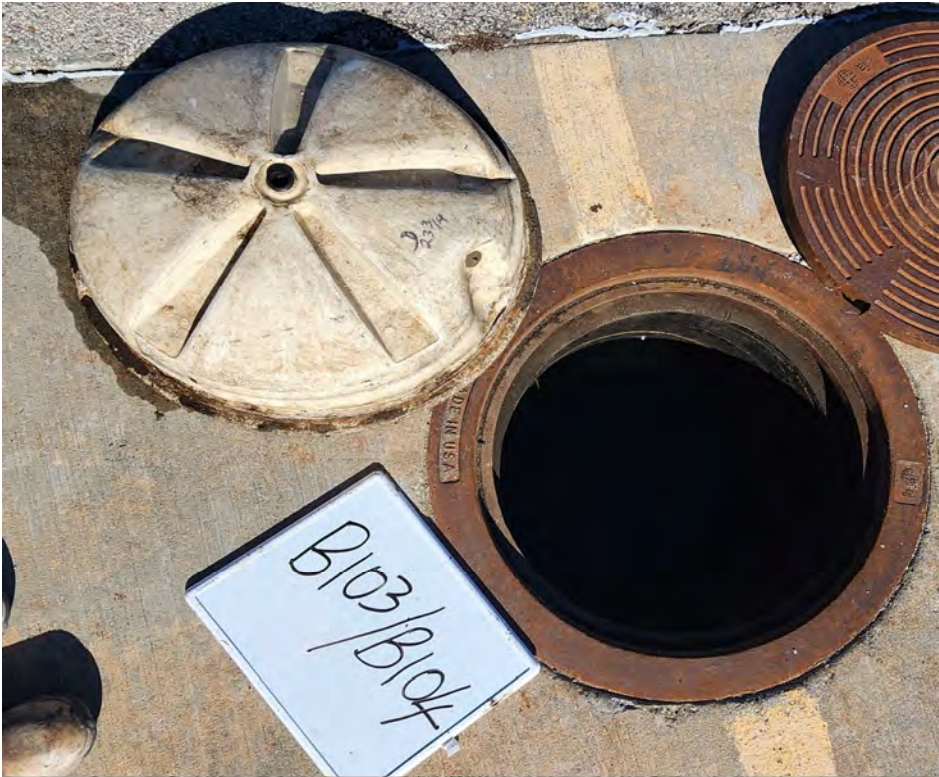
Description: Sump 2 (B103/B104), 14 inches of freeboard in sump. No odor or sheen observed, color noted as clear. Lat: 29.7842861 Long: - 95.3208611

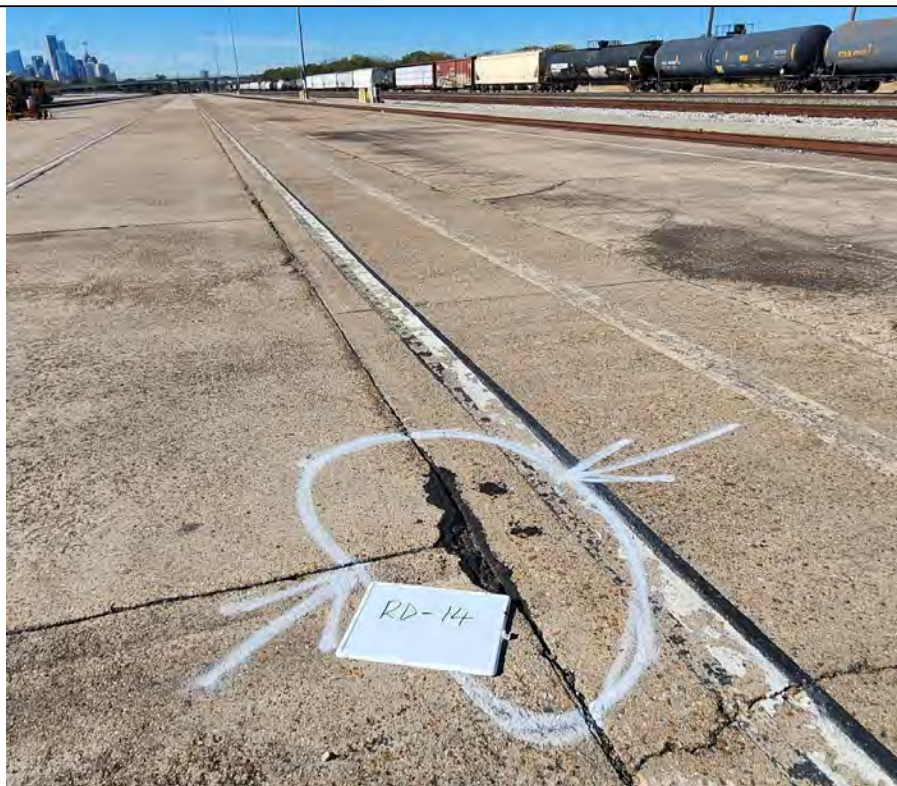
RD-14 Seep location observed within the concrete road area north of Track 802 (east of existing Track 802 seep location). No new tar-like material observed along a concrete joint.

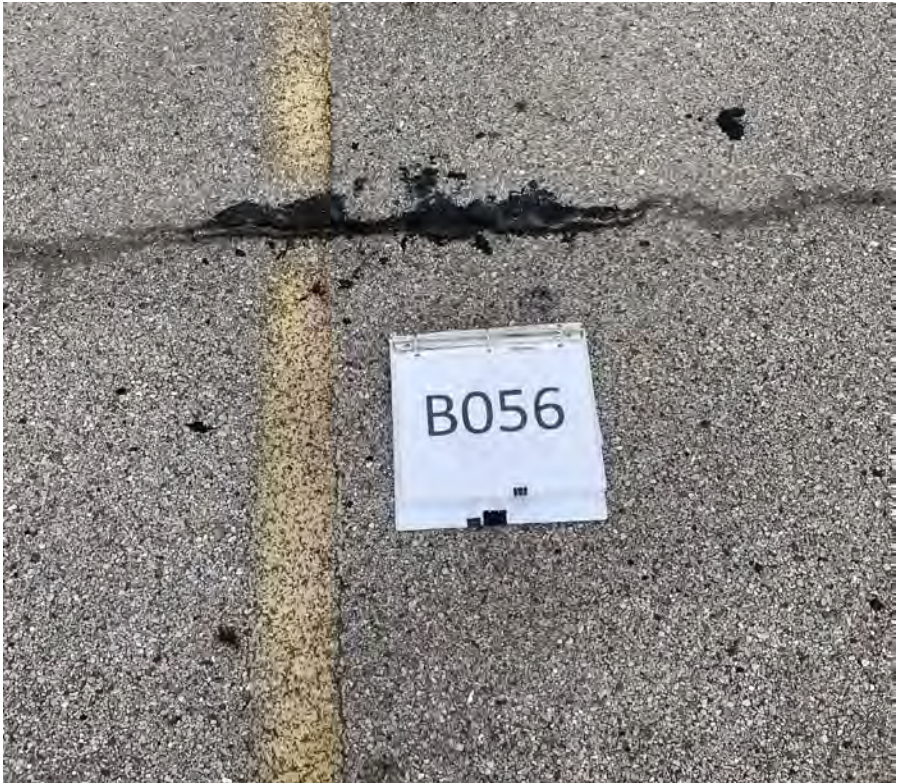
Description: Stall B056. No new tar-like material observed at historical seep location along asphalt crack. Lat: 29.7847472 Long: -95.3195417

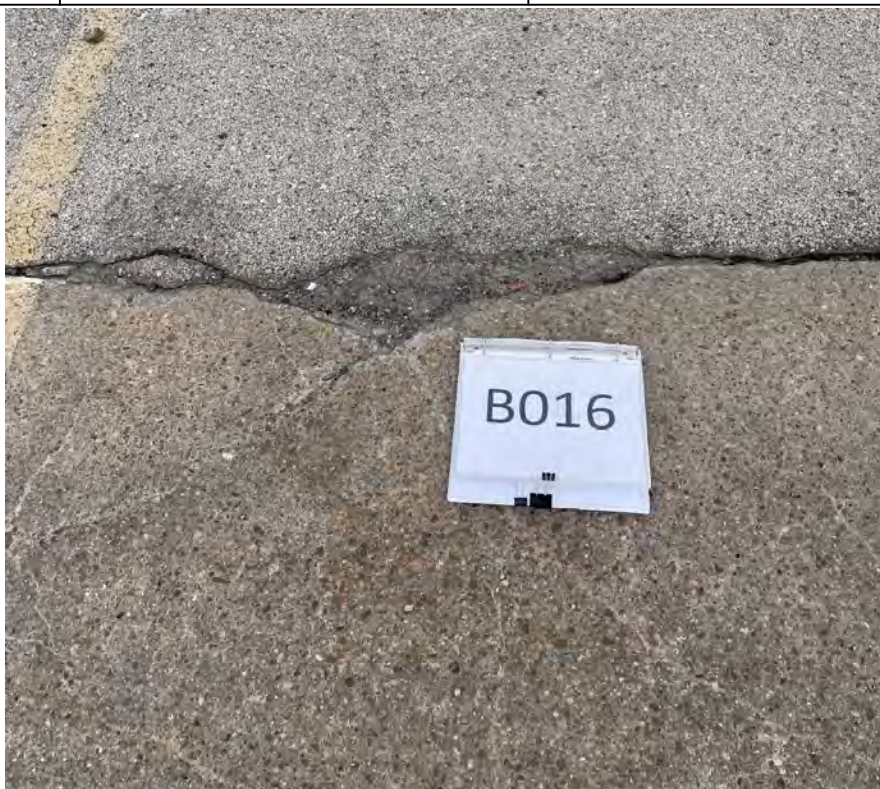
Stall B016. No new tar-like material observed at historical seep location along asphalt crack.

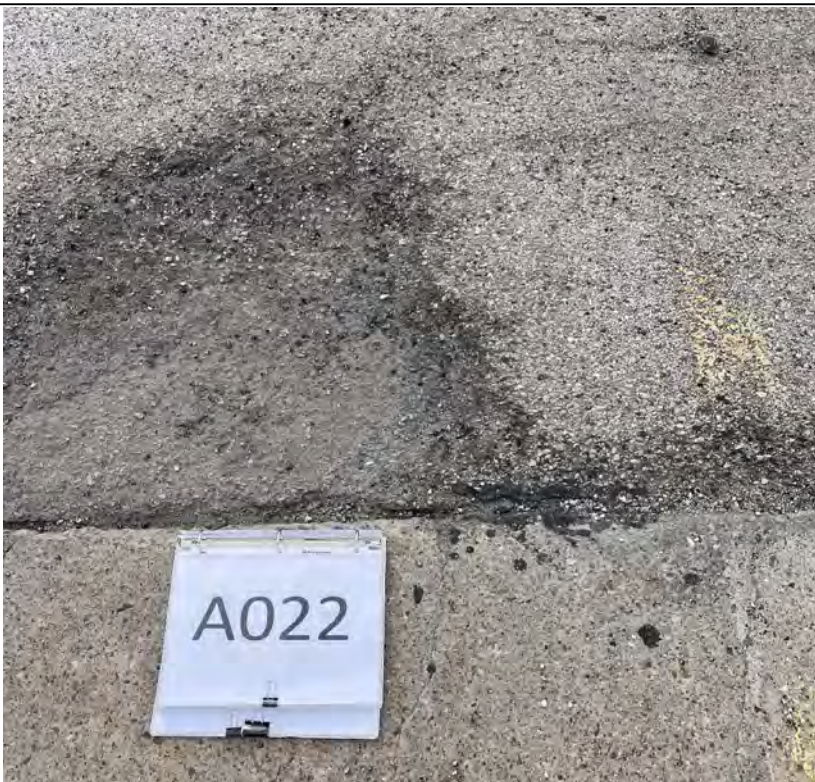
24

Stall A022. No new tar-like material observed at historical seep location along asphalt crack.

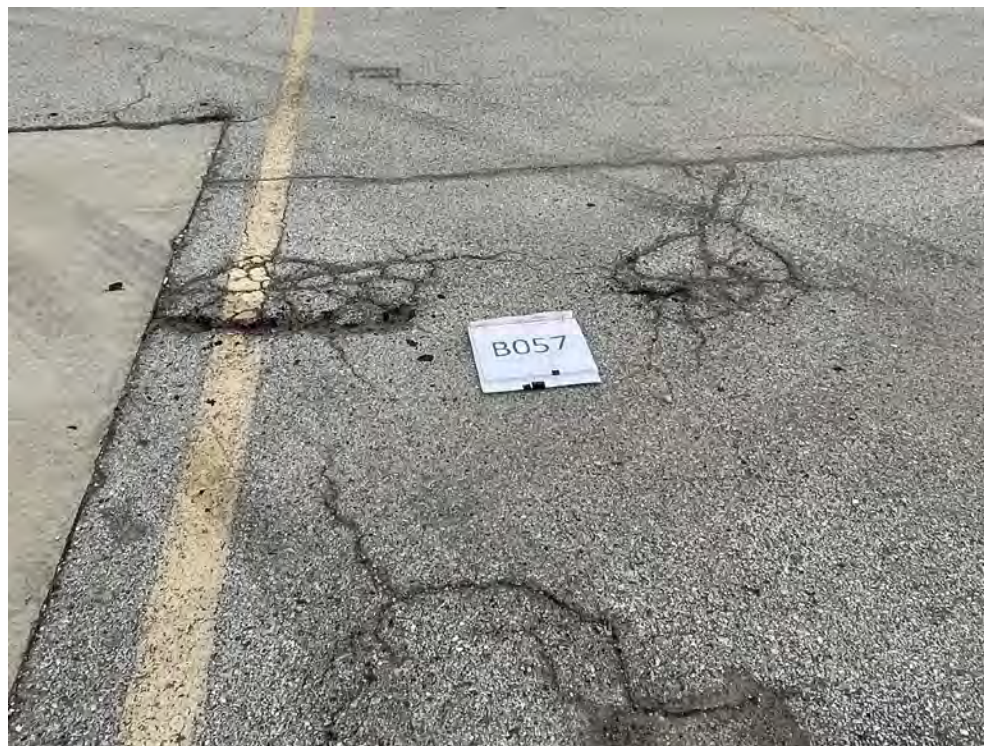
Stall B057, no new tar-like material observed along asphalt crack.

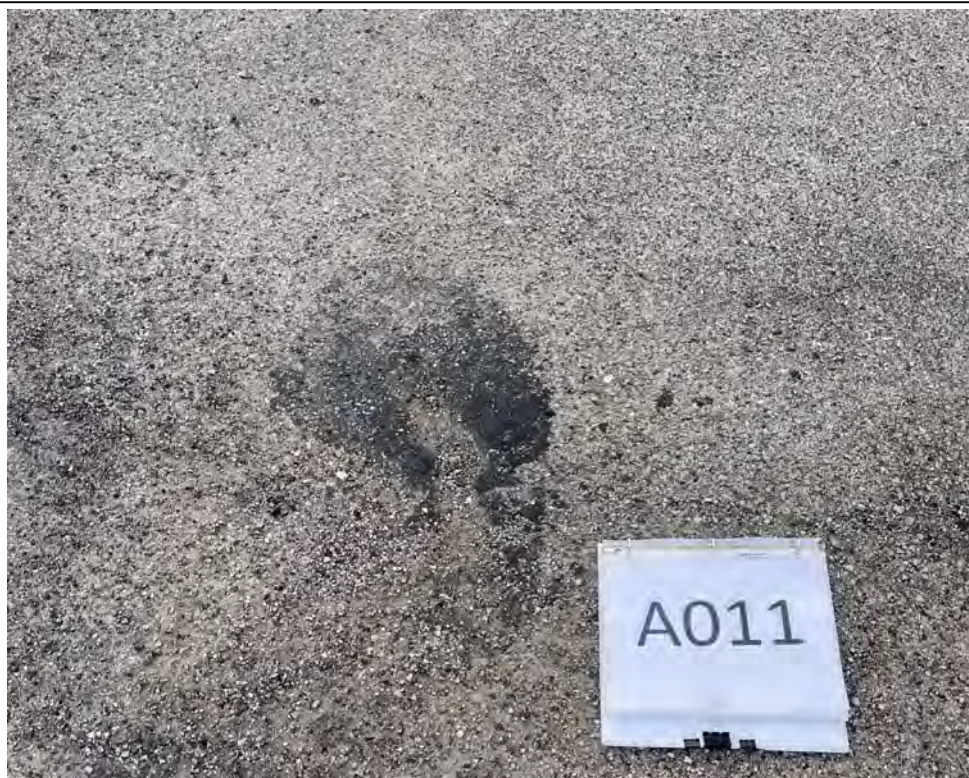
26

Stall A011. No tar-like material observed at historical seep location along asphalt crack.

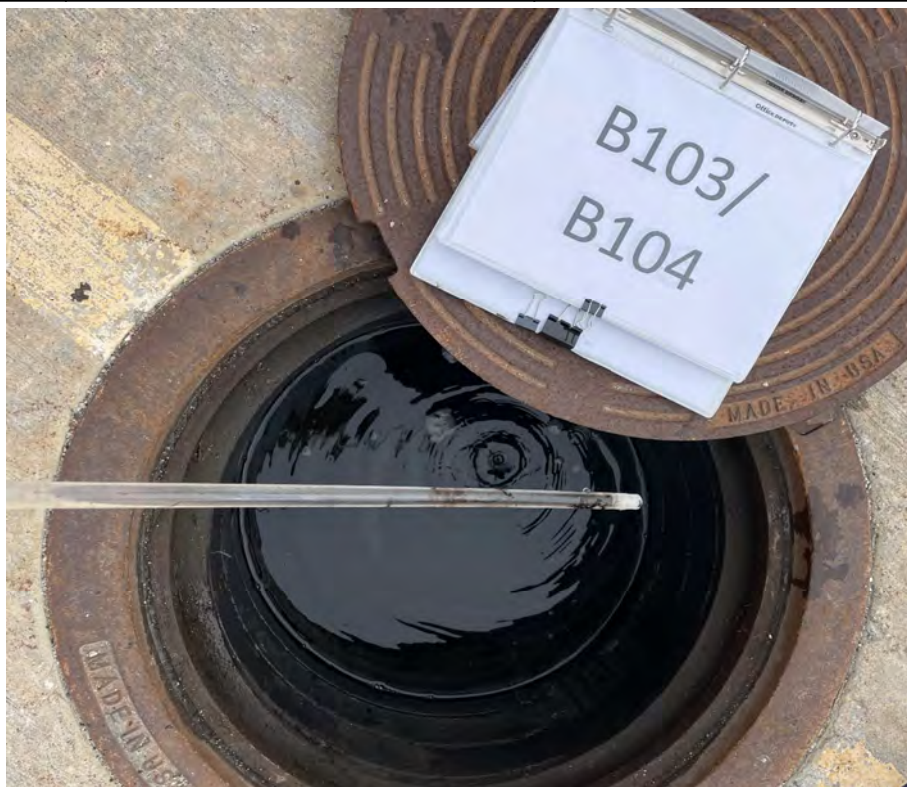
Sump 2 (B103/B104), 10 inches of freeboard in sump. No odor or sheen observed, color noted as clear.

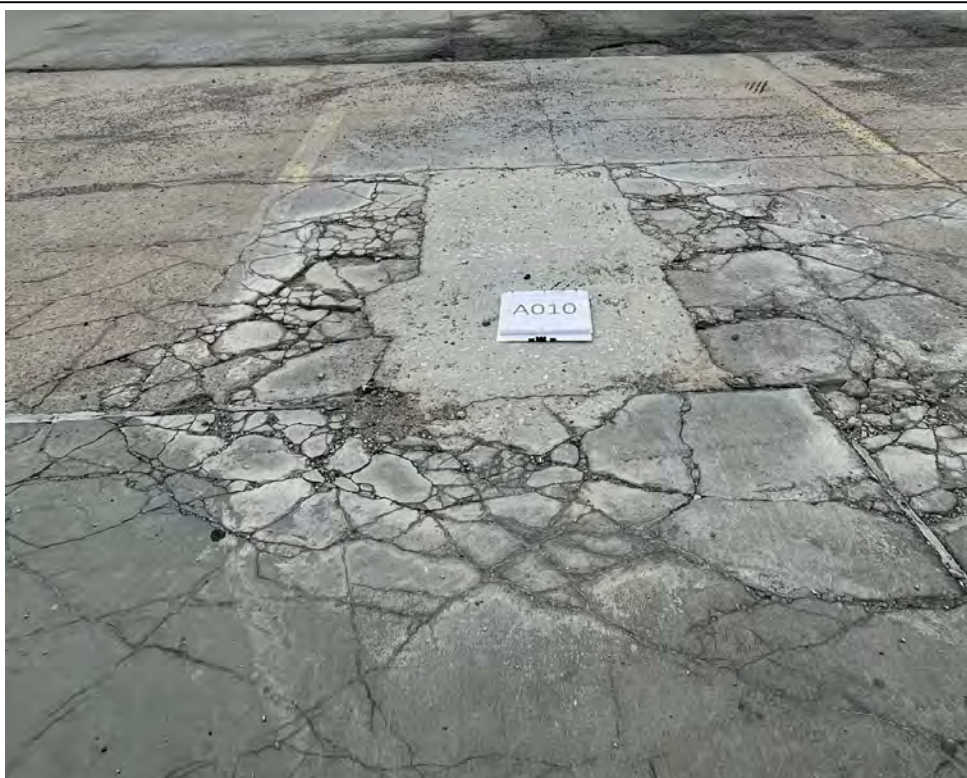
28

Stall A010. No tar-like material observed at Test Pit A010 location.

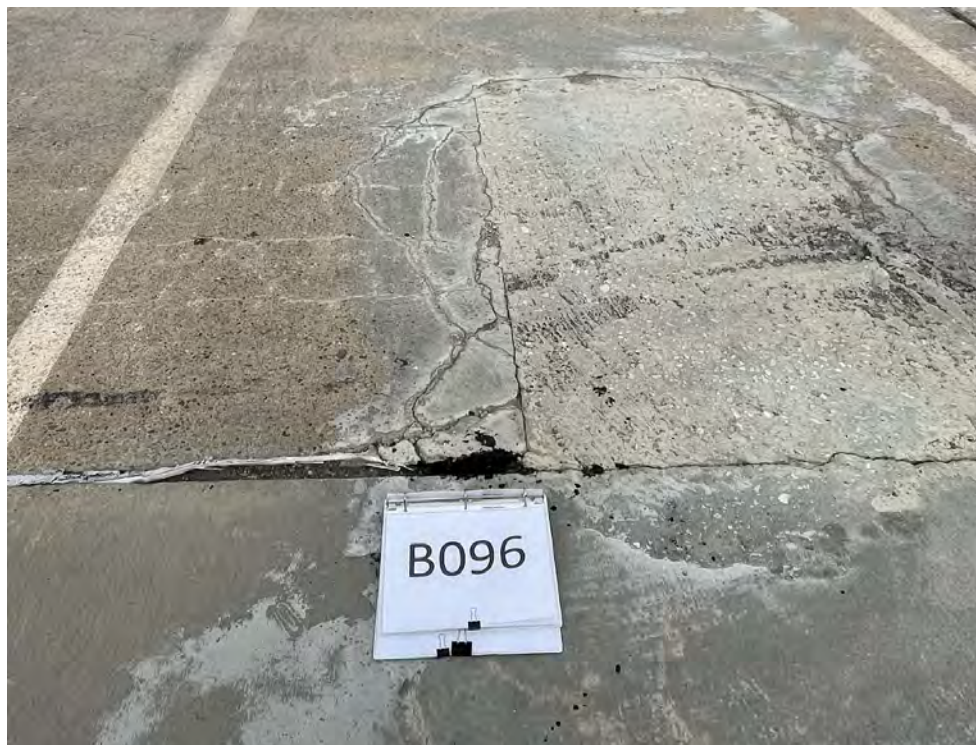
Stall B096, no new tar-like material observed at historical seep location along concrete joint.

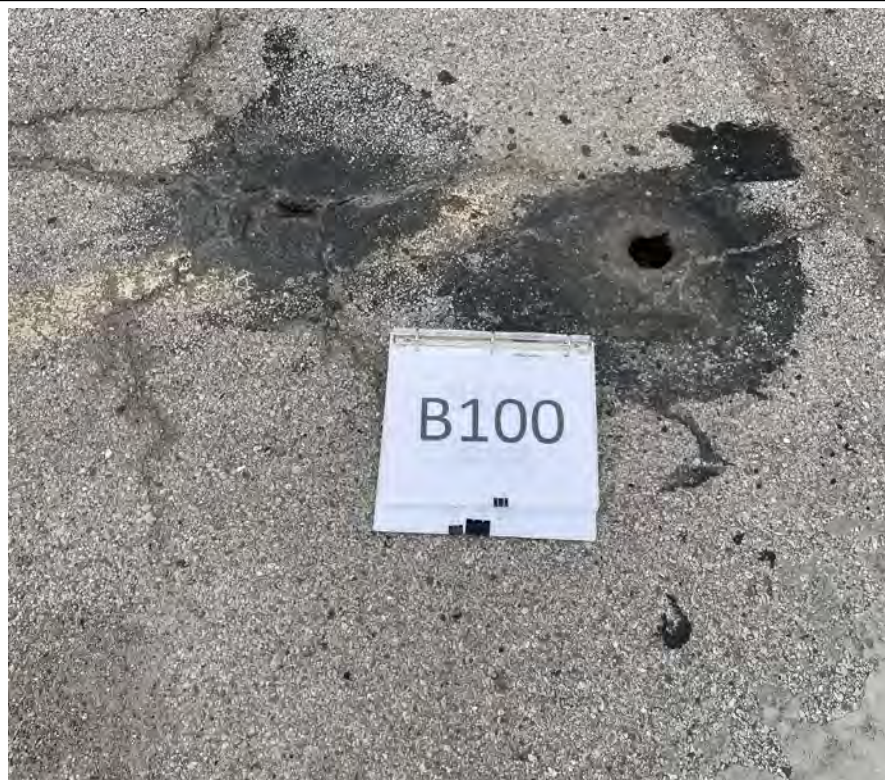
30

Stall B100, no new tar-like material observed at seep location along asphalt crack/ hole in the asphalt.

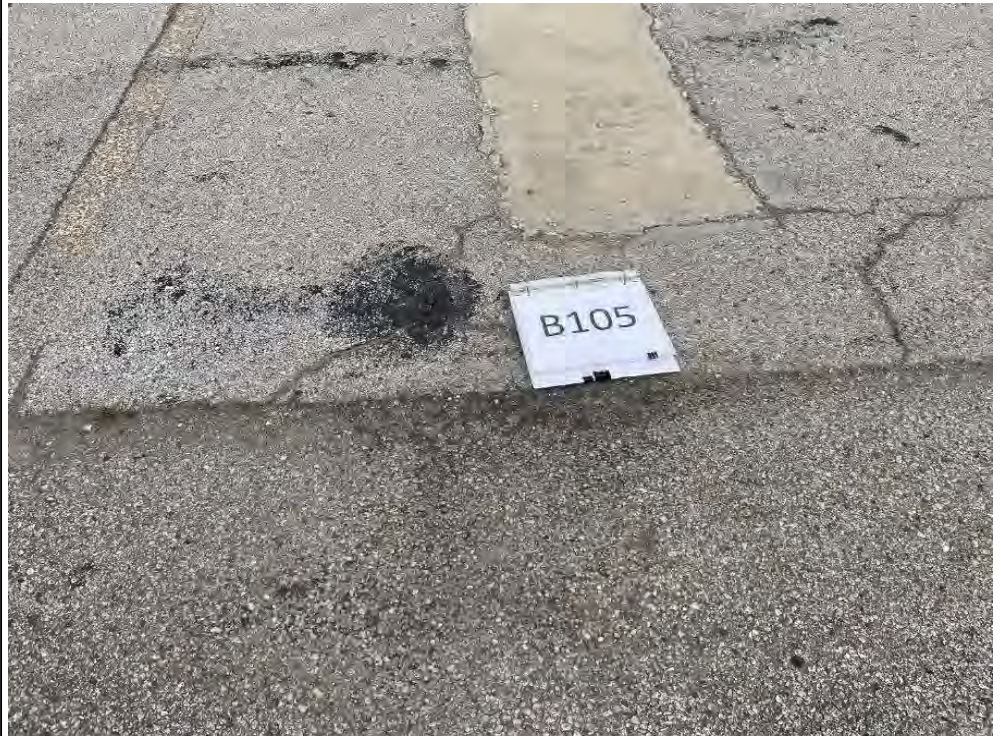
Stall B105, no new tar-like material observed at the historical seep location along asphalt crack.

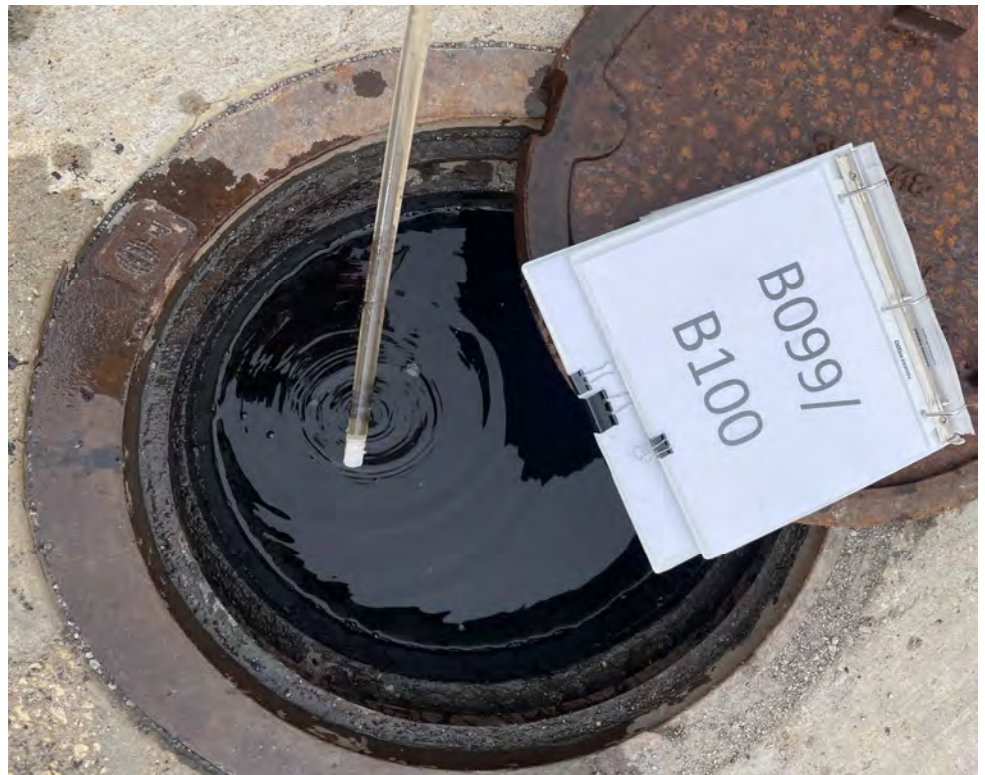
32

Sump 1 (B099/B100), 5 inches of freeboard in sump, no sheen observed, water color noted as light brown.
