January 12, 2024

Project No. 31406585.016

**Re: MONTHLY STATUS UPDATE – ENGLEWOOD INTERMODAL YARD – NAPL COLLECTION
SYSTEM/CONCRETE CAP REPAIRS
UNION PACIFIC RAILROAD HOUSTON WOOD PRESERVING WORKS FACILITY
4910 LIBERTY ROAD FACILITY, HOUSTON, TEXAS
POST-CLOSURE CARE PERMIT NO. HW-50343; INDUSTRIAL SWR NO. 31547**

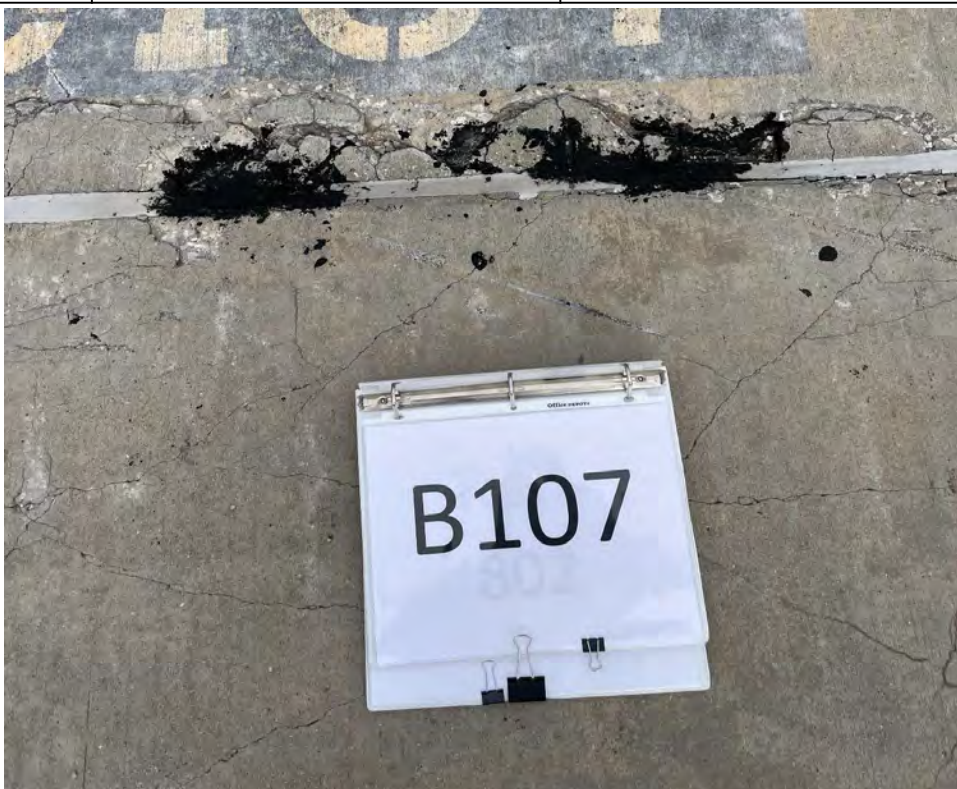
- No new tar-like material seeps were observed along the concrete joint between the NAPL Collection System and the existing concrete at Stall B107 during the December 2023 inspections (Photo Nos. 16, 33, 60, 82).

Stalls B107, no new tar-like material observed at seep location on concrete joint along the southern edge of the excavated area.

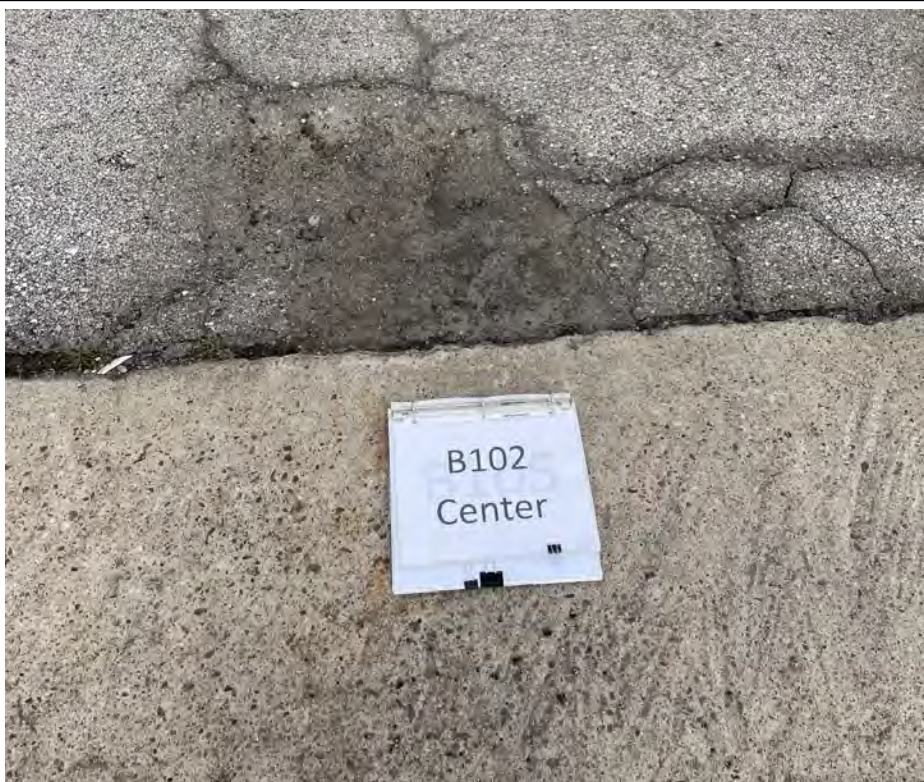
34

Stall B102 (center), no tar-like material observed at seep location where pavement is cracked.

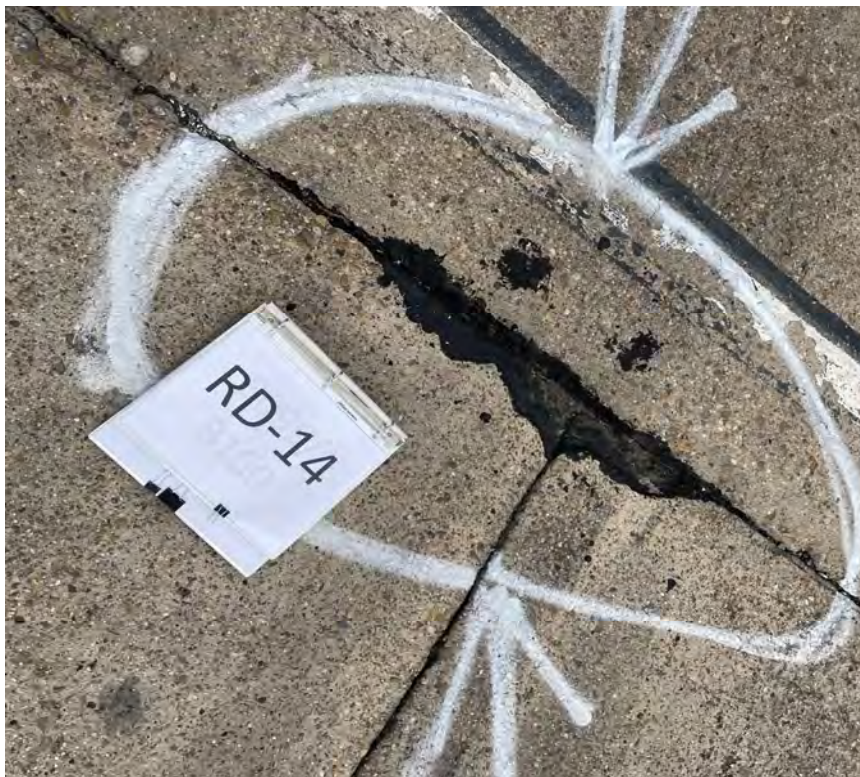
RD-14 Seep location observed within the concrete road area (RD-14) north of Track 802 (east of existing Track 802 seep location), no new tar-like material observed along a concrete joint.

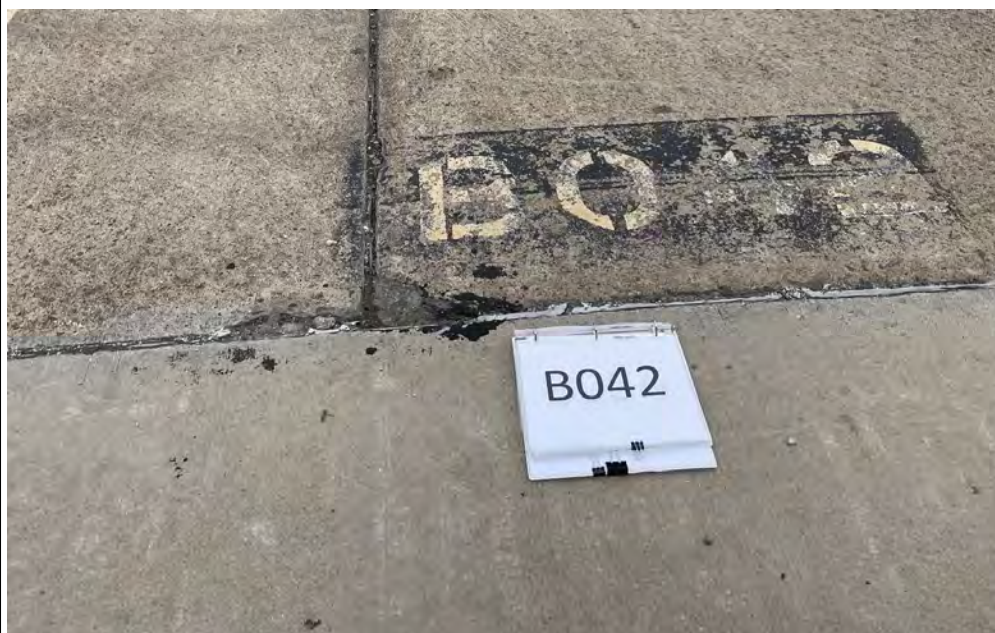
36

Stall B042. No new tar-like material observed at historical seep location along concrete crack.

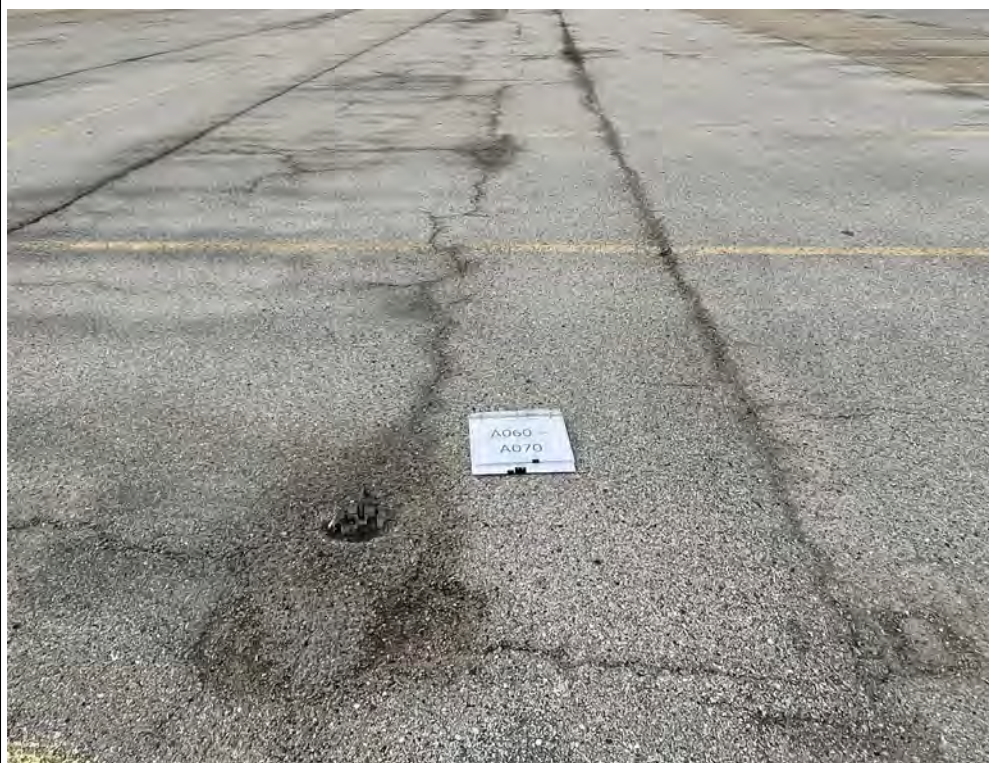
Stalls A060 - A070, some residual staining previously observed along cracks in pavement. No new water seeps observed. Viewing southwest.

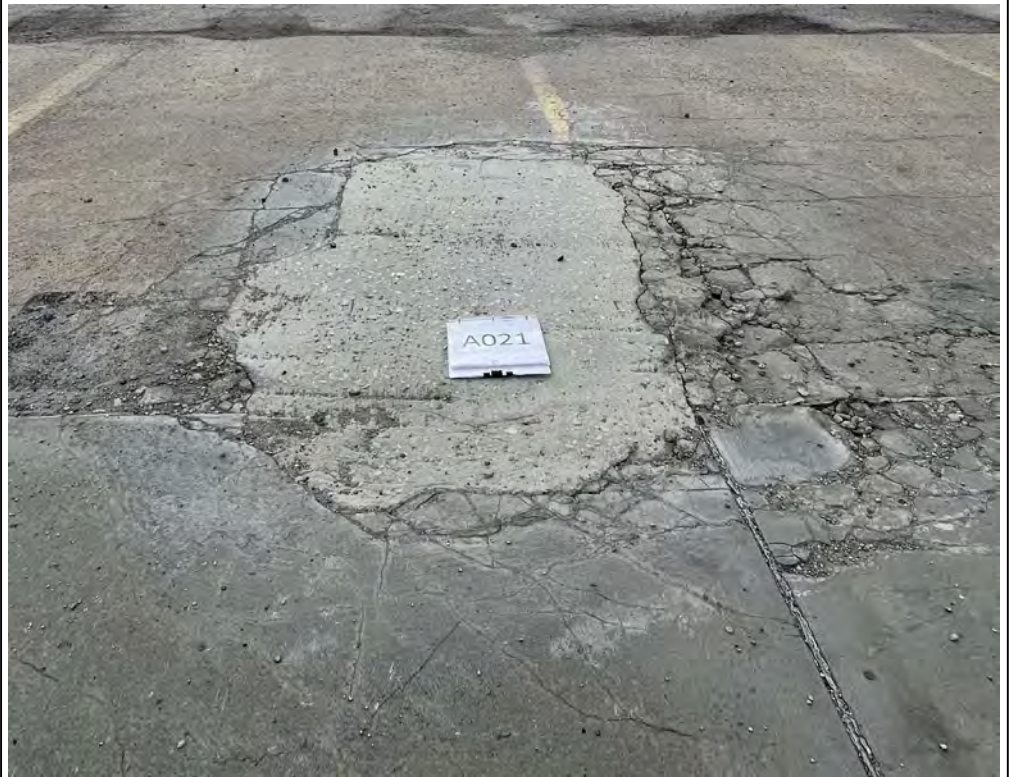
Stall A021. No seeps noted at Test Pit A021.

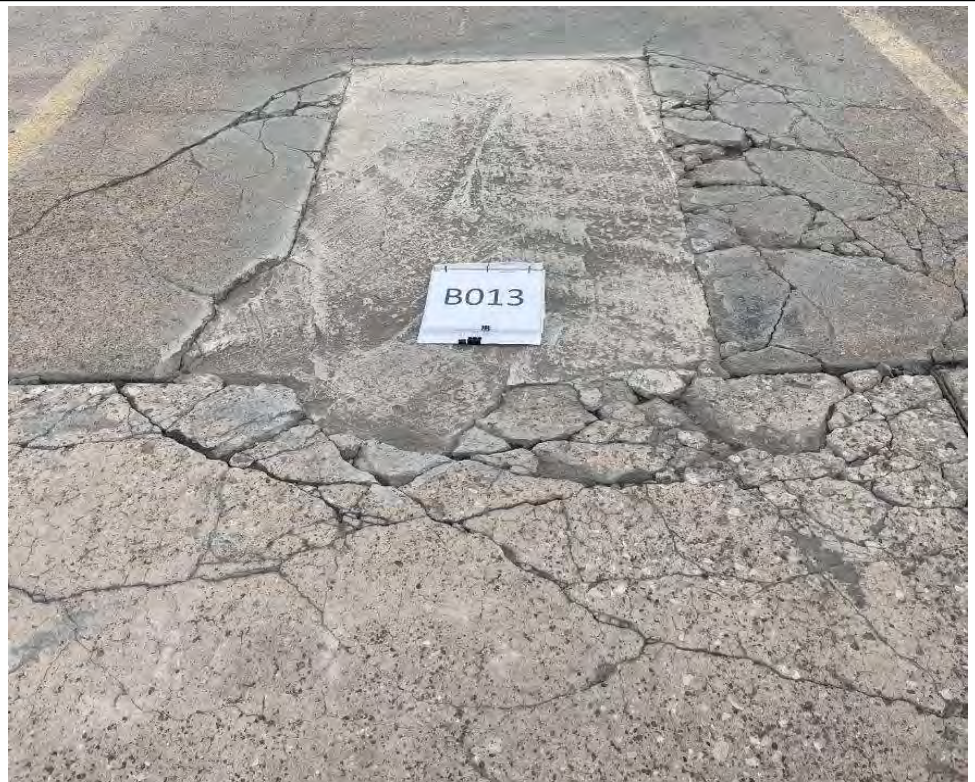
Photo No.
40

Stall B013. No seeps noted at Test Pit B013.

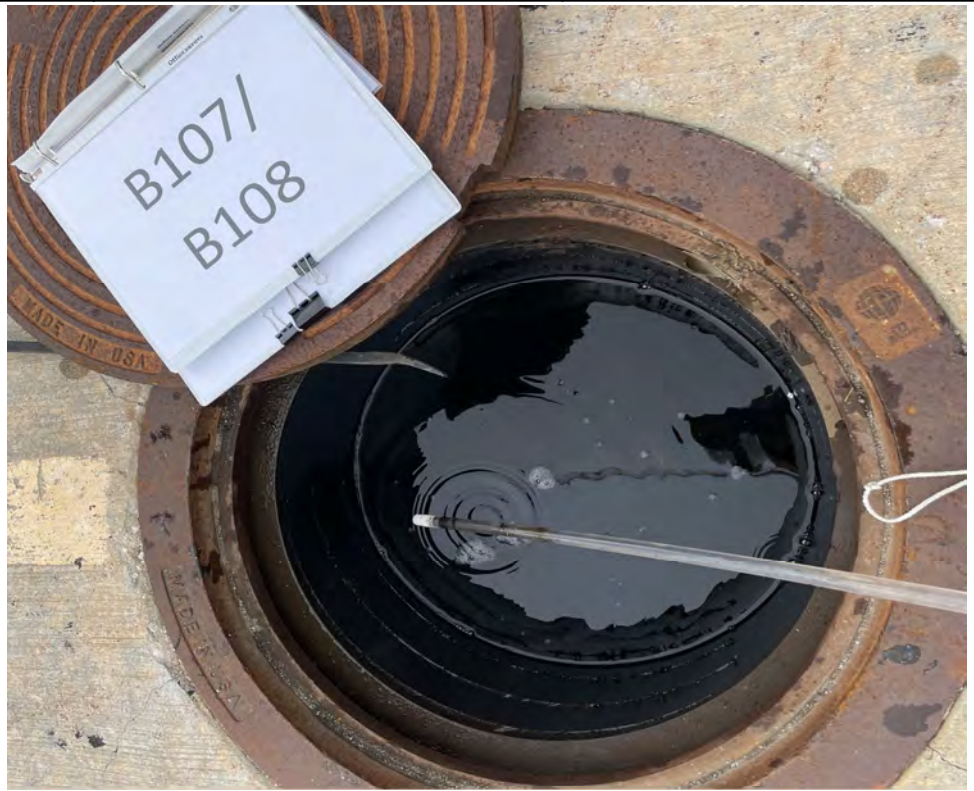
Sump 3 (B107/B108), 9.5 inches of freeboard in sump, no sheen observed, water color noted as clear.

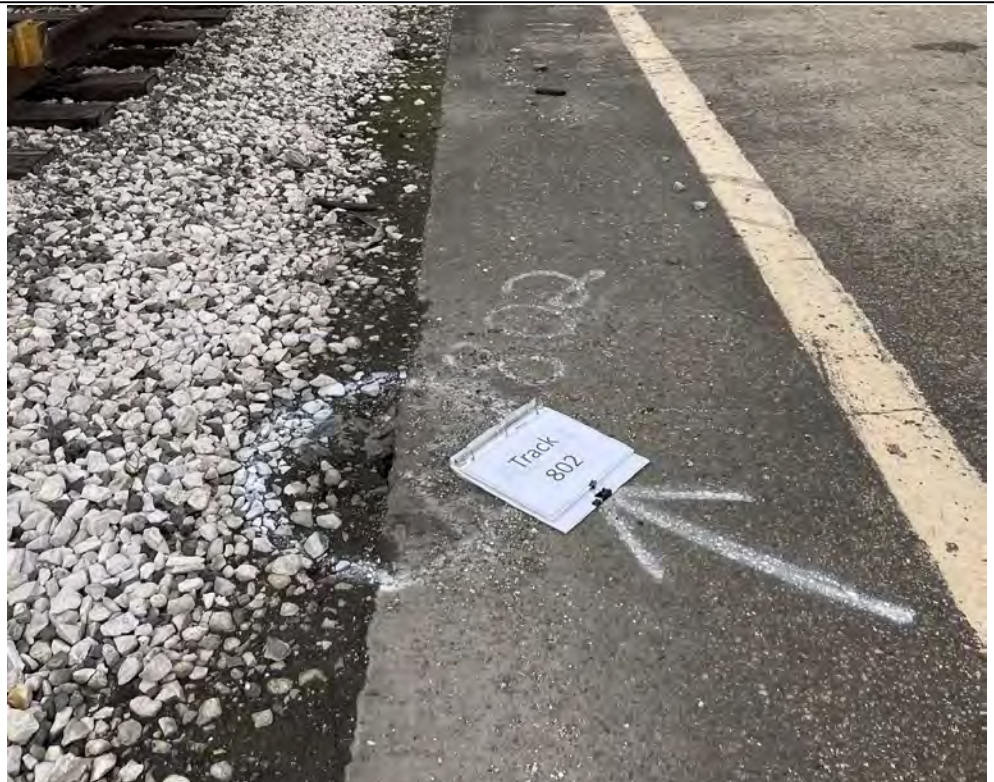
Photo No.
42

North side of Track 802, no new tar-like material observed at seep location near the edge of the ballast.

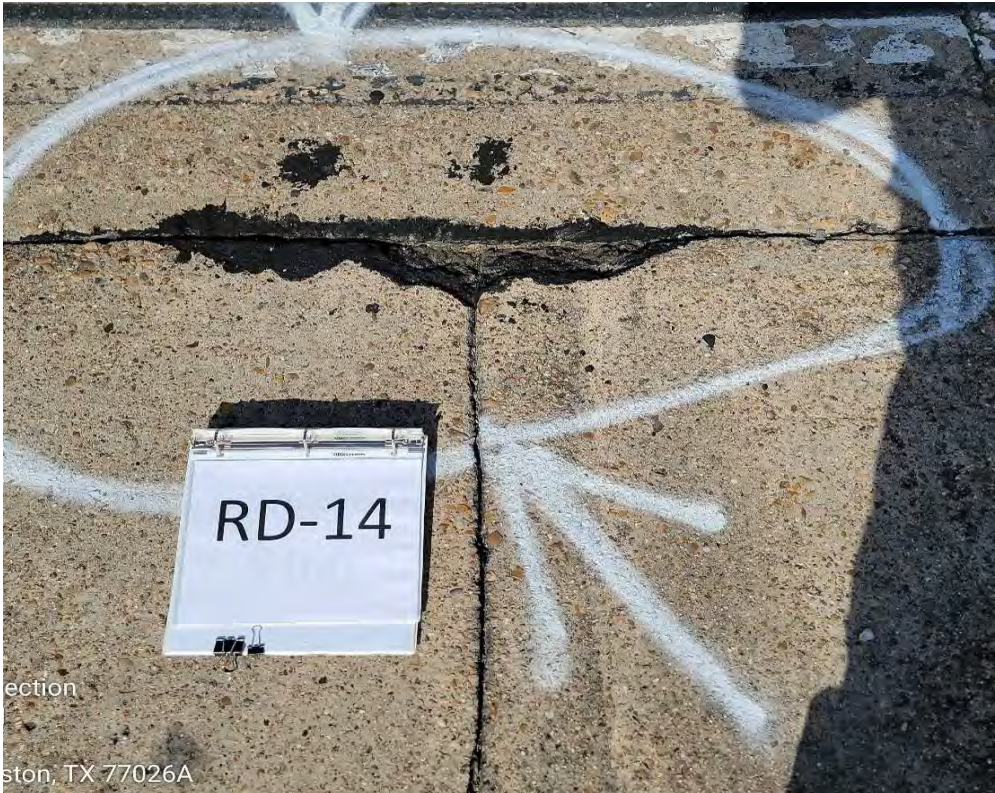
Description: RD-14 Seep location observed within the concrete road area north of Track 802 (east of existing Track 802 seep location), no new tar-like material observed along a concrete joint. Lat: 29.785064 Long: - 95.321219			
Photo No. 44	Inspection Date: 12/20/2023

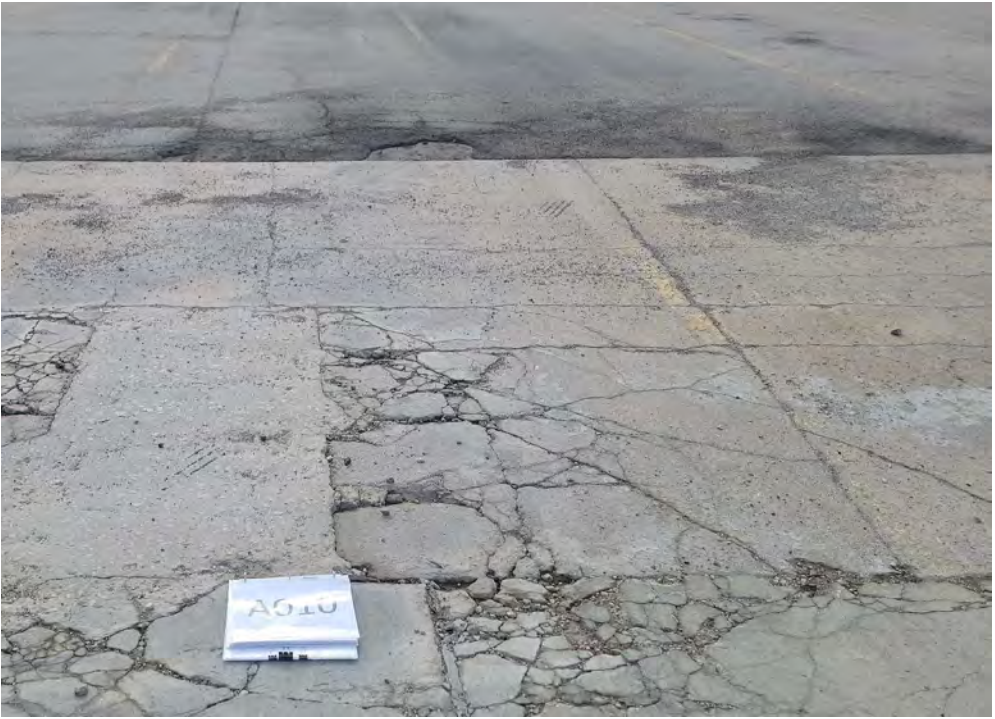
Description: Stall A010. No seeps noted at Test Pit A010. Lat: 29.785517 Long: -95.31834

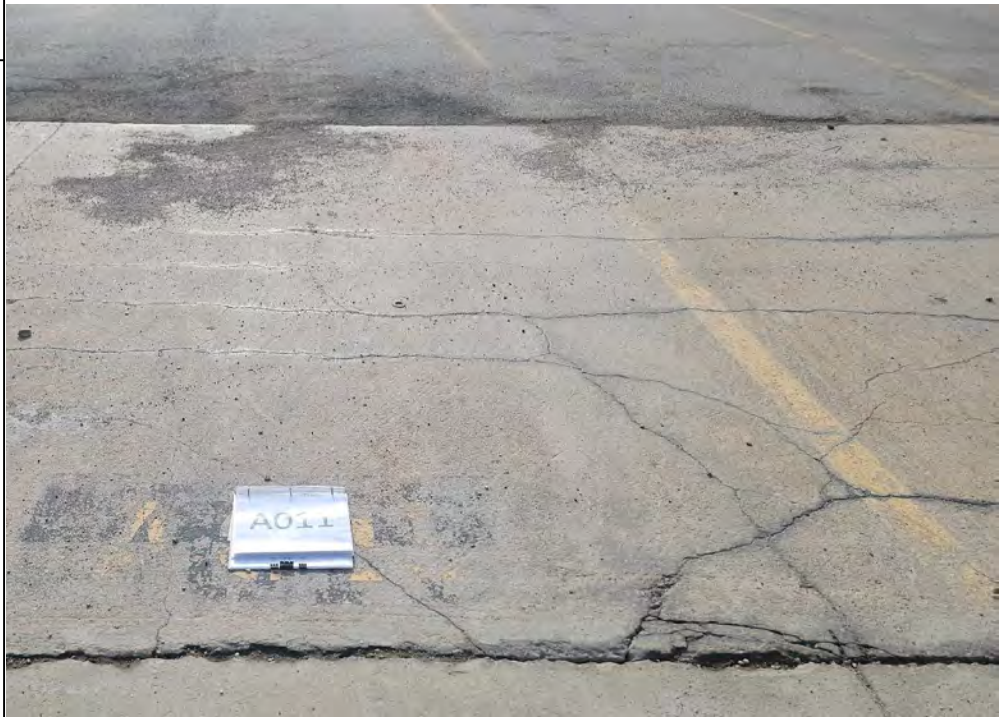
Stall A011. No tar-like material observed at historical seep location along asphalt crack.

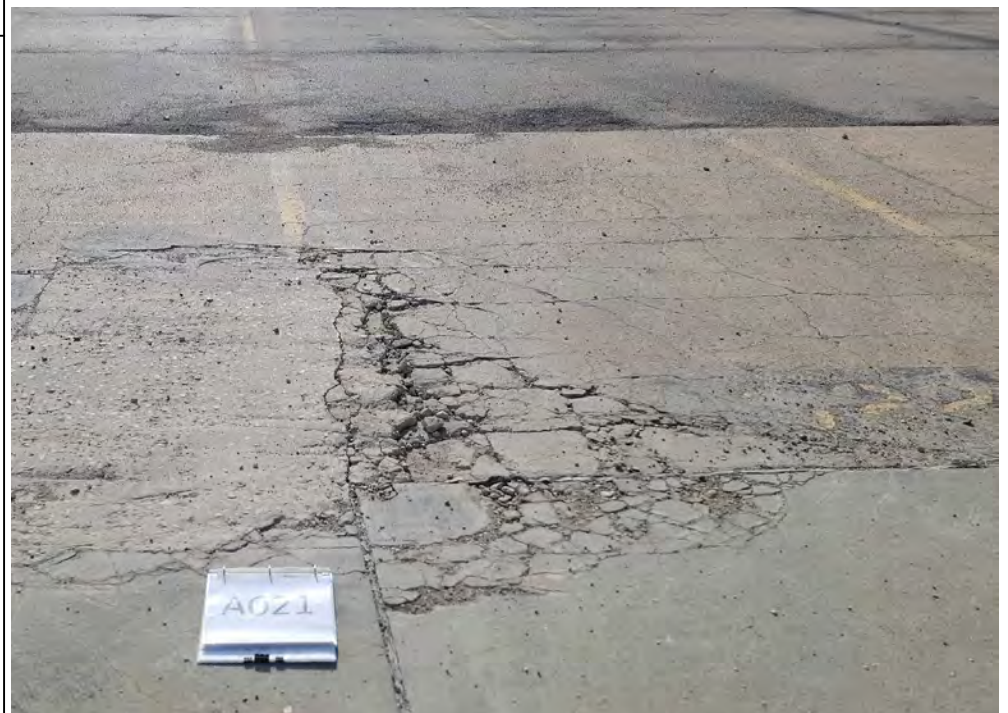
Photo No.
46

Stall A021. No seeps noted at Test Pit A021.

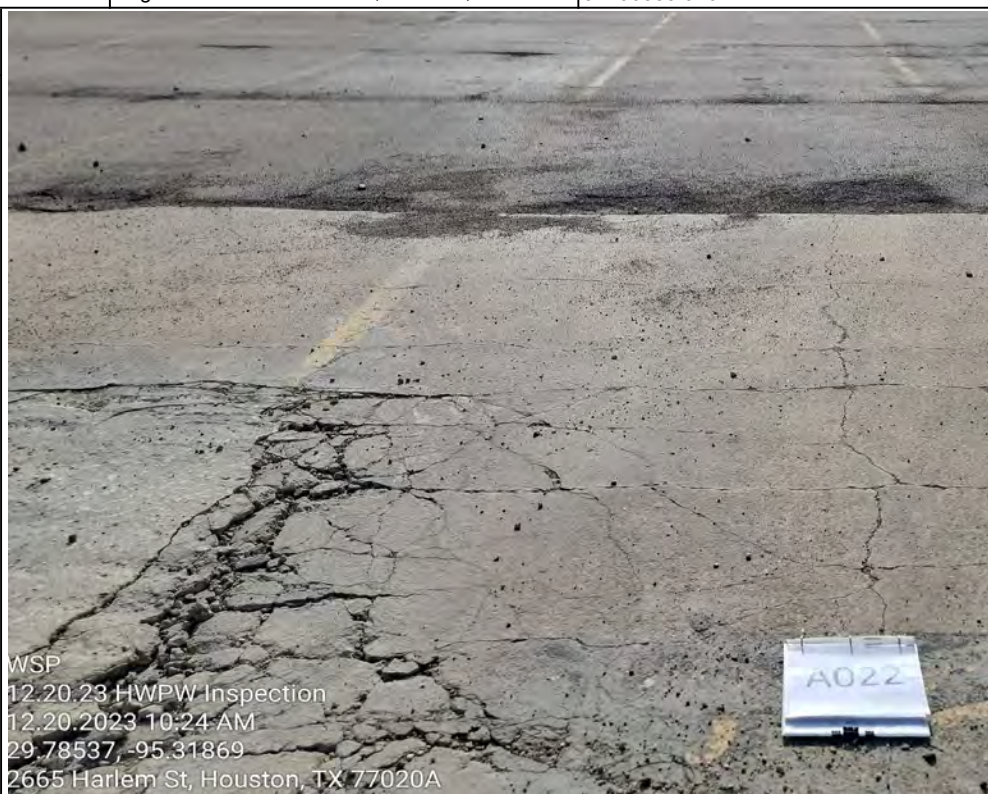
Stall A022, no new tar-like material observed at the seep location along the edge.

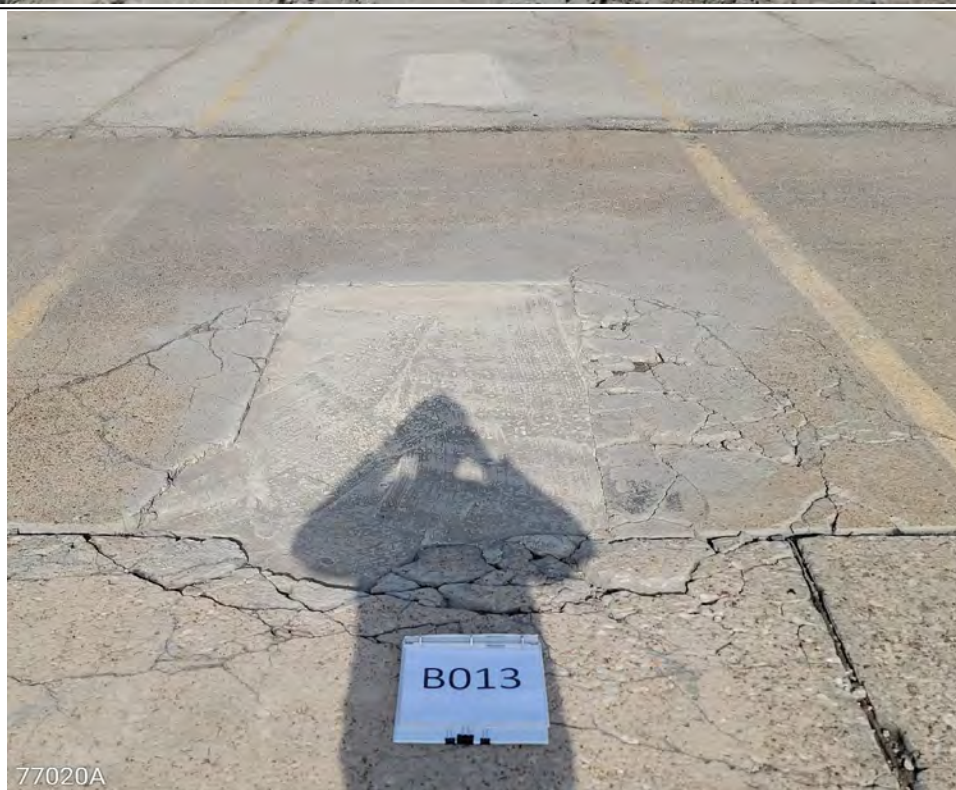
48

Stall B013. No seeps noted at Test Pit B013.

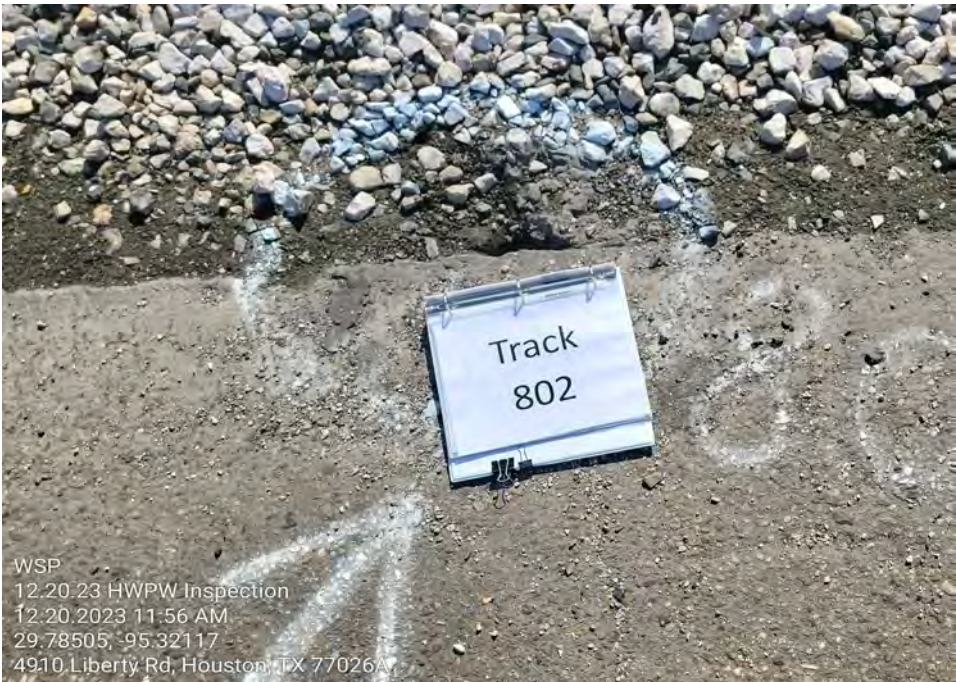
Description: North side of Track 802, no new tar-like material observed at seep location near the edge of the ballast. Lat: 29.784947 Long: -95.321214			
Photo No. 52	Inspection Date: 12/20/2023

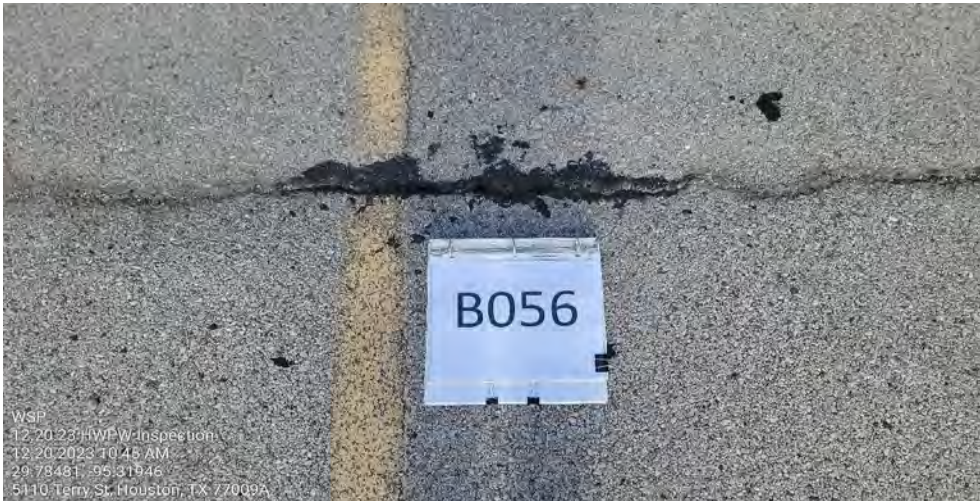
Description: Stall B056. No new tar-like material observed at historical seep location along asphalt crack. Lat: 29.7847472 Long: -95.3195417

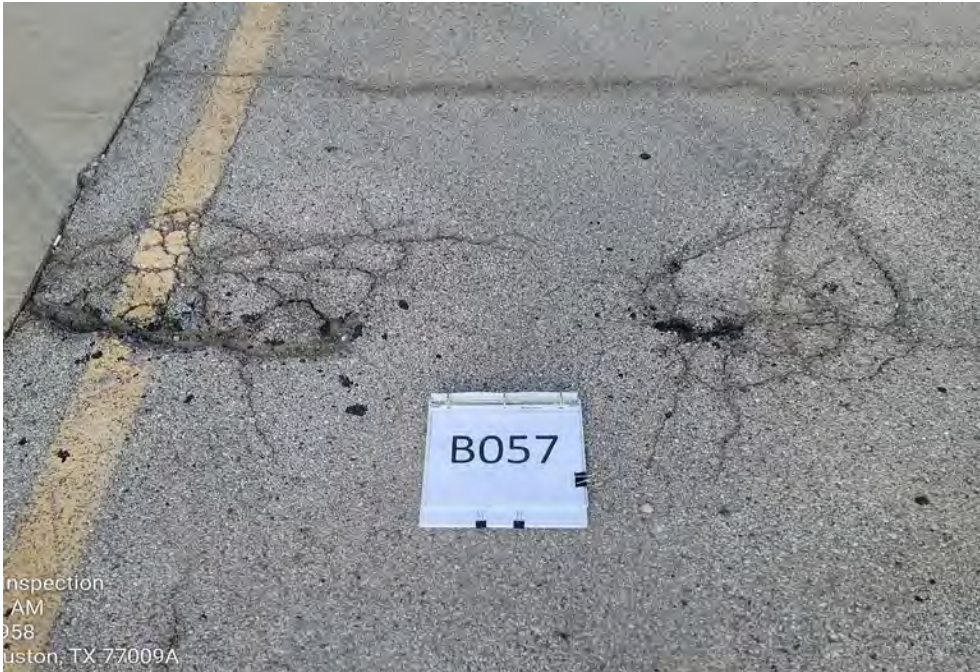
Description: Stall B057, no new tar-like material observed and removed at seep location along asphalt crack. Lat: 29.784769 Long: -95.3195798			
Photo No. 54	Inspection Date: 12/20/2023

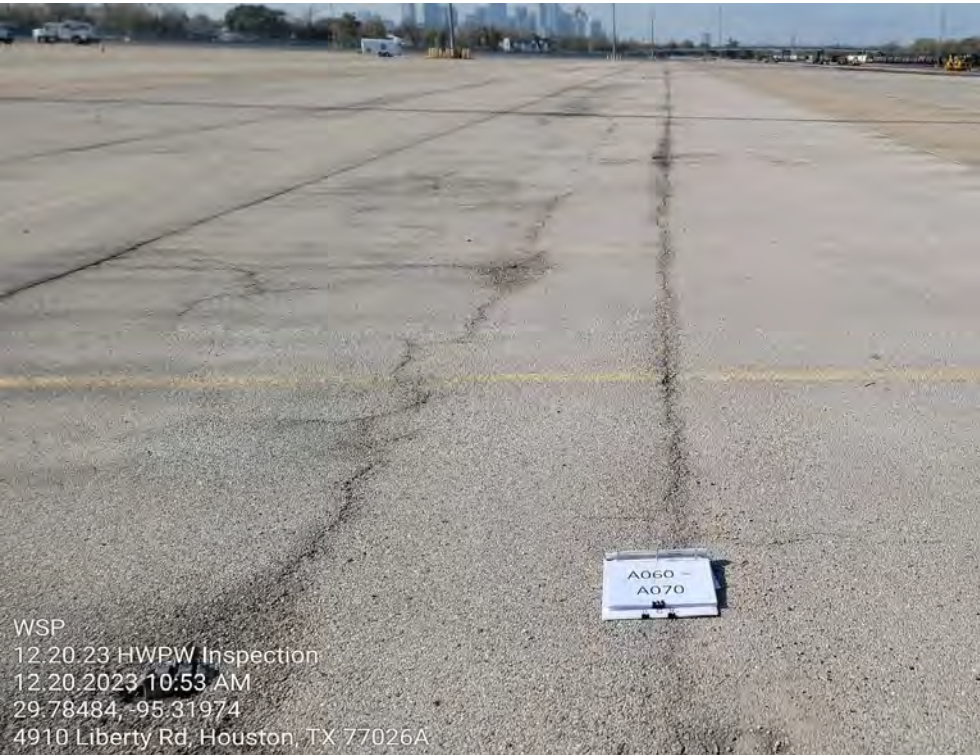
Description: Stalls A060 - A070, some residual staining previously observed along cracks in pavement. No new water seeps observed. Viewing southwest. Lat: 29.78484 Long: -95.31974

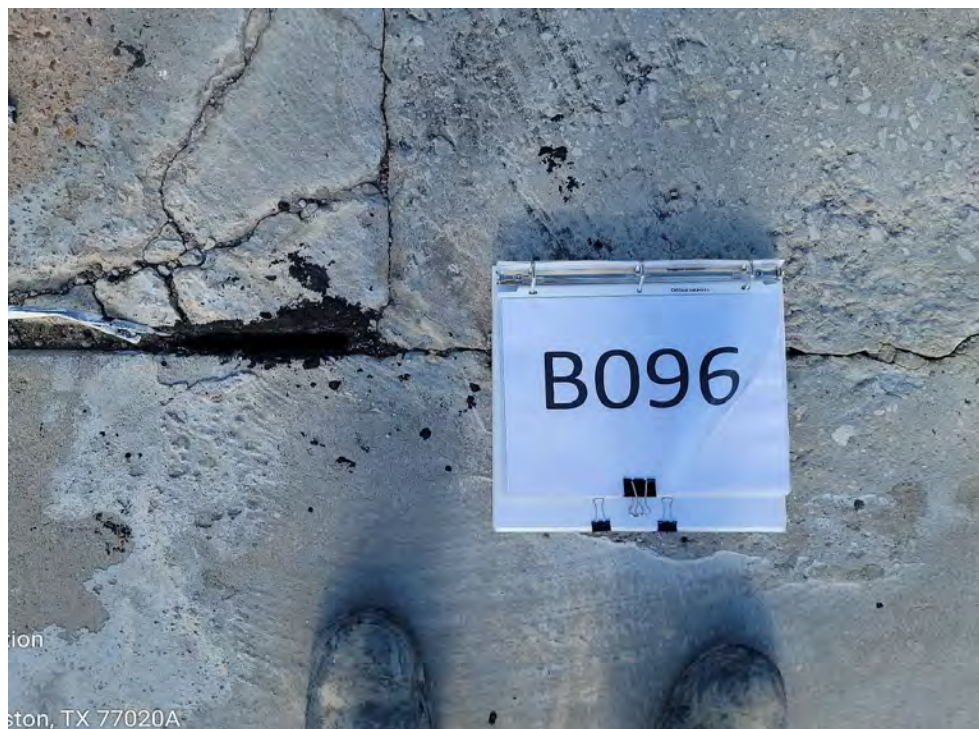
Stall B096, no new tar-like material observed at historical seep location along concrete joint.

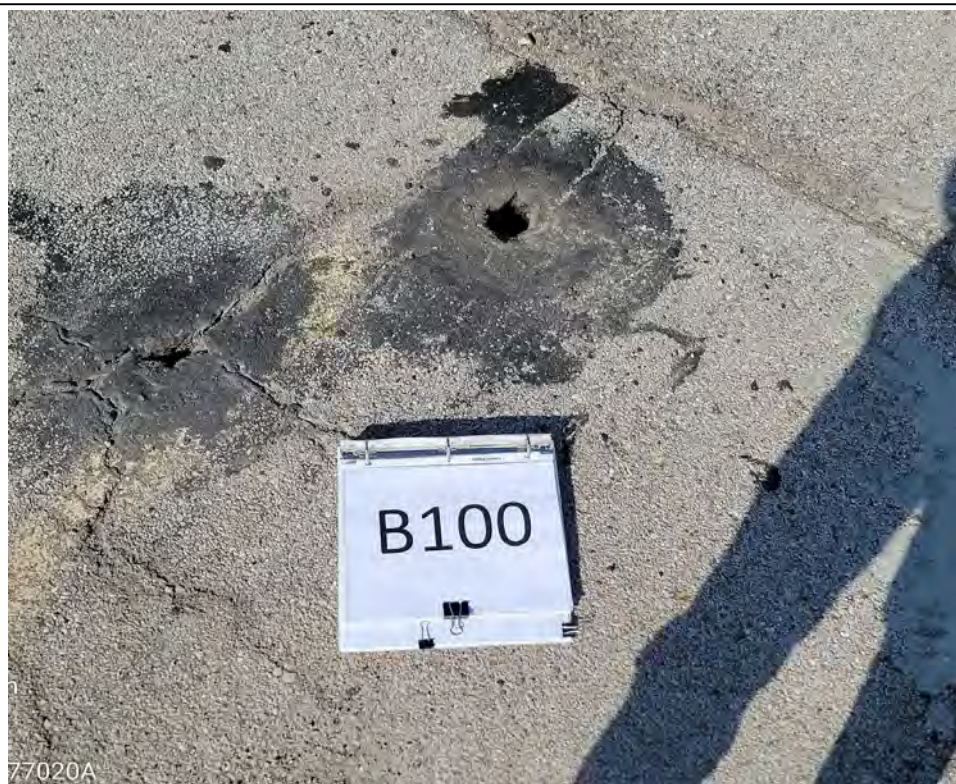
56

Stall B100, no new tar-like material observed at seep location along asphalt crack/ hole in the asphalt.

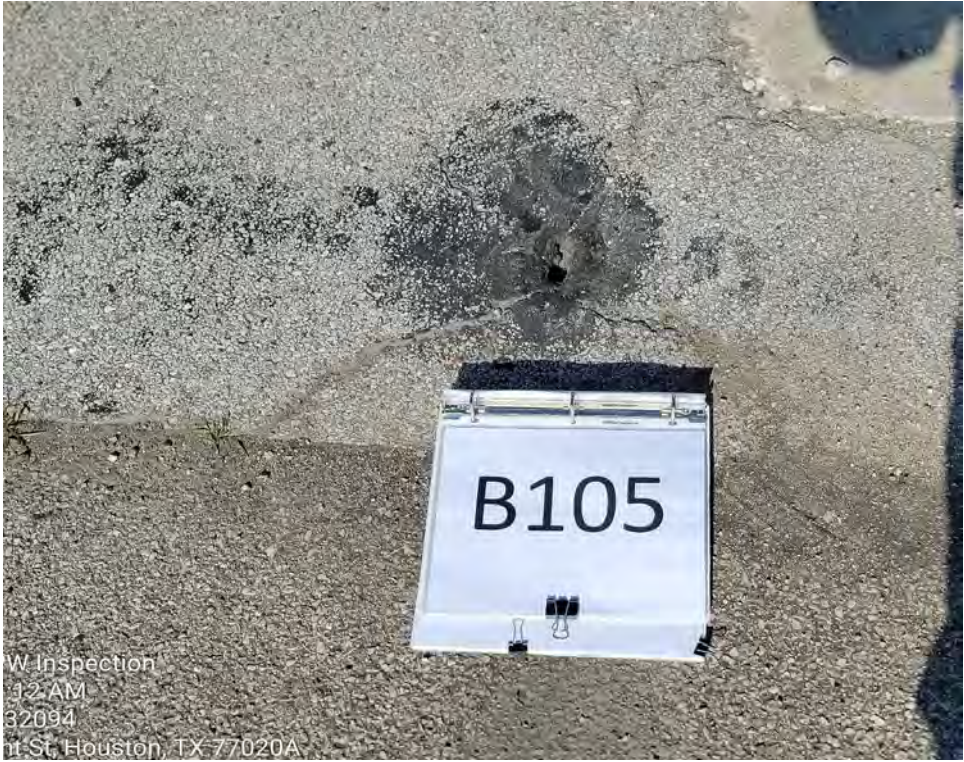
Description: Stall B105, no new tar-like material observed at the historical seep location along asphalt crack. Lat: 29.784209 Long: -95.320943			
Photo No. 60	Inspection Date: 12/20/2023

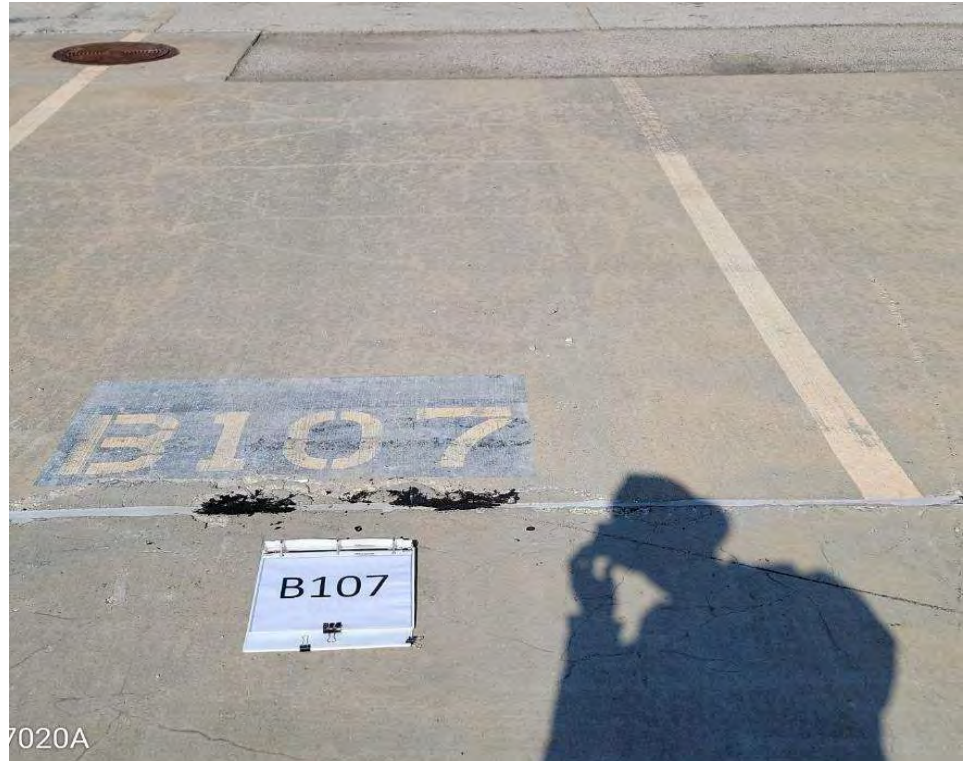
Description: Stalls B107, no new tar-like material observed at seep location on concrete joint along the southern edge of the excavated area. Lat: 29.784156 Long: -95.320953

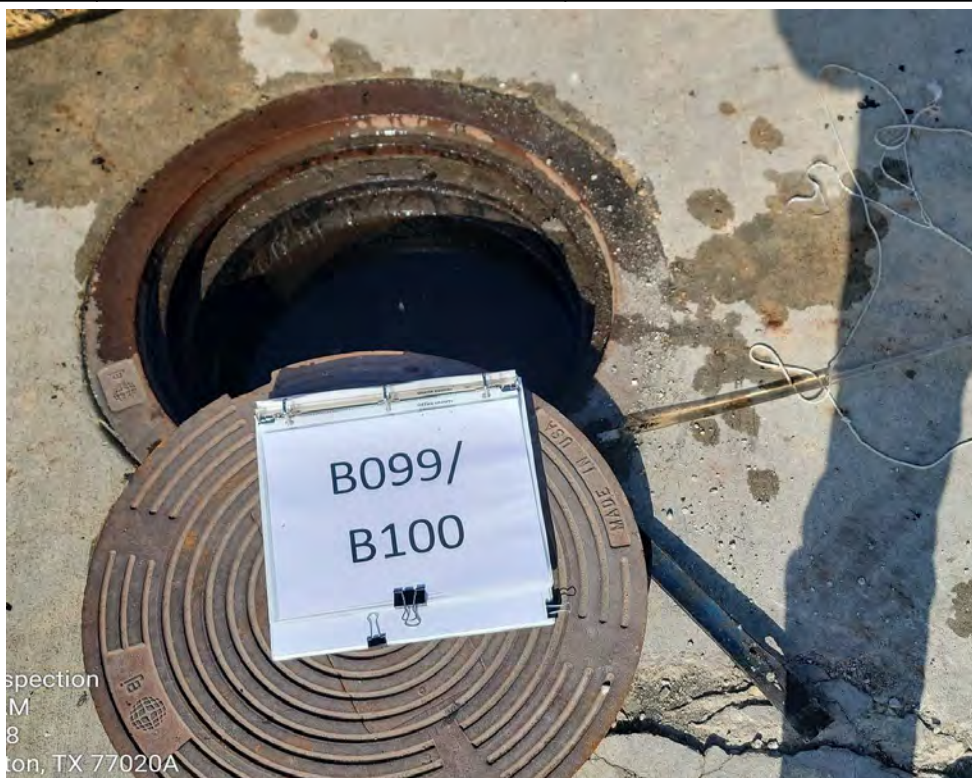
Sump 1 (B099/B100), 9 inches of freeboard in sump, no sheen observed, water color noted as light brown.

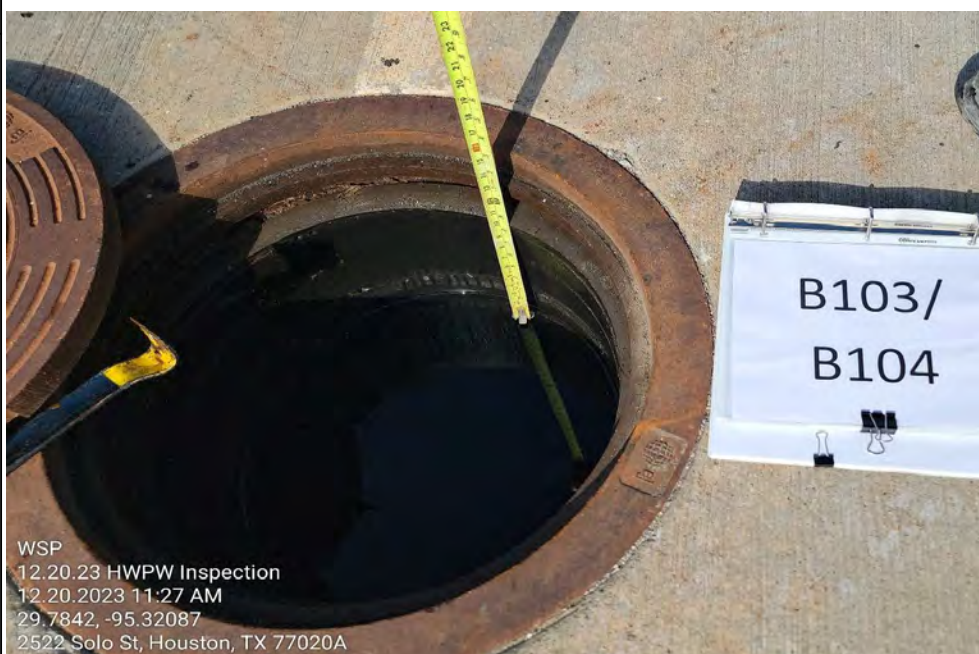
62

Sump 2 (B103/B104), 10 inches of freeboard in sump. No odor or sheen observed, color noted as clear.

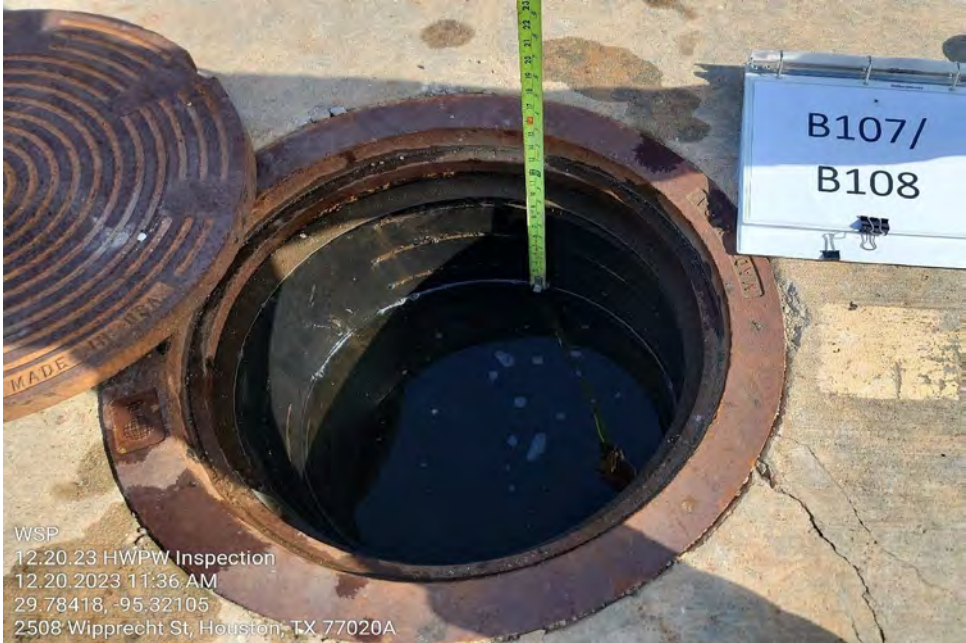
<p>WSP 12.20.23 HWPW Inspection 12.20.2023 11:36 AM 29.78418, -95.32105 2508 Wipprecht St, Houston, TX 77020A</p>	
Description: Sump 3 (B107/B108), 5 inches of freeboard in sump, no sheen observed, water color noted as clear. Lat: 29.7844000 Long: - 95.3205861			
Photo No. 64	Inspection Date: 12/27/2023

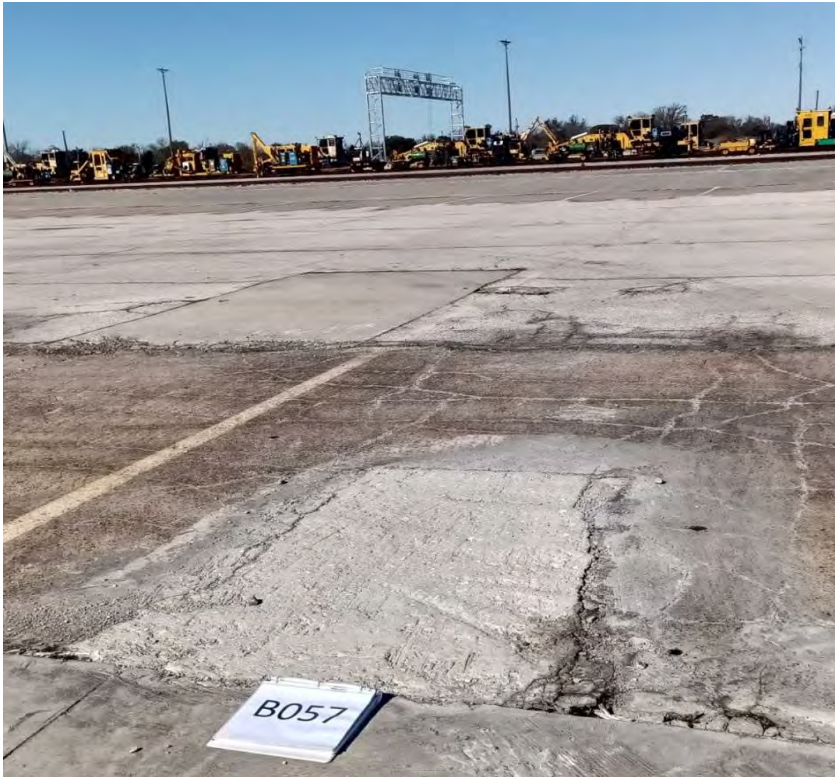
Description: Stall B057 (joint), no new tar-like material observed at historical seep location along concrete joint near Test Pit B057. Lat: 29.784747 Long: -95.319549

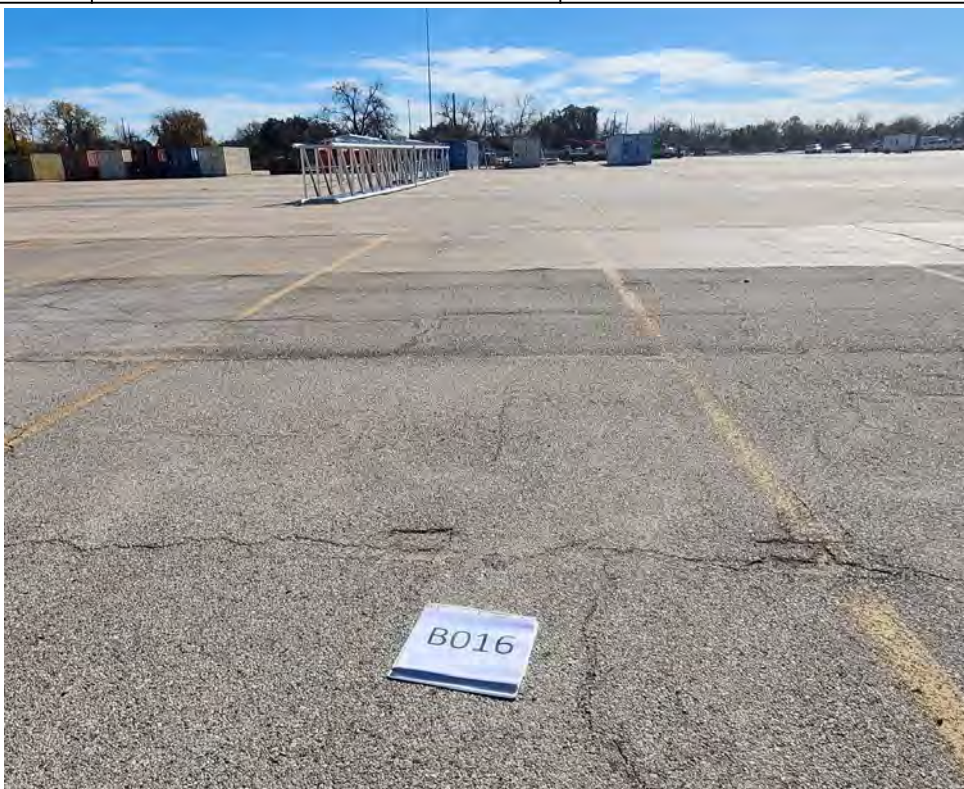
Stall B016. No tar-like material observed at historical seep location along asphalt crack.

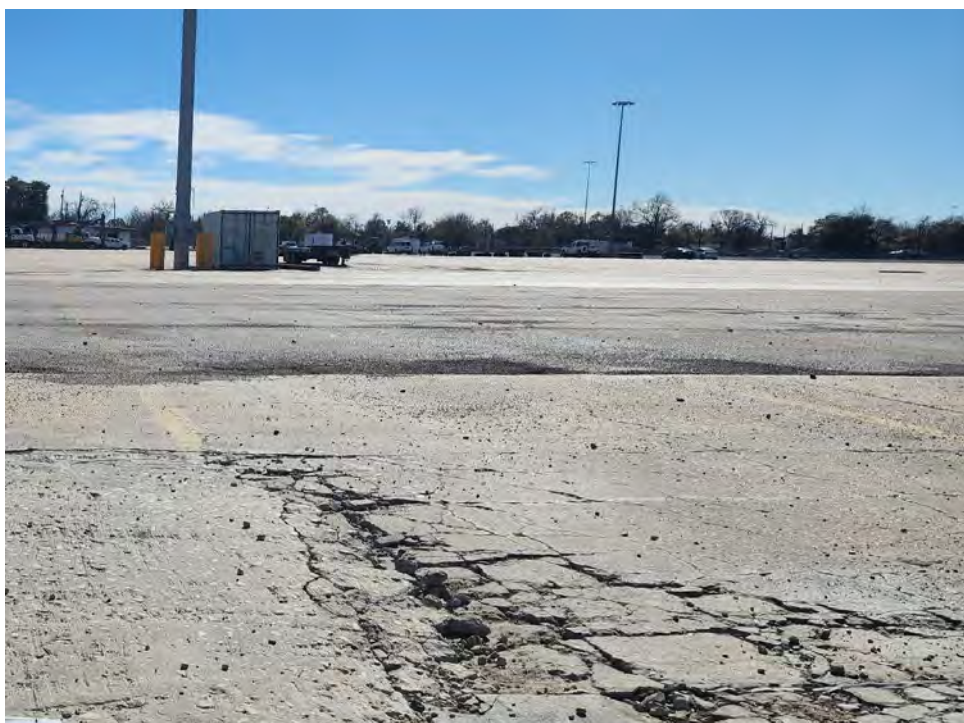
Stall A021. No seeps noted at Test Pit A021.

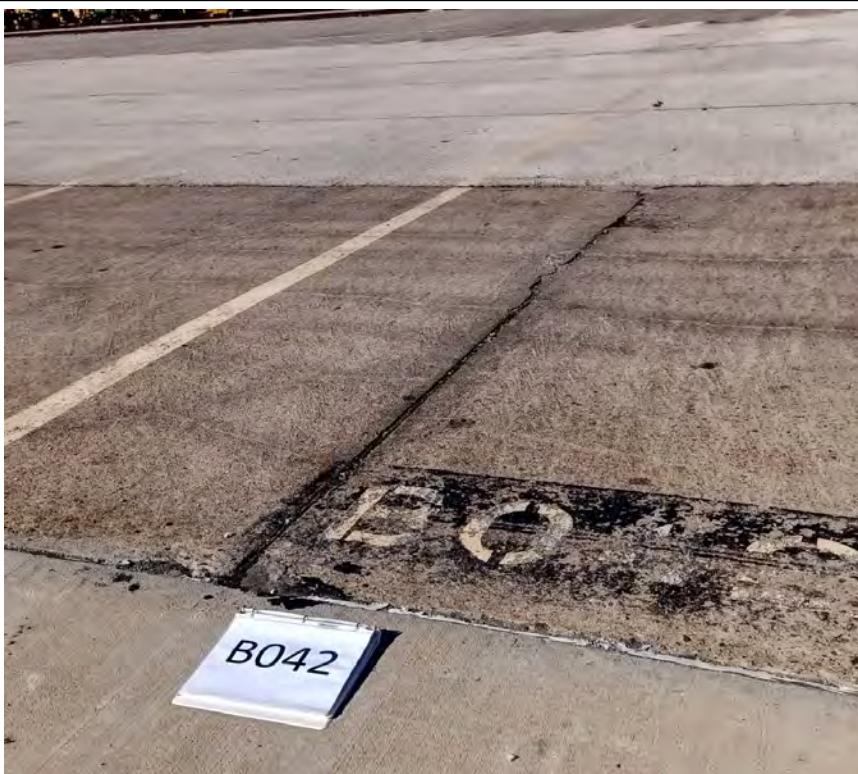
72

Stall B042. No new tar-like material observed at historical seep location along concrete joint.

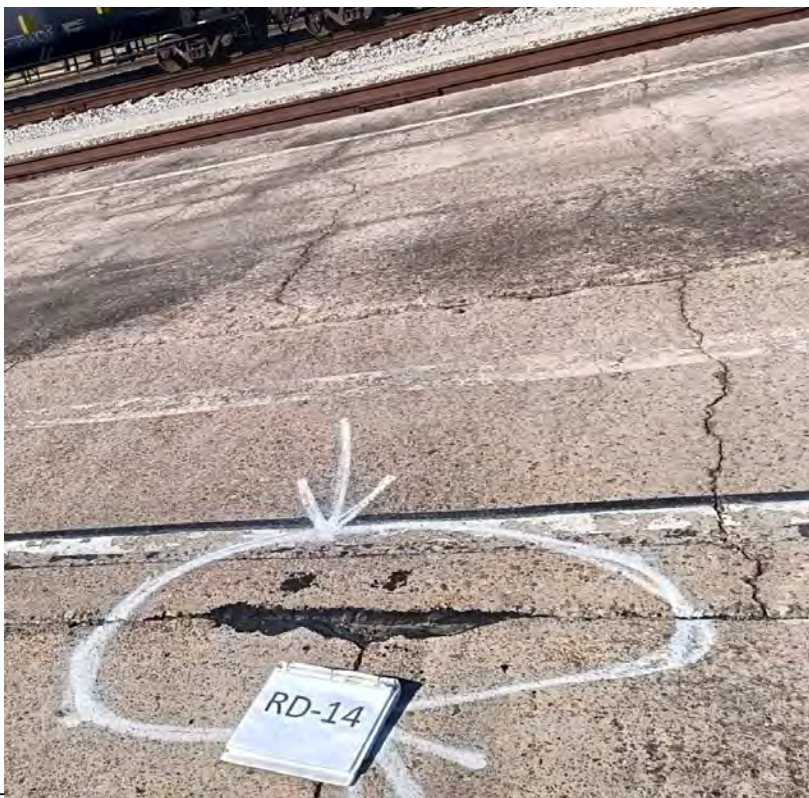
RD-14 Seep location observed within the concrete road area north of Track 802 (east of existing Track 802 seep location), no new tar-like material observed along a concrete joint.
