January 12, 2024

Project No. 31406585.016

**Re: MONTHLY STATUS UPDATE – ENGLEWOOD INTERMODAL YARD – NAPL COLLECTION
SYSTEM/CONCRETE CAP REPAIRS
UNION PACIFIC RAILROAD HOUSTON WOOD PRESERVING WORKS FACILITY
4910 LIBERTY ROAD FACILITY, HOUSTON, TEXAS
POST-CLOSURE CARE PERMIT NO. HW-50343; INDUSTRIAL SWR NO. 31547**

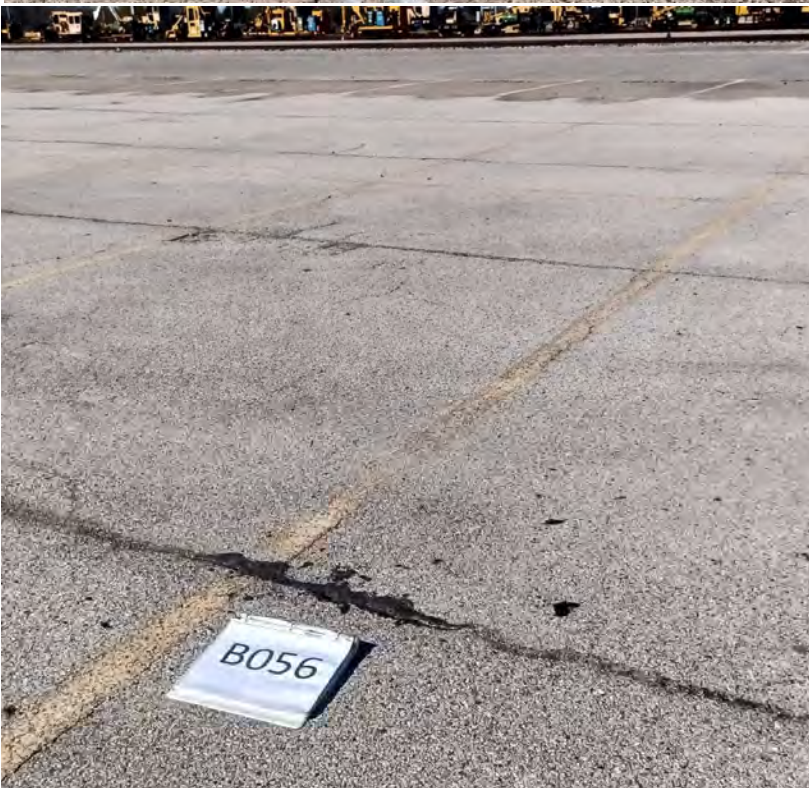
74

Stall B056. No new tar-like material observed at historical seep location along asphalt crack.

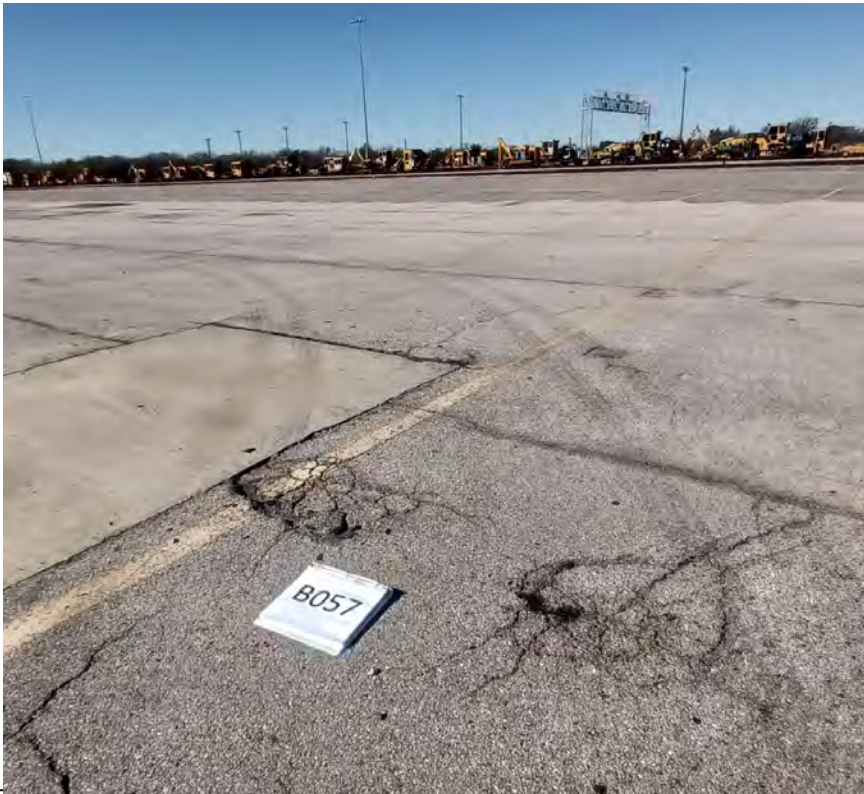
Description: Stall B057, no new tar-like material observed and removed at seep location along asphalt crack. Lat: 29.784769 Long: -95.3195798			
Photo No. 76	Inspection Date: 12/27/2023

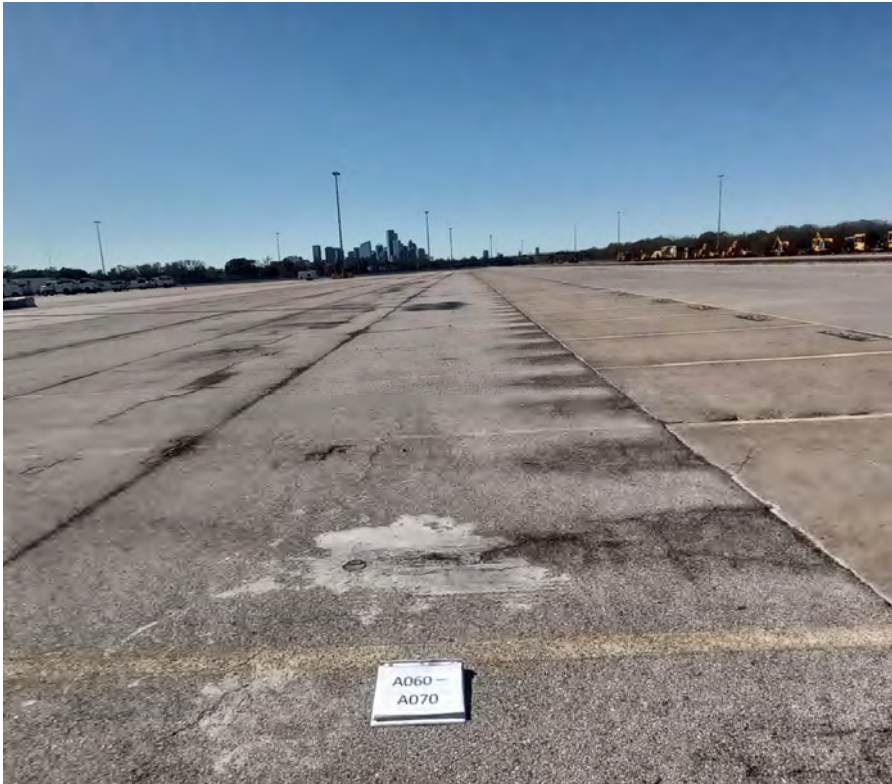
Description: Stalls A060 - A070, some residual staining previously observed along cracks in pavement. No new water seeps observed. Viewing southwest. Lat: 29.784858 Long: -95.319733

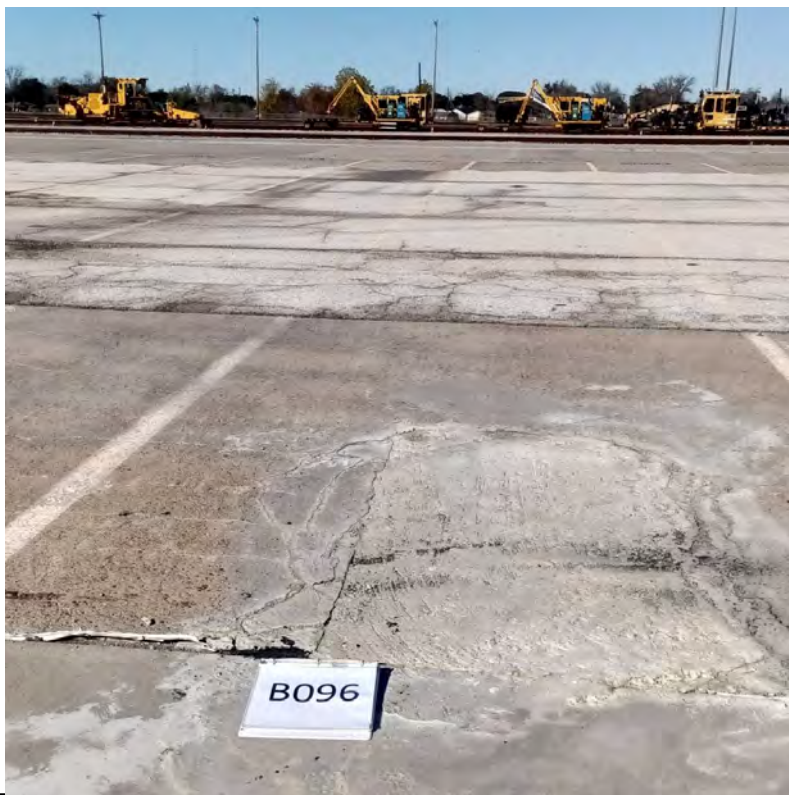
Stall B096, no new tar-like material observed at historical seep location along concrete joint next to Test Pit B096.

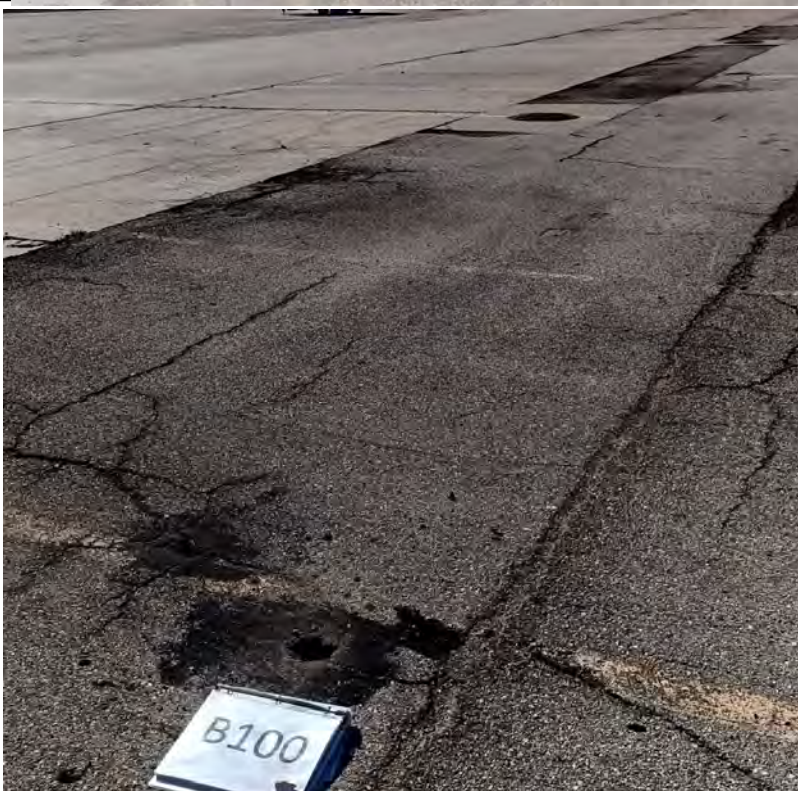
78

Stall B100, no new tar-like material observed at seep location along asphalt crack/ hole in the asphalt.

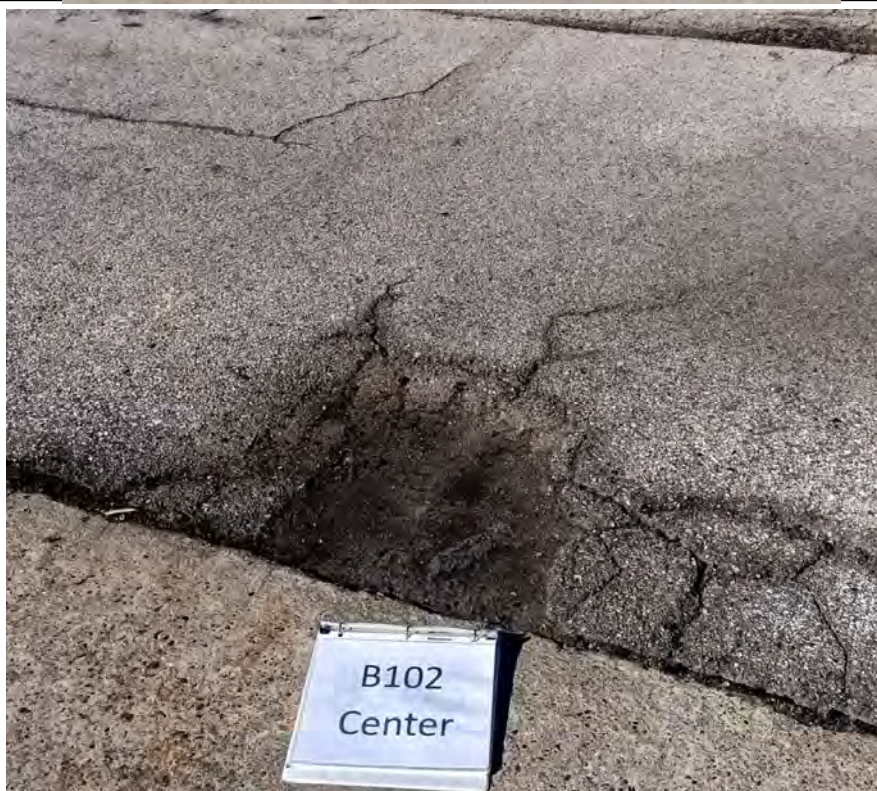
Stall B102 (center), no seep observed.

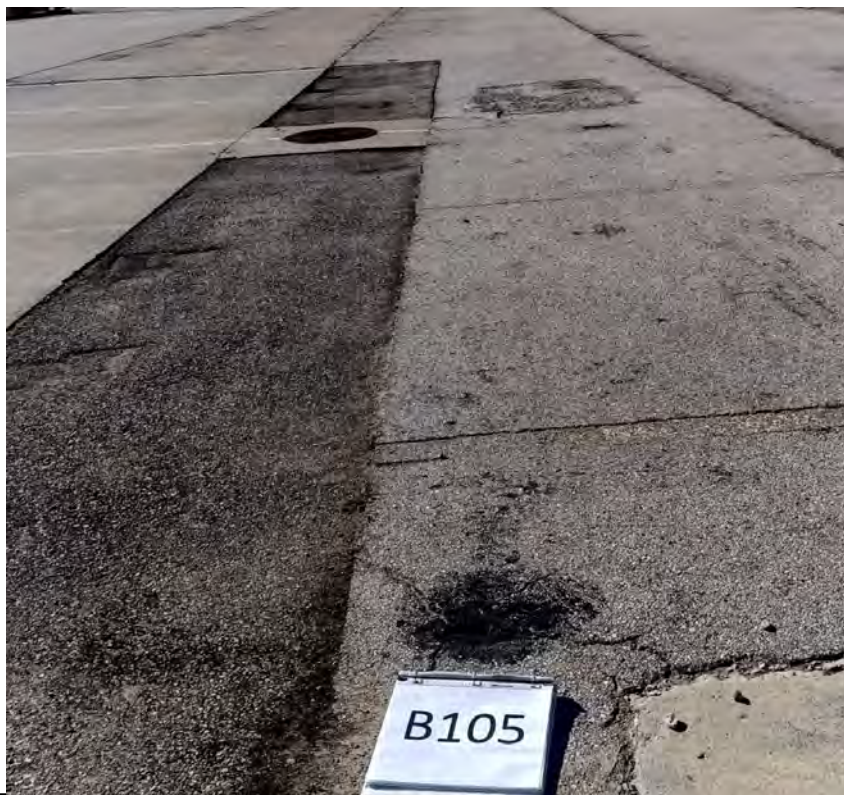
Stall B105, no new tar-like material observed at the historical seep location along asphalt crack.

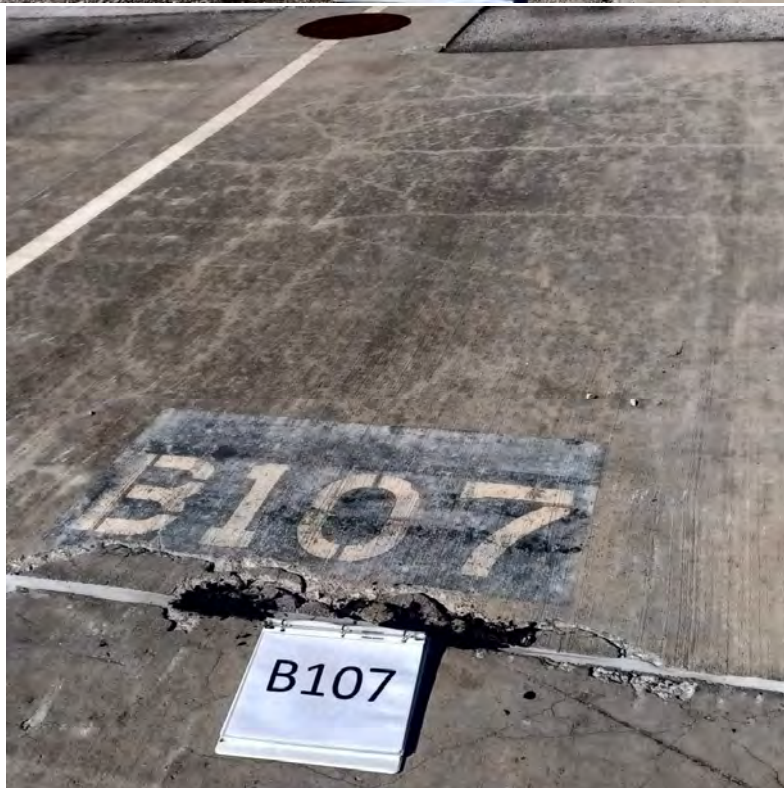
82

- No new tar-like material seeps were observed along the concrete joint between the NAPL Collection System and the existing concrete at Stall B107 during the December 2023 inspections (Photo Nos. 16, 33, 60, 82).

Stalls B107, no new tar-like material observed at seep location on concrete joint along the southern edge of the excavated area.

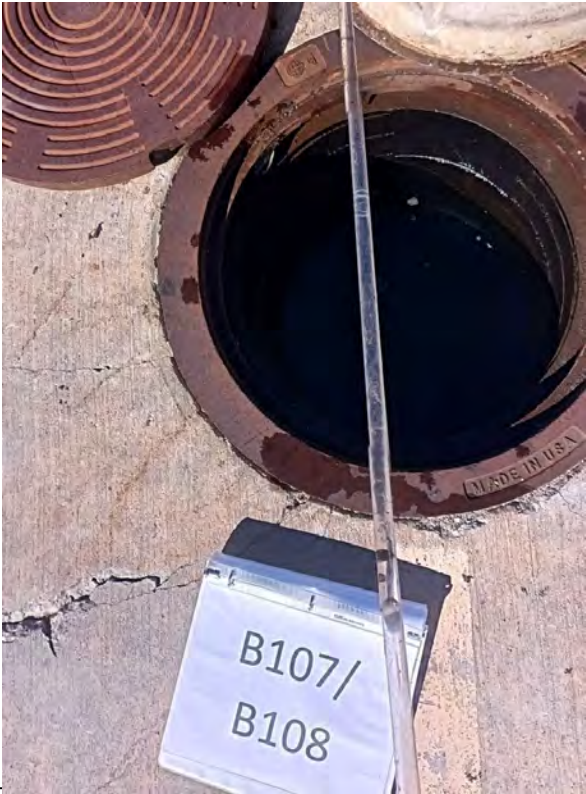
Description: Sump 3 (B107/B108), 11 inches of freeboard in sump, no sheen observed, water color noted as clear. Lat: 29.7844000 Long: - 95.3205861			
Photo No.	Inspection Date:		
Description:
