February 14, 2024

Project No. 31406585.016

**Re: MONTHLY STATUS UPDATE – ENGLEWOOD INTERMODAL YARD – NAPL COLLECTION
SYSTEM/CONCRETE CAP REPAIRS
UNION PACIFIC RAILROAD HOUSTON WOOD PRESERVING WORKS FACILITY
4910 LIBERTY ROAD FACILITY, HOUSTON, TEXAS
POST-CLOSURE CARE PERMIT NO. HW-50343; INDUSTRIAL SWR NO. 31547**

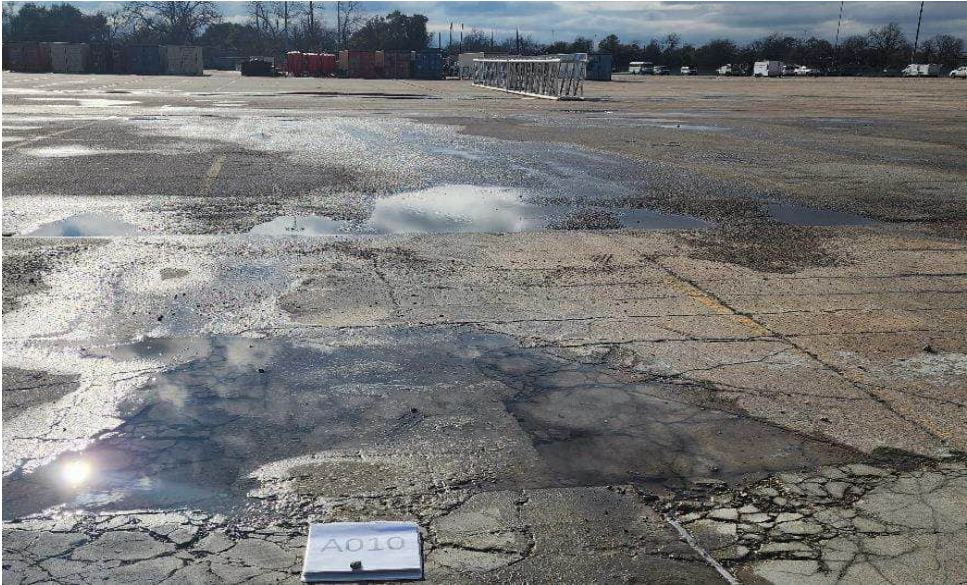
Description: Stall A010. No tar-like material observed at Test Pit A010. Lat: 29.785517 Long: -95.31834			
Photo No. 2	Inspection Date: 1/3/2024

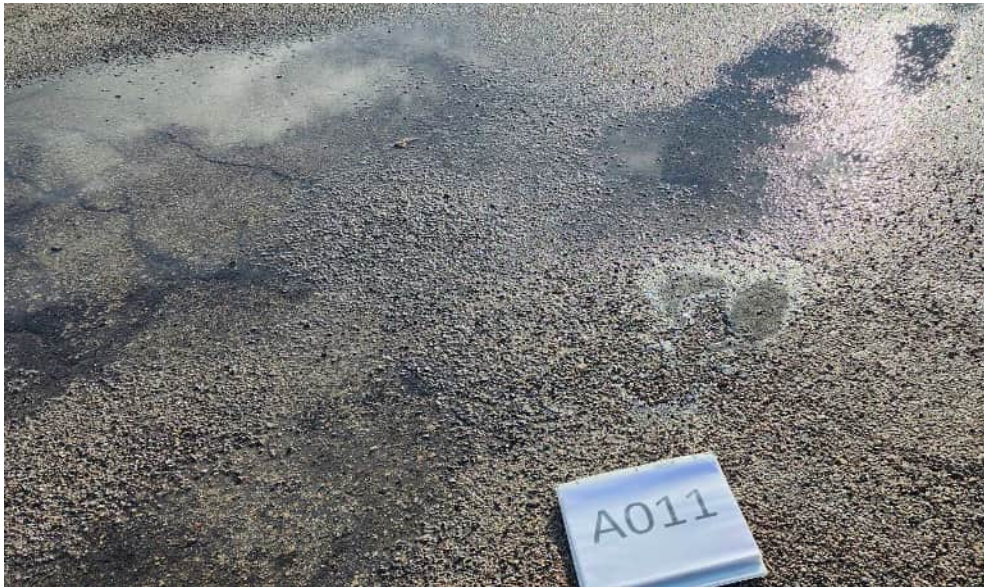
Description: Stall A011. No tar-like material observed at historical seep location along asphalt crack. Lat: 29.785467 Long: -95.318341

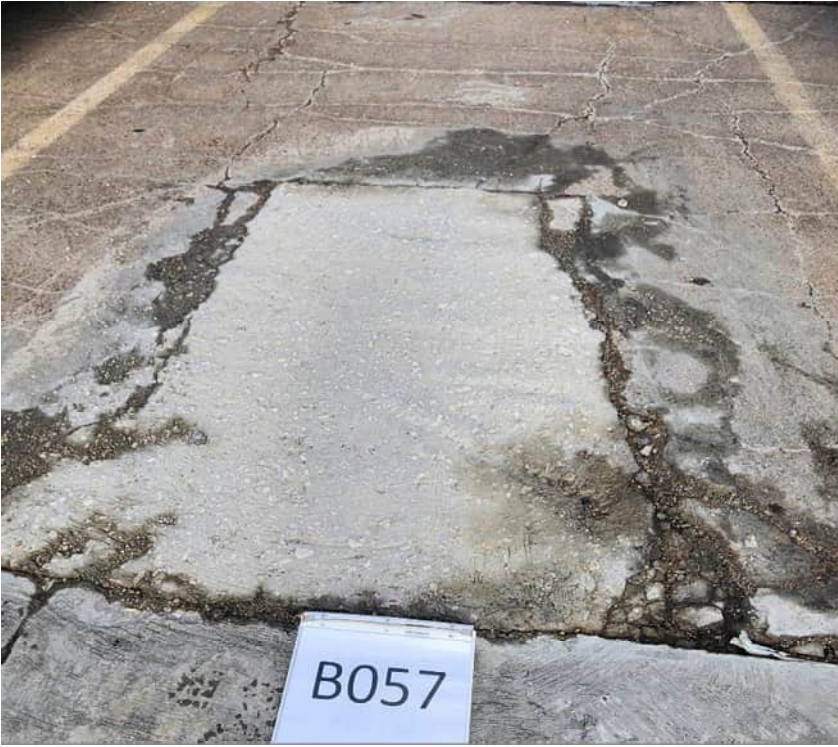
Description: Stall B057 (joint), no tar-like material observed at historical seep location at Test Pit B057. Lat: 29.784747 Long: -95.319549			
Photo No. 10	Inspection Date: 1/3/2024

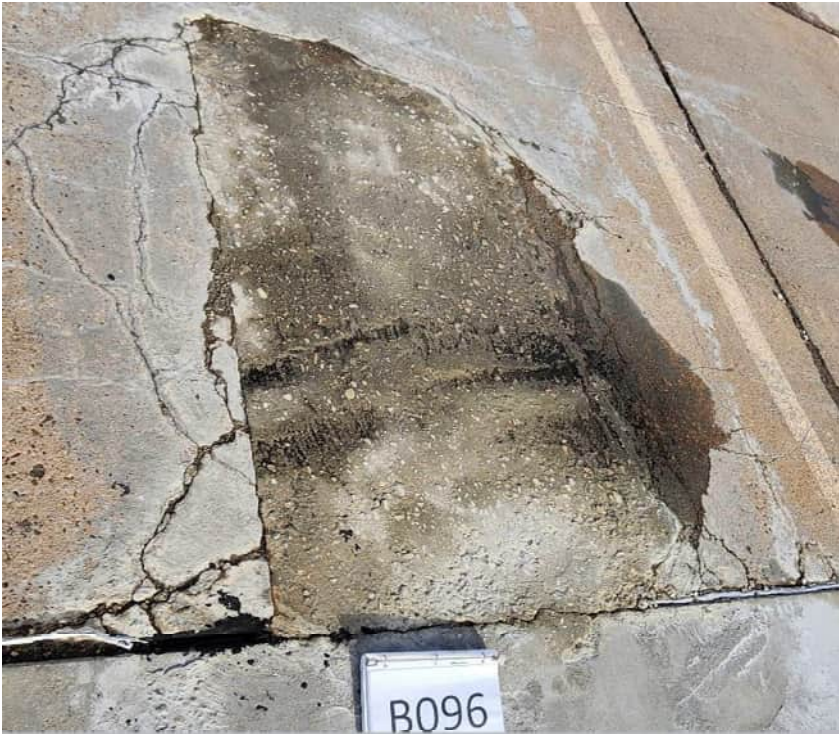
Description: Stall B096, no new tar-like material observed at historical seep location along concrete joint at Test Pit B096. Lat: 29.784276 Long: -95.320651			
Photo No. 12	Inspection Date: 1/3/2024

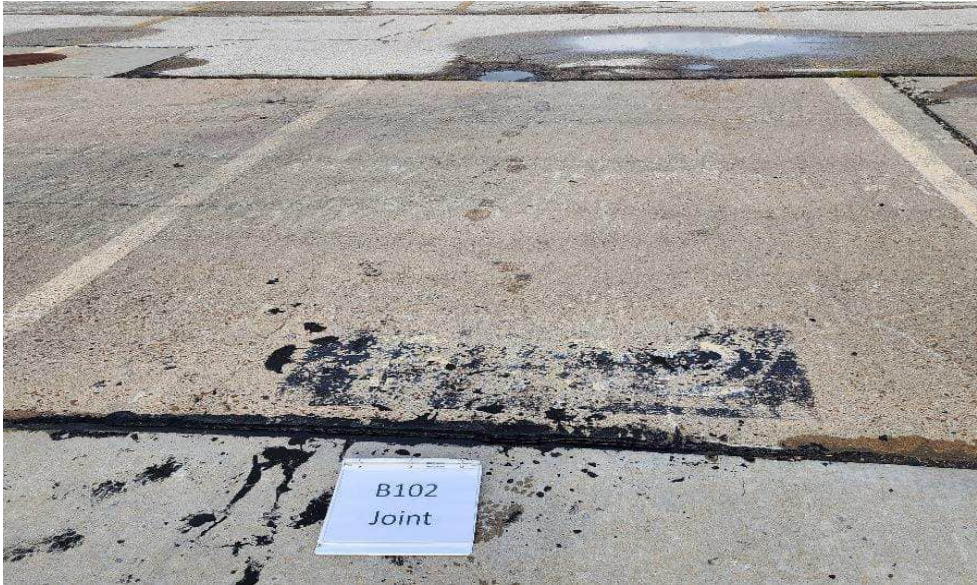
Description: Stall B102 (joint) no new tar-like material observed at historical seep site along concrete joint. Lat: 29.784197 Long: -95.320821

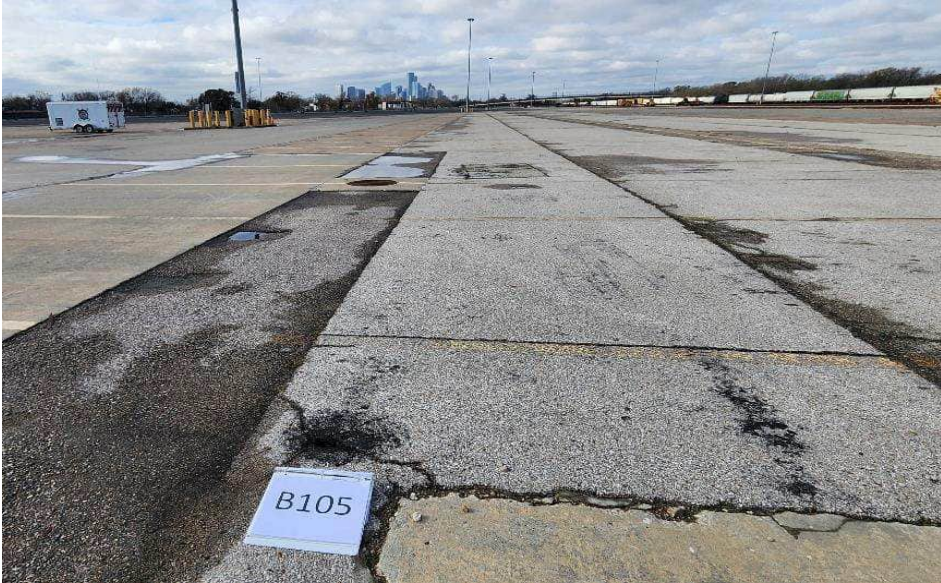
Description: Stall B105. No new tar-like material observed at historical seep location along asphalt crack. Lat: 29.784209 Long: -95.320943			
Photo No. 16	Inspection Date: 1/3/2024

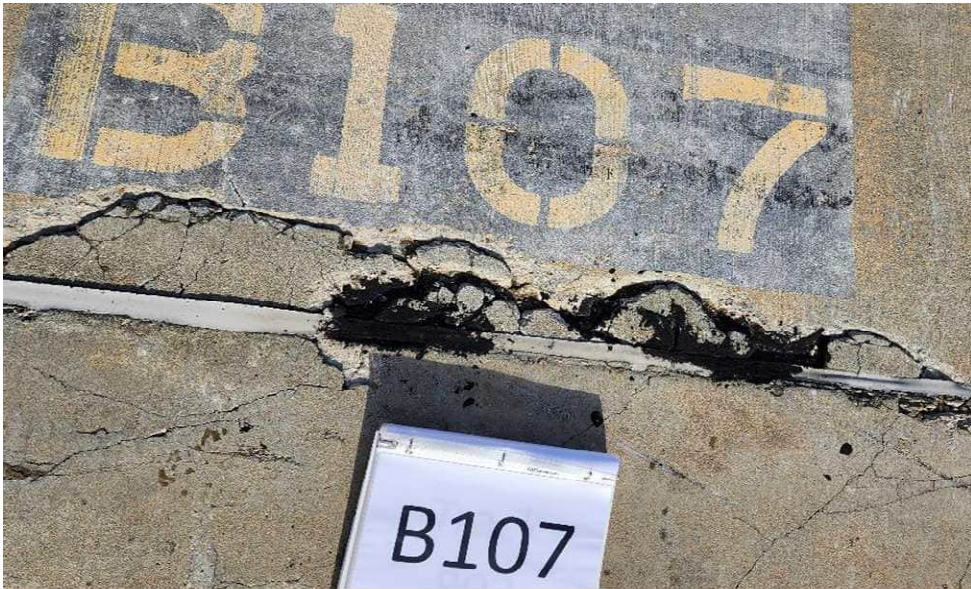
Description: Stall B107, no new tar-like material observed at seep location on concrete joint along the southern edge of the excavated area. Lat: 29.784137 Long: -95.32096

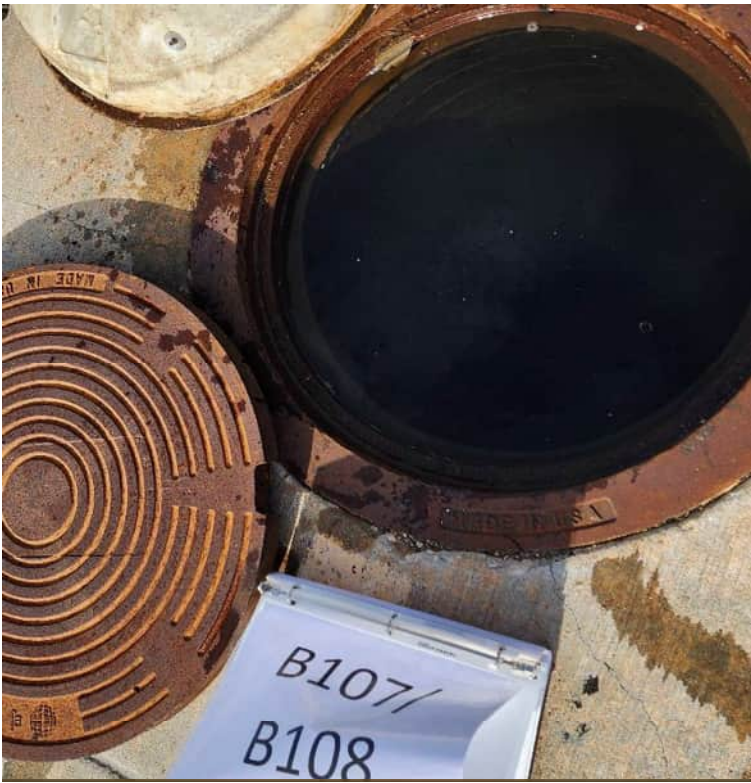
Description: Sump 3 (B107/B108), 0 inches of freeboard in sump, no sheen observed, water color noted as clear. Lat: 29.7844000 Long: - 95.3205861			
Photo No. 20	Inspection Date: 1/3/2024

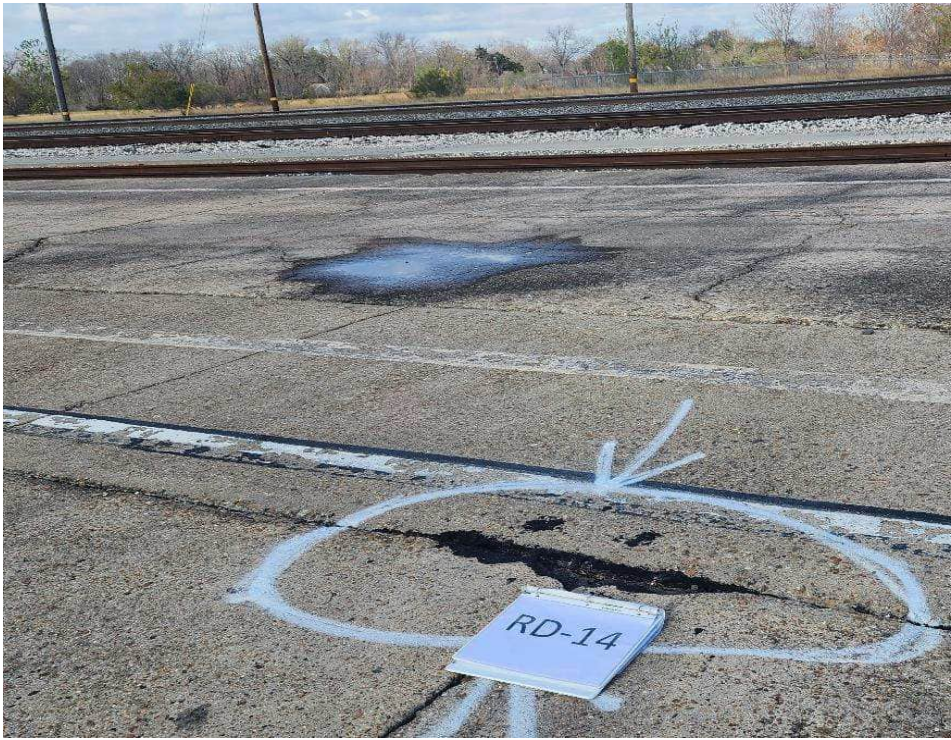
Description: RD-14 Seep location observed within the concrete road area north of Track 802 (east of existing Track 802 seep location), No new tar-like material observed along a concrete joint. Lat: 29.785064 Long: -95.321219

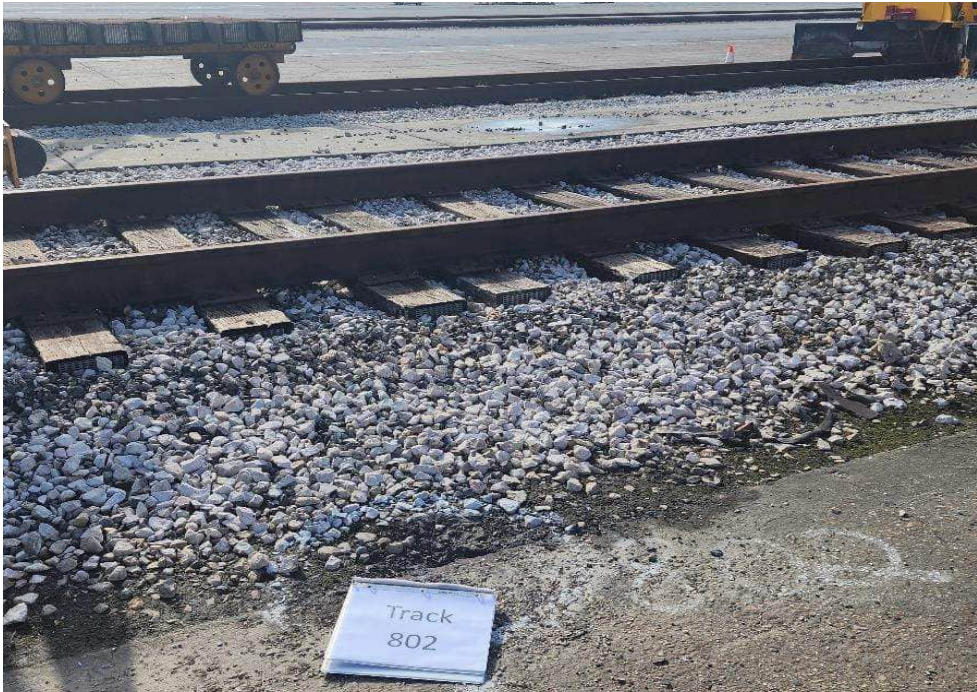
Description: North side of Track 802, no new tar-like material observed at seep location near the edge of the ballast. Lat: 29.784947 Long: -95.321214			
Photo No. 22	Inspection Date: 1/10/2024

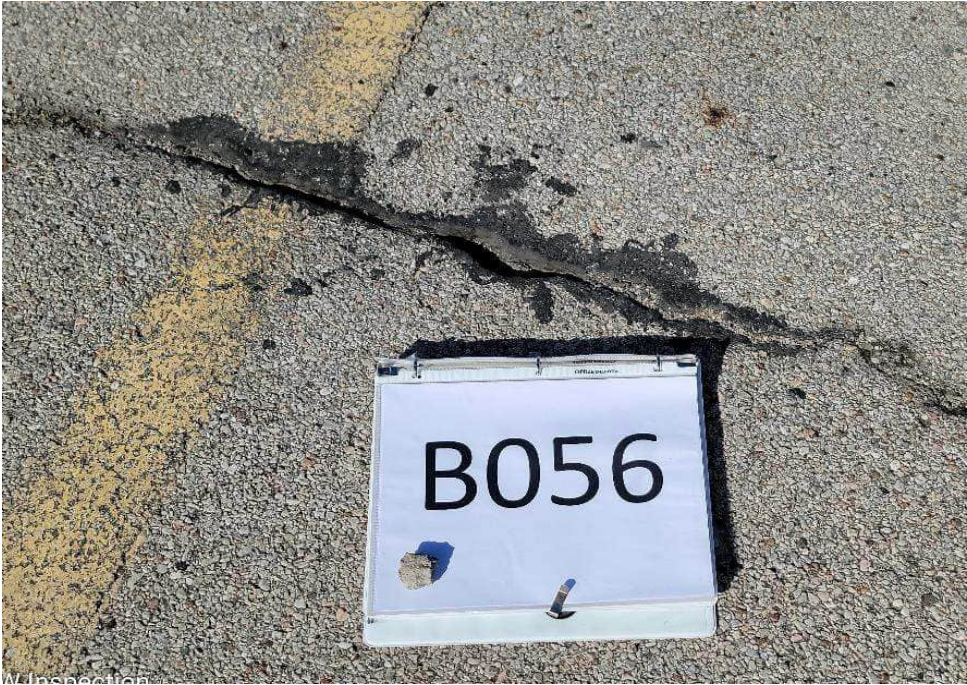
Description: Stall B056. No new tar-like material observed at historical seep location along asphalt crack. Lat: 29.7847472 Long: -95.3195417

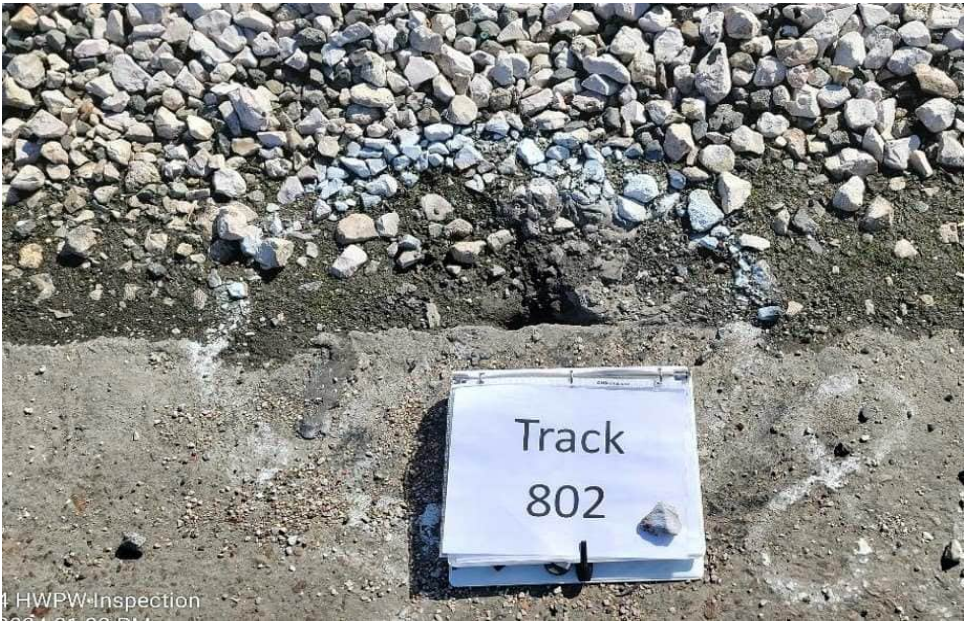
Description: North side of Track 802, no new tar-like material observed at seep location near the edge of the ballast. Lat: 29.784947 Long: -95.321214			
Photo No. 24	Inspection Date: 1/10/2024

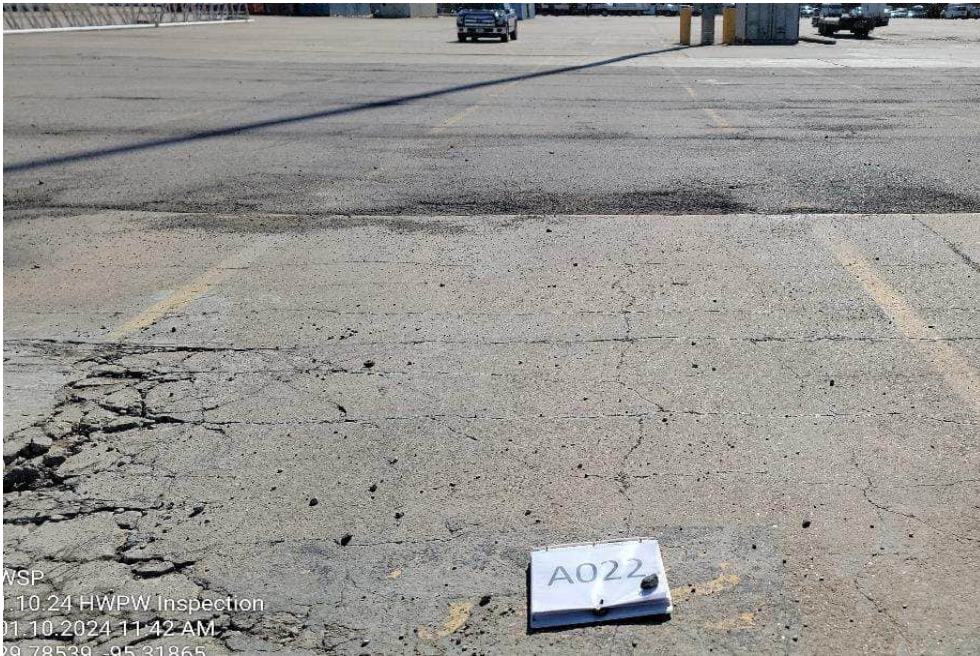
Description: Stall A022. No new tar-like material observed at historical seep location along asphalt crack. Lat: 29.785378 Long: -95.318694

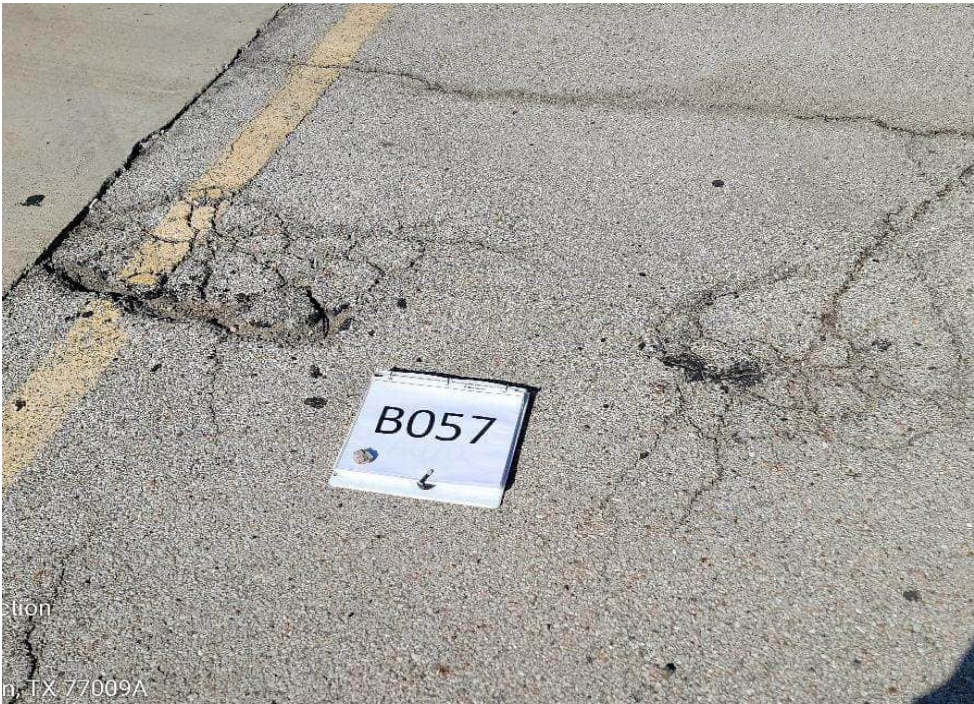
Description: Stall B057, no new tar-like material observed along asphalt crack. Lat: 29.784769 Long: -95.3195798			
Photo No. 26	Inspection Date: 1/10/2024

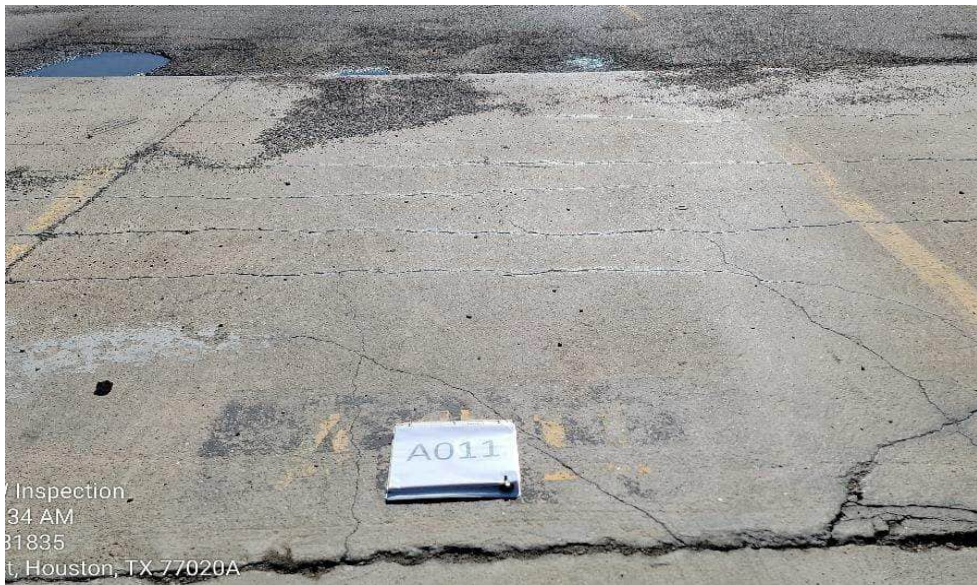
Description: Stall A011. No tar-like material observed at historical seep location along asphalt crack. Lat: 29.785467 Long: -95.318341

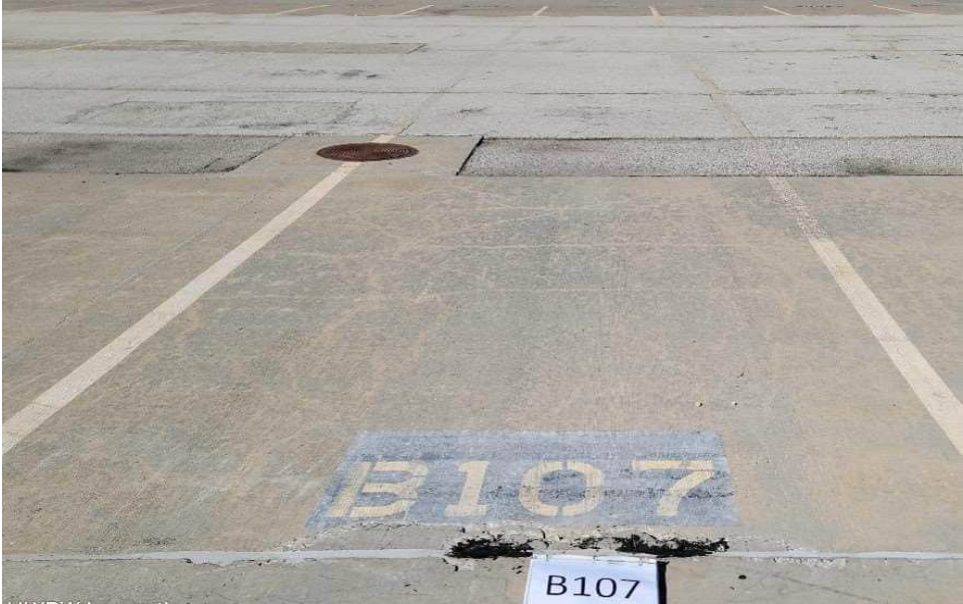
Description: Stall B107, no new tar-like material observed at seep location on concrete joint along the southern edge of the excavated area. Lat: 29.784137 Long: -95.32096			
Photo No. 28	Inspection Date: 1/10/2024

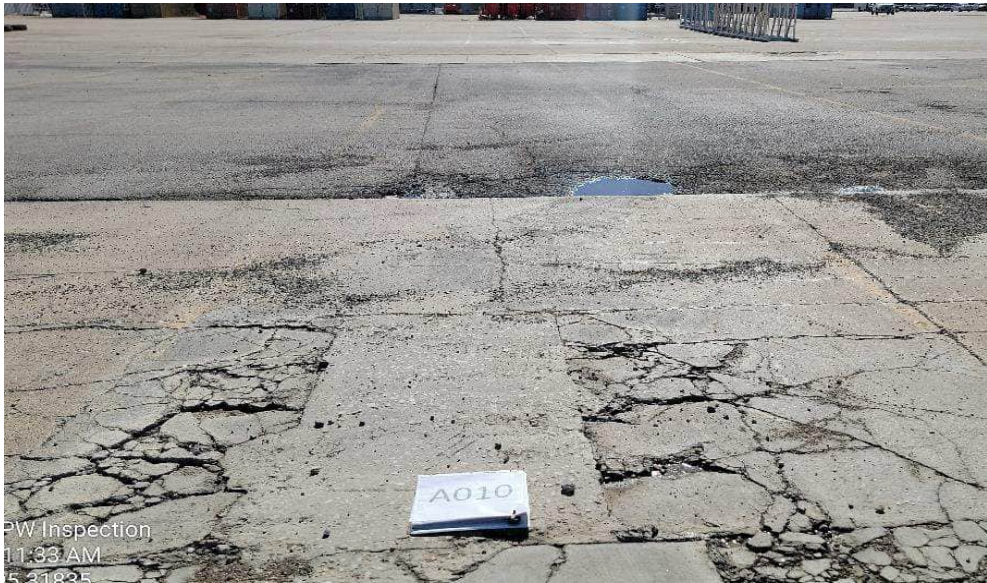
Description: Stall A010. No tar-like material observed at Test Pit A010 location. Lat: 29.785517 Long: -95.31834

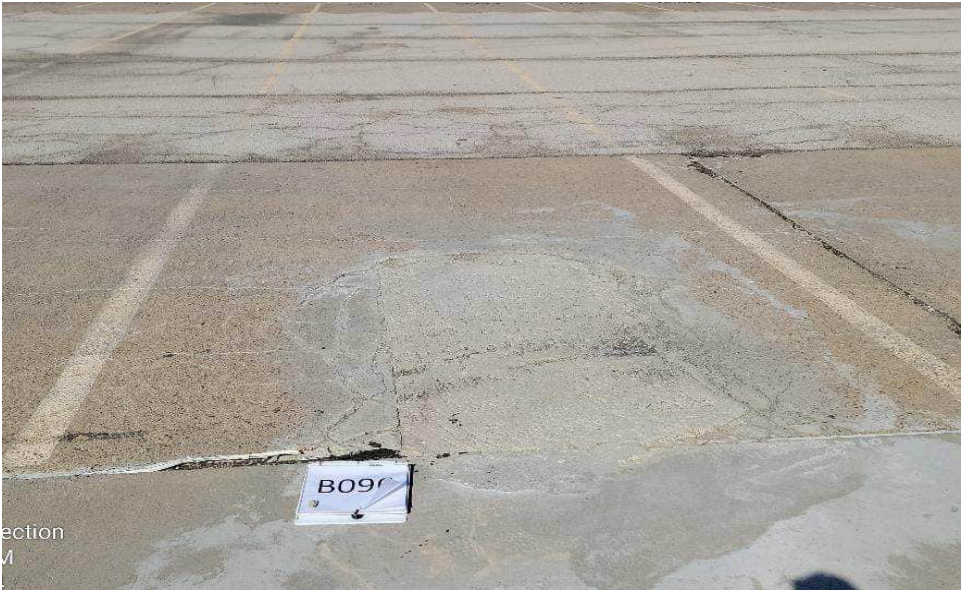
Description: Stall B096, no new tar-like material observed at historical seep location along concrete joint. Lat: 29.7842528 Long: -95.3206250			
Photo No. 30	Inspection Date: 1/10/2024

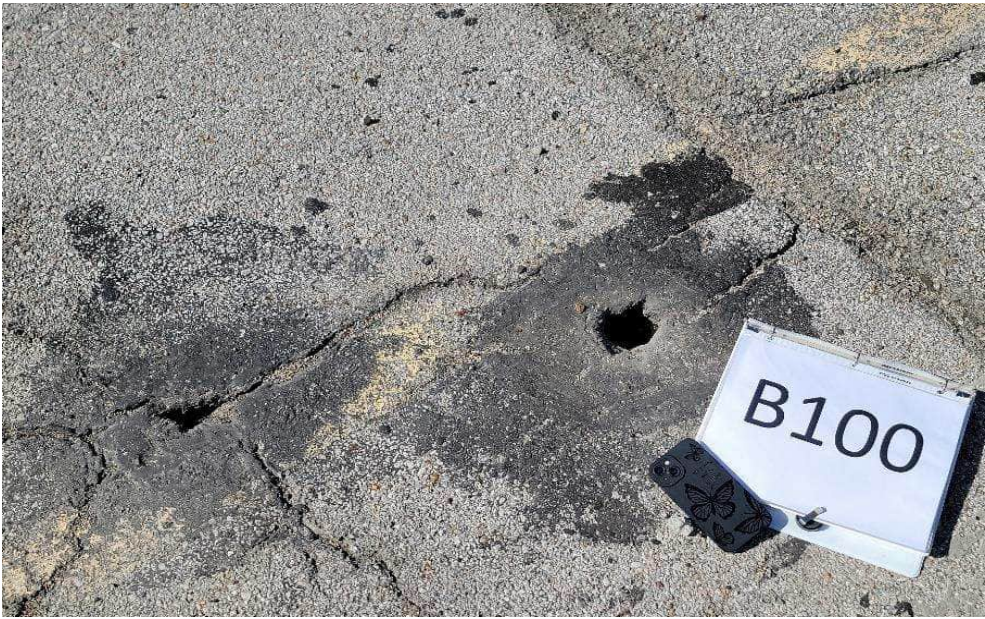
Description: Stall B100, no new tar-like material observed at seep location along asphalt crack/ hole in the asphalt. Lat: 29.7842528 Long: - 95.3206250

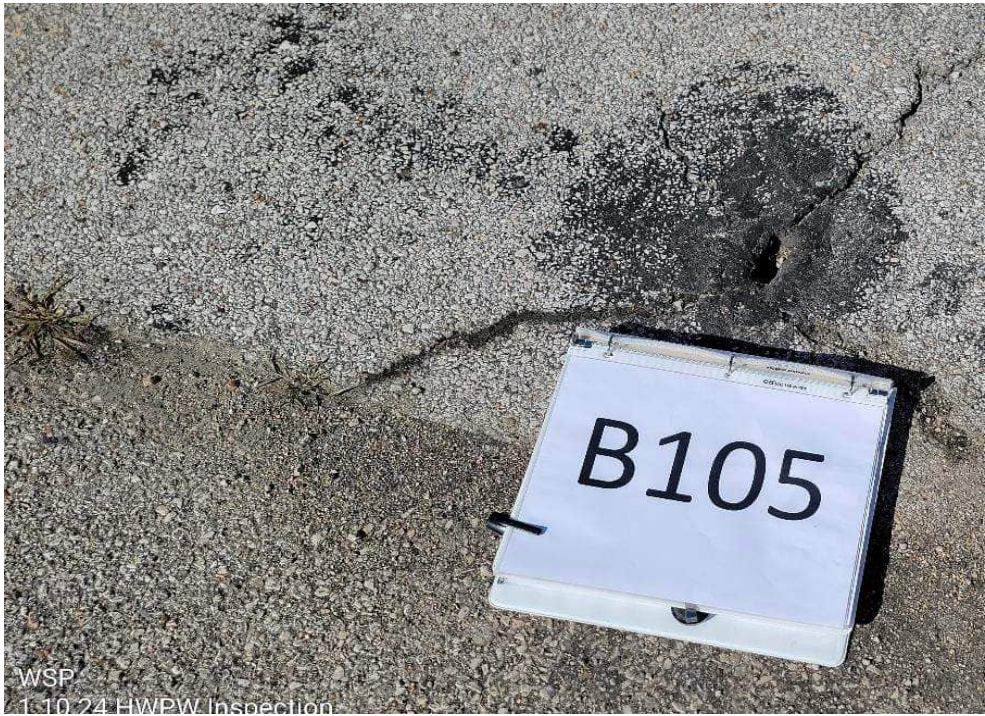
Description: Stall B105, no new tar-like material observed at the historical seep location along asphalt crack. Lat: 29.784209 Long: -95.320943			
Photo No. 32	Inspection Date: 1/10/2024

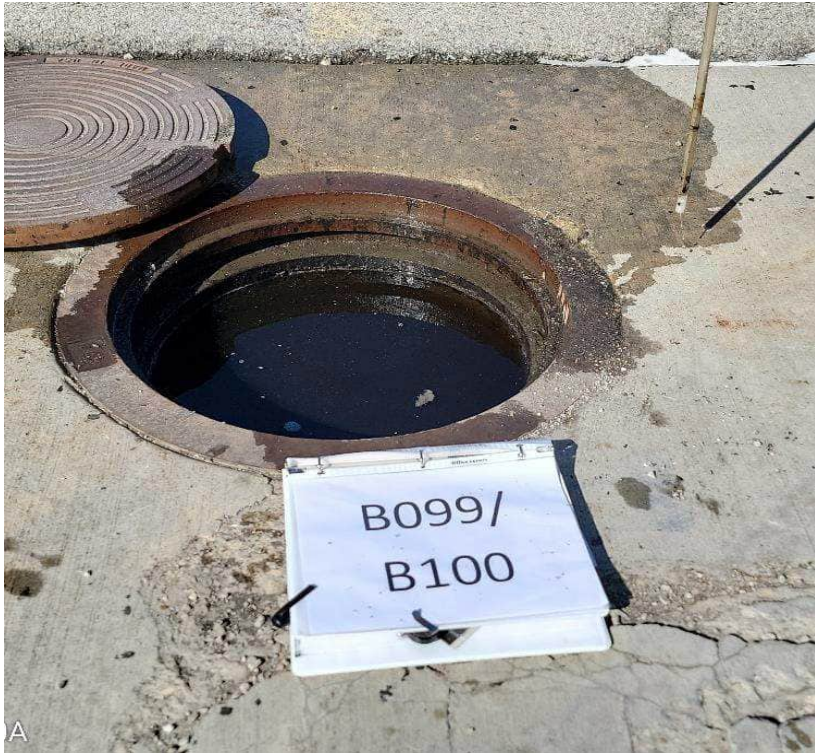
Description: Sump 1 (B099/B100), 5 inches of freeboard in sump, no sheen observed, water color noted as light brown. Lat: 29.7844000 Long: - 95.3205861

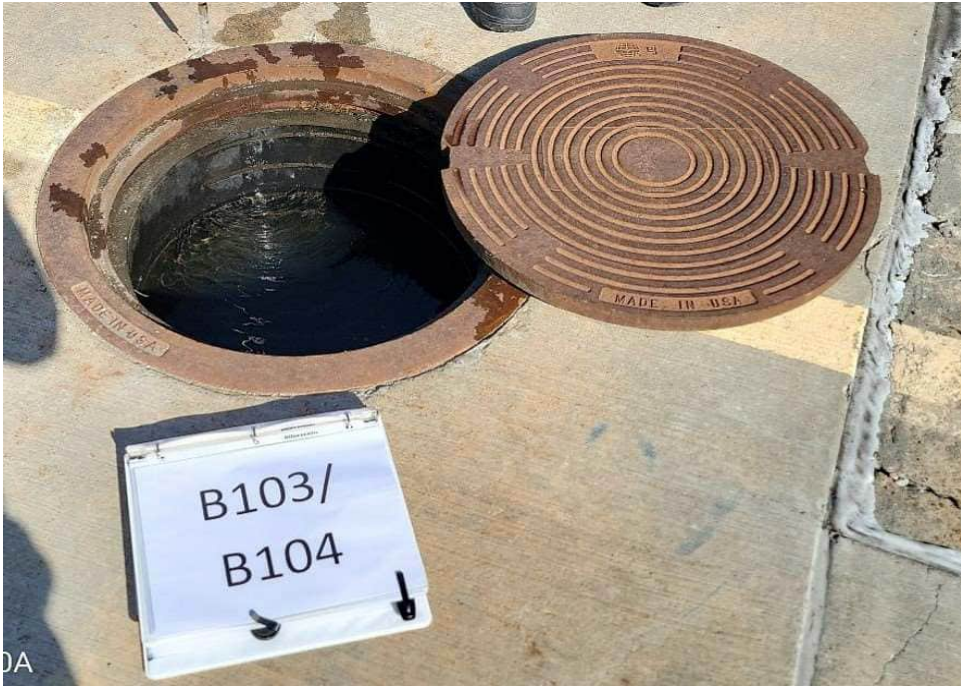
Description: Sump 2 (B103/B104), 10 inches of freeboard in sump. No odor or sheen observed, color noted as clear. Lat: 29.7842861 Long: - 95.3208611			
Photo No. 34	Inspection Date: 1/10/2024

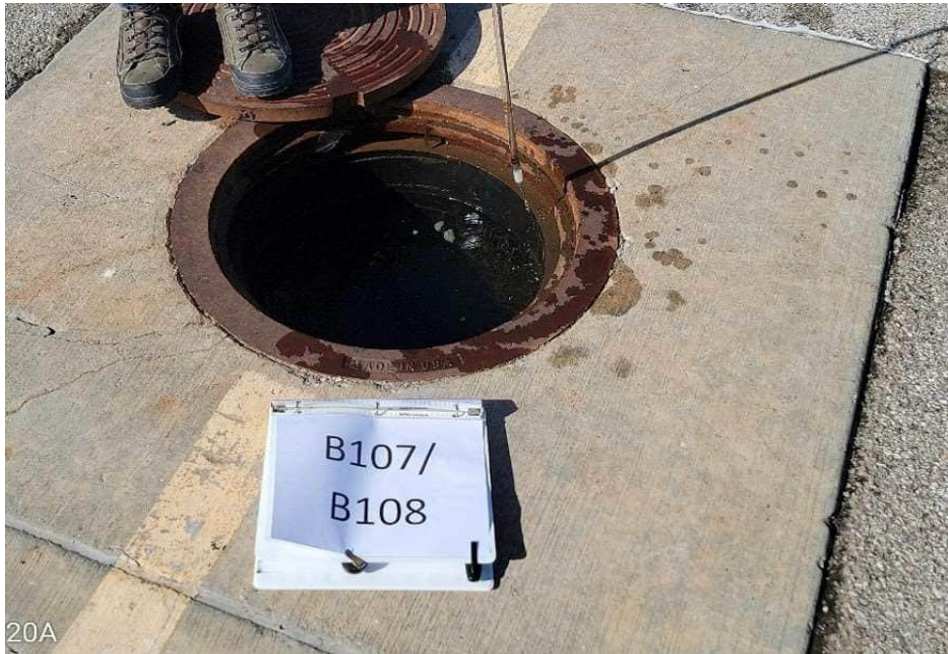
Description: Sump 3 (B107/B108), 9.5 inches of freeboard in sump, no sheen observed, water color noted as clear. Lat: 29.7844000 Long: - 95.3205861

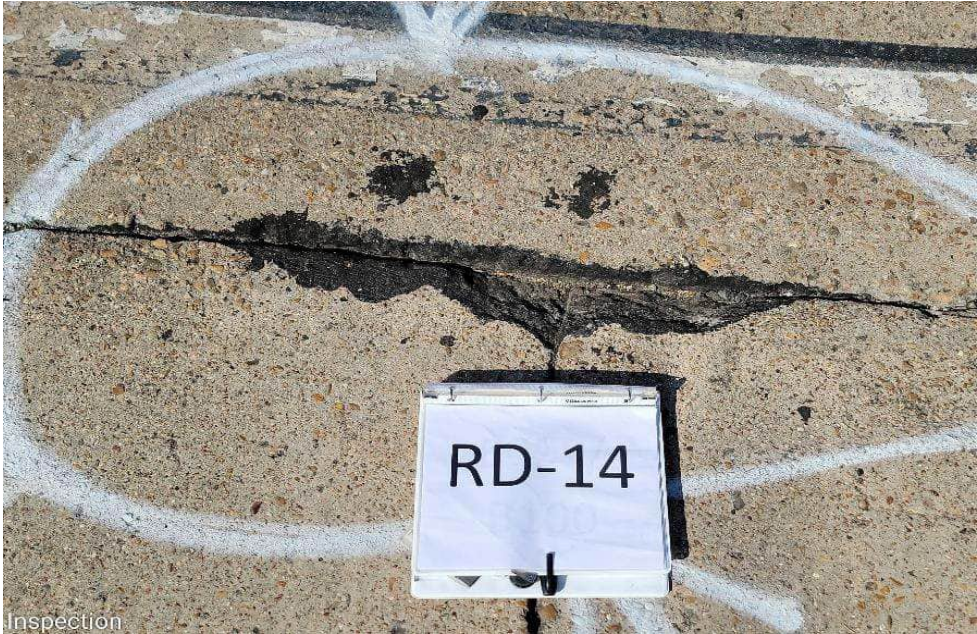
Description: RD-14 Seep location observed within the concrete road area (RD-14) north of Track 802 (east of existing Track 802 seep location), no new tar-like material observed along a concrete joint. Lat: 29.785064 Long: -95.321219			
Photo No. 36	Inspection Date: 1/10/2024

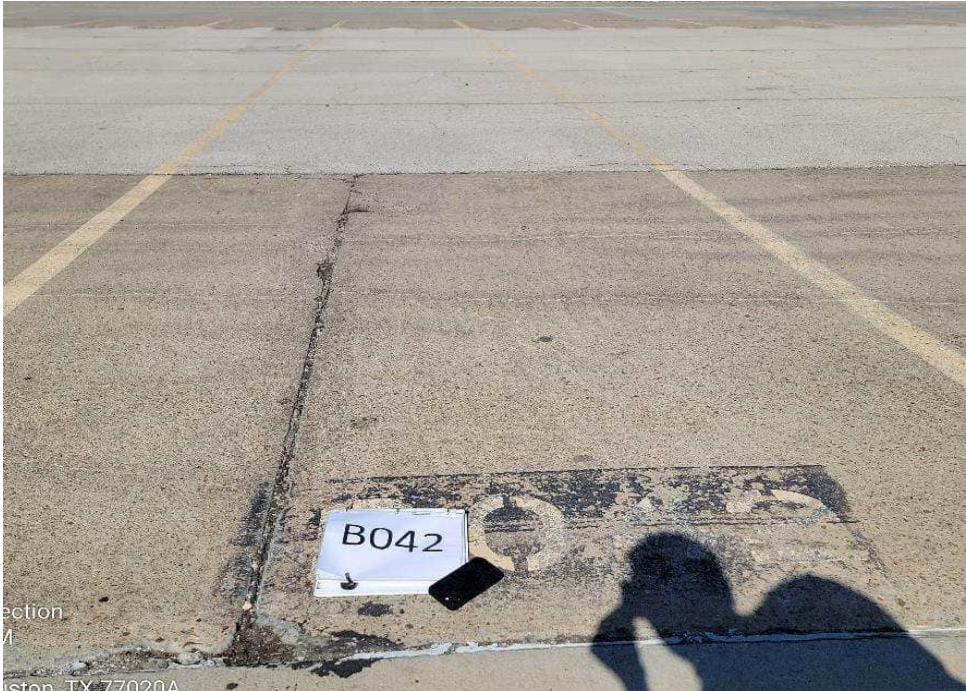
Description: Stall B042. No new tar-like material observed at historical seep location along concrete crack. Lat: 29.784923 Long: -95.319124

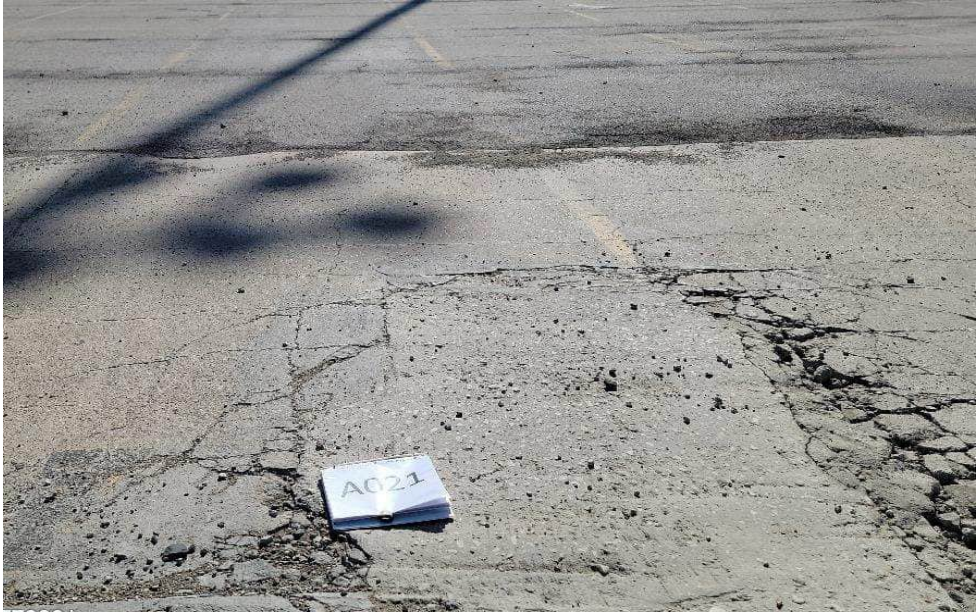
Description: Stall A021. No seeps noted at Test Pit A021. Lat: 29.785387 Long: -95.318654			
Photo No. 40	Inspection Date: 1/10/2024

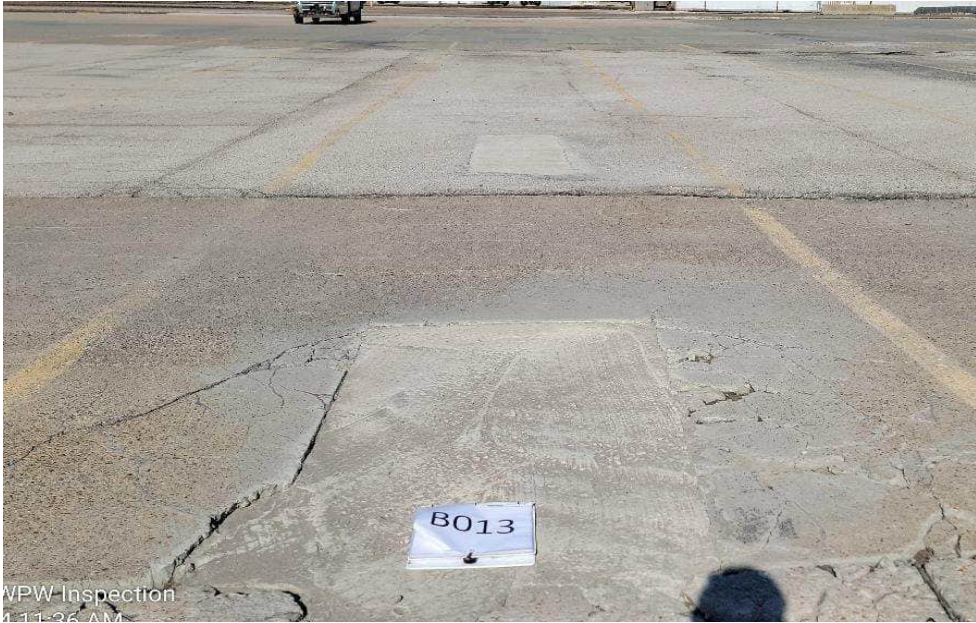
Description: Stall B013. No seeps noted at Test Pit B013. Lat: 29.78532 Long: -95.31833

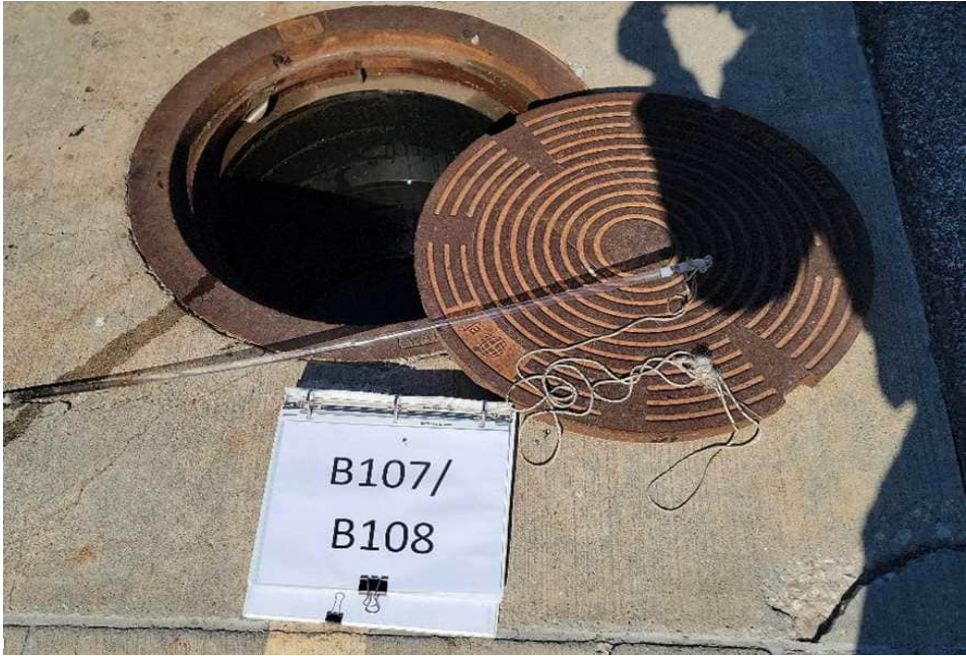
Description: Sump 3 (B107/B108), 15 inches of freeboard in sump, no sheen observed, water color noted as clear. Lat: 29.7844000 Long: - 95.3205861			
Photo No. 44	Inspection Date: 1/17/2024

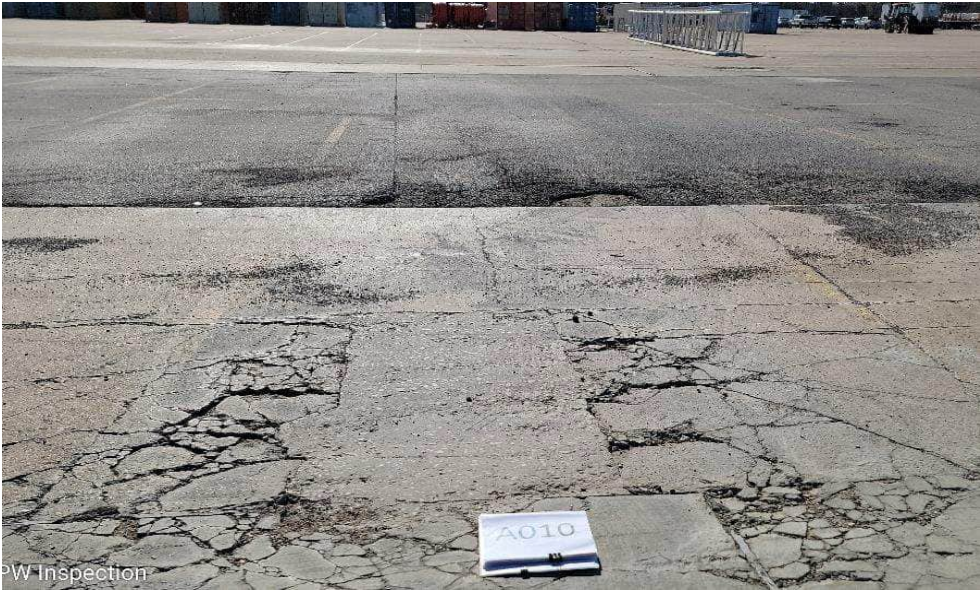
Description: Stall A010. No seeps noted at Test Pit A010. Lat: 29.785517 Long: -95.31834

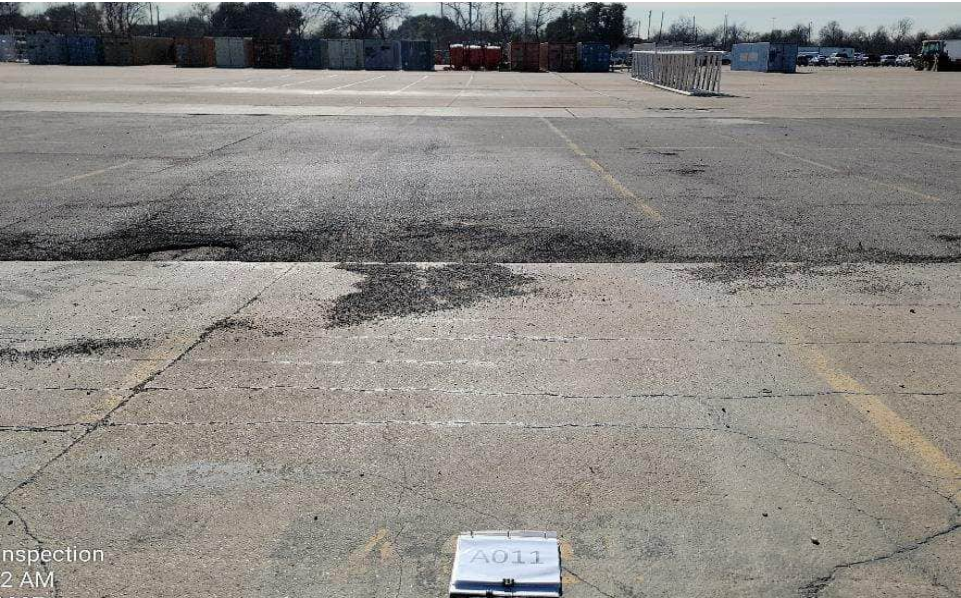
Description: Stall A011. No tar-like material observed at historical seep location along asphalt crack. Lat: 29.785467 Long: -95.318341			
Photo No. 46	Inspection Date: 1/17/2024

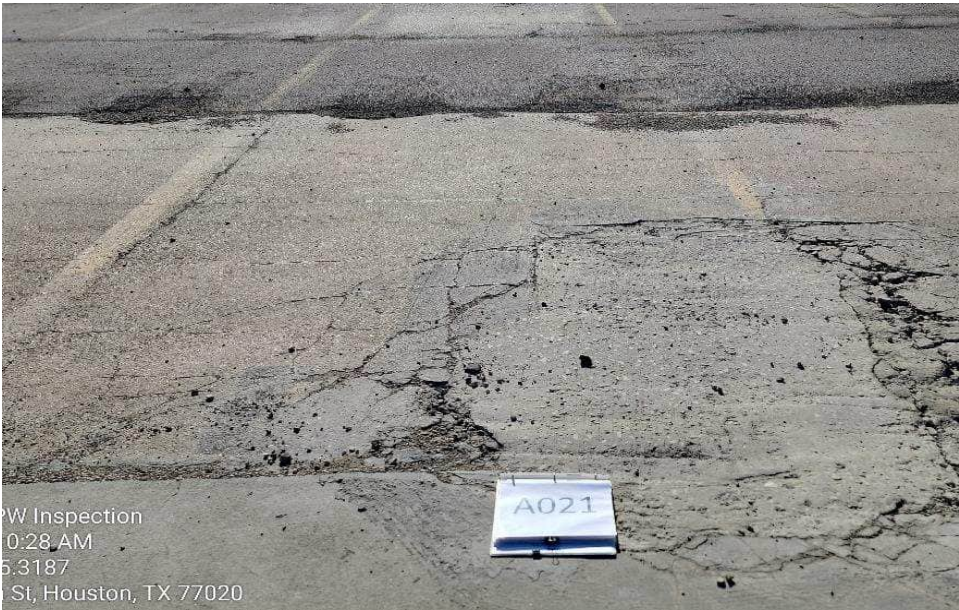
Description: Stall A021. No seeps noted at Test Pit A021. Lat: 29.785387 Long: -95.318654

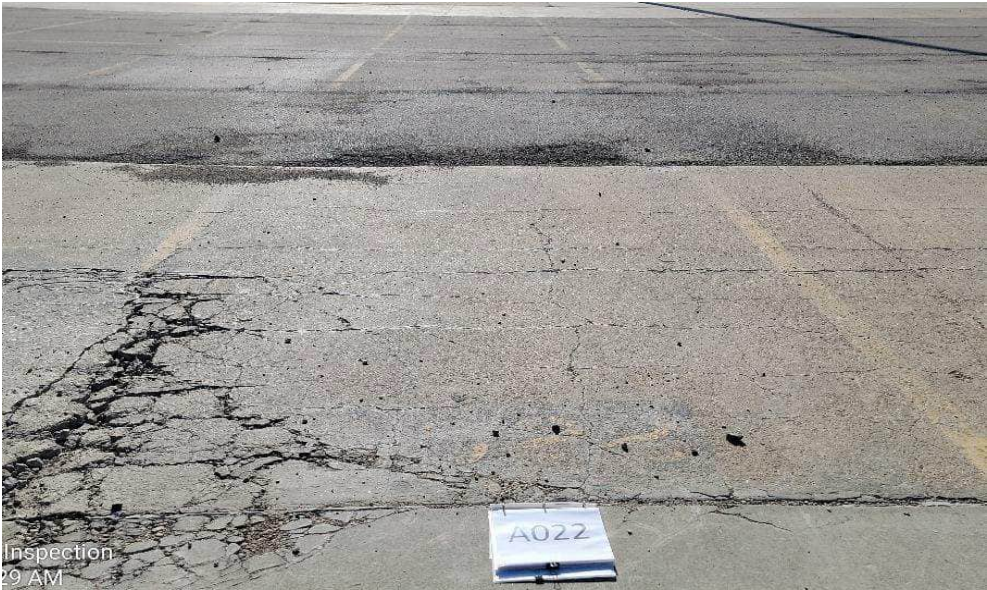
Description: Stall A022, no new tar-like material observed at the seep location along the edge. Lat: 29.78537 Long: - 95.31869			
Photo No. 48	Inspection Date: 1/17/2024

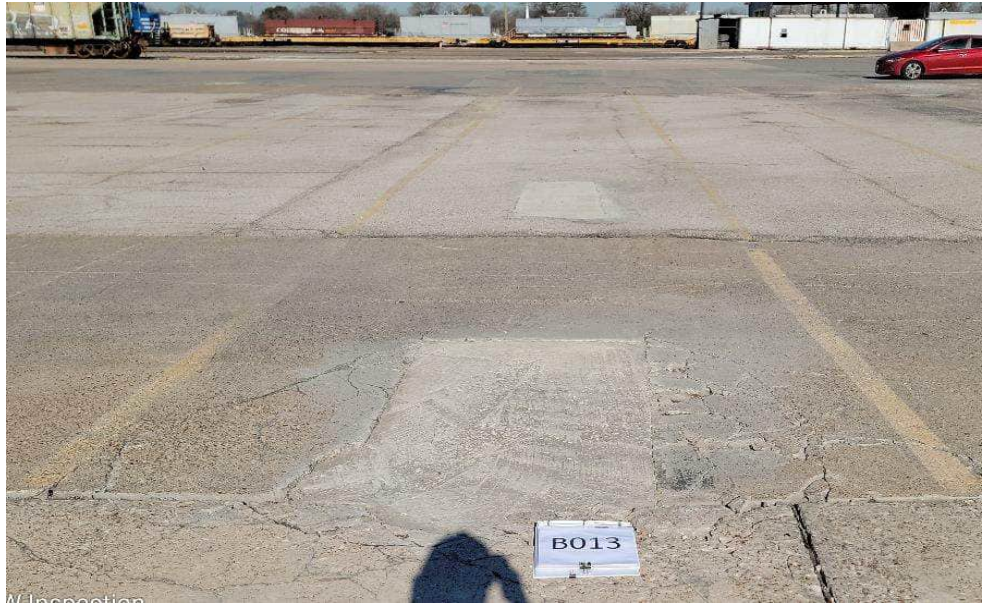
Description: Stall B013. No seeps noted at Test Pit B013. Lat: 29.78532 Long:-95.31833

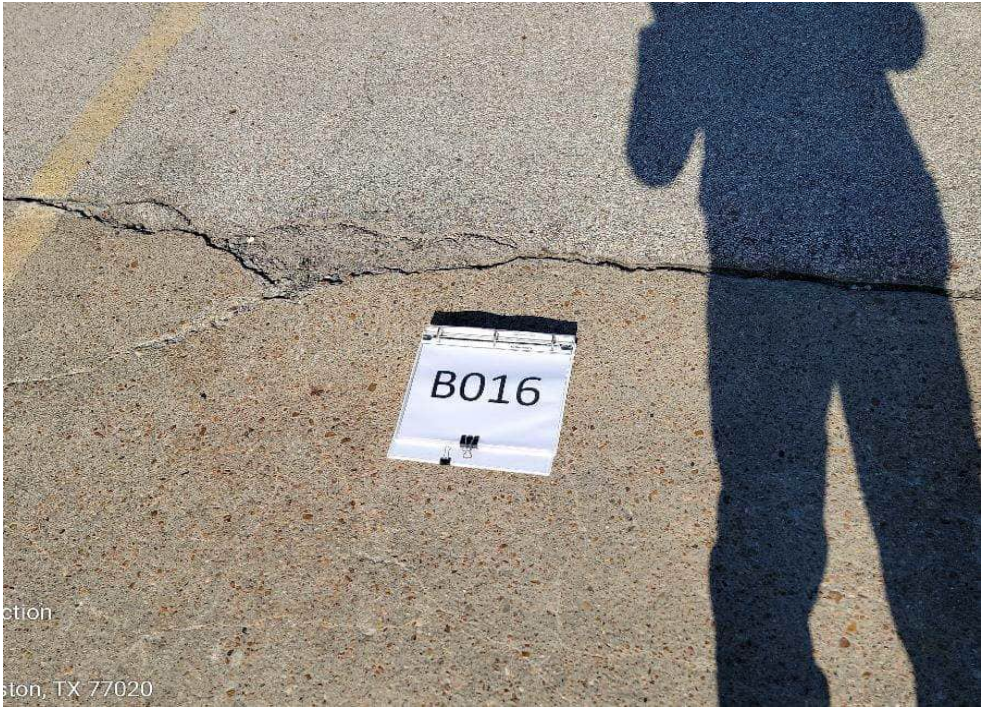
Description: Stall B016. No tar-like material observed at historical seep location along asphalt crack. Lat: 29.785271 Long: -95.31841			
Photo No. 50	Inspection Date: 1/17/2024

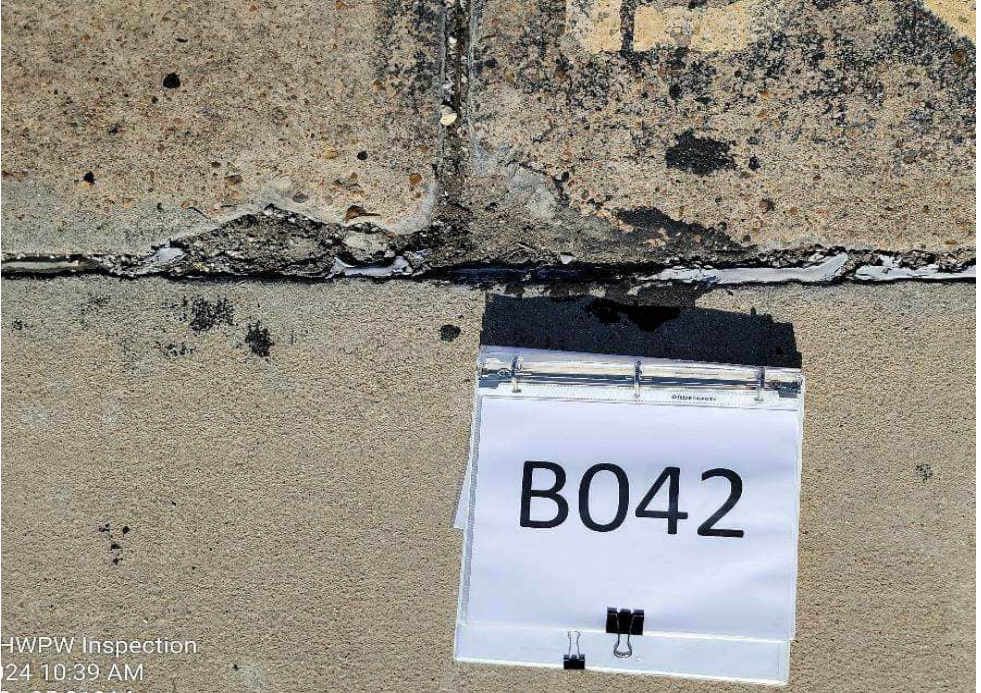
Description: Stall B042. No new tar-like material observed at historical seep location along asphalt crack. Lat: 29.784923 Long: -95.319124
