February 14, 2024

Project No. 31406585.016

**Re: MONTHLY STATUS UPDATE – ENGLEWOOD INTERMODAL YARD – NAPL COLLECTION
SYSTEM/CONCRETE CAP REPAIRS
UNION PACIFIC RAILROAD HOUSTON WOOD PRESERVING WORKS FACILITY
4910 LIBERTY ROAD FACILITY, HOUSTON, TEXAS
POST-CLOSURE CARE PERMIT NO. HW-50343; INDUSTRIAL SWR NO. 31547**

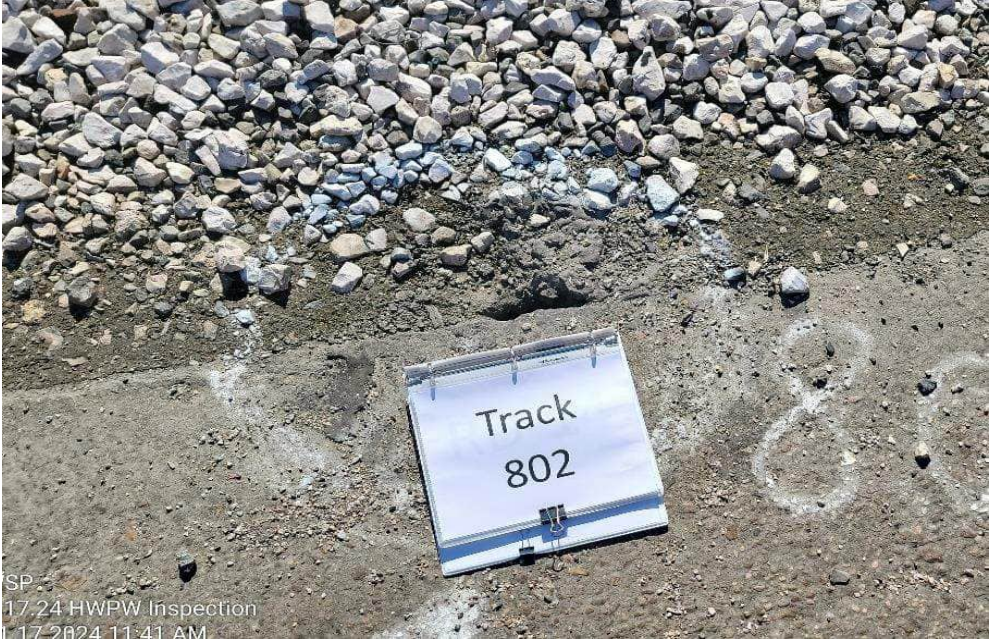
Description: North side of Track 802, no new tar-like material observed at seep location near the edge of the ballast. Lat: 29.784947 Long: -95.321214			
Photo No. 52	Inspection Date: 1/17/2024

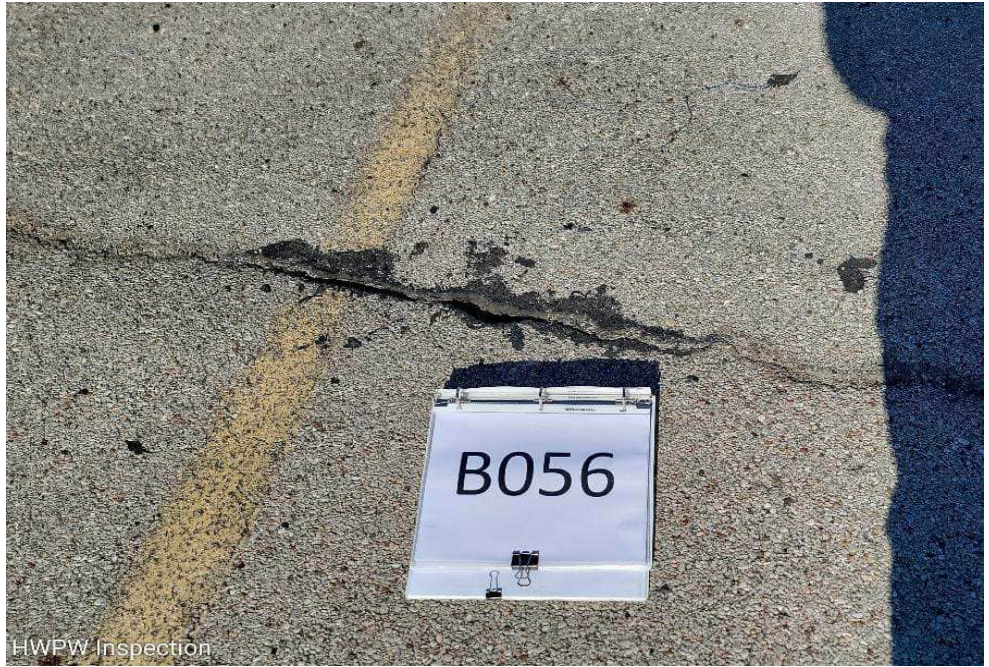
Description: Stall B056. No new tar-like material observed at historical seep location along asphalt crack. Lat: 29.7847472 Long: -95.3195417

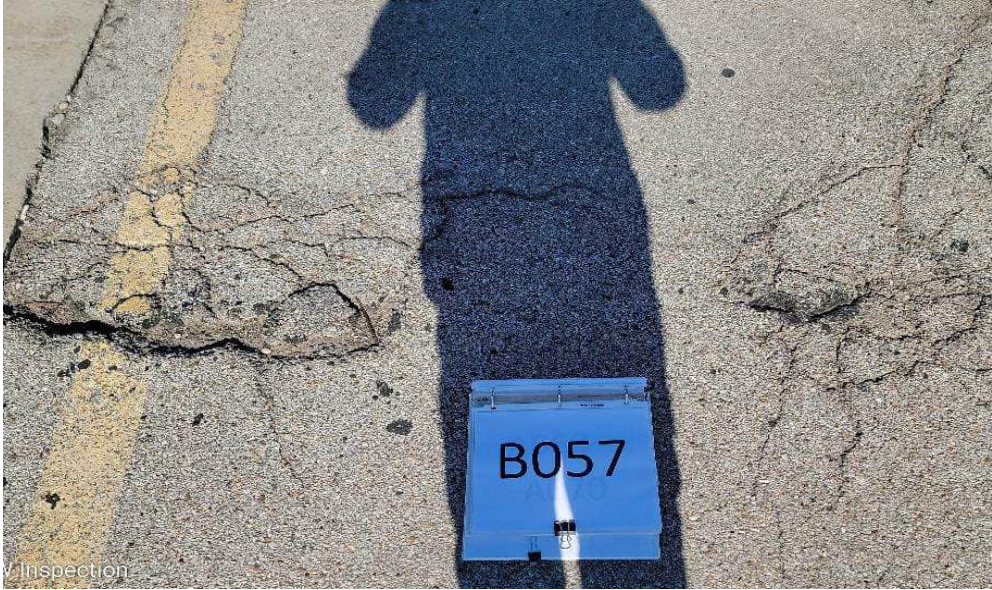
Description: Stall B057, no new tar-like material observed and removed at seep location along asphalt crack. Lat: 29.784769 Long: -95.3195798			
Photo No. 54	Inspection Date: 1/17/2024

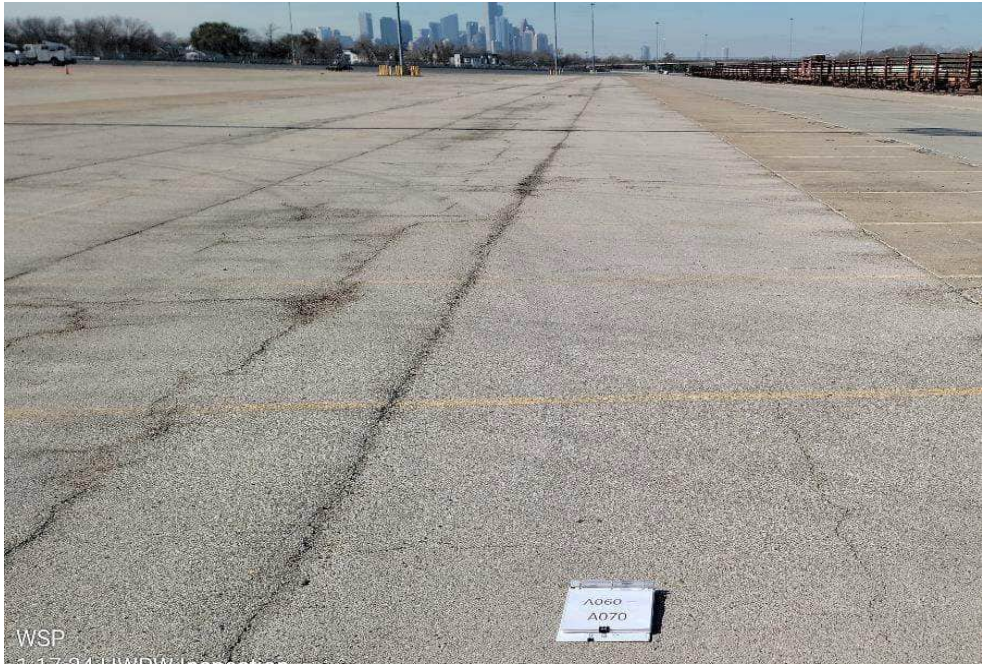
Description: Stalls A060 - A070, some residual staining previously observed along cracks in pavement. No new water seeps observed. Viewing southwest. Lat: 29.78484 Long: -95.31974

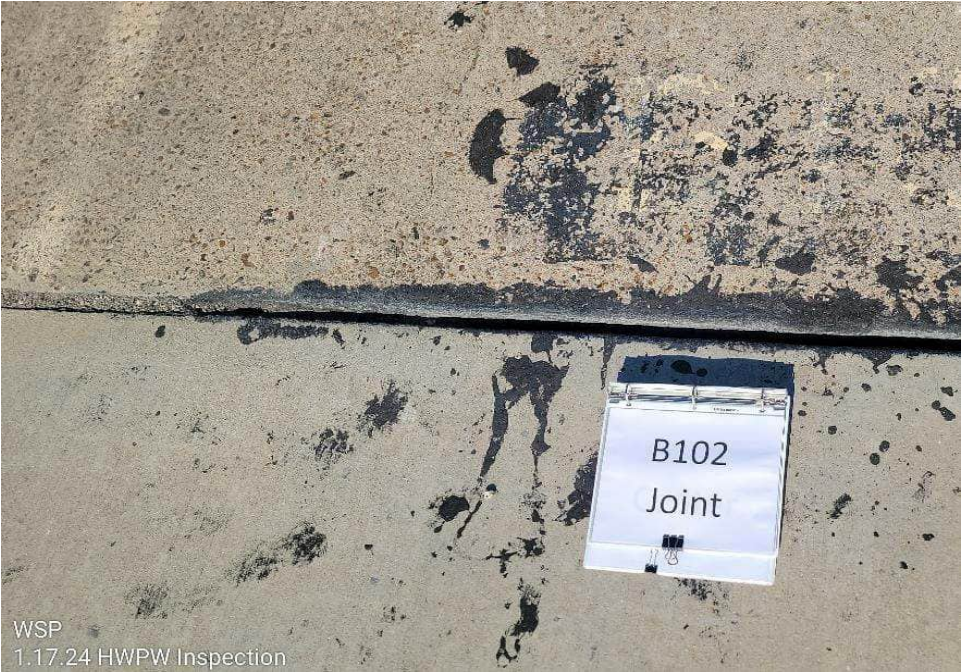
Description: Stall B102 Joint, no new tar-like material observed at seep location along stall joint. Lat: 29.7842203 Long: - 95.320827			
Photo No. 58	Inspection Date: 1/17/2024

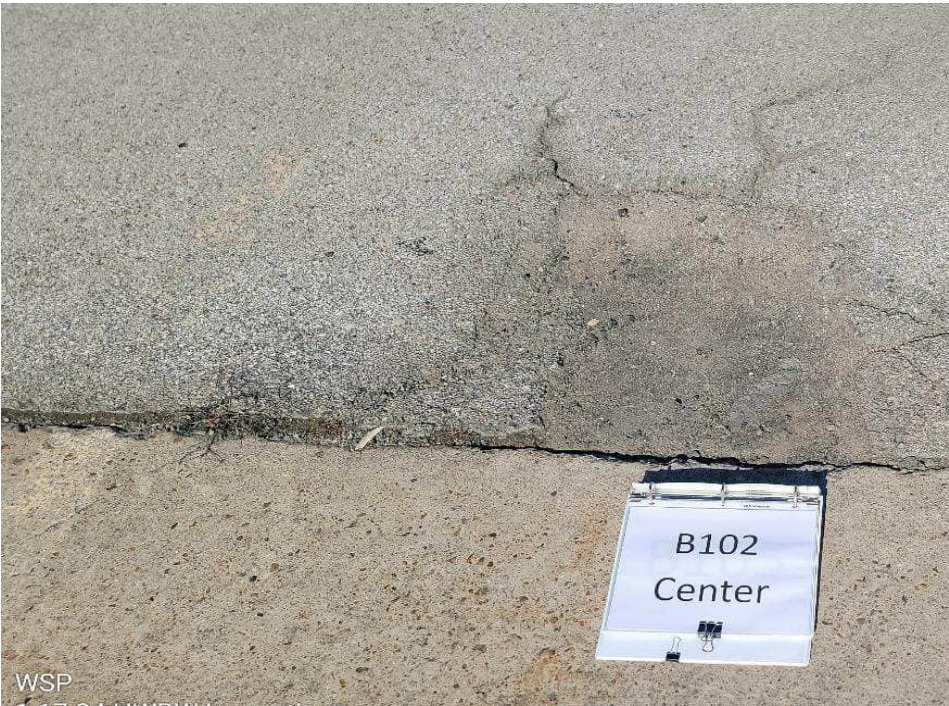
Description: Stall B102 (center), no tar-like material observed at seep location where pavement is cracked. Lat: 29.784769 Long: -95.3195798

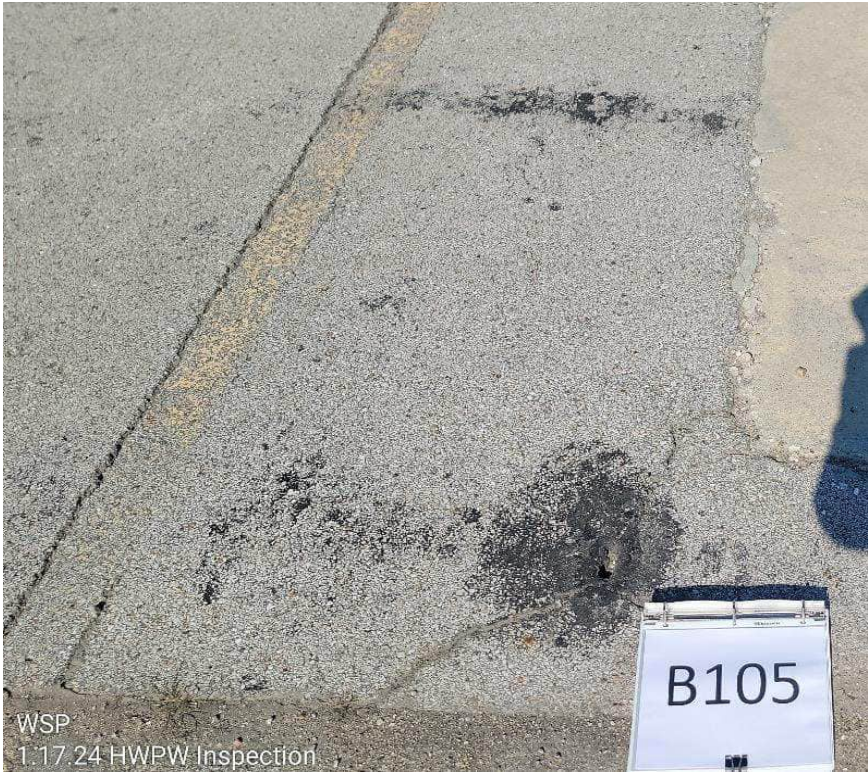
Description: Stall B105, no new tar-like material observed at the historical seep location along asphalt crack. Lat: 29.784209 Long: -95.320943			
Photo No. 60	Inspection Date: 1/17/2024

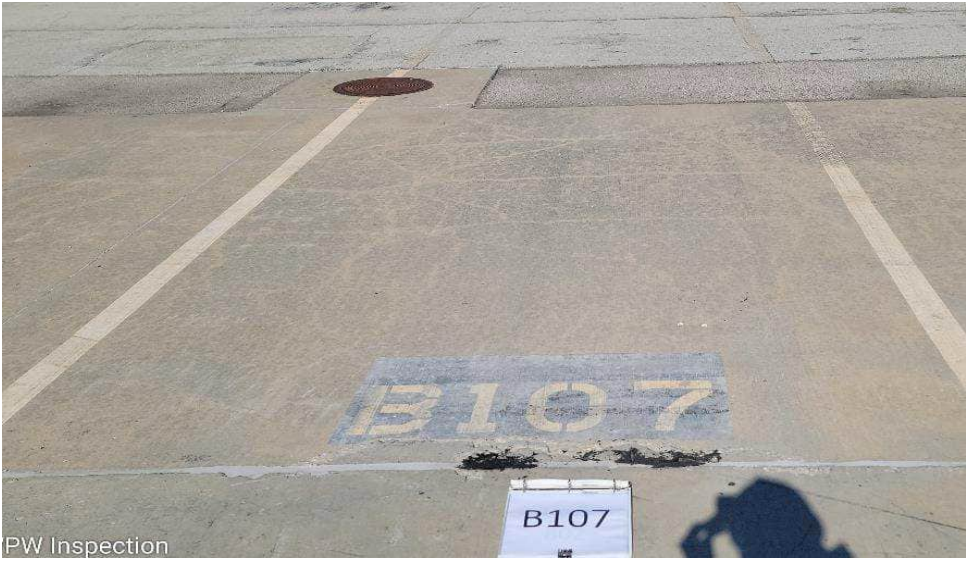
Description: Stalls B107, no new tar-like material observed at seep location on concrete joint along the southern edge of the excavated area. Lat: 29.784156 Long: -95.320953

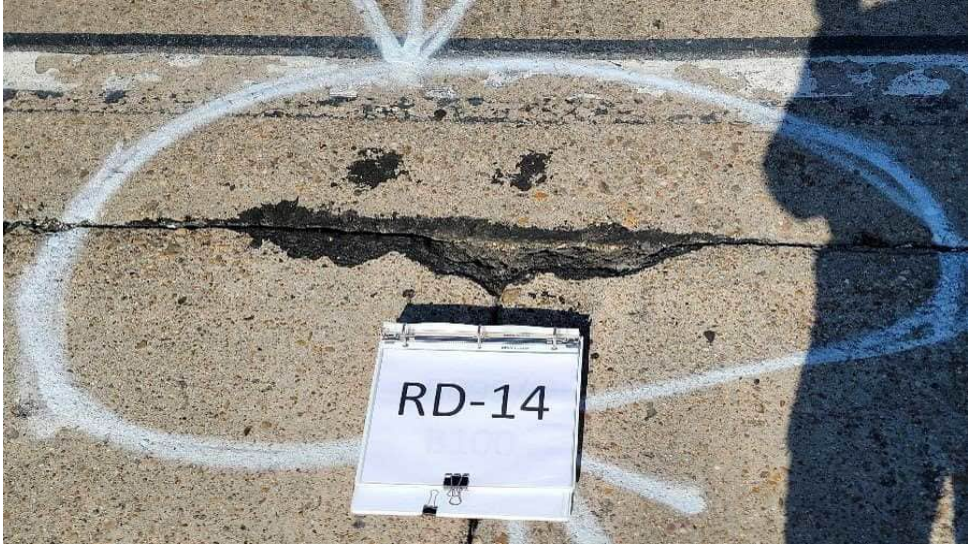
Description: RD-14 Seep location observed within the concrete road area (RD-14) north of Track 802 (east of existing Track 802 seep location), no new tar-like material observed along a concrete joint. Lat: 29.785064 Long: -95.321219			
Photo No. 62	Inspection Date: 1/24/2024

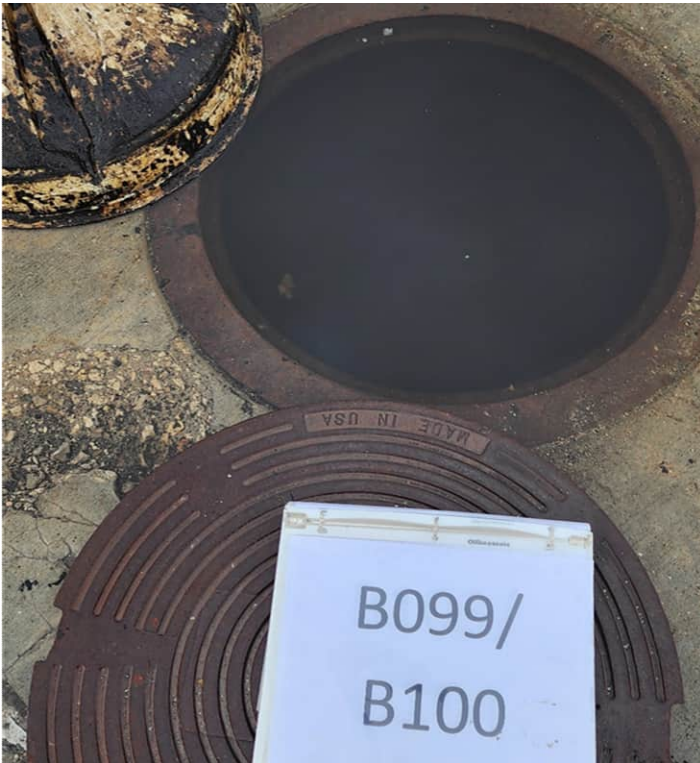
Description: Sump 1 (B099/B100), 0 inches of freeboard in sump, no sheen observed, water color noted as clear. Lat: 29.7844000 Long: - 95.3205861

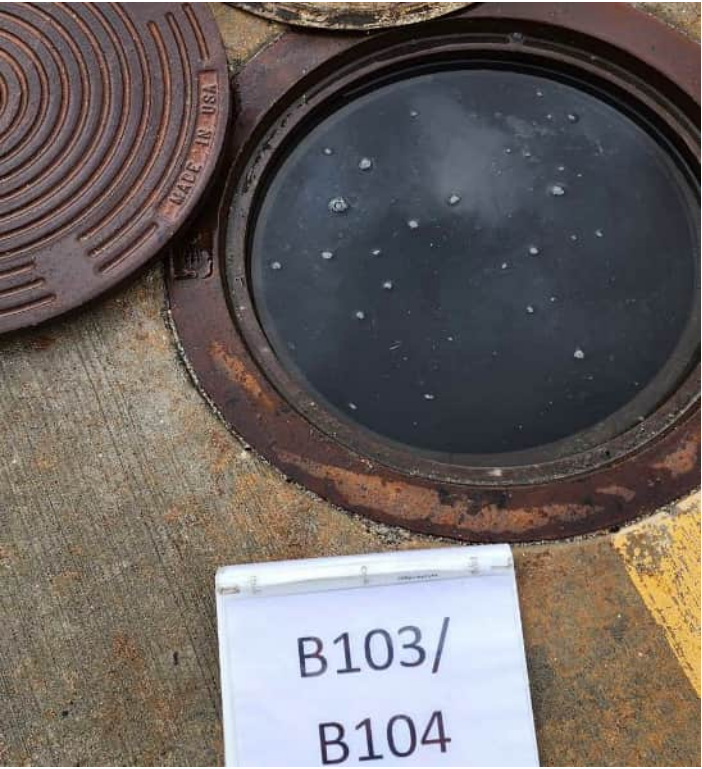
Description: Sump 2 (B103/B104), 0 inches of freeboard in sump. No odor or sheen observed, color noted as clear. Lat: 29.7842861 Long: - 95.3208611			
Photo No. 64	Inspection Date: 1/24/2024

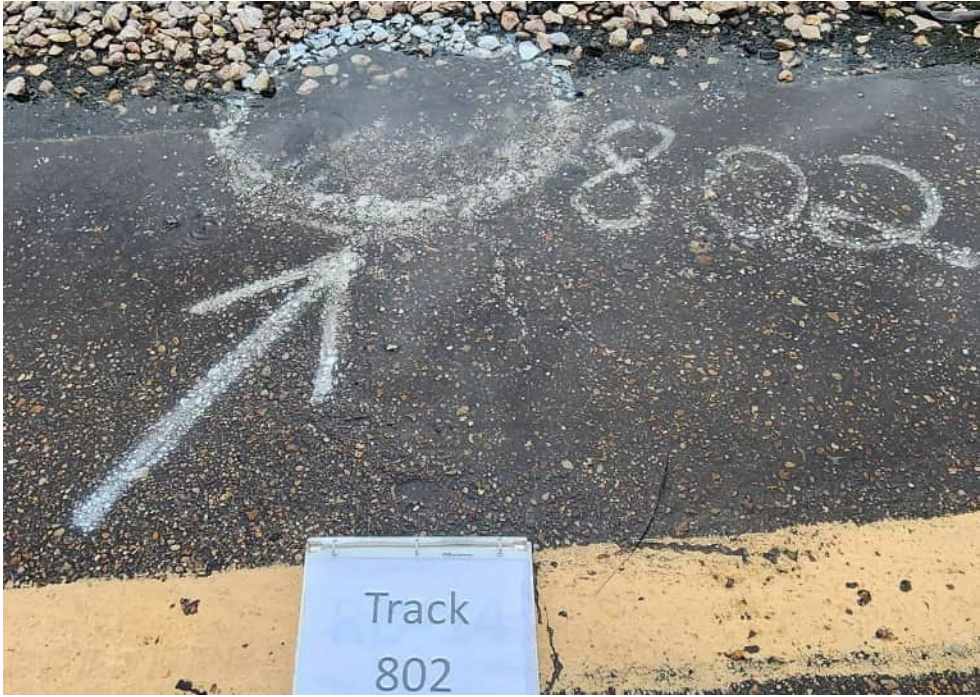
Description: North side of Track 802, no new tar-like material observed at seep location near the edge of the ballast. Lat: 29.784947 Long: -95.321214			
Photo No. 66	Inspection Date: 1/24/2024

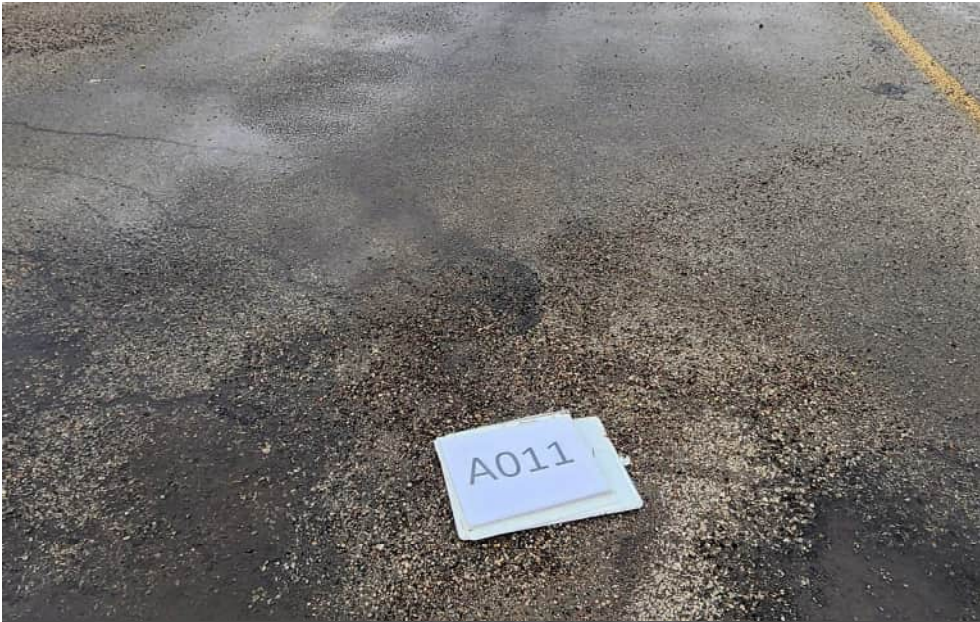
Description: Stall A011. No new tar-like material observed at historical seep location along asphalt crack. Lat: 29.785467 Long: -95.318341			
Photo No. 68	Inspection Date: 1/24/2024

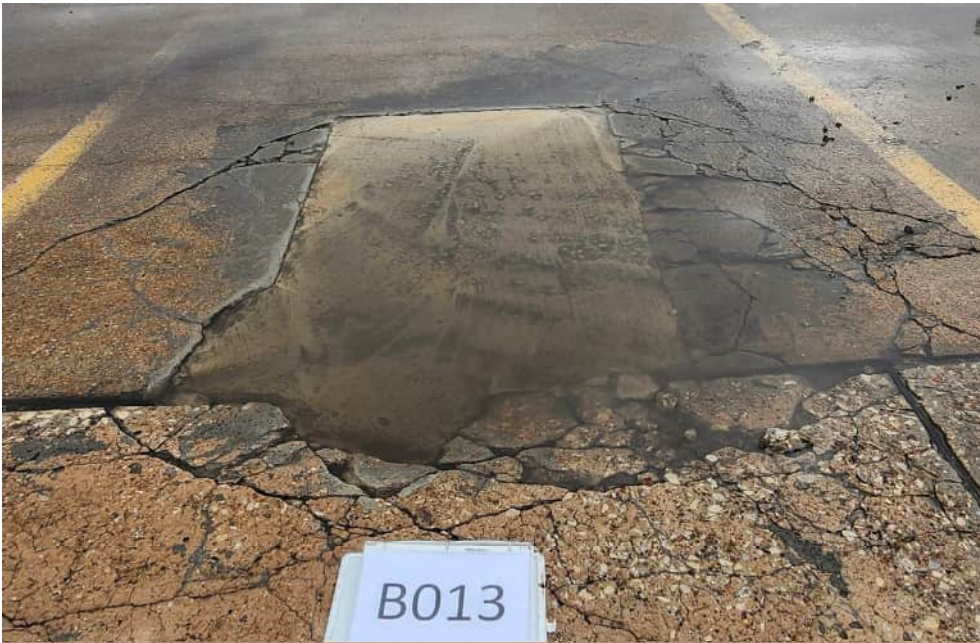
Description: Stall B013. No seeps noted at Test Pit B013. Lat: 29.78532 Long: -95.31833

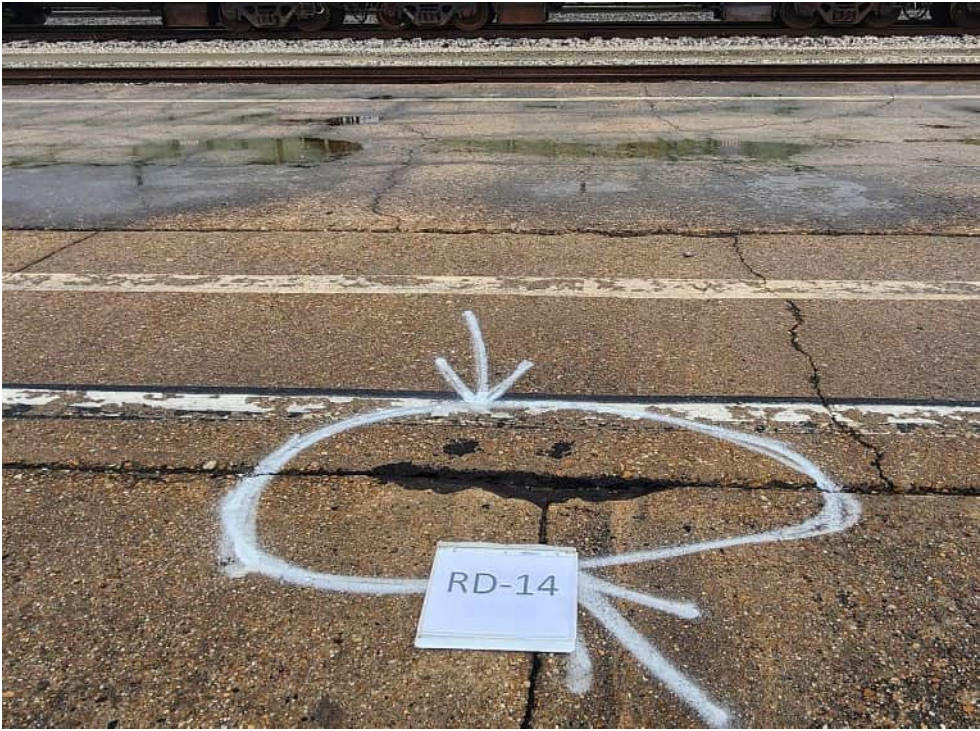
Description: RD-14 Seep location observed within the concrete road area north of Track 802 (east of existing Track 802 seep location), no new tar-like material observed along a concrete joint. Lat: 29.785064 Long: - 95.321219			
Photo No. 74	Inspection Date: 1/24/2024

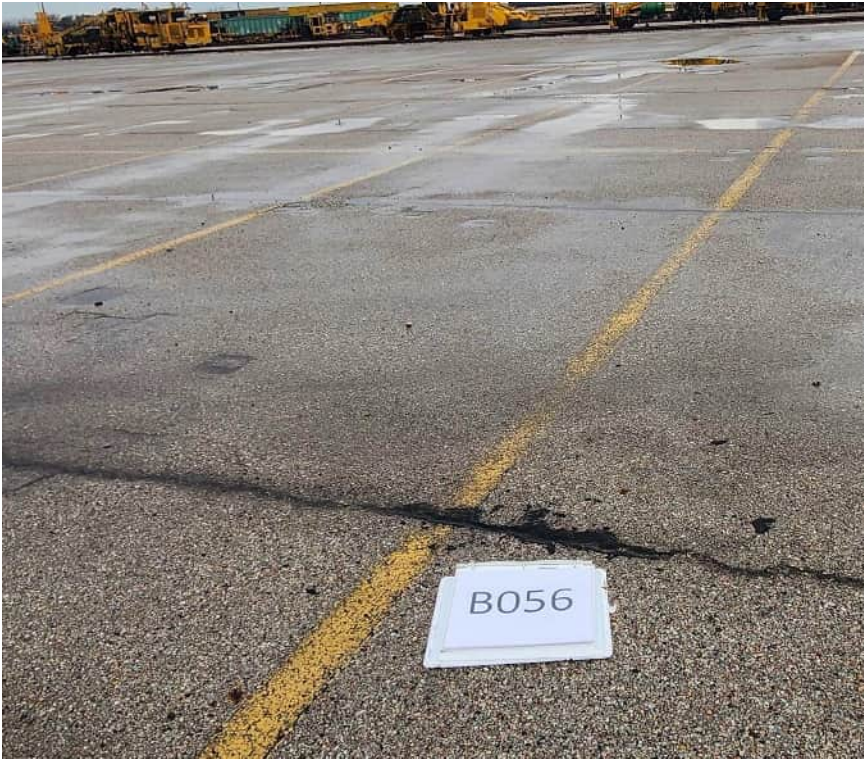
Description: Stall B056. No new tar-like material observed at historical seep location along asphalt crack. Lat: 29.7847472 Long: -95.3195417

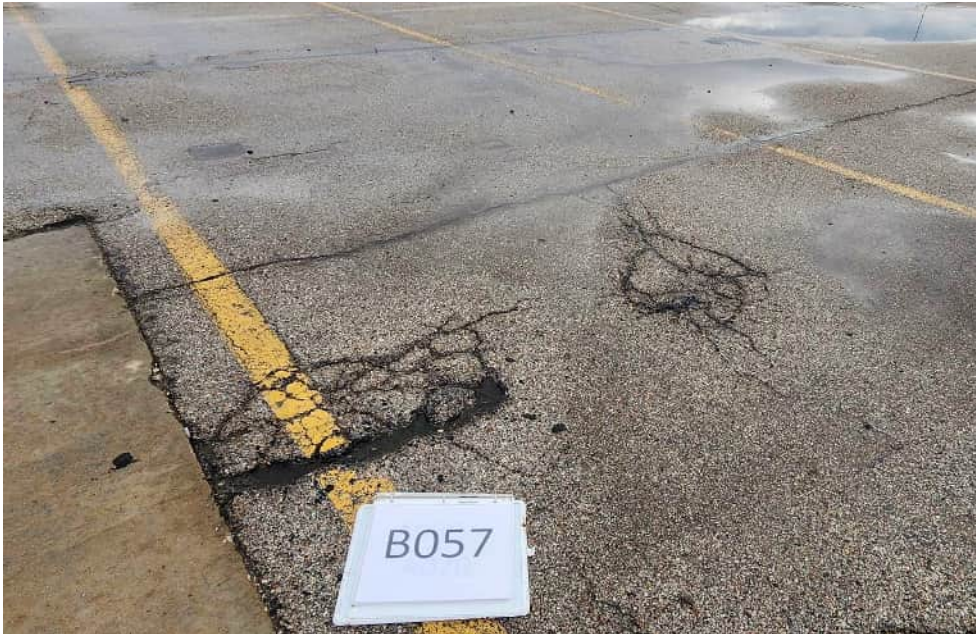
Description: Stall B057, no new tar-like material observed and removed at seep location along asphalt crack. Lat: 29.784769 Long: -95.3195798			
Photo No. 76	Inspection Date: 1/24/2024

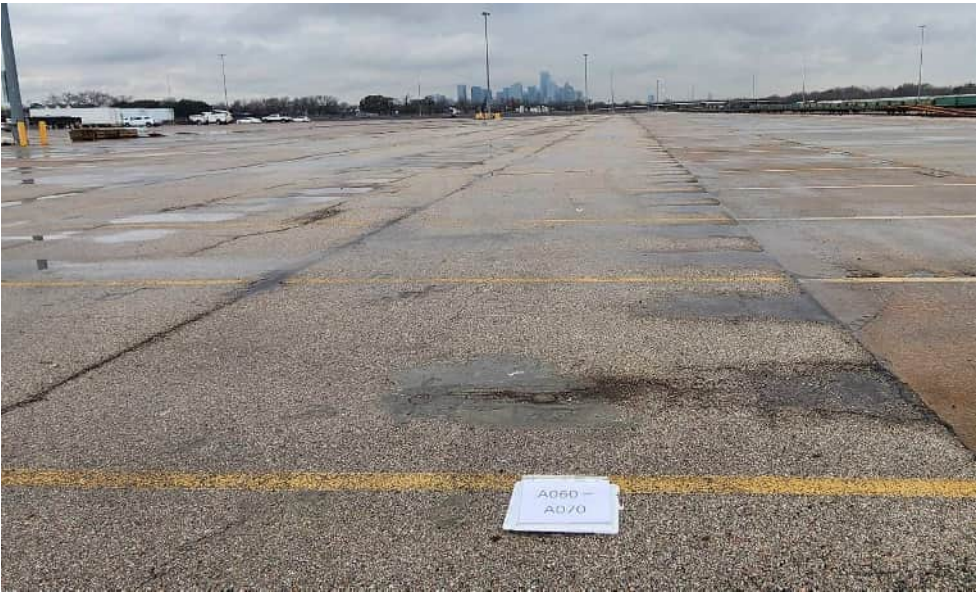
Description: Stalls A060 - A070, some residual staining previously observed along cracks in pavement. No new water seeps observed. Viewing southwest. Lat: 29.784858 Long: -95.319733

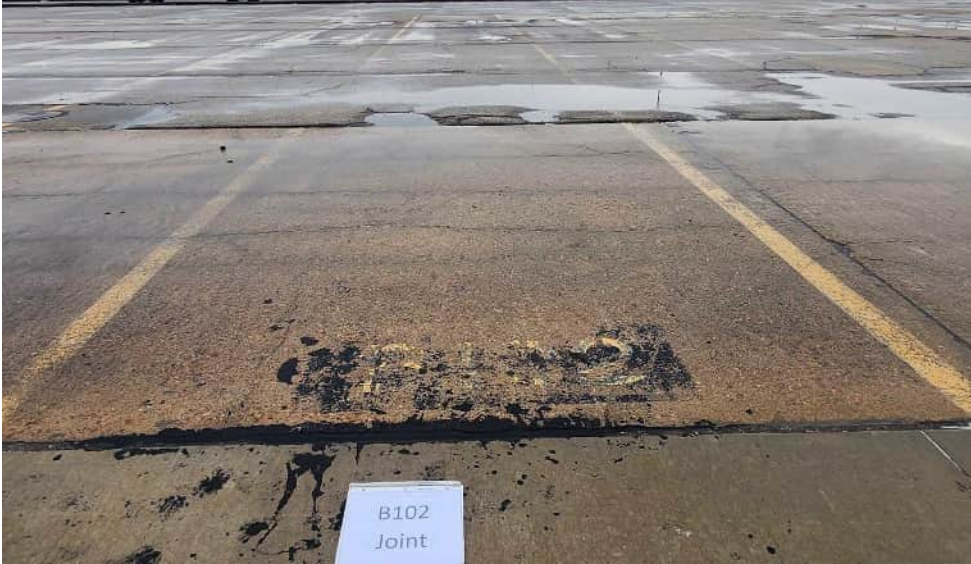
Description: Stall B102 Joint, no new tar-like material observed at seep location along stall joint. Lat: 29.7842203 Long: - 95.320827			
Photo No. 80	Inspection Date: 1/24/2024	 	
Description: Stall B102 (center), no seep observed. Lat: 29.784769 Long: -95.3195798

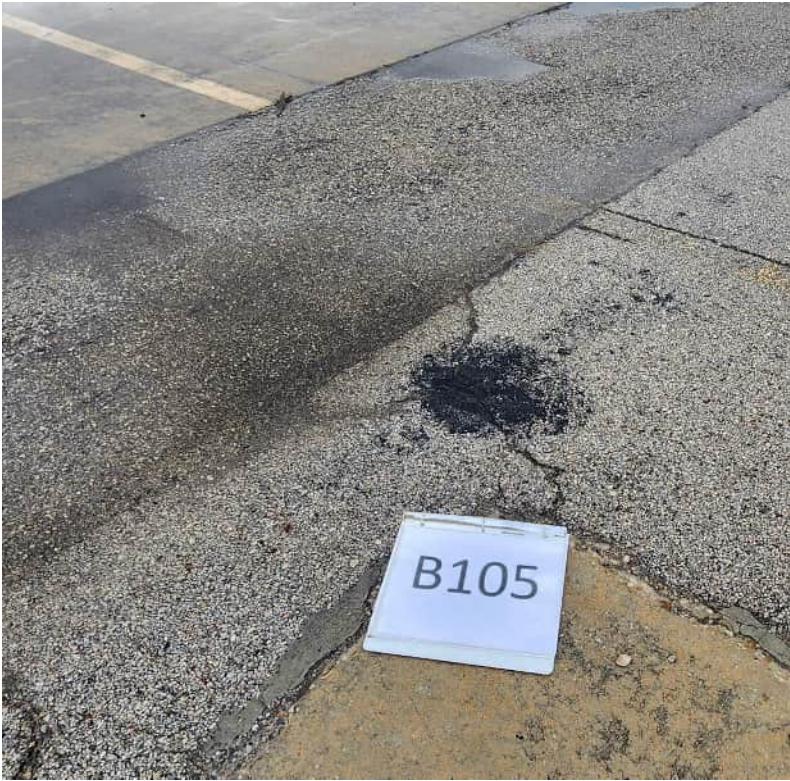
Description: Stall B105, no new tar-like material observed at the historical seep location along asphalt crack. Lat: 29.784209 Long: -95.320943			
Photo No. 82	Inspection Date: 1/24/2024

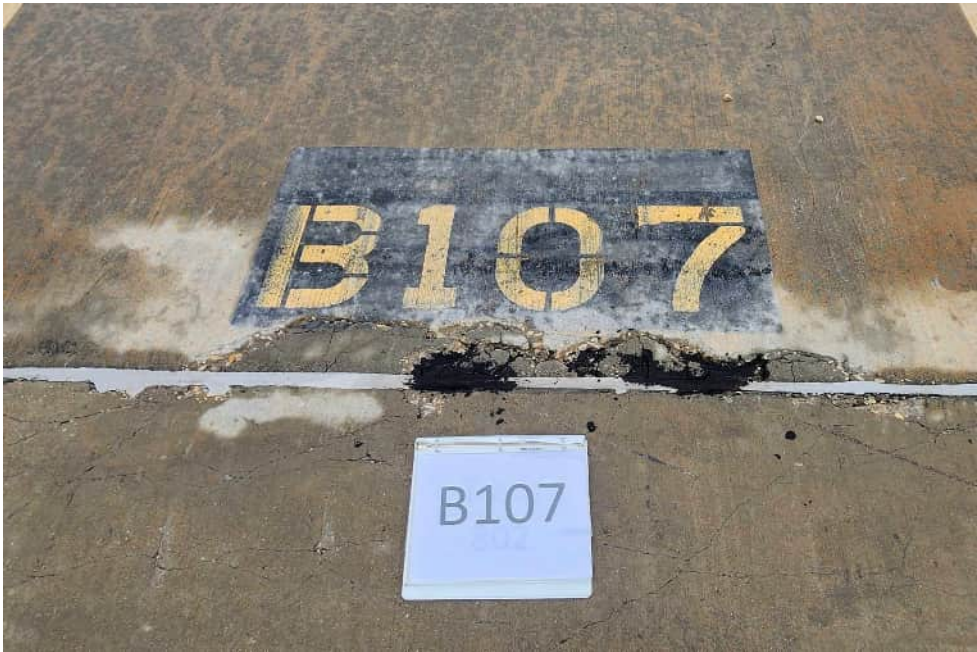
Description: Stalls B107, no new tar-like material observed at seep location on concrete joint along the southern edge of the excavated area. Lat: 29.784156 Long: -95.320953

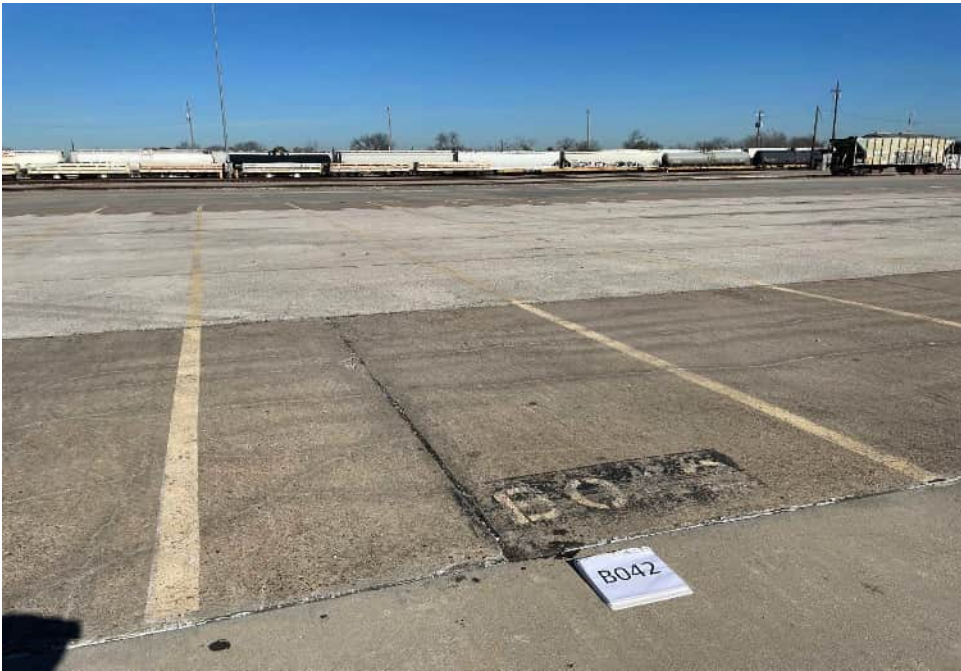
Description: Stall B042. No new tar-like material observed at historical seep location along concrete joint. Lat: 29.784923 Long: -95.319124			
Photo No. 88	Inspection Date: 1/31/2024

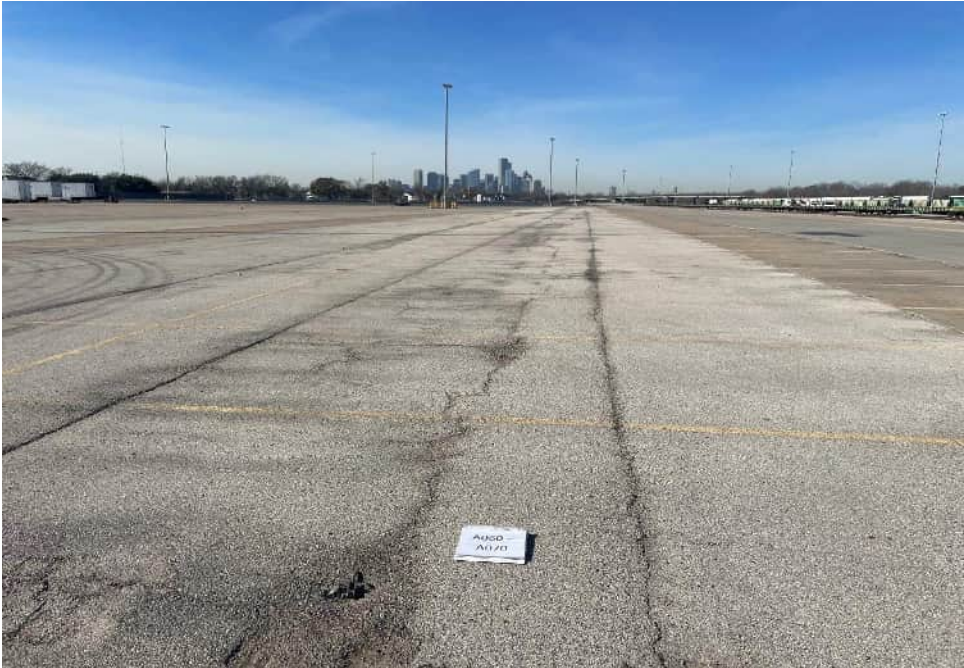
Description: Stalls A060 - A070, some residual staining previously observed along cracks in pavement. No new water seeps observed. Viewing southwest. Lat: 29.78484 Long: -95.31974			
Photo No. 90	Inspection Date: 1/31/2024

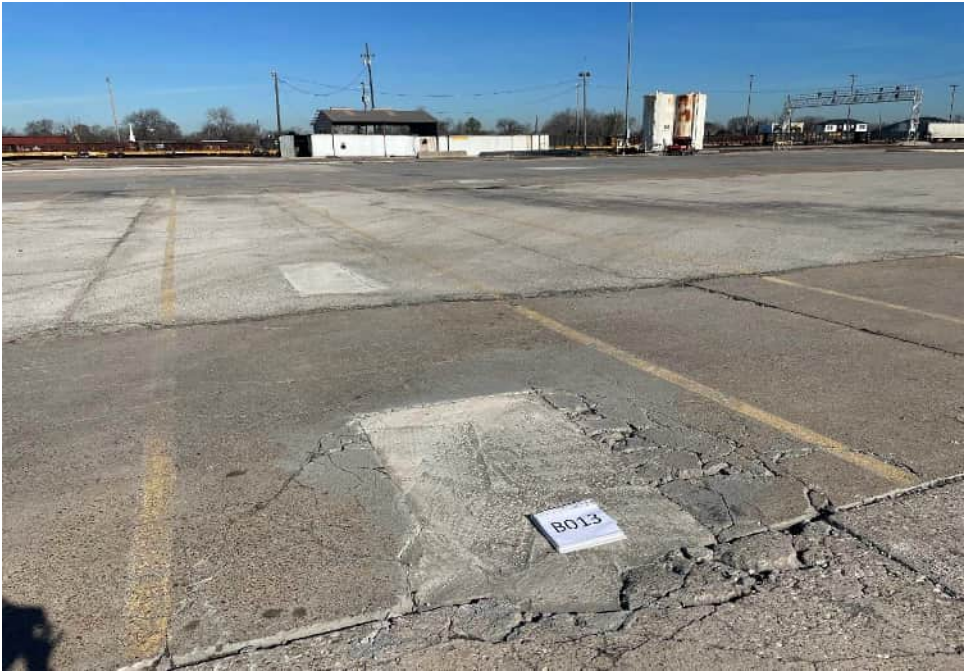
Description: Stall B013. No seeps noted at Test Pit B013. Lat: 29.78532 Long:-95.31833			
Photo No. 96	Inspection Date: 1/31/2024	<div style="background-color: #2c4e64; color: white; padding: 5px; text-align: center;"> North East Elevation </div> <div style="background-color: #e6f2ff; padding: 5px; text-align: center;"> \odot 226°SW (T) \odot 29°47'5"N, 95°19'16"W \pm13ft \blacktriangle 61ft </div>

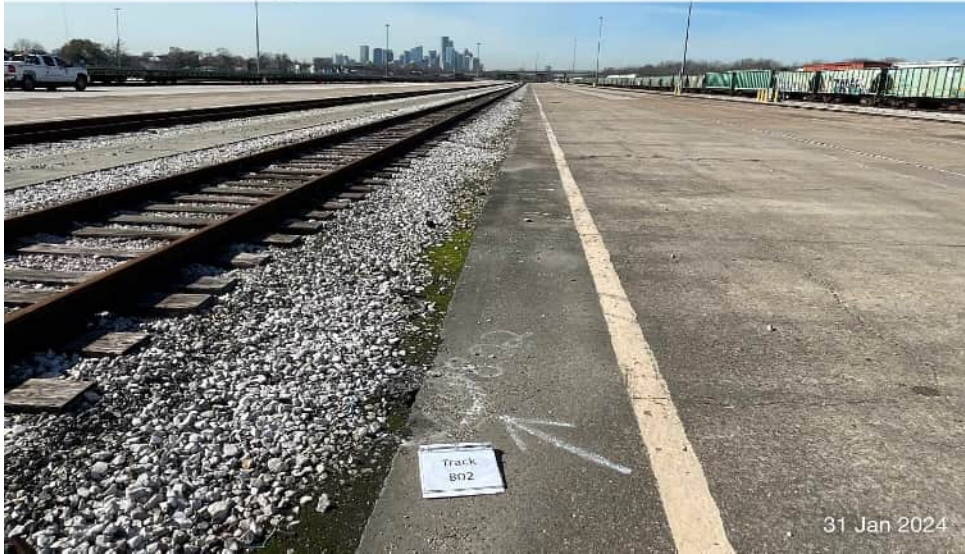
<div style="text-align: right; margin-top: 10px;"> 31 Jan 2024 </div>	
Description: North side of Track 802, no new tar-like material observed at seep location near the edge of the ballast. Lat: 29.784947 Long: -95.321214

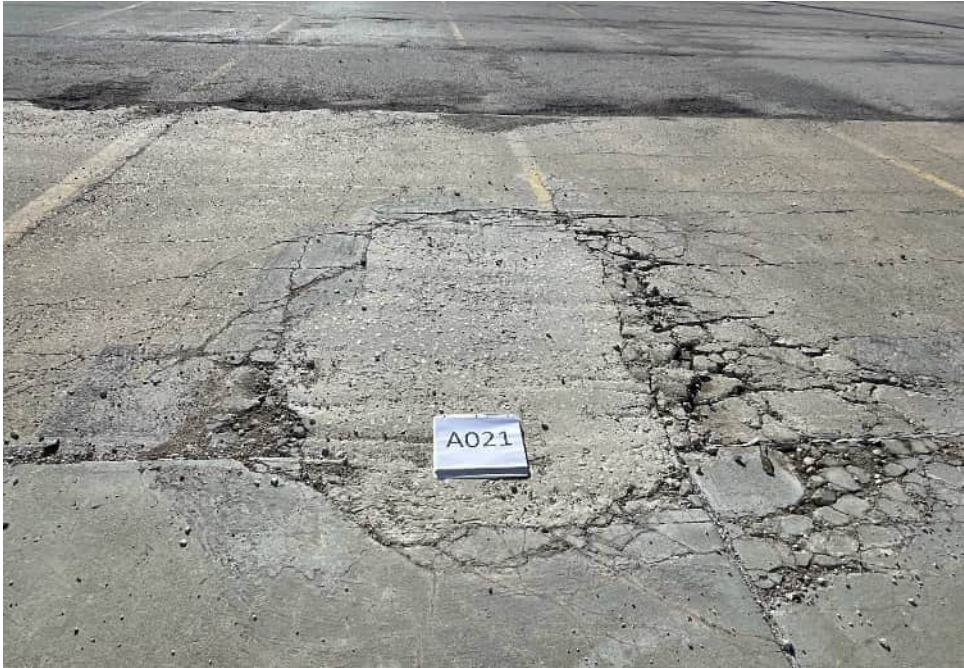
Description: Stall A021. No seeps noted at Test Pit A021. Lat: 29.785387 Long: -95.318654			
Photo No. 102	Inspection Date: 1/31/2024

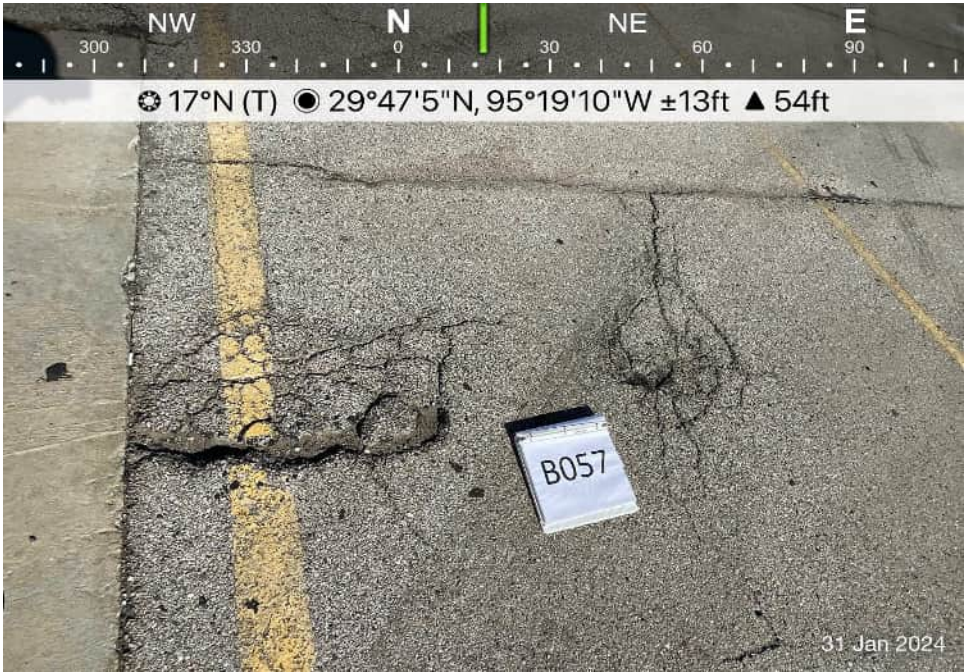
Description: Stall B057, no new tar-like material observed and removed at seep location along asphalt crack. Lat: 29.784769 Long: -95.3195798

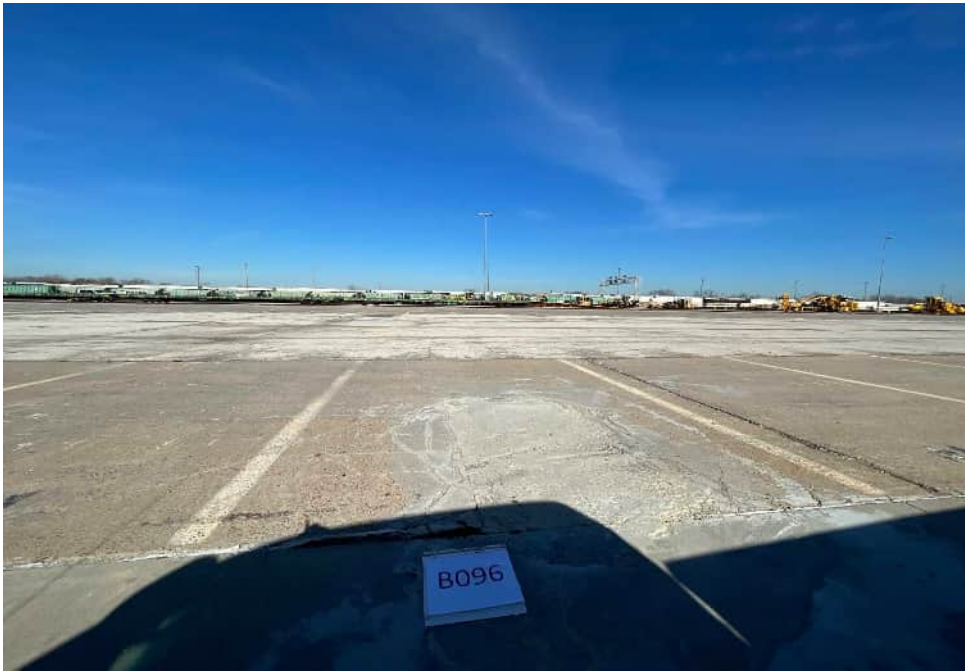
Description: Stall B096, no new tar-like material observed at historical seep location along concrete joint next to Test Pit B096. Lat: 29.7842528 Long: -95.3206250			
Photo No. 104	Inspection Date: 1/31/2024

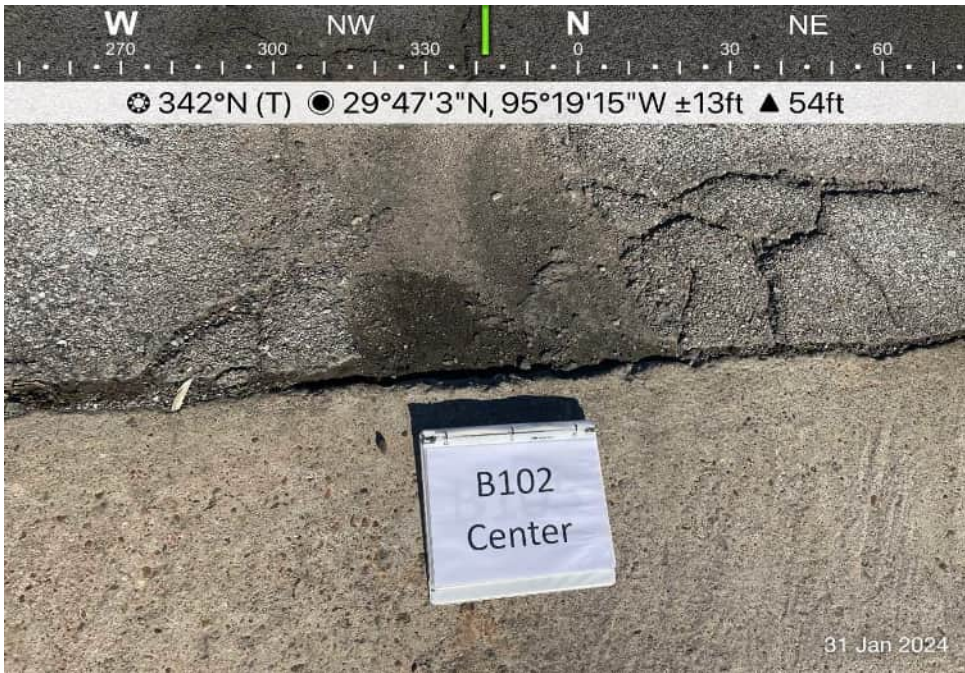
Description: Stall B102 (center), no tar-like material observed at seep location where pavement is cracked. Lat: 29.784769 Long: -95.3195798

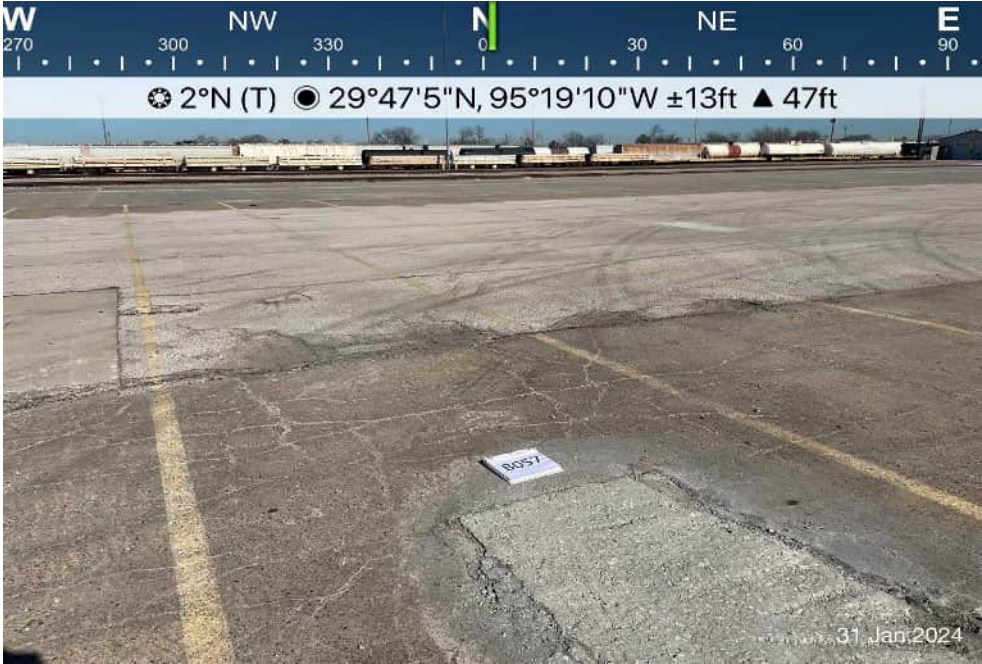
</div>	
Description: Stall B057 (joint), no tar-like material observed at historical seep location at Test Pit B057. Lat: 29.784747 Long: -95.319549			
Photo No.	Inspection Date:	Description:
