March 15, 2024

Project No. 31406585.016

Re: **MONTHLY STATUS UPDATE – ENGLEWOOD INTERMODAL YARD – NAPL COLLECTION SYSTEM/CONCRETE CAP REPAIRS
UNION PACIFIC RAILROAD HOUSTON WOOD PRESERVING WORKS FACILITY
4910 LIBERTY ROAD FACILITY, HOUSTON, TEXAS
POST-CLOSURE CARE PERMIT NO. HW-50343; INDUSTRIAL SWR NO. 31547**

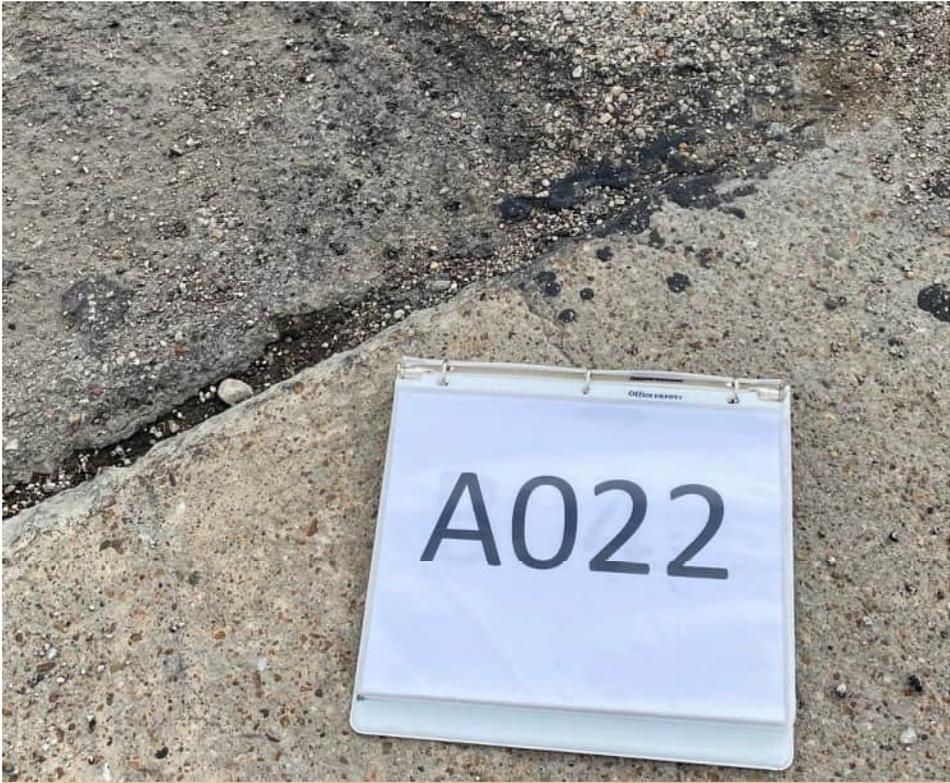
Stall A022. No new tar-like material observed at historical seep location along asphalt crack.

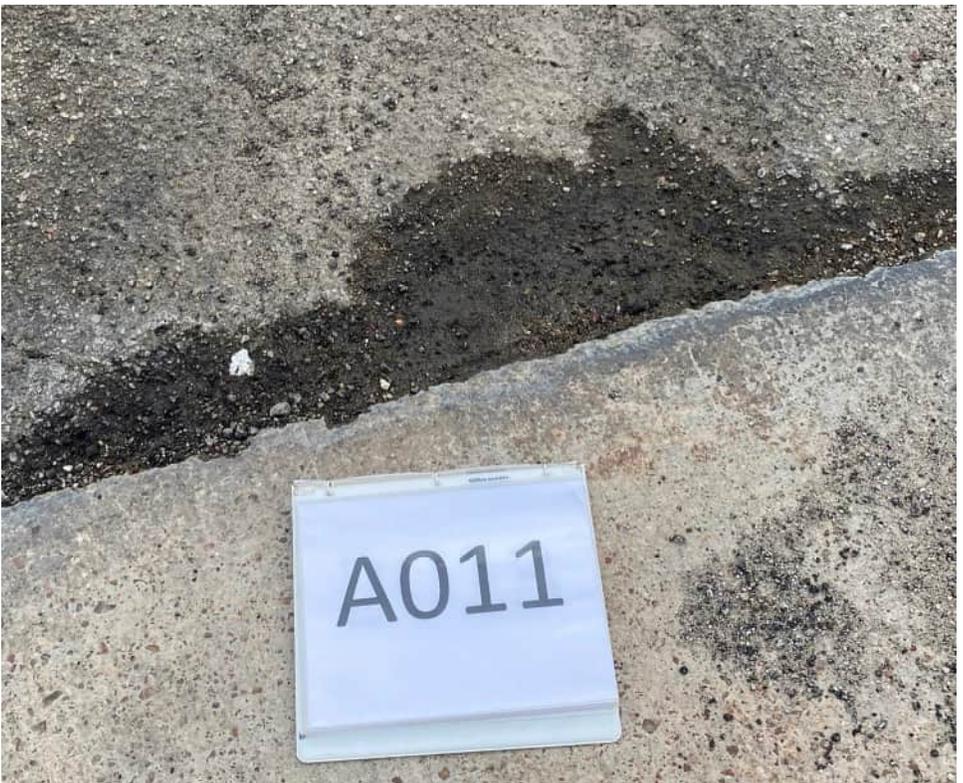
Photo No. 4	Inspection Date: 2/7/2024
------------------------------	-------------------------------------

Stall A011. No tar-like material observed at historical seep location along asphalt crack.

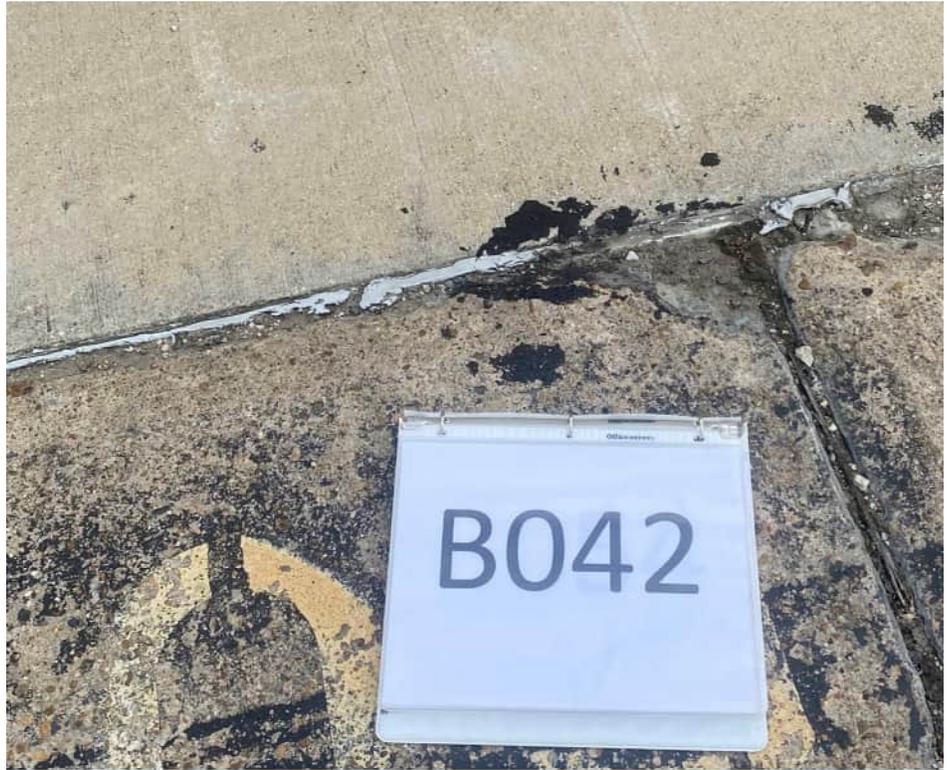
Photo No. 5	Inspection Date: 2/7/2024
Description: Stall B042. No new tar-like material observed at historical seep location along asphalt crack. Lat: 29.784923 Long: -95.319124

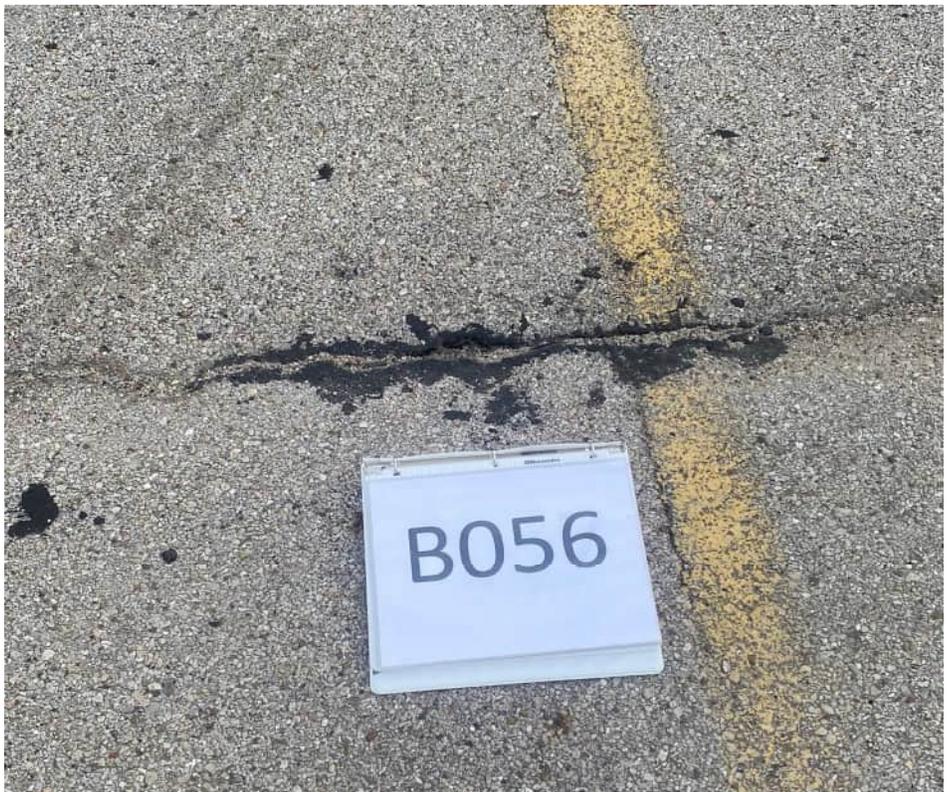
Photo No. 6	Inspection Date: 2/7/2024
Description: Stall B056. No new tar-like material observed at historical seep location along asphalt crack. Lat: 29.784751 Long: -95.319532

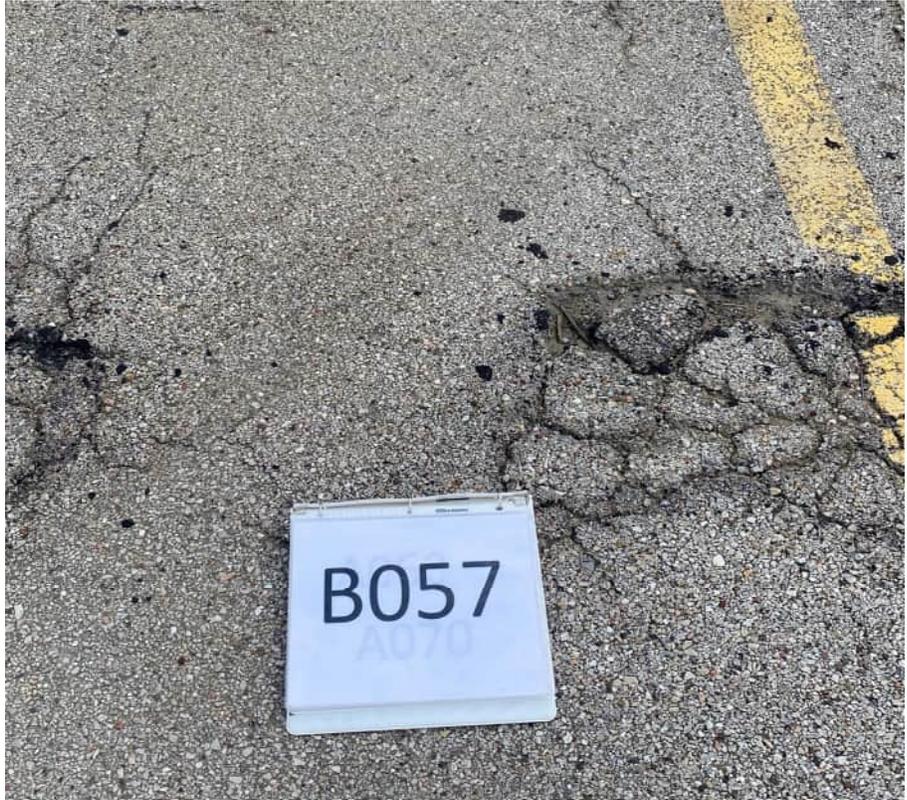
Photo No. 7	Inspection Date: 2/7/2024
Description: Stall B057 (joint), no tar-like material observed at historical seep location at Test Pit B057. Lat: 29.784747 Long: -95.319549

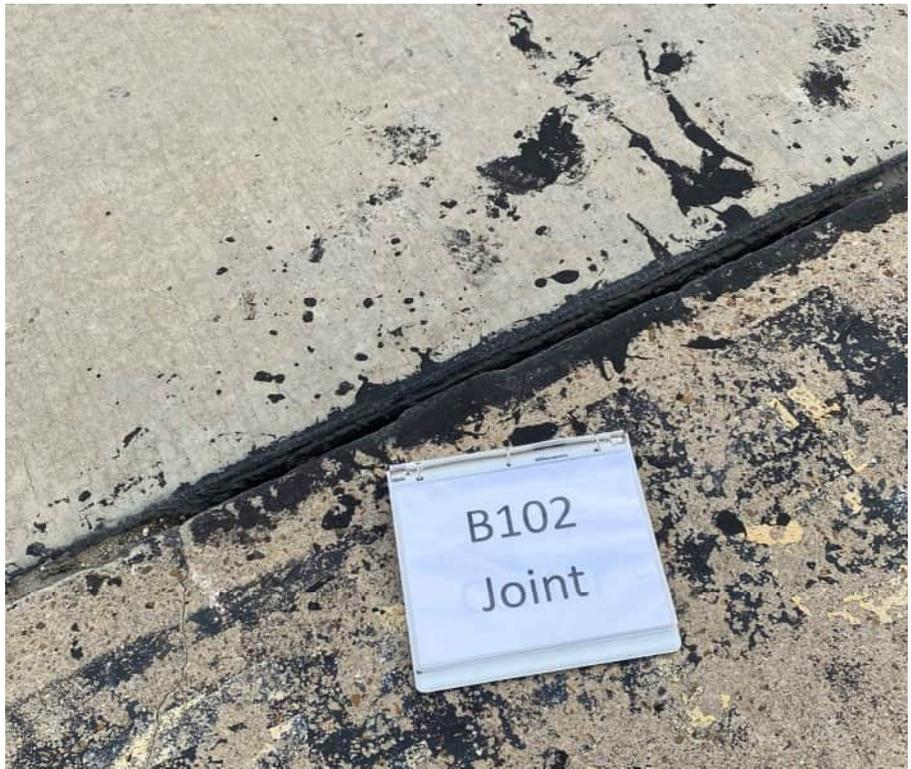
Photo No. 8	Inspection Date: 2/7/2024
Description: Stall B102 (joint) no new tar-like material observed at historical seep site along concrete joint. Lat: 29.784197 Long: -95.320821

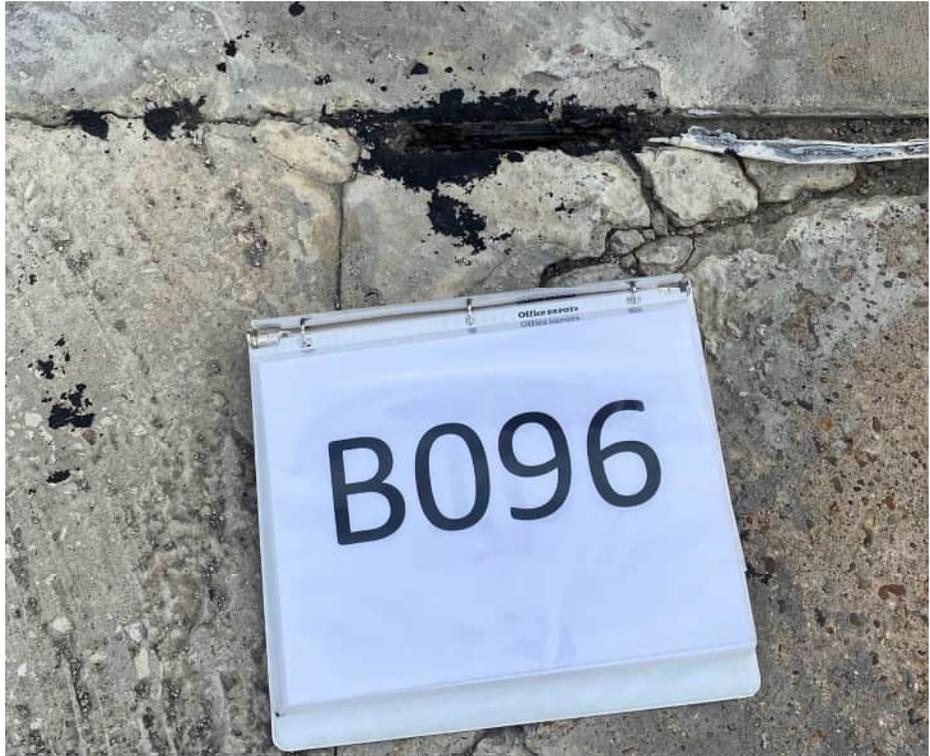
Stall B096, no new tar-like material observed at historical seep location along concrete joint at Test Pit B096.

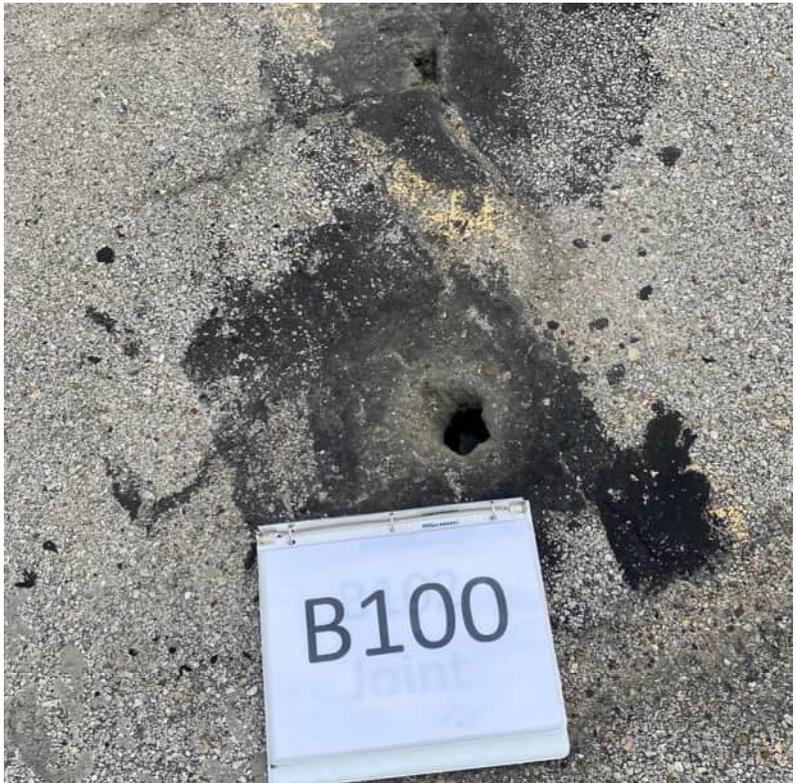
Photo No.: 10	Inspection Date: 2/7/2024
-------------------------	-------------------------------------

Stall B100, no new tar-like material observed on concrete crack/hole in concrete.

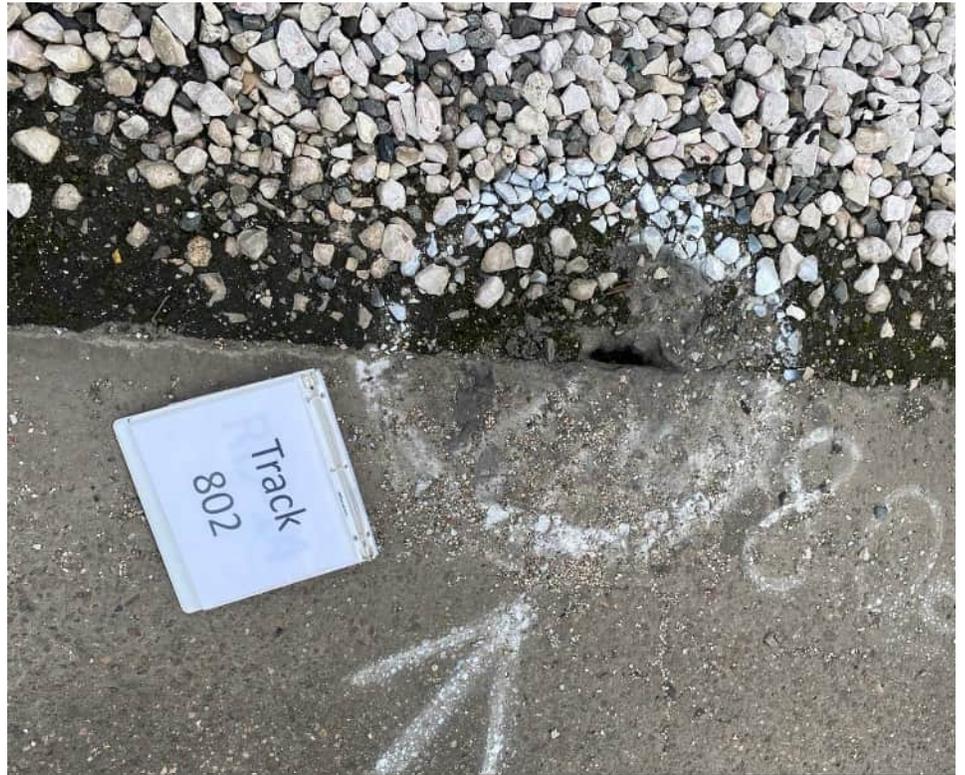
Photo No. 11	Inspection Date: 2/7/2024
Description: North side of Track 802, no new tar-like material observed at seep location near the edge of the ballast. Lat: 29.784947 Long: -95.321214

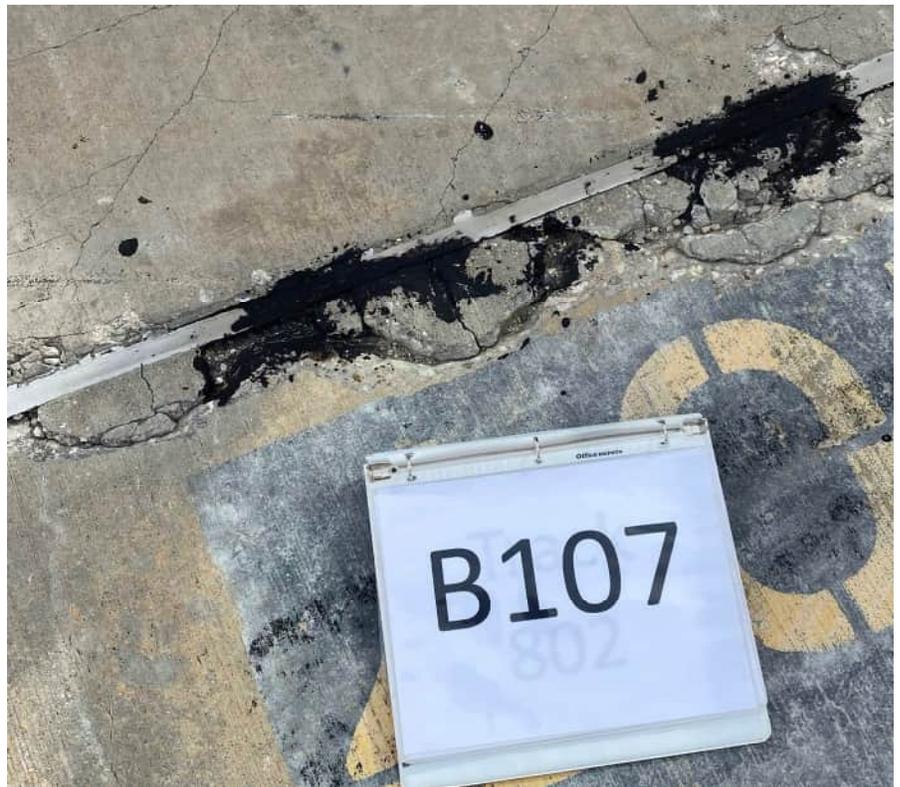
- No new tar-like material seeps were observed along the concrete joint between the NAPL Collection System and the existing concrete at Stall B107 during the February 2024 inspections (Photo Nos. 12, 23, 56, 82).

Photo No. 12	Inspection Date: 2/7/2024
Description: Stall B107, no new tar-like material observed at seep location on concrete joint along the southern edge of the excavated area. Lat: 29.784137 Long: -95.32096

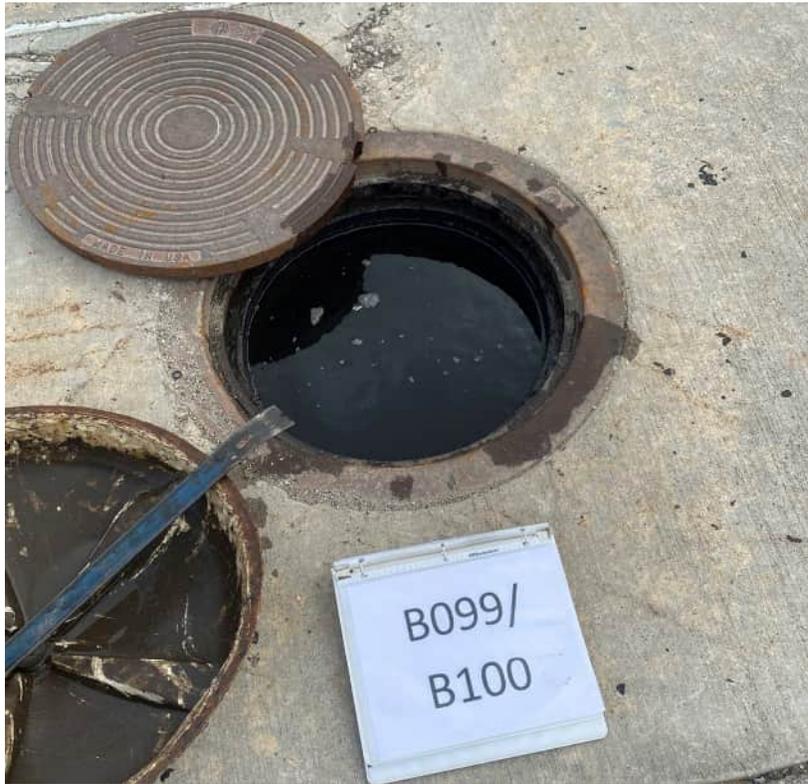
Sump 1 (B099/B100), 2 inches of freeboard in sump, no odor noted, no sheen observed, water color noted as tan.

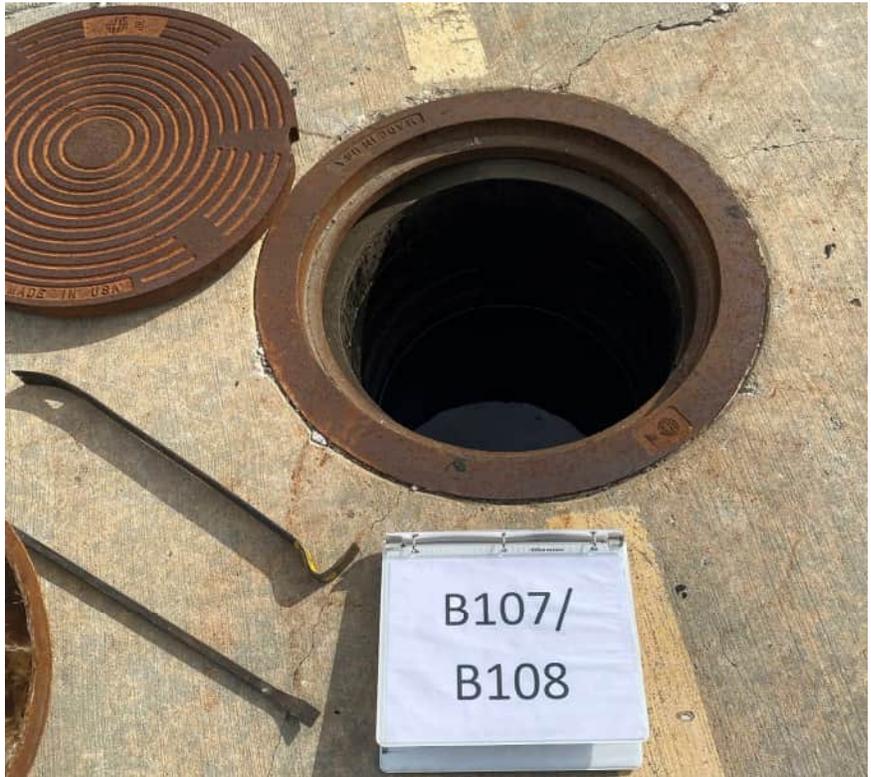
Description:
Sump 3 (B107/B108), 16 inches of freeboard in sump, no sheen observed, water color noted as clear.

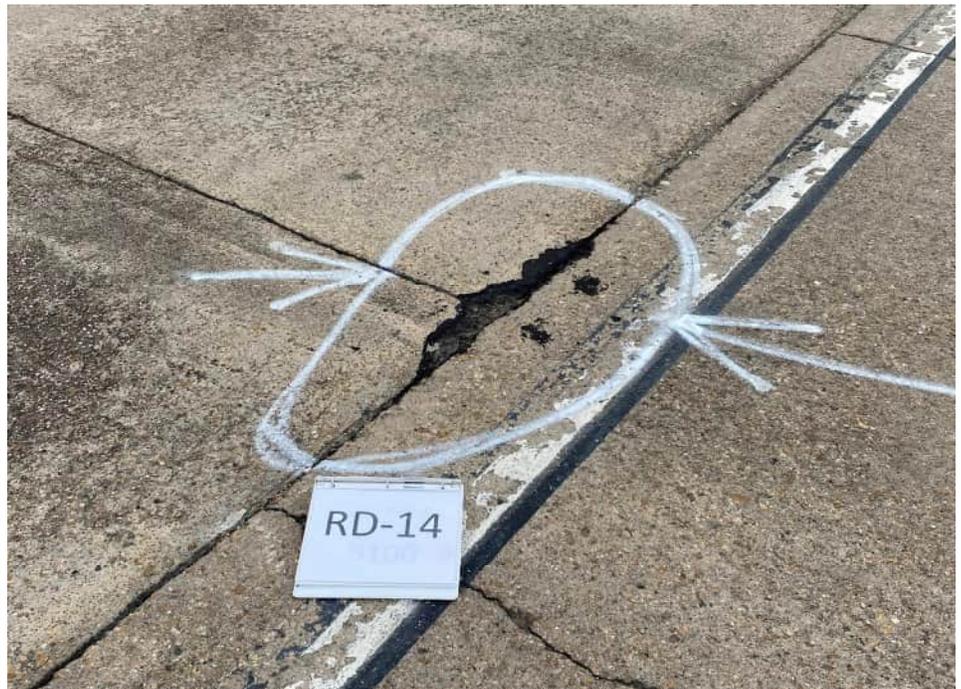
Photo No.: 16 **Inspection Date:** 2/7/2024

Description:
RD-14 Seep location observed within the concrete road area north of Track 802 (east of existing Track 802 seep location), No new tar-like material observed along a concrete joint.

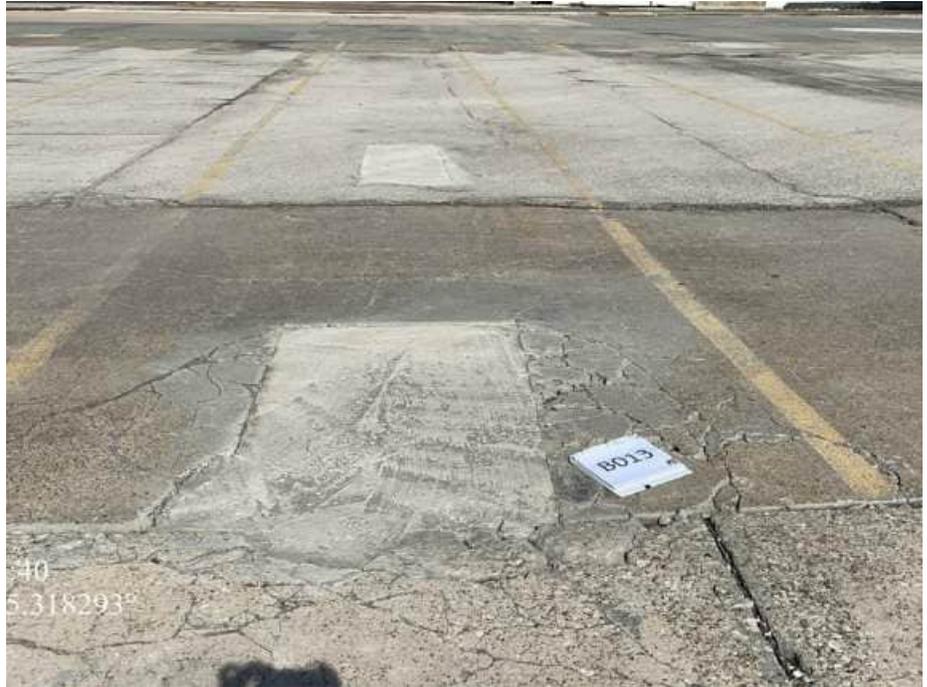
Stall B013. No seeps noted at Test Pit B013.

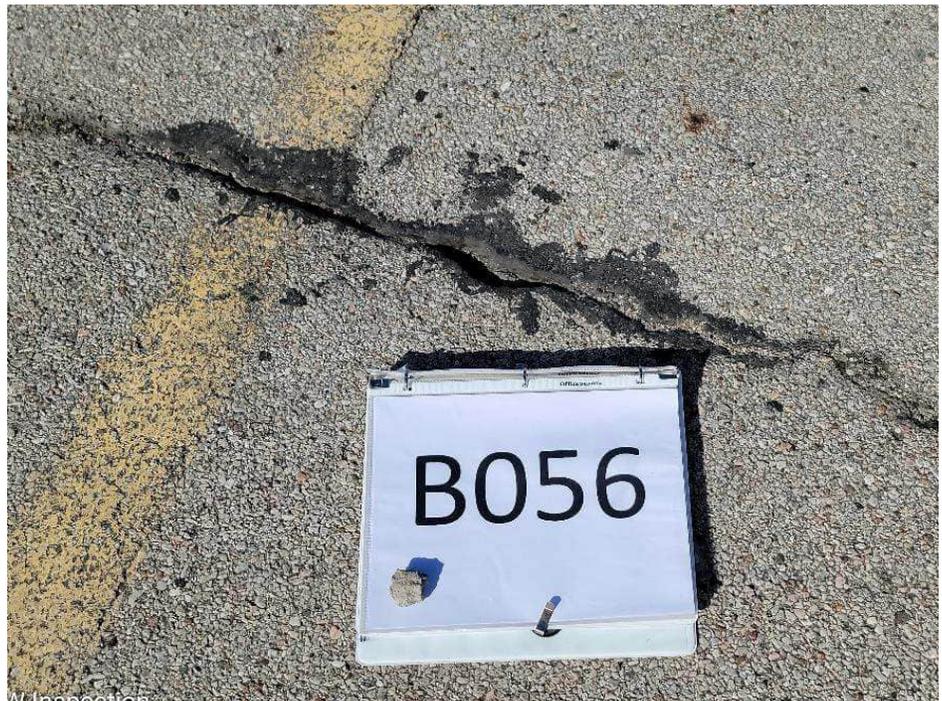
Photo No.
18

Stall B056. No new tar-like material observed at historical seep location along asphalt crack.

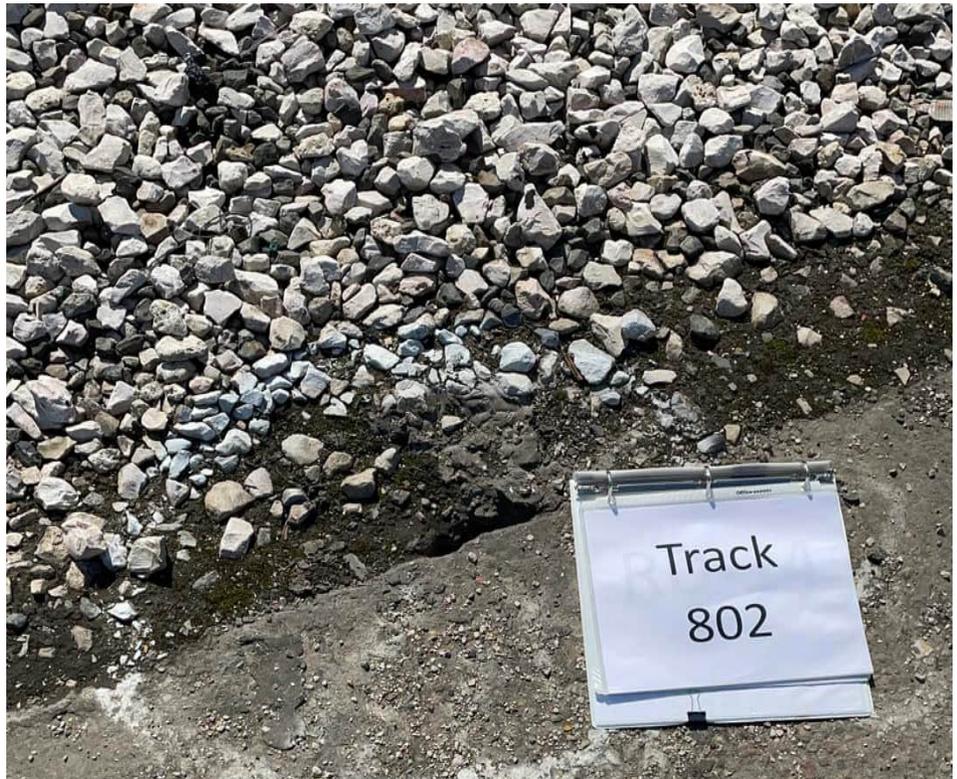
North side of Track 802, no new tar-like material observed at seep location near the edge of the ballast.

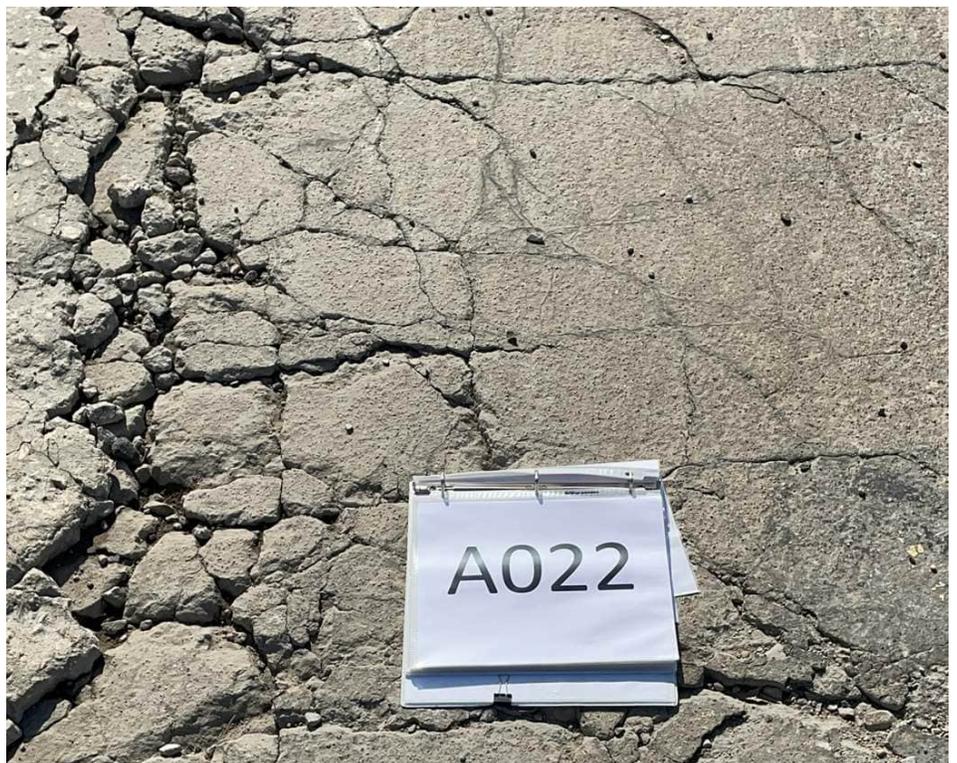
Photo No.
20

Stall A022. No new tar-like material observed at historical seep location along asphalt crack.

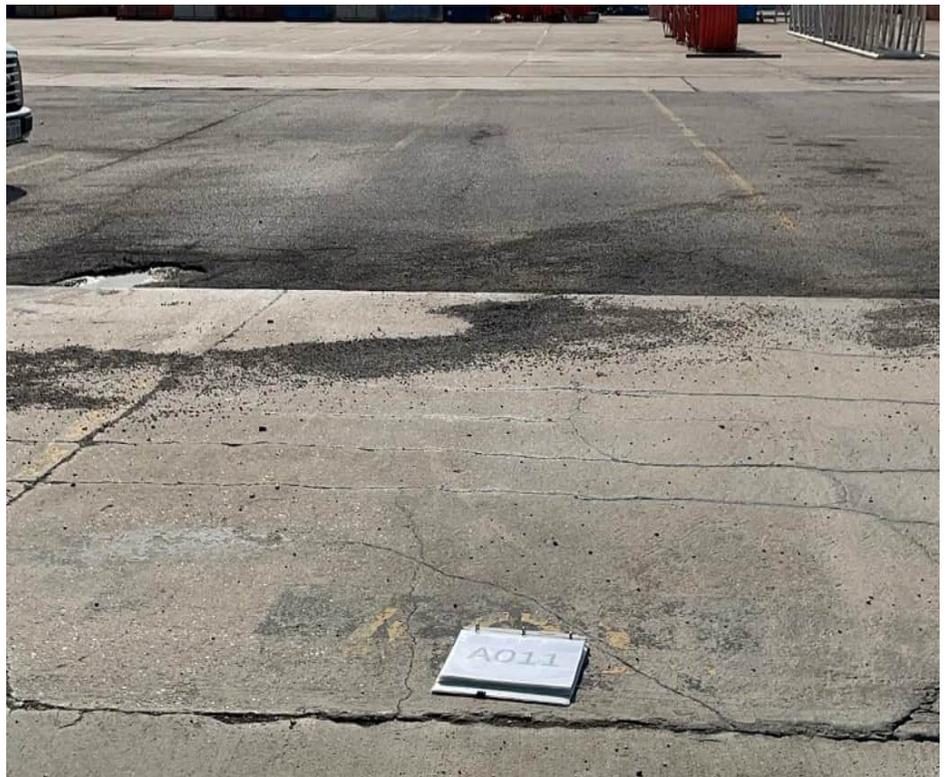
Stall A011. No tar-like material observed at historical seep location along asphalt crack.

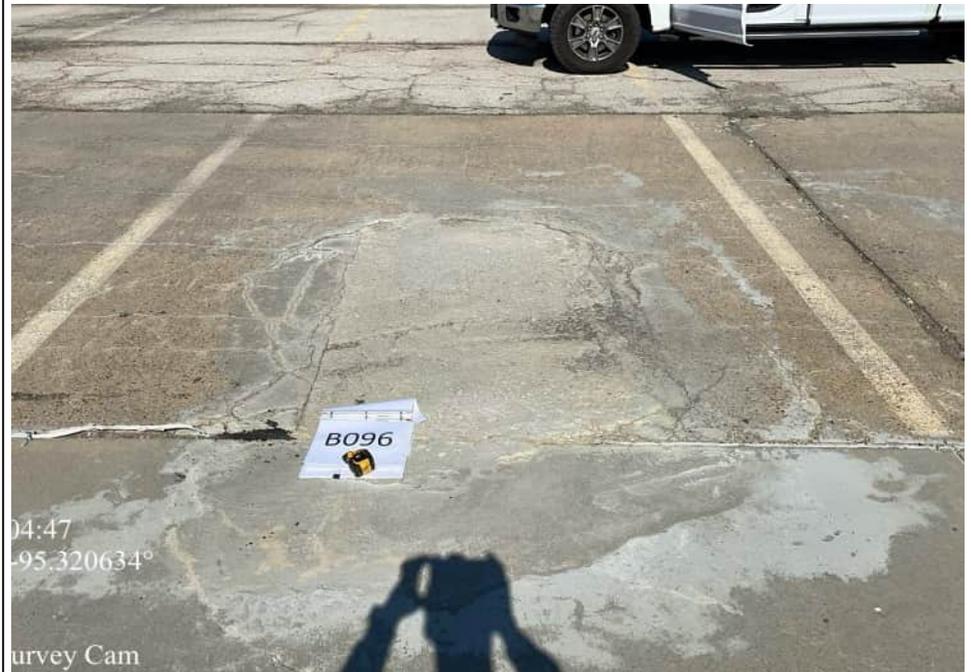
Description:
Stall B096, no new tar-like material observed at historical seep location along concrete joint.

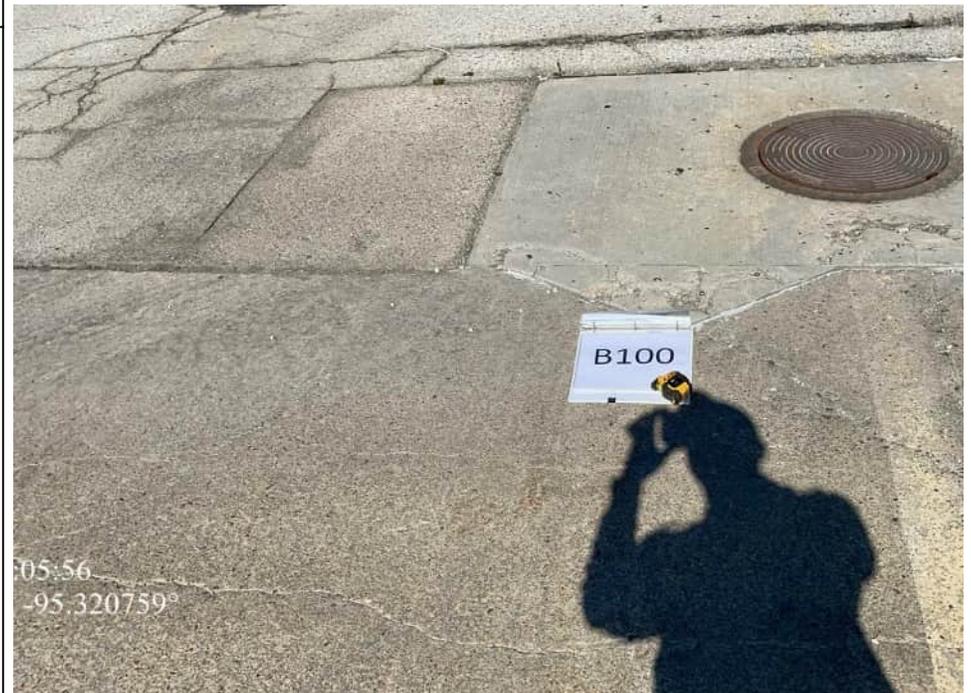
Photo No.:
26

Description:
Stall B100, no new tar-like material observed at seep location along asphalt crack/ hole in the asphalt.

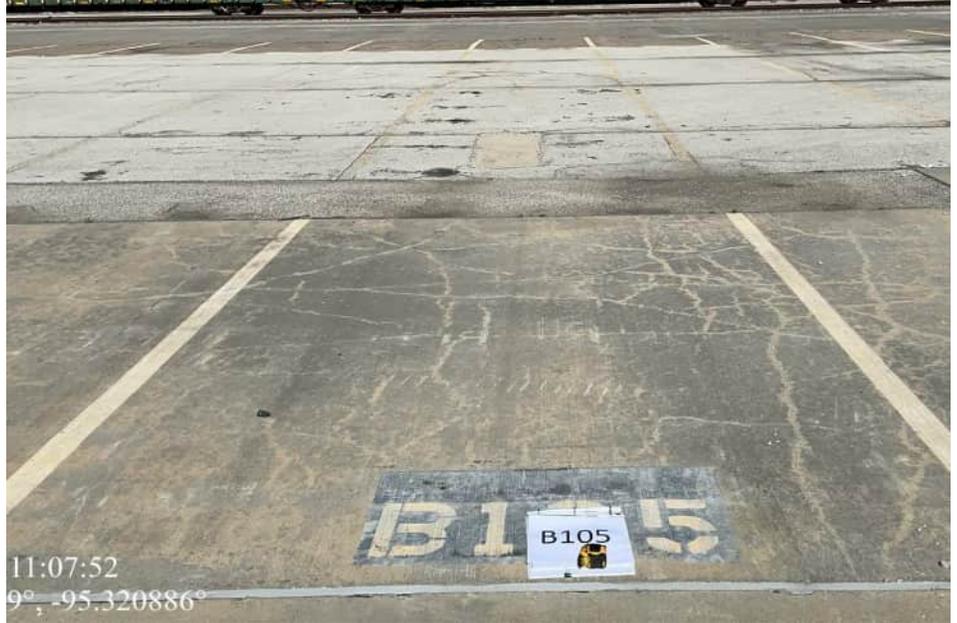
Stall B105, no new tar-like material observed at the historical seep location along asphalt crack.

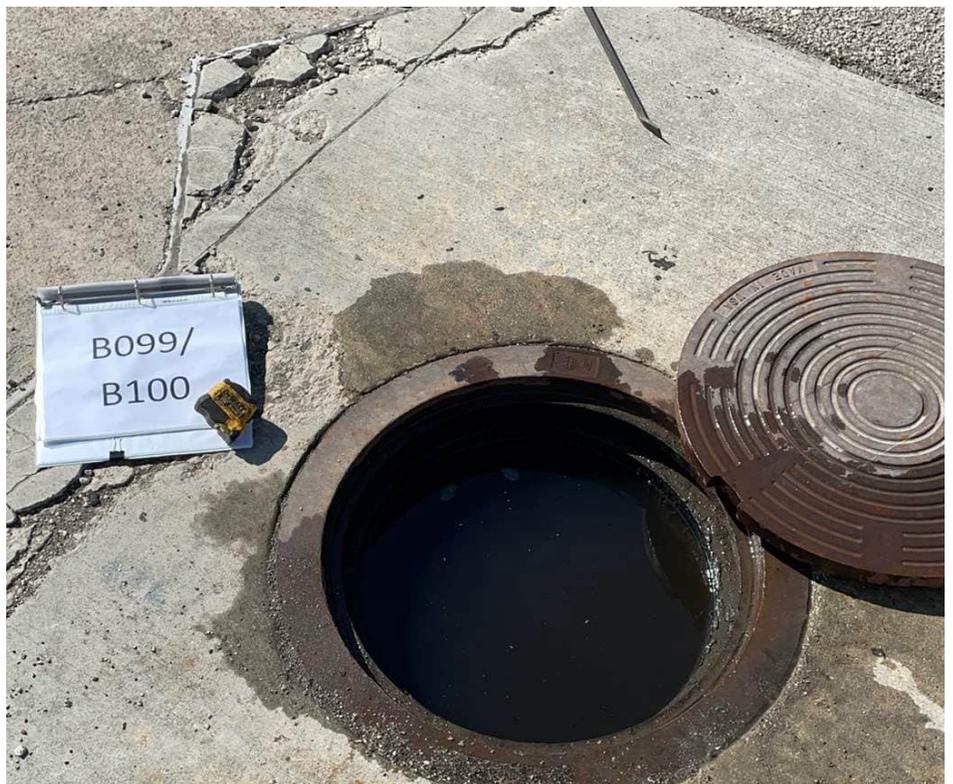
Photo No.
28

Sump 1 (B099/B100), 6 inches of freeboard in sump, no sheen observed, water color noted as clear.

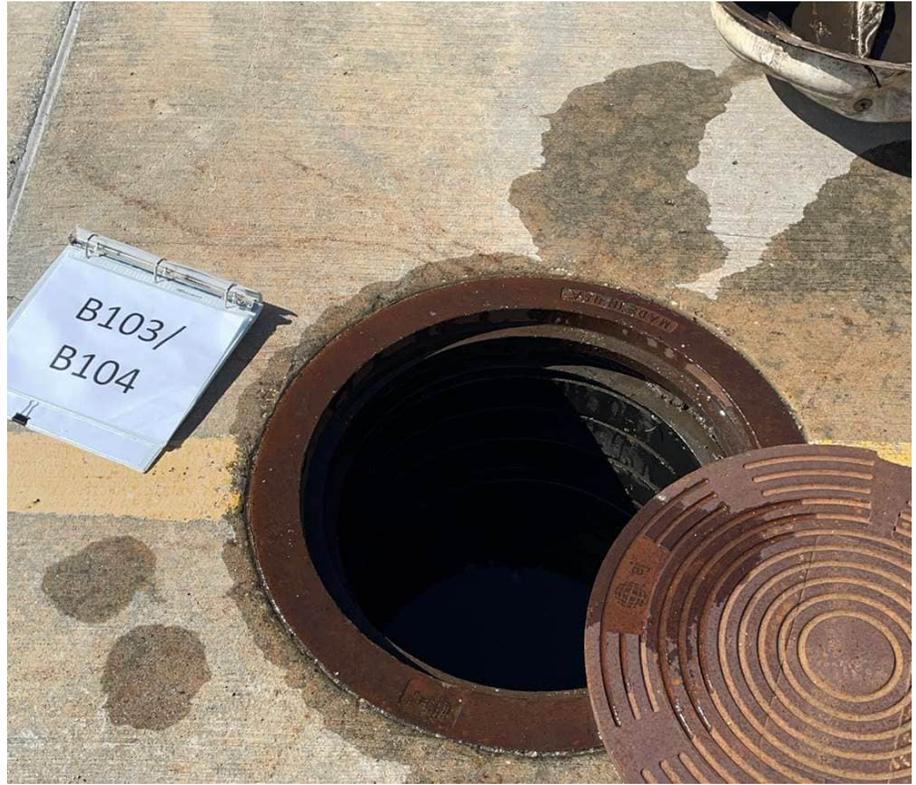
Sump 2 (B103/B104), 18 inches of freeboard in sump. No odor or sheen observed, color noted as clear.

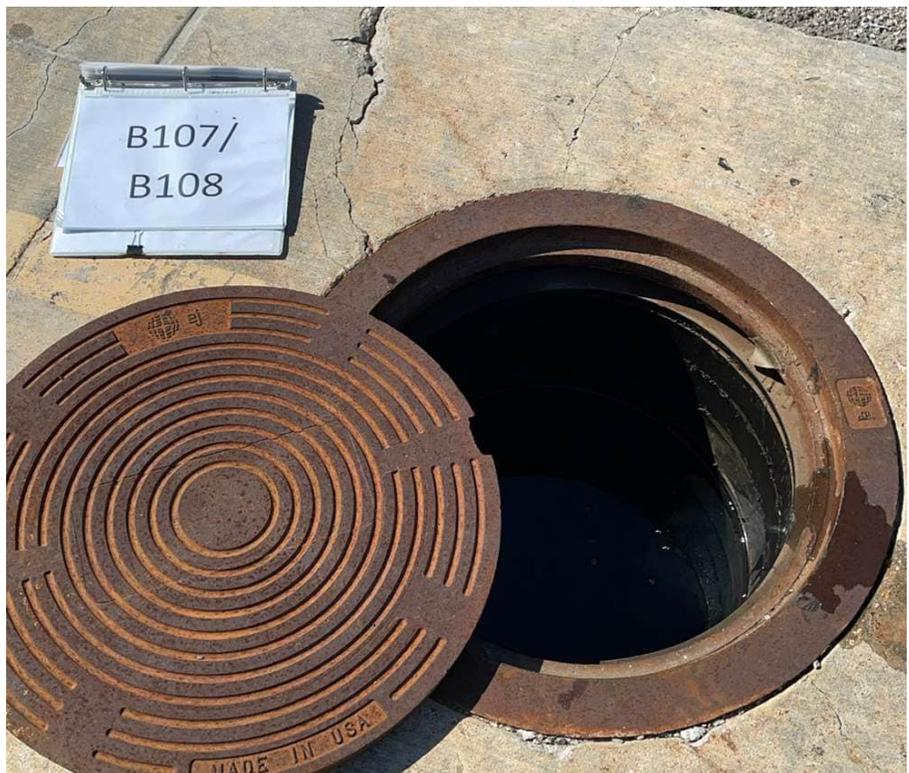
Photo No.
30

Sump 3 (B107/B108), 18 inches of freeboard in sump, no sheen observed, water color noted as clear.

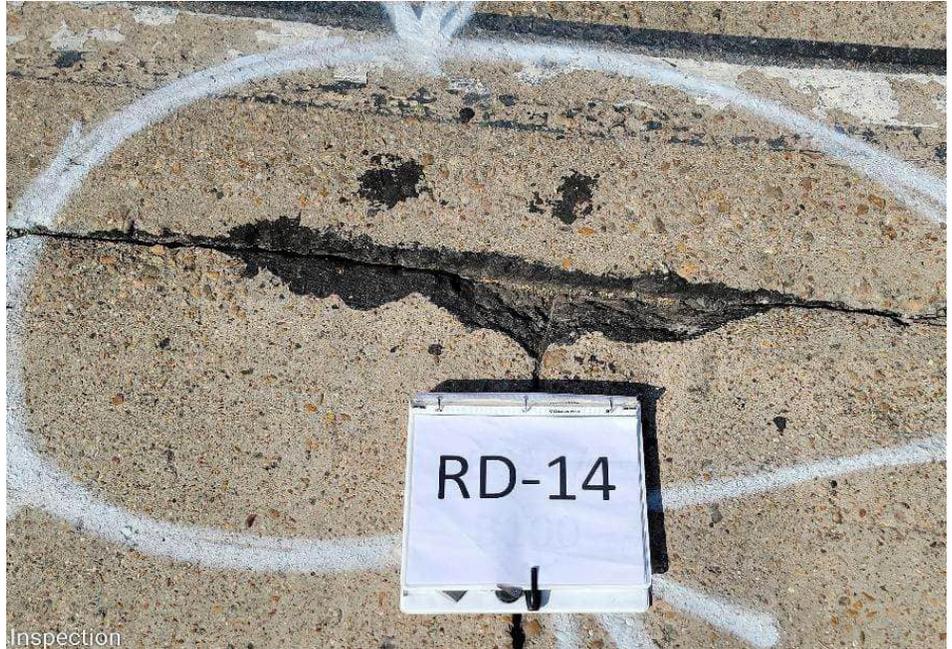
RD-14 Seep location observed within the concrete road area (RD-14) north of Track 802 (east of existing Track 802 seep location), no new tar-like material observed along a concrete joint.

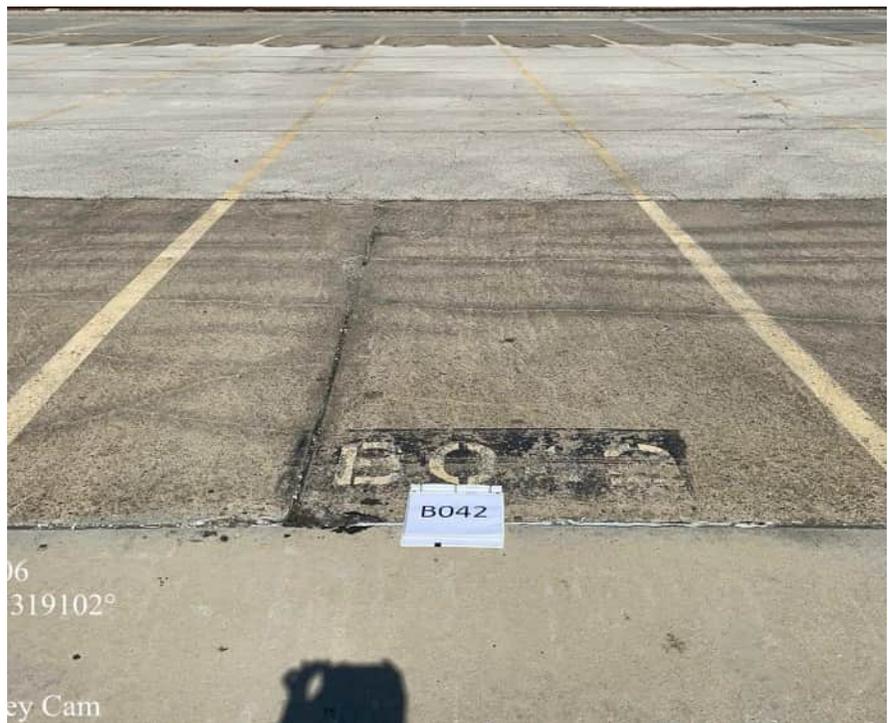
Photo No.
32

Stall B042. No new tar-like material observed at historical seep location along concrete crack.

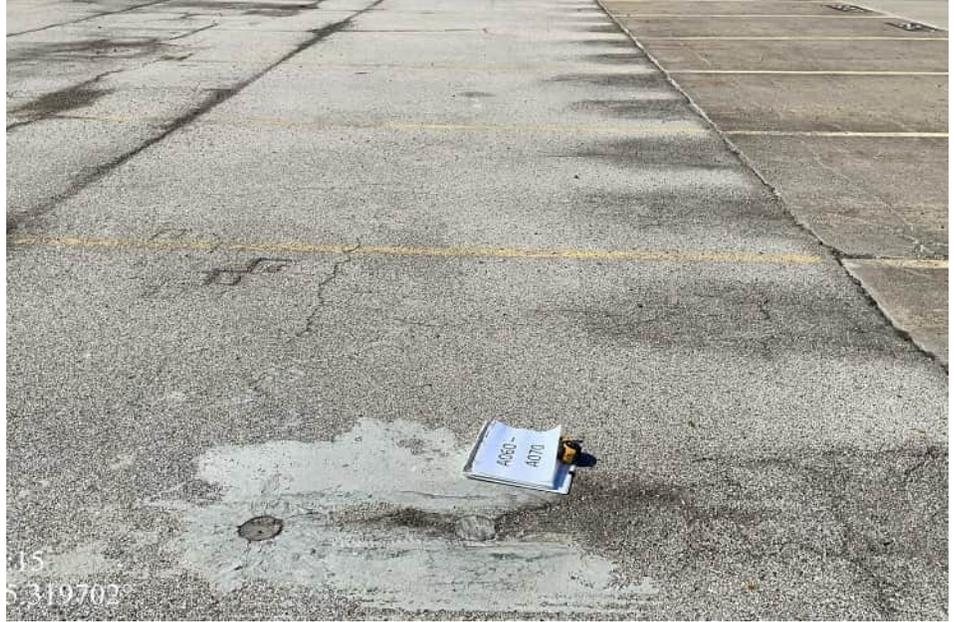
Stalls A060 - A070, some residual staining previously observed along cracks in pavement. No new water seeps observed. Viewing southwest.

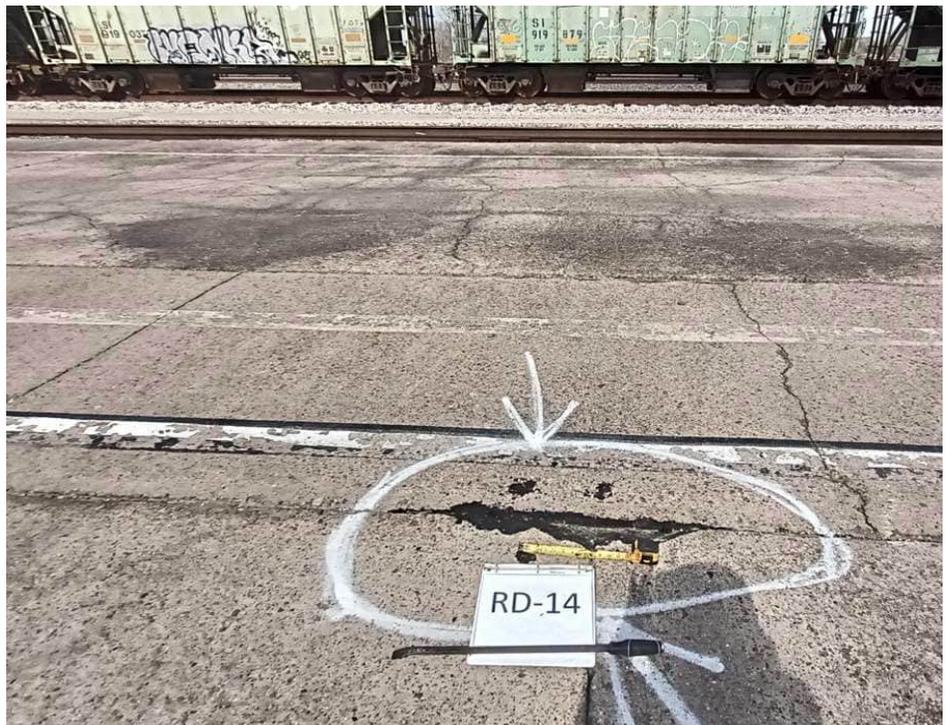
Seep Observations Outside the NAPL Collection System Area	
Stall Number	Observation Date(s)
B056	February 28 th (Photo No. 74)
B057	February 28 th (Photo No. 75)
B096	February 21 st and 28 th (Photo Nos. 51 and 77)
B100	February 21 st and 28 th (Photo Nos. 52 and 78)
Track 802	February 21 st (Photo No. 47)
RD-14	February 21 st (Photo No. 36)

RD-14 Seep location observed within the concrete road area (RD-14) north of Track 802 (east of existing Track 802 seep location), some tar-like material observed along a concrete joint. The material was removed.

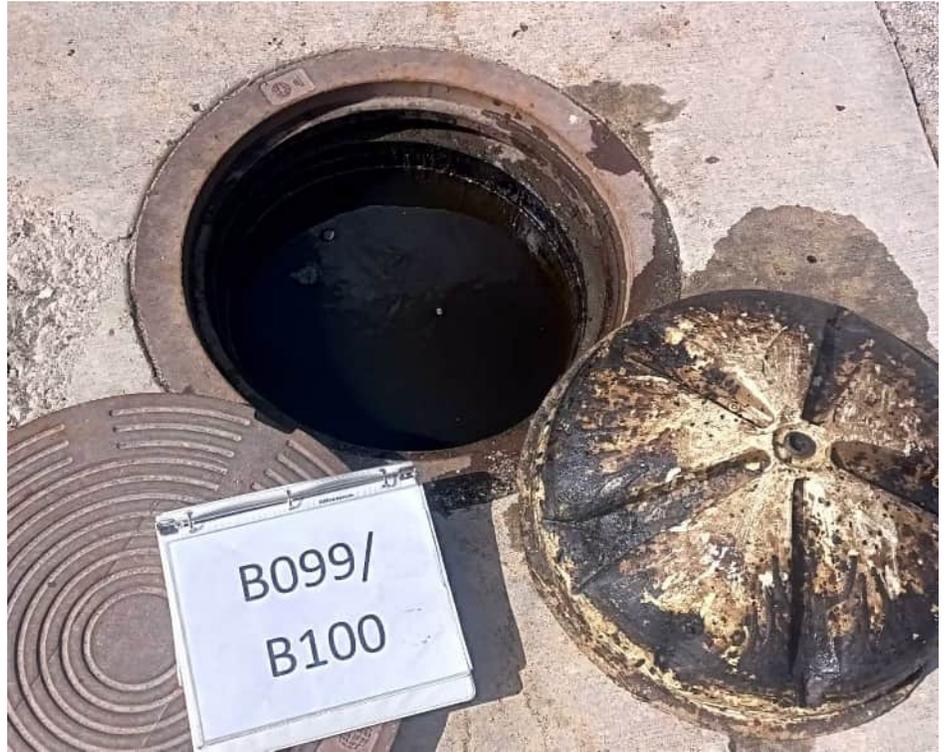
Sump 1 (B099/B100), 6 inches of freeboard in sump, no sheen observed, water color noted as light brown.

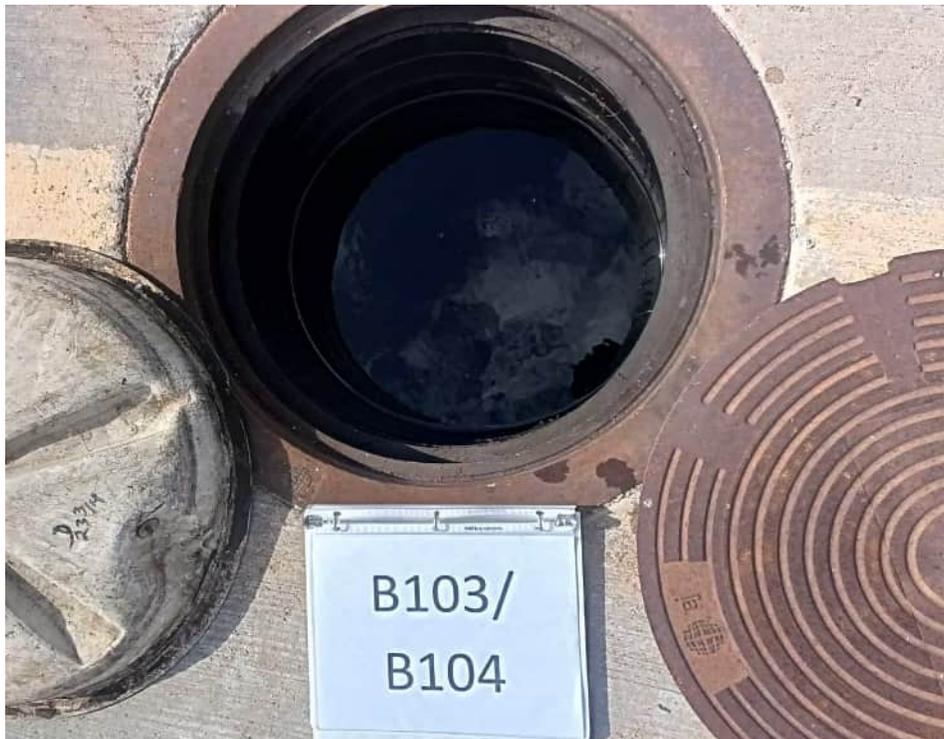
Photo No.
38

Sump 2 (B103/B104), 14 inches of freeboard in sump. No odor or sheen observed, color noted as clear.

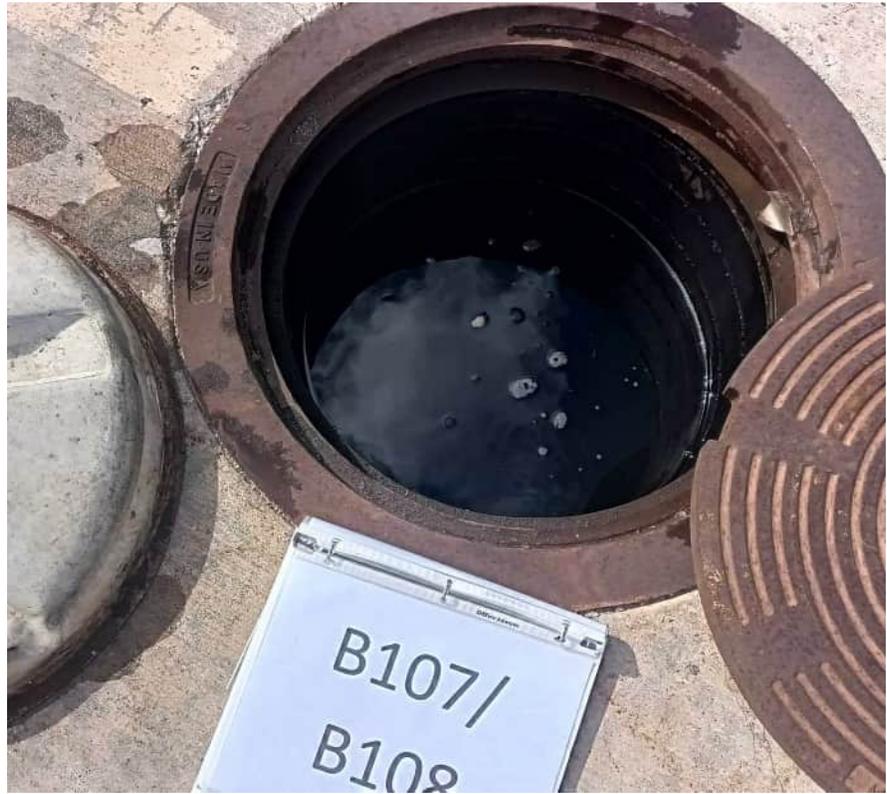
Sump 3 (B107/B108), 13 inches of freeboard in sump, no sheen observed, water color noted as clear.
