March 15, 2024

Project No. 31406585.016

Re: **MONTHLY STATUS UPDATE – ENGLEWOOD INTERMODAL YARD – NAPL COLLECTION SYSTEM/CONCRETE CAP REPAIRS
UNION PACIFIC RAILROAD HOUSTON WOOD PRESERVING WORKS FACILITY
4910 LIBERTY ROAD FACILITY, HOUSTON, TEXAS
POST-CLOSURE CARE PERMIT NO. HW-50343; INDUSTRIAL SWR NO. 31547**

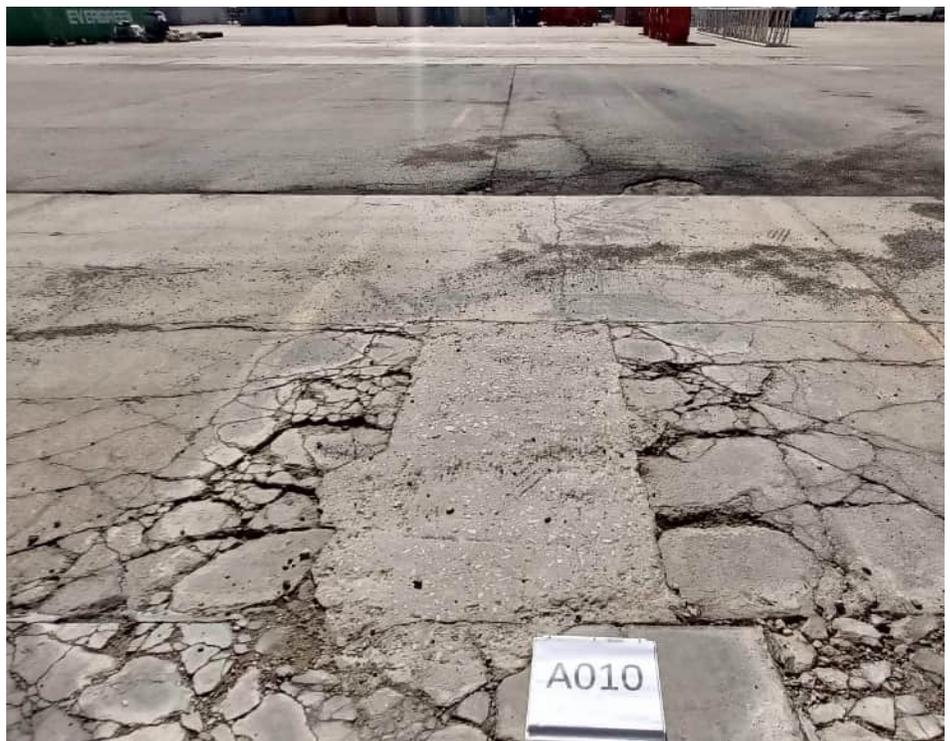
Photo No.
40

Stall A010. No seeps noted at Test Pit A010.

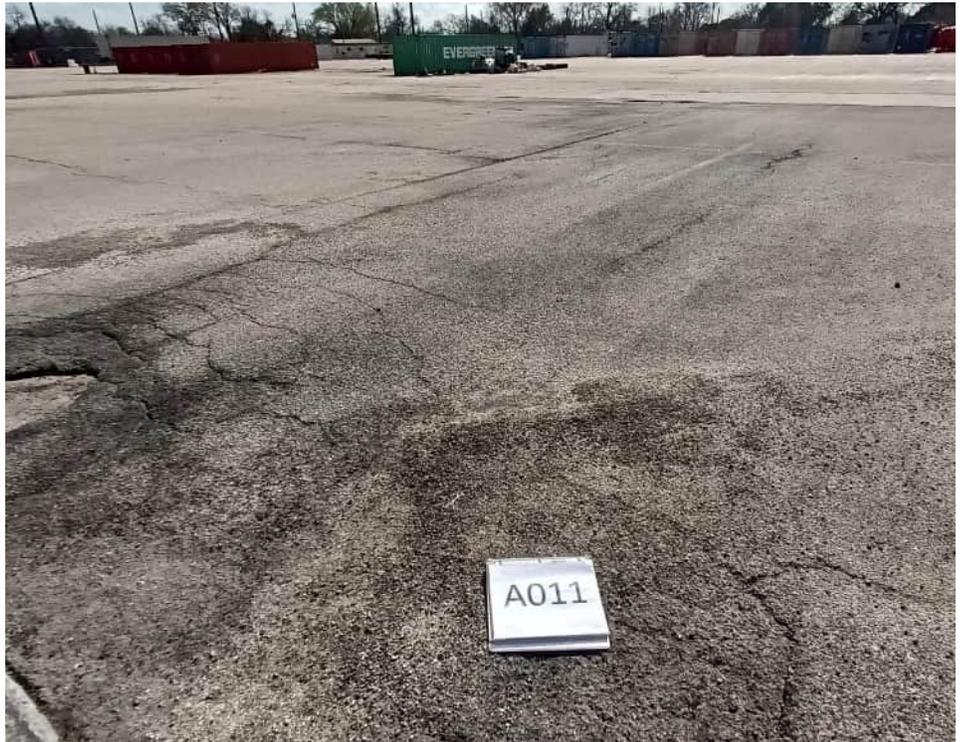
Stall A011. No tar-like material observed at historical seep location along asphalt crack.

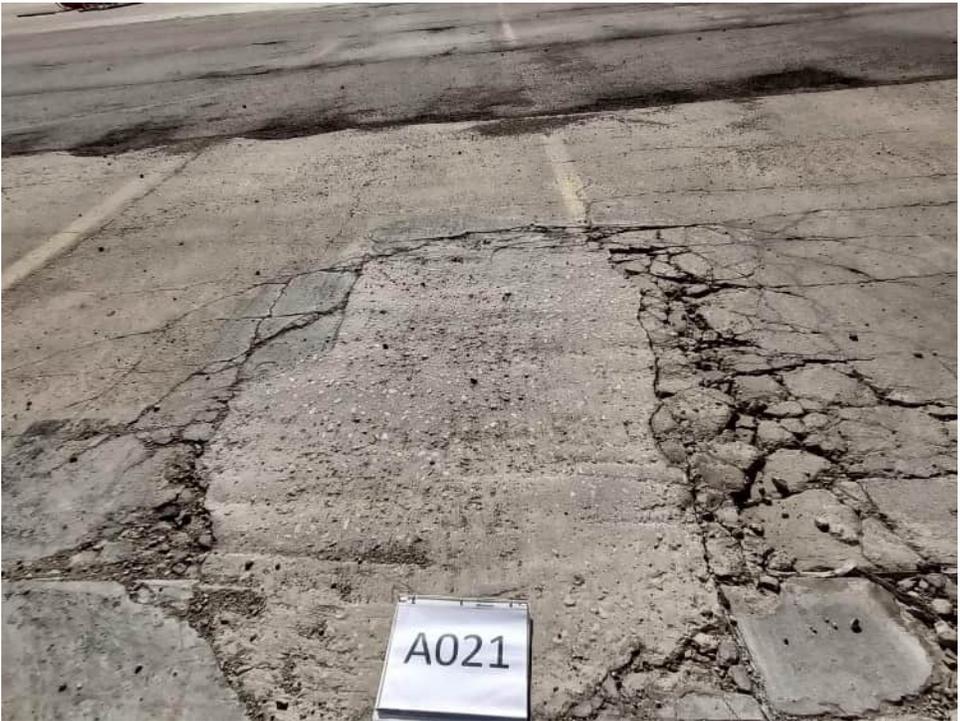
Photo No. 42	Inspection Date: 2/21/2024
-------------------------------	--------------------------------------

Stall A021. No seeps noted at Test Pit A021.

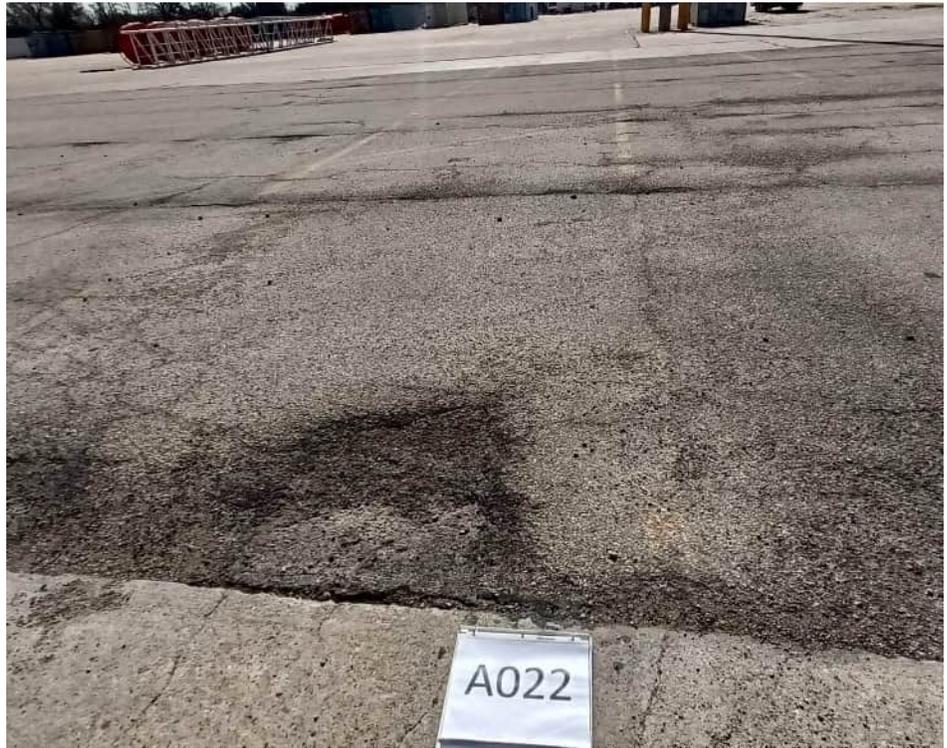
Stall A022, no new tar-like material observed at the seep location along the edge.

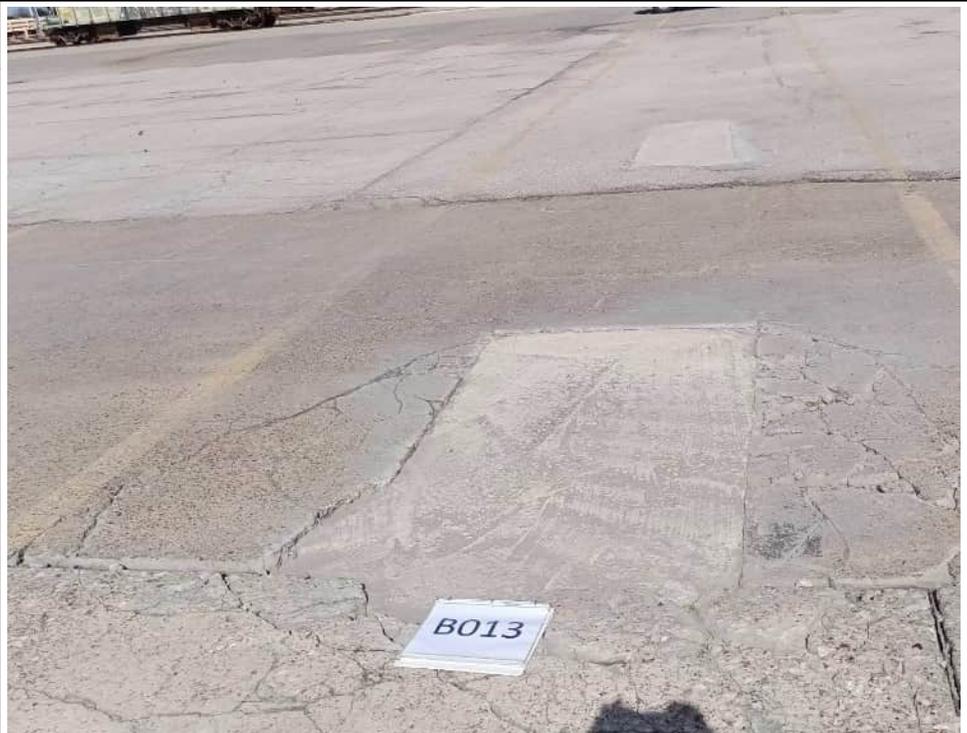
Photo No.
44

Stall B013. No seeps noted at Test Pit B013.

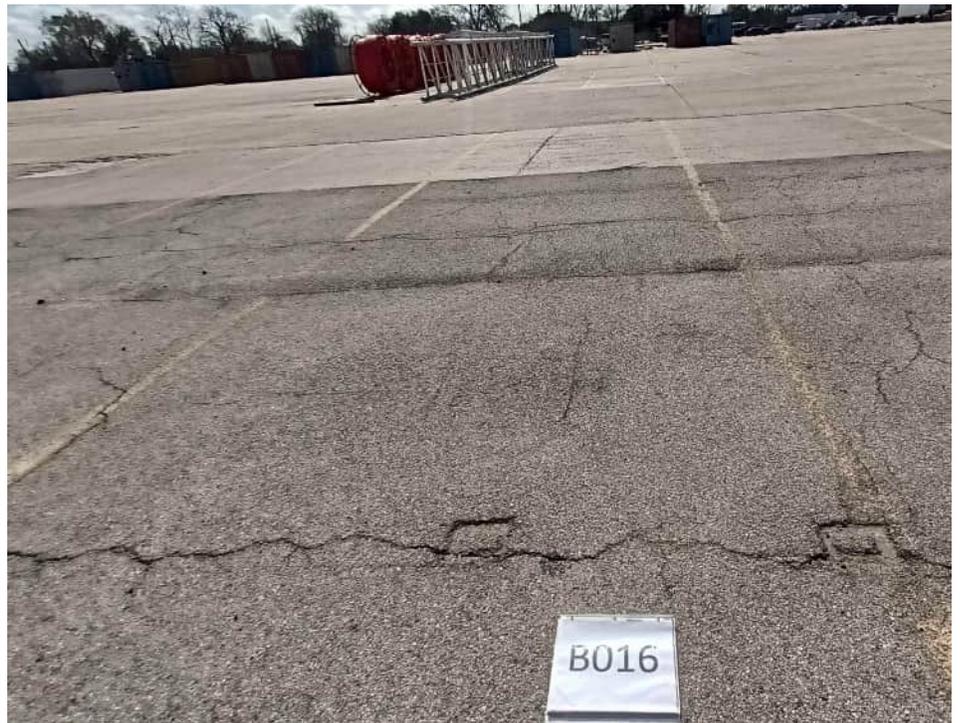
Stall B016. No tar-like material observed at historical seep location along asphalt crack.

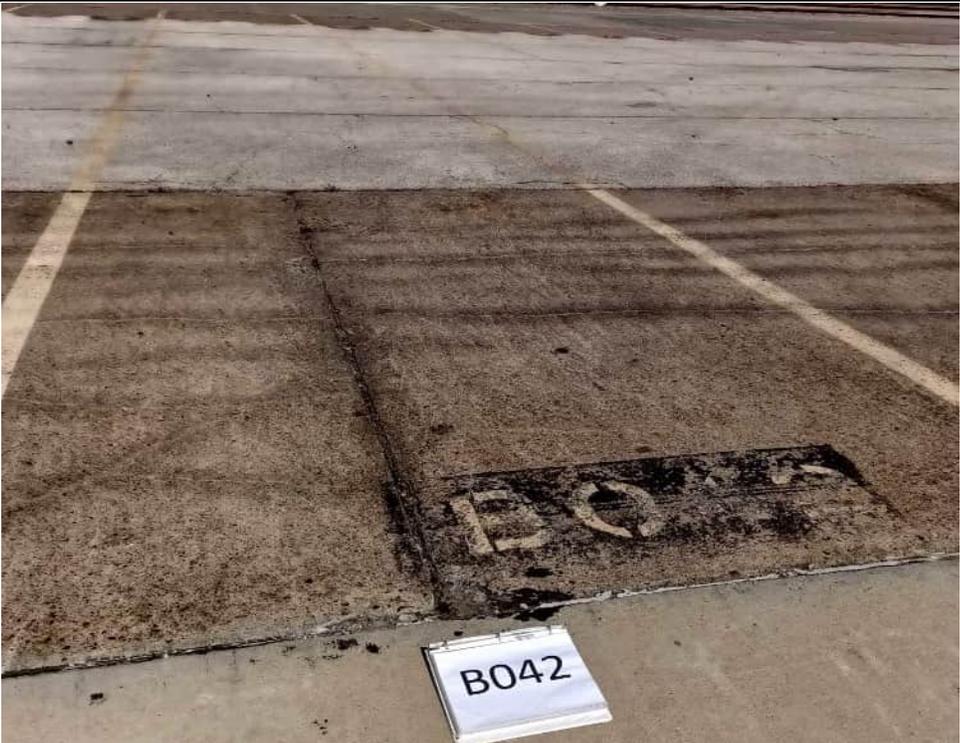
Photo No. 46	Inspection Date: 2/21/2024
-------------------------------	--------------------------------------

Stall B042. No new tar-like material observed at historical seep location along asphalt crack.

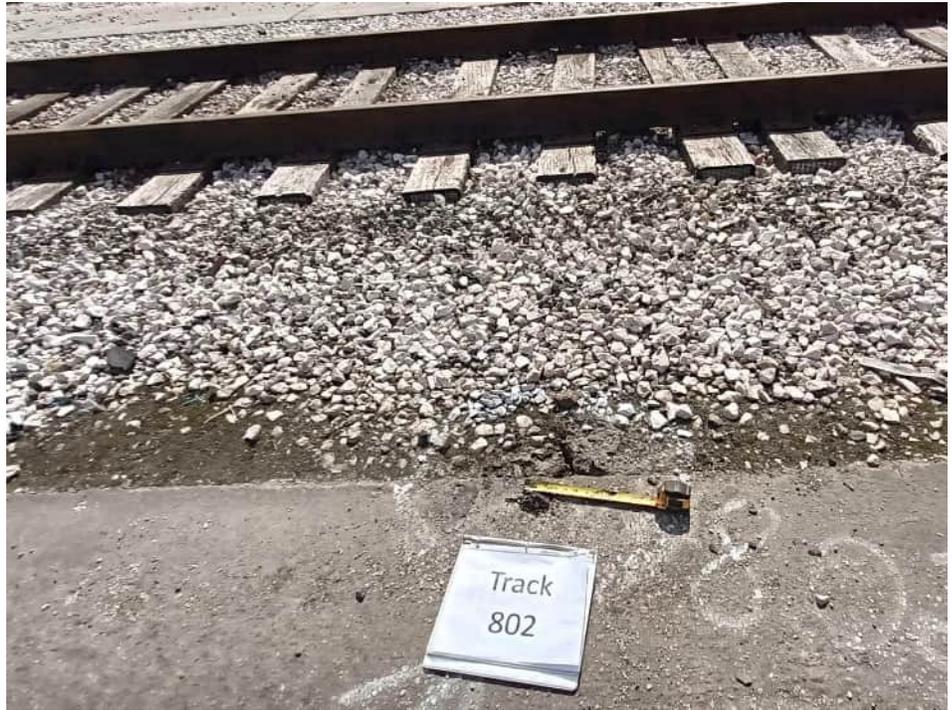
Seep Observations Outside the NAPL Collection System Area	
Stall Number	Observation Date(s)
B056	February 28 th (Photo No. 74)
B057	February 28 th (Photo No. 75)
B096	February 21 st and 28 th (Photo Nos. 51 and 77)
B100	February 21 st and 28 th (Photo Nos. 52 and 78)
Track 802	February 21 st (Photo No. 47)
RD-14	February 21 st (Photo No. 36)

Note: Seep observed next to Track 802 is approximately 280 feet northwest of the NAPL Collection System. Seep RD-14 is located within the concrete road area (RD-14) about 45 feet north of Track 802 and east of the existing Track 802 seep location.

North side of Track 802, some tar-like material observed at seep location near the edge of the ballast, material removed.

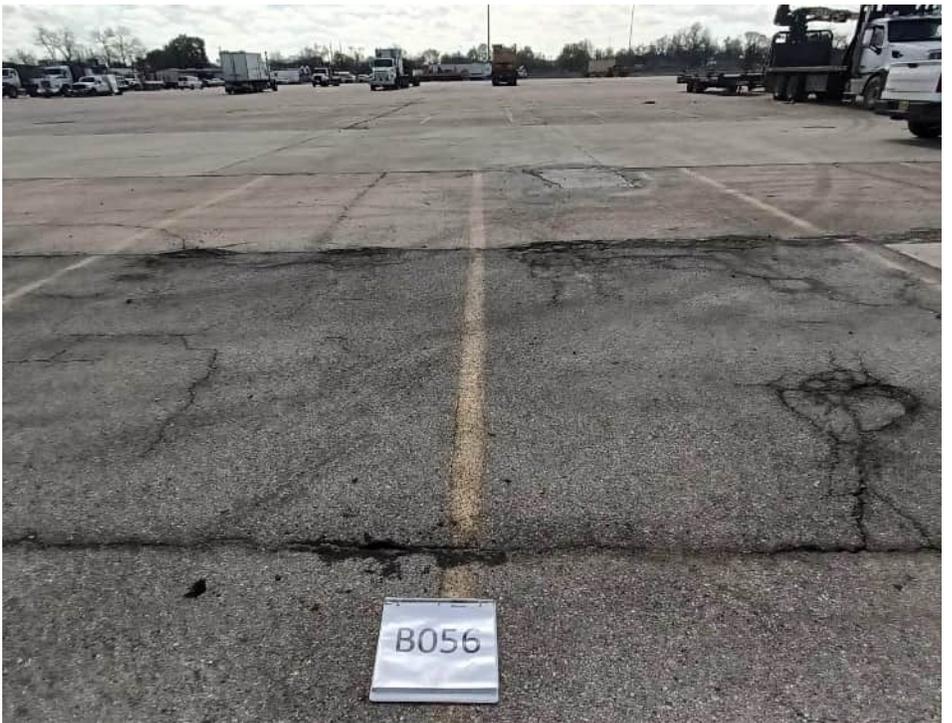
Photo No.: 48	Inspection Date: 2/21/2024
-------------------------	--------------------------------------

Stall B056. No new tar-like material observed at historical seep location along asphalt crack.

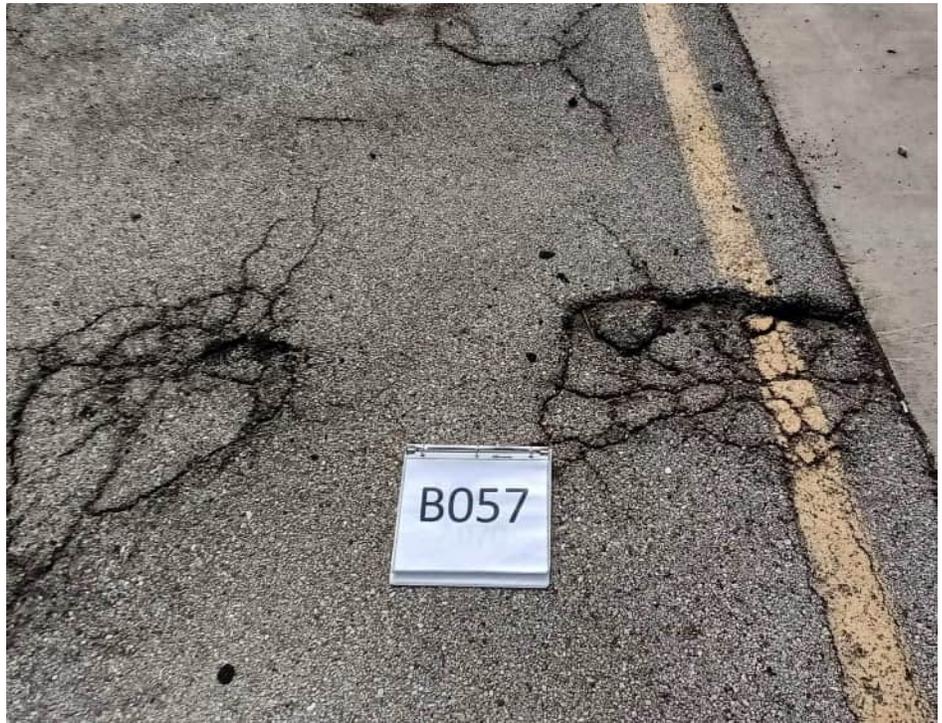
Photo No. 49	Inspection Date: 2/21/2024
Description: Stall B057, no new tar-like material observed and removed at seep location along asphalt crack. Lat: 29.784769 Long: -95.3195798

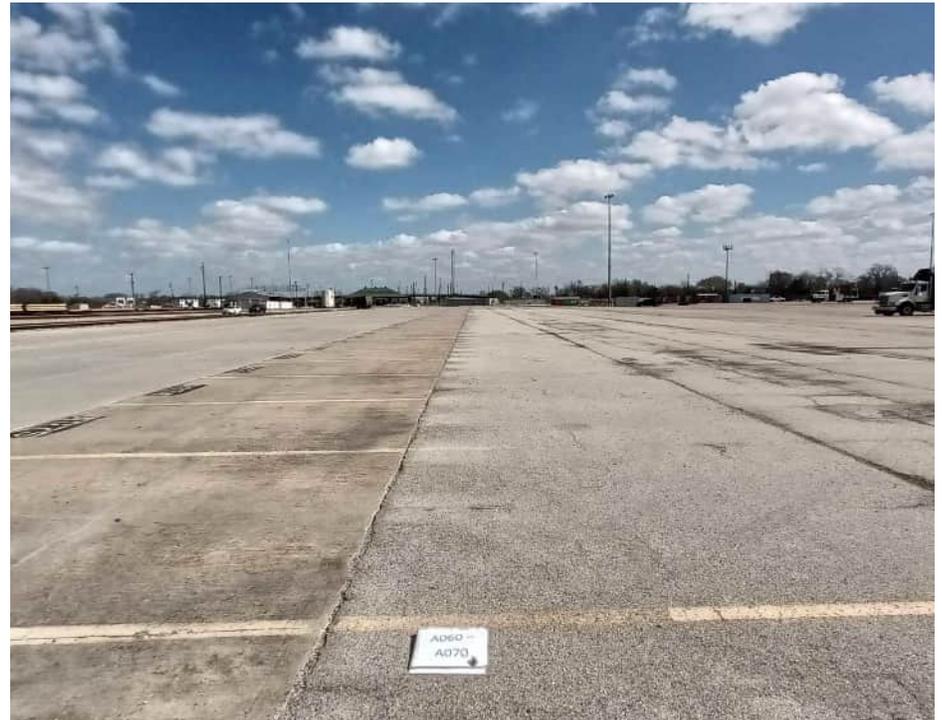
Photo No. 50	Inspection Date: 2/21/2024
Description: Stalls A060 - A070, some residual staining previously observed along cracks in pavement. No new water seeps observed. Viewing southwest. Lat: 29.78484 Long: -95.31974

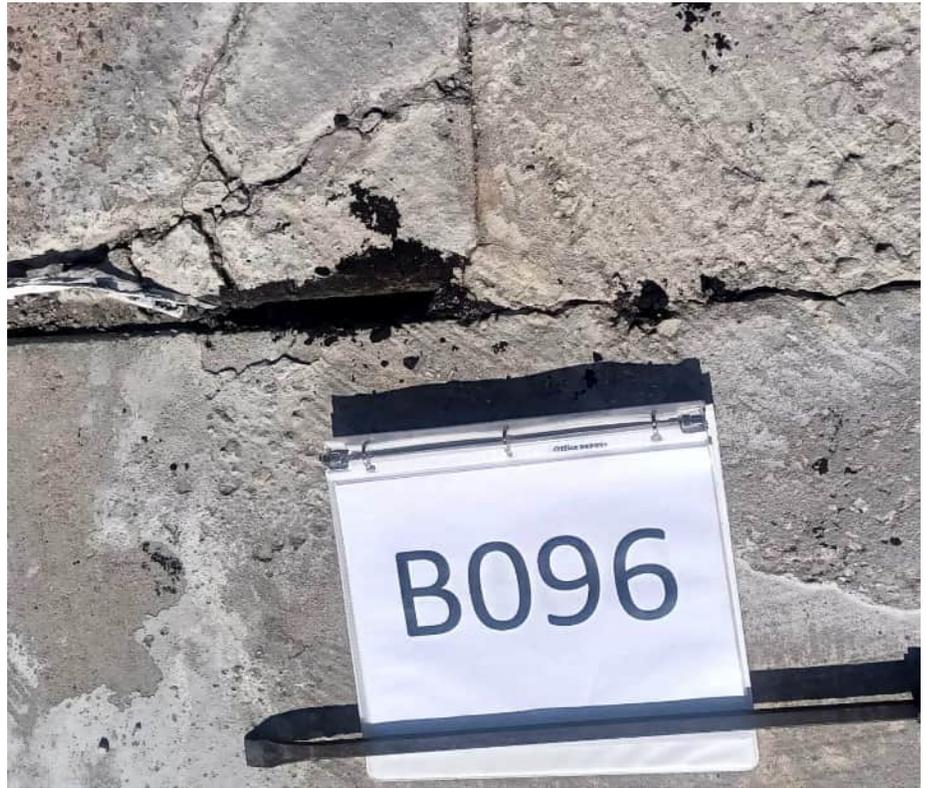
Stall B096, some tar-like material observed at historical seep location along concrete joint, material removed.

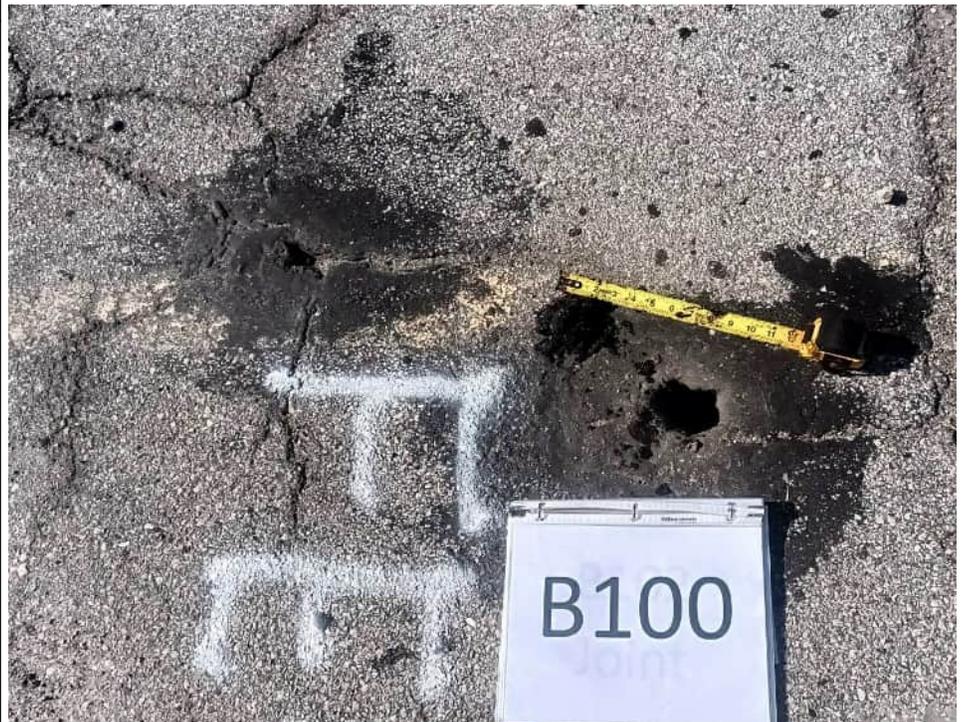
Photo No.
52

Stall B100, some tar-like material observed at seep location along asphalt crack/ hole in the asphalt.

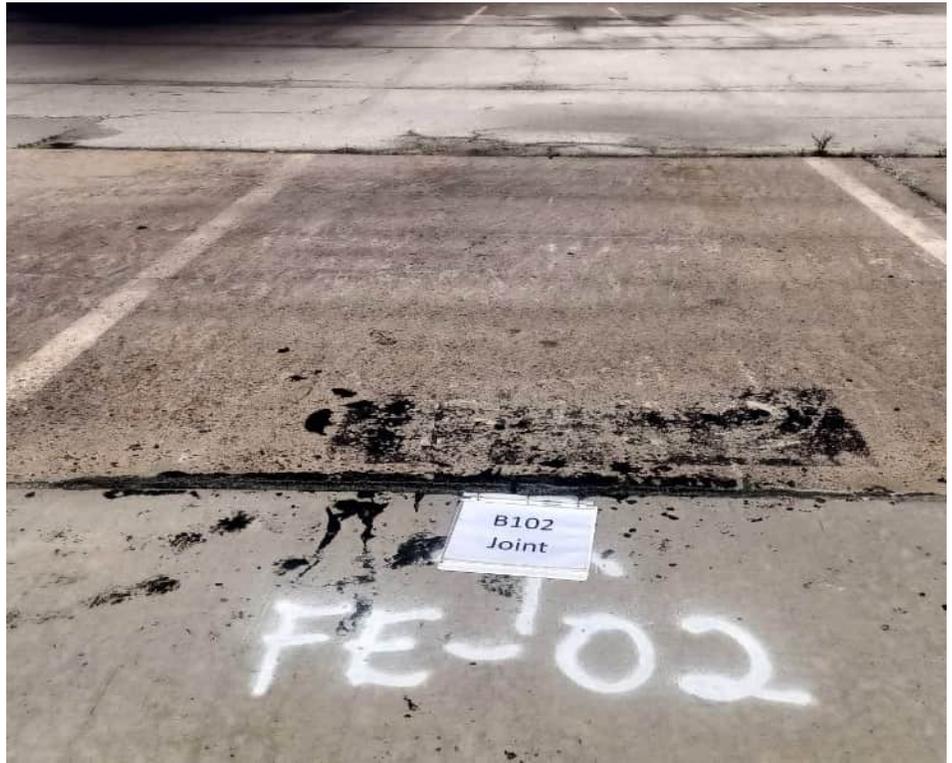
- No new tar-like material seeps were observed along the concrete joint between the NAPL Collection System and the existing concrete at Stall B107 during the February 2024 inspections (Photo Nos. 12, 23, 56, 82).

Description:
Stall B102 Joint, no new tar-like material observed at seep location along stall joint.

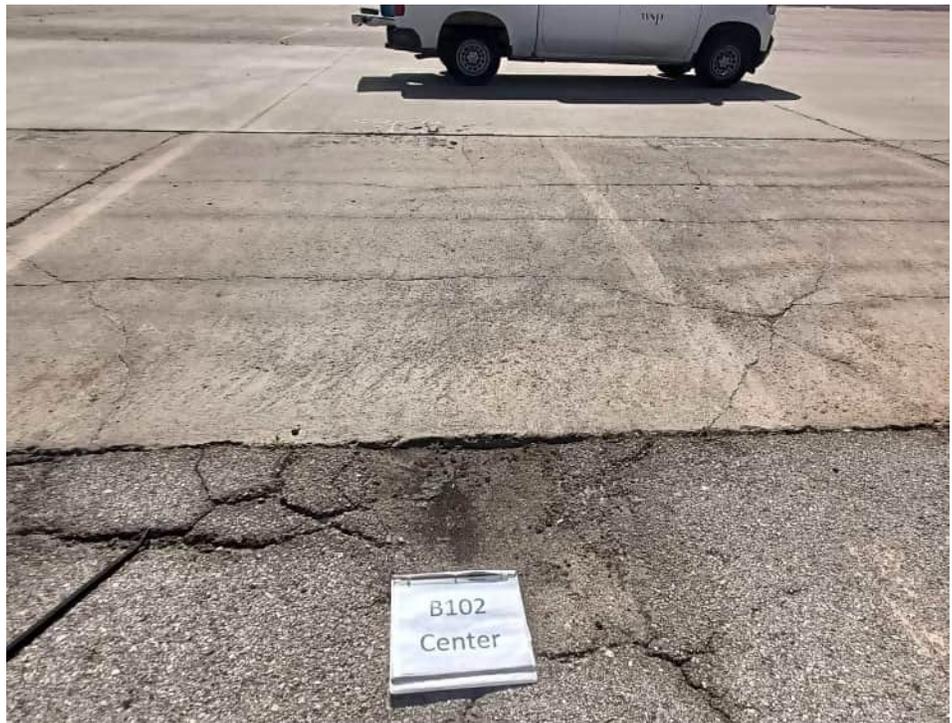
Photo No.
54

Description:
Stall B102 (center), no tar-like material observed at seep location where pavement is cracked.

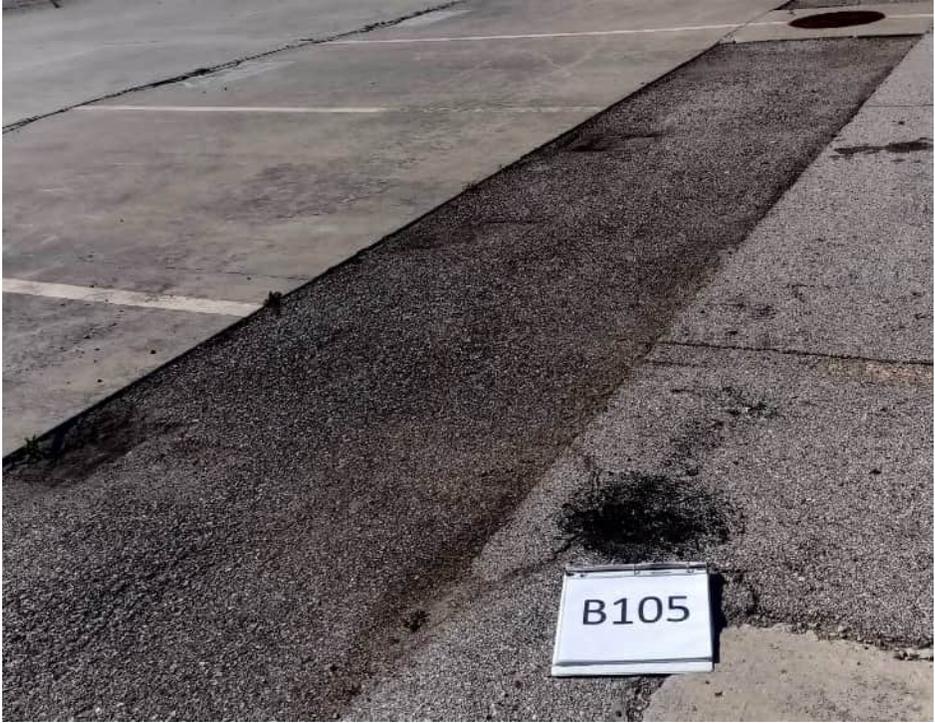
Photo No. 55	Inspection Date: 2/21/2024
Description: Stall B105, no new tar-like material observed at the historical seep location along asphalt crack. Lat: 29.784209 Long: -95.320943

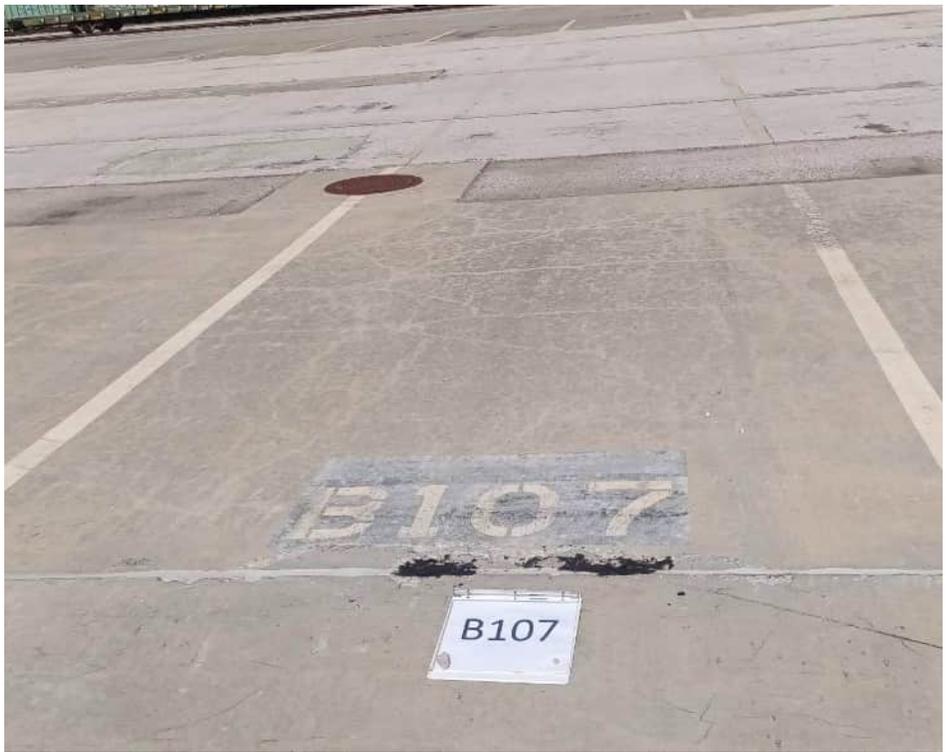
Photo No. 56	Inspection Date: 2/21/2024
Description: Stalls B107, no new tar-like material observed at seep location on concrete joint along the southern edge of the excavated area. Lat: 29.784156 Long: -95.320953

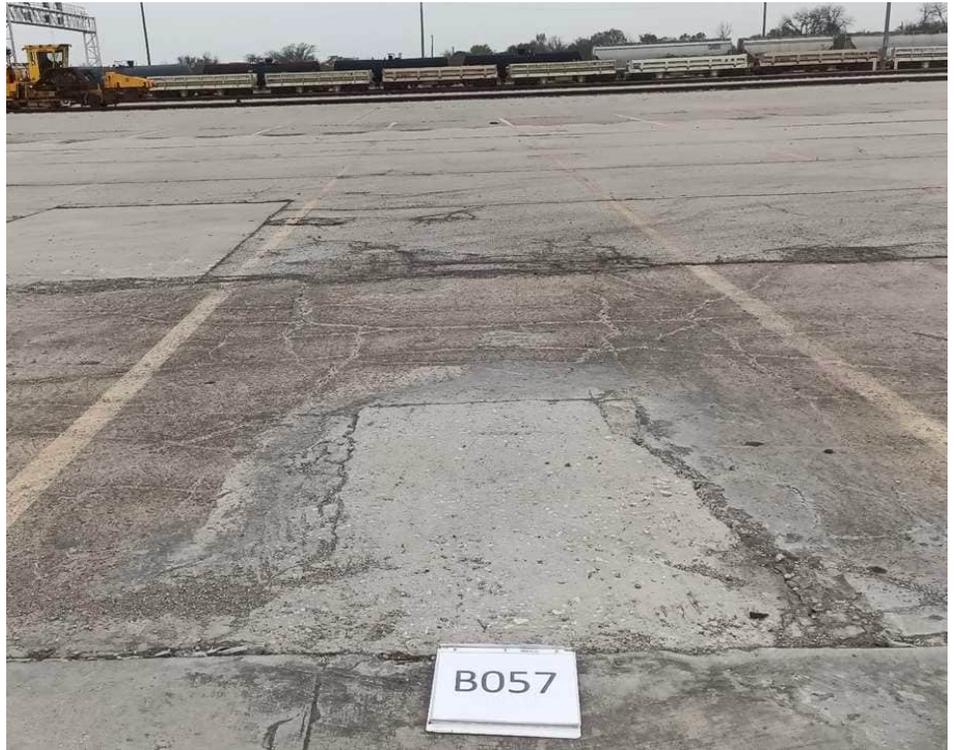
Stall B057 (joint), no new tar-like material observed at historical seep location at Test Pit B057.

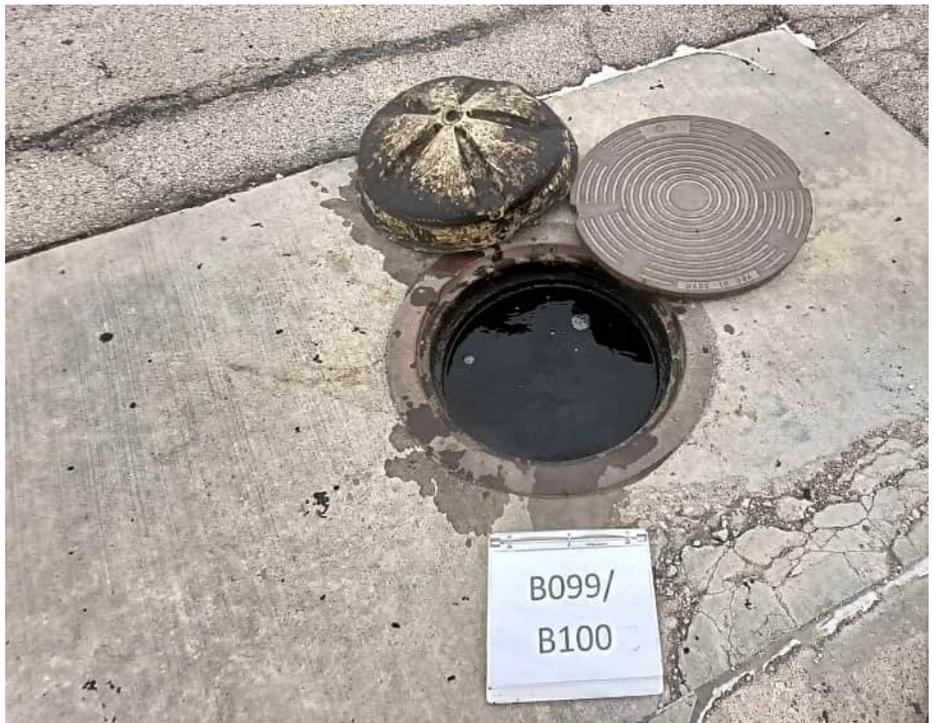
Photo No.:
58

Sump 1 (B099/B100), 4 inches of freeboard in sump, no sheen observed, water color noted as light brown.

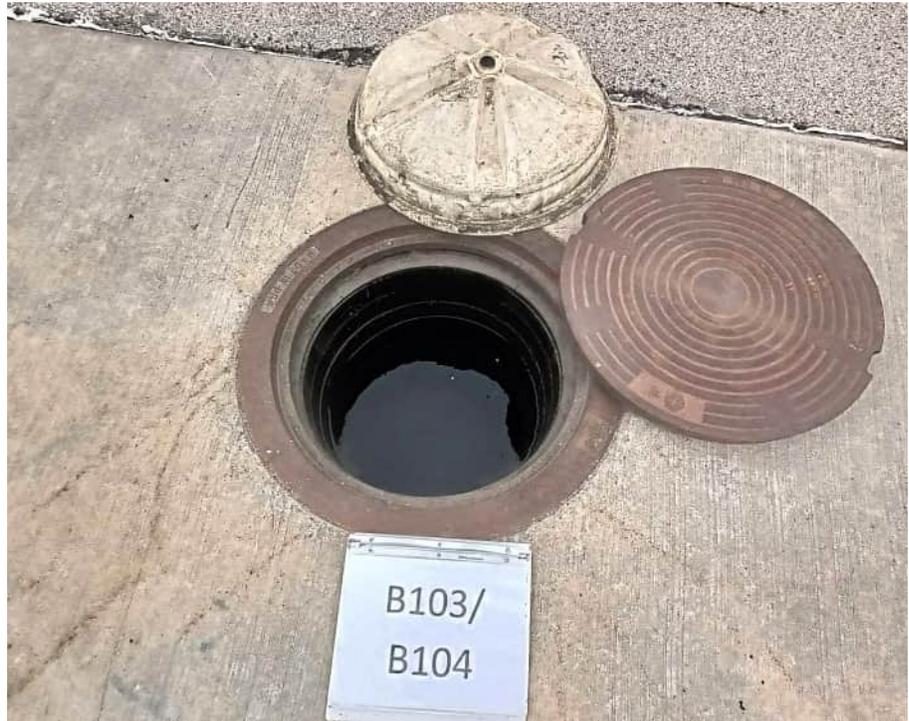
Sump 2 (B103/B104), 14 inches of freeboard in sump. No odor or sheen observed, color noted as clear.

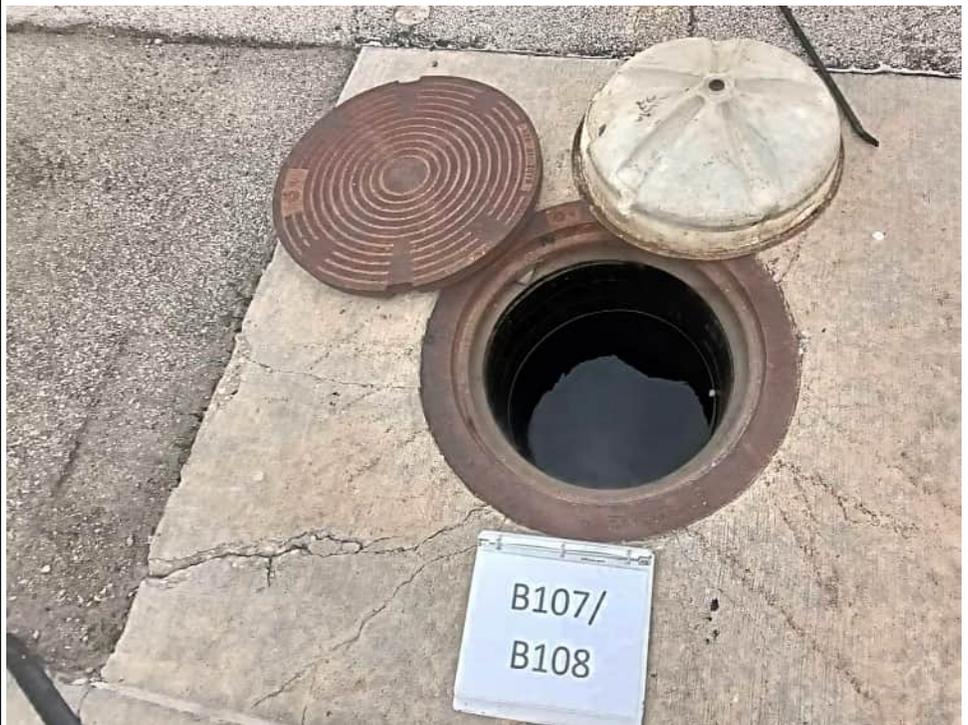
Photo No.
60

Sump 3 (B107/B108), 15 inches of freeboard in sump, no sheen observed, water color noted as clear.

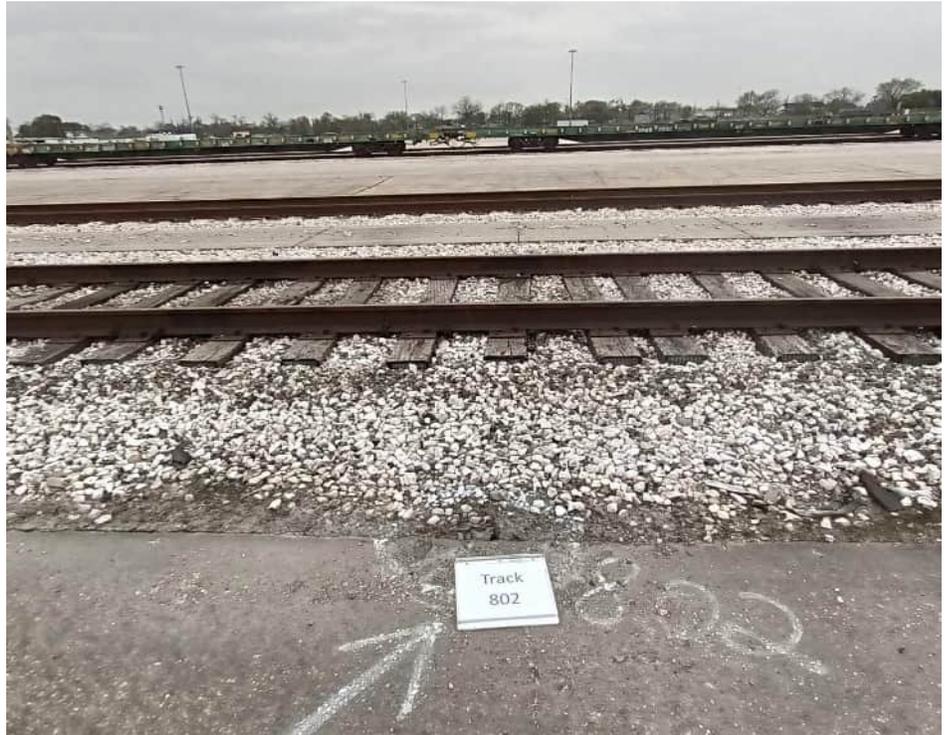
North side of Track 802, no new tar-like material observed at seep location near the edge of the ballast.

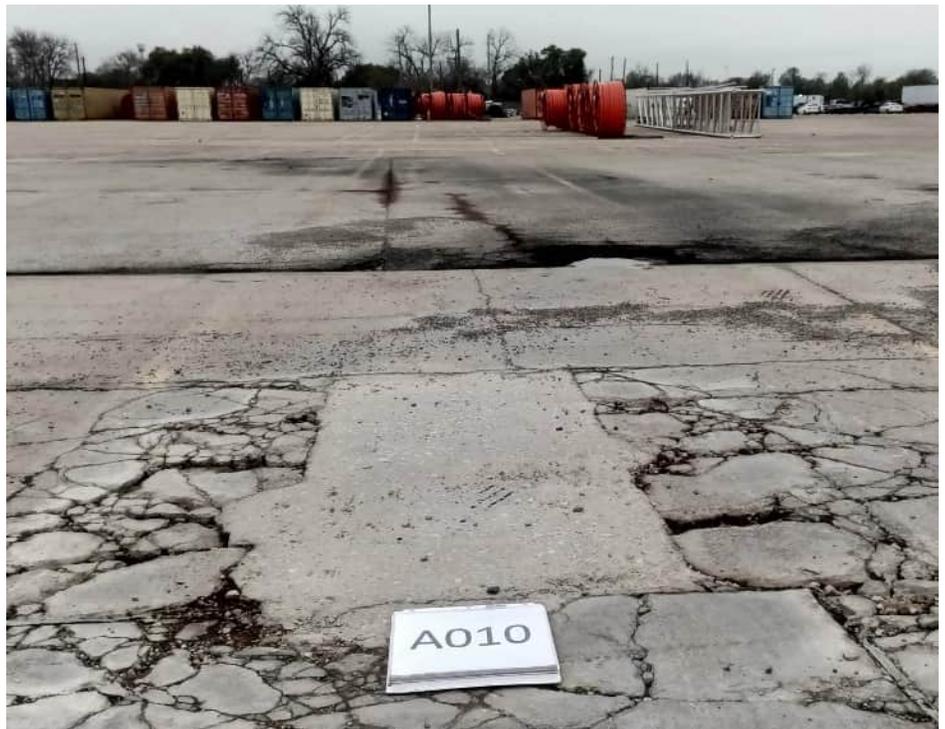
Photo No.
62

Stall A010. No seeps noted at Test Pit A010.

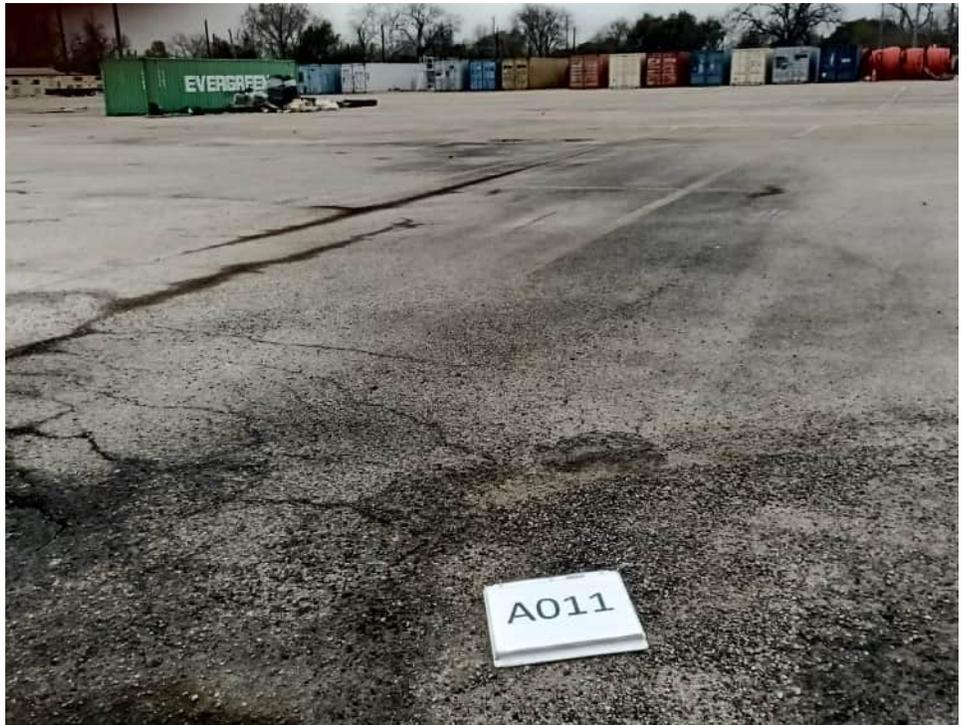
- A small amount of staining was visible at stall A011 during the inspection on February 28th (Photo No. 63). This is the first occurrence of the brown staining/residue since the last pressure washing event on August 18, 2023. This location will be monitored for the presence of brown colored seep water in this area. If seep water or heavy staining is observed in this area during the upcoming inspections, UPRR will mobilize a remediation contractor pressure wash and/or collect the water in the areas where the brown staining and seeps are observed.

Stall A011. No new tar-like material observed at historical seep location along asphalt crack. Some staining observed along cracks in pavement.

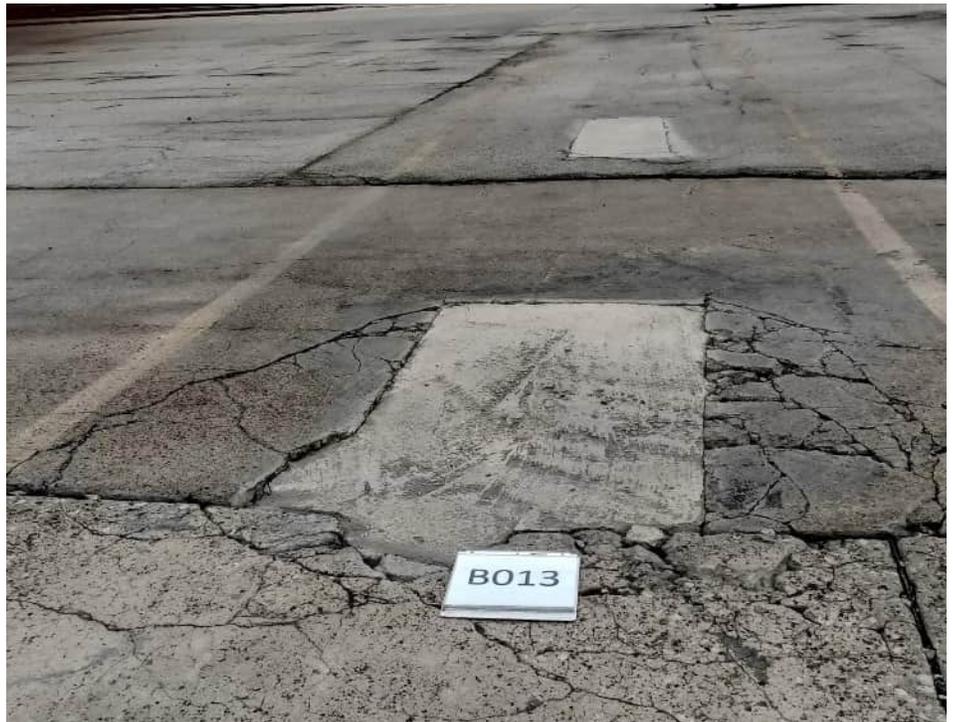
Photo No. 64	Inspection Date: 2/28/2024
-------------------------------	--------------------------------------

Stall B013. No seeps noted at Test Pit B013.

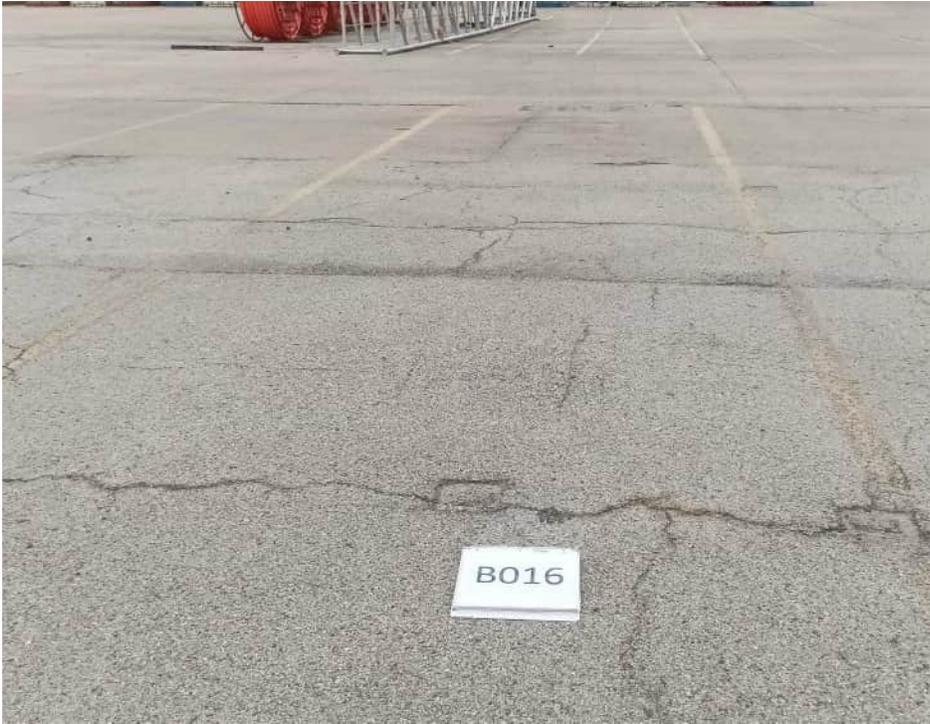
Photo No. 65	Inspection Date: 2/28/2024
Description: Stall B016. No tar-like material observed at historical seep location along asphalt crack. Lat: 29.785271 Long: -95.31841

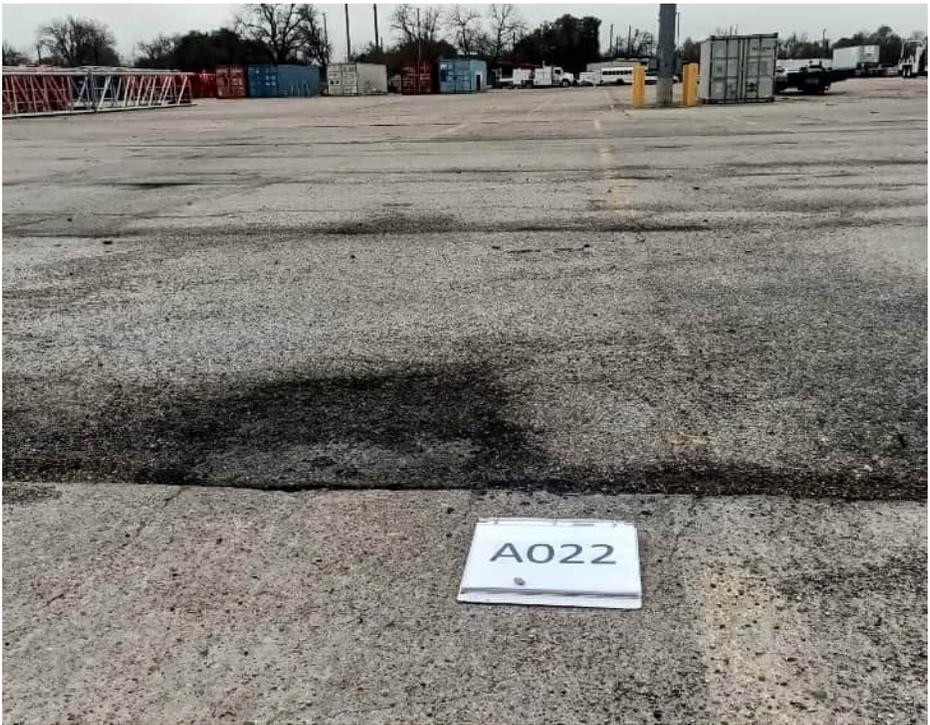
Photo No. 66	Inspection Date: 2/28/2024
Description: Stall A022, no new tar-like material observed at the seep location along the edge. Lat: 29.785381 Long: - 95.318619

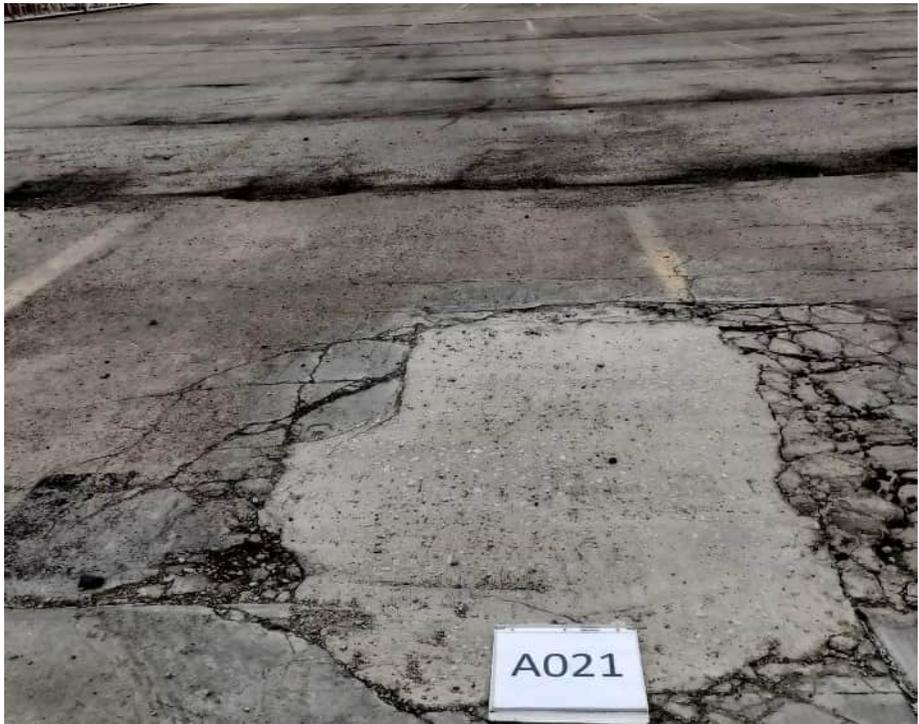
Photo No. 67	Inspection Date: 2/28/2024
Description: Stall A021. No seeps noted at Test Pit A021. Lat: 29.785387 Long: -95.318654

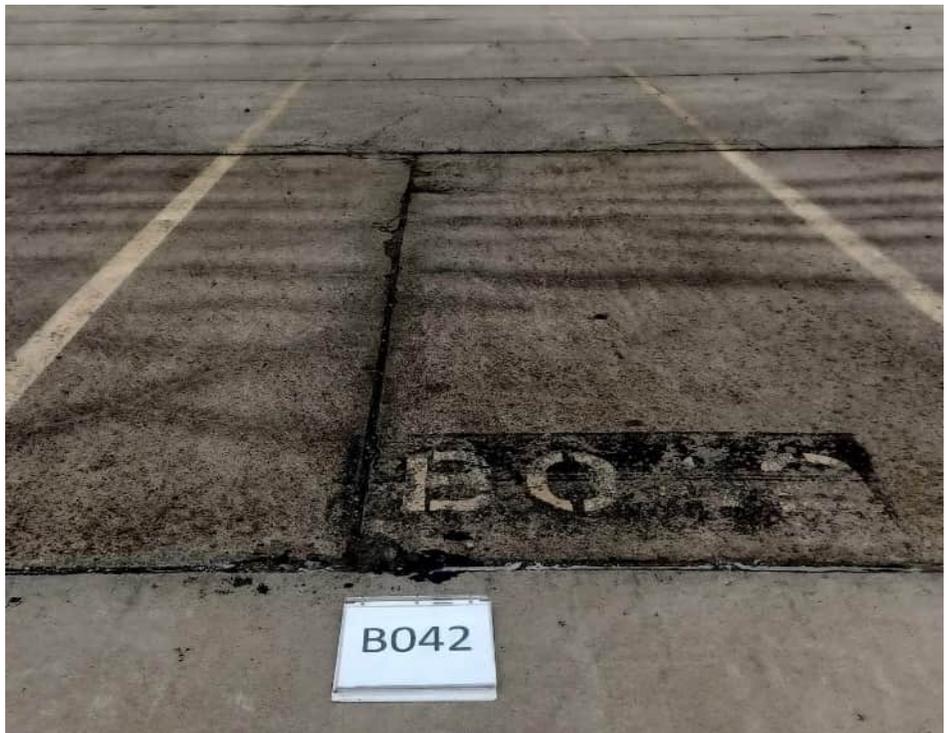
Photo No. 68	Inspection Date: 2/28/2024
Description: Stall B042. No new tar-like material observed at historical seep location along concrete joint. Lat: 29.784923 Long: -95.319124

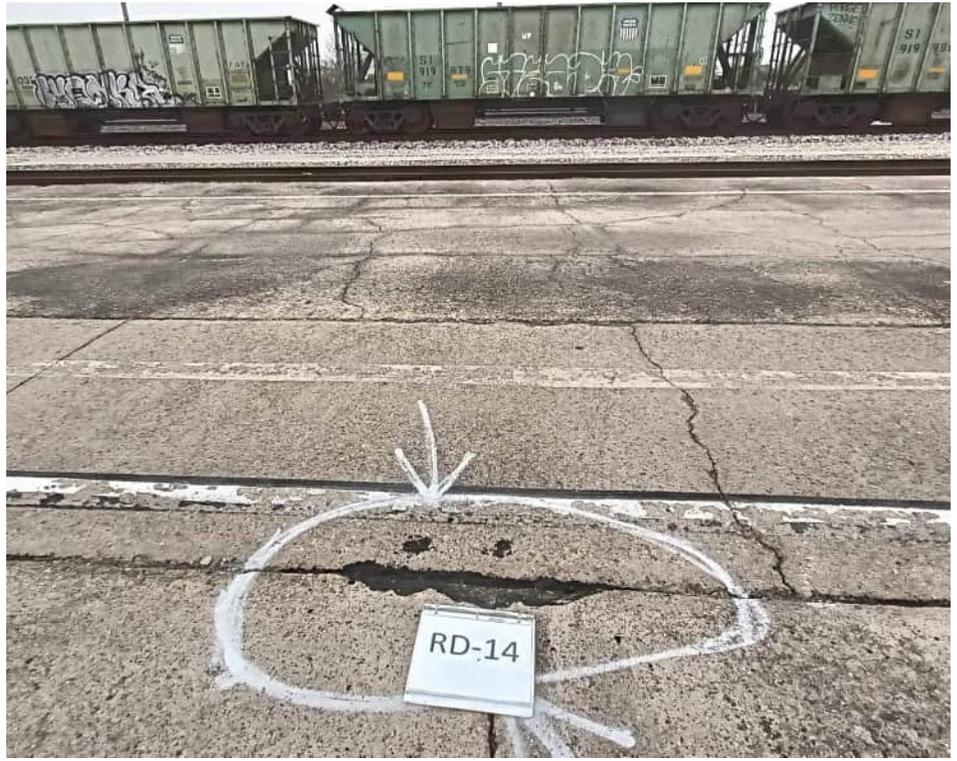
RD-14 Seep location observed within the concrete road area north of Track 802 (east of existing Track 802 seep location), no new tar-like material observed along a concrete joint.

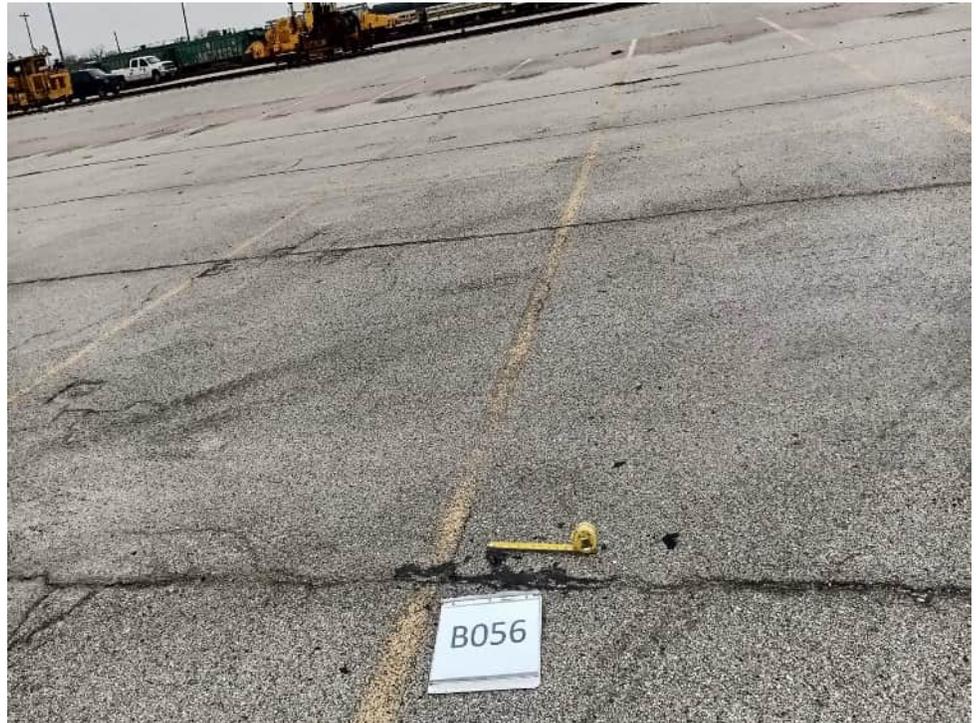
Photo No.
74

Stall B056. Some tar-like material observed at historical seep location along asphalt crack, material removed.
