March 15, 2024

Project No. 31406585.016

Re: **MONTHLY STATUS UPDATE – ENGLEWOOD INTERMODAL YARD – NAPL COLLECTION SYSTEM/CONCRETE CAP REPAIRS
UNION PACIFIC RAILROAD HOUSTON WOOD PRESERVING WORKS FACILITY
4910 LIBERTY ROAD FACILITY, HOUSTON, TEXAS
POST-CLOSURE CARE PERMIT NO. HW-50343; INDUSTRIAL SWR NO. 31547**

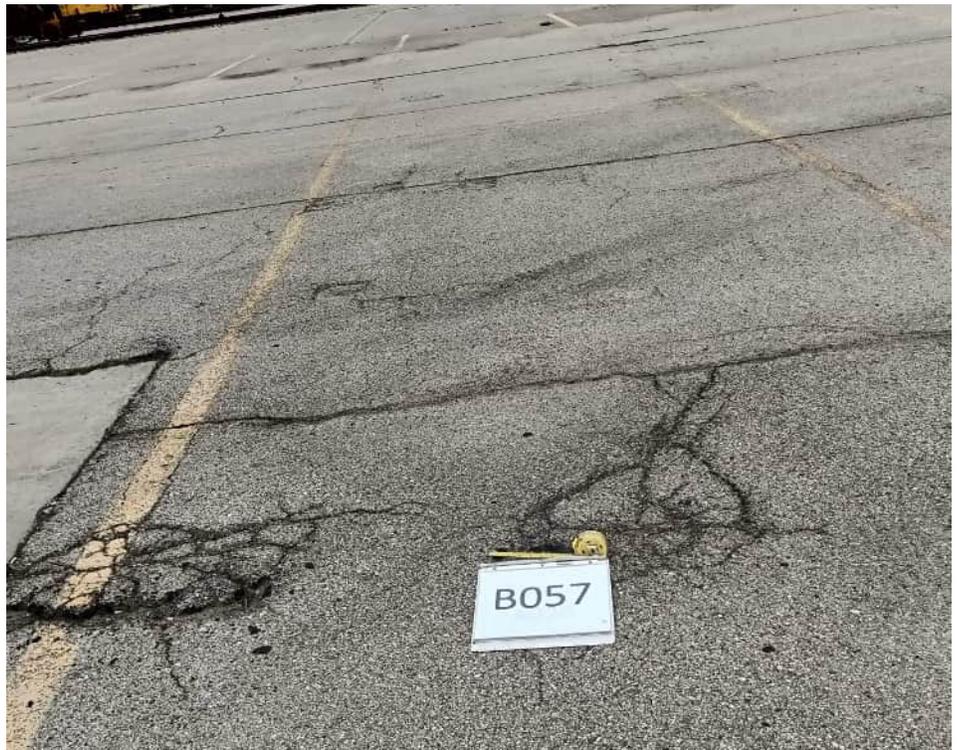
Seep Observations Outside the NAPL Collection System Area	
Stall Number	Observation Date(s)
B056	February 28 th (Photo No. 74)
B057	February 28 th (Photo No. 75)
B096	February 21 st and 28 th (Photo Nos. 51 and 77)
B100	February 21 st and 28 th (Photo Nos. 52 and 78)
Track 802	February 21 st (Photo No. 47)
RD-14	February 21 st (Photo No. 36)

Photo No. 75	Inspection Date: 2/28/2024
Description: Stall B057, some tar-like material observed and removed at seep location along asphalt crack. Lat: 29.784769 Long: -95.3195798

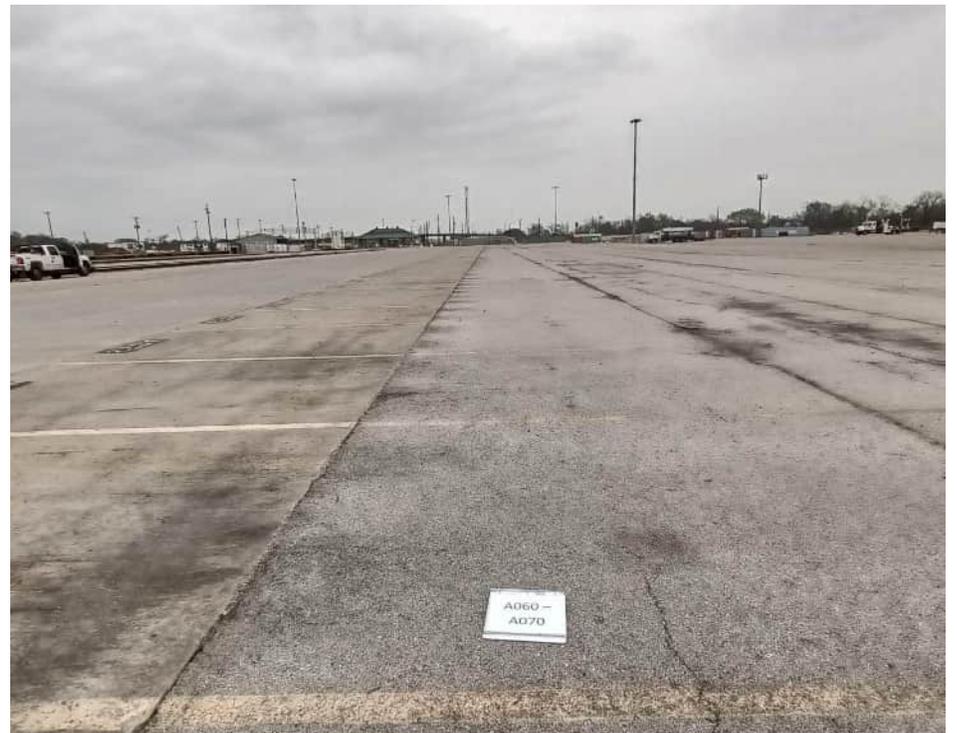
Photo No. 76	Inspection Date: 2/28/2024
Description: Stalls A060 - A070, some residual staining previously observed along cracks in pavement. No new water seeps observed. Viewing southwest. Lat: 29.784858 Long: -95.319733

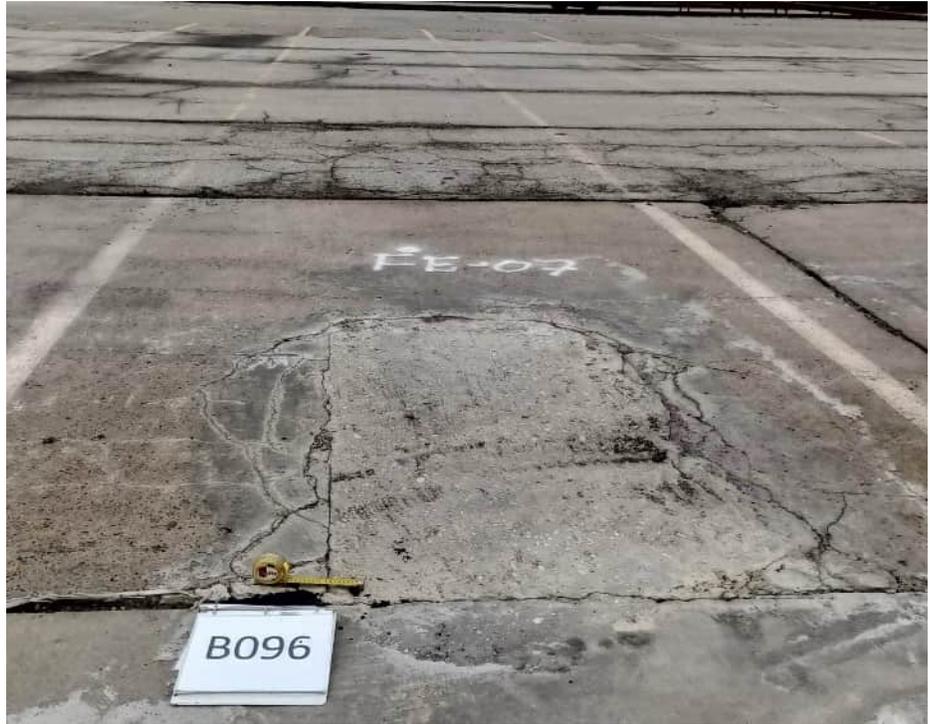
Photo No.: 77	Inspection Date: 2/28/2024
Description: Stall B096, some tar-like material observed at historical seep location along concrete joint next to Test Pit B096, material removed. Lat: 29.7842528 Long: -95.3206250

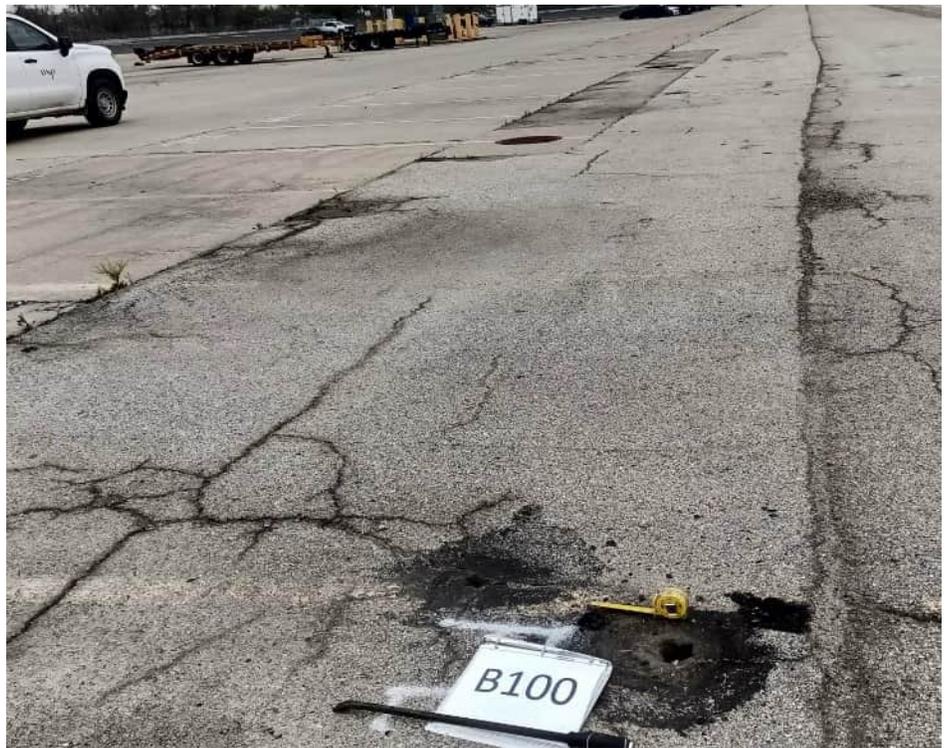
Photo No.: 78	Inspection Date: 2/28/2024
Description: Stall B100, some tar-like material observed at seep location along asphalt crack/ hole in the asphalt, material removed. Lat: 29.7842528 Long: - 95.3206250

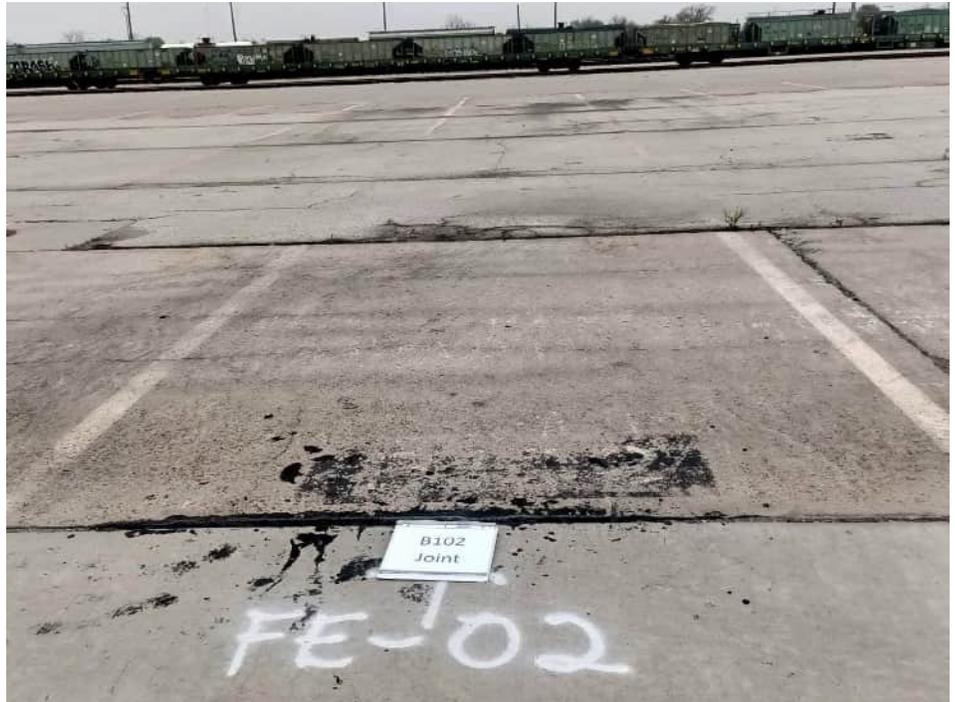
Stall B102 Joint, no new tar-like material observed at seep location along stall joint.

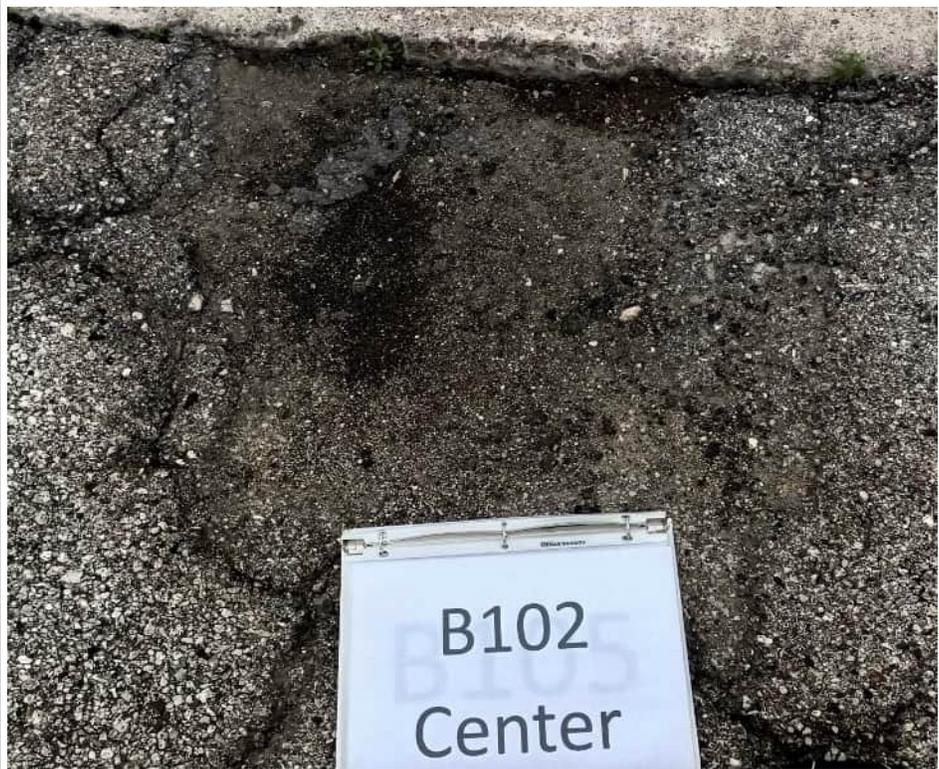
Photo No.
80

Stall B102 (center), no seep observed.

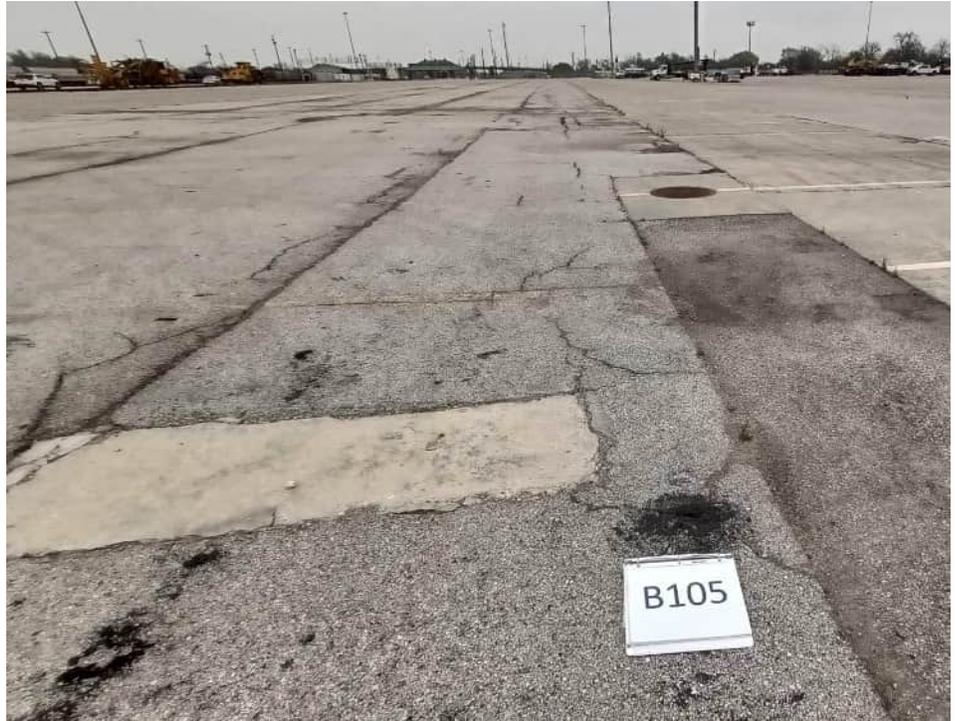
Stall B105, no new tar-like material observed at the historical seep location along asphalt crack.

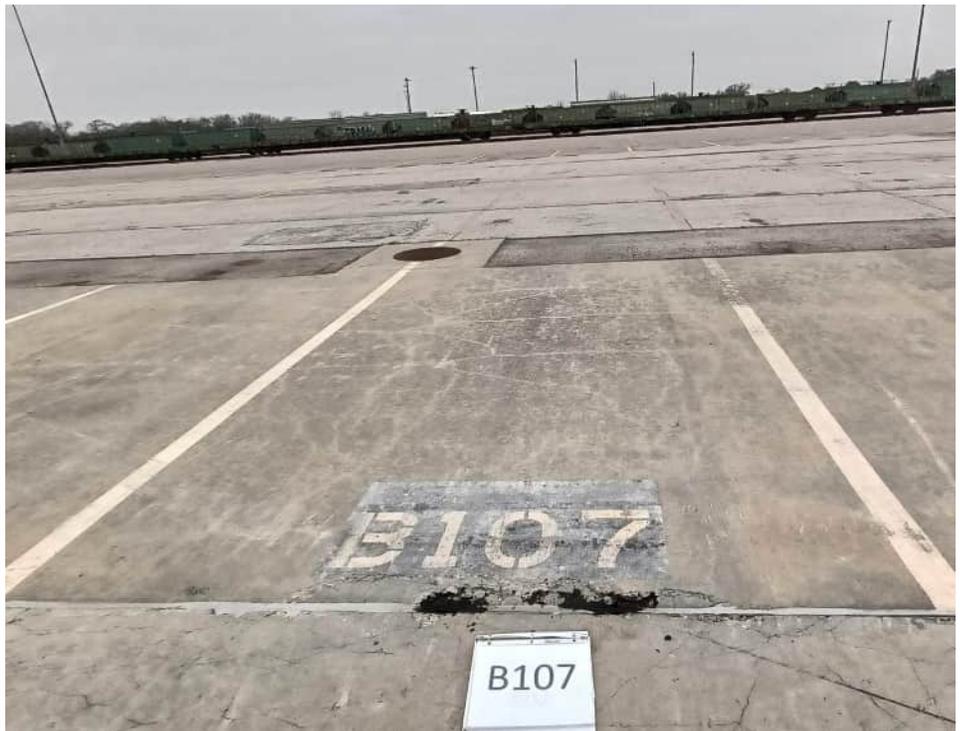
Photo No.
82

- No new tar-like material seeps were observed along the concrete joint between the NAPL Collection System and the existing concrete at Stall B107 during the February 2024 inspections (Photo Nos. 12, 23, 56, 82).

Stalls B107, no new tar-like material observed at seep location on concrete joint along the southern edge of the excavated area.
