April 15, 2024

Project No. 31406585.016

**Re: MONTHLY STATUS UPDATE – ENGLEWOOD INTERMODAL YARD – NAPL COLLECTION
SYSTEM/CONCRETE CAP REPAIRS
UNION PACIFIC RAILROAD HOUSTON WOOD PRESERVING WORKS FACILITY
4910 LIBERTY ROAD FACILITY, HOUSTON, TEXAS
POST-CLOSURE CARE PERMIT NO. HW-50343; INDUSTRIAL SWR NO. 31547**

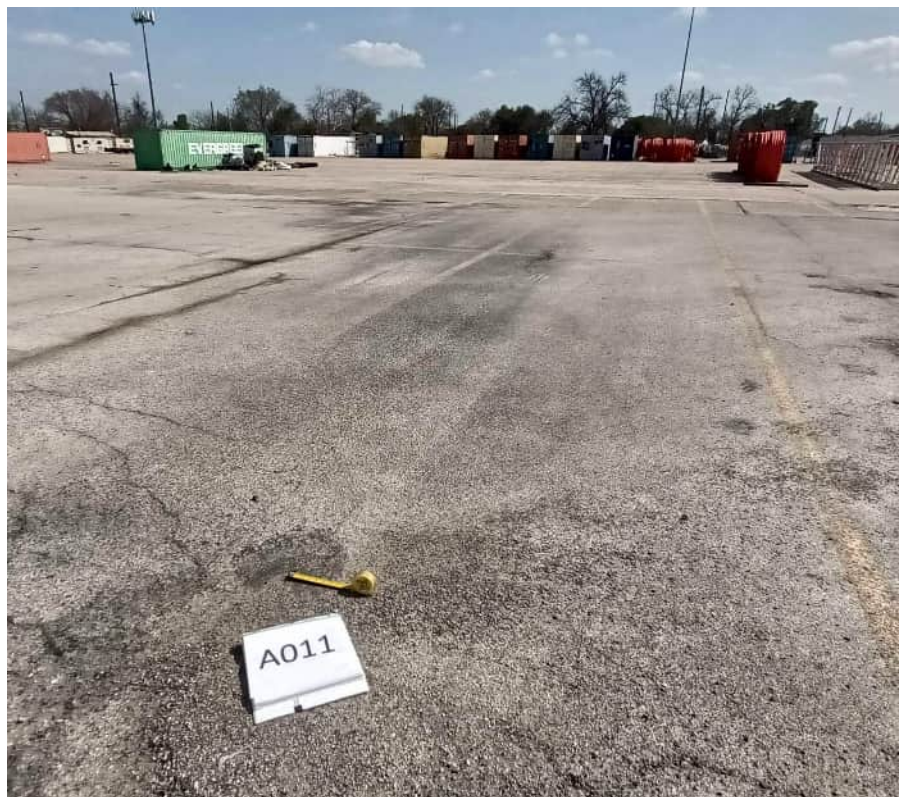
| Seep Observations Outside the NAPL Collection System Area | |
|---|--|
| A011 | March 6 th (Photo No. 2) |

Stall A011. Some tar-like material observed at historical seep location along asphalt crack, material removed.

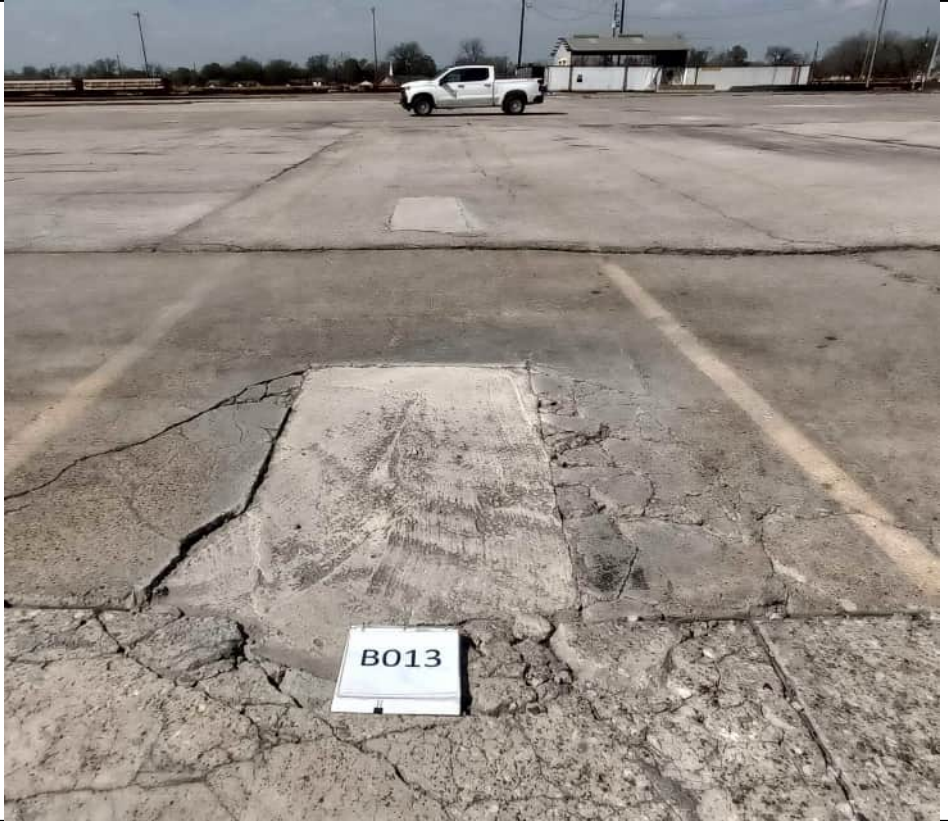
Stall B013. No seeps noted at Test Pit B013.

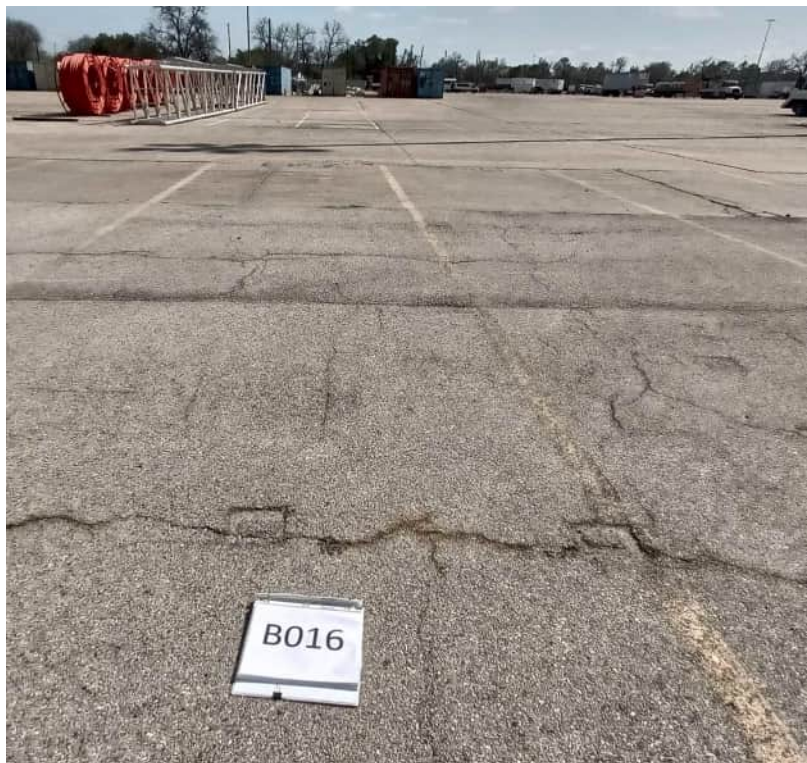
Photo No.
6

Stall B016. No tar-like material observed at historical seep location along asphalt crack.

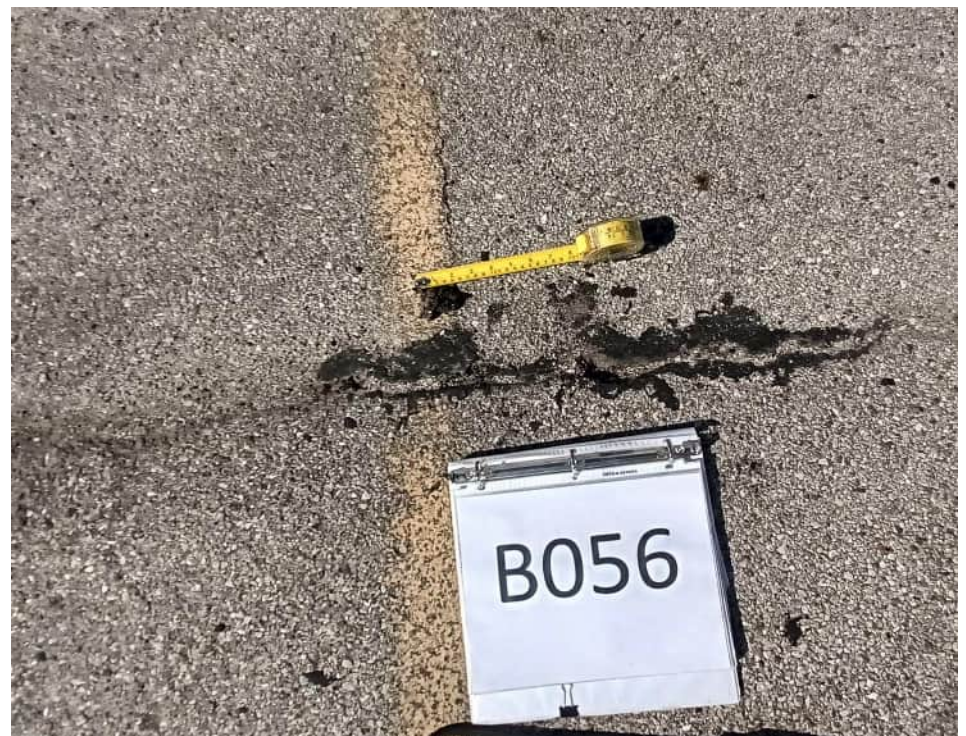
Photo No.
8

| Seep Observations Outside the NAPL Collection System Area | |
|---|--|
| B056 | March 6 th and 27 th (Photo Nos. 8 and 78) |

Stall B056. Some tar-like material was observed and removed from historical seep location along asphalt crack.

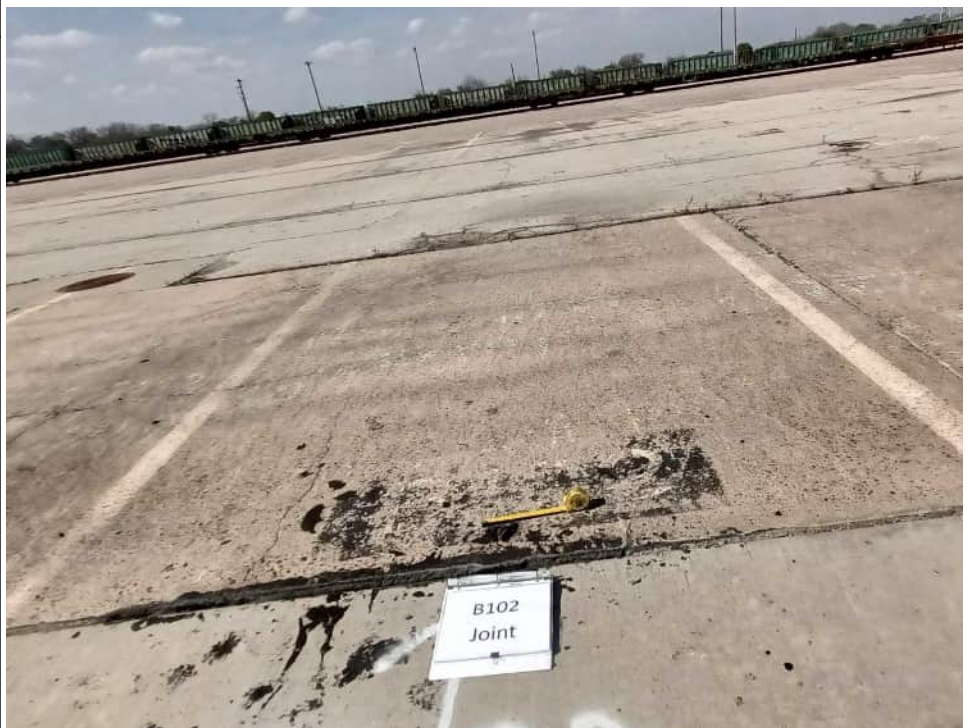
Photo No.
10

| Seep Observations Outside the NAPL Collection System Area | |
|---|--|
| B102 Joint | March 6 th (Photo No. 10) |

Stall B102 (joint) some tar-like material observed at historical seep site along concrete joint, material removed.

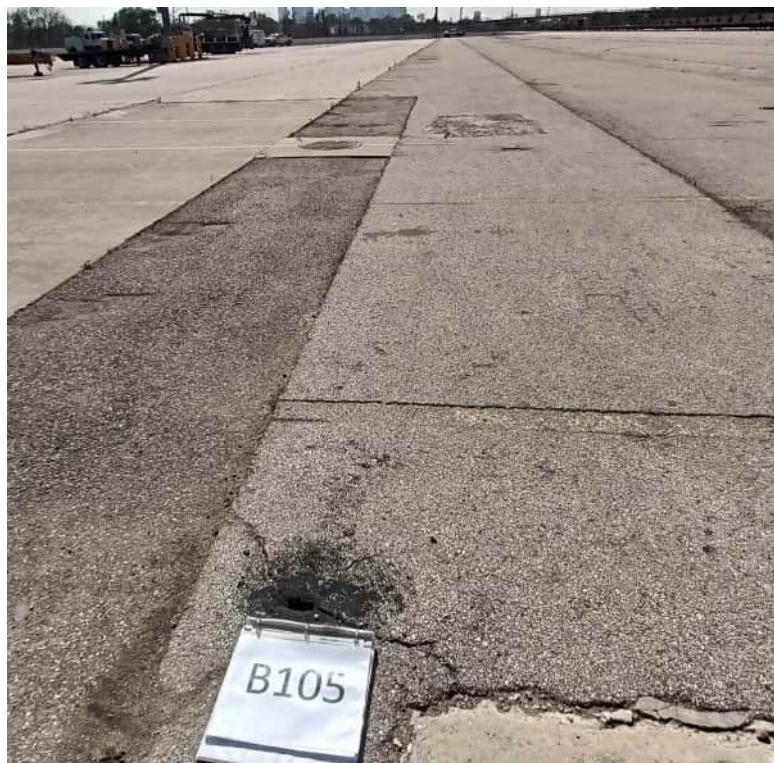
Photo No.
12

Stall B105, no new tar-like material observed at the historical seep location along asphalt crack.

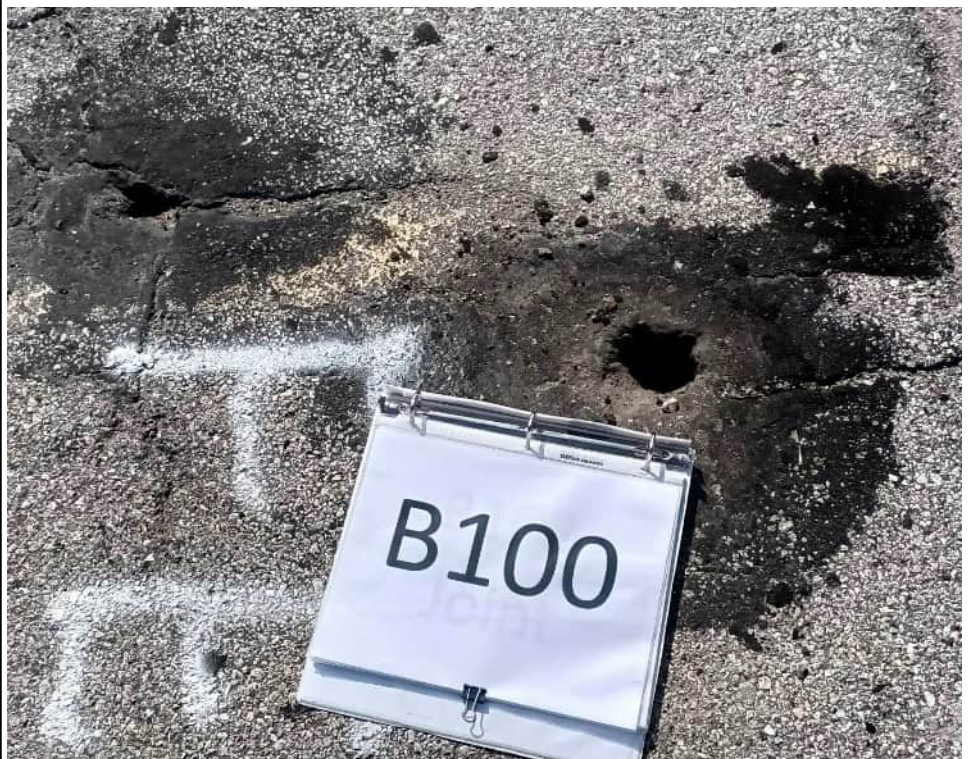
Photo No.
14

| Seep Observations Outside the NAPL Collection System Area | |
|---|--|
| B100 | March 6 th (Photo No. 14) |

Stall B100, some tar-like material observed on concrete crack/hole in concrete, material removed.

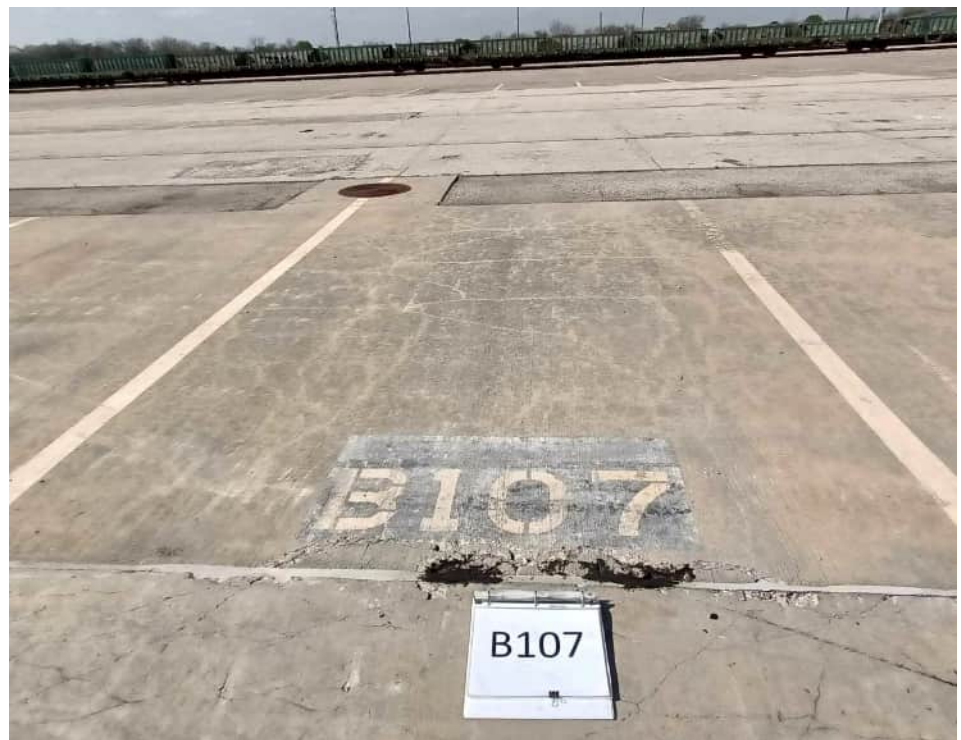
Photo No.
16

- No new tar-like material seeps were observed along the concrete joint between the NAPL Collection System and the existing concrete at Stall B107 during the March 2024 inspections (Photo Nos. 16, 27, 62, 64).
- For areas outside the NAPL Collection System, a small amount of tar-like material was observed on the concrete or asphalt surface at the following locations during the March 2024 weekly inspections. The tar-like material was recovered from these locations when observed:

Stall B107, no new tar-like material observed at seep location on concrete joint along the southern edge of the excavated area.

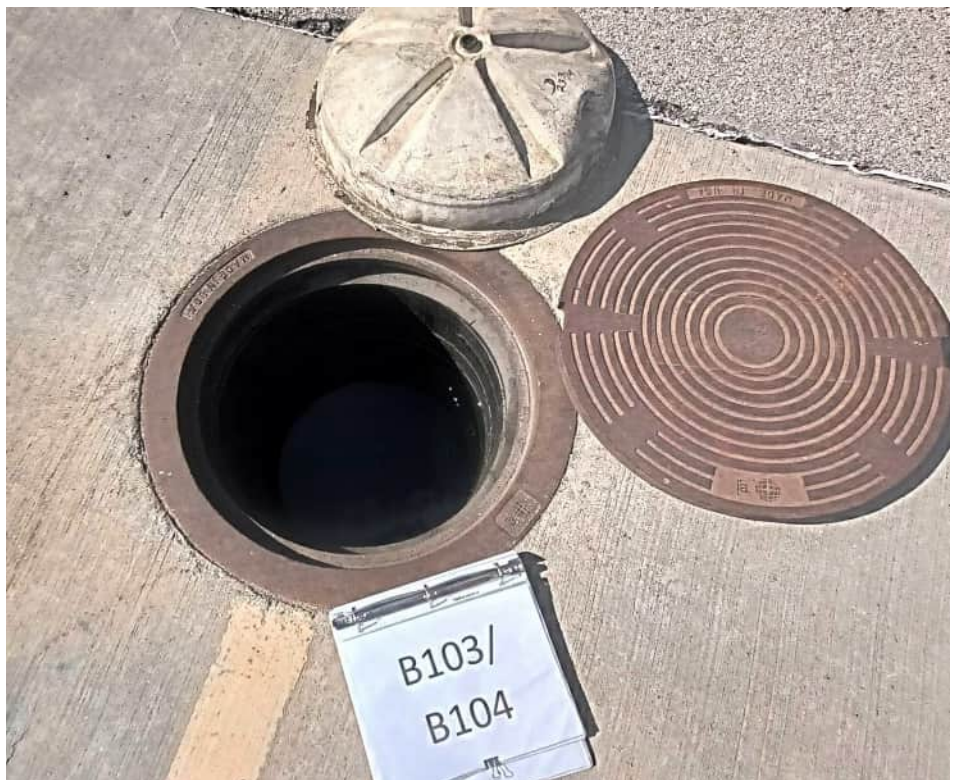
Photo No.
18

Sump 2 (B103/B104), 15 inches of freeboard in sump. No odor or sheen observed, color noted as clear.

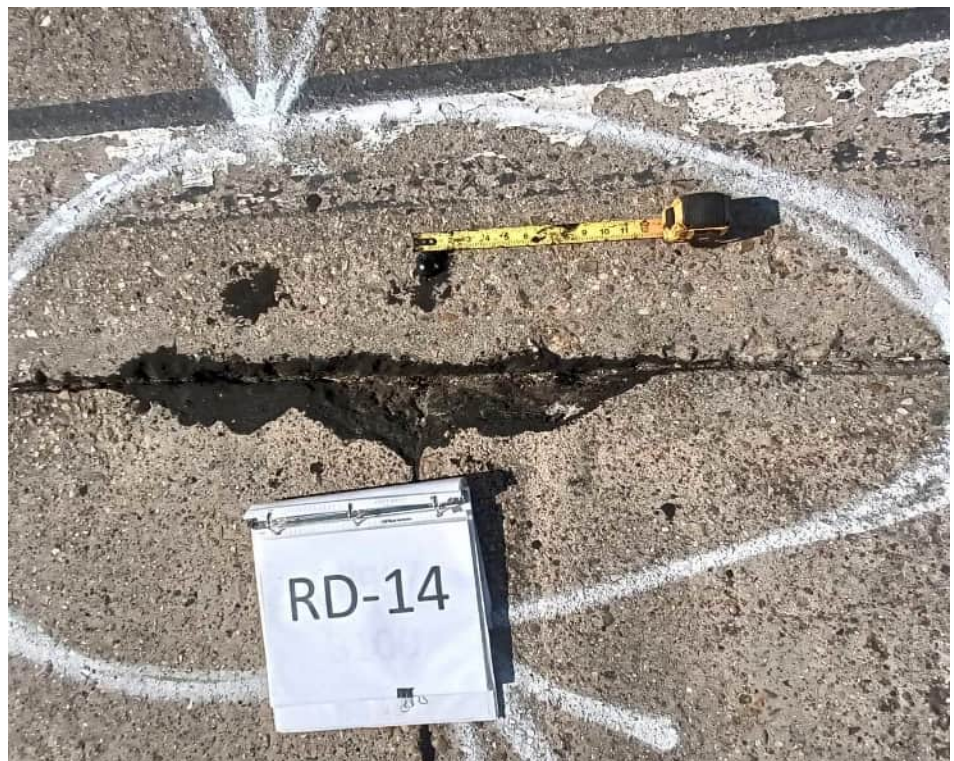
| Seep Observations Outside the NAPL Collection System Area | |
|---|--|
| RD-14 | March 6 th , 20 th and 27 th (Photo Nos. 20, 63 and 77) |

RD-14 Seep location observed within the concrete road area north of Track 802 (east of existing Track 802 seep location). Some tar-like material observed along a concrete joint, material removed.

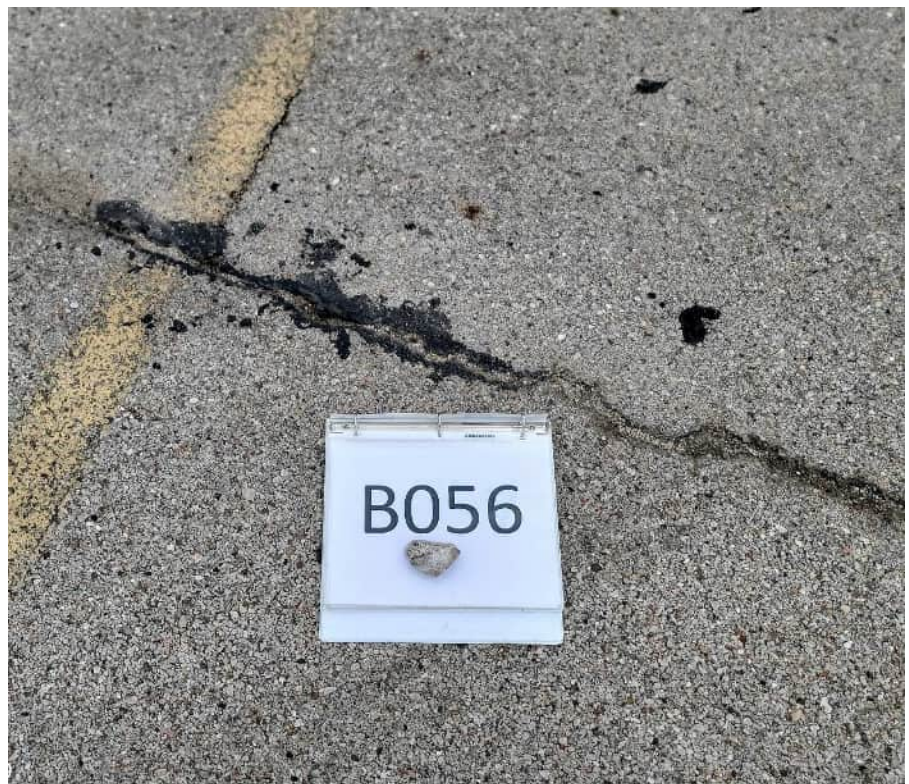
Photo No.
22

Stall B056. No new tar-like material observed at historical seep location along asphalt crack.

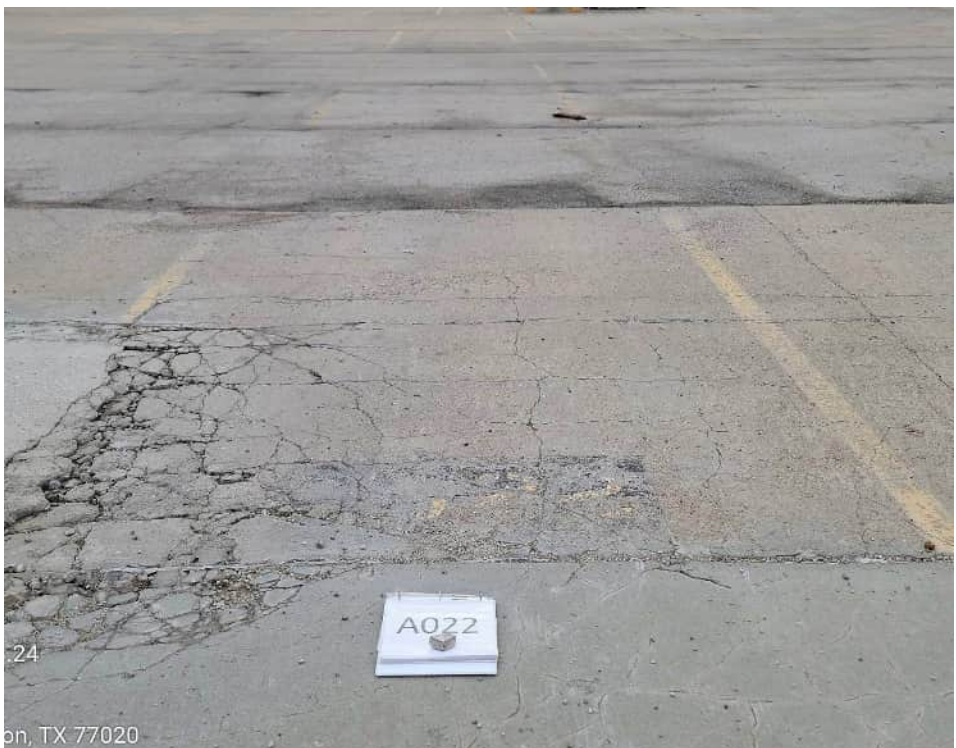
Photo No.
24

Stall A022. No new tar-like material observed at historical seep location along asphalt crack.

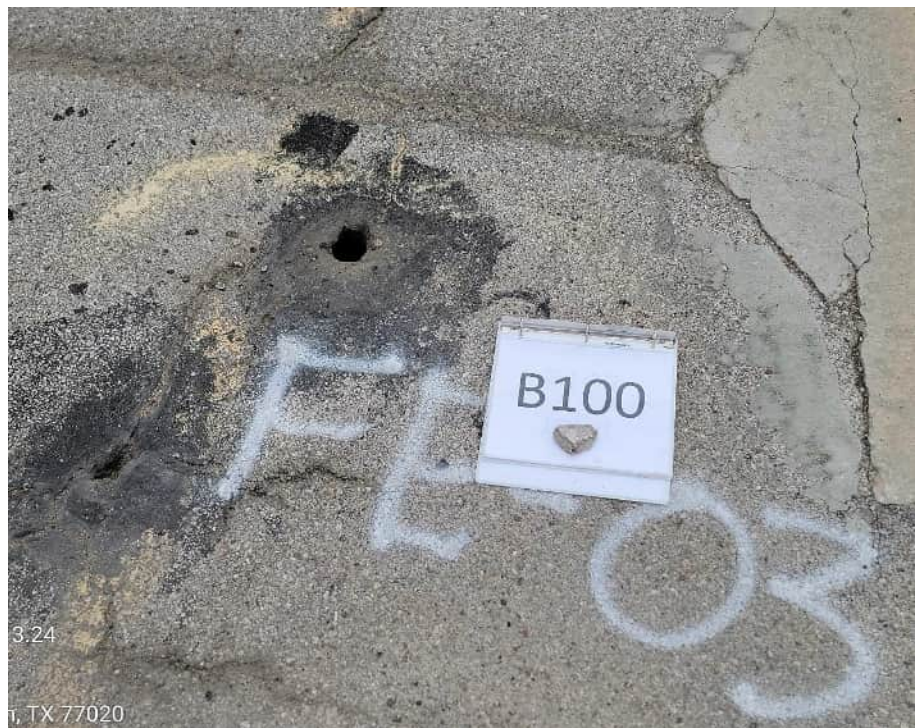
Photo No.
30

Stall B100, no new tar-like material observed at seep location along asphalt crack/ hole in the asphalt.

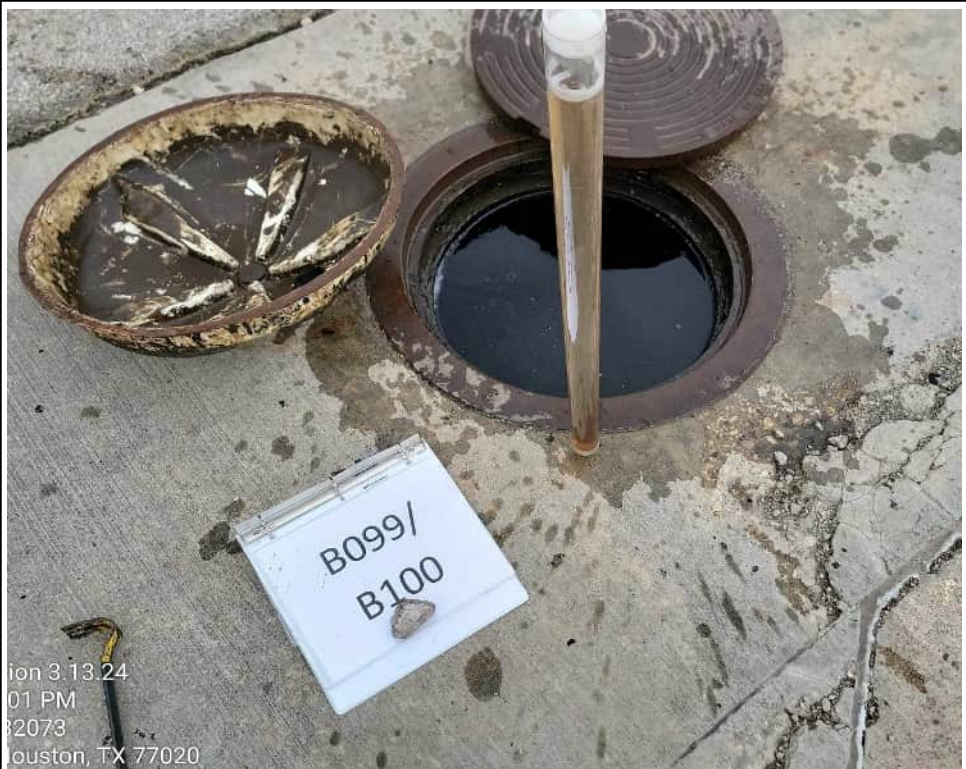
Photo No.
32

Sump 1 (B099/B100), 0 inches of freeboard in sump, no sheen observed, water color noted as light brown.

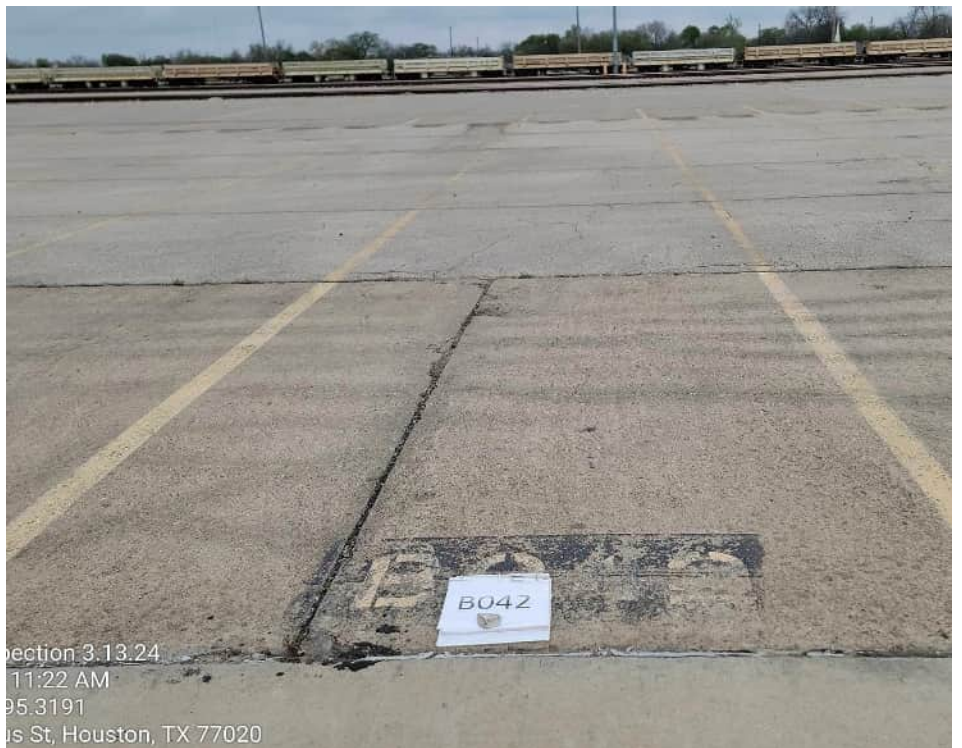
Photo No.
36

Stall B042. No new tar-like material observed at historical seep location along concrete crack.

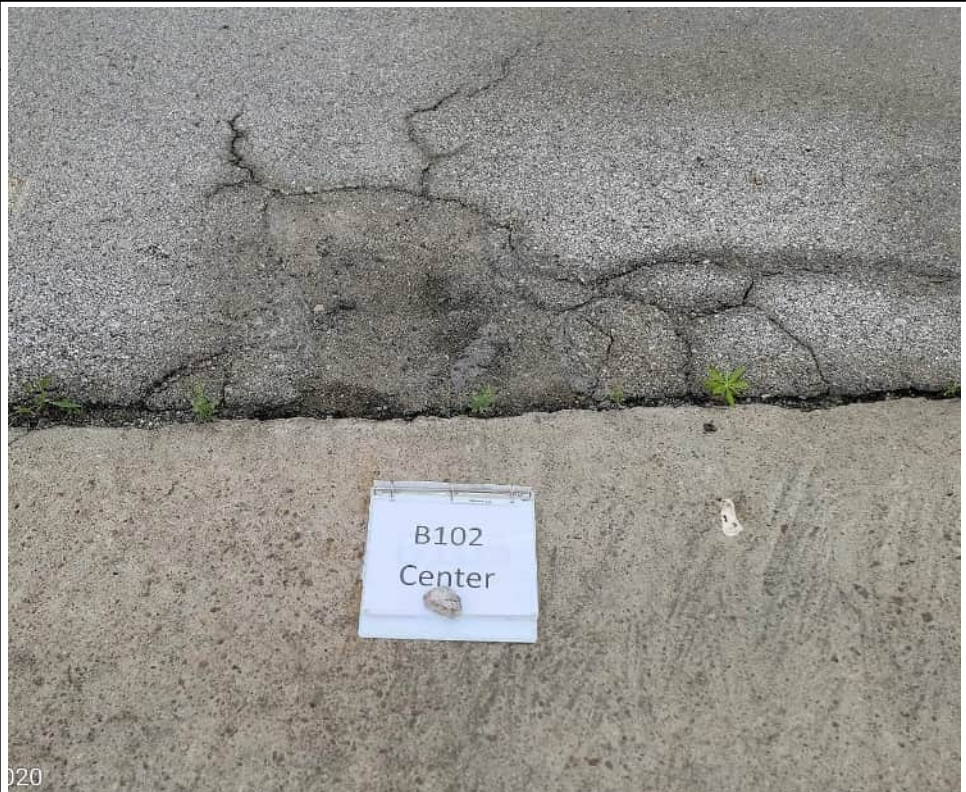
Photo No.
38

Stall B102 (center), no tar-like material observed at seep location along cracks in pavement.

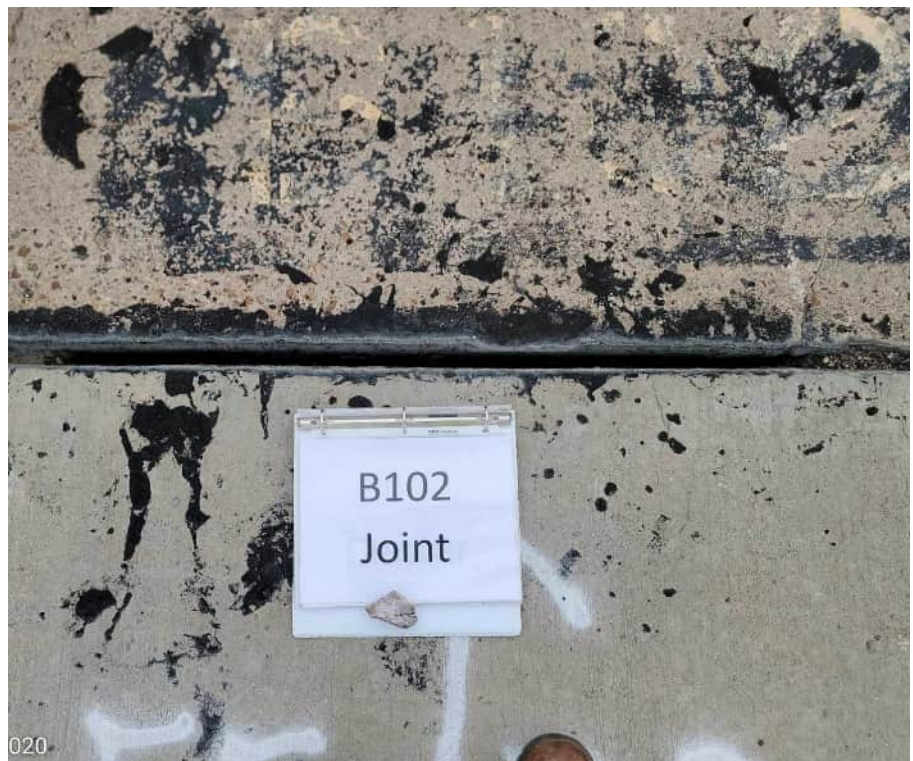
Photo No.
40

Stall B102 (joint) no new tar-like material observed at historical seep site along concrete joint.

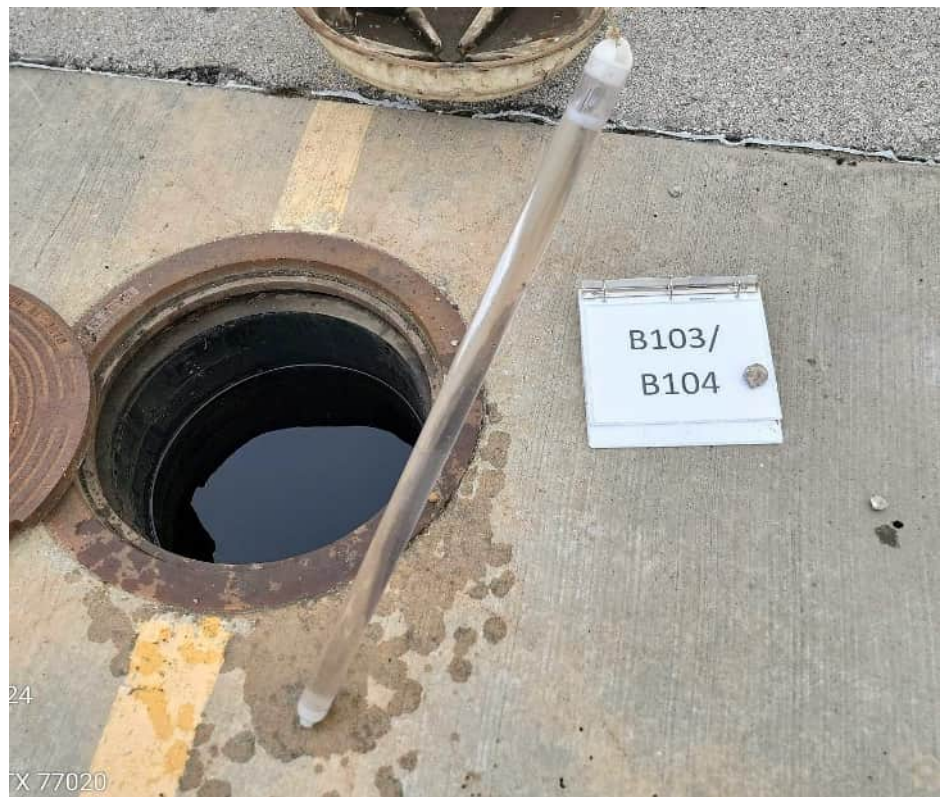
Photo No.
44

Sump 2 (B103/B104), 7.5 inches of freeboard in sump. No odor or sheen observed, color noted as clear.

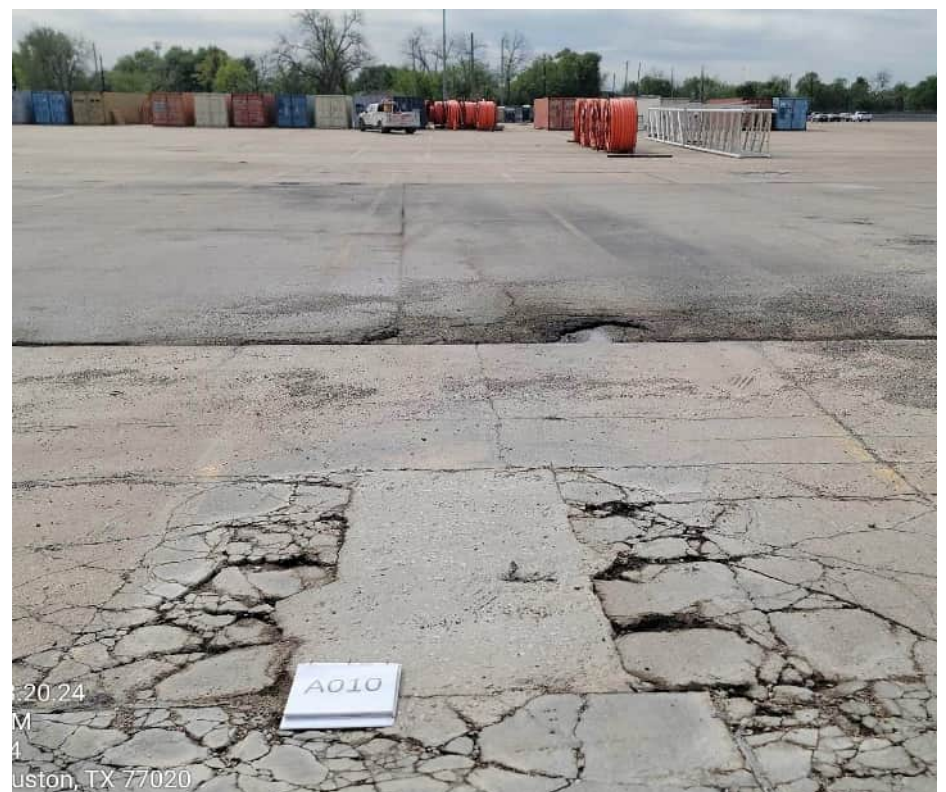
Photo No.
46

Stall A010. No seeps noted at Test Pit A010.

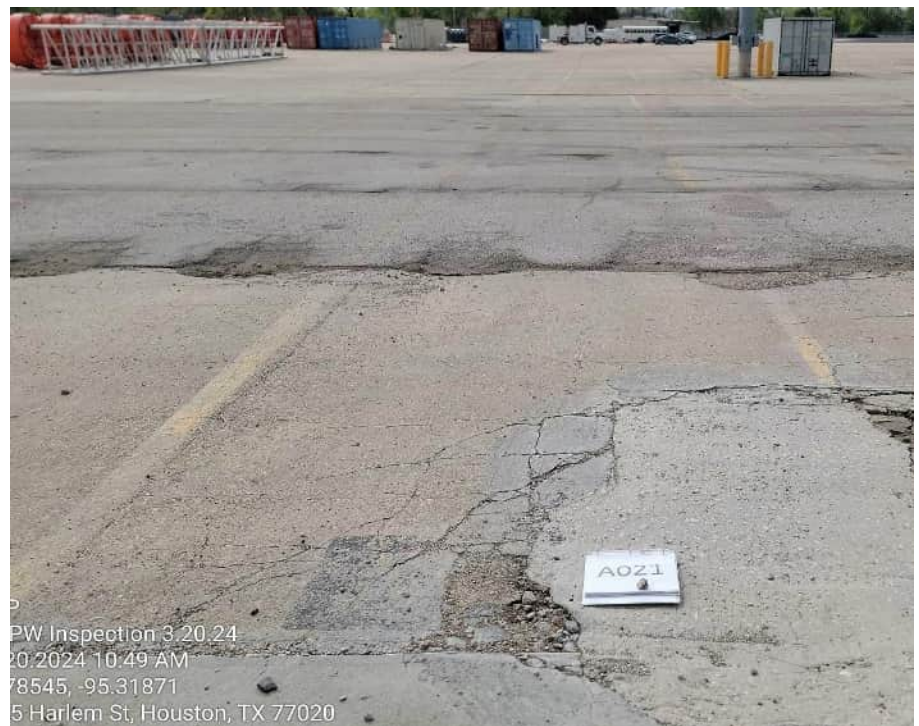
Photo No.
48

Stall A021. No seeps noted at Test Pit A021.

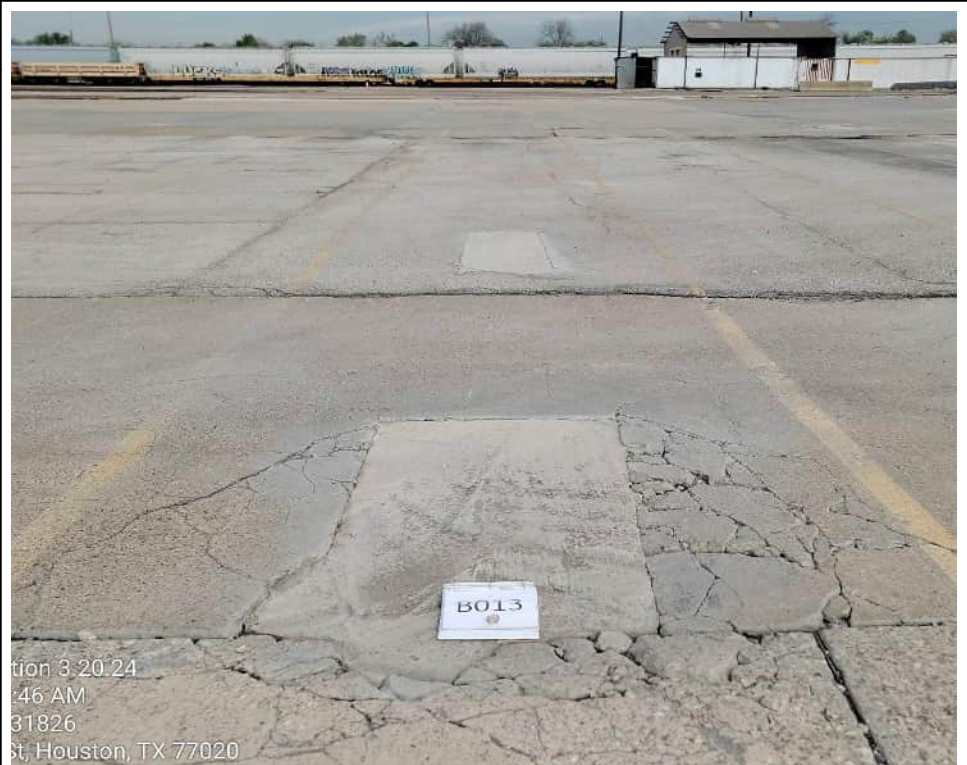
Photo No.
50

Stall B013. No seeps noted at Test Pit B013.

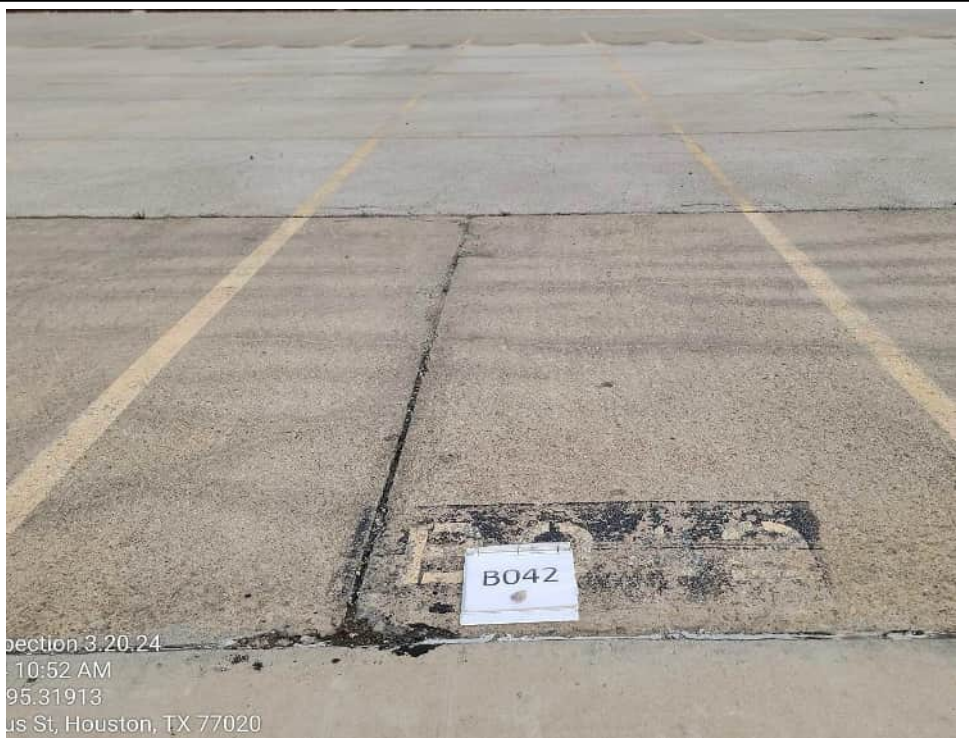
Photo No.
52

Stall B042. No new tar-like material observed at historical seep location along asphalt crack.

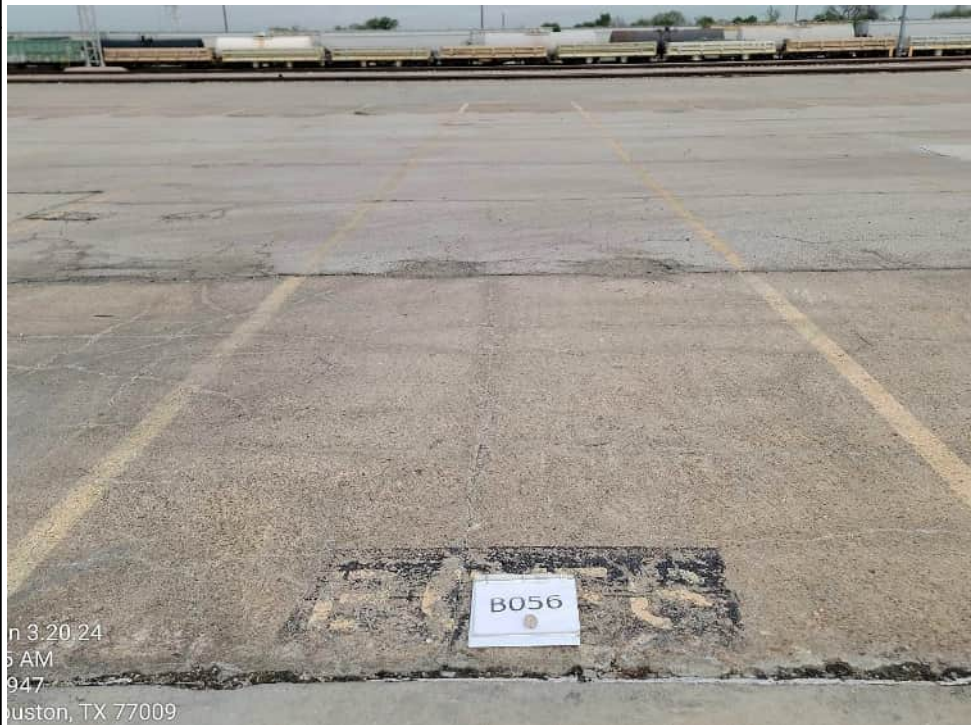
Photo No.
54

Stall B056. No new tar-like material observed at historical seep location along asphalt crack.

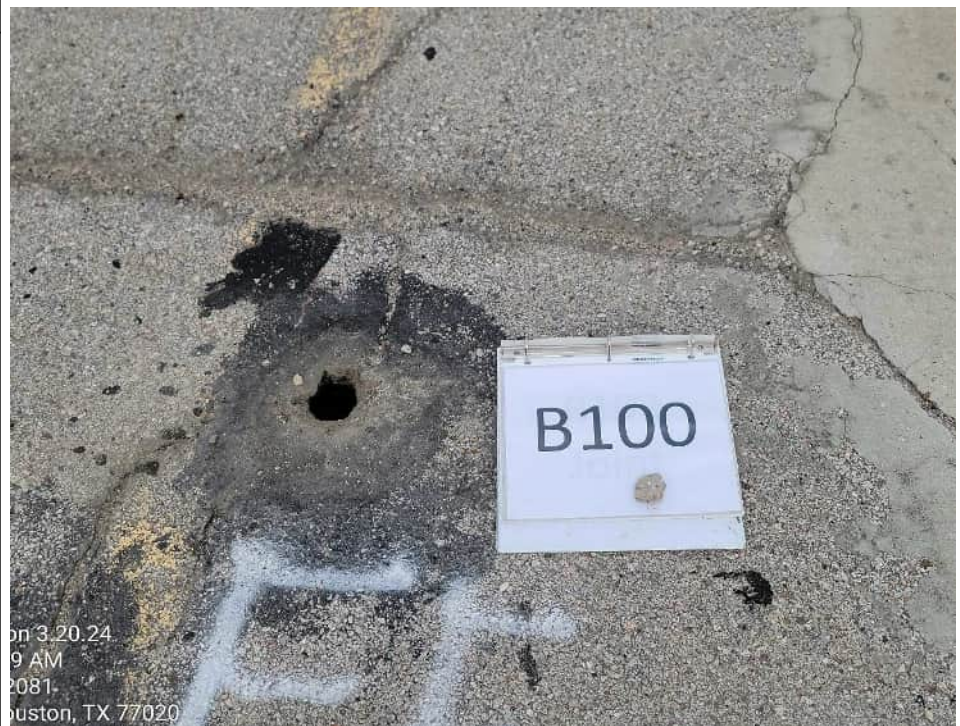
Photo No.
58

Stall B100, no new tar-like material observed at seep location along asphalt crack/ hole in the asphalt.

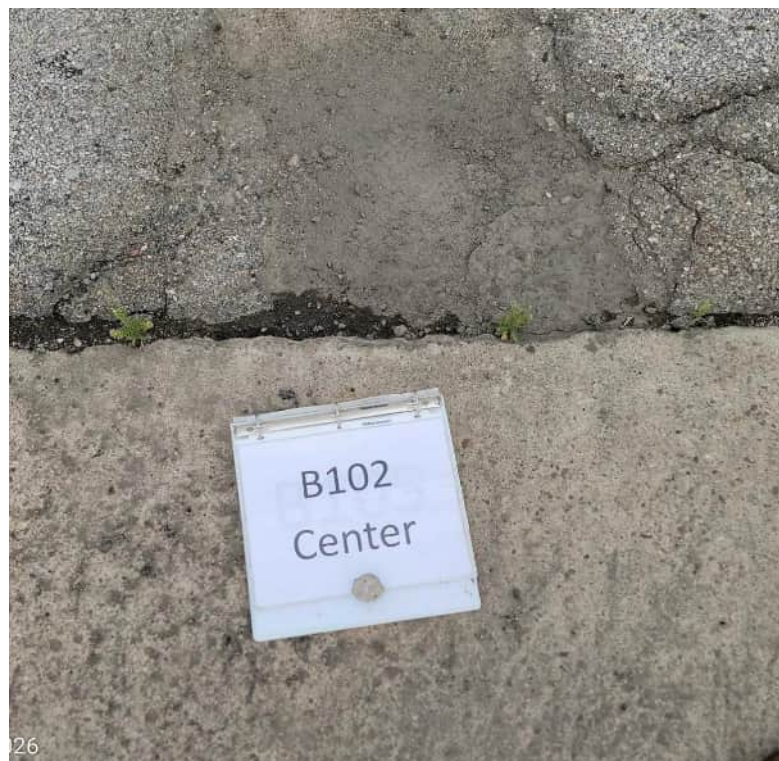
Photo No.
60

Stall B102 (center), no tar-like material observed at seep location where pavement is cracked.

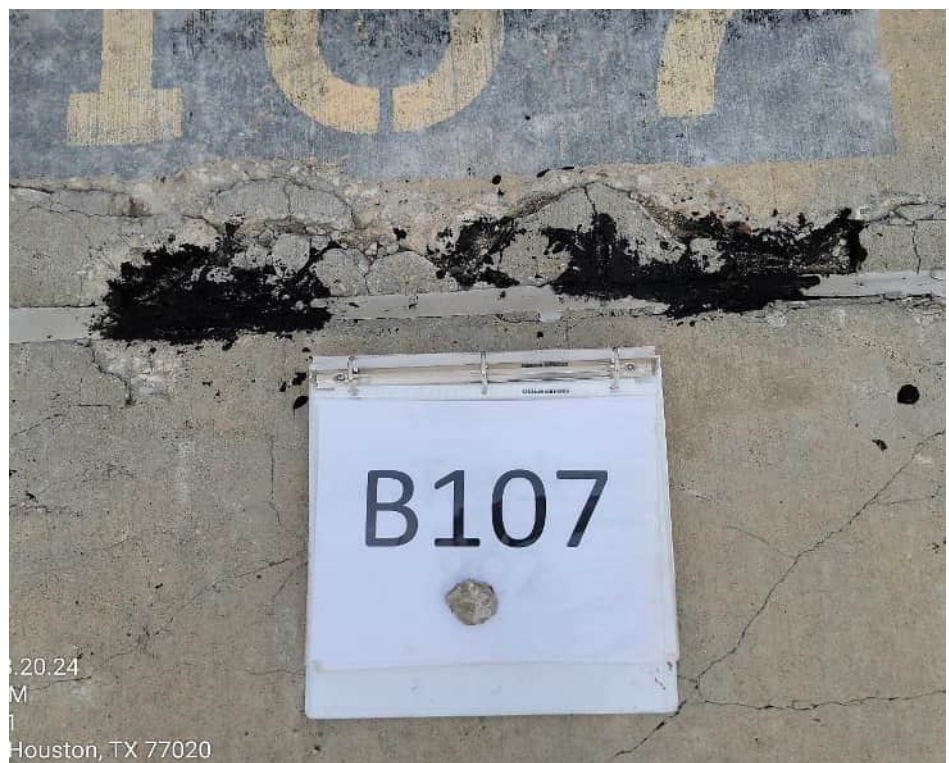
Photo No.
62

Stalls B107, no new tar-like material observed at seep location on concrete joint along the southern edge of the excavated area.

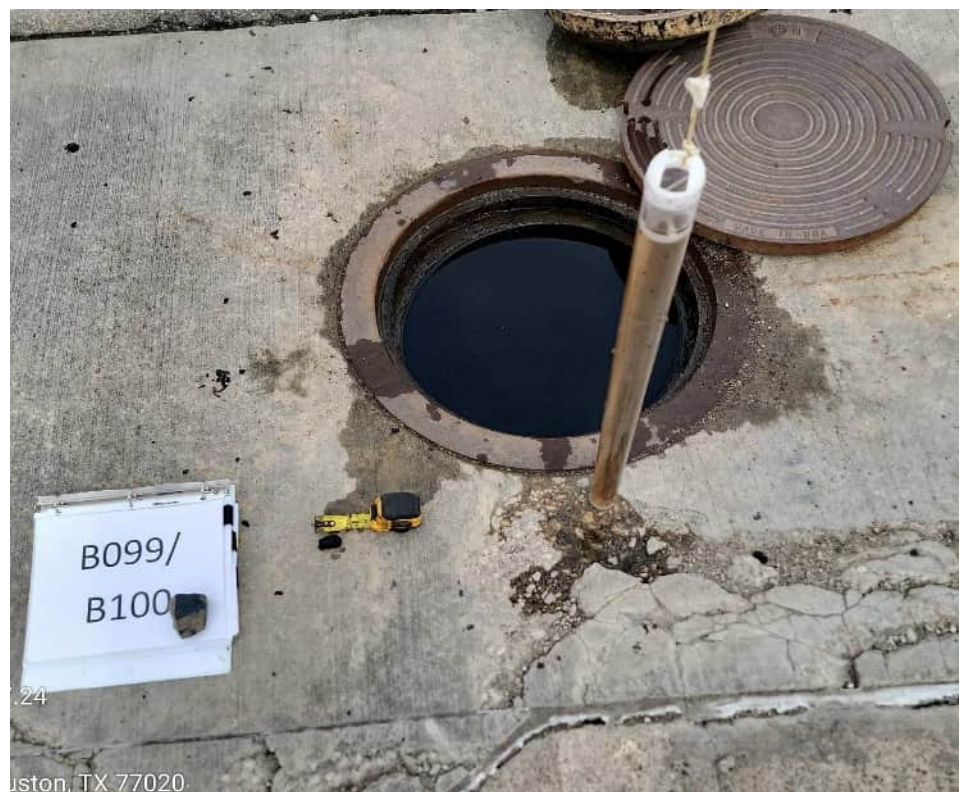
Photo No.
66

| Measured Date | Sump 1 (B099/B100) Freeboard (in) | Sump 2 (B103/B104) Freeboard (in) | Sump 3 (B107/B108) Freeboard (in) | Depth to DNAPL (in) | Comments |
|---|---|---|---|---|--|
| 3/27/2024 | 0 | 7 | 6 | Not measurable | No sheen observed in any of the sumps. Water color light brown on B099/B100 and clear on B103/B104 and B107/B108. Some DNAPL (1.5 inches) was recovered from the bottom of Sump 1. |

Sump 1 (B099/B100), 0 inches of freeboard in sump, no sheen observed, water color noted as light brown. Some NAPL was scraped from the bottom of the sump during the inspection.

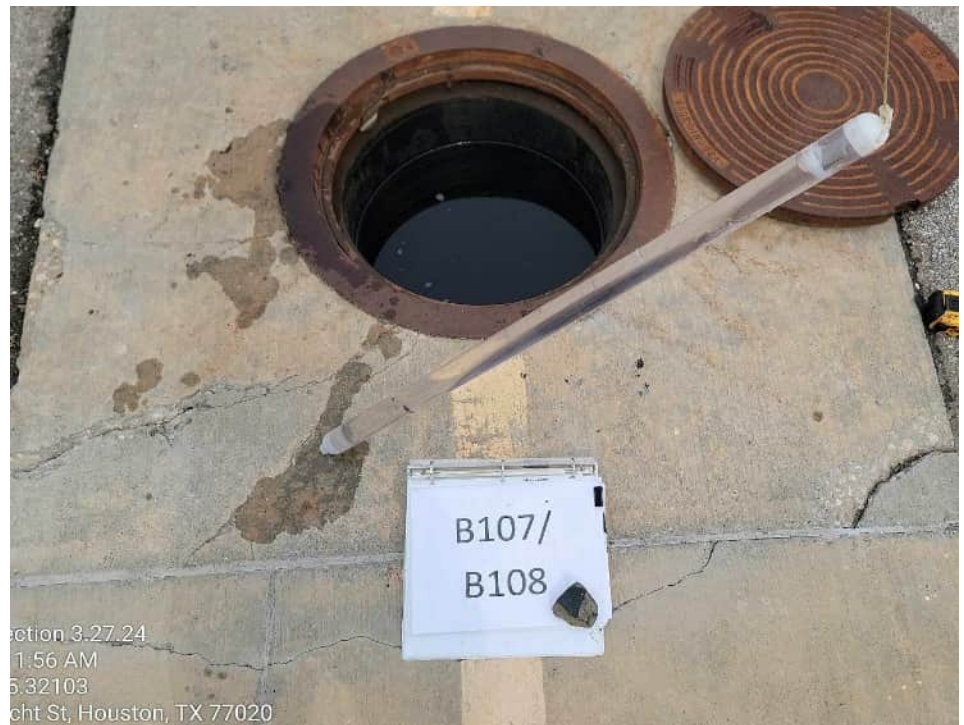
Photo No.
68

Sump 3 (B107/B108), 6 inches of freeboard in sump, no sheen observed, water color noted as clear.

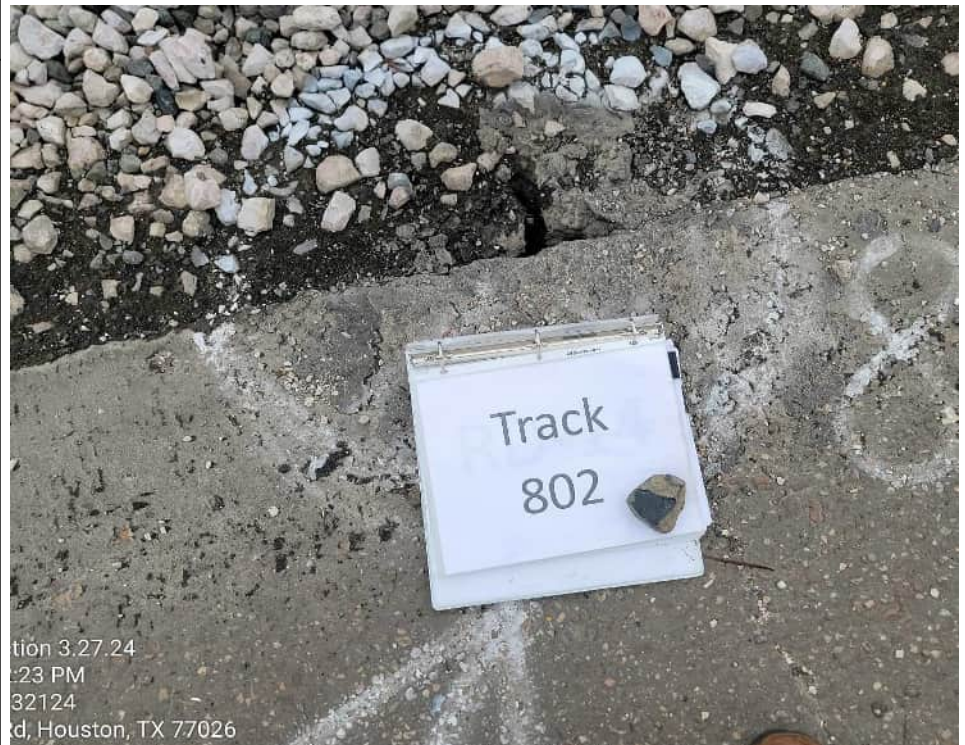
| Seep Observations Outside the NAPL Collection System Area | |
|---|--|
| Track 802 | March 6 th and 27 th (Photo Nos. 15 and 69) |

North side of Track 802, some new tar-like material observed at seep location near the edge of the ballast, material removed

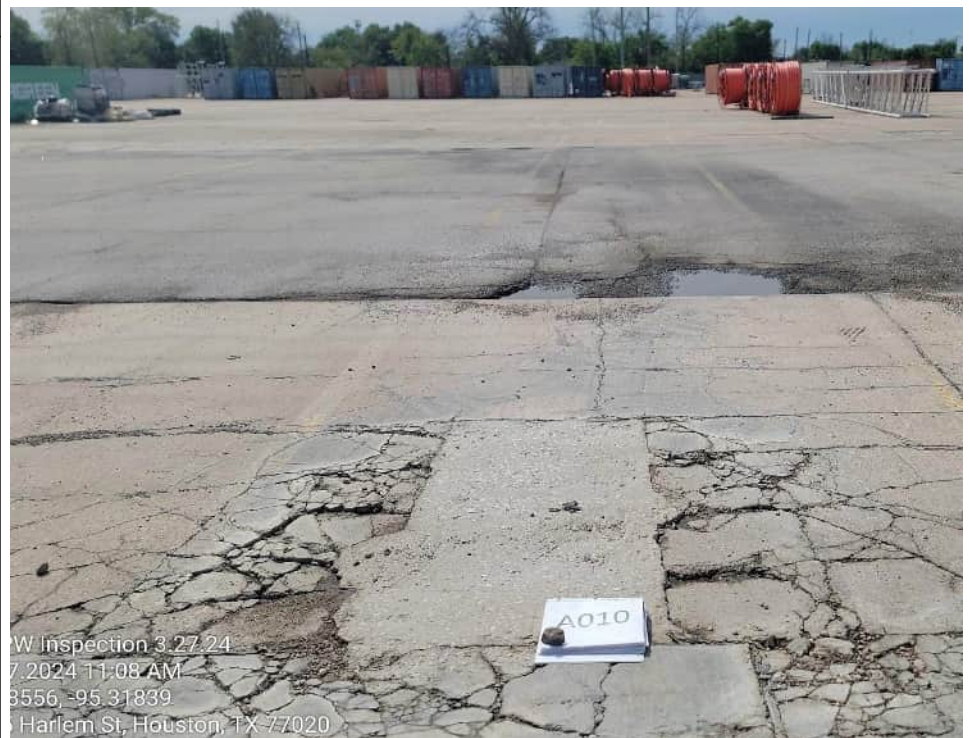
Photo No.
70

Stall A010. No seeps noted at Test Pit A010.
