April 15, 2024

Project No. 31406585.016

**Re: MONTHLY STATUS UPDATE – ENGLEWOOD INTERMODAL YARD – NAPL COLLECTION
SYSTEM/CONCRETE CAP REPAIRS
UNION PACIFIC RAILROAD HOUSTON WOOD PRESERVING WORKS FACILITY
4910 LIBERTY ROAD FACILITY, HOUSTON, TEXAS
POST-CLOSURE CARE PERMIT NO. HW-50343; INDUSTRIAL SWR NO. 31547**

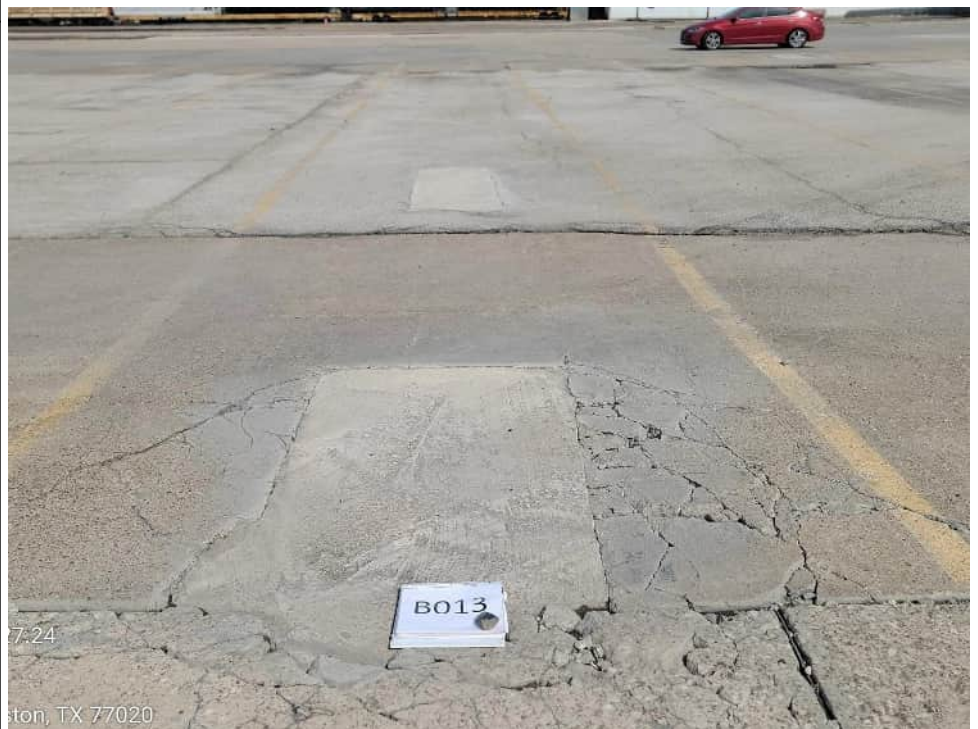
Photo No.
72

Stall B013. No seeps noted at Test Pit B013.

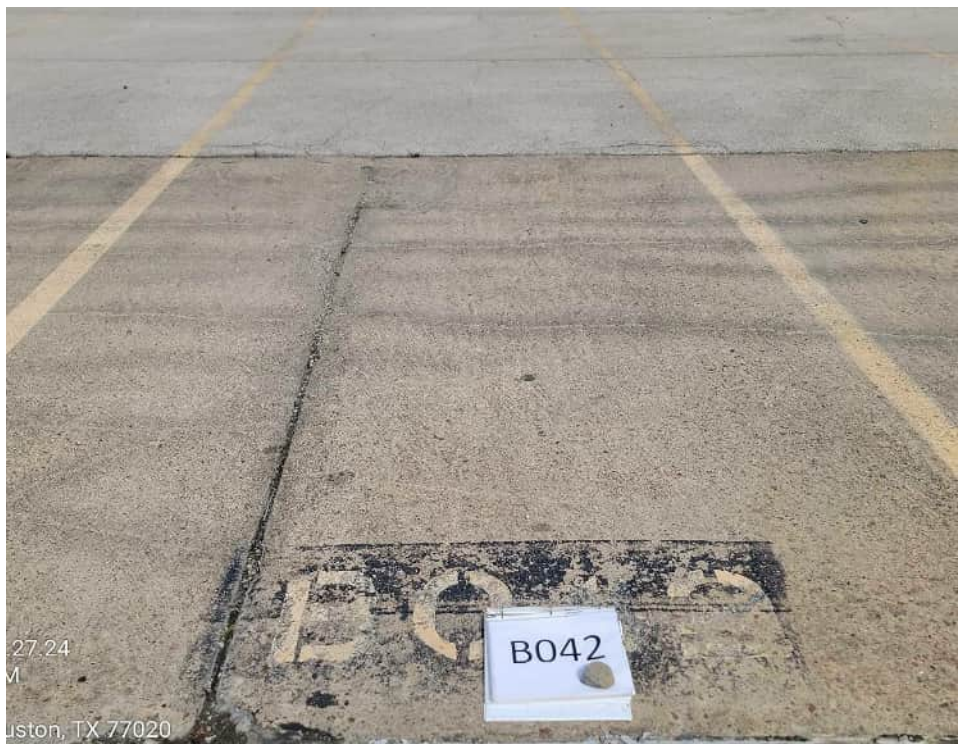
Photo No.
76

Stall B042. No new tar-like material observed at historical seep location along concrete joint.

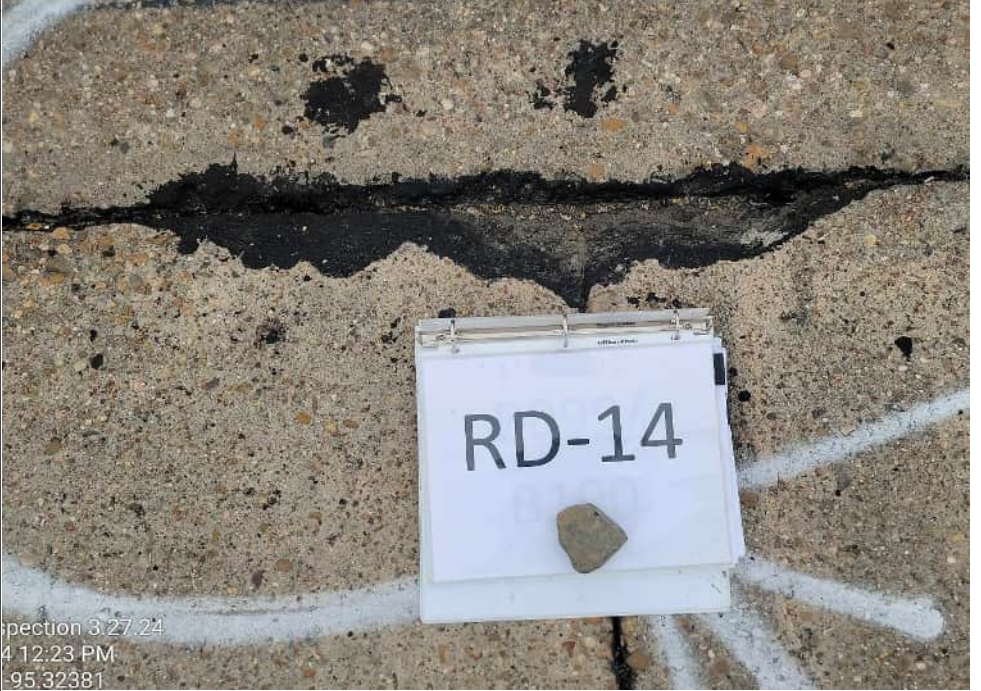
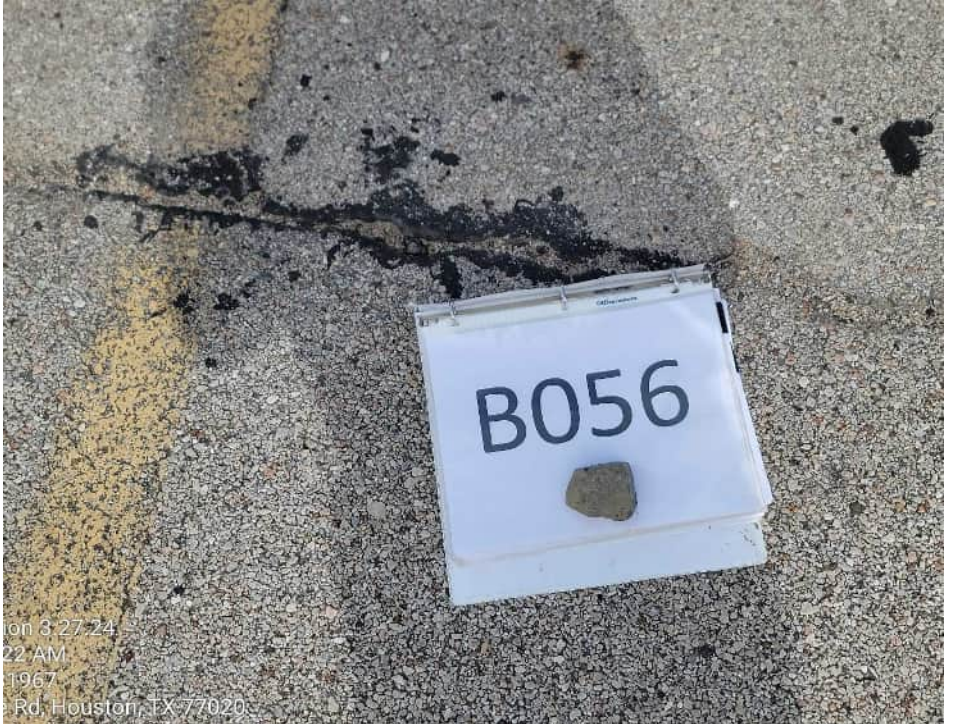
| Seep Observations Outside the NAPL Collection System Area | |
|---|--|
| B056 | March 6 th and 27 th (Photo Nos. 8 and 78) |

| <p>Photo No. 78</p> <p>Description:</p> <p>Stall B056. Some tar-like material observed at historical seep location along asphalt crack, material removed.</p> <p>Lat: 29.7847472 Long: -95.3195417</p> | | <p>Inspection 3/27/24 4 12:23 PM -95.32381</p> | |

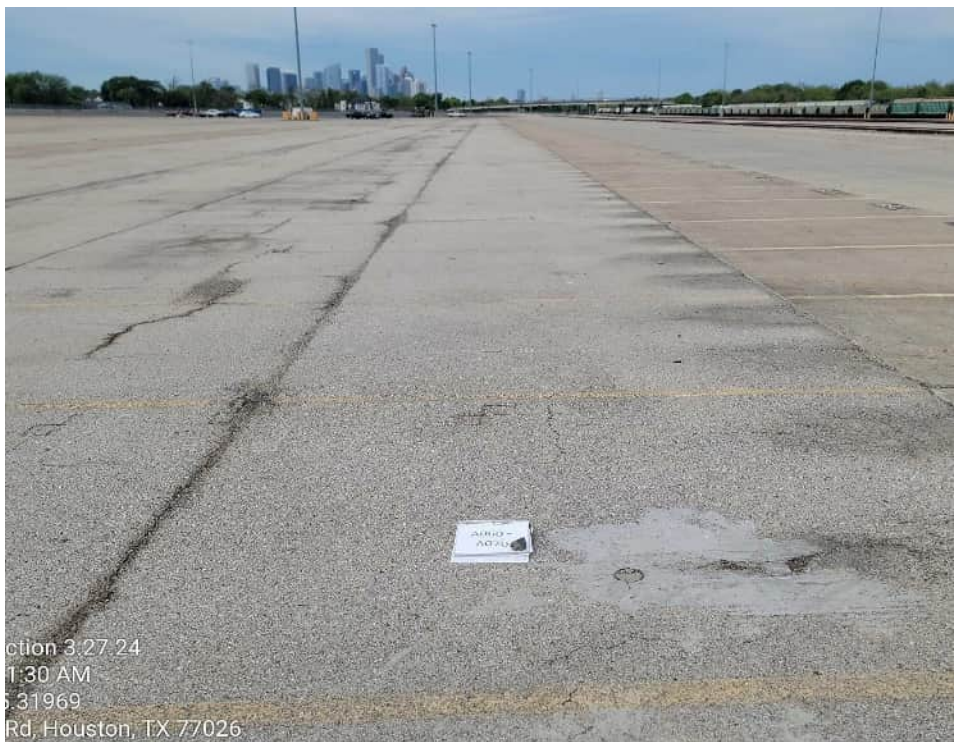
Photo No.
80

Stalls A060 - A070, some residual staining previously observed along cracks in pavement. No new water seeps observed. Viewing southwest.

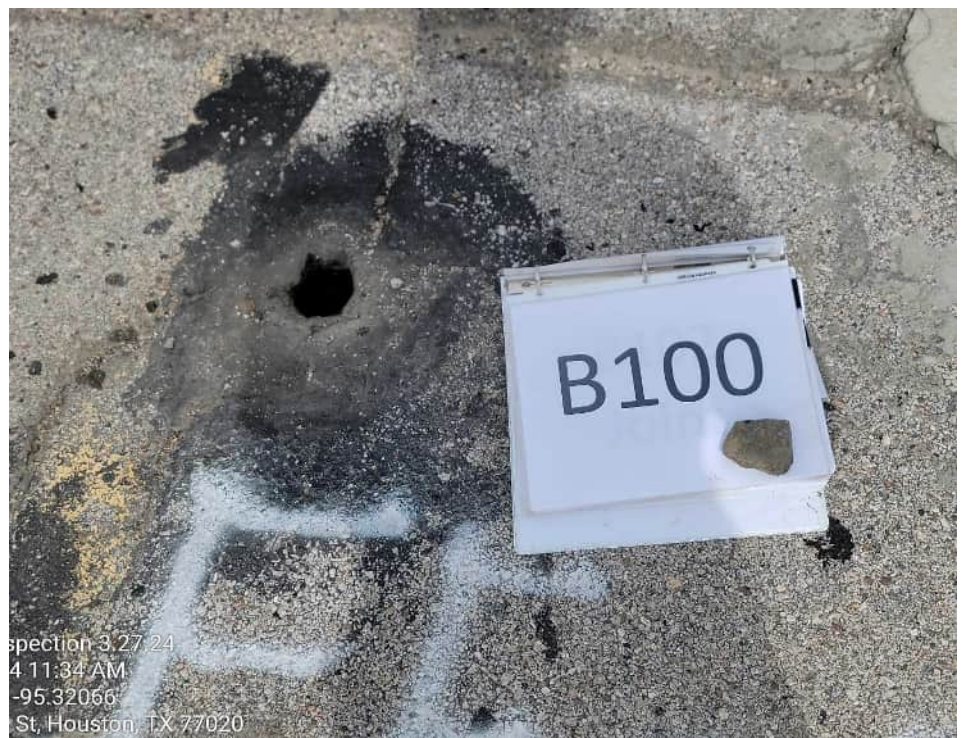
Photo No.
82

Stall B100, no new tar-like material observed at seep location along asphalt crack/ hole in the asphalt.

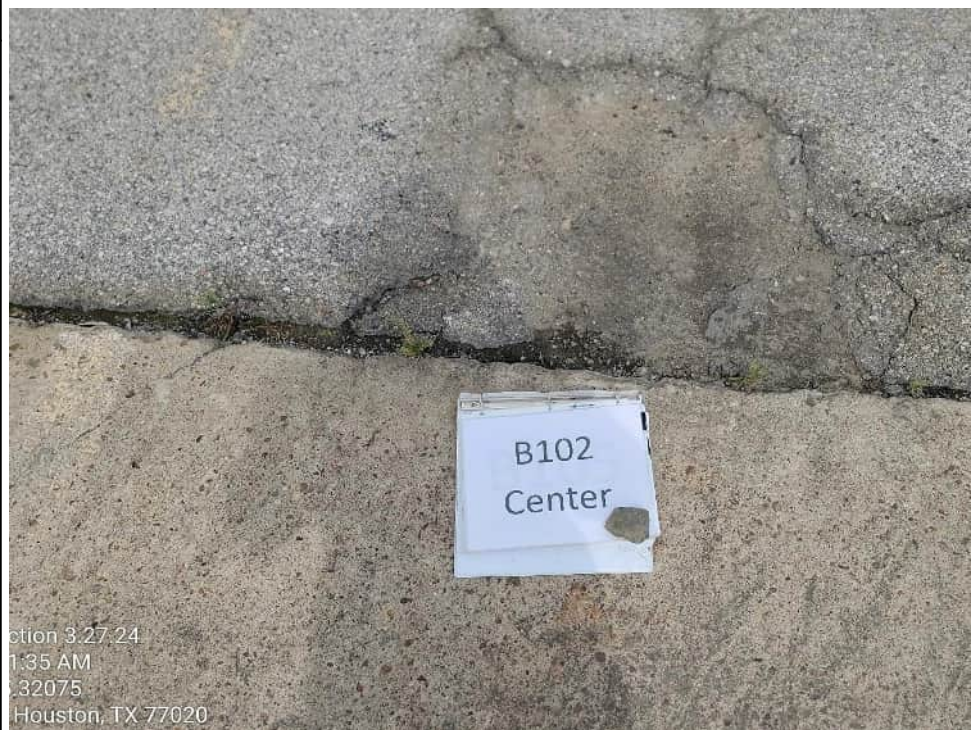
Photo No.
84

Stall B102 (center), no seep observed.
