May 15, 2024

Project No. 31406585.016

Re: **MONTHLY STATUS UPDATE – ENGLEWOOD INTERMODAL YARD – NAPL COLLECTION
SYSTEM/CONCRETE CAP REPAIRS/REVISED INTERIM MEASURES WORK PLAN CONSTRUCTION
ACTIVITIES
UNION PACIFIC RAILROAD HOUSTON WOOD PRESERVING WORKS FACILITY
4910 LIBERTY ROAD FACILITY, HOUSTON, TEXAS
POST-CLOSURE CARE PERMIT NO. HW-50343; INDUSTRIAL SWR NO. 31547**

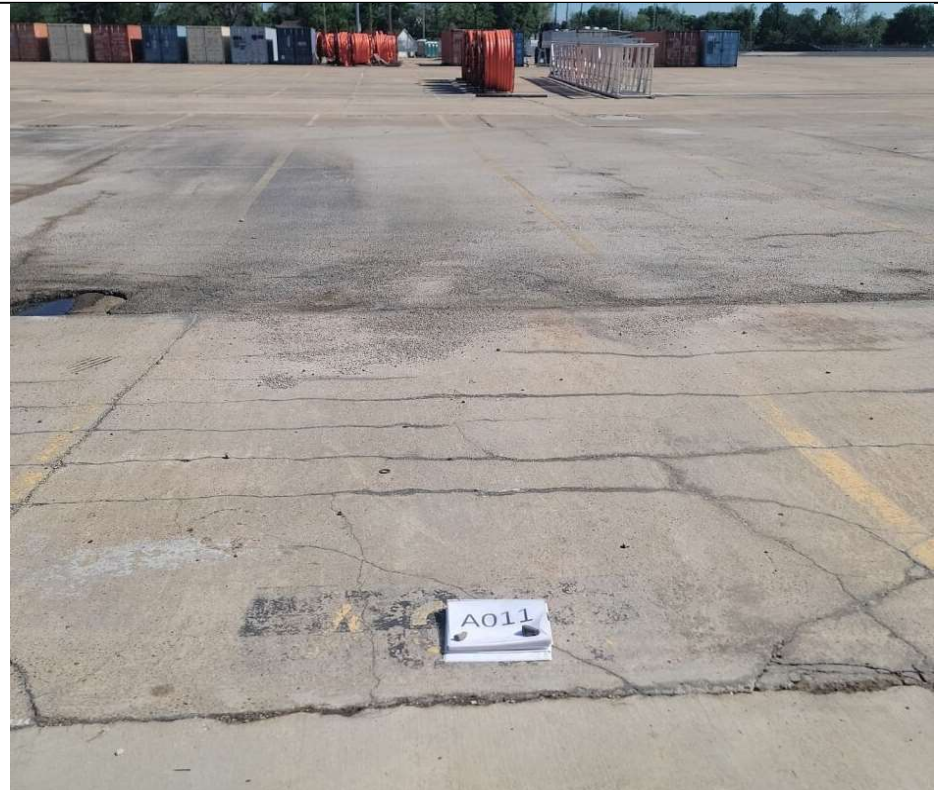
Stall A011. No tar-like material observed at Test Pit A011 location. Minimal seep water staining present in the cracks of the asphalt.

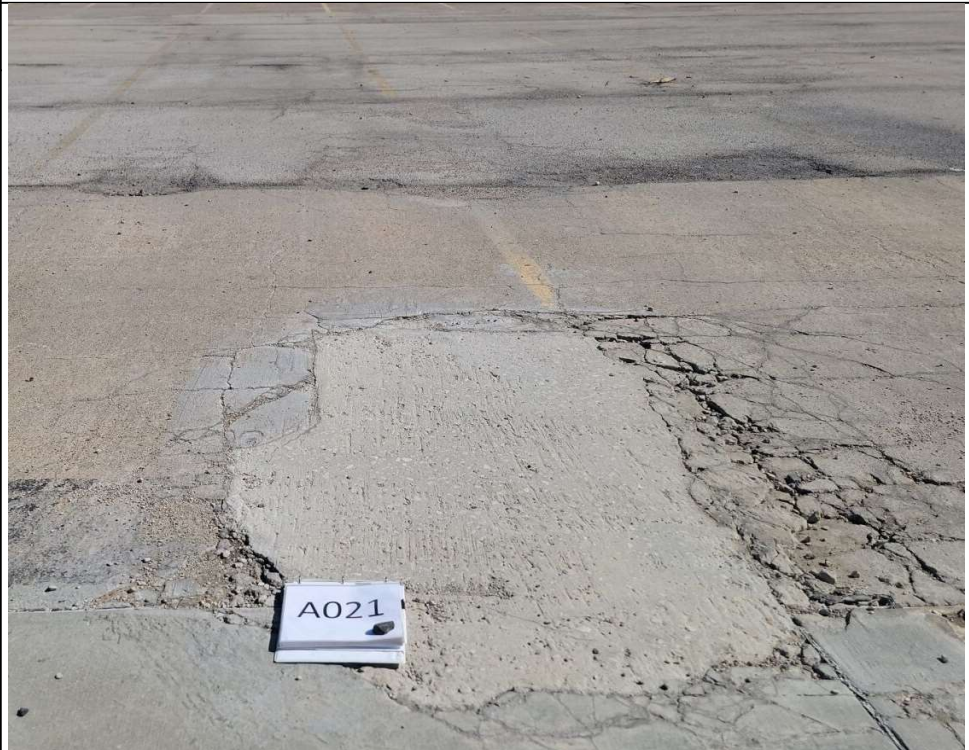
Stall A021. No tar-like material seeps observed at Test Pit A021.

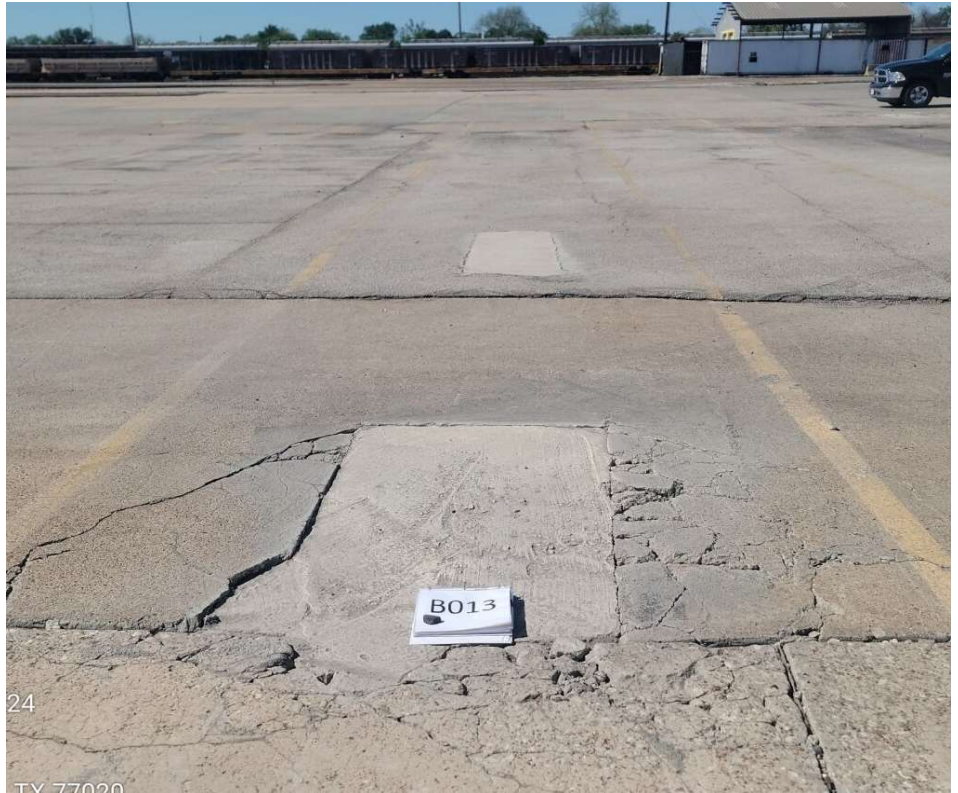
Stall B013. No tar-like material seeps noted at Test Pit B013.

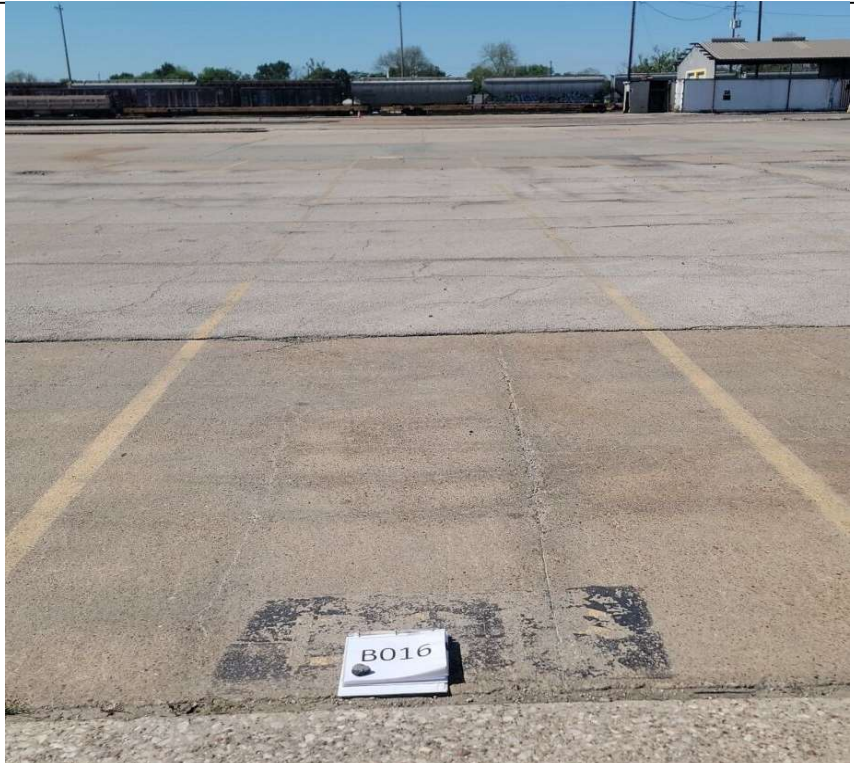
Stall B016. No tar-like material observed at historical seep location along asphalt crack.

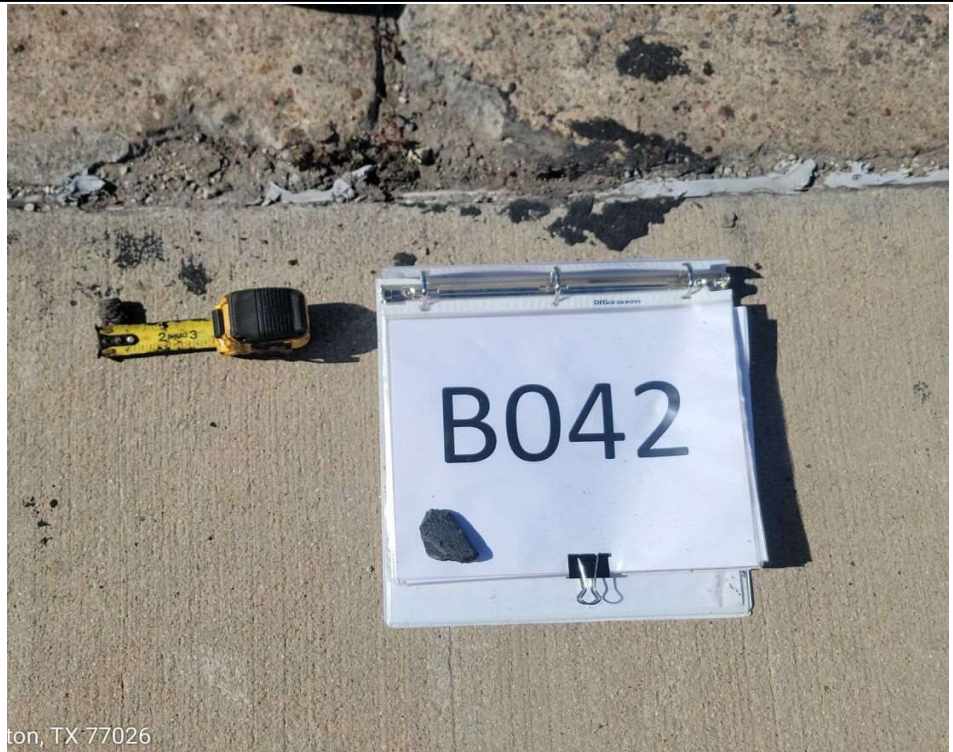
Stall B042. some tar-like material observed at historical seep site along concrete joint, material removed.

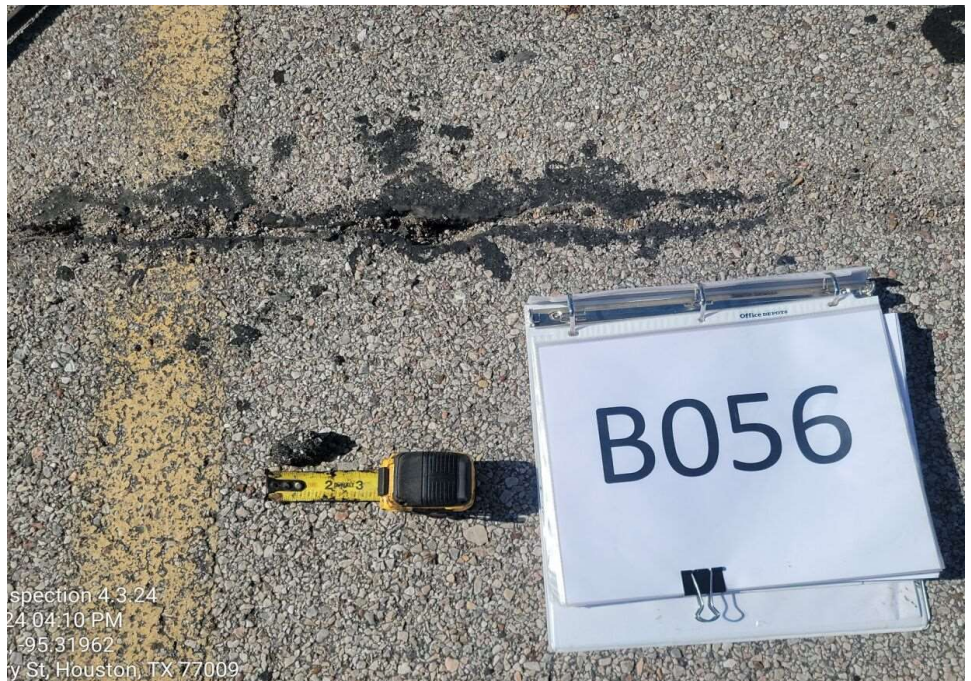
Stall B056. Some tar-like material was observed and removed from historical seep location along asphalt crack.

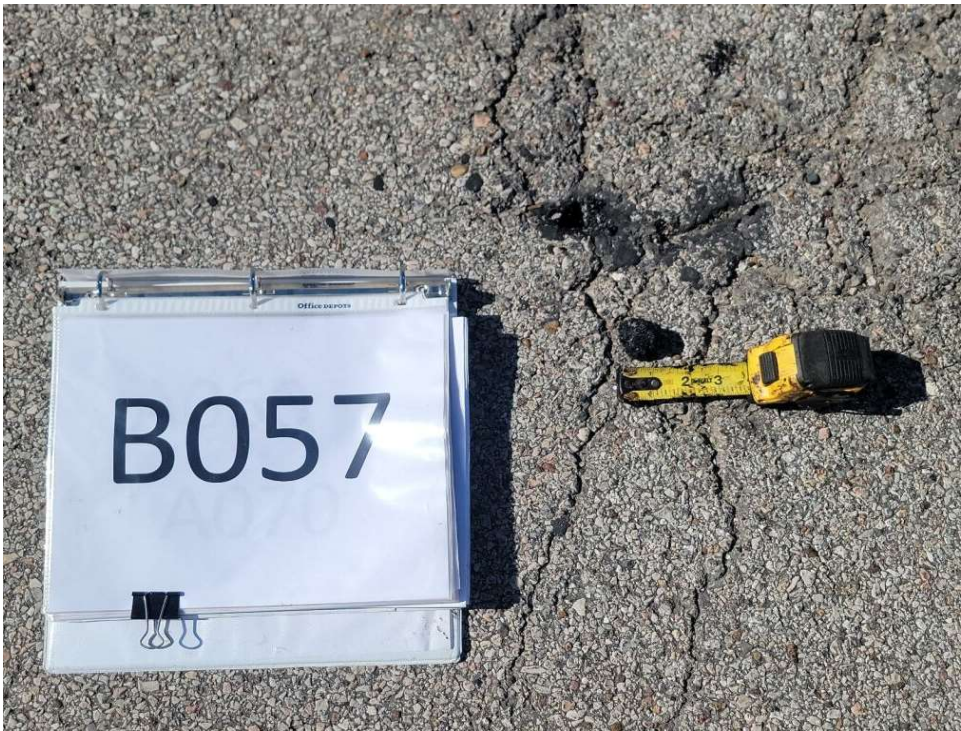
Stall B057 (joint), some tar-like material observed at historical seep site along concrete joint, material removed.

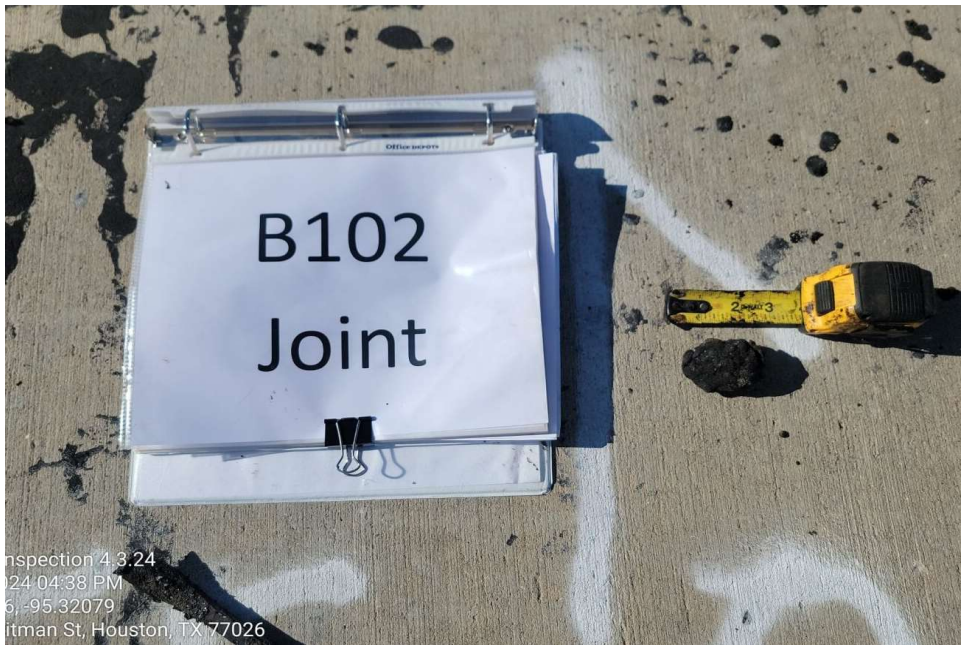
Stall B102 (joint) some tar-like material observed at historical seep site along concrete joint, material removed.

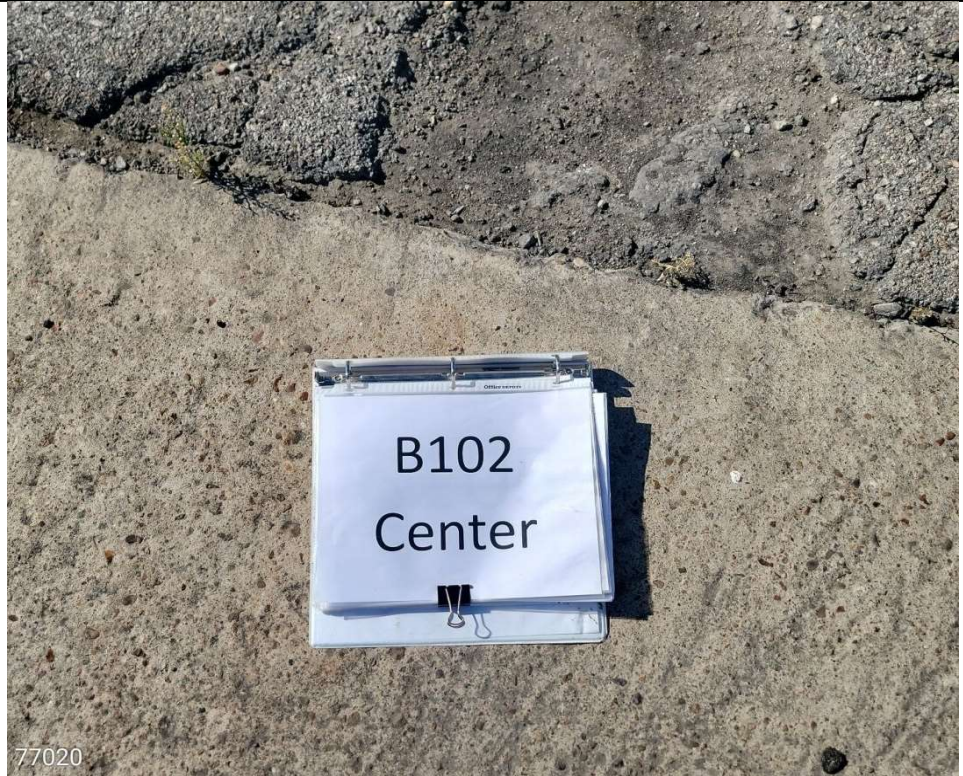
Stall B102 (center), no tar-like material observed at seep location along cracks in pavement.

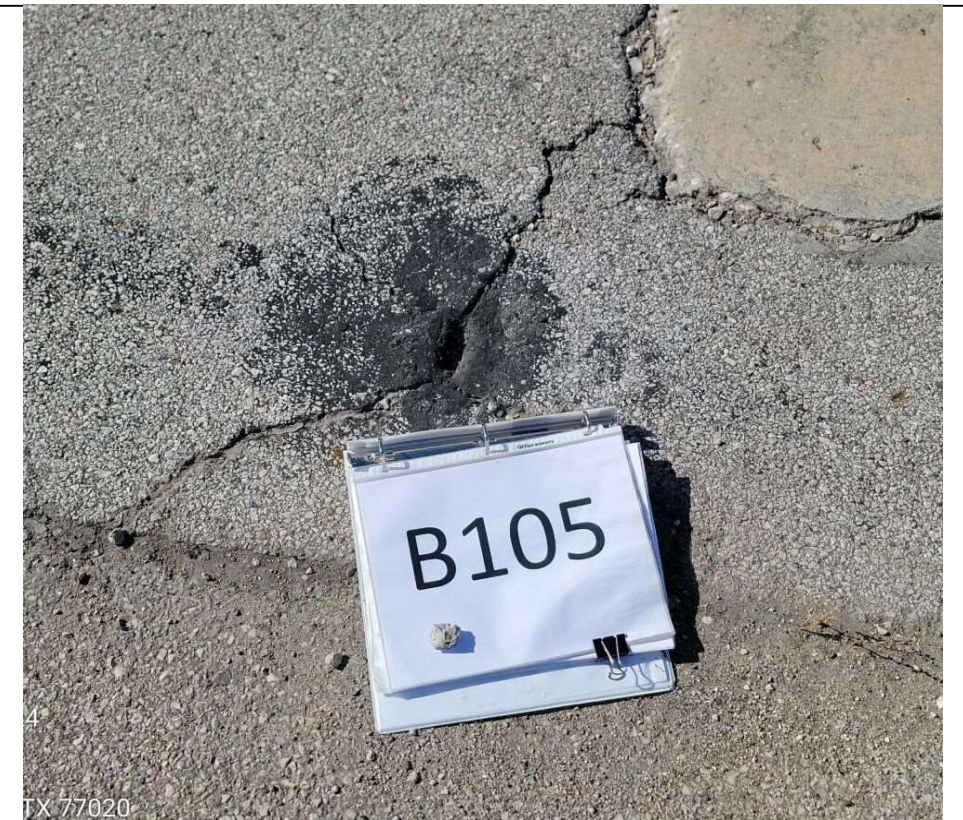
Stall B105, no new tar-like material observed at the historical seep location along asphalt crack.

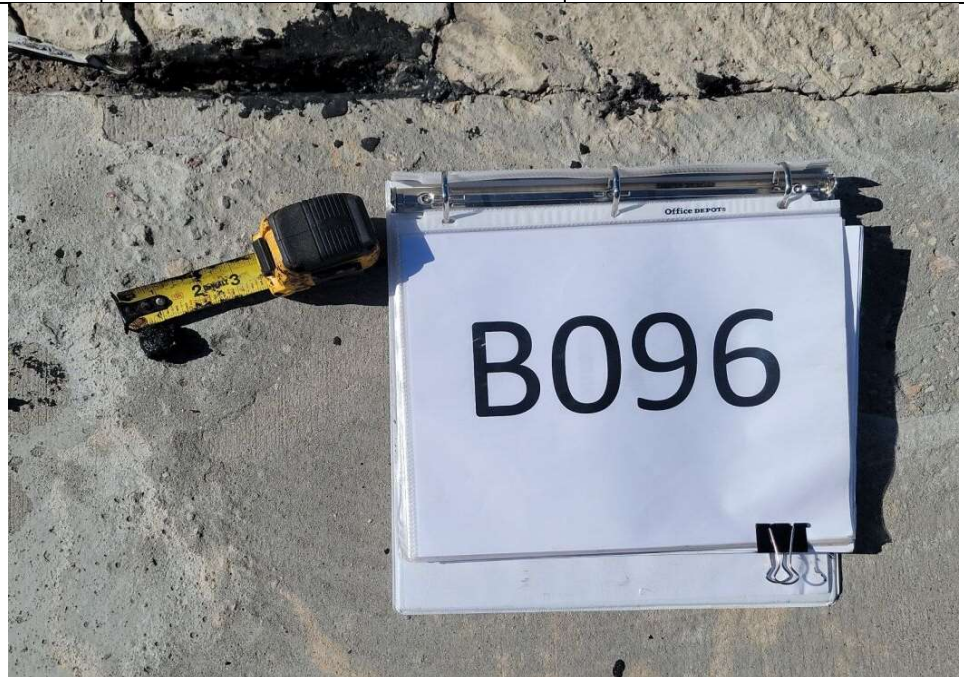
- During the April 3 and 17, 2024 inspections, a small amount of tar like material was observed in stall B096 adjacent to the test pit patch location. No NAPL seeps were observed at the other six July 2020 test pit locations (stalls A010, A021, A098, B013, B057 and B108). The seep observed in stall B057 is located in the cracks in the asphalt pavement and not at the test pit location.

Stall B096, some tar-like material observed at historical seep location along concrete joint at Test Pit B096, material removed.

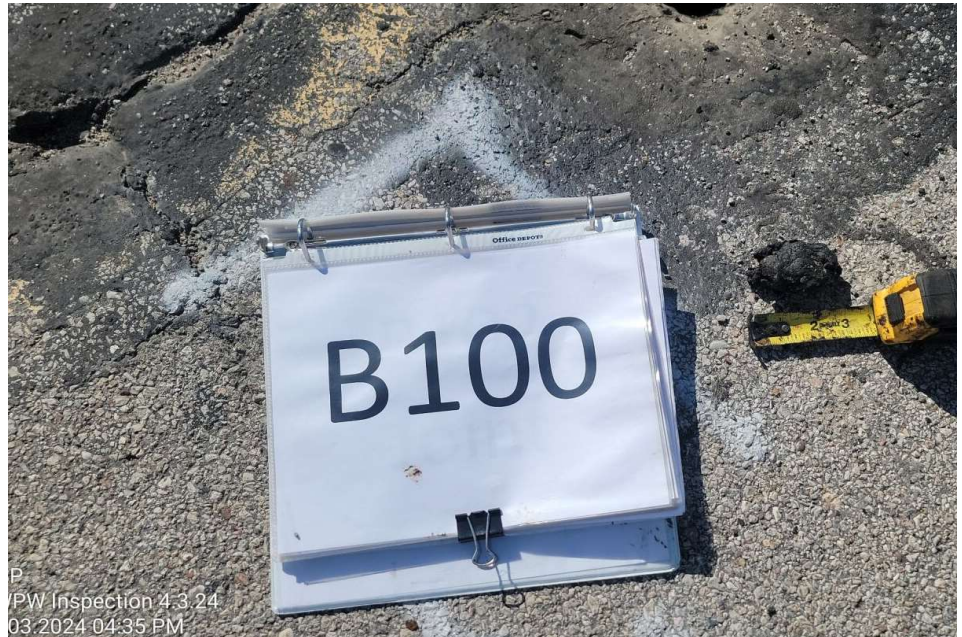
Stall B100, some tar-like material observed on concrete crack/hole in concrete, material removed.

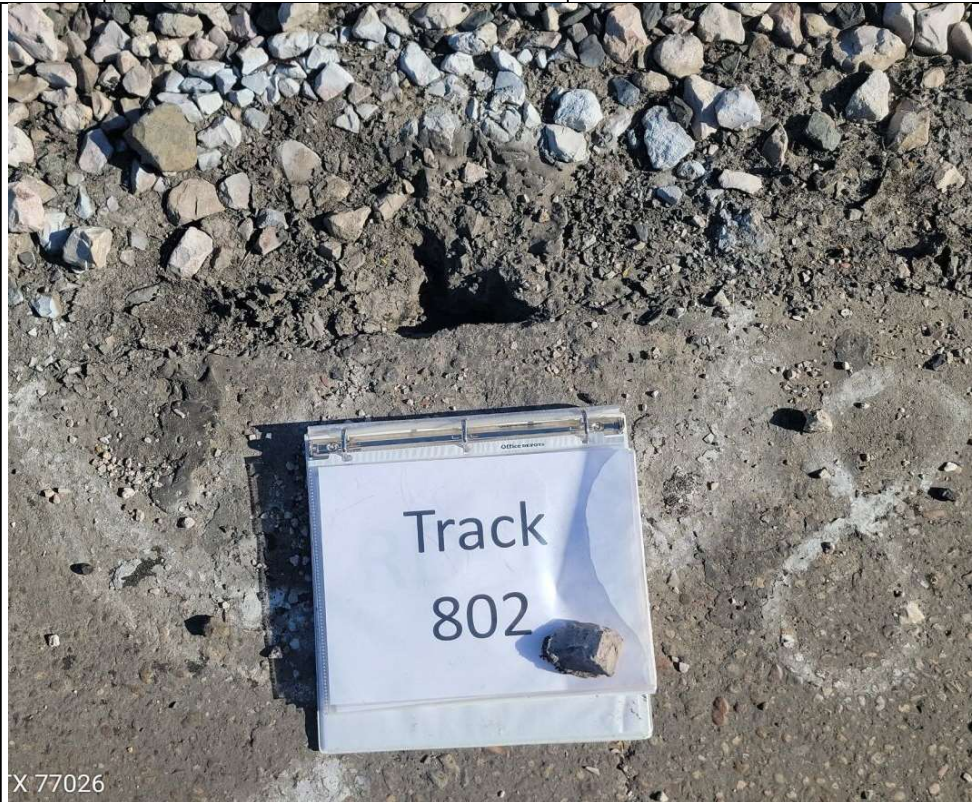
North side of Track 802, no new tar-like material observed at seep location near the edge of the ballast.

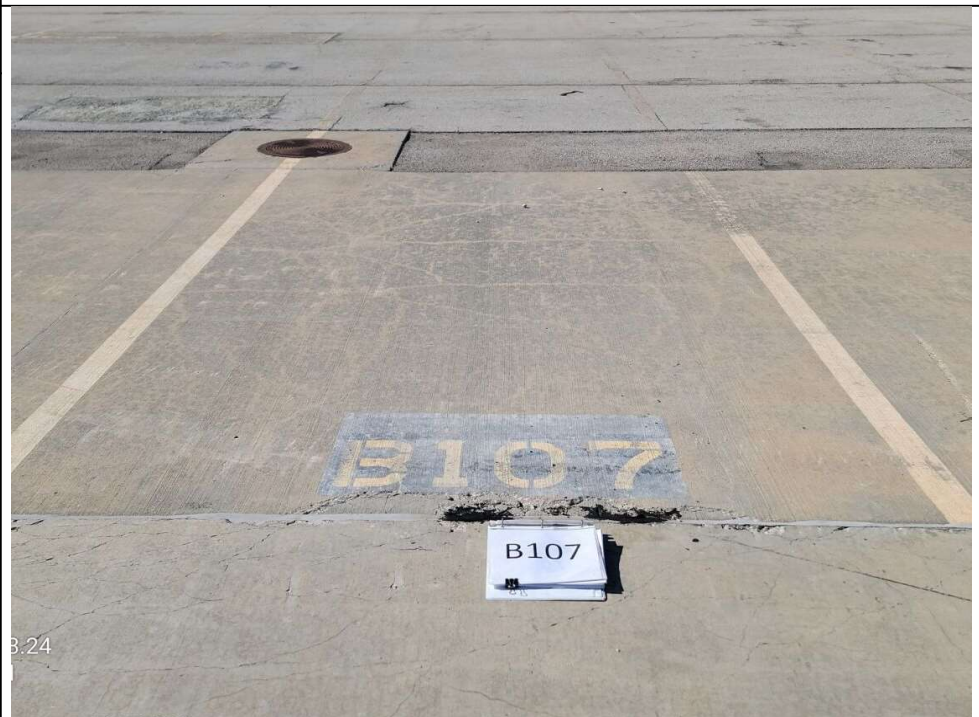
Stall B107, no new tar-like material observed at seep location on concrete joint along the southern edge of the excavated area.

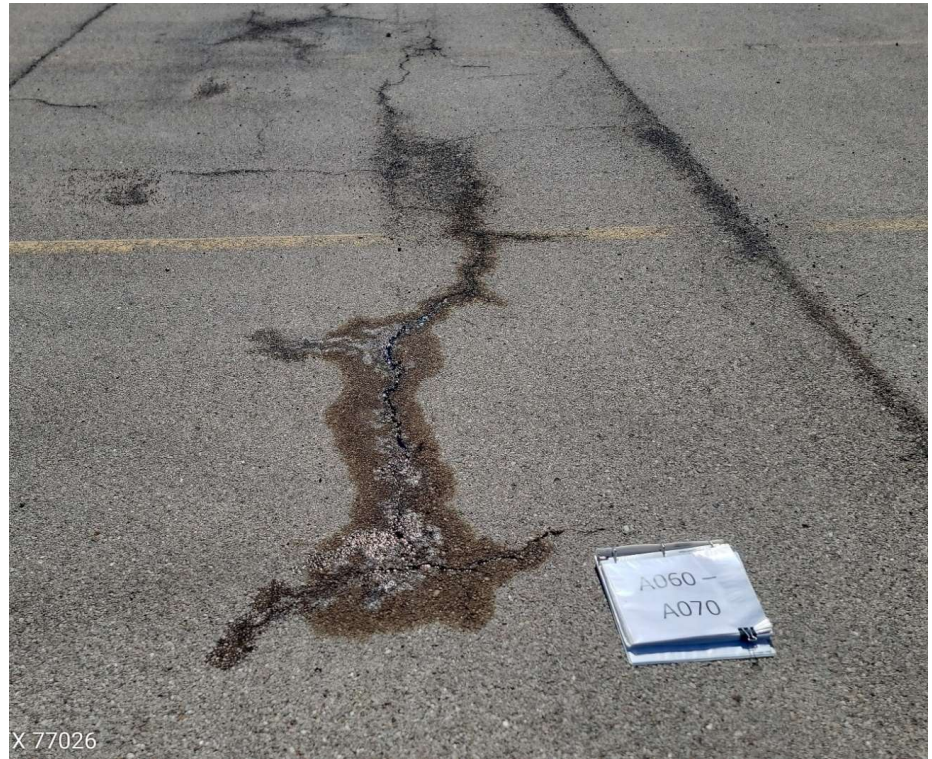
Stalls A060 - A070, some residual staining previously observed along cracks in pavement. No new water seeps observed. Viewing southwest.

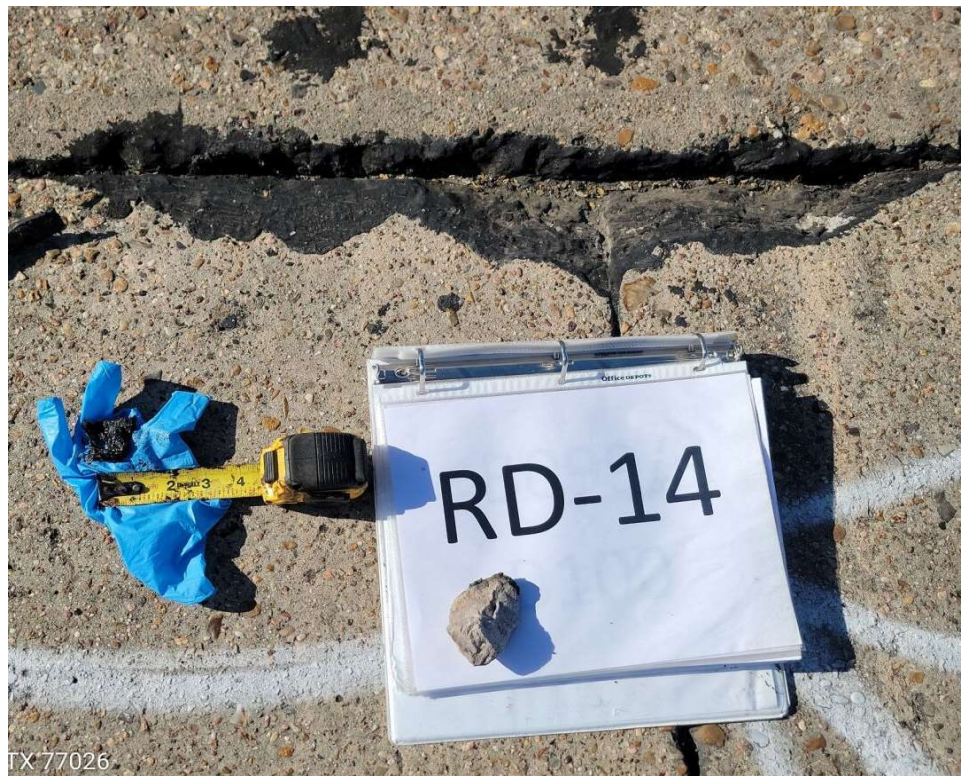
RD-14 Seep location observed within the concrete road area north of Track 802 (east of existing Track 802 seep location). Some tar-like material observed along a concrete joint, material removed.

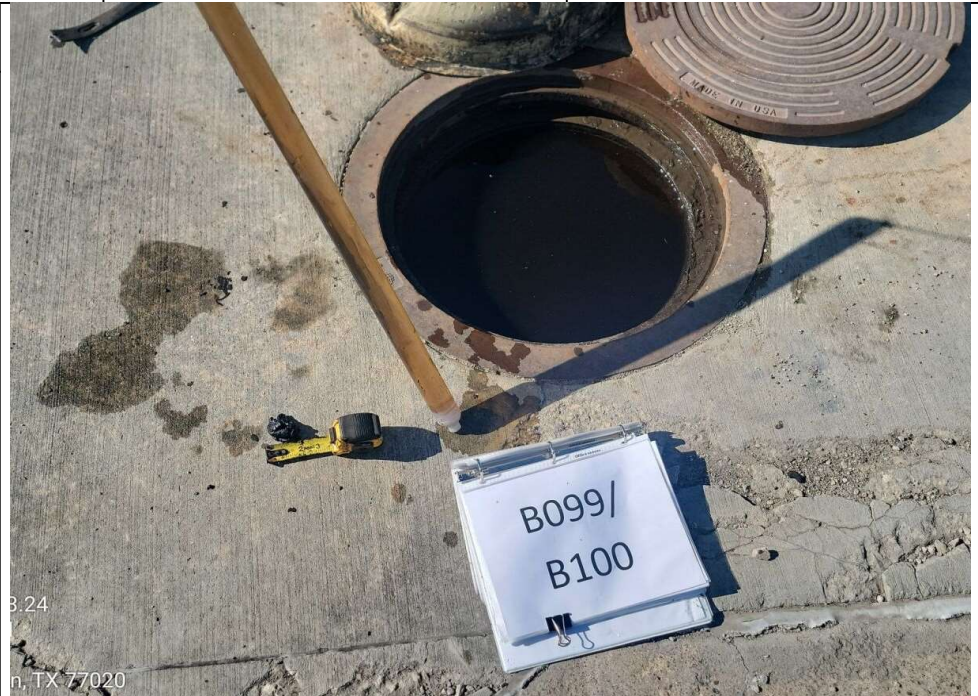
Sump 1 (B099/B100), 0 inches of freeboard in sump, no odor noted, no sheen observed, water color noted as light brown. Approximately 2 in³ of DNAPL was recovered.

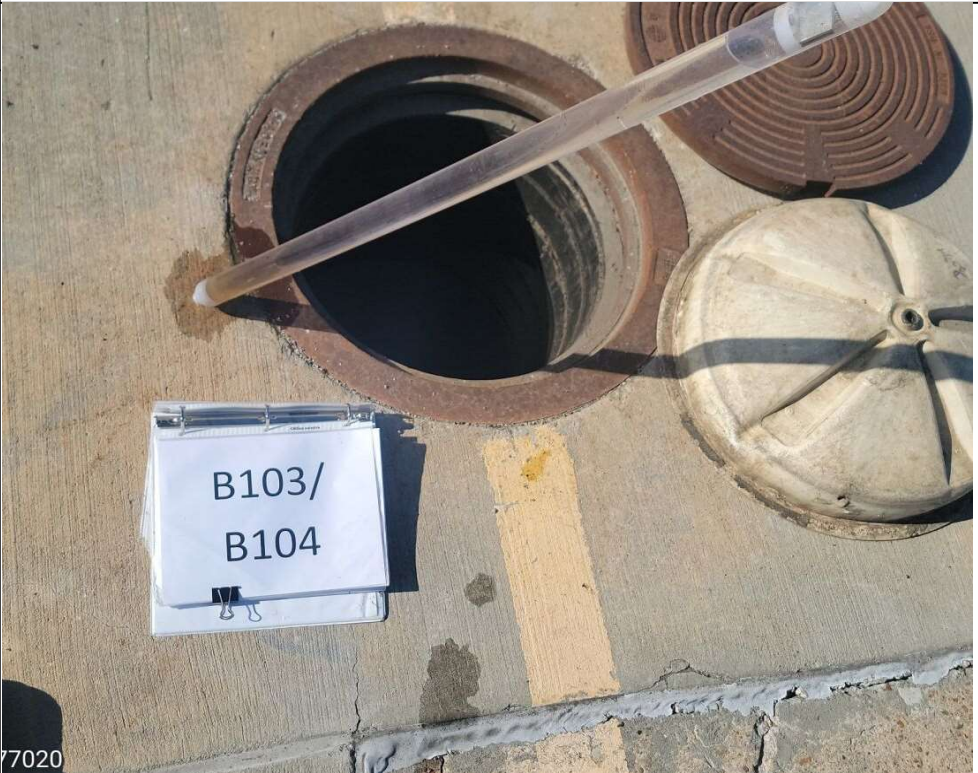
Sump 2 (B103/B104), 10 inches of freeboard in sump. No odor or sheen observed, color noted as clear.

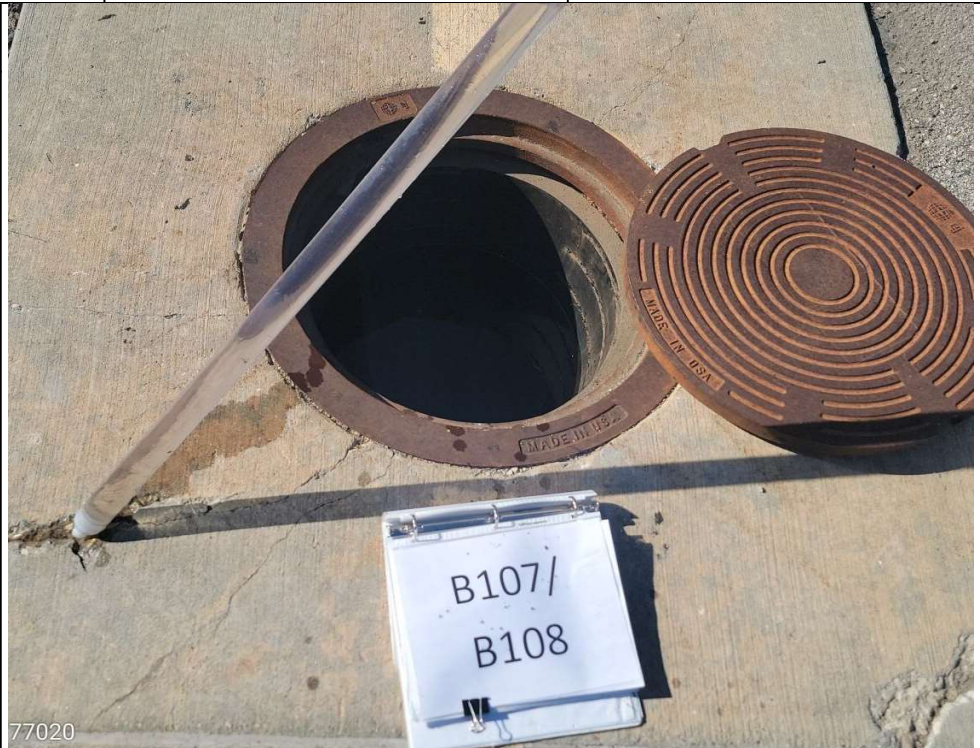
Sump 3 (B107/B108), 10 inches of freeboard in sump, no sheen observed, water color noted as clear.

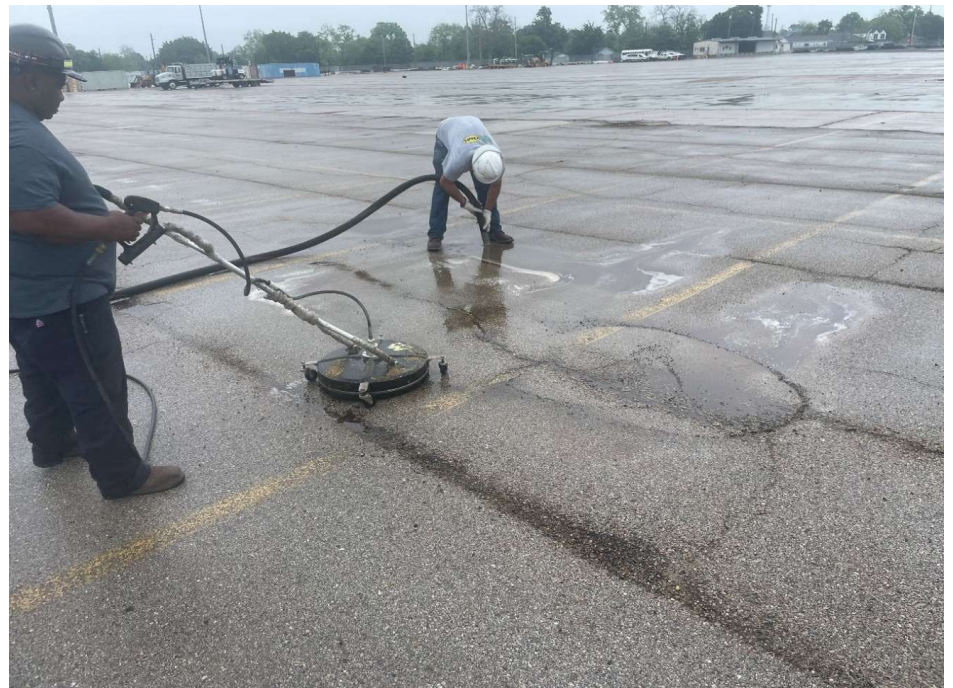
- UPRR remediation contractor E3 was mobilized to the site on April 8th to pressure wash areas of brown staining/residue present in cracks in the pavement in stall A010 and stalls A060-A061 (Photo No. 22). The heaviest staining was present in stalls A060- A061 (Photo No. 17). The brown staining was again observed in cracks in the pavement in stalls A060-A070 during the April 17th inspection (Photo No. 54); however, the staining was no longer present during the April 24th inspection (Photo No. 78). A small amount of seep water returned to the depression in the joint between the asphalt and concrete pavement in stall A010 during the April 24th inspection (Photo No. 69). E3 returned to the site on April 26, 2024, to recover this seep water. Wash water from the clean-up events was recovered and is staged in a tote onsite pending transportation and disposal. UPRR will continue to have a remediation contractor pressure wash and collect the water in the areas where the brown staining and seeps are observed, as needed.

Remediation contractor E3 pressure washing brown staining on stalls A060-A061.

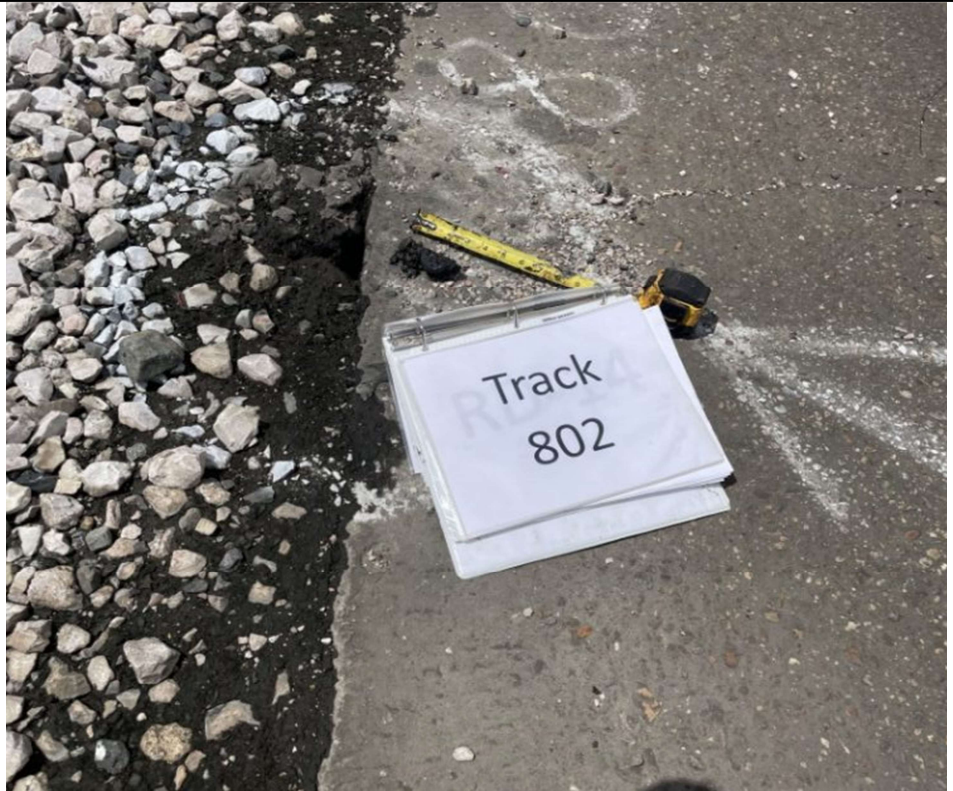
North side of Track 802, some tar-like material observed at seep location near the edge of the ballast, material removed.

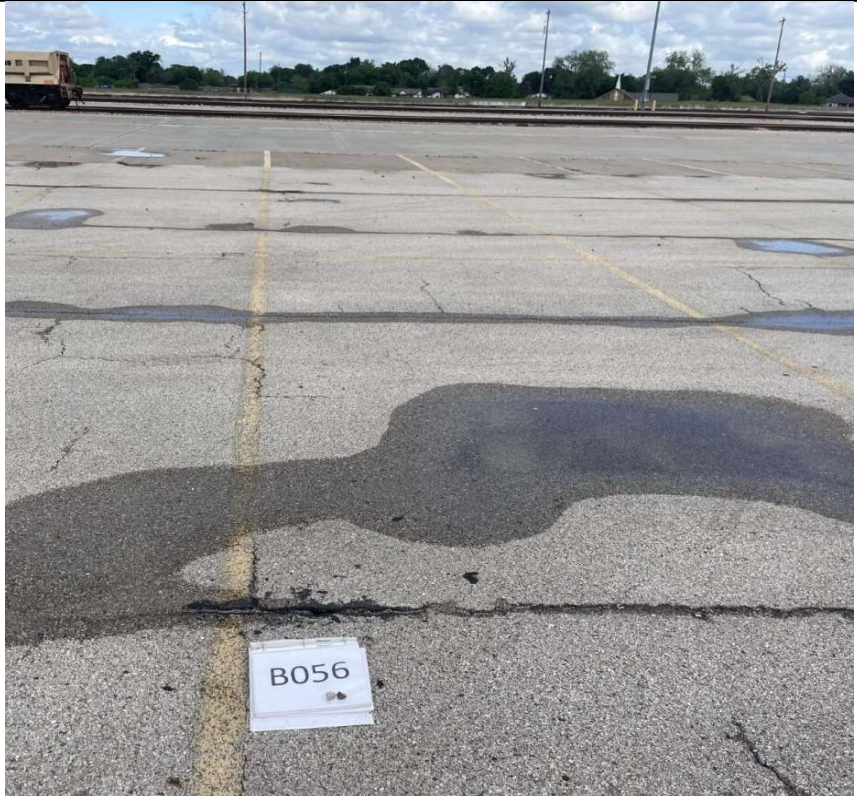
Stall B056. No new tar-like material observed at historical seep location along asphalt crack.

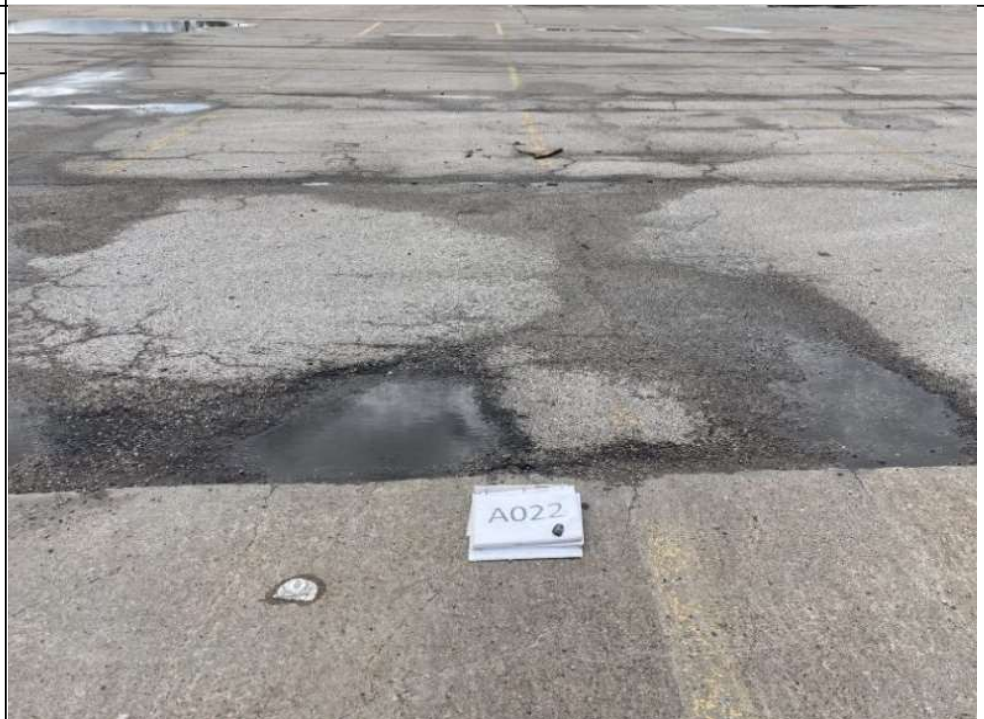
Stall A022. No new tar-like material observed at historical seep location along asphalt crack.

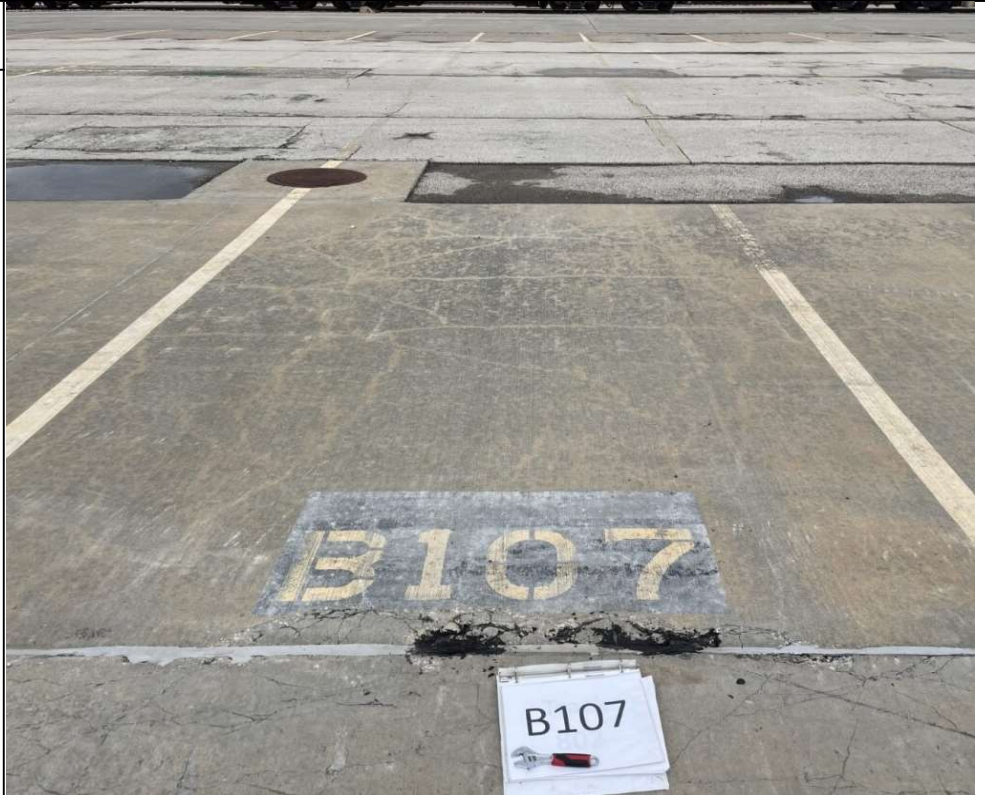
Stall B107, no new tar-like material observed at seep location on concrete joint along the southern edge of the excavated area.

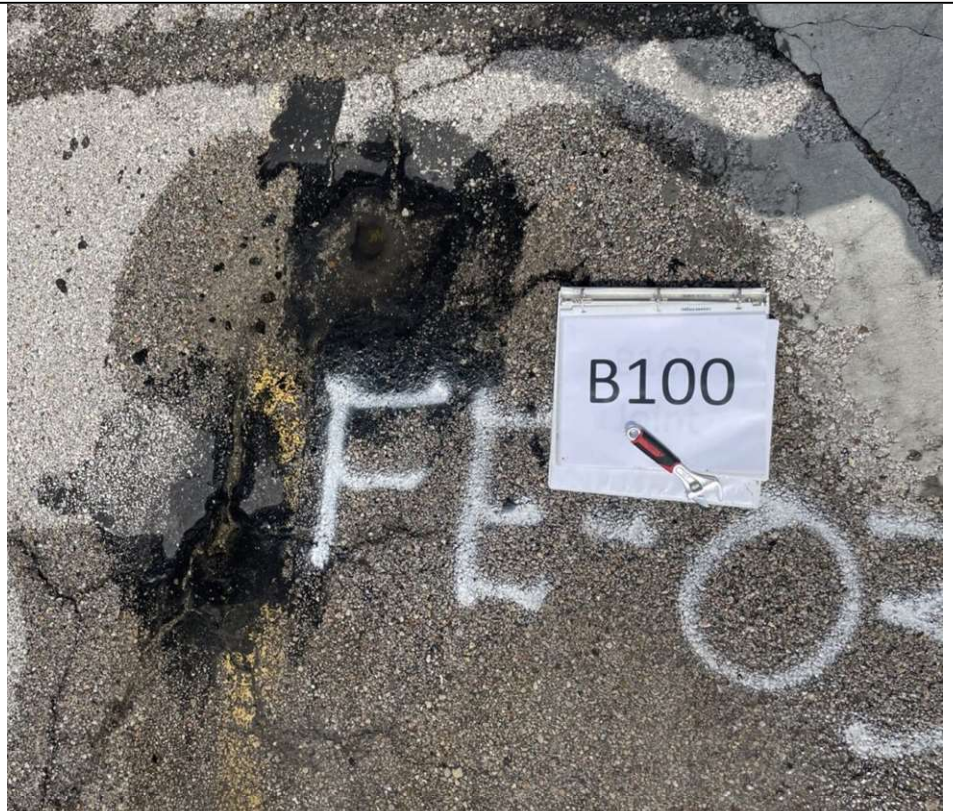
Stall B100, no new tar-like material observed at seep location along asphalt crack/ hole in the asphalt.

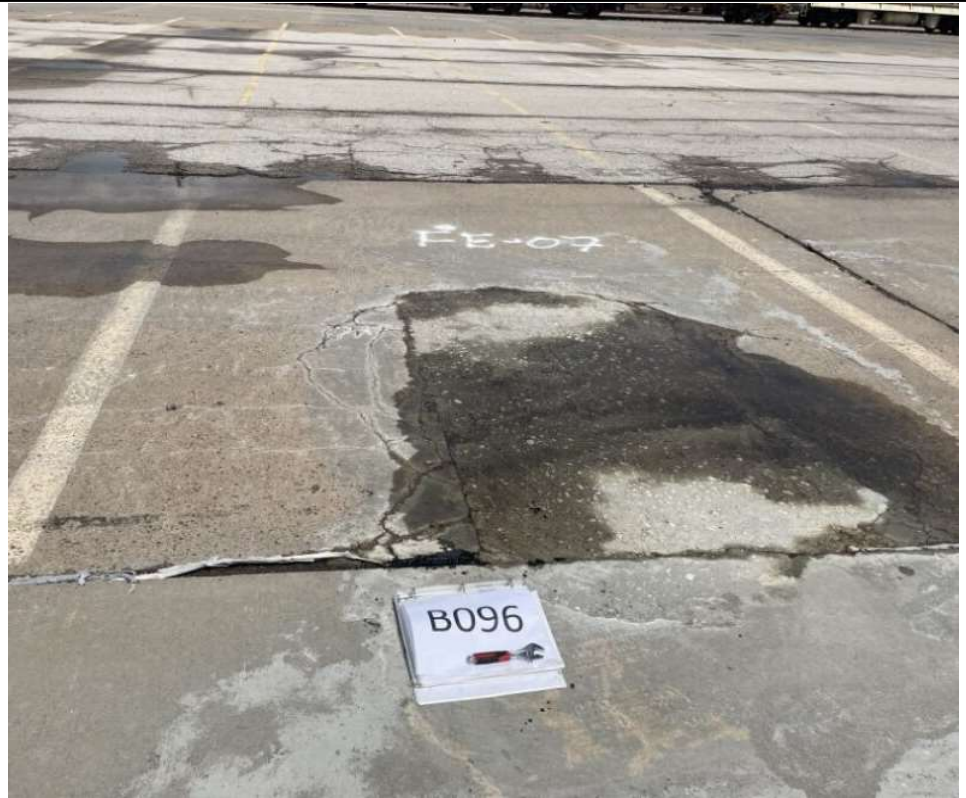
Stall B096, no new tar-like material observed at historical seep location along concrete joint.

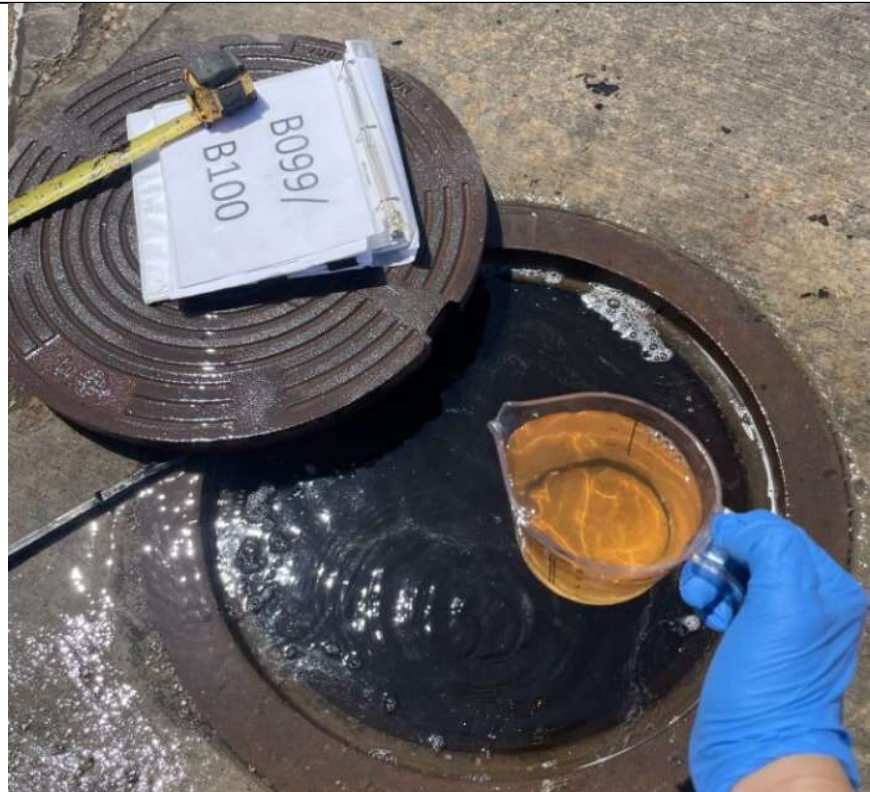
Sump 1 (B099/B100), 0 inches of freeboard in sump, no sheen observed, water color noted as brown.

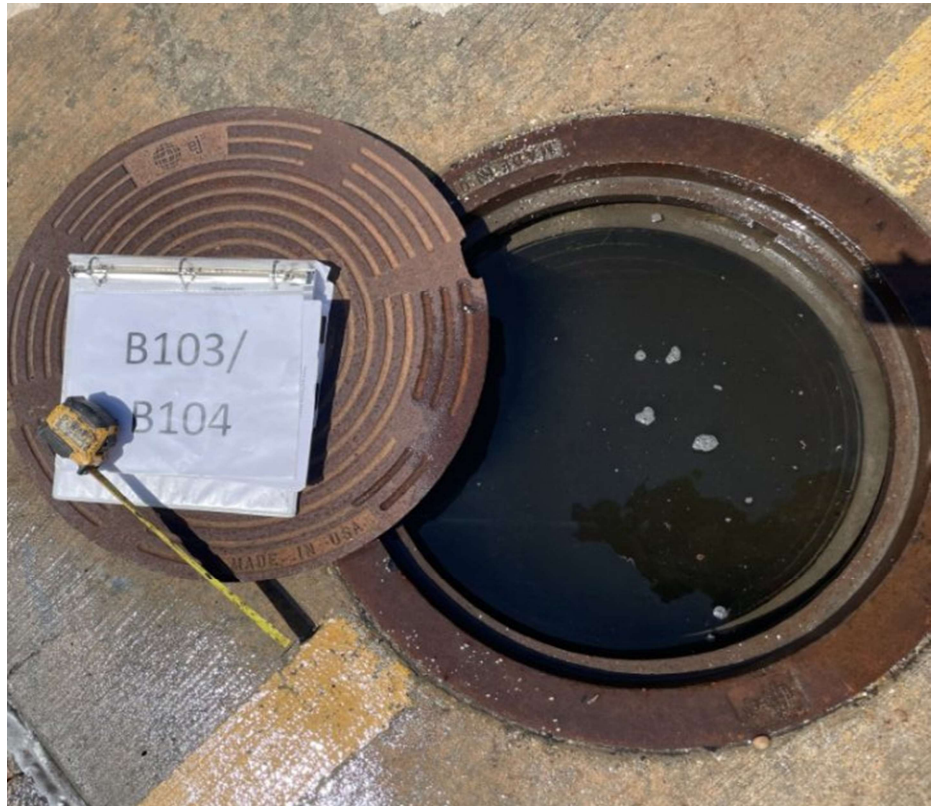
Sump 2 (B103/B104), 0 inches of freeboard in sump. No odor or sheen observed, color noted as clear.

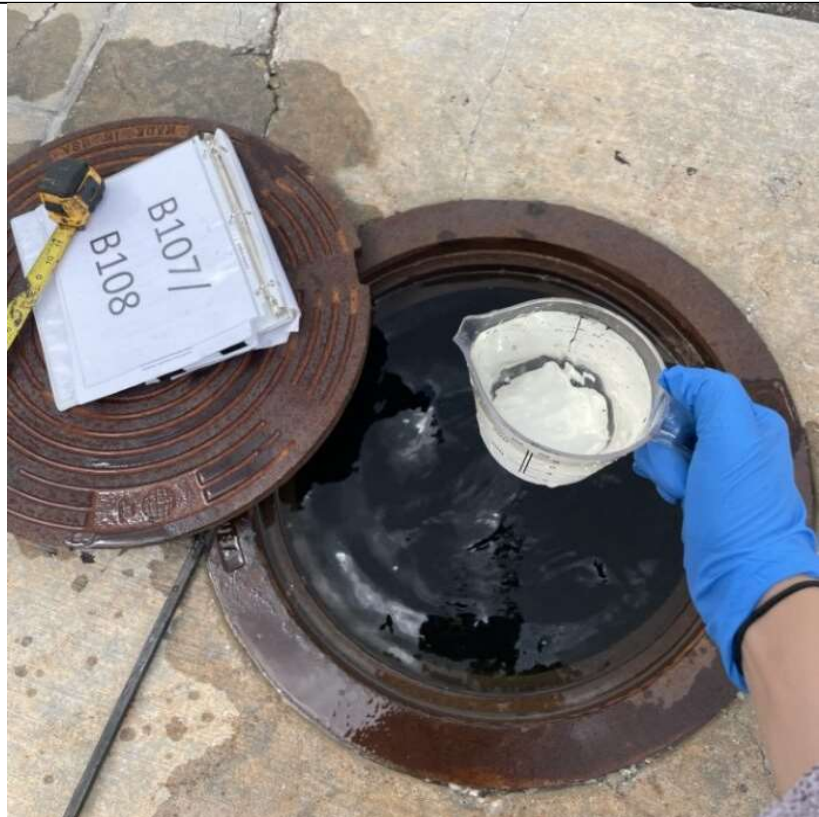
Sump 3 (B107/B108), 0 inches of freeboard in sump, no sheen observed, water color noted as clear.

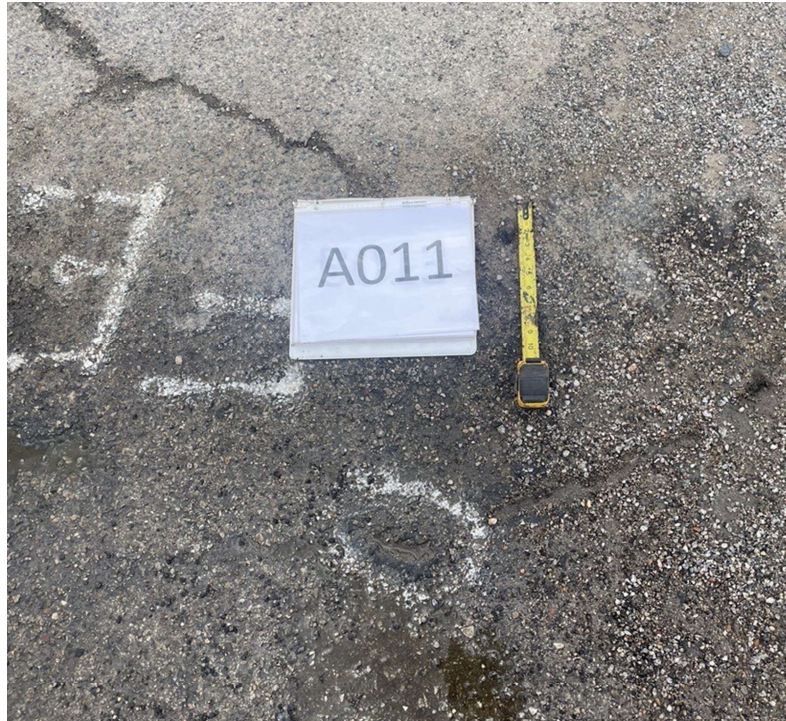
Stall A011. Some tar-like material observed at historical seep location along asphalt crack, material removed.
