May 15, 2024

Project No. 31406585.016

Re: **MONTHLY STATUS UPDATE – ENGLEWOOD INTERMODAL YARD – NAPL COLLECTION
SYSTEM/CONCRETE CAP REPAIRS/REVISED INTERIM MEASURES WORK PLAN CONSTRUCTION
ACTIVITIES
UNION PACIFIC RAILROAD HOUSTON WOOD PRESERVING WORKS FACILITY
4910 LIBERTY ROAD FACILITY, HOUSTON, TEXAS
POST-CLOSURE CARE PERMIT NO. HW-50343; INDUSTRIAL SWR NO. 31547**

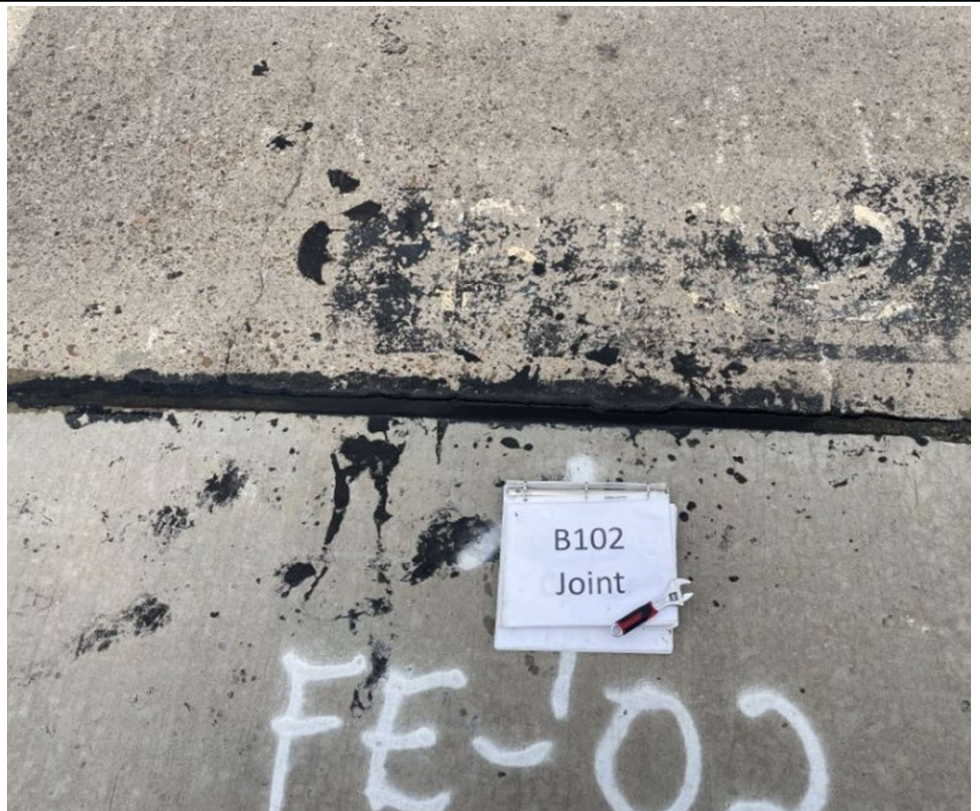
Stall B102 (joint) no new tar-like material observed at historical seep site along concrete joint.

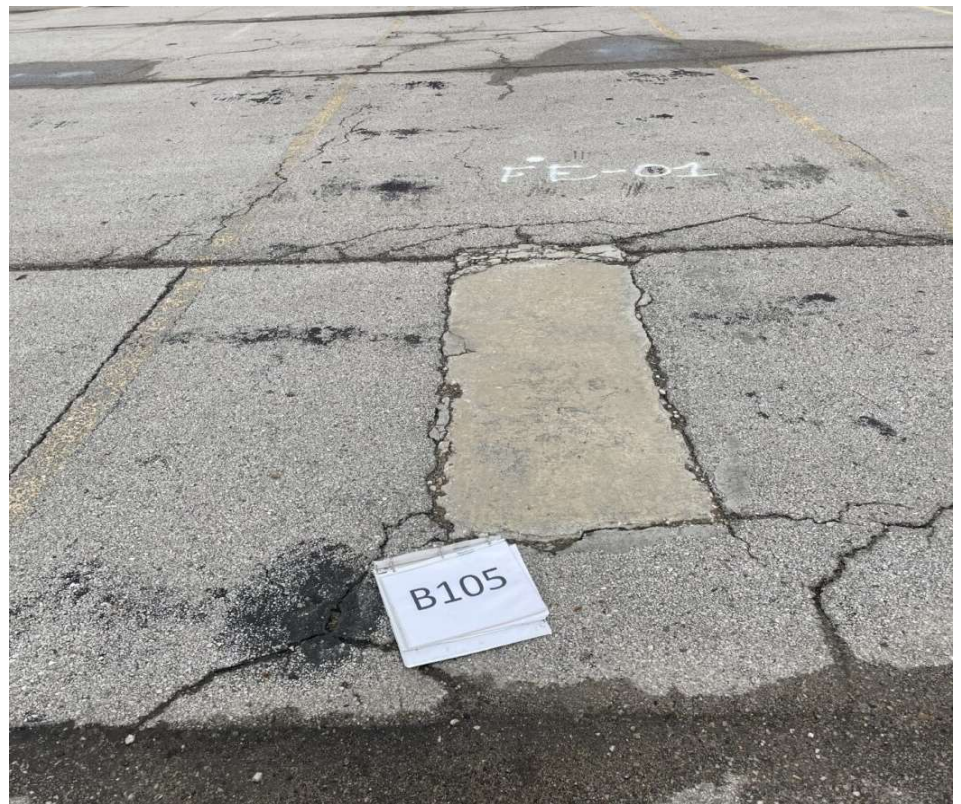
Stall B105, no new tar-like material observed at the historical seep location along asphalt crack.

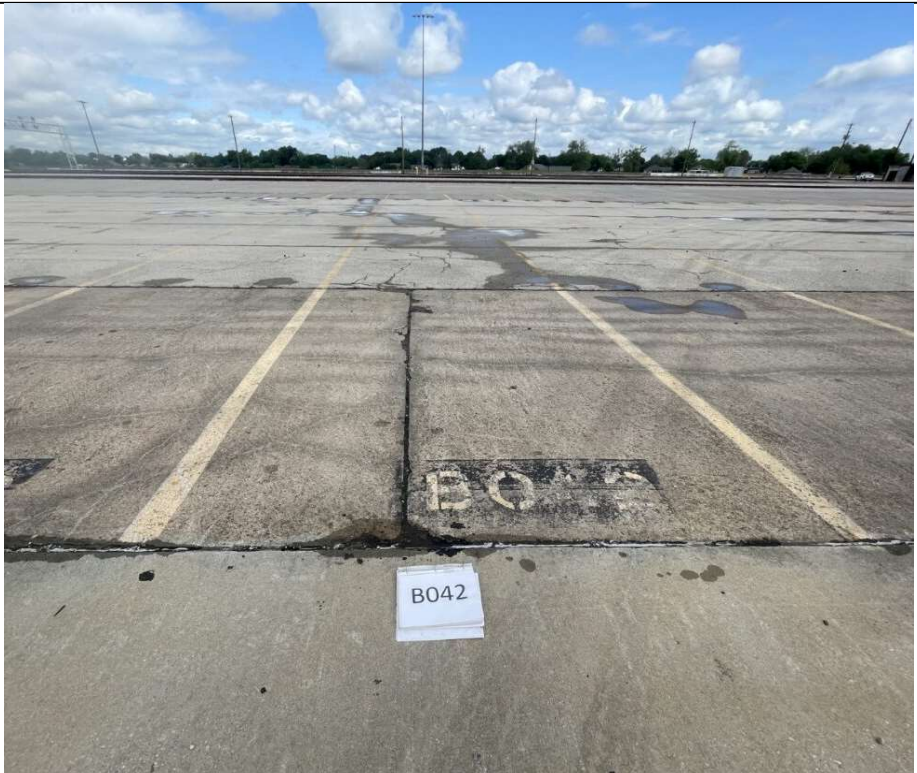
Stall B042. No new tar-like material observed at historical seep location along concrete crack.

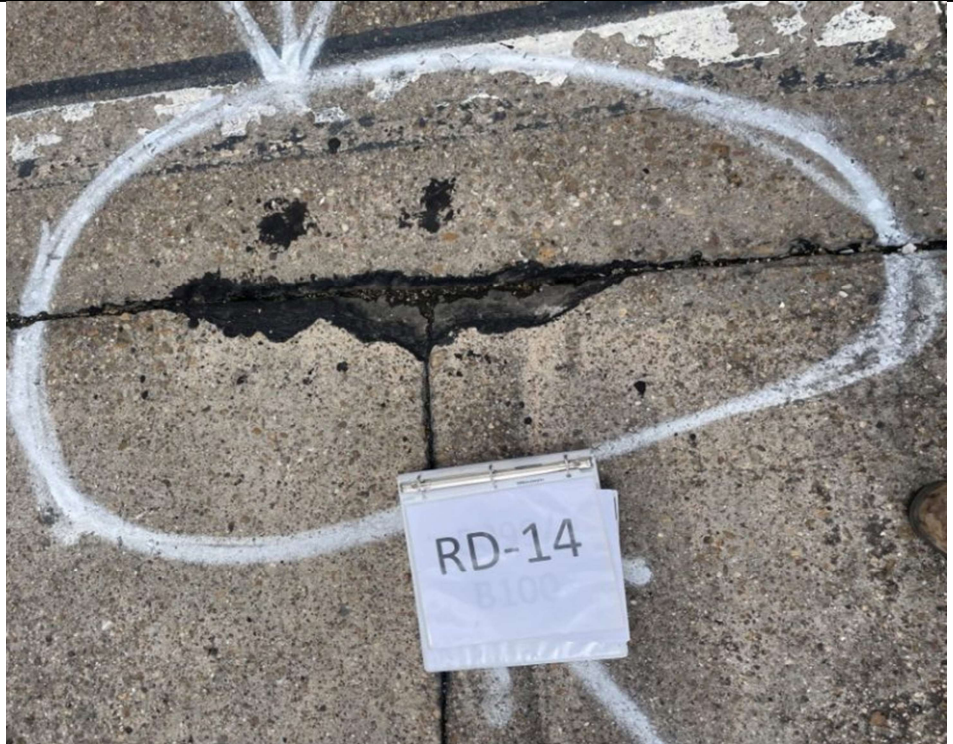
RD-14 Seep location observed within the concrete road area (RD-14) north of Track 802 (east of existing Track 802 seep location), no new tar-like material observed along a concrete joint.

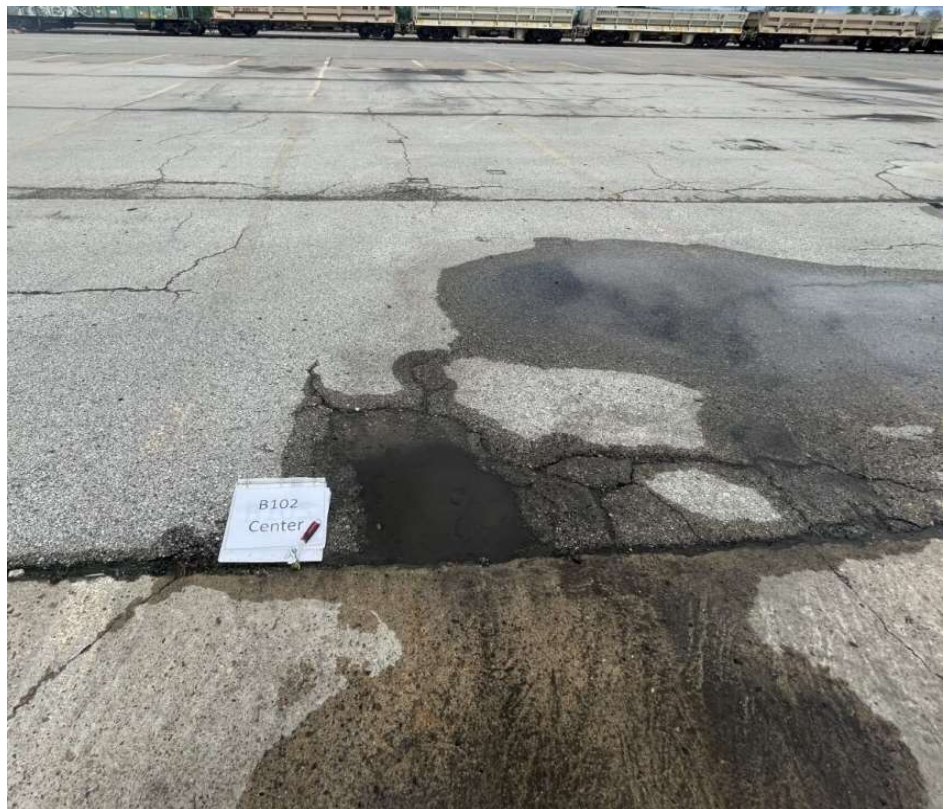
Stall B102 (center), no tar-like material observed at seep location along cracks in pavement.

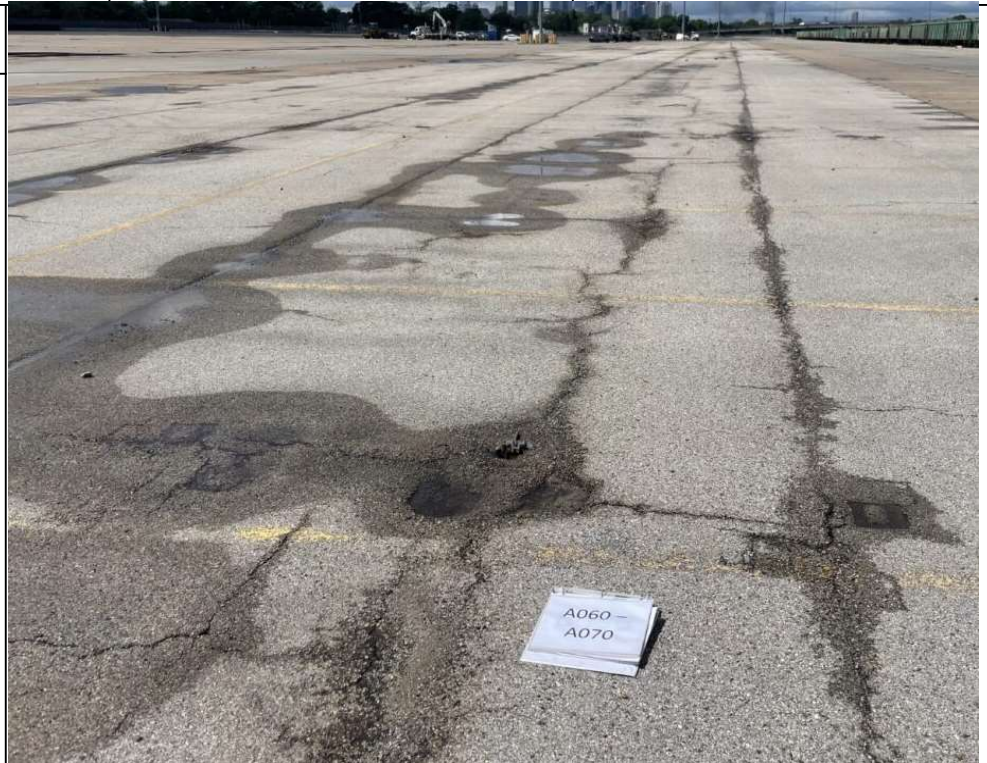
Stalls A060 - A070, some residual staining previously observed along cracks in pavement. No new water seeps observed. Viewing southwest.

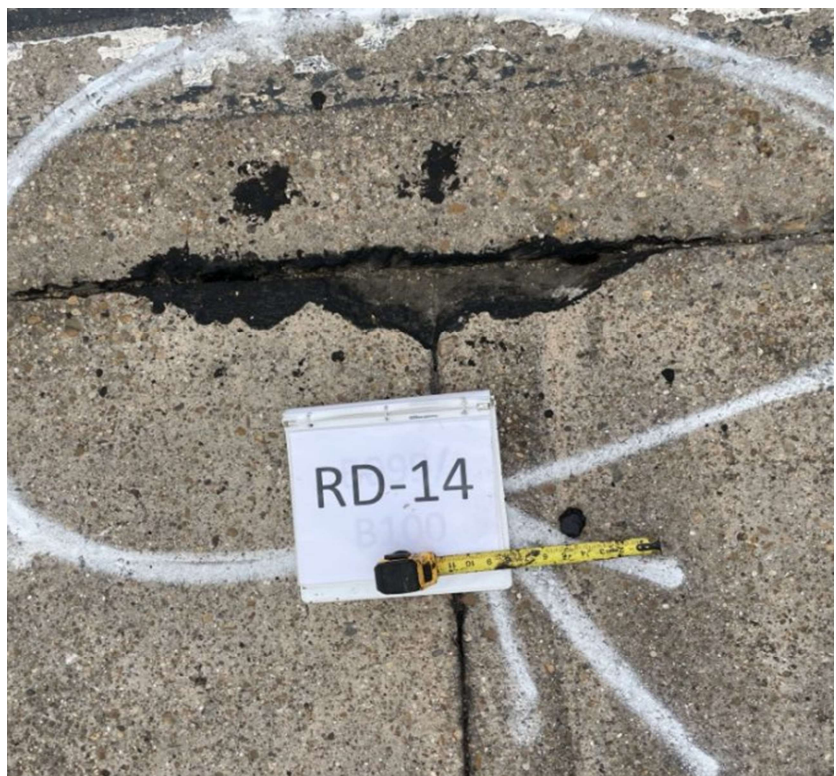
RD-14 Seep location observed within the concrete road area north of Track 802 (east of existing Track 802 seep location), some new tar-like material observed along a concrete joint. Material was removed.

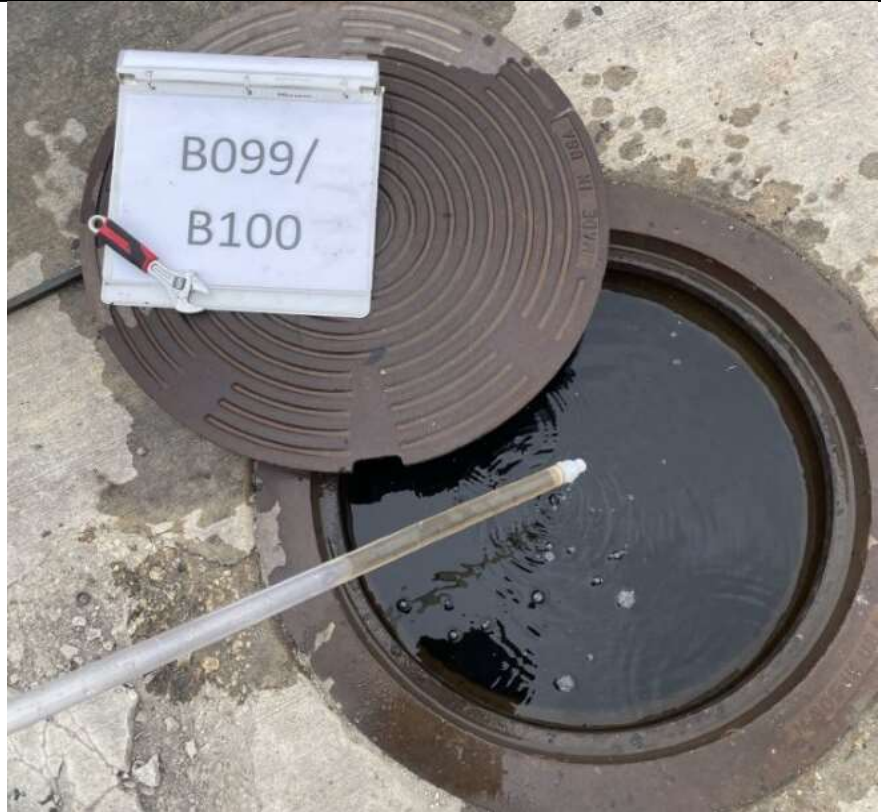
Sump 1 (B099/B100), 0 inches of freeboard in sump, no sheen observed, water color noted as light brown.

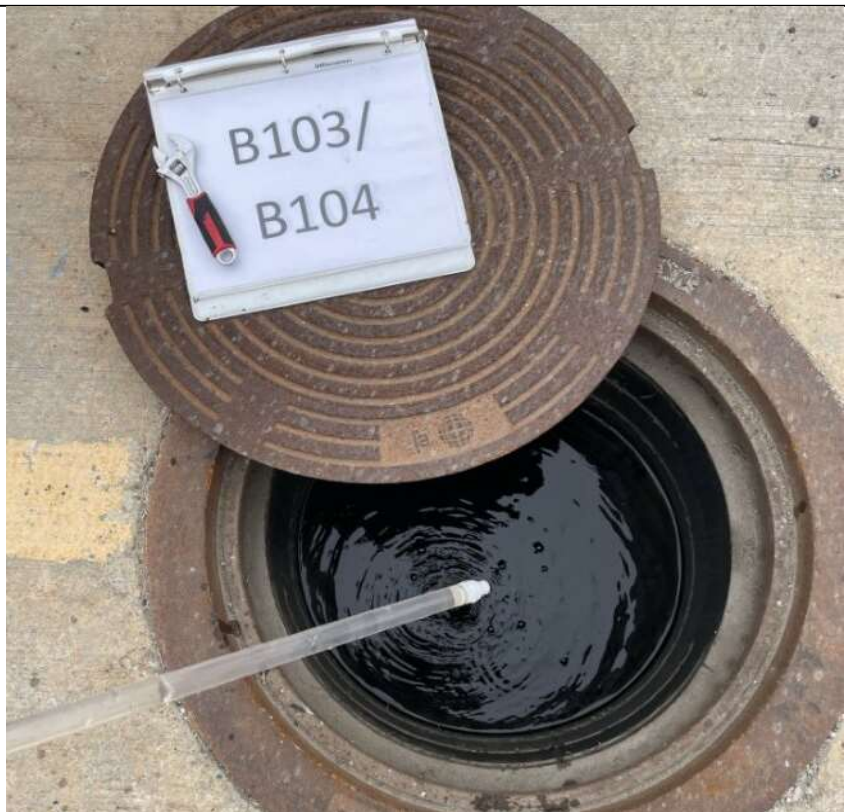
Sump 2 (B103/B104), 10 inches of freeboard in sump. No odor or sheen observed, color noted as clear.

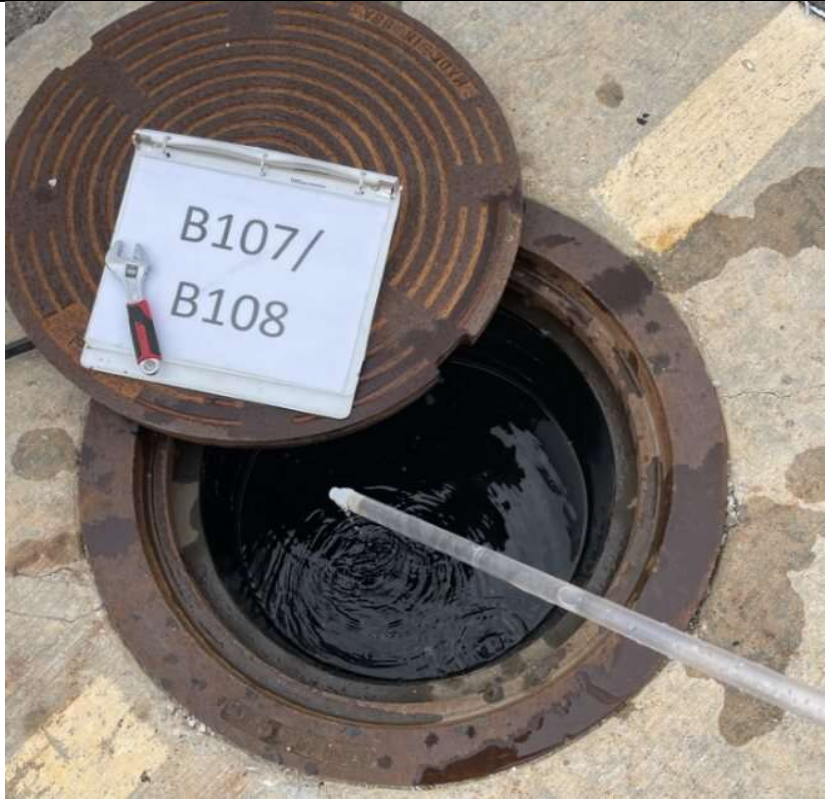
Sump 3 (B107/B108), 9.5 inches of freeboard in sump, no sheen observed, water color noted as clear.

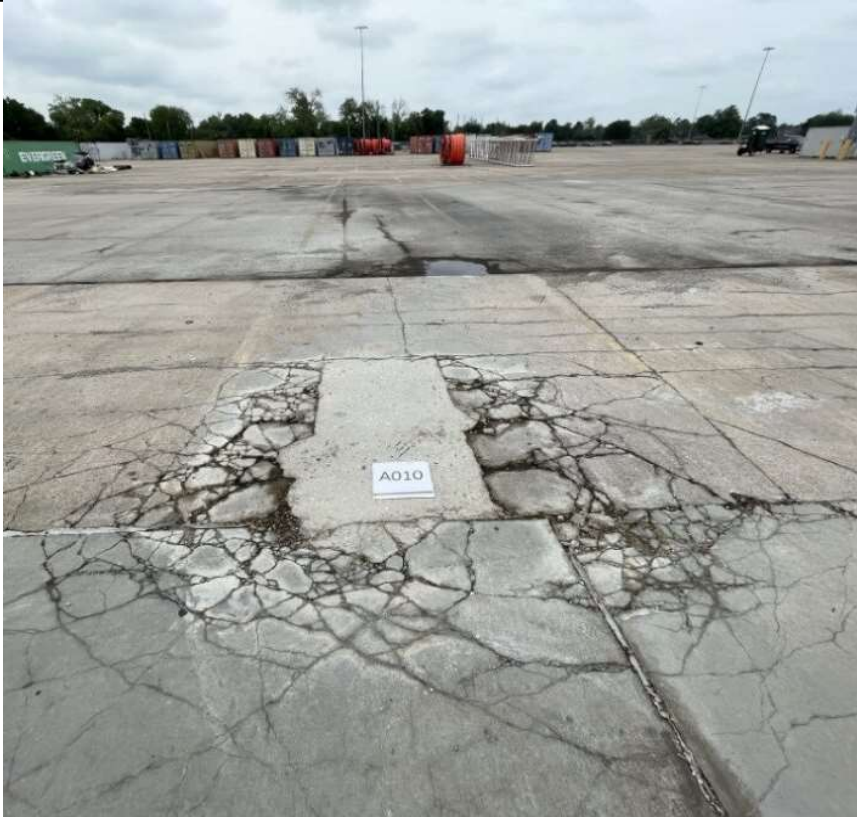
Stall A010. No tar-like material seeps observed at Test Pit A010.

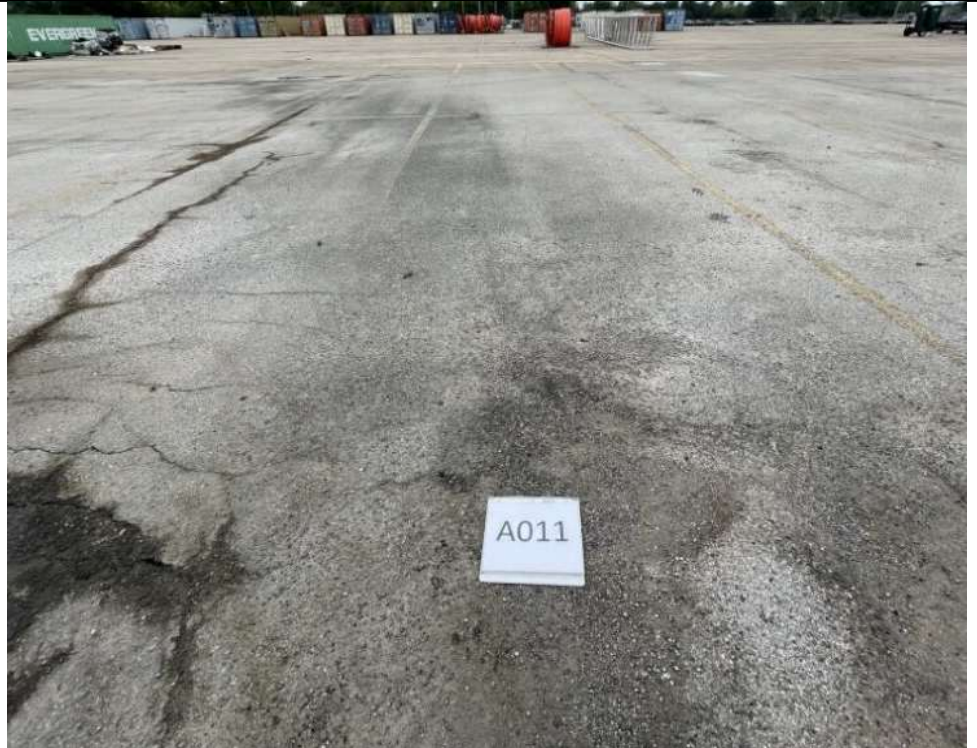
Stall A011. No new tar-like material observed at historical seep location along asphalt crack.

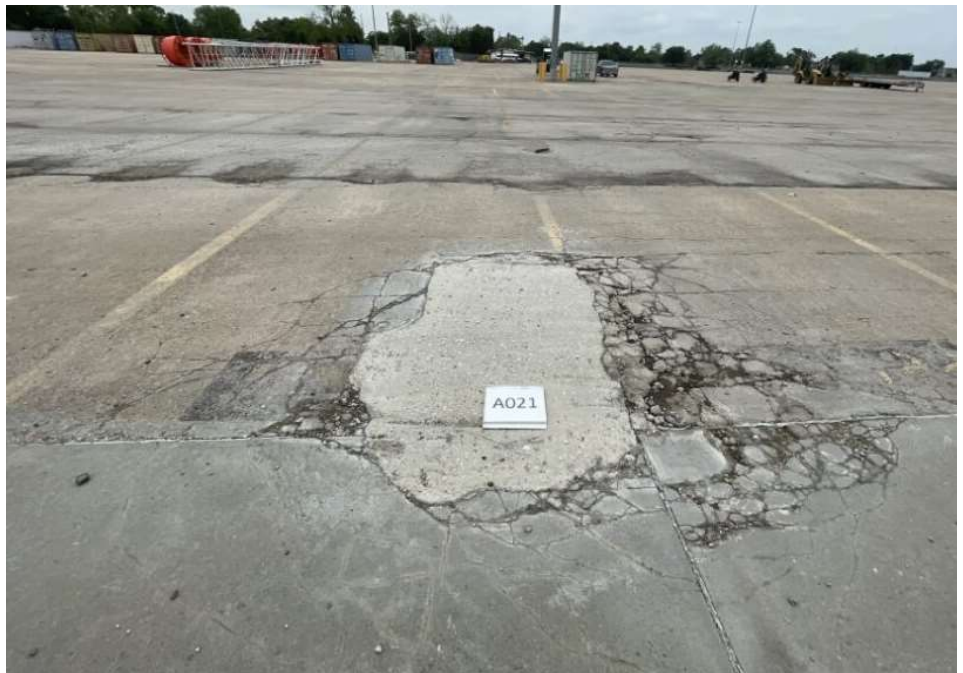
Stall A021. No tar-like material seeps observed at Test Pit A021.

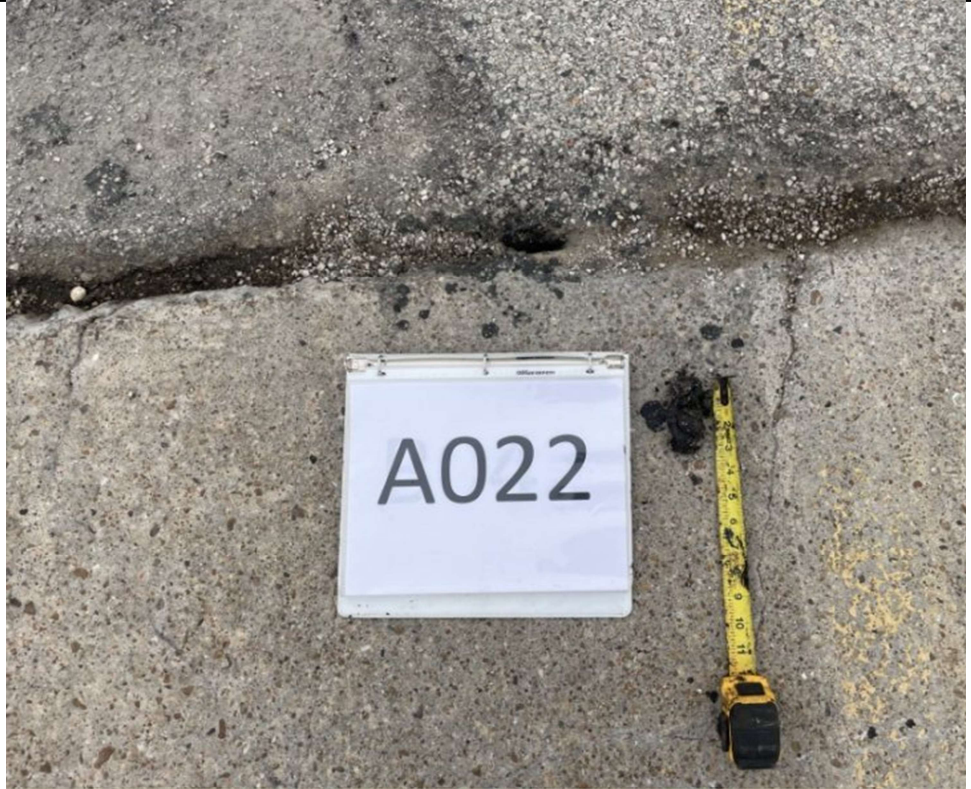
Stall A022, some tar-like material observed at the seep location along the edge, material removed.

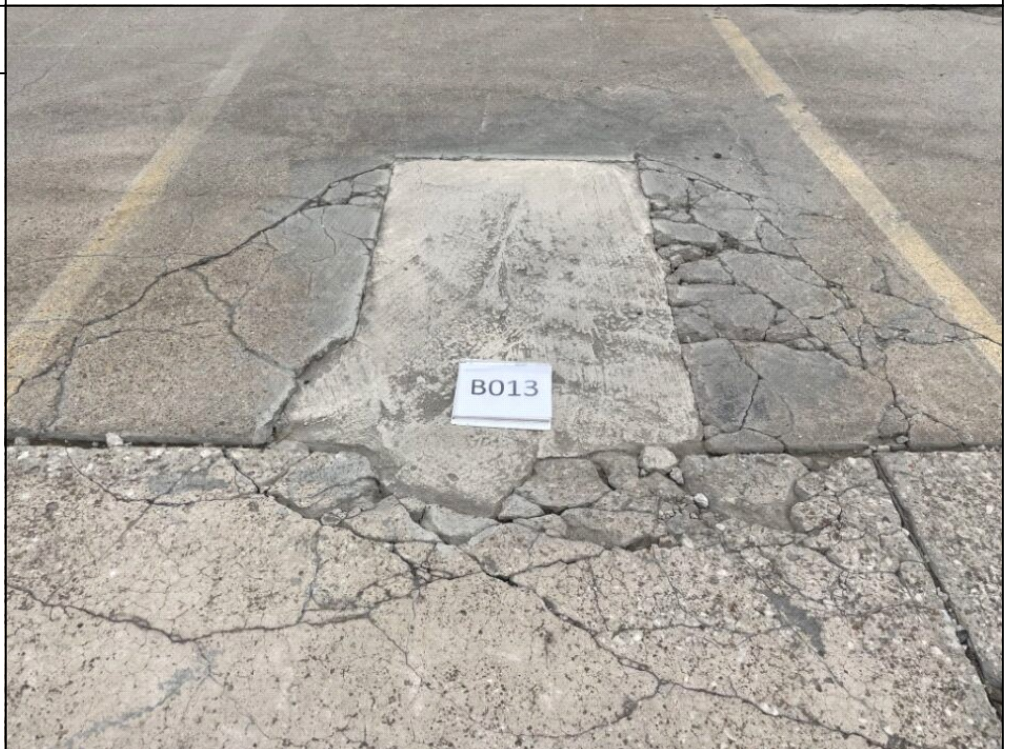
Stall B013. No tar-like material seeps observed at Test Pit B013.

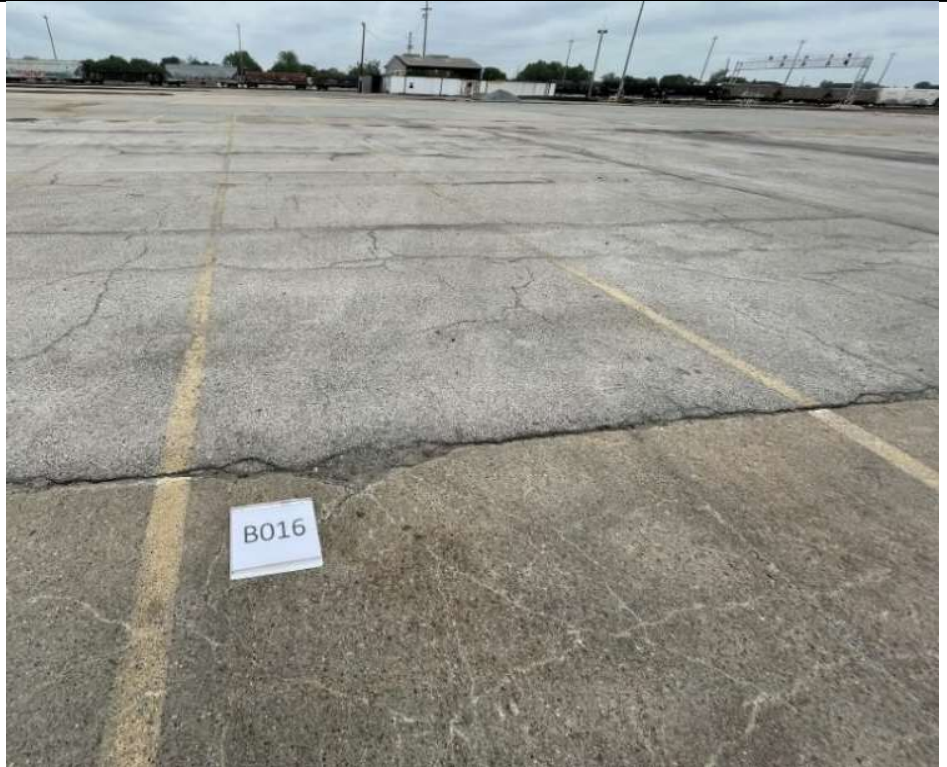
Stall B016. No tar-like material observed at historical seep location along asphalt crack.

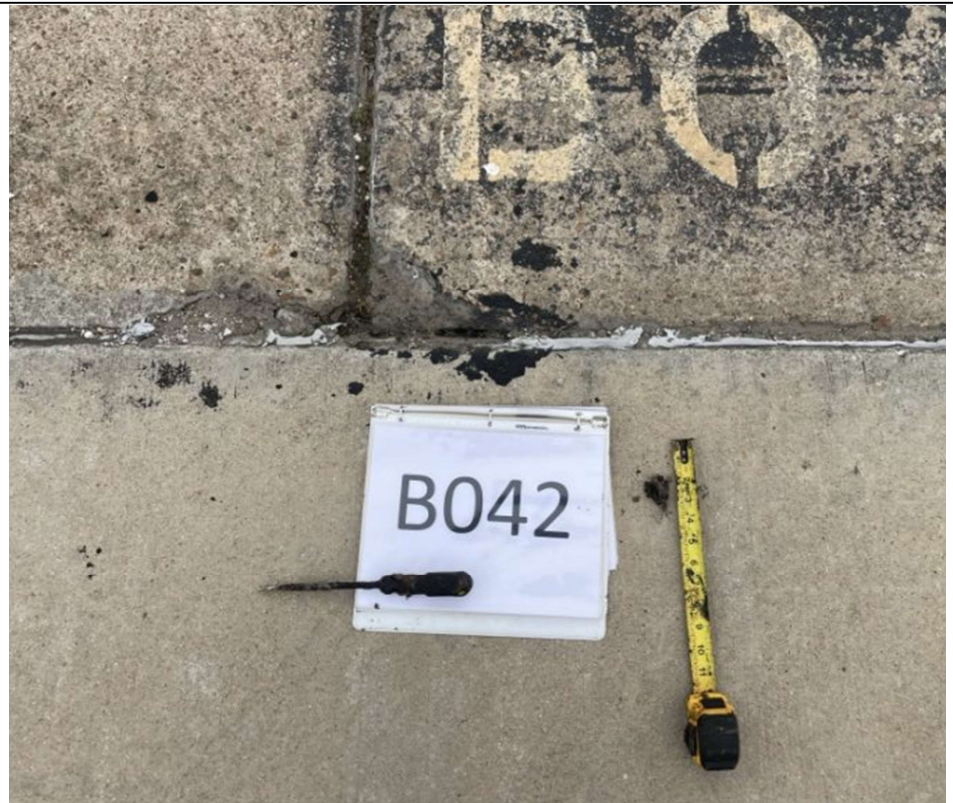
Stall B042. Some tar-like material observed at historical seep location along asphalt crack, material removed.

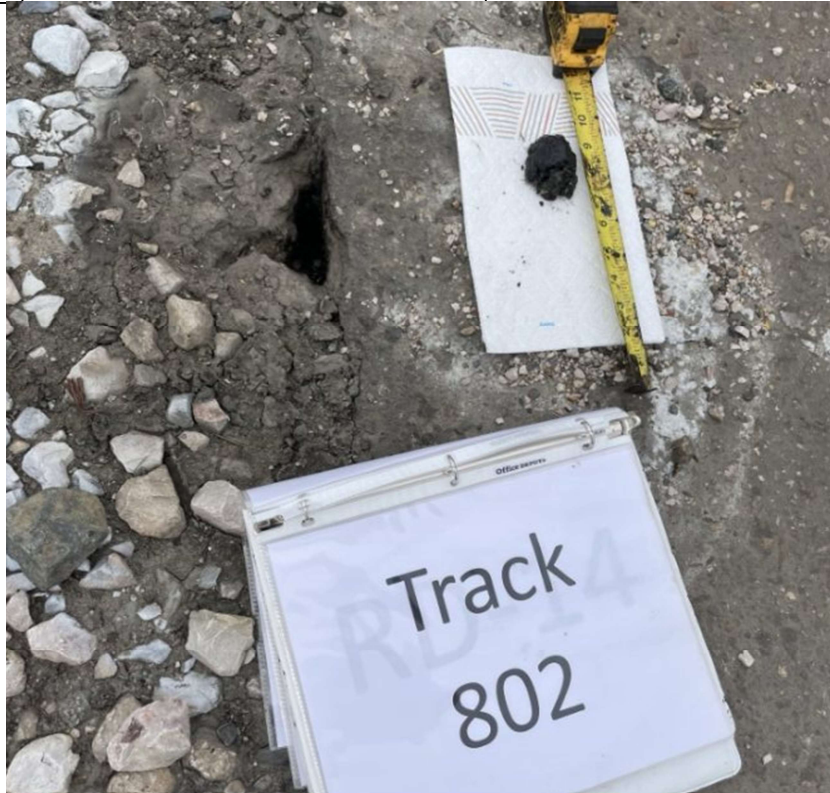
North side of Track 802, some tar-like material observed at seep location near the edge of the ballast, material removed.

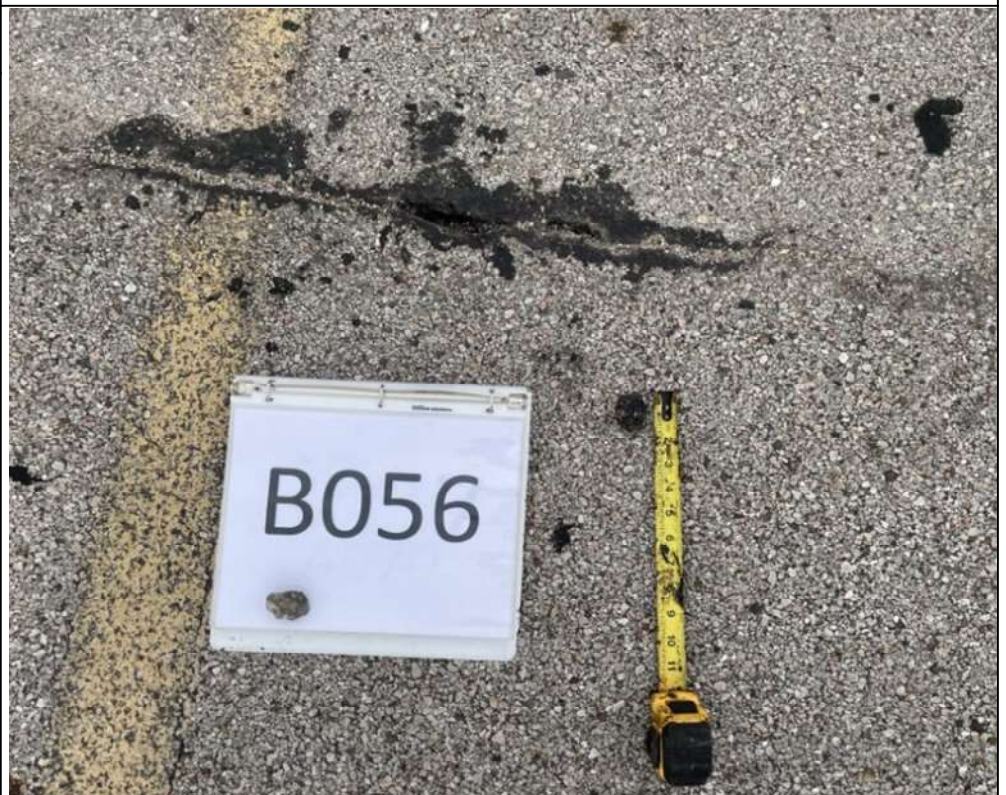
Stall B056. Some tar-like material observed at historical seep location along asphalt crack, material removed.

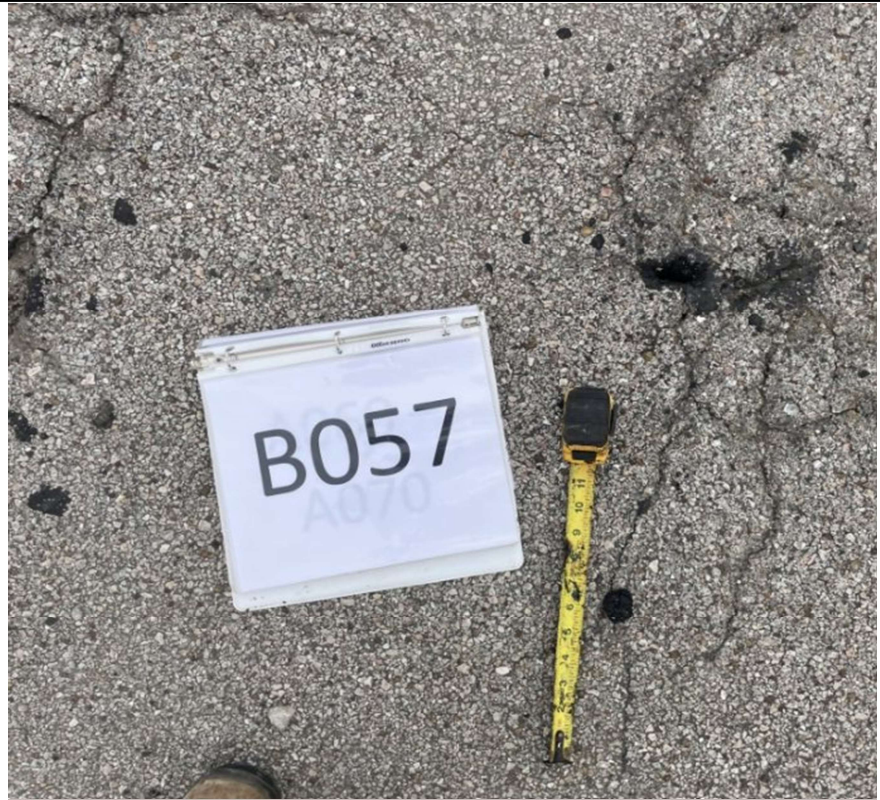
Stall B057, some tar-like material observed and removed at seep location along asphalt crack, material removed.

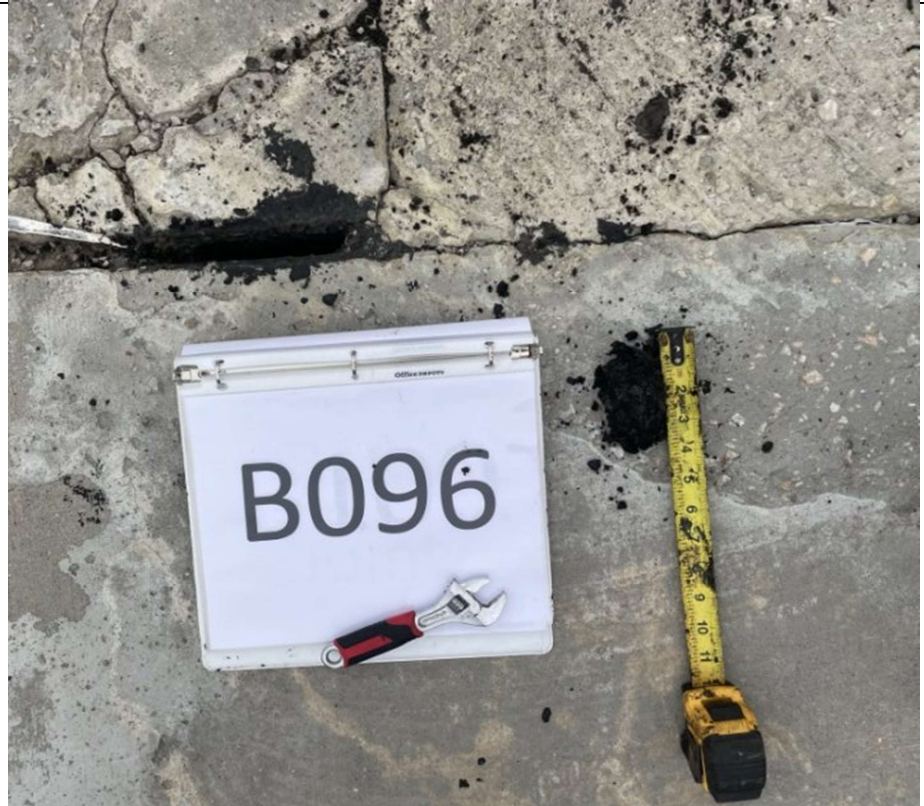
Stall B096, some tar-like material observed at historical seep location along concrete joint, material removed.

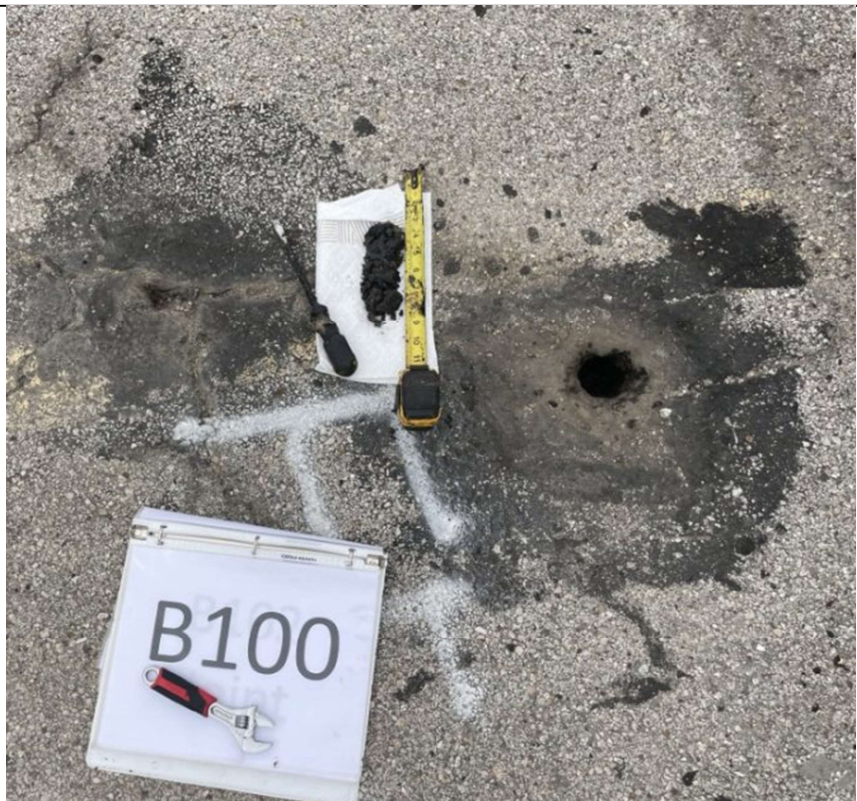
Stall B100, some tar-like material observed at seep location along asphalt crack/ hole in the asphalt, material removed.

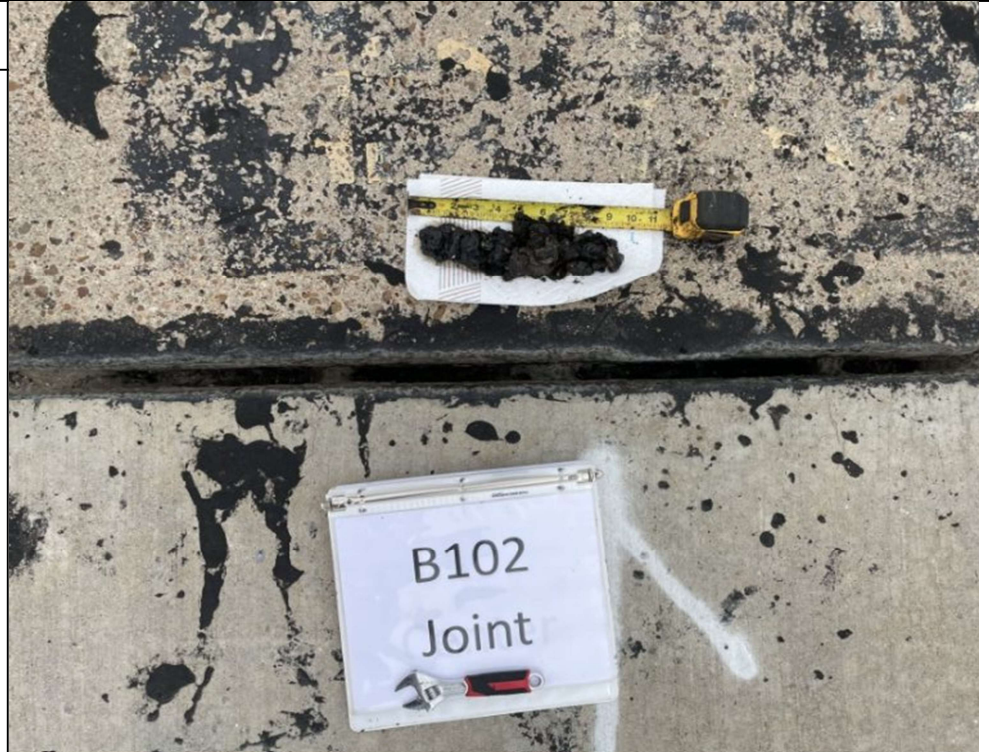
Stall B102 Joint, some tar-like material observed at seep location along stall joint, material removed.

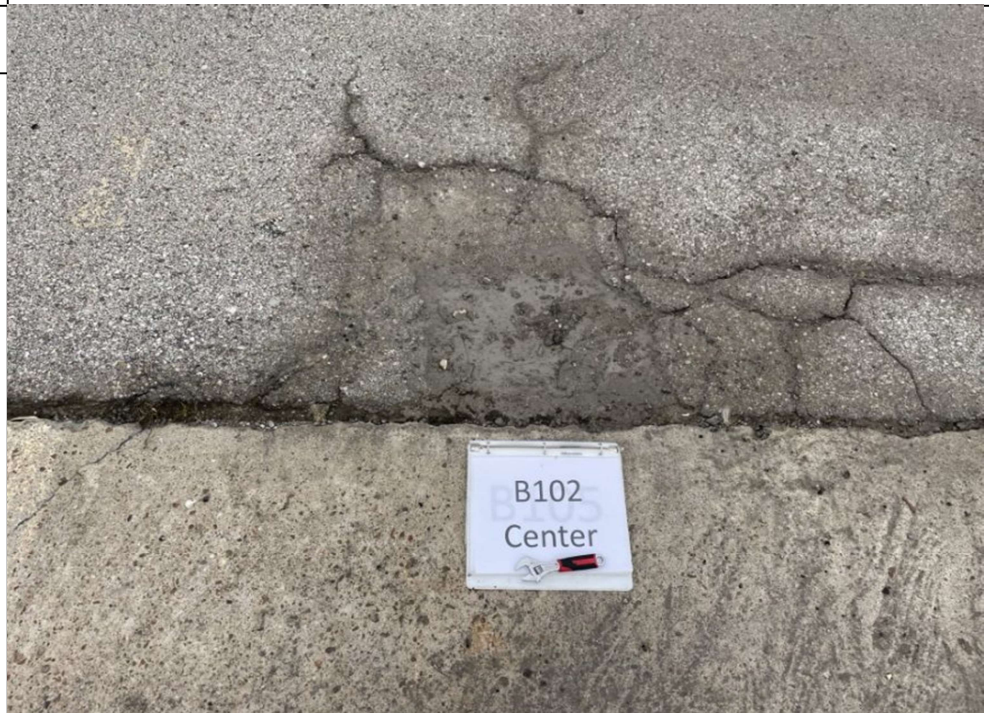
Stall B102 (center), no tar-like material observed at seep location where pavement is cracked.

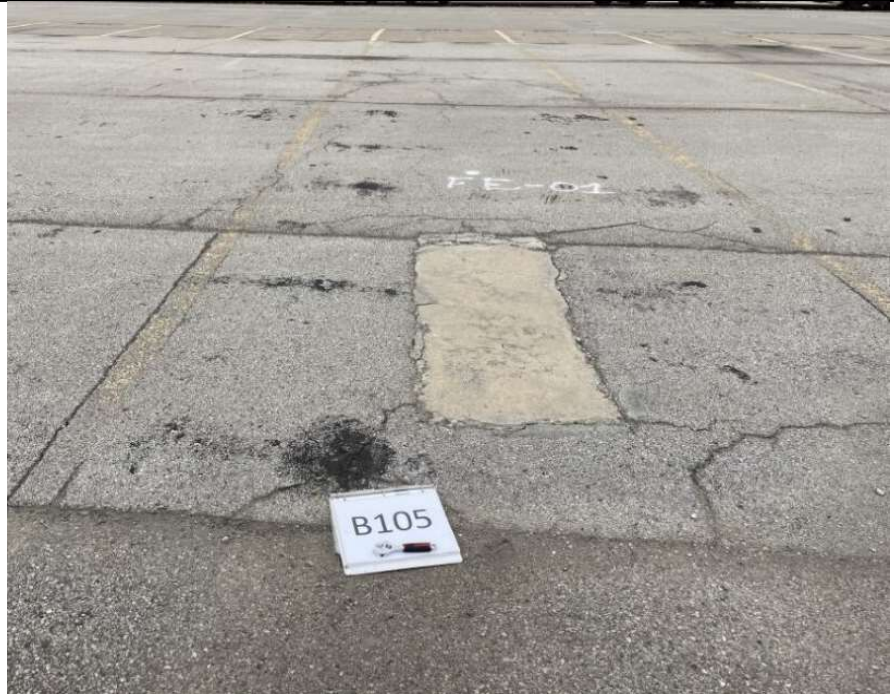
Stall B105, no new tar-like material observed at the historical seep location along asphalt crack.

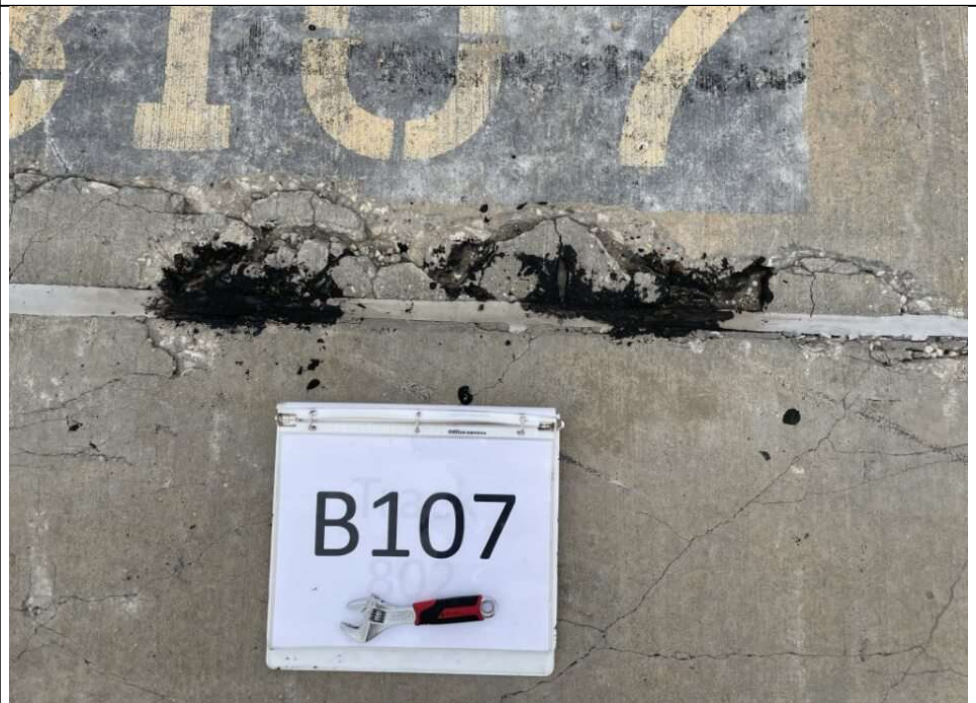
Stalls B107, no new tar-like material observed at seep location on concrete joint along the southern edge of the excavated area.

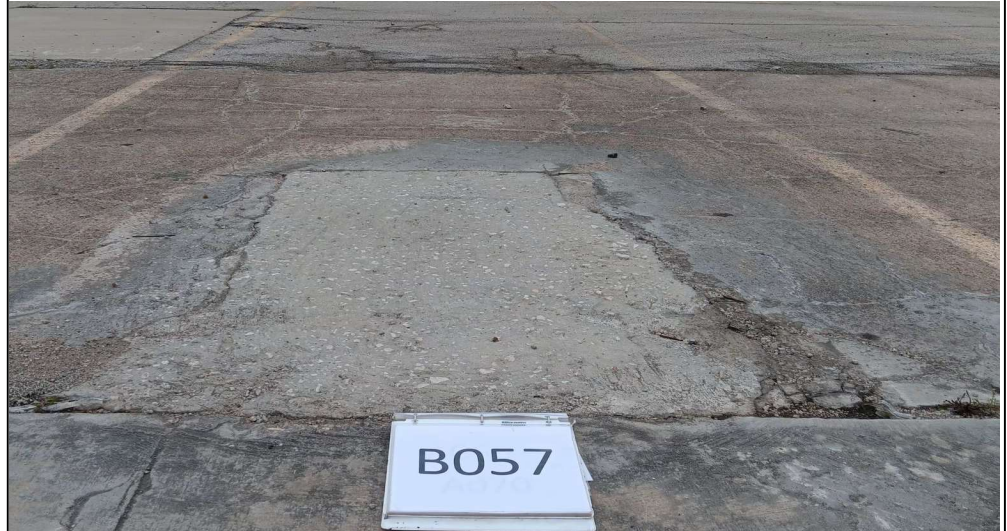
Stall B057 (joint), no new tar-like material observed at historical seep location at Test Pit B057.

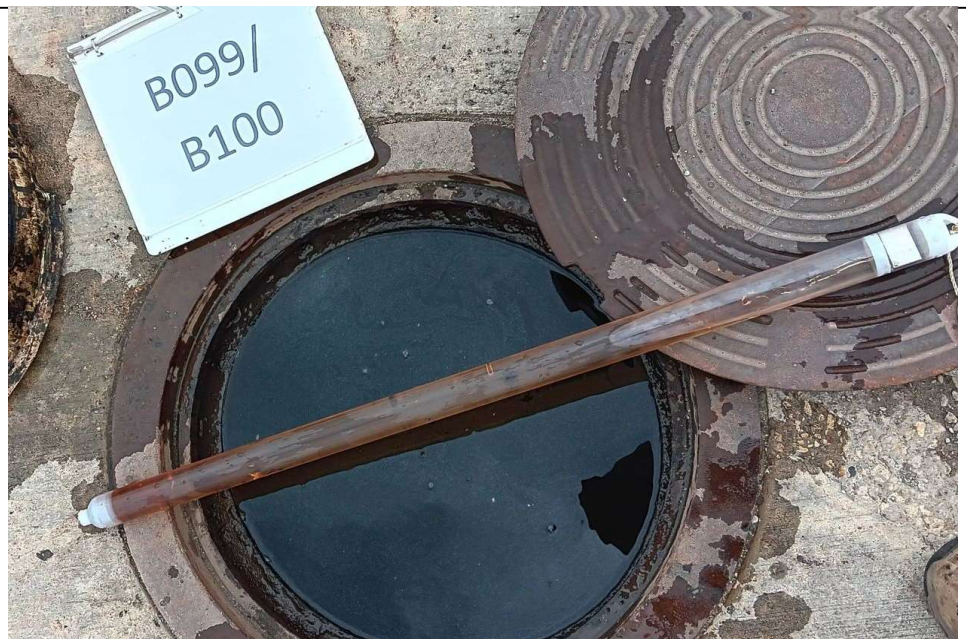
Sump 1 (B099/B100), 2.5 inches of freeboard in sump, a sheen on the water surface observed, water color noted as light brown.

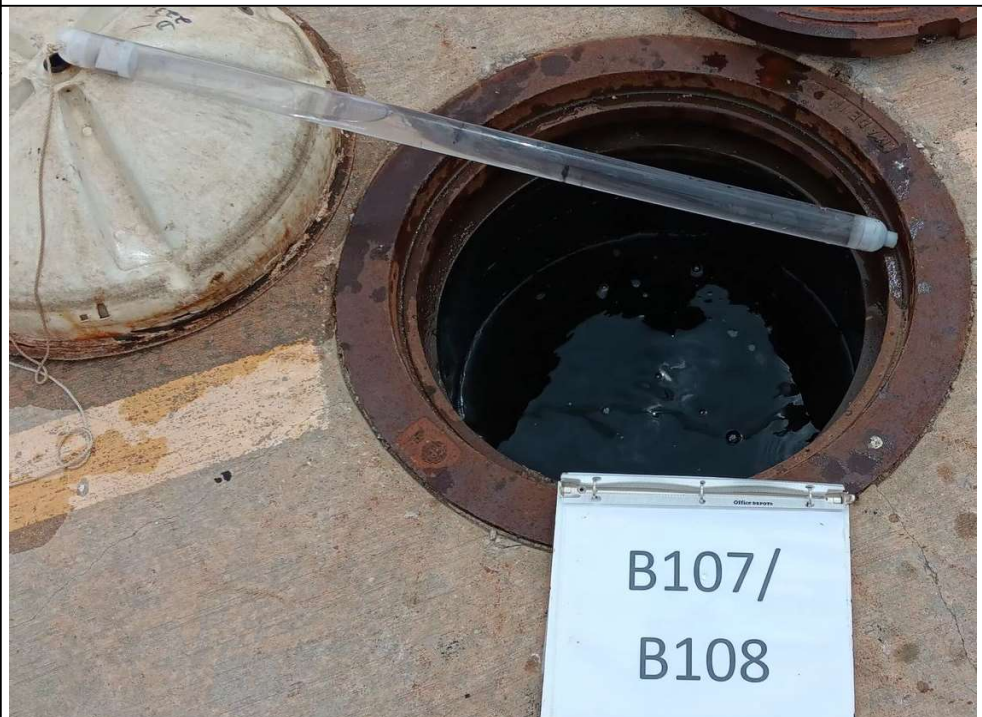
Sump 3 (B107/B108), 11 inches of freeboard in sump, no sheen observed, water color noted as clear.

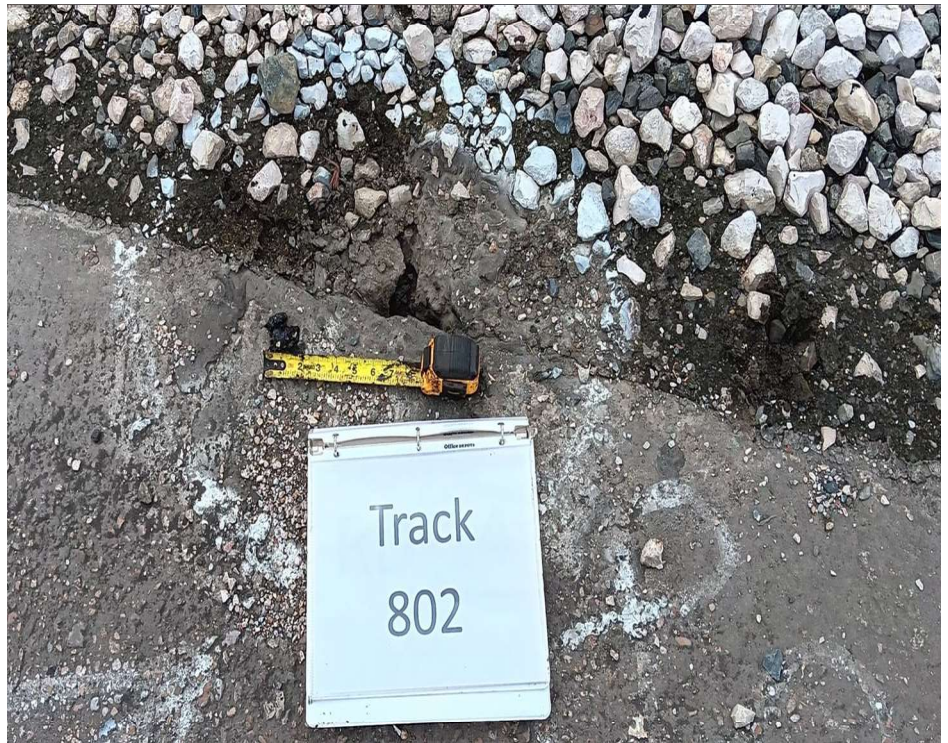
North side of Track 802, some new tar-like material observed at seep location near the edge of the ballast, material removed

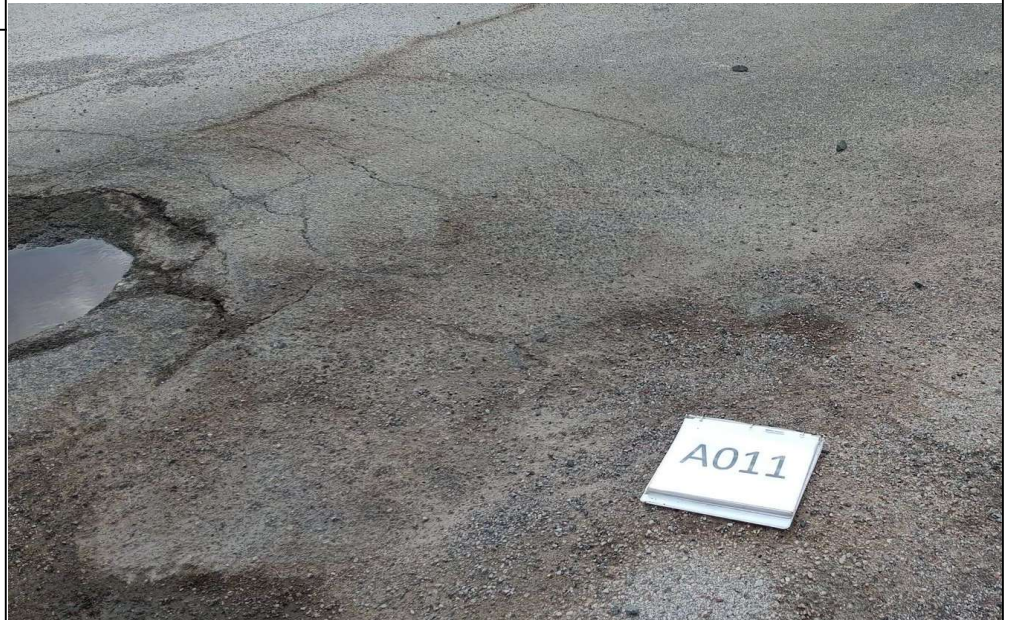
Stall A011. No new tar-like material observed at historical seep location along asphalt crack. Some staining observed along cracks in pavement.
