May 15, 2024

Project No. 31406585.016

Re: **MONTHLY STATUS UPDATE – ENGLEWOOD INTERMODAL YARD – NAPL COLLECTION
SYSTEM/CONCRETE CAP REPAIRS/REVISED INTERIM MEASURES WORK PLAN CONSTRUCTION
ACTIVITIES
UNION PACIFIC RAILROAD HOUSTON WOOD PRESERVING WORKS FACILITY
4910 LIBERTY ROAD FACILITY, HOUSTON, TEXAS
POST-CLOSURE CARE PERMIT NO. HW-50343; INDUSTRIAL SWR NO. 31547**

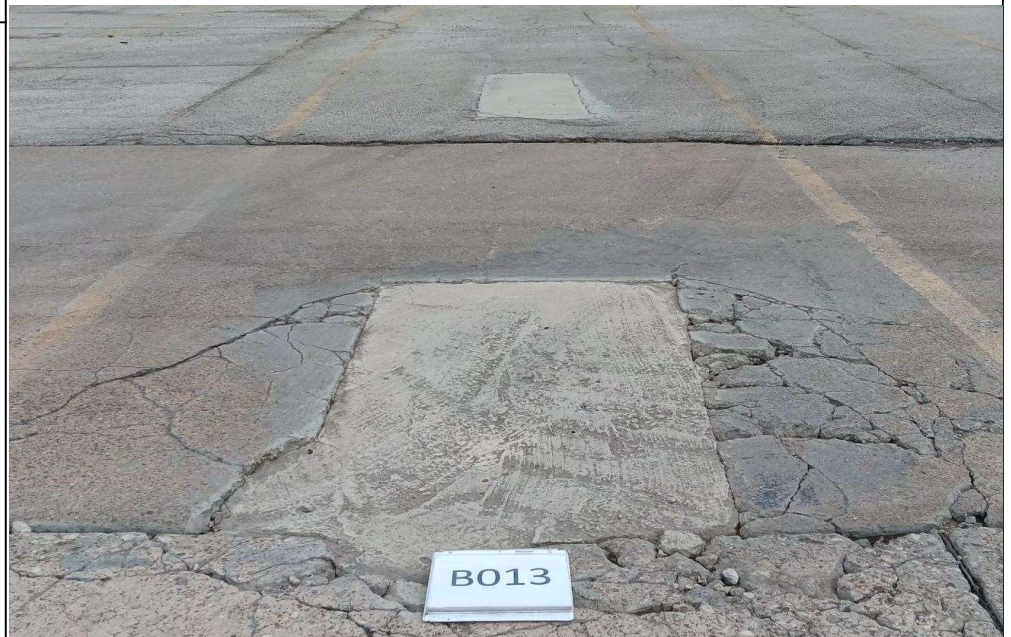
Stall B013. No seeps noted at Test Pit B013.

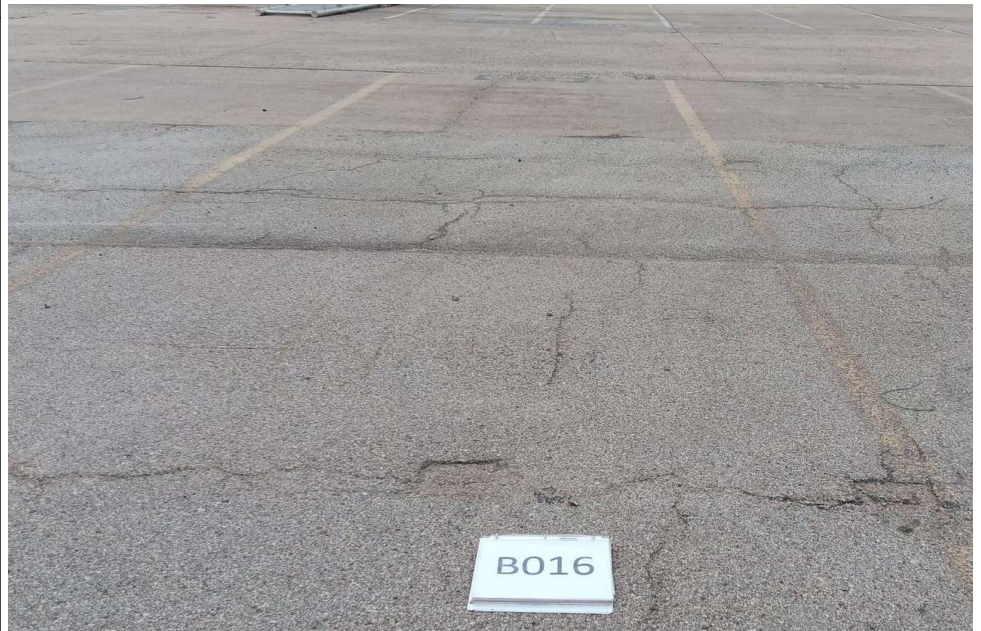
Stall B016. No tar-like material observed at historical seep location along asphalt crack.

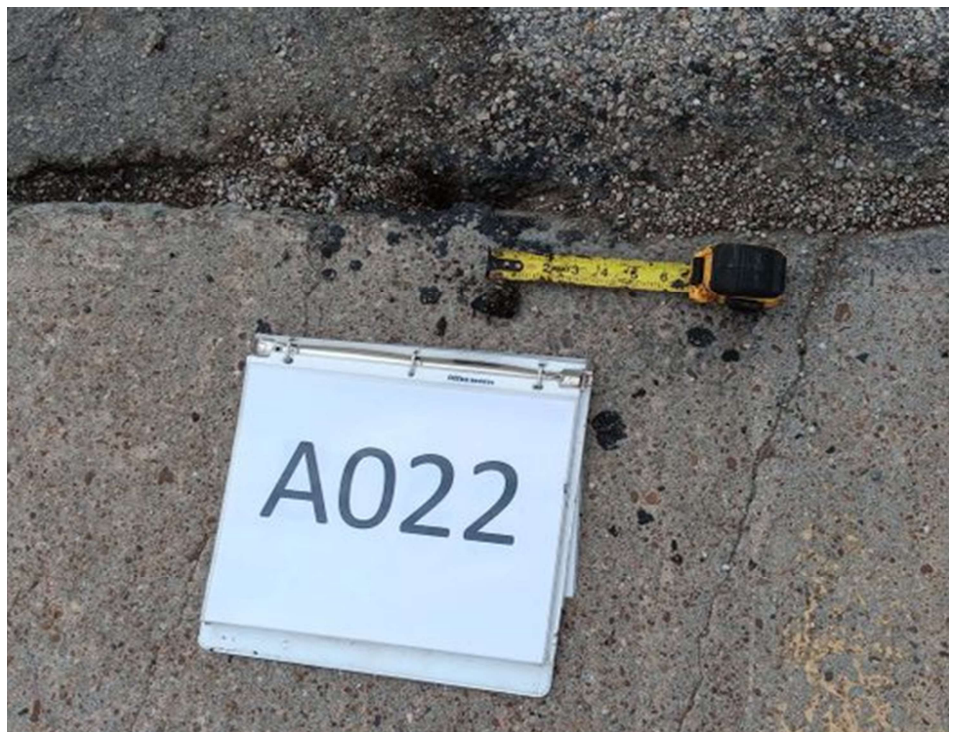
Stall A022, some tar-like material observed at the seep location along the edge, material removed.

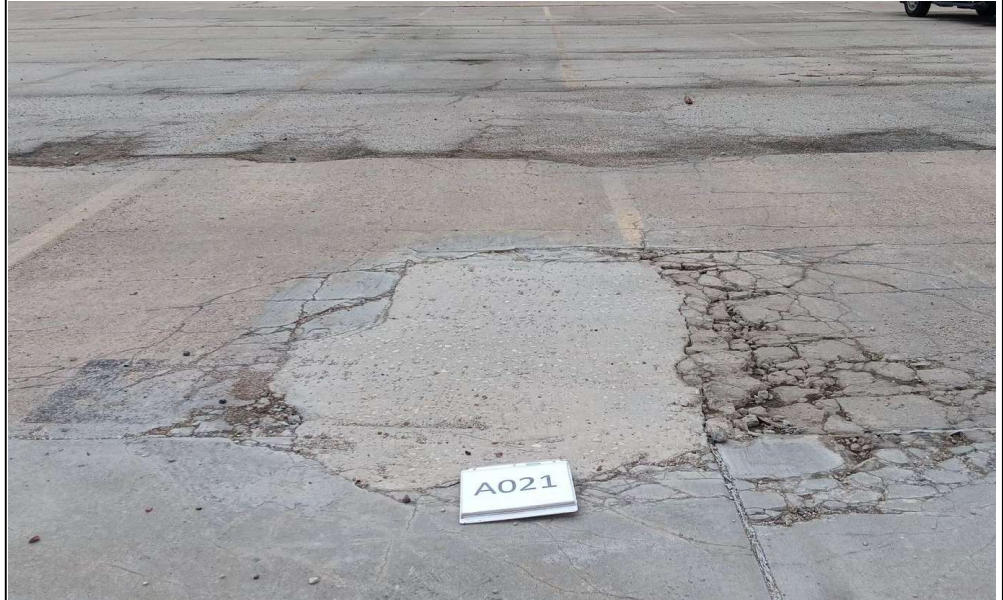
Stall A021. No seeps noted at Test Pit A021.

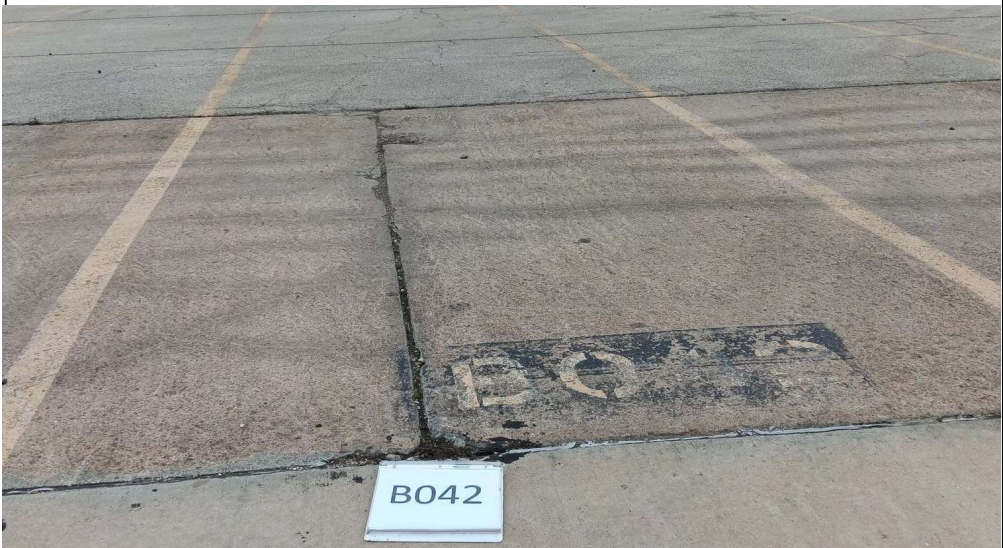
Stall B042. No new tar-like material observed at historical seep location along concrete joint.

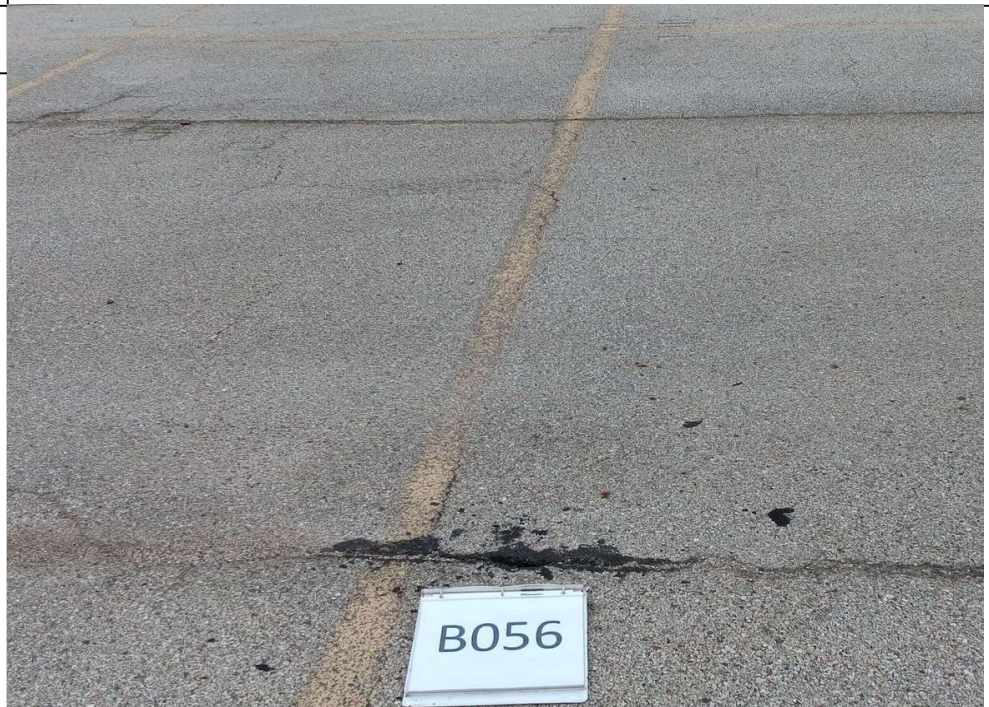
Stall B056. No new tar-like material observed at historical seep location along asphalt crack.

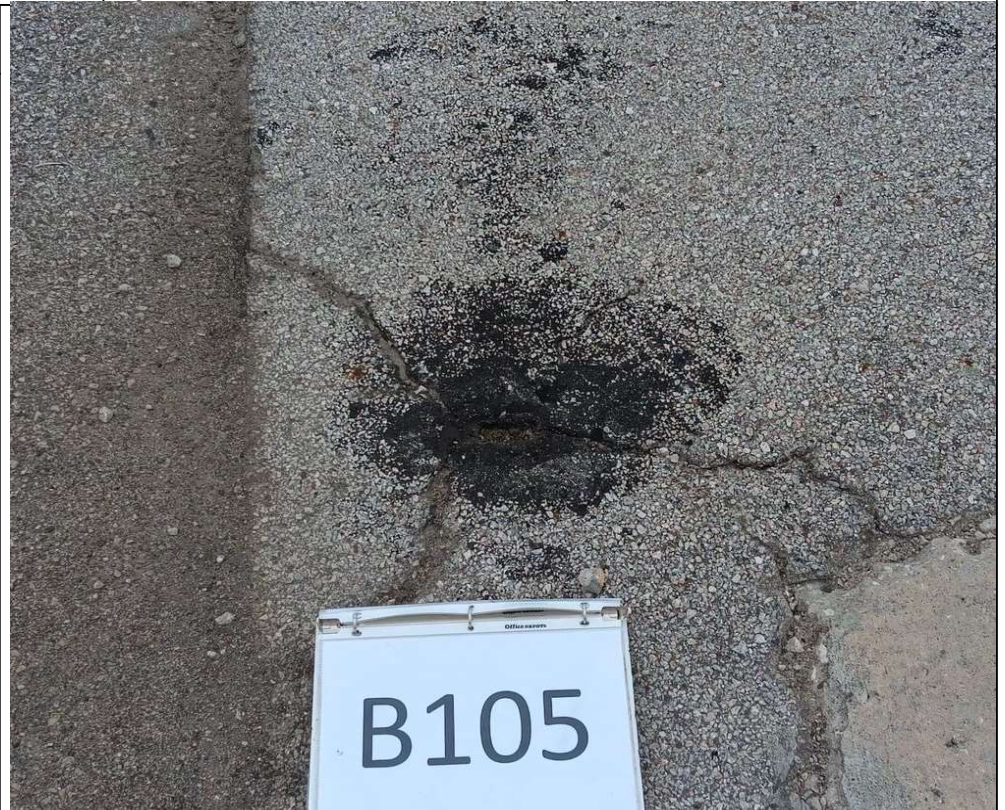
Stall B105, no new tar-like material observed at the historical seep location along asphalt crack.

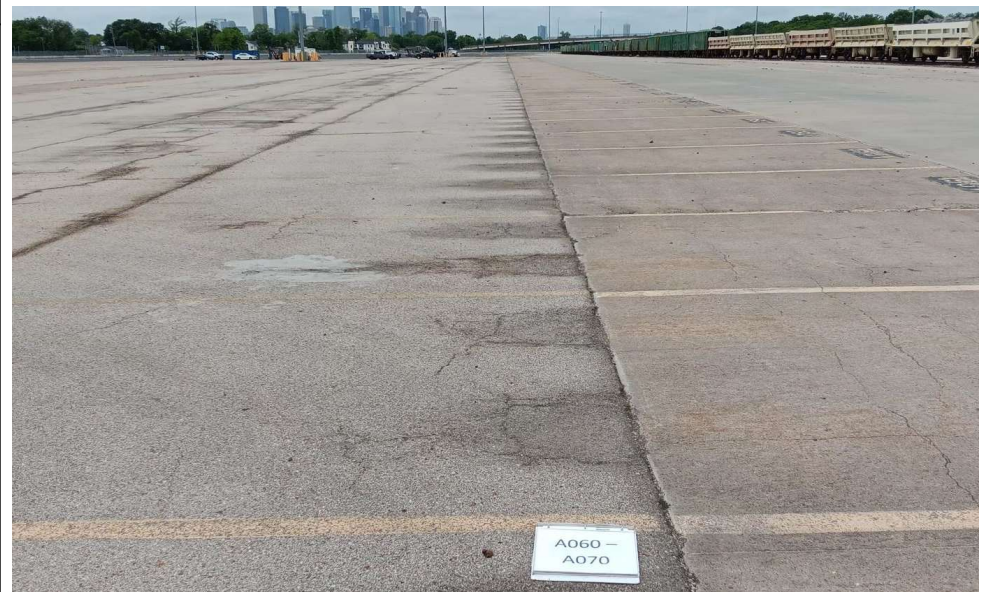
Stalls A060 - A070, some residual staining previously observed along cracks in pavement. No new water seeps observed. Viewing southwest.

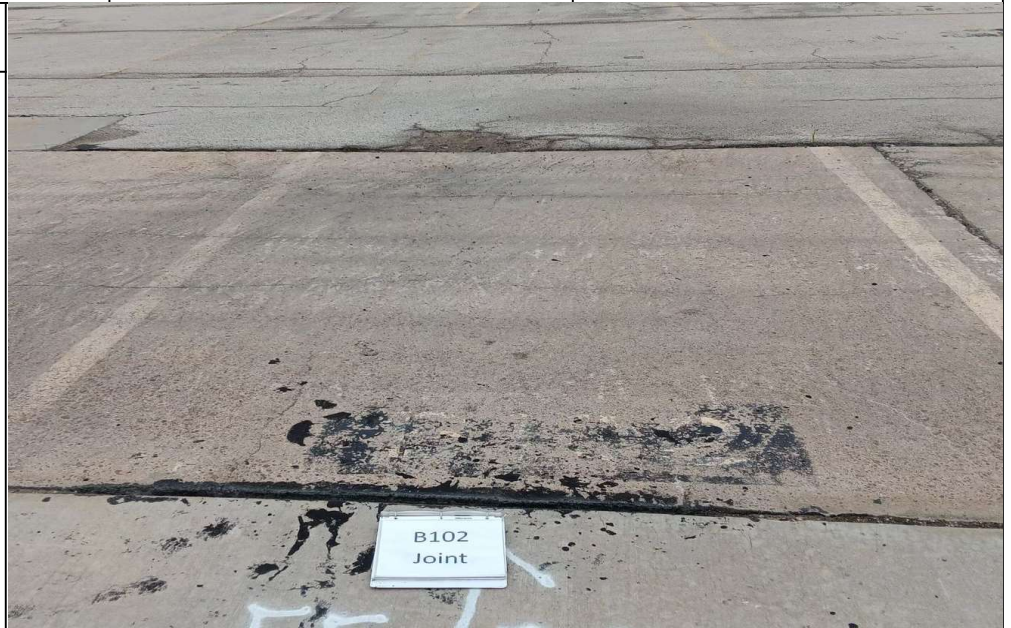
Stall B102 Joint, no new tar-like material observed at seep location along stall joint.
