November 15, 2024

Project No. 31406585.016

Re: **MONTHLY STATUS UPDATE – ENGLEWOOD INTERMODAL YARD – NAPL COLLECTION SYSTEM/CONCRETE CAP REPAIRS AND REVISED INTERIM MEASURES WORK PLAN CONSTRUCTION ACTIVITIES  
UNION PACIFIC RAILROAD HOUSTON WOOD PRESERVING WORKS FACILITY  
4910 LIBERTY ROAD FACILITY, HOUSTON, TEXAS  
POST-CLOSURE CARE PERMIT NO. HW-50343; INDUSTRIAL SWR NO. 31547**

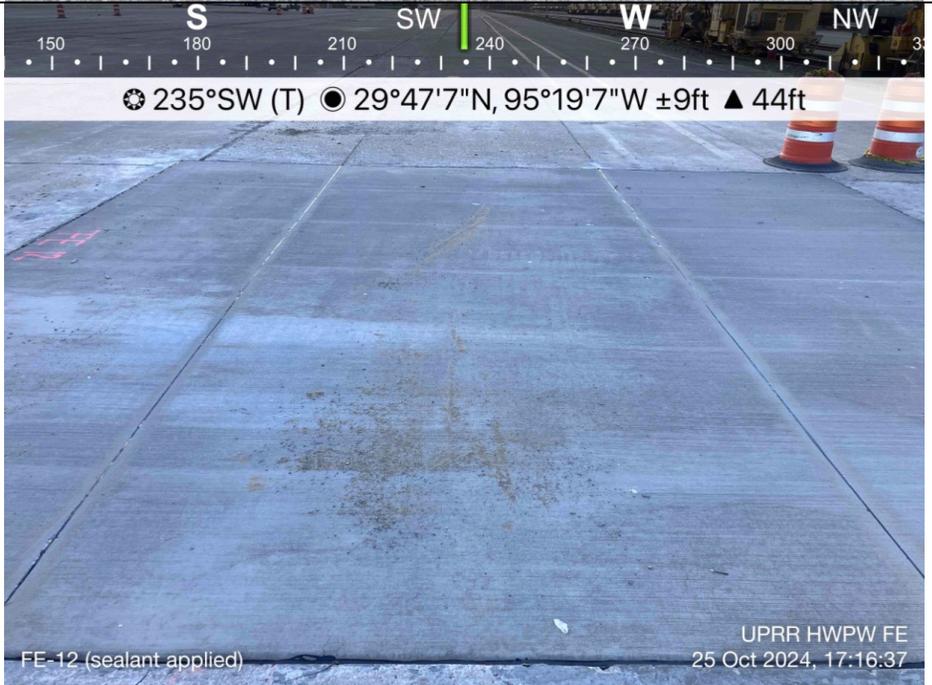
<b>Photo No.:</b> 12	<b>Inspection Date:</b> 10/25/2024
-------------------------	---------------------------------------

**Description:**  
Finished sealant on joints at FE-12.

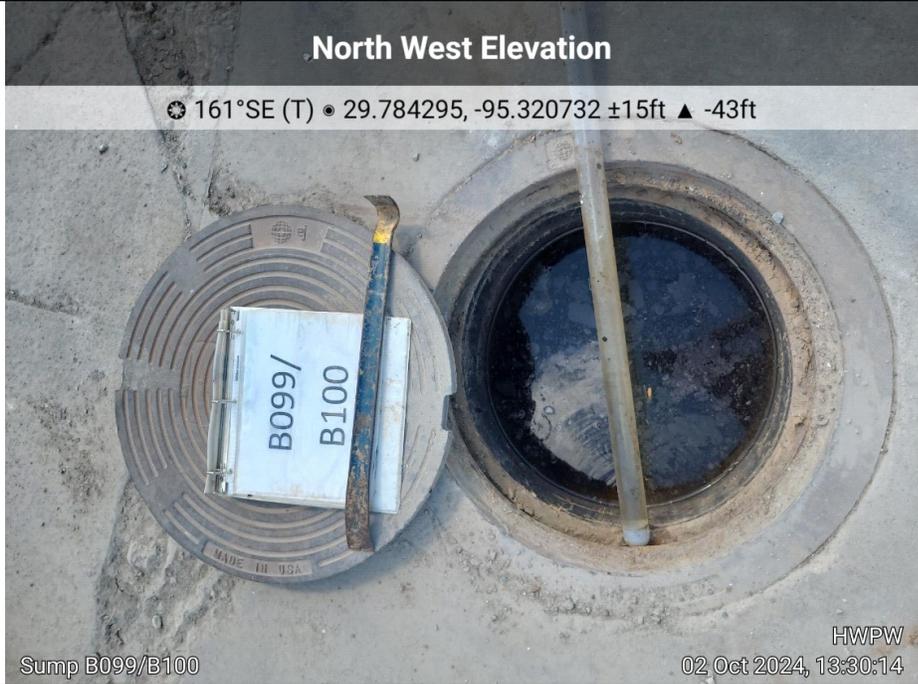
**Description:**  
Sump 1 (B99/B100), 11.5 inches of freeboard in sump. Color is clear, and no sheen or odor observed.

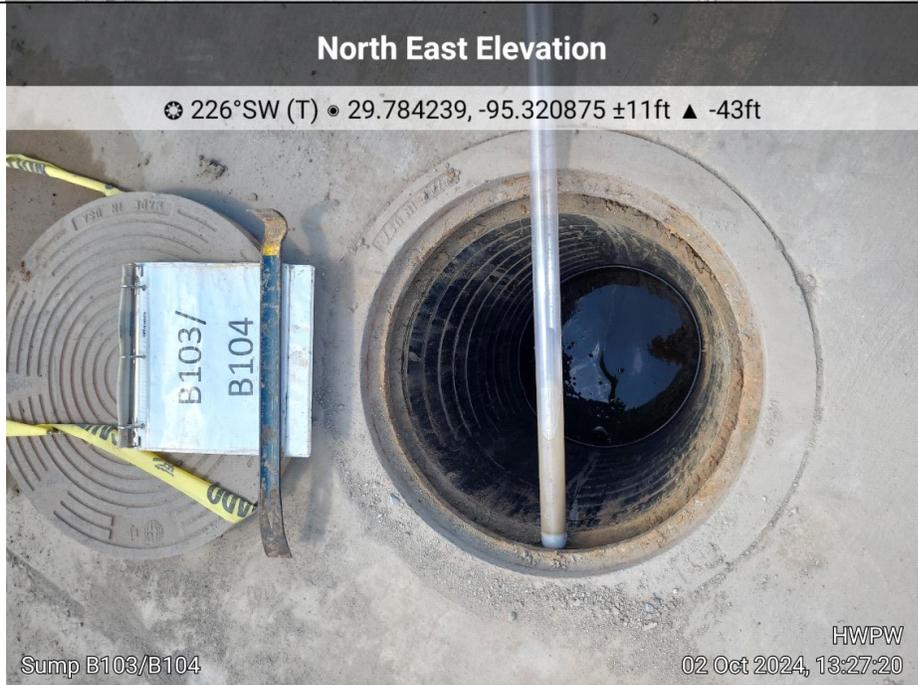
**Photo No.**  
**16**

**Description:**  
Sump 2 (B103/B104), 36.5 inches of freeboard in sump. Color is tan, and no sheen or odor observed.

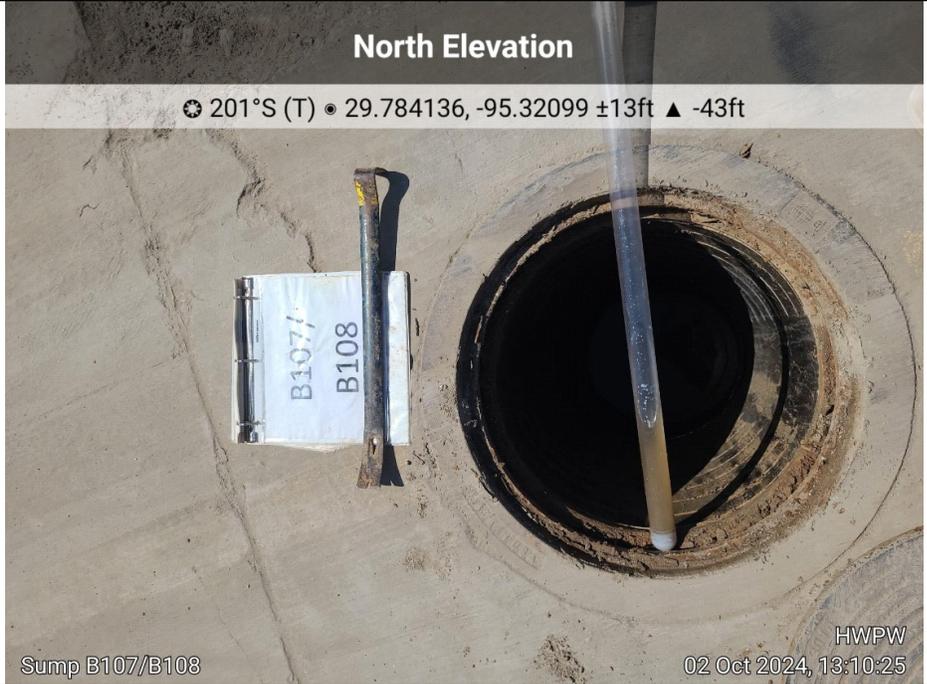
<b>Photo No.:</b> 17	<b>Inspection Date:</b> 10/2/2024
<b>Description:</b> Sump 3 (B107/B108), 36 inches of freeboard in sump. Color is brown, and no sheen or odor observed.  Lat: 29.784136 Long: -95.320990

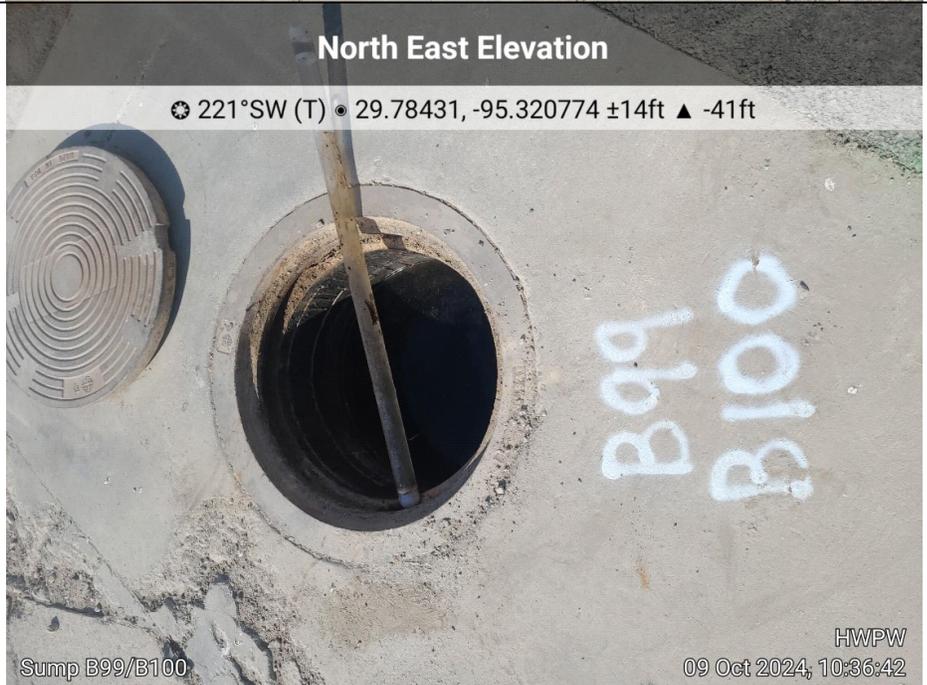
- During the October 2024 inspections, the water in Sump 1 was observed to be clear or light brown in color. The water in Sump 2 was observed to be clear to light brown in color. The water in Sump 3 was observed to be clear to brown in color. A sheen was observed at Sump 1 during the October 9<sup>th</sup>, 16<sup>th</sup>, and 24<sup>th</sup> inspections (Photos 18, 21, and 24). No odors were reported during the October inspections.

<b>Photo No.:</b> 18	<b>Inspection Date:</b> 10/9/2024
<b>Description:</b> Sump 1 (B99/B100), 10 inches of freeboard in sump. Color is clear, and no odor observed. Sheen observed on the surface.  Lat: 29.784310 Long: -95.320774

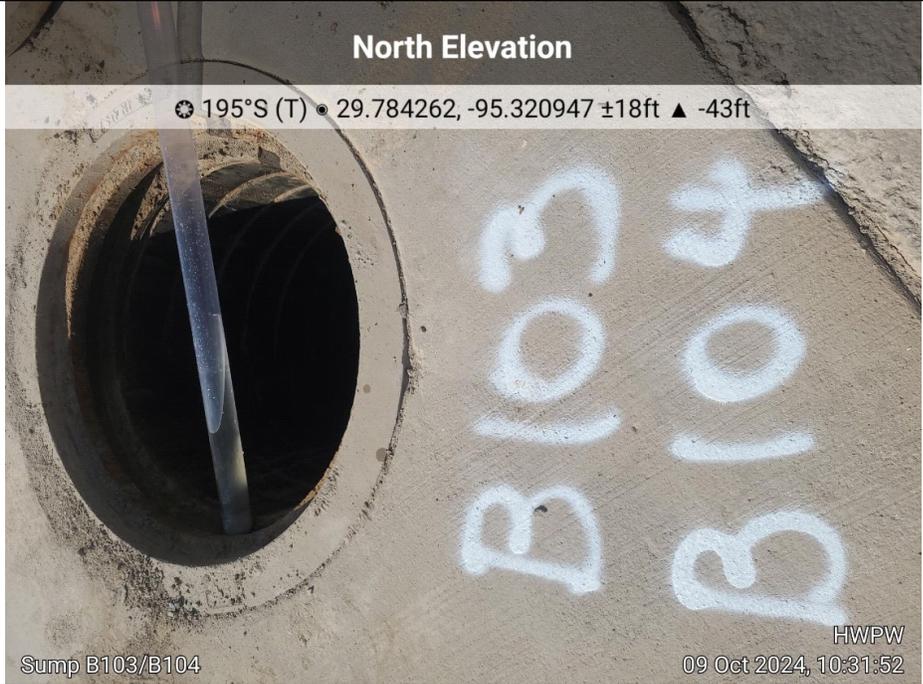
**Description:**  
Sump 2 (B103/B104), 37 inches of freeboard in sump. Color is clear, and no sheen or odor observed.

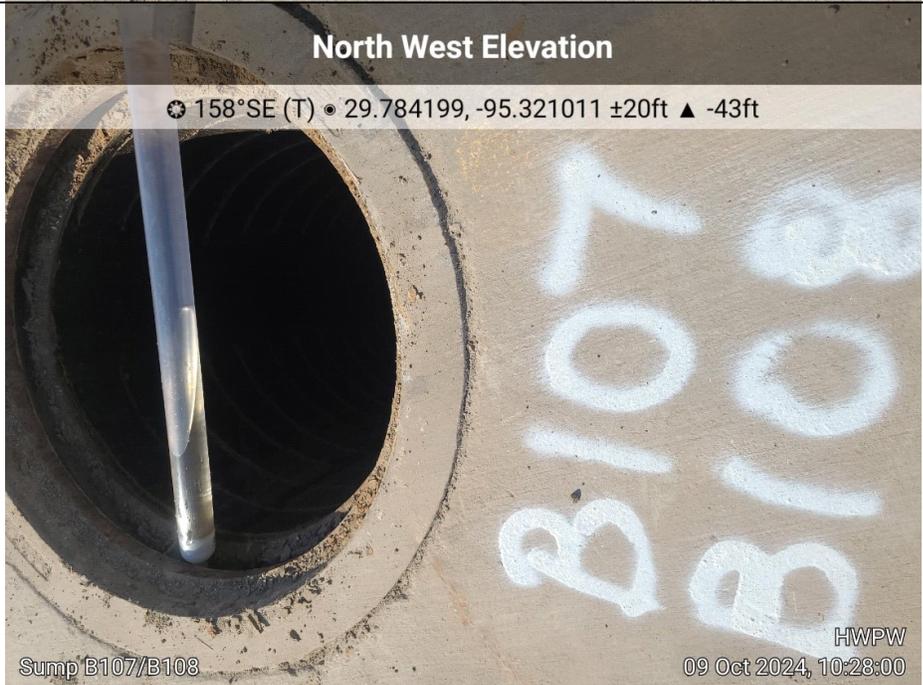
<b>Photo No.:</b> <b>20</b>	<b>Inspection Date:</b> 10/9/2024
--------------------------------	--------------------------------------

**Description:**  
Sump 3 (B107/B108), 36 inches of freeboard in sump. Color is clear, and no sheen or odor observed.

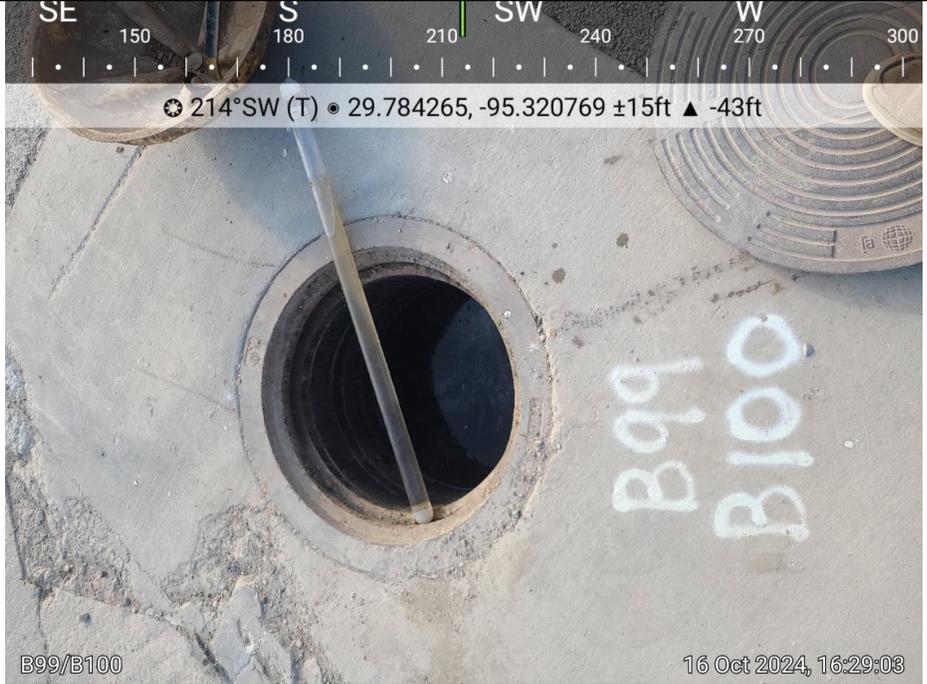
**Description:**  
Sump 1 (B99/B100), 12 inches of freeboard in sump. Color is clear, and no odor observed. Sheen observed on the surface.

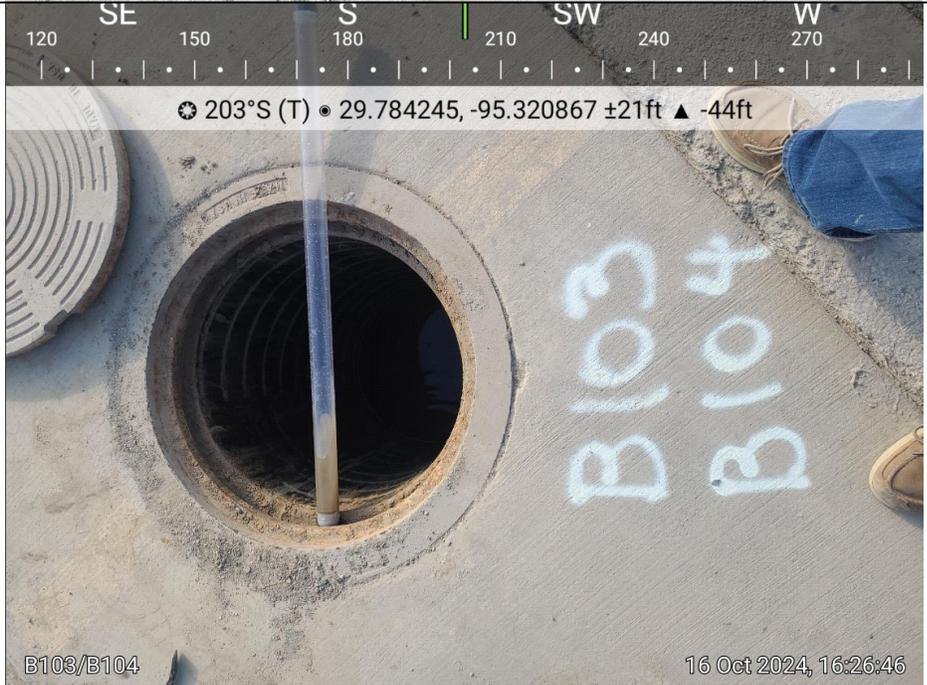
<b>Photo No.:</b> 22	<b>Inspection Date:</b> 10/16/2024
-------------------------	---------------------------------------

**Description:**  
Sump 2 (B103/B104), 38 inches of freeboard in sump. Color is clear, and no sheen or odor observed.

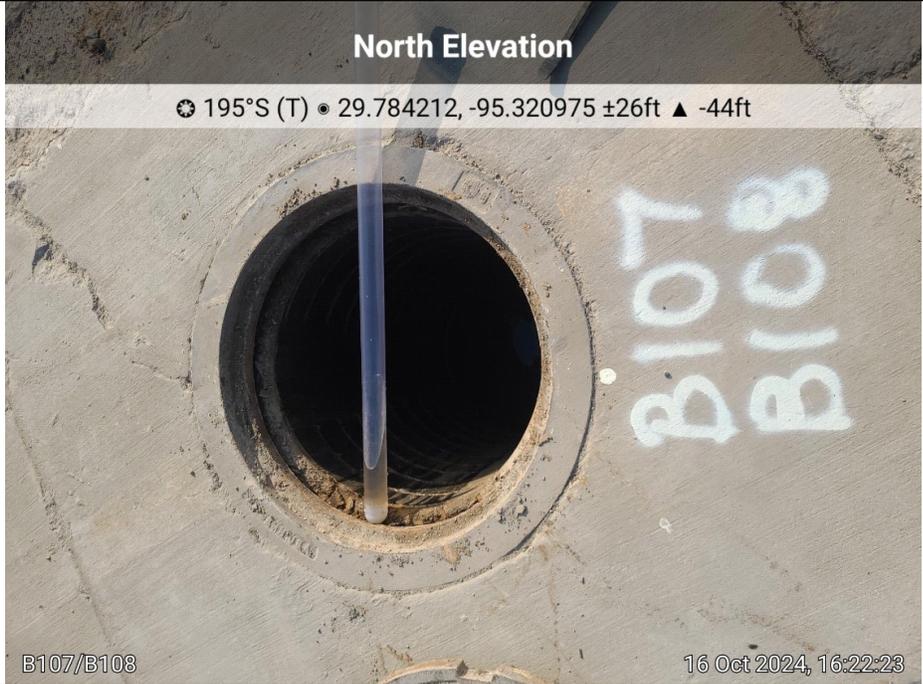
**Description:**  
Sump 3 (B107/B108), 36 inches of freeboard in sump. Color is clear, and no sheen or odor observed.

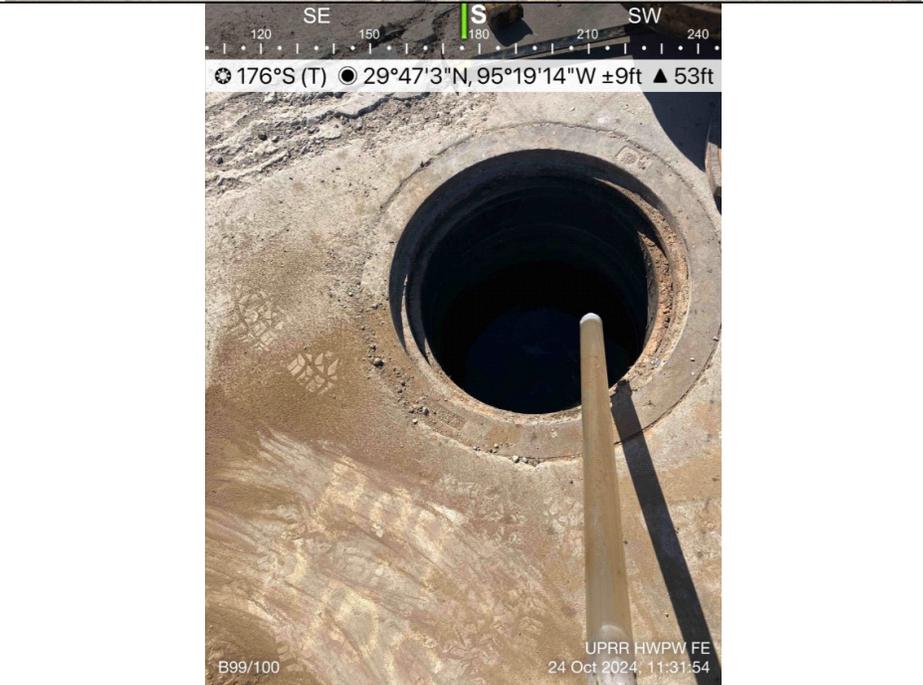
<b>Photo No.:</b> <b>24</b>	<b>Inspection Date:</b> 10/24/2024
--------------------------------	---------------------------------------

**Description:**  
Sump 1 (B99/B100), 14 inches of freeboard in sump. Color is light brown, and no odor observed. Sheen observed on the surface.

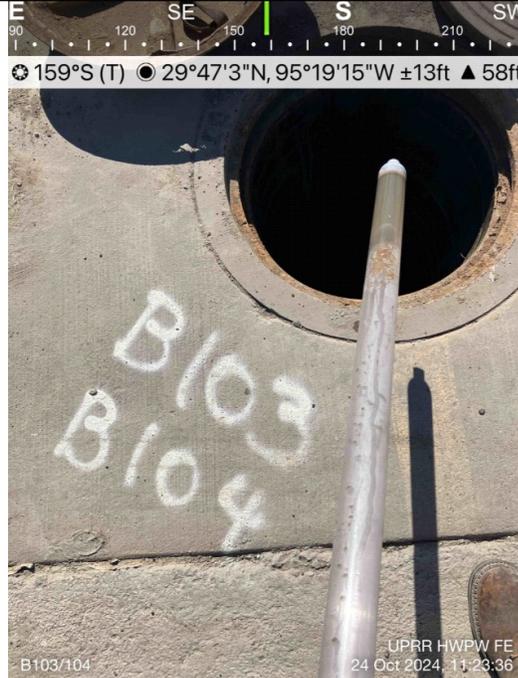
**Description:**  
Sump 2 (B103/B104), 41 inches of freeboard in sump. Color is light brown, and no sheen or odor observed.

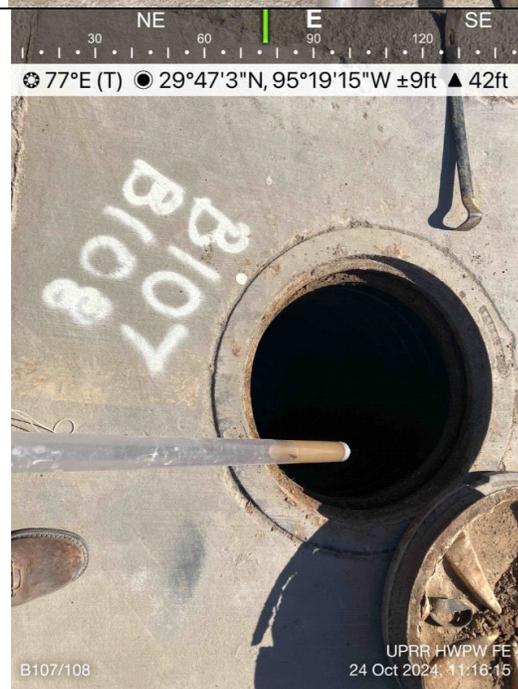
<b>Photo No.:</b> 26	<b>Inspection Date:</b> 10/24/2024
-------------------------	---------------------------------------

**Description:**  
Sump 3 (B107/B108), 40 inches of freeboard in sump. Color is brown, and no sheen or odor observed.

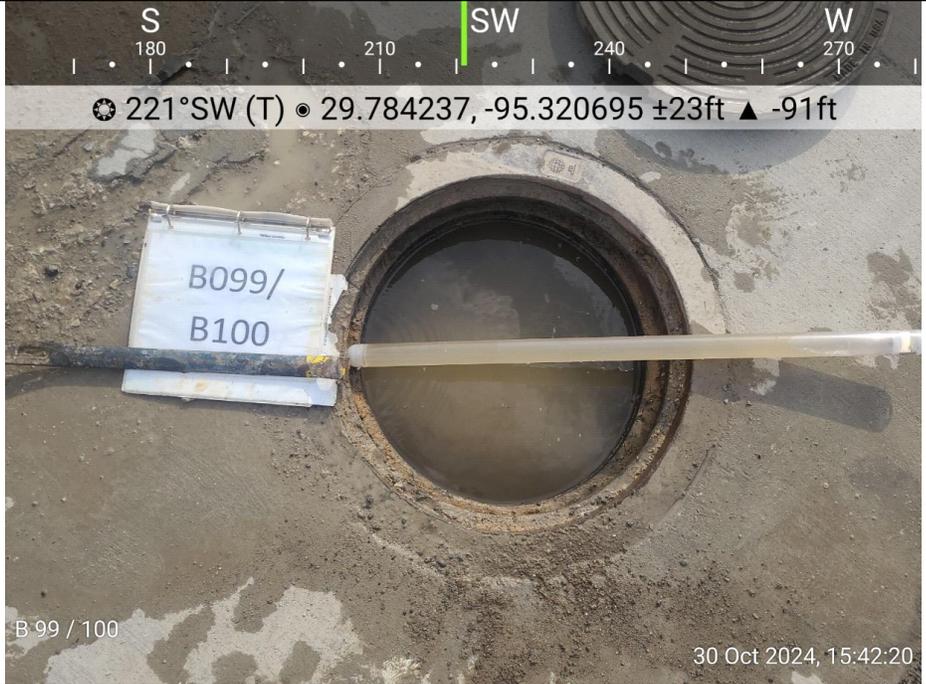
**Description:**  
Sump 1 (B99/B100), 4 inches of freeboard in sump. Color is turbid tan, and no sheen or odor observed.

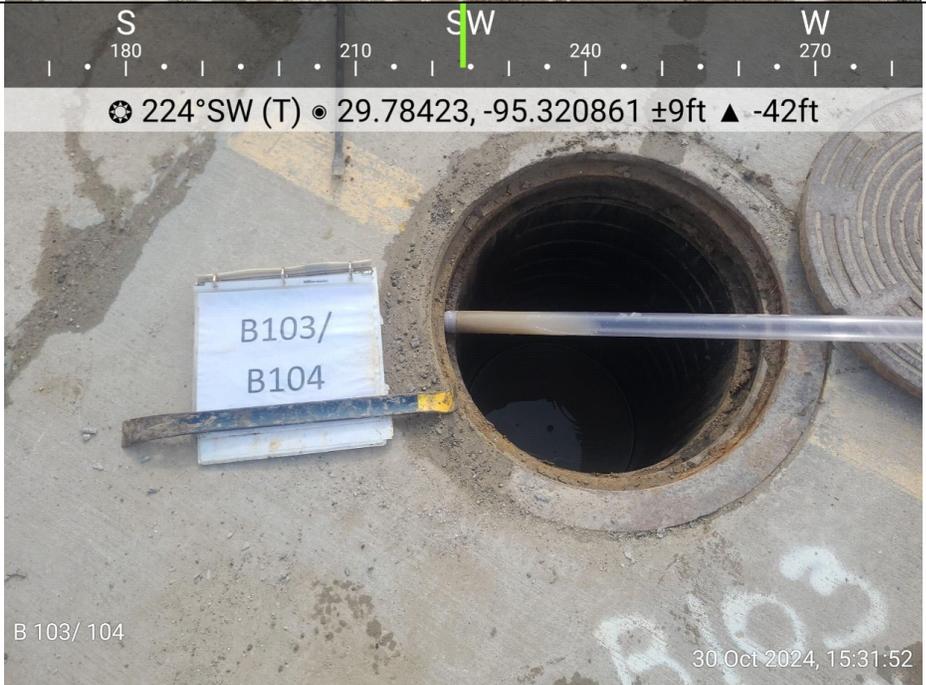
<b>Photo No.:</b> 28	<b>Inspection Date:</b> 10/30/2024
-------------------------	---------------------------------------

**Description:**  
Sump 2 (B103/B104), 37.5 inches of freeboard in sump. Color is turbid tan, and no sheen or odor observed.
