December 16, 2024

Project No. 31406585.016

Re: **MONTHLY STATUS UPDATE – ENGLEWOOD INTERMODAL YARD – NAPL COLLECTION
SYSTEM/CONCRETE CAP REPAIRS AND REVISED INTERIM MEASURES WORK PLAN
CONSTRUCTION ACTIVITIES
UNION PACIFIC RAILROAD HOUSTON WOOD PRESERVING WORKS FACILITY
4910 LIBERTY ROAD FACILITY, HOUSTON, TEXAS
POST-CLOSURE CARE PERMIT NO. HW-50343; INDUSTRIAL SWR NO. 31547**

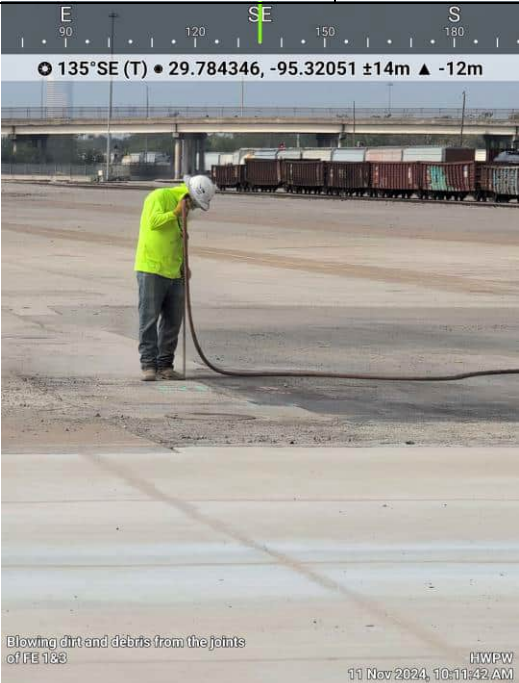
Description: Diamond Polish cleaned joints at FE-1&3. Lat: 29.784346 Long: -95.32051			
Photo No. 2	Inspection Date: 11/11/2024

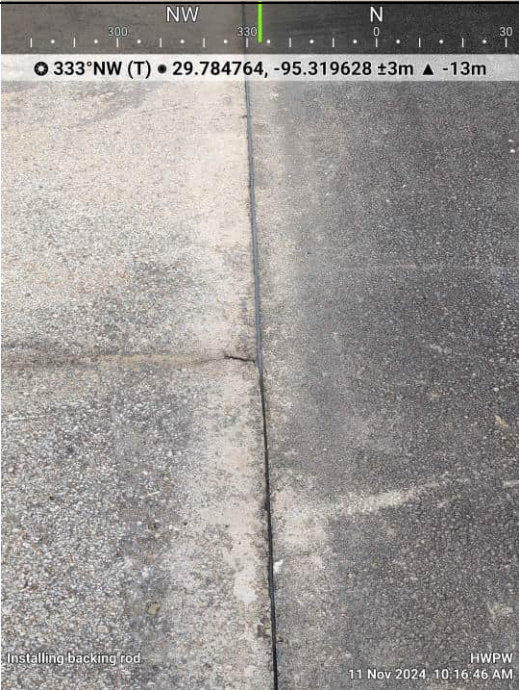
Description: Diamond Polish installing backing rod at FE-4. Lat: 29.784764 Long: -95.319628

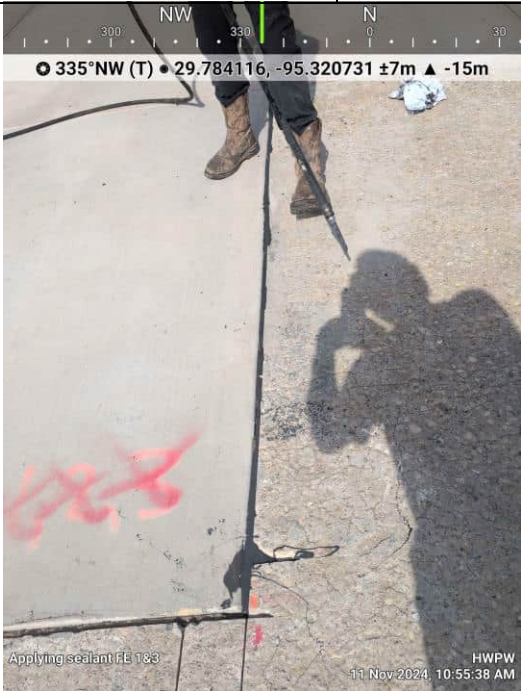
Description: Diamond Polish applying sealant to joints at FE-1&3. Lat: 29.784116 Long: -95.320731			
Photo No. 4	Inspection Date: 11/11/2024

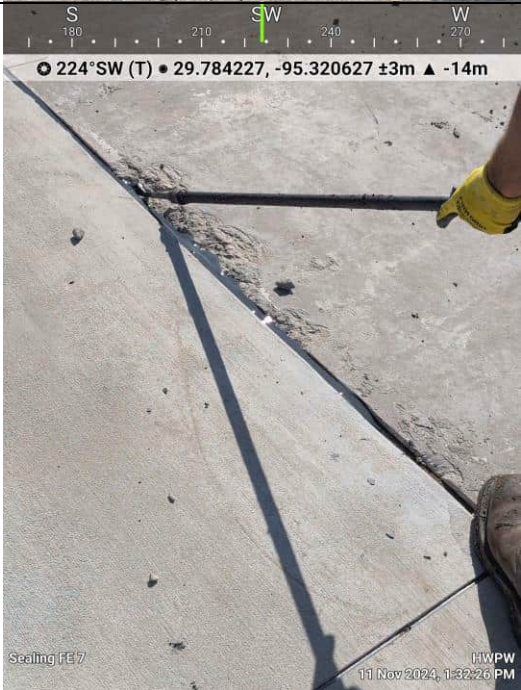
Description: Diamond Polish applying sealant to joints at FE-7. Lat: 29.784227 Long: -95.320627

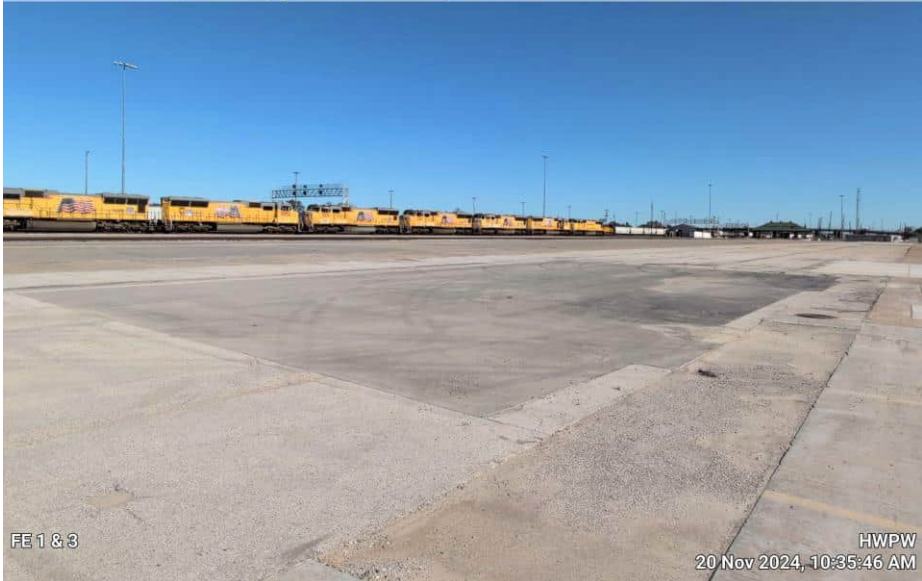
<div> FE 1 & 3 HWPW 20 Nov 2024, 10:35:46 AM </div> </div>	
Description: Finished FE-1&3 after sealing. Lat: 29.784196 Long: -95.321006			
Photo No. 6	Inspection Date: 11/20/2024	<div> <div> NE 60 E 90 SE 120 150 </div> <div> 97°E (T) • 29.784074, -95.320809 ±18m ▲ -12m </div>

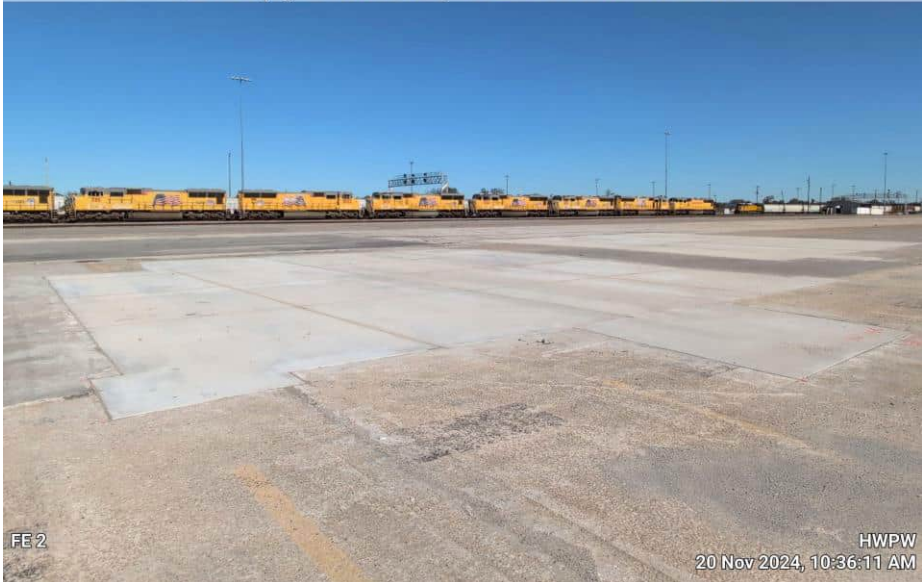
<div> FE 2 HWPW 20 Nov 2024, 10:36:11 AM </div> </div>	
Description: Finished FE-2 after sealing. Lat: 29.784074 Long: -95.320809

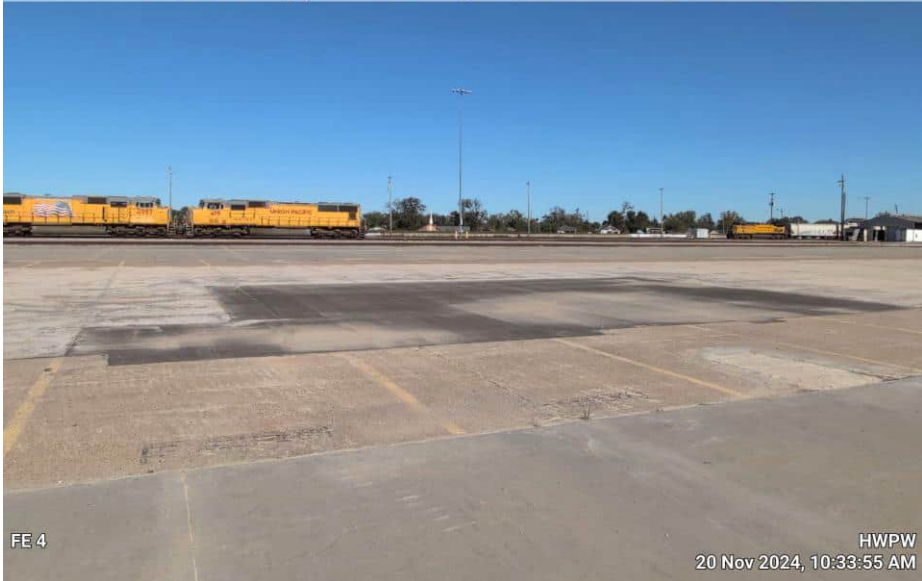
<div> FE 4 HWPW 20 Nov 2024, 10:33:55 AM </div> </div>	
Description: Finished FE-4 after sealing. Lat: 29.784707 Long: -95.319590			
Photo No. 8	Inspection Date: 11/20/2024	<div> <div> SE 120 150 S 180 210 </div> <div> 165°SE (T) • 29.785462, -95.318527 ±13m ▲ -12m </div>

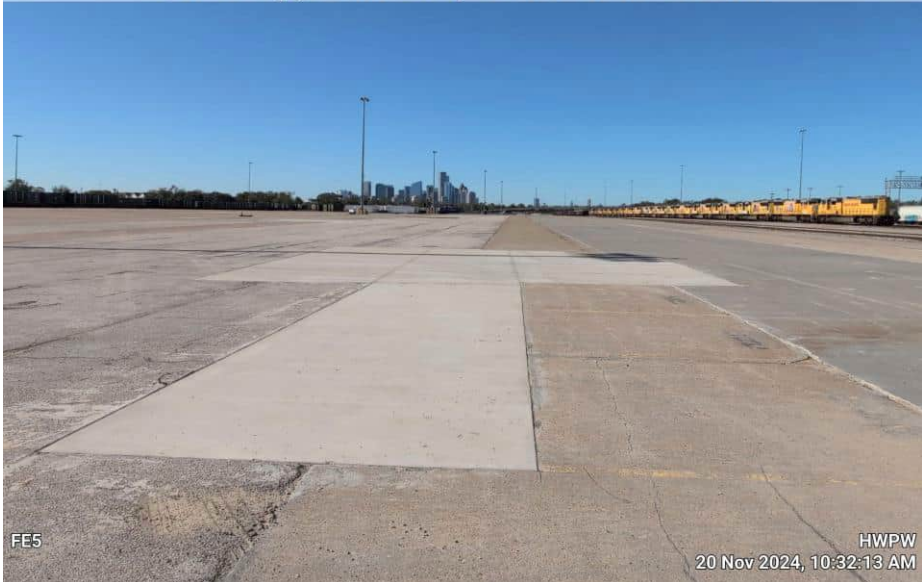
<div> FE5 HWPW 20 Nov 2024, 10:32:13 AM </div> </div>	
Description: Finished FE-5 after sealing. Lat: 29.785462 Long: -95.318527

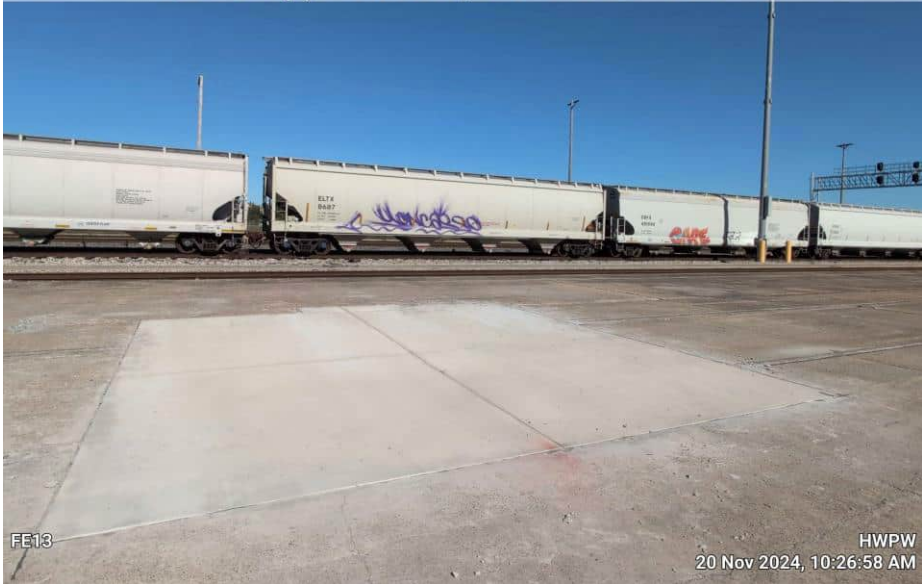
<div> <div>FE13</div> <div> HWPW 20 Nov 2024, 10:26:58 AM </div> </div>	
Description: Finished FE-13 after sealing.			
Lat: 29.784969 Long: -95.321241

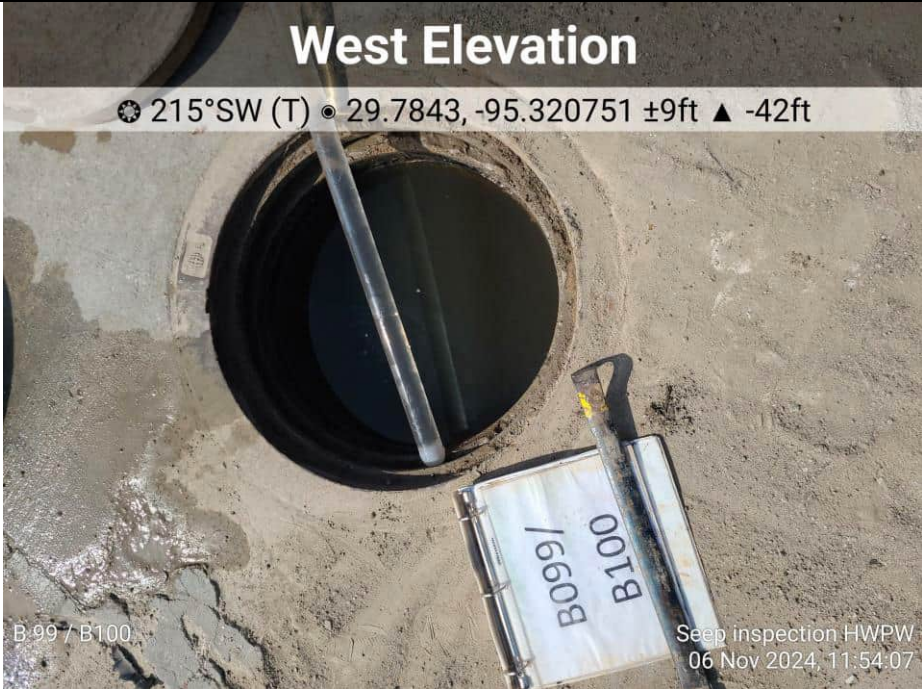
- During the November 2024 inspections, the water in Sump 1, Sump 2, and Sump 3 were observed to be clear in color. A sheen was observed at Sump 1 during the November 6th, 13th, 20th, and 27th inspections (Photos 17, 20, 23, and 26). No odors were reported during the November inspections.
-

<div> B 99 / B100 </div> <div> Seep inspection HWPW 06 Nov 2024, 11:54:07 </div> </div>	
Description: Sump 1 (B99/B100), 2.5 inches of freeboard in sump. Color is clear, and no odor observed. Sheen observed on the surface. Lat: 29.784300 Long: -95.320751			
Photo No. 18	Inspection Date: 11/6/2024	<div> <div> North Elevation </div> <div> 232°SW (T) • 29.784258, -95.320861 ±9ft ▲ -42ft </div>

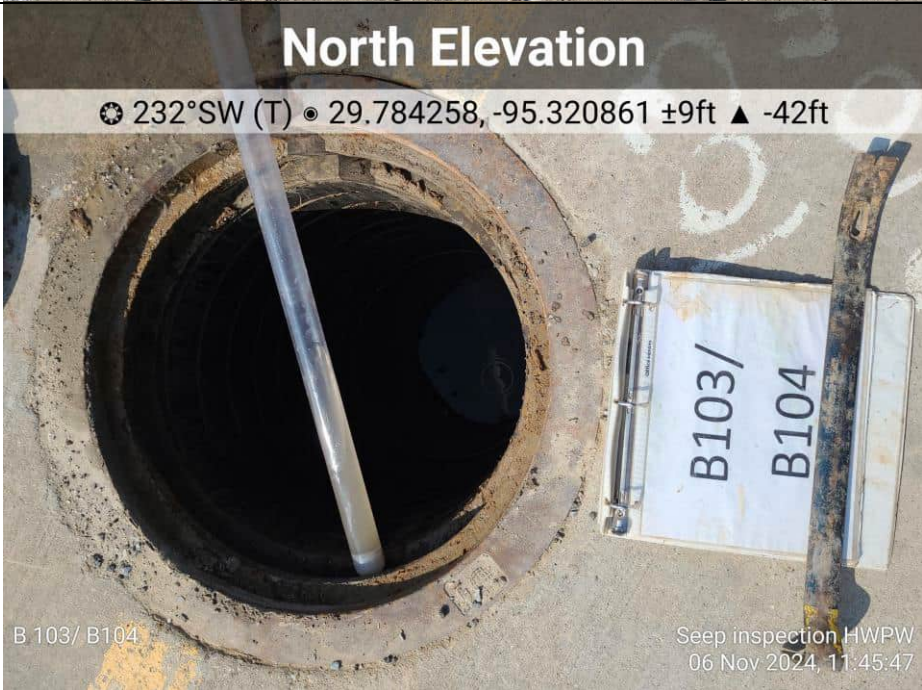
<div> B 103 / B104 </div> <div> Seep inspection HWPW 06 Nov 2024, 11:45:47 </div> </div>	
Description: Sump 2 (B103/B104), 32.0 inches of freeboard in sump. Color is clear, and no sheen or odor observed. Lat: 29.784258 Long: -95.320861

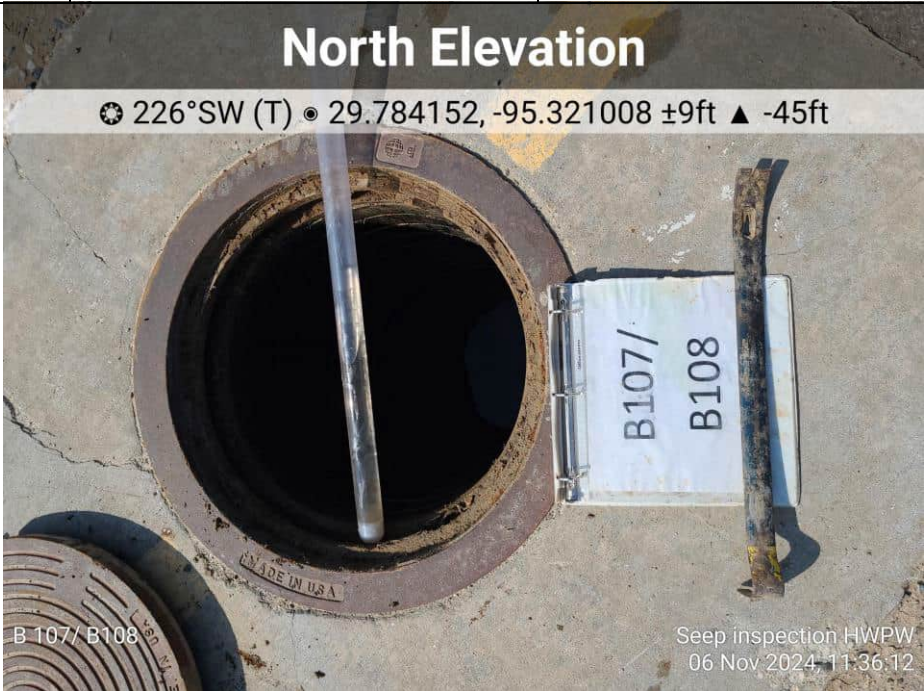
Description: Sump 3 (B107/B108), 31.0 inches of freeboard in sump. Color is clear, and no sheen or odor observed. Lat: 29.784152 Long: -95.321008			
Photo No. 20	Inspection Date: 11/13/2024

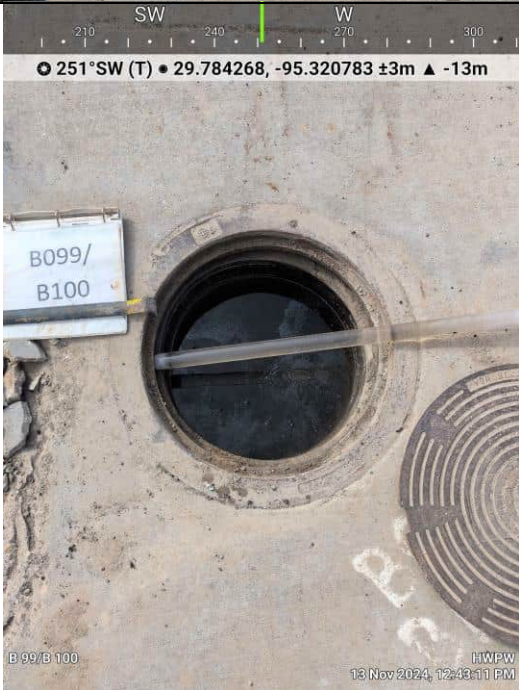
Description: Sump 1 (B99/B100), 5.0 inches of freeboard in sump. Color is clear, and no odor observed. Sheen observed on the surface. Lat: 29.784268 Long: -95.320783

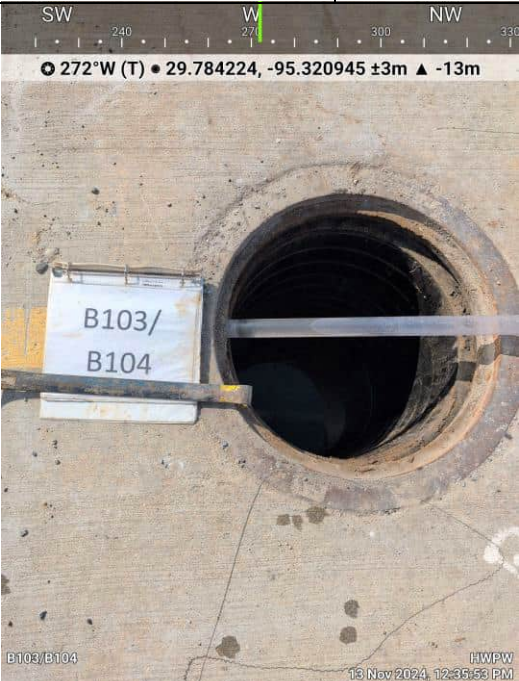
Description: Sump 2 (B103/B104), 32.5 inches of freeboard in sump. Color is clear, and no sheen or odor observed. Lat: 29.784224 Long: -95.320945			
Photo No. 22	Inspection Date: 11/13/2024

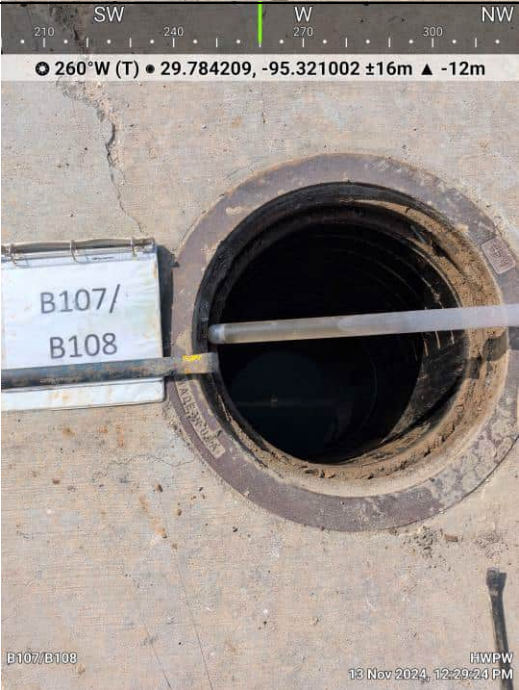
Description: Sump 3 (B107/B108), 32.0 inches of freeboard in sump. Color is clear, and no sheen or odor observed. Lat: 29.784209 Long: -95.321002

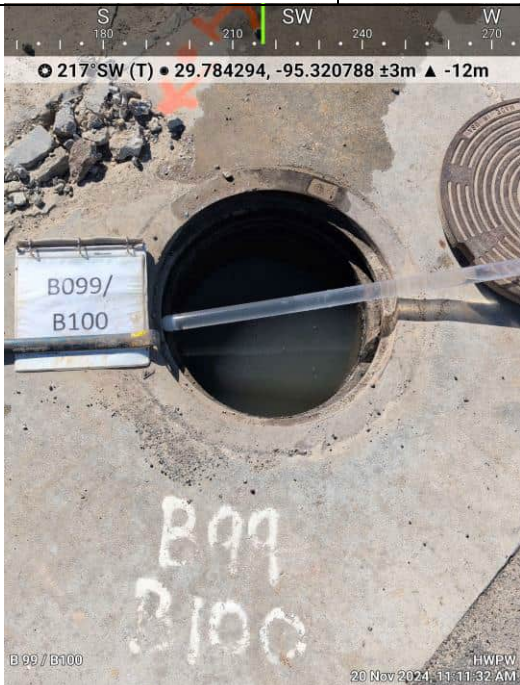
Description: Sump 1 (B99/B100), 3.5 inches of freeboard in sump. Color is clear, and no odor observed. Sheen observed on the surface. Lat: 29.784294 Long: -95.320788			
Photo No. 24	Inspection Date: 11/20/2024

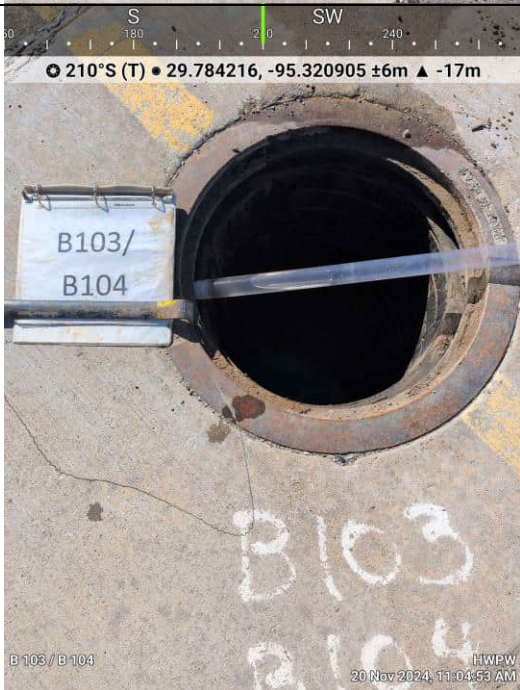
Description: Sump 2 (B103/B104), 34 inches of freeboard in sump. Color is clear, and no sheen or odor observed. Lat: 29.784216 Long: -95.320905

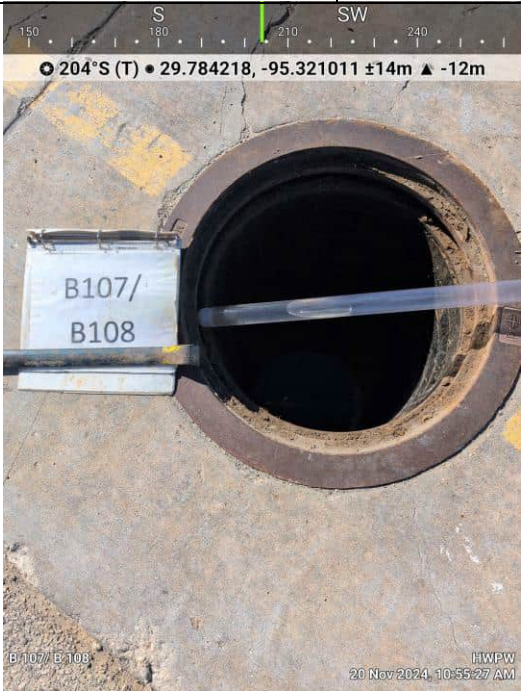
Description: Sump 3 (B107/B108), 34 inches of freeboard in sump. Color is clear, and no sheen or odor observed. Lat: 29.784218 Long: -95.321011			
Photo No. 26	Inspection Date: 11/27/2024

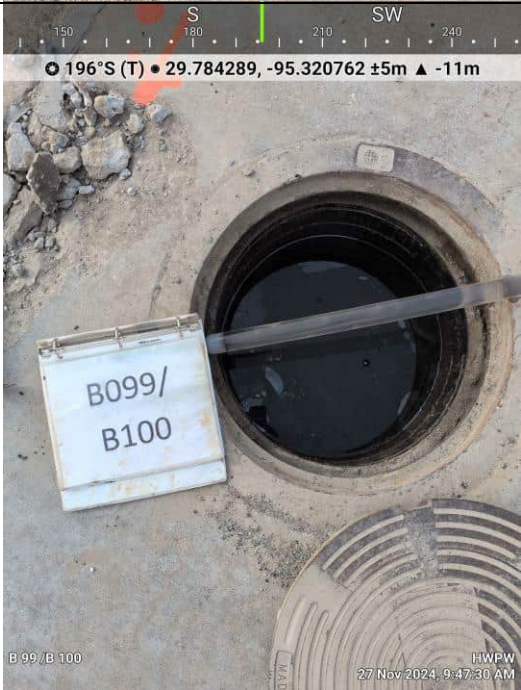
Description: Sump 1 (B99/B100), 8 inches of freeboard in sump. Color is clear, and no odor observed. Sheen observed on the surface. Lat: 29.784289 Long: -95.320762

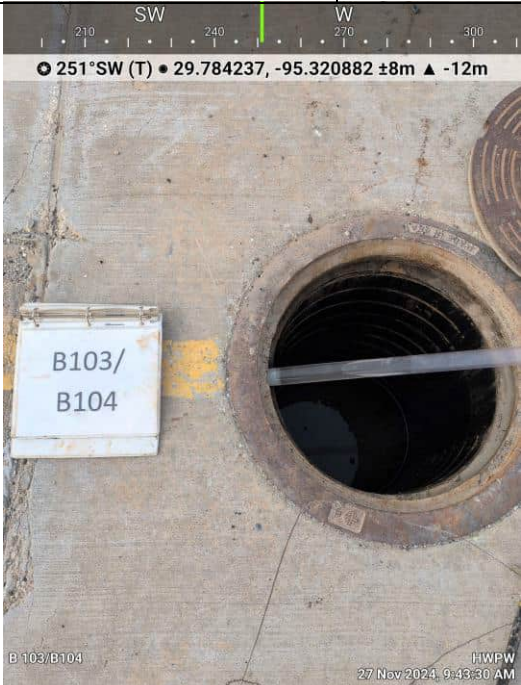
Description: Sump 2 (B103/B104), 34.5 inches of freeboard in sump. Color is clear, and no sheen or odor observed. Lat: 29.784237 Long: -95.320882			
Photo No. 28	Inspection Date: 11/27/2024

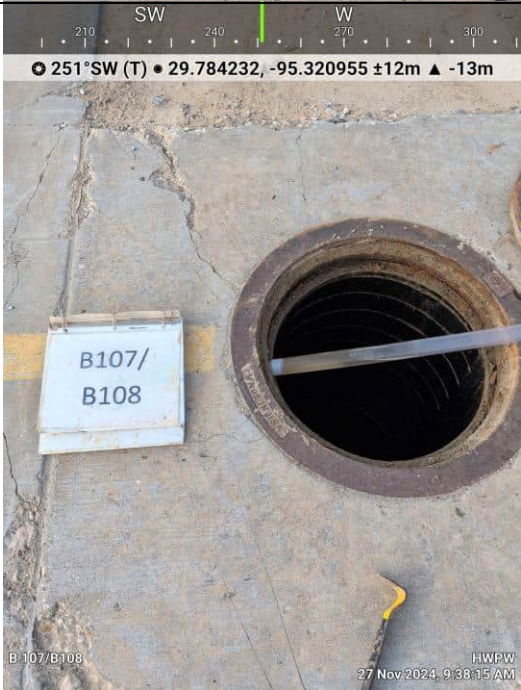
Description: Sump 3 (B107/B108), 34 inches of freeboard in sump. Color is clear, and no sheen or odor observed. Lat: 29.784232 Long: -95.320955

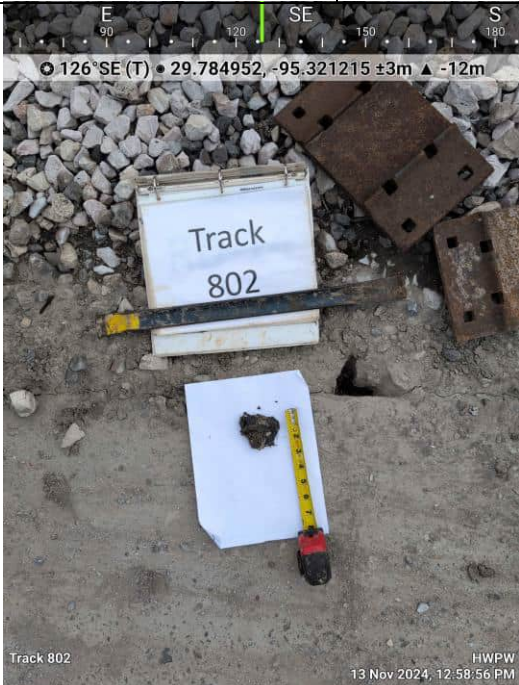
- A small amount of tar-like material was observed and recovered at the Track 802 location on November 13th and November 20th. The tar-like material was recovered during the weekly inspections (Photo 29 and 30).

Description: NAPL seep at Track 802. ~3 in ³ of tar removed. Lat: 29.784952 Long: -95.321215			
Photo No. 30	Inspection Date: 11/20/2024

- Tar-like material observed during the weekly inspection events was removed and recovered using a hand tool to scrape up the material. With the implementation of the Focused Excavations, there is only one location where tar material seeps were observed (Track 802). The seep activity during the month of November was similar compared to the October inspections. The collection volume of the tar material from the seep remained the same from 0.02 gallons over 5 inspections to 0.02 gallons over 4 inspections at the seep locations. The material recovered was placed in a drum staged at the CSA for disposal. The previously observed seeps at A010, A022, B042, B056, B057, B096, B100, B102, B105, and RD-14 have been addressed through the Focused Excavation activities. No seeps have developed around the newly completed Focused Excavations (Photo 5 – 16).

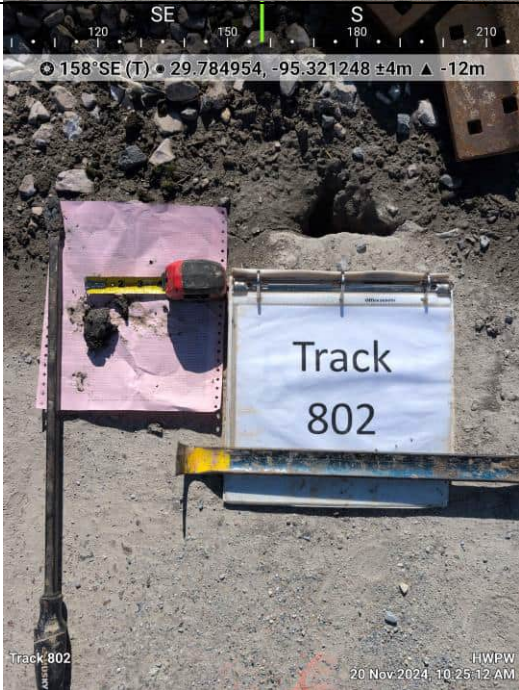
Description: NAPL seep at Track 802. ~2 in ³ of tar removed. Lat: 29.784954 Long: -95.321248
