January 15, 2025

Project No. 31406585.016

Re: MONTHLY STATUS UPDATE – ENGLEWOOD INTERMODAL YARD – NAPL COLLECTION SYSTEM/CONCRETE CAP REPAIRS AND REVISED INTERIM MEASURES WORK PLAN CONSTRUCTION ACTIVITIES UNION PACIFIC RAILROAD HOUSTON WOOD PRESERVING WORKS FACILITY 4910 LIBERTY ROAD FACILITY, HOUSTON, TEXAS POST-CLOSURE CARE PERMIT NO. HW-50343; INDUSTRIAL SWR NO. 31547

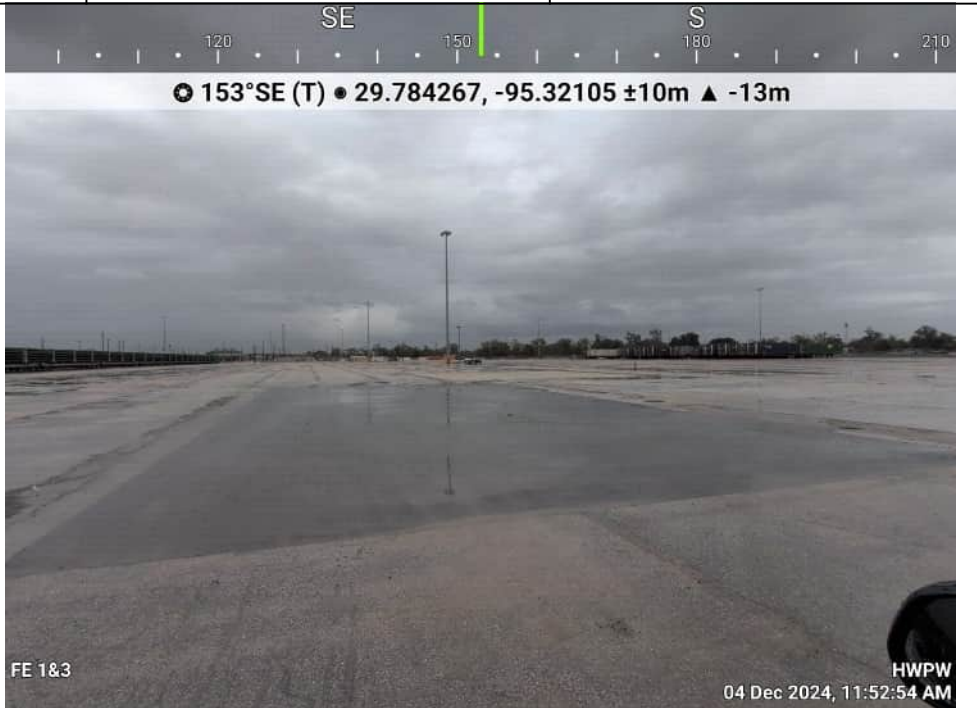
Description:
FE-1&3 weekly inspection of asphalt cap. No NAPL observed at joints.

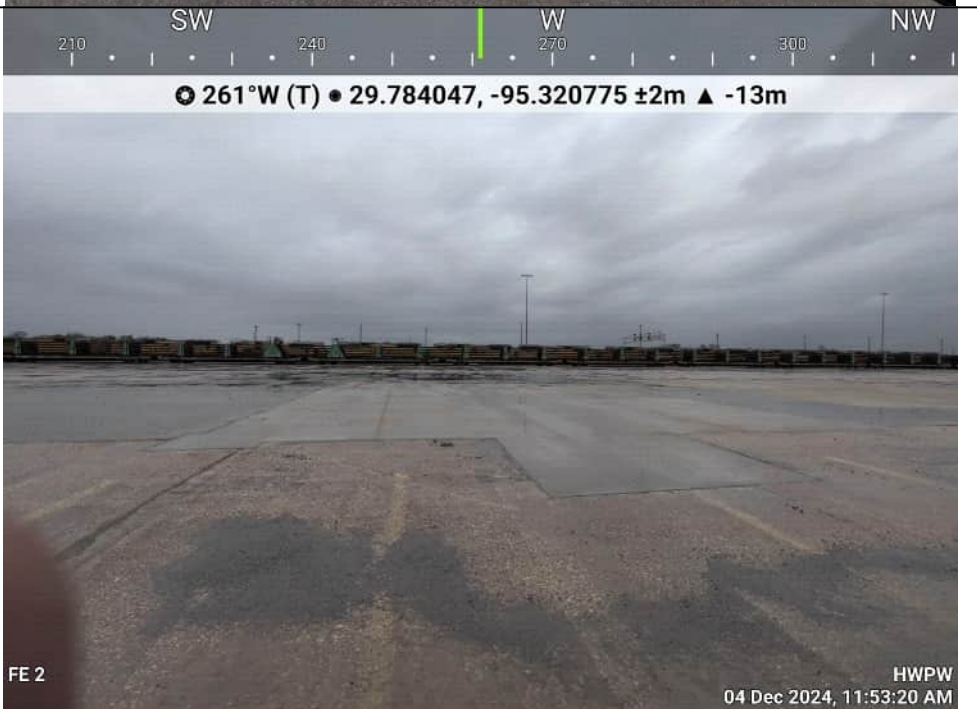
Photo No. 2
Inspection Date: 12/4/2024

Description:
FE-2 weekly inspection of concrete cap. No NAPL observed at joints.

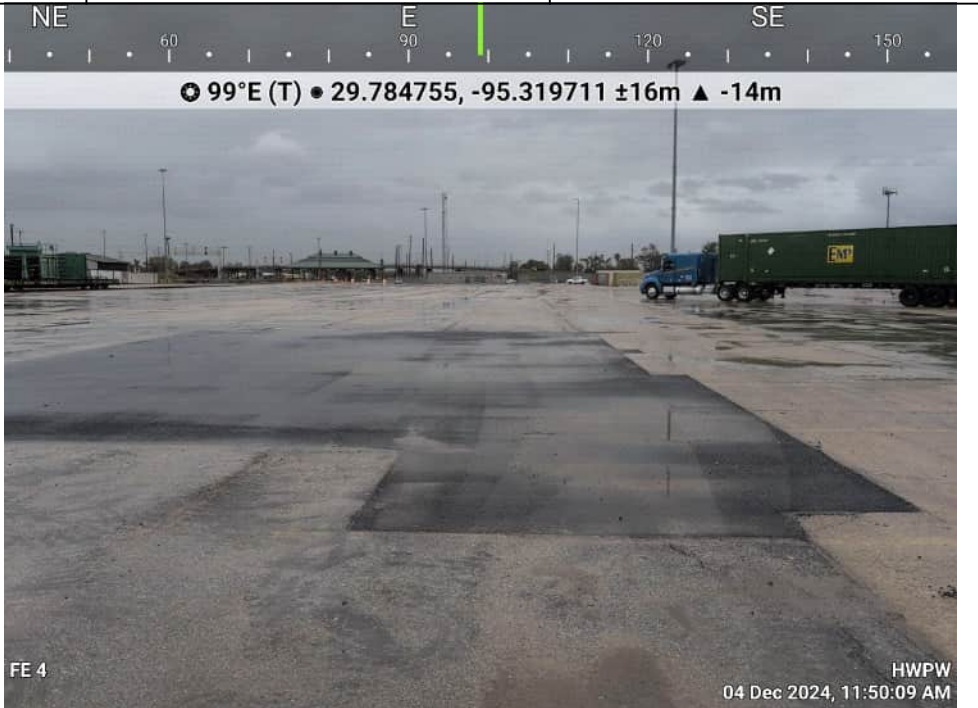
Photo No.: 3	Inspection Date: 12/4/2024
Description: FE-4 weekly inspection of asphalt cap. No NAPL observed at joints.	
Lat: 29.784755 Long: -95.319711

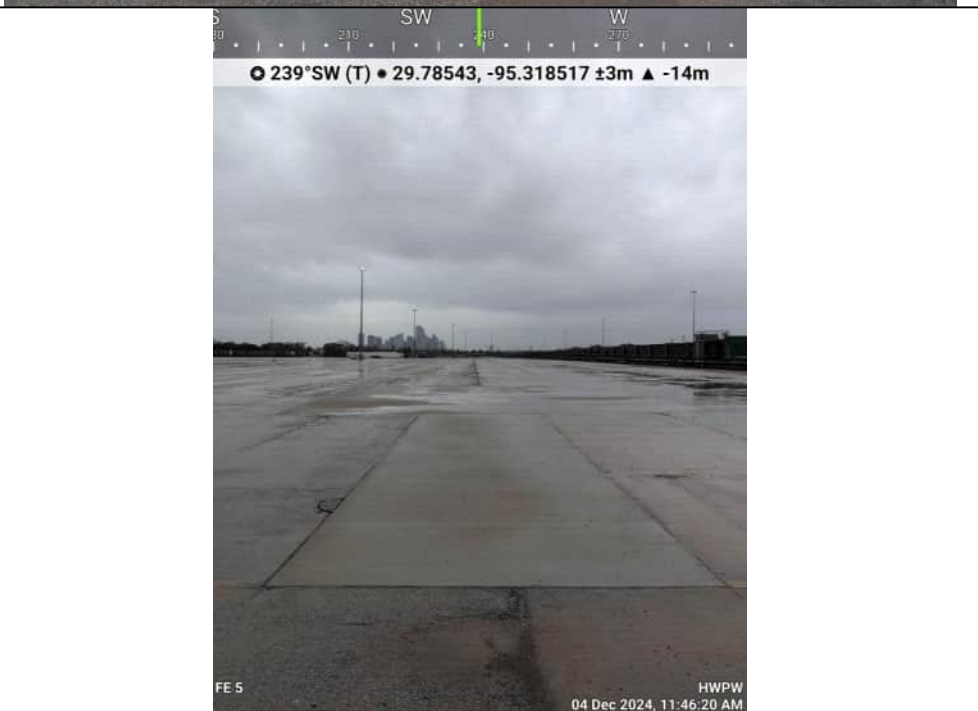
Photo No.: 4	Inspection Date: 12/4/2024
Description: FE-5 weekly inspection of concrete cap. No NAPL observed at joints.	
Lat: 29.785430 Long: -95.318517

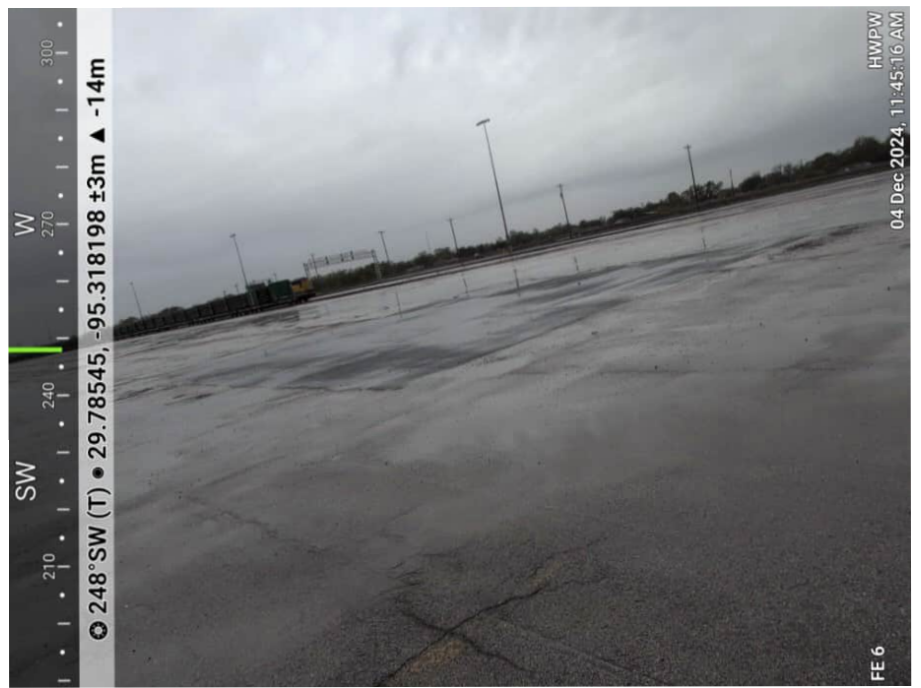
Description:
FE-6 weekly inspection of asphalt cap. No NAPL observed at joints.

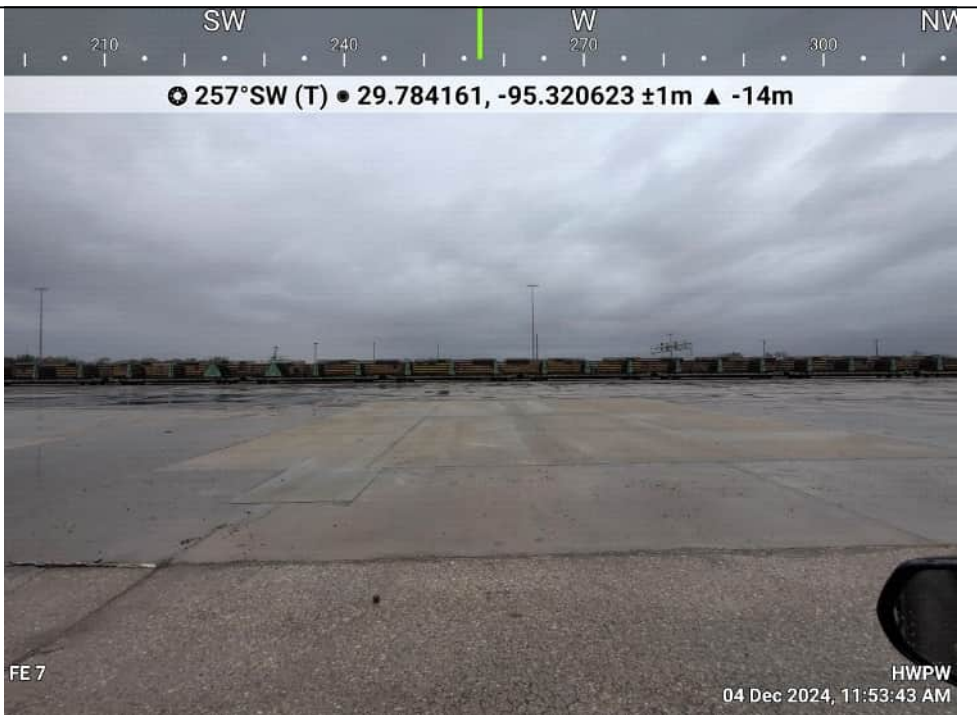
Photo No.
6

Description:
FE-7 weekly inspection of concrete cap. No NAPL observed at joints.

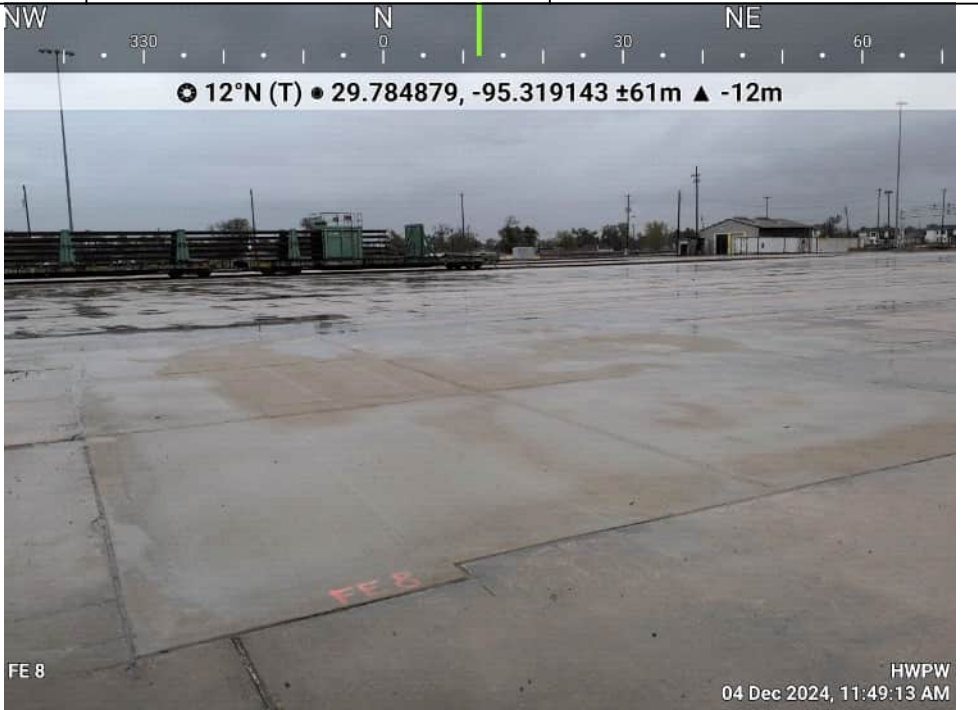
Description:
FE-8 weekly inspection of concrete cap. No NAPL observed at joints.

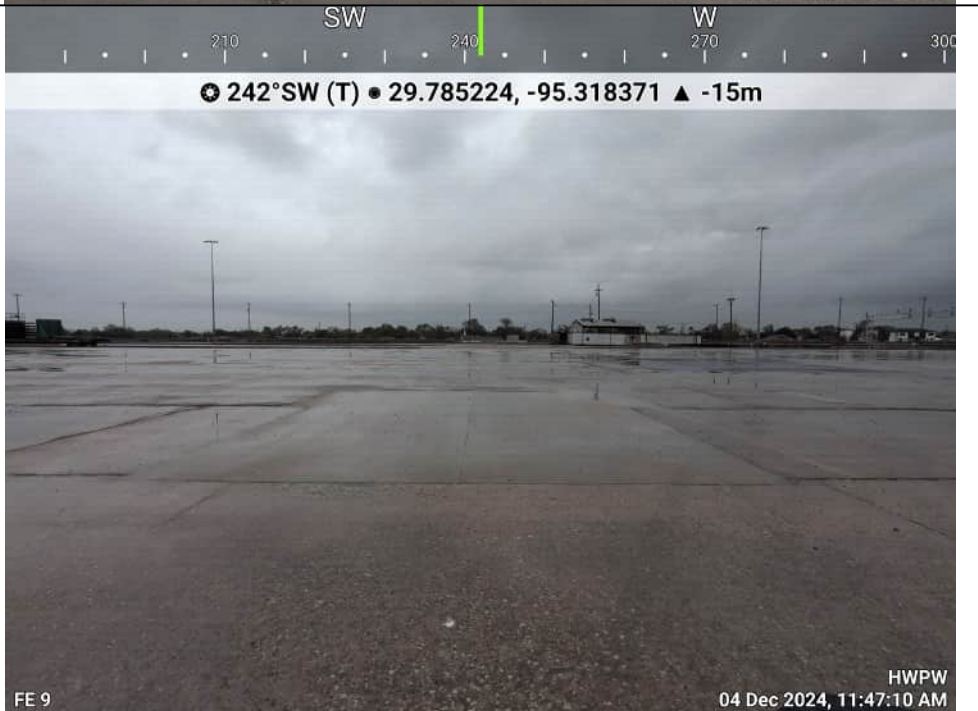
Photo No.: 8	Inspection Date: 12/4/2024
------------------------	--------------------------------------

Description:
FE-9 weekly inspection of concrete cap. No NAPL observed at joints.

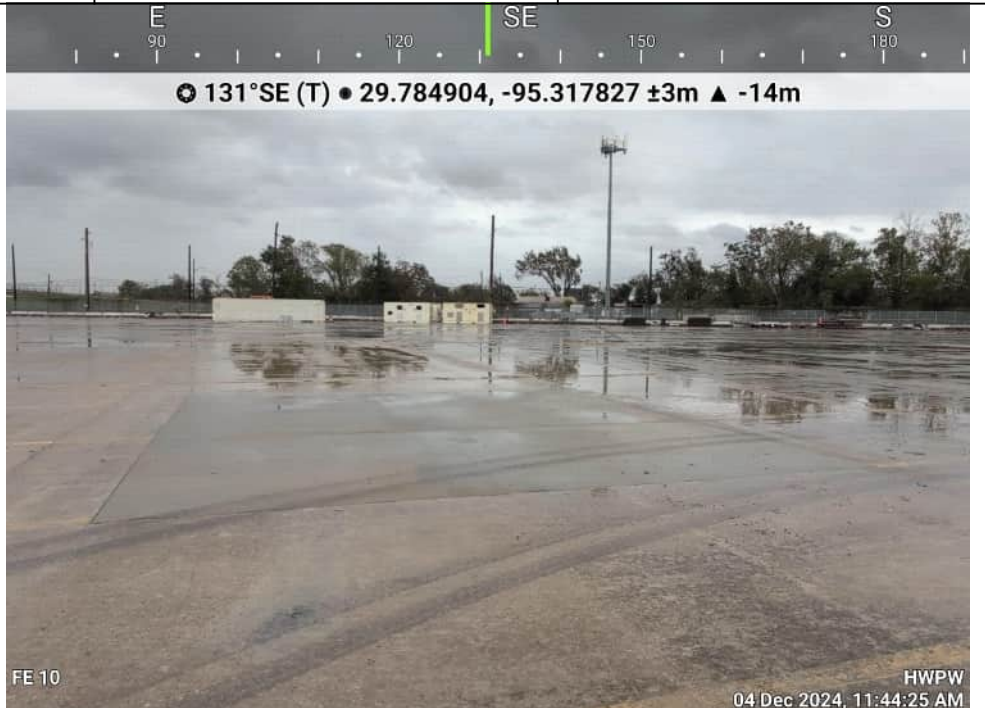
Description:
FE-10 weekly inspection of concrete cap. No NAPL observed at joints.

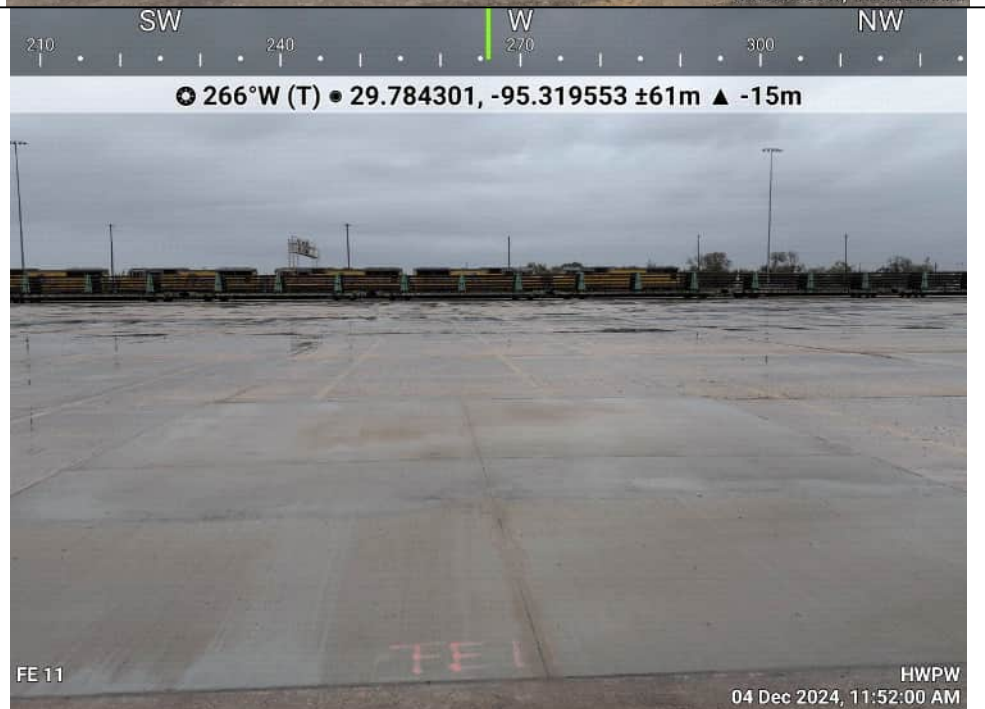
Photo No.
10

Description:
FE-11 weekly inspection of concrete cap. No NAPL observed at joints.

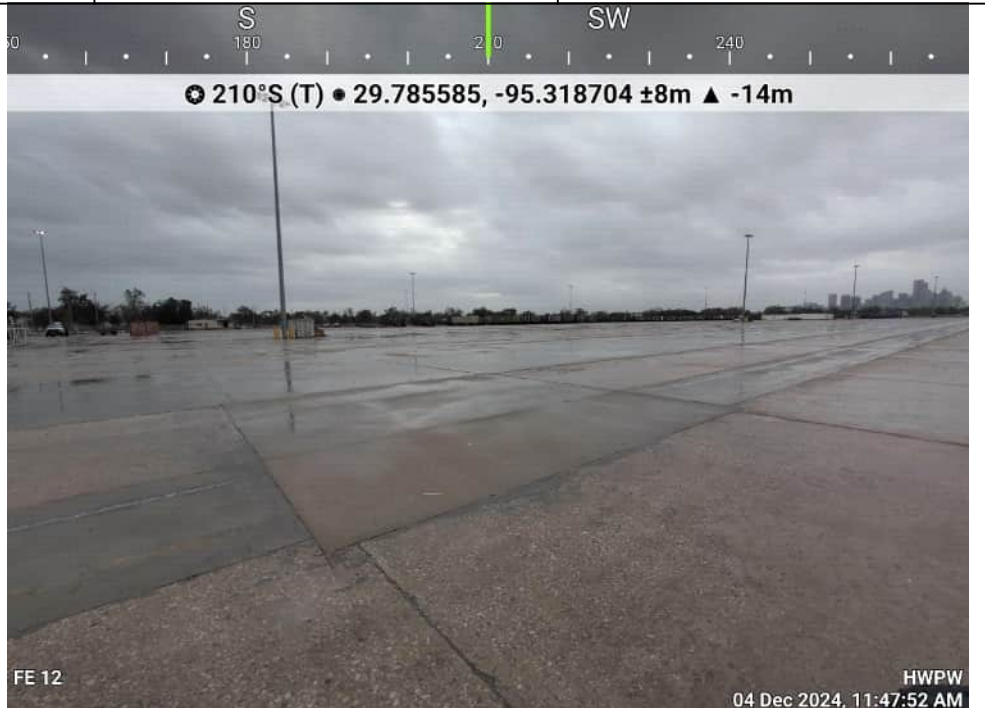
Description:
FE-12 weekly inspection of concrete cap. No NAPL observed at joints.

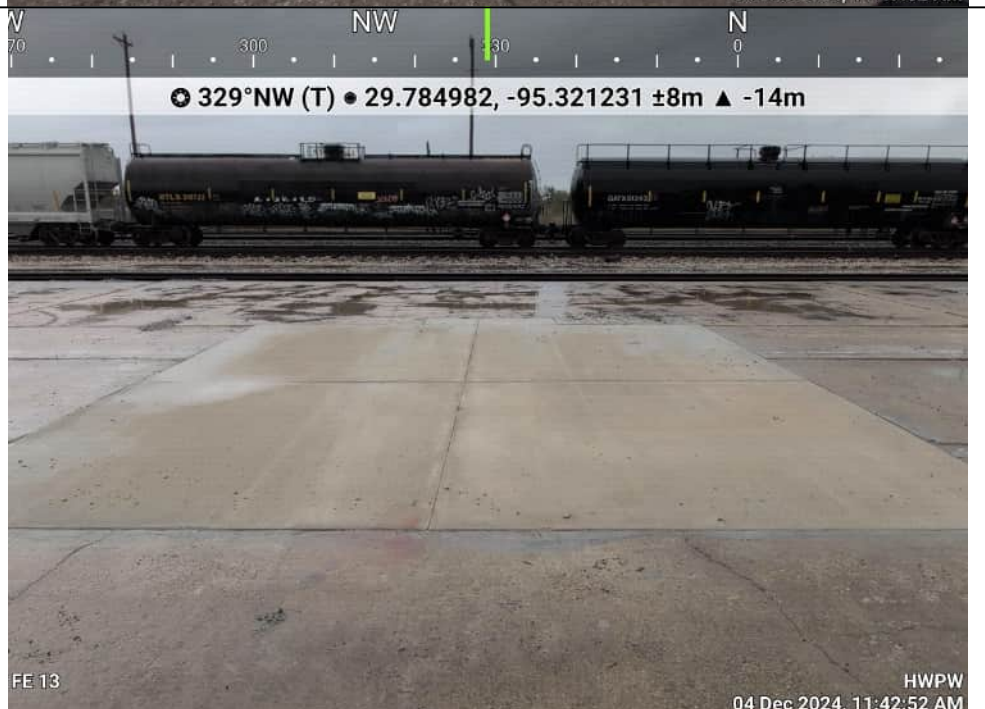
Photo No.
12

Description:
FE-13 weekly inspection of concrete cap. No NAPL observed at joints.

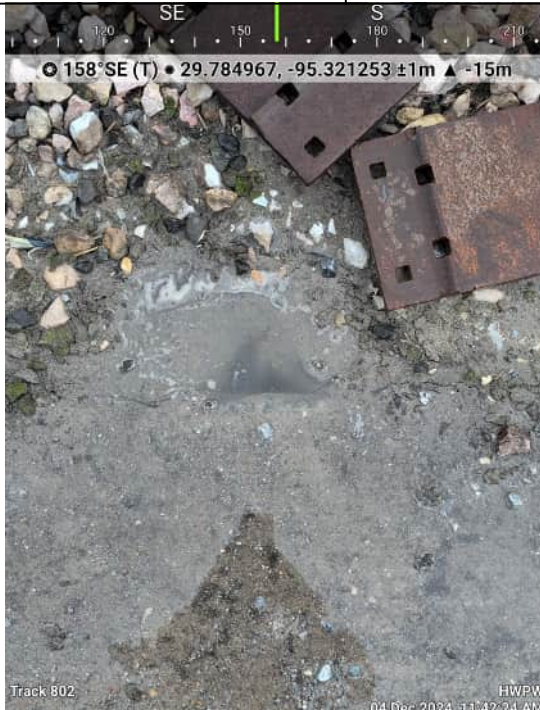
Photo No. 13	Inspection Date: 12/4/2024
Description: Track 802 weekly inspection. No NAPL observed at joints.	
Lat: 29.784967 Long: -95.321253

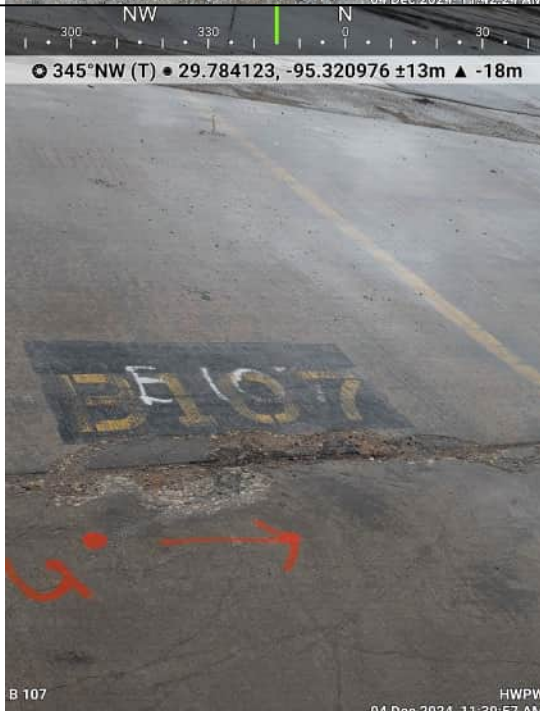
Photo No. 14	Inspection Date: 12/4/2024
Description: Joint B-107 weekly inspection. No NAPL observed at joints.	
Lat: 29.784123 Long: -95.320976

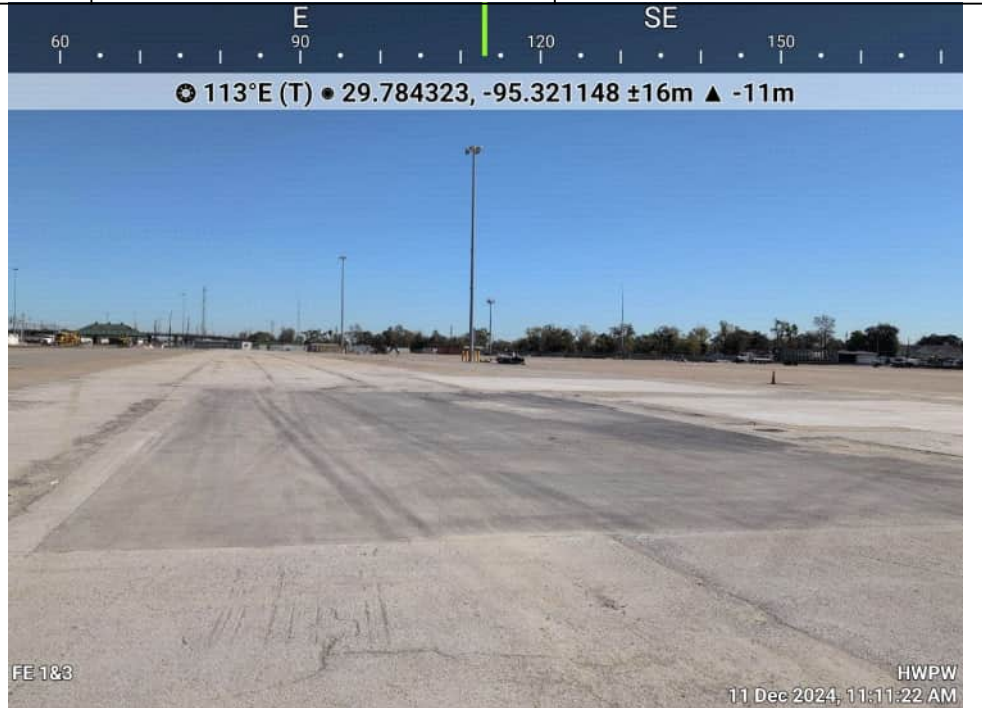
Description:
FE-1&3 weekly inspection of asphalt cap. No NAPL observed at joints.

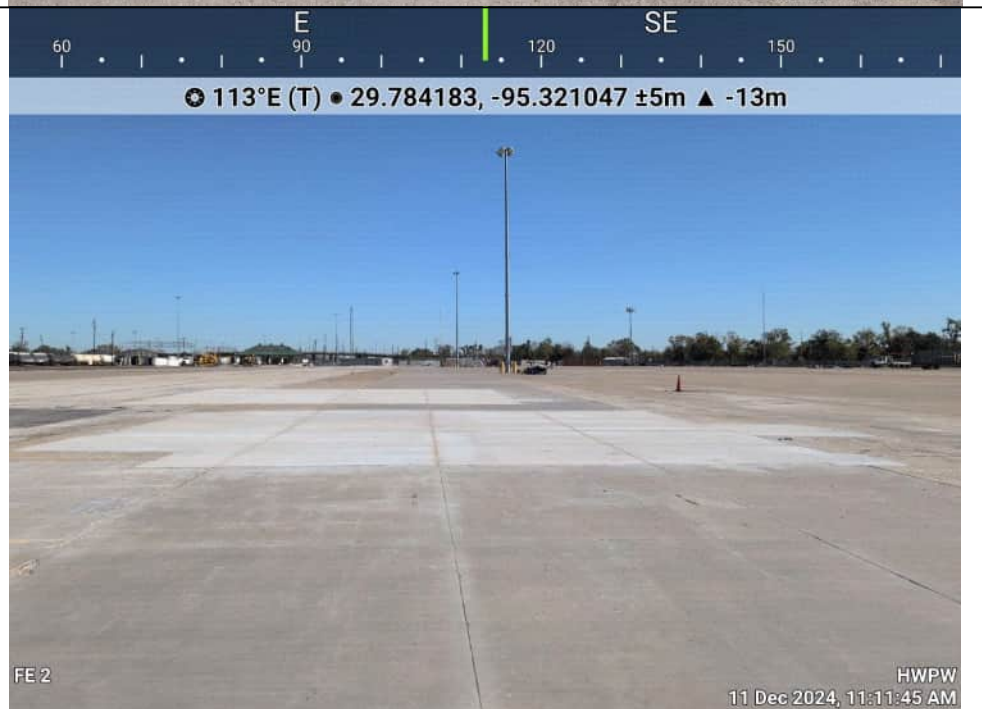
Photo No.
16

Description:
FE-2 weekly inspection of concrete cap. No NAPL observed at joints.

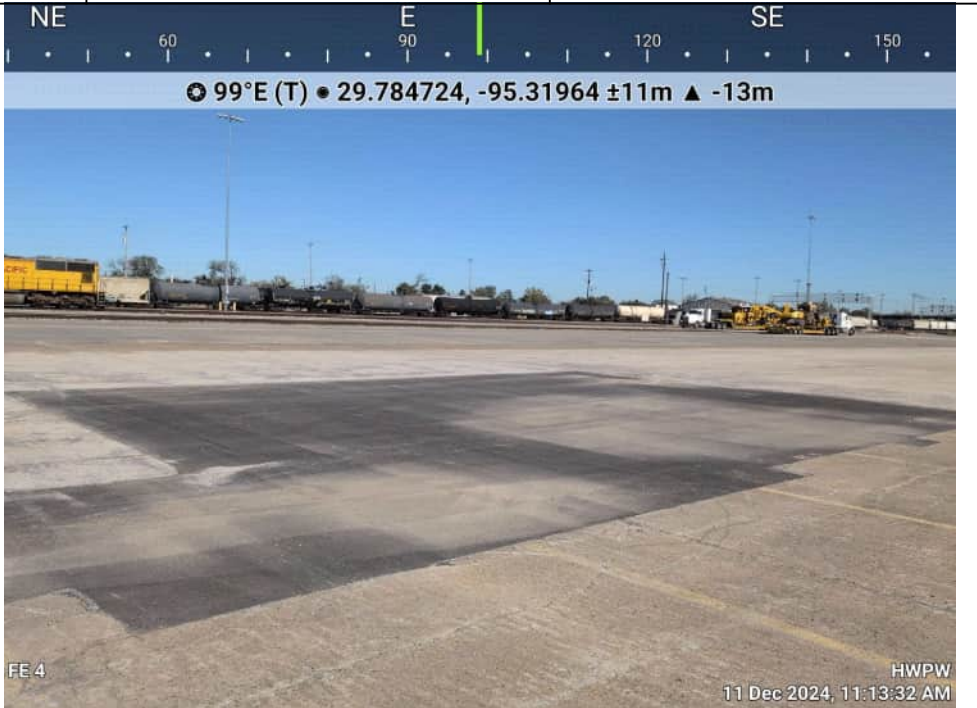
Description:
FE-4 weekly inspection of asphalt cap. No NAPL observed at joints.

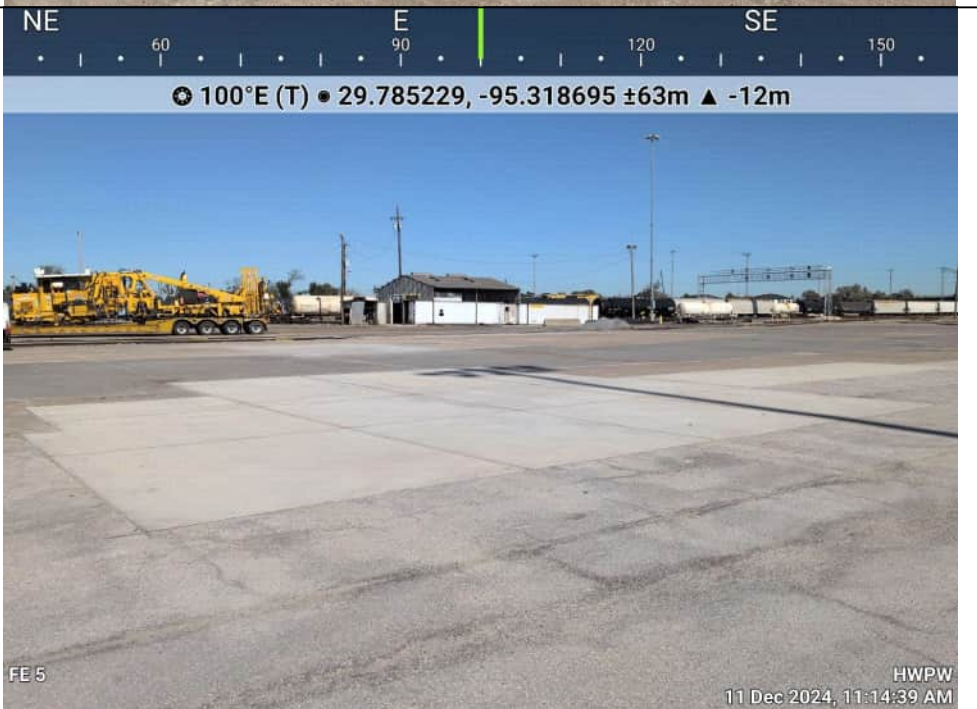
Photo No.
18

Description:
FE-5 weekly inspection of concrete cap. No NAPL observed at joints.

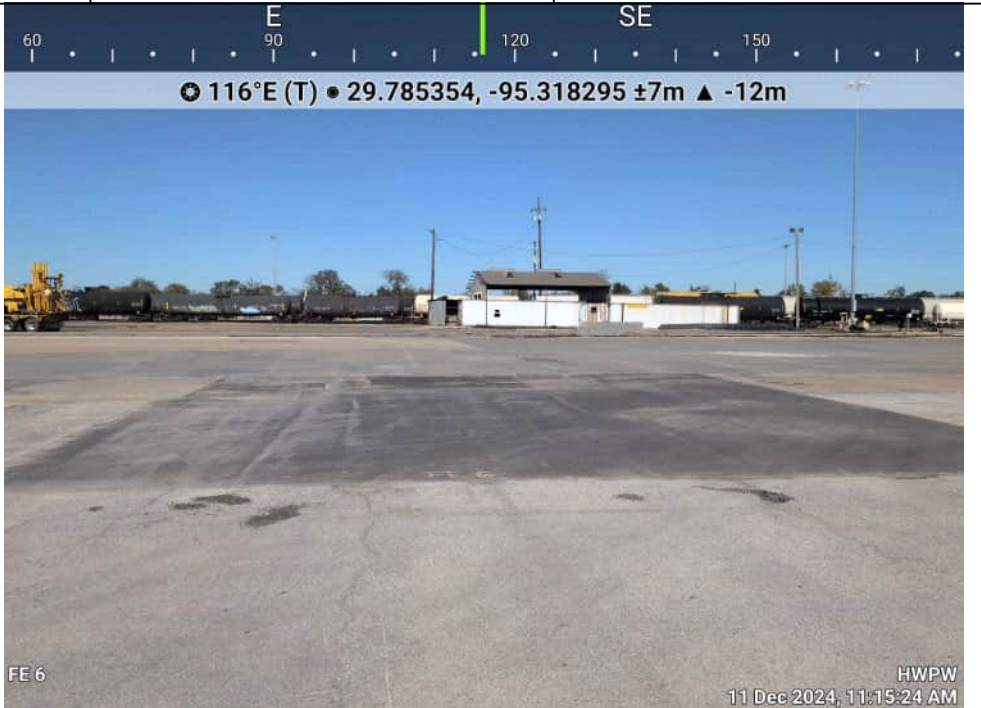
Description:
FE-6 weekly inspection of asphalt cap. No NAPL observed at joints.

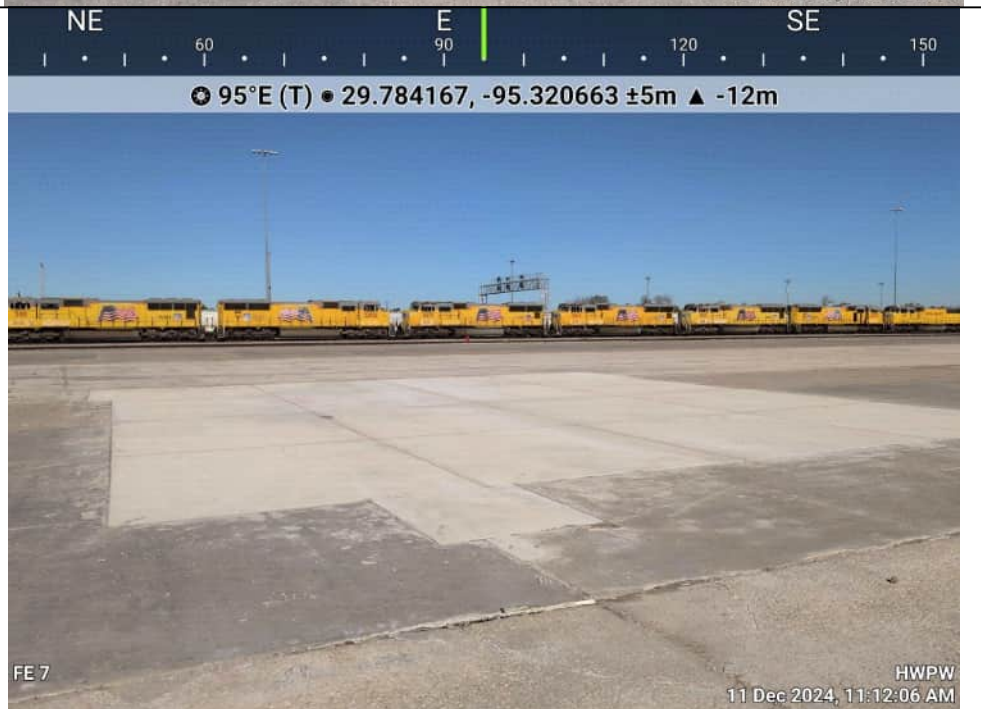
Photo No.
20

Description:
FE-7 weekly inspection of concrete cap. No NAPL observed at joints.

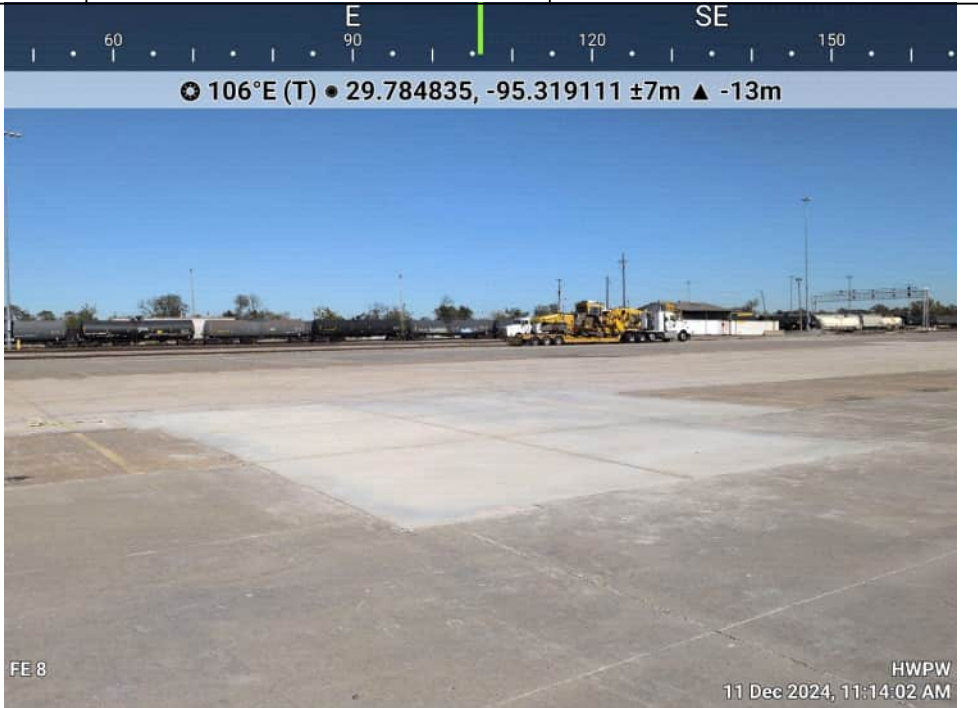
Description:
FE-8 weekly inspection of concrete cap. No NAPL observed at joints.

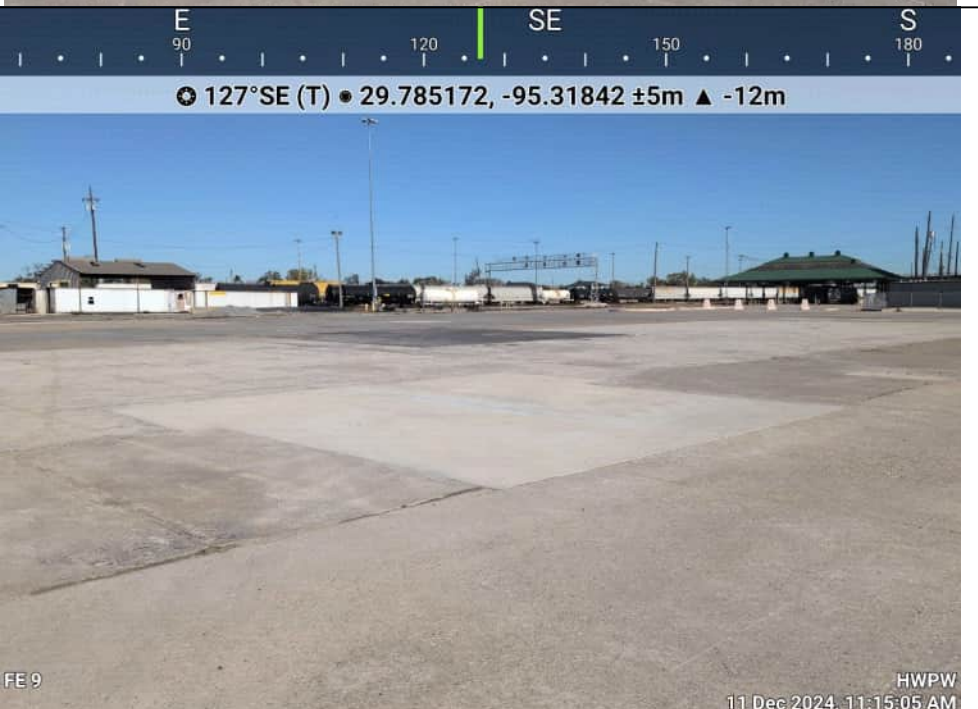
Photo No.: 22	Inspection Date: 12/11/2024
-------------------------	---------------------------------------

Description:
FE-9 weekly inspection of concrete cap. No NAPL observed at joints.

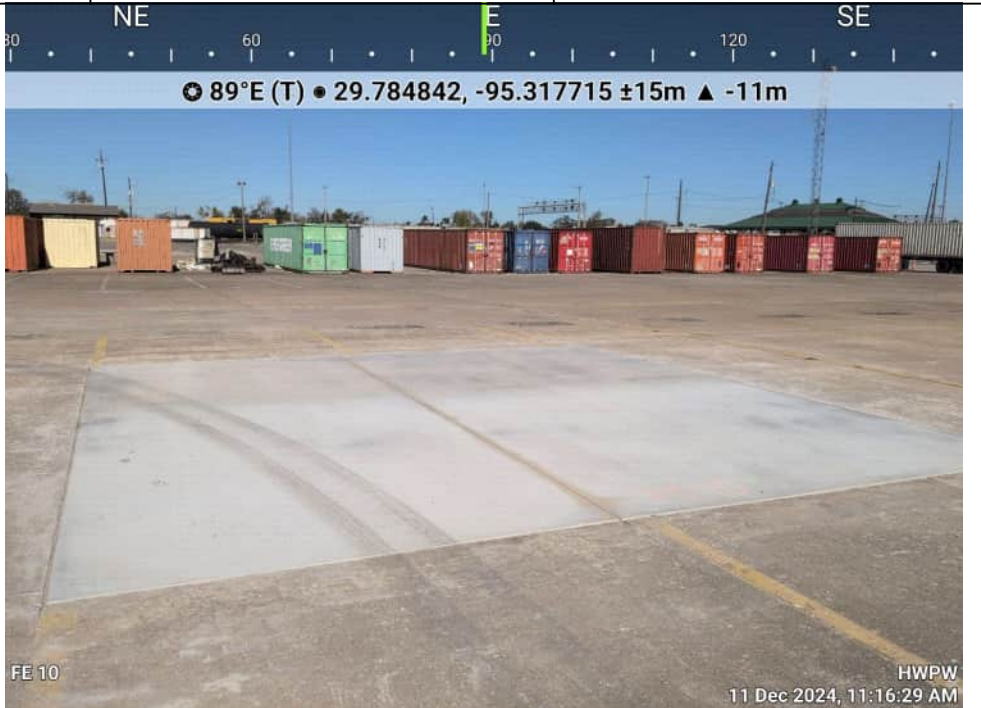
Description:
FE-10 weekly inspection of concrete cap. No NAPL observed at joints.

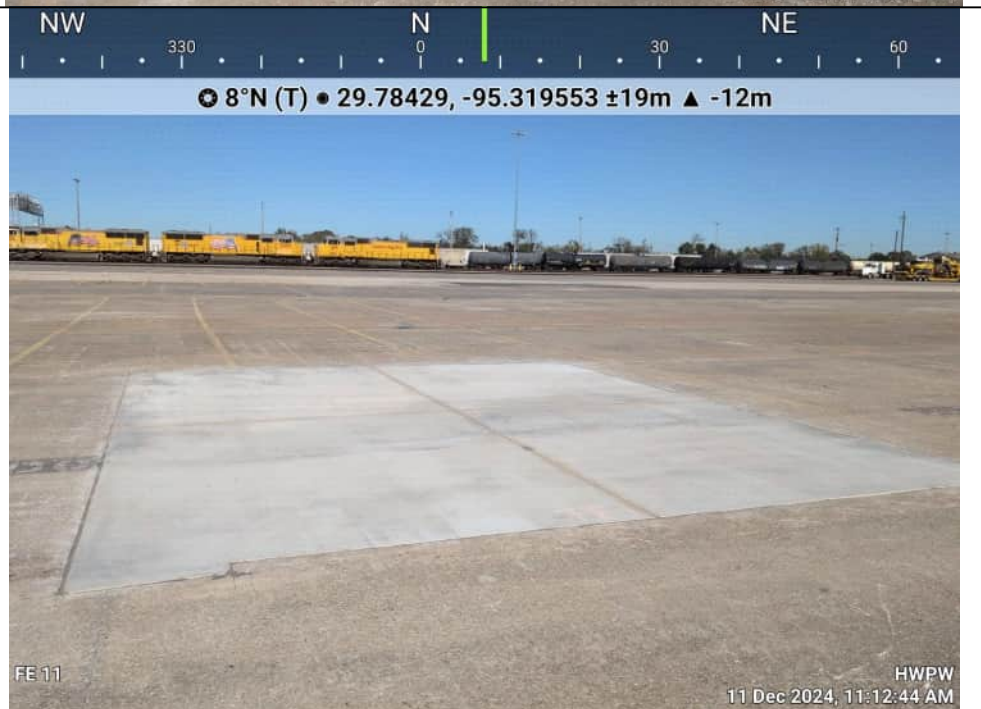
Photo No.
24

Description:
FE-11 weekly inspection of concrete cap. No NAPL observed at joints.

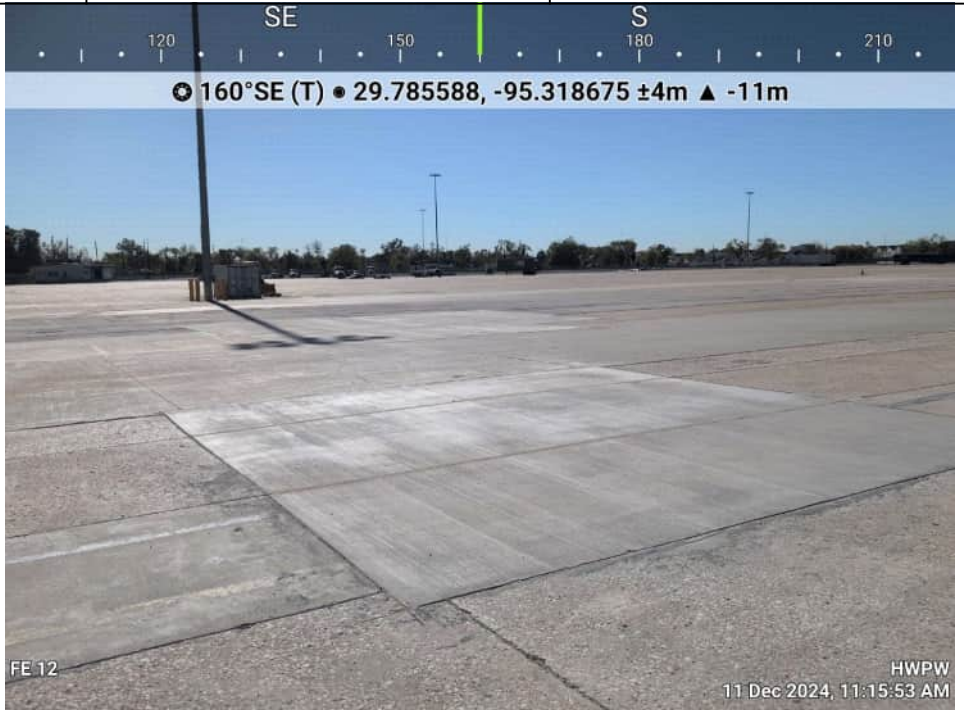
Photo No. 25	Inspection Date: 12/11/2024
Description: FE-12 weekly inspection of concrete cap. No NAPL observed at joints.	
Lat: 29.785588 Long: -95.318675

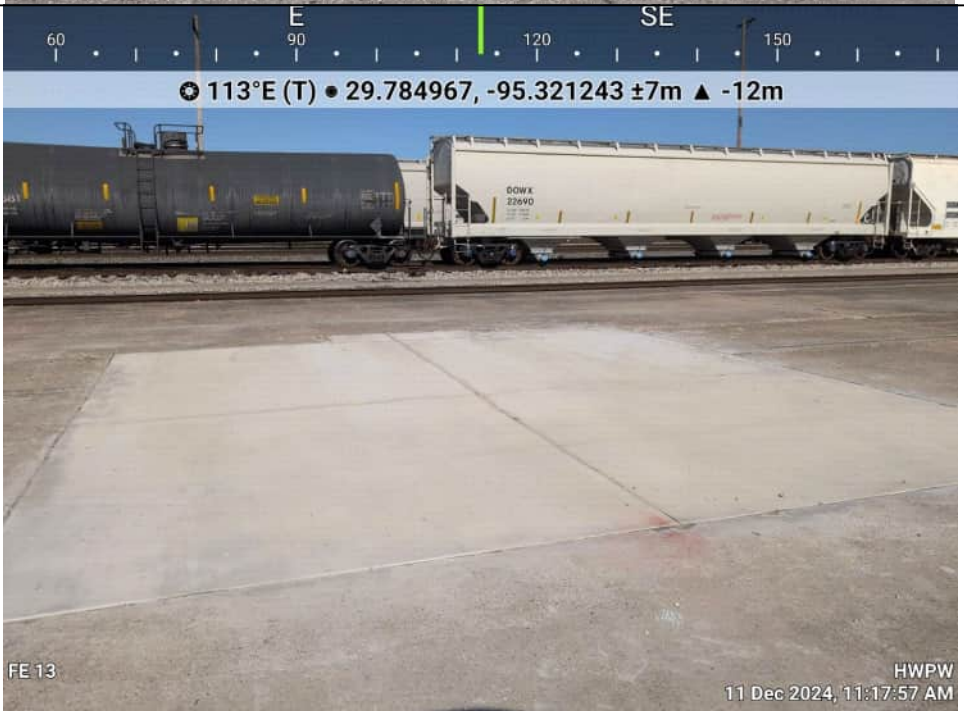
Photo No. 26	Inspection Date: 12/11/2024
Description: FE-13 weekly inspection of concrete cap. No NAPL observed at joints.	
Lat: 29.784967 Long: -95.321243

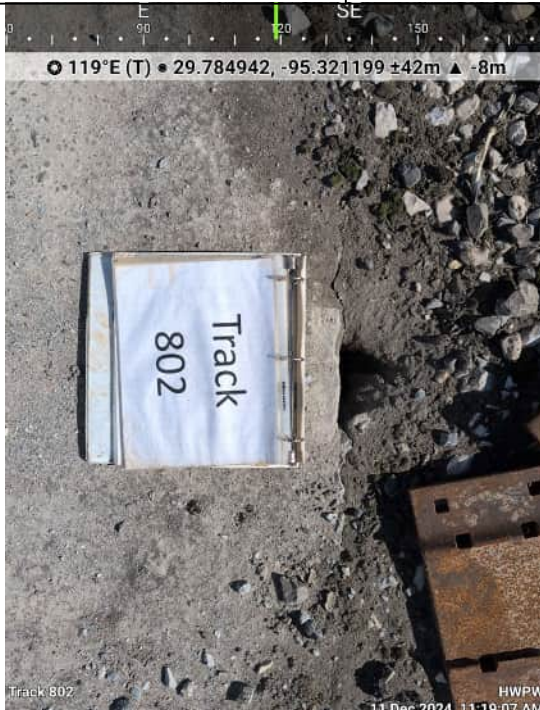
Photo No. 27	Inspection Date: 12/11/2024
Description: Track 802 weekly inspection. No NAPL observed at joints.	
Lat: 29.784942 Long: -95.321199

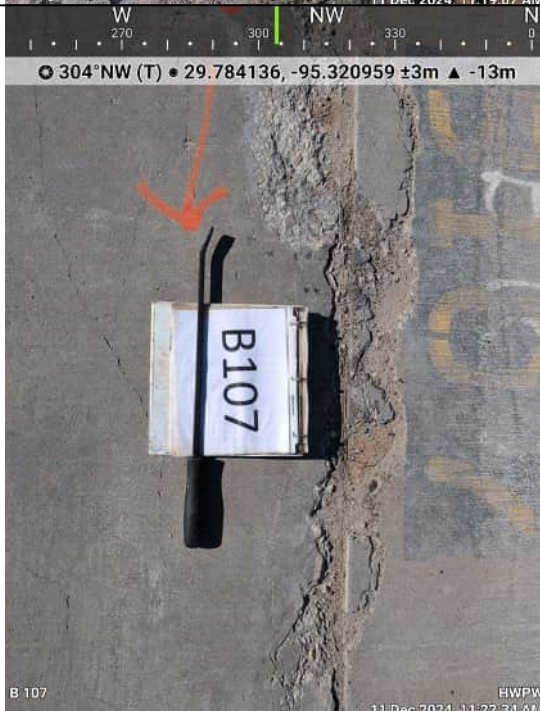
Photo No. 28	Inspection Date: 12/11/2024
Description: Joint B-107 weekly inspection. No NAPL observed at joints.	
Lat: 29.784136 Long: -95.320959

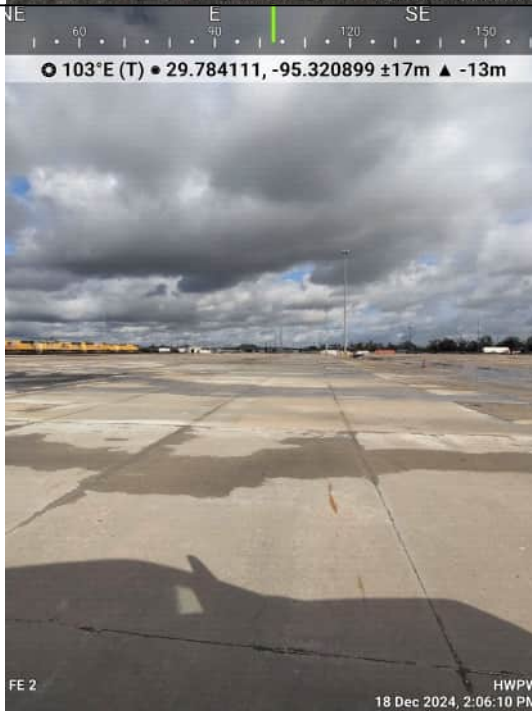
Photo No. 30	Inspection Date: 12/18/2024
Description: FE-2 weekly inspection of concrete cap. No NAPL observed at joints.	
Lat: 29.784111 Long: -95.320899

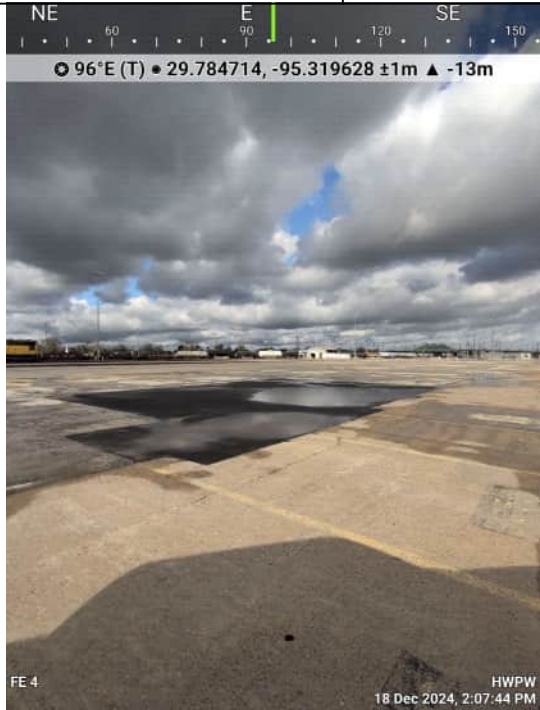
Photo No. 31	Inspection Date: 12/18/2024
Description: FE-4 weekly inspection of asphalt cap. No NAPL observed at joints.	
Lat: 29.784714 Long: -95.319628

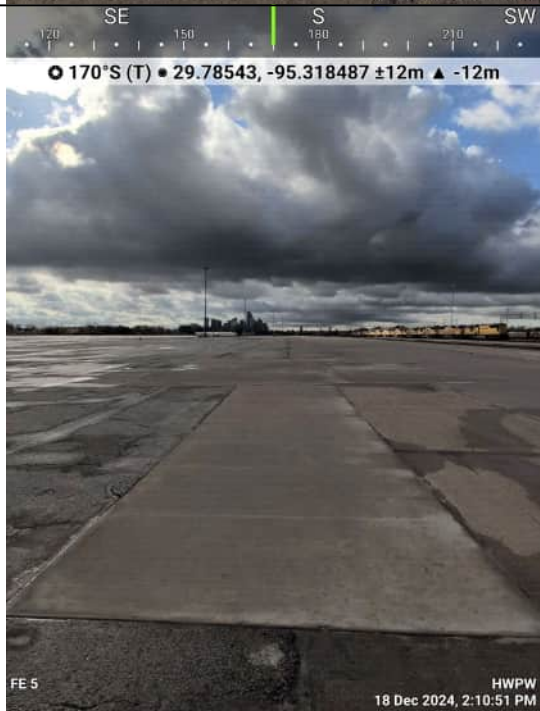
Photo No. 32	Inspection Date: 12/18/2024
Description: FE-5 weekly inspection of concrete cap. No NAPL observed at joints.	
Lat: 29.7852430 Long: -95.318487

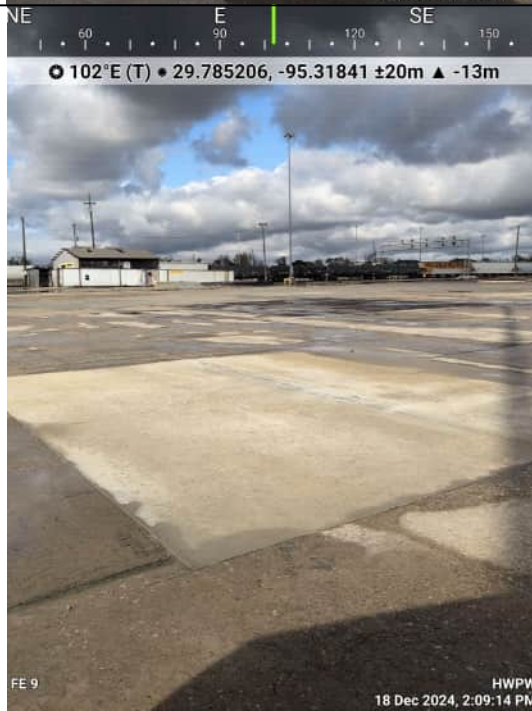
Photo No. 36	Inspection Date: 12/18/2024
Description: FE-9 weekly inspection of concrete cap. No NAPL observed at joints.	
Lat: 29.785206 Long: -95.318410

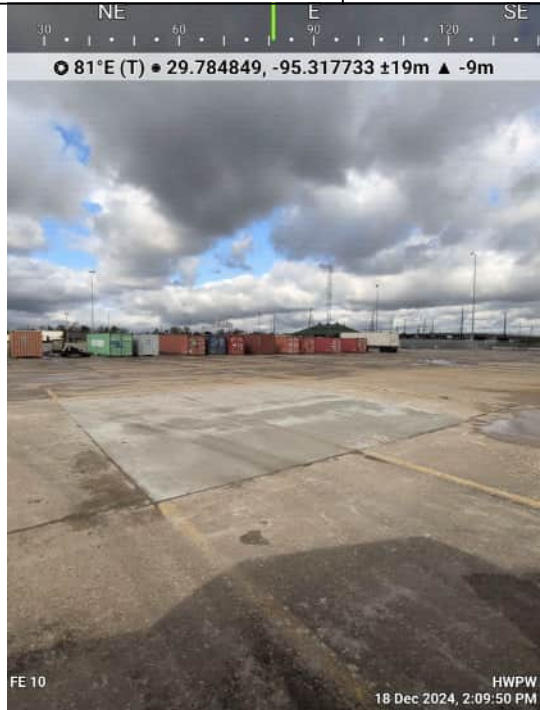
Description:
FE-10 weekly inspection of concrete cap. No NAPL observed at joints.

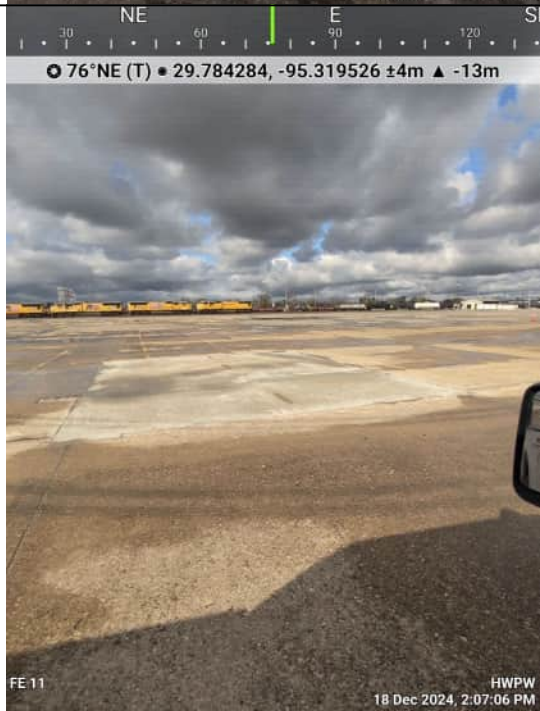
Photo No.: 38 **Inspection Date:** 12/18/2024

Description:
FE-11 weekly inspection of concrete cap. No NAPL observed at joints.

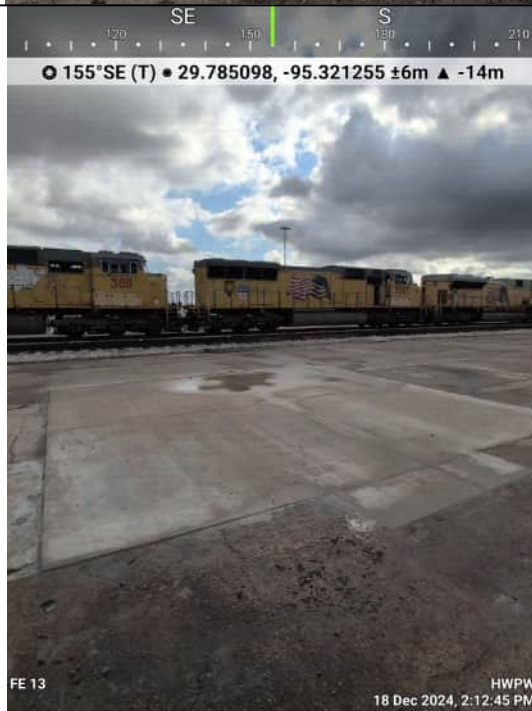
Photo No. 40	Inspection Date: 12/18/2024
Description: FE-13 weekly inspection of concrete cap. No NAPL observed at joints. Lat: 29.785098 Long: -95.321255

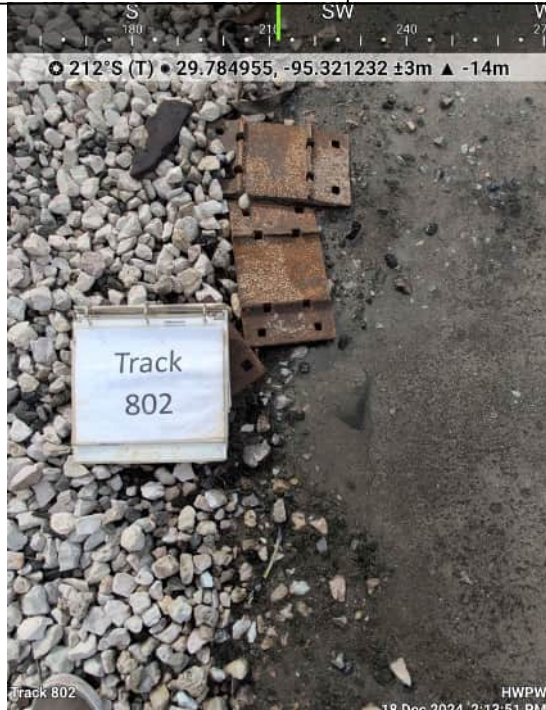
Description:
Track 802 weekly inspection. No NAPL observed at joints.

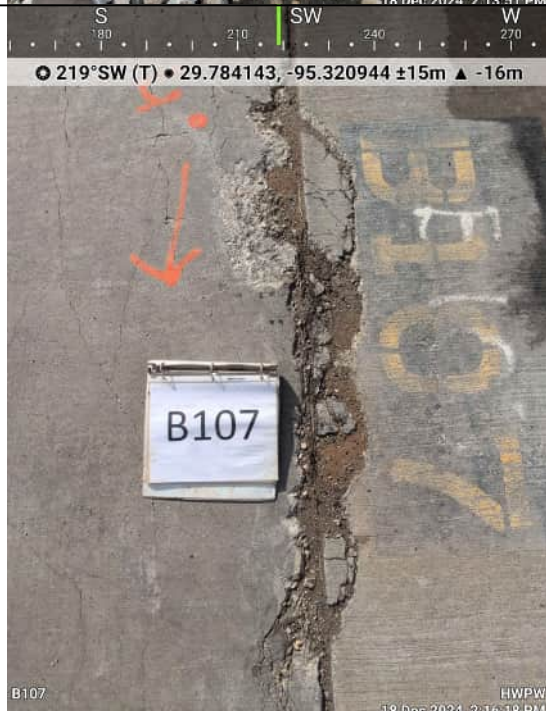
Photo No.
42

Description:
Joint B-107 weekly inspection. No NAPL observed at joints.

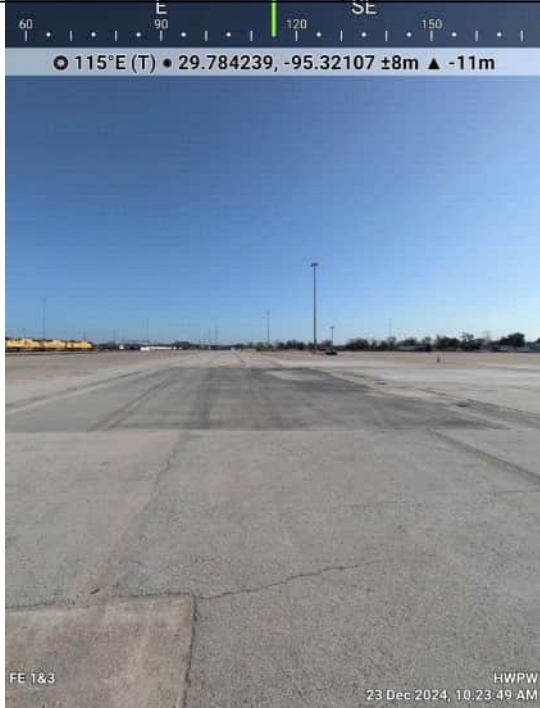
Photo No. 43	Inspection Date: 12/23/2024
Description: FE-1&3 weekly inspection of asphalt cap. No NAPL observed at joints.	
Lat: 29.784239 Long: -95.321070
