January 15, 2025

Project No. 31406585.016

Re: MONTHLY STATUS UPDATE – ENGLEWOOD INTERMODAL YARD – NAPL COLLECTION SYSTEM/CONCRETE CAP REPAIRS AND REVISED INTERIM MEASURES WORK PLAN CONSTRUCTION ACTIVITIES UNION PACIFIC RAILROAD HOUSTON WOOD PRESERVING WORKS FACILITY 4910 LIBERTY ROAD FACILITY, HOUSTON, TEXAS POST-CLOSURE CARE PERMIT NO. HW-50343; INDUSTRIAL SWR NO. 31547

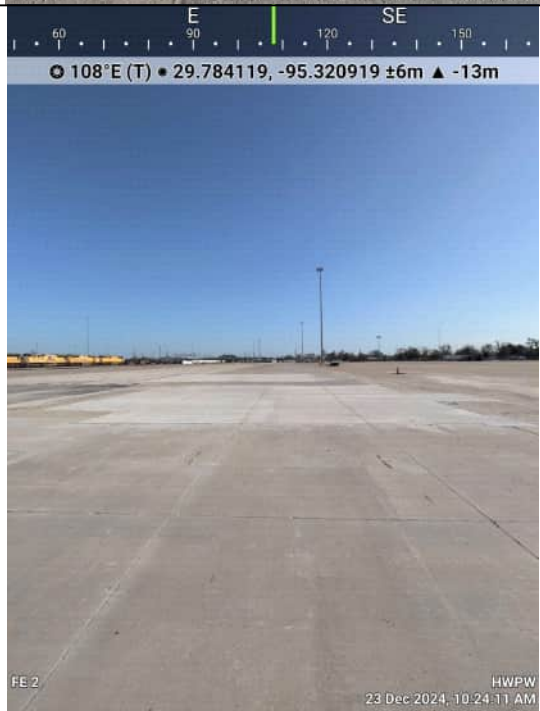
Photo No. 44	Inspection Date: 12/23/2024
Description: FE-2 weekly inspection of concrete cap. No NAPL observed at joints.	
Lat: 29.784119 Long: -95.320919

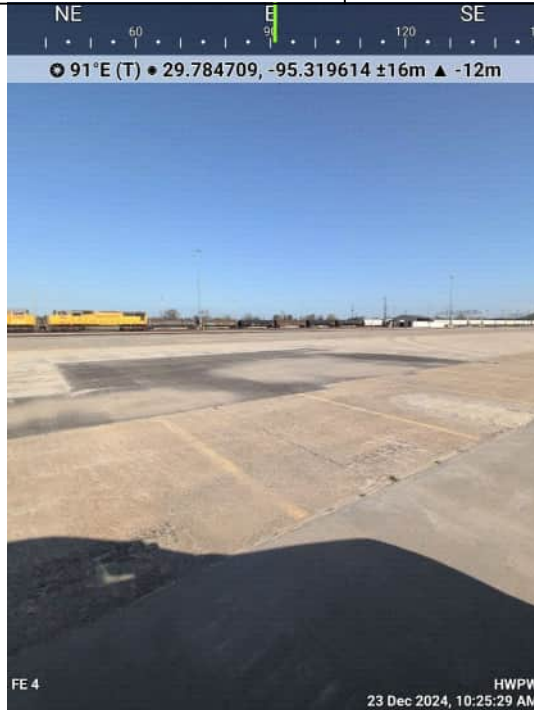
Photo No. 45	Inspection Date: 12/23/2024
Description: FE-4 weekly inspection of asphalt cap. No NAPL observed at joints.	
Lat: 29.784709 Long: -95.319614

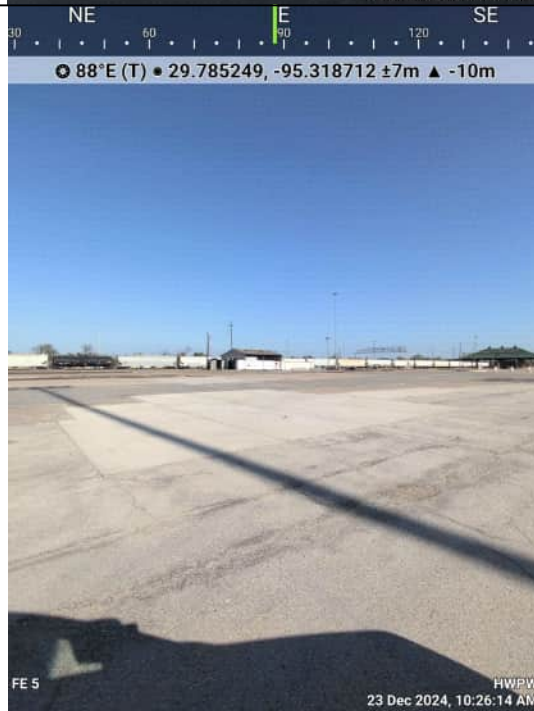
Photo No. 46	Inspection Date: 12/23/2024
Description: FE-5 weekly inspection of concrete cap. No NAPL observed at joints.	
Lat: 29.785249 Long: -95.318712

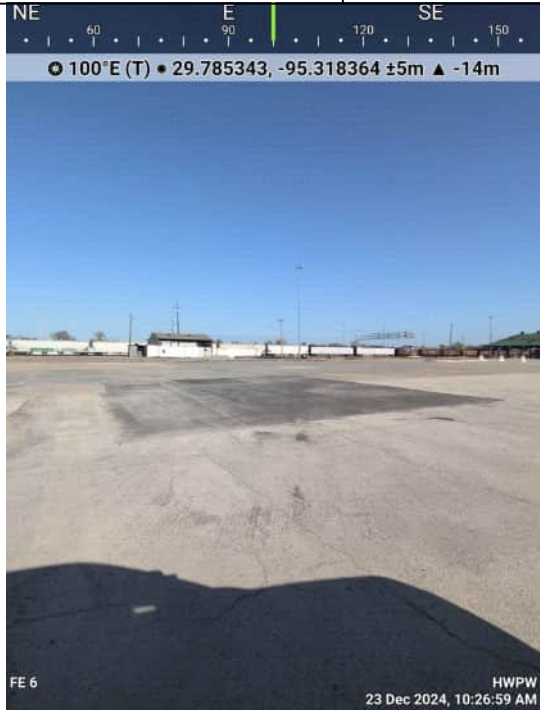
Photo No. 47	Inspection Date: 12/23/2024
Description: FE-6 weekly inspection of asphalt cap. No NAPL observed at joints.	
Lat: 29.785343 Long: -95.318364

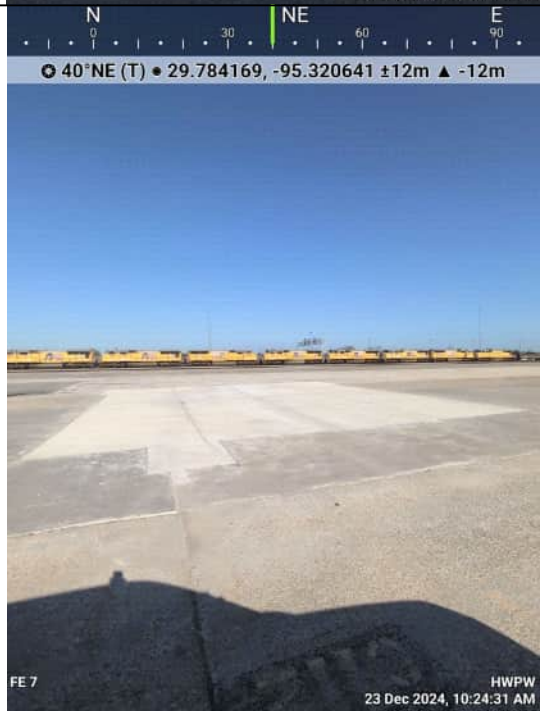
Photo No. 48	Inspection Date: 12/23/2024
Description: FE-7 weekly inspection of concrete cap. No NAPL observed at joints.	
Lat: 29.784169 Long: -95.320641

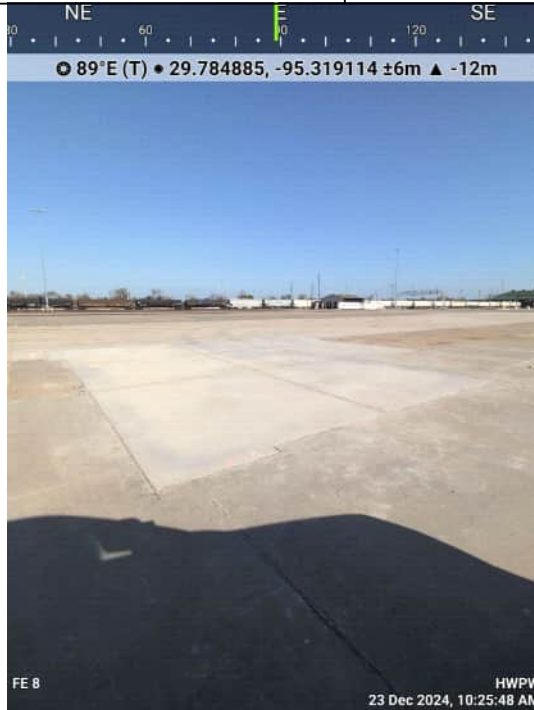
Photo No. 49	Inspection Date: 12/23/2024
Description: FE-8 weekly inspection of concrete cap. No NAPL observed at joints.	
Lat: 29.784885 Long: -95.319114

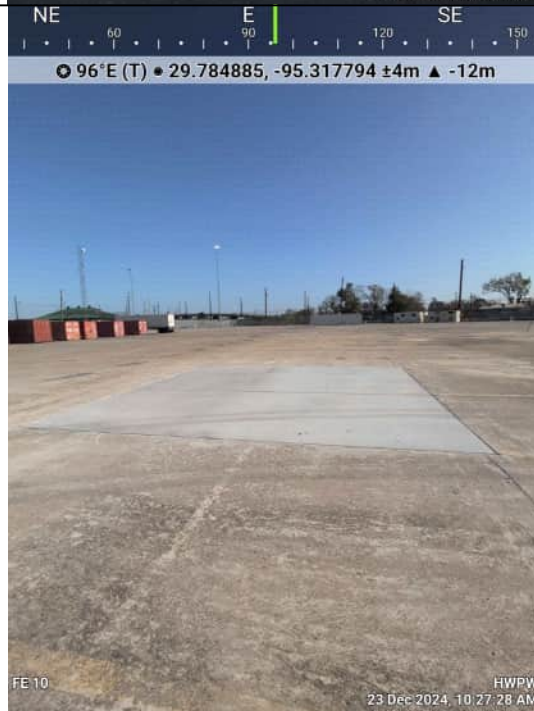
Photo No. 50	Inspection Date: 12/23/2024
Description: FE-10 weekly inspection of concrete cap. No NAPL observed at joints.	
Lat: 29.784885 Long: -95.317794

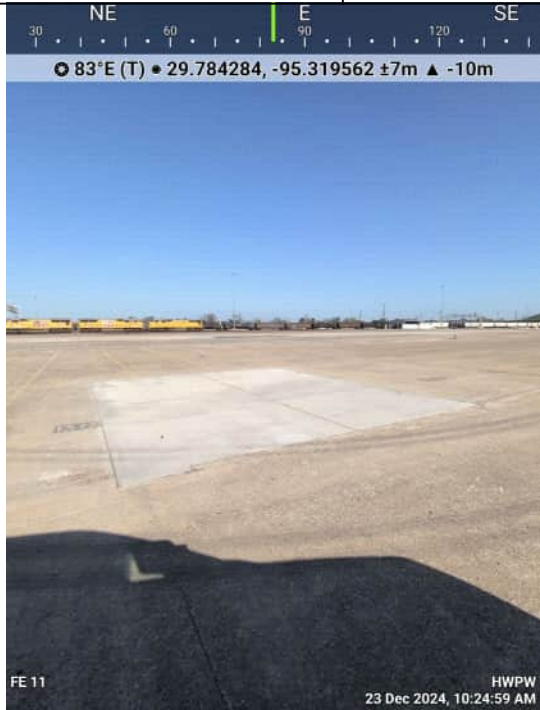
Photo No. 51	Inspection Date: 12/23/2024
Description: FE-11 weekly inspection of concrete cap. No NAPL observed at joints.	
Lat: 29.784284 Long: -95.319562

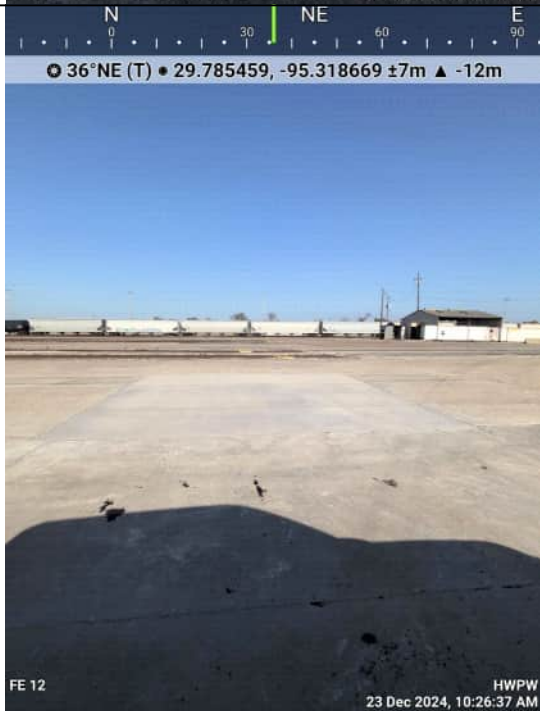
Photo No. 52	Inspection Date: 12/23/2024
Description: FE-12 weekly inspection of concrete cap. No NAPL observed at joints.	
Lat: 29.785459 Long: -95.318669

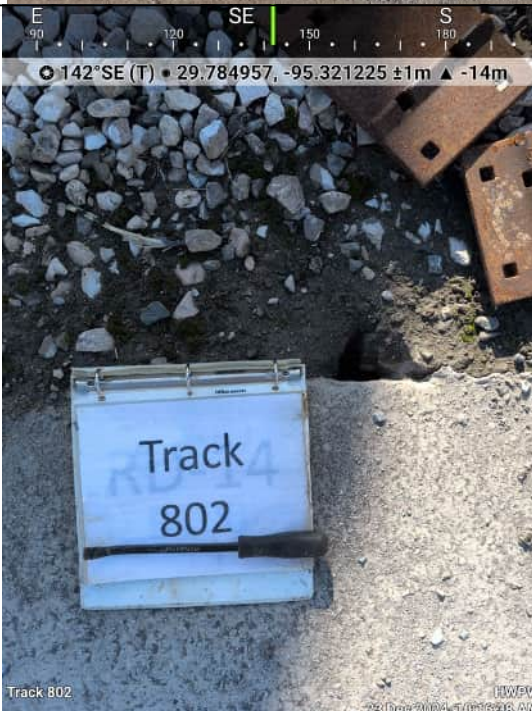
Description:
Track 802 weekly inspection. No NAPL observed at joints.

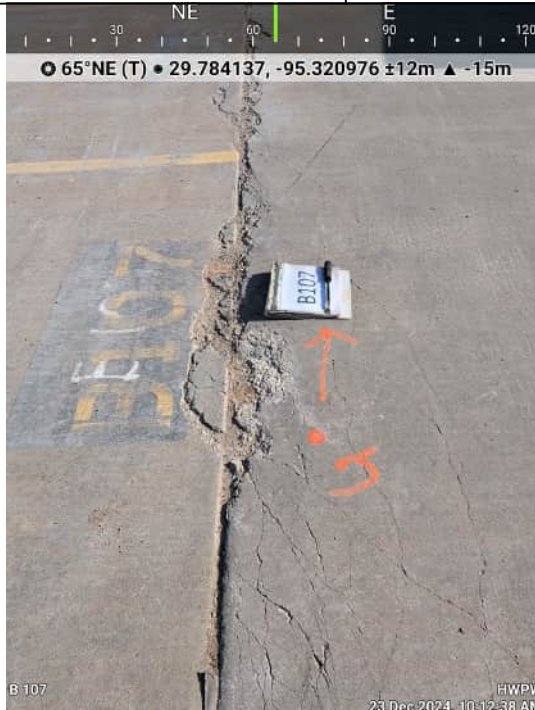
Description:
Joint B-107 weekly inspection. No NAPL observed at joints.

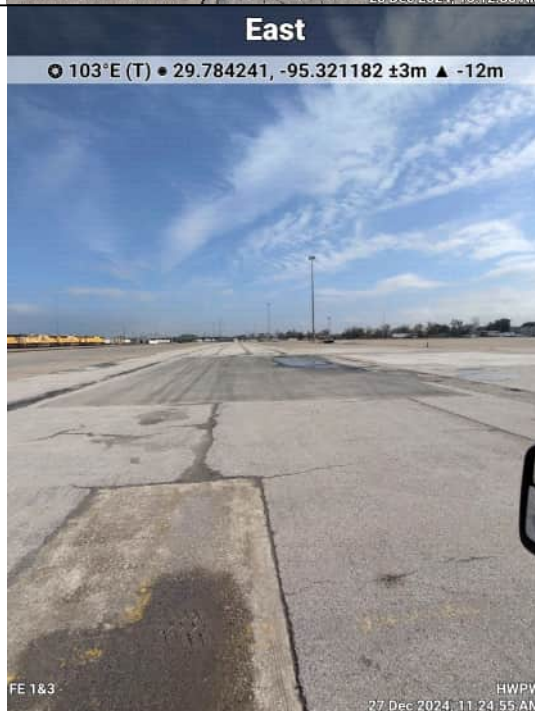
Photo No.
56

Description:
FE-1&3 weekly inspection of asphalt cap. No NAPL observed at joints.

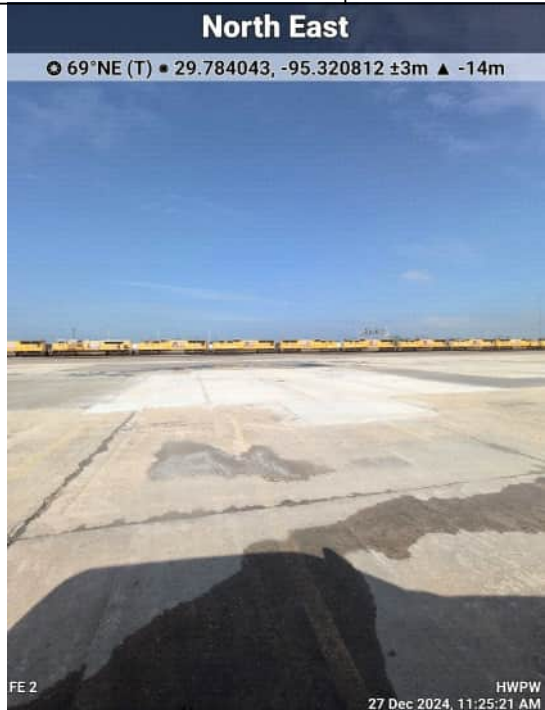
Photo No. 57	Inspection Date: 12/27/2024
Description: FE-2 weekly inspection of concrete cap. No NAPL observed at joints.	
Lat: 29.784043 Long: -95.320812

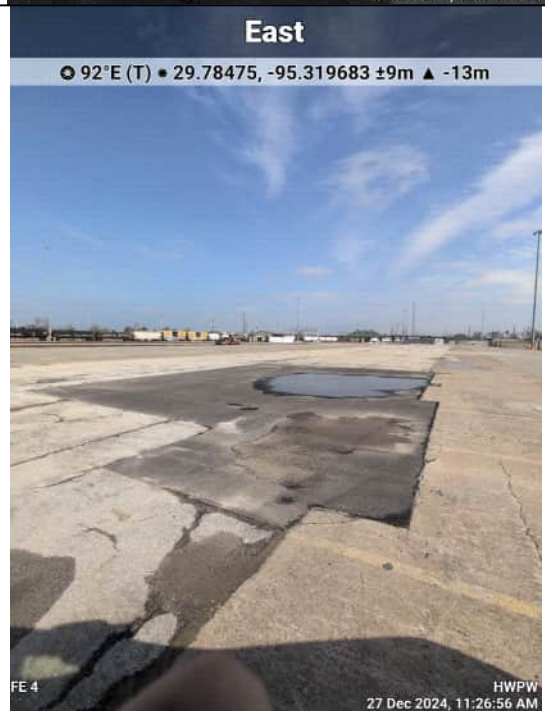
Photo No. 58	Inspection Date: 12/27/2024
Description: FE-4 weekly inspection of asphalt cap. No NAPL observed at joints.	
Lat: 29.784750 Long: -95.319683

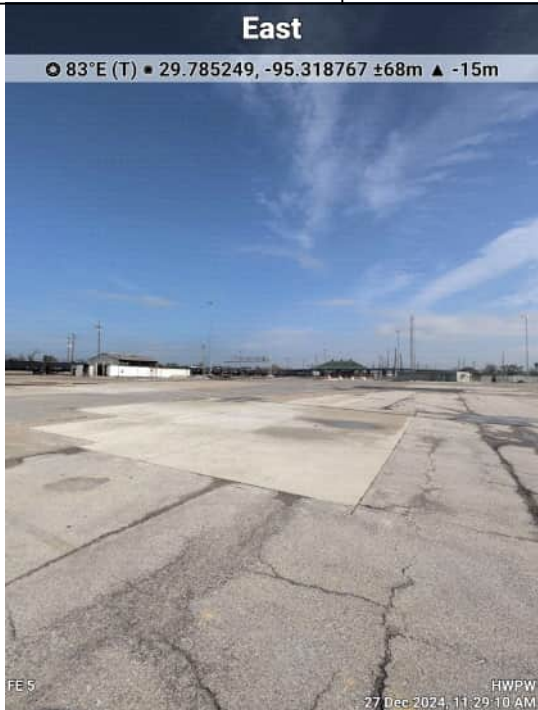
Photo No. 59	Inspection Date: 12/27/2024
Description: FE-5 weekly inspection of concrete cap. No NAPL observed at joints. Lat: 29.785249 Long: -95.318767

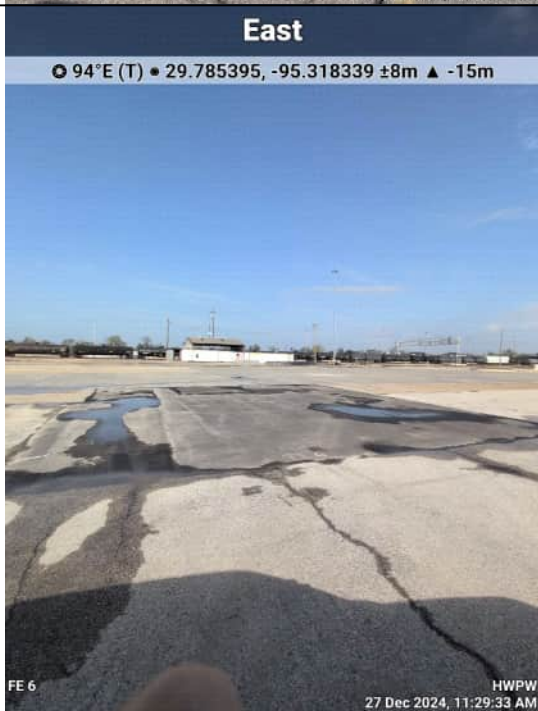
Photo No. 60	Inspection Date: 12/27/2024
Description: FE-6 weekly inspection of asphalt cap. No NAPL observed at joints. Lat: 29.785395 Long: -95.318339

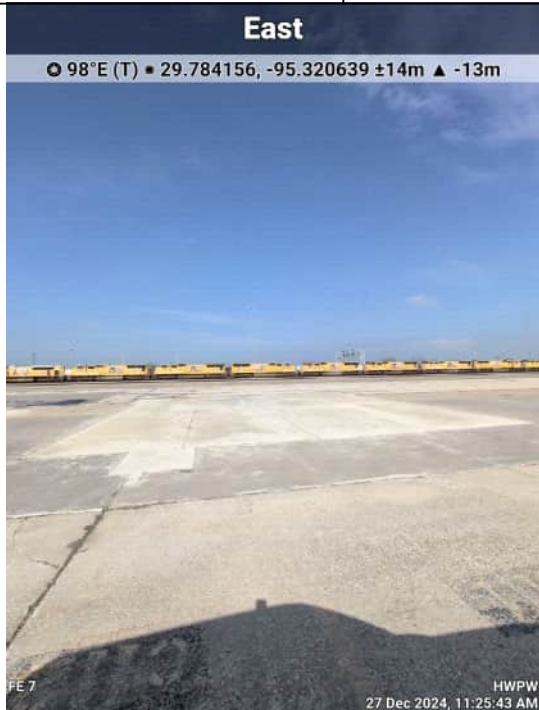
Description:
FE-7 weekly inspection of concrete cap. No NAPL observed at joints.

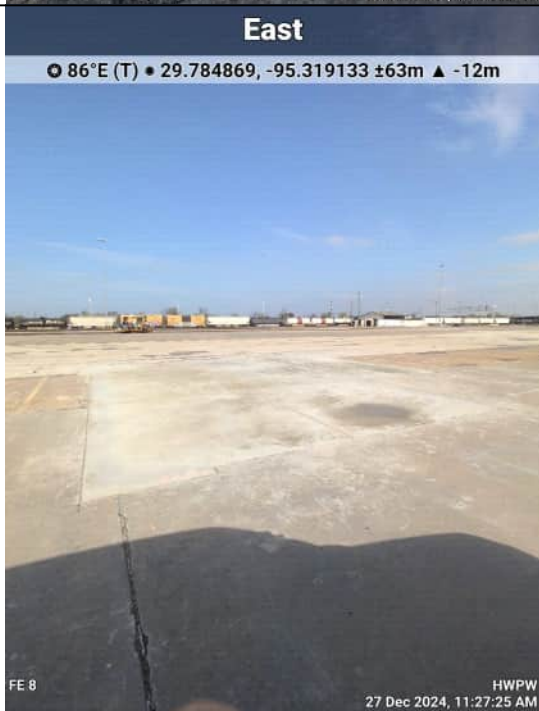
Photo No.
62

Description:
FE-8 weekly inspection of concrete cap. No NAPL observed at joints.

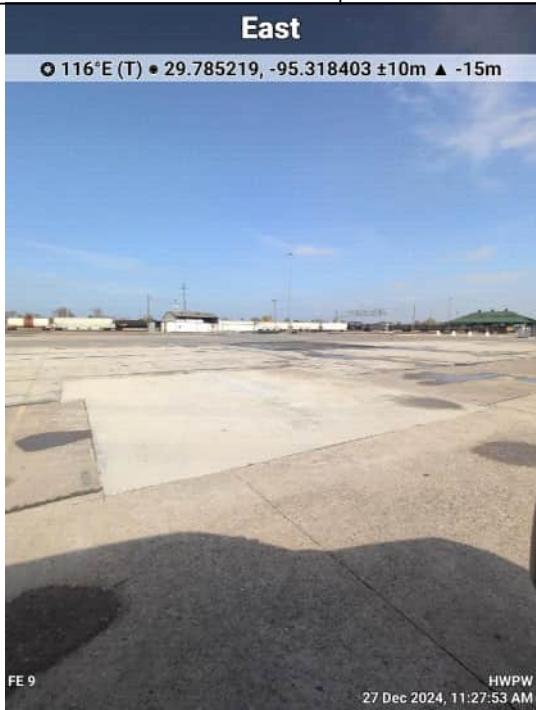
Photo No. 63	Inspection Date: 12/27/2024
Description: FE-9 weekly inspection of concrete cap. No NAPL observed at joints. Lat: 29.785219 Long: -95.318403

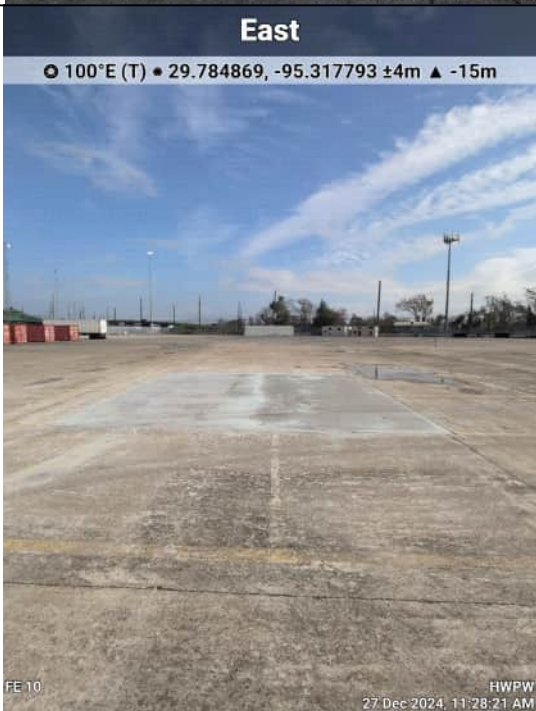
Photo No. 64	Inspection Date: 12/27/2024
Description: FE-10 weekly inspection of concrete cap. No NAPL observed at joints. Lat: 29.784869 Long: -95.317793

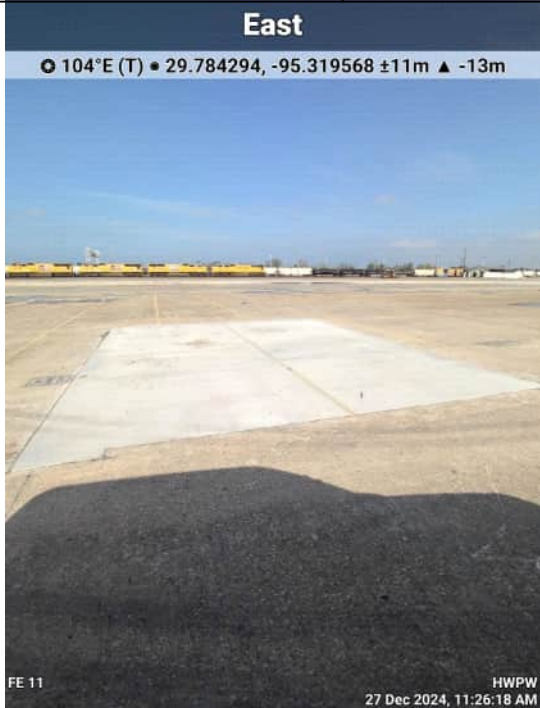
Photo No. 65	Inspection Date: 12/27/2024
Description: FE-11 weekly inspection of concrete cap. No NAPL observed at joints. Lat: 29.784294 Long: -95.319568

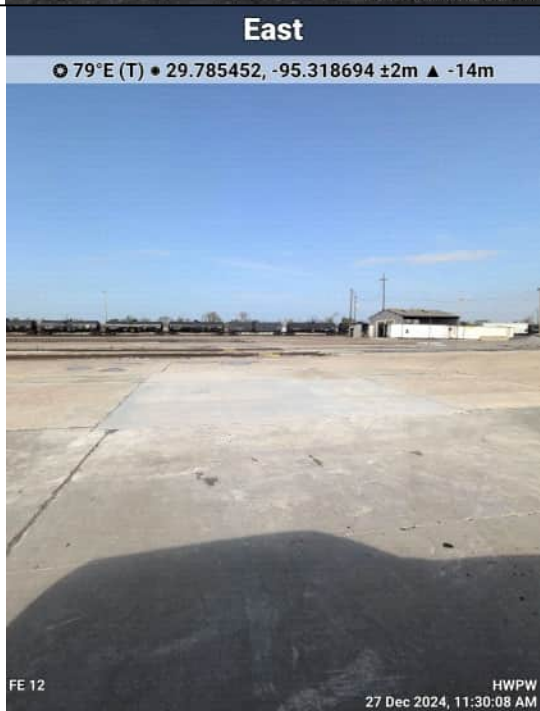
Photo No. 66	Inspection Date: 12/27/2024
Description: FE-12 weekly inspection of concrete cap. No NAPL observed at joints. Lat: 29.785452 Long: -95.318694

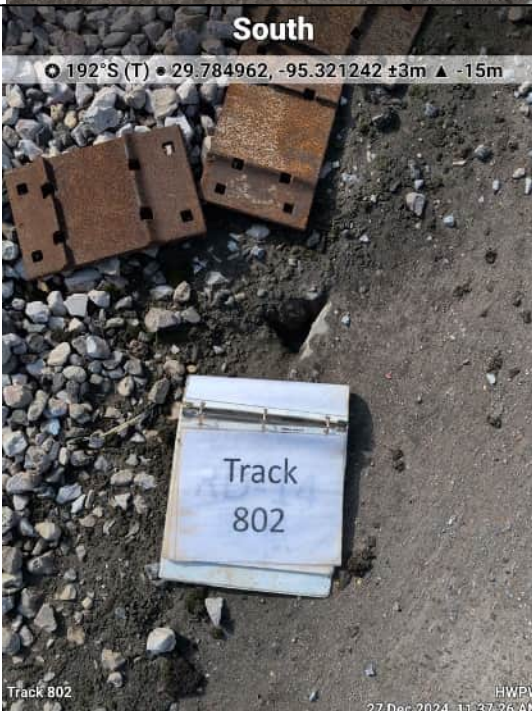
Description:
Track 802 weekly inspection. No NAPL observed at joints.

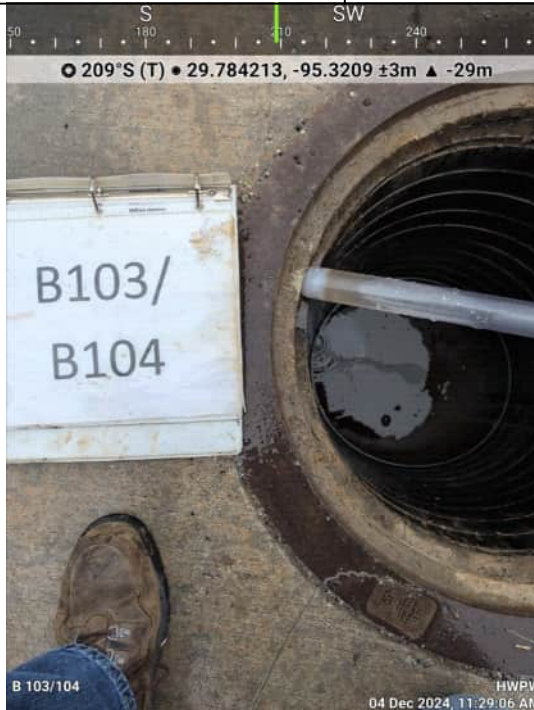
Photo No. 71	Inspection Date: 12/4/2024
Description: Sump 2 (B103/B104), 35.0 inches of freeboard in sump. Color is clear, and no odor observed. Sheen observed on the surface.	
Lat: 29.784213 Long: -95.320900

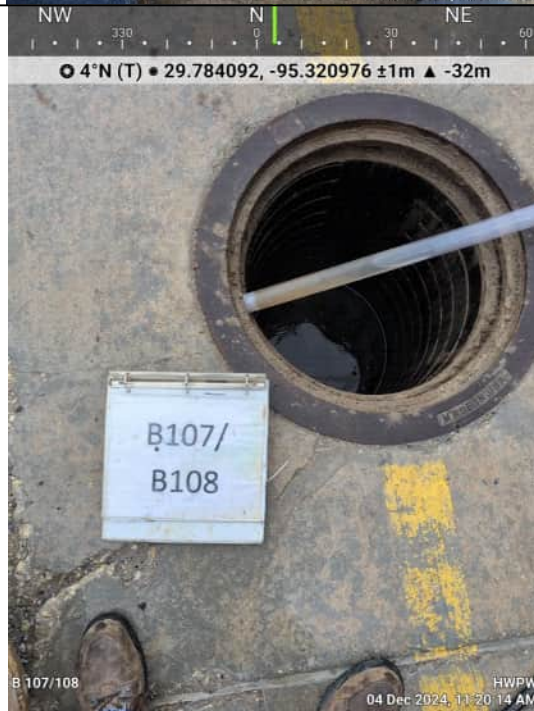
Photo No. 72	Inspection Date: 12/4/2024
Description: Sump 3 (B107/B108), 33.5 inches of freeboard in sump. Color is clear, and no sheen or odor observed.	
Lat: 29.784092 Long: -95.320976

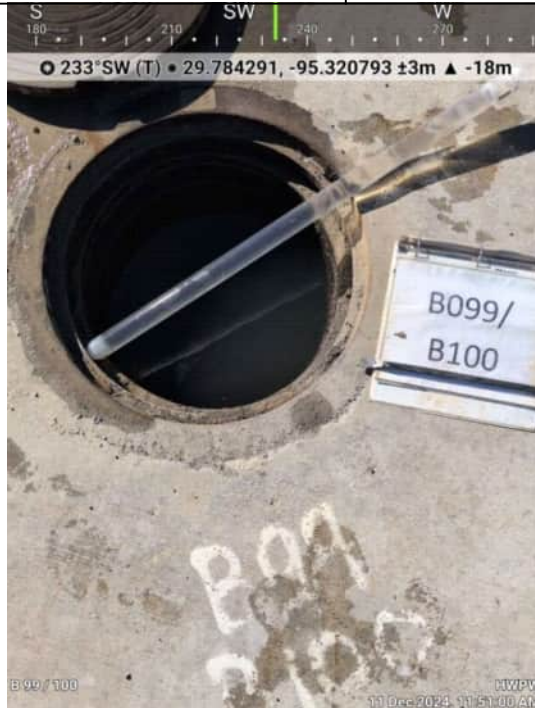
Description:
Sump 1 (B99/B100), 4.0 inches of freeboard in sump. Color is clear, and no odor observed. Sheen observed on the surface.

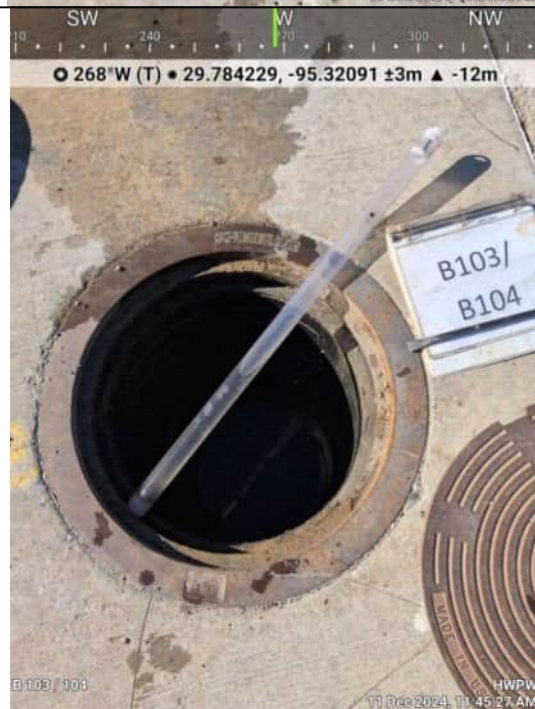
Photo No.
74

Description:
Sump 2 (B103/B104), 26.0 inches of freeboard in sump. Color is clear, and no sheen or odor observed.

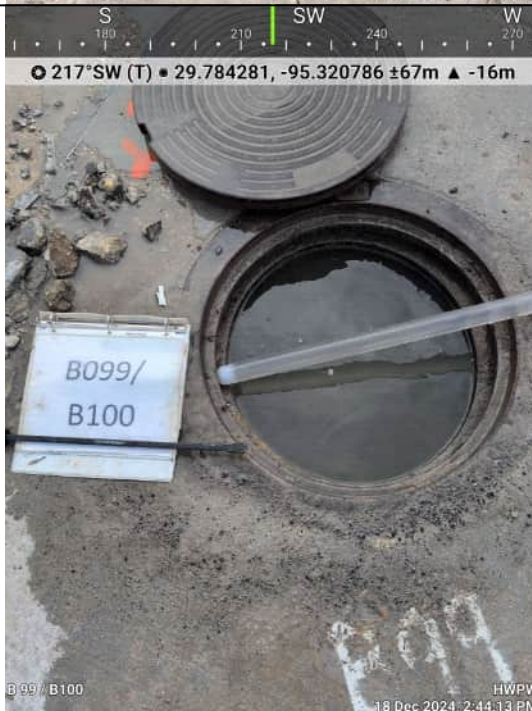
Description:
Sump 1 (B99/B100), 5.0 inches of freeboard in sump. Color is clear, and no odor observed. Sheen observed on the surface.

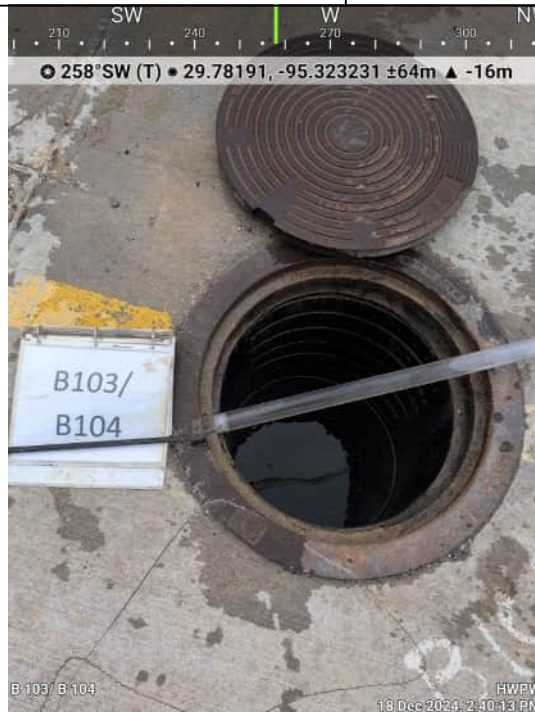
Description:
Sump 2 (B103/B104), 23.0 inches of freeboard in sump. Color is clear, and no sheen or odor observed.

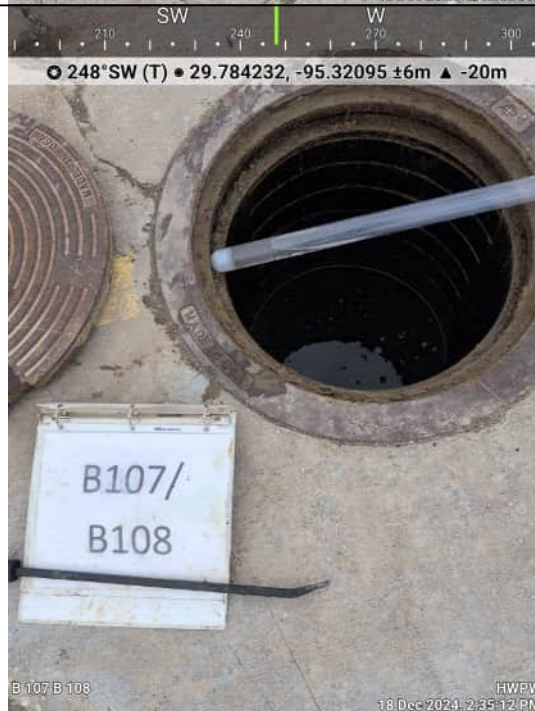
Photo No.:
78

Description:
Sump 3 (B107/B108), 22.0 inches of freeboard in sump. Color is clear, and no sheen or odor observed.

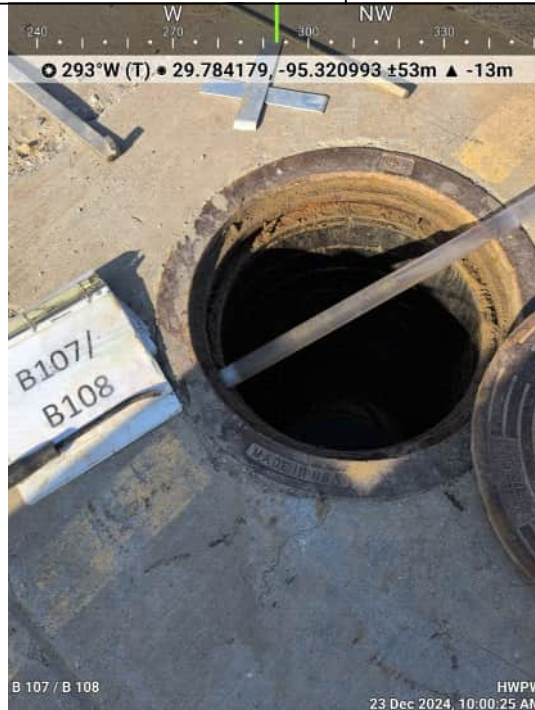
Description:
Sump 3 (B107/B108), 22.5 inches of freeboard in sump. Color is clear, and no sheen or odor observed.

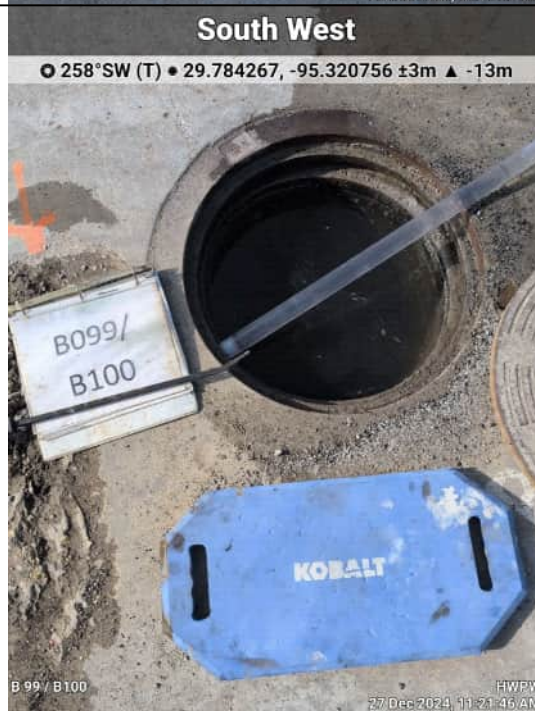
Photo No.
82

- December 27th – at 2, 12, and 11.5 inches (Photo 82, 83, and 84).
- During the December 2024 inspections, the water in Sump 1, Sump 2, and Sump 3 were observed to be clear in color. A sheen was observed at Sump 1 during the December 4th, 11th, 18th, and 27th inspections (Photos 70, 73, 76, and 82). Additionally, a sheen was observed at Sump 2 during the December 4th inspection (Photo 71). No odors were reported during the December inspections.
