February 15, 2025

Project No. US0039040.4227

**Re: MONTHLY STATUS UPDATE – ENGLEWOOD INTERMODAL YARD – NAPL COLLECTION
SYSTEM/CONCRETE CAP REPAIRS AND REVISED INTERIM MEASURES WORK PLAN
CONSTRUCTION ACTIVITIES
UNION PACIFIC RAILROAD HOUSTON WOOD PRESERVING WORKS FACILITY
4910 LIBERTY ROAD FACILITY, HOUSTON, TEXAS
POST-CLOSURE CARE PERMIT NO. HW-50343; INDUSTRIAL SWR NO. 31547**

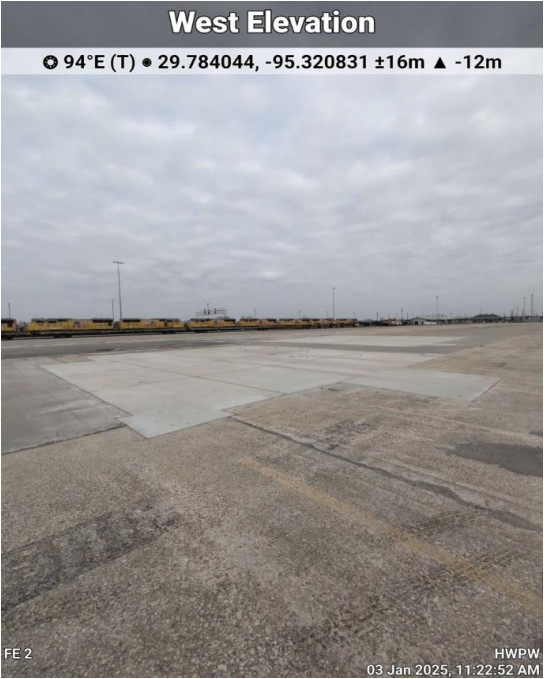
<div> FE 2 <div> HWPW 03 Jan 2025, 11:22:52 AM </div> </div> </div>	
Description: FE-2 weekly inspection of concrete cap. Reconstructed cap in good conditions. No NAPL observed at FE location. Lat: 29.784044 Long: -95.320831			
Photo No. 6	Inspection Date: 1/3/2025	<div> <div> North Elevation </div> <div> ⊙ 88°E (T) • 29.784734, -95.319648 ±21m ▲ -11m </div>

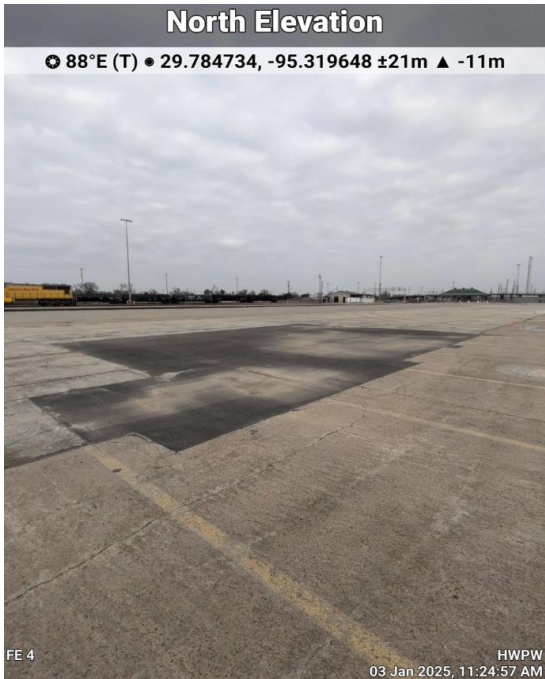
<div> FE 4 <div> HWPW 03 Jan 2025, 11:24:57 AM </div> </div> </div>	
Description: FE-4 weekly inspection of asphalt cap. Reconstructed cap in good conditions. No NAPL observed at FE location. Lat: 29.784734 Long: -95.319648

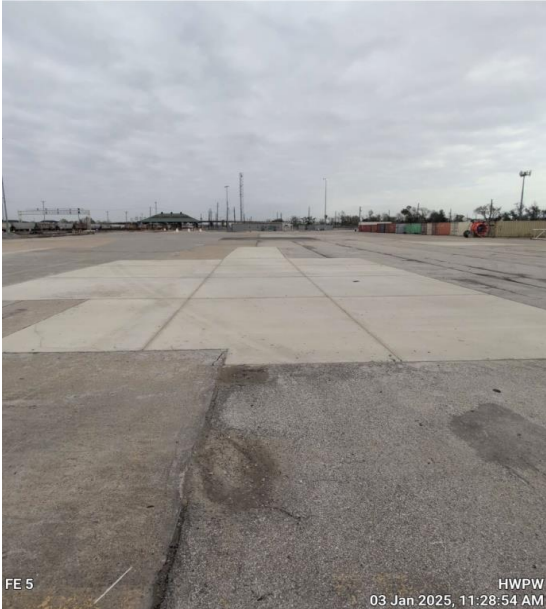
<div> FE 5 HWPW 03 Jan 2025, 11:28:54 AM </div> </div>	
Description: FE-5 weekly inspection of concrete cap. Reconstructed cap in good conditions. No NAPL observed at FE location. Lat: 29.785285 Long: -95.318776			
Photo No. 8	Inspection Date: 1/3/2025	<div> <div> South Elevation </div> <div> ☉ 301°W (T) • 29.785375, -95.318292 ±13m ▲ -13m </div>

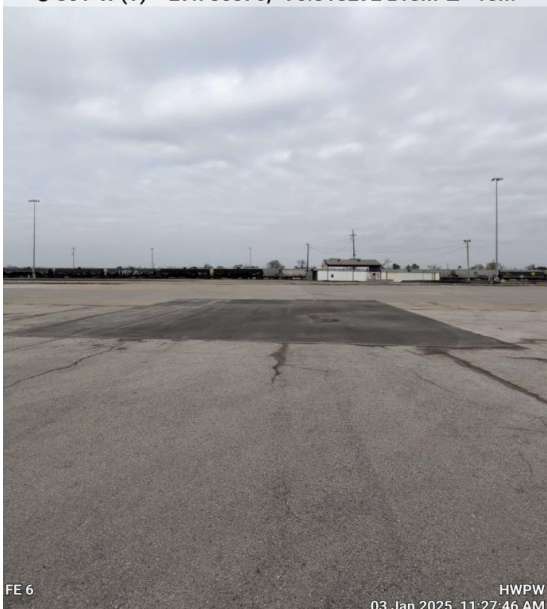
<div> FE 6 HWPW 03 Jan 2025, 11:27:46 AM </div> </div>	
Description: FE-6 weekly inspection of asphalt cap. Reconstructed cap in good conditions. No NAPL observed at FE location. Lat: 29.785375 Long: -95.318292

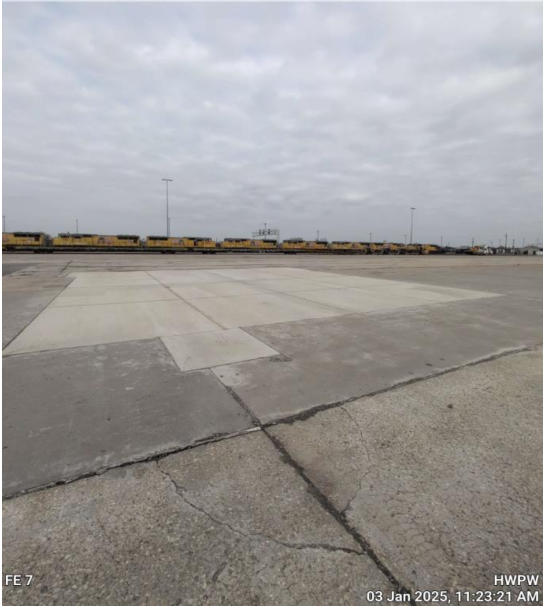
<div> FE 7 HWPW 03 Jan 2025, 11:23:21 AM </div> </div>	
Description: FE-7 weekly inspection of concrete cap. Reconstructed cap in good conditions. No NAPL observed at FE location. Lat: 29.784161 Long: -95.320659			
Photo No. 10	Inspection Date: 1/3/2025	<div> <div> West Elevation </div> <div> ☉ 74°NE (T) • 29.784856, -95.319101 ±22m ▲ -9m </div>

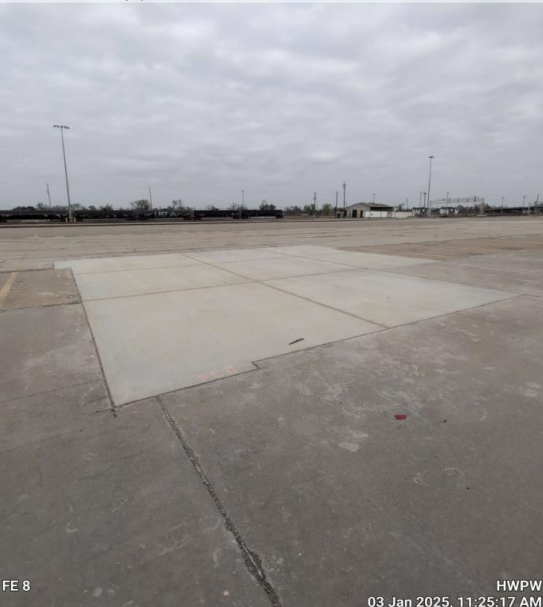
<div> FE 8 HWPW 03 Jan 2025, 11:25:17 AM </div> </div>	
Description: FE-8 weekly inspection of concrete cap. Reconstructed cap in good conditions. No NAPL observed at FE location. Lat: 29.784856 Long: -95.319101

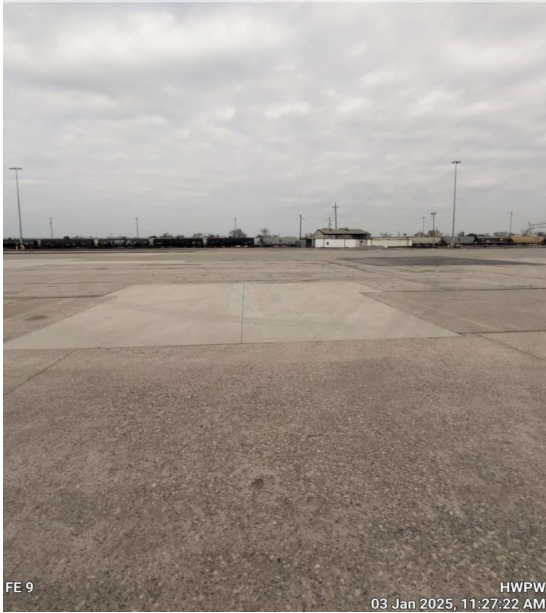
<div> FE 9 HWPW 03 Jan 2025, 11:27:22 AM </div> </div>	
Description: FE-9 weekly inspection of concrete cap. Reconstructed cap in good conditions. No NAPL observed at FE location. Lat: 29.785190 Long: -95.318375			
Photo No. 12	Inspection Date: 1/3/2025	<div> <div> North Elevation </div> <div> ☉ 113°E (T) • 29.784873, -95.317809 ±2m ▲ -13m </div>

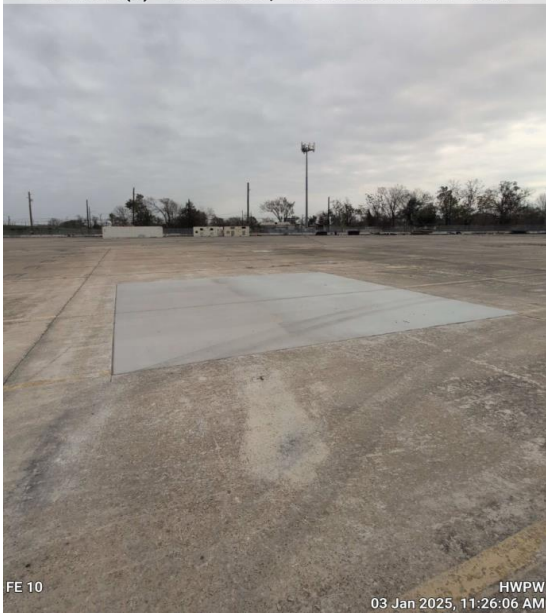
<div> FE 10 HWPW 03 Jan 2025, 11:26:06 AM </div> </div>	
Description: FE-10 weekly inspection of concrete cap. Reconstructed cap in good conditions. No NAPL observed at FE location. Lat: 29.784873 Long: -95.317809

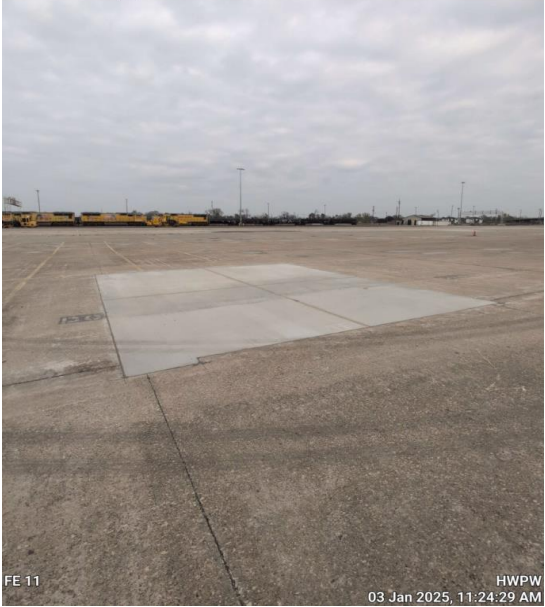
<div> FE 11 HWPW 03 Jan 2025, 11:24:29 AM </div> </div>	
Description: FE-11 weekly inspection of concrete cap. Reconstructed cap in good conditions. No NAPL observed at FE location. Lat: 29.784279 Long: -95.319572			
Photo No. 14	Inspection Date: 1/3/2025	<div> <div> North Elevation </div> <div> 148°SE (T) • 29.785553, -95.318718 ±17m ▲ -13m </div>

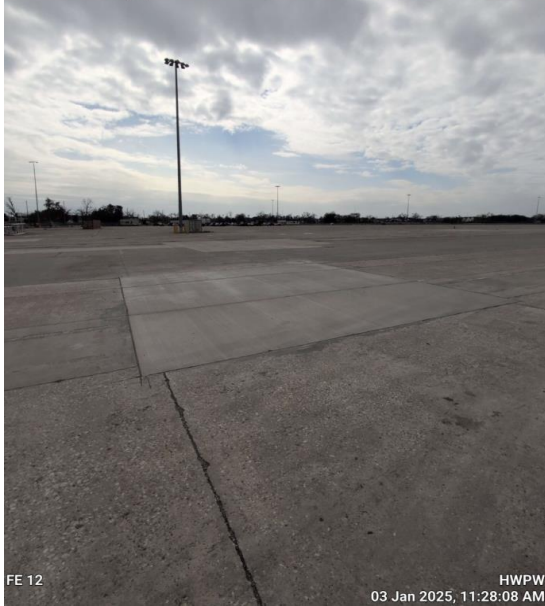
<div> FE 12 HWPW 03 Jan 2025, 11:28:08 AM </div> </div>	
Description: FE-12 weekly inspection of concrete cap. Reconstructed cap in good conditions. No NAPL observed at FE location. Lat: 29.785553 Long: -95.318718

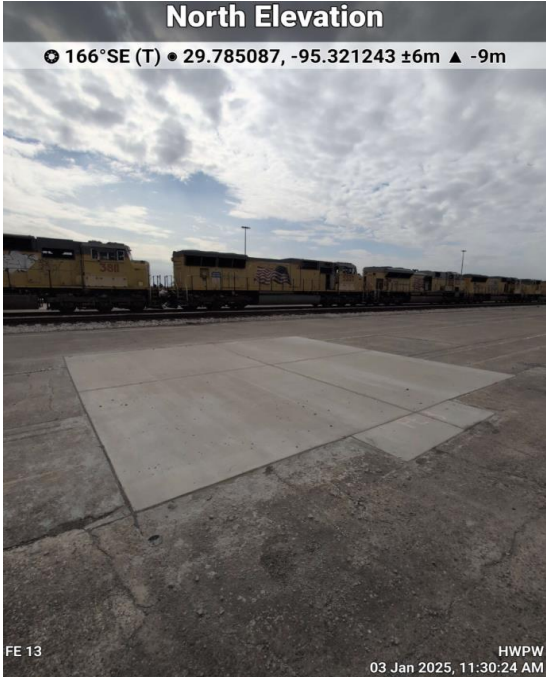
<div> FE 13 HWPW 03 Jan 2025, 11:30:24 AM </div> </div>	
Description: FE-13 weekly inspection of concrete cap. Reconstructed cap in good conditions. No NAPL observed at FE location. Lat: 29.785087 Long: -95.321243			
Photo No. 16	Inspection Date: 1/3/2025	<div> <div> West Elevation </div> <div> 121°E (T) • 29.784945, -95.321223 ±9m ▲ -13m </div>

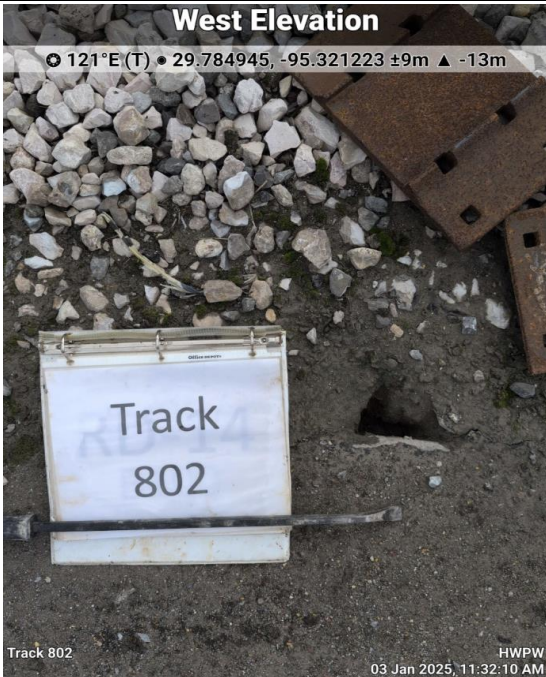
<div> Track 802 HWPW 03 Jan 2025, 11:32:10 AM </div> </div>	
Description: Track 802 weekly inspection of track. Surrounding concrete in good conditions. No NAPL observed at location. Lat: 29.784945 Long: -95.321223

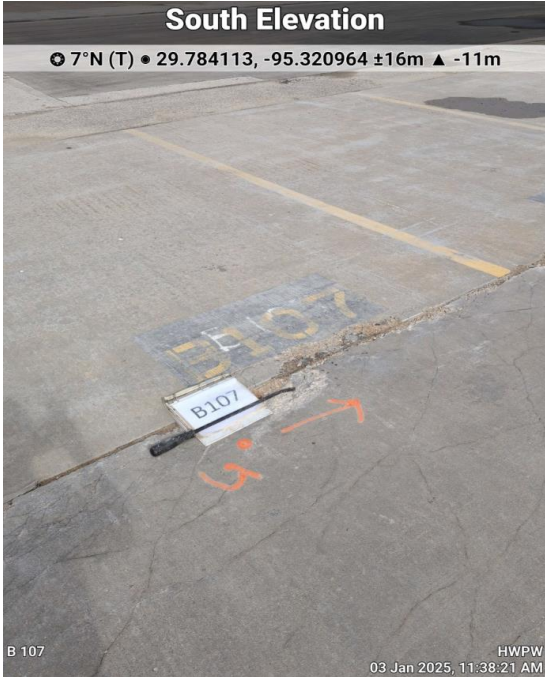
<div> B 107 </div> <div> HWPW 03 Jan 2025, 11:38:21 AM </div> </div>	
Description: B107 weekly inspection of joint. Surrounding concrete in good conditions. No NAPL observed along joint. Lat: 29.784113 Long: -95.320964			
Photo No. 18	Inspection Date: 1/8/2025	<div> <div> North Elevation </div> <div> 116°E (T) • 29.784221, -95.321059 ±3m ▲ -17m </div>

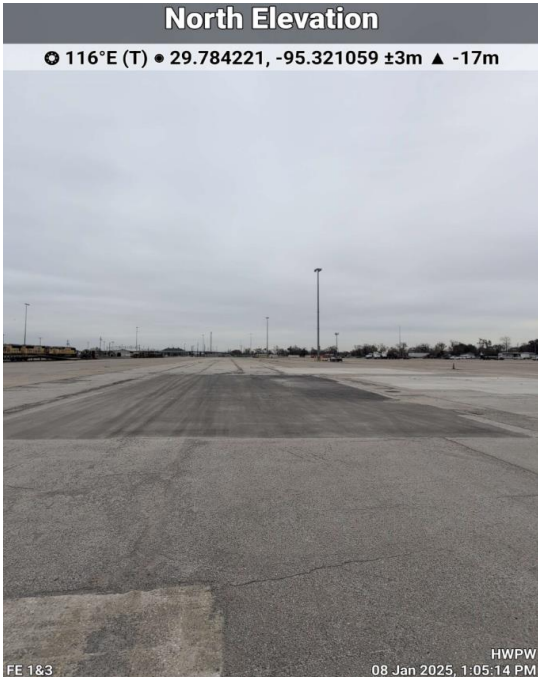
<div> FE 1&3 </div> <div> HWPW 08 Jan 2025, 1:05:14 PM </div> </div>	
Description: FE-1&3 weekly inspection of asphalt cap. Reconstructed cap in good conditions. No NAPL observed at FE location. Lat: 29.784221 Long: -95.321059

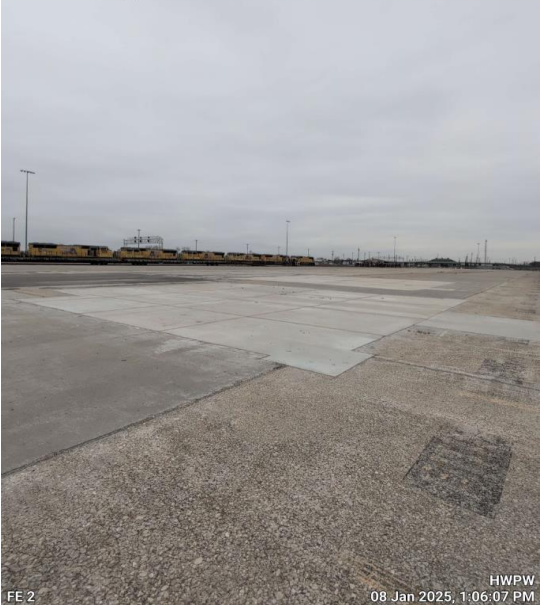
<div> FE 2 <div> HWPW 08 Jan 2025, 1:06:07 PM </div> </div> </div>	
Description: FE-2 weekly inspection of concrete cap. Reconstructed cap in good conditions. No NAPL observed at FE location. Lat: 29.784062 Long: -95.320856			
Photo No. 20	Inspection Date: 1/8/2025	<div> <div>North Elevation</div> <div> 134°SE (T) • 29.784706, -95.31962 ±7m ▲ -18m </div>

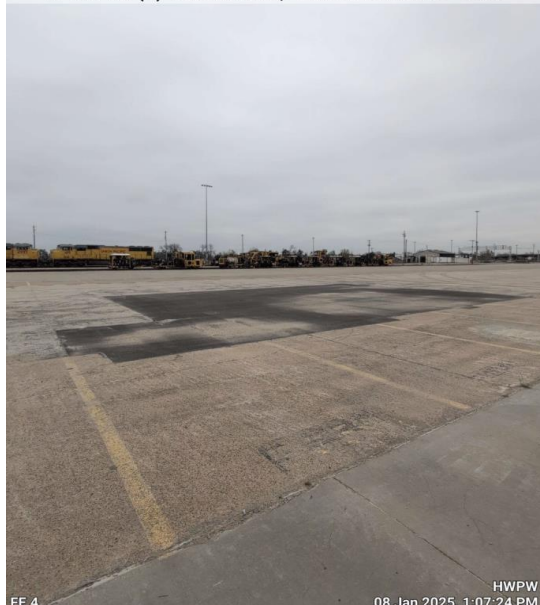
<div> FE 4 <div> HWPW 08 Jan 2025, 1:07:24 PM </div> </div> </div>	
Description: FE-4 weekly inspection of asphalt cap. Reconstructed cap in good conditions. No NAPL observed at FE location. Lat: 29.784706 Long: -95.319620

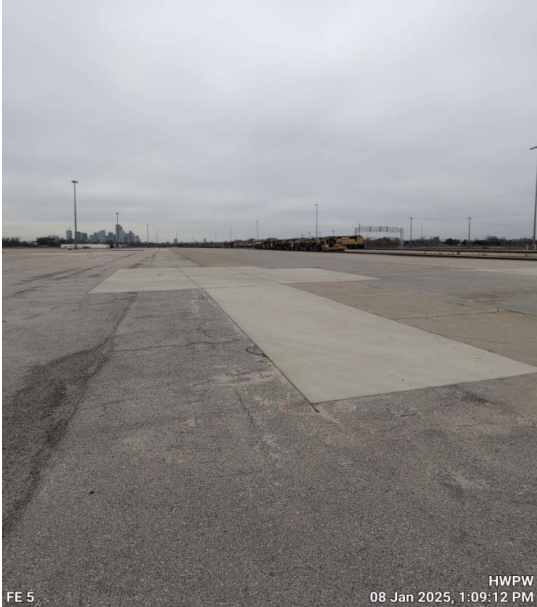
<div> FE 5 HWPW 08 Jan 2025, 1:09:12 PM </div> </div>	
Description: FE-5 weekly inspection of concrete cap. Reconstructed cap in good conditions. No NAPL observed at FE location. Lat: 29.785406 Long: -95.318492			
Photo No. 22	Inspection Date: 1/8/2025	<div> <div> North Elevation </div> <div> ☉ 126°SE (T) • 29.785513, -95.318443 ±5m ▲ -18m </div>

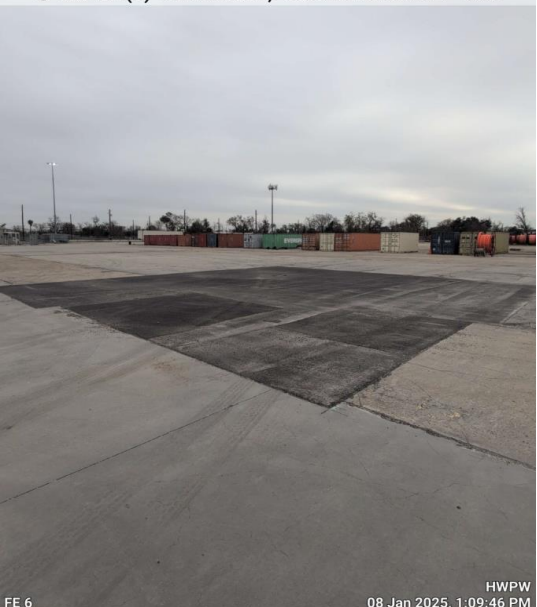
<div> FE 6 HWPW 08 Jan 2025, 1:09:46 PM </div> </div>	
Description: FE-6 weekly inspection of asphalt cap. Reconstructed cap in good conditions. No NAPL observed at FE location. Lat: 29.785513 Long: -95.318443

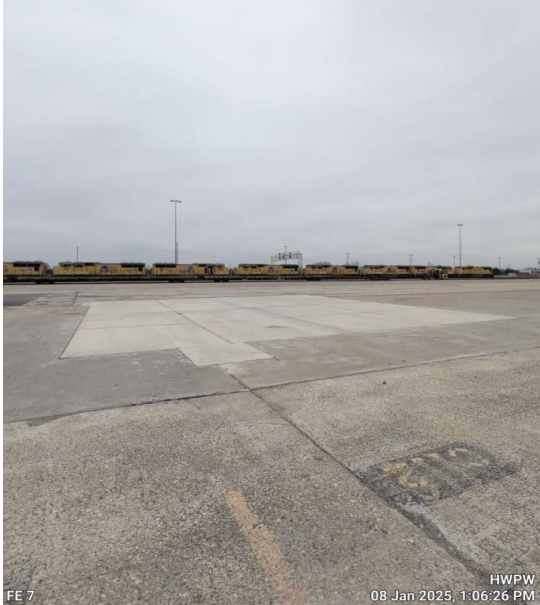
<div> FE 7 <div> HWPW 08 Jan 2025, 1:06:26 PM </div> </div> </div>	
Description: FE-7 weekly inspection of concrete cap. Reconstructed cap in good conditions. No NAPL observed at FE location. Lat: 29.784128 Long: -95.320639			
Photo No. 24	Inspection Date: 1/8/2025	<div> <div> West Elevation </div> <div> 82°E (T) • 29.784894, -95.319113 ±6m ▲ -17m </div>

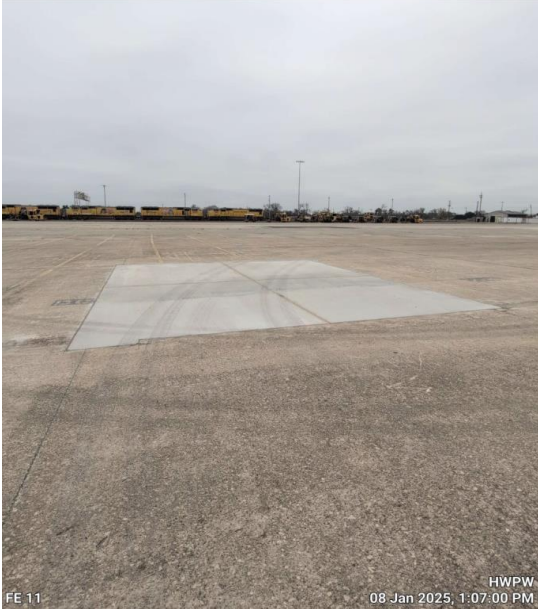
<div> FE 11 HWPW 08 Jan 2025, 1:07:00 PM </div> </div>	
Description: FE-11 weekly inspection of concrete cap. Reconstructed cap in good conditions. No NAPL observed at FE location. Lat: 29.784290 Long: -95.319554			
Photo No. 28	Inspection Date: 1/8/2025	<div> <div> East Elevation </div> <div> 179°S (T) • 29.785534, -95.318635 ±8m ▲ -18m </div>

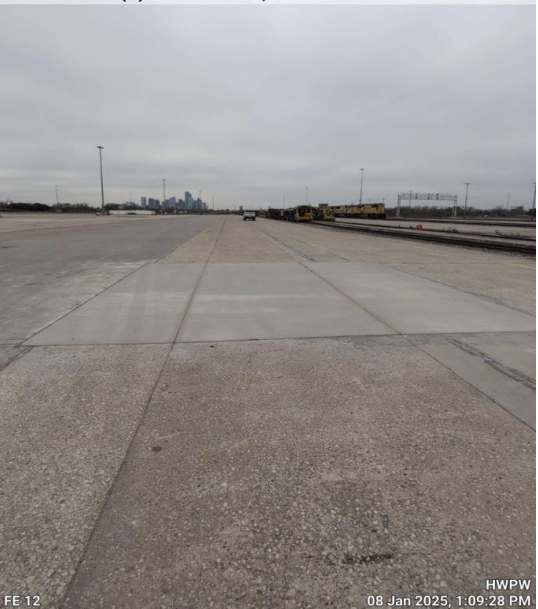
<div> FE 12 HWPW 08 Jan 2025, 1:09:28 PM </div> </div>	
Description: FE-12 weekly inspection of concrete cap. Reconstructed cap in good conditions. No NAPL observed at FE location. Lat: 29.785534 Long: -95.318635

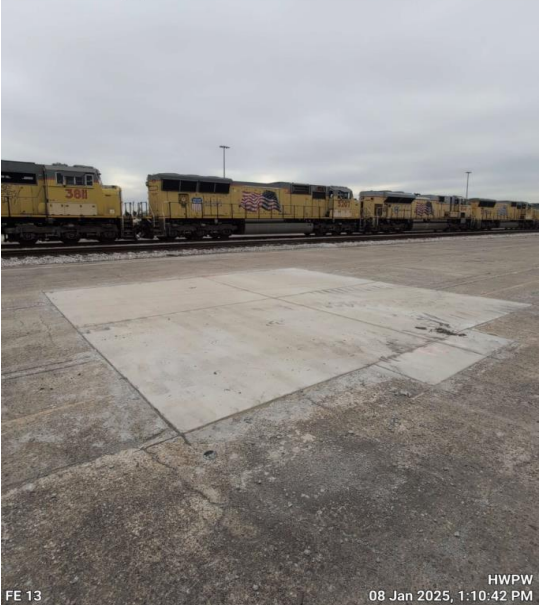
<div> FE 13 </div> <div> HWPW 08 Jan 2025, 1:10:42 PM </div> </div>	
Description: FE-13 weekly inspection of concrete cap. Reconstructed cap in good conditions. No NAPL observed at FE location. Lat: 29.785103 Long: -95.321246			
Photo No. 30	Inspection Date: 1/8/2025	<div> <div> North Elevation </div> <div> 162°SE (T) • 29.784864, -95.321249 ±0m ▲ -26m </div>

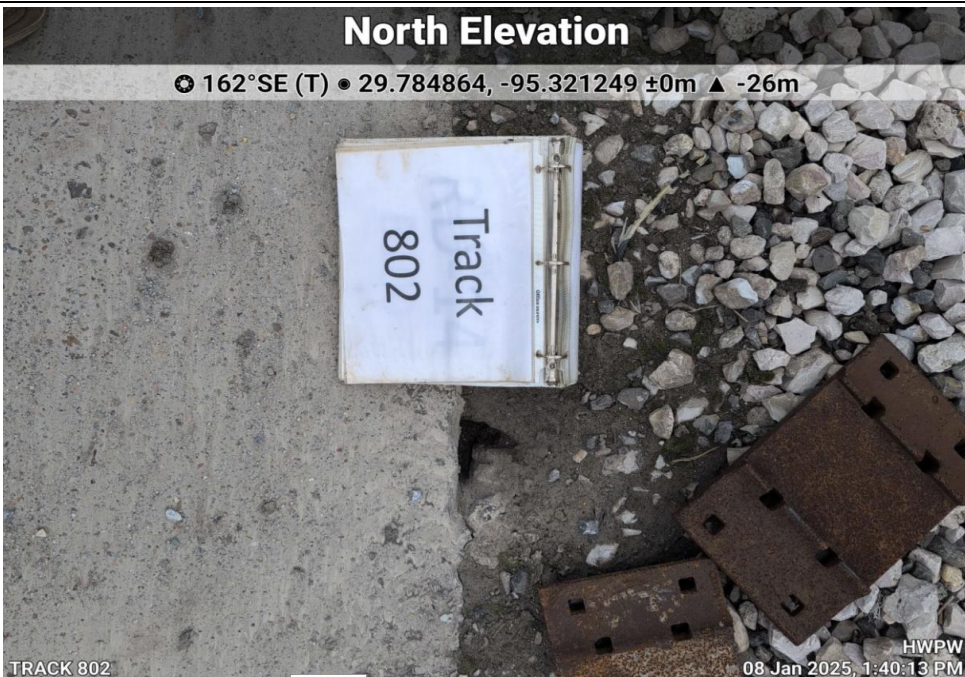
<div> TRACK 802 </div> <div> HWPW 08 Jan 2025, 1:40:13 PM </div> </div>	
Description: Track 802 weekly inspection of track. Surrounding concrete in good conditions. No NAPL observed at location. Lat: 29.784864 Long: -95.321249

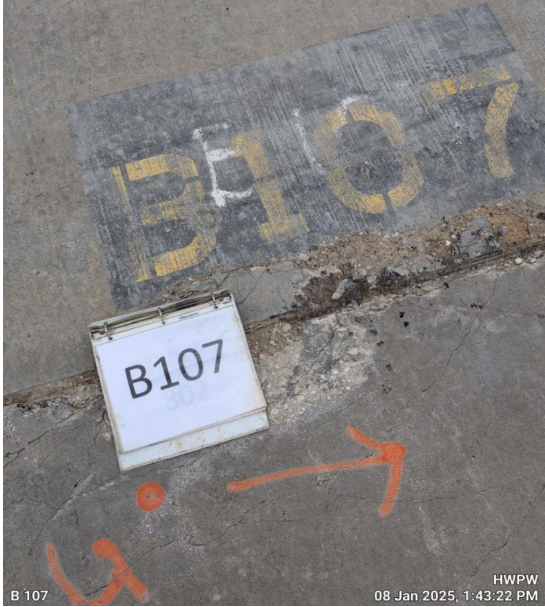
<div> B 107 </div> <div> HWPW 08 Jan 2025, 1:43:22 PM </div> </div>	
Description: B107 weekly inspection of joint. Surrounding concrete in good conditions. No NAPL observed along joint. Lat: 29.784149 Long: -95.320971			
Photo No. 32	Inspection Date: 1/15/2025	<div> <div> North Elevation </div> <div> ☉ 103°E (T) • 29.784201, -95.321045 ±2m ▲ -15m </div>

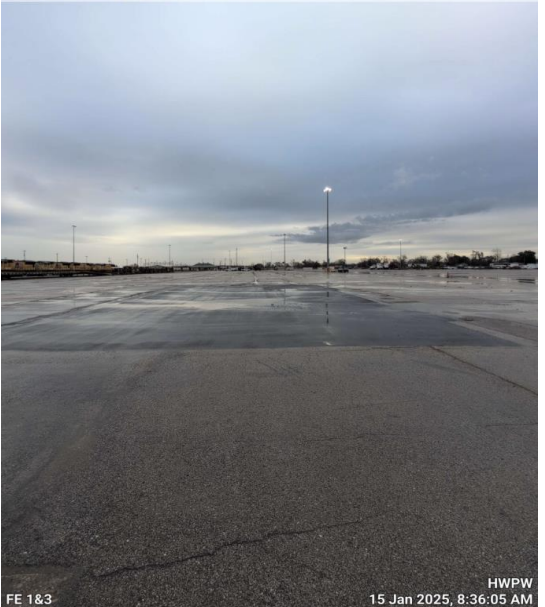
<div> FE 1&3 </div> <div> HWPW 15 Jan 2025, 8:36:05 AM </div> </div>	
Description: FE-1&3 weekly inspection of asphalt cap. Reconstructed cap in good conditions. No NAPL observed at FE location. Lat: 29.784201 Long: -95.321045

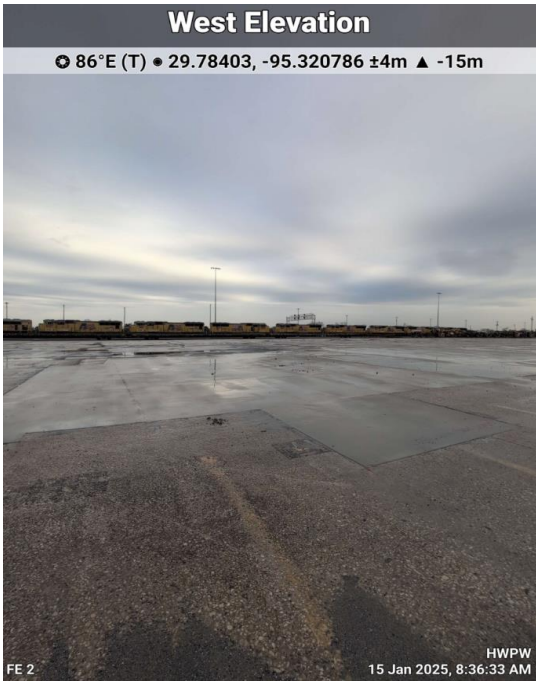
<div> FE 2 HWPW 15 Jan 2025, 8:36:33 AM </div> </div>	
Description: FE-2 weekly inspection of concrete cap. Reconstructed cap in good conditions. No NAPL observed at FE location. Lat: 29.784030 Long: -95.320786			
Photo No. 34	Inspection Date: 1/15/2025	<div> <div> North Elevation </div> <div> ☉ 104°E (T) • 29.784753, -95.319707 ±2m ▲ -16m </div>

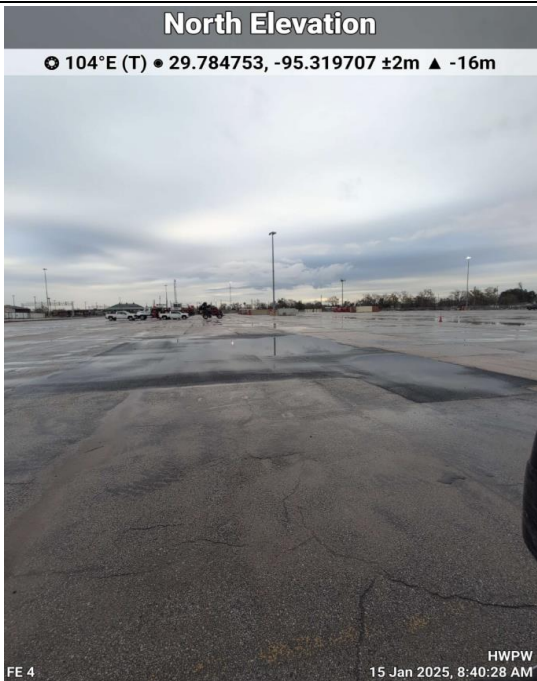
<div> FE 4 HWPW 15 Jan 2025, 8:40:28 AM </div> </div>	
Description: FE-4 weekly inspection of asphalt cap. Reconstructed cap in good conditions. No NAPL observed at FE location. Lat: 29.784753 Long: -95.319707

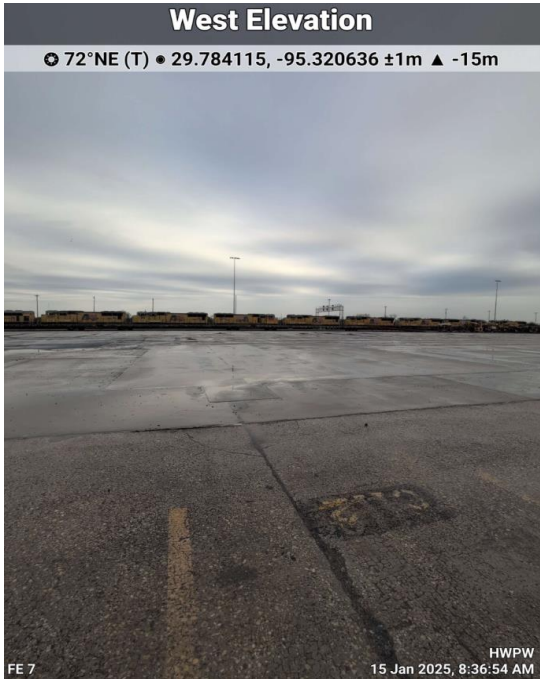
</div>	
Description: FE-7 weekly inspection of concrete cap. Reconstructed cap in good conditions. No NAPL observed at FE location. Lat: 29.784115 Long: -95.320636			
Photo No. 38	Inspection Date: 1/15/2025	<div> <div> West Elevation </div> <div> ☉ 56°NE (T) • 29.784844, -95.319115 ±6m ▲ -17m </div>

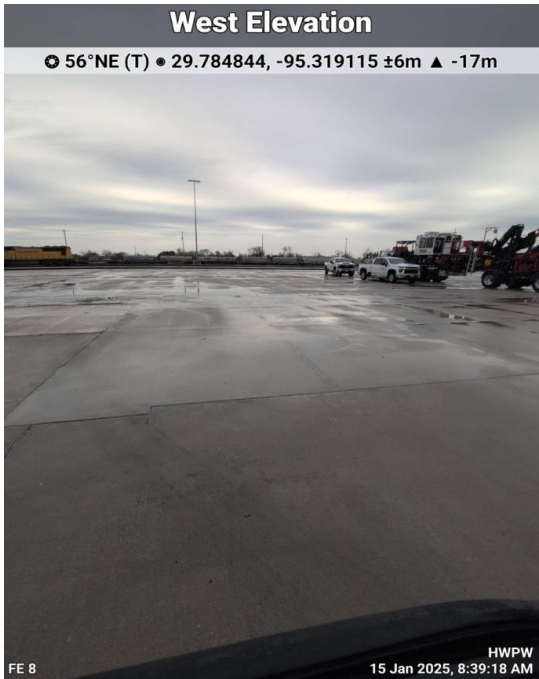
</div>	
Description: FE-8 weekly inspection of concrete cap. Reconstructed cap in good conditions. No NAPL observed at FE location. Lat: 29.784844 Long: -95.319115

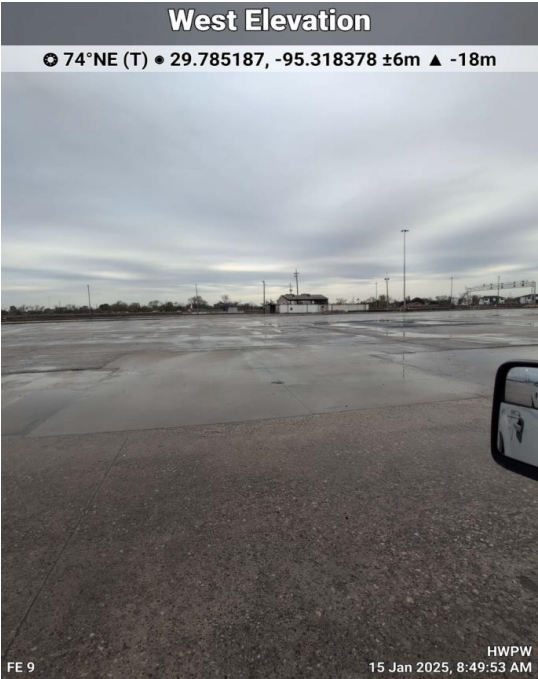
<div> FE 9 <div> HWPW 15 Jan 2025, 8:49:53 AM </div> </div> </div>	
Description: FE-9 weekly inspection of concrete cap. Reconstructed cap in good conditions. No NAPL observed at FE location. Lat: 29.785187 Long: -95.318378			
Photo No. 40	Inspection Date: 1/15/2025	<div> <div> West Elevation </div> <div> ⦿ 69°NE (T) • 29.784834, -95.317716 ±1m ▲ -16m </div>

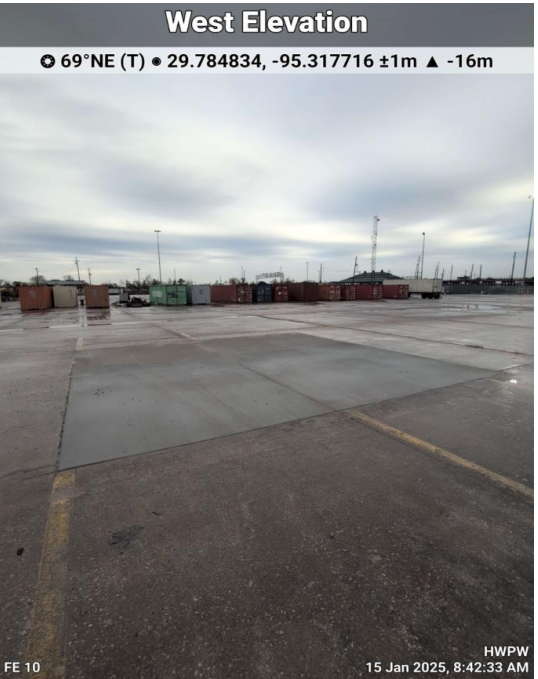
<div> FE 10 <div> HWPW 15 Jan 2025, 8:42:33 AM </div> </div> </div>	
Description: FE-10 weekly inspection of concrete cap. Reconstructed cap in good conditions. No NAPL observed at FE location. Lat: 29.784834 Long: -95.317716

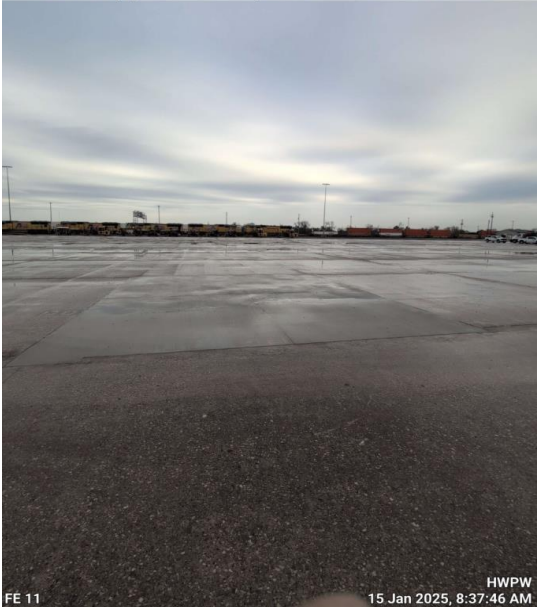
<div> FE 11 HWPW 15 Jan 2025, 8:37:46 AM </div> </div>	
Description: FE-11 weekly inspection of concrete cap. Reconstructed cap in good conditions. No NAPL observed at FE location. Lat: 29.784263 Long: -95.319559			
Photo No. 42	Inspection Date: 1/15/2025	<div> <div> West Elevation </div> <div> ☉ 125°SE (T) • 29.785533, -95.318729 ±1m ▲ -15m </div>

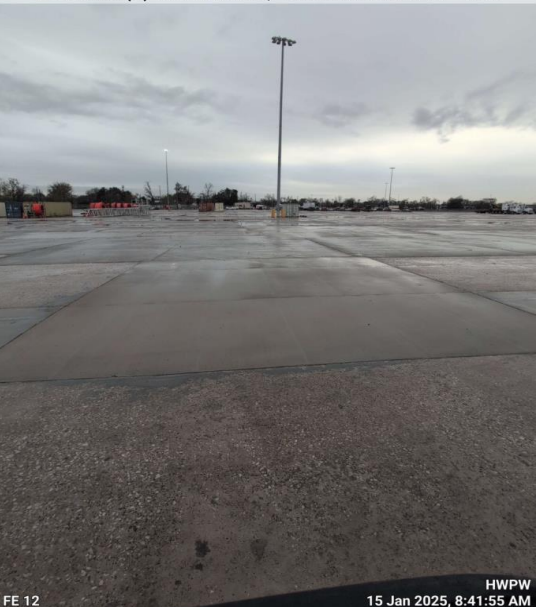
<div> FE 12 HWPW 15 Jan 2025, 8:41:55 AM </div> </div>	
Description: FE-12 weekly inspection of concrete cap. Reconstructed cap in good conditions. No NAPL observed at FE location. Lat: 29.785533 Long: -95.318729

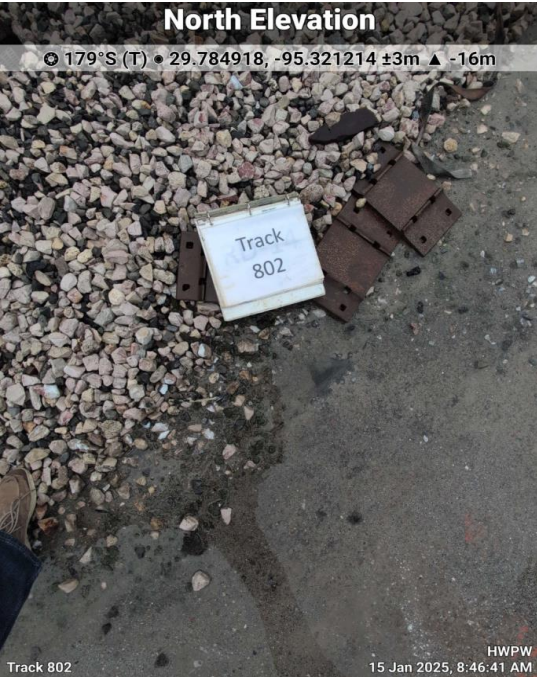
<div> Track 802 </div> <div> HWPW 15 Jan 2025, 8:46:41 AM </div> </div>	
Description: Track 802 weekly inspection of track. Surrounding concrete in good conditions. No NAPL observed at location. Lat: 29.784918 Long: -95.321214

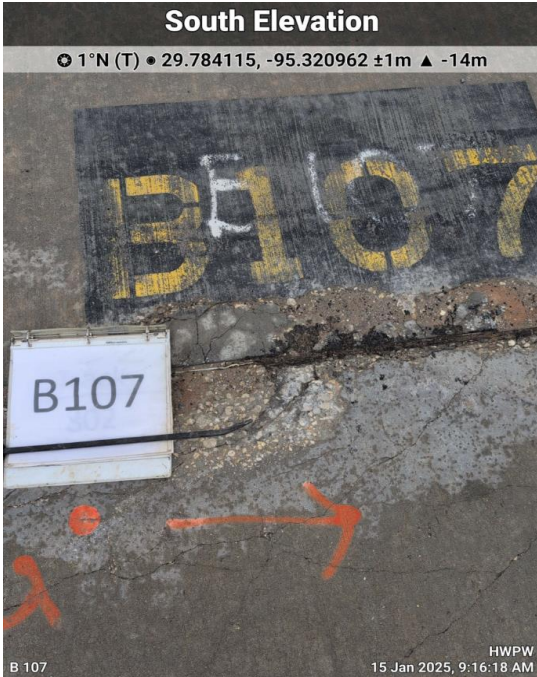
<div> B 107 </div> <div> HWPW 15 Jan 2025, 9:16:18 AM </div> </div>	
Description: B107 weekly inspection of joint. Surrounding concrete in good conditions. No NAPL observed along joint. Lat: 29.784115 Long: -95.320962			
Photo No. 46	Inspection Date: 1/22/2025	<div> <div> West Elevation </div> <div> 96°E (T) • 29.784233, -95.321076 ±5m ▲ -13m </div>

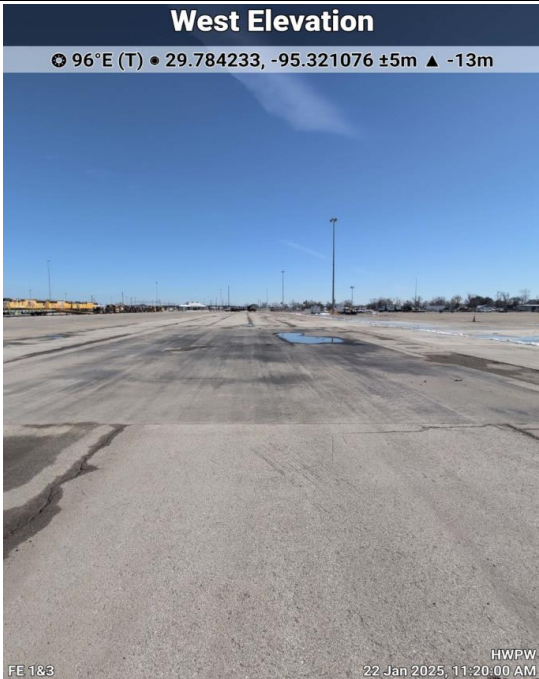
<div> FE 1&3 </div> <div> HWPW 22 Jan 2025, 11:20:00 AM </div> </div>	
Description: FE-1&3 weekly inspection of asphalt cap. Reconstructed cap in good conditions. No NAPL observed at FE location. Lat: 29.784233 Long: -95.321076

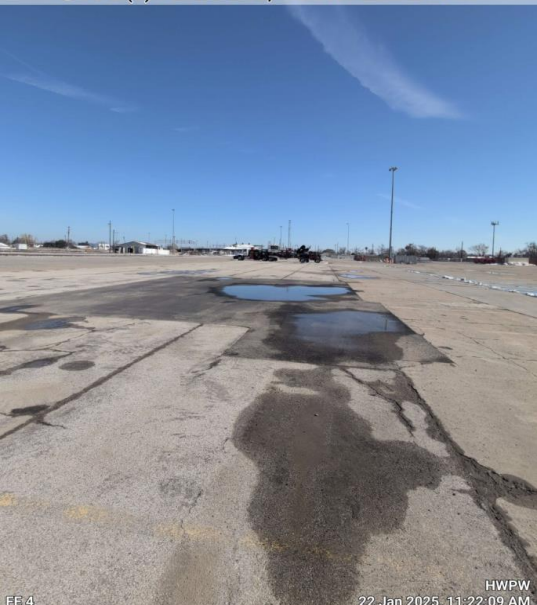
<div> FE 4 </div> <div> HWPW 22 Jan 2025, 11:22:09 AM </div> </div>	
Description: FE-4 weekly inspection of asphalt cap. Reconstructed cap in good conditions. No NAPL observed at FE location. Lat: 29.784745 Long: -95.319700

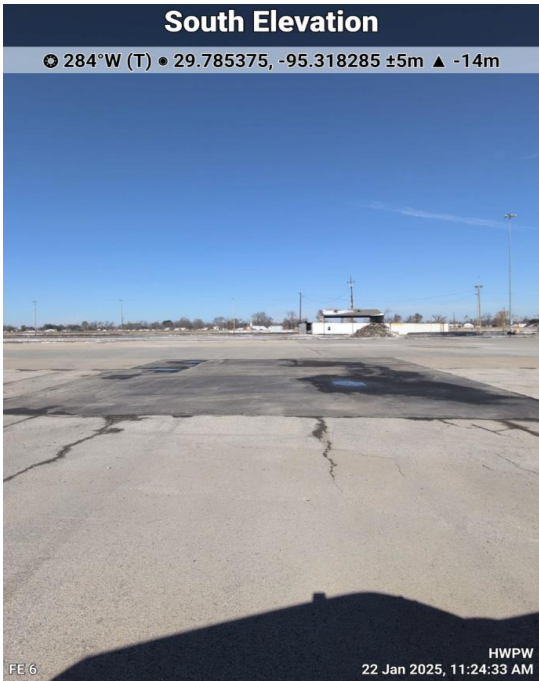
<div> FE/6 HWPW 22 Jan 2025, 11:24:33 AM </div> </div>	
Description: FE-6 weekly inspection of asphalt cap. Reconstructed cap in good conditions. No NAPL observed at FE location. Lat: 29.785375 Long: -95.318285

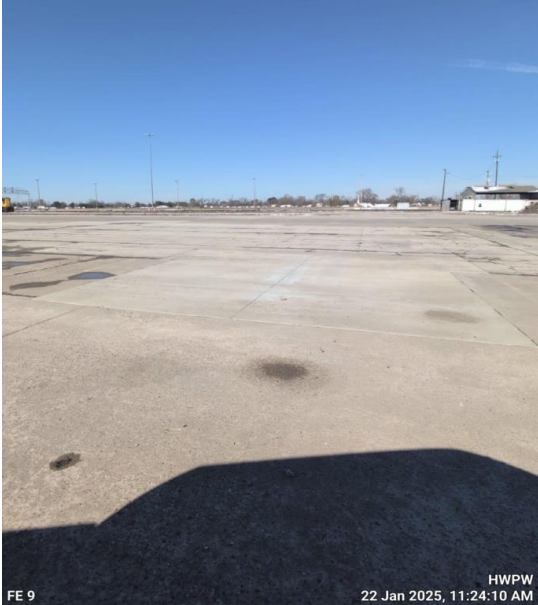
<div> FE 9 HWPW 22 Jan 2025, 11:24:10 AM </div> </div>	
Description: FE-9 weekly inspection of concrete cap. Reconstructed cap in good conditions. No NAPL observed at FE location. Lat: 29.785207 Long: -95.318370			
Photo No. 54	Inspection Date: 1/22/2025	<div> <div> North Elevation </div> <div> 95°E (T) • 29.784864, -95.317775 ±4m ▲ -14m </div>

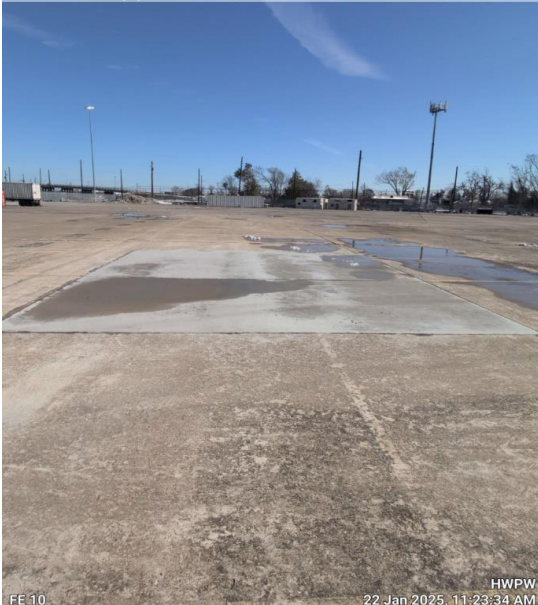
<div> FE 10 HWPW 22 Jan 2025, 11:23:34 AM </div> </div>	
Description: FE-10 weekly inspection of concrete cap. Reconstructed cap in good conditions. No NAPL observed at FE location. Lat: 29.784864 Long: -95.317775

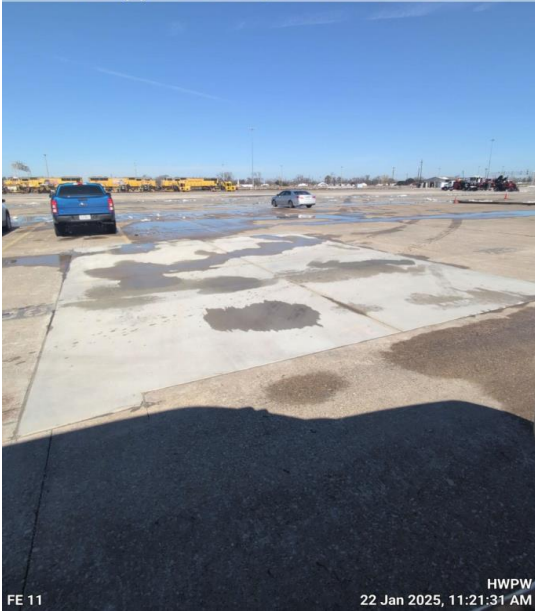
<div> FE 11 </div> <div> HWPW 22 Jan 2025, 11:21:31 AM </div> </div>	
Description: FE-11 weekly inspection of concrete cap. Reconstructed cap in good conditions. No NAPL observed at FE location. Lat: 29.784302 Long: -95.319598			
Photo No. 56	Inspection Date: 1/22/2025	<div> <div> North Elevation </div> <div> ⊙ 87°E (T) • 29.785473, -95.318701 ±4m ▲ -14m </div>

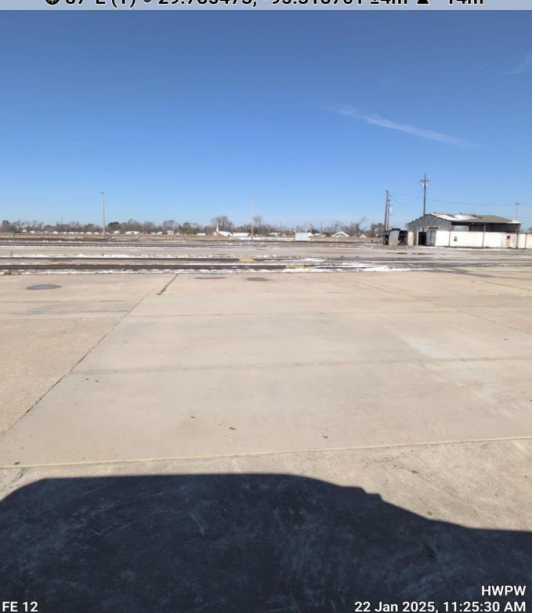
<div> FE 12 </div> <div> HWPW 22 Jan 2025, 11:25:30 AM </div> </div>	
Description: FE-12 weekly inspection of concrete cap. Reconstructed cap in good conditions. No NAPL observed at FE location. Lat: 29.785473 Long: -95.318701

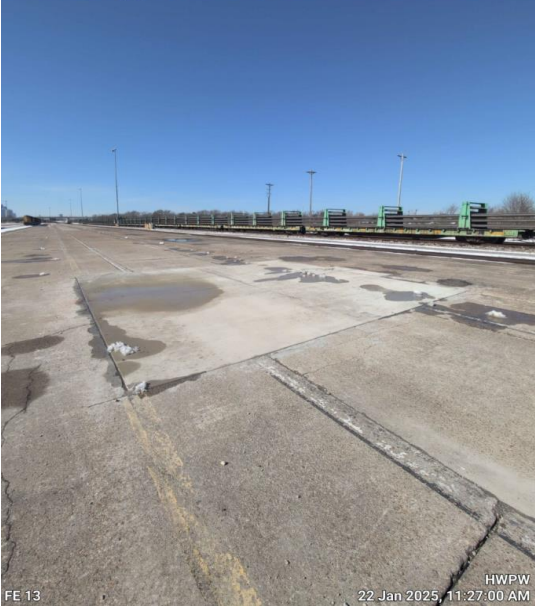
<div> FE 13 </div> <div> HWPW 22 Jan 2025, 11:27:00 AM </div> </div>	
Description: FE-13 weekly inspection of concrete cap. Reconstructed cap in good conditions. No NAPL observed at FE location. Lat: 29.785026 Long: -95.321192			
Photo No. 58	Inspection Date: 1/22/2025	<div> <div> North Elevation </div> <div> 160°SE (T) • 29.784937, -95.321226 ±5m ▲ -14m </div>

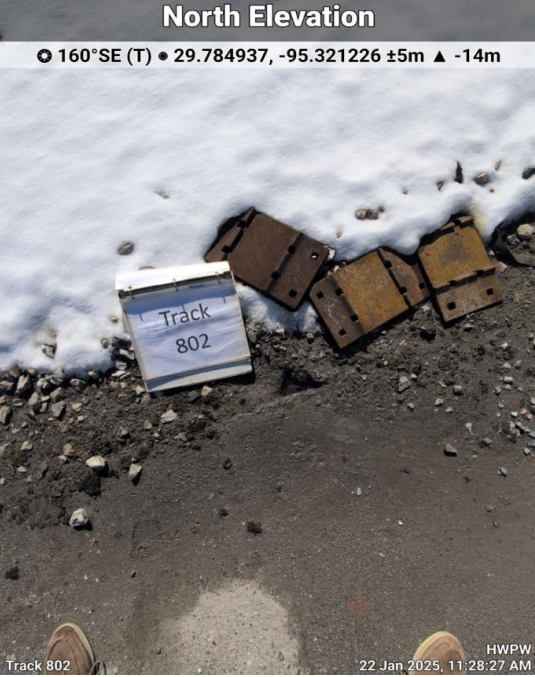
<div> Track 802 </div> <div> HWPW 22 Jan 2025, 11:28:27 AM </div> </div>	
Description: Track 802 weekly inspection of track. Surrounding concrete in good conditions. No NAPL observed at location. Lat: 29.784937 Long: -95.321226

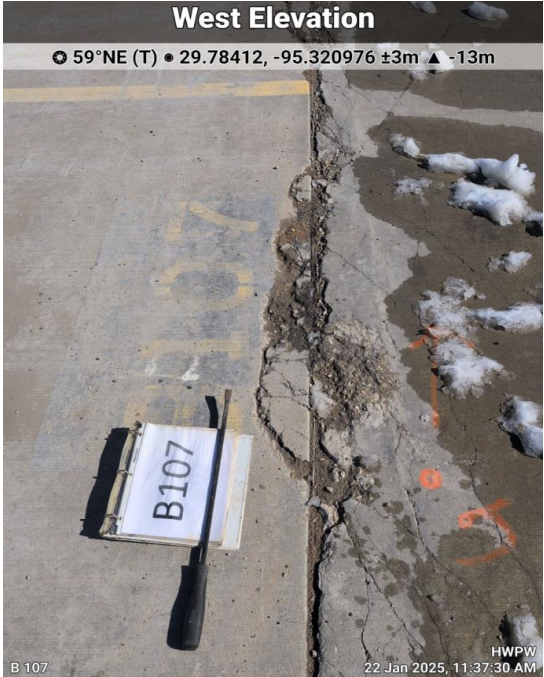
<div> B 107 </div> <div> HWPW 22 Jan 2025, 11:37:30 AM </div> </div>	
Description: B107 weekly inspection of joint. Surrounding concrete in good conditions. No NAPL observed along joint. Lat: 29.784120 Long: -95.320976			
Photo No. 60	Inspection Date: 1/29/2025	<div> <div> West Elevation </div> <div> 92°E (T) • 29.784244, -95.321075 ±2m ▲ -13m </div>

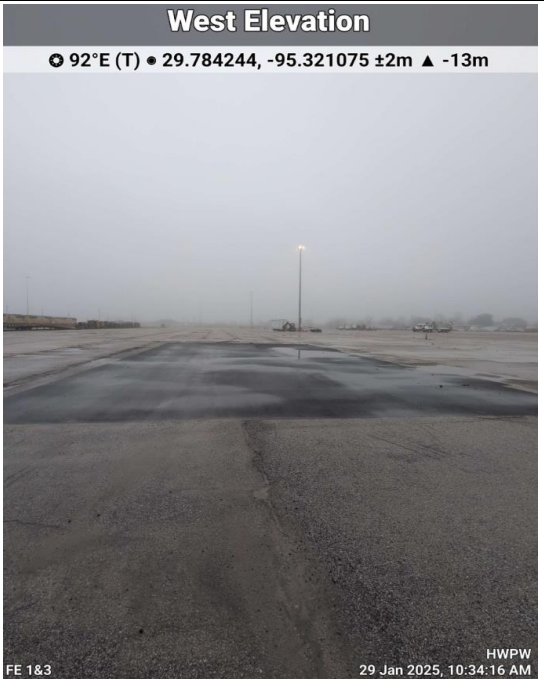
<div> FE 1&3 </div> <div> HWPW 29 Jan 2025, 10:34:16 AM </div> </div>	
Description: FE-1&3 weekly inspection of asphalt cap. Reconstructed cap in good conditions. No NAPL observed at FE location. Lat: 29.784244 Long: -95.321075

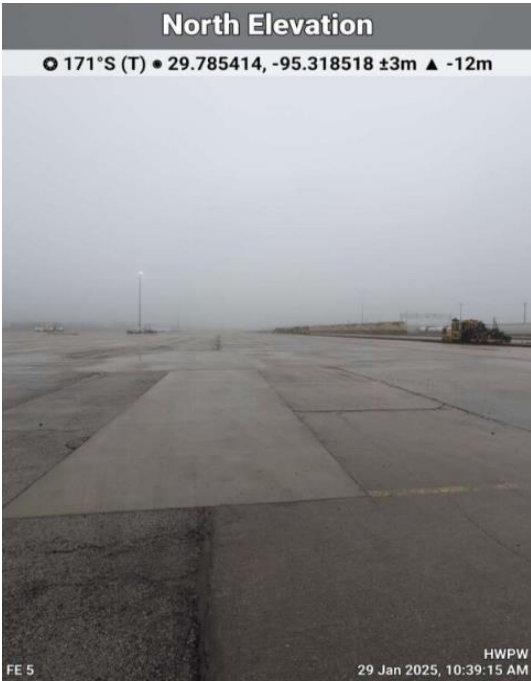
<div> FE 5 HWPW 29 Jan 2025, 10:39:15 AM </div> </div>	
Description: FE-5 weekly inspection of concrete cap. Reconstructed cap in good conditions. No NAPL observed at FE location. Lat: 29.785414 Long: -95.318518			
Photo No. 64	Inspection Date: 1/29/2025	<div> <div> West Elevation </div> <div> 93°E (T) • 29.785348, -95.318317 ±6m ▲ -13m </div>

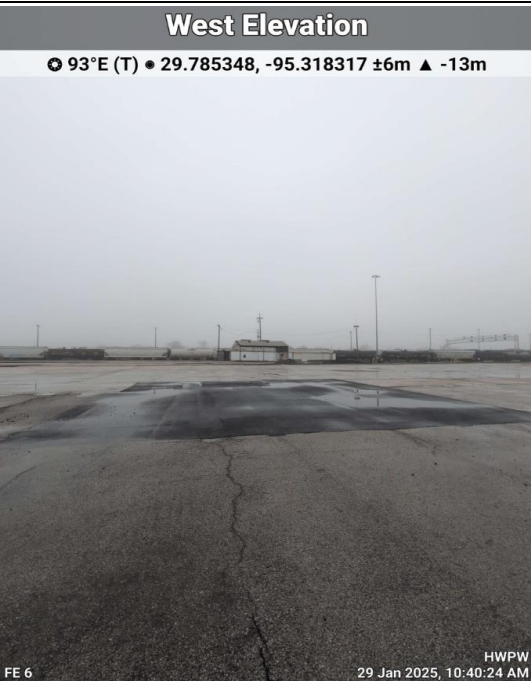
<div> FE 6 HWPW 29 Jan 2025, 10:40:24 AM </div> </div>	
Description: FE-6 weekly inspection of asphalt cap. Reconstructed cap in good conditions. No NAPL observed at FE location. Lat: 29.785348 Long: -95.318317

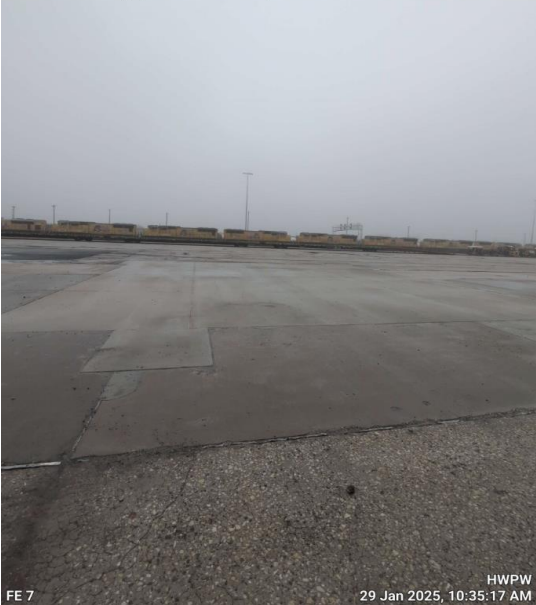
<div> FE 7 HWPW 29 Jan 2025, 10:35:17 AM </div> </div>	
Description: FE-7 weekly inspection of concrete cap. Reconstructed cap in good conditions. No NAPL observed at FE location. Lat: 29.784173 Long: -95.320629			
Photo No. 66	Inspection Date: 1/29/2025	<div> <div> West Elevation </div> <div> 77°NE (T) • 29.784852, -95.319108 ±2m ▲ -13m </div>

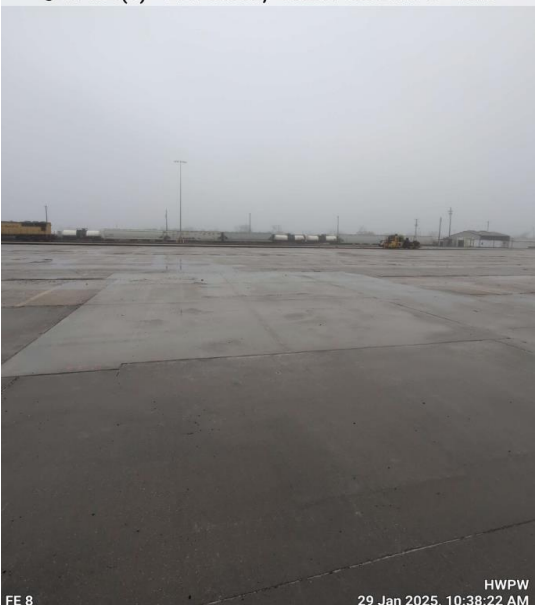
<div> FE 8 HWPW 29 Jan 2025, 10:38:22 AM </div> </div>	
Description: FE-8 weekly inspection of concrete cap. Reconstructed cap in good conditions. No NAPL observed at FE location. Lat: 29.784852 Long: -95.319108
