Re: **MONTHLY STATUS UPDATE – ENGLEWOOD INTERMODAL YARD – NAPL COLLECTION
SYSTEM/CONCRETE CAP REPAIRS AND REVISED INTERIM MEASURES WORK PLAN POST-
CONSTRUCTION ACTIVITIES
UNION PACIFIC RAILROAD HOUSTON WOOD PRESERVING WORKS FACILITY
4910 LIBERTY ROAD FACILITY, HOUSTON, TEXAS
POST-CLOSURE CARE PERMIT NO. HW-50343; INDUSTRIAL SWR NO. 31547**

WSP USA Inc. (WSP), on behalf of Union Pacific Railroad Company (UPRR), is pleased to provide this monthly status update for February 2025 summarizing the weekly inspections being conducted at the Englewood Intermodal Yard (EIY) concrete cap area within the UPRR Houston Wood Preserving Works Facility (the Site). The weekly inspections are being conducted to evaluate the post-construction Focused Excavations as detailed in the *Revised Interim Measures Work Plan – Englewood Intermodal Yard (EIY)*, (Revised IMWP) dated October 20, 2023. In addition, a summary of the weekly NAPL Collection System and concrete cap area inspections conducted at the EIY is provided as requested by the TCEQ in a letter dated March 20, 2018. Below is a summary of the weekly Focused Excavation and EIY inspections for February 2025.

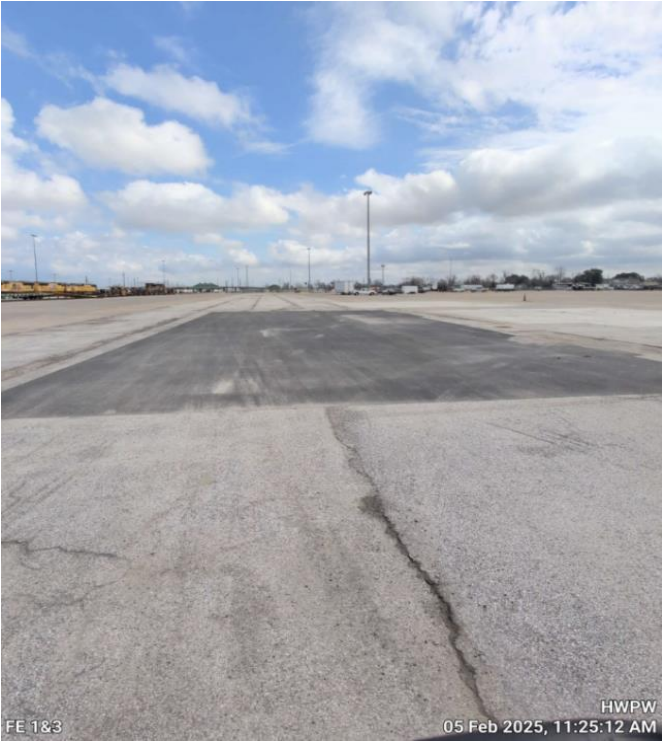
PHOTOGRAPH LOG	
Client Name: Union Pacific Railroad		Site Location: Englewood Intermodal Yard, Houston, Texas	Project No. US0039040.4227
Photo No. 1	Inspection Date: 2/5/2025	<div> <div> Description: FE-1&3 weekly inspection of asphalt cap. Reconstructed cap in good condition. No NAPL observed at FE location. Facing northeast. </div> <div> Lat: 29.784224 Long: -95.321042 </div> </div> <div>

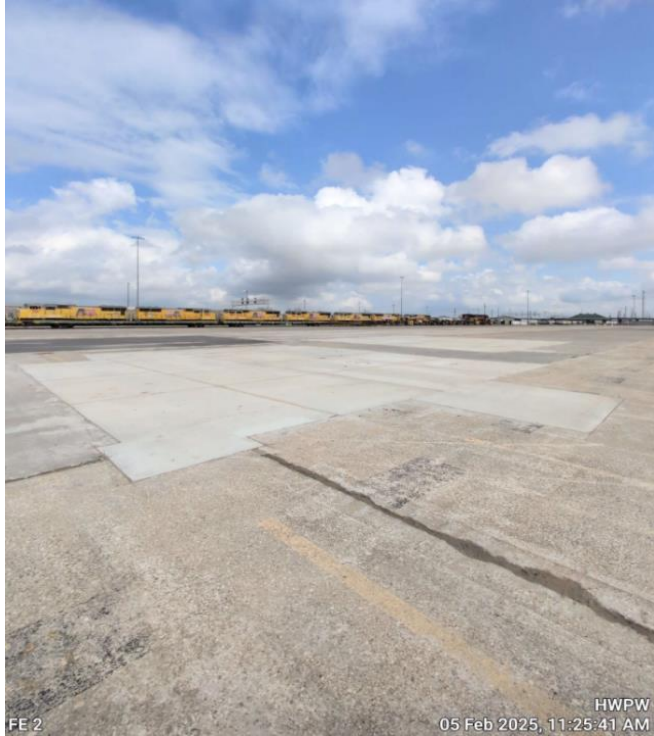
<div> FE 1&3 HWPW 05 Feb 2025, 11:25:12 AM </div> </div>	
Photo No. 2	Inspection Date: 2/5/2025	<div> <div> Description: FE-2 weekly inspection of concrete cap. Reconstructed cap in good condition. No NAPL observed at FE location. Facing north. </div> <div> Lat: 29.784086 Long: -95.320849 </div> </div> <div>

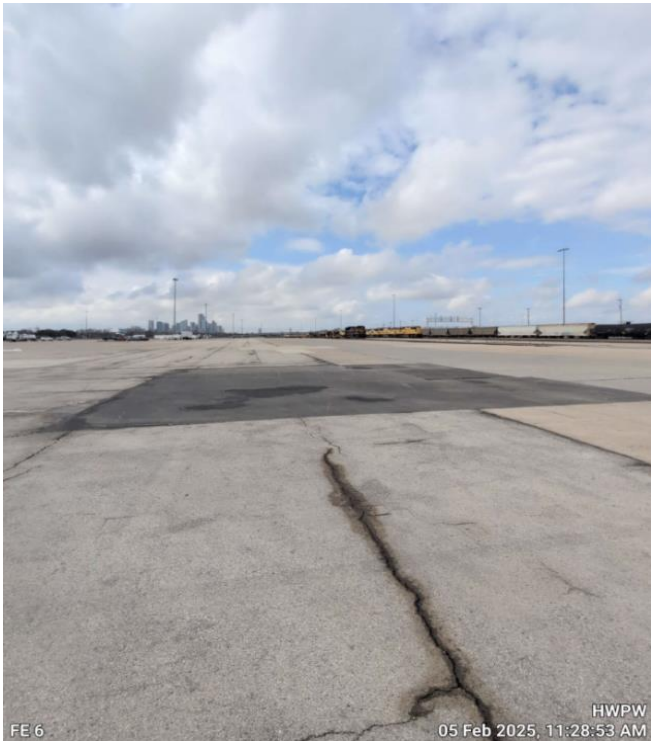
- During the weekly inspection on February 5, 2025, there was minimal brown staining observed near FE-6 (Photo No. 5). Brown staining was not observed throughout the rest of the February 2025 inspections.

PHOTOGRAPH LOG	
Client Name: Union Pacific Railroad		Site Location: Englewood Intermodal Yard, Houston, Texas	Project No. US0039040.4227
Photo No. 5	Inspection Date: 2/5/2025	<div> <div> Description: FE-6 weekly inspection of asphalt cap. Reconstructed cap in good condition. No NAPL observed at FE location. Minimal brown staining along asphalt crack observed east of FE location. Facing southwest. Lat: 29.785514 Long: -95.318226 </div> <div>

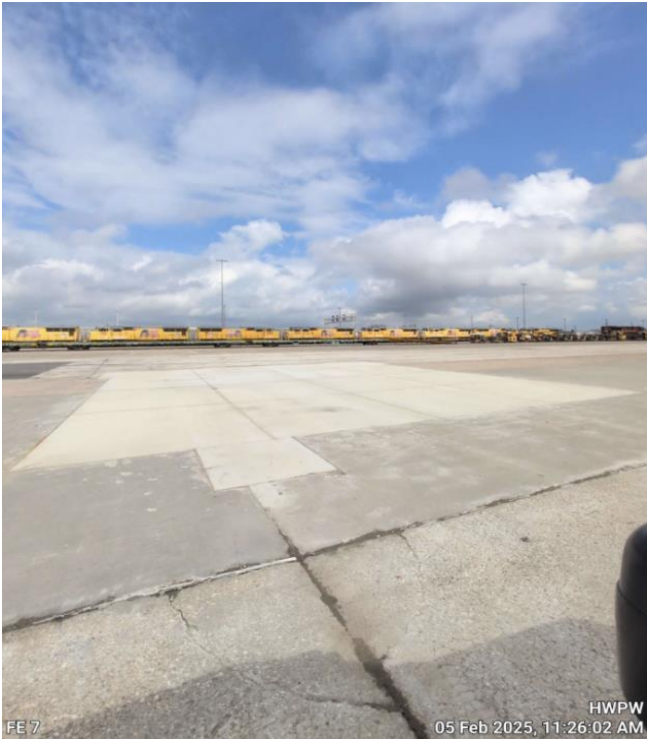
<div> FE 6 <div> HWPW 05 Feb 2025, 11:28:53 AM </div> </div> </div> </div>	
Photo No. 6	Inspection Date: 2/5/2025	<div> <div> Description: FE-7 weekly inspection of concrete cap. Reconstructed cap in good condition. No NAPL observed at FE location. Facing northwest. Lat: 29.784168 Long: -95.320670 </div> <div>

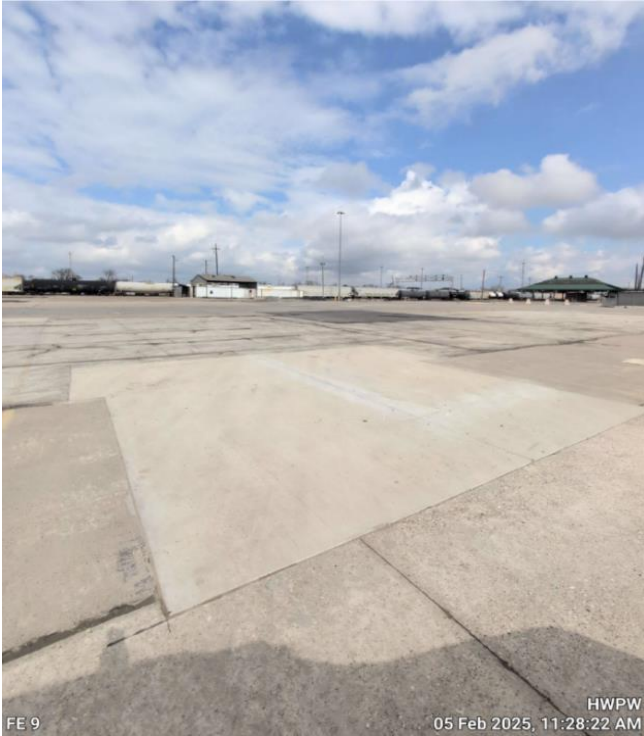
Photo No. 8	Inspection Date: 2/5/2025	<div> <div> Description: FE-9 weekly inspection of concrete cap. Reconstructed cap in good condition. No NAPL observed at FE location. Facing northwest. </div> <div> Lat: 29.785216 Long: -95.318416 </div> </div>

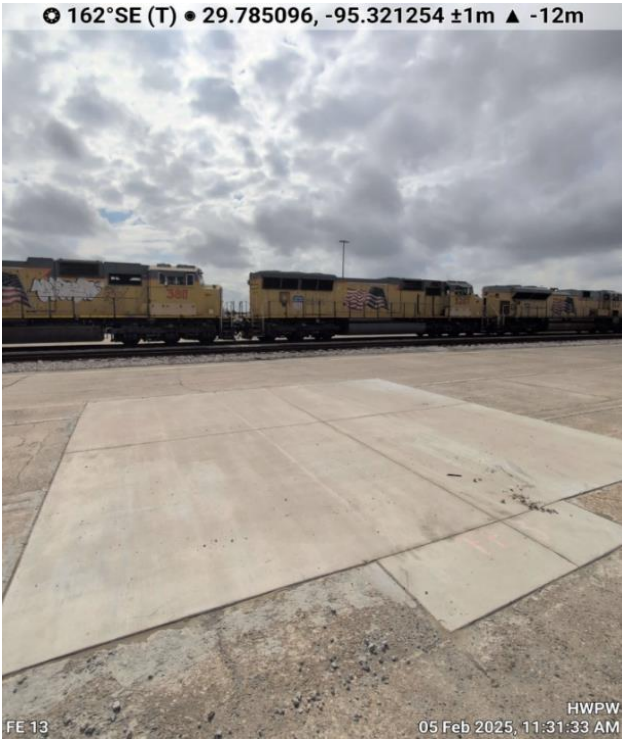
<div> <div>FE 13</div> <div> HWPW 05 Feb 2025, 11:31:33 AM </div> </div> </div>	
Description: FE-13 weekly inspection of concrete cap. Reconstructed cap in good condition. No NAPL observed at FE location. Facing southeast.			
Lat: 29.785096 Long: -95.321254

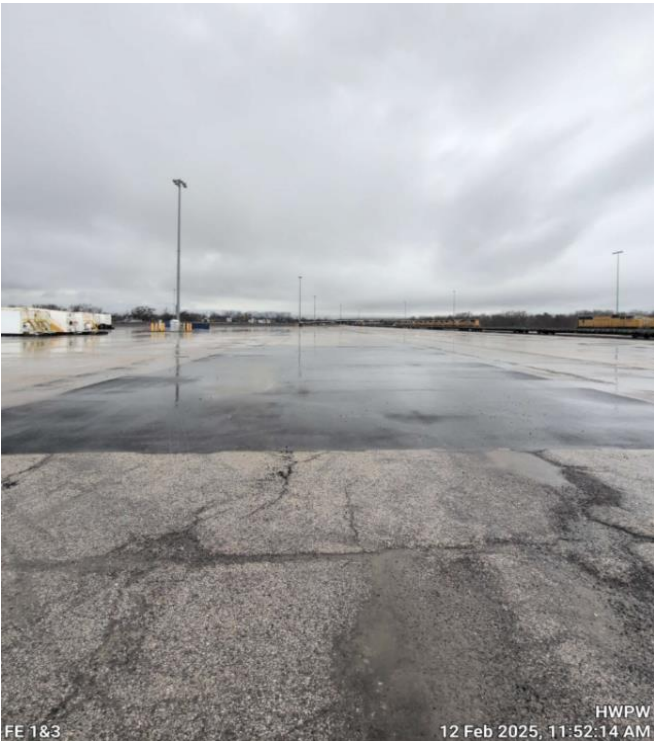
PHOTOGRAPH LOG	
Client Name: Union Pacific Railroad		Site Location: Englewood Intermodal Yard, Houston, Texas	Project No. US0039040.4227
Photo No. 15	Inspection Date: 2/12/2025	<div> <div> Description: FE-1&3 weekly inspection of asphalt cap. Reconstructed cap in good condition. No NAPL observed at FE location. Facing southwest. </div> <div> Lat: 29.784345 Long: -95.320761 </div> </div>

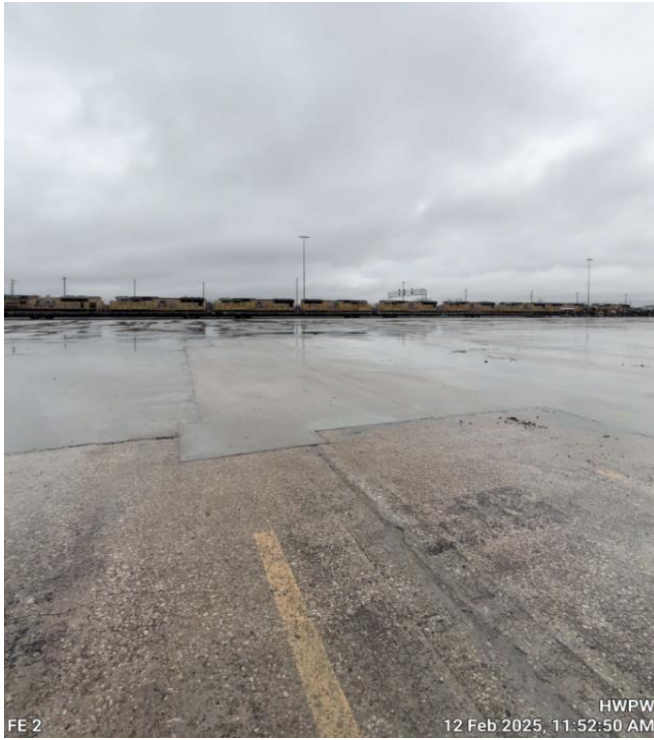
<div> <div>FE 1&3</div> <div>HWPW 12 Feb 2025, 11:52:14 AM</div> </div>	
Photo No. 16	Inspection Date: 2/12/2025	<div> <div> Description: FE-2 weekly inspection of concrete cap. Reconstructed cap in good condition. No NAPL observed at FE location. Facing northwest. </div> <div> Lat: 29.784066 Long: -95.320810 </div> </div>

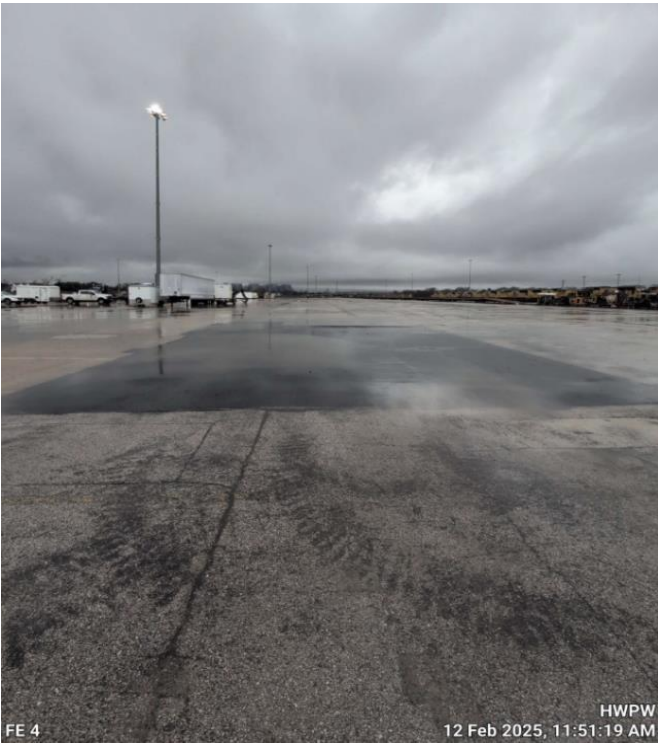
PHOTOGRAPH LOG	
Client Name: Union Pacific Railroad		Site Location: Englewood Intermodal Yard, Houston, Texas	Project No. US0039040.4227
Photo No. 17	Inspection Date: 2/12/2025	<div> <div> Description: FE-4 weekly inspection of asphalt cap. Reconstructed cap in good condition. No NAPL observed at FE location. Facing southwest. </div> <div> Lat: 29.784875 Long: -95.319469 </div> </div>

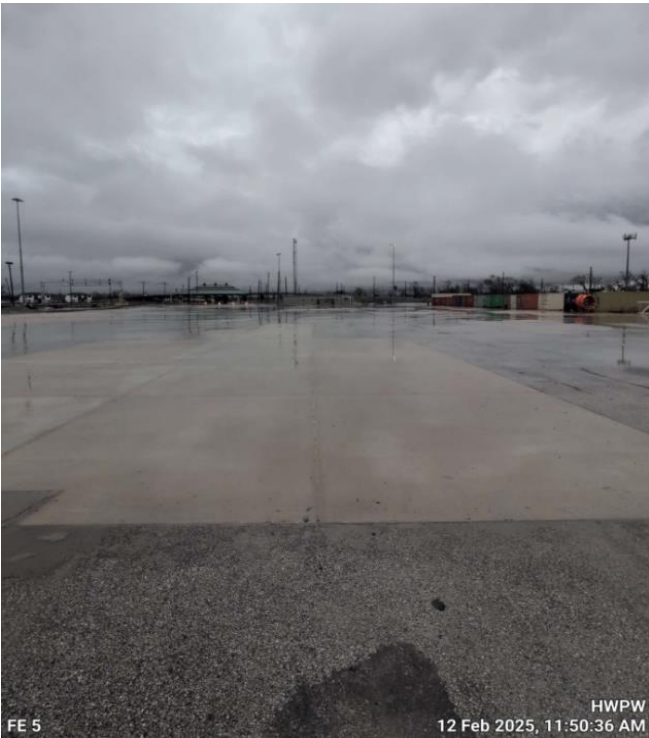
<div> <div>FE 4</div> <div> HWPW 12 Feb 2025, 11:51:19 AM </div> </div>	
Photo No. 18	Inspection Date: 2/12/2025	<div> <div> Description: FE-5 weekly inspection of concrete cap. Reconstructed cap in good condition. No NAPL observed at FE location. Facing northeast. </div> <div> Lat: 29.785301 Long: -95.318756 </div> </div>

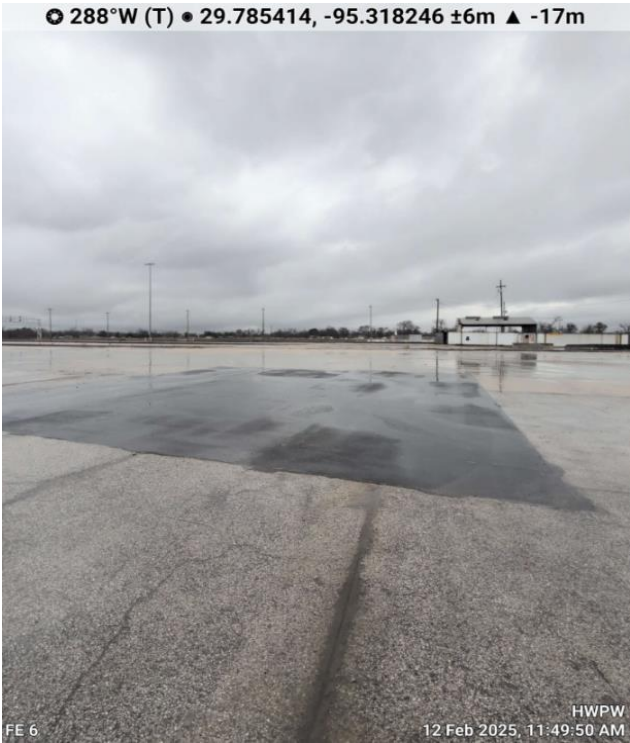
</div>	
Description: FE-6 weekly inspection of asphalt cap. Reconstructed cap in good condition. No NAPL observed at FE location. Facing west.			
Lat: 29.785414 Long: -95.318246			
Photo No. 20	Inspection Date: 2/12/2025	<div>

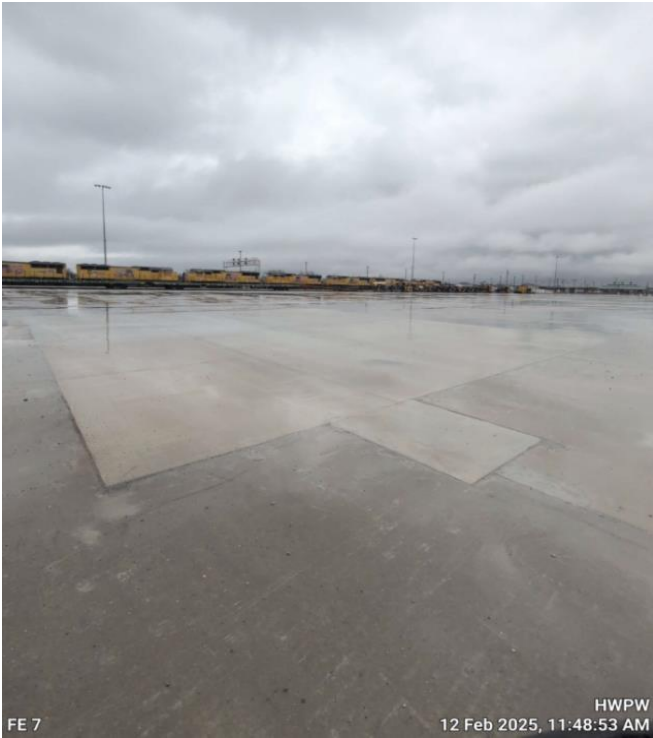
</div>	
Description: FE-7 weekly inspection of concrete cap. Reconstructed cap in good condition. No NAPL observed at FE location. Facing north.			
Lat: 29.784178 Long: -95.320683

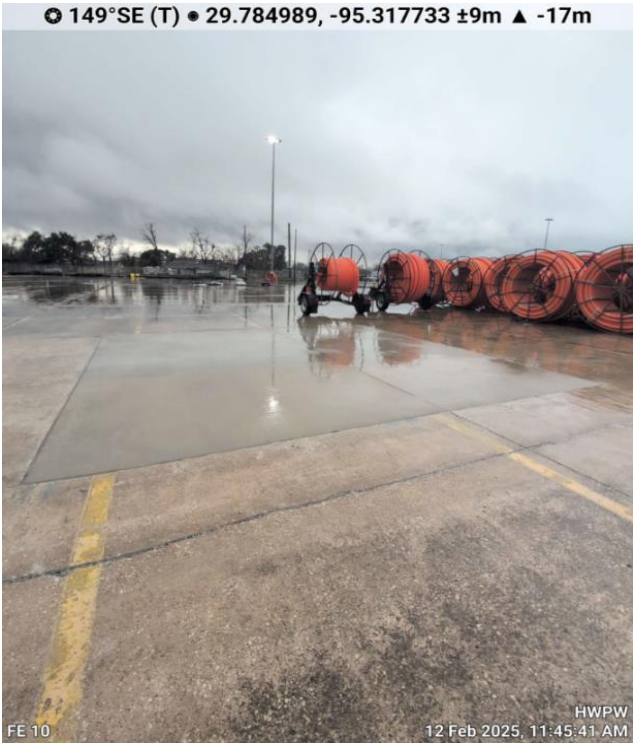
<div> FE 10 <div> HWPW 12 Feb 2025, 11:45:41 AM </div> </div> </div>	
Description: FE-10 weekly inspection of concrete cap. Reconstructed cap in good condition. No NAPL observed at FE location. Facing southeast.			
Lat: 29.784989 Long: -95.317733			
Photo No. 24	Inspection Date: 2/12/2025	<div>

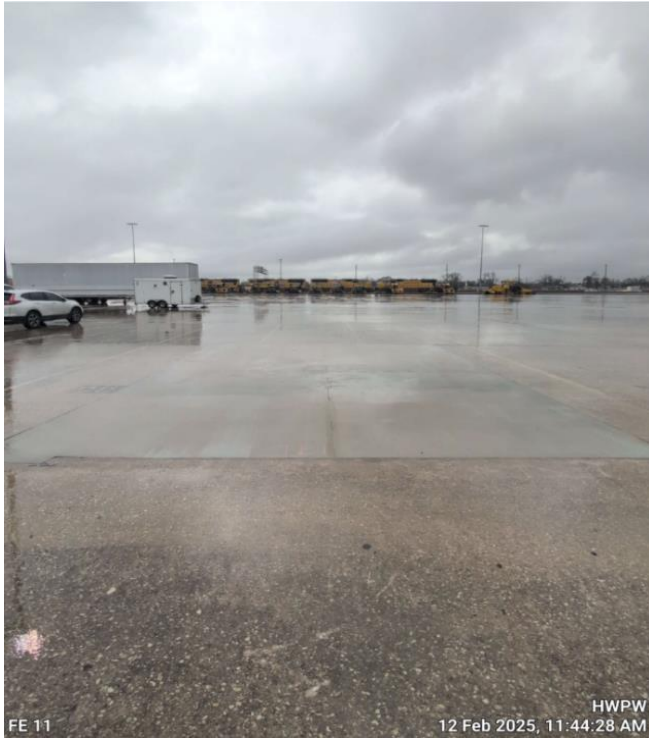
<div> FE 11 <div> HWPW 12 Feb 2025, 11:44:28 AM </div> </div> </div>	
Description: FE-11 weekly inspection of concrete cap. Reconstructed cap in good condition. No NAPL observed at FE location. Facing northwest.			
Lat: 29.784306 Long: -95.319542

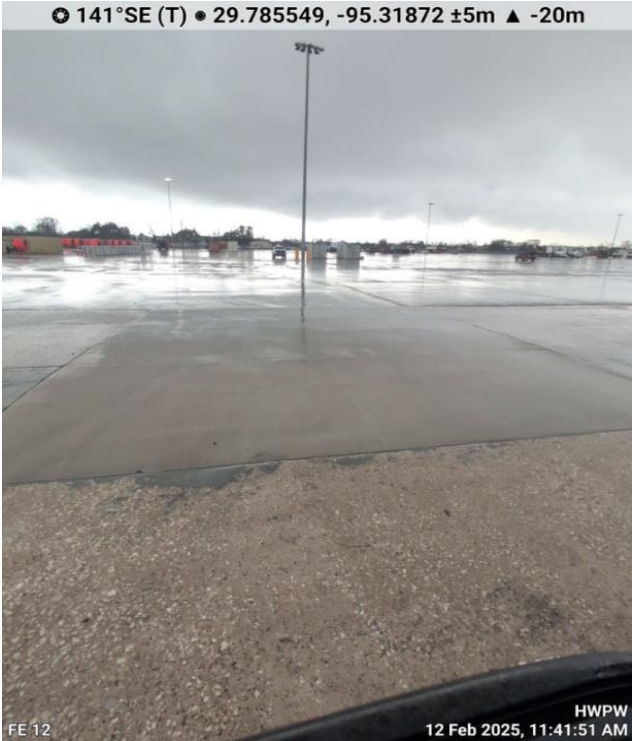
<div> FE 12 <div> HWPW 12 Feb 2025, 11:41:51 AM </div> </div> </div>	
Description: FE-12 weekly inspection of concrete cap. Reconstructed cap in good condition. No NAPL observed at FE location. Facing southeast.			
Lat: 29.785549 Long: -95.318720			
Photo No. 26	Inspection Date: 2/12/2025	<div>

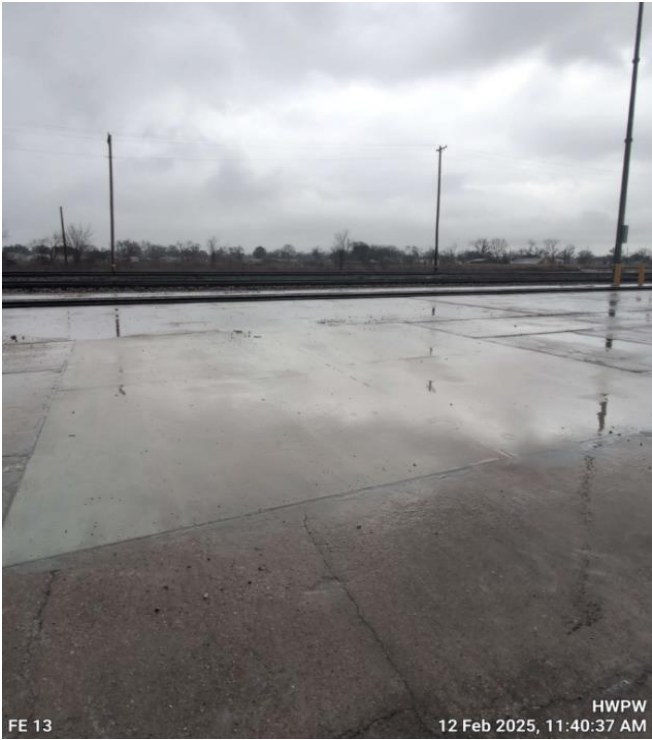
<div> FE 13 <div> HWPW 12 Feb 2025, 11:40:37 AM </div> </div> </div>	
Description: FE-13 weekly inspection of concrete cap. Reconstructed cap in good condition. No NAPL observed at FE location. Facing north.			
Lat: 29.784982 Long: -95.321237

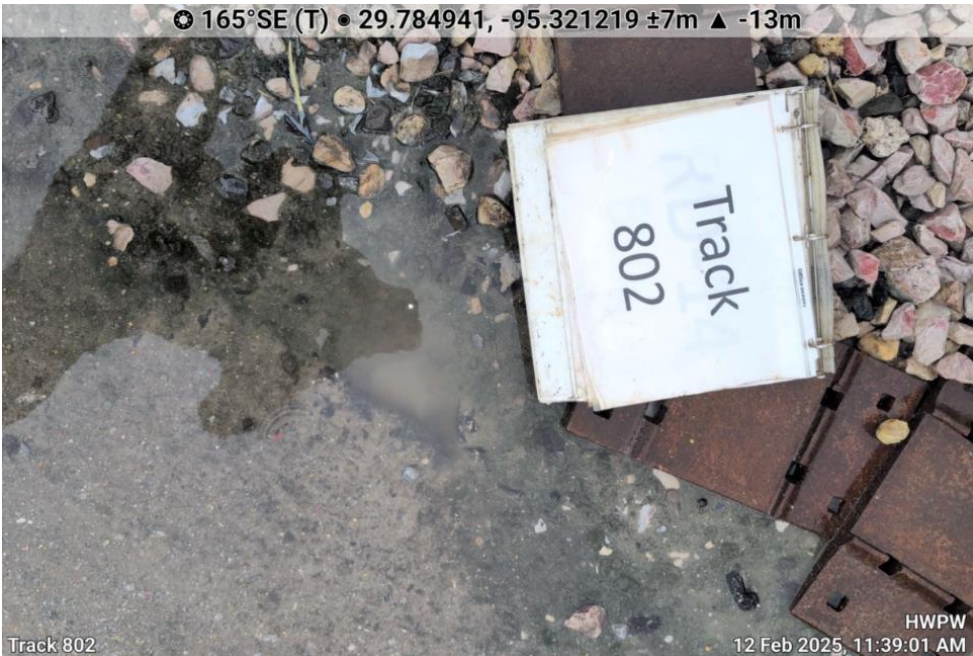
<div style="display: flex; justify-content: space-between; font-size: small;"> Track 802 HWPW 12 Feb 2025, 11:39:01 AM </div>	
Description: Track 802 weekly inspection of track. Surrounding concrete in good condition. No NAPL observed at location. Lat: 29.784941 Long: -95.321219			
Photo No. 28	Inspection Date: 2/12/2025	☉ 70°NE (T) • 29.784147, -95.320958 ±6m ▲ -16m

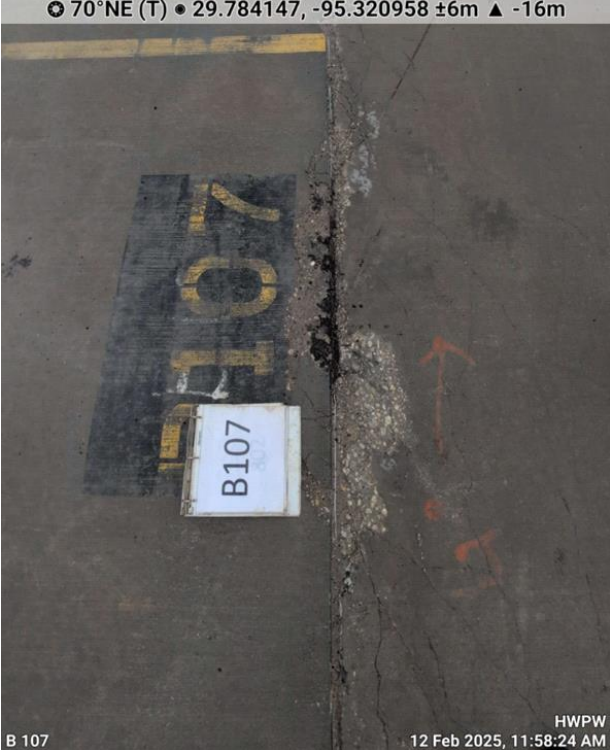
<div style="display: flex; justify-content: space-between; font-size: small;"> B 107 HWPW 12 Feb 2025, 11:58:24 AM </div>	
Description: B107 weekly inspection of joint. Surrounding concrete in good condition. No NAPL observed along joint. Lat: 29.784147 Long: -95.320958

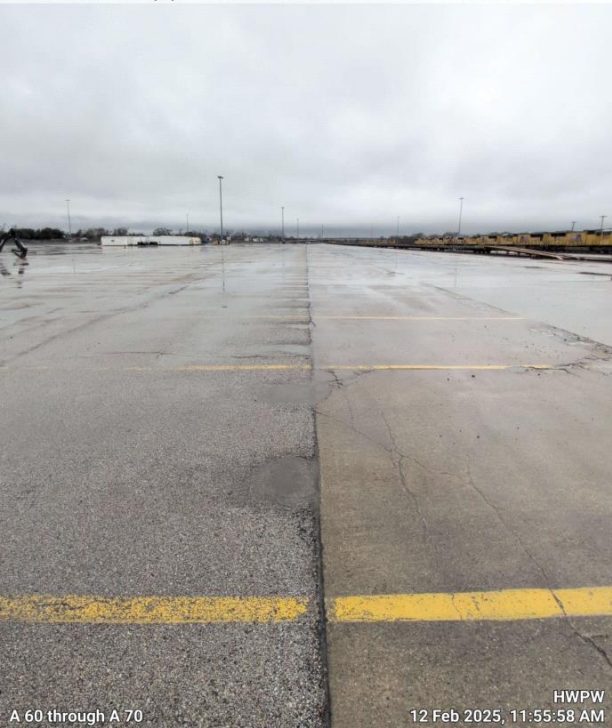
<div style="display: flex; justify-content: space-between; font-size: small;"> A 60 through A 70 HWPW 12 Feb 2025, 11:55:58 AM </div>	
Description: A060 - A070 weekly inspection of joint. Surrounding asphalt and concrete in good condition. No brown staining observed along joint. Facing southwest. Lat: 29.784837 Long: -95.319891			
Photo No. 30	Inspection Date: 2/12/2025

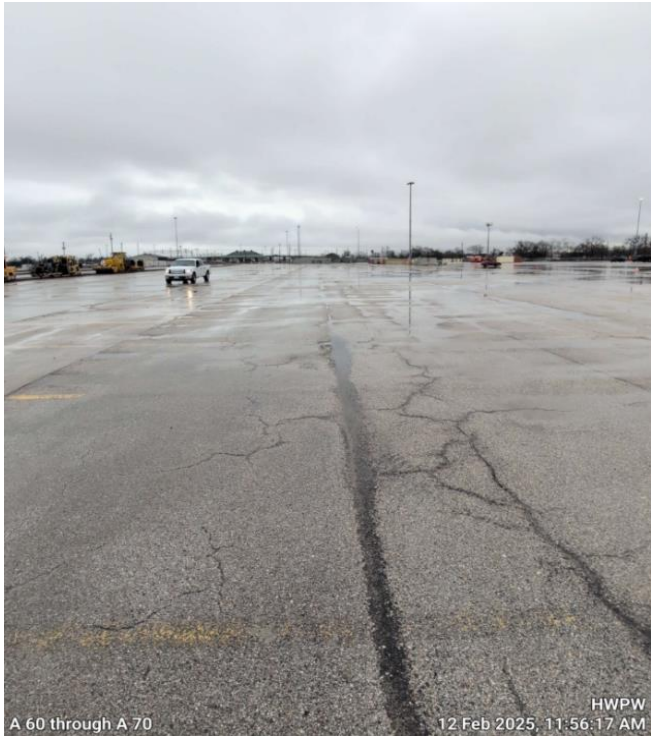
<div style="display: flex; justify-content: space-between; font-size: small;"> A 60 through A 70 HWPW 12 Feb 2025, 11:56:17 AM </div>	
Description: A060 - A070 weekly inspection of joint. Surrounding asphalt and concrete in good condition. No brown staining observed along joint. Facing northeast. Lat: 29.784736 Long: -95.320018

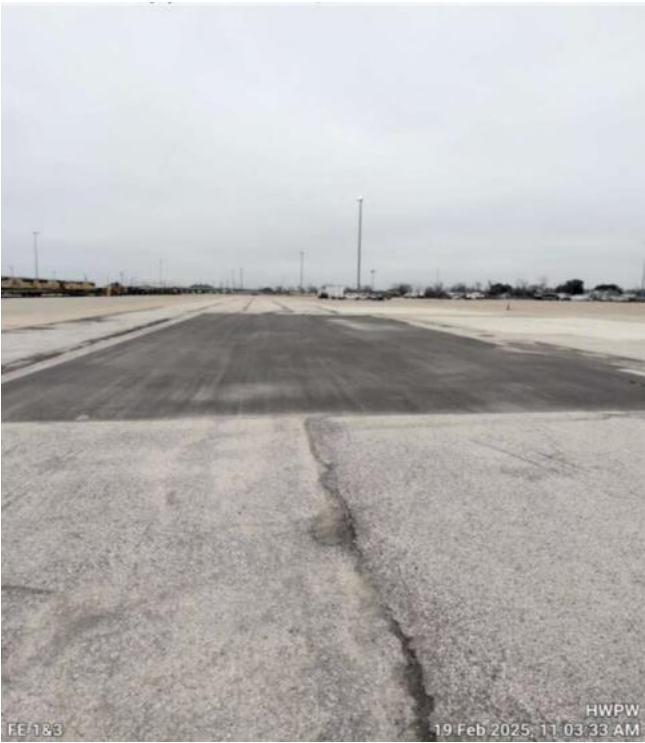
PHOTOGRAPH LOG	
Client Name: Union Pacific Railroad		Site Location: Englewood Intermodal Yard, Houston, Texas	Project No. US0039040.4227
Photo No. 31	Inspection Date: 2/19/2025	<div> <div> Description: FE-1&3 weekly inspection of asphalt cap. Reconstructed cap in good condition. No NAPL observed at FE location. Facing northeast. </div> <div> Lat: 29.784254 Long: -95.321042 </div> </div>

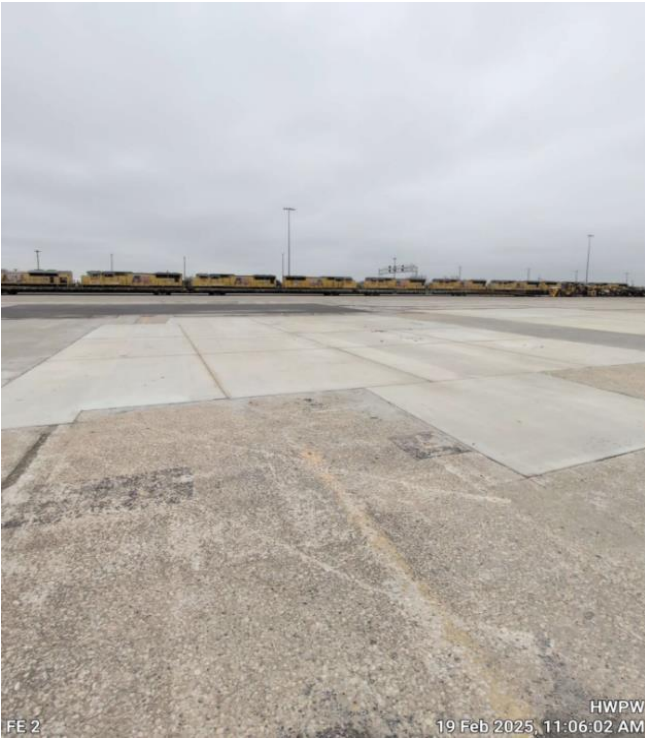
Photo No. 32	Inspection Date: 2/19/2025	<div> <div> Description: FE-2 weekly inspection of concrete cap. Reconstructed cap in good condition. No NAPL observed at FE location. Facing northwest. </div> <div> Lat: 29.784062 Long: -95.320770 </div> </div>

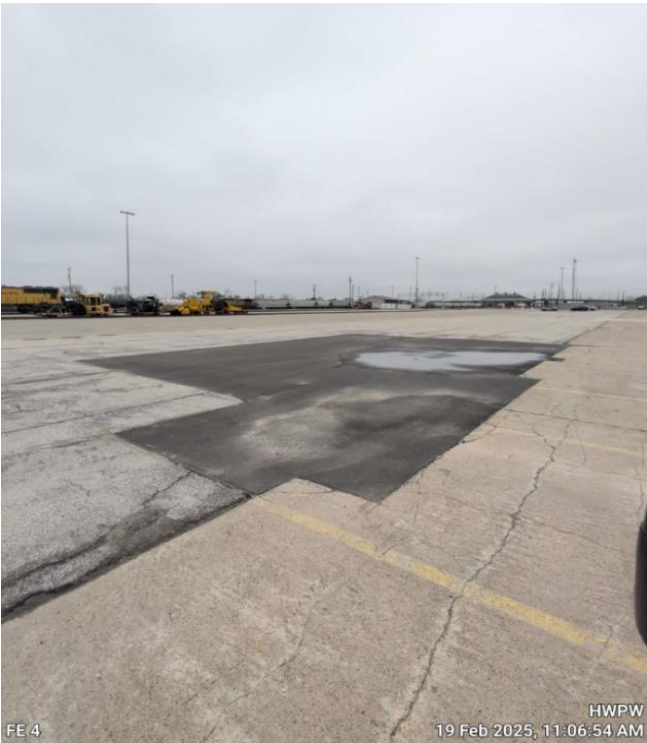
PHOTOGRAPH LOG	
Client Name: Union Pacific Railroad		Site Location: Englewood Intermodal Yard, Houston, Texas	Project No. US0039040.4227
Photo No. 33	Inspection Date: 2/19/2025	<div> <div> Description: FE-4 weekly inspection of asphalt cap. Reconstructed cap in good condition. No NAPL observed at FE location. Facing north. </div> <div> Lat: 29.784719 Long: -95.319647 </div> </div>

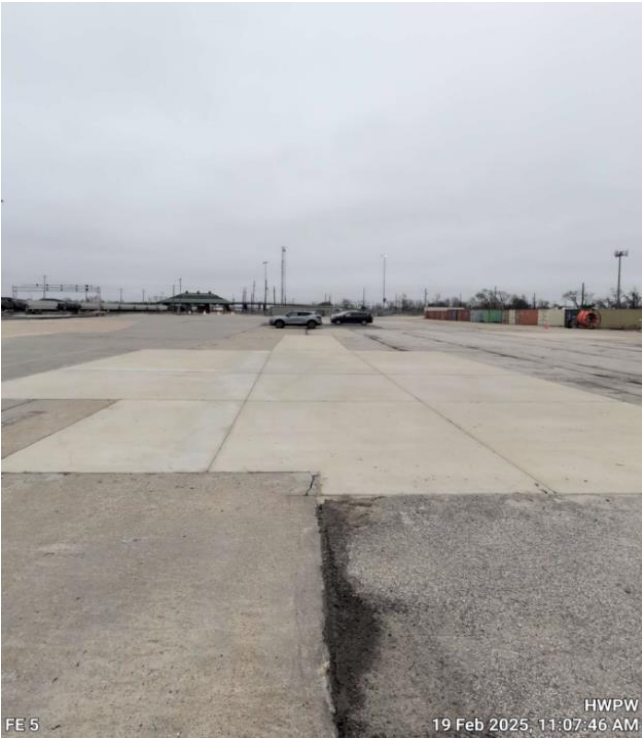
Photo No. 34	Inspection Date: 2/19/2025	<div> <div> Description: FE-5 weekly inspection of concrete cap. Reconstructed cap in good condition. No NAPL observed at FE location. Facing northeast. </div> <div> Lat: 29.785317 Long: -95.318772 </div> </div>

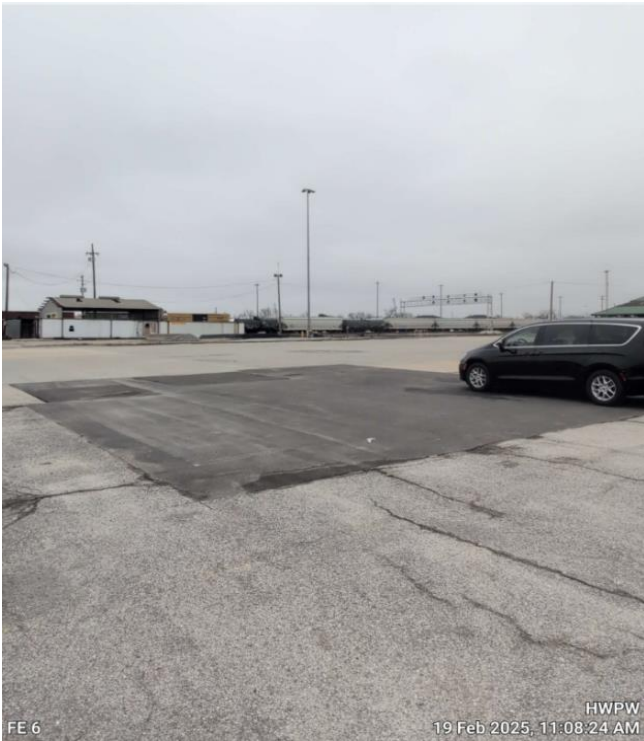
PHOTOGRAPH LOG	
Client Name: Union Pacific Railroad		Site Location: Englewood Intermodal Yard, Houston, Texas	Project No. US0039040.4227
Photo No. 35	Inspection Date: 2/19/2025	<div> <div> Description: FE-6 weekly inspection of asphalt cap. Reconstructed cap in good condition. No NAPL observed at FE location. Facing north. </div> <div> Lat: 29.785362 Long: -95.318388 </div> </div>

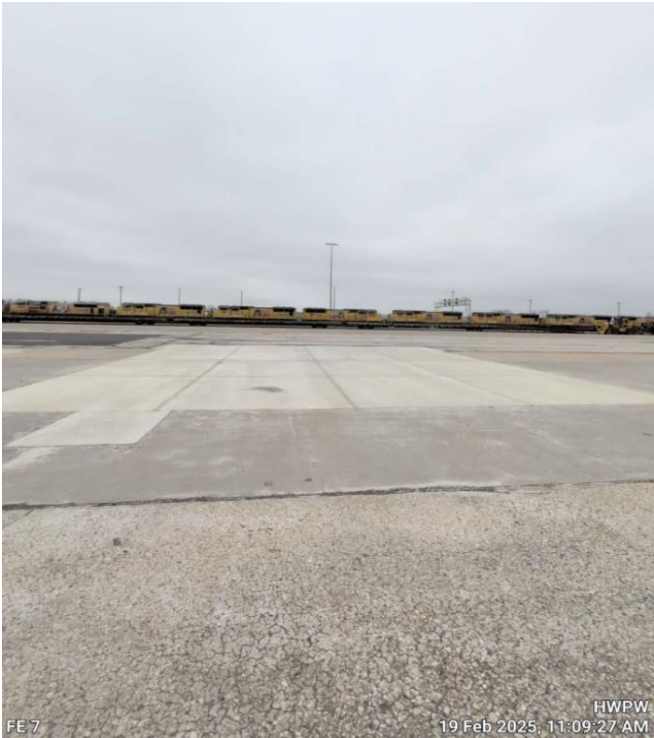
Photo No. 36	Inspection Date: 2/19/2025	<div> <div> Description: FE-7 weekly inspection of concrete cap. Reconstructed cap in good condition. No NAPL observed at FE location. Facing northwest. </div> <div> Lat: 29.784163 Long: -95.320607 </div> </div>

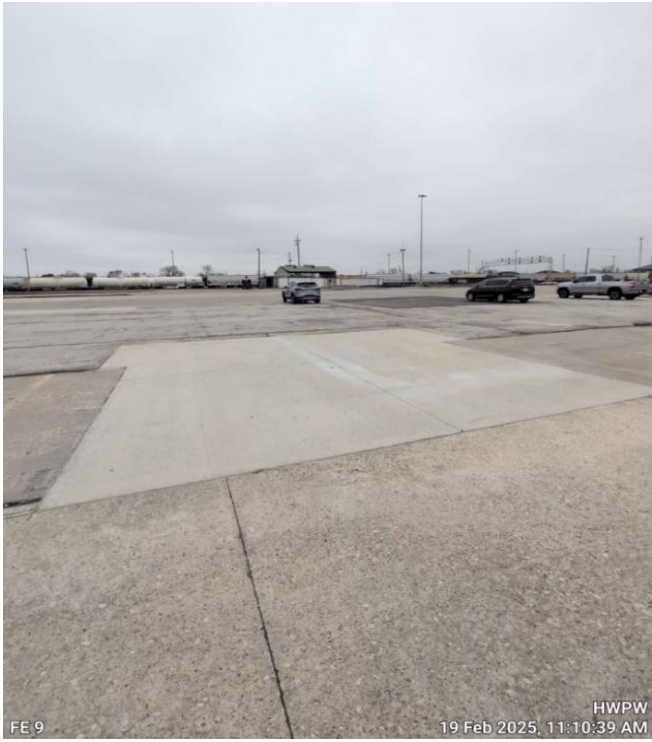
Photo No. 38	Inspection Date: 2/19/2025	<div> <div> Description: FE-9 weekly inspection of concrete cap. Reconstructed cap in good condition. No NAPL observed at FE location. Facing northwest. </div> <div> Lat: 29.785222 Long: -95.318375 </div> </div>

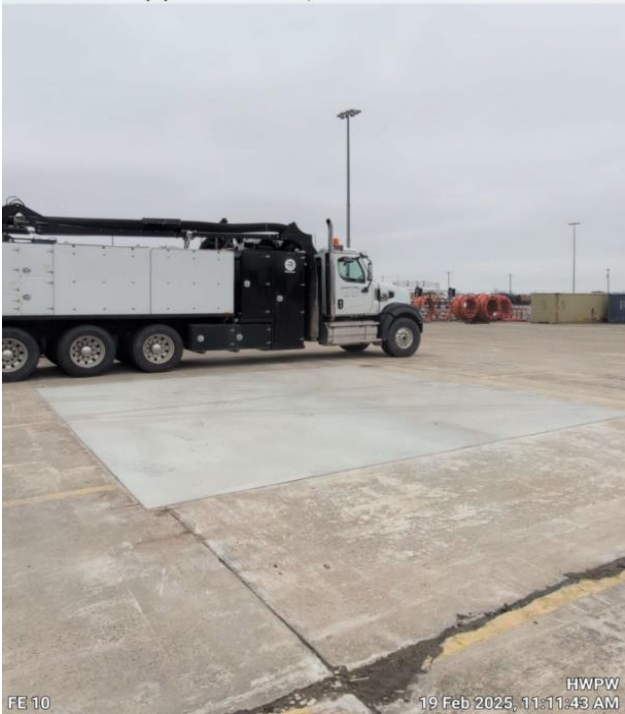
<div> <div>FE 10</div> <div> <div>HWPW</div> <div>19 Feb 2025, 11:11:43 AM</div> </div> </div> </div>	
Description: FE-10 weekly inspection of concrete cap. Reconstructed cap in good condition. No NAPL observed at FE location. Facing south.			
Lat: 29.784923 Long: -95.317642			
Photo No. 40	Inspection Date: 2/19/2025

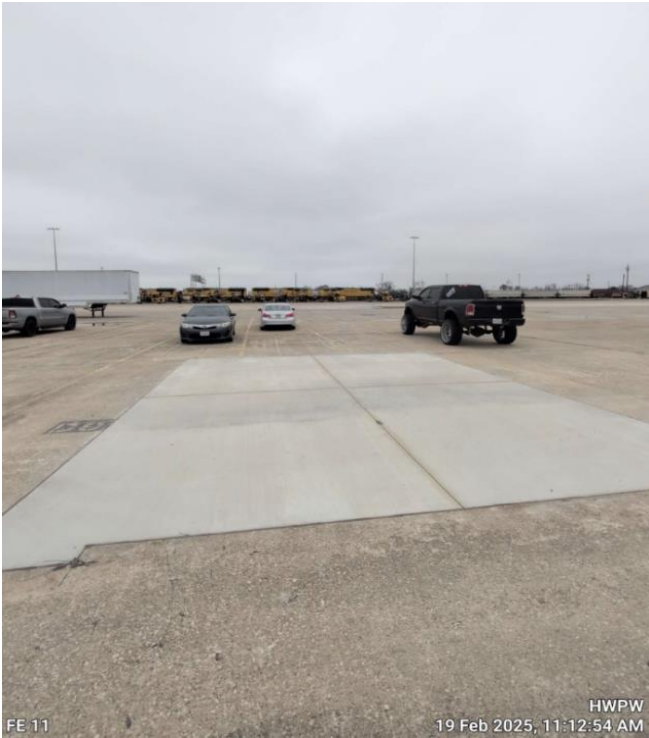
<div> <div>FE 11</div> <div> <div>HWPW</div> <div>19 Feb 2025, 11:12:54 AM</div> </div> </div>	
Description: FE-11 weekly inspection of concrete cap. Reconstructed cap in good condition. No NAPL observed at FE location. Facing northwest.			
Lat: 29.784300 Long: -95.319558

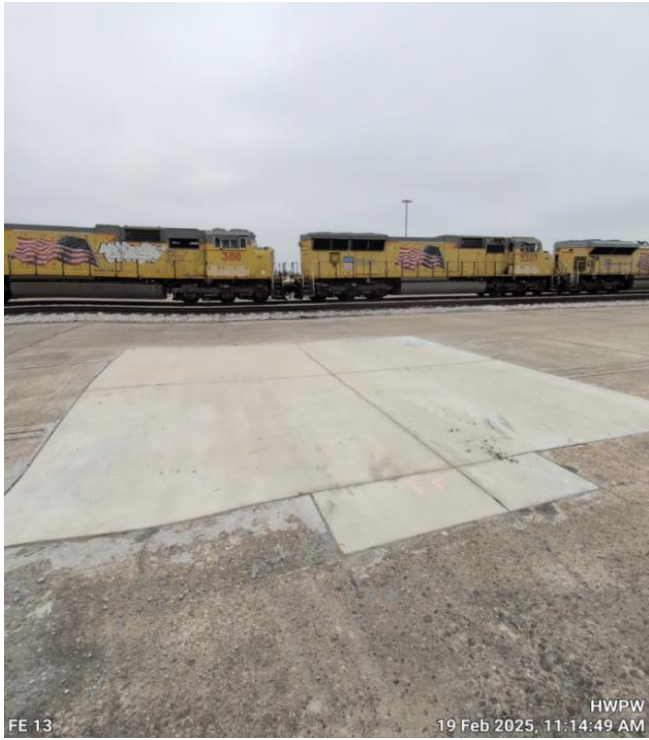
<div> <div>FE 12</div> <div>HWPW 19 Feb 2025, 11:13:40 AM</div> </div>	
Photo No. 42	Inspection Date: 2/19/2025	<div> <div> Description: FE-13 weekly inspection of concrete cap. Reconstructed cap in good condition. No NAPL observed at FE location. Facing northwest. </div> <div> Lat: 29.785085 Long: -95.321257 </div> </div>

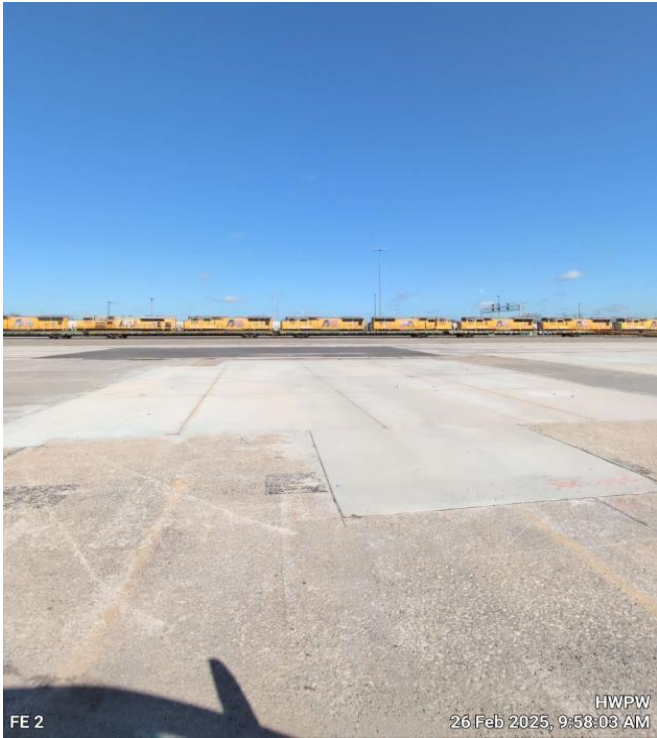
Photo No. 48	Inspection Date: 2/26/2025	<div> <div> Description: FE-2 weekly inspection of concrete cap. Reconstructed cap in good condition. No NAPL observed at FE location. Facing northwest. </div> <div> Lat: 29.784066 Long: -95.320766 </div> </div>

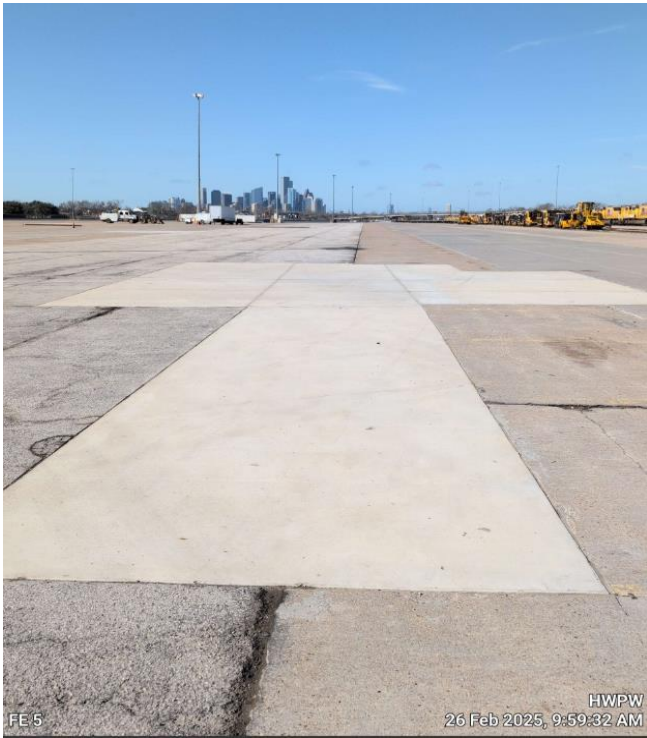
Photo No. 50	Inspection Date: 2/26/2025	<div> <div> Description: FE-5 weekly inspection of concrete cap. Reconstructed cap in good condition. No NAPL observed at FE location. Facing southwest. </div> <div> Lat: 29.785435 Long: -95.318521 </div> </div>

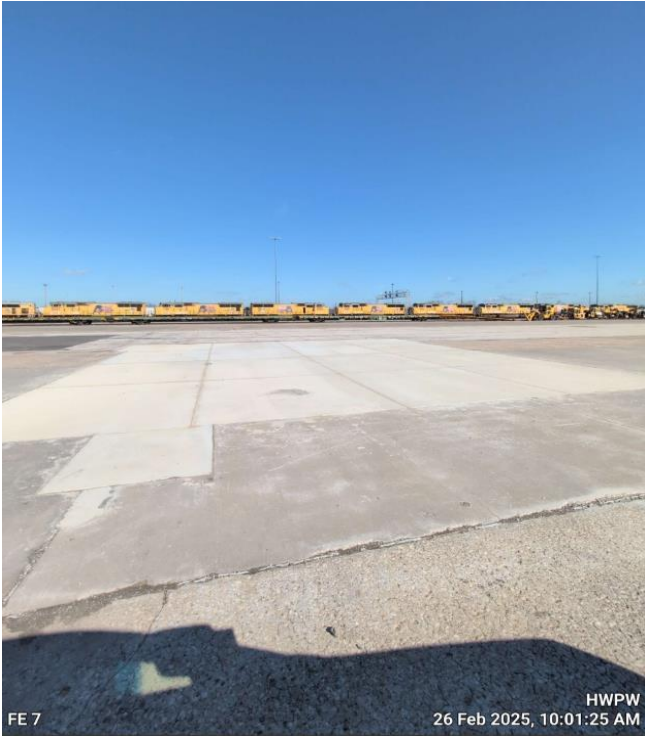
</div> </div> <div> <div>FE 6</div> <div>HWPW 26 Feb 2025, 10:00:05 AM</div> </div>	
Photo No. 52	Inspection Date: 2/26/2025	<div> <div> Description: FE-7 weekly inspection of concrete cap. Reconstructed cap in good condition. No NAPL observed at FE location. Facing northwest. Lat: 29.784178 Long: -95.320636 </div> <div>

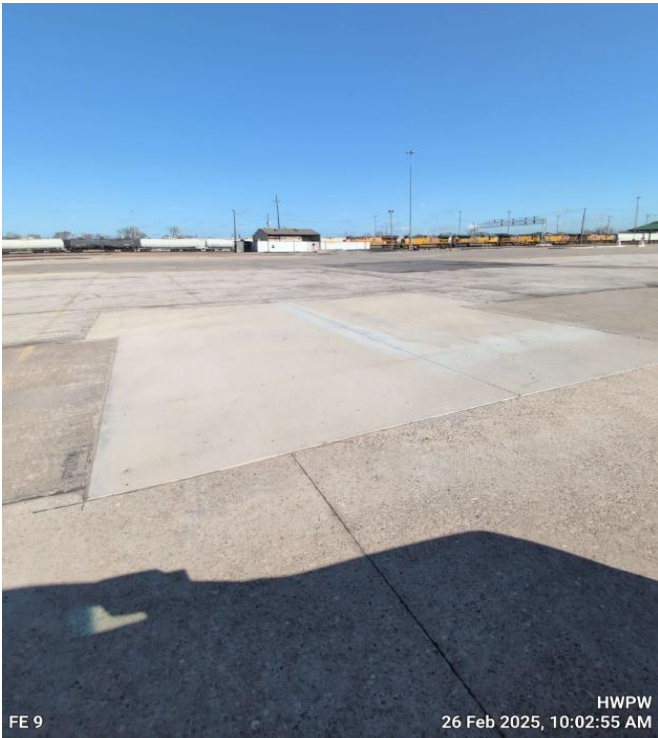
<div> FE 8 HWPW 26 Feb 2025, 10:02:25 AM </div> </div>	
Photo No. 54	Inspection Date: 2/26/2025	<div> <div> Description: FE-9 weekly inspection of concrete cap. Reconstructed cap in good condition. No NAPL observed at FE location. Facing northwest. </div> <div> Lat: 29.785211 Long: -95.318409 </div> </div> <div>

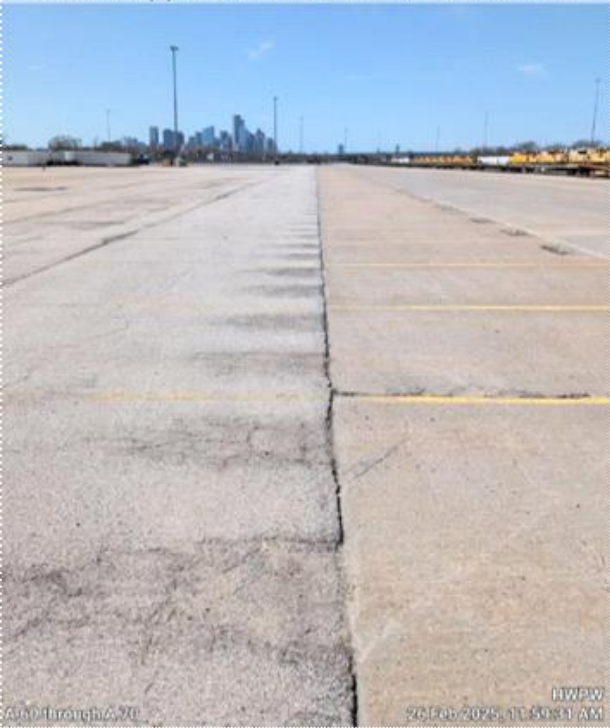
<div> <small>View through A70</small> <small>HWPW 26 Feb 2025 11:59:31 AM</small> </div> </div>	
Description: A060 - A070 weekly inspection of joint. Surrounding asphalt and concrete in good condition. No brown staining observed along joint. Facing southwest. Lat: 29.784899 Long: -95.319693			
Photo No. 62	Inspection Date: 2/26/2025	<div> <div> ○ 54°NE (T) • 29.784728, -95.320012 ±3m ▲ -11m </div>

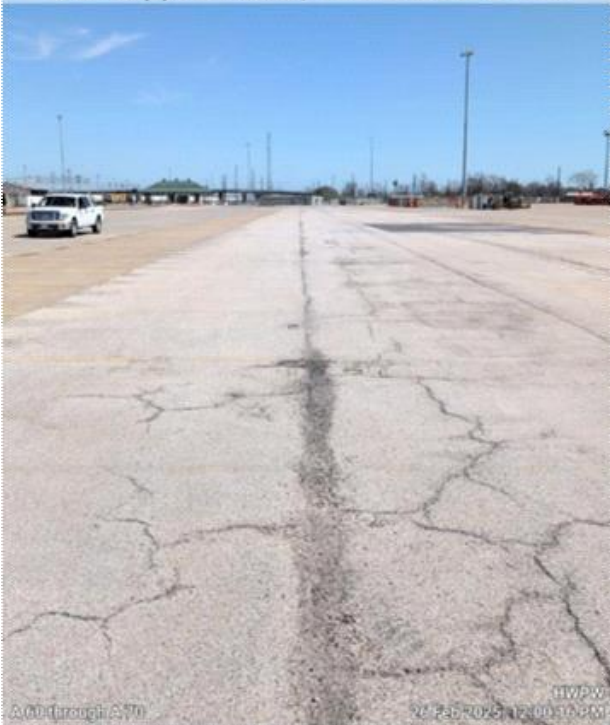
<div> <small>View through A70</small> <small>HWPW 26 Feb 2025 12:00:17 PM</small> </div> </div>	
Description: A060 - A070 weekly inspection of joint. Surrounding asphalt and concrete in good condition. No brown staining observed along joint. Facing northeast. Lat: 29.784728 Long: -95.320012

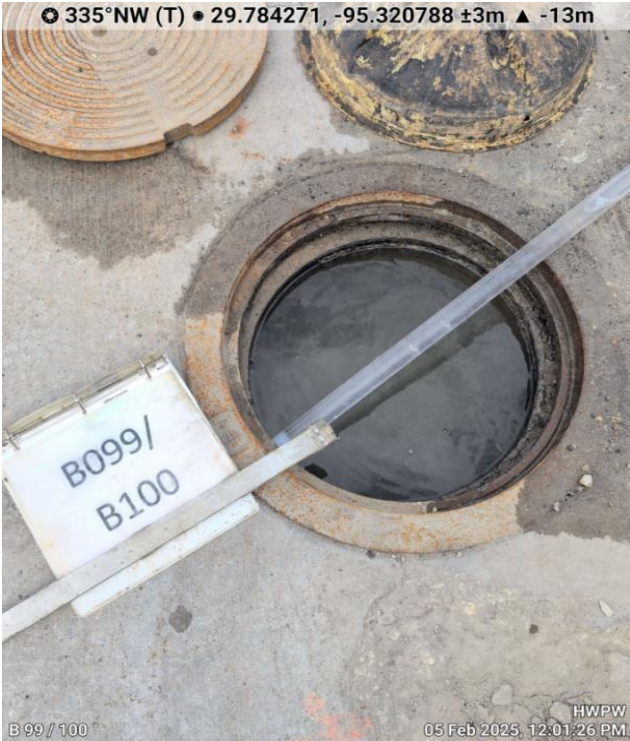
<div> <div>B 99 / 100</div> <div>HWPW 05 Feb 2025, 12:01:26 PM</div> </div> </div>	
Description: Sump 1 (B99/B100), 1.0 inches of freeboard in sump. Color is clear, and no sheen or odor observed.			
Lat: 29.784271 Long: -95.320788			
Photo No. 64	Inspection Date: 2/5/2025	<div> <div> 305°NW (T) • 29.784217, -95.320905 ±2m ▲ -11m </div>

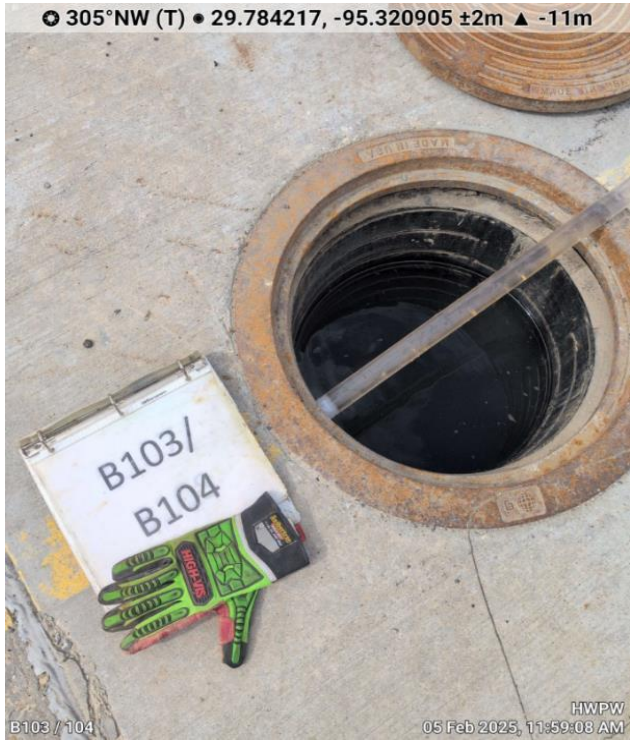
- During the February 5 inspection the water in Sump 2 was observed to be tan (Photo No. 64). During the February 12 inspection the water was observed to be brown in Sump 2 (Photo No. 67) and tan in Sump 3 (Photo No. 68). Other than these exceptions above, the water in Sump 1, Sump 2, and Sump 3 were observed to be clear in color during the February 2025 inspections. No odors or sheen were reported during the February inspections. Sumps were full of water on February 12th due to rain event.
- NAPL seeps were not observed along the concrete joints along the NAPL Collection System (including Slot B107) during the February 2025 inspections.

<div> <div>B103 / 104</div> <div>HWPW 05 Feb 2025, 11:59:08 AM</div> </div> </div>	
Description: Sump 2 (B103/B104), 8.5 inches of freeboard in sump. Color is tan, and no sheen or odor observed.			
Lat: 29.784217 Long: -95.320905

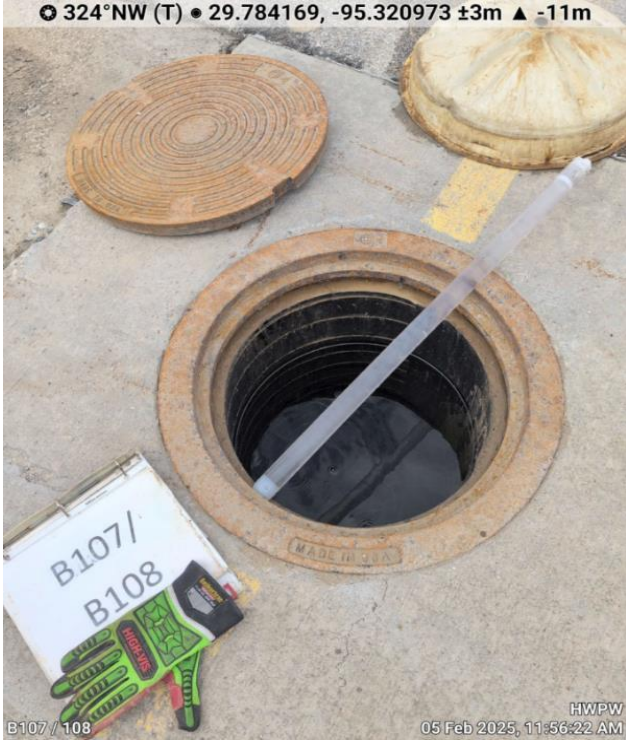
<p> <small>B107 / 108</small> </p> </div> <div> <p> <small>HWPW</small> <small>05 Feb 2025, 11:56:22 AM</small> </p> </div> </div>	
Description: Sump 3 (B107/B108), 9.0 inches of freeboard in sump. Color is clear, and no sheen or odor observed.			
Lat: 29.784169 Long: -95.320973			
Photo No. 66	Inspection Date: 2/12/2025	<div> <div> <p> ⬤ 258°SW (T) • 29.784275, -95.320778 ±3m ▲ -20m </p>
