Re: **MONTHLY STATUS UPDATE – ENGLEWOOD INTERMODAL YARD – NAPL COLLECTION
SYSTEM/CONCRETE CAP REPAIRS AND REVISED INTERIM MEASURES WORK PLAN POST-
CONSTRUCTION ACTIVITIES
UNION PACIFIC RAILROAD HOUSTON WOOD PRESERVING WORKS FACILITY
4910 LIBERTY ROAD FACILITY, HOUSTON, TEXAS
POST-CLOSURE CARE PERMIT NO. HW-50343; INDUSTRIAL SWR NO. 31547**

WSP USA Inc. (WSP), on behalf of Union Pacific Railroad Company (UPRR), is pleased to provide this monthly status update for February 2025 summarizing the weekly inspections being conducted at the Englewood Intermodal Yard (EIY) concrete cap area within the UPRR Houston Wood Preserving Works Facility (the Site). The weekly inspections are being conducted to evaluate the post-construction Focused Excavations as detailed in the *Revised Interim Measures Work Plan – Englewood Intermodal Yard (EIY)*, (Revised IMWP) dated October 20, 2023. In addition, a summary of the weekly NAPL Collection System and concrete cap area inspections conducted at the EIY is provided as requested by the TCEQ in a letter dated March 20, 2018. Below is a summary of the weekly Focused Excavation and EIY inspections for February 2025.

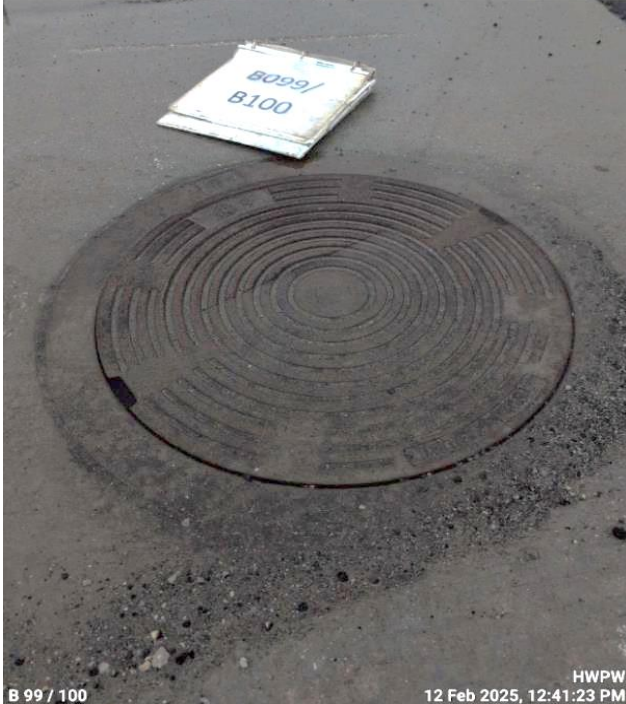
<p> <small>B 99 / 100</small> </p> </div> <div> <p> <small>HWPW</small> <small>12 Feb 2025, 12:41:23 PM</small> </p> </div> </div>	
Description: Sump 1 (B99/B100), 0.0 inches of freeboard in sump. Color is clear, and no sheen or odor observed.			
Lat: 29.784275 Long: -95.320778

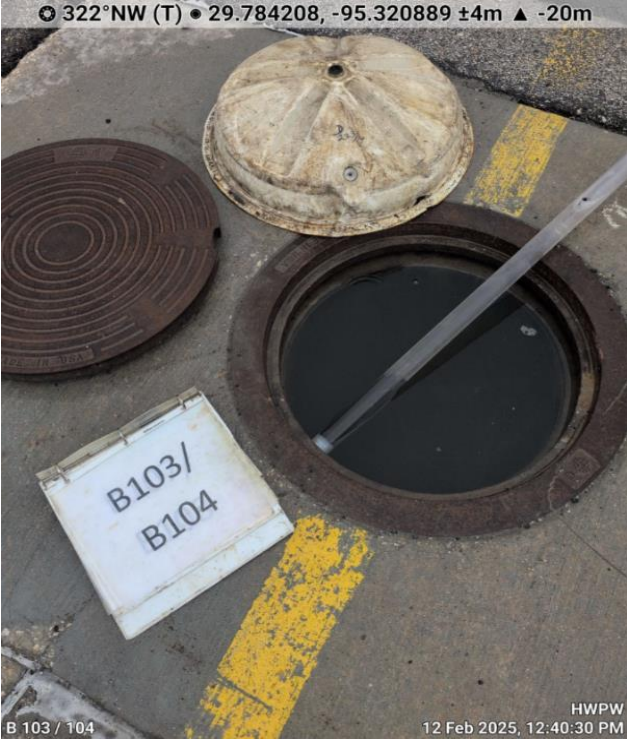
- During the February 5 inspection the water in Sump 2 was observed to be tan (Photo No. 64). During the February 12 inspection the water was observed to be brown in Sump 2 (Photo No. 67) and tan in Sump 3 (Photo No. 68). Other than these exceptions above, the water in Sump 1, Sump 2, and Sump 3 were observed to be clear in color during the February 2025 inspections. No odors or sheen were reported during the February inspections. Sumps were full of water on February 12th due to rain event.
- NAPL seeps were not observed along the concrete joints along the NAPL Collection System (including Slot B107) during the February 2025 inspections.

<div> B 103 / 104 </div> <div> HWPW 12 Feb 2025, 12:40:30 PM </div> </div>	
Description: Sump 2 (B103/B104), 0.0 inches of freeboard in sump. Color is brown, and no sheen or odor observed.			
Lat: 29.784208 Long: -95.320889			
Photo No. 68	Inspection Date: 2/12/2025	<div> <div> 276°W (T) • 29.784184, -95.32098 ±7m ▲ -11m </div>

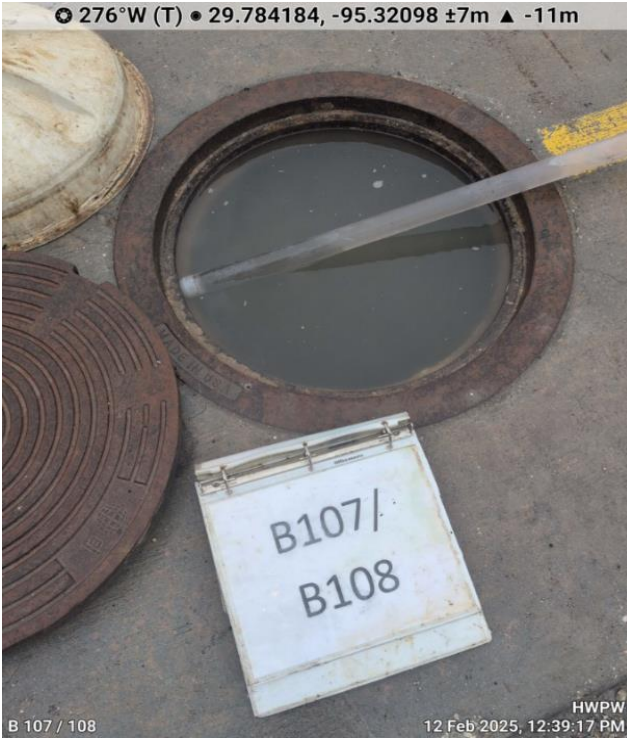
<div> B 107 / 108 </div> <div> HWPW 12 Feb 2025, 12:39:17 PM </div> </div>	
Description: Sump 3 (B107/B108), 0.0 inches of freeboard in sump. Color is tan, and no sheen or odor observed.			
Lat: 29.784184 Long: -95.320980

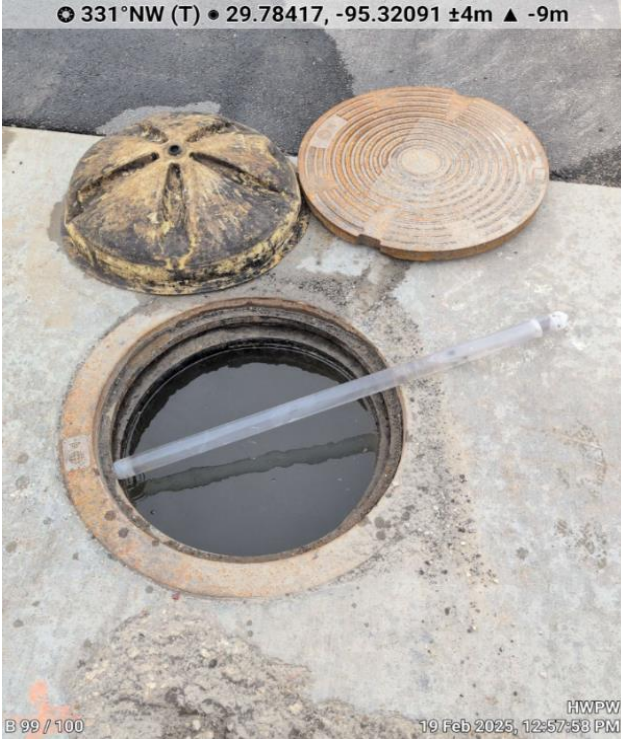
<div> B 99 / 100 <div> HWPW 19 Feb 2025, 12:57:58 PM </div> </div> </div>	
Description: Sump 1 (B99/B100), 1.0 inches of freeboard in sump. Color is clear, and no sheen or odor observed.			
Lat: 29.784170 Long: -95.320910			
Photo No. 70	Inspection Date: 2/19/2025	<div> <div> 266°W (T) • 29.784181, -95.32094 ±3m ▲ -13m </div>

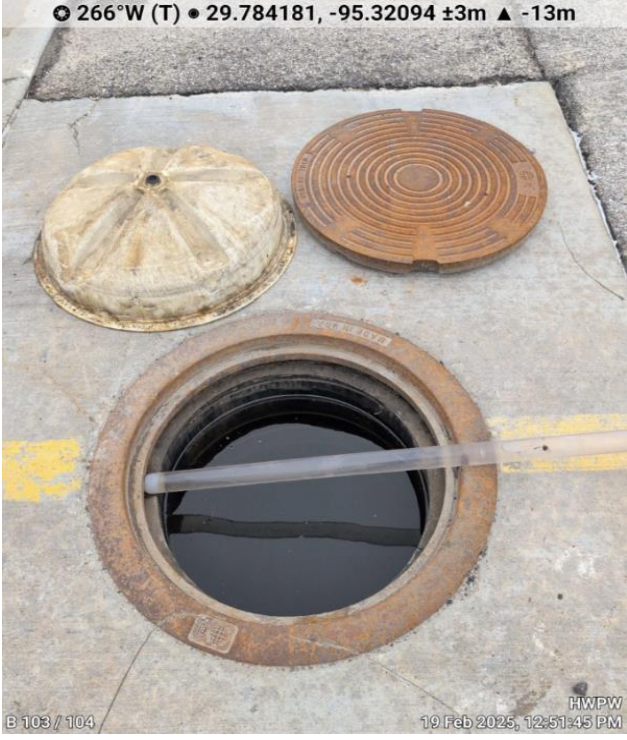
<div> B 103 / 104 <div> HWPW 19 Feb 2025, 12:51:45 PM </div> </div> </div>	
Description: Sump 2 (B103/B104), 3.0 inches of freeboard in sump. Color is clear, and no sheen or odor observed.			
Lat: 29.784181 Long: -95.320940

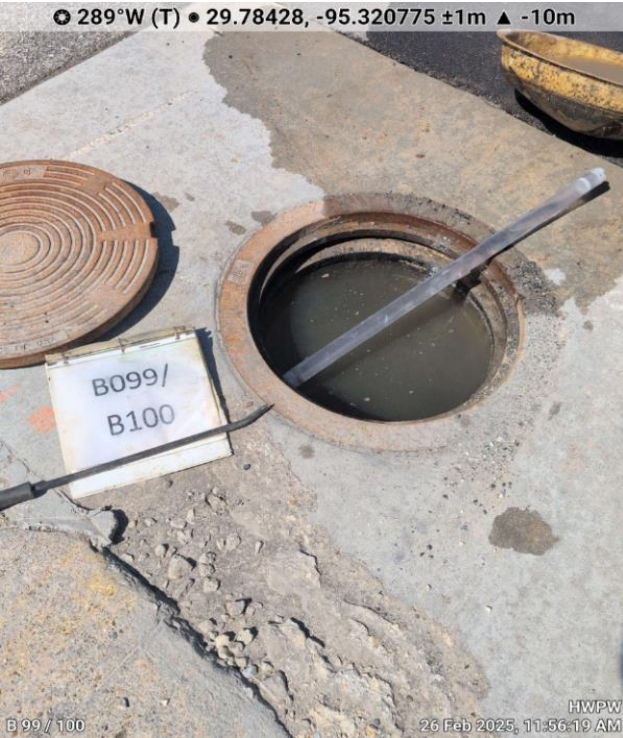
Lat: 29.784161 Long: -95.320965			
Photo No. 72	Inspection Date: 2/26/2025	Coordinates: 289°W (T) • 29.78428, -95.320775 ±1m ▲ -10m	
Description: Sump 1 (B99/B100), 1.5 inches of freeboard in sump. Color is clear, and no sheen or odor observed.

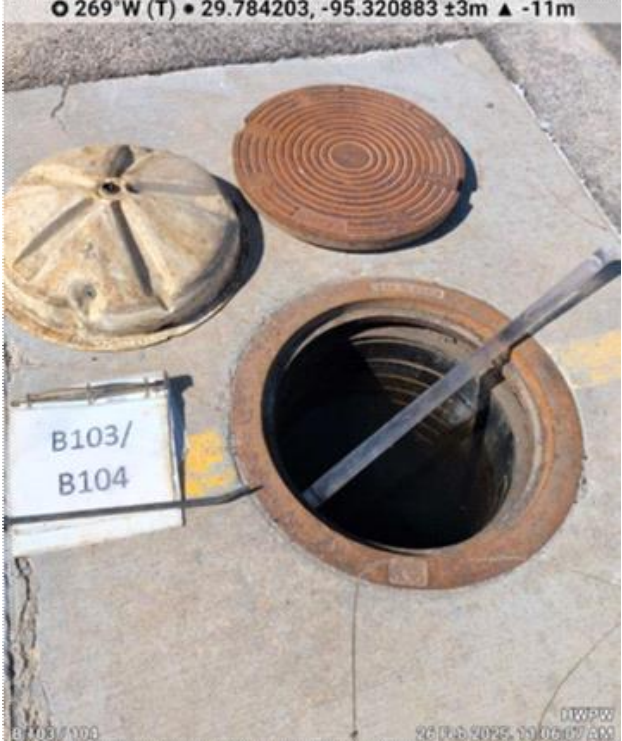
</div>	
Description: Sump 2 (B103/B104), 5.0 inches of freeboard in sump. Color is clear, and no sheen or odor observed.			
Lat: 29.7841203 Long: -95.320883			
Photo No. 74	Inspection Date: 2/26/2025	<div> <div> ○ 271°W (T) • 29.784171, -95.320984 ±2m ▲ -10m </div>

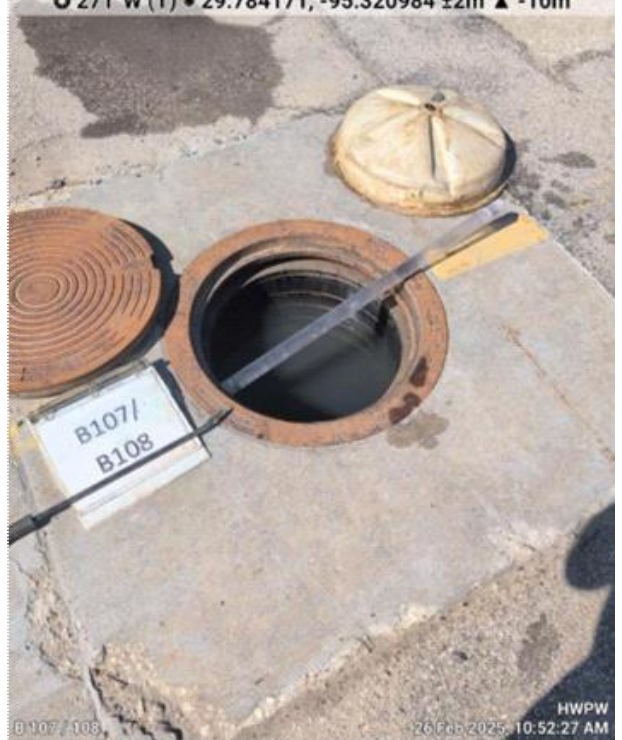
</div>	
Description: Sump 3 (B107/B108), 4.5 inches of freeboard in sump. Color is clear, and no sheen or odor observed.			
Lat: 29.784171 Long: -95.320984
