April 15, 2025

Project No. US0039040.4227

Re: **MONTHLY STATUS UPDATE – ENGLEWOOD INTERMODAL YARD – NAPL COLLECTION  
SYSTEM/CONCRETE CAP REPAIRS AND REVISED INTERIM MEASURES WORK PLAN POST-  
CONSTRUCTION ACTIVITIES  
UNION PACIFIC RAILROAD HOUSTON WOOD PRESERVING WORKS FACILITY  
4910 LIBERTY ROAD FACILITY, HOUSTON, TEXAS  
POST-CLOSURE CARE PERMIT NO. HW-50343; INDUSTRIAL SWR NO. 31547**

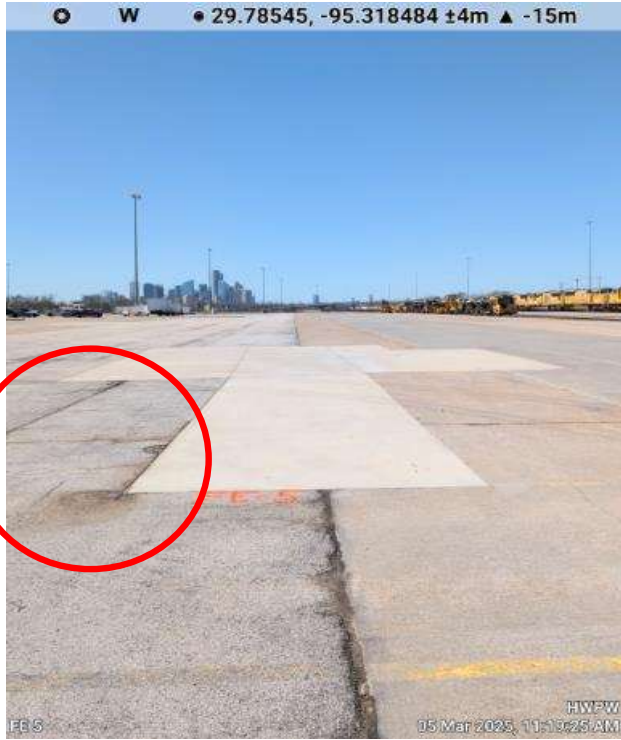
- During the weekly inspection on March 5, WSP observed minimal brown staining in cracks and joints of the asphalt immediately adjacent to the reconstructed concrete cap for FE-5 (Photo No. 4). During the March 12 inspection, WSP noted that a small amount standing water (brown water) was observed within the same cracks and joints of the asphalt immediately adjacent to the reconstructed concrete cap (Photo Nos. 16 and 17). The small amount of standing water at the cracks and joints was observed with additional brown staining, particularly the southern and southeastern corners of the reconstructed cap during the remaining March inspections (Photo Nos. 29, 30, 31, 32, 45, and 46).

<div> <small>FE5</small> <small>HWPW</small>  <small>05 Mar 2025, 11:13:25 AM</small> </div> </div>	
<b>Description:</b> FE-5 weekly inspection of concrete cap. Reconstructed cap in good condition. No NAPL observed at FE location. Minimal brown water staining along asphalt joint outside of the FE and southeastern corner observed. Facing west.

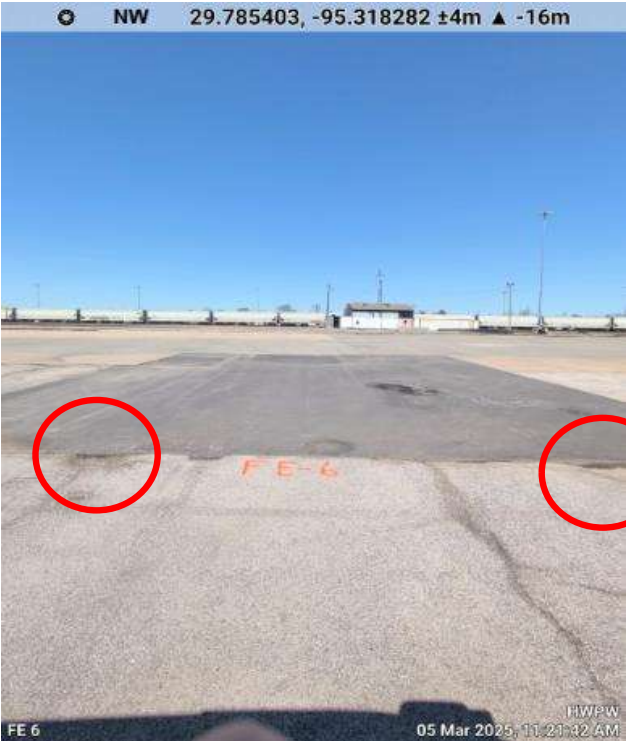
- During the weekly inspections on March 5 and March 12, WSP observed minimal brown staining along the edges of the reconstructed asphalt cap at FE-6 (Photo Nos. 5 and 18). On March 19, minor brown water staining was observed at the northwestern corner of the asphalt cap (Photo No. 34). By March 26, other minor brown water stains were observed along the edges of FE-6 and along an asphalt joint which intersects the southern edge of FE-6 (Photo Nos. 47 through 49).

<div> FE 6 05 Mar 2025, 11:21:32 AM HWPW </div> </div>	
<b>Description:</b> FE-6 weekly inspection of asphalt cap. Reconstructed cap in good condition. No NAPL observed at FE location. Minimal brown water staining along the edges of the FE cap observed (red circles). Facing northwest.  Lat: 29.785403 Long: -95.318282			
<b>Photo No.</b> <b>6</b>	<b>Inspection Date:</b> 3/5/2025	<div> <div> NW 29.78417, -95.320605 ±1m ▲ -15m </div>

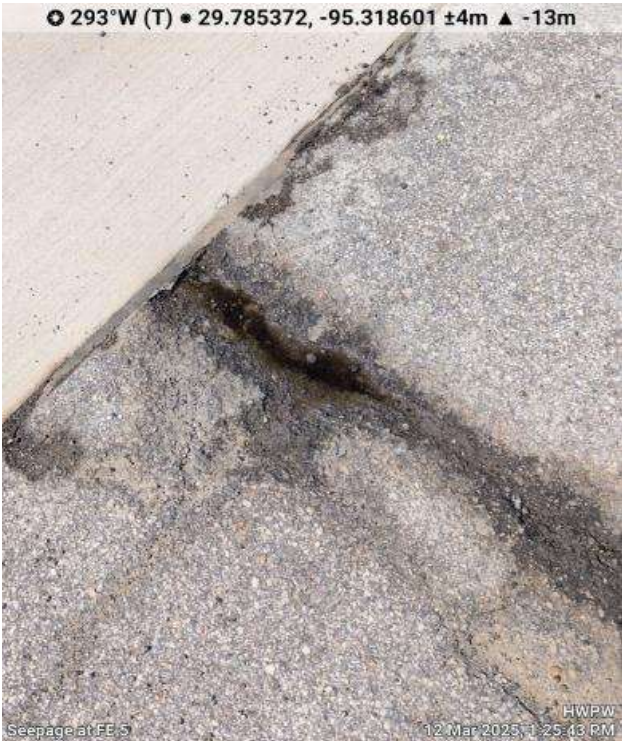
<p>Seepage at FE 5</p> <p>HWPW 12 Mar 2025 1:25:43 PM</p>	
<p><b>Description:</b> FE-5 brown water staining observed where the asphalt joint meets the reconstructed concrete cap, located within the red circle on Photo 16.</p> <p>Lat: 29.785372 Long: -95.318601</p>			
Photo No. 18	Inspection Date: 3/12/2025	<p>☉ 320°NW (T) • 29.785411, -95.318294 ±4m ▲ -13m</p>

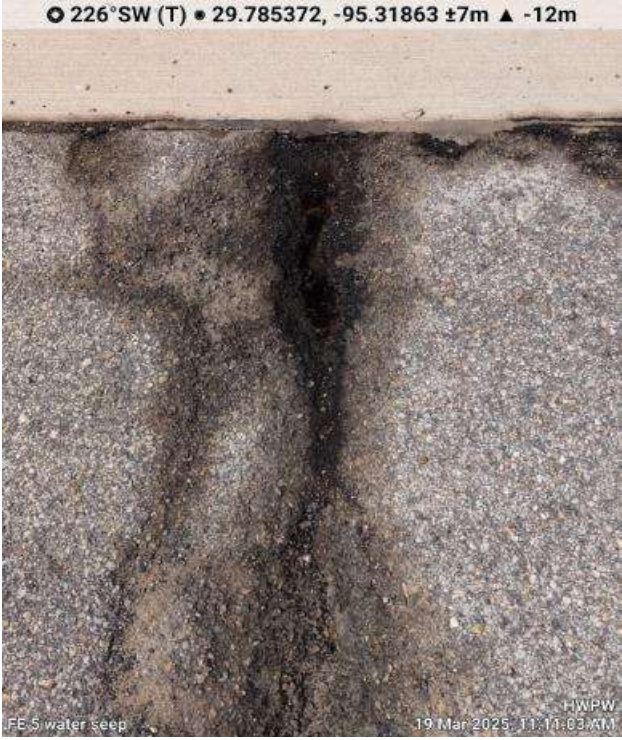
<div> <b>FE 5 water seep</b> </div> <div> <b>HWPW</b>  <b>19 Mar 2025, 11:11:03 AM</b> </div> </div>

<b>Description:</b> FE-5 brown water staining observed where the asphalt joint meets the reconstructed FE-5 concrete cap, located within the red circle on Photo 29.  Lat: 29.785372 Long: -95.318630

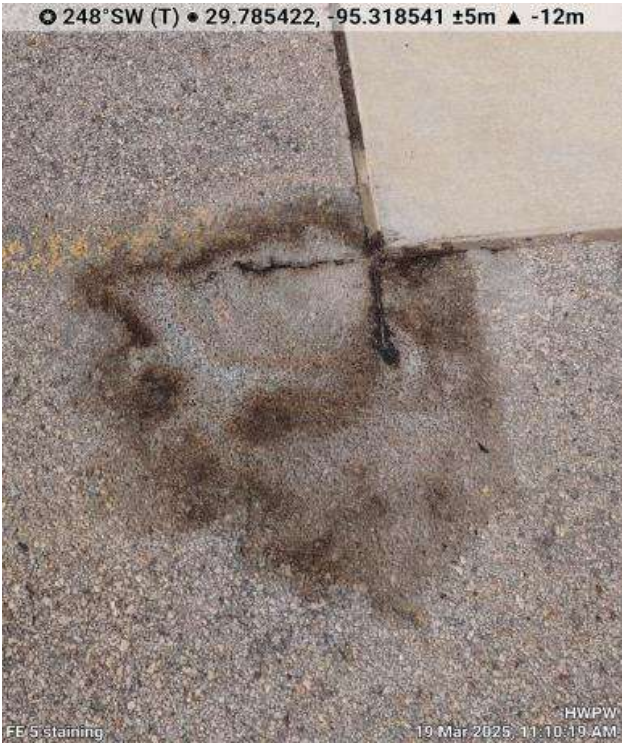
<div> <b>FE 5 staining</b> </div> <div> <b>HWPW</b>  <b>19 Mar 2025 11:10:19 AM</b> </div> </div>	
<b>Description:</b> FE-5 brown water staining observed at the southeastern corner of the FE reconstructed cap, located within the yellow circle on Photo 29.			
Lat: 29.785422 Long: -95.318541			
<b>Photo No.</b> <b>32</b>	<b>Inspection Date:</b> 3/19/2025	<div> <div> <b>171°S (T) • 29.78536, -95.318628 ±2m ▲ -11m</b> </div>

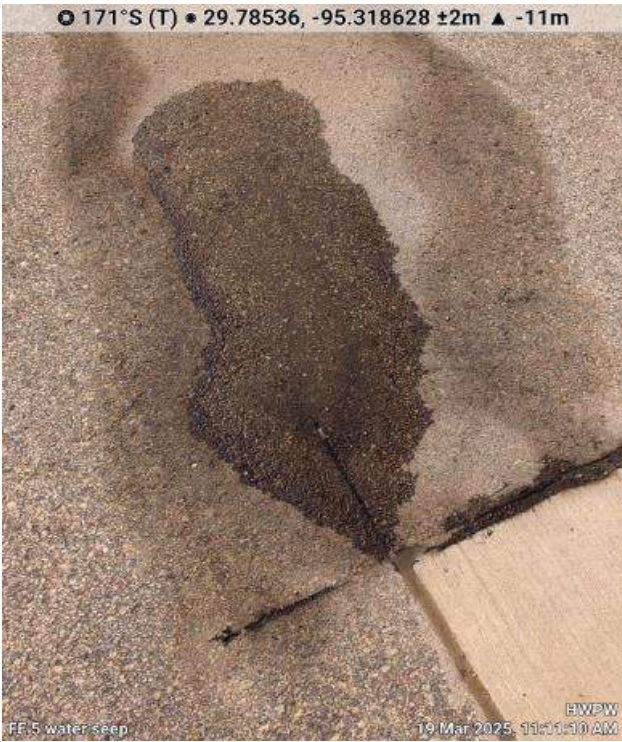
<div> <b>FE 5 water seep</b> </div> <div> <b>HWPW</b>  <b>19 Mar 2025 11:11:10 AM</b> </div> </div>	
<b>Description:</b> FE-5 brown water staining observed at the southern corner of the FE reconstructed cap, located within the blue circle on Photo 29.

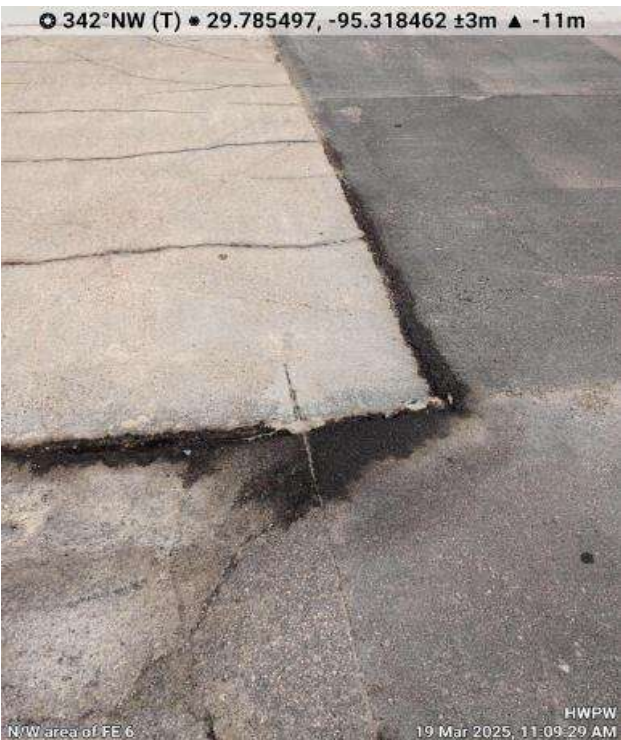
<div> N/W area of FE 6 HWPW 19 Mar 2025, 11:09:29 AM </div> </div>	
<b>Description:</b> FE-6 brown water staining observed at the edges of the northwestern corner of the asphalt cap, located within the red circle on Photo 33.  Lat: 29.785497 Long: -95.318462

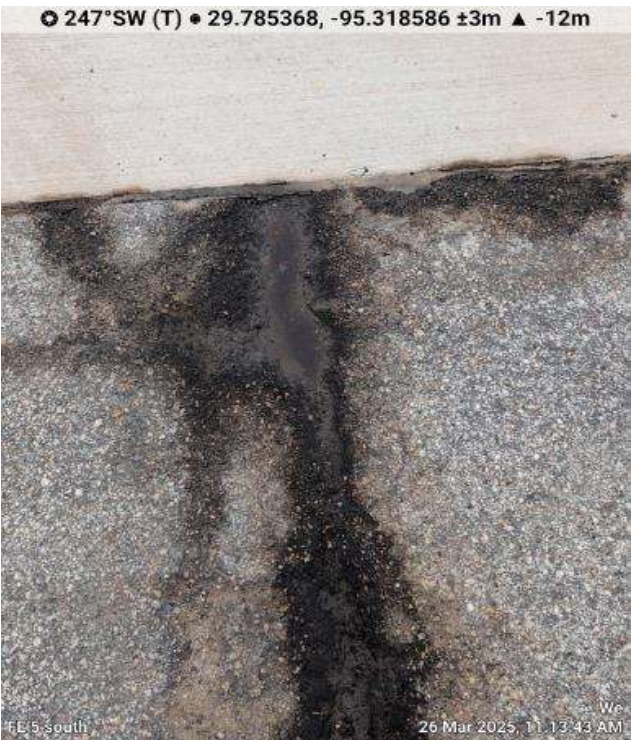
<div> FE 5, south We 26 Mar 2025, 11:13:43 AM </div> </div>	
<b>Description:</b> FE-5 brown water staining observed where the asphalt joint meets the concrete cap, located within the red circle on Photo 45.

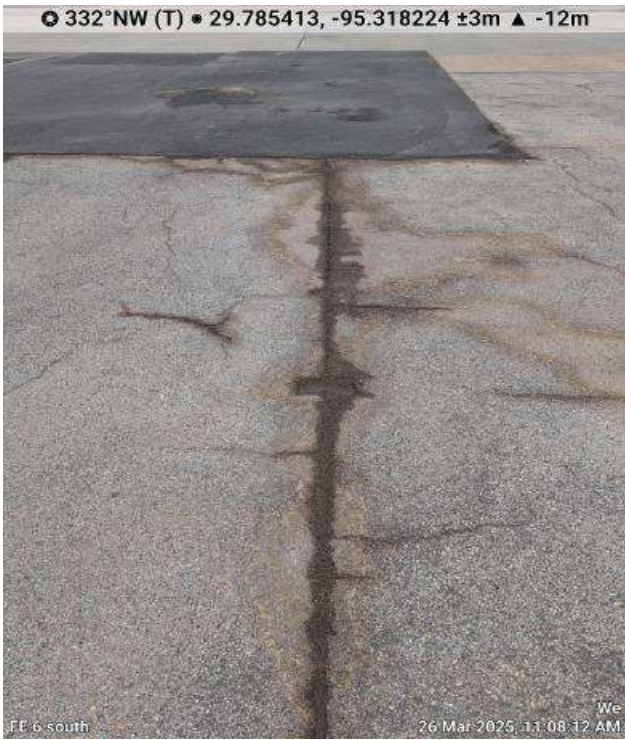
<div> FE 6 south <div> We  26 Mar 2025, 11:08:12 AM </div> </div> </div>	
<b>Description:</b> FE-6 brown water staining observed along the asphalt joint that intersects the asphalt FE cap. Directly east and out of frame in Photo 47.

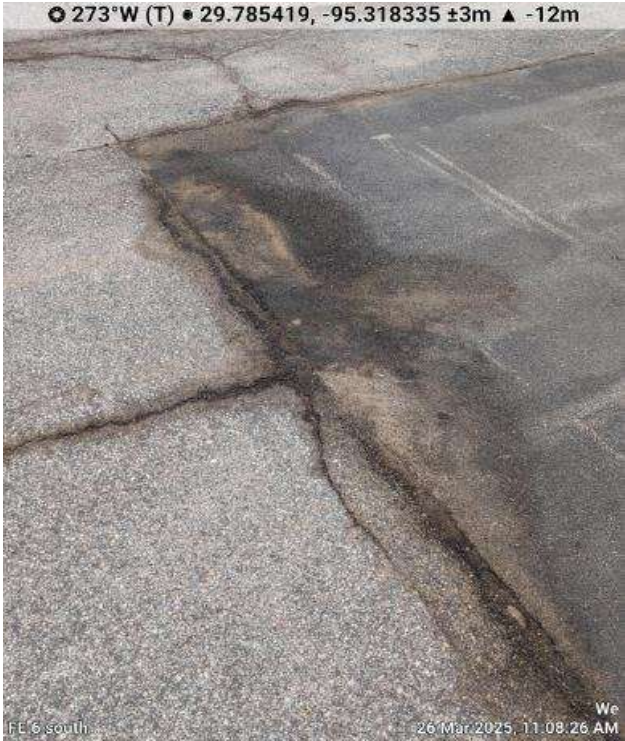
</div> <p> <b>Description:</b>            FE-6 brown water staining observed along the edges of the western corner.         </p> <p>           Lat: 29.785419            Long: -95.318335         </p>	
<b>Photo No.</b> <b>50</b>	<b>Inspection Date:</b> 3/26/2025	<div>
