May 12, 2025

Project No. US0039040.4227

Re: **MONTHLY STATUS UPDATE – ENGLEWOOD INTERMODAL YARD – NAPL COLLECTION
SYSTEM/CONCRETE CAP REPAIRS AND REVISED INTERIM MEASURES WORK PLAN POST-
CONSTRUCTION ACTIVITIES
UNION PACIFIC RAILROAD HOUSTON WOOD PRESERVING WORKS FACILITY
4910 LIBERTY ROAD FACILITY, HOUSTON, TEXAS
POST-CLOSURE CARE PERMIT NO. HW-50343; INDUSTRIAL SWR NO. 31547**

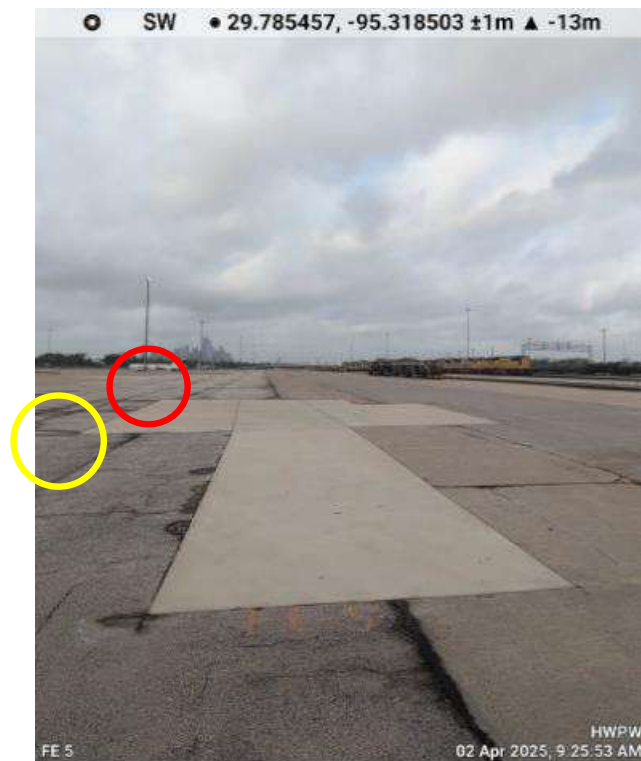
FE-5 weekly inspection of concrete cap.
Reconstructed cap in good condition. No NAPL
observed at FE location. Minimal brown water
staining along the southern joint of FE-5
observed. Facing southwest.

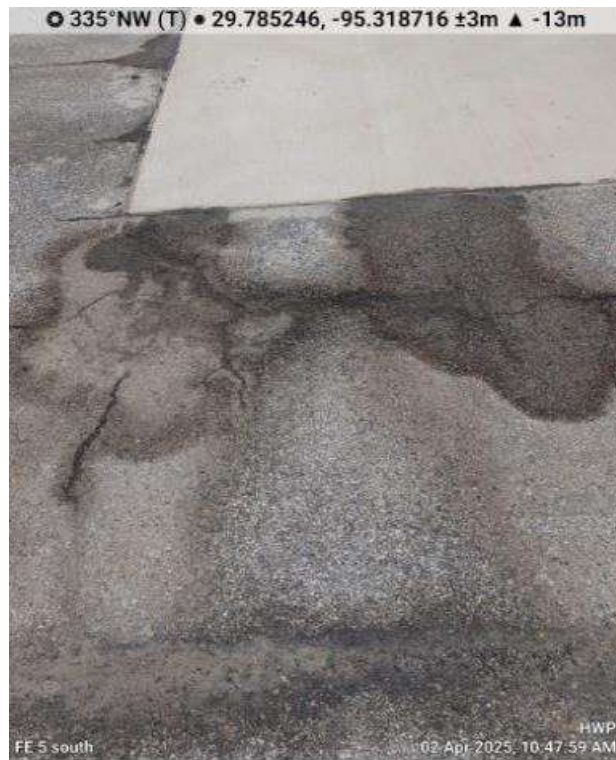
FE-5 brown water staining observed at the southern corner of the FE reconstructed cap, located within the red circle on Photo No. 4.

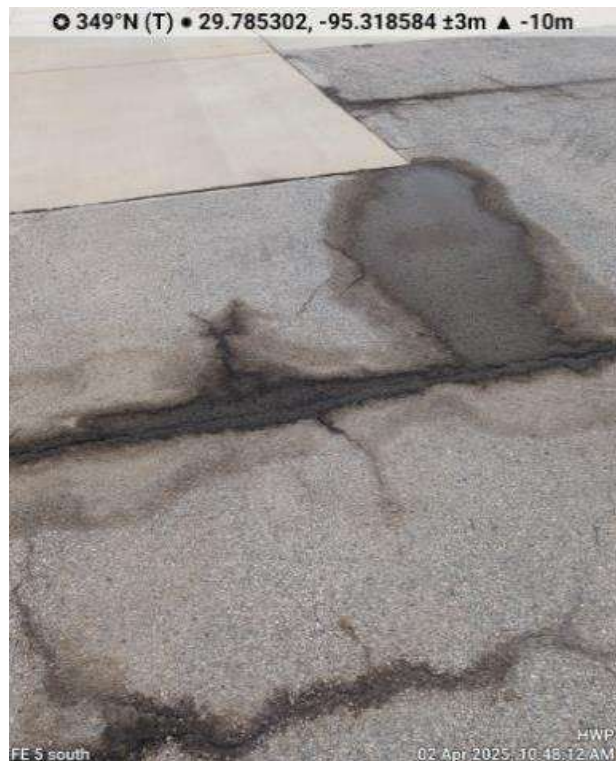
FE-5 brown water staining observed at the southeastern corner of the FE reconstructed cap, located within the yellow circle on Photo No. 4.

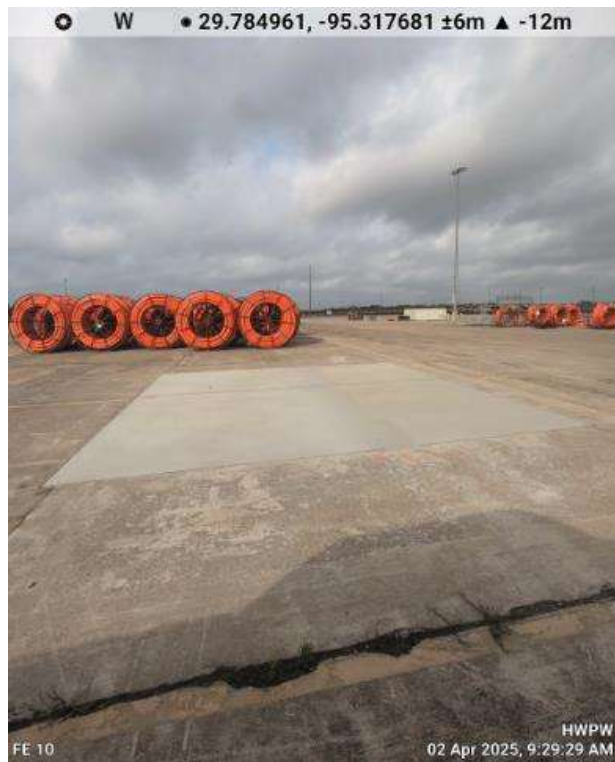
FE-10 weekly inspection of concrete cap.
Reconstructed cap in good condition. No NAPL
observed at FE location. Facing west.

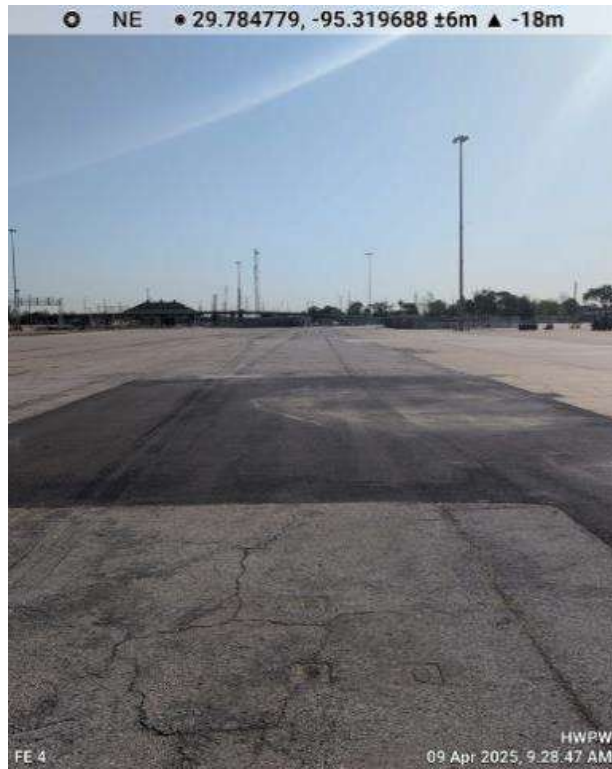
FE-4 weekly inspection of asphalt cap.
Reconstructed cap in good condition. No NAPL
observed at FE location. Facing northeast.

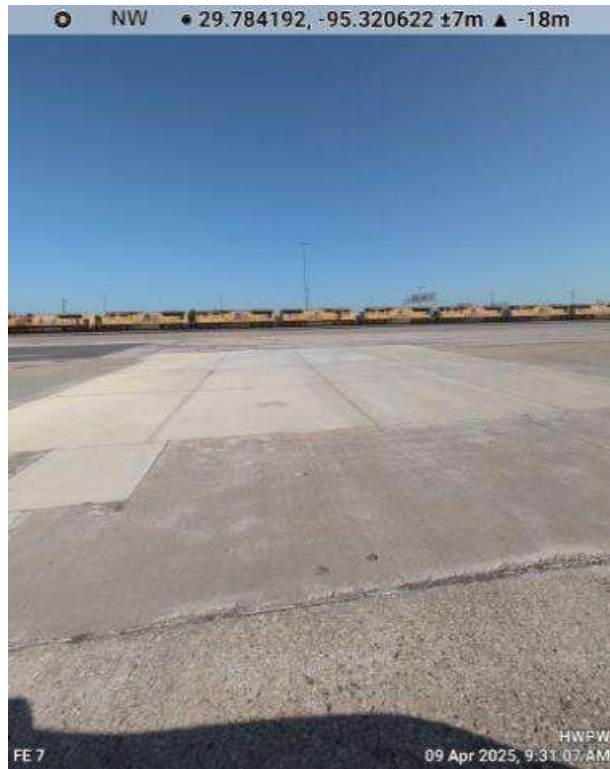
FE-7 weekly inspection of concrete cap.
Reconstructed cap in good condition. No NAPL
observed at FE location. Facing northwest.

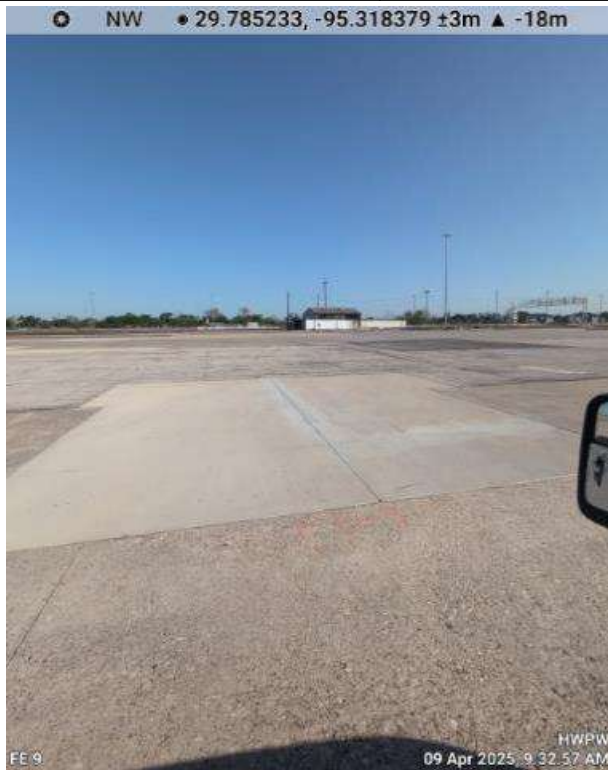
FE-9 weekly inspection of concrete cap.
Reconstructed cap in good condition. No NAPL
observed at FE location. Facing northwest.

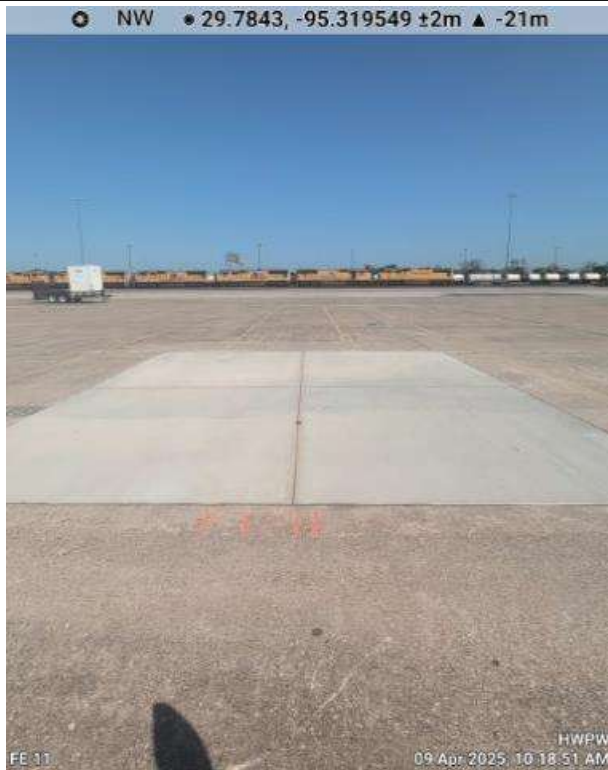
FE-11 weekly inspection of concrete cap.
Reconstructed cap in good condition. No NAPL
observed at FE location. Facing northwest.

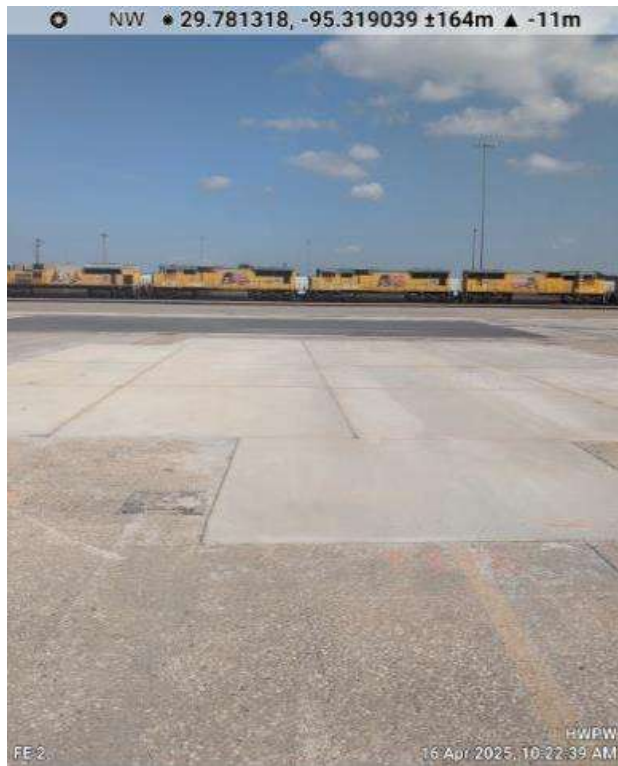
FE-2 weekly inspection of concrete cap.
Reconstructed cap in good condition. No NAPL
observed at FE location. Facing northwest.

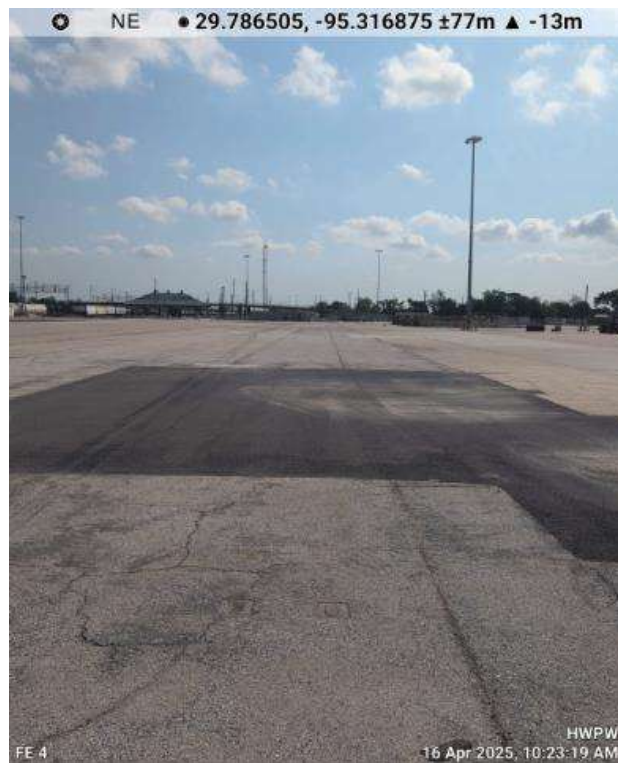
FE-4 weekly inspection of asphalt cap.
Reconstructed cap in good condition. No NAPL
observed at FE location. Facing northeast.

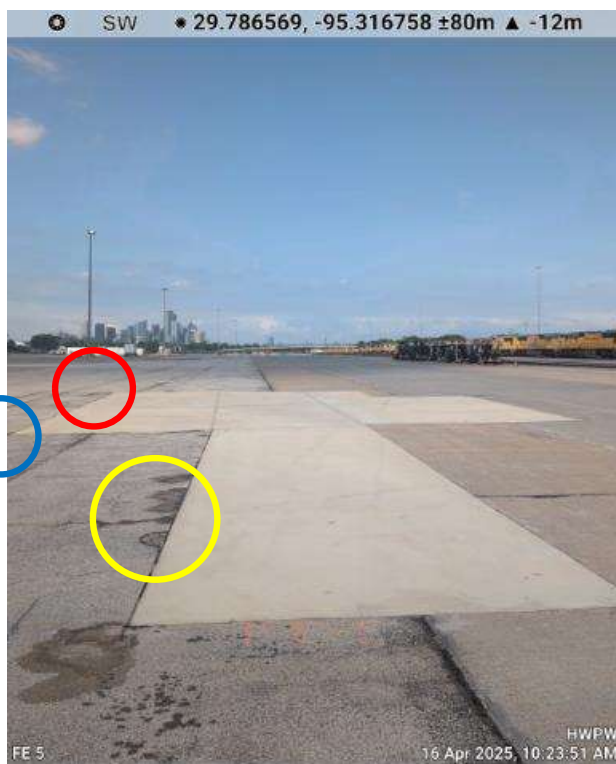
FE-5 weekly inspection of concrete cap.
Reconstructed cap in good condition. No NAPL
observed at FE location. Brown water staining
along the southern joint of FE-5 observed.
Facing southwest.

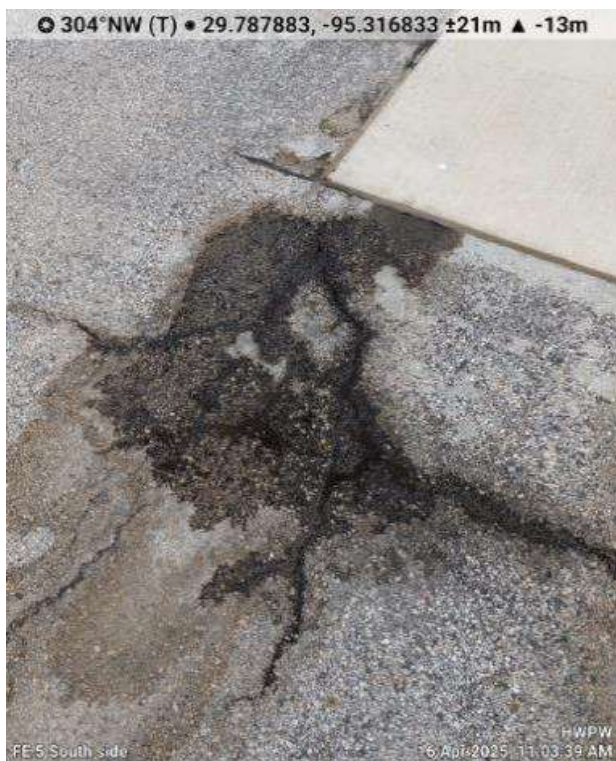
FE-5 brown water staining observed at the
southern corner of the FE reconstructed cap,
located within the red circle on Photo No. 31.

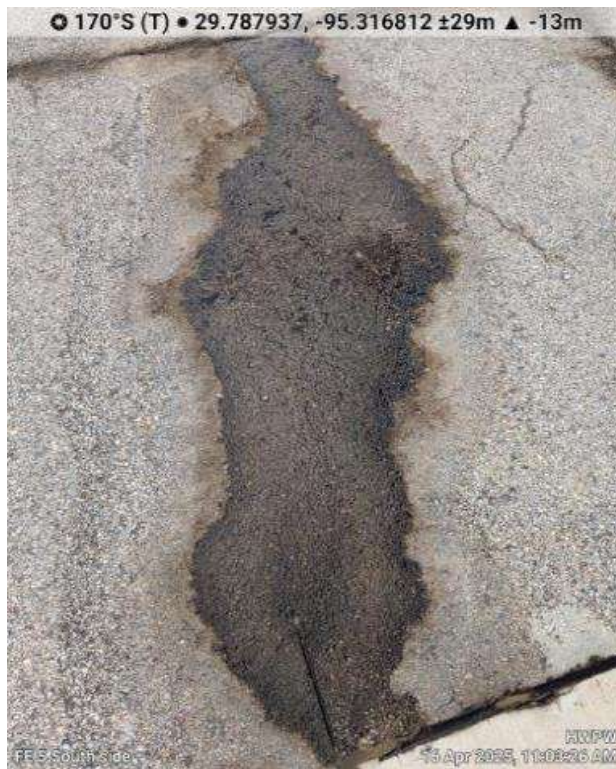
FE-5 brown water staining observed at the southeastern corner of the FE reconstructed cap, located within the blue circle on Photo No. 31.

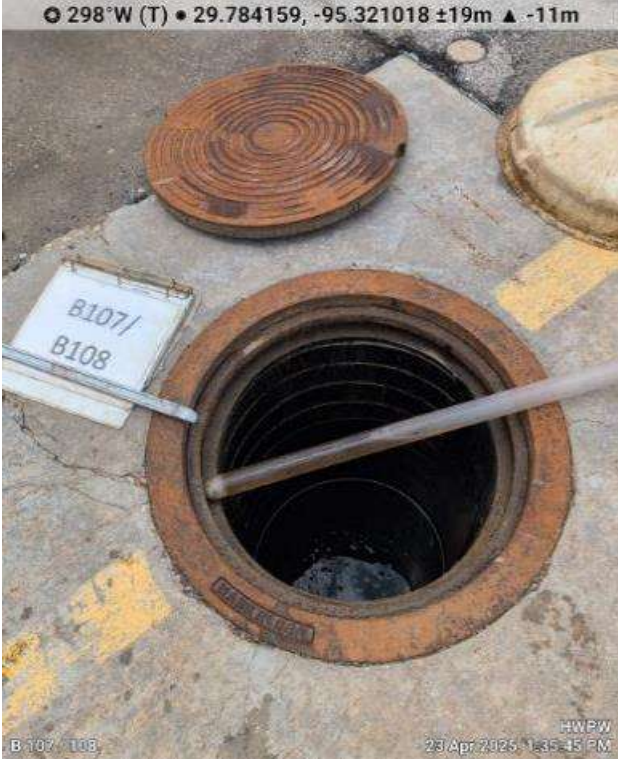
<div> B 107 / 108 </div> <div> HWPW 23 Apr 2025, 1:35:45 PM </div> </div>	
Description: Sump 3 (B107/B108), 30.5 inches of freeboard in sump. Color is brown, and no sheen or odor observed.			
Lat: 29.784159 Long: -95.321018

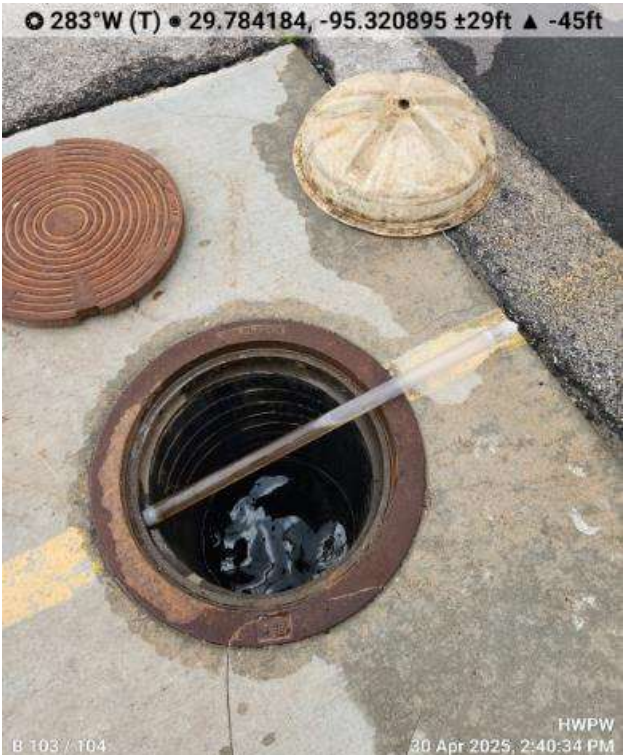
<div> B 103 / 104 HWPW 30 Apr 2025, 2:40:34 PM </div> </div>	
Description: Sump 2 (B103/B104), 28.5 inches of freeboard in sump. Color is brown, and no sheen or odor observed.			
Lat: 29.784184 Long: -95.320895

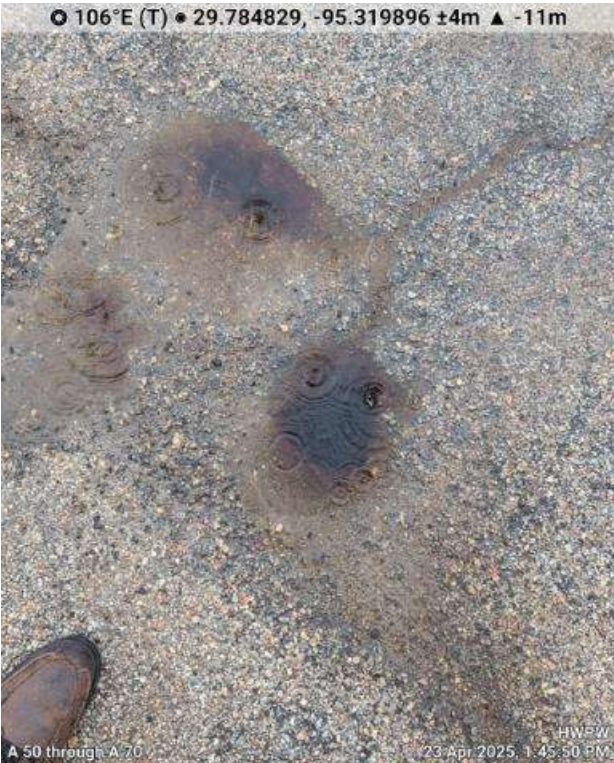
<div> A 50 through A 70 <div> HWPW 23 Apr 2025, 1:45:50 PM </div> </div> </div>	
Description: Brown water staining within the cracks near the joint that runs from A050 through A070. Standing water from recent and on-going rain event.			
Lat: 29.784829 Long: -95.319896

brown staining between stalls A050 and A070 and B014 and B029 during the remaining April inspections (Photo Nos. 113 through 120). UPRR remediation contractor E3 will be mobilized to the site in early May to pressure wash areas of brown water staining and to collect any water generated during pressure washing or from the brown water seeps to be properly disposed.

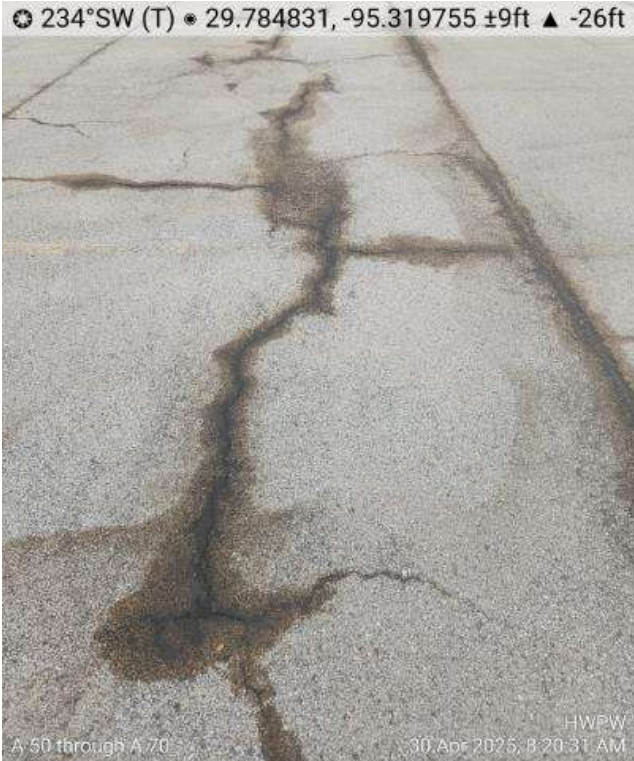
</div> <div> <p> 234°SW (T) • 29.784831, -95.319755 ±9ft ▲ -26ft </p> <p> A 50 through A 70 </p> <p> HWPW 30 Apr 2025, 8:20:31 AM </p> </div> </div>	
Description: Brown water staining along the joint that runs from A050 through A070. Facing southwest.			
Lat: 29.784831 Long: -95.319755
