July 15, 2025

Project No. US0039040.4227

Re: **MONTHLY STATUS UPDATE – ENGLEWOOD INTERMODAL YARD – NAPL COLLECTION
SYSTEM/CONCRETE CAP REPAIRS AND REVISED INTERIM MEASURES WORK PLAN POST-
CONSTRUCTION ACTIVITIES
UNION PACIFIC RAILROAD HOUSTON WOOD PRESERVING WORKS FACILITY
4910 LIBERTY ROAD FACILITY, HOUSTON, TEXAS
POST-CLOSURE CARE PERMIT NO. HW-50343; INDUSTRIAL SWR NO. 31547**

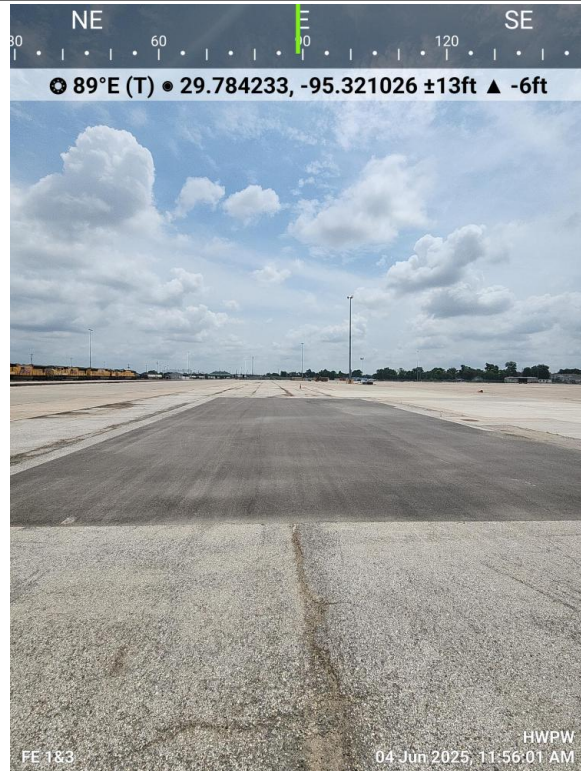
FE-1&3 weekly inspection of asphalt cap.
Reconstructed cap in good condition. No NAPL
observed at FE location. Facing east.

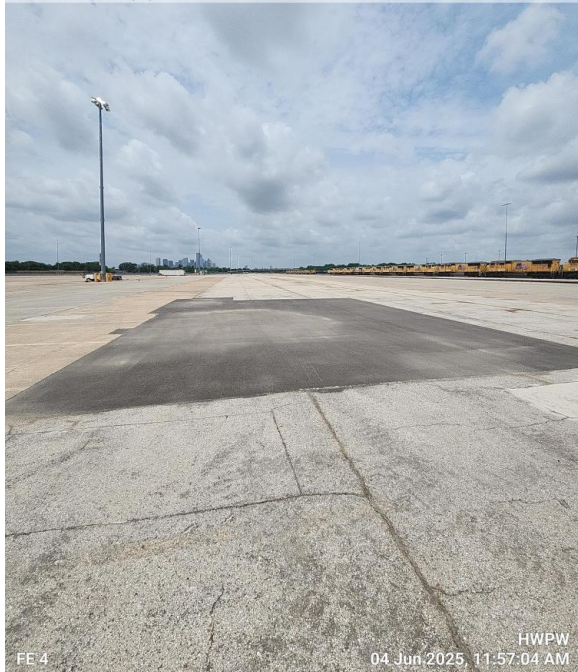
</div>
Description: FE-4 weekly inspection of asphalt cap. Reconstructed cap in good condition. No NAPL observed at FE location. Facing south. Lat: 29.78488 Long: -95.31946			
Photo No. 4	Inspection Date: 06/04/2025		<div><div>NE6090120150SE</div><div>96°E (T) • 29.785312, -95.318766 ±26ft ▲ -13ft</div>

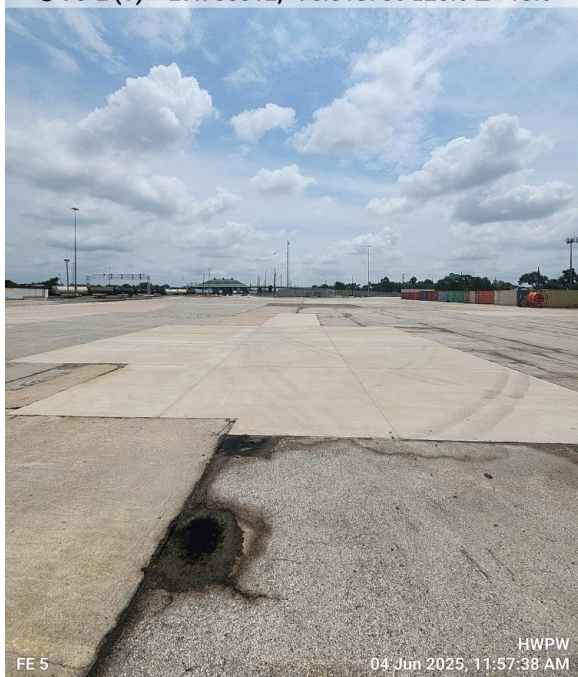
- Brown water staining was observed at FE-5 during the weekly inspection on June 4th along the southern joint of the reconstructed cap (Photo Nos. 4 through 7). Along the joint perpendicular to the western edge of FE-5, standing brown water was observed (Photo No. 5). The standing brown water was only observed in the concrete joint running west from FE-5 and not within the joints immediately adjacent to FE-5. Brown water staining was not observed during the weekly inspection on June 11th due to a rain event. Minimal brown water staining was noted at FE-5 during the weekly inspection on June 18th and June 25th along the southern joint of the reconstructed cap

</div>
Description: FE-5 weekly inspection of concrete cap. Reconstructed cap in good condition. No NAPL observed at FE location. Brown water staining along the southern joint of FE-5 observed. Facing east. Lat: 29.78531 Long: -95.31877

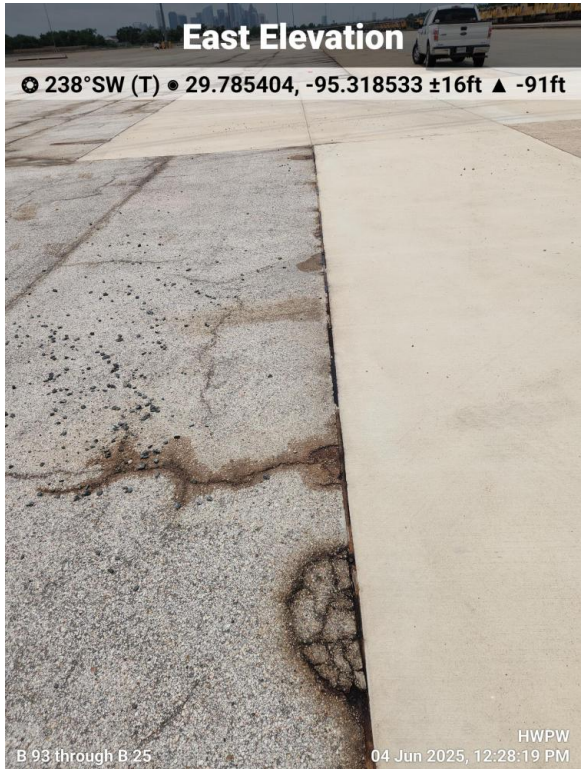
FE-5 brown water staining observed along the eastern joint of the FE reconstructed cap. Standing water was solely along the joint perpendicular to eastern edge of FE-5.

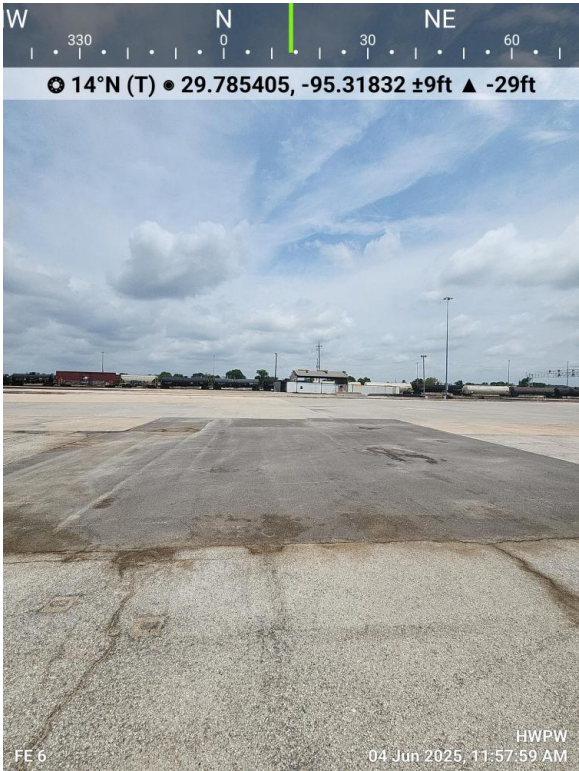
<div>FE 6HWPW04 Jun 2025, 11:57:59 AM</div></div>	
Description: FE-5 brown water staining observed at the southeastern corner of the FE reconstructed cap. Lat: 29.78532 Long: -95.31862		Description: FE-6 weekly inspection of asphalt cap. Reconstructed cap in good condition. No NAPL observed at FE location. Facing north. Lat: 29.7854 Long: -95.31832

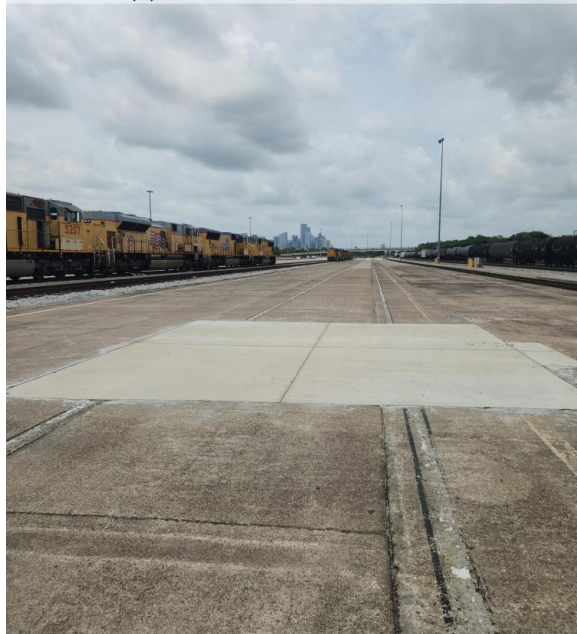
</div> <div>FE 13 HWPW 04 Jun 2025, 12:03:47 PM</div>
Description: FE-13 weekly inspection of concrete cap. Reconstructed cap in good condition. No NAPL observed at FE location. Facing south. Lat: 29.7851 Long: -95.32119

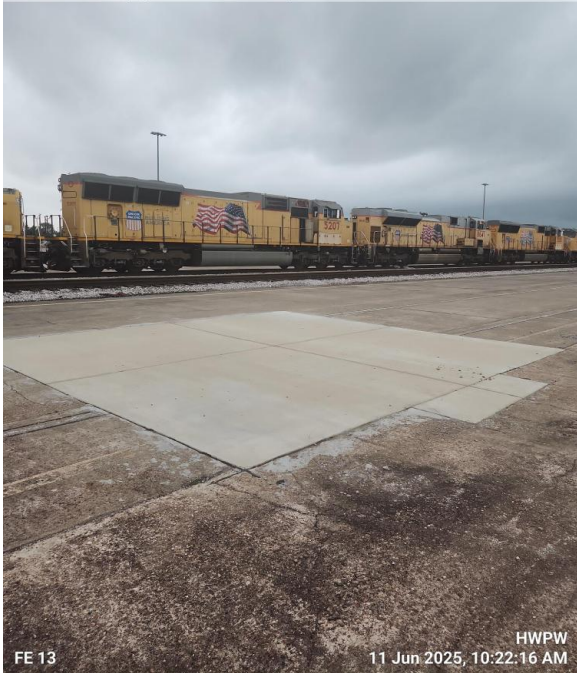
<div>FE 13 HWPW 11 Jun 2025, 10:22:16 AM</div>	
Description: FE-13 weekly inspection of concrete cap. Reconstructed cap in good condition. No NAPL observed at FE location. Facing west. Lat: 29.78509 Long: -95.32124

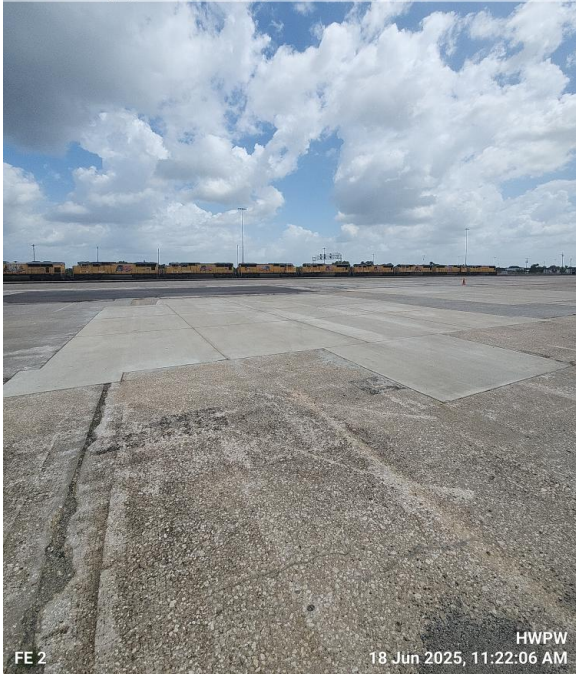
<div>FE 2HWPW 18 Jun 2025, 11:22:06 AM</div></div>
Description: FE-2 weekly inspection of concrete cap. Reconstructed cap in good condition. No NAPL observed at FE location. Facing north. Lat: 29.78406 Long: -95.32078

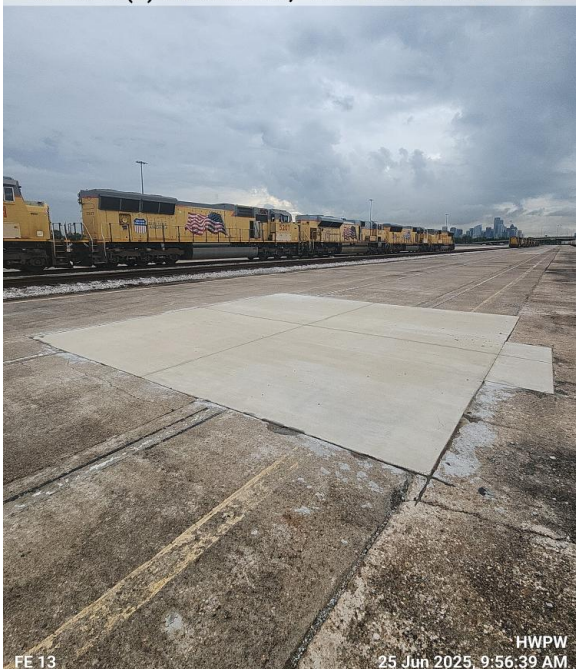
</div> <div>FE 13HWPW 25 Jun 2025, 9:56:39 AM</div>	
Description: FE-13 weekly inspection of concrete cap. Reconstructed cap in good condition. No NAPL observed at FE location. Facing south. Lat: 29.78508 Long: -95.32122

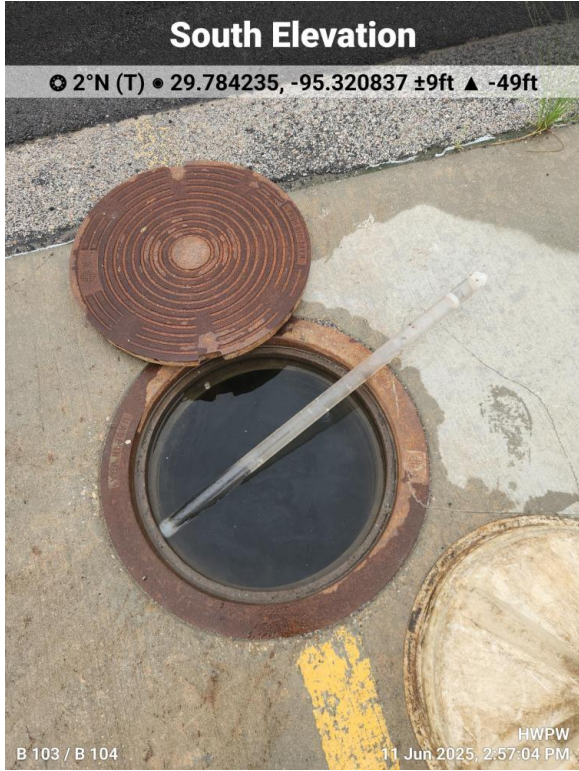
<p>B 103 / B 104 HWPW 11 Jun 2025, 2:57:04 PM</p></div>	
Description: Sump 2 (B103/B104), 0.0 inches of freeboard in sump. Color is tan, and no sheen or odor observed. Lat: 29.78424 Long: -95.32084		<div><p>East Elevation</p><p>291°W (T) • 29.784206, -95.320984 ±23ft ▲ -16ft</p>

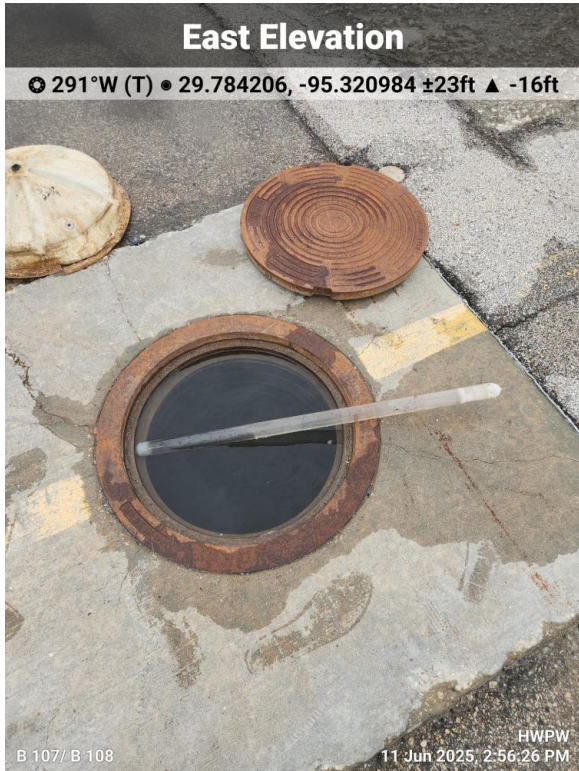
<p>B 107 / B 108 HWPW 11 Jun 2025, 2:56:26 PM</p></div>	
Description: Sump 3 (B107/B108), 0.0 inches of freeboard in sump. Color is tan, and no sheen or odor observed. Lat: 29.78421 Long: -95.32098

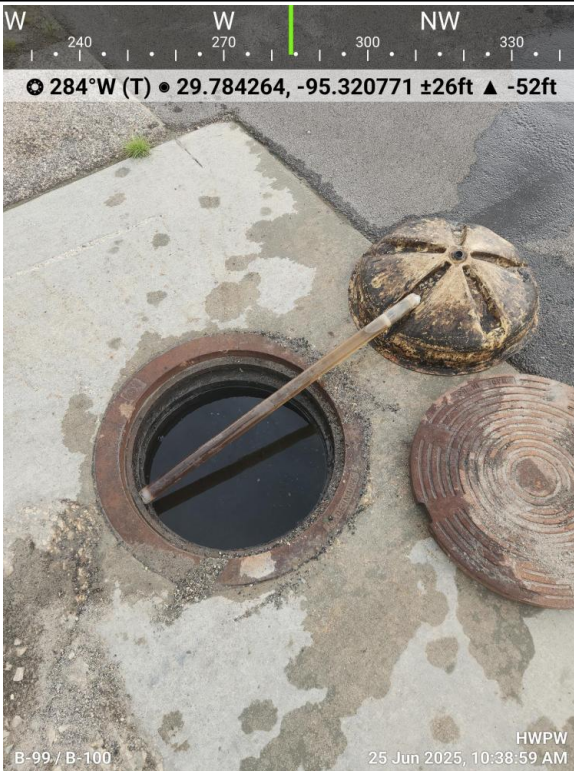
<div>B-99 / B-100</div><div>HWPW 25 Jun 2025, 10:38:59 AM</div></div>
Description: Sump 1 (B99/B100), 0.0 inches of freeboard in sump. Color is dark brown, and no sheen or odor observed. Lat: 29.78426 Long: -95.32077

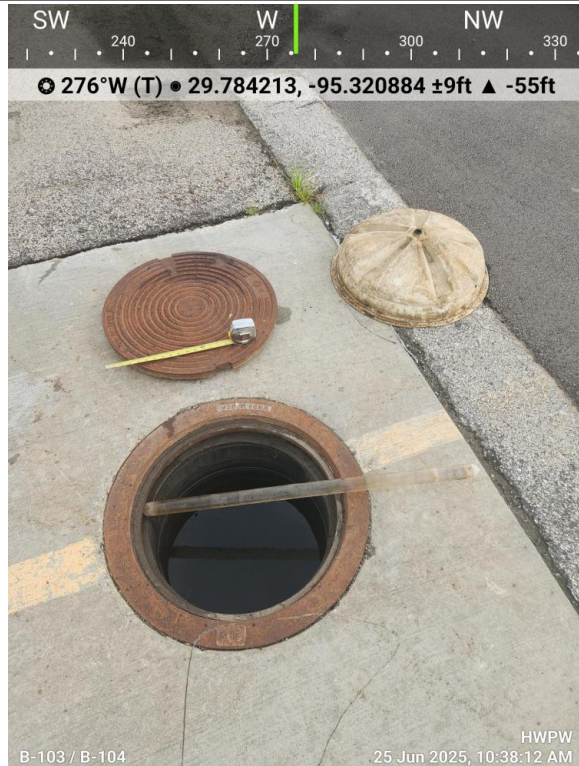
<p>B-103 / B-104</p> <p>HWPW 25 Jun 2025, 10:38:12 AM</p>
Description: Sump 2 (B103/B104), 6.5 inches of freeboard in sump. Color is brown, and no sheen or odor observed. Lat: 29.78421 Long: -95.32088			
Photo No. 64	Inspection Date: 06/25/2025

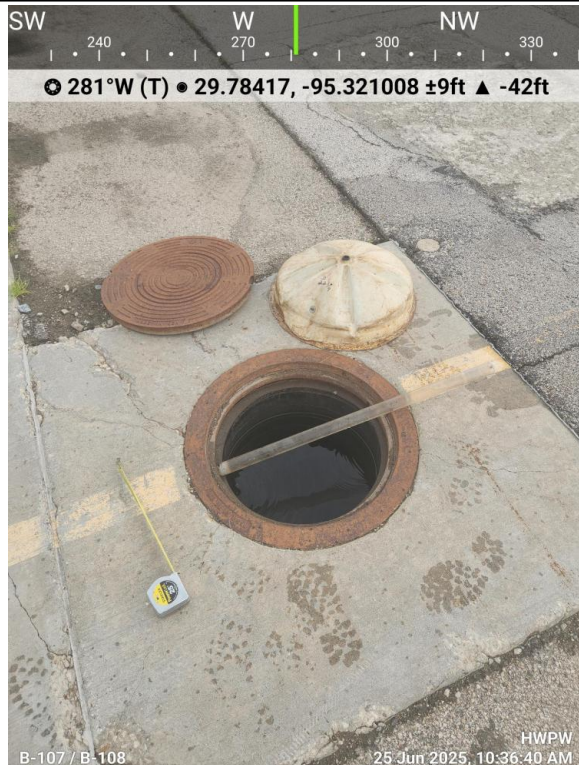
<p>B-107 / B-108</p> <p>HWPW 25 Jun 2025, 10:36:40 AM</p>
Description: Sump 3 (B107/B108), 6.0 inches of freeboard in sump. Color is brown, and no sheen or odor observed. Lat: 29.78417 Long: -95.32101

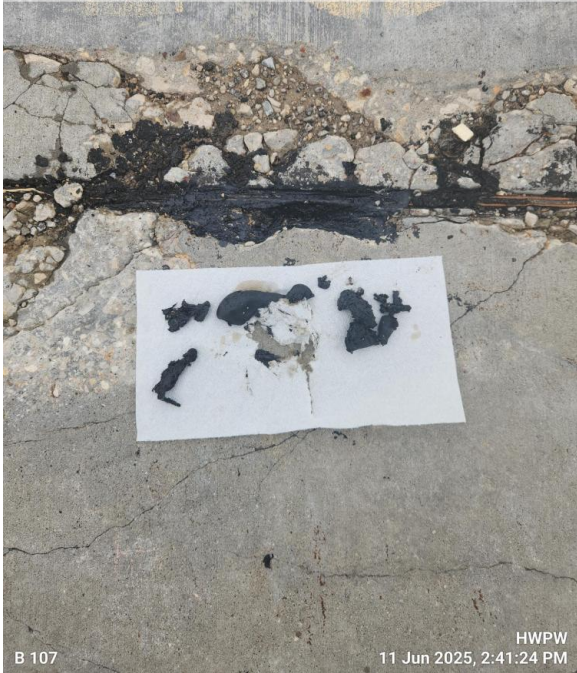
<div>B 107HWPW 11 Jun 2025, 2:41:24 PM</div></div>	
Description: B107 weekly inspection of joint. Surrounding concrete in good condition. Approximately 3 cubic inches of NAPL observed along joint. Lat: 29.78414 Long: -95.3201		Description: B107 weekly inspection of joint. Surrounding concrete in good condition. Approximately 3 cubic inches of NAPL observed along joint. Lat: 29.7842 Long: -95.321

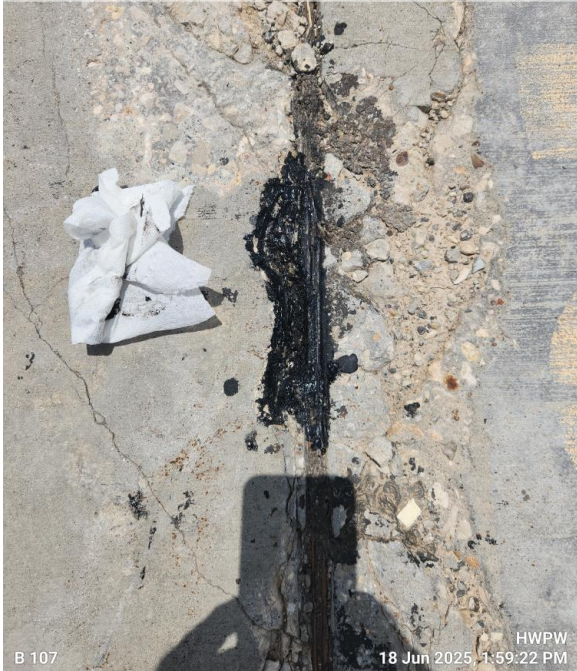
<div>B 107 HWPW 18 Jun 2025, 1:59:22 PM</div></div>
<div>Description: B107 weekly inspection of joint. Surrounding concrete in good condition. Approximately 3 cubic inches of NAPL observed along joint. Lat: 29.78418 Long: -95.32101</div>

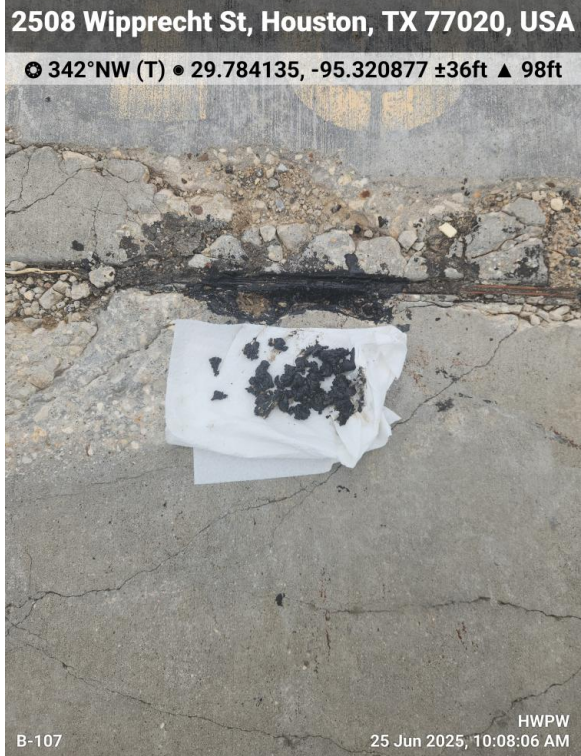
<p>2508 Wipprecht St, Houston, TX 77020, USA</p> <p>⊙ 342°NW (T) • 29.784135, -95.320877 ±36ft ▲ 98ft</p> <p>HWPW B-107 25 Jun 2025, 10:08:06 AM</p>	
Description: B107 weekly inspection of joint. Surrounding concrete in good condition. Approximately 5 cubic inches of NAPL observed along joint.		Description: B107 weekly inspection of joint. Surrounding concrete in good condition. Approximately 5 cubic inches of NAPL observed along joint.	
Lat: 29.78415 Long: -95.32096		Lat: 29.78414 Long: -95.32088

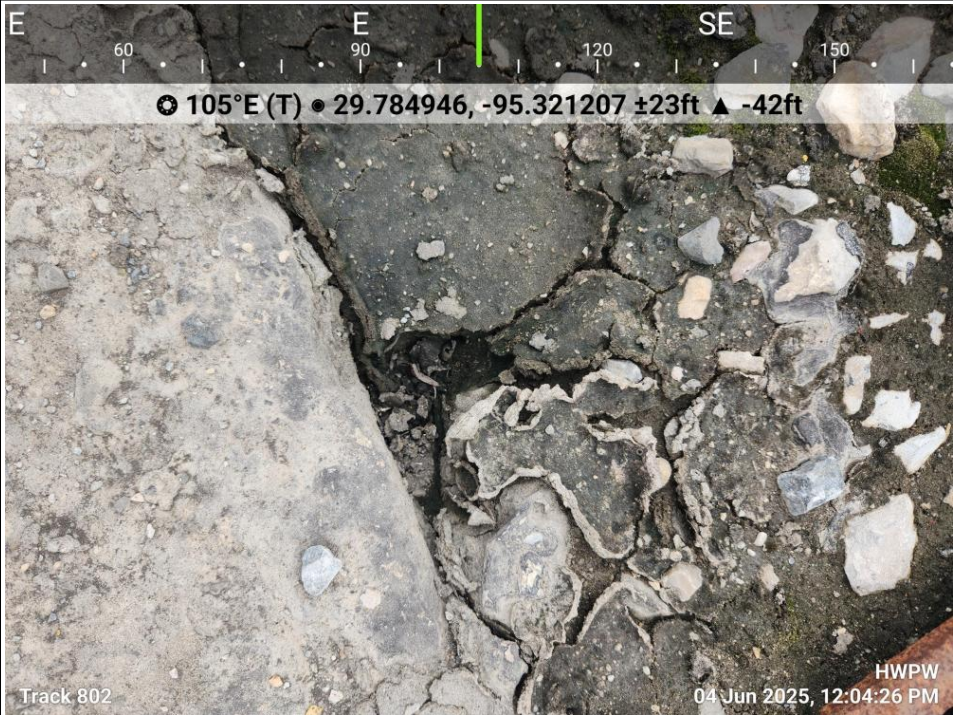
Description: Track 802 weekly inspection of track. Surrounding concrete and ballast in good condition. No NAPL observed at location. Lat: 29.78495 Long: -95.32121			
Photo No. 74	Inspection Date: 06/11/2025

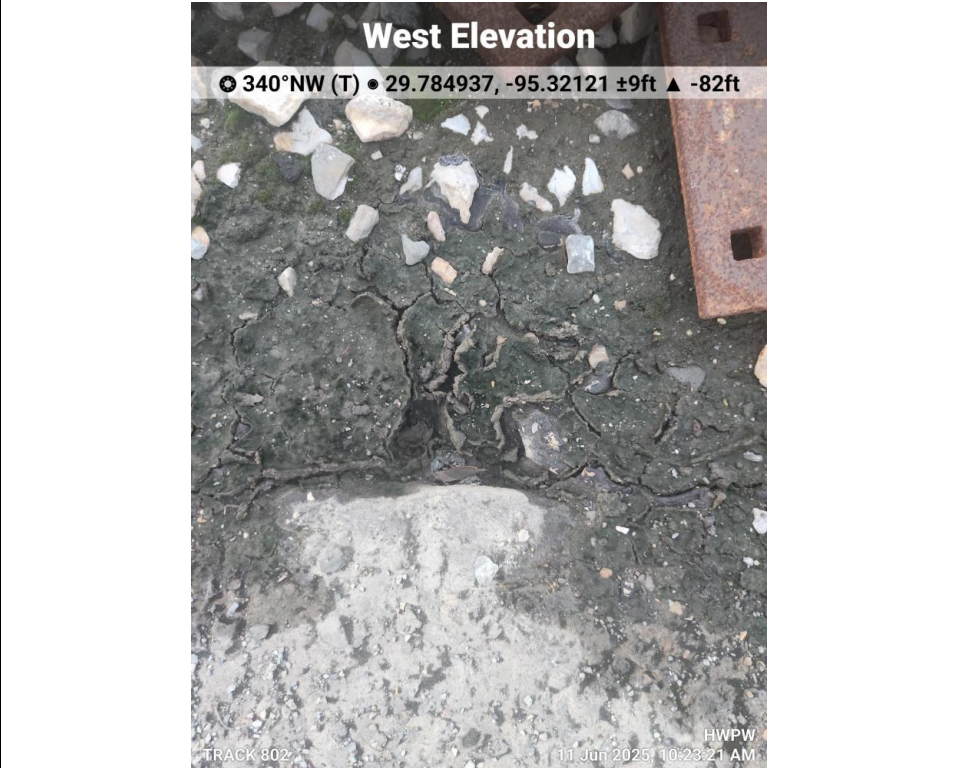
Description: Track 802 weekly inspection of track. Surrounding concrete and ballast in good condition. No NAPL observed at location. Lat: 29.78494 Long: -95.32121

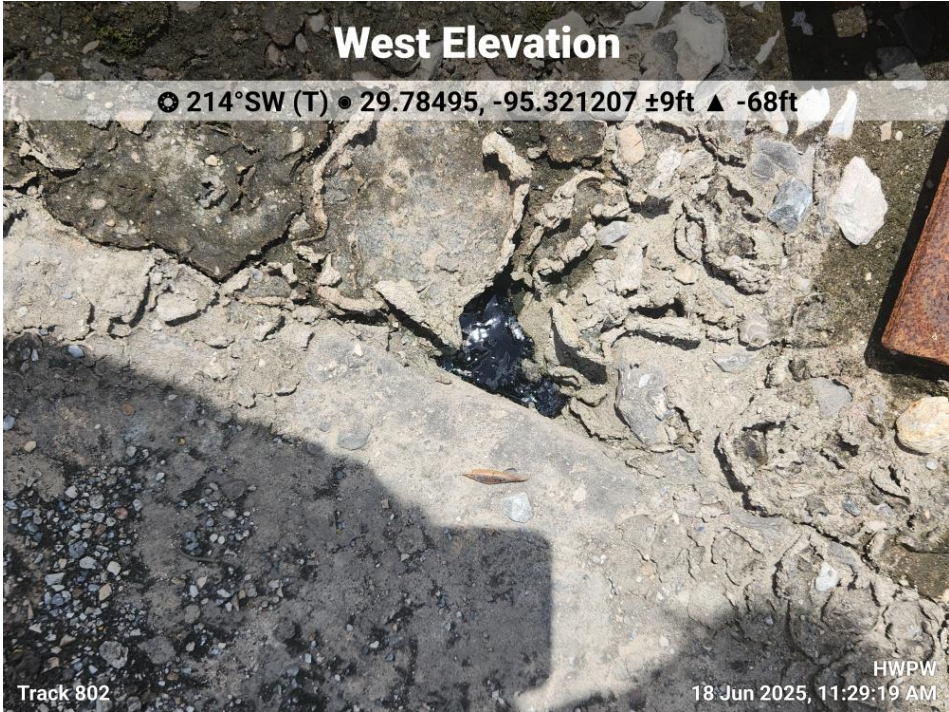
<div>Track 802</div> <div>HWPW 18 Jun 2025, 11:29:19 AM</div>
Description: Track 802 weekly inspection of track. Surrounding concrete and ballast in good condition. Approximately 1 cubic inches of NAPL observed along joint. Lat: 29.78495 Long: -95.32121			
Photo No. 76	Inspection Date: 06/18/2025		<div>North Elevation</div> <div>☉ 137°SE (T) • 29.784941, -95.321201 ±9ft ▲ -88ft</div>
