Project No. US0039040.4227

**Re: MONTHLY STATUS UPDATE – ENGLEWOOD INTERMODAL YARD – REVISED INTERIM MEASURES
WORK PLAN POST-CONSTRUCTION AND NAPL COLLECTION SYSTEM/CONCRETE CAP REPAIR
INSPECTIONS
UNION PACIFIC RAILROAD HOUSTON WOOD PRESERVING WORKS FACILITY
4910 LIBERTY ROAD FACILITY, HOUSTON, TEXAS
POST-CLOSURE CARE PERMIT NO. HW-50343; INDUSTRIAL SWR NO. 31547**

WSP USA Inc. (WSP), on behalf of Union Pacific Railroad Company (UPRR), is pleased to provide this monthly status update for December 2025 summarizing the weekly inspections being conducted at the Englewood Intermodal Yard (EIY) concrete cap area within the UPRR Houston Wood Preserving Works Facility (the Site). The weekly inspections are being conducted to evaluate the post-construction Focused Excavations as detailed in the *Revised Interim Measures Work Plan – Englewood Intermodal Yard (EIY)*, (Revised IMWP) dated October 20, 2023. In addition, a summary of the weekly Non-Aqueous Phase Liquid (NAPL) Collection System and concrete cap area inspections conducted at the EIY is provided as requested by the Texas Commission on Environmental Quality (TCEQ) in a letter dated March 20, 2018. Below is a summary of the weekly

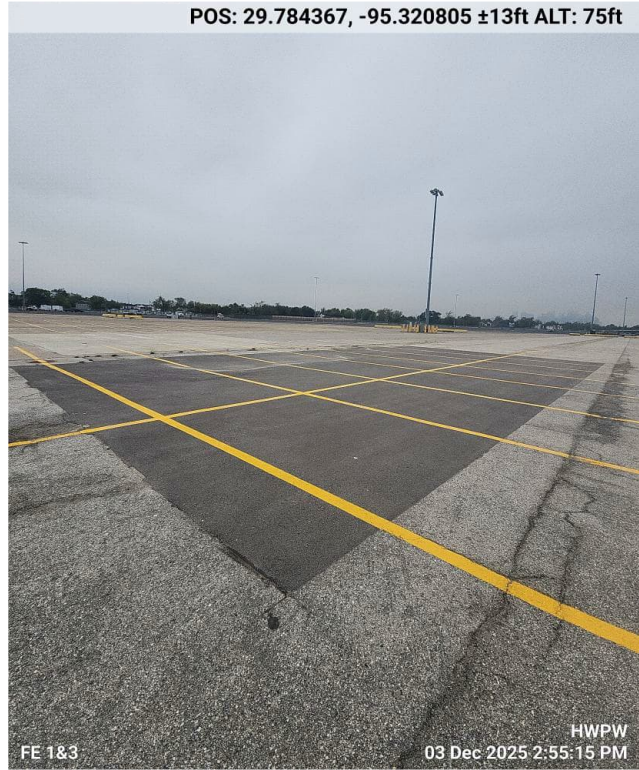
FE-1&3 weekly inspection of asphalt cap. Reconstructed cap in good condition. No NAPL observed at FE location. Facing southwest.

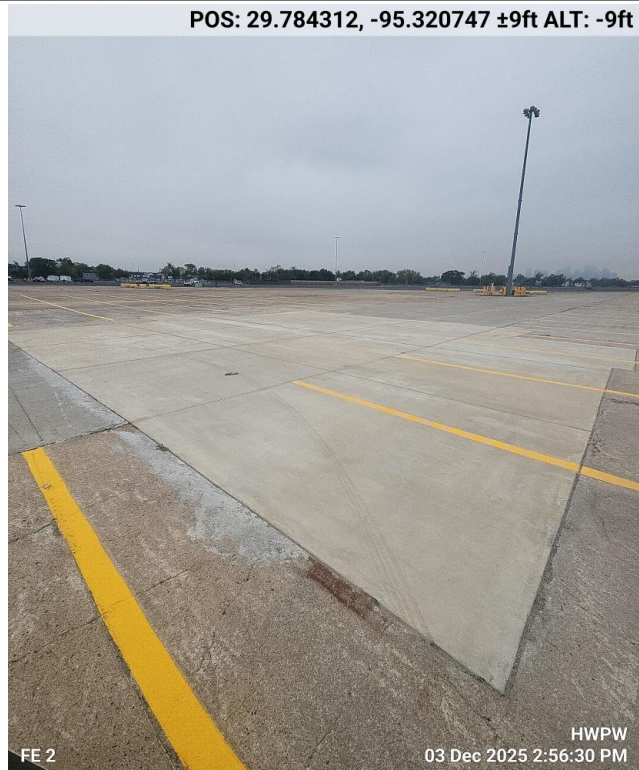
Photo No. 2
Inspection Date: 12/03/2025

FE-2 weekly inspection of concrete cap. Reconstructed cap in good condition. No NAPL observed at FE location. Facing southwest.

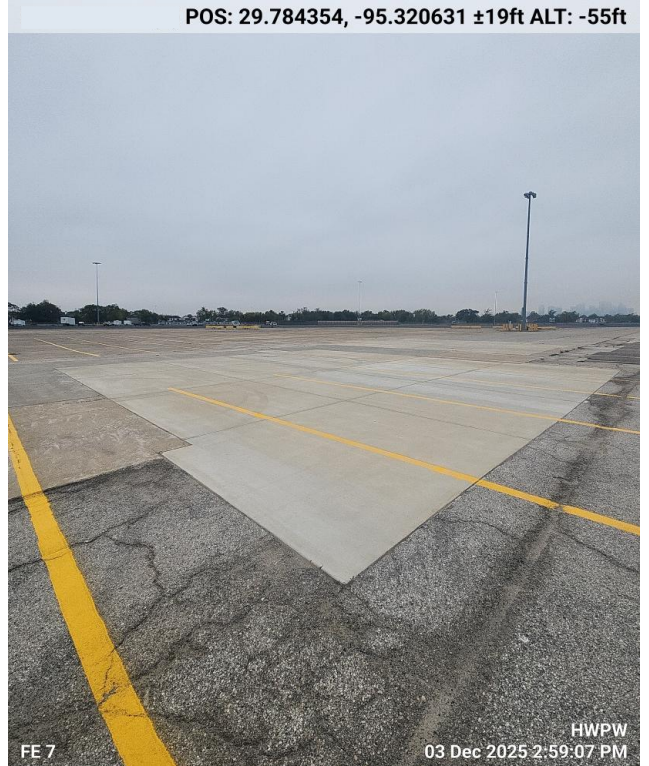
Photo No.: 6
Inspection Date: 12/03/2025

FE-7 weekly inspection of concrete cap. Reconstructed cap in good condition. No NAPL observed at FE location. Facing southwest.

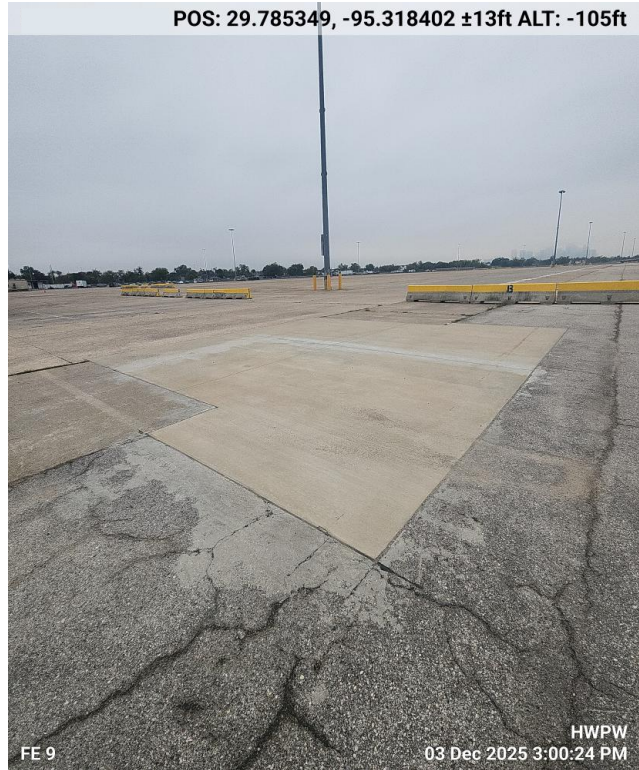
Photo No.: 8
Inspection Date: 12/03/2025

FE-9 weekly inspection of concrete cap. Reconstructed cap in good condition. No NAPL observed at FE location. Facing southwest.

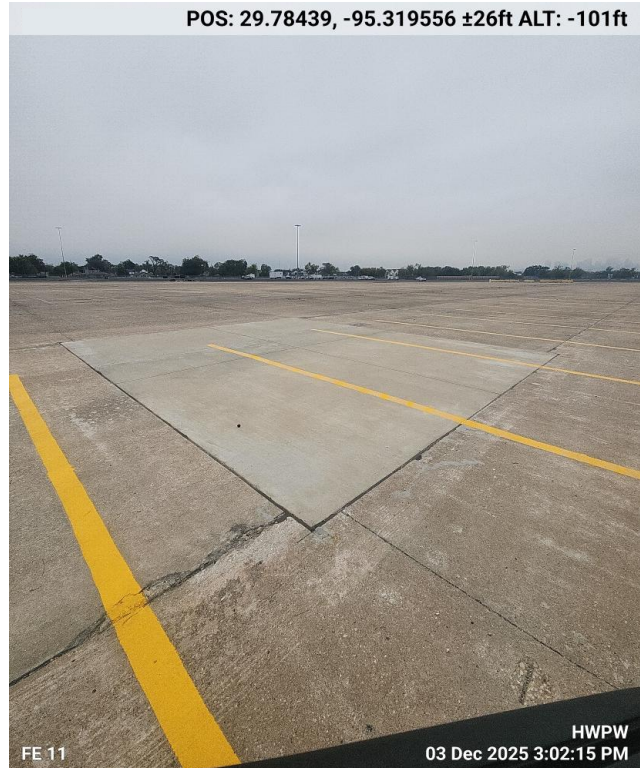
Photo No. 10	Inspection Date: 12/03/2025
------------------------	---------------------------------------

FE-11 weekly inspection of concrete cap.
Reconstructed cap in good condition. No NAPL observed at FE location. Facing southwest.

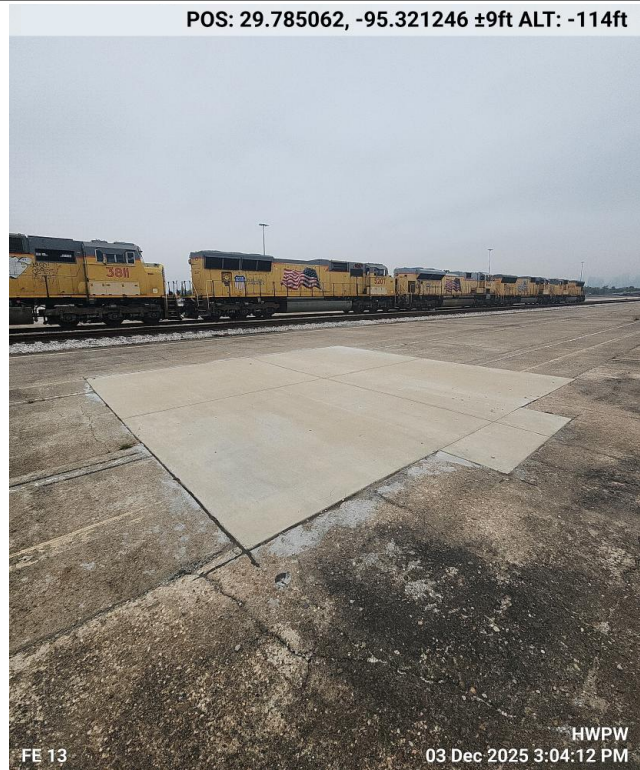
Photo No. 12
Inspection Date: 12/03/2025

FE-13 weekly inspection of concrete cap. Reconstructed cap in good condition. No NAPL observed at FE location. Facing southwest.

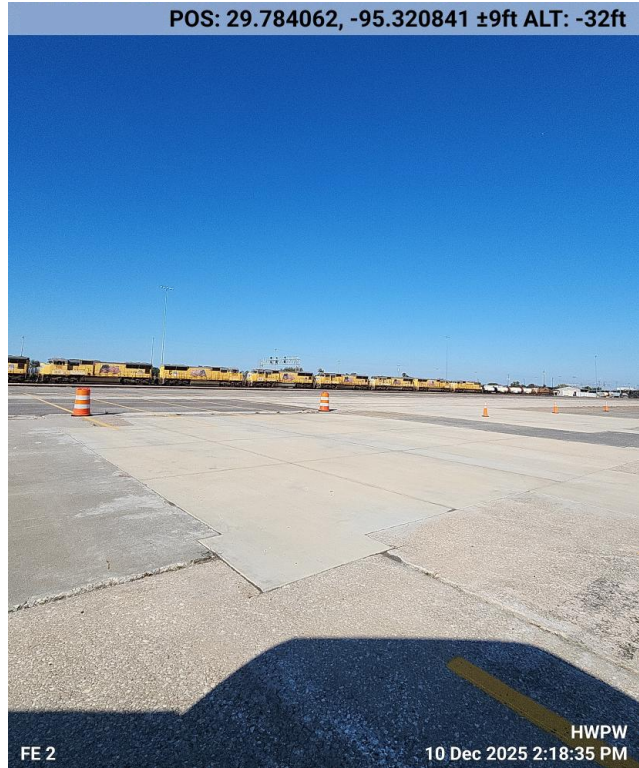
Photo No.: 14
Inspection Date: 12/10/2025

FE-2 weekly inspection of concrete cap. Reconstructed cap in good condition. No NAPL observed at FE location. Facing northeast.

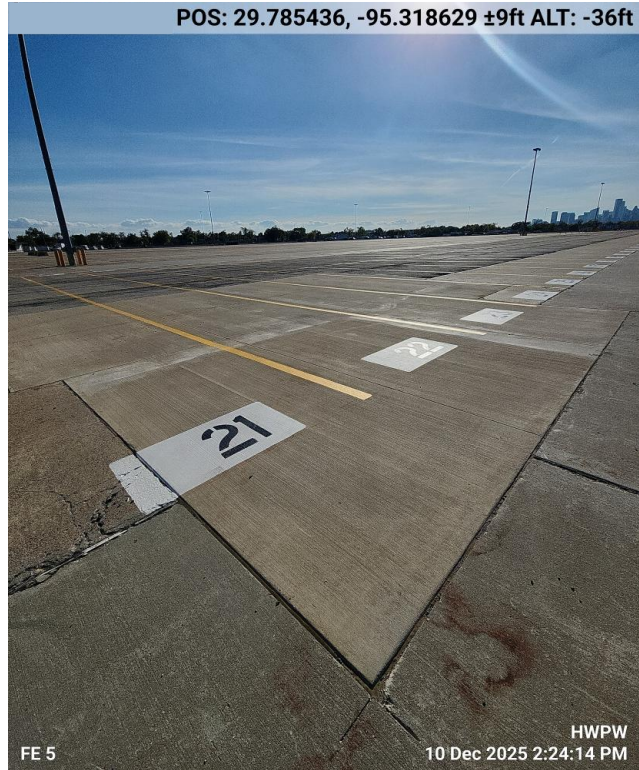
Photo No.
16

FE-5 weekly inspection of concrete cap.
Reconstructed cap in good condition. No NAPL observed at FE location. Facing southwest.

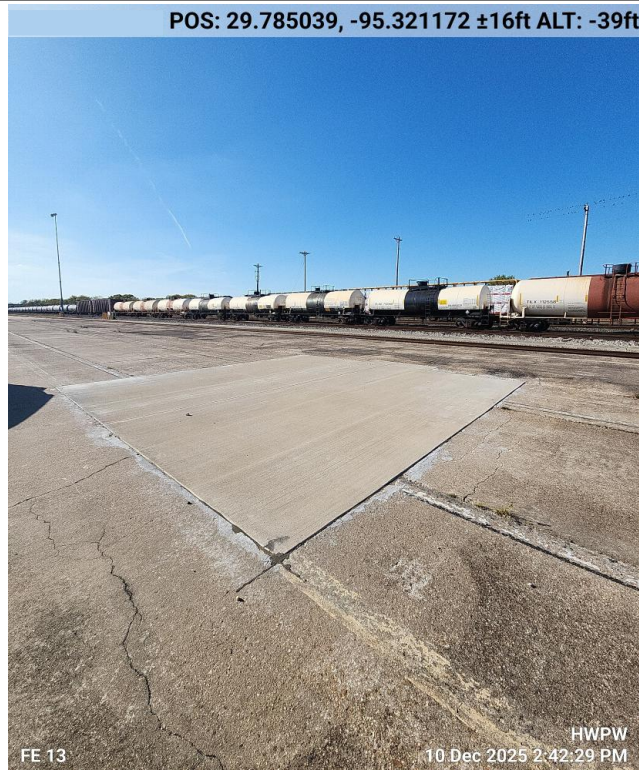
Photo No.
24

FE-13 weekly inspection of concrete cap.
Reconstructed cap in good condition. No NAPL observed at FE location. Facing northwest.

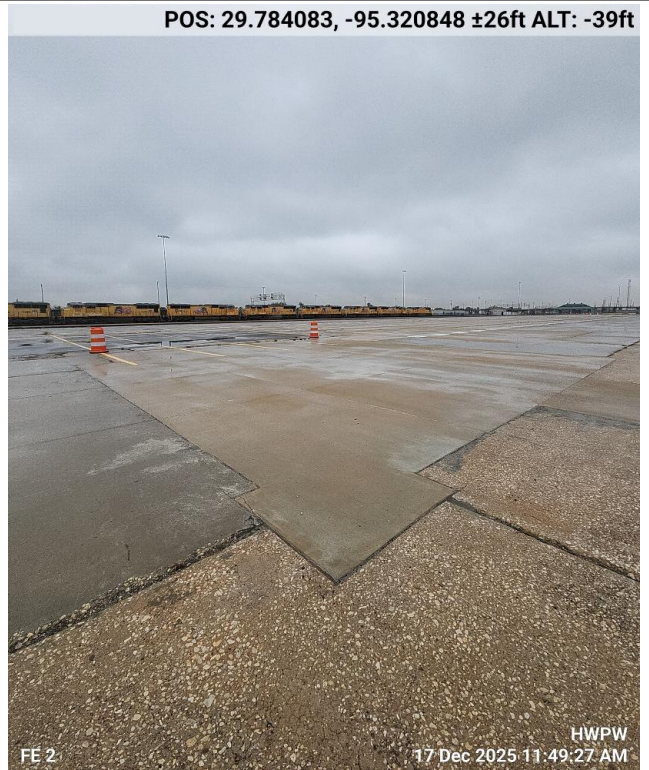
Photo No.: 26
Inspection Date: 12/17/2025

FE-2 weekly inspection of concrete cap. Reconstructed cap in good condition. No NAPL observed at FE location. Standing water from recent rain event. Facing northeast.

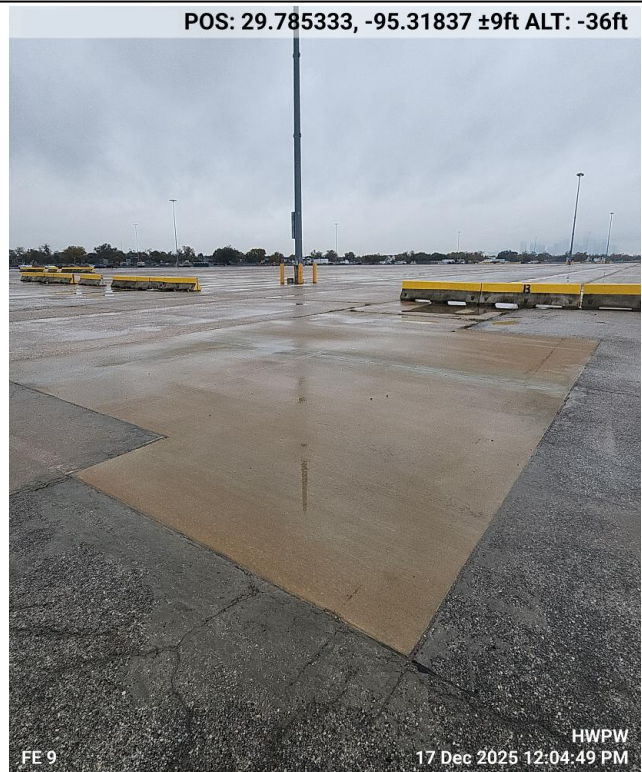
Photo No. 32
Inspection Date: 12/17/2025

FE-9 weekly inspection of concrete cap. Reconstructed cap in good condition. No NAPL observed at FE location. Standing water from recent rain event. Facing southwest.

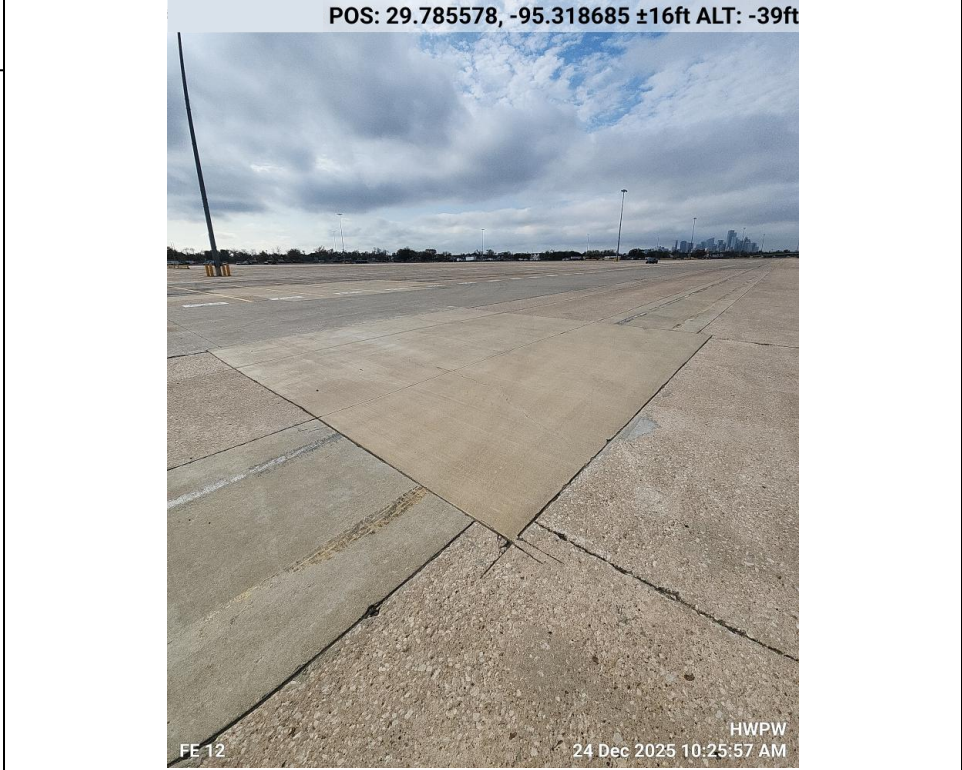
Photo No.
47

FE-12 weekly inspection of concrete cap. Reconstructed cap in good condition. No NAPL observed at FE location. Facing southwest.

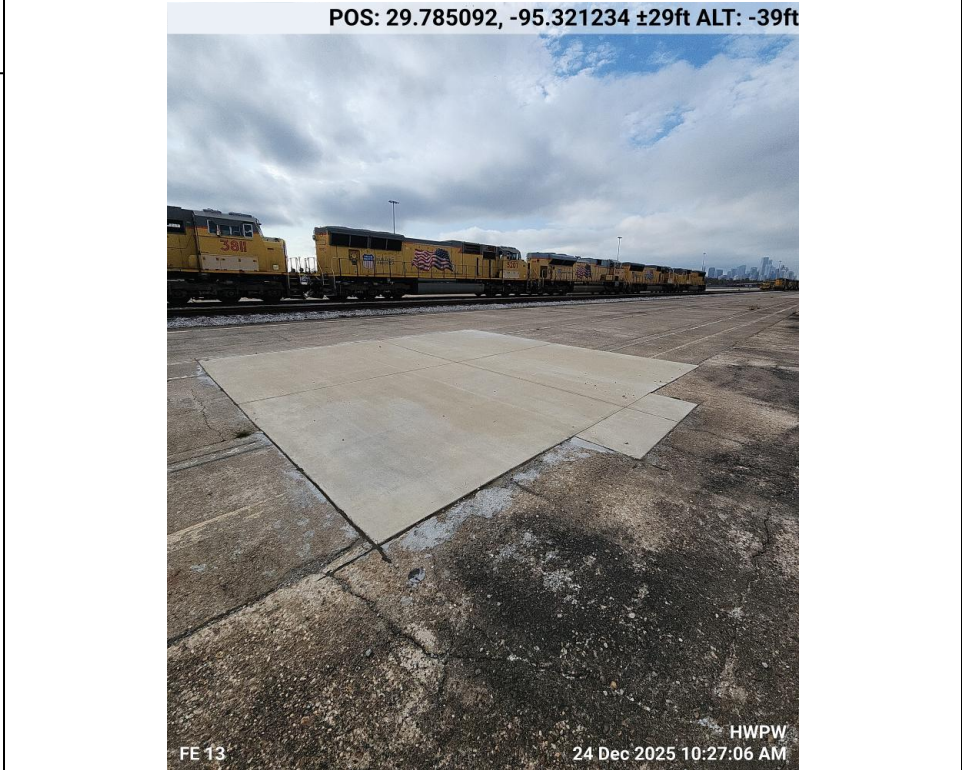
FE-13 weekly inspection of concrete cap. Reconstructed cap in good condition. No NAPL observed at FE location. Facing southwest.

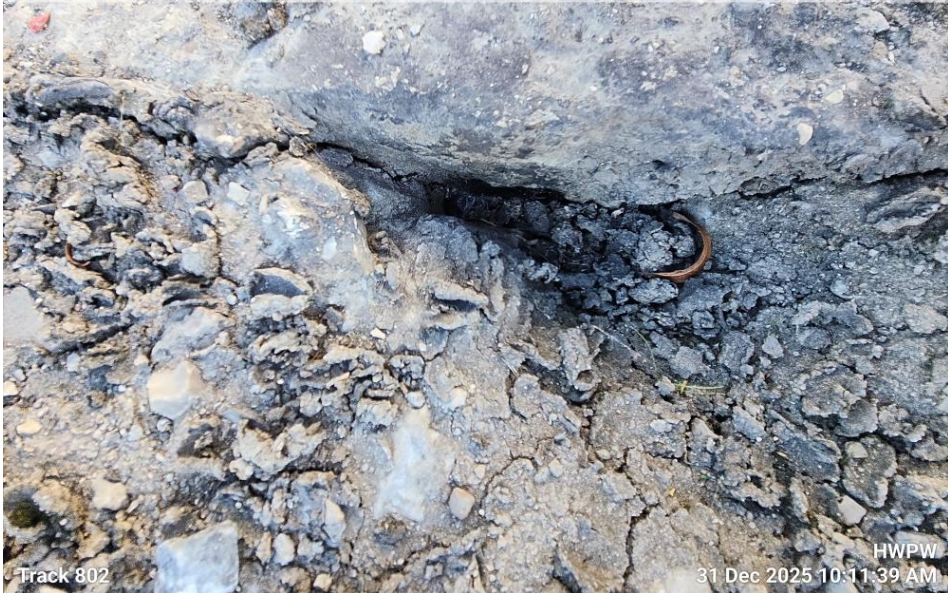
Photo No. 85	Inspection Date: 12/31/2025	BRG: 319°NW (T) POS: 29.784926, -95.321224 ±19ft ALT: -42ft

Track 802 HWPW 31 Dec 2025 10:11:39 AM
Description: Track 802 weekly inspection of track. Surrounding concrete and ballast in good condition. No active NAPL seep observed along joint. Lat: 29.78493 Long: -95.32122

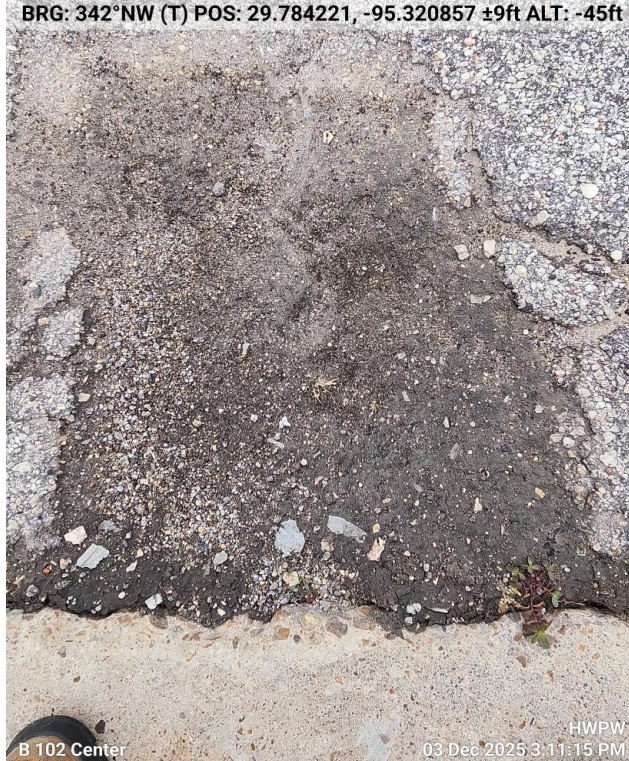
Photo No. 86	Inspection Date: 12/03/2025	BRG: 342°NW (T) POS: 29.784221, -95.320857 ±9ft ALT: -45ft

B 102 Center HWPW 03-Dec 2025 3:11:15 PM
Description: B102 Center weekly inspection of previously identified seep. Surrounding asphalt in good condition. No active NAPL seep observed along joint. Lat: 29.78422 Long: -95.32086

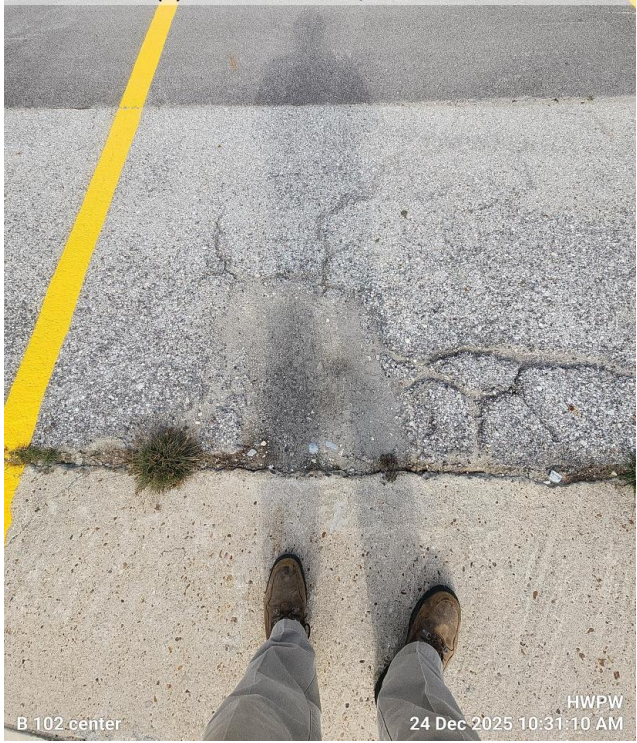
Photo No. 89	Inspection Date: 12/24/2025	BRG: 330°NW (T) POS: 29.784251, -95.32085 ±9ft ALT: -39ft

<p>Description: B102 Center weekly inspection of previously identified seep. Surrounding asphalt in good condition. No active NAPL seep observed along joint.</p> <p>Lat: 29.78425 Long: -95.32085</p>
------------------------	---------------------------------------	---

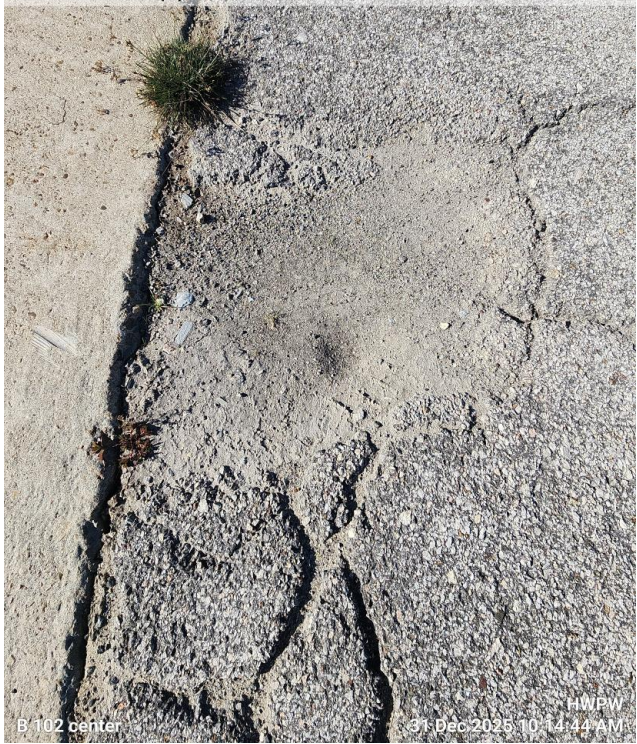
Photo No. 90	Inspection Date: 12/31/2025	BRG: 245°SW (T) POS: 29.784238, -95.320845 ±9ft ALT: -39ft

<p>Description: B102 Center weekly inspection of previously identified seep. Surrounding asphalt in good condition. No active NAPL seep observed along joint.</p> <p>Lat: 29.78424 Long: -95.32085</p>
------------------------	---------------------------------------	---
