November 14, 2025

Project No. US0039040.4227

**Re: MONTHLY STATUS UPDATE – ENGLEWOOD INTERMODAL YARD – REVISED INTERIM MEASURES
WORK PLAN POST-CONSTRUCTION AND NAPL COLLECTION SYSTEM/CONCRETE CAP REPAIR
INSPECTIONS
UNION PACIFIC RAILROAD HOUSTON WOOD PRESERVING WORKS FACILITY
4910 LIBERTY ROAD FACILITY, HOUSTON, TEXAS
POST-CLOSURE CARE PERMIT NO. HW-50343; INDUSTRIAL SWR NO. 31547**

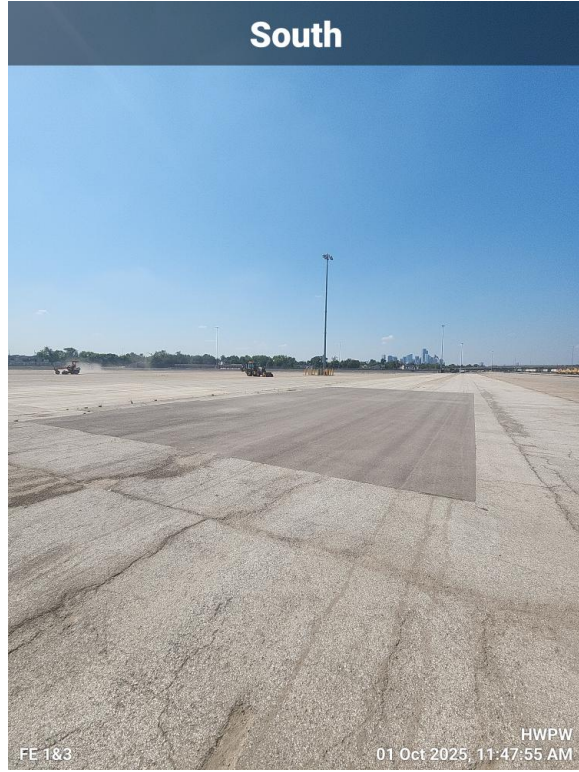
Photo No. 1
Inspection Date: 10/01/2025

Description:
FE-1&3 weekly inspection of asphalt cap. Reconstructed cap in good condition. No NAPL observed at FE location. Facing south.
Lat: 29.78438
Long: -95.32075

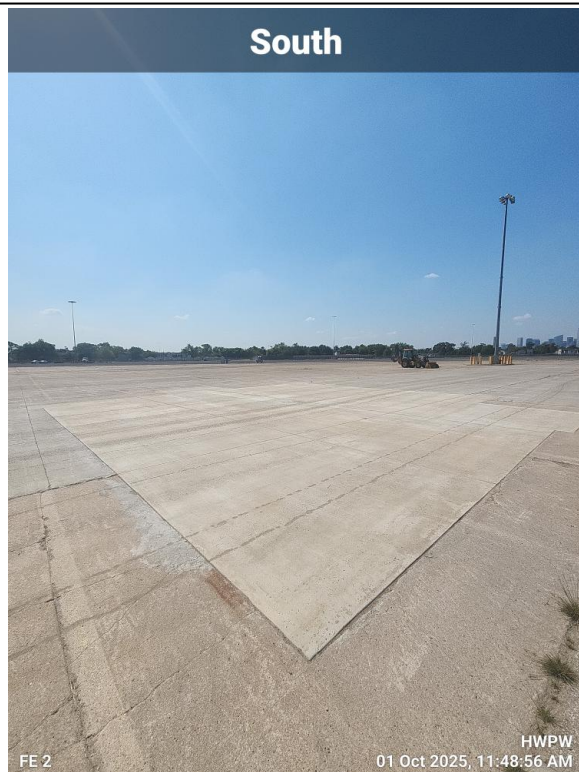
Photo No. 2
Inspection Date: 10/01/2025

Description:
FE-2 weekly inspection of concrete cap. Reconstructed cap in good condition. No NAPL observed at FE location. Facing south.
Lat: 29.78428
Long: -95.32076

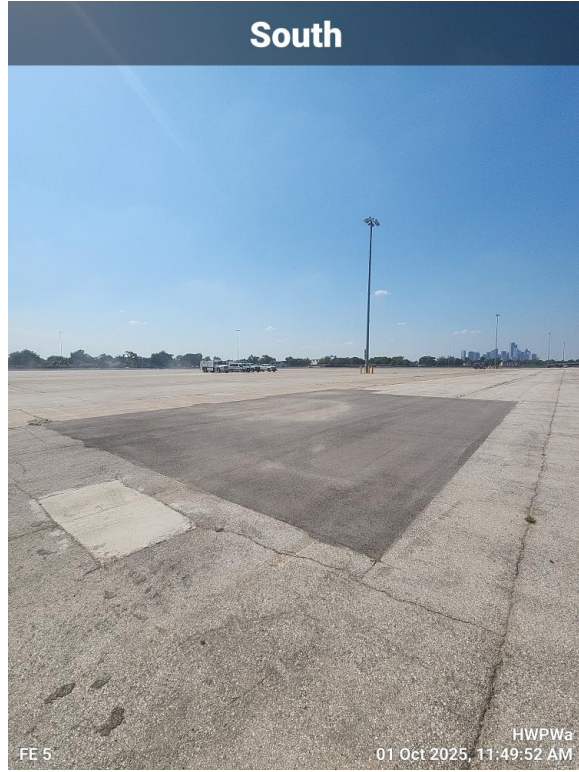
FE-4 weekly inspection of asphalt cap. Reconstructed cap in good condition. No NAPL observed at FE location. Facing south. Mislabeled FE-5.

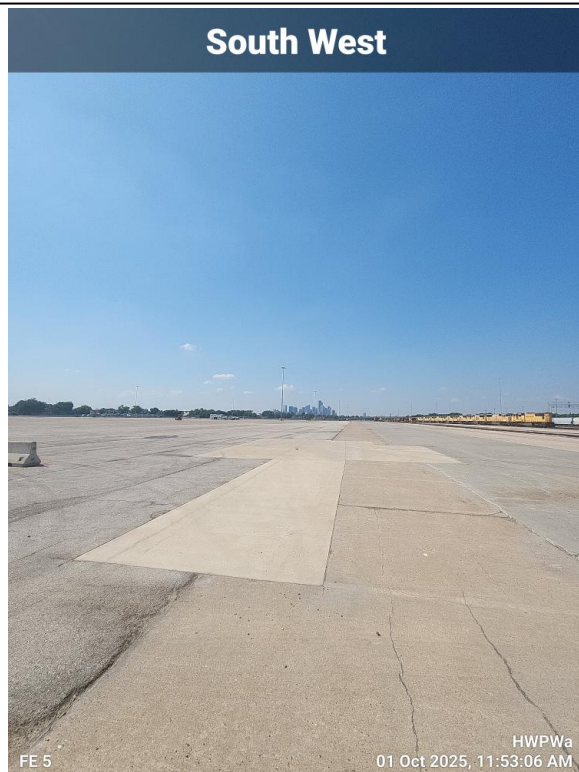
Photo No.: 4
Inspection Date: 10/01/2025

FE-5 weekly inspection of concrete cap. Reconstructed cap in good condition. No NAPL observed at FE location. Facing southwest.

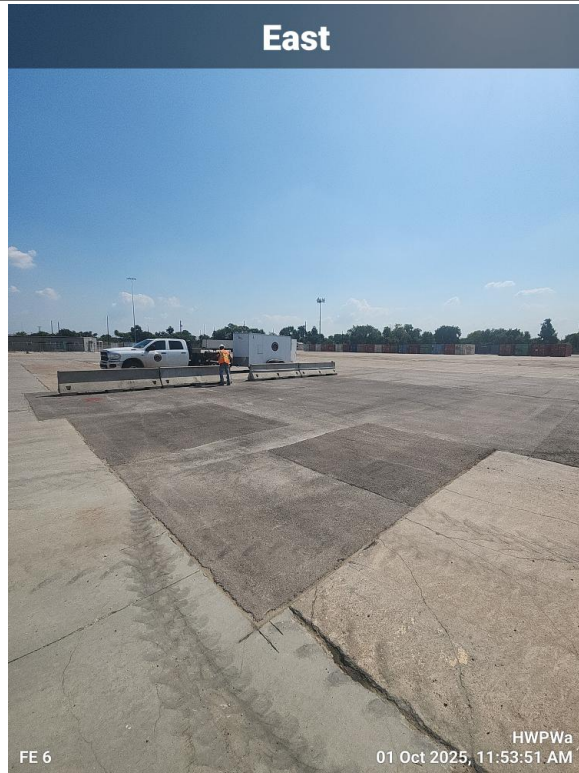
FE-6 weekly inspection of asphalt cap. Reconstructed cap in good condition. No NAPL observed at FE location. Facing east.

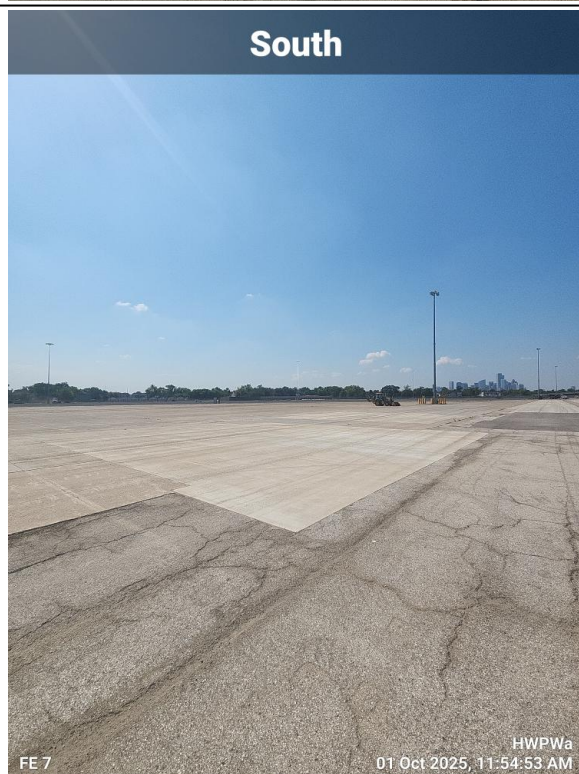
Photo No. 6	Inspection Date: 10/01/2025
-----------------------	---------------------------------------

FE-7 weekly inspection of concrete cap. Reconstructed cap in good condition. No NAPL observed at FE location. Facing south.

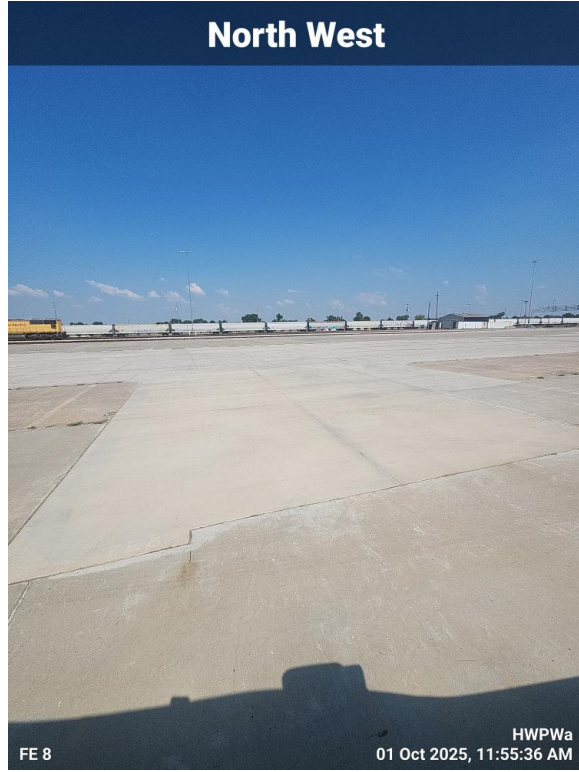
FE-8 weekly inspection of concrete cap. Reconstructed cap in good condition. No NAPL observed at FE location. Facing northwest.

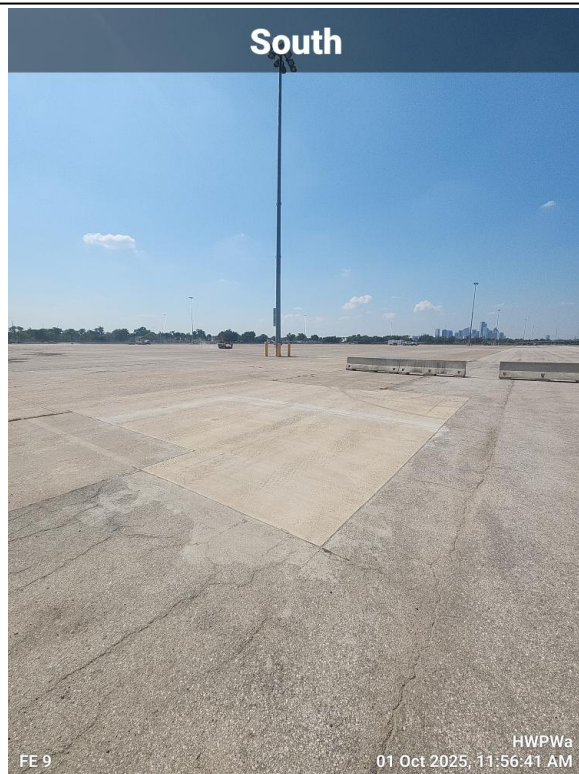
Photo No. 8
Inspection Date: 10/01/2025

FE-9 weekly inspection of concrete cap. Reconstructed cap in good condition. No NAPL observed at FE location. Facing south.

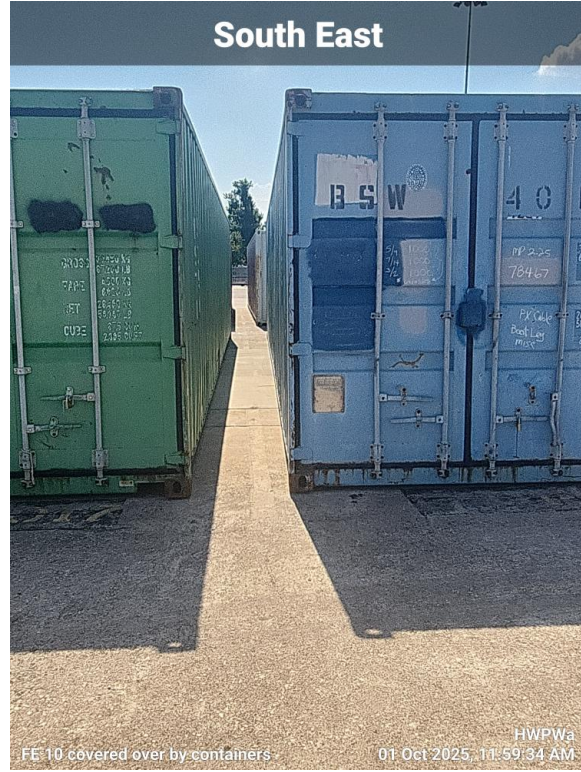
FE-10 weekly inspection of concrete cap.
Reconstructed cap in good condition. No NAPL
observed at FE location. Facing southeast.

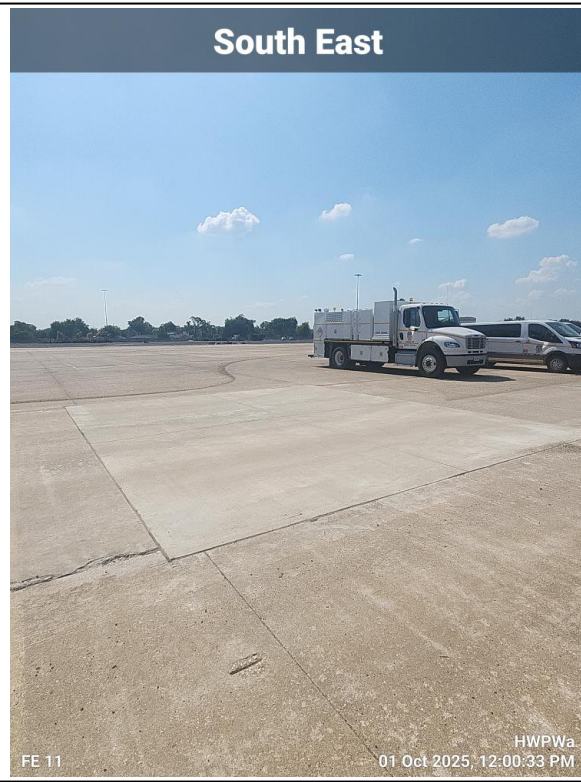
Photo No.
10

FE-11 weekly inspection of concrete cap.
Reconstructed cap in good condition. No NAPL
observed at FE location. Facing southeast.

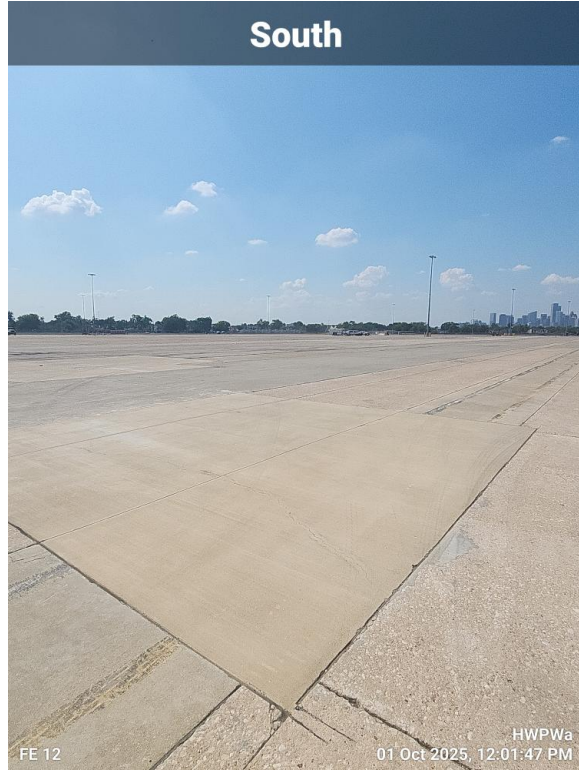
FE-12 weekly inspection of concrete cap. Reconstructed cap in good condition. No NAPL observed at FE location. Facing south.

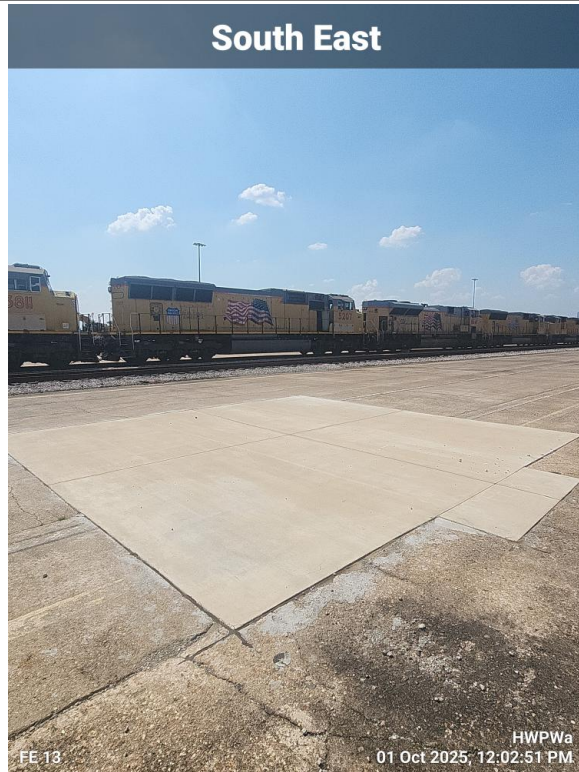
Photo No. 12	Inspection Date: 10/01/2025
------------------------	---------------------------------------

FE-13 weekly inspection of concrete cap. Reconstructed cap in good condition. No NAPL observed at FE location. Facing southeast.

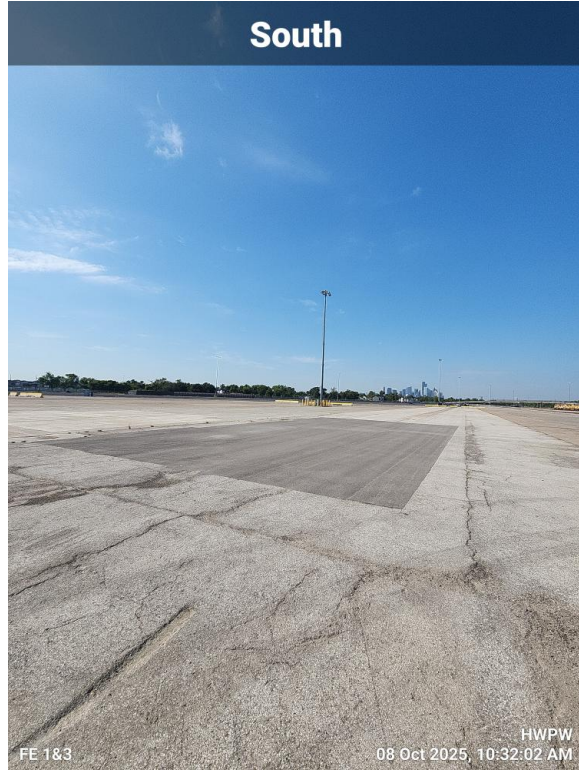
Photo No.: 13
Inspection Date: 10/08/2025

Description:
FE-1&3 weekly inspection of asphalt cap. Reconstructed cap in good condition. No NAPL observed at FE location. Facing south.
Lat: 29.78439
Long: -95.32069

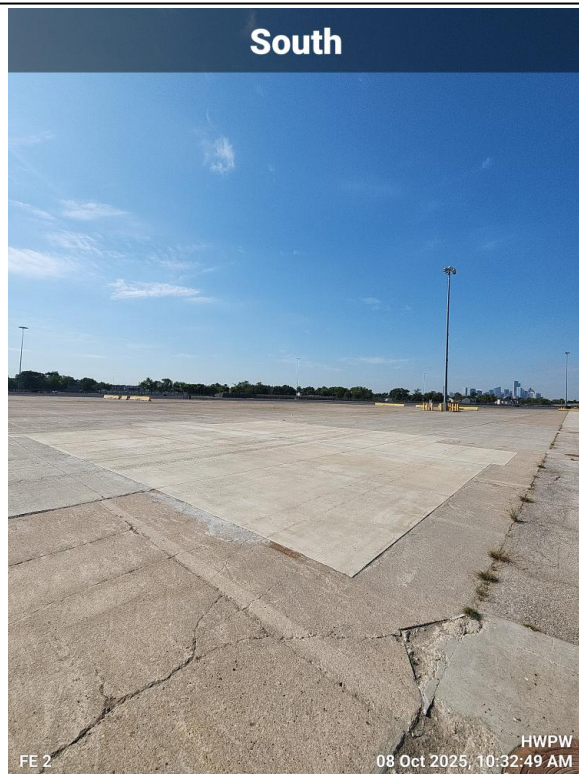
Photo No.: 14
Inspection Date: 10/08/2025

Description:
FE-2 weekly inspection of concrete cap. Reconstructed cap in good condition. No NAPL observed at FE location. Facing south.
Lat: 29.7843
Long: -95.32075

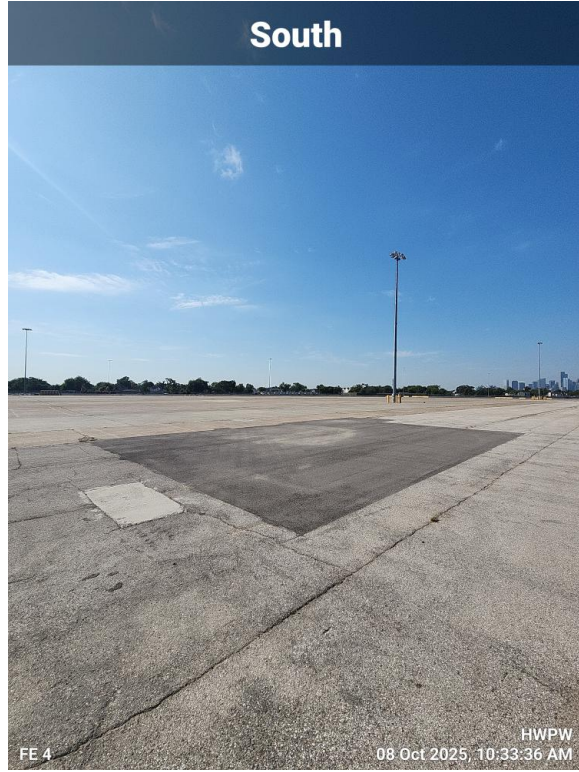
Photo No.: 15
Inspection Date: 10/08/2025

Description:
FE-4 weekly inspection of asphalt cap. Reconstructed cap in good condition. No NAPL observed at FE location. Facing south.
Lat: 29.78494
Long: -95.31951

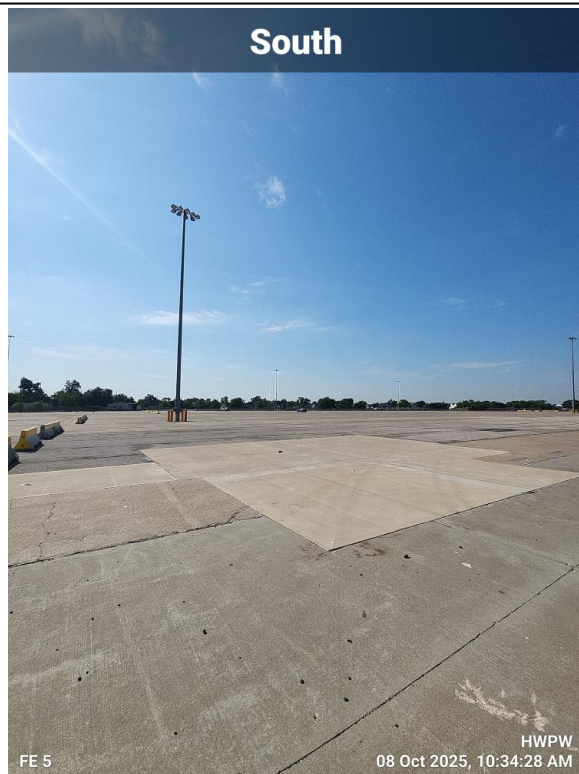
Photo No.: 16
Inspection Date: 10/08/2025

Description:
FE-5 weekly inspection of concrete cap. Reconstructed cap in good condition. No NAPL observed at FE location. Facing south.
Lat: 29.78542
Long: -95.31862

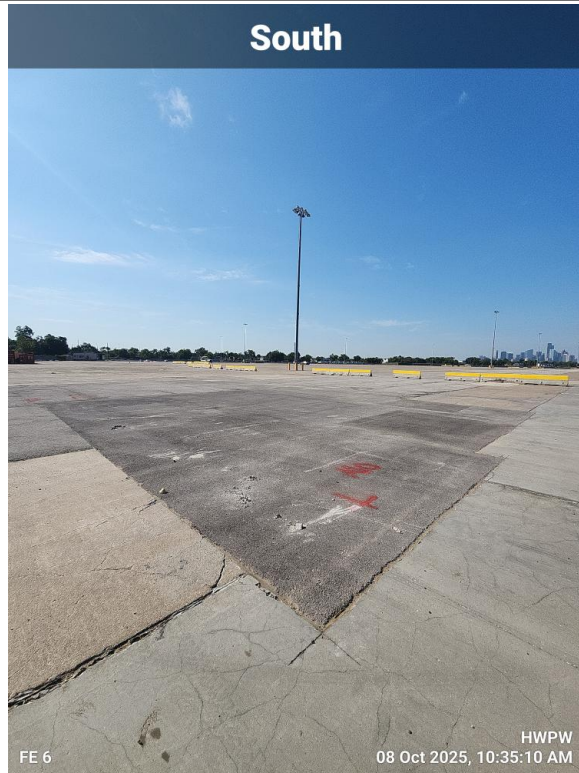
FE-6 weekly inspection of asphalt cap. Reconstructed cap in good condition. No NAPL observed at FE location. Facing south.

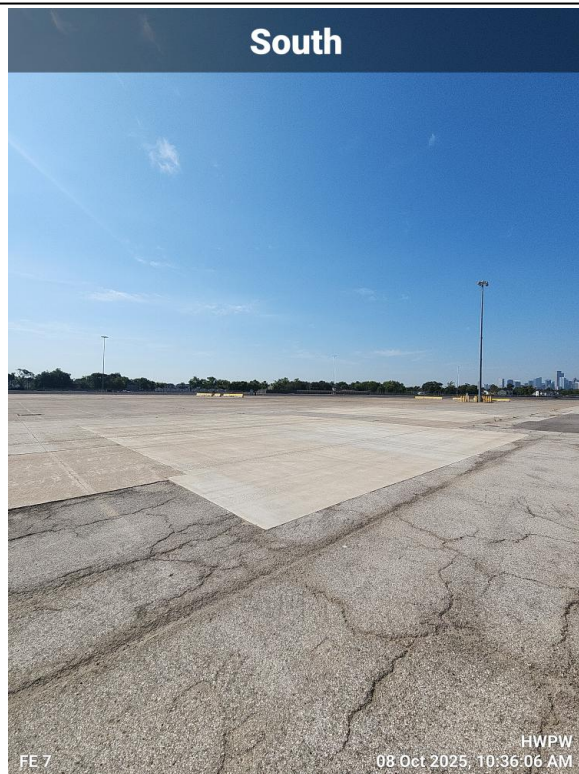
Photo No.: 18
Inspection Date: 10/08/2025

FE-7 weekly inspection of concrete cap. Reconstructed cap in good condition. No NAPL observed at FE location. Facing south.

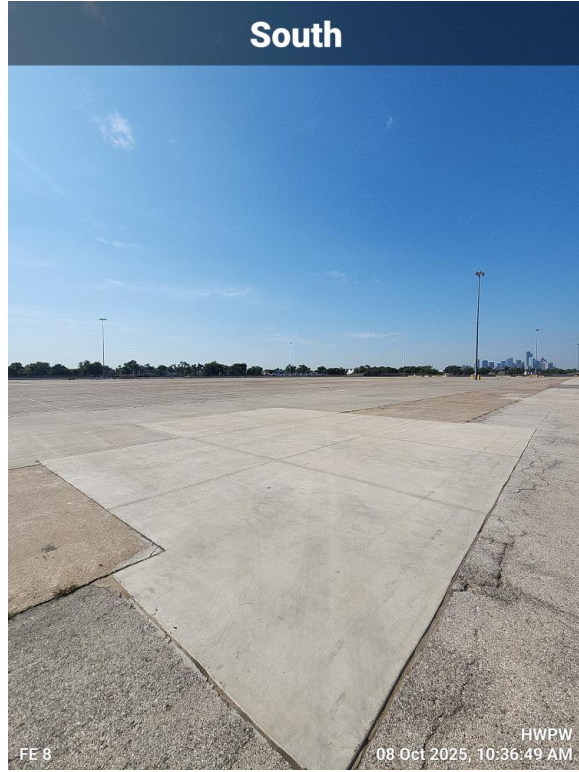
Photo No.: 19
Inspection Date: 10/08/2025

Description:
FE-8 weekly inspection of concrete cap. Reconstructed cap in good condition. No NAPL observed at FE location. Facing south.
Lat: 29.785
Long: -95.31907

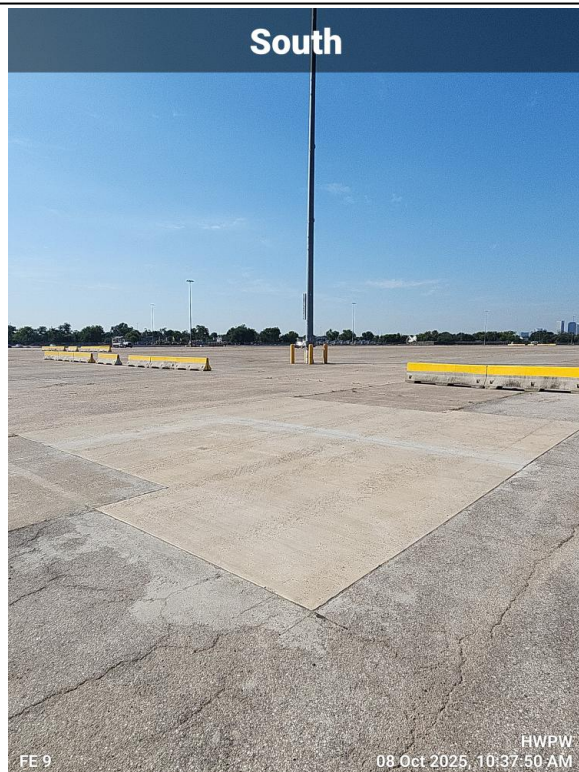
Photo No.: 20
Inspection Date: 10/08/2025

Description:
FE-9 weekly inspection of concrete cap. Reconstructed cap in good condition. No NAPL observed at FE location. Facing south.
Lat: 29.78521
Long: -95.31828

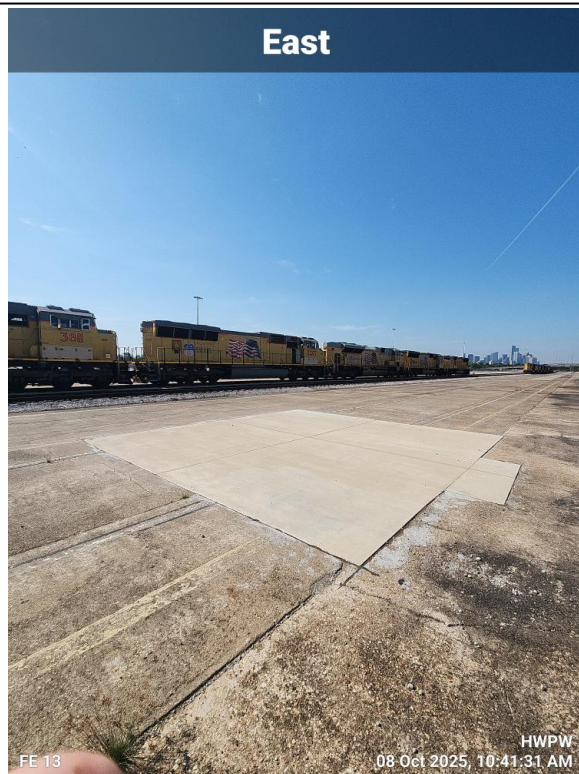
Photo No.
24

FE-13 weekly inspection of concrete cap.
Reconstructed cap in good condition. No NAPL
observed at FE location. Facing east.

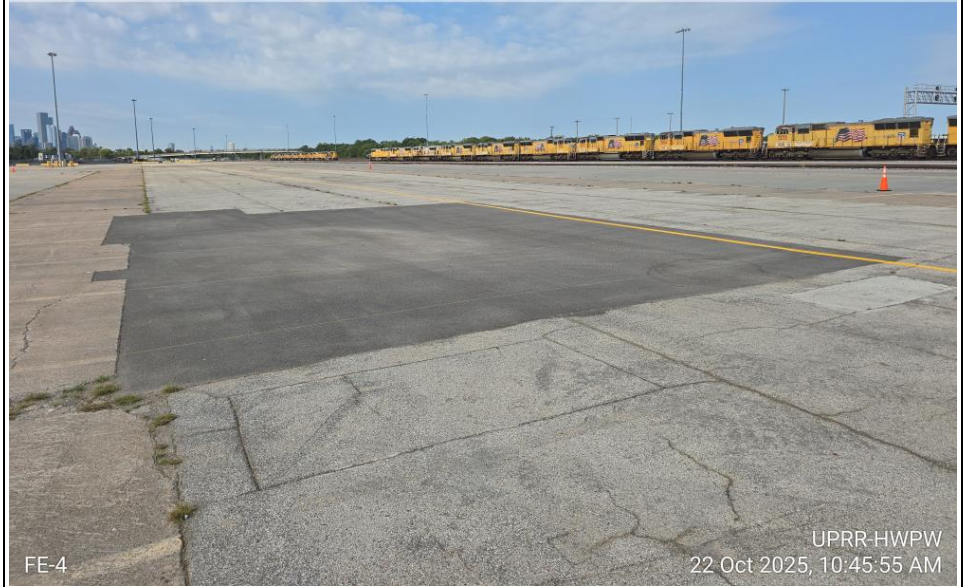
Description:
FE-4 weekly inspection of asphalt cap. Reconstructed cap in good condition. No NAPL observed at FE location. Facing west.

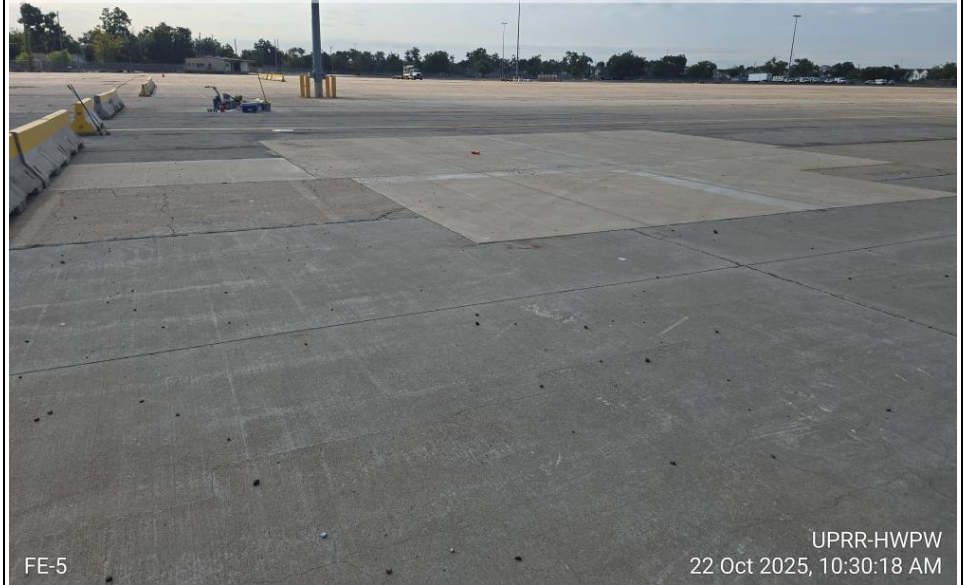
Description:
FE-5 weekly inspection of concrete cap. Reconstructed cap in good condition. No NAPL observed at FE location. Facing south.

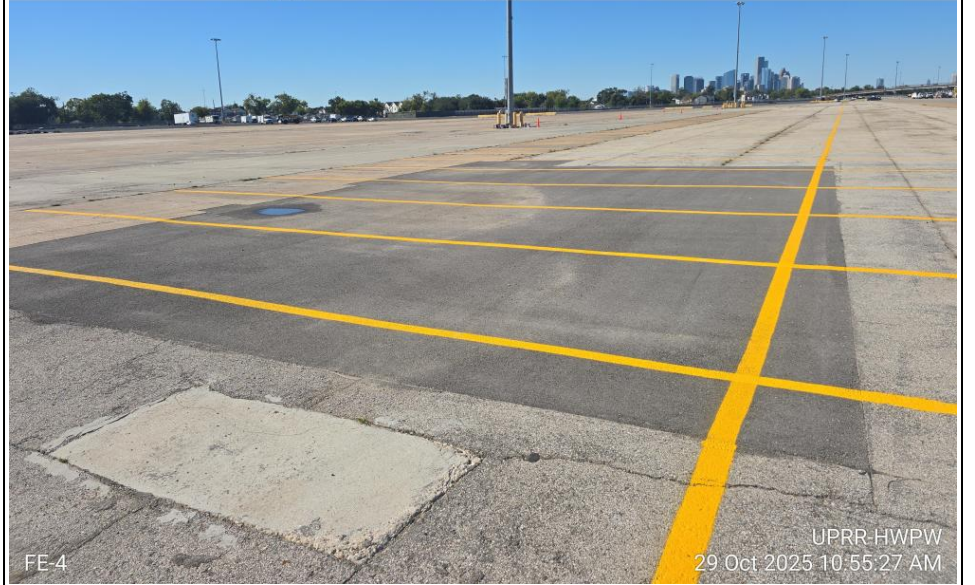
FE-4 weekly inspection of asphalt cap. Reconstructed cap in good condition. No NAPL observed at FE location. Facing south.

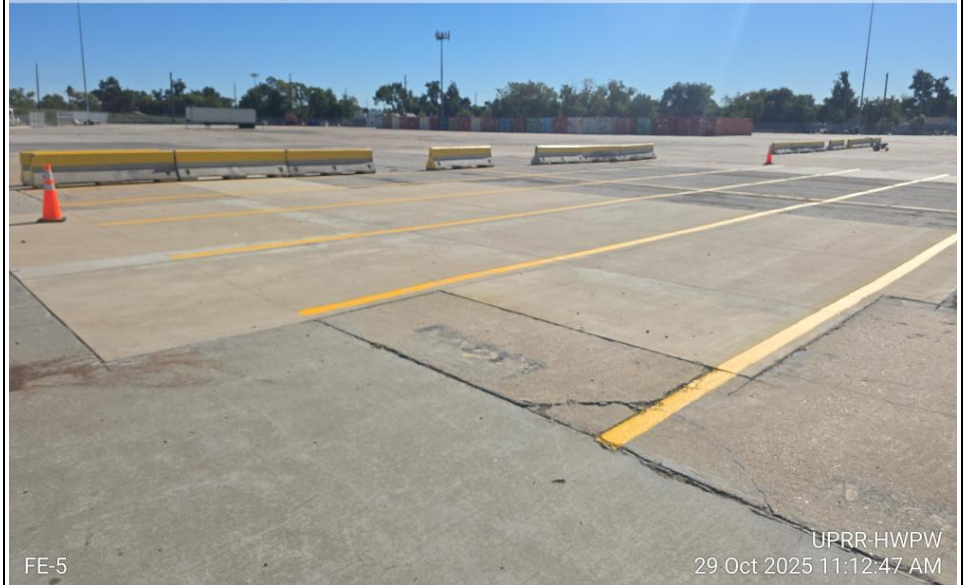
FE-5 weekly inspection of concrete cap. Reconstructed cap in good condition. No NAPL observed at FE location. Facing southeast.

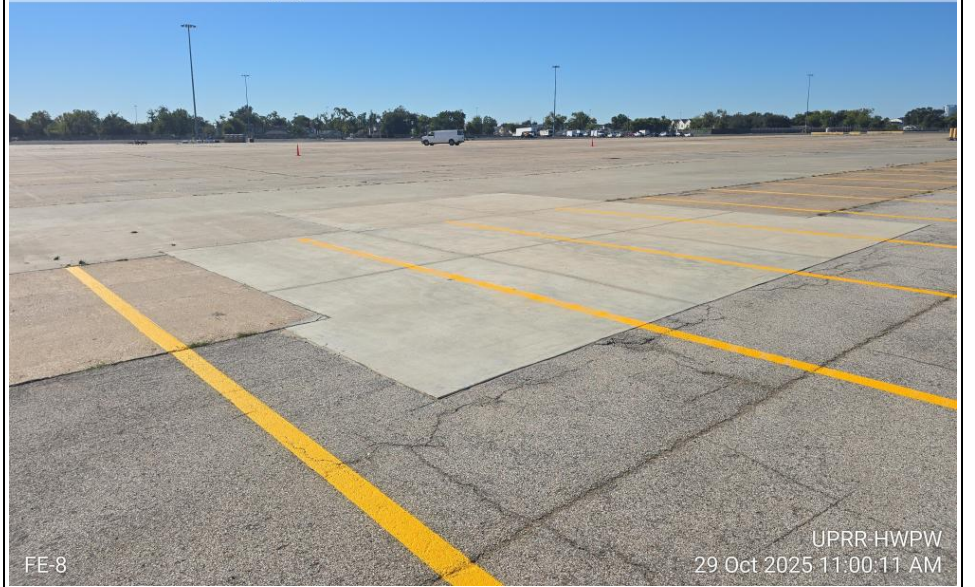
Description:
FE-8 weekly inspection of concrete cap. Reconstructed cap in good condition. No NAPL observed at FE location. Facing south.

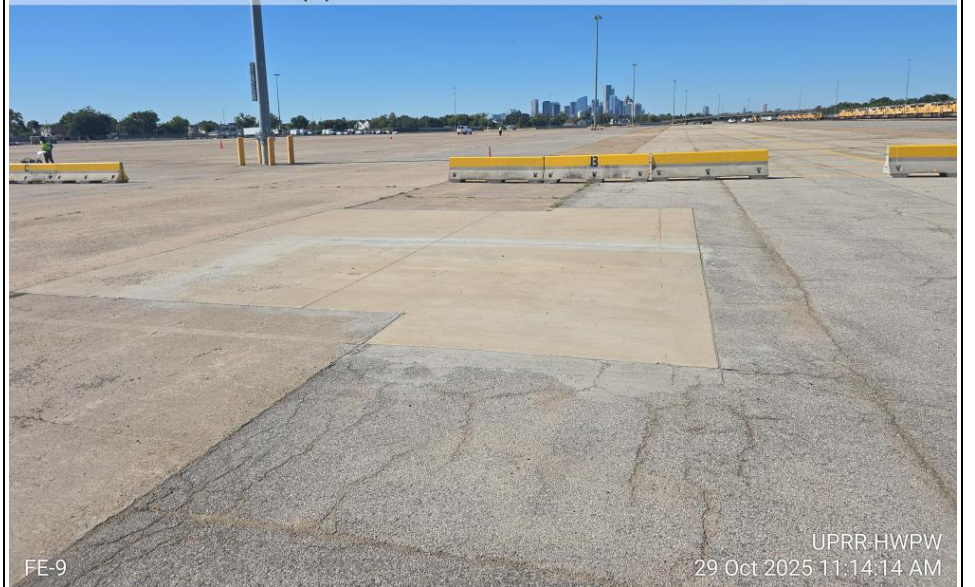
Description:
FE-9 weekly inspection of concrete cap. Reconstructed cap in good condition. No NAPL observed at FE location. Facing southwest.

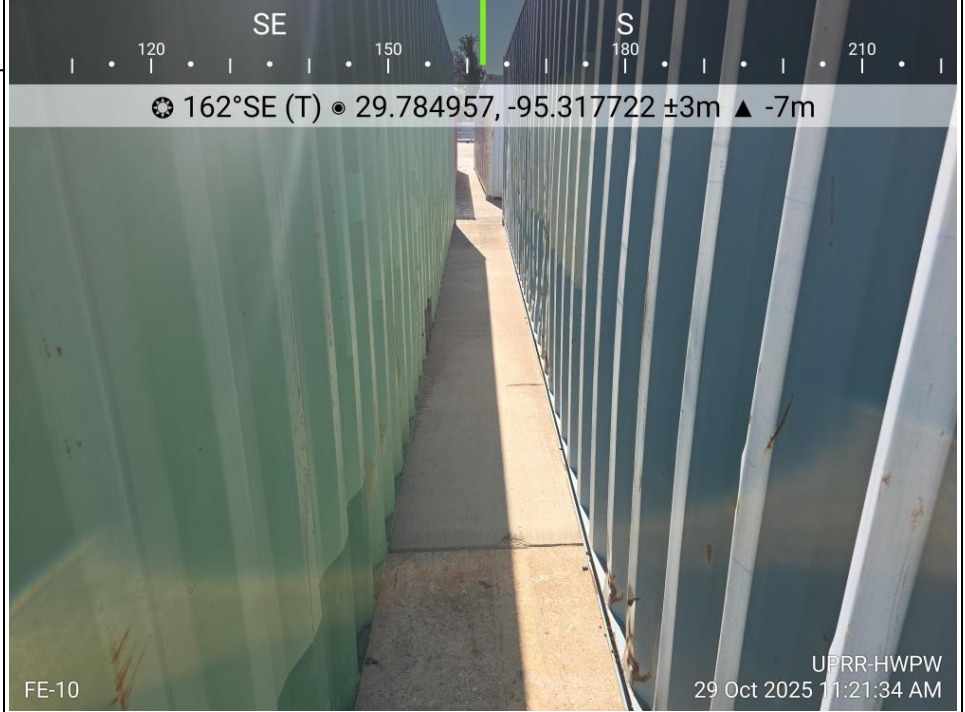
Photo No.
57

Description:
FE-10 weekly inspection of concrete cap.
Reconstructed cap in good condition. No NAPL observed at FE location. Facing southeast.

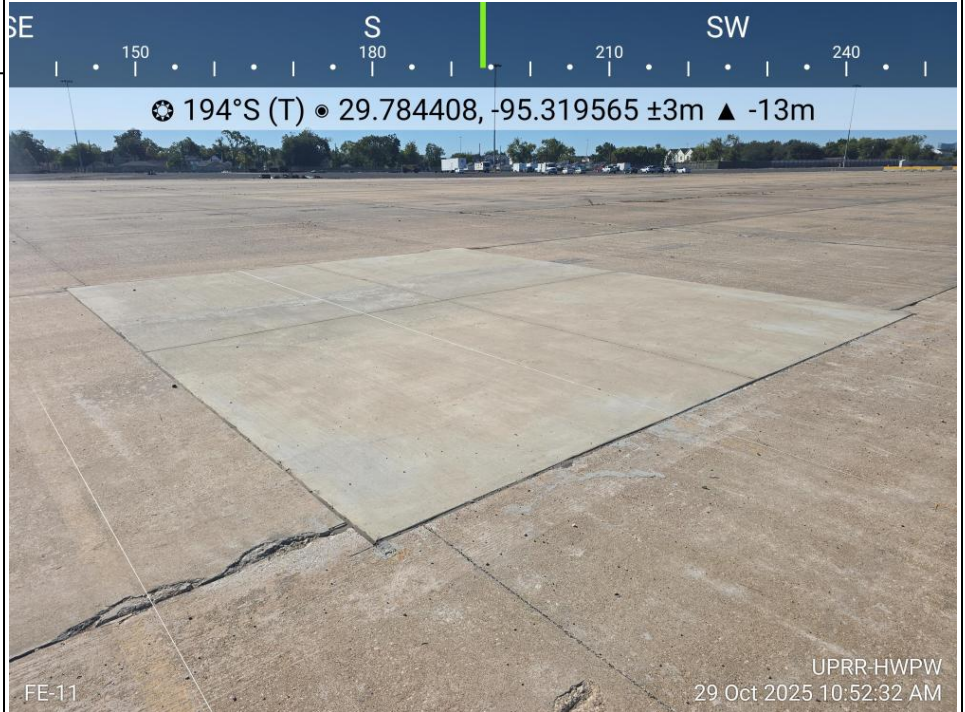
Photo No.
58

Description:
FE-11 weekly inspection of concrete cap.
Reconstructed cap in good condition. No NAPL observed at FE location. Facing south.

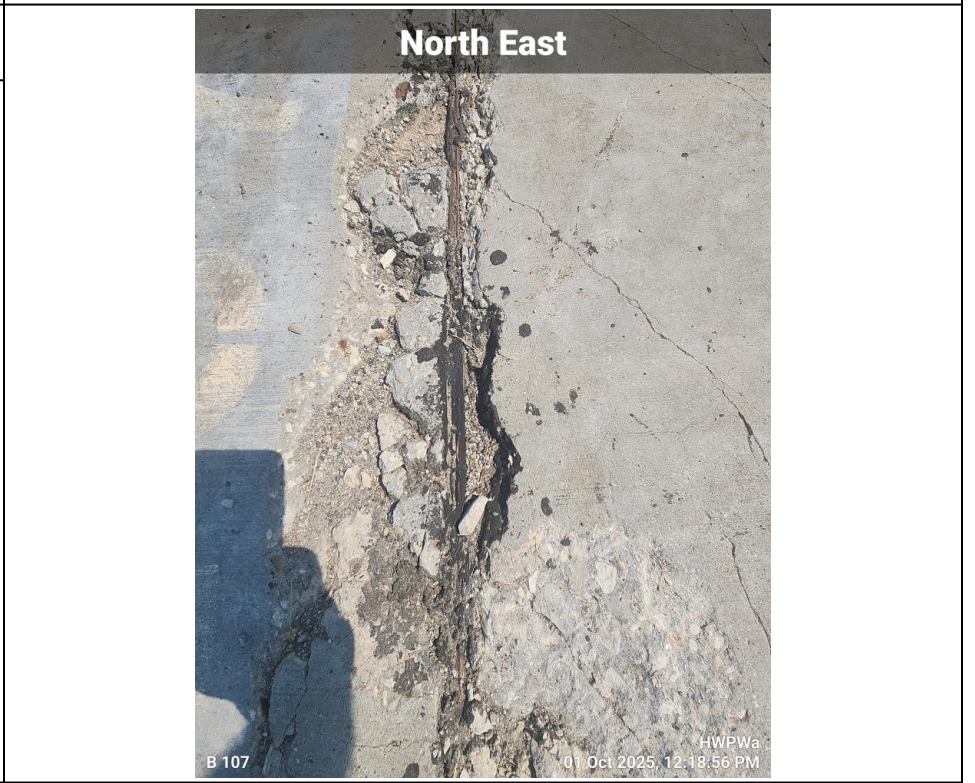
Photo No.
76

Description:
B107 weekly inspection of joint. Surrounding concrete in good condition. No NAPL observed along joint.

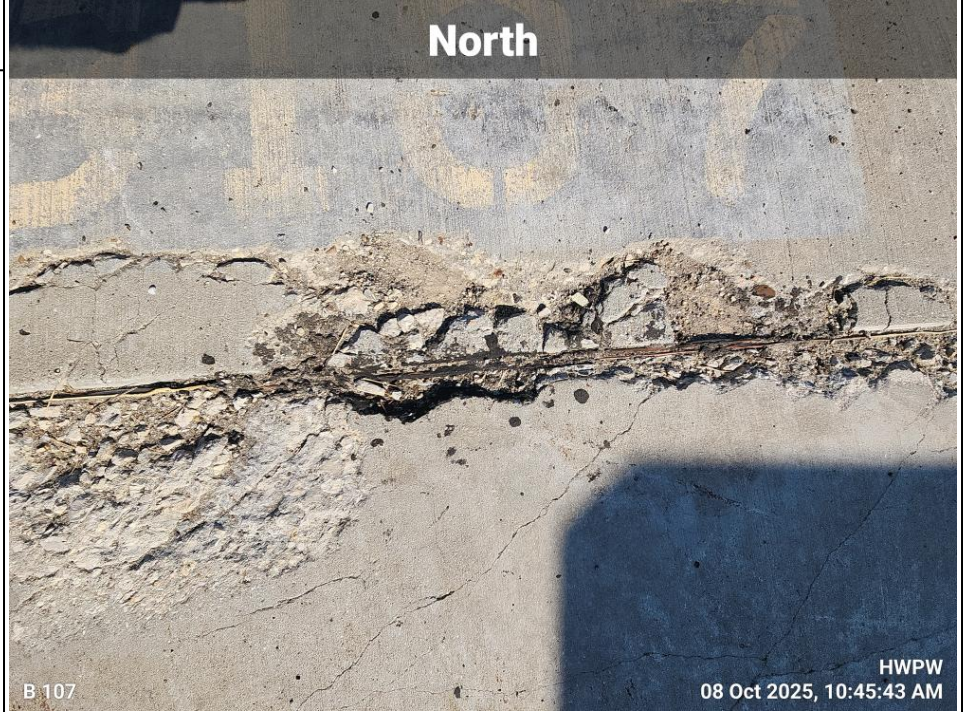
Description:
B107 weekly inspection of joint. Surrounding concrete in good condition. No NAPL observed along joint.

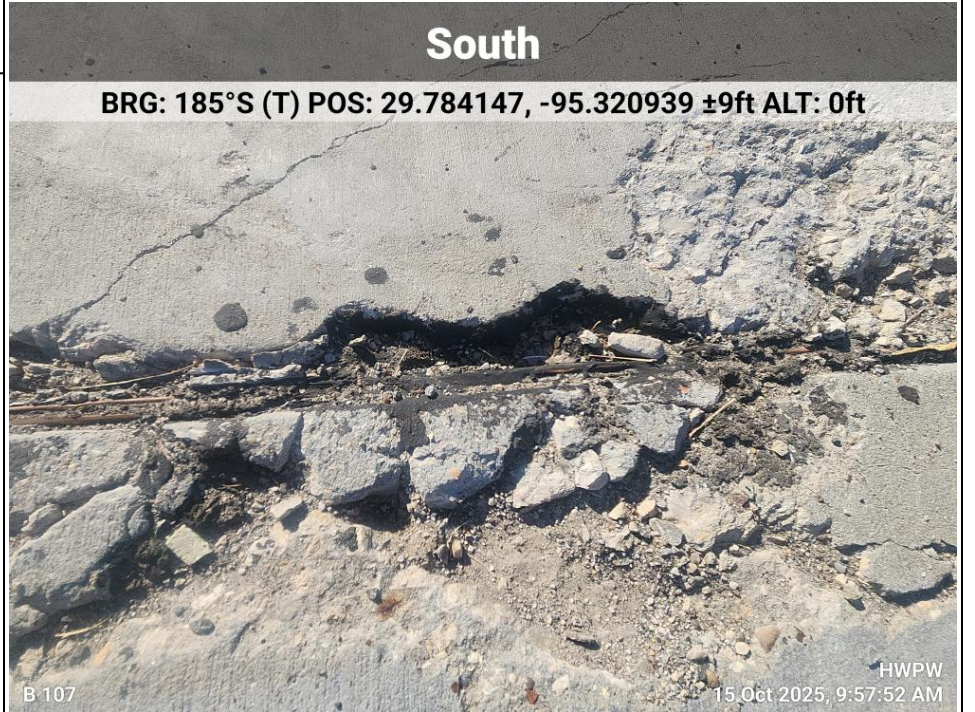
Description:
B107 weekly inspection of joint. Surrounding concrete in good condition. No NAPL observed along joint.

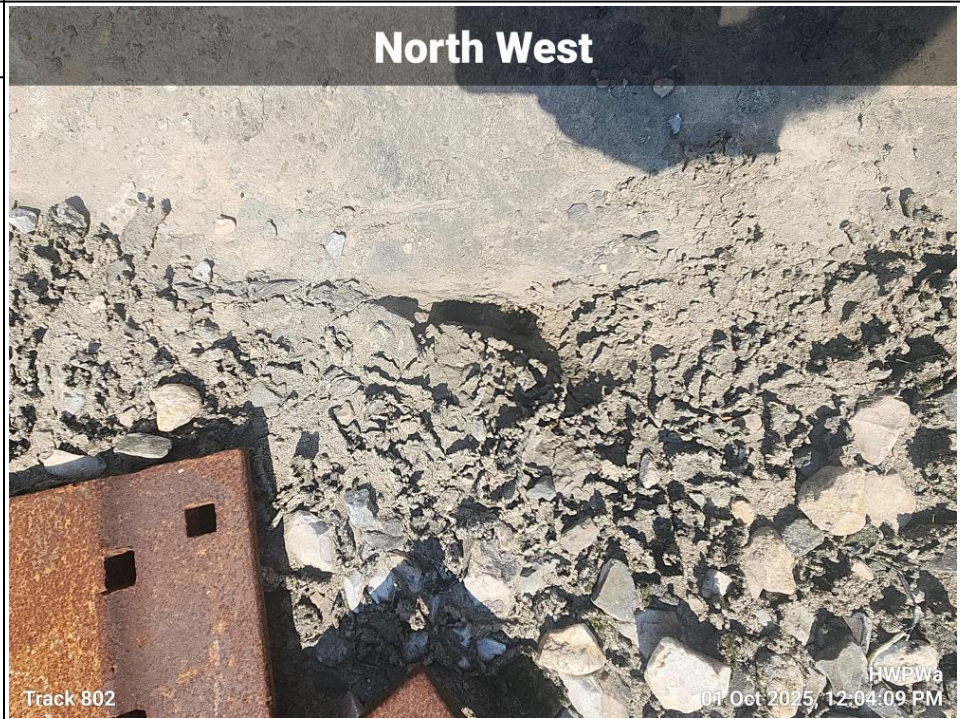
- Tar-like material seeps at the following two locations:
 - Tar-like material seep was not observed at Track 802 during the October inspections (Photo Numbers 81 through 85).

Description:
Track 802 weekly inspection of track. Surrounding concrete and ballast in good condition. No NAPL observed along joint.

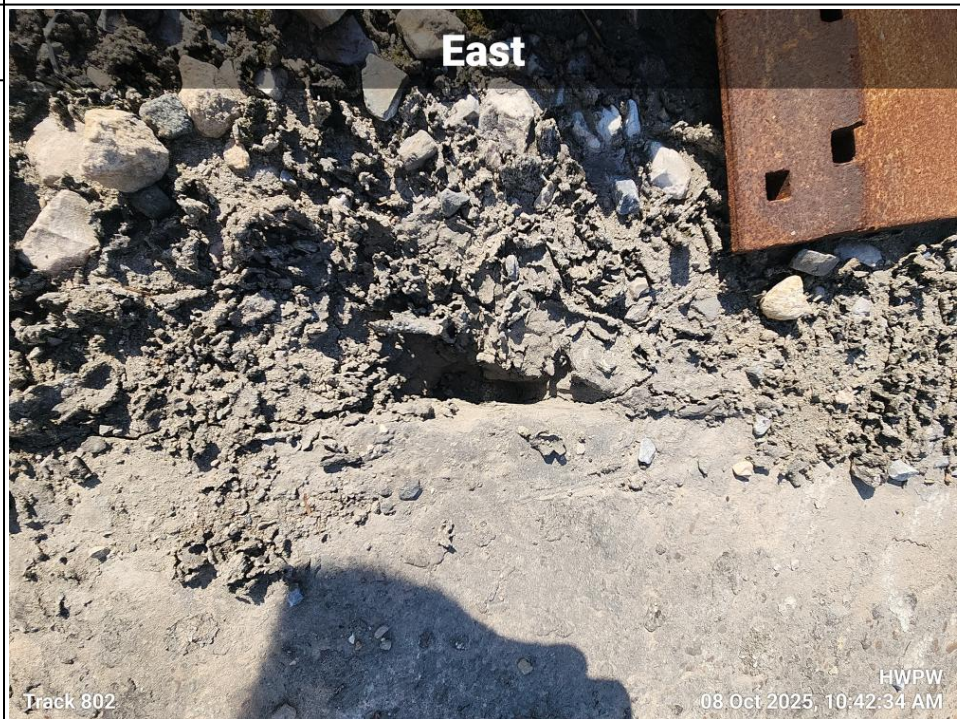
Description:
Track 802 weekly inspection of track. Surrounding concrete and ballast in good condition. No NAPL observed along joint.

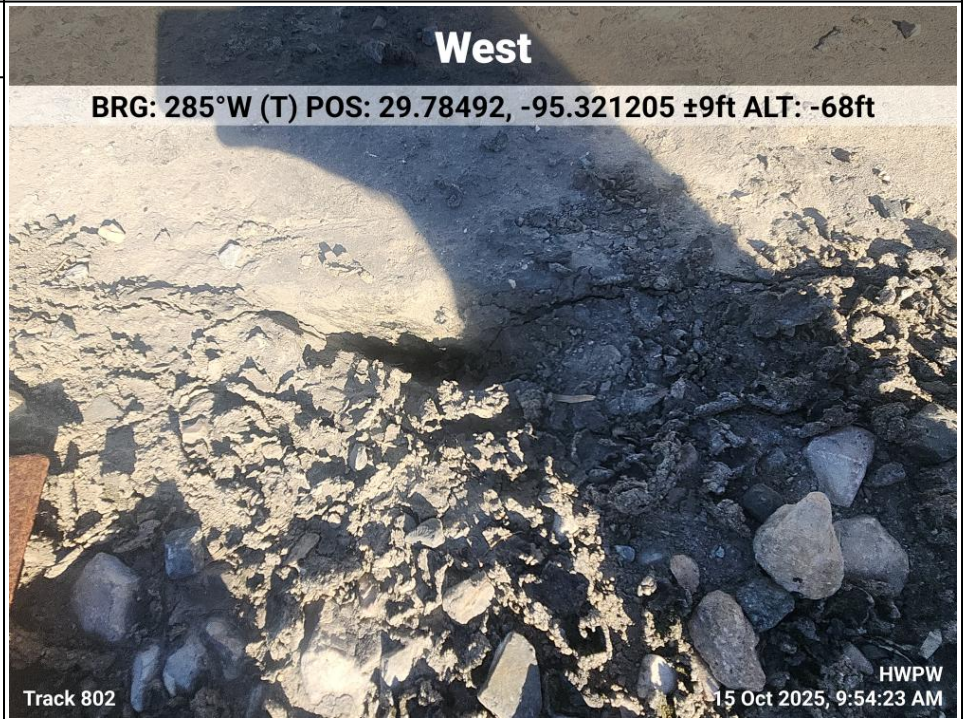
Description:
Track 802 weekly inspection of track. Surrounding concrete and ballast in good condition. No NAPL observed along joint.

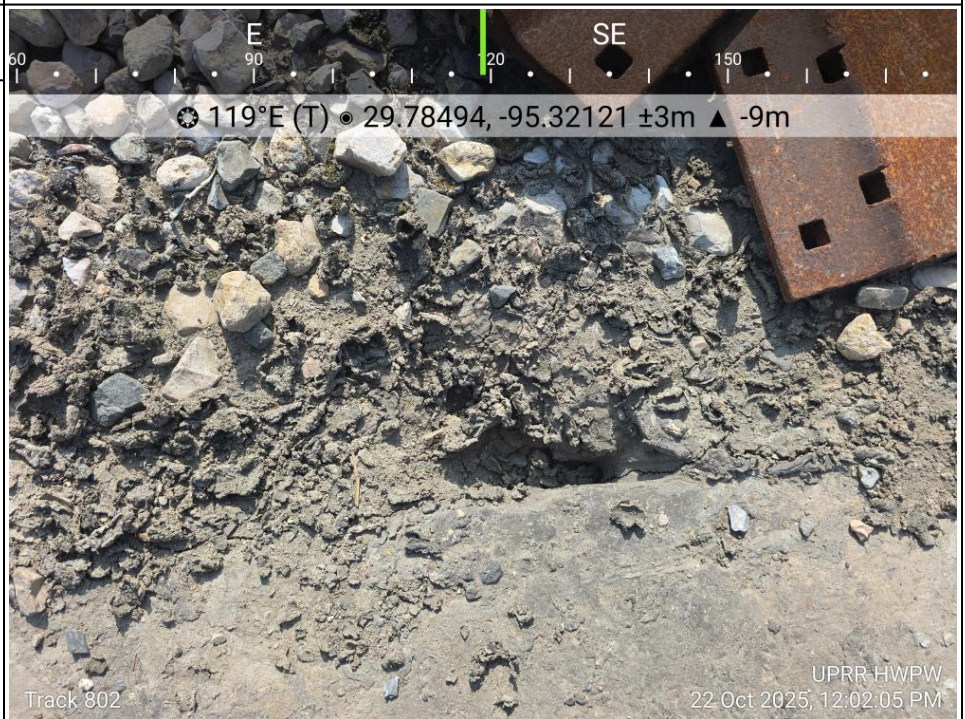
Description:
Track 802 weekly inspection of track. Surrounding concrete and ballast in good condition. No NAPL observed along joint.

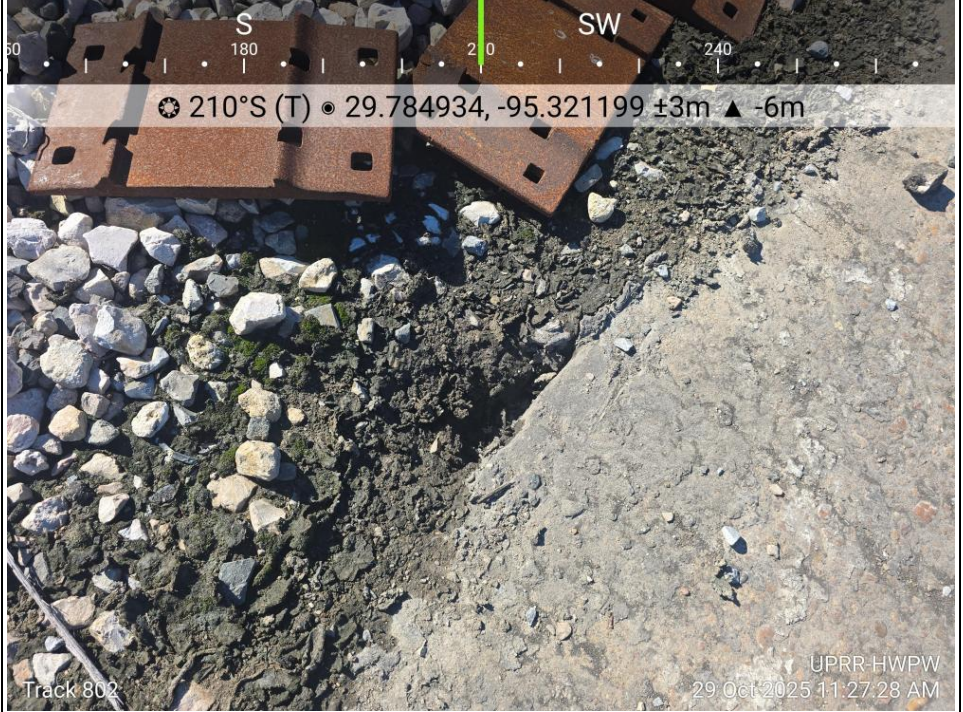
Description:
Track 802 weekly inspection of track. Surrounding concrete and ballast in good condition. No NAPL observed along joint.

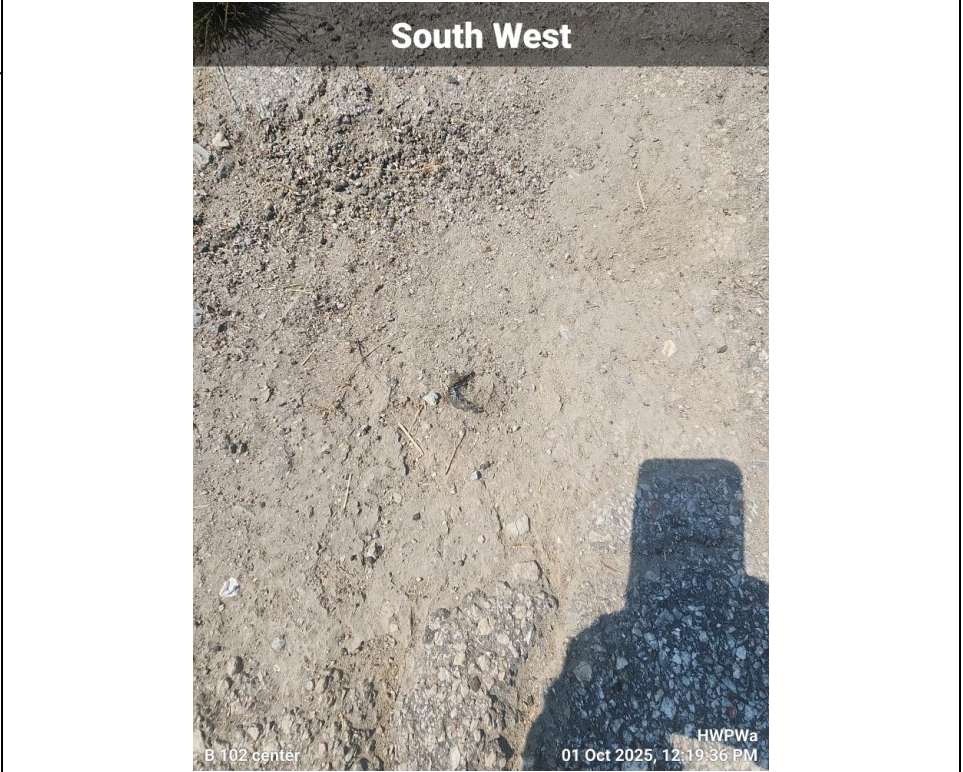
- A tar-like NAPL seep was observed on October 1 and 8 within Stall B102. Approximately 9 cubic inches (approximately 5.0 fluid ounces) of tar-like material was scraped up and removed from the location (Photo Numbers 86 through 92).

Description:
B102 Center weekly inspection of previously identified seep. Surrounding asphalt in good condition. Approximately 3 cubic inches of NAPL observed at seep location.

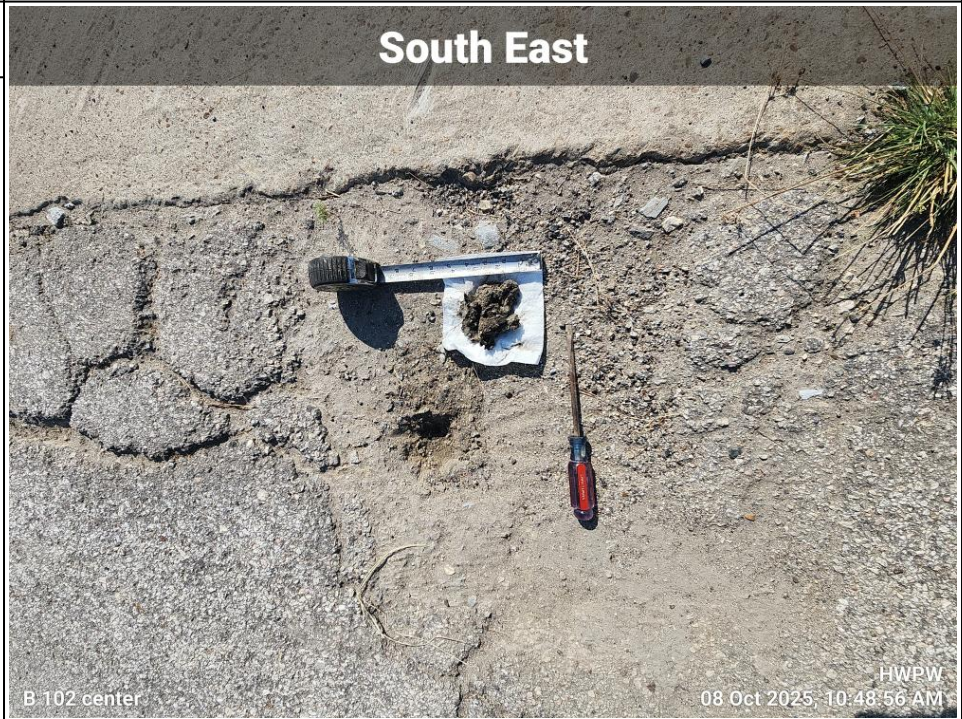
Description:
B102 Center weekly inspection of previously identified seep. Surrounding asphalt in good condition. Approximately 6 cubic inches of NAPL observed at seep location.
