November 14, 2025

Project No. US0039040.4227

**Re: MONTHLY STATUS UPDATE – ENGLEWOOD INTERMODAL YARD – REVISED INTERIM MEASURES
WORK PLAN POST-CONSTRUCTION AND NAPL COLLECTION SYSTEM/CONCRETE CAP REPAIR
INSPECTIONS
UNION PACIFIC RAILROAD HOUSTON WOOD PRESERVING WORKS FACILITY
4910 LIBERTY ROAD FACILITY, HOUSTON, TEXAS
POST-CLOSURE CARE PERMIT NO. HW-50343; INDUSTRIAL SWR NO. 31547**

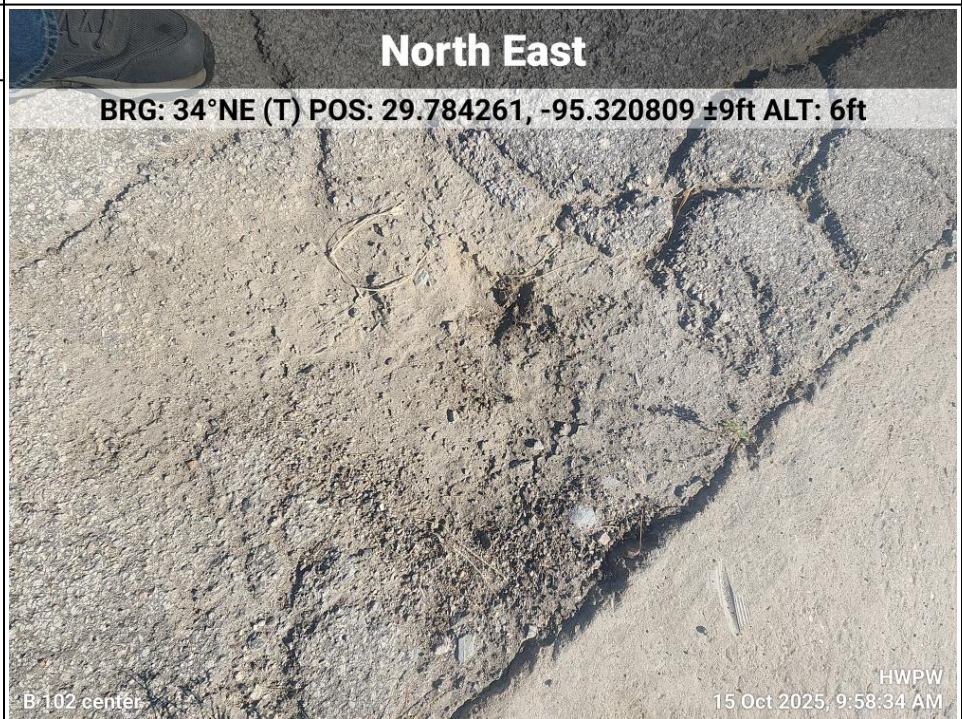
Description:
B102 Center weekly inspection of previously identified seep. Surrounding asphalt in good condition. No NAPL observed along joint.
