December 15, 2025

Project No. US0039040.4227

Re: **MONTHLY STATUS UPDATE – ENGLEWOOD INTERMODAL YARD – REVISED INTERIM MEASURES WORK PLAN POST-CONSTRUCTION AND NAPL COLLECTION SYSTEM/CONCRETE CAP REPAIR INSPECTIONS
UNION PACIFIC RAILROAD HOUSTON WOOD PRESERVING WORKS FACILITY
4910 LIBERTY ROAD FACILITY, HOUSTON, TEXAS
POST-CLOSURE CARE PERMIT NO. HW-50343; INDUSTRIAL SWR NO. 31547**

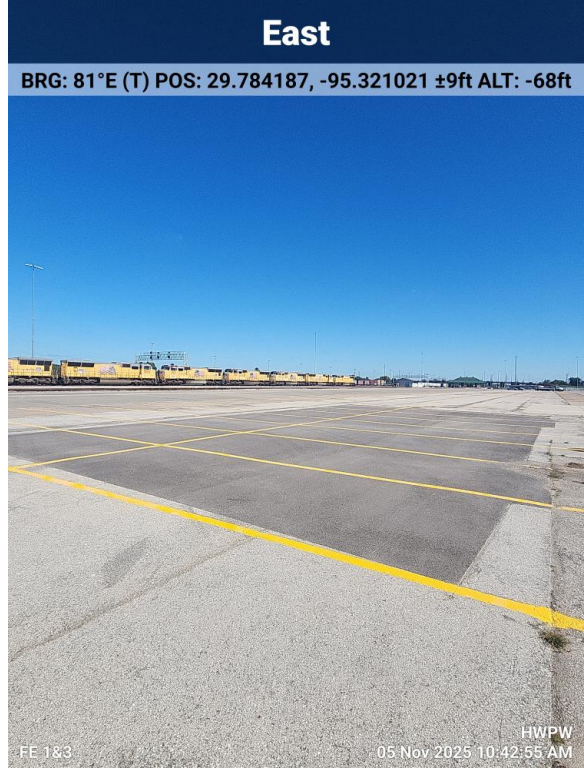
FE-1&3 weekly inspection of asphalt cap. Reconstructed cap in good condition. No NAPL observed at FE location. Facing east.

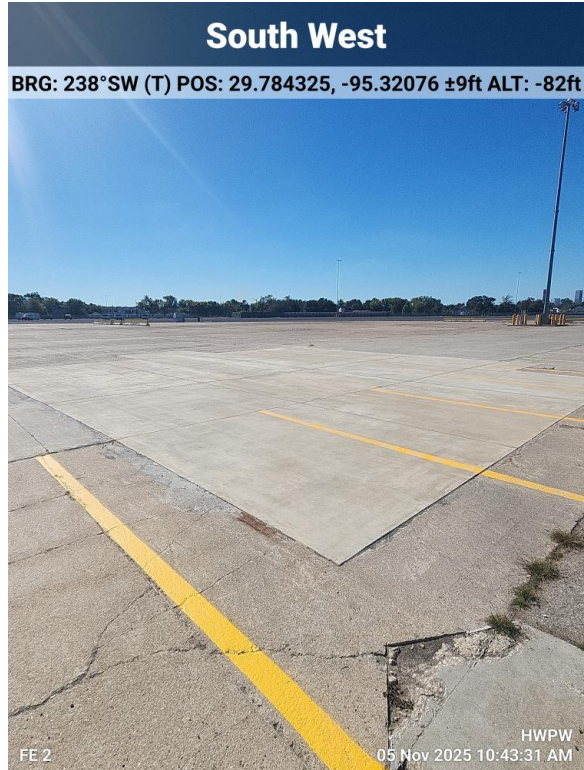
Photo No. 2	Inspection Date: 11/05/2025
-----------------------	---------------------------------------

FE-2 weekly inspection of concrete cap. Reconstructed cap in good condition. No NAPL observed at FE location. Facing southwest.

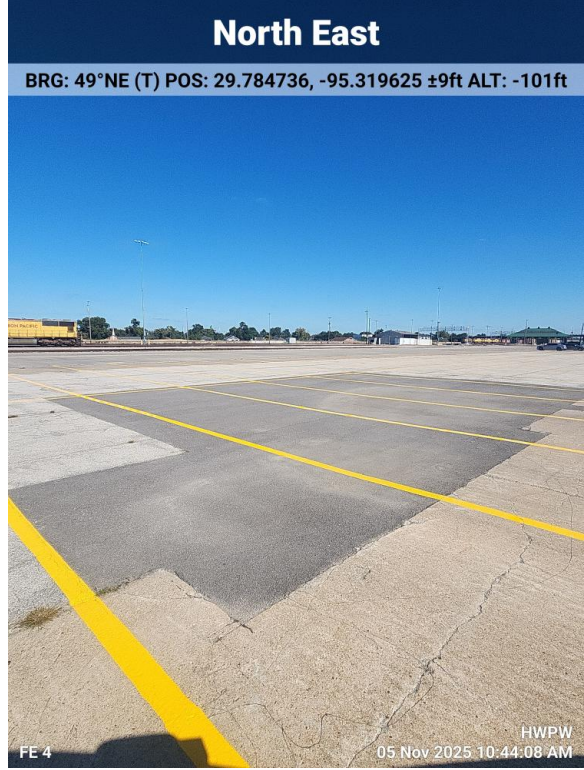
FE-4 weekly inspection of asphalt cap. Reconstructed cap in good condition. No NAPL observed at FE location. Facing northeast.

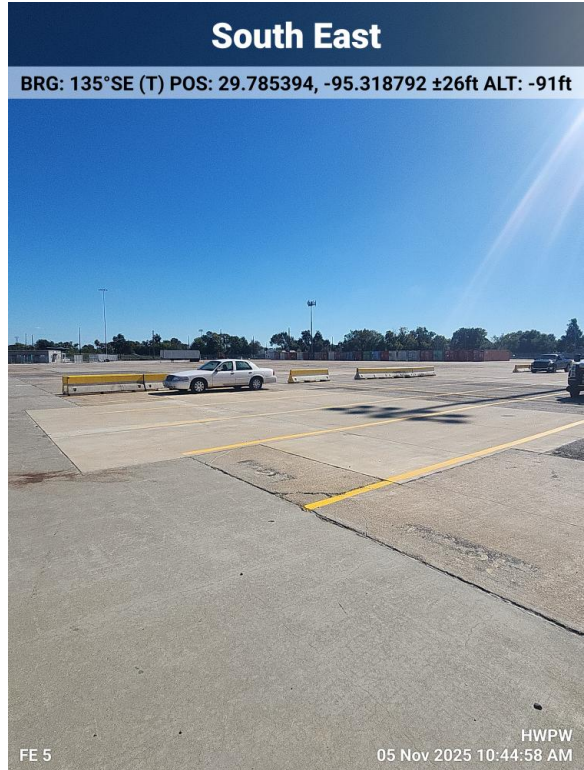
Photo No. 4	Inspection Date: 11/05/2025
-----------------------	---------------------------------------

FE-5 weekly inspection of concrete cap. Reconstructed cap in good condition. No NAPL observed at FE location. Facing southeast.

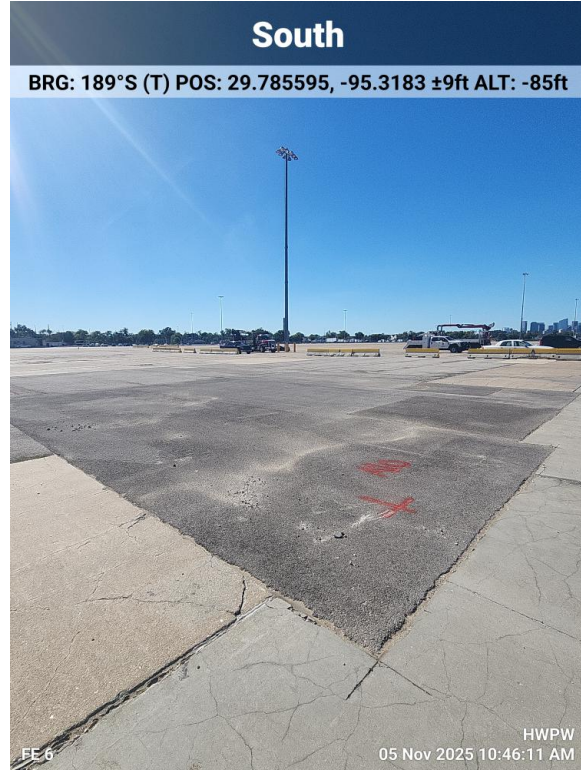
FE-6 weekly inspection of asphalt cap. Reconstructed cap in good condition. No NAPL observed at FE location. Facing south.

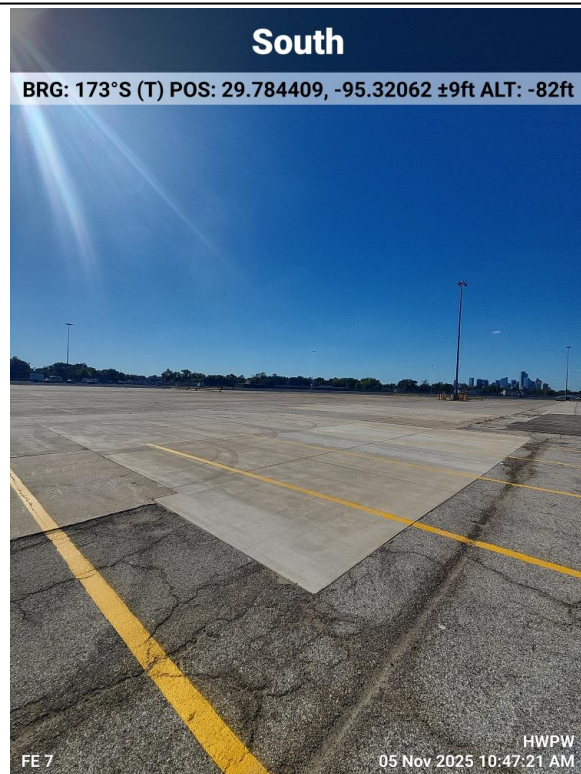
Photo No.: 6
Inspection Date: 11/05/2025

FE-7 weekly inspection of concrete cap. Reconstructed cap in good condition. No NAPL observed at FE location. Facing south.

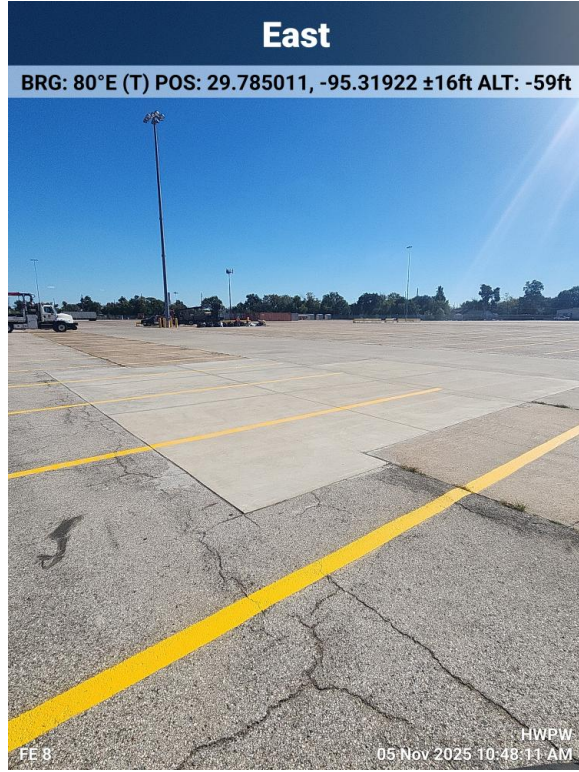
FE-8 weekly inspection of concrete cap. Reconstructed cap in good condition. No NAPL observed at FE location. Facing east.

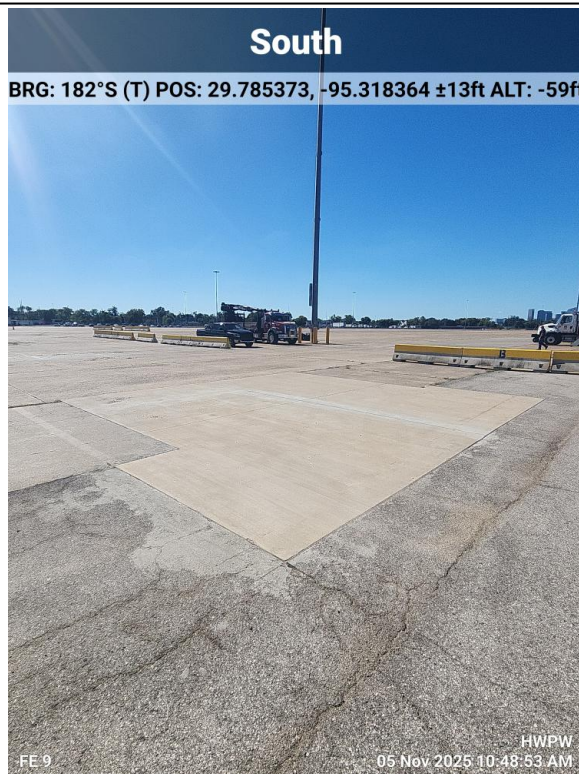
Photo No.: 8
Inspection Date: 11/05/2025

FE-9 weekly inspection of concrete cap. Reconstructed cap in good condition. No NAPL observed at FE location. Facing south.

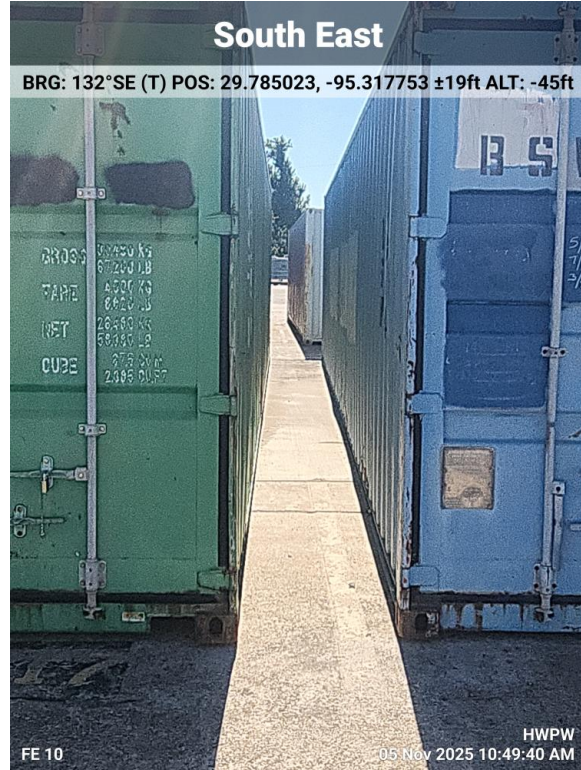
FE-10 weekly inspection of concrete cap.
Reconstructed cap in good condition. No NAPL
observed at FE location. Facing southeast.

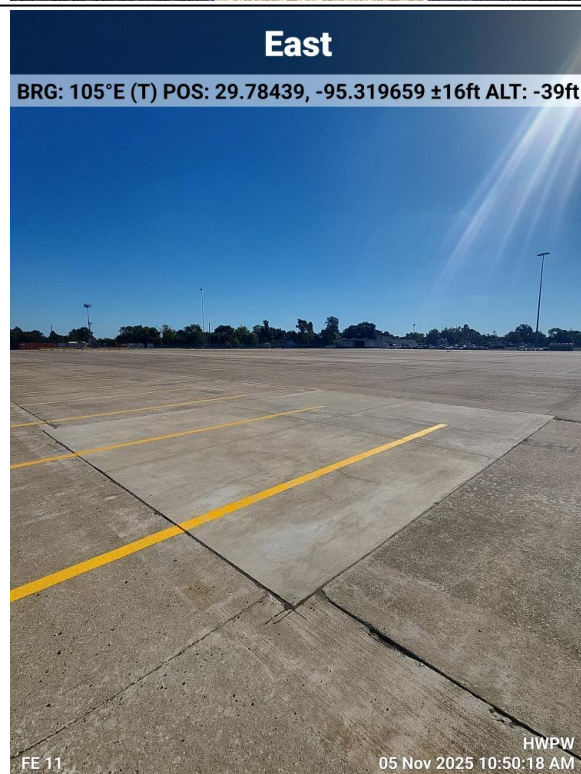
Photo No.
10

FE-11 weekly inspection of concrete cap.
Reconstructed cap in good condition. No NAPL
observed at FE location. Facing east.

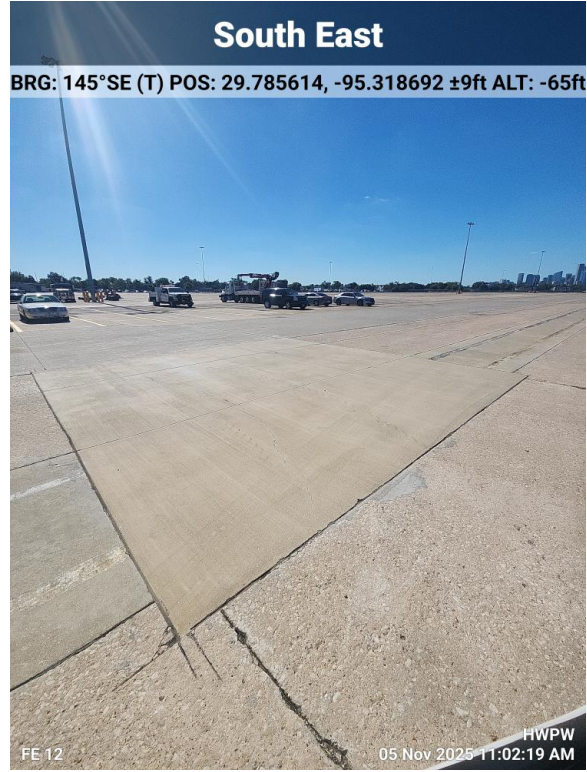
FE-12 weekly inspection of concrete cap. Reconstructed cap in good condition. No NAPL observed at FE location. Facing southeast.

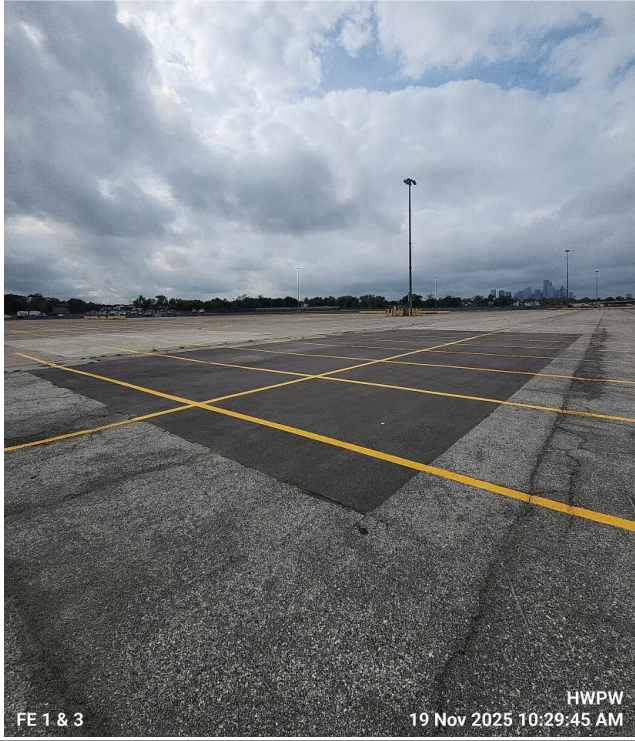
Photo No. 25	Inspection Date: 11/19/2025	<p>BRG: 192°S (T) POS: 29.784398, -95.320806 ±19ft ALT: -45ft</p>

<p>FE 1 & 3 HWPW 19 Nov 2025 10:29:45 AM</p>
<p>Description: FE-1&3 weekly inspection of asphalt cap. Reconstructed cap in good condition. No NAPL observed at FE location. Facing south.</p> <p>Lat: 29.7844 Long: -95.32081</p>

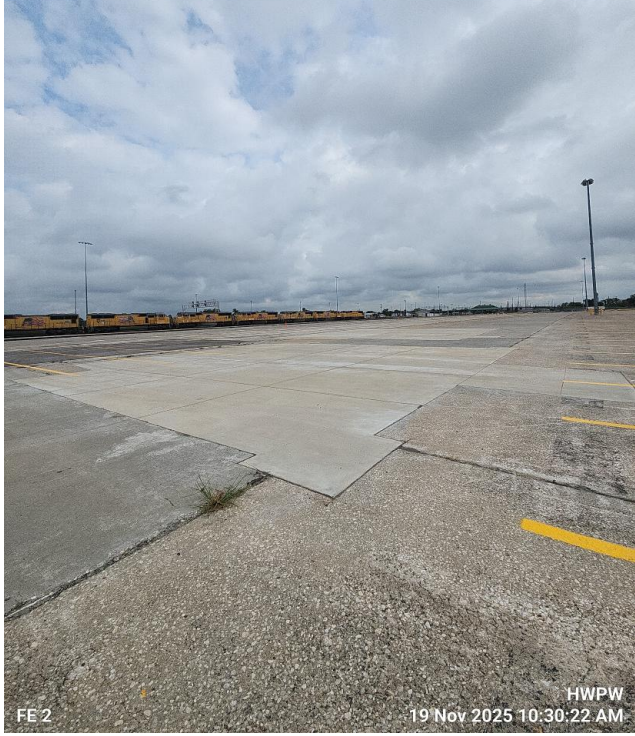
Photo No. 26	Inspection Date: 11/19/2025	<p>BRG: 30°N (T) POS: 29.784069, -95.32084 ±26ft ALT: -32ft</p>

<p>FE 2 HWPW 19 Nov 2025 10:30:22 AM</p>
<p>Description: FE-2 weekly inspection of concrete cap. Reconstructed cap in good condition. No NAPL observed at FE location. Facing north.</p> <p>Lat: 29.78407 Long: -95.32084</p>

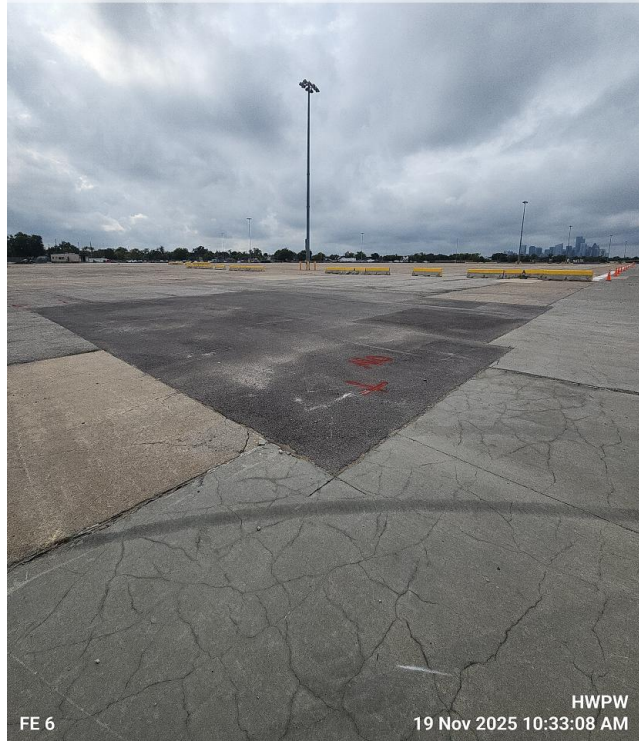
FE-6 weekly inspection of asphalt cap. Reconstructed cap in good condition. No NAPL observed at FE location. Facing south.

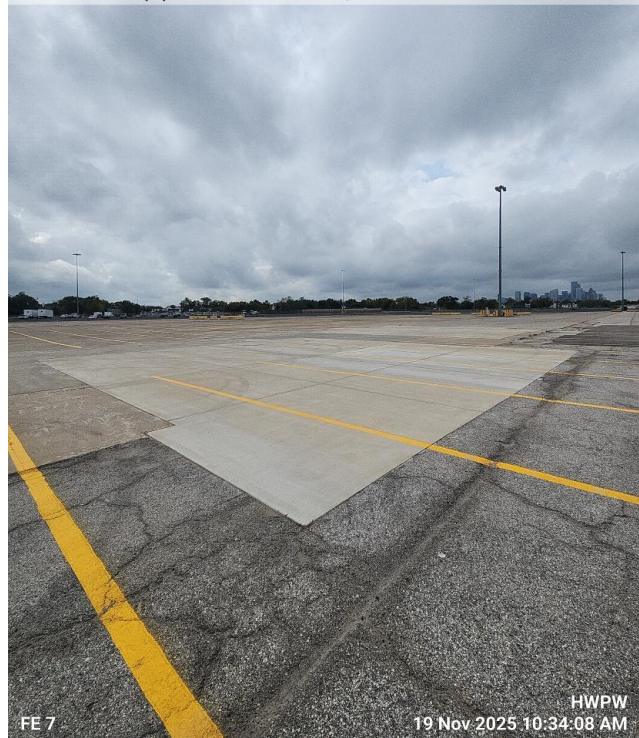
FE-7 weekly inspection of concrete cap. Reconstructed cap in good condition. No NAPL observed at FE location. Facing south.

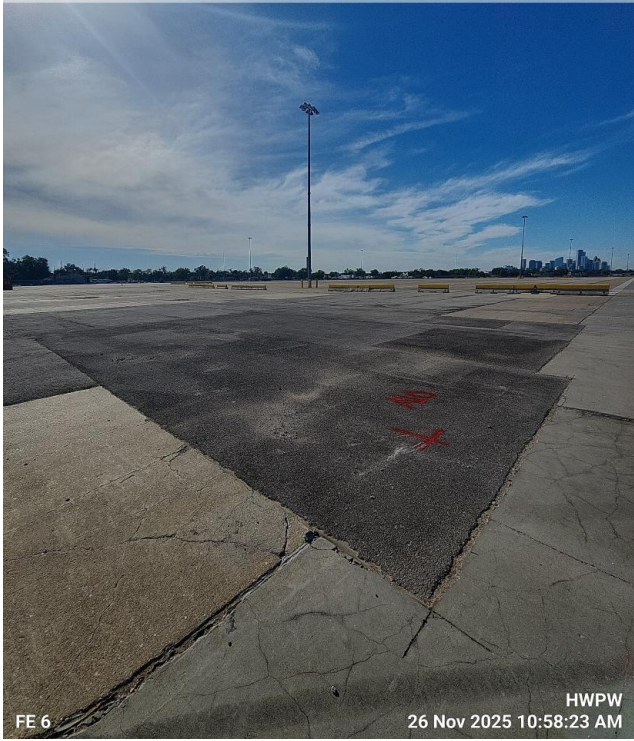
Photo No. 41	Inspection Date: 11/26/2025	BRG: 194°S (T) POS: 29.785603, -95.318305 ±26ft ALT: -72ft

<p>FE 6</p> <p>HWPW 26 Nov 2025 10:58:23 AM</p>
Description: FE-6 weekly inspection of asphalt cap. Reconstructed cap in good condition. No NAPL observed at FE location. Facing south. Lat: 29.7856 Long: -95.31831

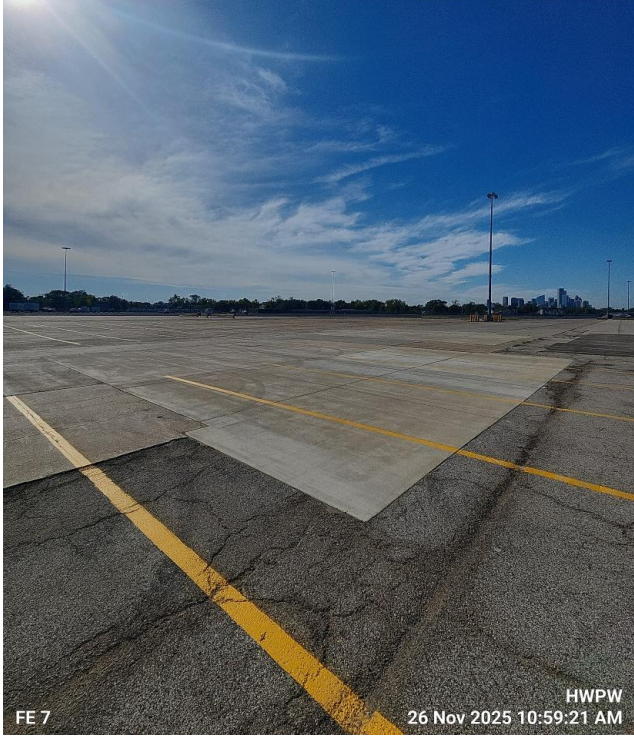
Photo No. 42	Inspection Date: 11/26/2025	BRG: 198°S (T) POS: 29.784389, -95.320596 ±19ft ALT: -42ft

<p>FE 7</p> <p>HWPW 26 Nov 2025 10:59:21 AM</p>
Description: FE-7 weekly inspection of concrete cap. Reconstructed cap in good condition. No NAPL observed at FE location. Facing south. Lat: 29.78439 Long: -95.3206

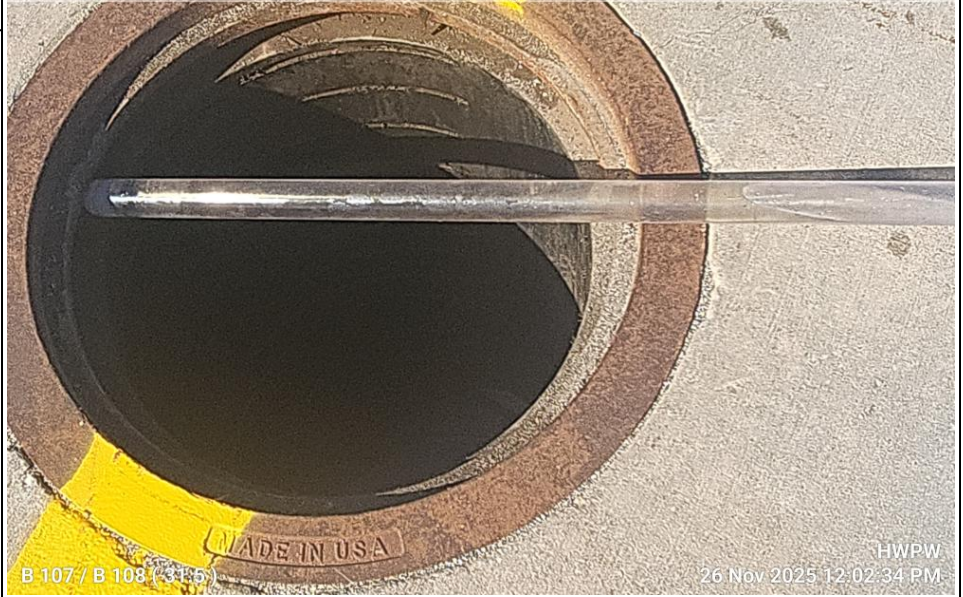
Sump 3 (B107/B108), 31.5 inches of freeboard in sump. Color is clear, and no sheen or odor was reported.

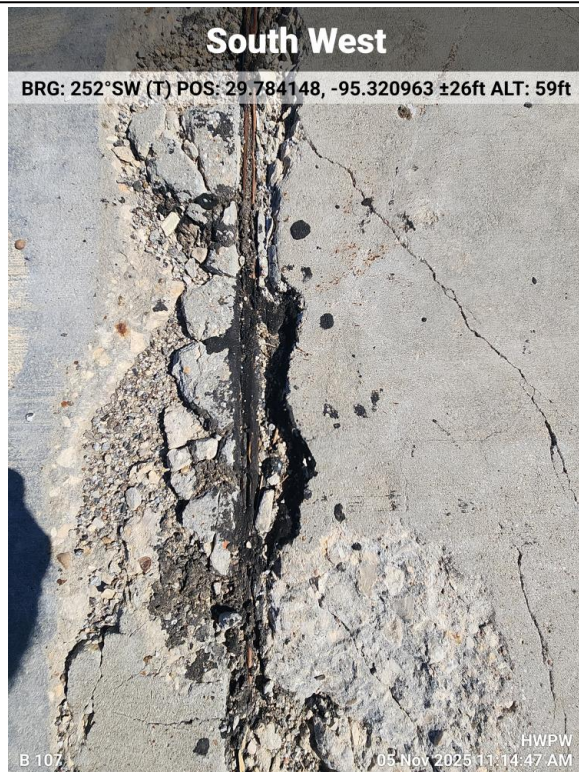
- Approximately 2 cubic inches (approximately 1.1 fluid ounces) of tar-like NAPL were recovered from the concrete joint along the perimeter of the NAPL Collection System at Stall B107 on November 5 (Attachment A, Photo Numbers 62 through 66). The material recovered was placed in a drum staged at the CSA pending disposal. No other NAPL seeps were observed along the concrete joints near the NAPL Collection System during the November inspections.

B107 weekly inspection of joint. Surrounding concrete in good condition. Approximately 2 cubic inches of NAPL observed at seep location.

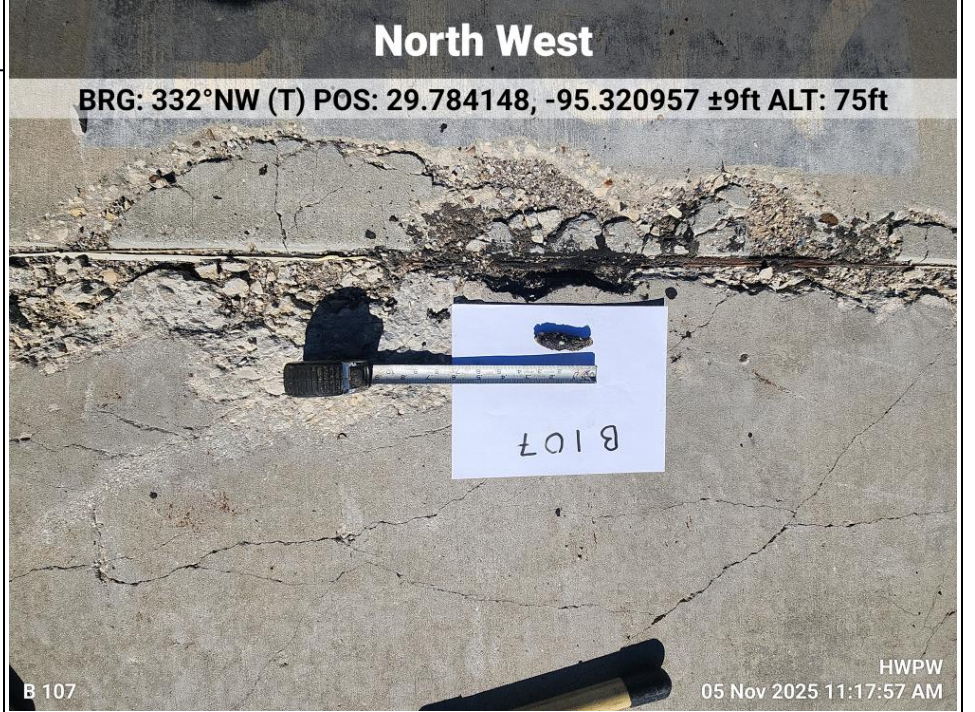
Description:
B107 weekly inspection of joint. Surrounding concrete in good condition. Approximately 2 cubic inches of NAPL observed at seep location.

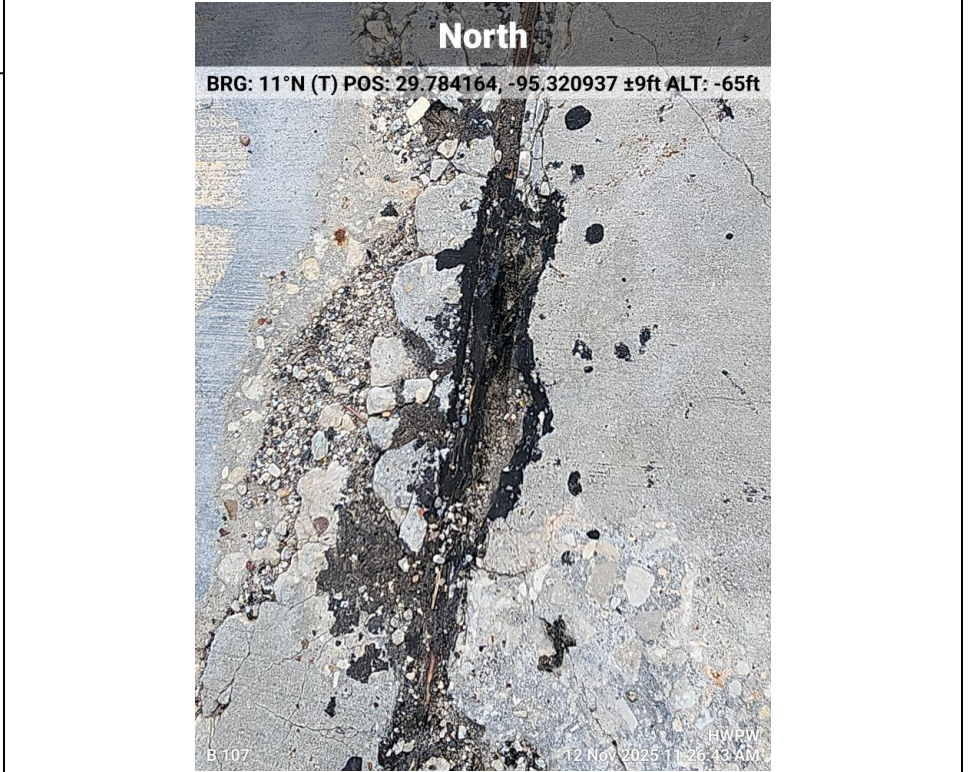
Description:
B107 weekly inspection of joint. Surrounding concrete in good condition. No NAPL observed along joint.

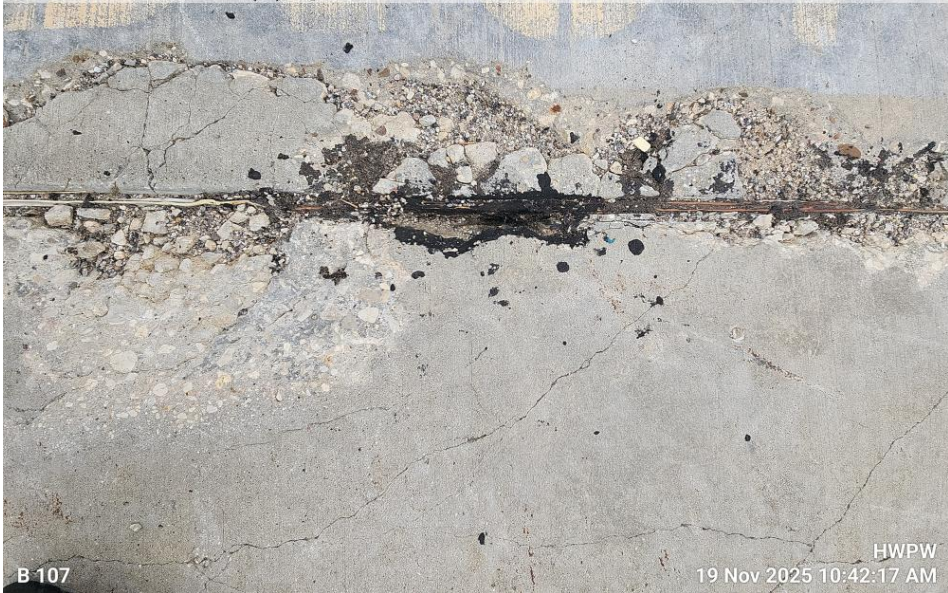
Photo No. 65	Inspection Date: 11/19/2025	BRG: 335°NW (T) POS: 29.784143, -95.320953 ±26ft ALT: -32ft
Description: B107 weekly inspection of joint. Surrounding concrete in good condition. No NAPL observed along joint. Lat: 29.78414 Long: -95.32095

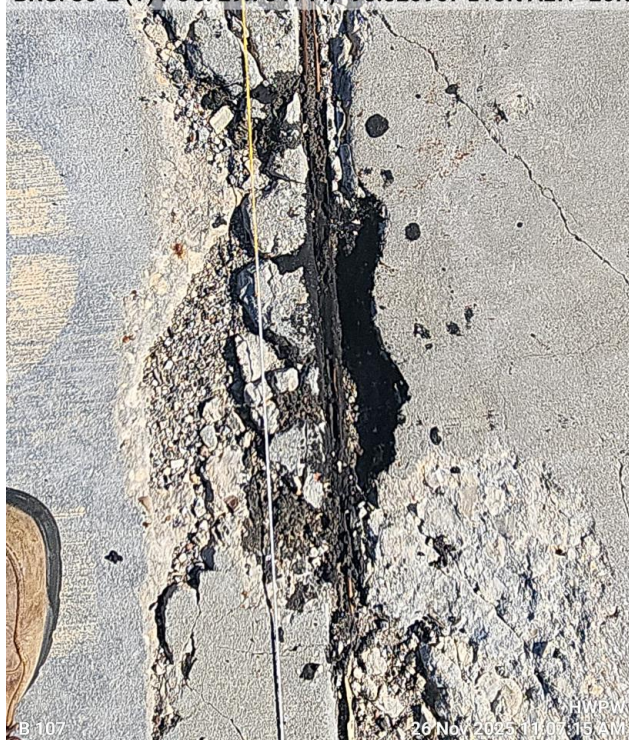
Photo No. 66	Inspection Date: 11/26/2025	BRG: 86°E (T) POS: 29.784144, -95.320967 ±13ft ALT: -26ft
Description: B107 weekly inspection of joint. Surrounding concrete in good condition. No NAPL observed along joint. Lat: 29.78414 Long: -95.32097

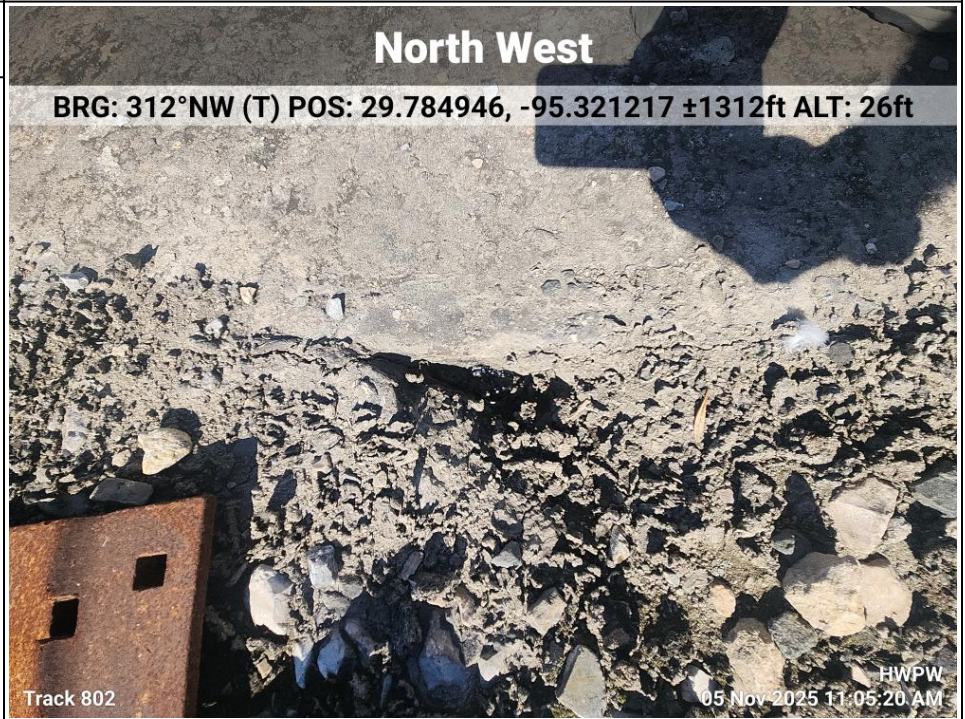
- Tar-like material seeps at the following two locations:
 - A tar-like material seep was observed at Track 802 on November 5. Approximately 5 cubic inches (approximately 2.8 fluid ounces) of NAPL were recovered. No seep activity was noted at Track 802 during the other November weekly inspections (Photo Numbers 67 through 71).

Track 802 weekly inspection of track. Surrounding concrete and ballast in good condition. Approximately 5 cubic inches of NAPL observed at seep location.

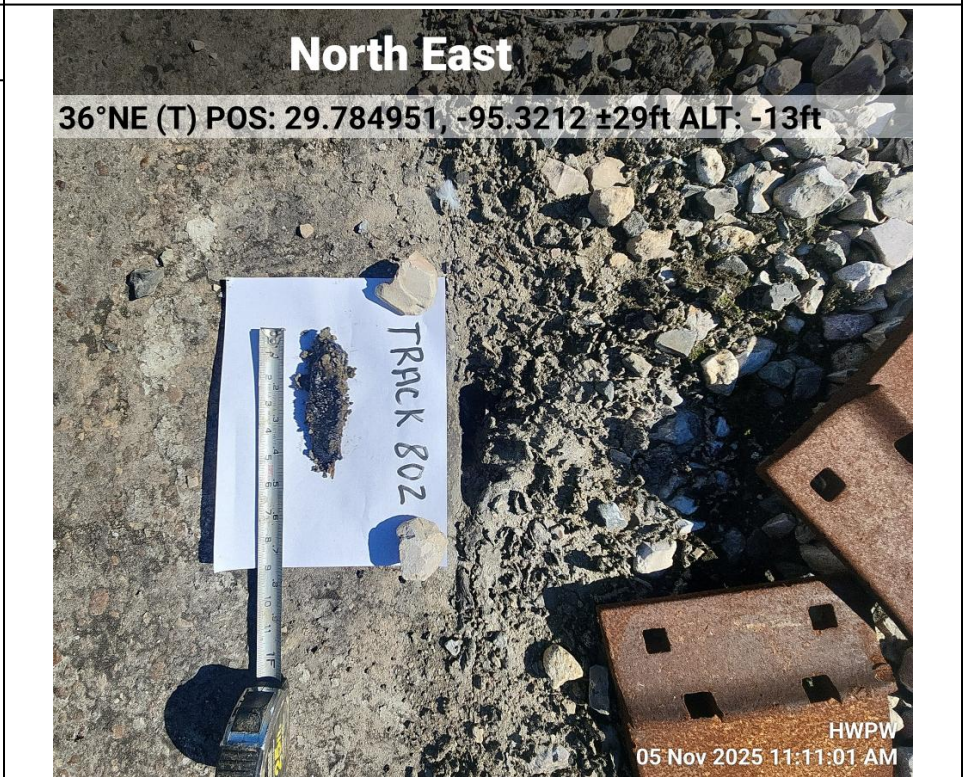
Track 802 weekly inspection of track. Surrounding concrete and ballast in good condition. Approximately 5 cubic inches of NAPL observed at seep location.

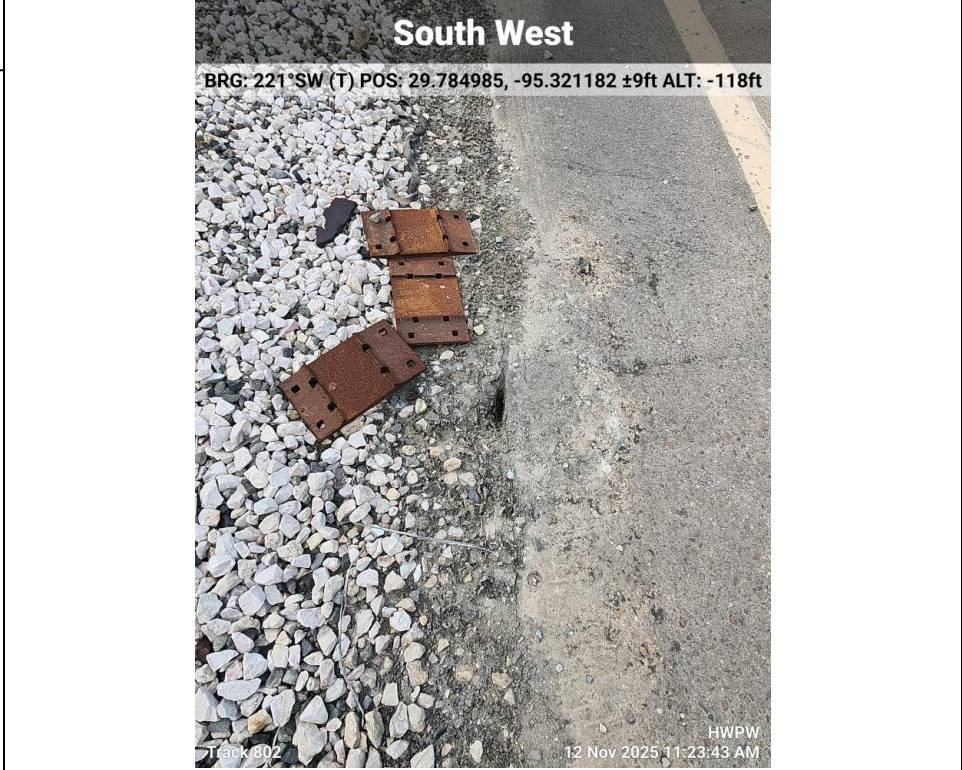
Track 802 weekly inspection of track. Surrounding concrete and ballast in good condition. No NAPL observed along joint.

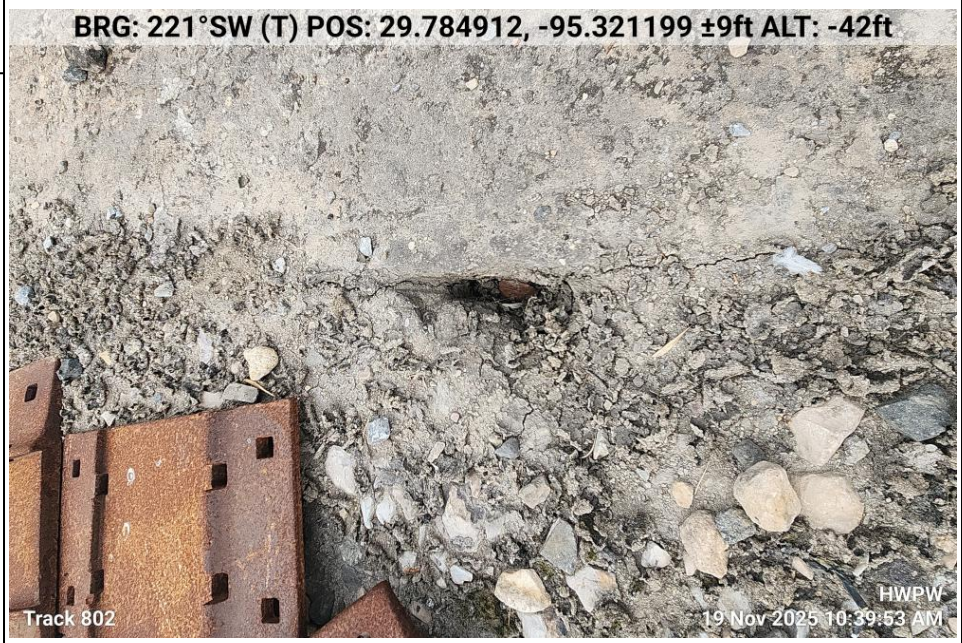
Track 802 weekly inspection of track. Surrounding concrete and ballast in good condition. No NAPL observed along joint.

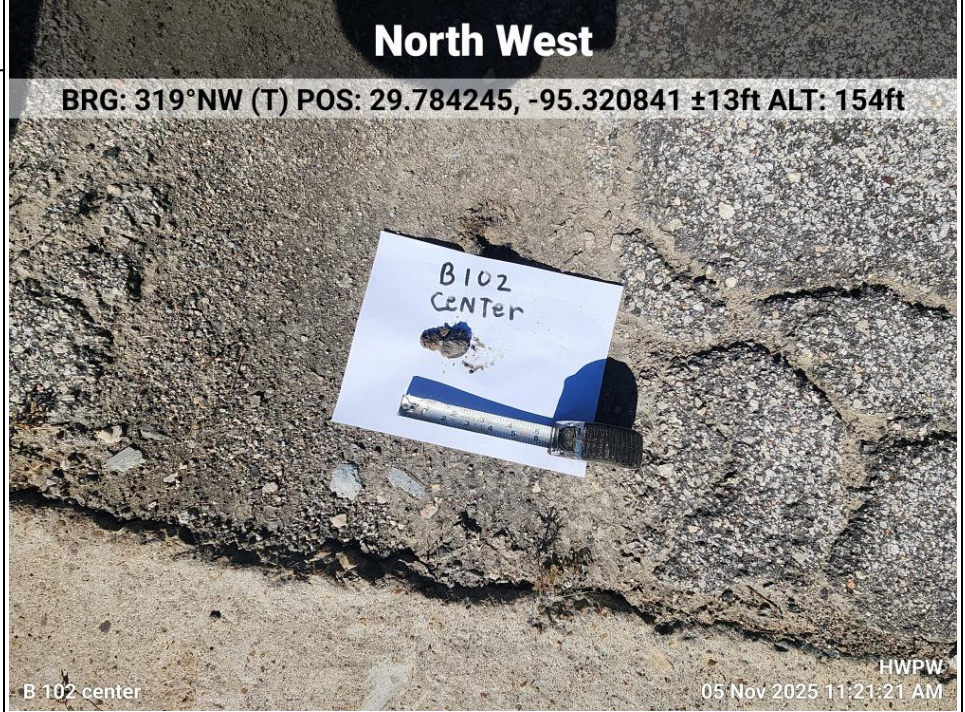
- A tar-like material seep was observed at Stall B102 on November 5. Approximately 2 cubic inches (approximately 1.1 fluid ounces) of NAPL were recovered. No seep activity was noted at Stall B102 during the other November weekly inspections (Photo Numbers 71 through 76).

B102 Center weekly inspection of previously identified seep. Surrounding asphalt in good condition. Approximately 2 cubic inches of NAPL observed at seep location.

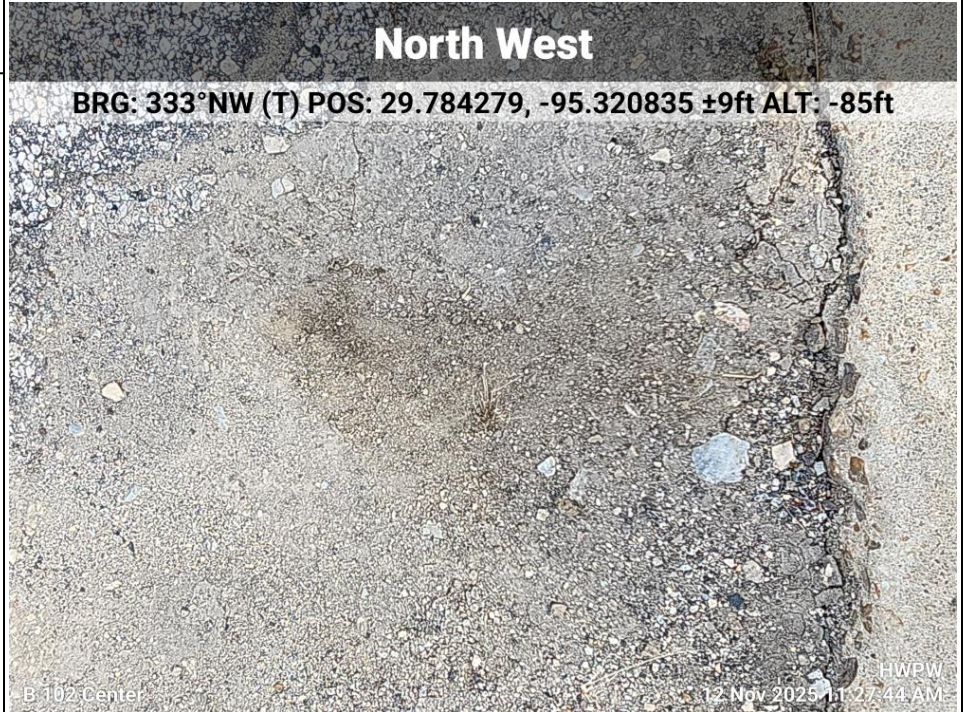
B102 Center weekly inspection of previously identified seep. Surrounding asphalt in good condition. No NAPL observed along joint.
