March 16, 2026

Project No. US0039040.3990

Re: **MONTHLY STATUS UPDATE – ENGLEWOOD INTERMODAL YARD – REVISED INTERIM MEASURES WORK PLAN POST-CONSTRUCTION AND NAPL COLLECTION SYSTEM/CONCRETE CAP REPAIR INSPECTIONS  
UNION PACIFIC RAILROAD HOUSTON WOOD PRESERVING WORKS FACILITY  
4910 LIBERTY ROAD FACILITY, HOUSTON, TEXAS  
POST-CLOSURE CARE PERMIT NO. HW-50343; INDUSTRIAL SWR NO. 31547**

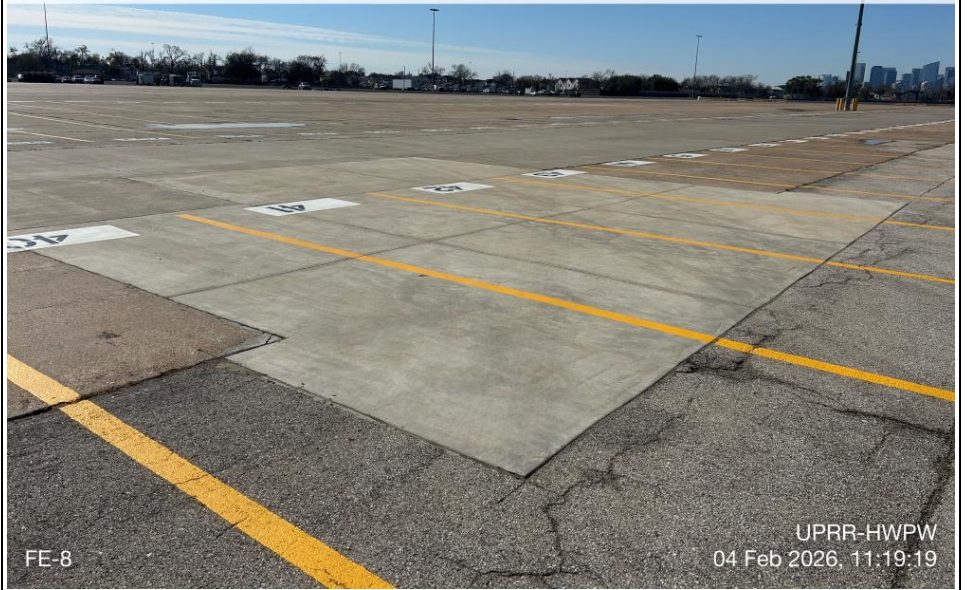
**Description:**  
FE-8 weekly inspection of concrete cap. Reconstructed cap in good condition. No NAPL observed at FE location. Facing southwest.

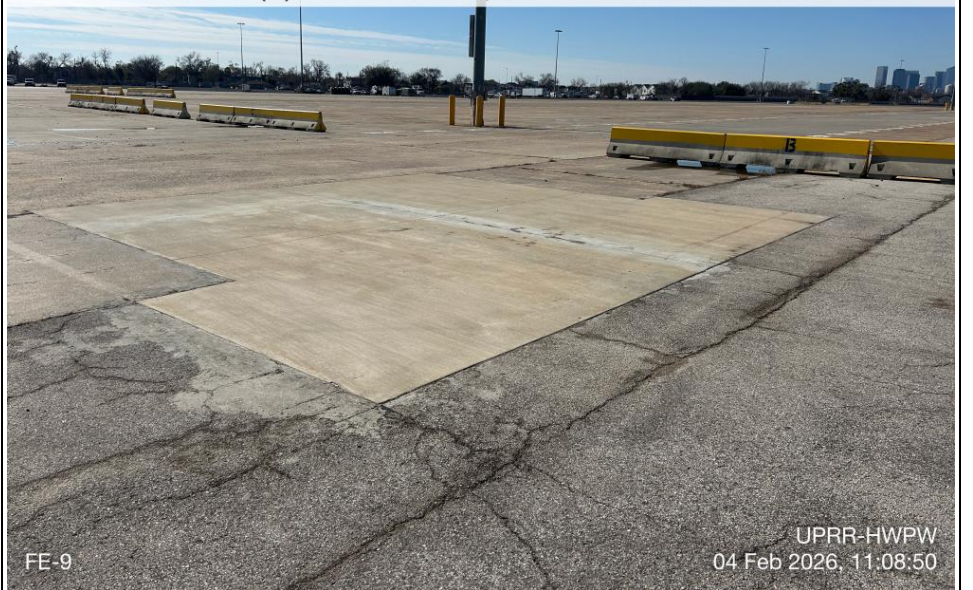
**Description:**  
FE-9 weekly inspection of concrete cap. Reconstructed cap in good condition. No NAPL observed at FE location. Facing south.

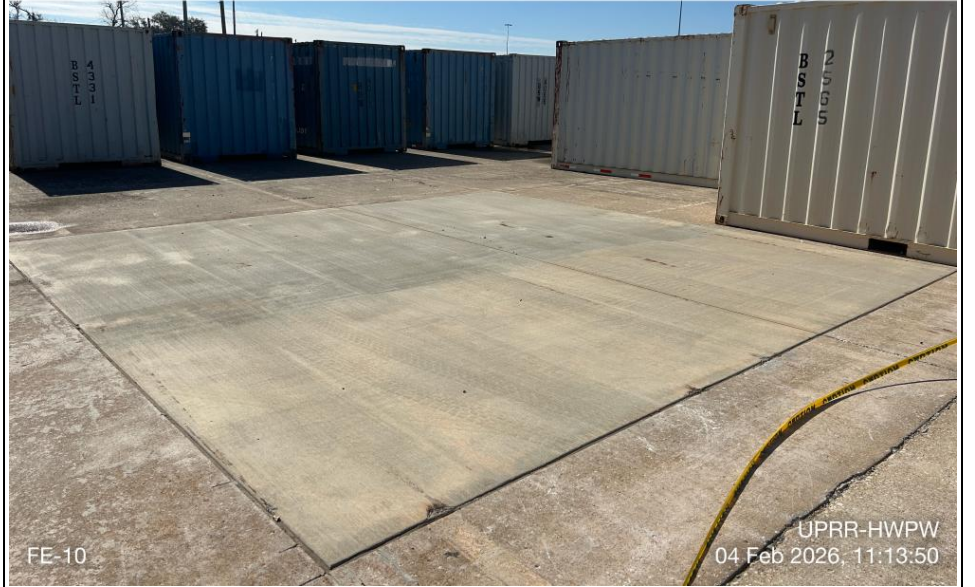
FE-10 weekly inspection of concrete cap. Reconstructed cap in good condition. No NAPL observed at FE location. Facing southwest.

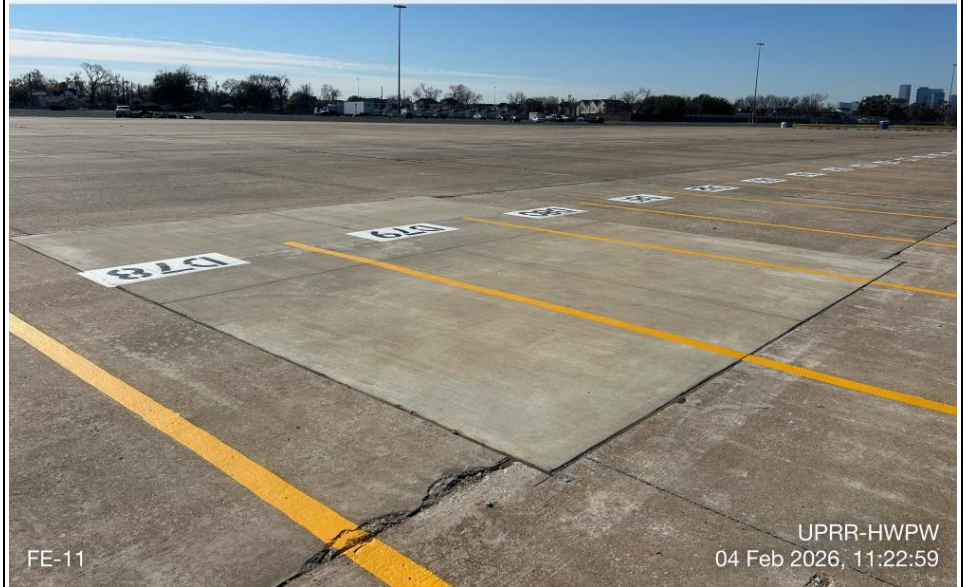
FE-11 weekly inspection of concrete cap. Reconstructed cap in good condition. No NAPL observed at FE location. Facing southwest.

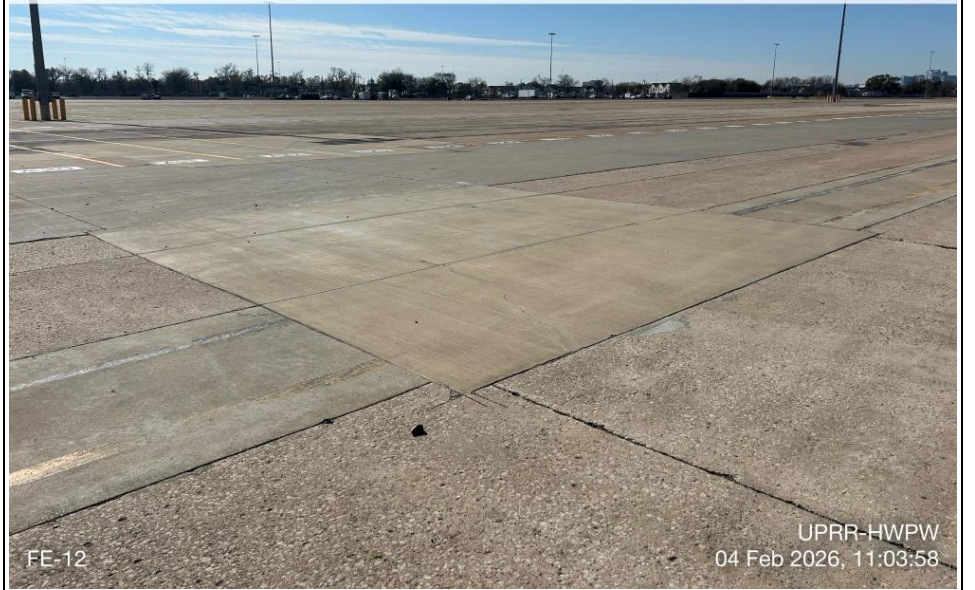
FE-12 weekly inspection of concrete cap.  
Reconstructed cap in good condition. No NAPL observed at FE location. Facing south.

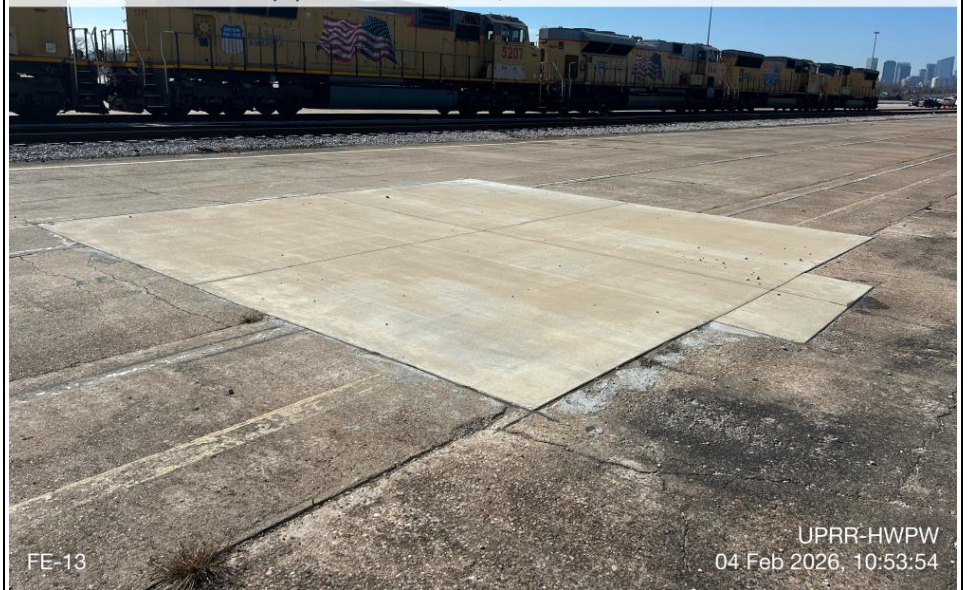
FE-13 weekly inspection of concrete cap.  
Reconstructed cap in good condition. No NAPL observed at FE location. Facing southwest.

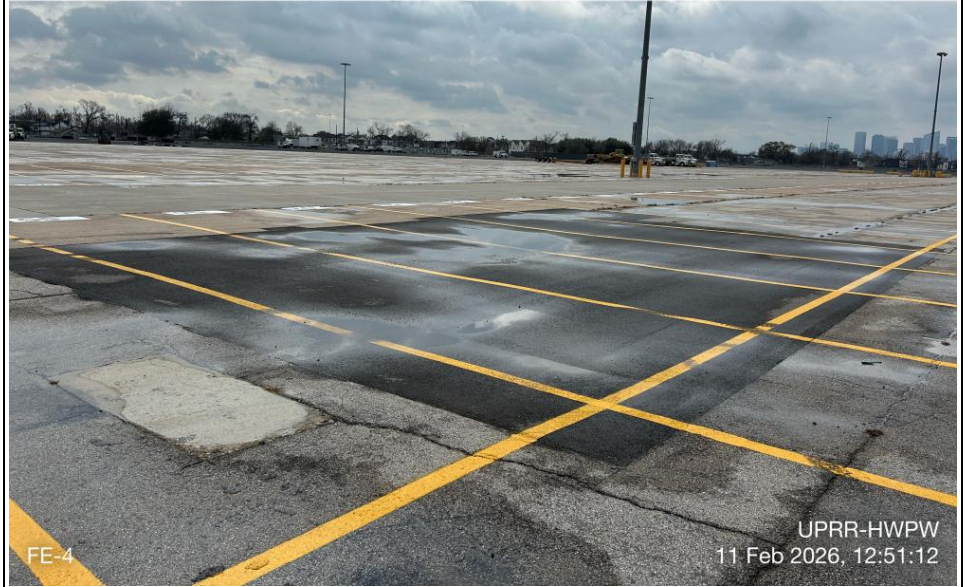
FE-4 weekly inspection of asphalt cap. Reconstructed cap in good condition. No NAPL observed at FE location. Standing water from recent rain event. Facing southwest.

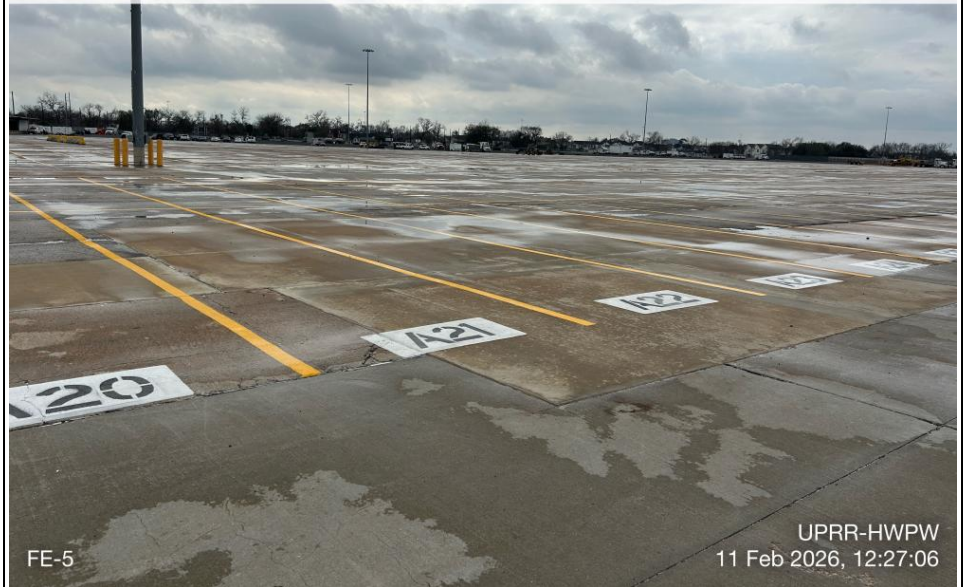
FE-5 weekly inspection of concrete cap. Reconstructed cap in good condition. No NAPL observed at FE location. Standing water from recent rain event. Facing south.

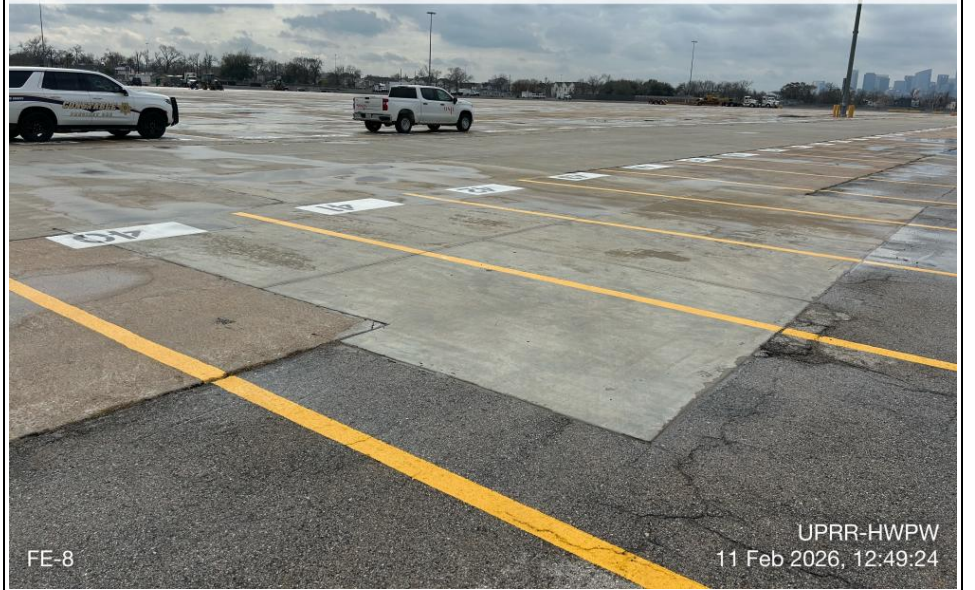
FE-8 weekly inspection of concrete cap. Reconstructed cap in good condition. No NAPL observed at FE location. Standing water from recent rain event. Facing southwest.

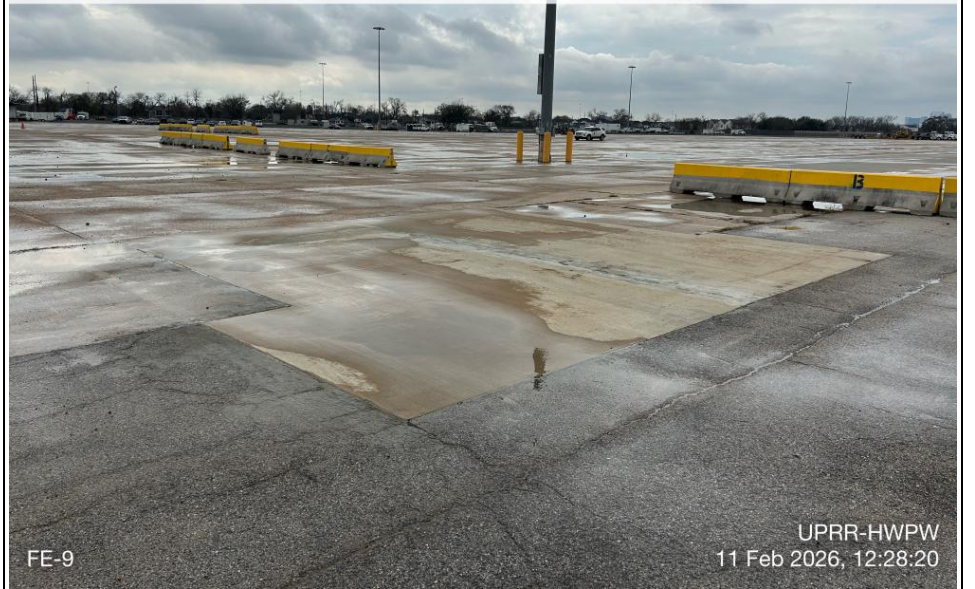
FE-9 weekly inspection of concrete cap. Reconstructed cap in good condition. No NAPL observed at FE location. Standing water from recent rain event. Facing south.

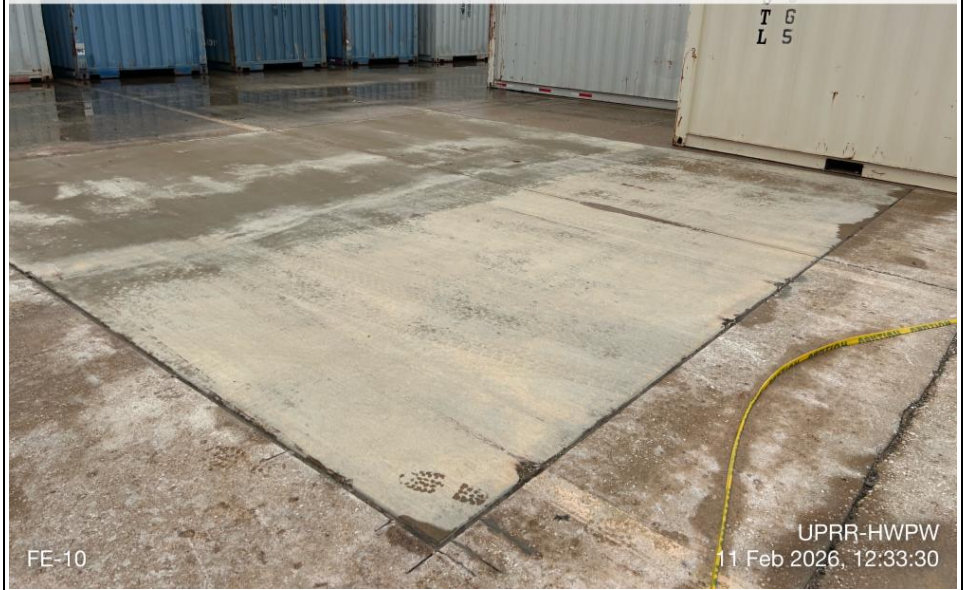
FE-10 weekly inspection of concrete cap. Reconstructed cap in good condition. No NAPL observed at FE location. Standing water from recent rain event. Facing southwest.

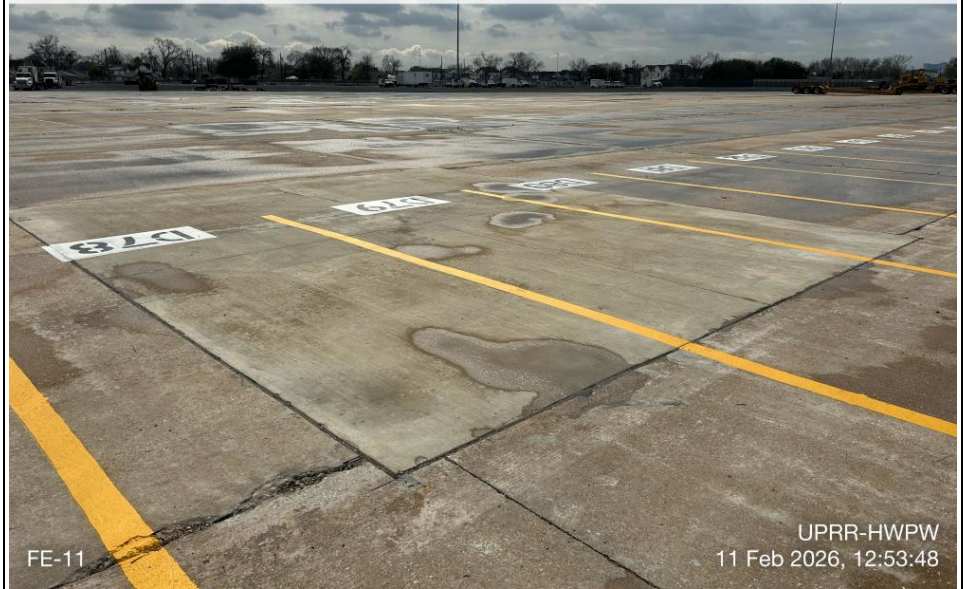
FE-11 weekly inspection of concrete cap. Reconstructed cap in good condition. No NAPL observed at FE location. Standing water from recent rain event. Facing south.

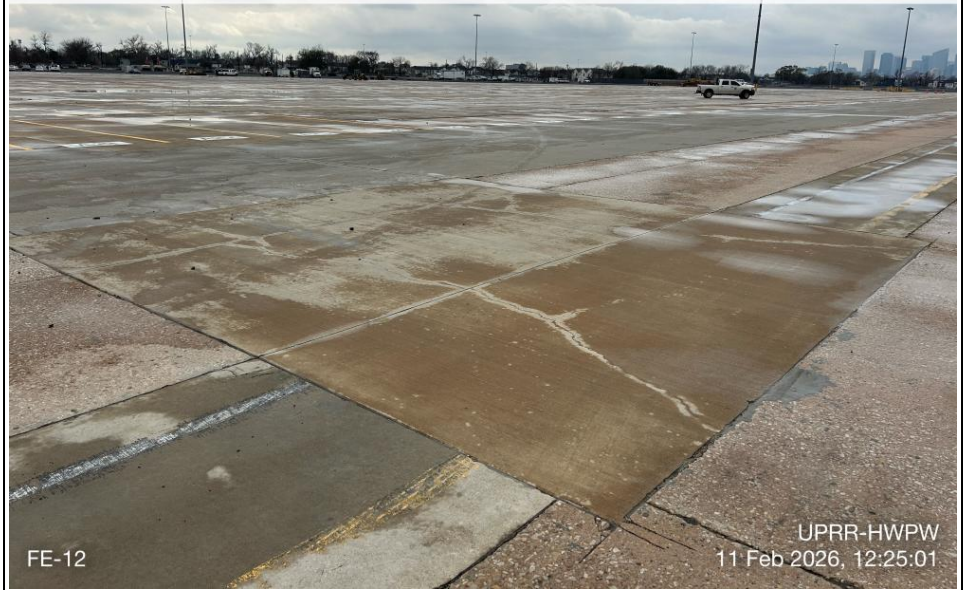
FE-12 weekly inspection of concrete cap. Reconstructed cap in good condition. No NAPL observed at FE location. Standing water from recent rain event. Facing southwest.

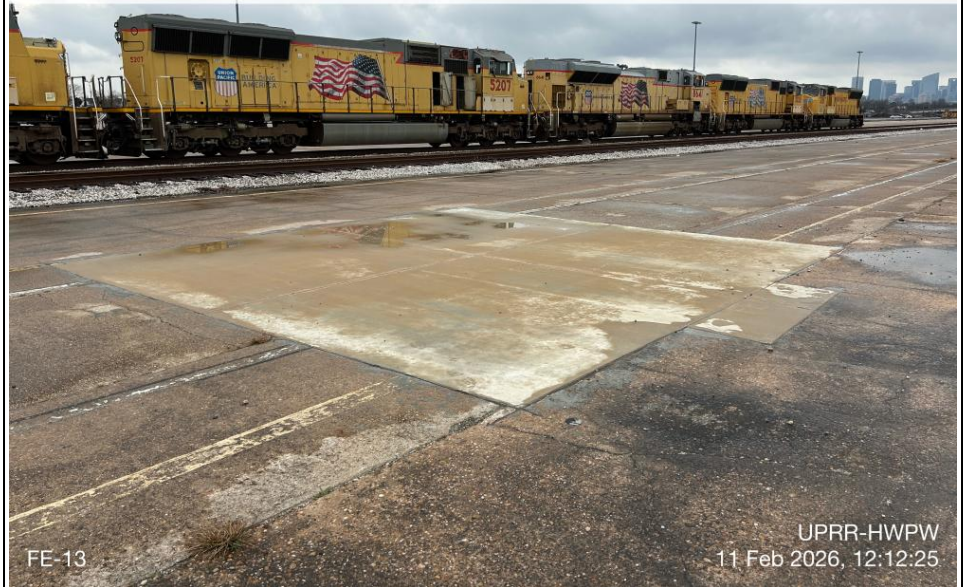
FE-13 weekly inspection of concrete cap. Reconstructed cap in good condition. No NAPL observed at FE location. Standing water from recent rain event. Facing south.

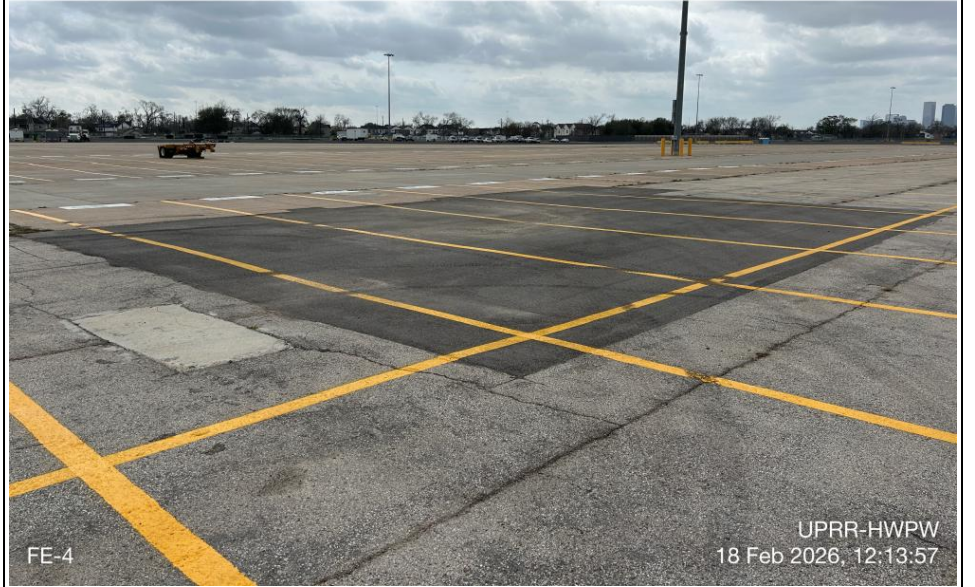
FE-4 weekly inspection of asphalt cap. Reconstructed cap in good condition. No NAPL observed at FE location. Facing south.

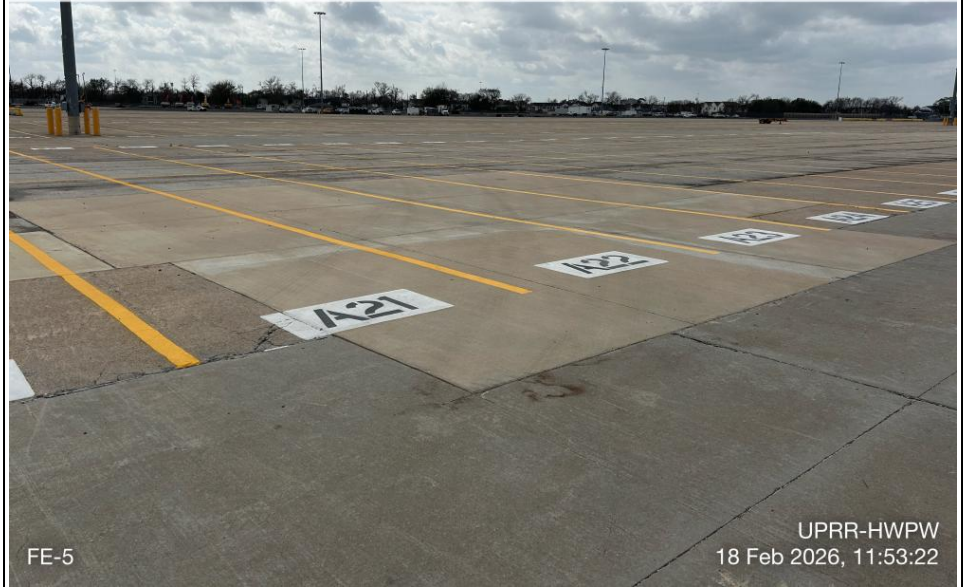
FE-5 weekly inspection of concrete cap. Reconstructed cap in good condition. No NAPL observed at FE location. Facing southwest.

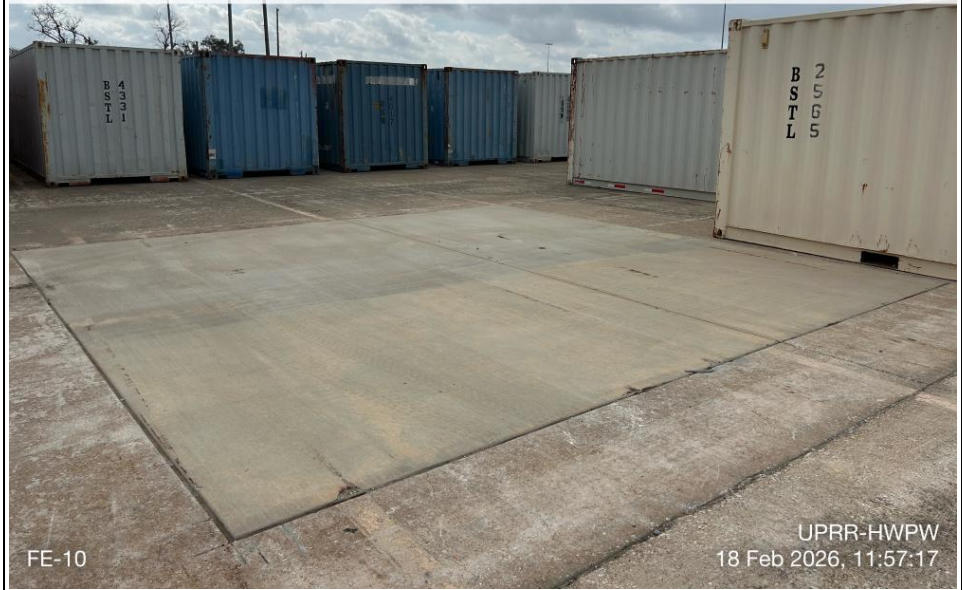
FE-10 weekly inspection of concrete cap. Reconstructed cap in good condition. No NAPL observed at FE location. Facing south.

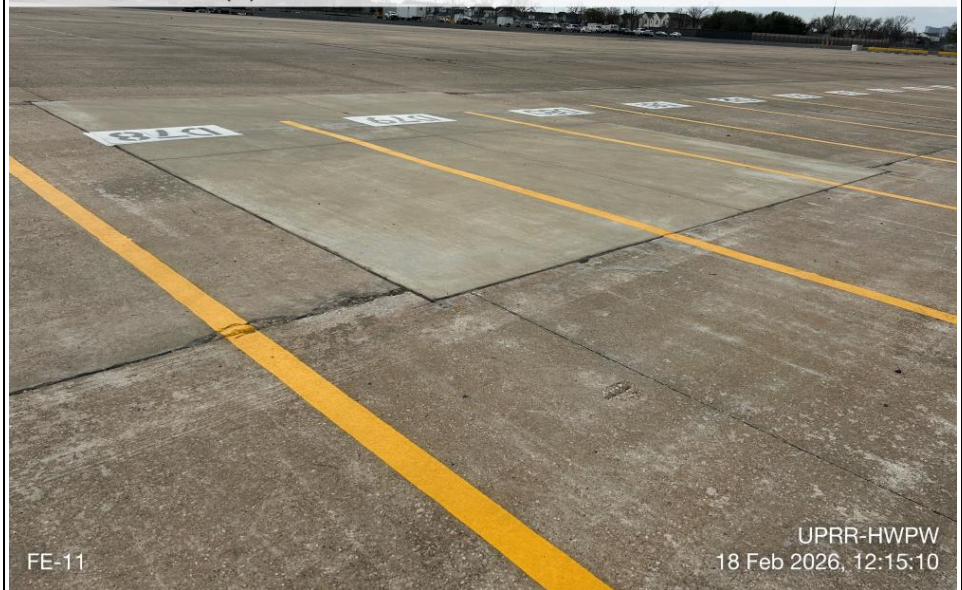
FE-11 weekly inspection of concrete cap. Reconstructed cap in good condition. No NAPL observed at FE location. Facing southwest.

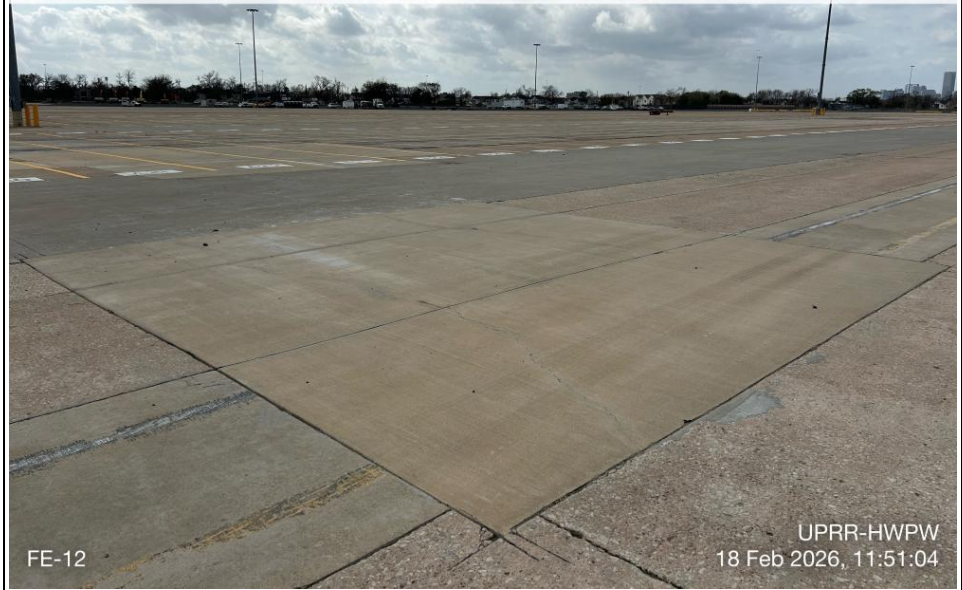
FE-12 weekly inspection of concrete cap.  
Reconstructed cap in good condition. No NAPL  
observed at FE location. Facing south.

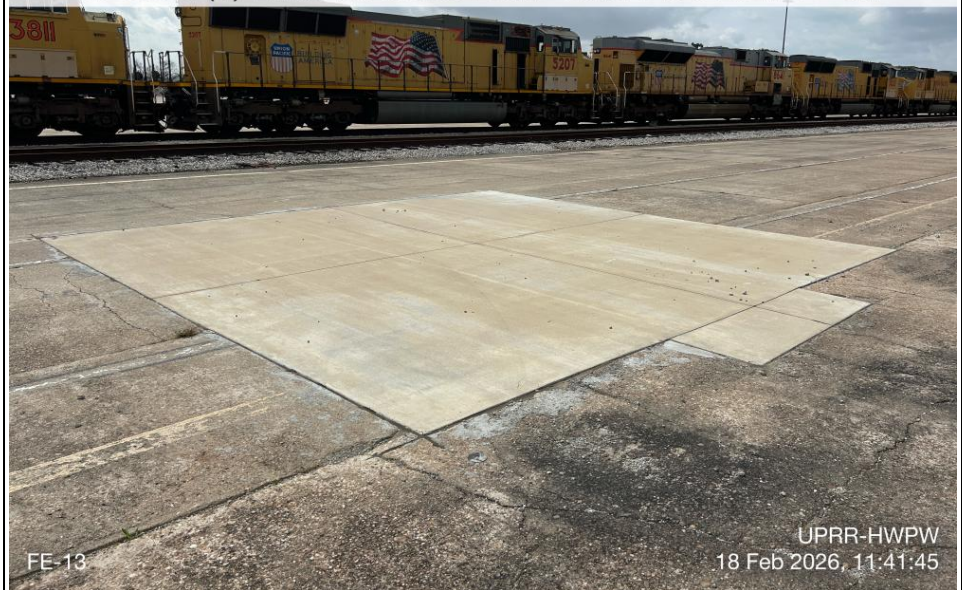
FE-13 weekly inspection of concrete cap.  
Reconstructed cap in good condition. No NAPL  
observed at FE location. Facing south.

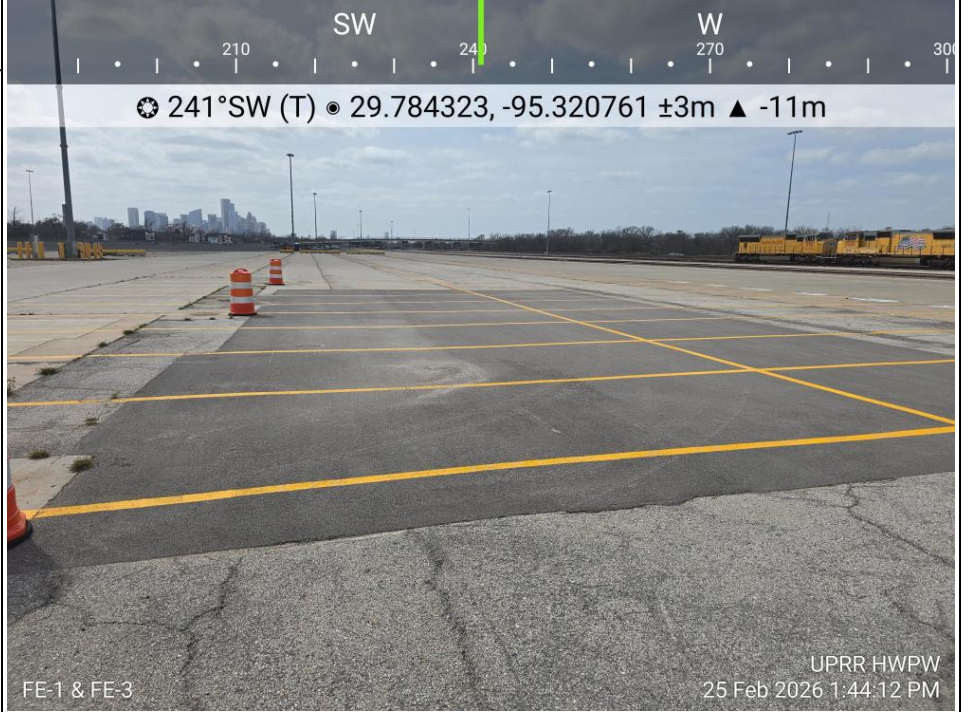
**Description:**  
FE-1&3 weekly inspection of asphalt cap.  
Reconstructed cap in good condition. No NAPL observed at FE location. Facing southwest.

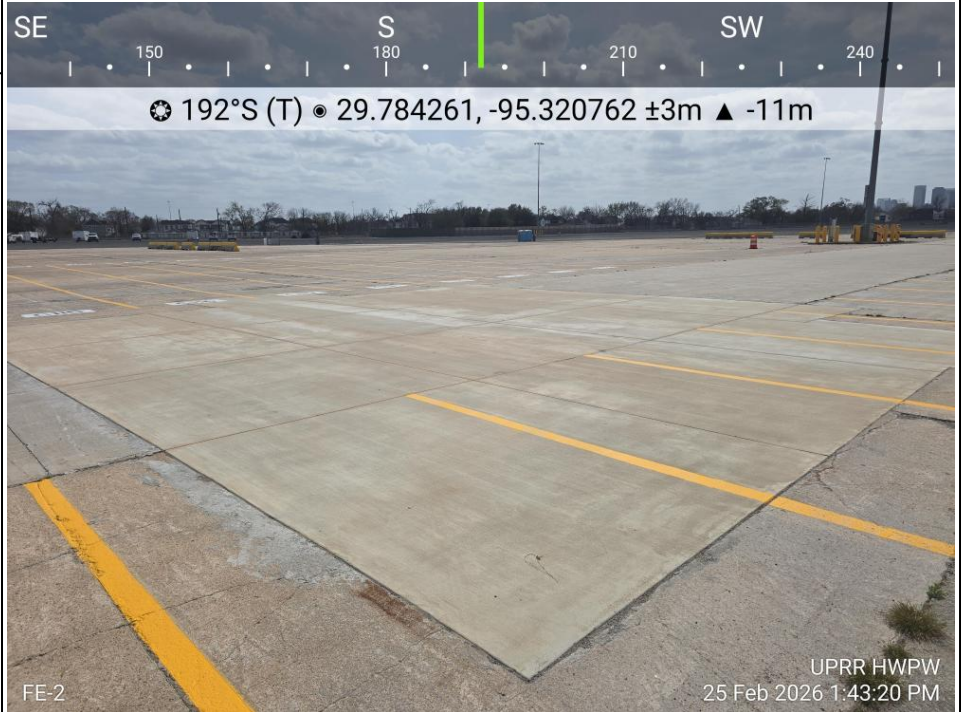
**Description:**  
FE-2 weekly inspection of concrete cap.  
Reconstructed cap in good condition. No NAPL observed at FE location. Facing south.

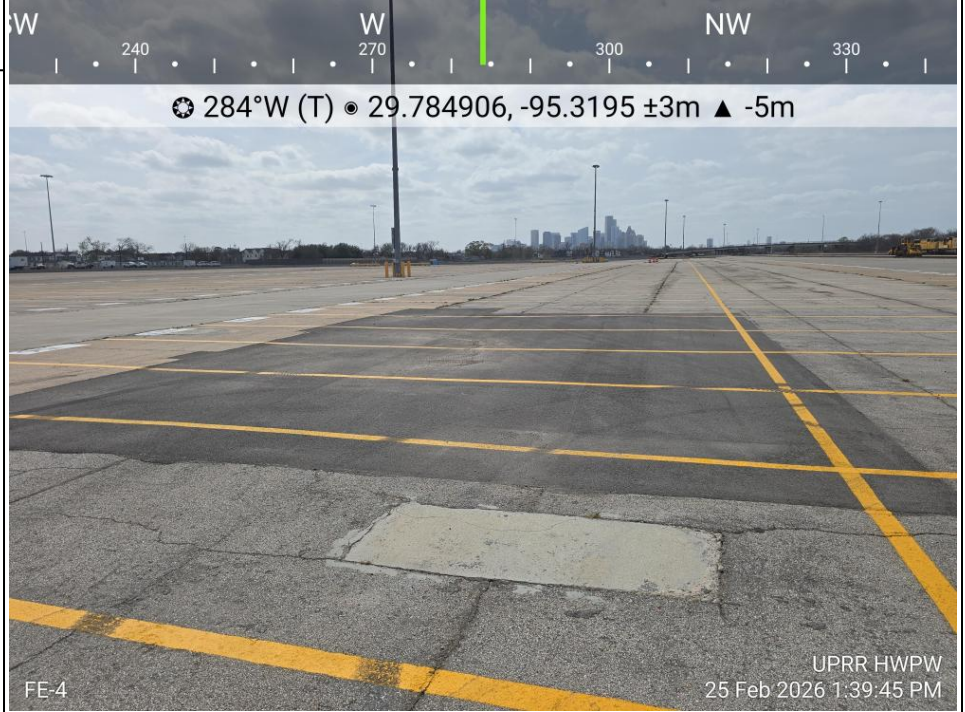
FE-4 weekly inspection of asphalt cap. Reconstructed cap in good condition. No NAPL observed at FE location. Facing west.

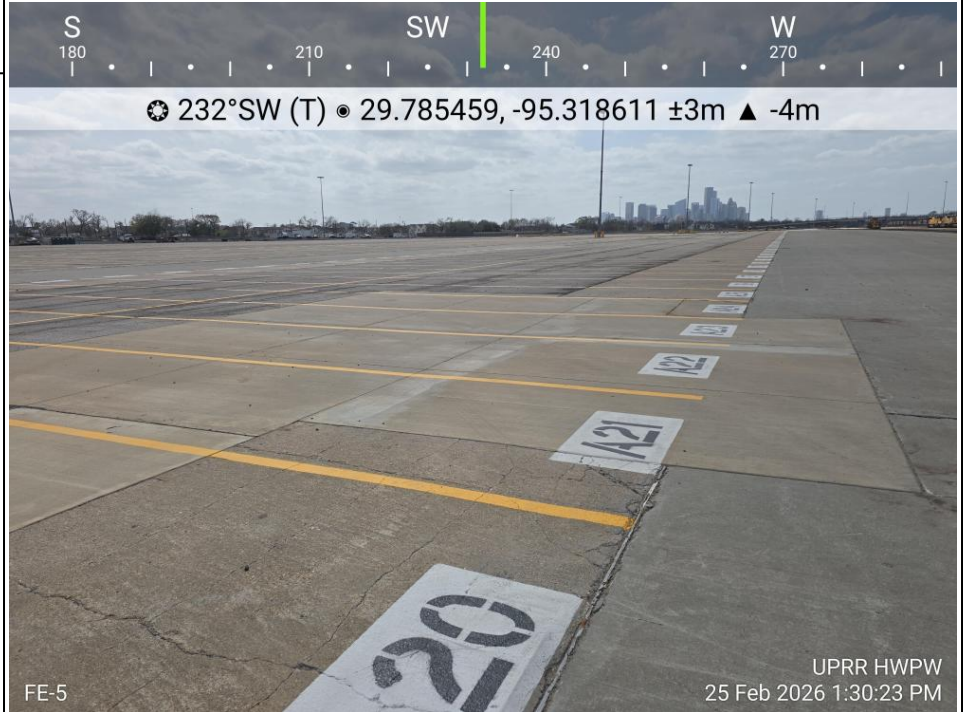
FE-5 weekly inspection of concrete cap. Reconstructed cap in good condition. No NAPL observed at FE location. Facing southwest.

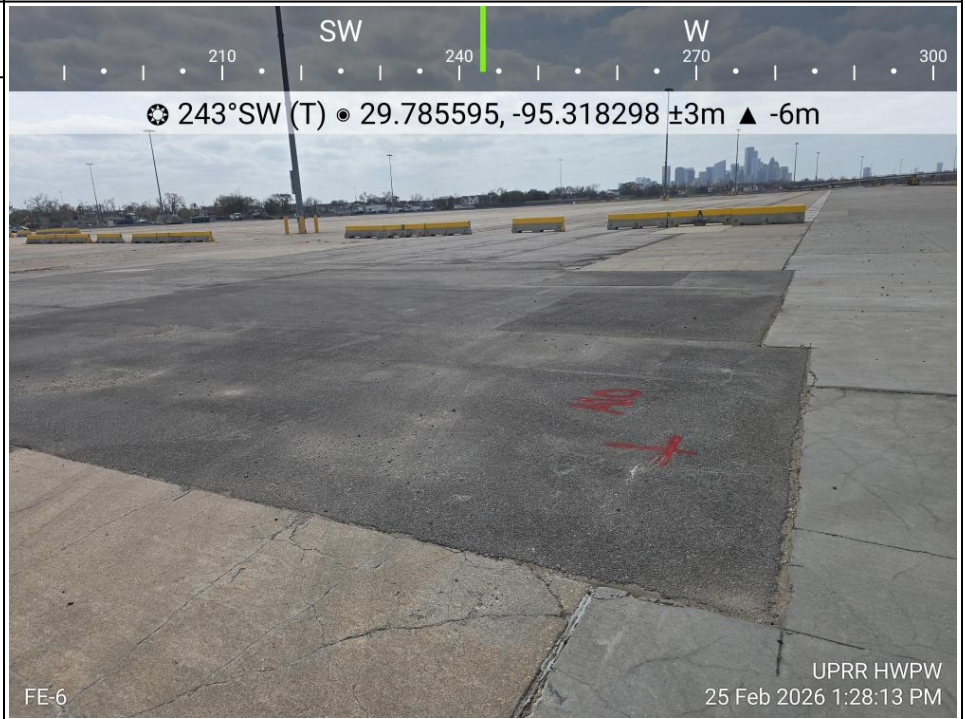
**Description:**  
FE-6 weekly inspection of asphalt cap. Reconstructed cap in good condition. No NAPL observed at FE location. Facing southwest.

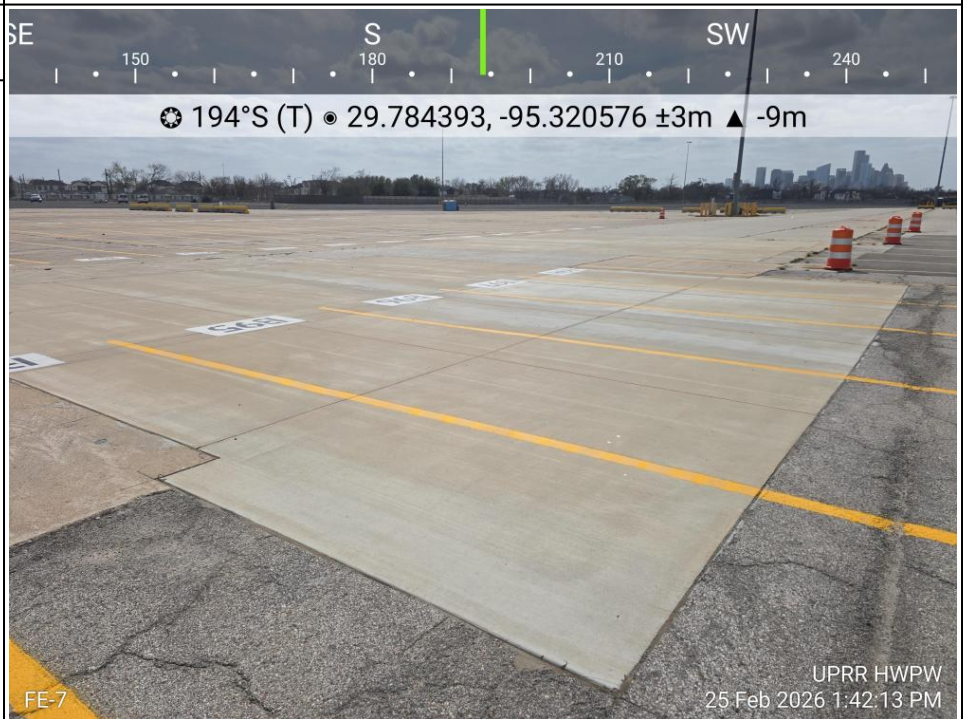
**Description:**  
FE-7 weekly inspection of concrete cap. Reconstructed cap in good condition. No NAPL observed at FE location. Facing south.

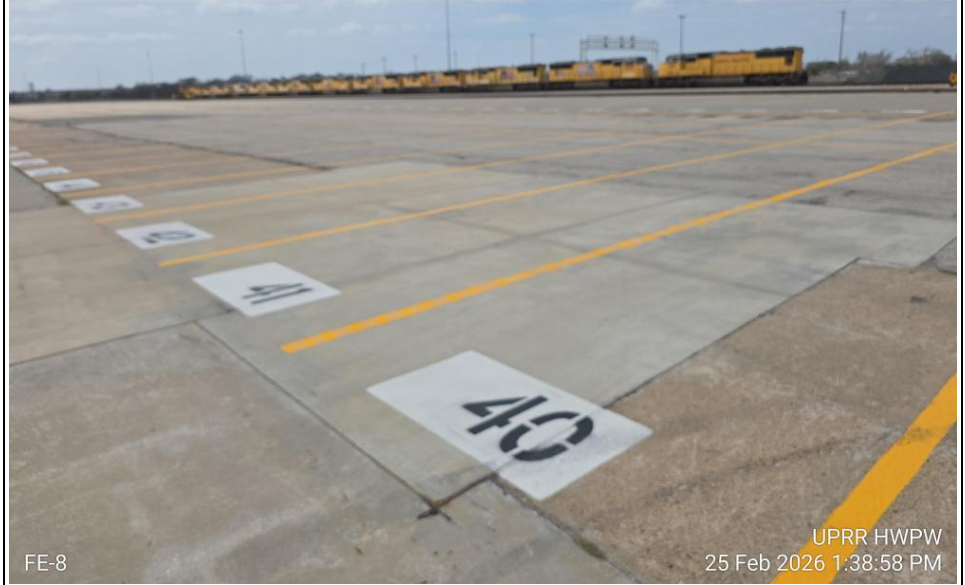
FE-8 weekly inspection of concrete cap.  
Reconstructed cap in good condition. No NAPL observed at FE location. Facing northwest.

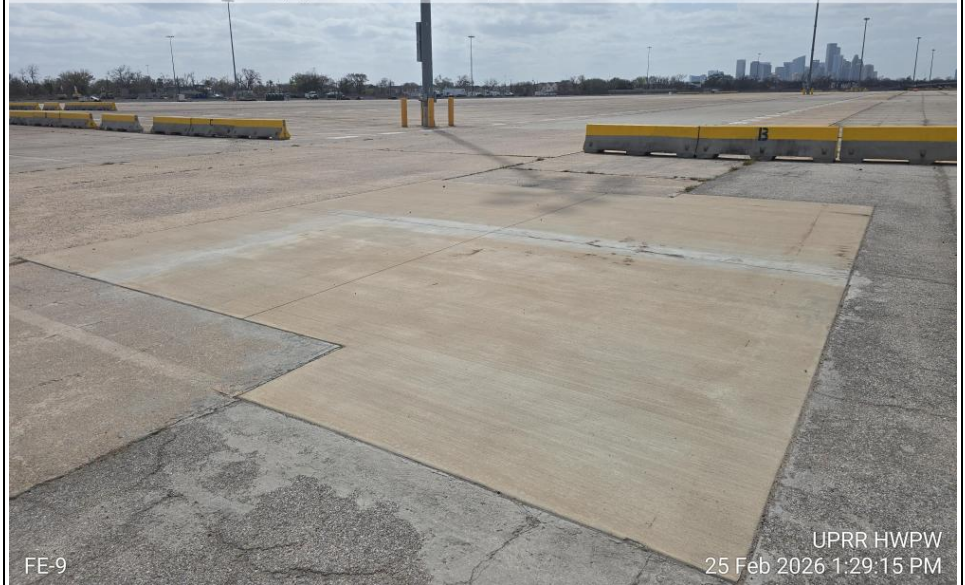
FE-9 weekly inspection of concrete cap.  
Reconstructed cap in good condition. No NAPL observed at FE location. Facing south.

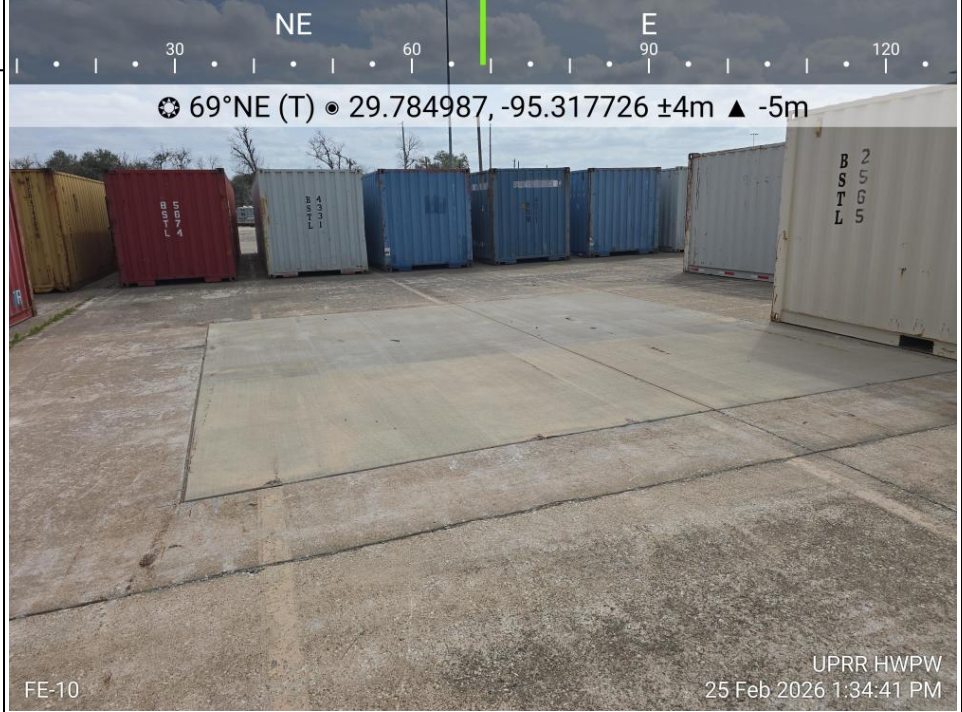
FE-10 weekly inspection of concrete cap. Reconstructed cap in good condition. No NAPL observed at FE location. Facing northeast.

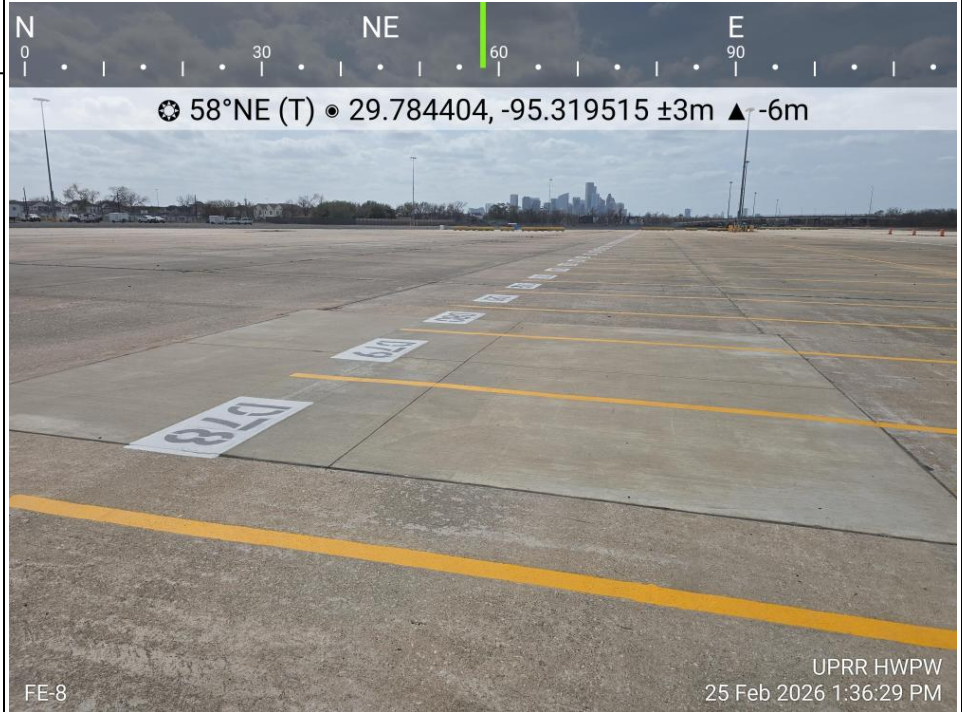
FE-11 weekly inspection of concrete cap. Mislabeled FE-8. Reconstructed cap in good condition. No NAPL observed at FE location. Facing northeast.

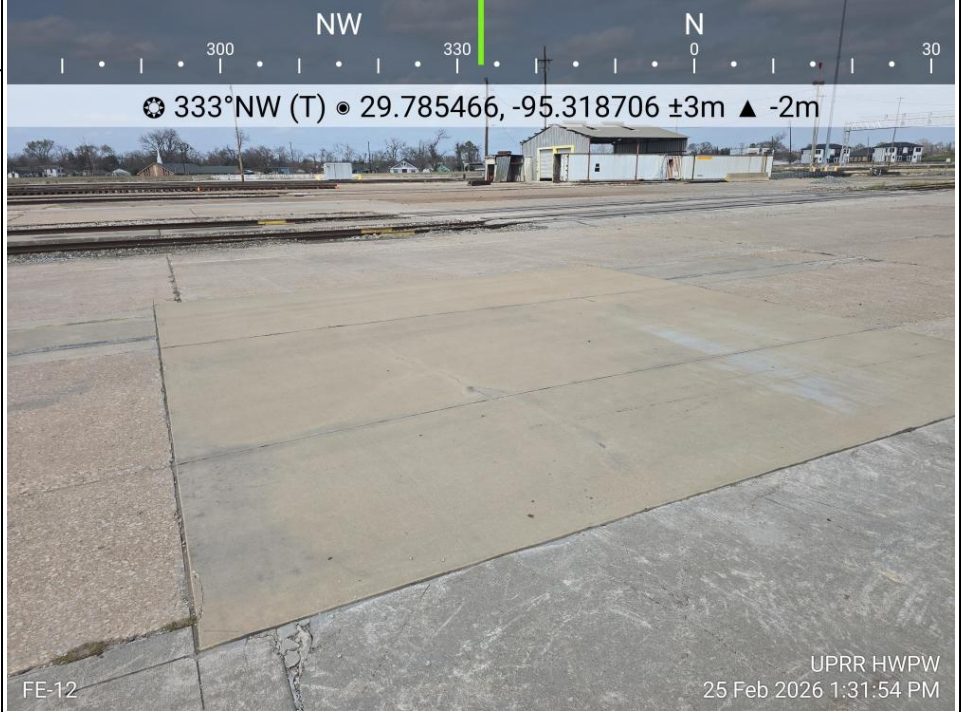
**Description:**  
FE-12 weekly inspection of concrete cap. Reconstructed cap in good condition. No NAPL observed at FE location. Facing northwest.

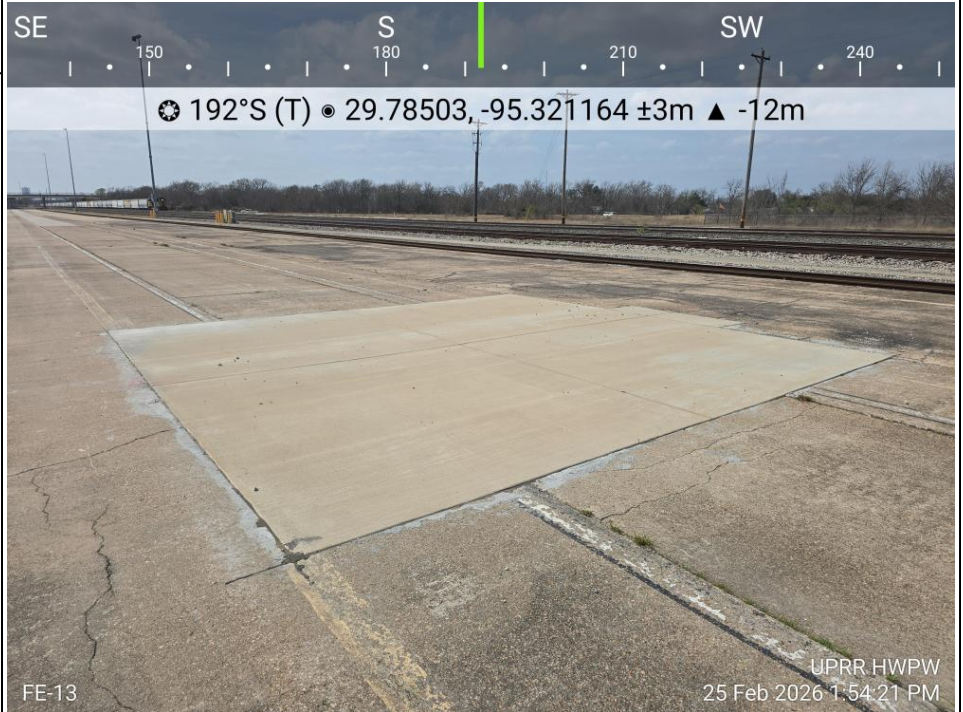
**Description:**  
FE-13 weekly inspection of concrete cap. Reconstructed cap in good condition. No NAPL observed at FE location. Facing south.

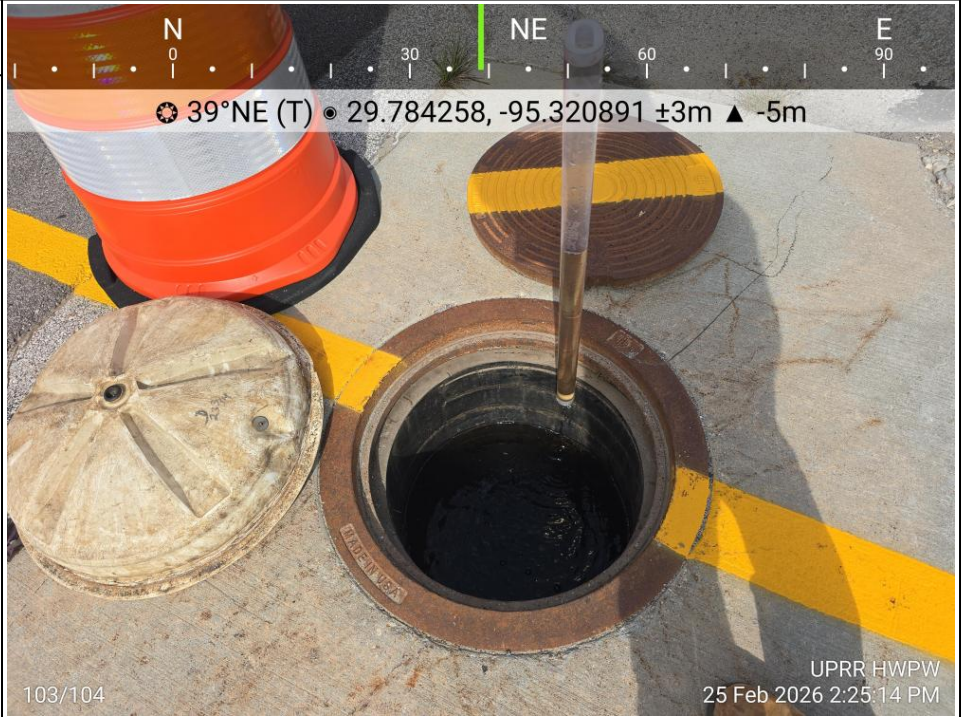
Sump 2 (B103/B104), 11 inches of freeboard in sump. Color is brown, and no sheen or odor was reported.

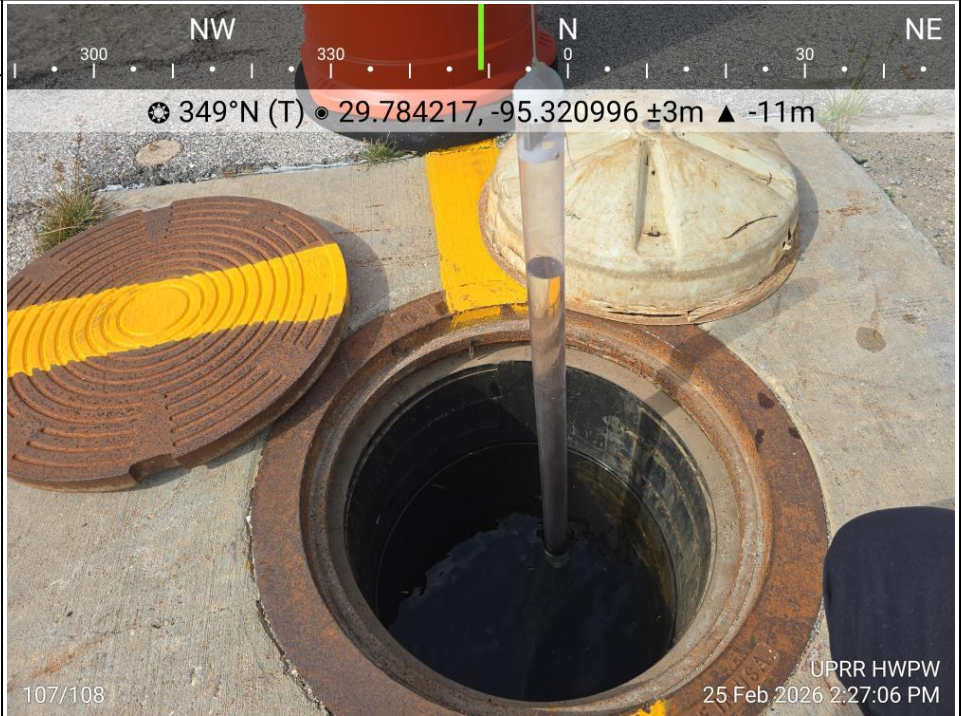
Sump 3 (B107/B108), 10.5 inches of freeboard in sump. Color is brown, and no sheen or odor was reported.

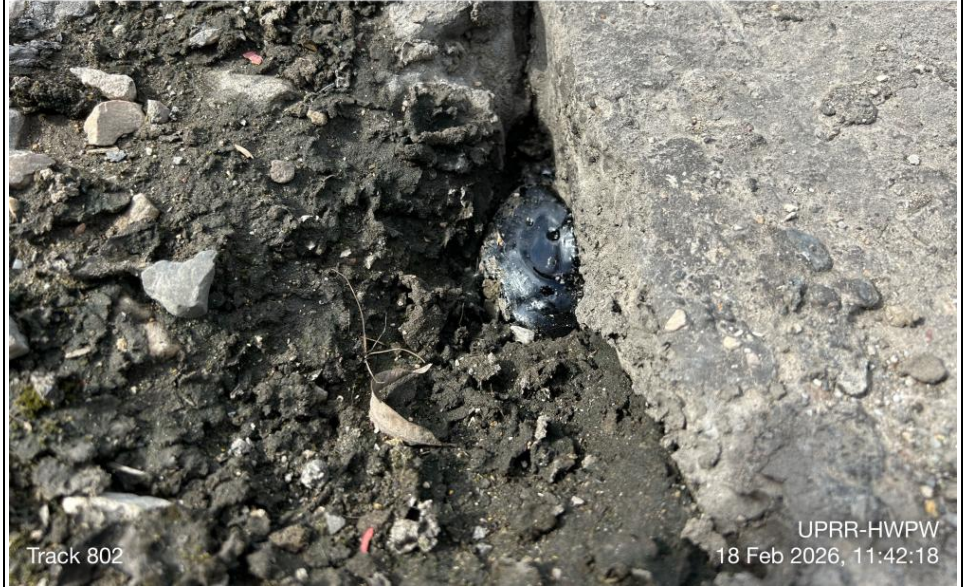
- Tar-like material seeps at the following two locations:
  - A tar-like material seep was observed at Track 802 on February 18 and 25, 2026. Approximately 5.25 cubic inches (approximately 2.9 fluid ounces) of NAPL were recovered. No seep activity was noted at Track 802 during the other February weekly inspections (Photo Numbers 65 through 70).

Track 802 weekly inspection of track. Surrounding concrete and ballast in good condition. Approximately 2.25 cubic inches of NAPL observed at seep location.
