March 16, 2026

Project No. US0039040.3990

Re: **MONTHLY STATUS UPDATE – ENGLEWOOD INTERMODAL YARD – REVISED INTERIM MEASURES WORK PLAN POST-CONSTRUCTION AND NAPL COLLECTION SYSTEM/CONCRETE CAP REPAIR INSPECTIONS  
UNION PACIFIC RAILROAD HOUSTON WOOD PRESERVING WORKS FACILITY  
4910 LIBERTY ROAD FACILITY, HOUSTON, TEXAS  
POST-CLOSURE CARE PERMIT NO. HW-50343; INDUSTRIAL SWR NO. 31547**

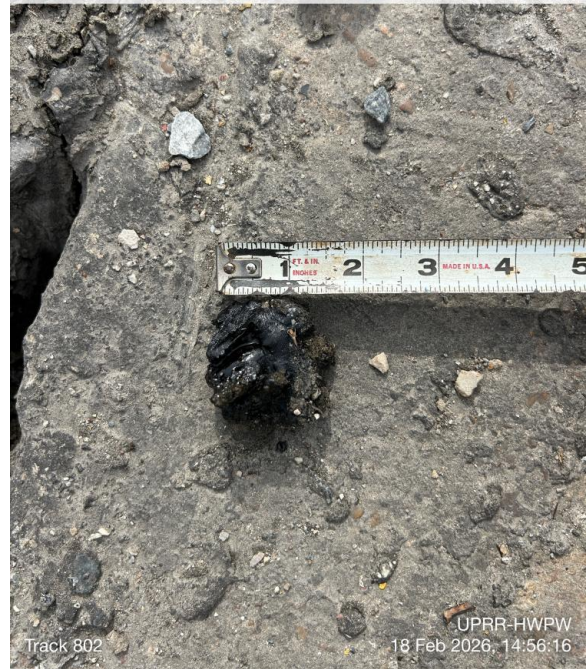
- Tar-like material seeps at the following two locations:
  - A tar-like material seep was observed at Track 802 on February 18 and 25, 2026. Approximately 5.25 cubic inches (approximately 2.9 fluid ounces) of NAPL were recovered. No seep activity was noted at Track 802 during the other February weekly inspections (Photo Numbers 65 through 70).

Track 802 weekly inspection of track. Surrounding concrete and ballast in good condition. Approximately 2.25 cubic inches of NAPL observed at seep location.

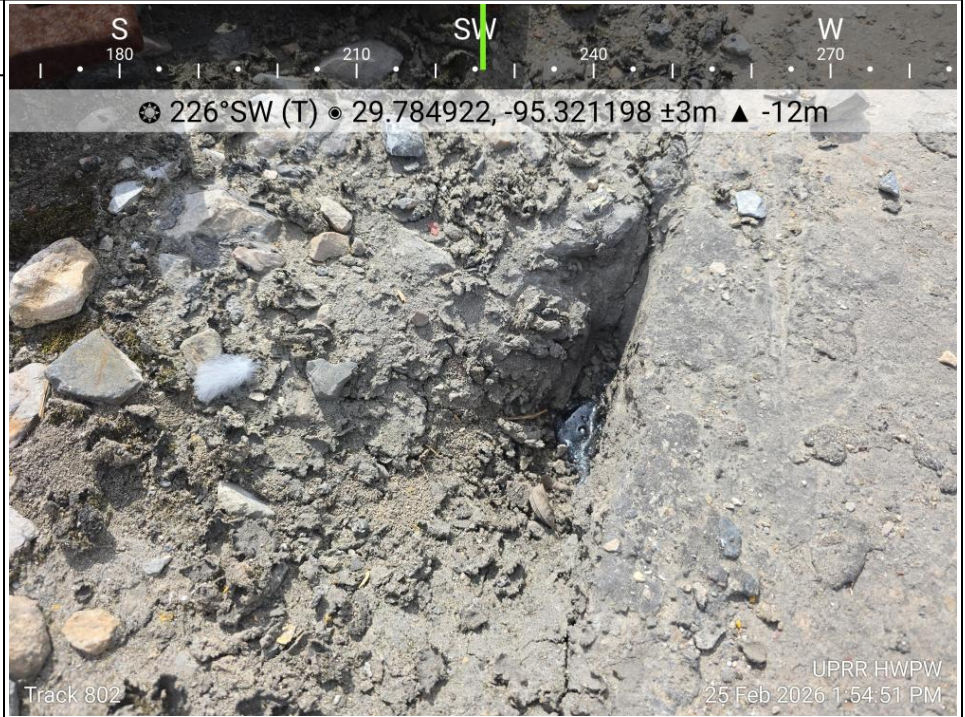
Track 802 weekly inspection of track. Surrounding concrete and ballast in good condition. Approximately 3 cubic inches of NAPL observed at seep location.

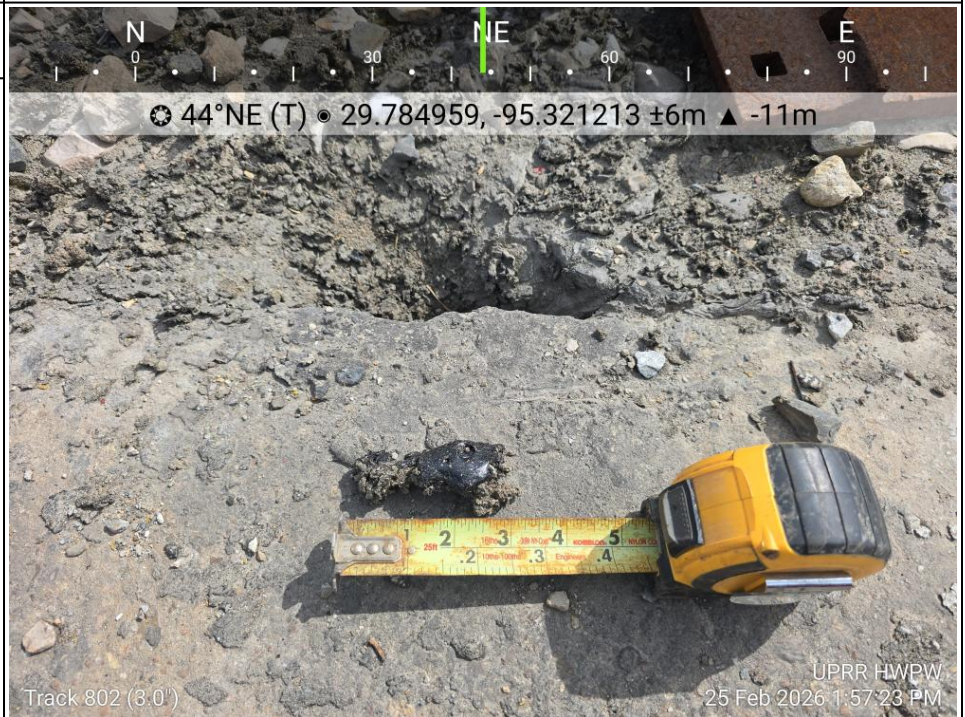
Track 802 weekly inspection of track. Surrounding concrete and ballast in good condition. Approximately 3 cubic inches of NAPL observed at seep location.

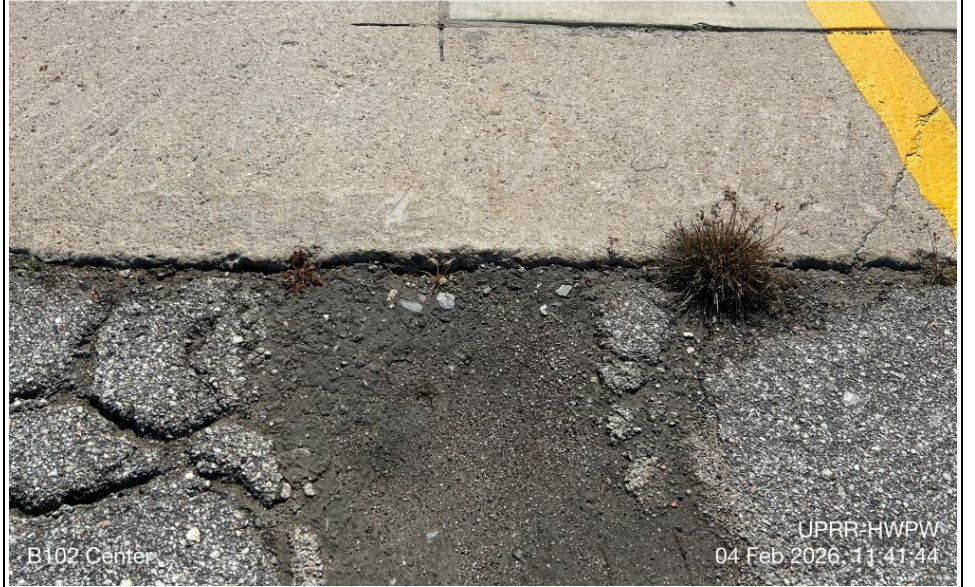
B102 Center

- No seep activity was noted at Stall B102 during the February weekly inspections (Photo Numbers 71 through 74).
- Overall, the volume of NAPL recovered from the surface seeps increased from January to February 2026 (approximately 0 fluid ounces in January compared to 2.9 fluid ounces in February). Annual increases in NAPL recovery volume are anticipated and considered normal at this site as ambient temperatures increase. In comparison, prior to implementing the Focused Excavations, approximately 8 fluid ounces (approximately 0.1 gallons) of NAPL were collected from the surface seeps during February 2024.
